**SECTION 2:
DETAILED STUDY OF
SELECTED LANDSLIDES
ON SLOPE NO. 11NE-D/C45
HIU MING STREET
KWUN TONG**

Halcrow China Limited

**This report was originally produced in August 2001
as GEO Landslide Study Report No. LSR 7/2001**

1. INTRODUCTION

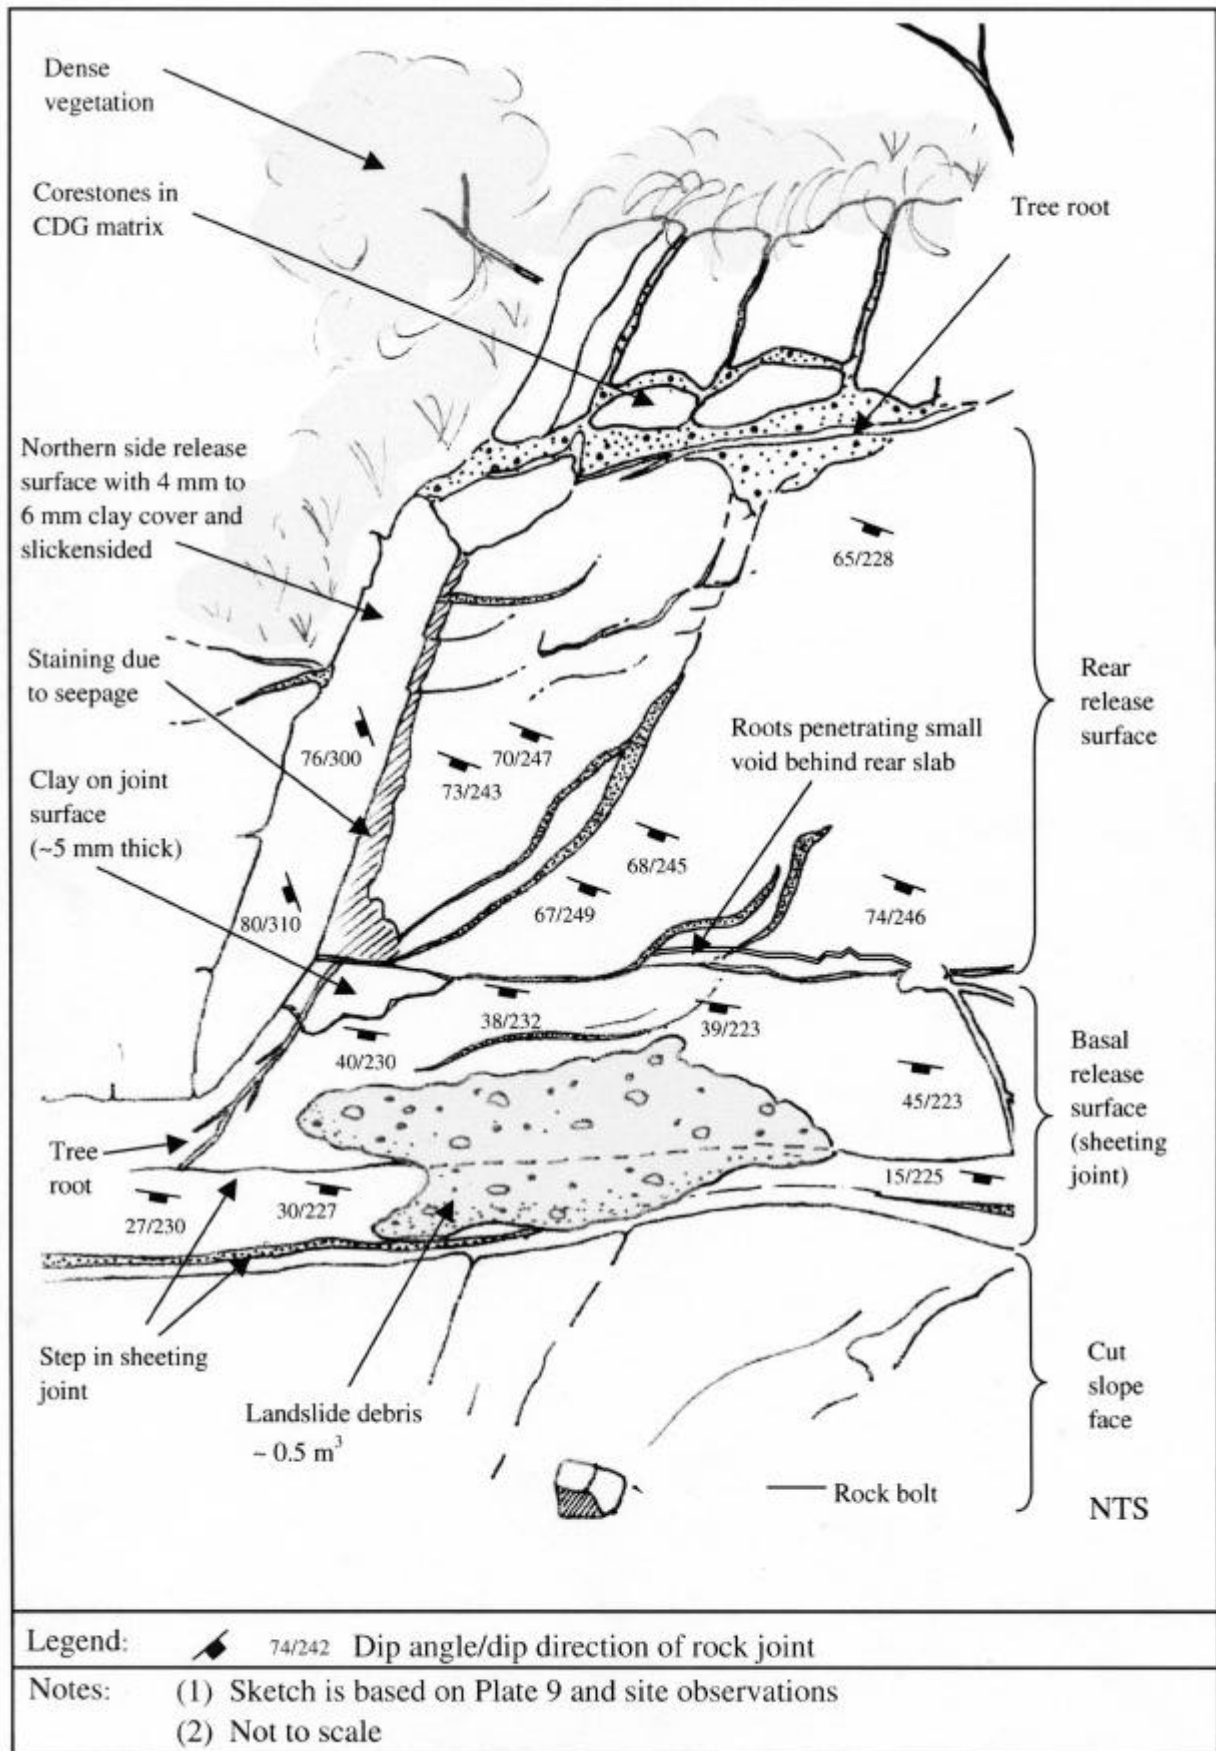
Figure 5 - Sketch of the Scar of the 2000 Rockfall

The basal release surface is about 3.5 m wide and 2.5 m long with a mean orientation of $37^{\circ}/232^{\circ}$ (Figure 5). At the northwestern end of the basal release surface, tree roots are present. A 5 mm thick layer of light brown soft to firm clay was found over an area of about 0.2 m x 0.2 m near the intersection of the three release surfaces (Plate 12). A close inspection of the basal release surface revealed other small accumulations of firm clay (about 1 mm thick and less than 3 mm in diameter) within minor depressions over much of the granular granitic rock surface. The firm nature of the clay indicates that the clay had probably accumulated sometime prior to the failure, suggesting that the joint was partially open prior to the 2000 rockfall.

The continuation of the joint forming the basal release surface is observed to become steeper to the southeast from an inclination of about 37° to greater than 45° , and appears to terminate against the sheeting joint below (Figure 5). The joint forming the basal release surface would therefore not appear to be part of the persistent sheeting joints that traverse the cut slope. However, the joint does appear to be closely associated with the sheeting joints

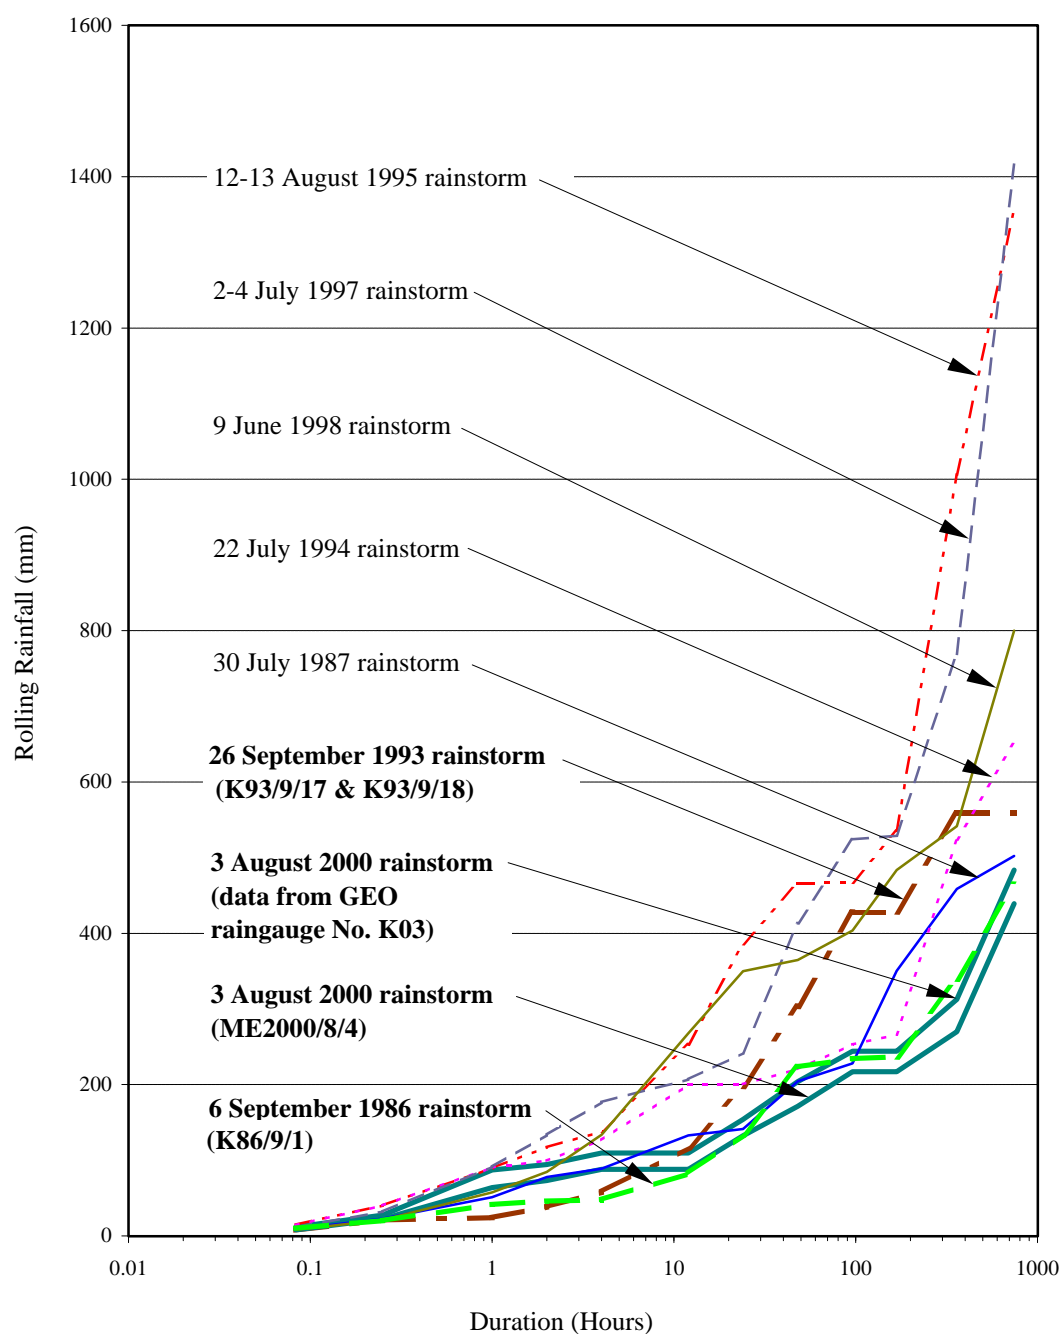
Figure 17 - Rolling Rainfall at GEO Raingauge No. K08 for Selected Major Rainstorms

A comparison of the 3 August 2000 rainstorm with that of other past major storms recorded by raingauge No. K08 is presented in Figure 17. Since data are missing from raingauge No. K03 for the rainstorm in September 1993, data from raingauge No. K08, the second closest raingauge, has been used for the purposes of comparing different rainstorms. The 3 August 2000 rainstorm was less severe than several other previously recorded significant storms, since installation of raingauge No. K08 in 1983.

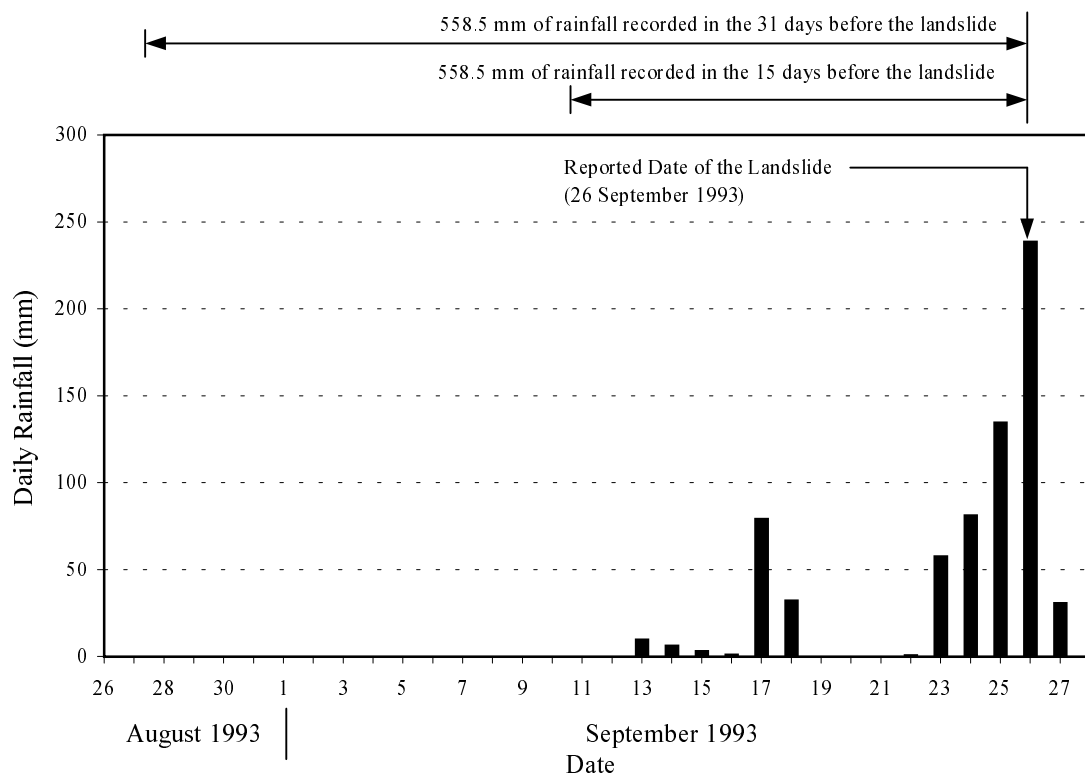
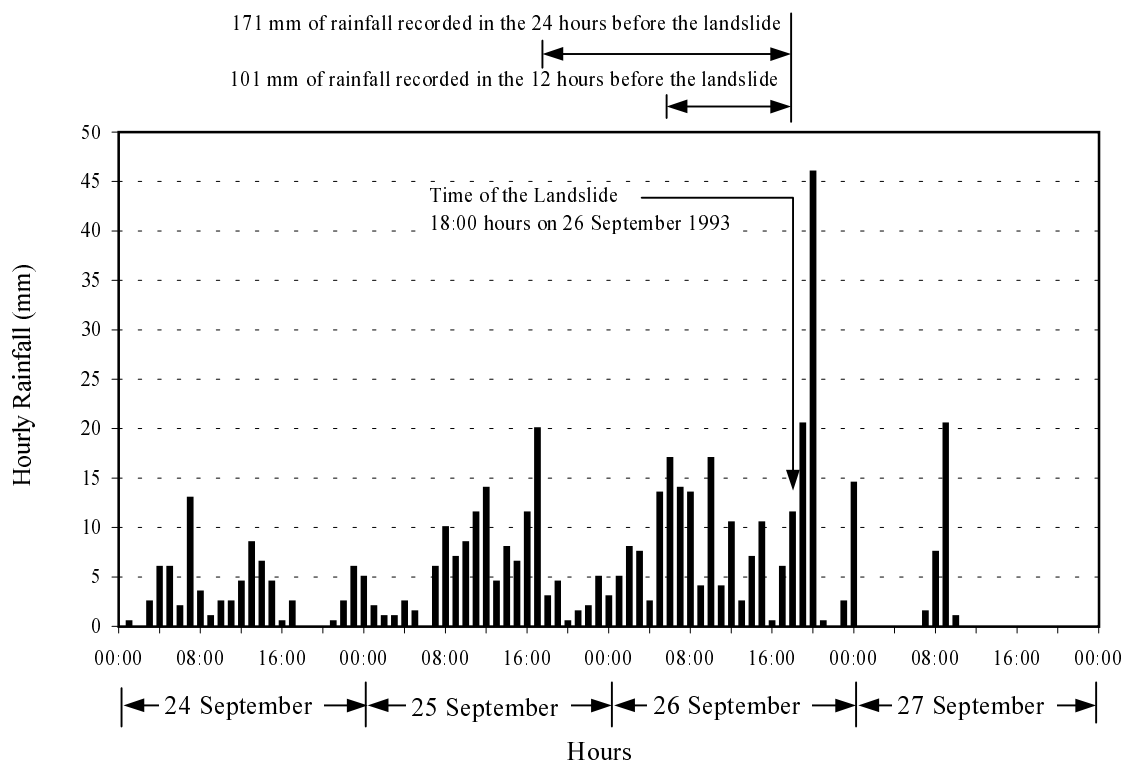
Figure 18 - Daily and Hourly Rainfall Recorded at GEO Raingauge No. K08 in September 1993

The daily rainfall recorded by raingauge No. K08 over a period of one month preceding and two days following the landslide is presented in Figure 18. The one-hour rainfall prior to the failure at about 18:00 hours was less than 20 mm.

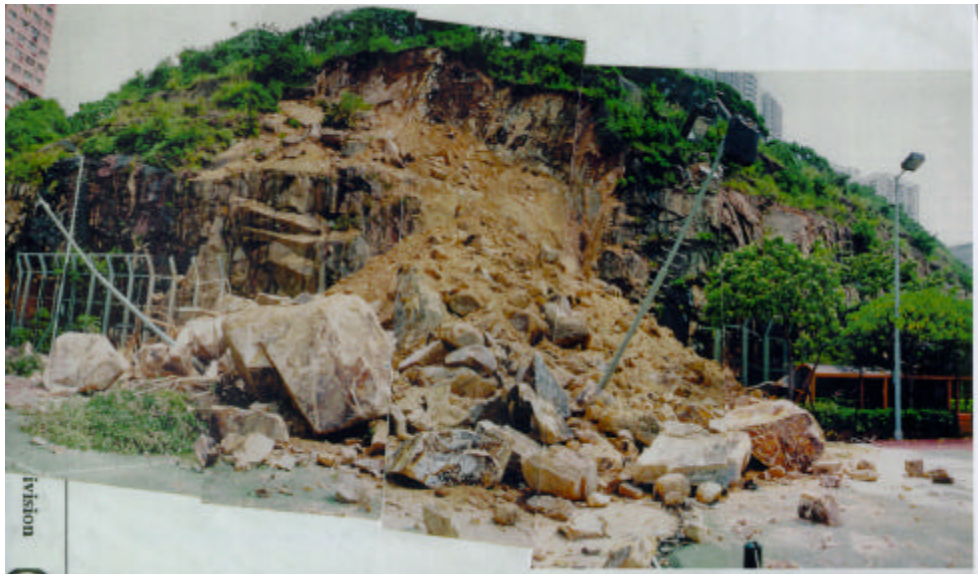
Plate 5 - View of the 1993 Landslide (Photograph Taken in September 1993)

On 26 September 1993, Incident No. K93/9/17 occurred within the northern section of slope No. 11NE-D/C45 (Figure 2 and Plates 4 to 6). The GEO Incident Report described the failure as a “rockfall” within “weathered rock”. The possible cause of the failure was stated as “infiltration” and “blocked/broken drains”. The debris from the landslide, with an estimated volume of about 200 m^3 , inundated part of the tennis courts below and destroyed the boulder fence that had been constructed along the toe of the slope. While the Incident Report does not record any seepage, the Landslip Card for the incident indicates seepage from the joint forming the basal release surface. The release surfaces exposed by the landslide were extensively stained black and reddish brown (Plate 5), indicating weathering associated with flowing groundwater along possibly open joints. Following the landslide, urgent repair work comprising removal of landslide debris, reconstruction of the boulder fence and provision of reinforced shotcrete over the landslide scar were carried out.

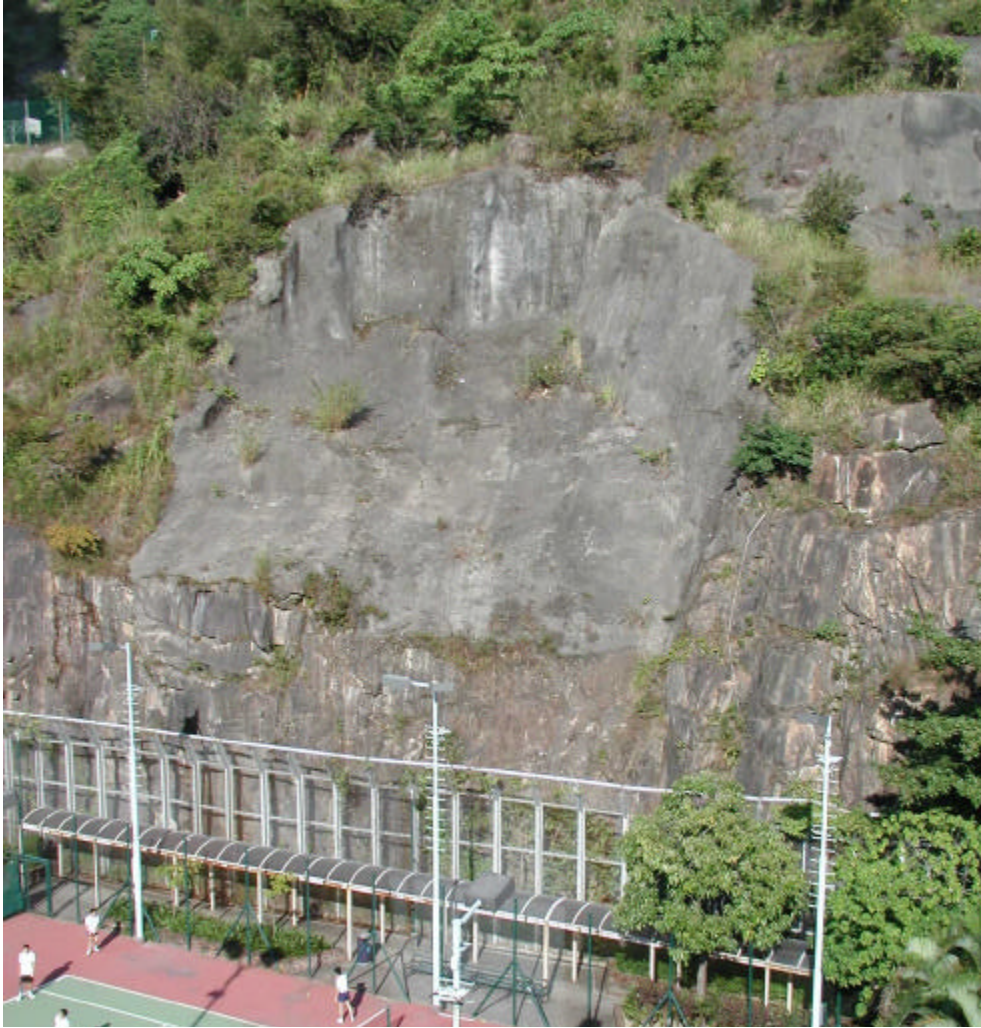
Plate 6 - View of the 1993 Landslide Scar after Completion of Remedial Works
(Photograph Taken on 22 November 2000)

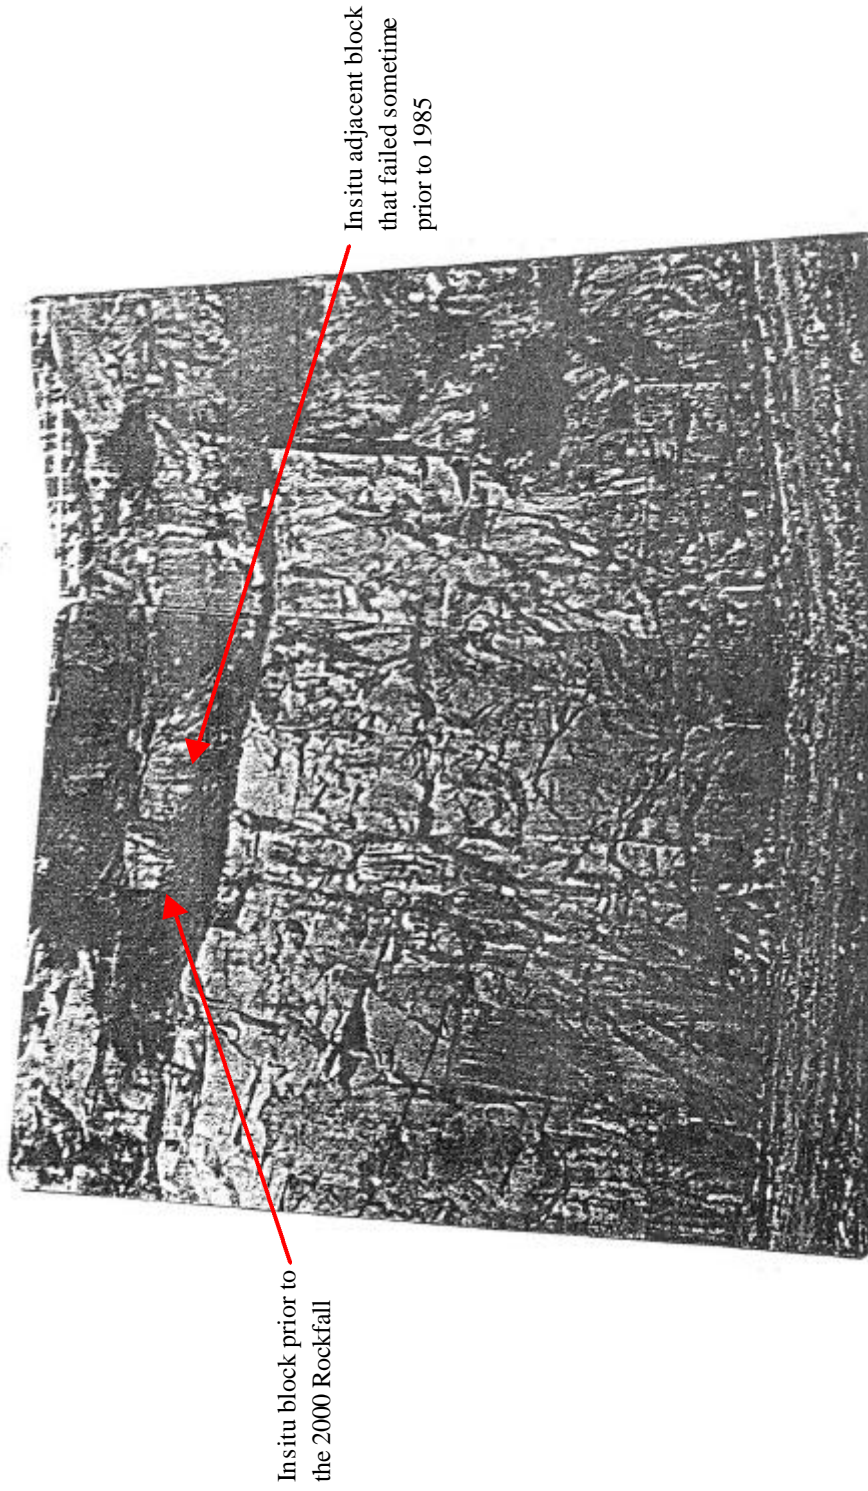
Plate 7 - View of the Location of the 2000 Rockfall Taken about 20 Years before the Failure (Photograph Taken in May 1980)

In addition to the above recorded landslides, there appears to be a failure scar adjacent to, and directly to the south of, the 2000 rockfall (Figure 2). An insitu block is visible in a poor quality site photograph taken by HIP in May 1980 (Plate 7), located adjacent to the block which failed in the 2000 rockfall, but this block was no longer observed in a site photograph taken by FF in July 1985 (Plate 8). There is no record of a failure at this location but such occurrence, which might have been unreported to the GEO, could not be ruled out. It is also possible that the block was removed during stabilisation works in the early 1980’s, although no record of such stabilisation works at this location has been found.

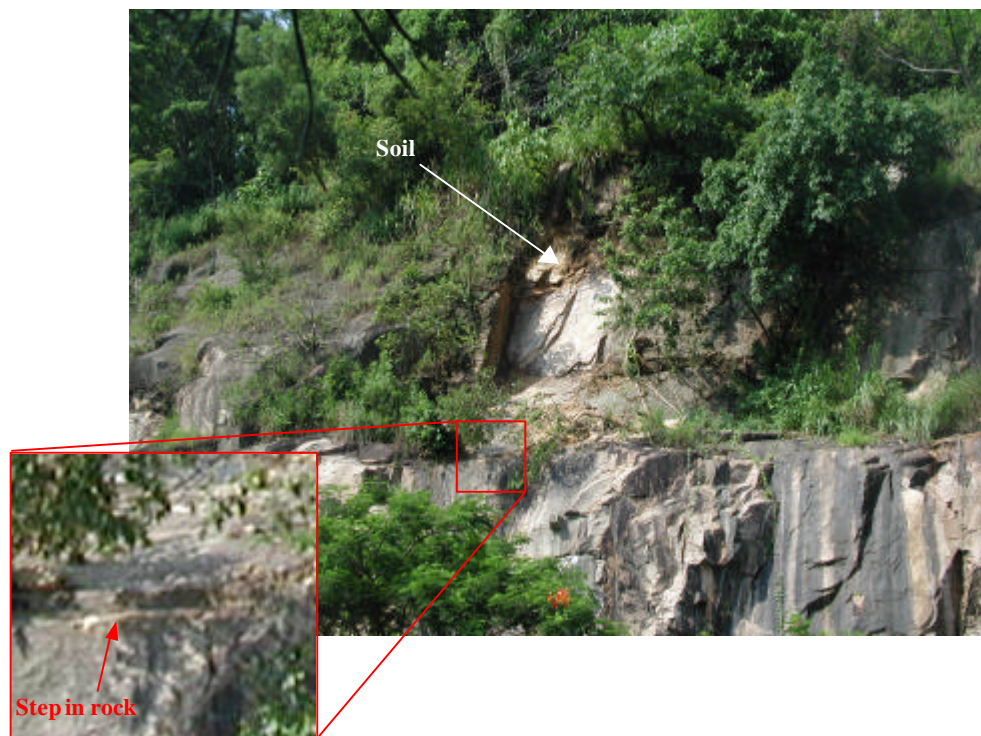
Plate 9 - View of the 2000 Rockfall Scar (Photograph Taken on 10 August 2000)

Above the rock portions of the rear and side release surfaces is a 1 m to 1.5 m thick layer of completely to highly decomposed granite, within which there are overhanging and sometimes loosened, boulders (corestones) of moderately decomposed granite. Tree roots protrude from the top of the soil layer. Above this soil layer is an about 1 m high thick band of subvertically jointed moderately decomposed granite (Figure 5 and Plate 9).

An accumulation of about 0.5 m³ of landslide debris comprising granitic soil was present at the toe of the basal release surface. The joint surface in front of, and continuous with, the basal release surface appears stepped with its inclination decreasing to about 27° towards the front face of the rock slope (Figure 4). At that location, the joint is observed to be separated from an underlying, sub-parallel sheeting joint by a 50 mm high step (Plate 9).

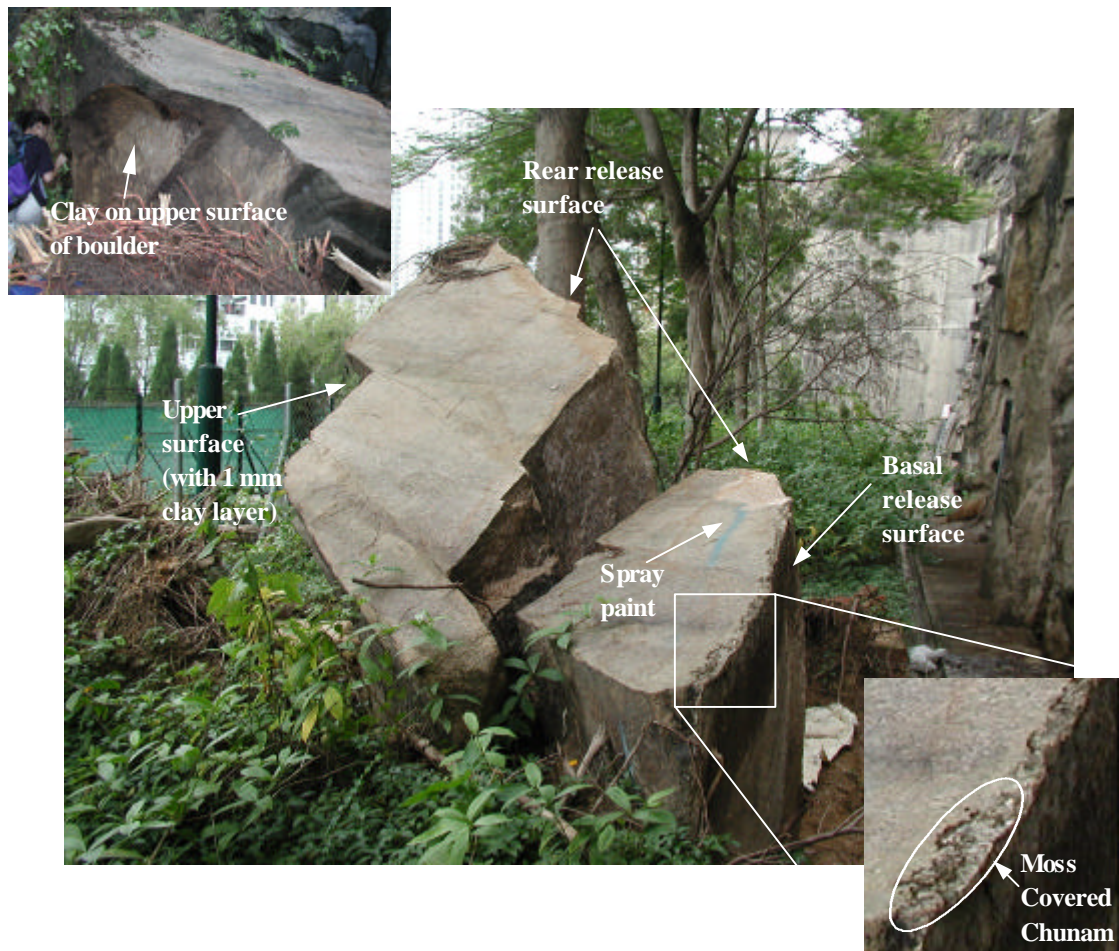
Plate 10 - View of Fallen Block from the 2000 Rockfall
(Photograph Taken on 4 August 2000)

On the side of the rock block, which was exposed prior to the landslide, a 0.5 m long blue line of spray paint could be seen (Plate 10). Also, a short section (about 0.2 m) of moss-covered chunam was noted at what would have been the base of the southern side release surface of the granite block.

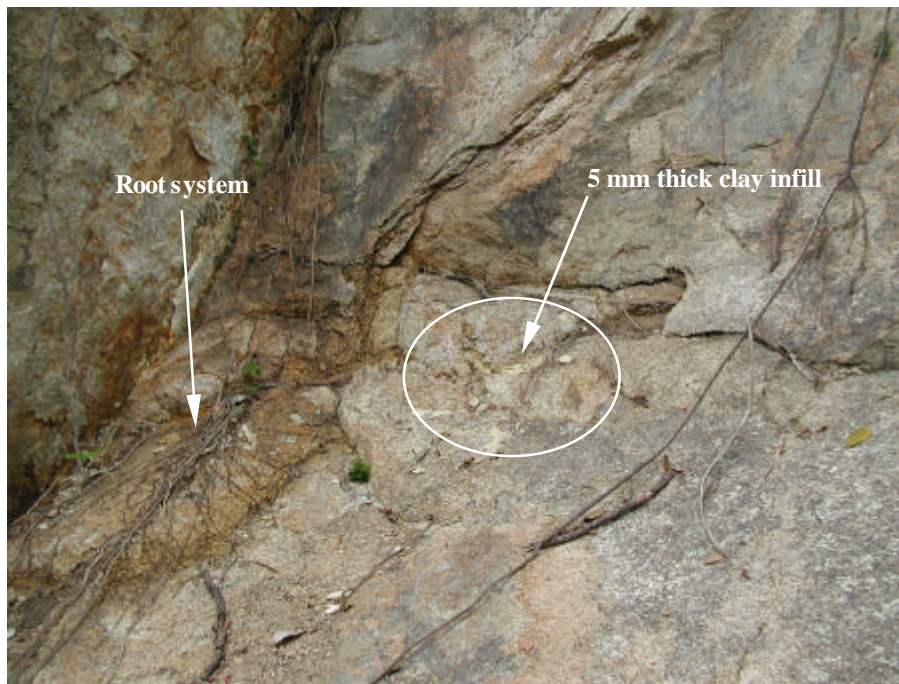
Plate 12 - Detail of the 5 mm Thick Clay Layer on the Basal Release Surface
of the 2000 Rockfall (Photograph Taken on 11 December 2000)

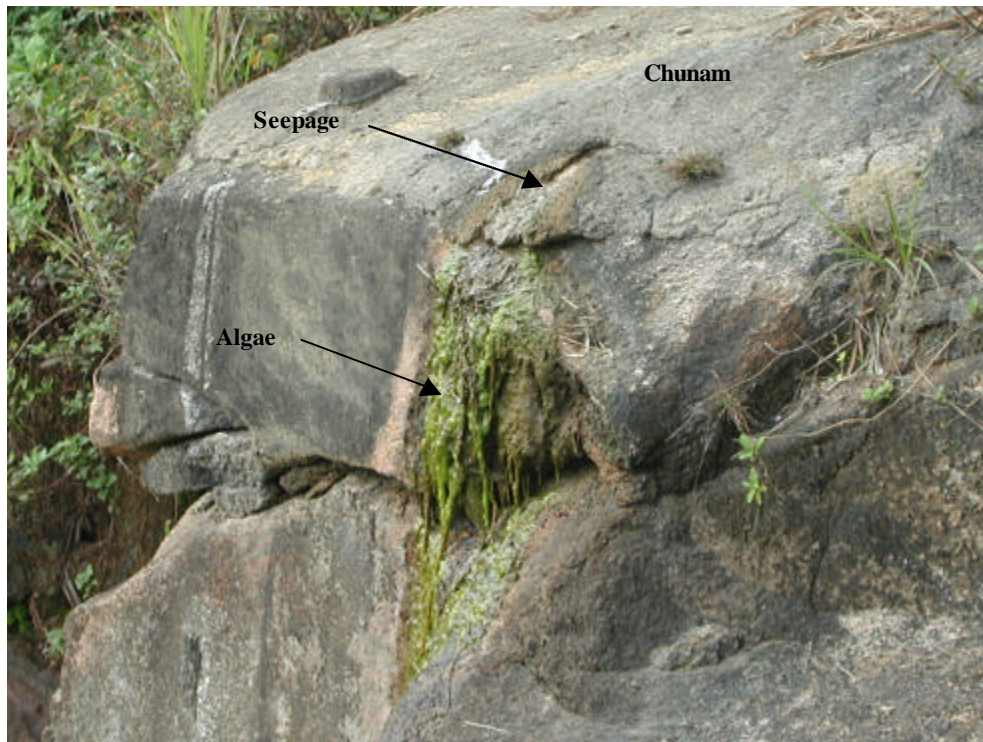
Plate 13 - Detailed View Showing Seepage between Chunam and Rock Interface
at the Crest of the Northern End of Slope No. 11NE-D/C45 at
Chainage 225 (Photograph Taken on 6 December 2000)

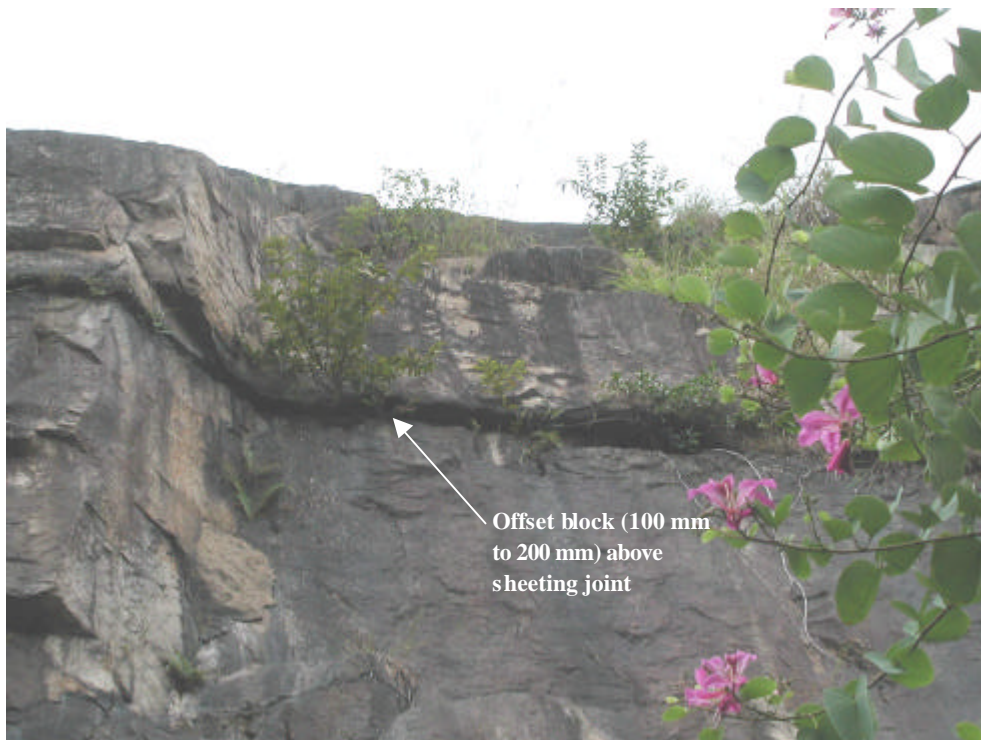
Plate 14 - Detailed View of Offset Block above a Sheeting Joint at Chainage 150
(Photograph Taken on 15 December 2000)

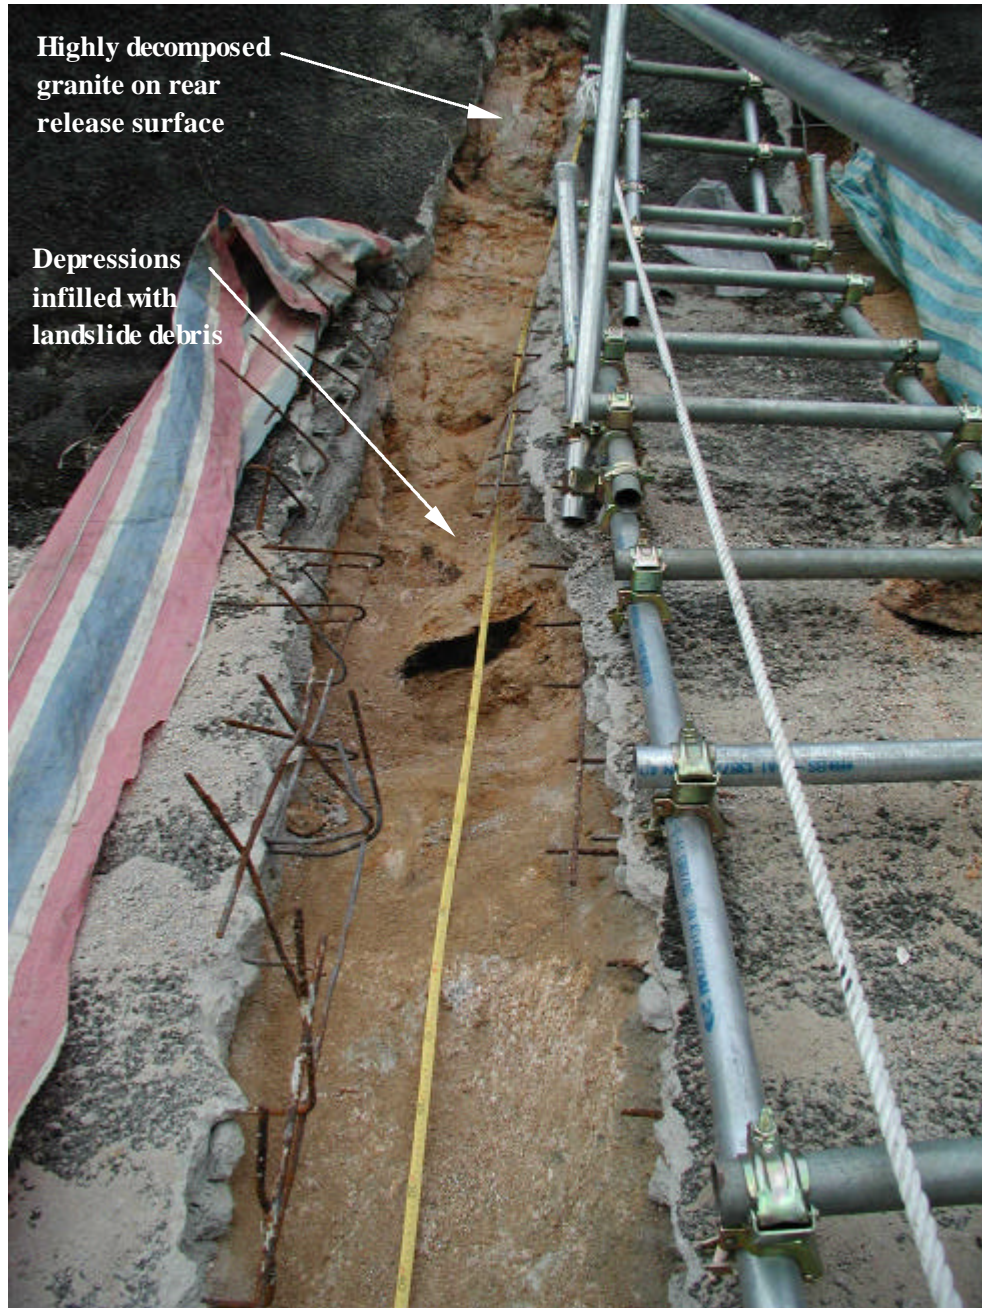
Plate 15 - View of Surface Strip SS1 Revealing Completely to Highly Decomposed Granite at the 1993 Landslide Scar
(Photograph Taken on 27 December 2000)

From about 1 m to 12 m along slope strips SS1 (Plate 15) and SS2 and from 2.9 m to 9.6 m along slope strip S4, loose to medium dense silty fine to coarse sand with angular gravel sized quartz and occasional boulder-sized fragments of completely decomposed granite (CDG) was exposed. Roots from some small bushes have grown within the upper 50 mm to 100 mm of soil within this section. Small depressions up to 300 mm deep within the soil at this section were infilled with very loose granitic soil and also contained fragments of old chunam/shotcrete surface which were probably debris from the 1993 landslide. However, the underlying soil had some relict structures indicating that it is insitu. At about 6 m to 6.7 m along slope strip S4, a planar, manganese and iron oxide stained joint surface was observed, with an orientation of $42^{\circ}/223^{\circ}$. This is adversely orientated with respect to the slope face and may be parallel to the basal release surface for the 1993 landslide. At about 8.5 m along slope strip S4, a daylighting, shallow dipping ($15^{\circ}/221^{\circ}$) iron oxide and manganese stained joint with up to an 8 mm thickness of white kaolin clay infill is present. The portion of the slope (i.e. base of the 1993 landslide scar) along this section of the strips is typically inclined at about 40° to 45° to the horizontal, increasing to about 60° immediately below the rear release surface.

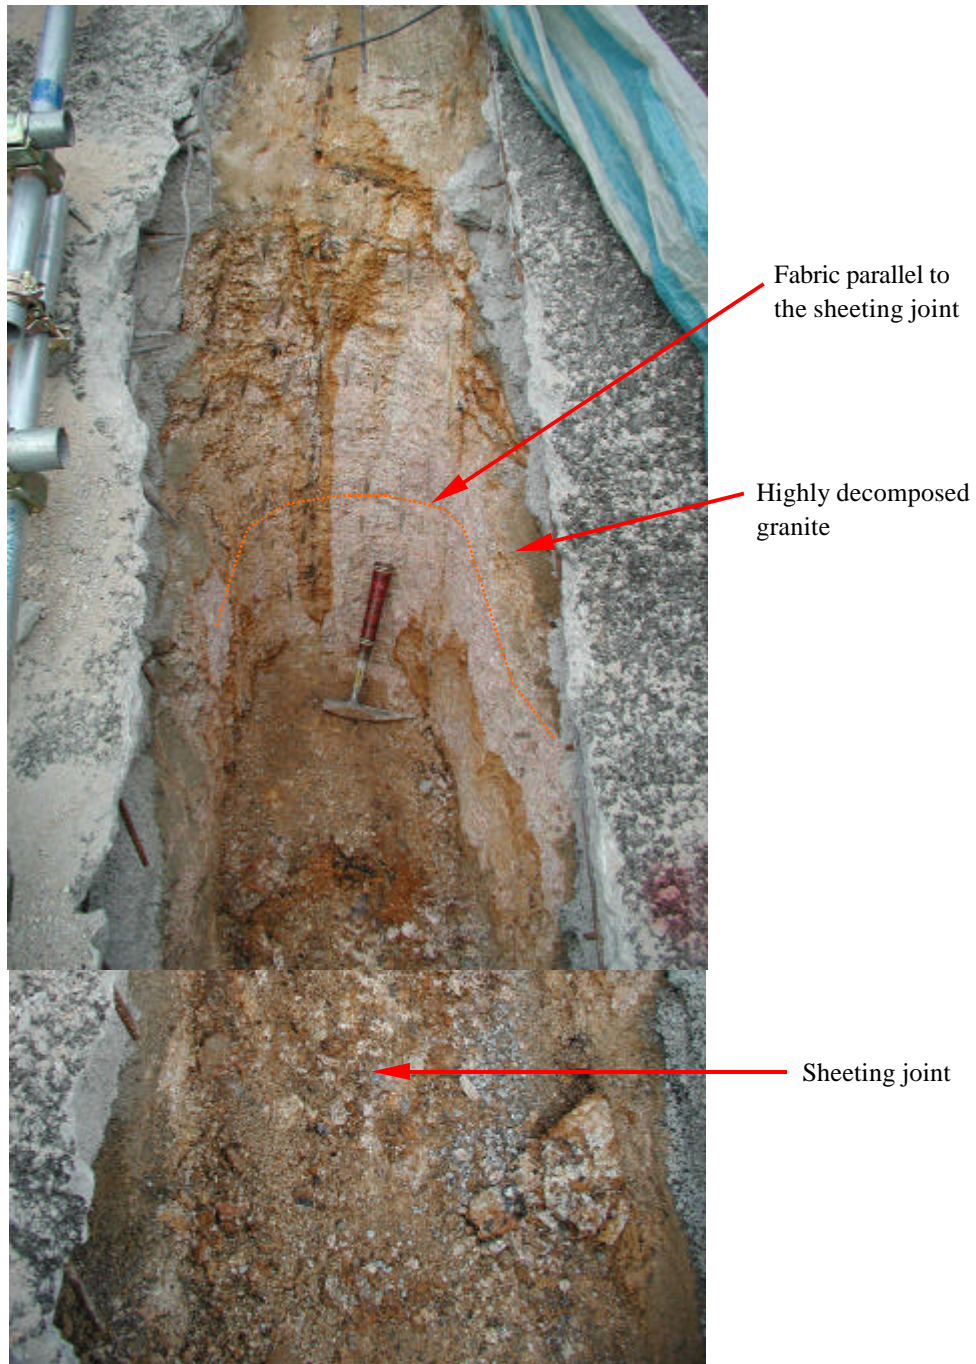
Plate 16 - View of Trial Trench Showing Highly Decomposed Granite above Sheeting Joint at the 1993 Landslide Scar (Photograph Taken on 27 December 2000)

Trial trench TT1 was excavated between 10.5 m and 12 m along slope strip SS2 (Plate 16). This confirmed that HDG observed in slope strip SS2 at that location was an insitu weathered band, at least 1 m thick above and associated with the sheeting joint, which is present at the toe of the 1993 landslide scar. The HDG contained a planar fabric, roughly parallel to the underlying rock surface and is interpreted as exfoliation fractures. The insitu HDG is also present from 9.6 m to 11.9 m along slope strip S4, which was also noted to contain steeply dipping manganese and iron oxide stained joints, with orientations similar to the rear and side release surfaces, $75^{\circ}/228^{\circ}$ and $80^{\circ}/310^{\circ}$ respectively, of the 1993 landslide. The rock cut slope below the 1993 landslide scar was observed to have up to a 100 mm thickness of HDG present in places, indicating severe weathering along steep joints to depths greater than 17 m below the slope crest.
