**INVESTIGATION OF SOME  
SELECTED LANDSLIDES  
IN 2000  
(VOLUME 3)**

**GEO REPORT No. 131**

# **SECTION 1: DETAILED STUDY OF THE 24 AUGUST 2000 LANDSLIDE NEAR 2B BOWEN ROAD**

This report presents the findings of a detailed study of a landslide (GEO Incident No. HK2000/08/006) which occurred on 24 August 2000 involving unregistered fill on the hillside adjacent to No. 2B Bowen Road on Hong Kong Island. Debris from the landslide, with an estimated volume of 120 m<sup>3</sup>, entered the adjacent nullah and was transported downstream for a long distance beyond the landslide site (up to about 250 m on plan) to reach Hong Kong Park below Kennedy Road.

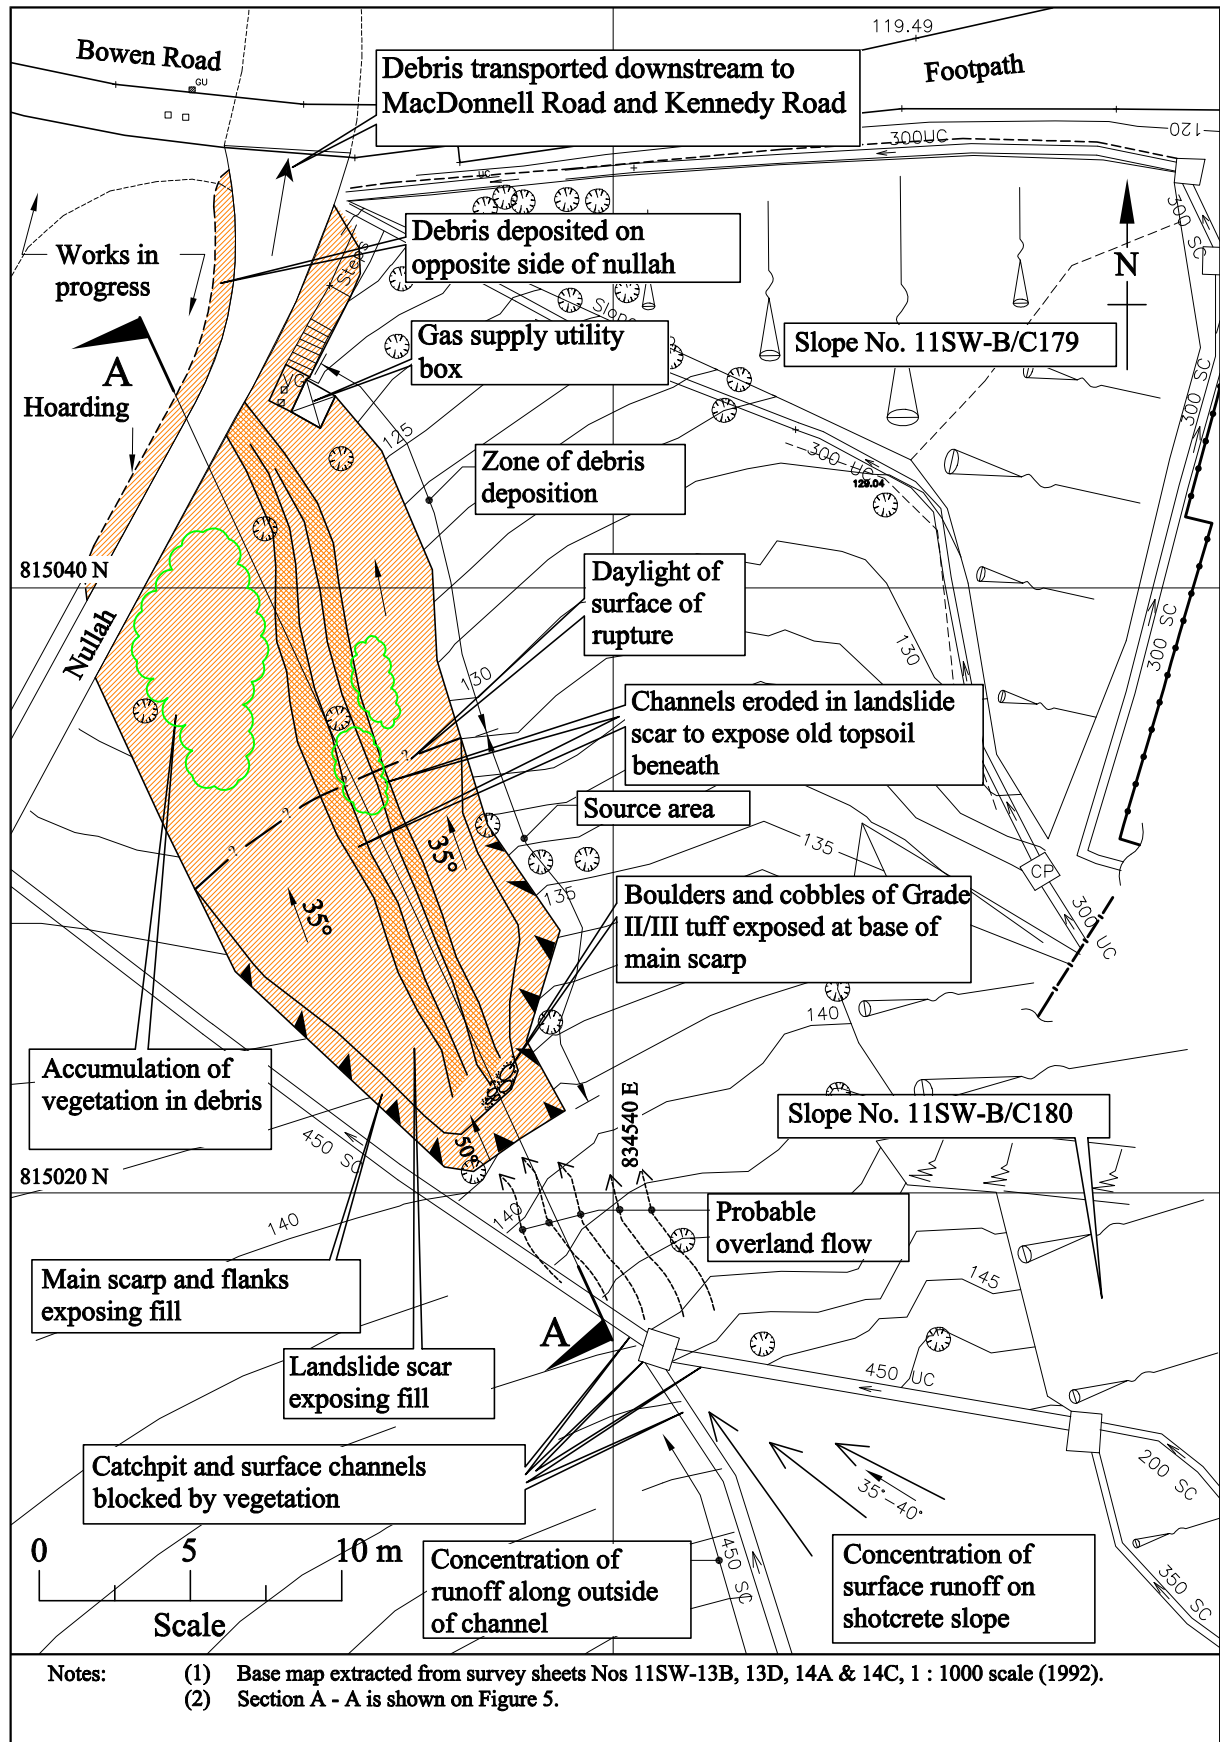
Figure 4 - Plan View of the Landslide

Based on the results of the post-failure topographic survey of the landslide site, the general topography and profile of the landslide are presented on Figures 4 and 5.

The surface drainage channels and catchpit associated with slope No. 11SW-B/C180 located above the landslide scar were observed to have been blocked with vegetation (Figure 4 and Plate 8). There was also evidence of overland flow in the form of aligned vegetation and surface erosion between the channel and the main scarp (Figure 4 and Plate 9). No groundwater seepage was noted from the scar area at the time of inspection.

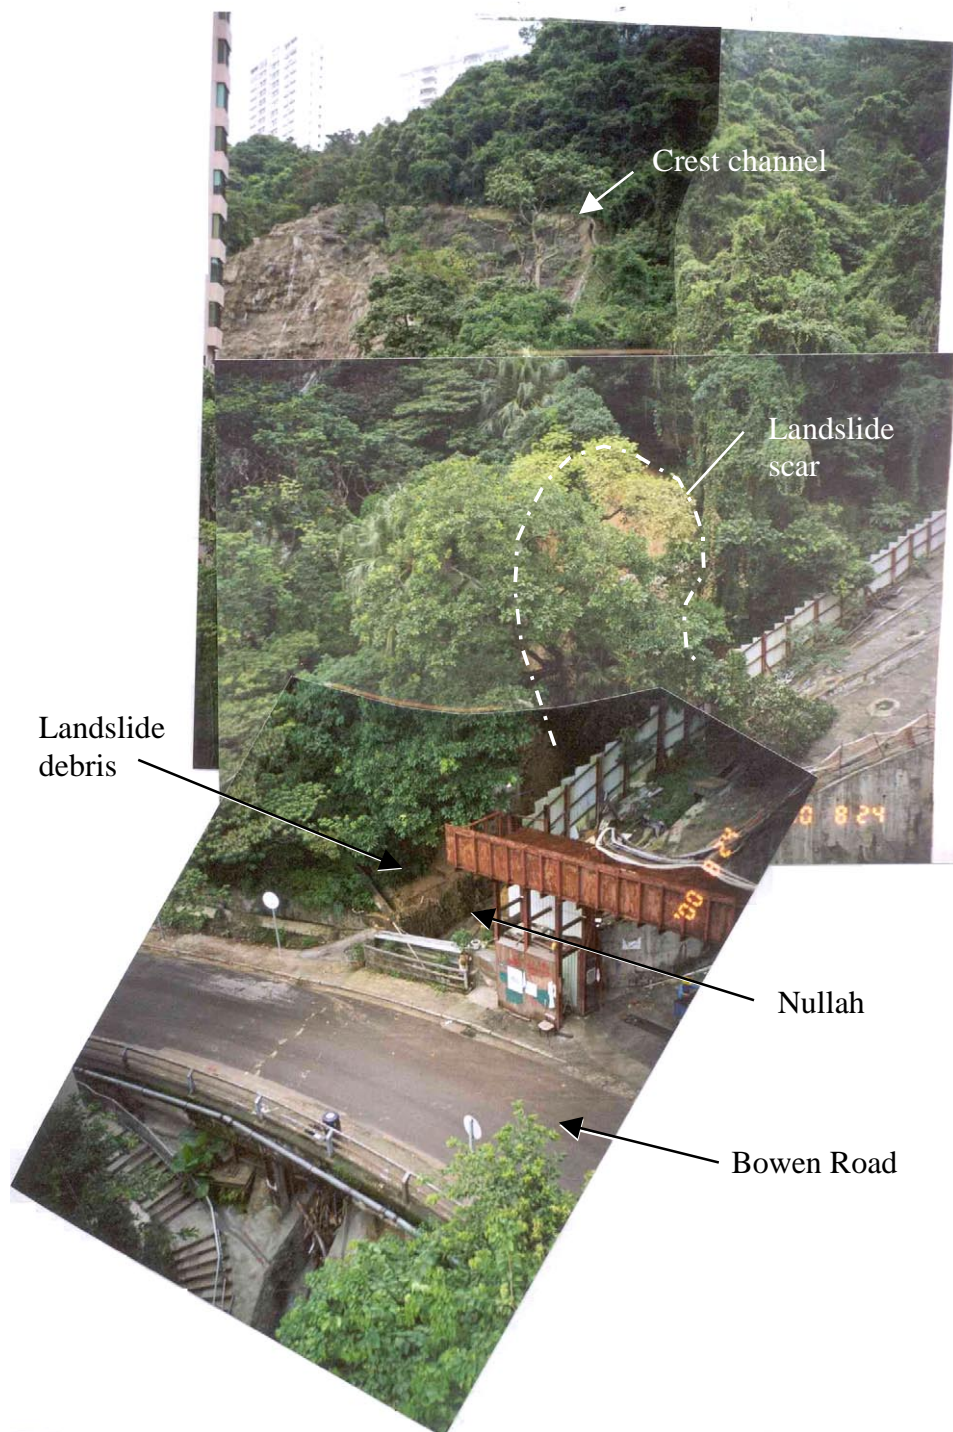
Plate 1 - View Southeast across Bowen Road towards Landslide Site (Photograph Taken on 24 August 2000. Extent of Landslide Scar Indicated. Slope No. 11SW-B/C180 Visible in Upper Left of Frame. Crest U-channel Indicated. Note Debris on Ground Surface Adjacent to Nullah and Absence of Debris on Bowen Road)

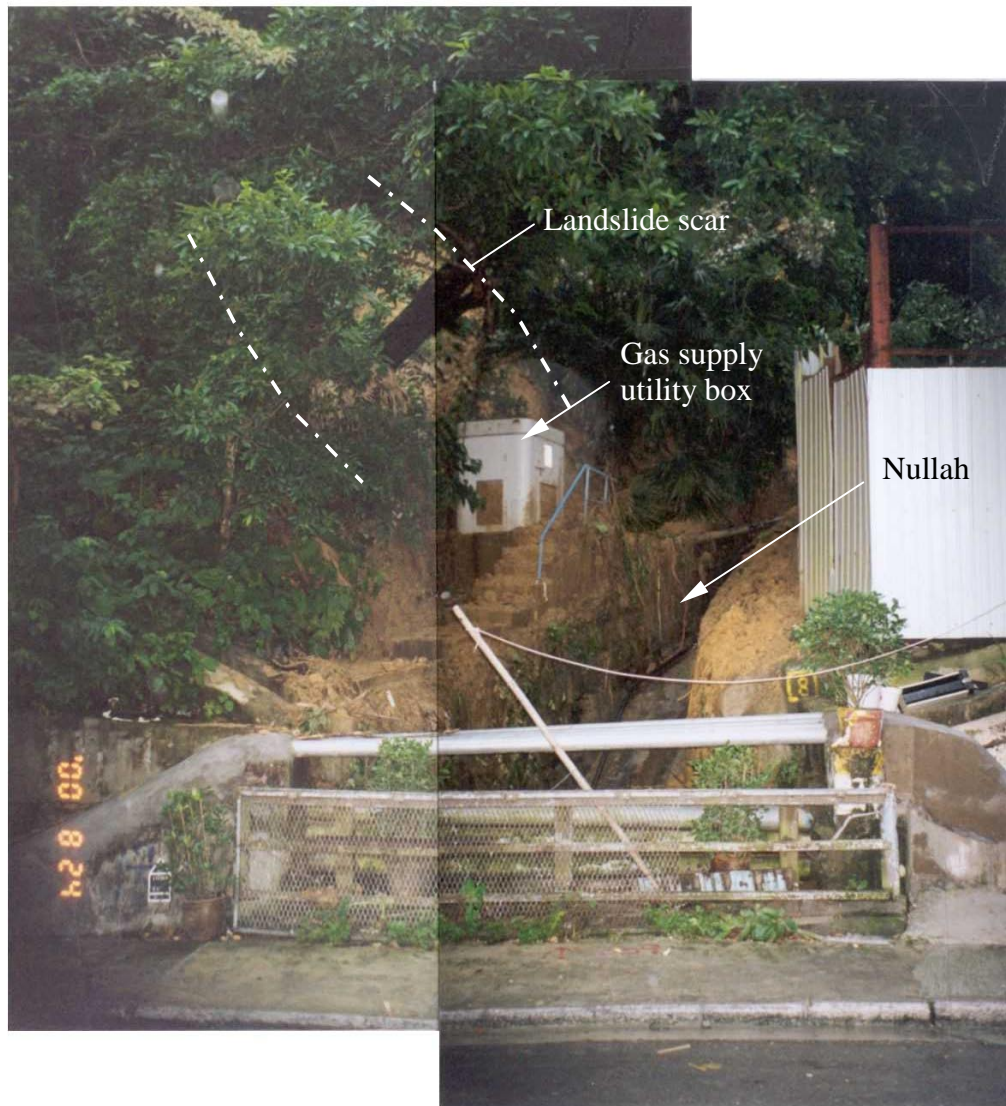
Plate 2 - View South along Nullah from Bowen Road (Photograph Taken on 24 August 2000. Landslide Scar Visible through Trees. Gas Supply Utility Box Adjacent to Nullah in Centre of Frame. Note Debris Deposited on Western side of Nullah)

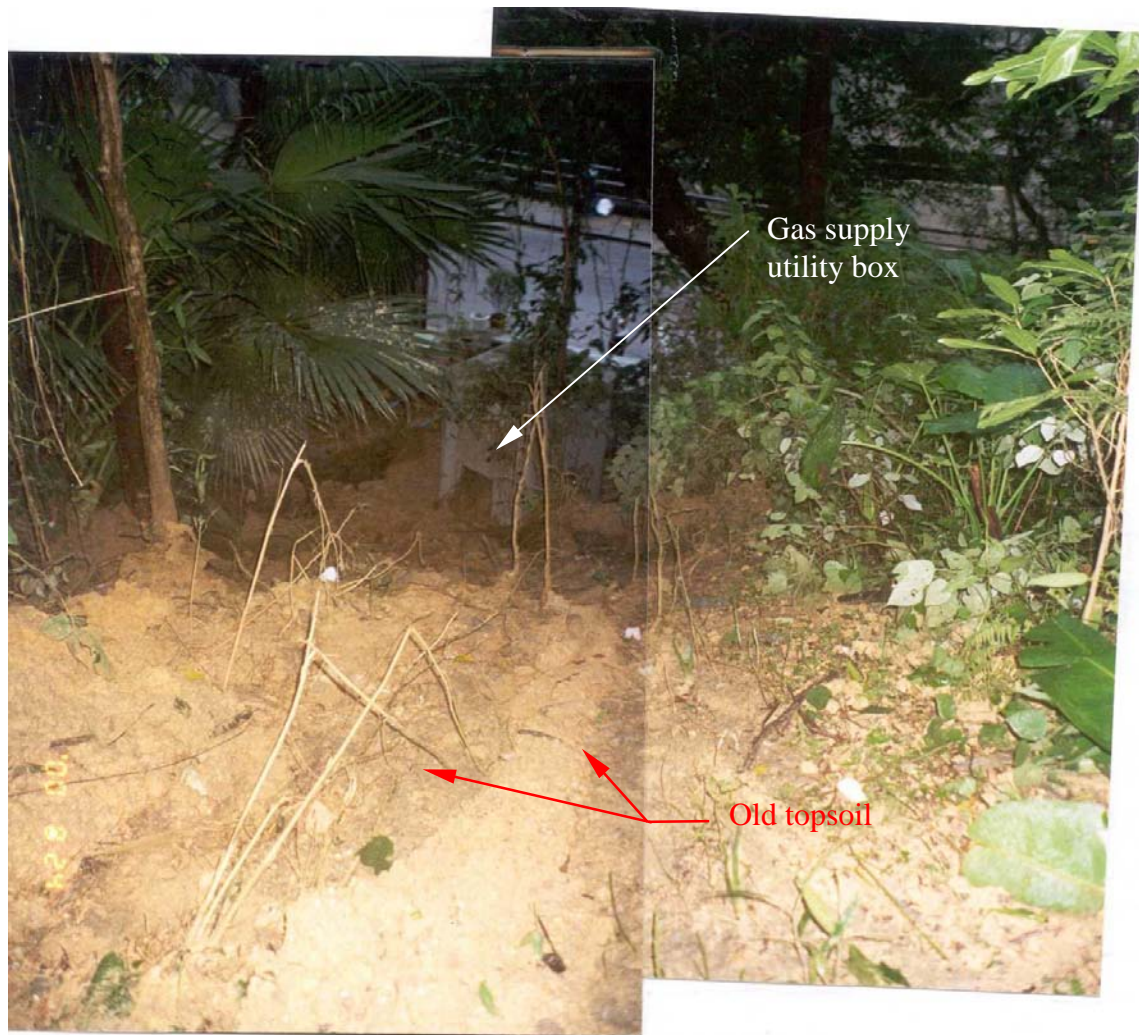
The maximum depth of the landslide scar, measured normal to the surface of rupture, was about 1 to 1.5 m. The scar was planar in appearance, with the main scarp dipping at 50° and with relatively well defined flanks. The surface of rupture dipped sub-parallel to the inferred pre-failure ground surface (inclined at about 35°). The toe of the surface of rupture was poorly defined and was estimated to lie about 10 m on plan above the nullah. General views of the landslide scar are presented in Plates 6 and 7. Material exposed in the scar

The landslide debris consisted mostly of fill material. There was little evidence that the surface of rupture had penetrated the insitu profile to a significant depth, and the exposures of the insitu profile appeared to have resulted from erosion of the fill by subsequent flow of water (Plate 6).

Plate 6 - View Northwest down Landslide Scar from Main Scarp  
(Photograph Taken on 24 August 2000. Note Old  
Topsoil Horizon Exposed in Channels Scoured in Fill)

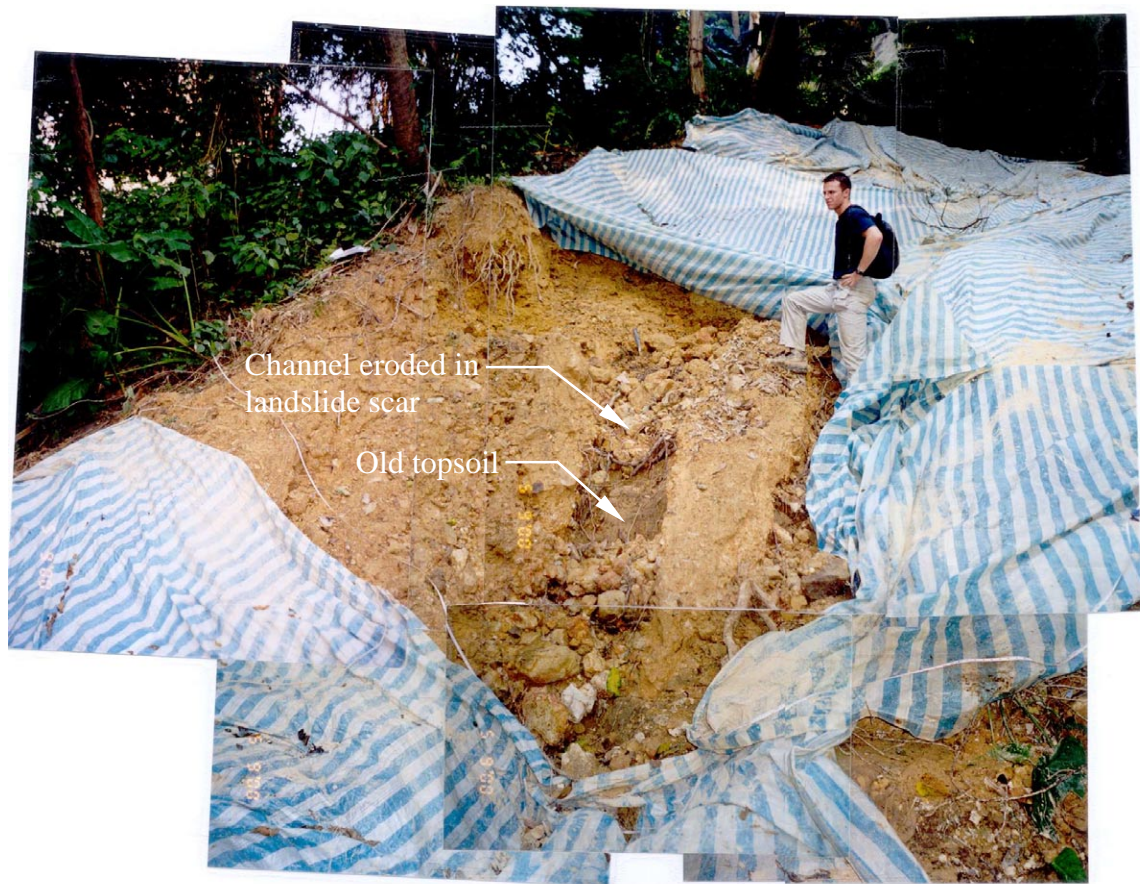
comprised fill of sandy, clayey silt with distinct layering and voiding within selected layers. A topsoil horizon was exposed beneath the fill in two erosion channels, about 0.5 m wide and 0.1 m to 0.2 m deep, on the surface of rupture.

Plate 7 - View Southeast up Landslide Scar Showing Fill Material Exposed in Scar and Old Topsoil Horizon Exposed in Scoured Channel (Photograph Taken on 9 September 2000)

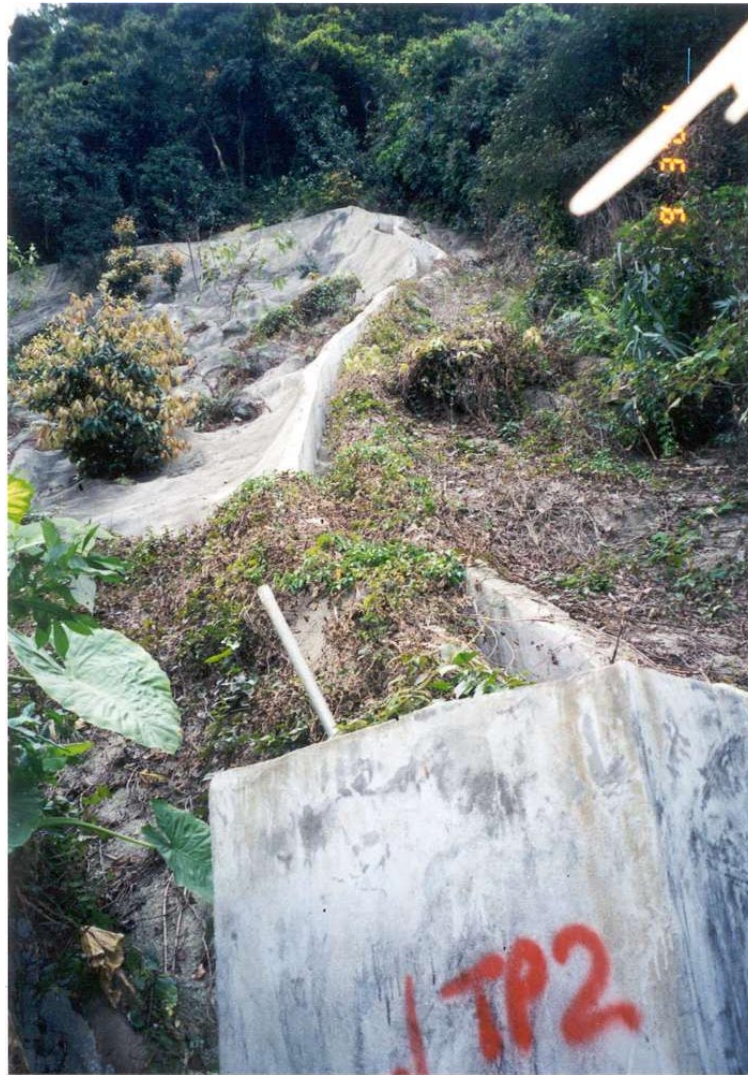
Concentrated surface runoff originating from the poorly detailed surface drainage provisions of the adjacent slope No. 11SW-B/C180, which was exacerbated by blockages of the drainage channels (with vegetation), is likely to have been an important source of water ingress at the landslide site. Thus, poor detailing and inadequate maintenance of surface drainage provisions were contributory factors to the failure.

Plate 8 - View South from Catchpit above August 2000 Landslide Scar  
Showing Steeply Inclined 450 mm Crest U-channel of Slope  
No. 11SW-B/C180 (Photograph Taken on 9 March 2001)

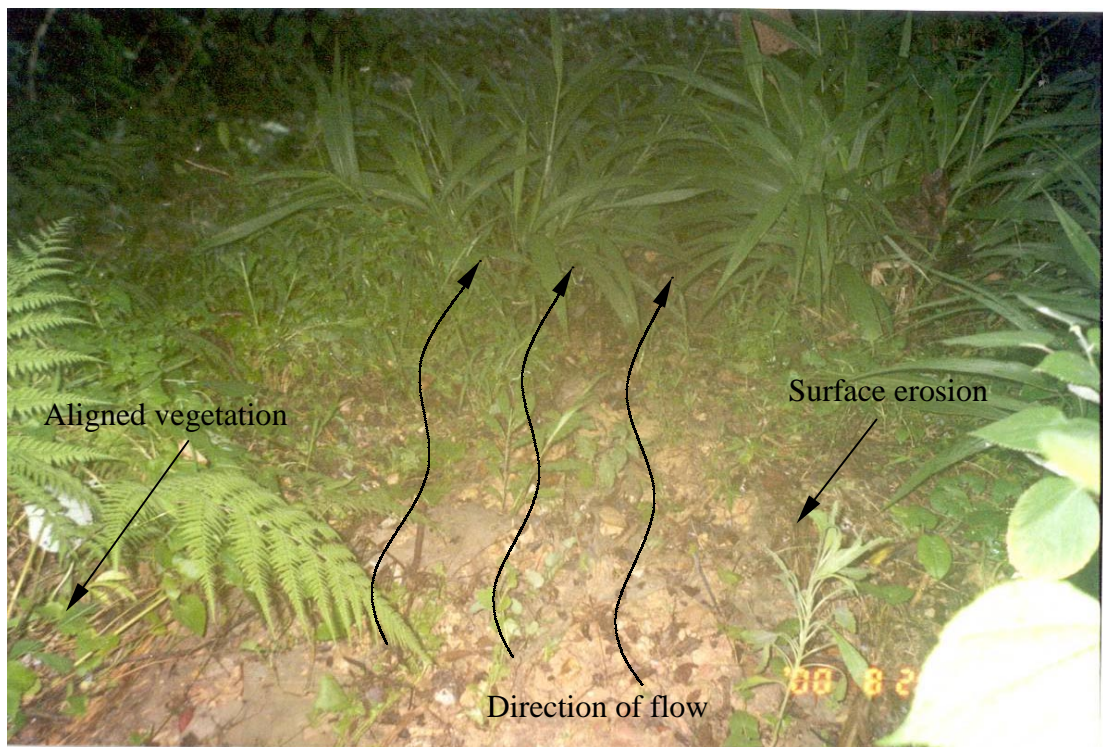
The surface drainage system associated with slope No. 11SW-B/C180 concentrates runoff from a potentially large catchment (about 1000 m<sup>2</sup>) immediately above the landslide scar. The drainage channels and a catchpit were observed to have been blocked by vegetation on the day of failure and there was evidence of overland flow between the channel and the landslide scar (Section 4.2), indicating that water had overspilled from the drainage system.

Plate 9 - Close View of Ground Surface below Catchpit and Crest Drainage Channel of Slope No. 11SW-B/C180 Showing Evidence of Overland Flow (Photograph Taken on 24 August 2000)

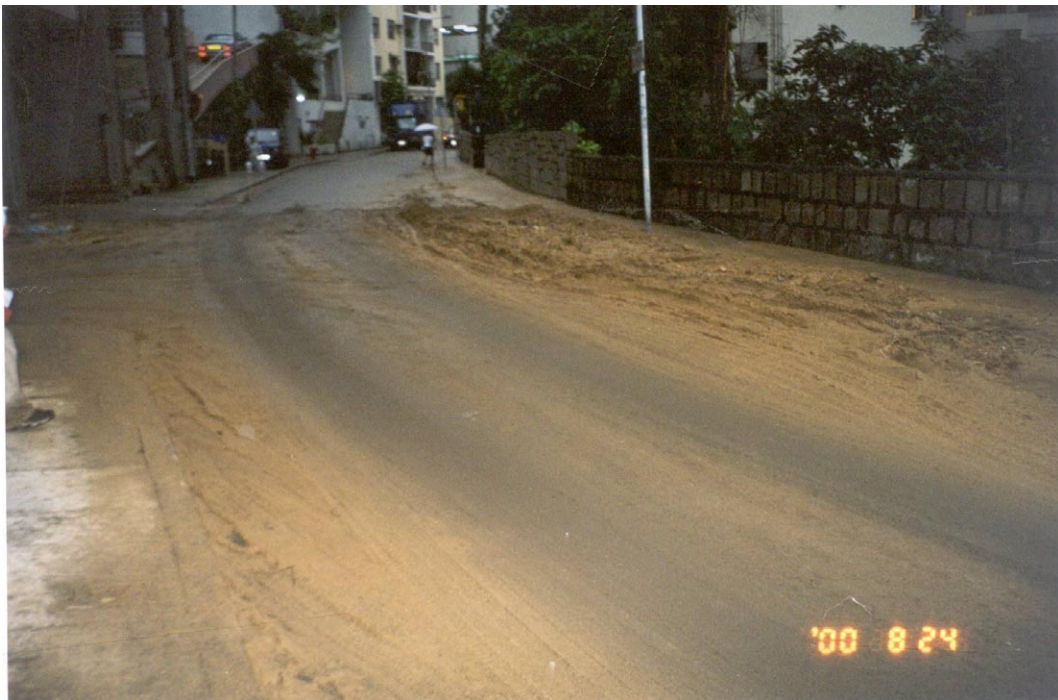
Bowen Road was observed to be free of debris on 24 August 2000, while much of the debris remained on MacDonnell Road and Kennedy Road (Plate 10), with paths having been cleared to permit the passage of vehicles. From the landslide scar to MacDonnell Road, the nullah is an open stepped-channel. It is culverted beneath Bowen Road and MacDonnell Road, with a trash screen located upstream of the MacDonnell Road culvert. Much vegetation and debris was observed blocking the culvert beneath Bowen Road. The debris deposited on MacDonnell Road comprised a very wet, sandy, clayey silt with gravel, some cobbles and vegetation.

Plate 10 - View West along MacDonnell Road Showing Deposited Landslide Debris (Photograph Taken on 24 August 2000)

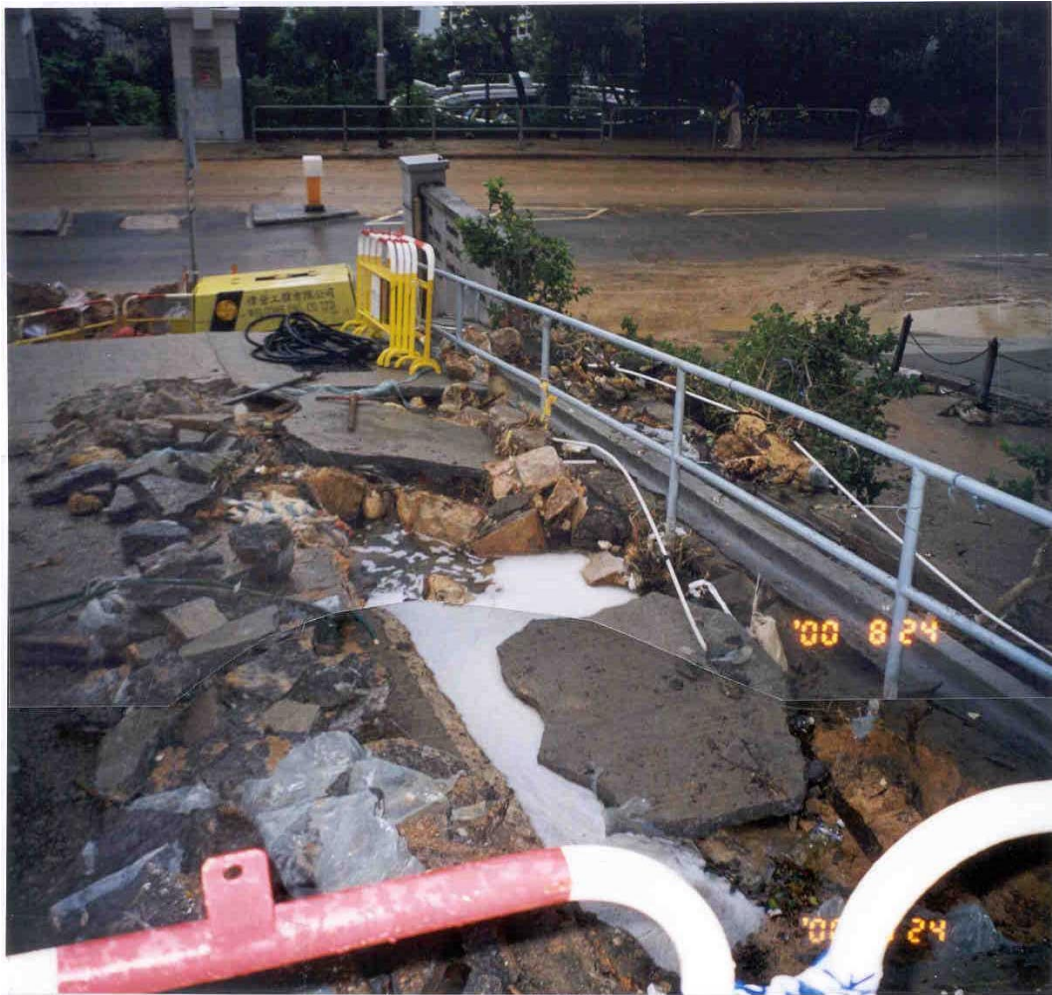
The debris that entered the nullah caused blockage of the channel at MacDonnell Road and Kennedy Road, resulting in overflow of water and debris onto the respective carriageways, and into Hong Kong Park via access steps off Kennedy Road (Figure 1).

Plate 11 - View North along Covered Nullah at Kennedy Road Showing Cover Slabs Having Been Lifted and Broken by Force of Water and Debris (Photograph Taken on 24 August 2000)

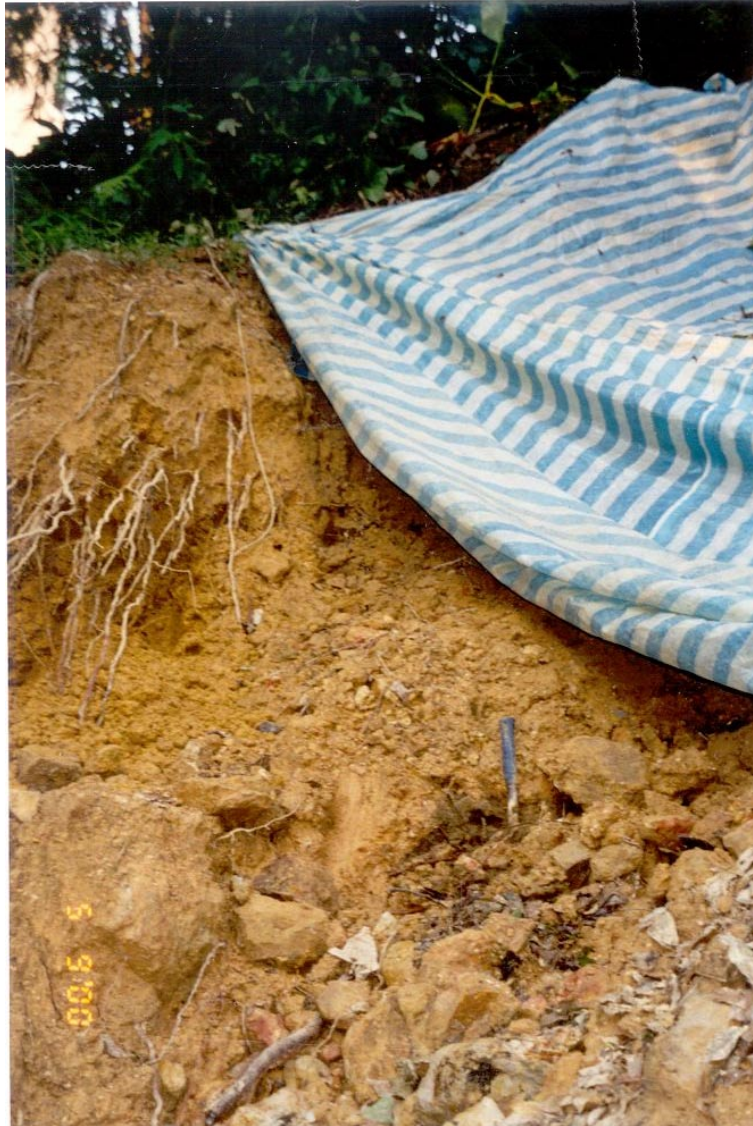
The landslide scar exposed about 1 m to 1.5 m of fill consisting of brown and orangish-brown, gravelly sandy silt in the main scarp (Plates 6, 7 and 12) and flanks. Similar material was exposed along the surface of rupture. Two well-defined channels eroded into the surface of rupture exposed topsoil consisting of a brown and greyish-brown sandy silt beneath the fill. A similar thickness of fill was indicated by trial pits TP1, TP2 and TP5 excavated around the scar periphery, as well trial pit TP6, located at the crest of the trimmed face of slope No. 11SW-B/C179 above Bowen Road, which exposed approximately 2 m of fill.

Plate 12 - Close View of Main Scarp Showing Exposed Fill Material  
(Photograph Taken on 9 September 2000. Note Old  
Topsoil Horizon Exposed in Base of Scarp at Location of  
Geological Hammer)

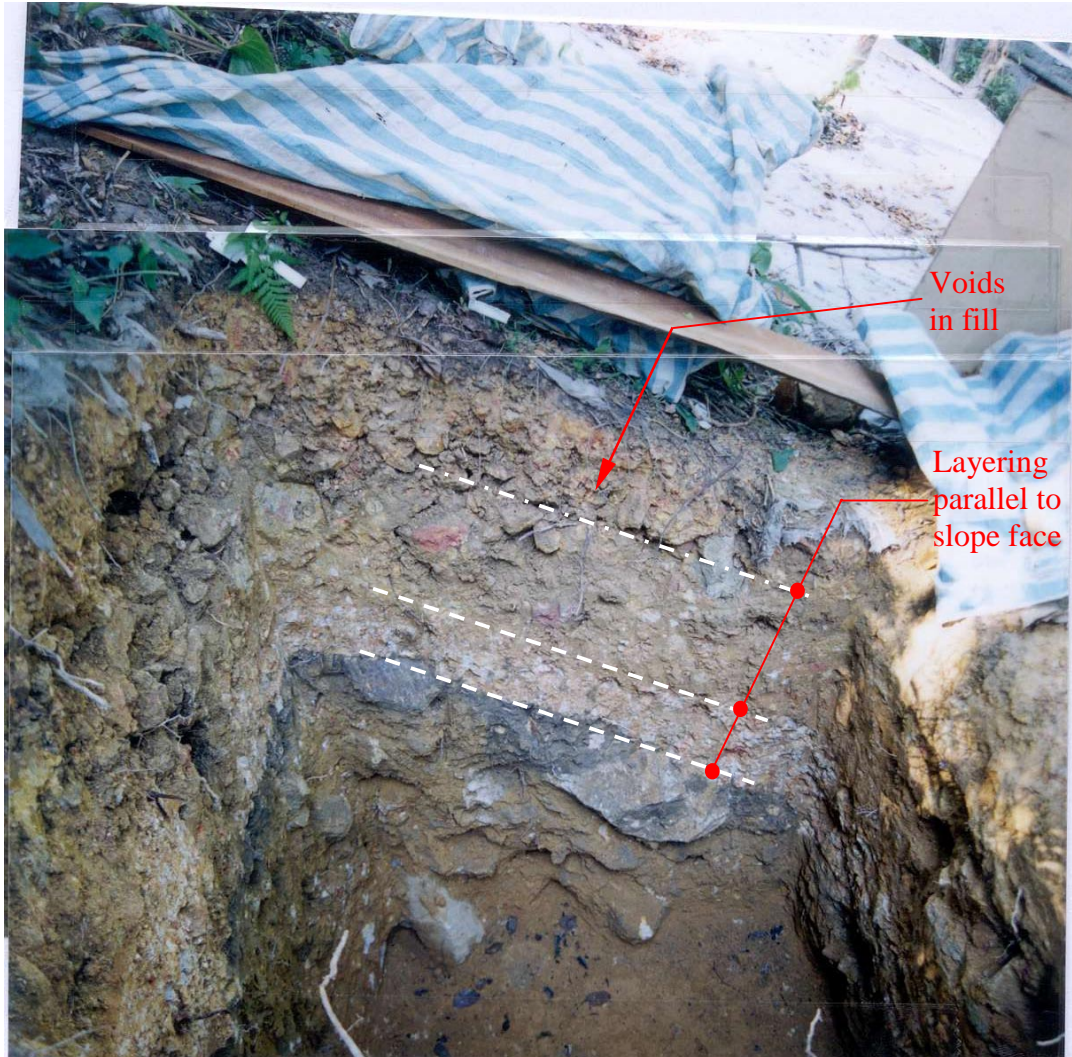
Particular observations made in relation to the fill material were the presence of layering parallel to the slope face (Plate 13) in trial pits TP1 to TP6, voiding (Plates 13 and 14) in trial pits TP1 to TP6, which provides some indication of the manner of placement (i.e. probably loosely tipped). The presence of thin (20 to 50 mm) topsoil horizons separating the fill layers (Plate 15) in trial pit TP1 indicates that the fill was deposited in distinct layers over a period of time.

Plate 13 - Southwestern Face of Trial Pit TP5 Showing Fill Material Overlying Topsoil and Colluvium/CDT (Photograph Taken on 5 March 2001. Note Layering Parallel to Slope Face, and Voiding of Fill Indicated. Shotcreted Landslide Scar Visible at Top of Frame)

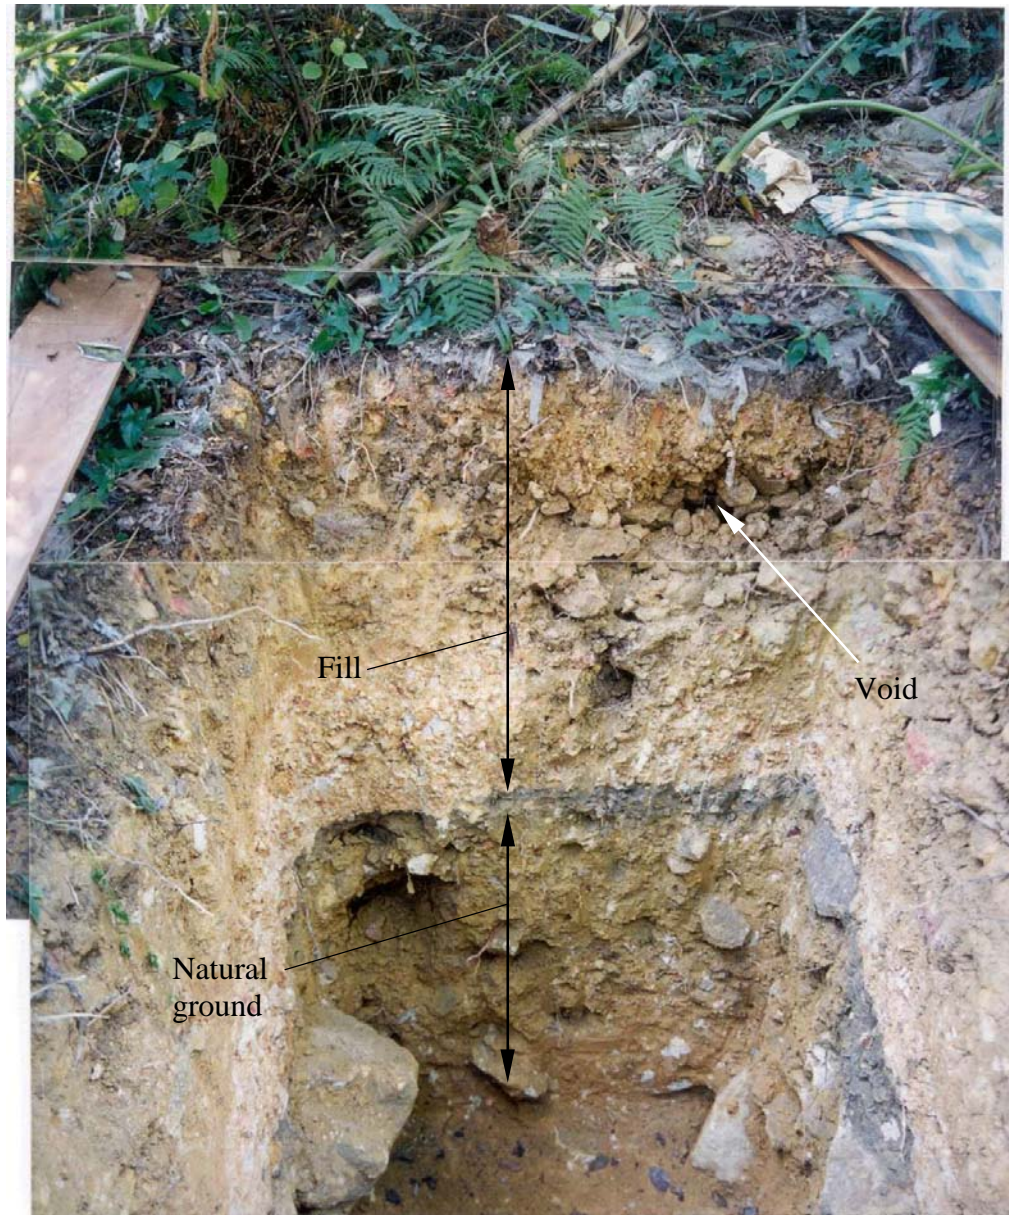
Plate 14 - Southwestern Face of Trial Pit TP5 Showing Voids in Fill  
(Photograph Taken on 5 March 2001)

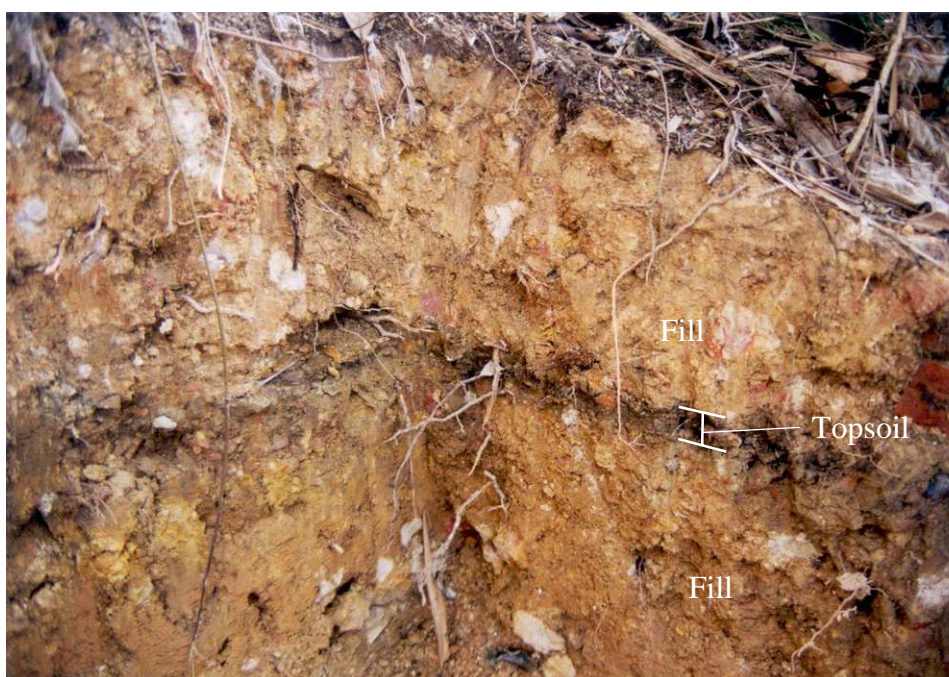
Plate 15 - Southwestern Face of Trial Pit TP1 Showing Thin Topsoil Layer Separating Fill Layers (Photograph Taken on 28 February 2001)
