A STUDY ON PAST FAILURES OF TRENCH EXCAVATIONS

GEO REPORT No. 137

J.S.M. Kwong

**GEOTECHNICAL ENGINEERING OFFICE
CIVIL ENGINEERING DEPARTMENT
THE GOVERNMENT OF THE HONG KONG
SPECIAL ADMINISTRATIVE REGION**

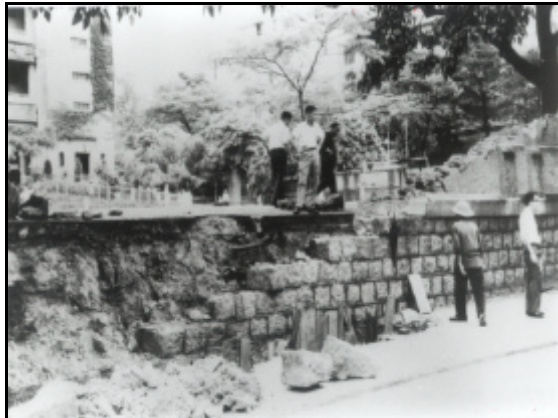
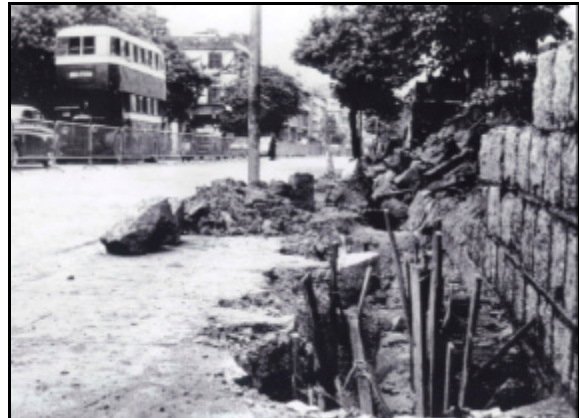
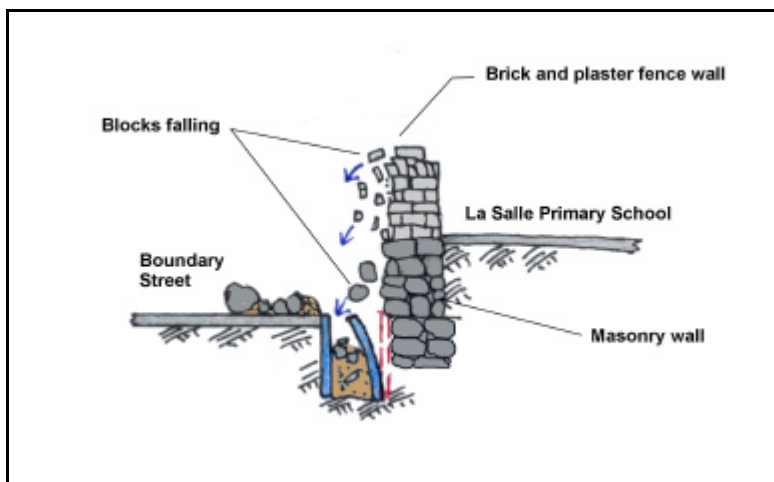
- Poor drainage in the wall allowed infiltration of surface water.
- Removal of support at wall toe.

6 fatalities, 16 injuries (all members of the public)

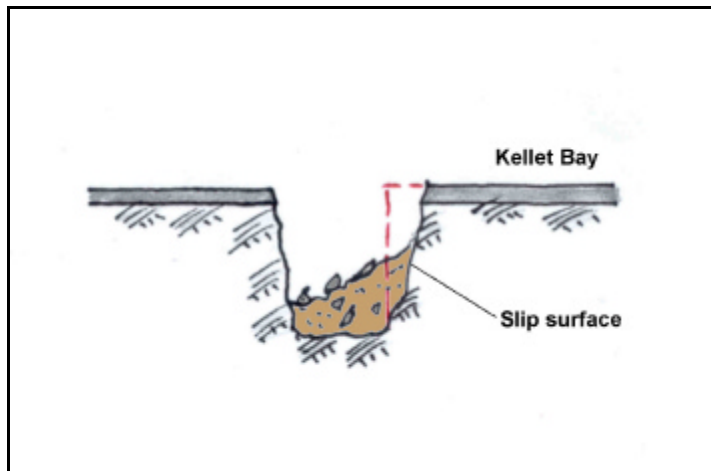
Case No.: 2

Improper working procedure

One worker was killed

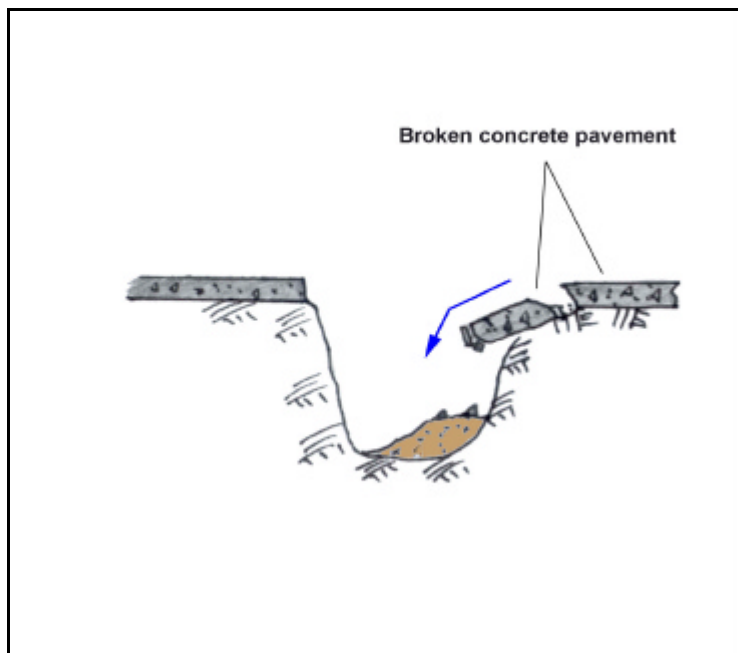
Case No.: 3

A trench was being excavated for pipe laying. A broken concrete pavement slab fell inside the trench and hit a worker.

Improper works method

One worker was killed

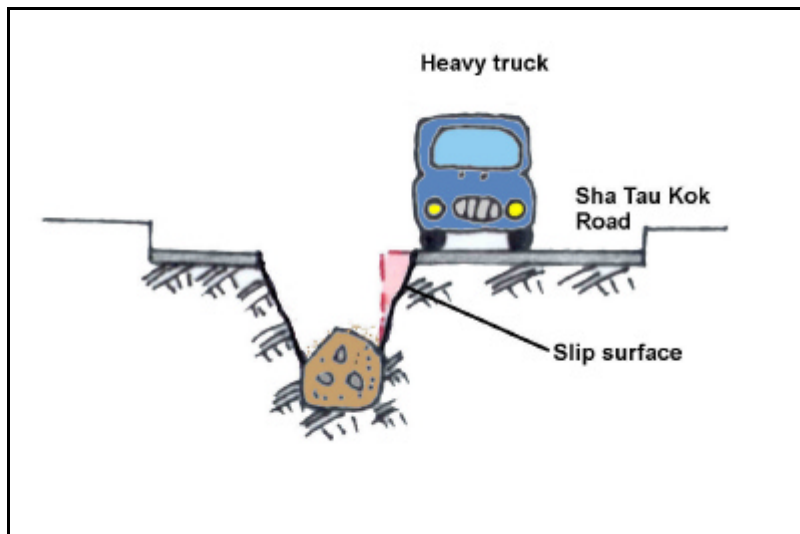
Case No.: 4

One worker was killed

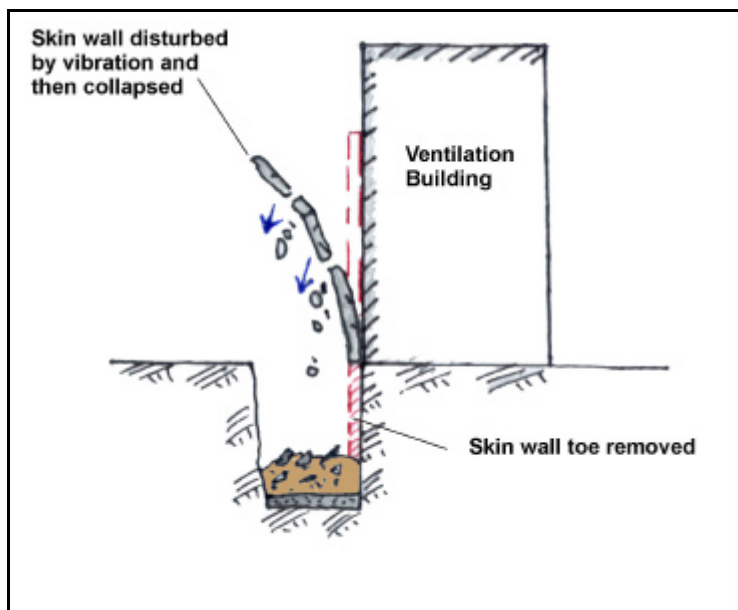
Case No.: 5

One worker was killed

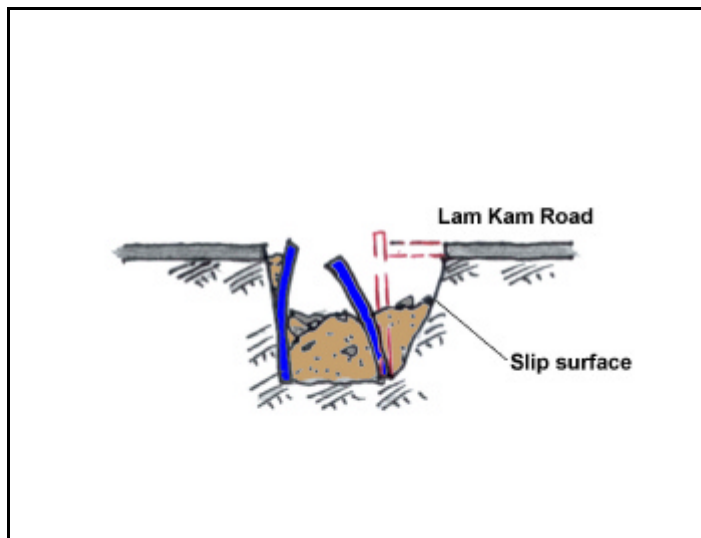
Case No.: 6

- Rise in groundwater level due to heavy rainfall
- Poor groundwater control
- Inadequate shoring

Collapse of Lam Kam Road (lane towards Shek Kong direction) interrupted traffic

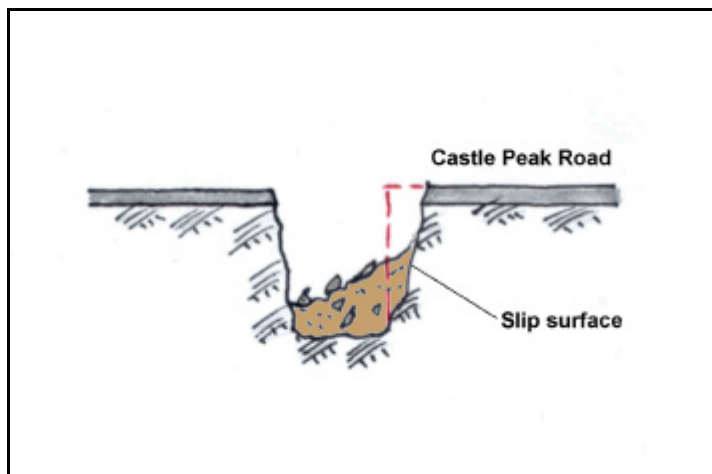
Case No.: 7

A trench was being dug manually. A worker was hit by collapsed soil when the trench failed.

One worker killed, one injured

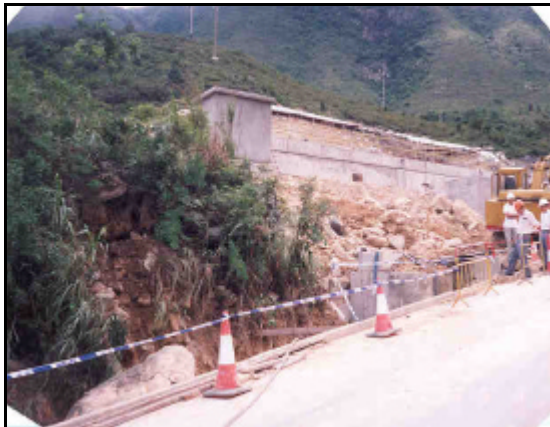
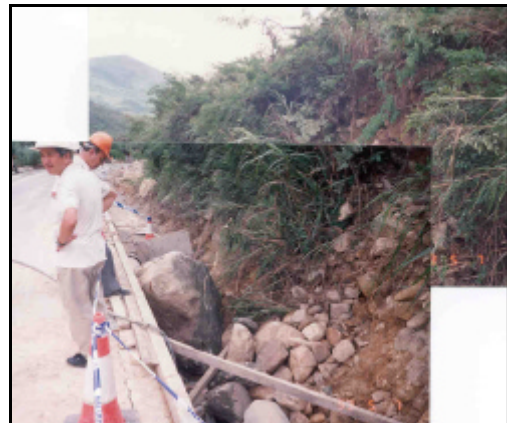
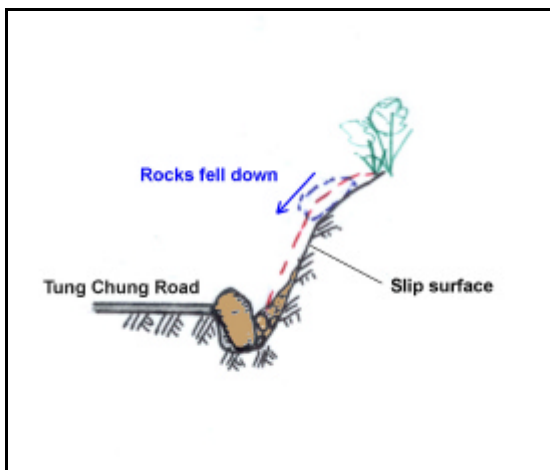
Case No.: 8

- Inadequate shoring support

- One worker was killed
- Failure of a upslope

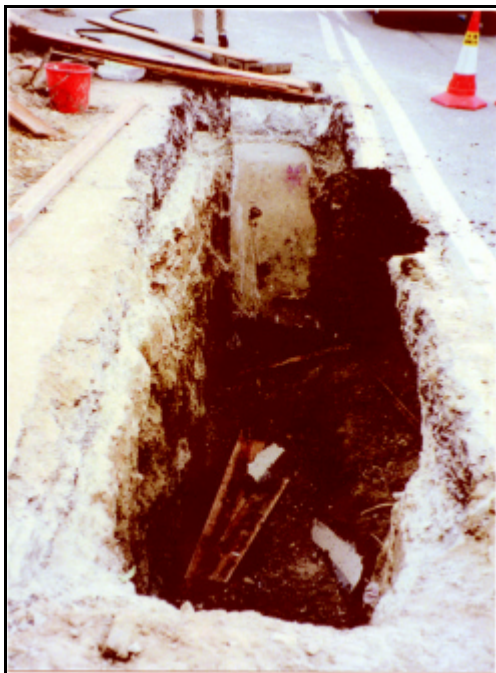
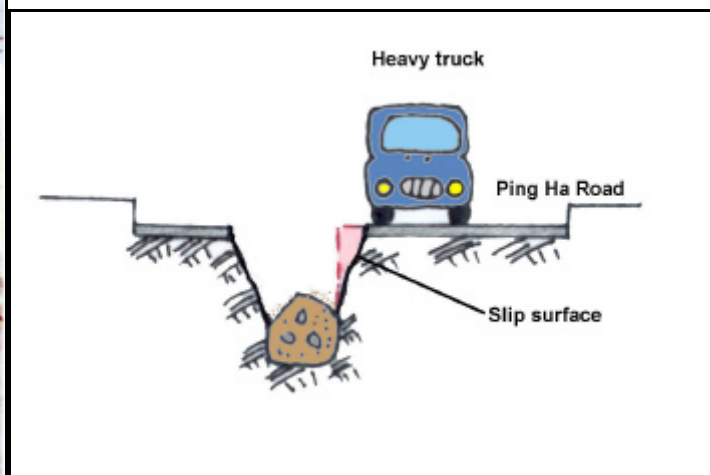
Case No.: 9

One worker was killed and one was injured

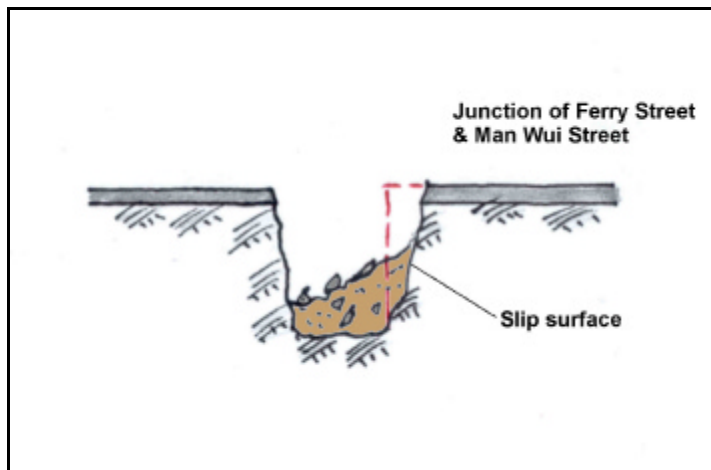
Case No.: 10

One worker was killed

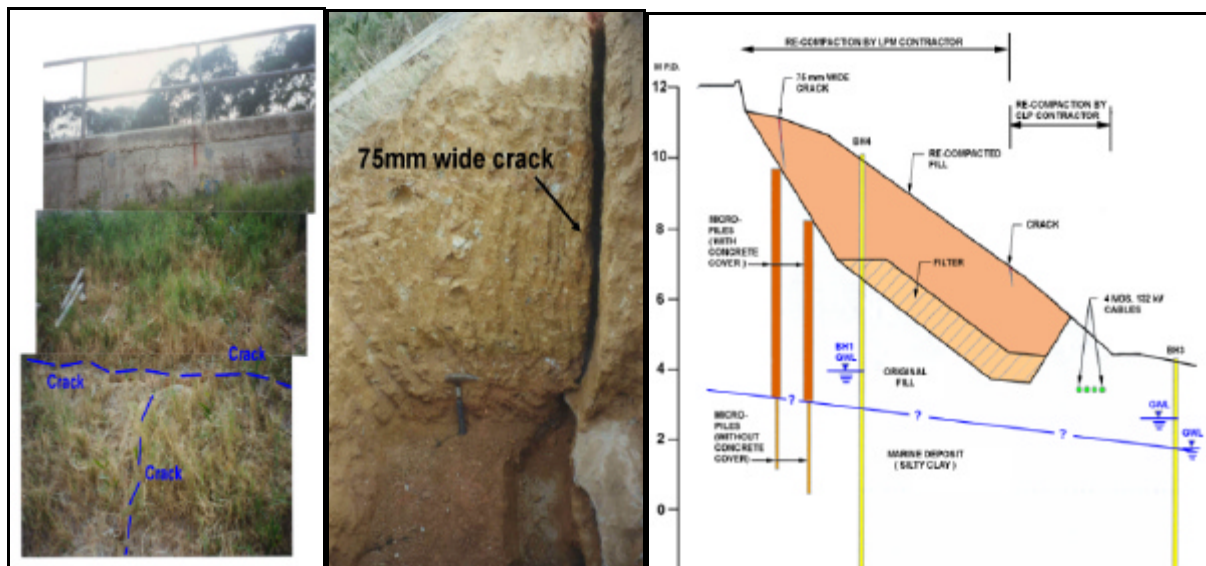
Case No.: 11

An utility undertaker (UU) dug a trench to locate four 132 kV electric cables found buried along the toe of a fill slope being compacted in December 1994. When compaction of the backfill in the trench was found not up to standard, the UU returned and recompact the backfill from July to September 1995. By that time compaction of the fill slope had long been completed. During a site inspection on 9.1.1996, it was noted that continuous cracks had developed on the fill slope.

- Removal of toe support during UU's excavation works
- Improper construction sequences
- Inadequate compaction of backfill

The entire fill slope had to be recompact.

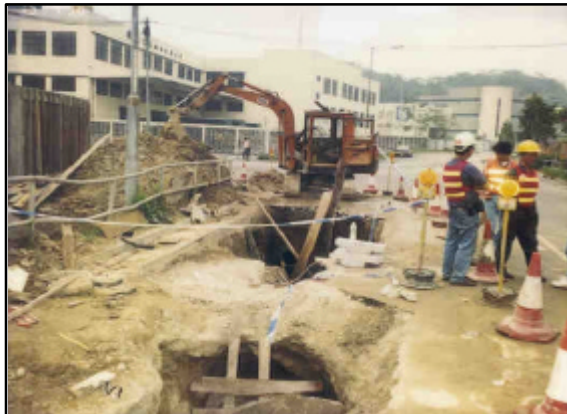
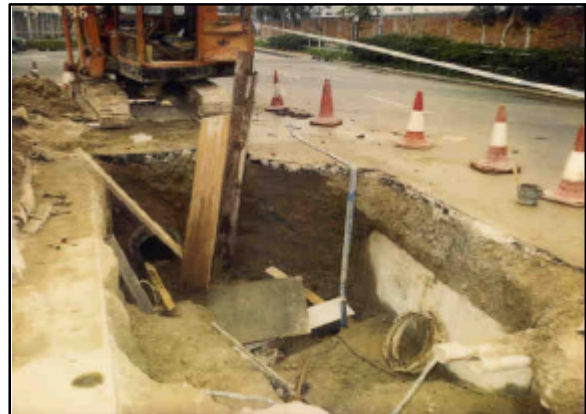
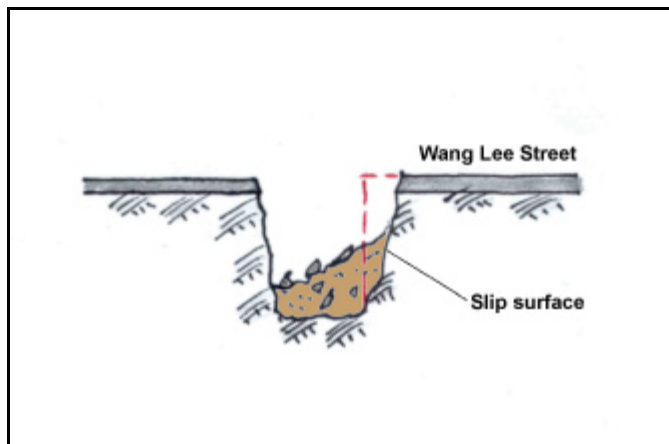
Case No.: 12

- Improper shoring
- Presence of water inside trench

One worker was killed

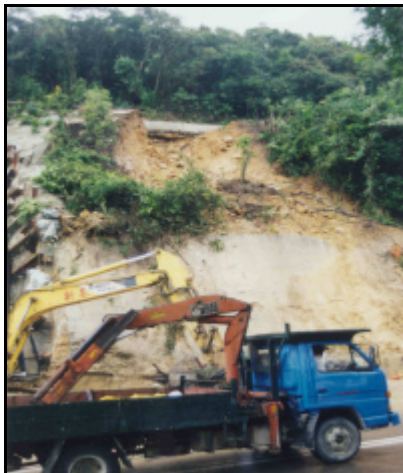
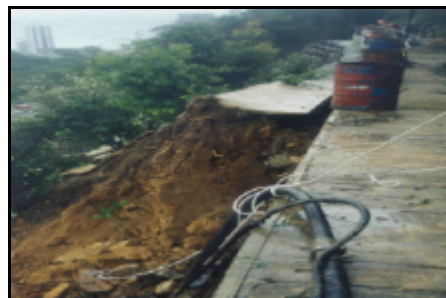
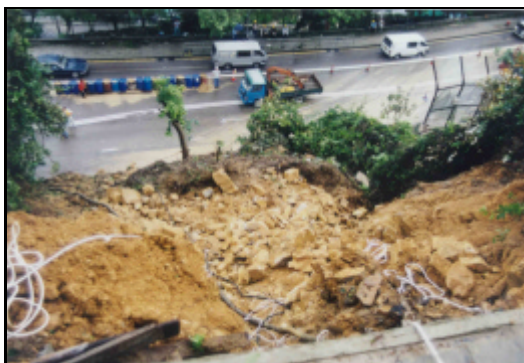
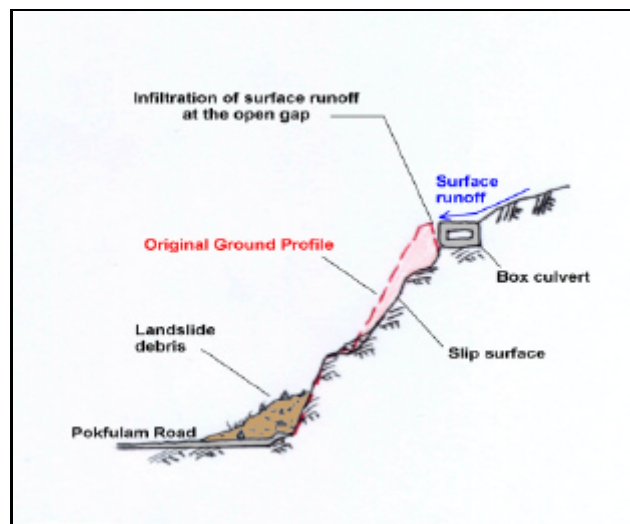
Case No.: 13

A new box culvert was being constructed at the slope crest. Water entered the open gap between the box culvert and the ground and infiltrated into the slope. A landslide occurred.

- Infiltration of water
- Inadequate drainage provisions (affected stability of the slope during rainfall)
- No protective apron has been constructed along the outside edge of box culvert

- Failure of a downslope
- Closure of Pokfulam Road

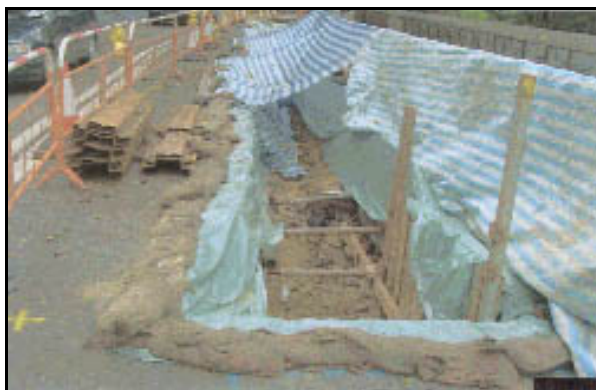
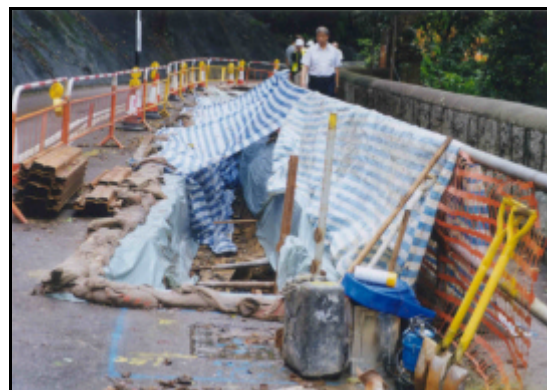
14-8-1999 (Before Landslide)

A trench was being excavated at the slope crest. Water entered the trench and infiltrated into the slope. A landslide occurred.

Inadequate drainage provisions

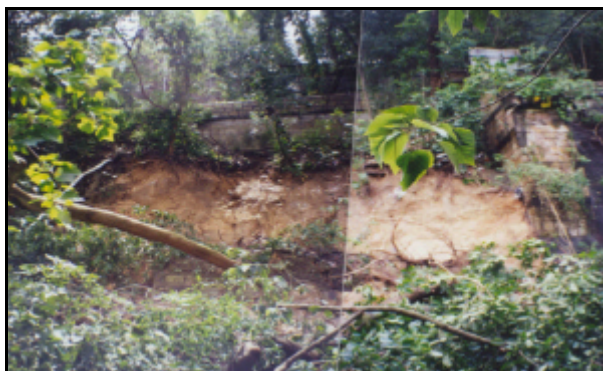
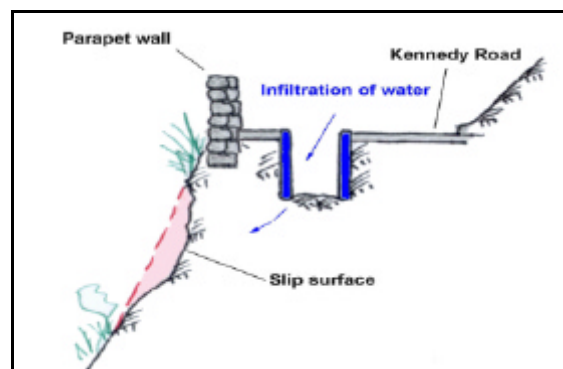
26-8-1999 (After Landslide)

- Vacant site and Kennedy Road affected
- Failure of a downslope

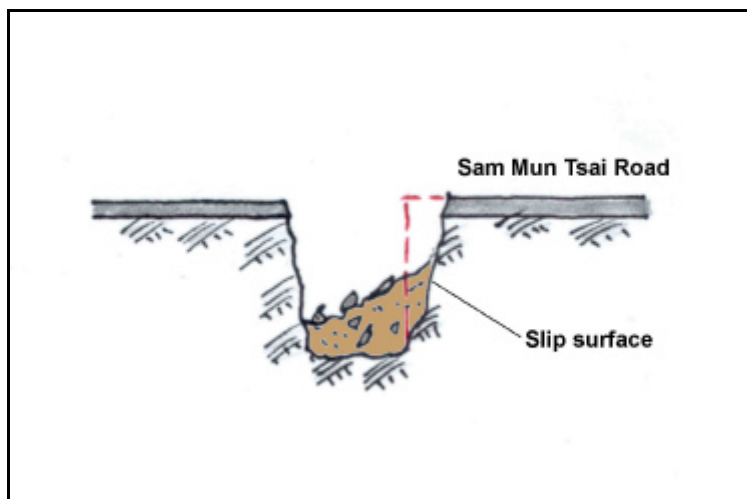
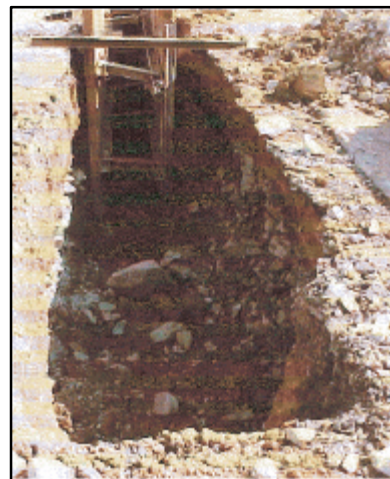
Case No.: 15

One worker was killed and one was injured

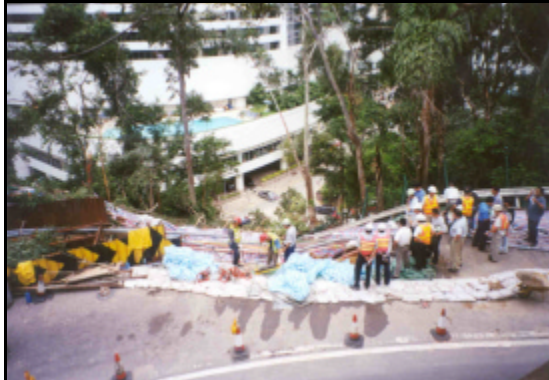
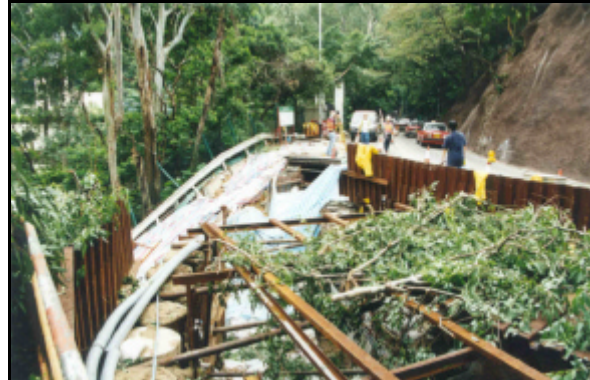
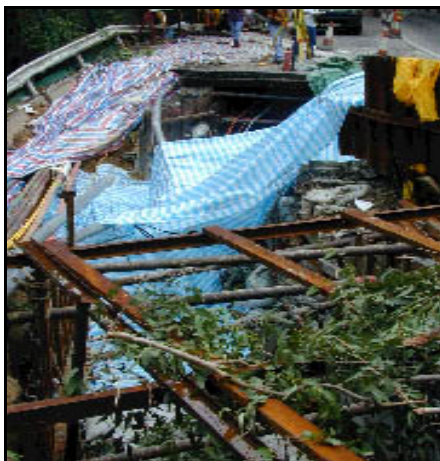
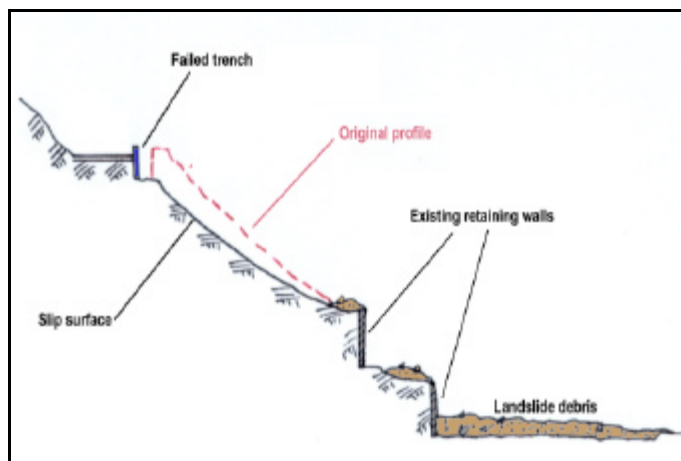
Case No.: 16

- One minor injury
- Closure of roads
- Damage to buildings
- Failure of a downslope
