ENHANCING THE RELIABILITY AND ROBUSTNESS OF ENGINEERED SLOPES

GEO REPORT No. 139

K.K.S. Ho, H.W. Sun & T.H.H. Hui

**GEOTECHNICAL ENGINEERING OFFICE
CIVIL ENGINEERING DEPARTMENT
THE GOVERNMENT OF THE HONG KONG
SPECIAL ADMINISTRATIVE REGION**

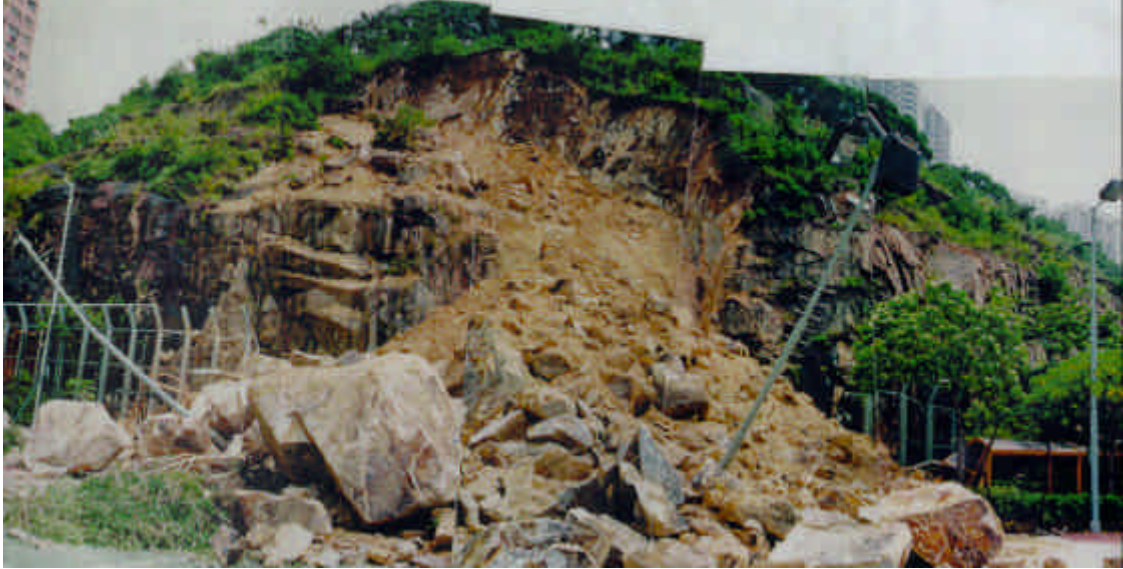
Plate 1 - The 26 September 1993 Landslide at Hiu Ming Street

Note: The landslide (200 m^3) affected a playground.

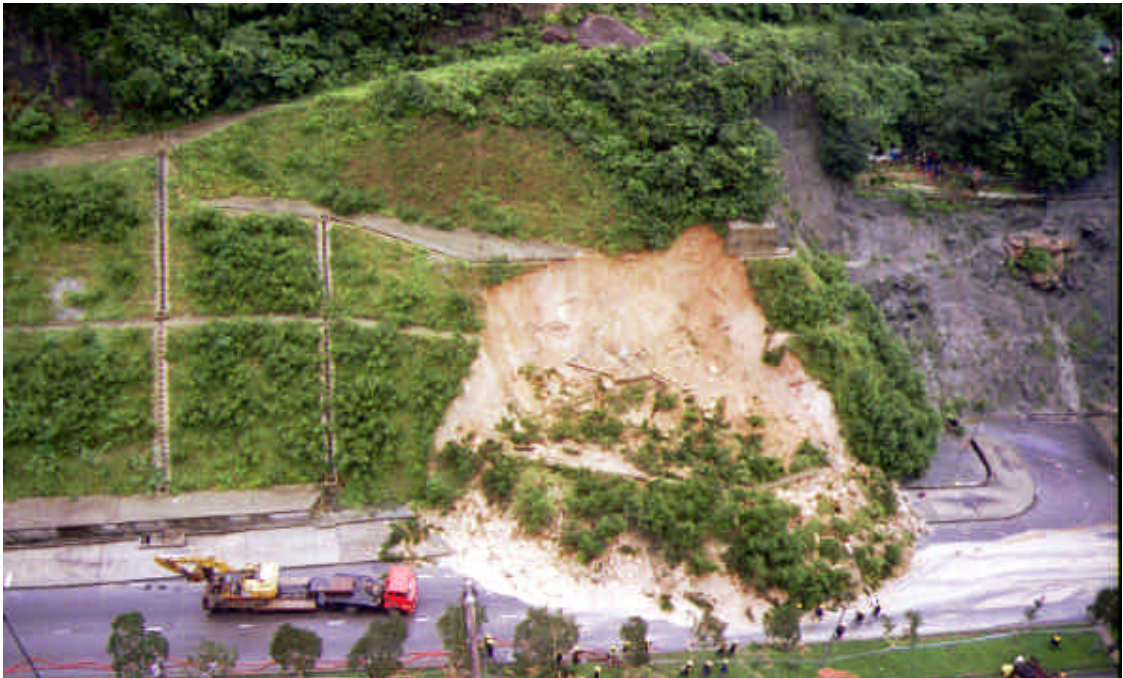
Plate 2 - The 25 July 1994 Landslide at New Clear Water Bay Road

Note: The landslide (500 m^3) completely blocked two traffic lanes of New Clear Water Bay Road.

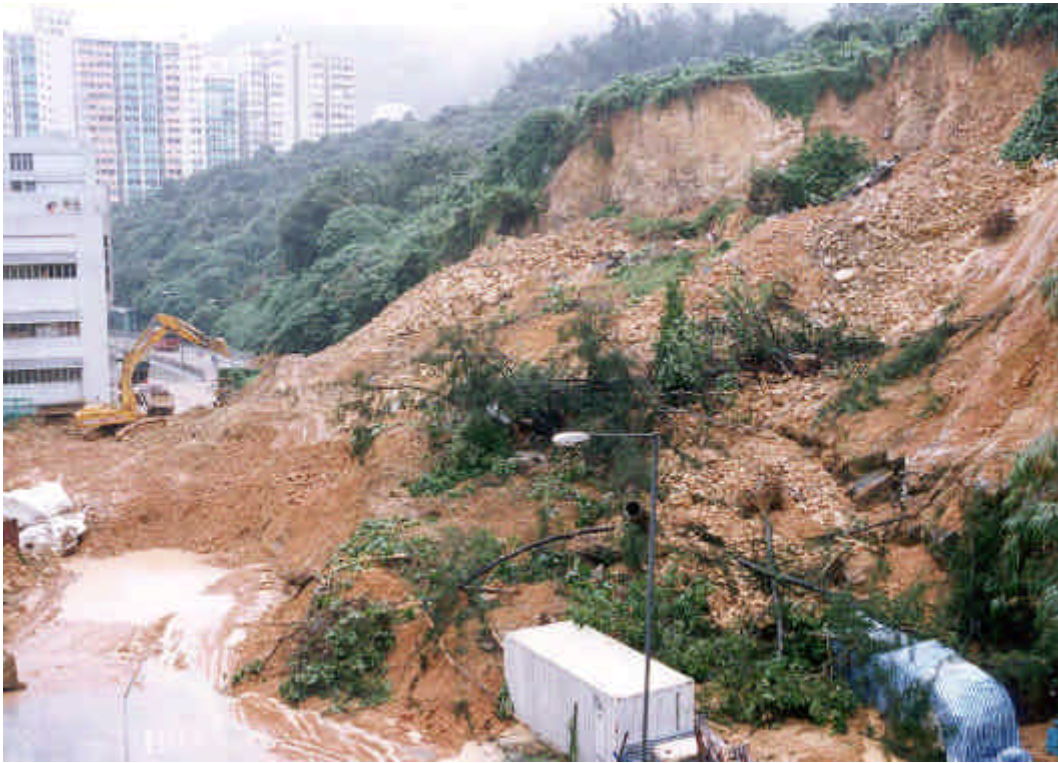
Plate 3 - The 13 August 1995 Landslide at Fei Tsui Road

Under-prediction of groundwater response has been a key problem in some of the large-scale failures. For example, the significant build-up of groundwater pressure above clay seams or infilled relict discontinuities not previously considered in slope design has contributed to deep-seated landslides (e.g. 1995 Fei Tsui Road landslide and the 1999 Shek Kip Mei landslide).

Note: The landslide ($14\,000\text{ m}^3$) resulted in one fatality.

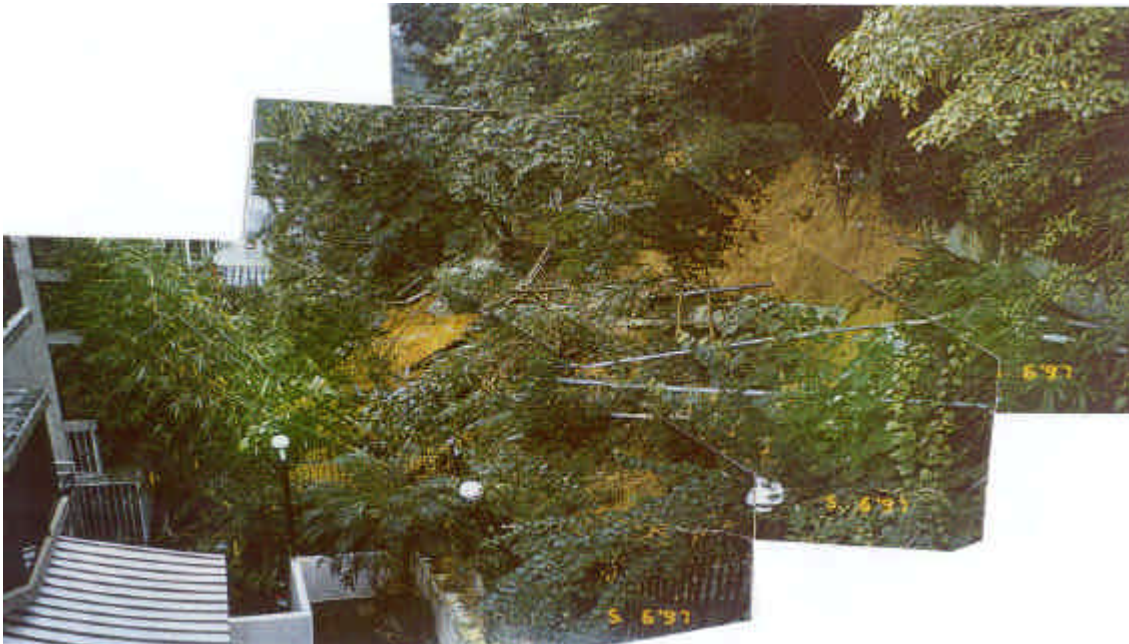
Plate 4 - The 4 June 1997 Landslide at Chung Shan Terrace, Lai Chi Kok

Note: The landslide (80 m^3) affected a residential building.

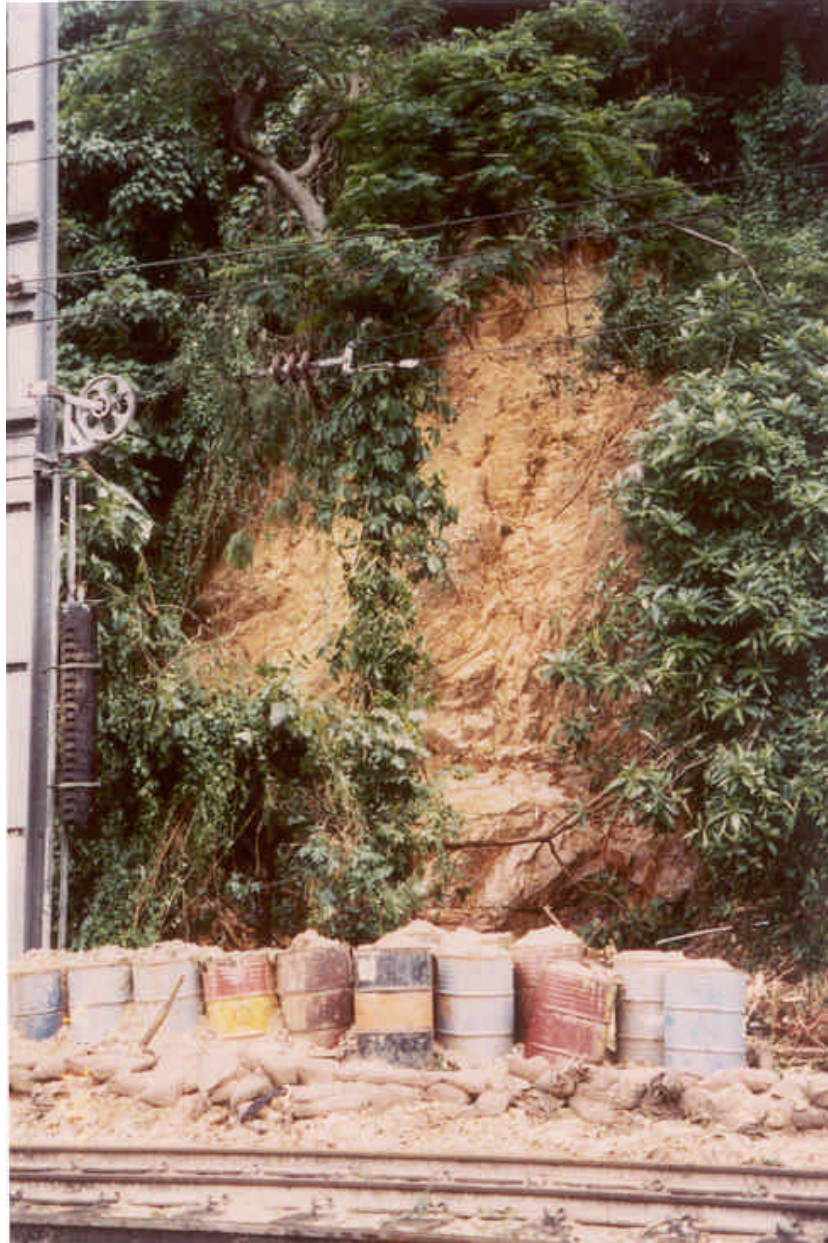
Plate 5 - The 2 July 1997 Landslide at Kowloon-Canton Railway Corporation (KCRC) University Station

Note: The landslide (30 m^3) affected the northbound KCRC railway track and caused disruption to the rail service.

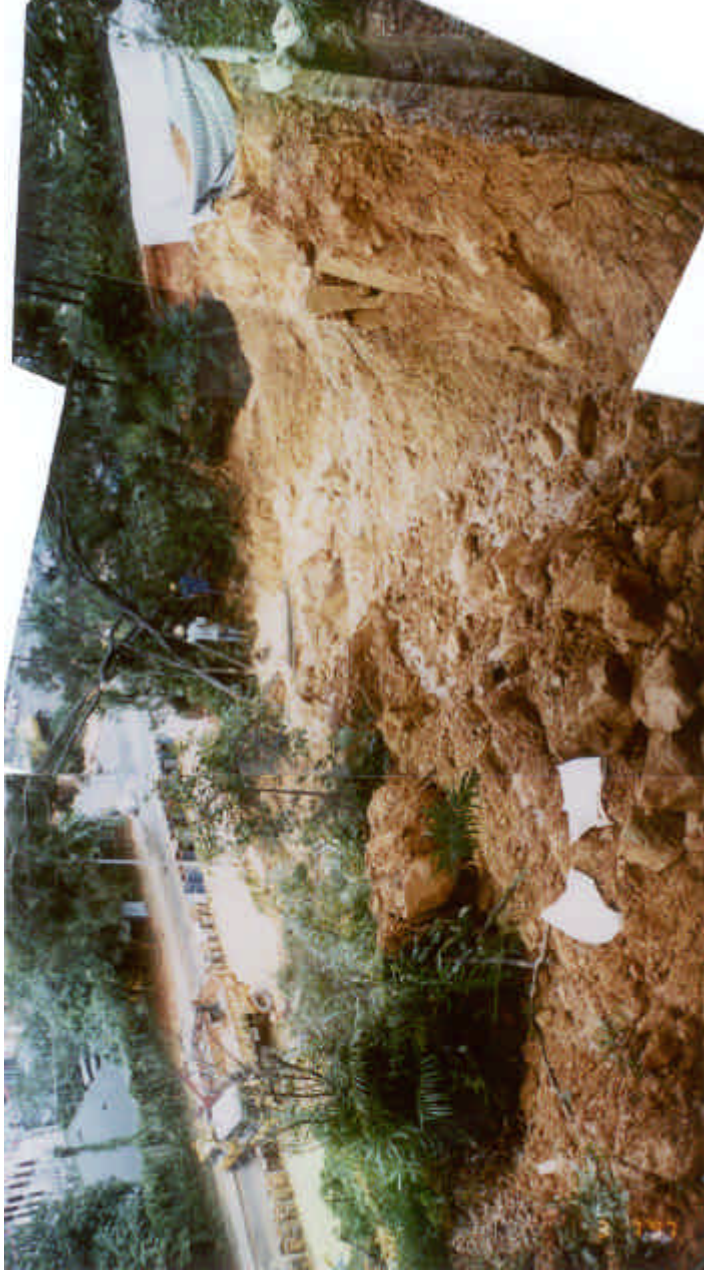
Plate 6 - The 3 July 1997 Landslide at Hong Tsuen Road, Sai Kung

Note: The landslide (250 m^3) completely blocked a two-lane road.

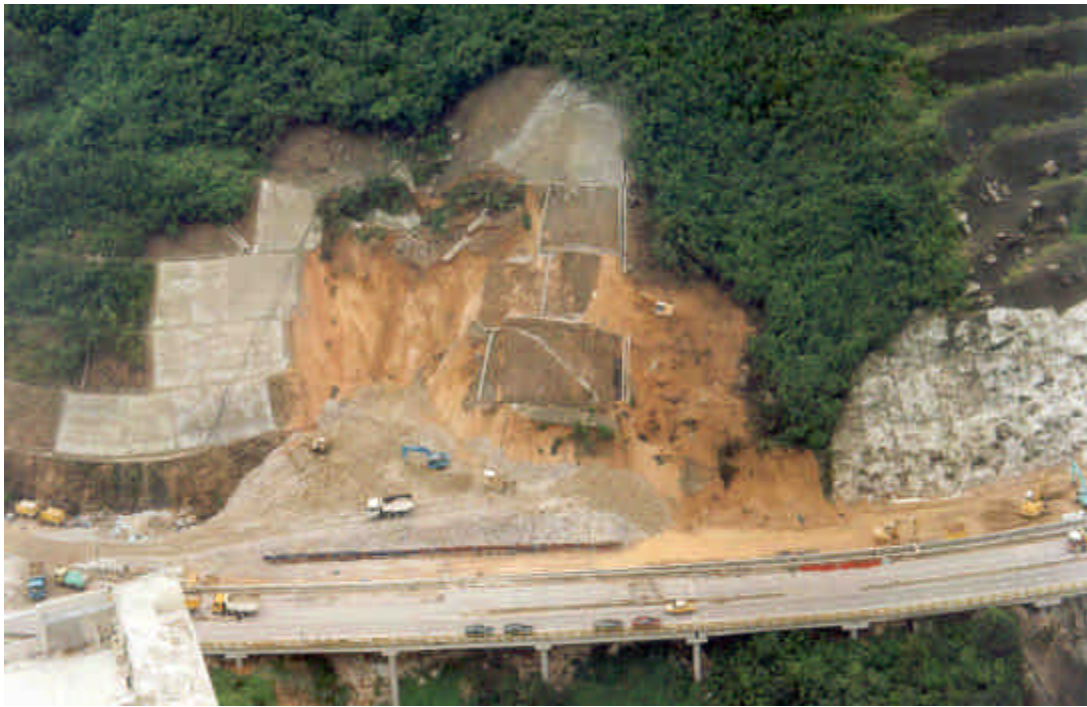
Plate 7 - The 3 August 1997 Landslide at Ching Cheung Road

Note: The landslide ($3\,200\text{ m}^3$) trapped a car and resulted in significant disruption to the traffic along Ching Cheung Road.

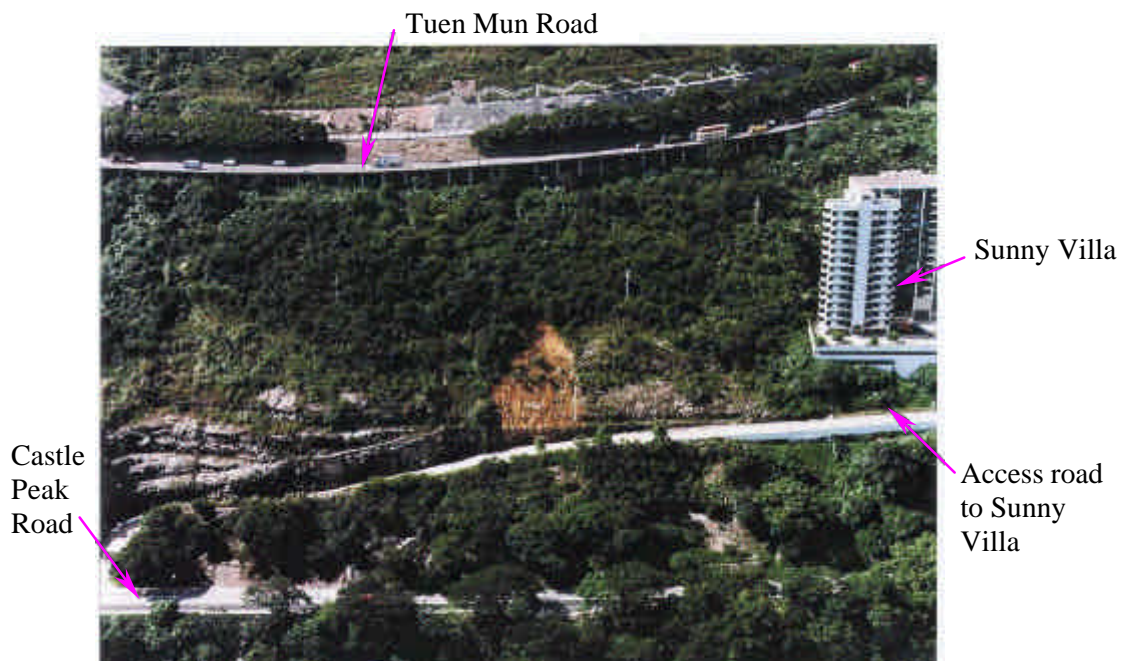
Plate 8 - The 9 June 1998 Landslide at Sunny Villa, Castle Peak Road

Note: The landslide (200 m^3) blocked an access road to several private residential blocks.

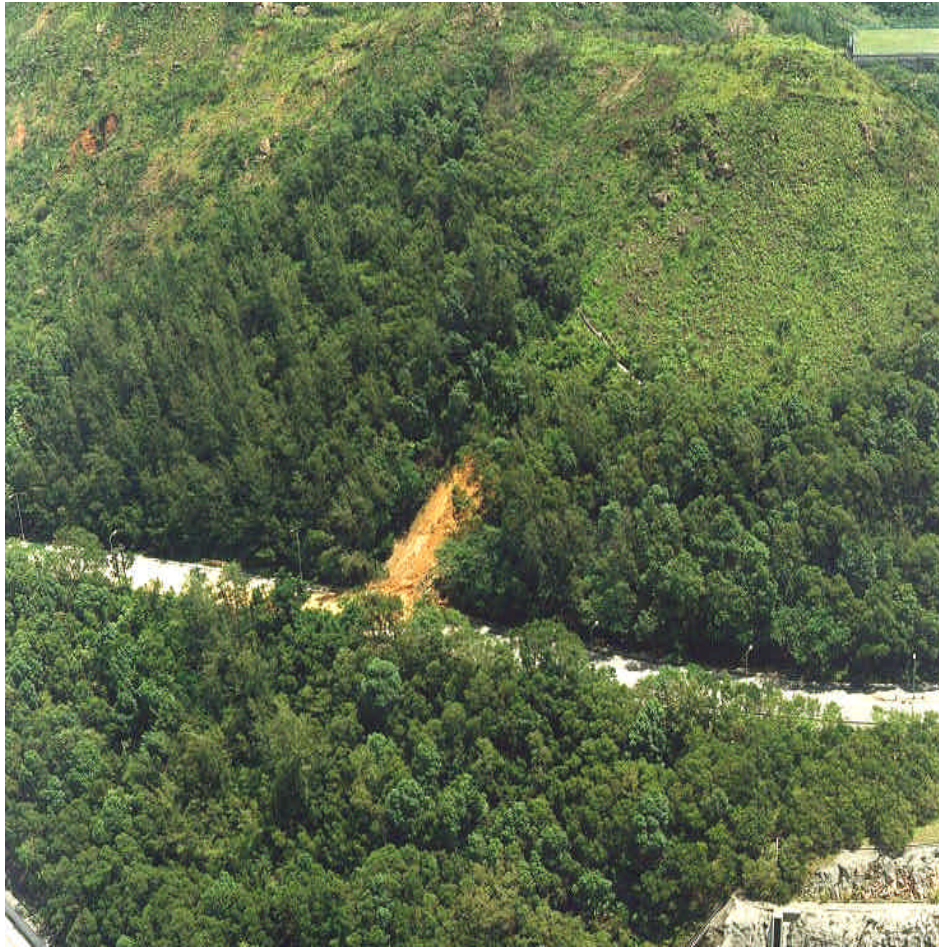
Plate 9 - The 24 August 1999 Landslide at Tsing Yi Road, Tsing Yi Island

Note: The landslide (1 000 m³) completely blocked a two-lane road and trapped a taxi and a lorry.

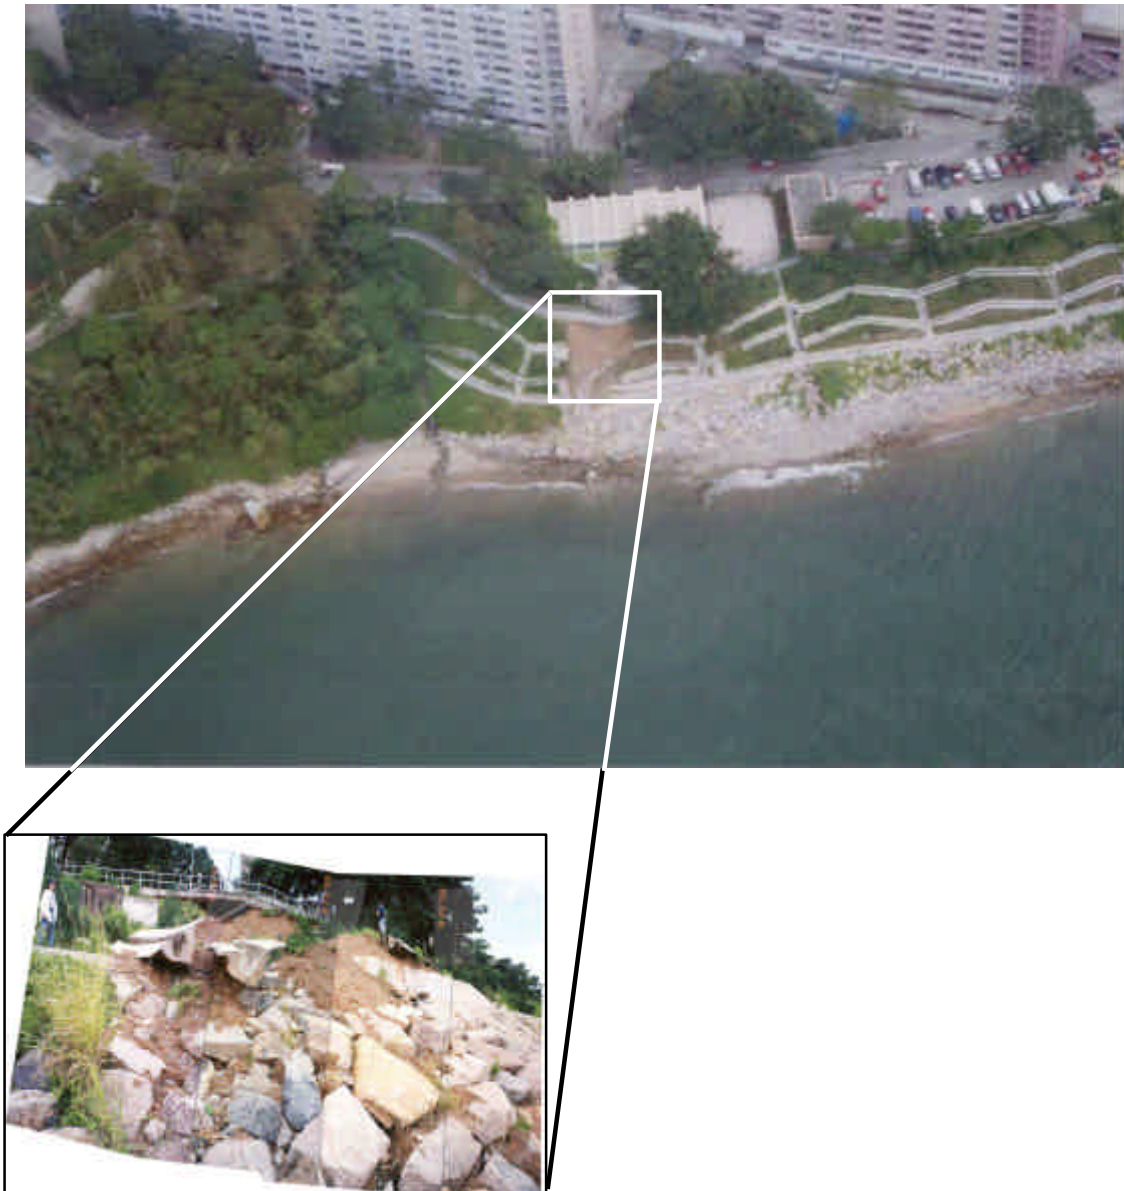
Plate 10 - The 24 August 1999 Landslide at Waterfall Bay Park, Wah Fu Estate

Note: The landslide (65 m^3) severed a footpath at the crest of the slope.
