**DETAILED STUDY  
OF THE 25 JUNE 2001  
ROCKFALL INCIDENT ON  
SLOPE NO. 11SE-A/C561  
ABOVE KING'S ROAD**

**GEO REPORT No. 150**

**Fugro Maunsell Scott Wilson Joint Venture**

**This report was originally produced in March 2002  
as GEO Landslide Study Report No. LSR 3/2002**

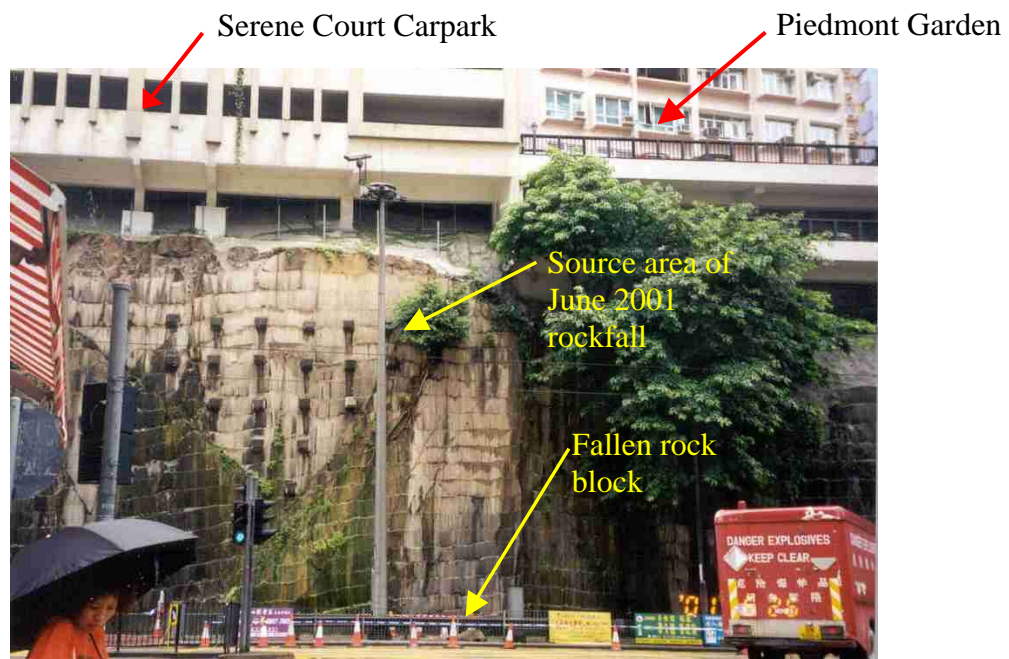
The rock cut face of slope No. 11SE-A/C561 exposes a large wedge, formed by the intersection of two persistent joint sets, below Serene Court (Plate 1). The toe of the wedge daylight about 3 m above the slope toe and the wedge is about 20 m wide at the slope crest. The wedge has previously been assessed and stabilised (see Section 4) by the installation of twenty rock bolts, the concrete heads of which are visible on the slope face.

Plate 1 - View East across King's Road towards Slope No. 11SE-A/C561 Showing Large Bolted Wedge Exposed in Slope Face, Source of Fallen Rock Block and Location of Fallen Block at Road Level (Photograph Taken on 26 June 2001)

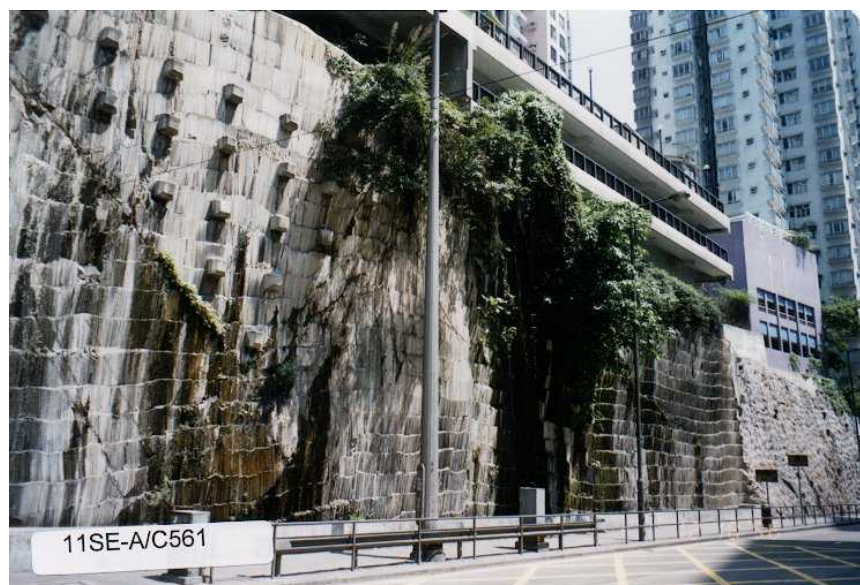
Plate 2 - View Southeast across King's Road towards Slope No. 11SE-A/C561 Showing Vegetation Growing on Slope Face and Seepage Issuing from Joints Defining Large Wedge (Photograph Taken in April 1996)

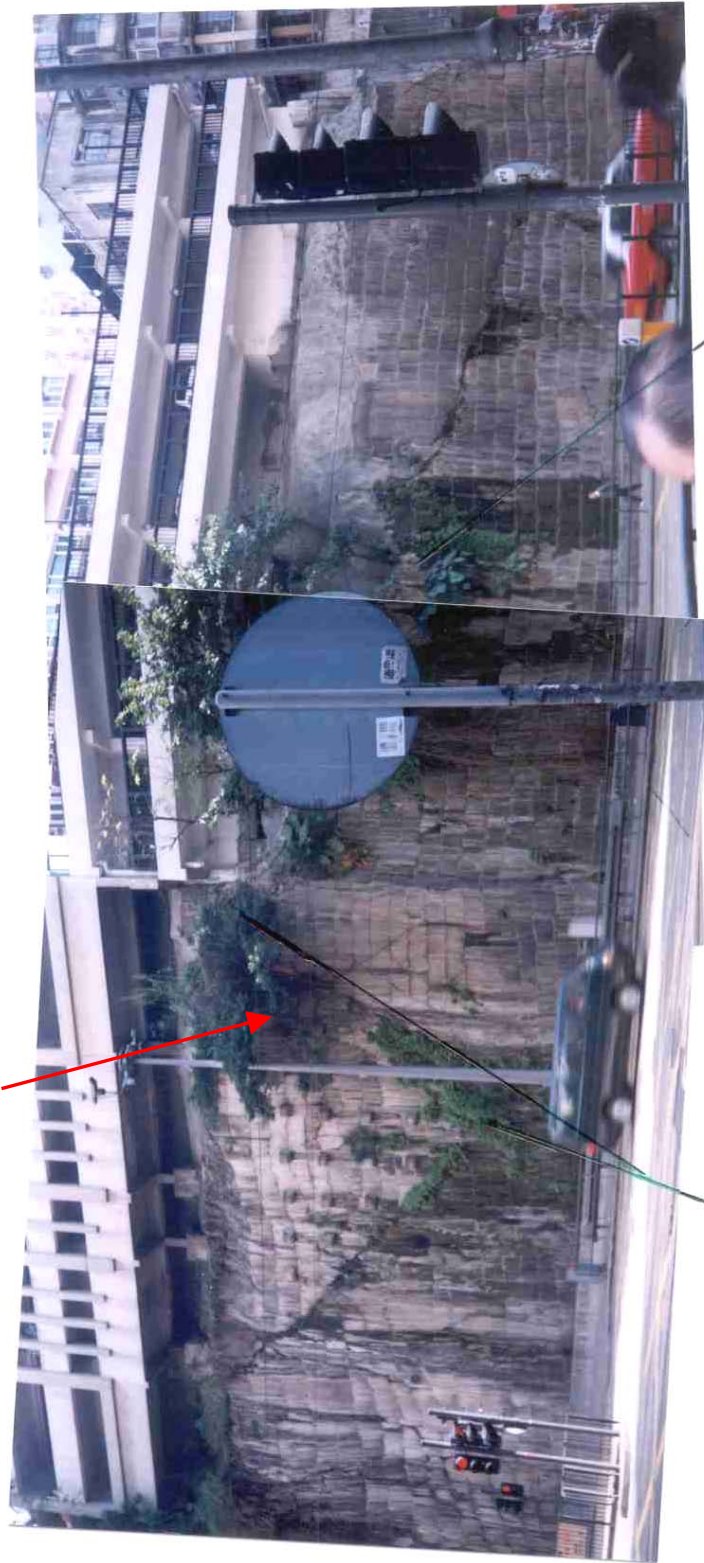
Clear vegetation

Plate 3 - View East towards Slope No. 11SE-A/C561 Showing Vegetation Growing on Slope Face. Handwritten Annotations are by the HyD and Identify Recommended Vegetation Clearance Following Routine Maintenance Inspection in December 1998.

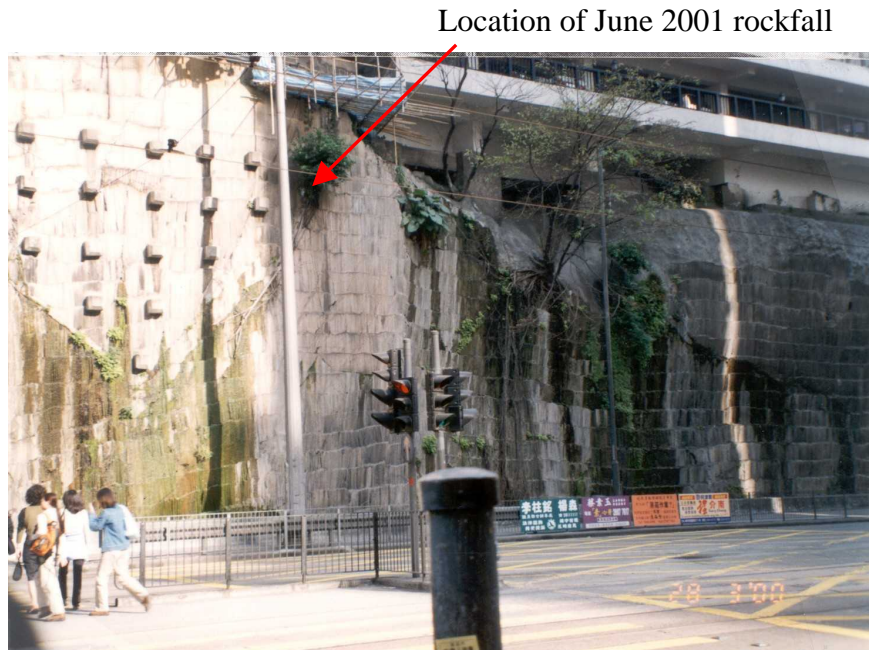
Plate 4 - View East across King's Road towards Slope No. 11SE-A/C561  
Showing Tree Growing on Slope Face at Location of June 2001  
Rockfall (Photograph Taken by MGS in March 2000)

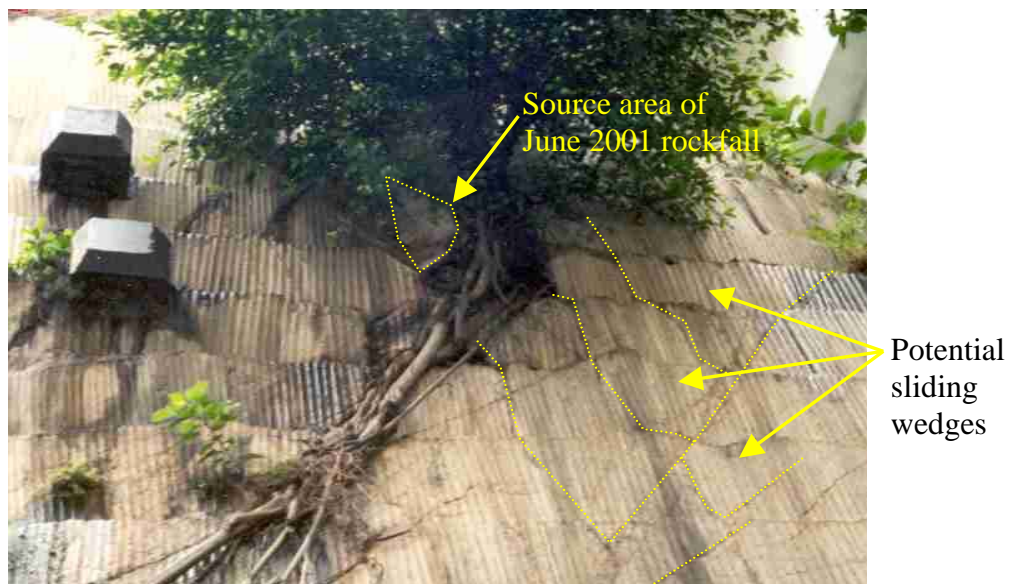
Root growth from the tree on the slope face near the source area of the June 2001 rockfall (Plate 5) was observed to extend above and below the trunk along joint apertures. Due to the relative location of the source area on the slope face, close inspection was not possible. However, the source area was located in the area affected by tree root growth. From the road level, the exposed surfaces in the source area appeared relatively clean and free of infill and/or staining (Plate 5). No seepage was observed issuing from joint apertures in the vicinity of the source area at the time of the inspection when there was no rain.

The detached rock block was probably in a metastable condition as a result of progressive tree root growth penetrating into adverse joint apertures and wedging them open. The exposed surfaces of the detached rock block and the source area of the June 2001 rockfall were generally clean and free from staining or infill material, suggesting that the destabilising mechanism involved displacement of the block (by the jacking action of the tree roots and possible build-up of cleft water pressure in the open joint) as opposed to deterioration of the joint surfaces. Record photographs indicate that a small wedge failure may have occurred below the toe of the failed block in 1999, which could have contributed to the June 2001 rockfall.

Plate 5 - Close View of Slope Face Showing Source Location of Rock Fall  
Immediately above Tree (Unplanned Vegetation) Growing on Slope  
Face. Intersection of Predominant Joint Orientations Results in  
Potential Sliding Wedges (Photograph Taken on 26 June 2001)

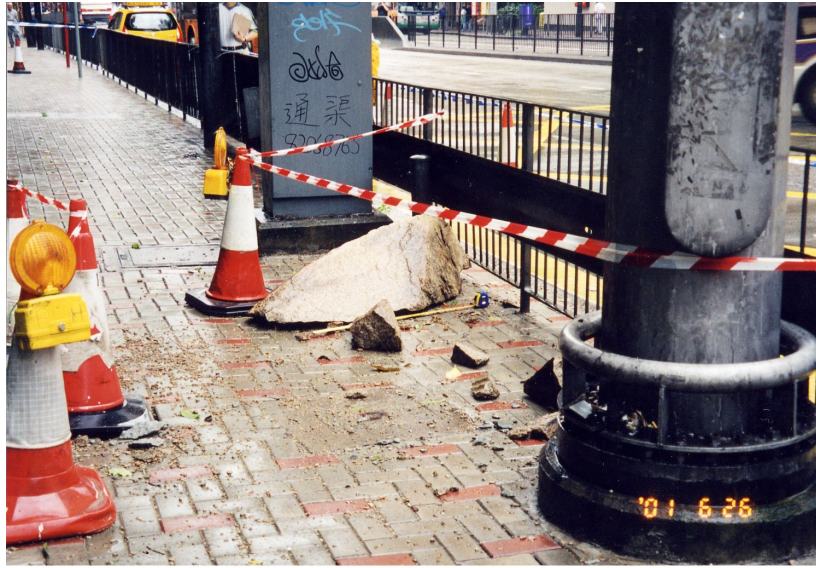
Plate 6 - View South along King's Road Footway Showing Detached Rock Block and Associated Fragments. Note Wedge-shaped Geometry of Block. (Photograph Taken on 26 June 2001)

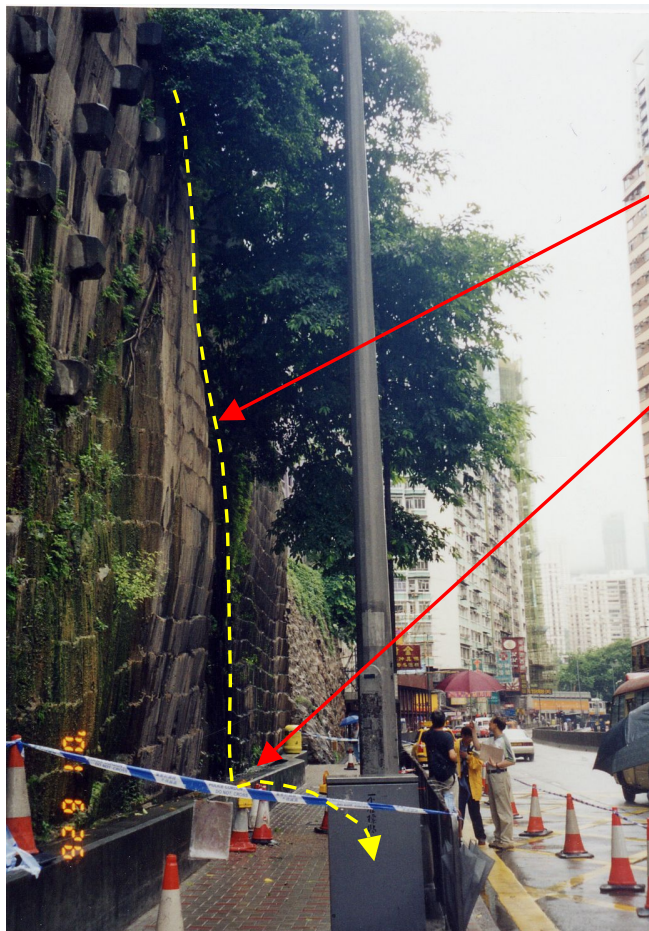
The detached rock block (Plate 6) probably struck the toe wall (Plate 7), as evidenced by recent minor damage, which broke a number of smaller fragments from the block. The detached rock block and smaller fragments came to rest on the King's Road pedestrian footway. The footway and westbound lane of King's Road were temporarily closed as a result of the rockfall. No injuries or other damage resulted from the incident.

Probable path of rock block

Impact with toe wall

Plate 7 - View South along King's Road Footway Showing Near-vertical Face of Slope No. 11SE-A/C561 and Probable Path of Fallen Rock Block, with Impact on Toe Wall. (Photograph Taken on 26 June 2001)

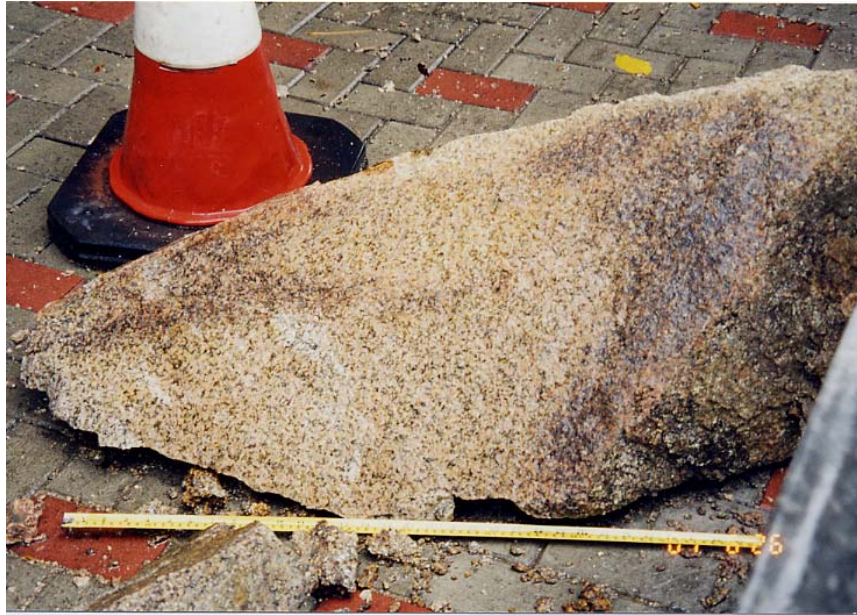
Plate 8 - Close View of Detached Rock Block Showing Clean Joint Surfaces Free of Staining and/or Infill Material. (Photograph Taken on 26 June 2001)

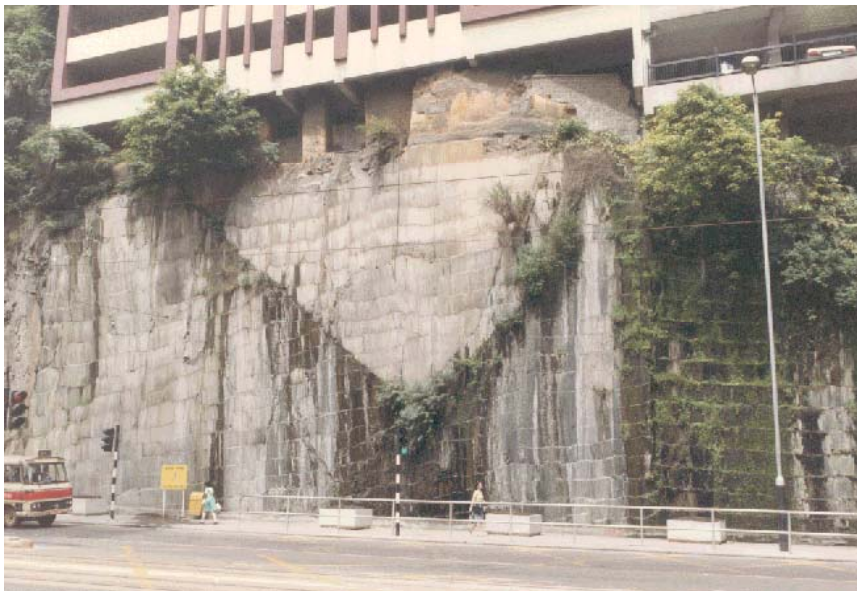
Plate 9 - View East across King's Road towards Slope No. 11SE-A/C14 Prior to Installation of Rock Bolts in Large Wedge Exposed in Slope Face. Note Seepage from Joint Sets Forming Wedge and Vegetation Growing on Slope Face, Notably at Location of June 2001 Rockfall. (Photograph Taken in 1983)

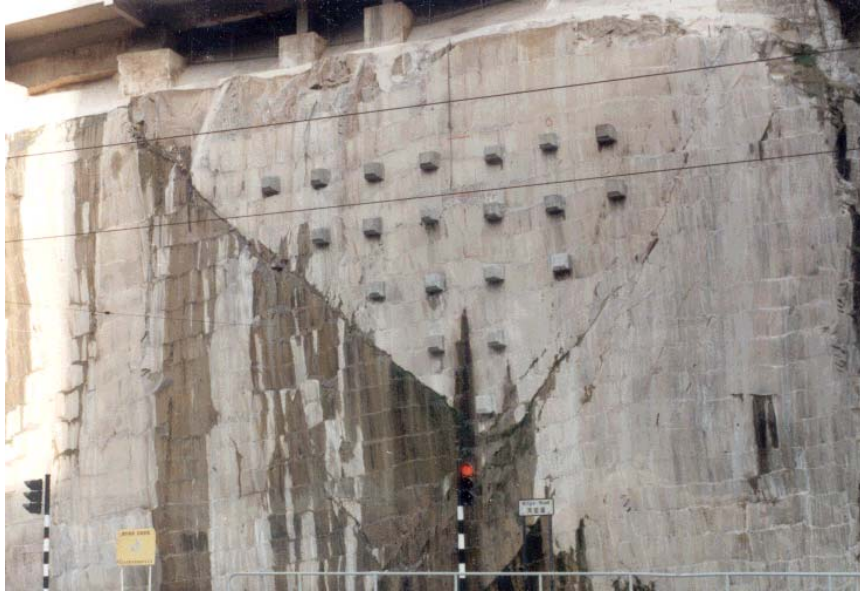
Plate 10 - View East across King's Road towards Slope No. 11SE-A/C14 Following Installation of Rock Bolts in Large Wedge Exposed in Slope Face. Note Seepage from Joint Sets Forming Wedge. Vegetation on Slope Face in 1983 Photograph (Plate 9) Removed. (Photograph Taken by the GEO in January 1984)

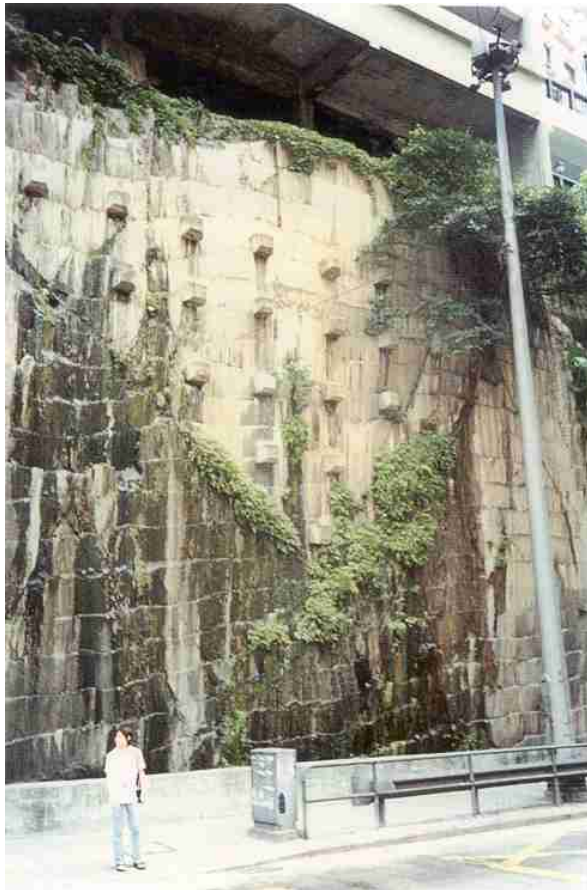
Plate 11 - View Southeast across King's Road towards Slope No. 11SE-A/C561 Showing Vegetation Growing on Slope Face and Seepage Issuing from Joints Defining the Large Wedge. (Photograph Taken by HAP in May 1998)

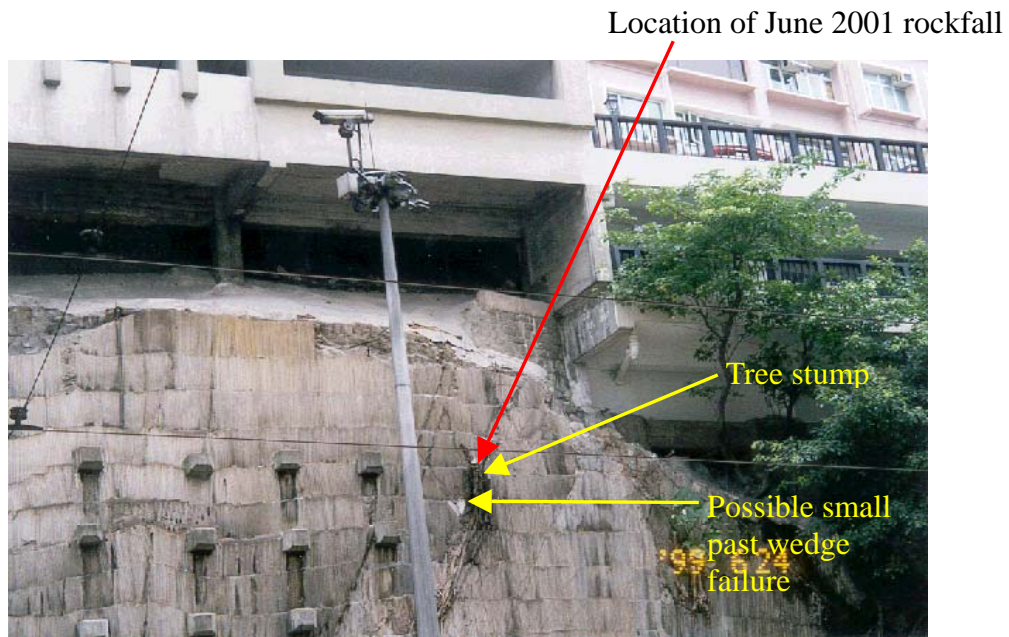
adjacent to the 2001 rockfall source area to have been heavily trimmed to the main trunk, but not entirely removed. The photograph also shows an area with an apparently 'missing' small wedge (estimated size about 0.3 m by 0.3 m by 0.3 m) adjacent to the base of the tree, which is coincident with the lower extent of the June 2001 rockfall source area, suggesting possible previous minor failure.

Plate 12 - View East towards Slope No. 11SE-A/C561 Showing Tree Stump at Source Location of June 2001 Rockfall Remaining on Slope Face Following Routine Maintenance Works. Note also Possible Small Past Wedge Failure Adjacent to Tree Stump. (Photograph Taken by the GE on 24 June 1999)

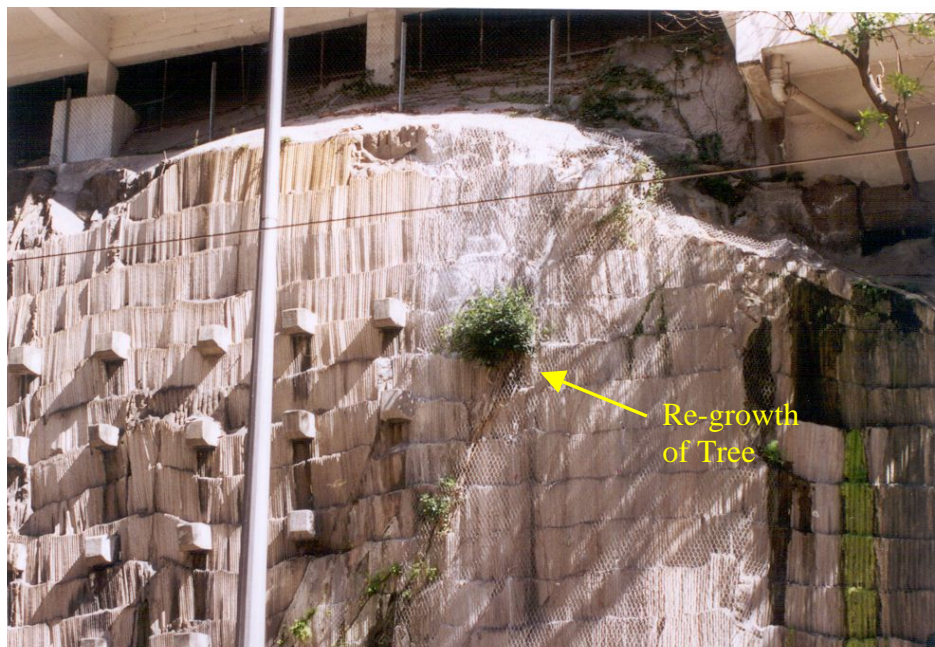
Plate 13 - View East towards Slope No. 11SE-A/C561 in November 2001 Showing Tree Remaining on Slope Face and Regeneration to have Commenced. (Photograph Taken on 7 November 2001)
