**DETAILED STUDY
OF THE 9 JUNE 2001
ROCKFALL INCIDENT
AT SLOPE NO. 11NW-A/C58
AT CASTLE PEAK ROAD
BELOW WAH YUEN CHUEN**

GEO REPORT No. 151

Maunsell Geotechnical Services Ltd.

**GEOTECHNICAL ENGINEERING OFFICE
CIVIL ENGINEERING AND DEVELOPMENT DEPARTMENT
THE GOVERNMENT OF THE HONG KONG
SPECIAL ADMINISTRATIVE REGION**

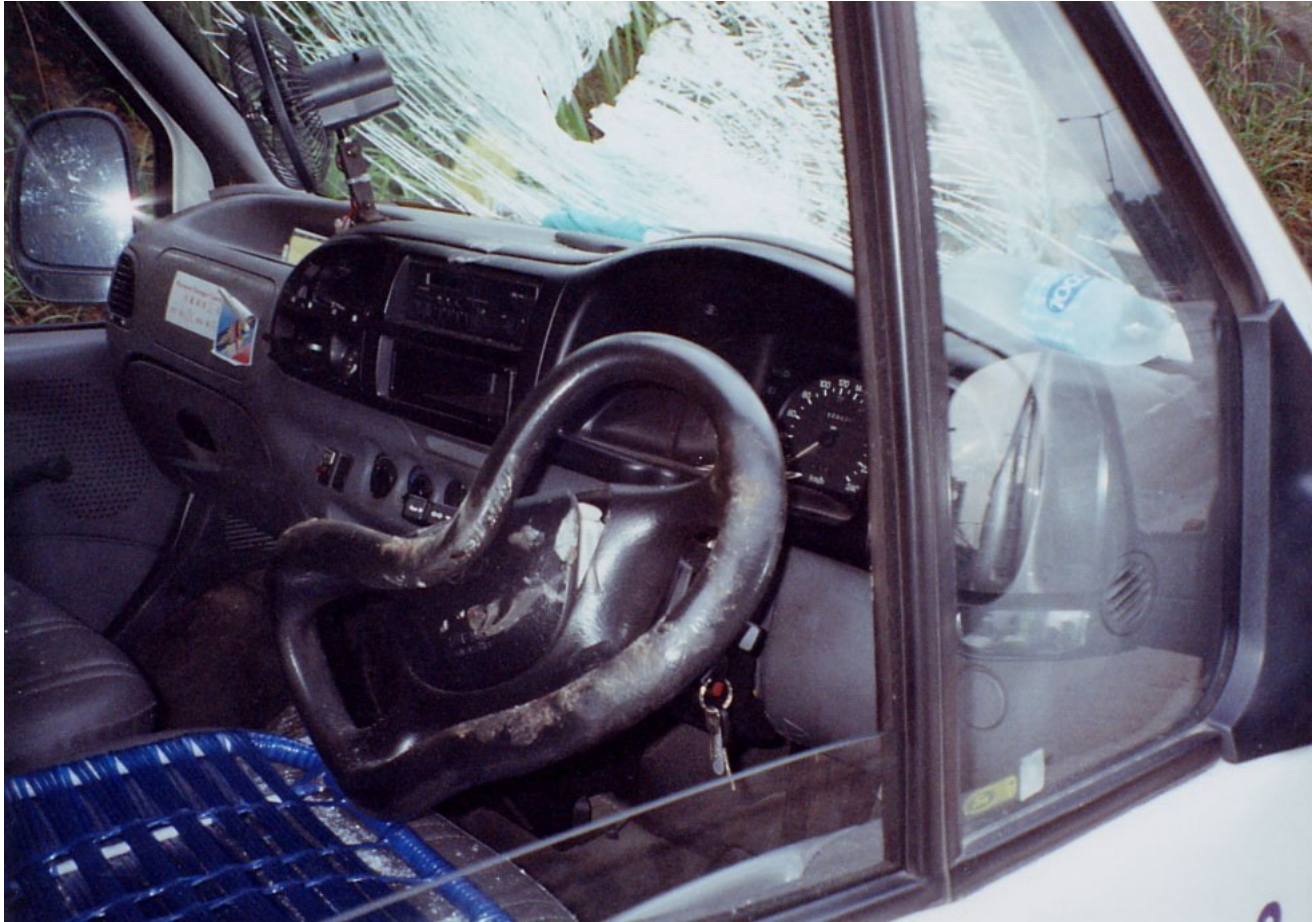
According to the driver and the passenger of the van, the road surface was slightly wet at the time. Just before the accident, the driver of the Post Office van observed a rock fragment as it fell onto the road some 10 m in front of the van while the van was travelling on the inside lane of the southeast bound carriageway of Castle Peak Road. Another rock fragment punched through the windscreen and severely damaged the steering wheel (Plate 1). The driver and the passenger could not identify the source of the fallen rocks. The driver became unconscious and lost control of the van which continued along the road, mounted the footpath and skidded along the toe of the slope before coming to a halt against the slope. As a result, the driver and the only passenger, who was also in the front seat of the van, were injured.

Plate 1 - View of Damage to Windscreen and Steering Wheel Caused by Falling Rock Fragment
(GEO Incident No. MW2001/06/007) (Photograph taken by Police on 9 June 2001)

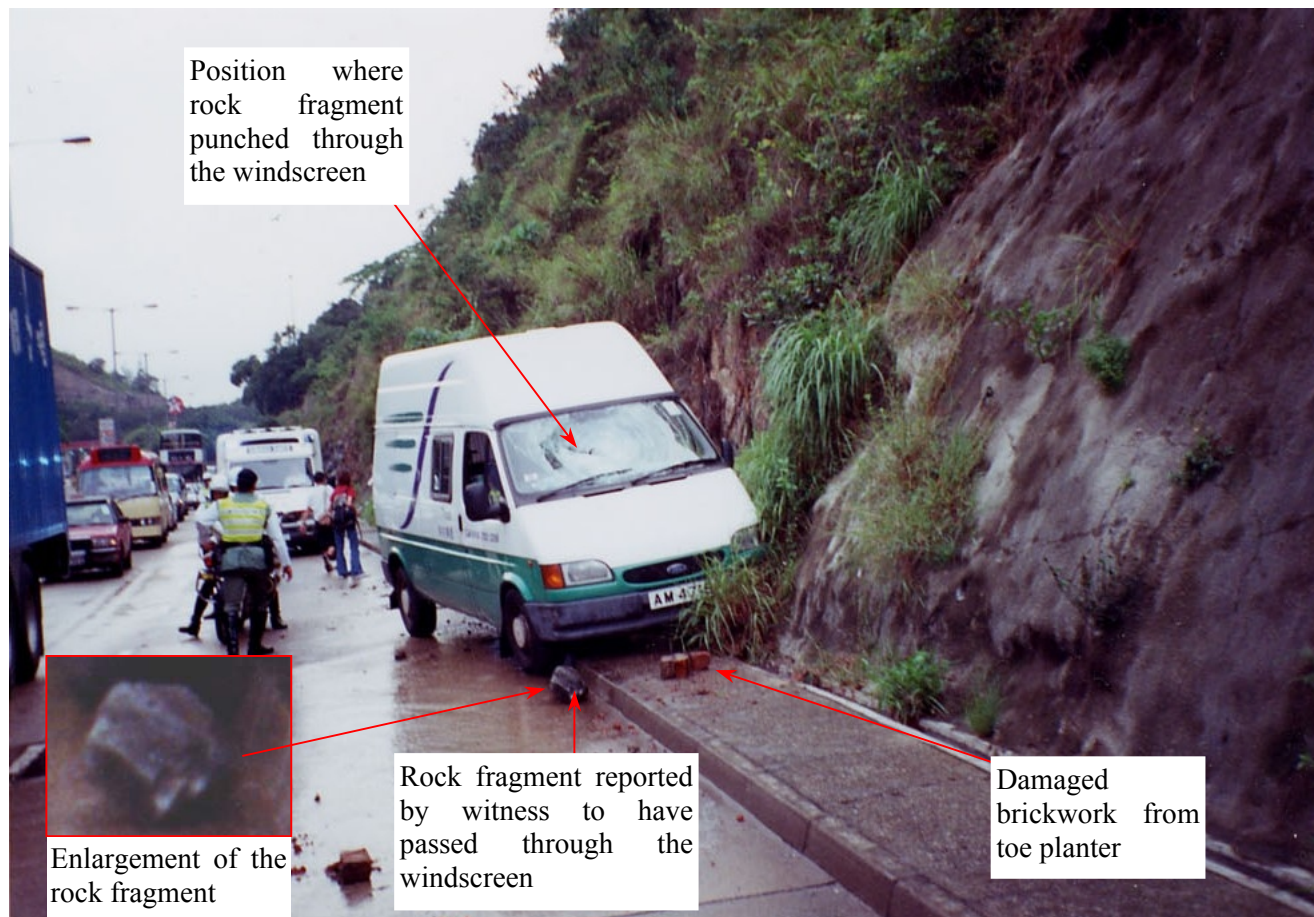
The rock fragment which punched through the windscreen was sub-angular, spherical in shape and about 300 mm in size (Plate 2). It is apparent that the van travelled some distance after the rockfall but this distance is unknown and it is therefore difficult to determine the exact location on the rock face from which the rock fragments have detached. The poor condition of the rock face with unplanned vegetation and a notable number of loose blocks also renders it difficult to establish the precise location of the source of the rockfall. The position of the van after the accident is shown on Figure 2. Based on the skid marks along the slope toe (Plate 3), the van probably travelled at least 10 m after the impact by the rock fragment.

Plate 2 - View from Front of Post Office Van after Rockfall Incident (GEO Incident No. MW2001/06/007)
(Photograph taken by Police on 9 June 2001)

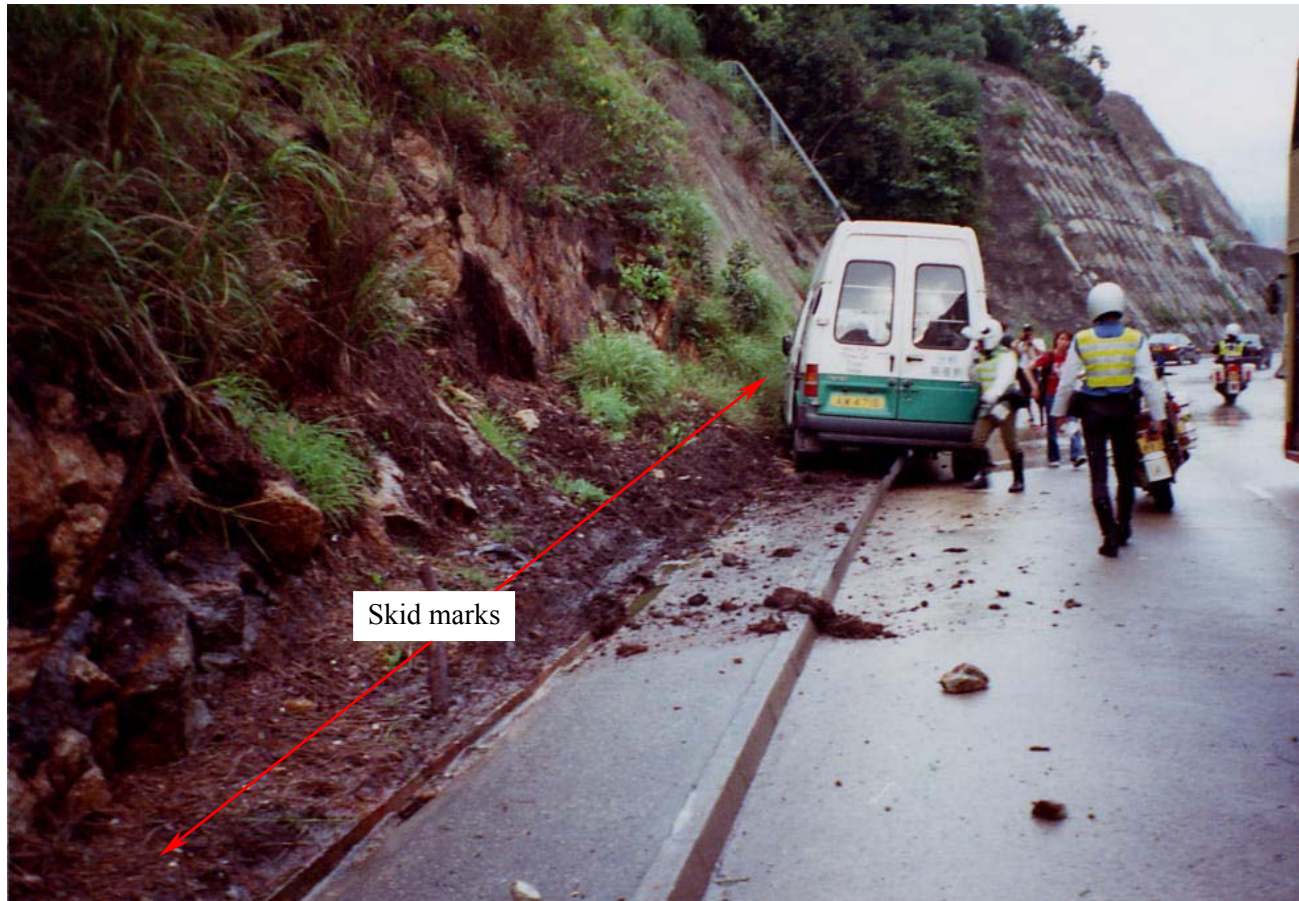
Plate 3 - View from Rear of Post Office Van after Rockfall Incident (GEO Incident No. MW2001/06/007)
(Note skid marks at toe of slope shows the van travelled at least 10 m after the incident.
Photograph taken by Police on 9 June 2001)

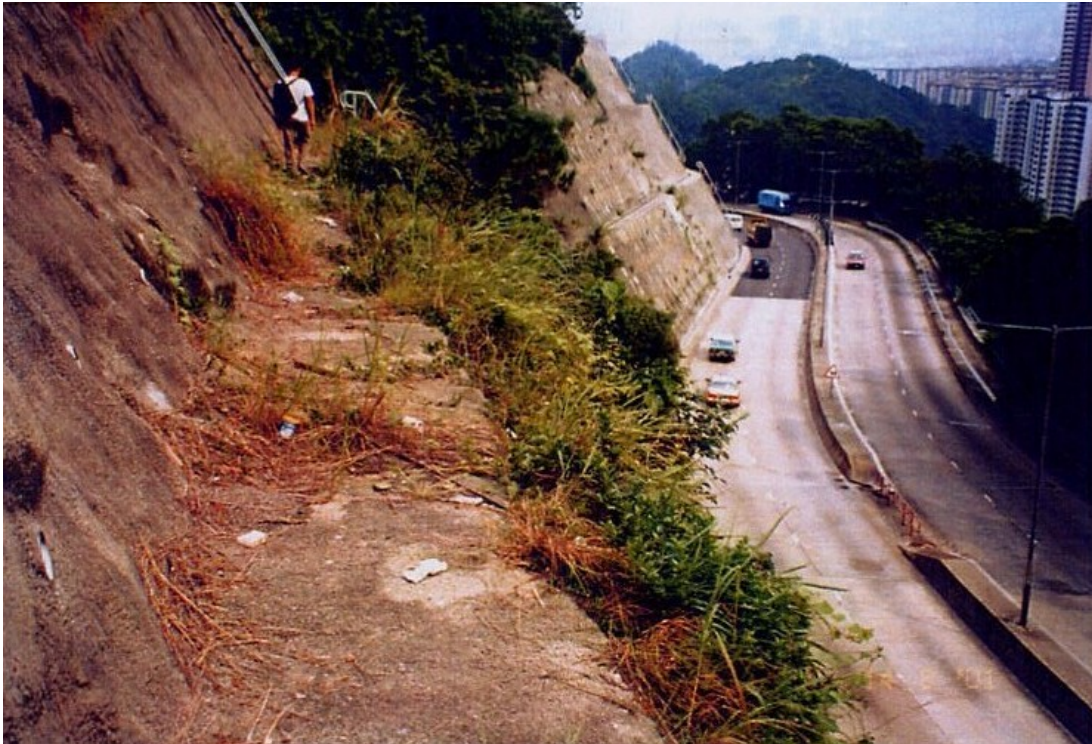
Plate 6 - View of Second Berm on Slope No. 11NW-A/C58 (Note there is no drainage provision on the berm near the southeastern end. Photograph taken on 14 August 2001)

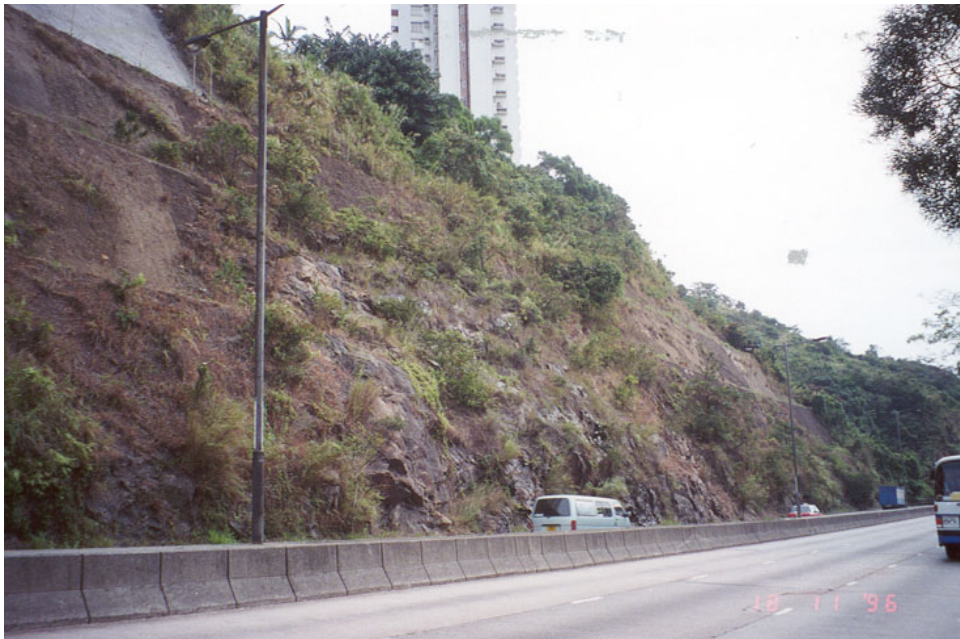
On 28 October 1996, HyD informed the GEO that they would shortly shotcrete slope No. 11NW-A/C58 (see Section 2.4.1). The GEO’s Design Division inspected the slope in November 1996 just after the commencement of the shotcreting works. The GEO inspection record noted seepage along joints on the exposed rock portion of the slope below the second berm. No record of loose rock blocks was mentioned in the GEO’s inspection record. Areas of unplanned vegetation on the exposed rock portion of the slope are shown in the accompanying photographs (Plate 10) and indicated in a sketch attached to the inspection record.

Plate 10 - General View of Slope No. 11NW-A/C 58 in 1996 showing Unplanned Vegetation on Exposed Rock Portion (Photograph taken by GEO on 18 November 1996)

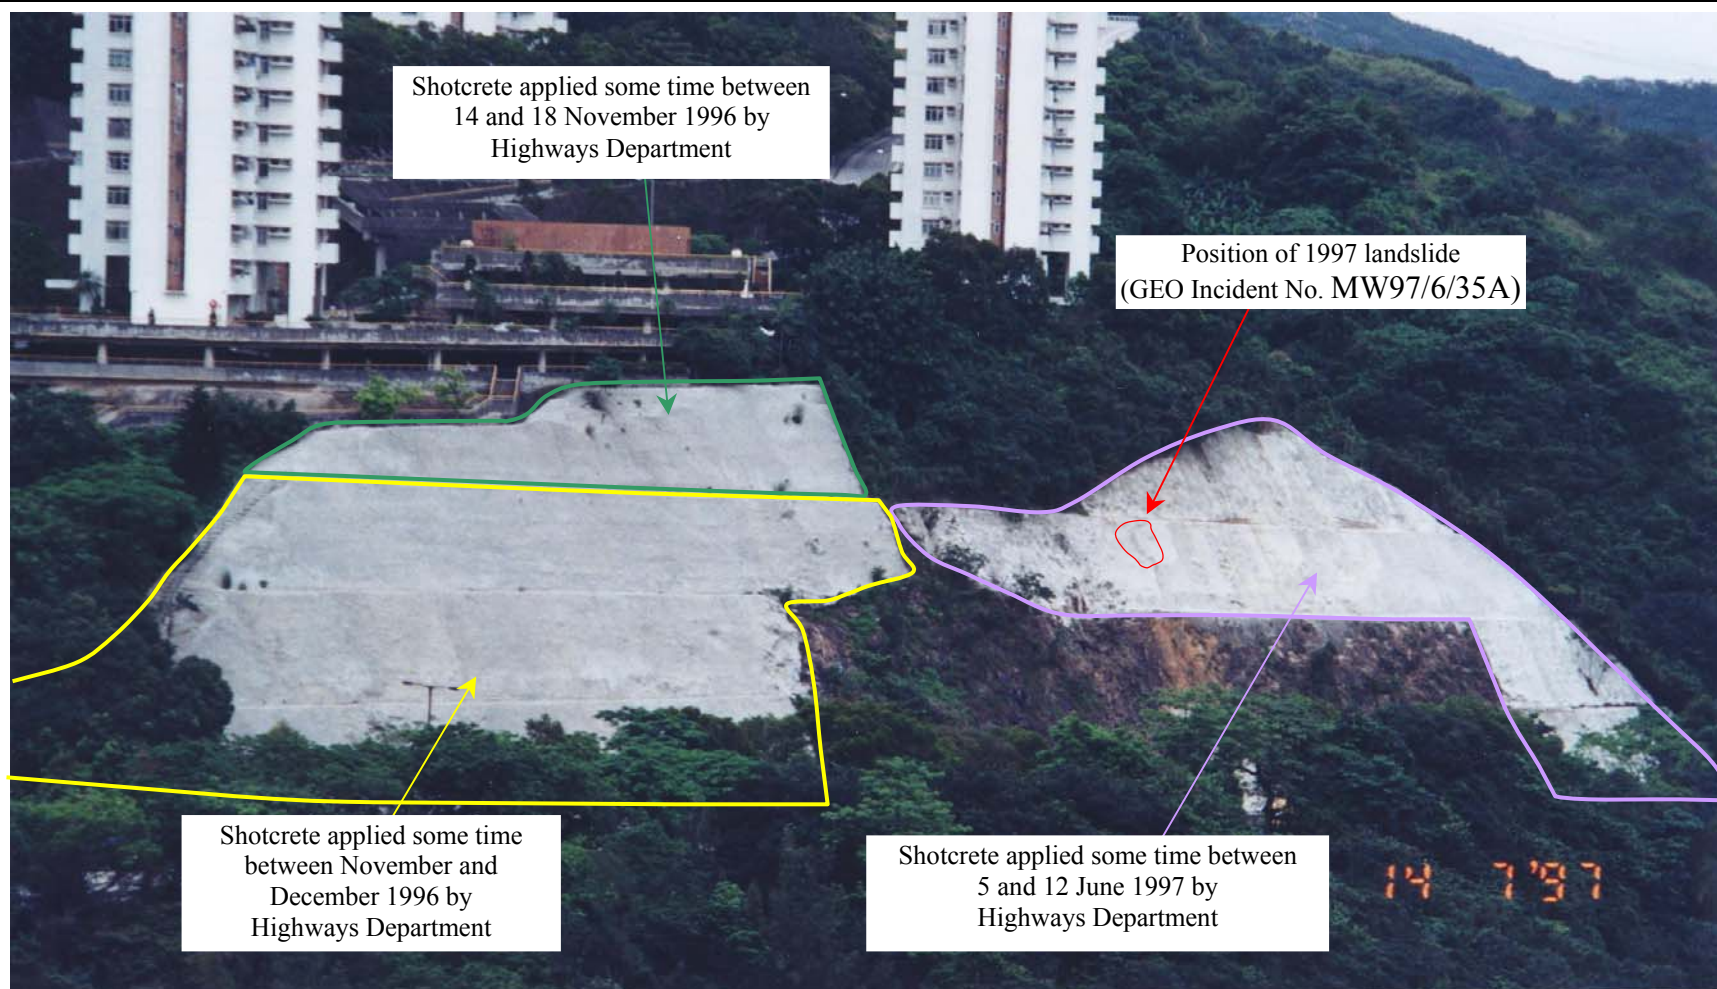
Photographs taken by HAP in mid-1997 (Plate 11) show extensive new shotcrete on the northwest and southeast portions of slope No. 11NW-A/C58. HAP's observations of the surface drainage are shown in Figure 9. HAP noted that the surface drainage channels on all three berms to the northwest of the exposed rock portion drain towards the northwest. These observations are inconsistent with the post-failure site observations made by MGSL (see Section 2.1) that the drainage channels on the northwest portion of the slope drain to the southeast and onto the exposed rock portion of the slope (Figure 2). On the southeast portion of the slope, HAP observed no drainage on any of the berms, which is consistent with MGSL's observations (see Section 2.1), whereas W&O's approved site formation plan (Figure 8) shows drains on each of the berms with spot heights that indicate falls towards the southeast. It is possible that the drains on the southeast portion of the slope have been concealed by the shotcreting applied in 1997 (see Section 2.4.1). For the central, exposed rock slope portion, HAP noted "A small number of shrubs and unplanned vegetation were present".

Plate 11 - General View of Slope No. 11NW-A/C58 showing Date and Extent of New Shotcreting Based on API and Site Inspection Record (Photograph taken by HAP on 14 July 1997)

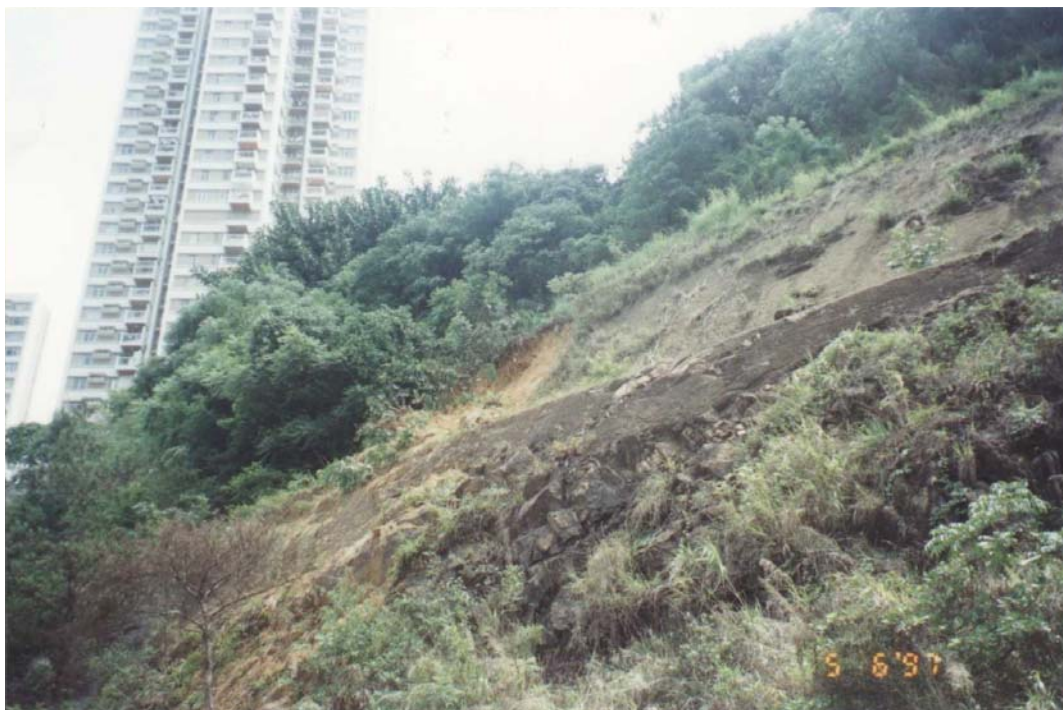
According to the GEO's landslide database, a minor landslide (GEO Incident No. MW97/6/35A) occurred on slope No. 11NW-A/C58 on 4 June 1997 resulting in the closure of one lane of Castle Peak Road. The photograph attached to the GEO Incident Report (reproduced as Plate 15) shows that the landslide, with an estimated volume of less than 10 m³, occurred at a chunam covered portion of the third batter of the slope (Figure 7 and Plate 11). Urgent repair works, recommended by GEO to HyD at a joint site inspection, comprised removal of loose materials on the failure surface, trimming back of the failure scar to remove any oversteepened area, provision of surface protection (with weepholes) to the failure surface, repair of any damaged drains and replacement of cracked/damaged chunam.

Plate 15 - Failure Scar on Slope No. 11NW-A/C58 of the GEO Incident
No. MW97/6/35A (Photograph taken by GEO on 5 June 1997)

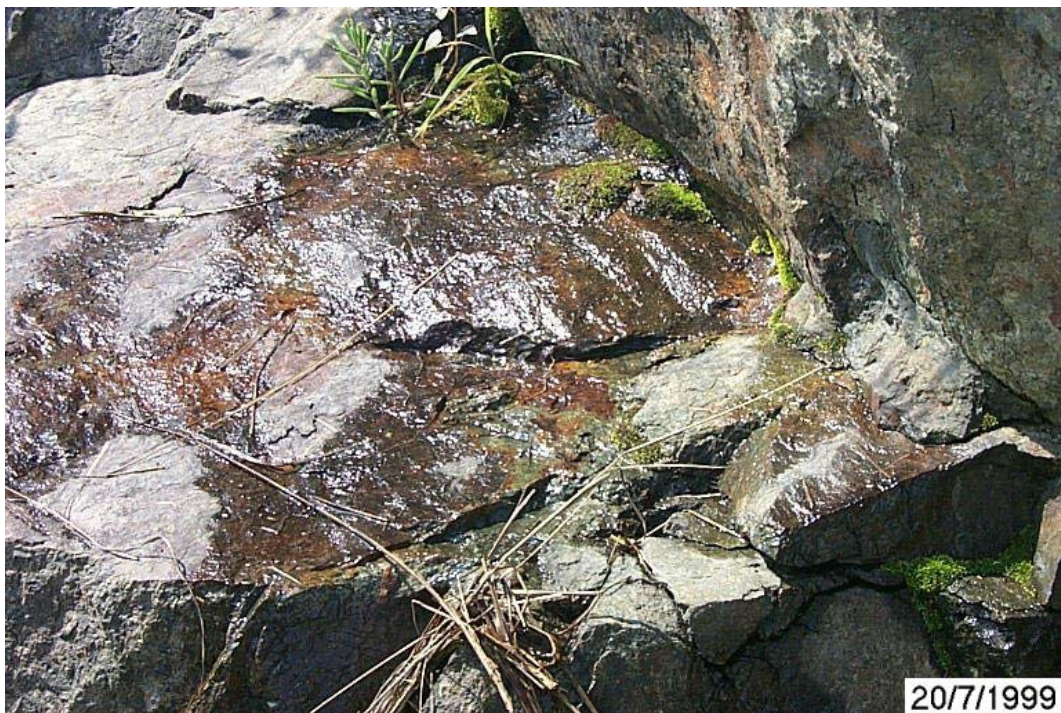
Plate 16 - Slight to Moderate Seepage at Mid-height on Slope No. 11NW-A/C58
(Photograph taken by GEO on 20 July 1999)

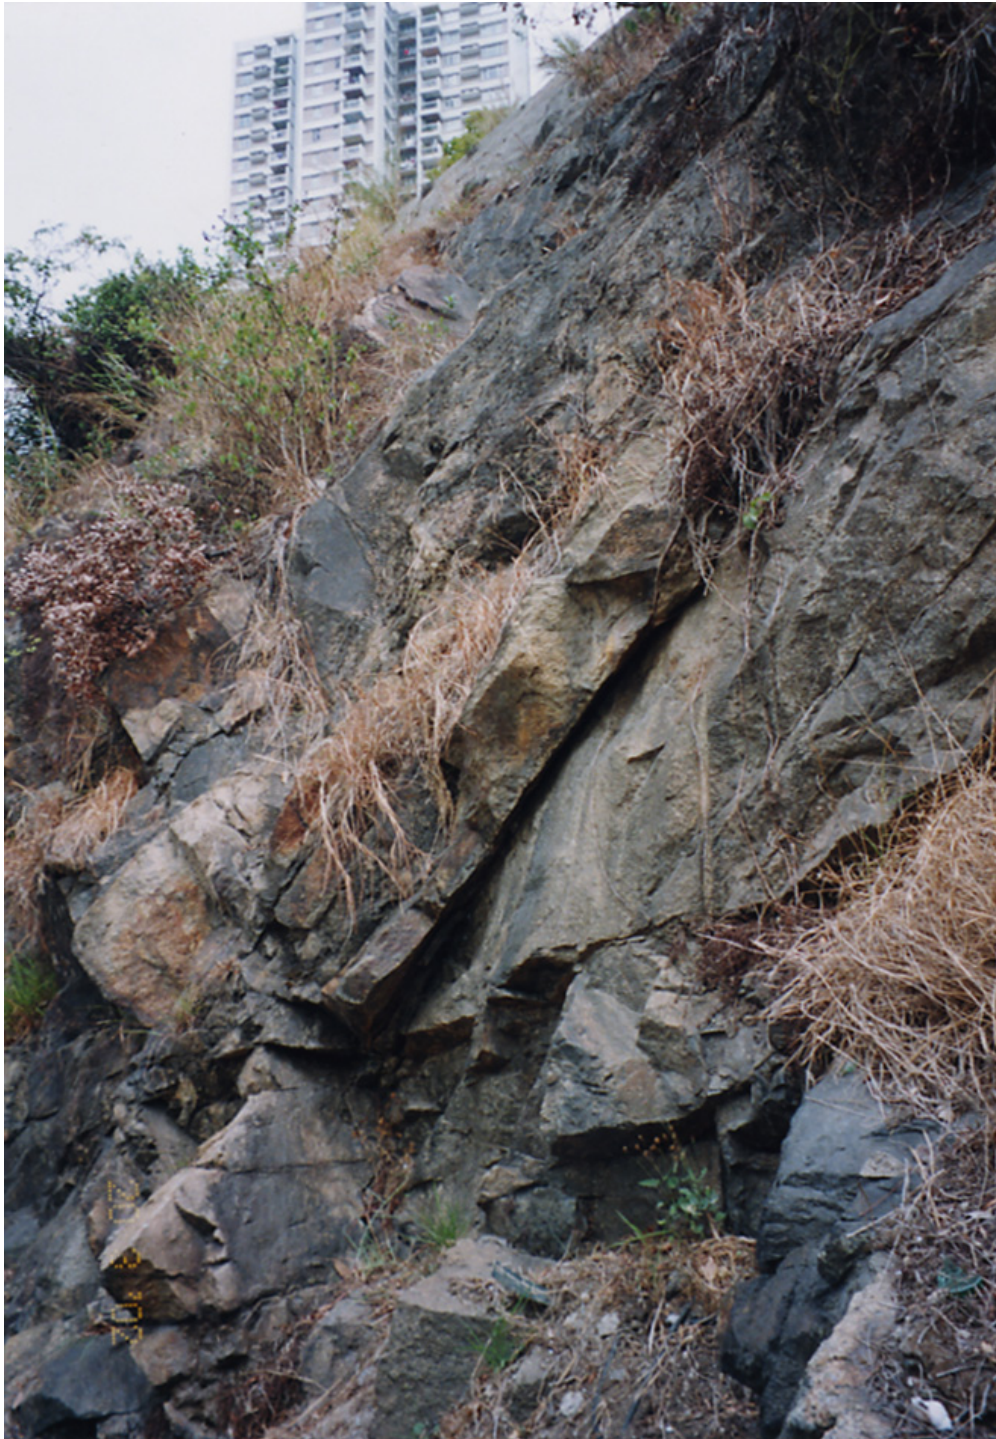
Joints are generally closely, locally medium spaced, rough and slightly undulating and often iron stained to brown and brownish yellow, generally tight to very narrow with no evidence of extensive infill. MGSL measured the typical slope orientation as 60°/228° and the most common joint sets as 59°/082°, 76°/144° and 86°/325°, and concluded that there were no major adverse joint sets. The stereoplots produced by MGSL and HAP are reproduced in Appendix B and both suggest that the slope is liable to minor toppling failure. However, site observations by MGSL showed adversely orientated sheeting joints striking

parallel to the slope surface and dipping steeply towards Castle Peak Road (Plate 17) at several localities along the first batter of the rock portion of the slope. Minor wedge failures (Plate 18) were also noted by MGSL which appear to have resulted from the intersection of two of the major joint sets ($59^{\circ}/082^{\circ}$ and $86^{\circ}/325^{\circ}$) with a minor joint set dipping out of the rock face at about 20° to 30° . The intersection of the same two sets of joints (viz. $59^{\circ}/082^{\circ}$ and $86^{\circ}/325^{\circ}$) with the sheeting joints (60° to $70^{\circ}/220^{\circ}$) could mean that larger potential wedge failures are kinematically feasible.

Plate 17 - View of Adverse Sheeting Joint near Centre of Rock Portion of Slope No. 11NW-A/C 58 (Photograph taken on 20 March 2002)

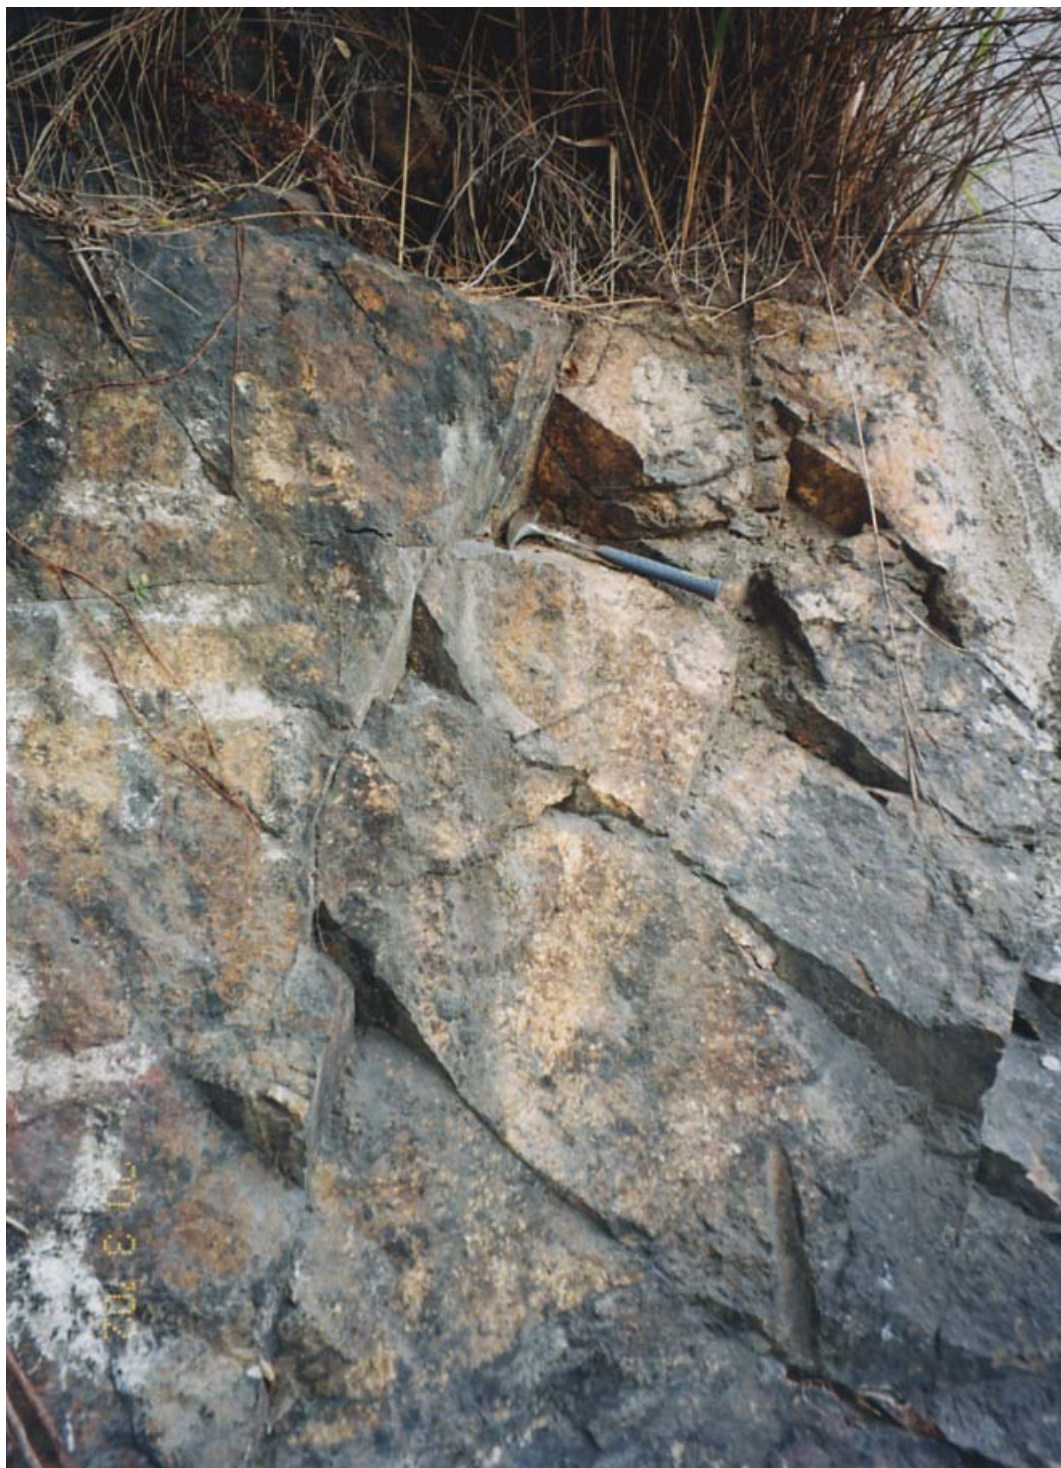
Plate 18 - View of Wedge Failure at the Rock Portion of Slope No. 11NW-A/C 58
(Photograph taken on 20 March 2002)

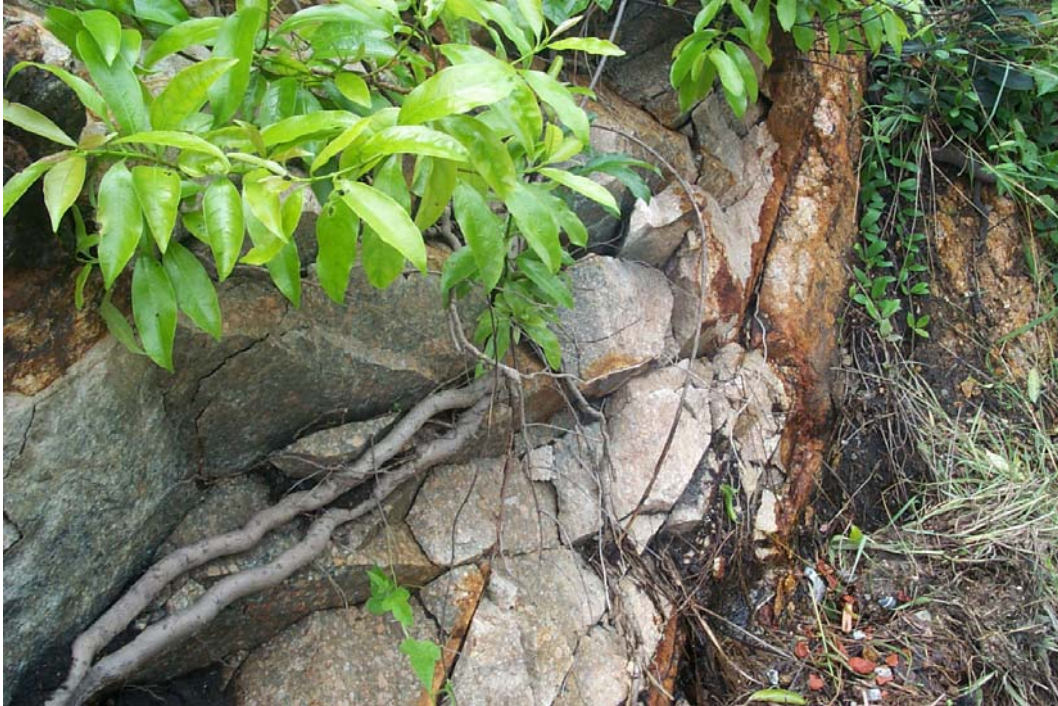
The joints have been exploited by unplanned vegetation leading to the development of discrete rock blocks (Plates 19 and 20). There are, however, some localities on the rock slope portion where the broken fragments are so small and irregular (Plate 21) that they may be a result of blasting during the original slope formation.

Plate 19 - View of Very Closely Spaced Joints Being Exploited by Vegetation to Permit Rock Fragments to Detach (Photograph taken on 21 June 2001)

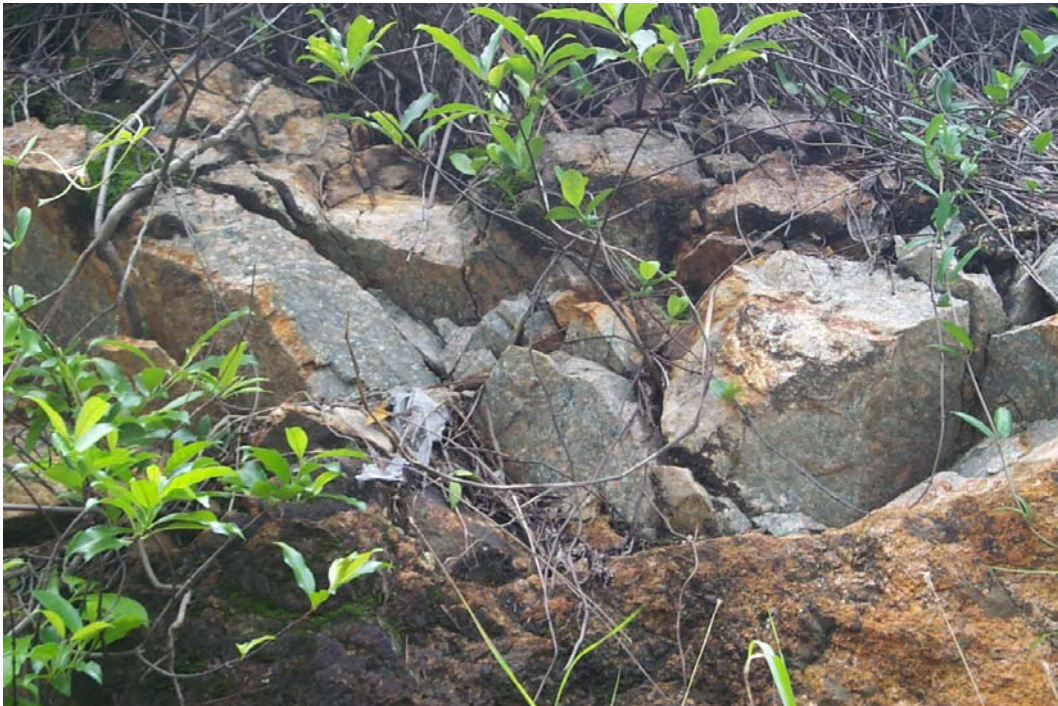
Plate 20 - View of Loose Rock Fragments with Vegetation Growing in the Joints (Photograph taken on 14 June 2001)

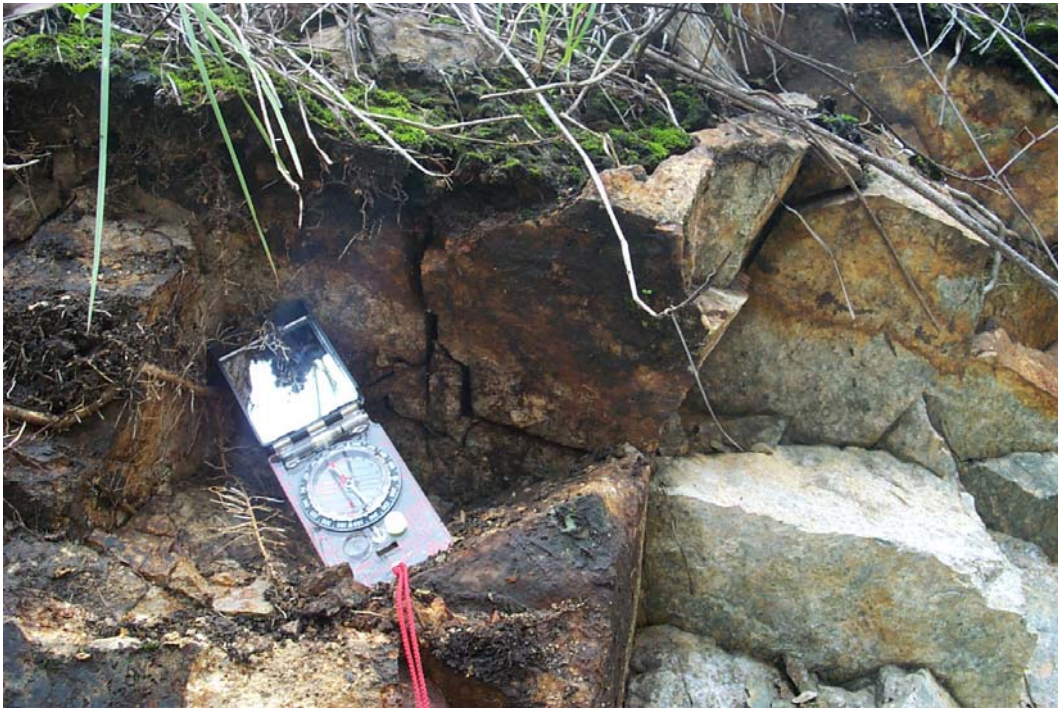
Plate 21 - View of Loose Rock Fragments on the Surface of the Exposed Rock Portion of Slope No. 11NW-A/C58 (Photograph taken on 14 June 2001)

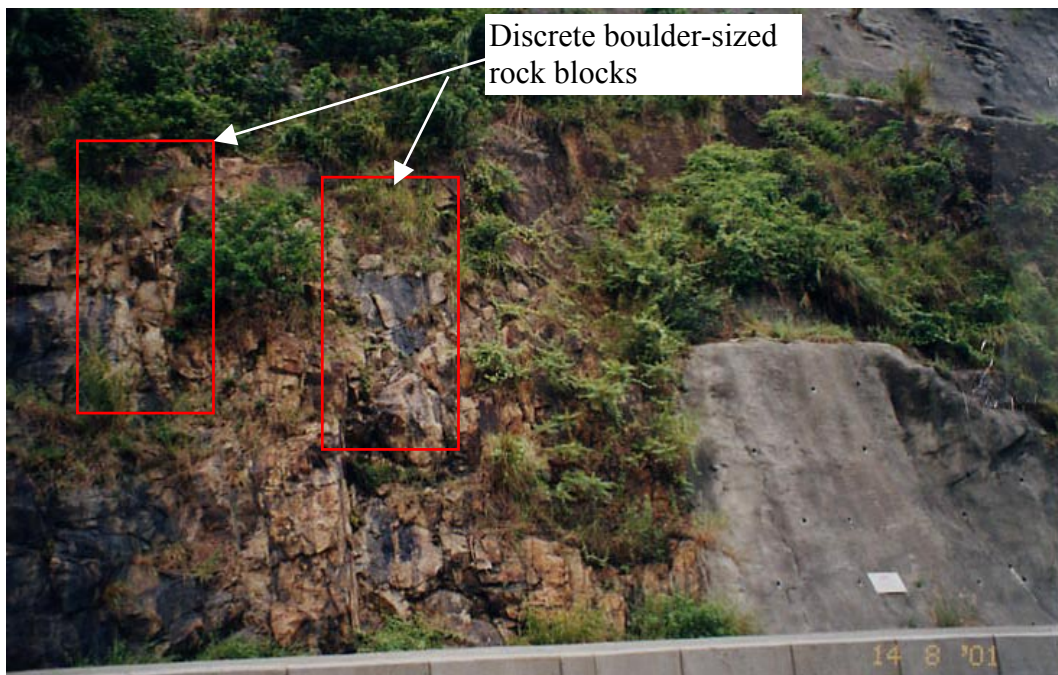
Plate 22 - View of Discrete Boulder-sized Rock Blocks near the Middle of the Exposed Rock Portion of Slope No. 11NW-A/C58 (Photograph taken on 14 August 2001)

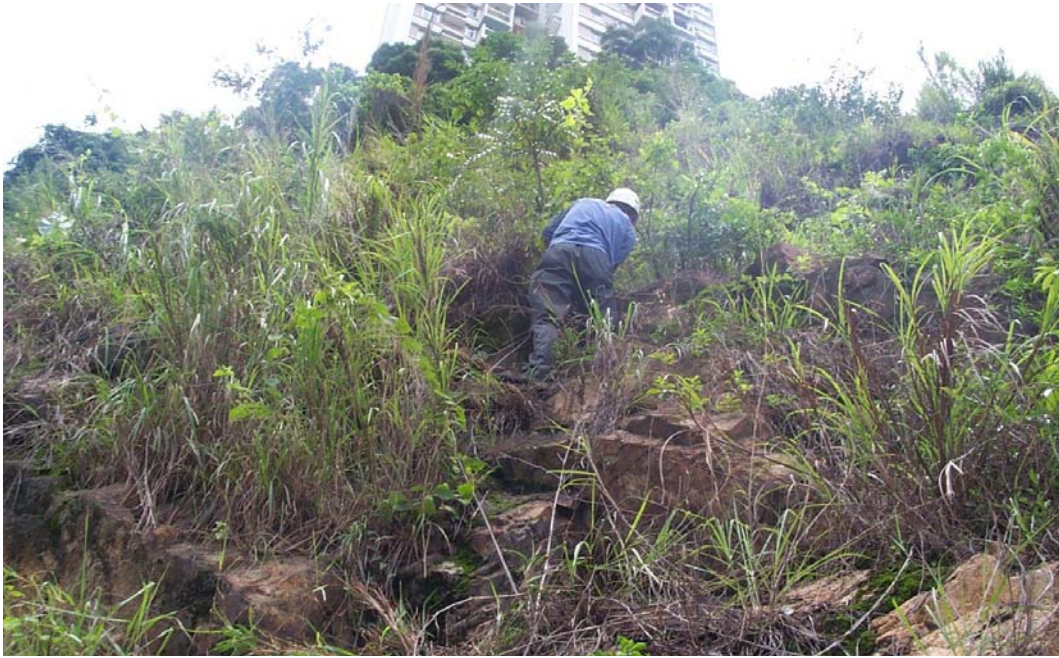
Plate 23 - Heavy Growth of Vegetation on the Exposed Rock Portion of Slope No. 11NW-A/C58 (Photograph taken on 21 June 2001)

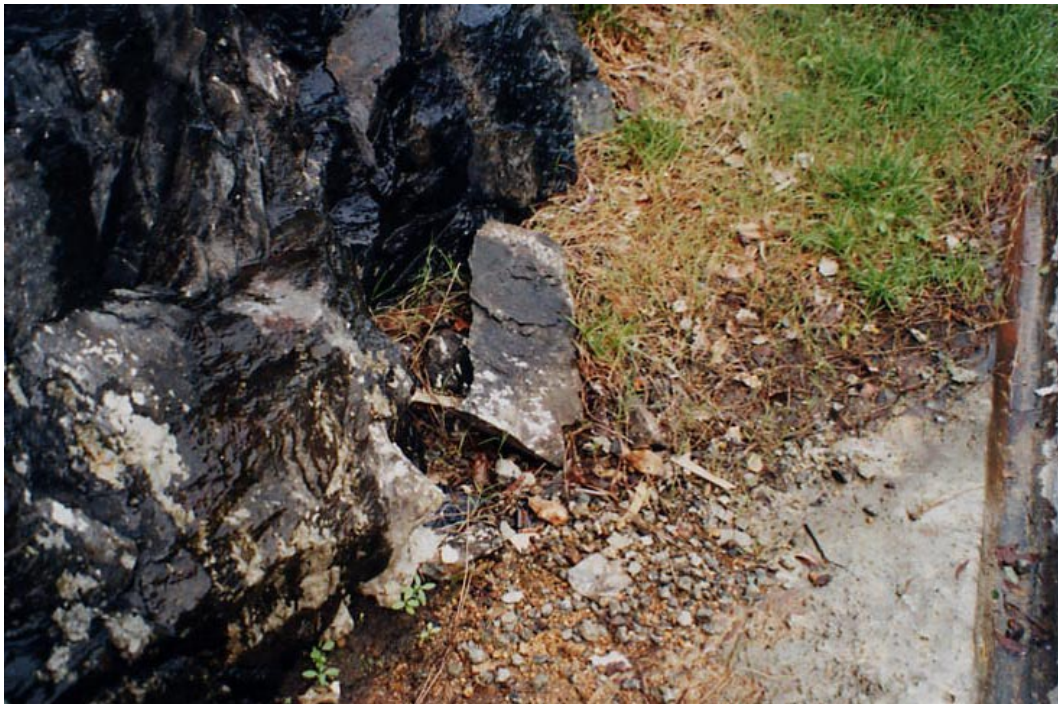
Numerous angular rock fragments were littered along the toe of the rock slope indicating similar minor failures in the past (Plate 24).

Plate 24 - View of Rock Debris and Seepage at Toe near the Middle of the Exposed Rock Portion of Slope No. 11NW-A/C58 (Photograph taken on 14 August 2001)

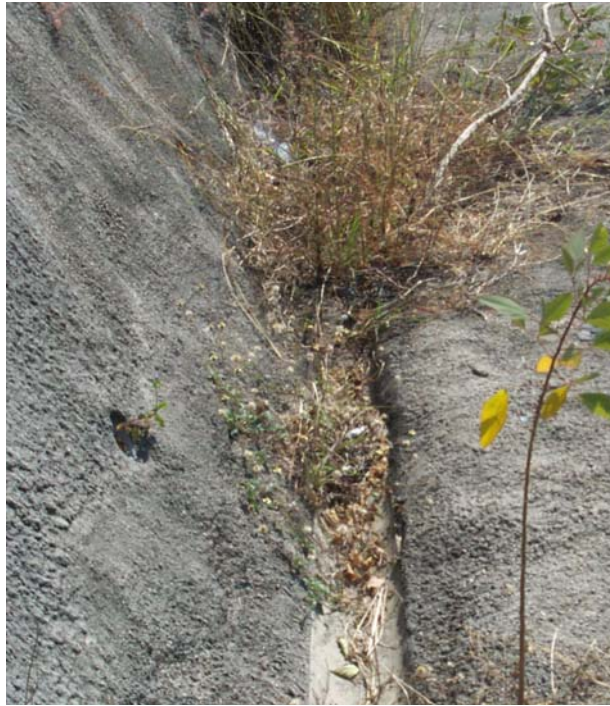
Plate 27 - View Looking Southeast along Second Berm showing Berm Drainage Partly Blocked by Unplanned Vegetation (Photograph taken on 14 August 2001)

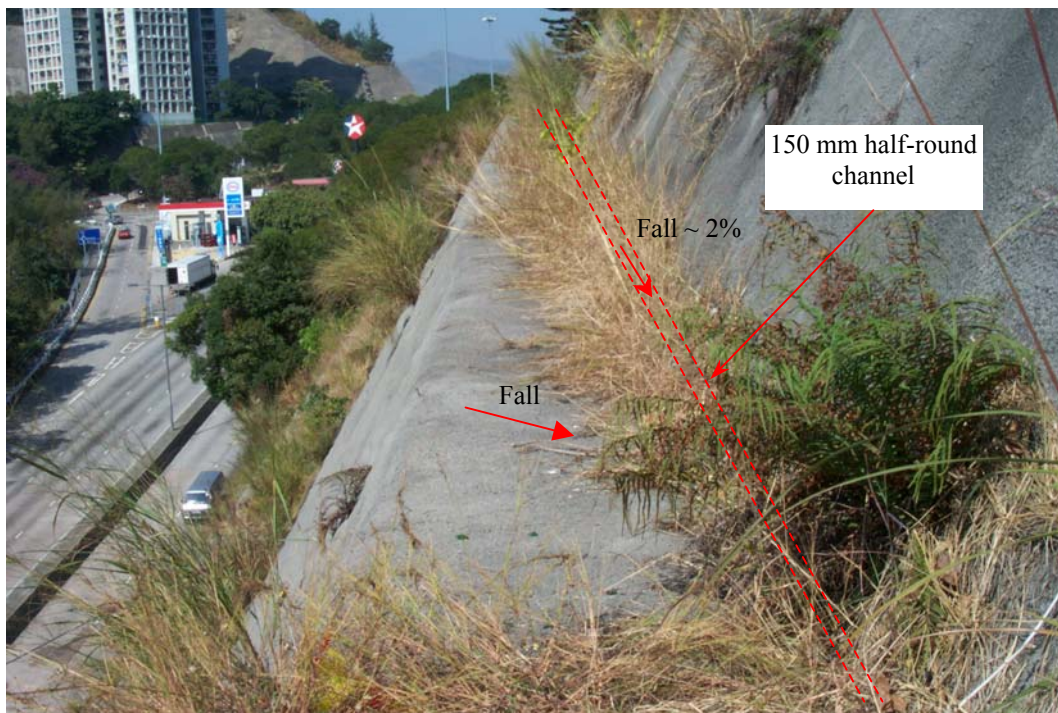
Plate 28 - View Looking Northwest along Second Berm near Location of Discharge onto Exposed Rock Face (Photograph taken on 14 August 2001)
