**DETAILED STUDY OF
THE 14 DECEMBER 2001
WASHOUT INCIDENT
BELOW POKFIELD ROAD,
KENNEDY TOWN**

GEO REPORT No. 152

Fugro Maunsell Scott Wilson Joint Venture

**GEOTECHNICAL ENGINEERING OFFICE
CIVIL ENGINEERING AND DEVELOPMENT DEPARTMENT
THE GOVERNMENT OF THE HONG KONG
SPECIAL ADMINISTRATIVE REGION**

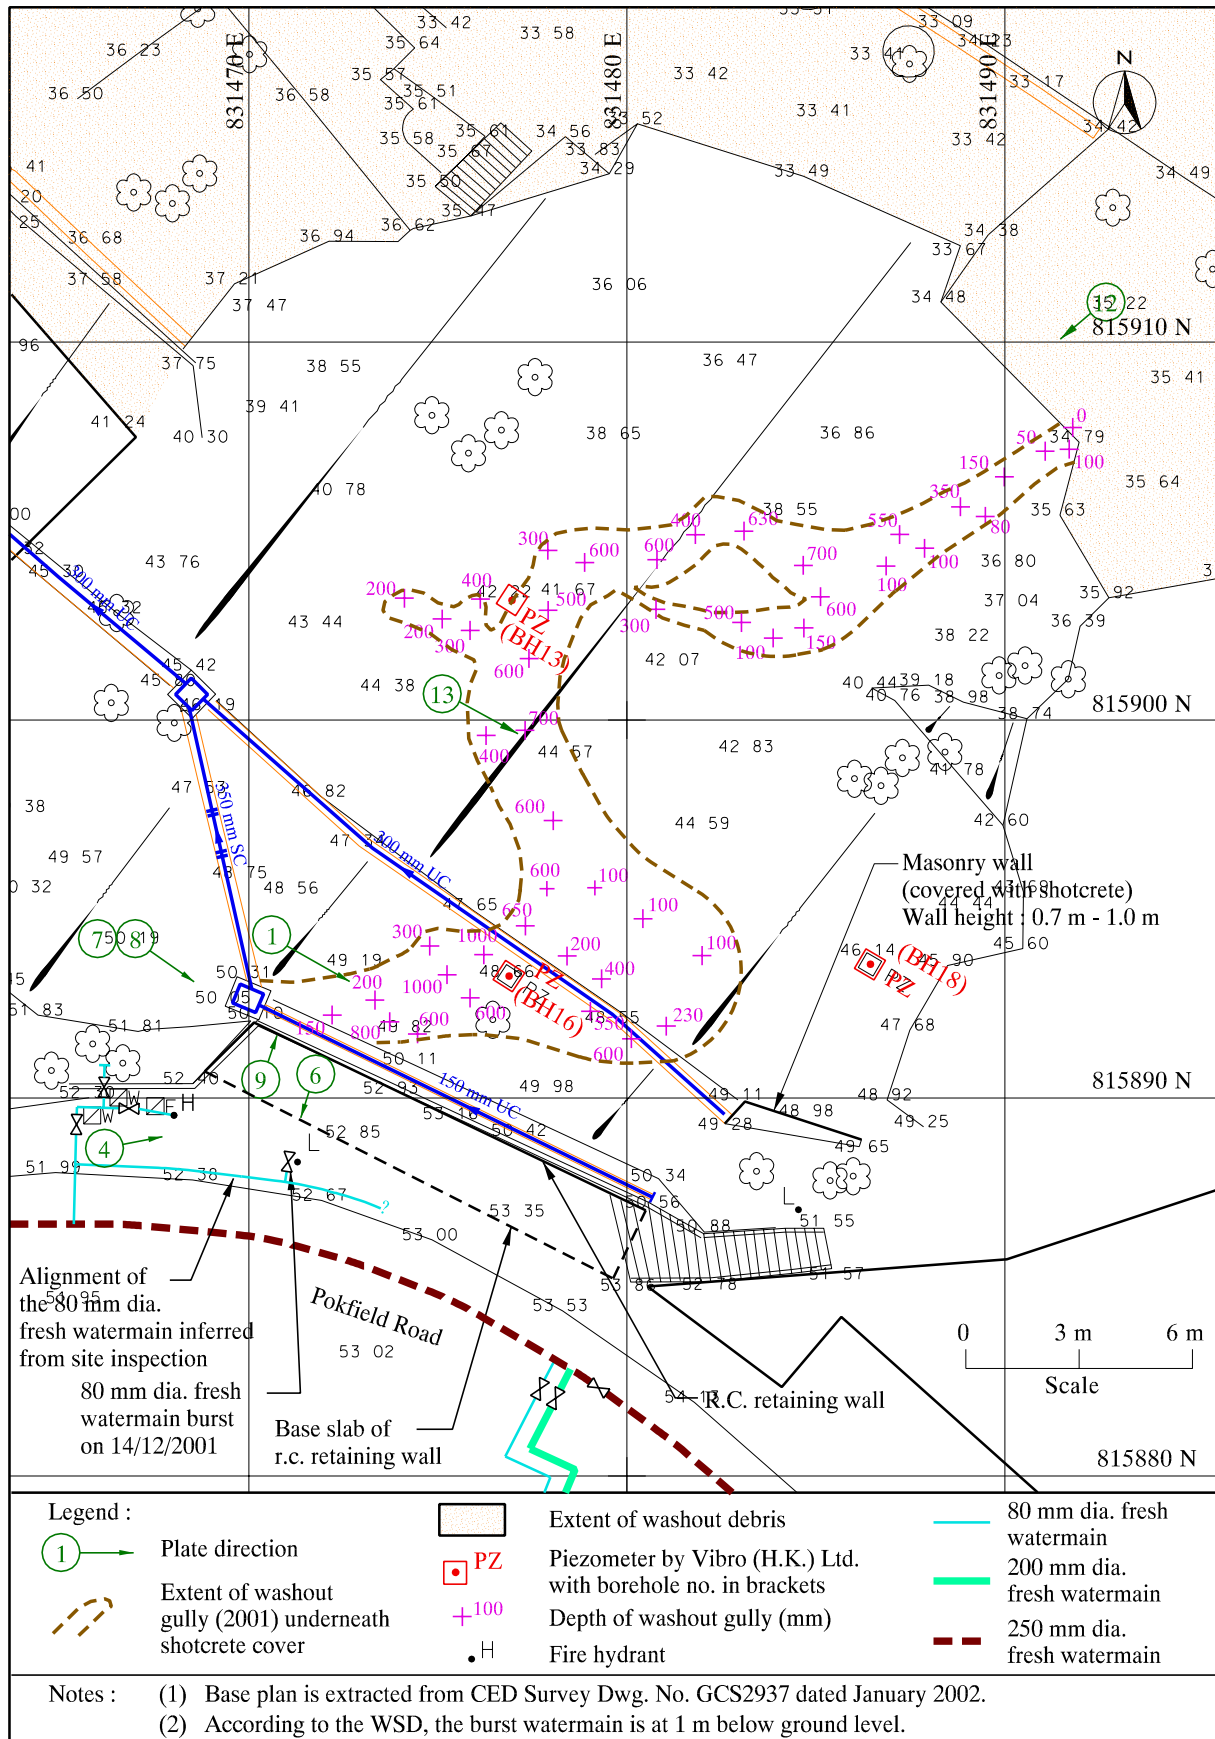
Figure 2 - Plan of the Washout Scar

Cracking of the shotcrete surface, up to 20 mm wide, was observed at several locations along the toe of the subject slope (Plate 10). Voids (subsequently found to be erosion gullies, the extent of which is shown in Figure 2) were detected underneath the shotcrete cover at the time of the inspection. There were signs of material having been washed out underneath the shotcrete cover through some weepholes and through the cracks on the shotcrete cover (Plate 10). Most of the eroded soil debris was deposited on the platform at the toe of the subject slope, covering an area of about 200 m² with an average thickness of about 100 mm (Plate 3). The outwash cascaded down the face of slope No. 11SW-A/C747 (Plate 2). Some of the debris was carried further down by the water from the burst watermain to Rock Hill Street via surface drainage channels and footpaths (Plate 11).

Based on the relative positions of the burst watermain section and the erosion gully, uncontrolled water flow resulting from the burst watermain appeared to have flowed underneath the base of the retaining wall causing erosion of the slope below (Figure 2). The lowest row of weepholes on the retaining wall (located about 0.2 m above the ground surface in front of the wall) is at an elevation of about 2 m below that of the burst watermain and it was noted that these weepholes exhibited no signs of seepage or water stain. Following the stripping of the shotcrete cover, the section below the base of the wall immediately above the erosion gully was exposed. No major signs of significant washout below the base of the retaining wall were observed by FMSW.

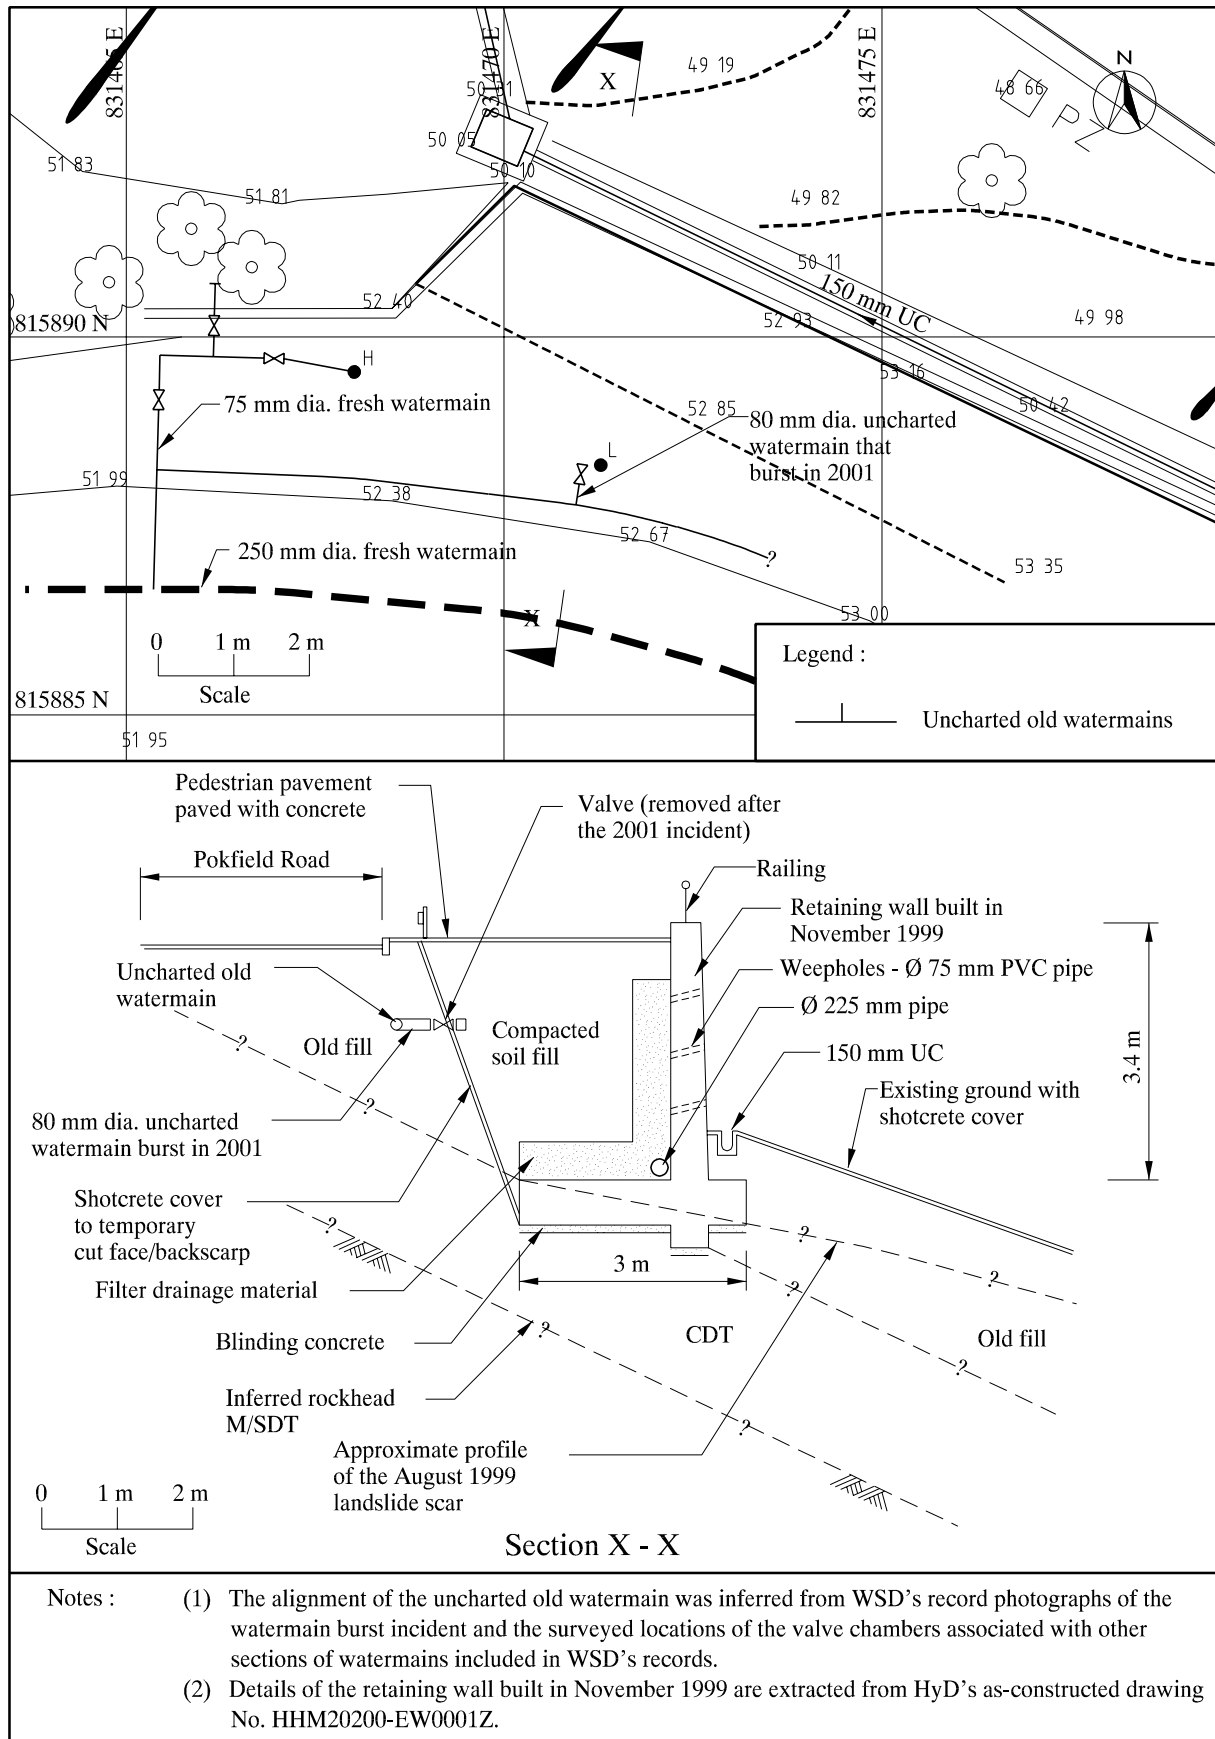
Figure 8 - Location of the Burst Watermain

The subsequent investigation by WSD revealed that "external corrosion of the pipe body leading to subsequent main burst is the main cause of burst incident" and that "cracks appears on the defective pipe body". The location of the burst was within the pipe section behind the stop valve. WSD further confirmed that the burst fresh water main was constructed over 20 years ago and as such the corresponding as built record drawings could no longer be located. It is also noted that the old water main that burst on 14 December 2001 was not included in the WSD's master record plans on fresh water mains and salt water mains underneath Pokfield Road above the crest of the subject slope.

FMSW inspected the site on 15 December 2001, i.e. one day after the washout incident was reported to the GEO. The burst watermain had been repaired at the time of the inspection, as evidenced by the lack of water flow on site and the presence of a newly cast section of concrete pavement at Pokfield Road. The location of the newly cast concrete on the pavement matches approximately with the location of the burst 80 mm diameter watermain.

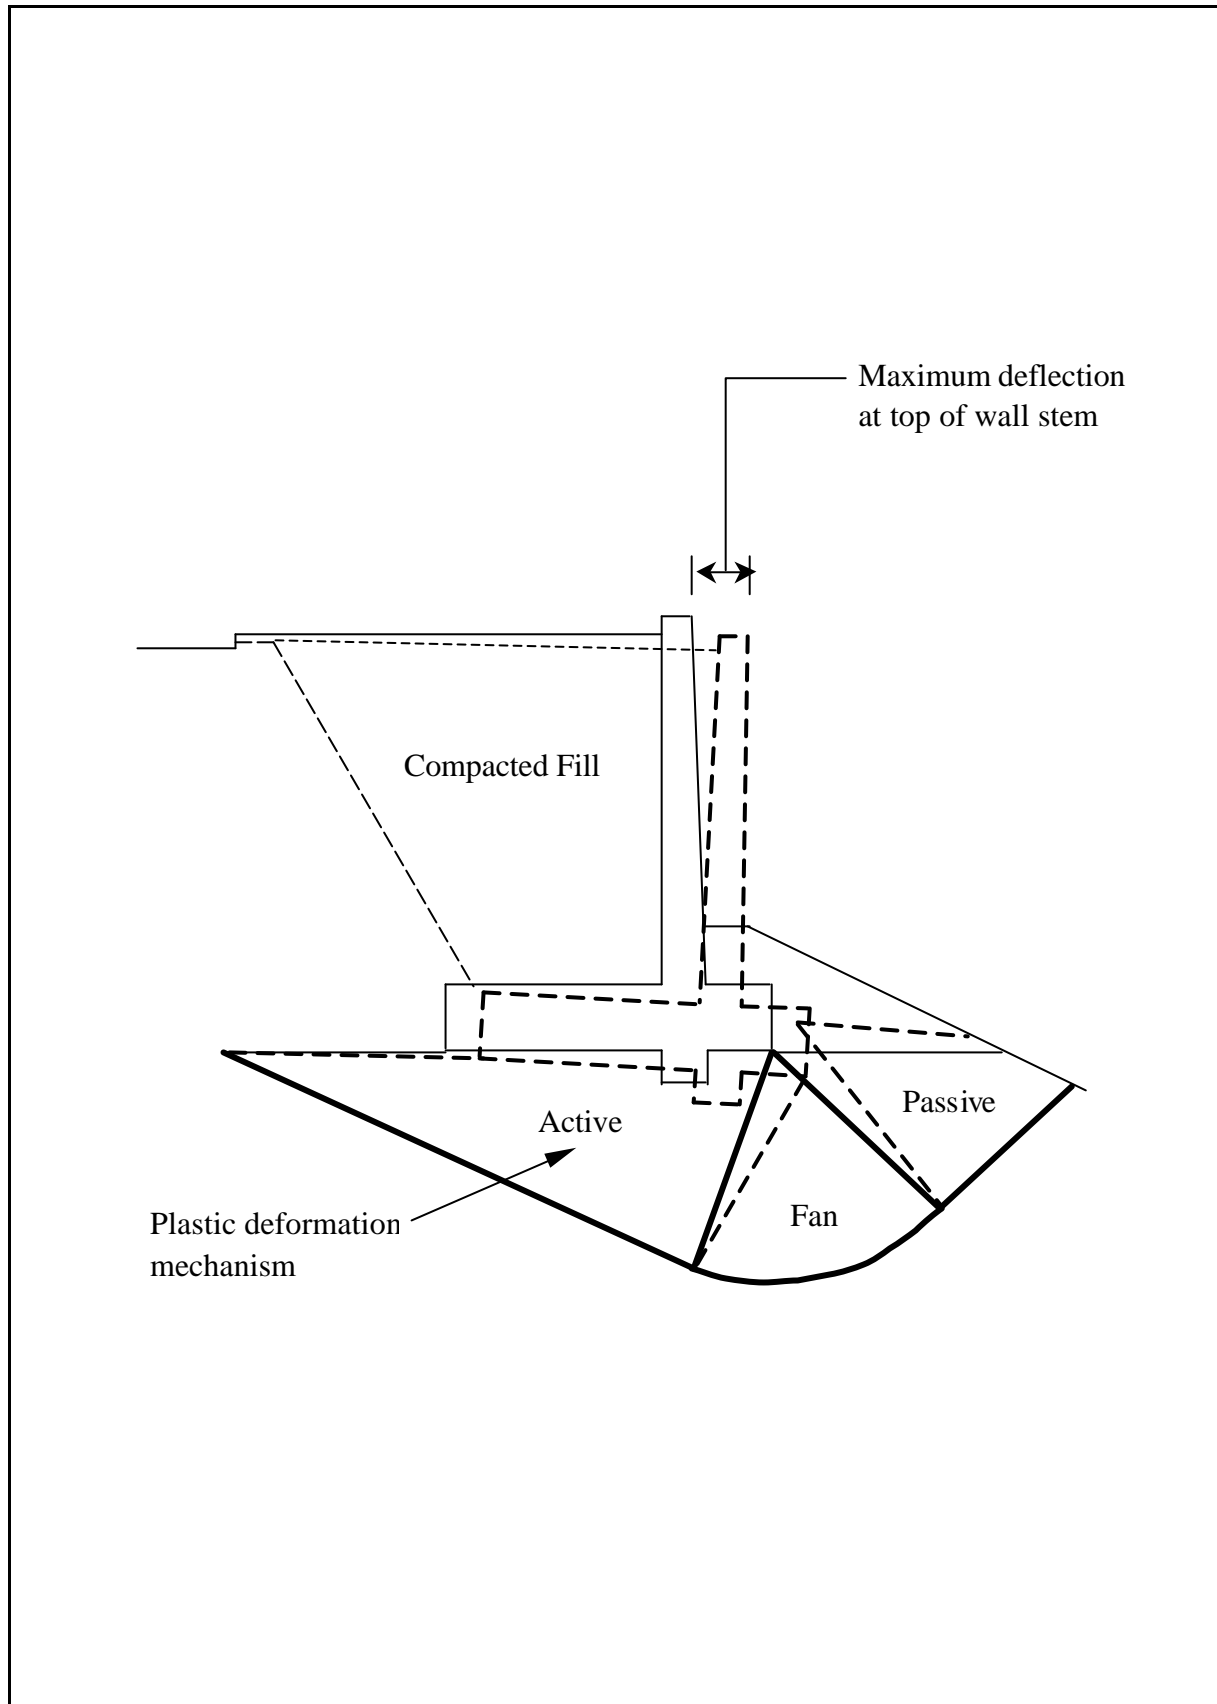
Figure 10 - Ground Deformation and Wall Movement Calculation using Plastic Deformation Mechanism Calculations

The calculations show that the movement of the retaining wall prior to the watermain burst was negligible (i.e. 1 to 2 mm movement of the top of the wall stem). Following the watermain burst, the calculations predict that the top of the wall stem would move forward by a further 15 mm to 20 mm. The above is consistent with the post failure site observations for the wall section close to the location of the burst watermain.

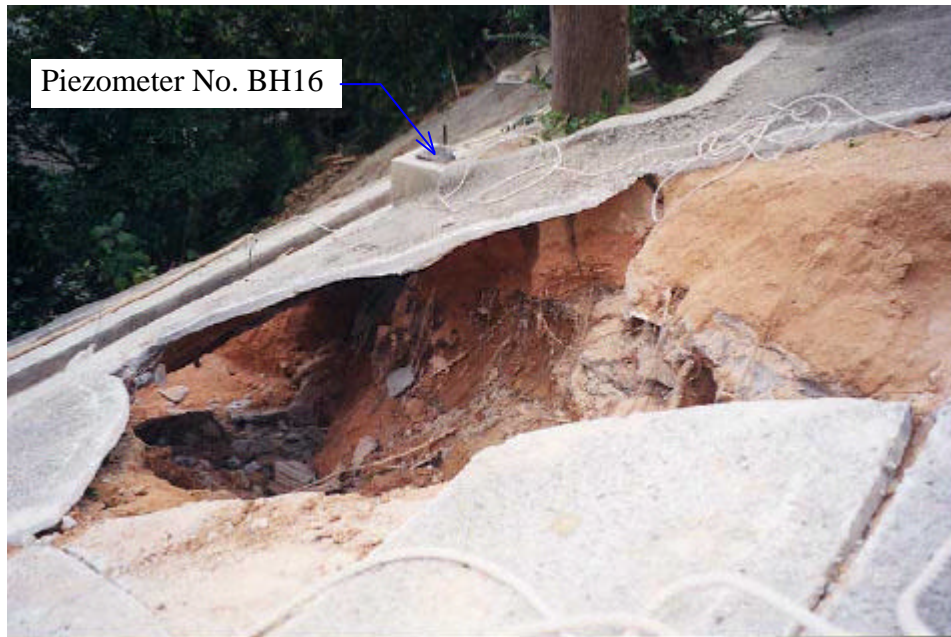
On 14 December 2001, a washout incident (GEO Incident No. 2001/12/0123) caused by a burst watermain occurred on a slope below Pokfield Road opposite University Heights, Kennedy Town (Figure 1 and Plate 1). The incident involved the erosion of approximately 30 m³ of soil underneath the shotcrete cover to the slope (referred to as the 'subject slope' in this report). Some of the outwash material cascaded down the face of slope No. 11SW-A/C747 above Rock Hill Street (Plate 2). Most of the debris was deposited on a platform at the toe of the subject slope whilst some was deposited on the pedestrian pavement of Rock Hill Street. No casualties were reported as a result of the incident.

Plate 1 - Washout of Soil from underneath the Shotcrete Cover at the Subject Slope
(Photograph taken on 4 February 2002)

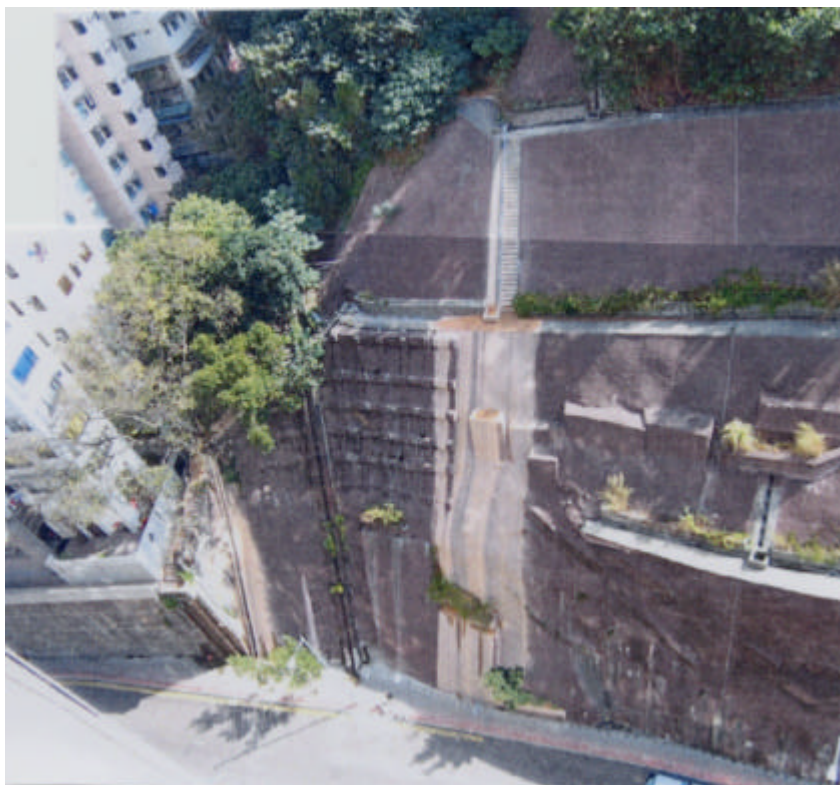
The outwash material from the failure was largely deposited on the platform at the toe of the subject slope, although some of the outwash material cascaded down the surface of slope No. 11SW-A/C747 and reached Rock Hill Street (see Plate 2).

Plate 2 - Outwash Cascaded down the Face of Slope No. 11SW-A/C747
(Photograph taken on 15 December 2001)

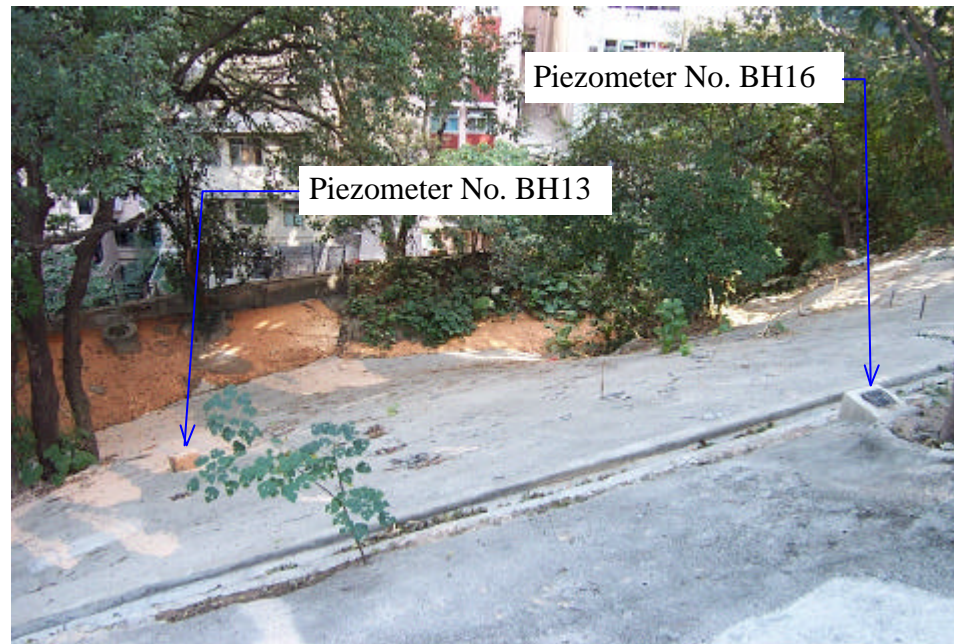
Plate 3 - Washout Debris Deposited on the Platform at the Toe of the Subject Slope
(Photograph taken on 15 December 2001)

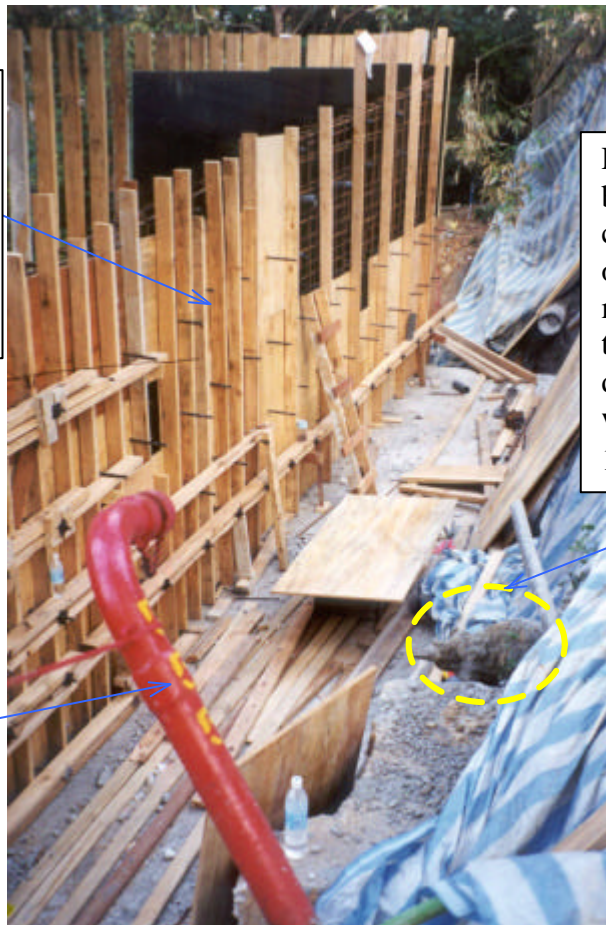
Protrusion from the backscarp/temporary cut face, the location of which appears to match the position of the uncharted 80 mm diameter watermain which burst on 14 December 2001

Plate 4 - L-shaped Retaining Wall being Constructed After the August 1999 Landslide Incident
(Photograph taken in November 1999 by HyD)

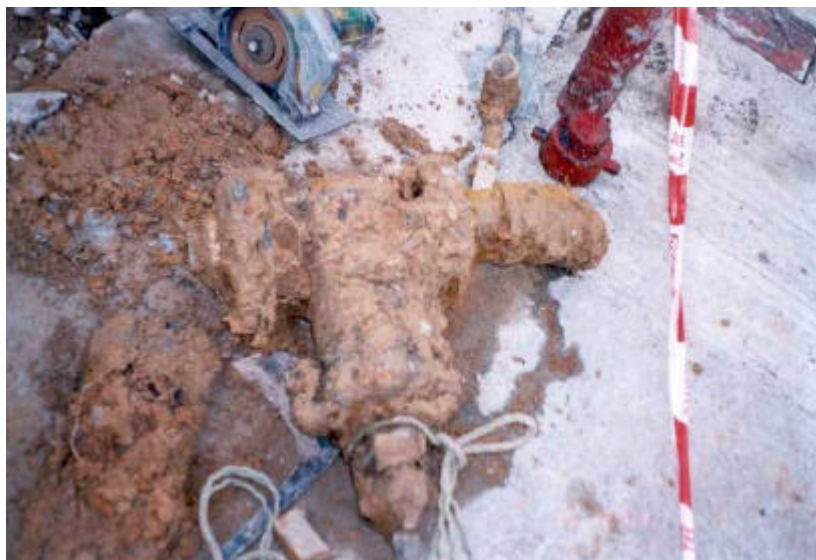
Record photograph taken by WSD (Plate 5) during the repair works shows a section of the watermain that burst on 14 December 2001. The damaged section of the watermain, together with the stop valve, was removed and the remaining pipe was capped off by WSD on the same day (Plate 6).

Plate 5 - Corroded Watermain and Stop-valve Removed
(Photograph taken on 14 December 2001 by WSD)

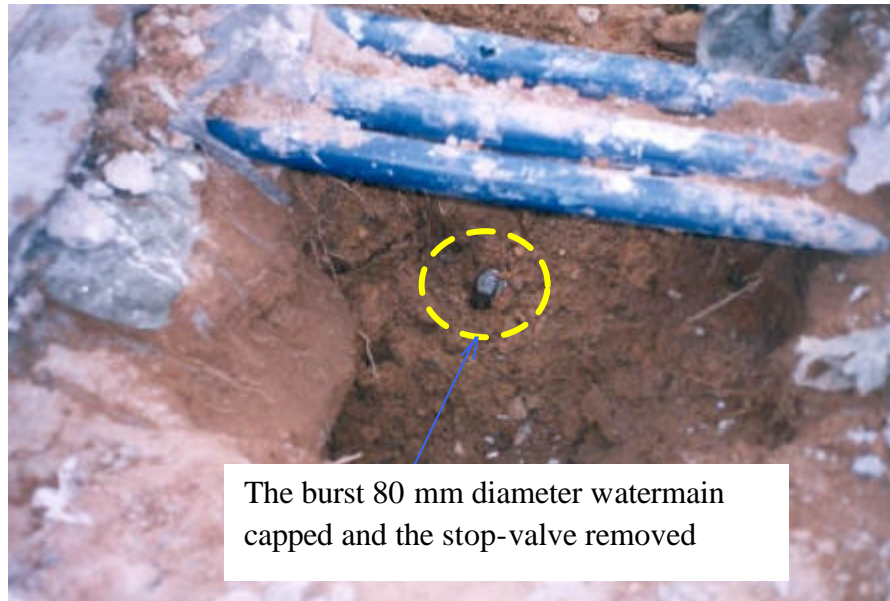
Plate 6 - The Burst Watermain Capped
(Photograph taken on 14 December 2001 by WSD)

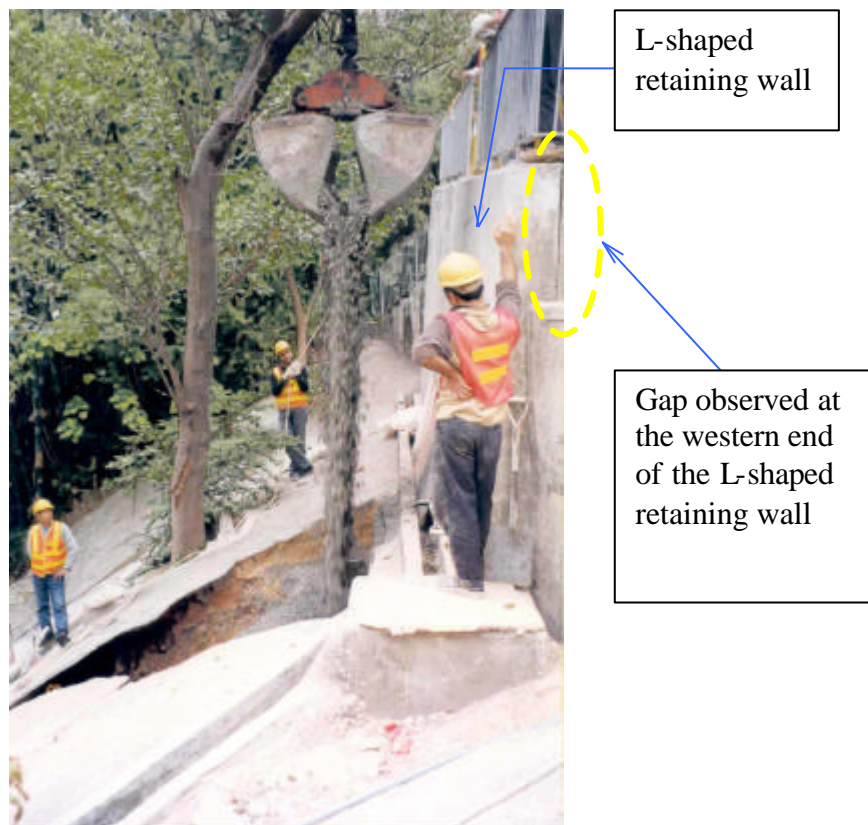
A gap of about 20 mm wide was observed along the construction joint between the concrete wall stem and the pedestrian pavement of Pokfield Road near the western end of the retaining wall in the vicinity of the location of the burst watermain (see Plates 7 and 8). As a

Plate 7 - Filling of No-fines Concrete After the December 2001 Washout Incident
(Photograph taken after the 14 December 2001 watermain burst)

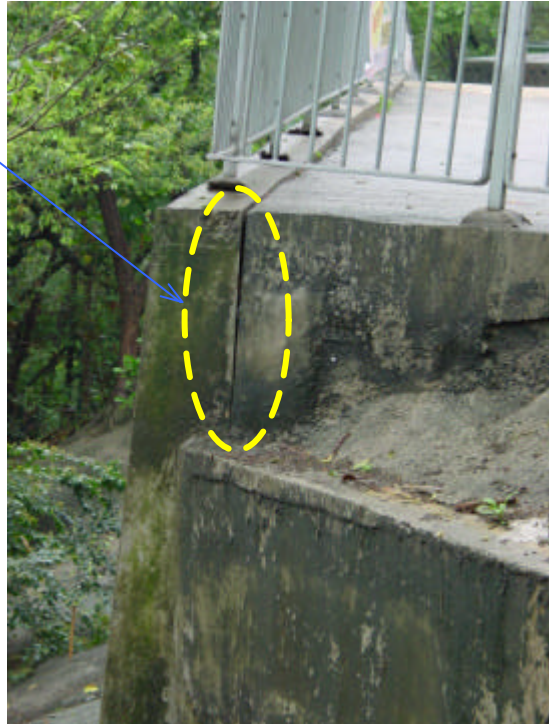
Gap observed at the western end of the L-shaped retaining wall

Plate 8 - Gap Observed at the Western End of the Wall
(Photograph taken after the 14 December 2001 watermain burst)

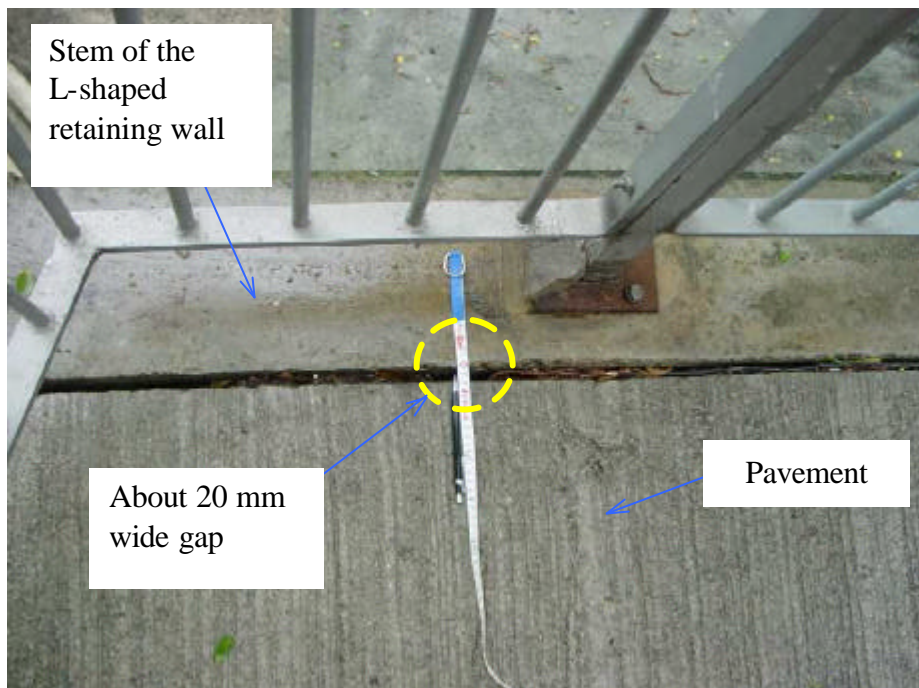
result of the movement, part of the mastic sealant of the construction joint had dropped into the gap (see Plate 9). No movement of the retaining wall was observed apart from this locality. No other conspicuous signs of distress or cracking were observed on the retaining wall or the pavement above.

About 20 mm wide gap

Plate 9 - Gap Observed at the Western End of the Wall Crest
(Photograph taken after the 14 December 2001 watermain burst)

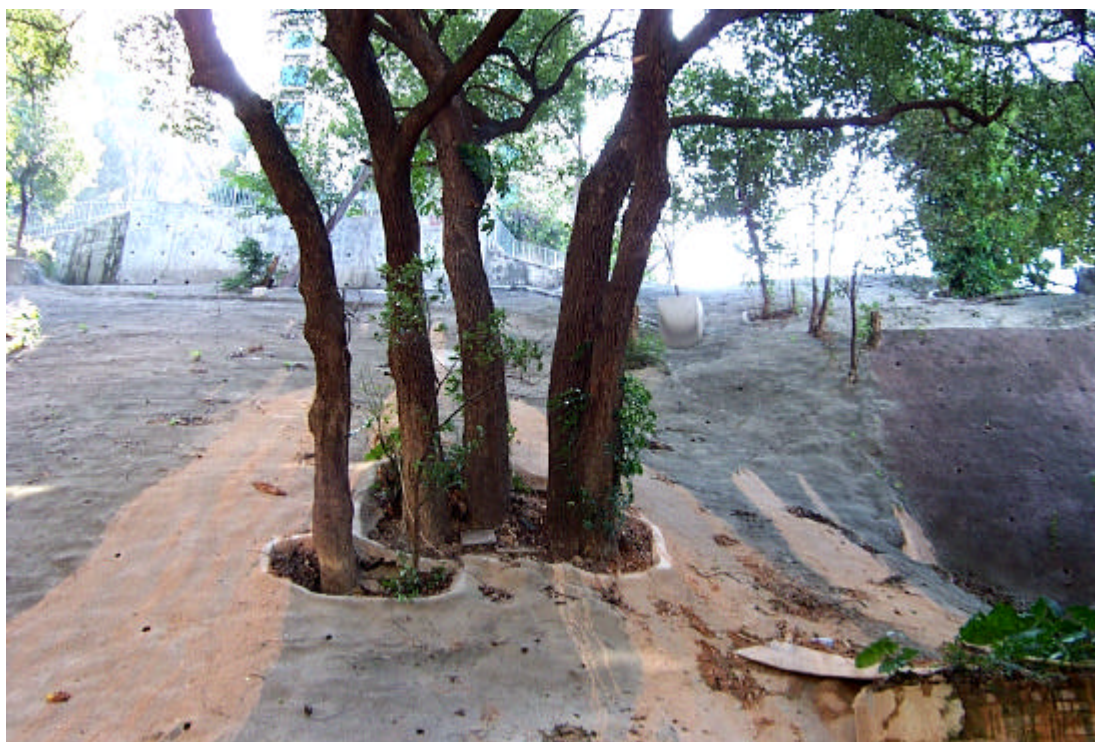
Plate 10 - Washout of Soil at the Subject Slope through Weepholes and Cracks on the Shotcrete Cover
(Photograph taken on 15 December 2001)

Following the 2001 incident, GEO recommended HyD on 28 December 2001 to strip off the cracked shotcrete cover to expose the extent of the erosion gully beneath. The surface stripping and the subsequent reinstatement works, comprising a new layer of 75 mm thick shotcrete cover, were carried out by HyD between January and February 2002.

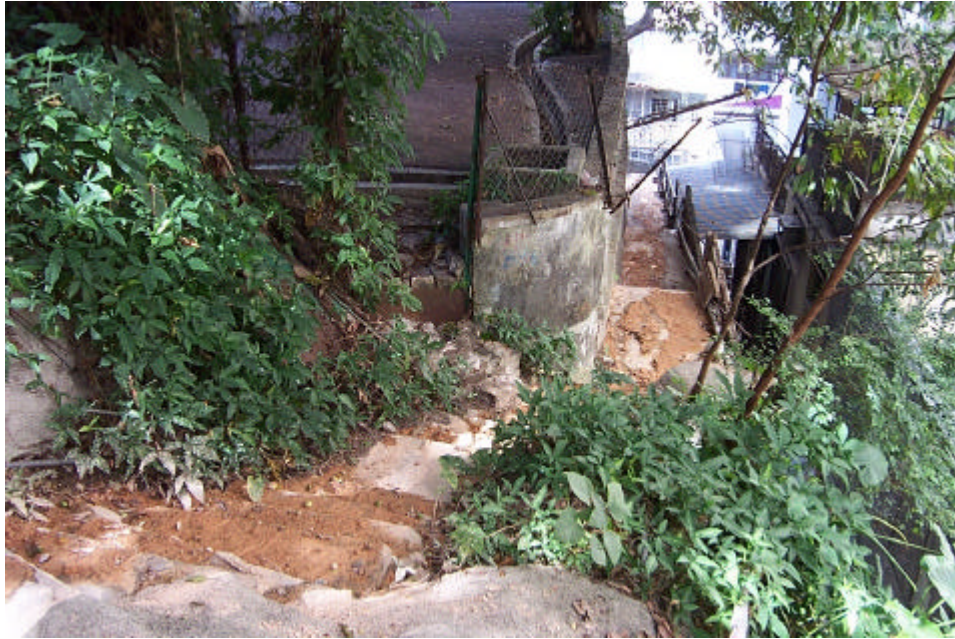
Plate 11 - Washout Debris Deposited along a Footpath Leading to Rock Hill Street (Photograph taken on 15 December 2001)

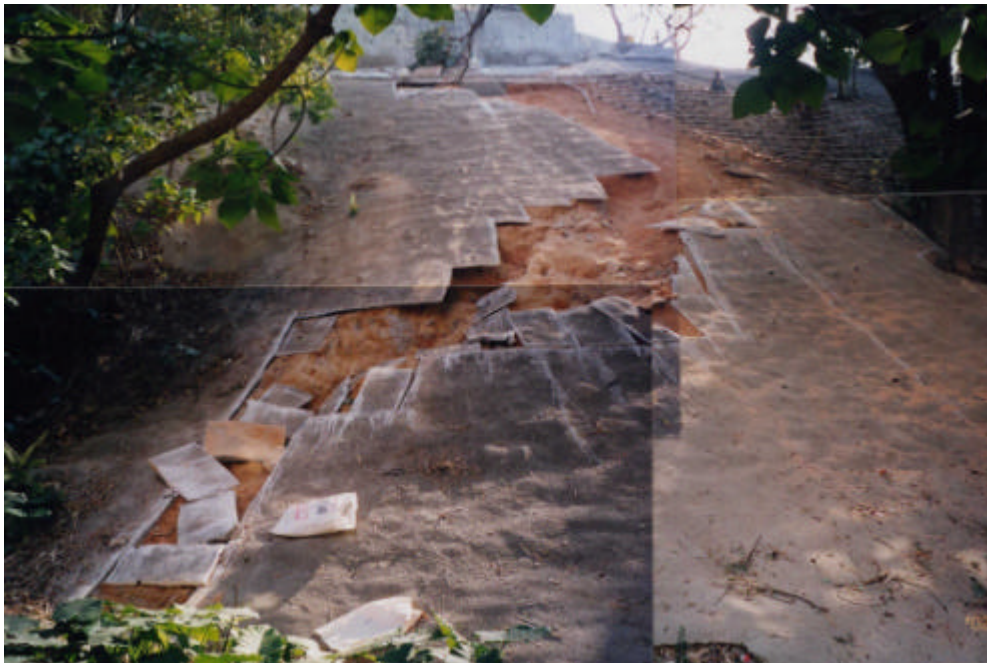
Plate 12 - Erosion Gully at the Subject Slope
(Photograph taken on 25 February 2002)

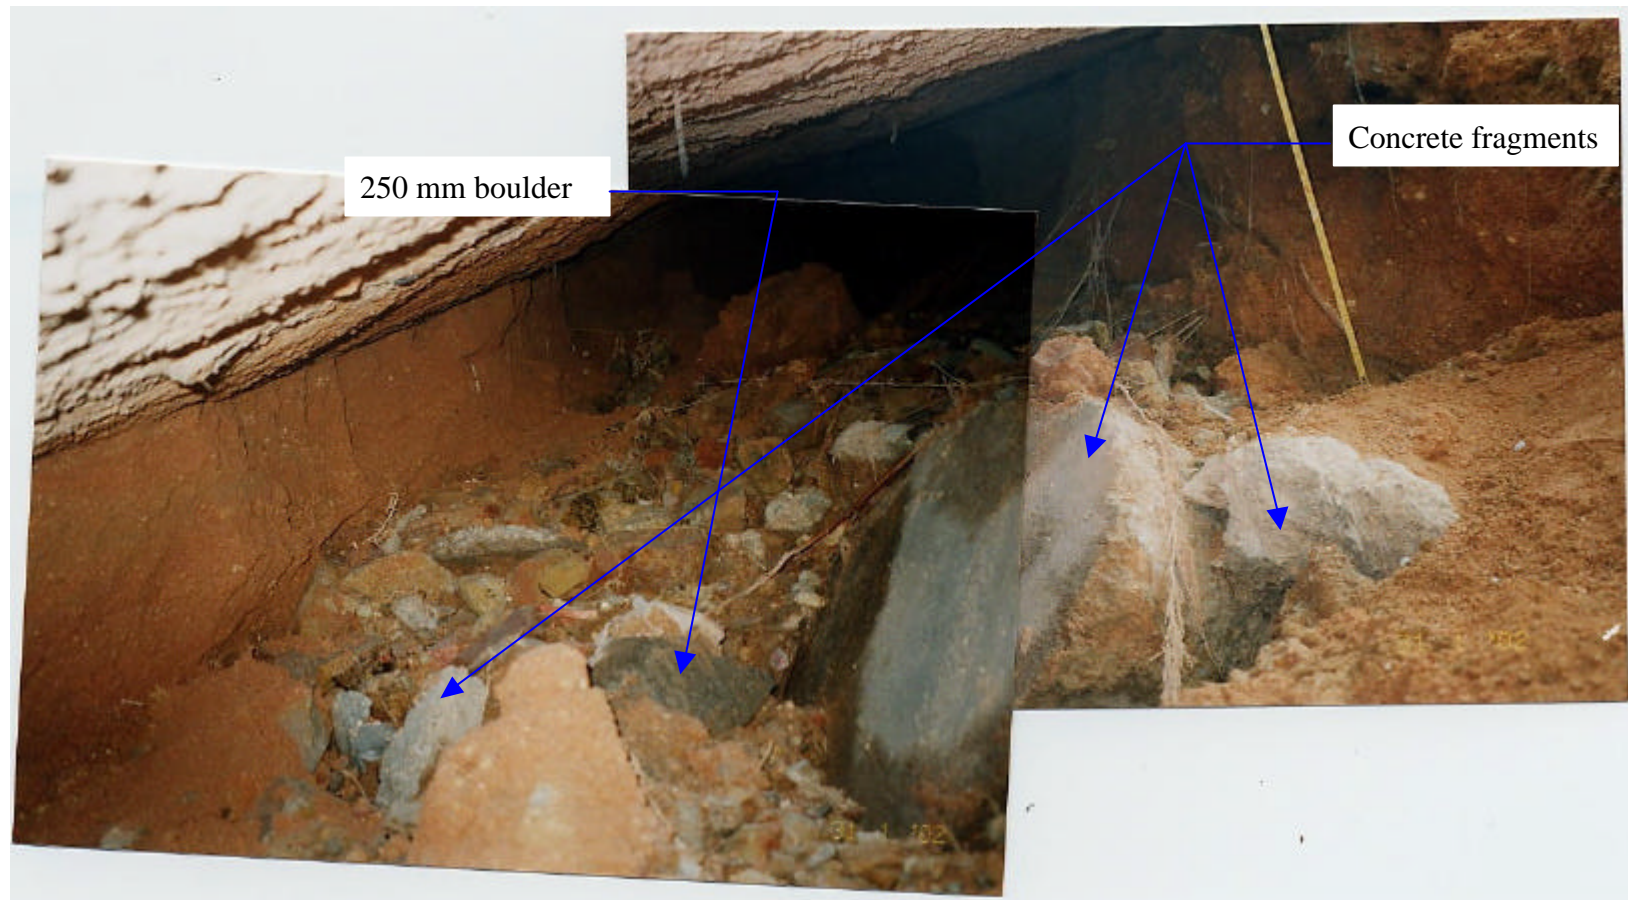
Plate 13 - Concrete Fragments and Boulders Exposed within the Erosion Gully
(Photograph taken on 31 January 2002)
