**DETAILED STUDY OF
THE SEPTEMBER 2001
LANDSLIDE ON THE HILLSIDE
BELOW KWUN PING ROAD,
NORTH OF TSZ WAN SHAN**

GEO REPORT No. 153

Maunsell Geotechnical Services Ltd.

**This report was originally produced in December 2002
as GEO Landslide Study Report No. LSR 10/2002**

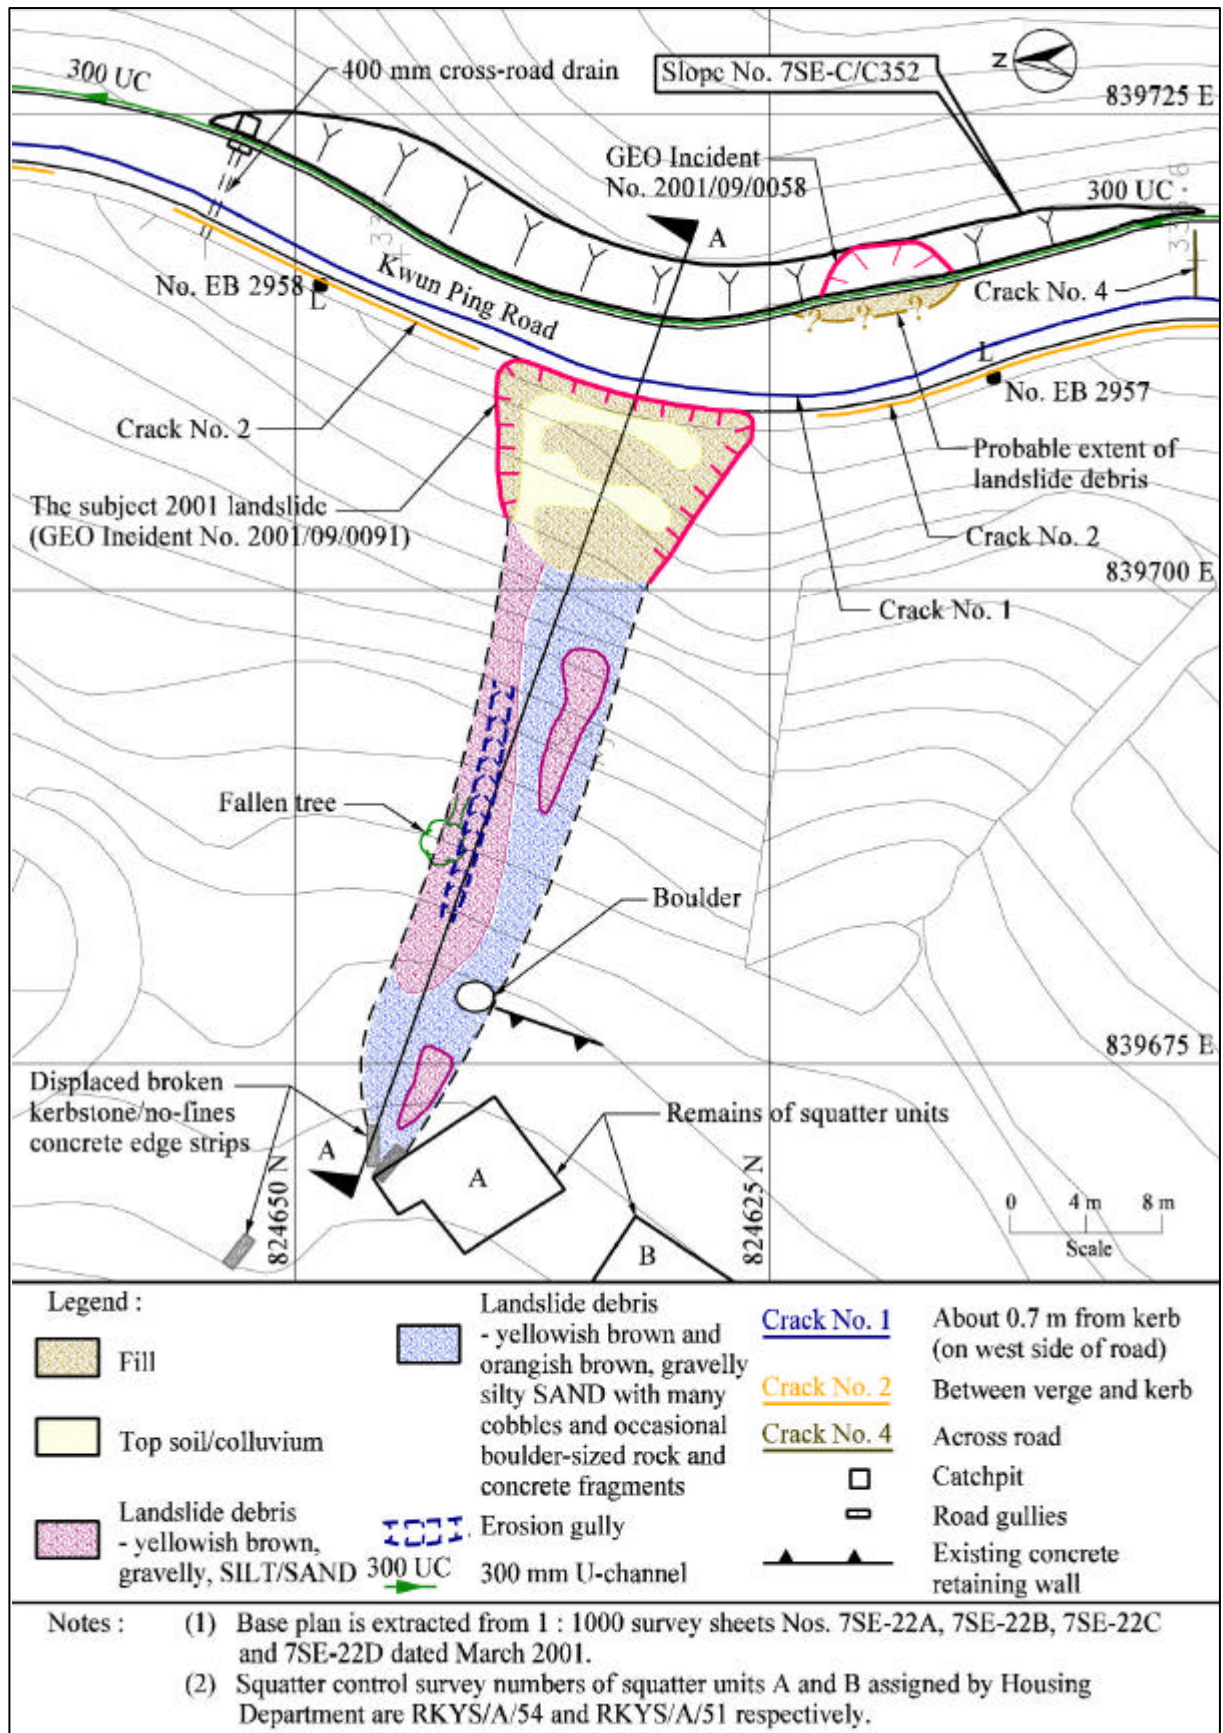
Figure 2 - Site Observations

Landslide debris, mainly sandy material with a few boulders up to about 1 m³, was deposited downhill as far as the area with remains of Squatters Units A, B and C, some 45 m from the road (Figure 2 and Plates 5 and 6). An old, 2.2 m high, concrete wall at the end of the debris trail and located behind the area with the remains of Squatters Units A, B and C might have obstructed the movements of the landslide debris. The concrete wall was apparently damaged by the landslide debris, which included boulders and possibly the broken segments of kerbstone and strips of no-fines concrete (Figure 2 and Plate 5). The travel angle of the landslide debris was calculated to be 30° (based on field measurement from the crest of the main scarp to the portion of the segment of kerbstone and strips of no-fines concrete deposited on the hillside at an elevation of about 307 mPD, i.e. excluding the outwash of the debris).

Another landslide (GEO Incident No. 2001/09/0058) occurred on slope No. 7SE-C/C352 on the east side of Kwun Ping Road. At the time of MGSL's inspection on 10 September 2001, the landslide debris had been removed and the landslide scar had been covered with shotcrete as part of the urgent repair works and a detailed examination of the material exposed at the landslide scar could not be made. The landslide scar was about 5 m wide by 6 m high with a maximum depth of about 300 mm. The estimated volume of the landslide was about 8 m³ (Figure 2).

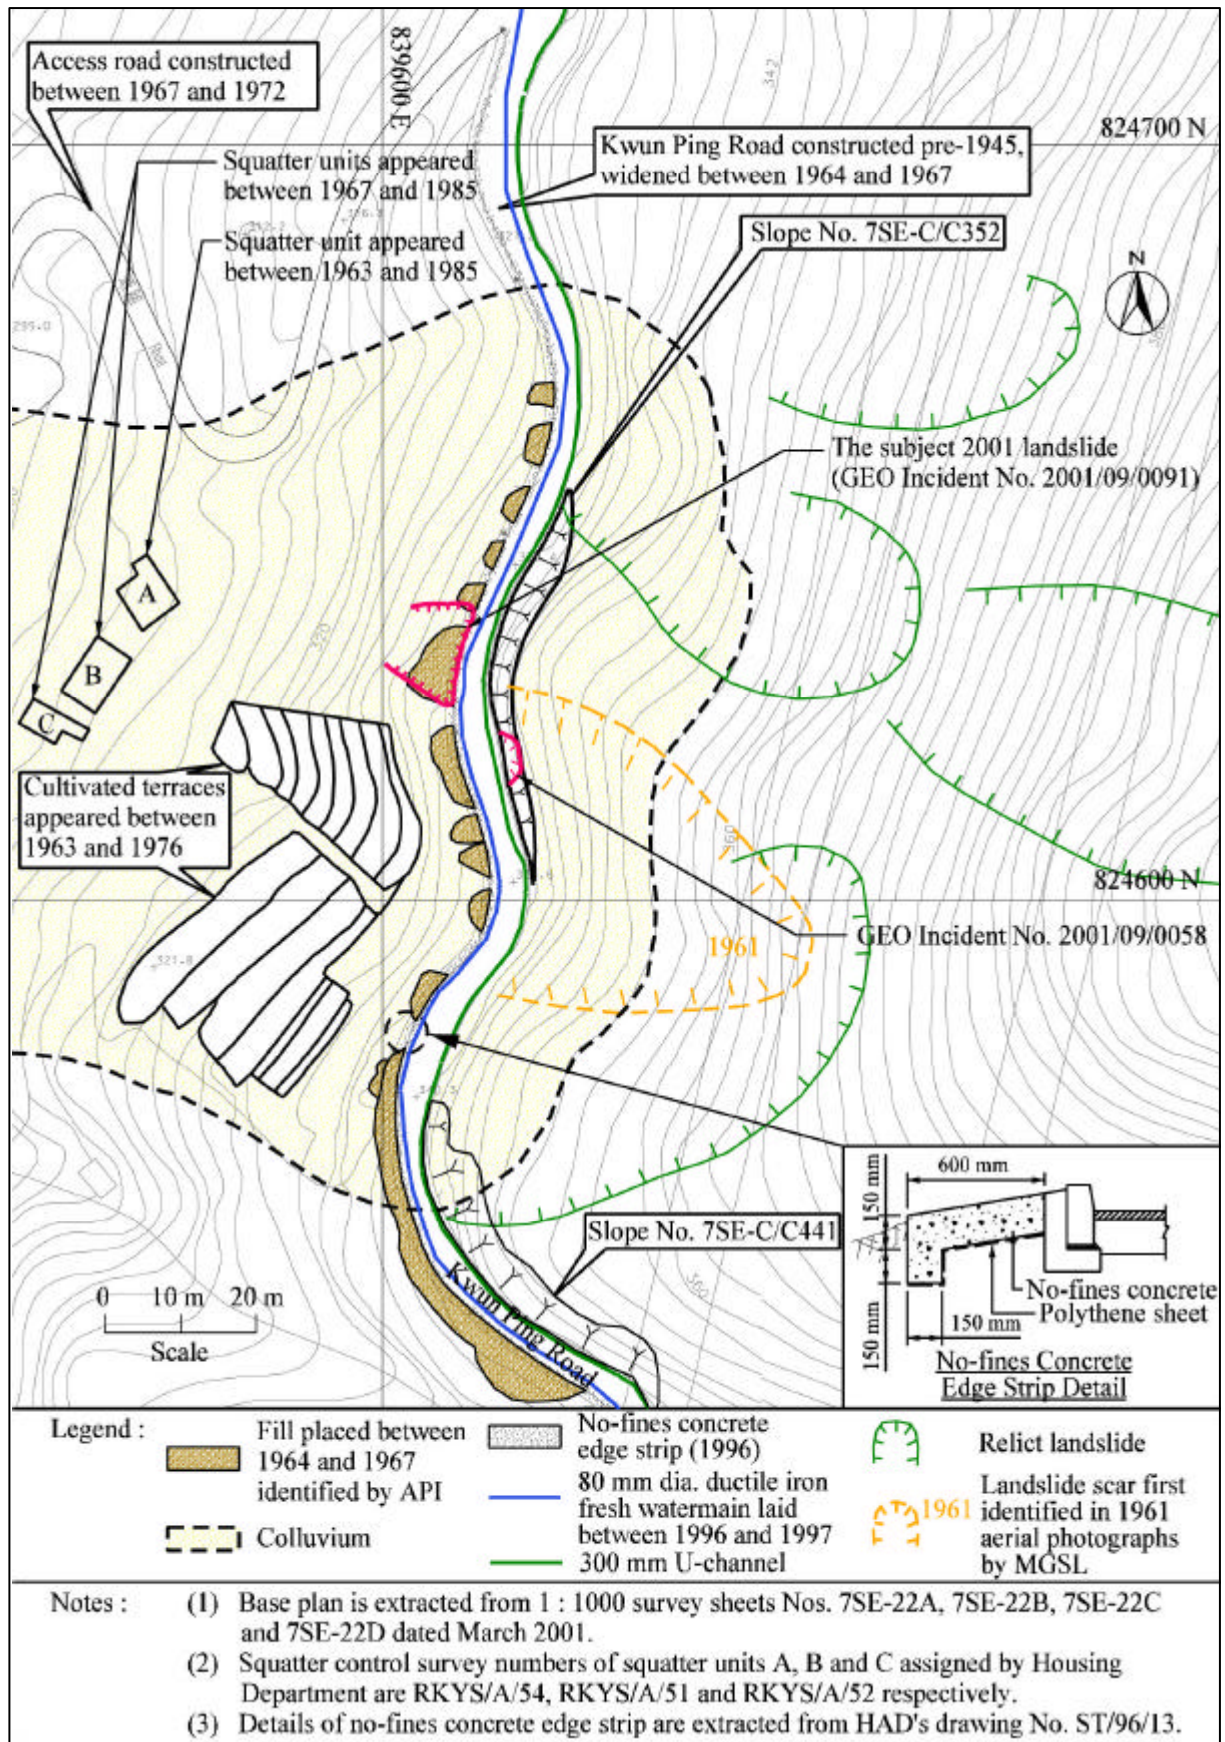
Figure 3 - Site History and Past Instability

Under the API carried out by MGSL, an old landslide scar on the natural hillside above slope No. 7SE-C/C352 was observed in the 1961 aerial photographs. The scar had become re-vegetated some time before 1963. Several relict landslides were also identified upslope of Kwun Ping Road (Figure 3 and Appendix A).

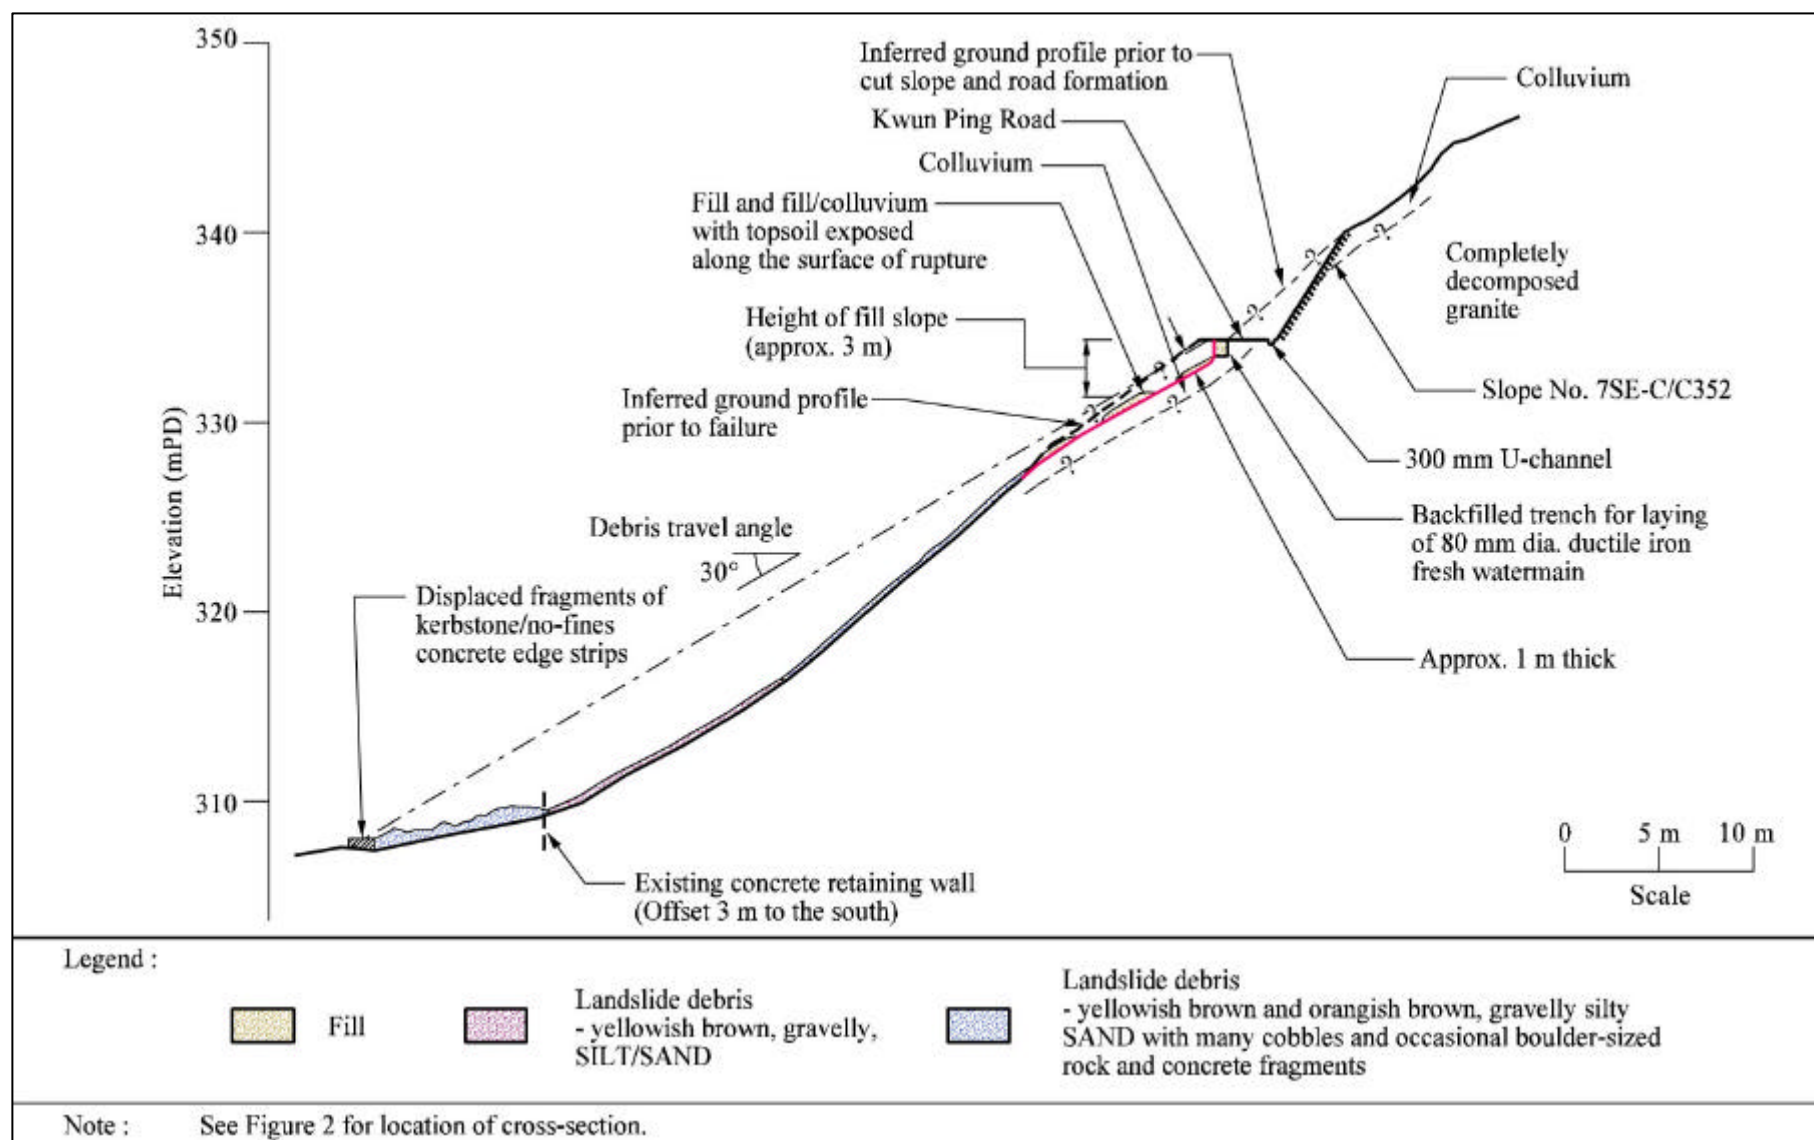
Figure 5 - Section A-A through the Landslide Scar

Theoretical stability analyses using the rigorous solution of Morgenstern & Price (1965) were carried out to assist in the diagnosis of the probable causes of the landslide. The analyses examined the likely operative range of shear strength parameters along the surface of rupture for different groundwater conditions at the time of failure. The cross-section through the landslide included in the stability analyses was based on Section A-A presented in Figure 5.

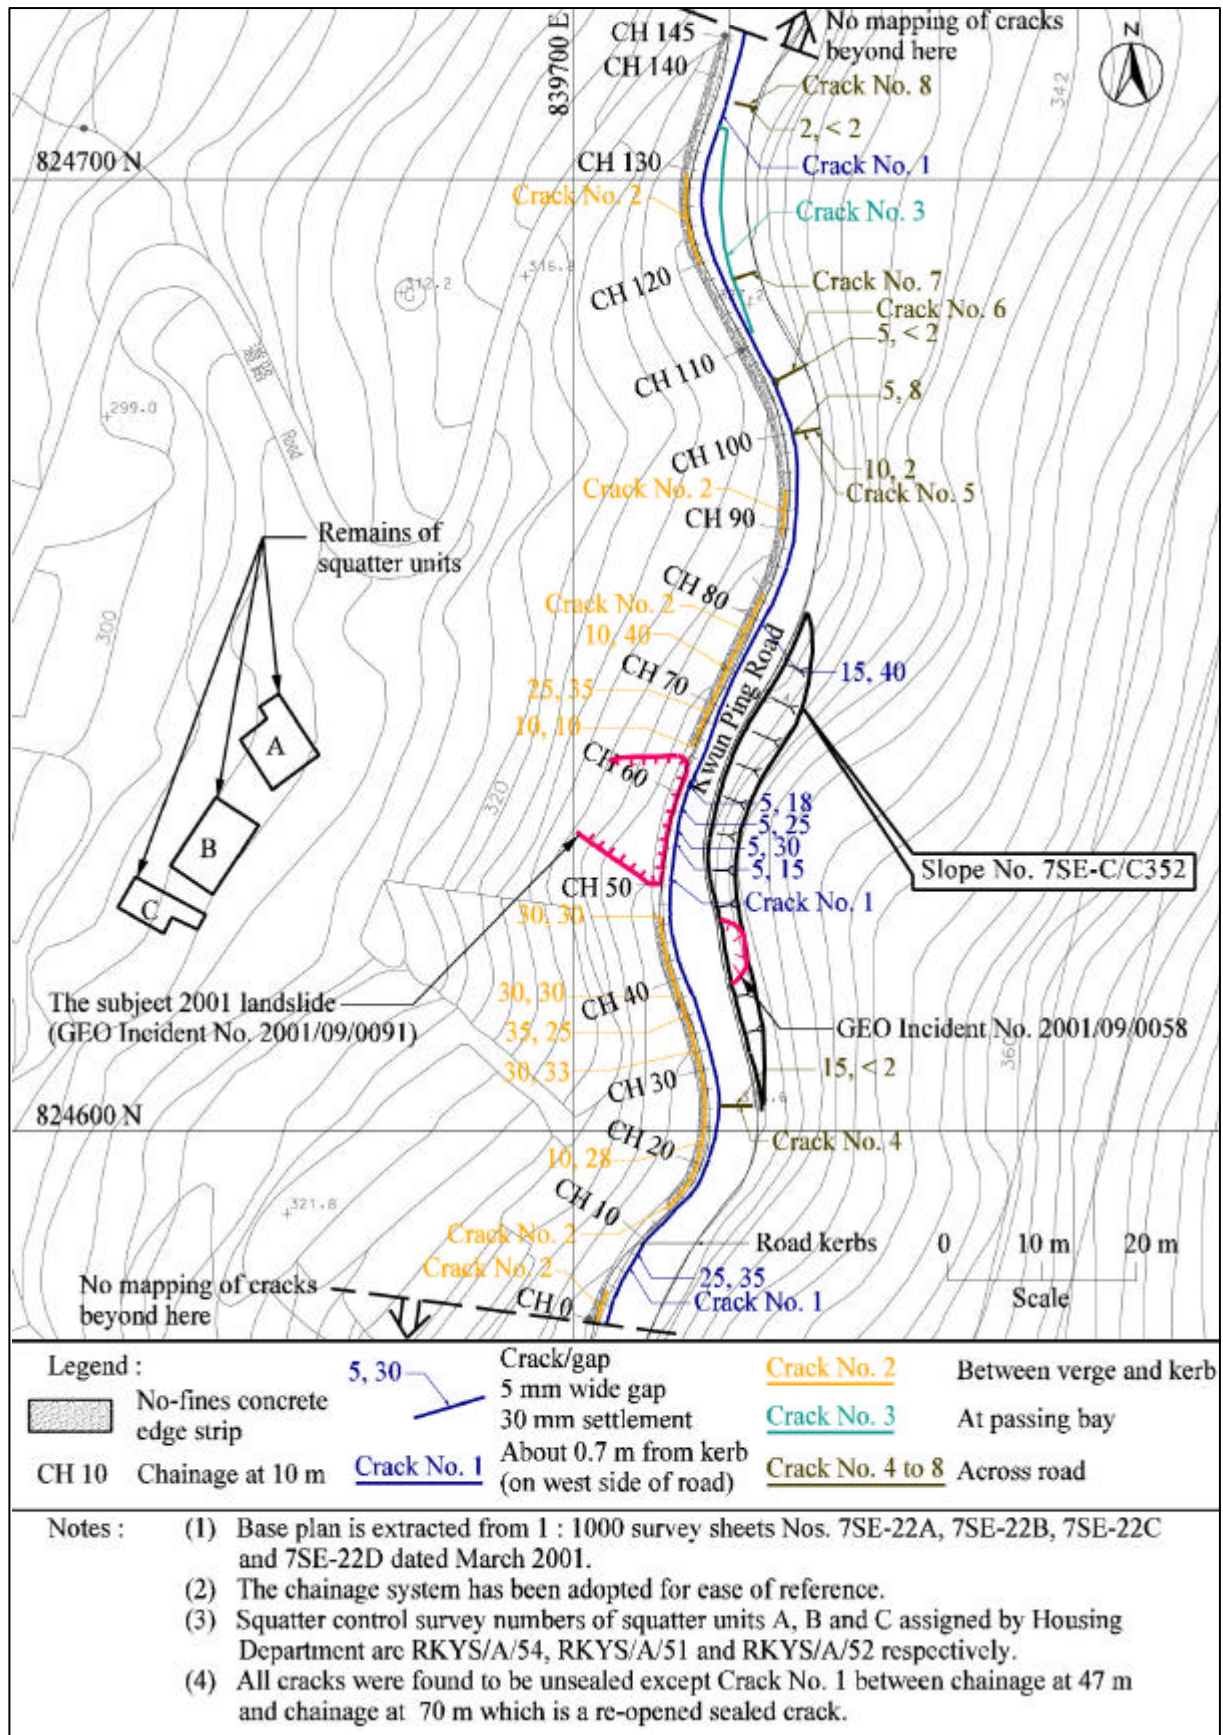
Figure 6 - Mapping of Cracks

Crack No. 1, which is the most conspicuous and persistent (Figure 6 and Plate 8), was observed on the west side of the Kwun Ping Road about 0.7 m from the kerb. The alignment of this crack was observed to coincide approximately with the east edge of the trench excavated for the laying of the 80 mm diameter fresh watermain as confirmed by MGSL's ground investigation (see Section 5.4). The crack was continuous and could be traced back as far as the junction with Shatin Pass Road, which is approximately 600 m to the south of the landslide site. Downward and outward displacement had occurred on the west side of the crack. The crack width at the landslide location was about 5 mm and the differential settlement ranged from 15 mm to 30 mm. The maximum crack width recorded was about 25 mm, approximately 23 m to the south of the landslide site at about Chainage 8. The maximum differential settlement of the road pavement across the crack was approximately 40 mm at about Chainage 80 (Plates 8 and 9), some 20 m to the north of the subject landslide site. The crack was found to have extended through the pavement of Kwun Ping Road (about 200 mm in depth) and terminating at the top of the subgrade (see Section 5.4).

A section of Crack No. 1 (between Chainages 47 and 70 which is immediately above the September 2001 landslide site) was sealed with cement mortar. This sealed section of Crack No. 1 was found by MGSL to have re-opened (Figure 6 and Plate 3).

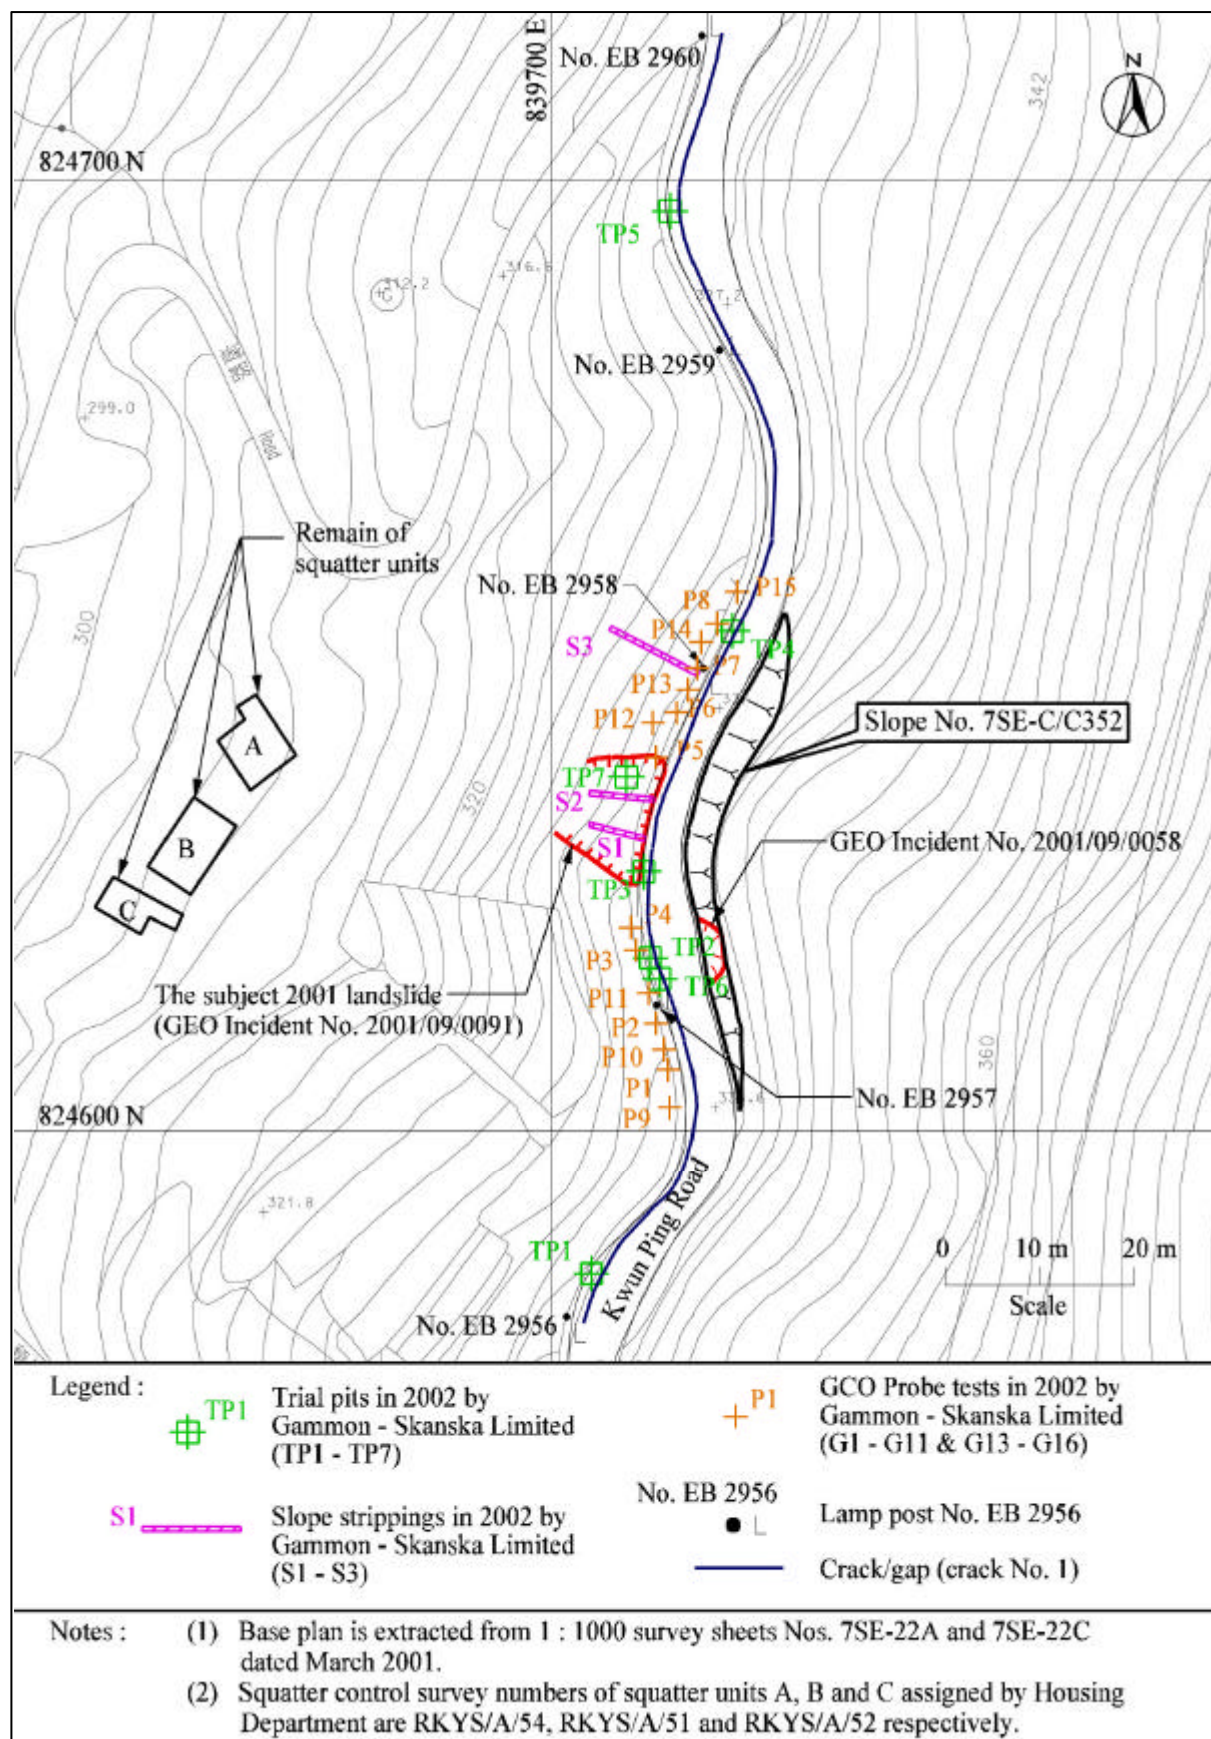
Figure 7 - Ground Investigation Plan

On 7 June 2002, 15 GCO probes tests (Nos. P1 to P15) were carried out to depths of between 1.2 m and 5.5 m on the hillside below Kwun Ping Road within the area of fill on the hillside (Figure 7). The probe values were recorded as the number of blows for every 100 mm depth of penetration of the probe. The tests were terminated when three consecutive readings with more than 30 blows for 100 mm penetration were achieved. More than 70% of the test results recorded probe values below 10 and about 47% of the results were below 5. The GCO probe tests generally indicated the presence of loose materials (probably fill and colluvium), which extended to a maximum depth of almost 4 m within the area of the small unregistrable fill slopes.

In January and February 2002, seven trial pits (Nos. TP1 to TP7) were excavated (Figure 7). Five of the trial pits (Nos. TP1 to TP5) were excavated to investigate the ground conditions at several locations to the west of Crack No. 1 along the edge of Kwun Ping Road. Trial pit No. TP6 was excavated across Crack No. 1 and trial pit No. TP7 was located on the hillside at the north edge of the landslide scar. Details of in-situ density tests carried out in the trial pits are discussed in Section 5.5.

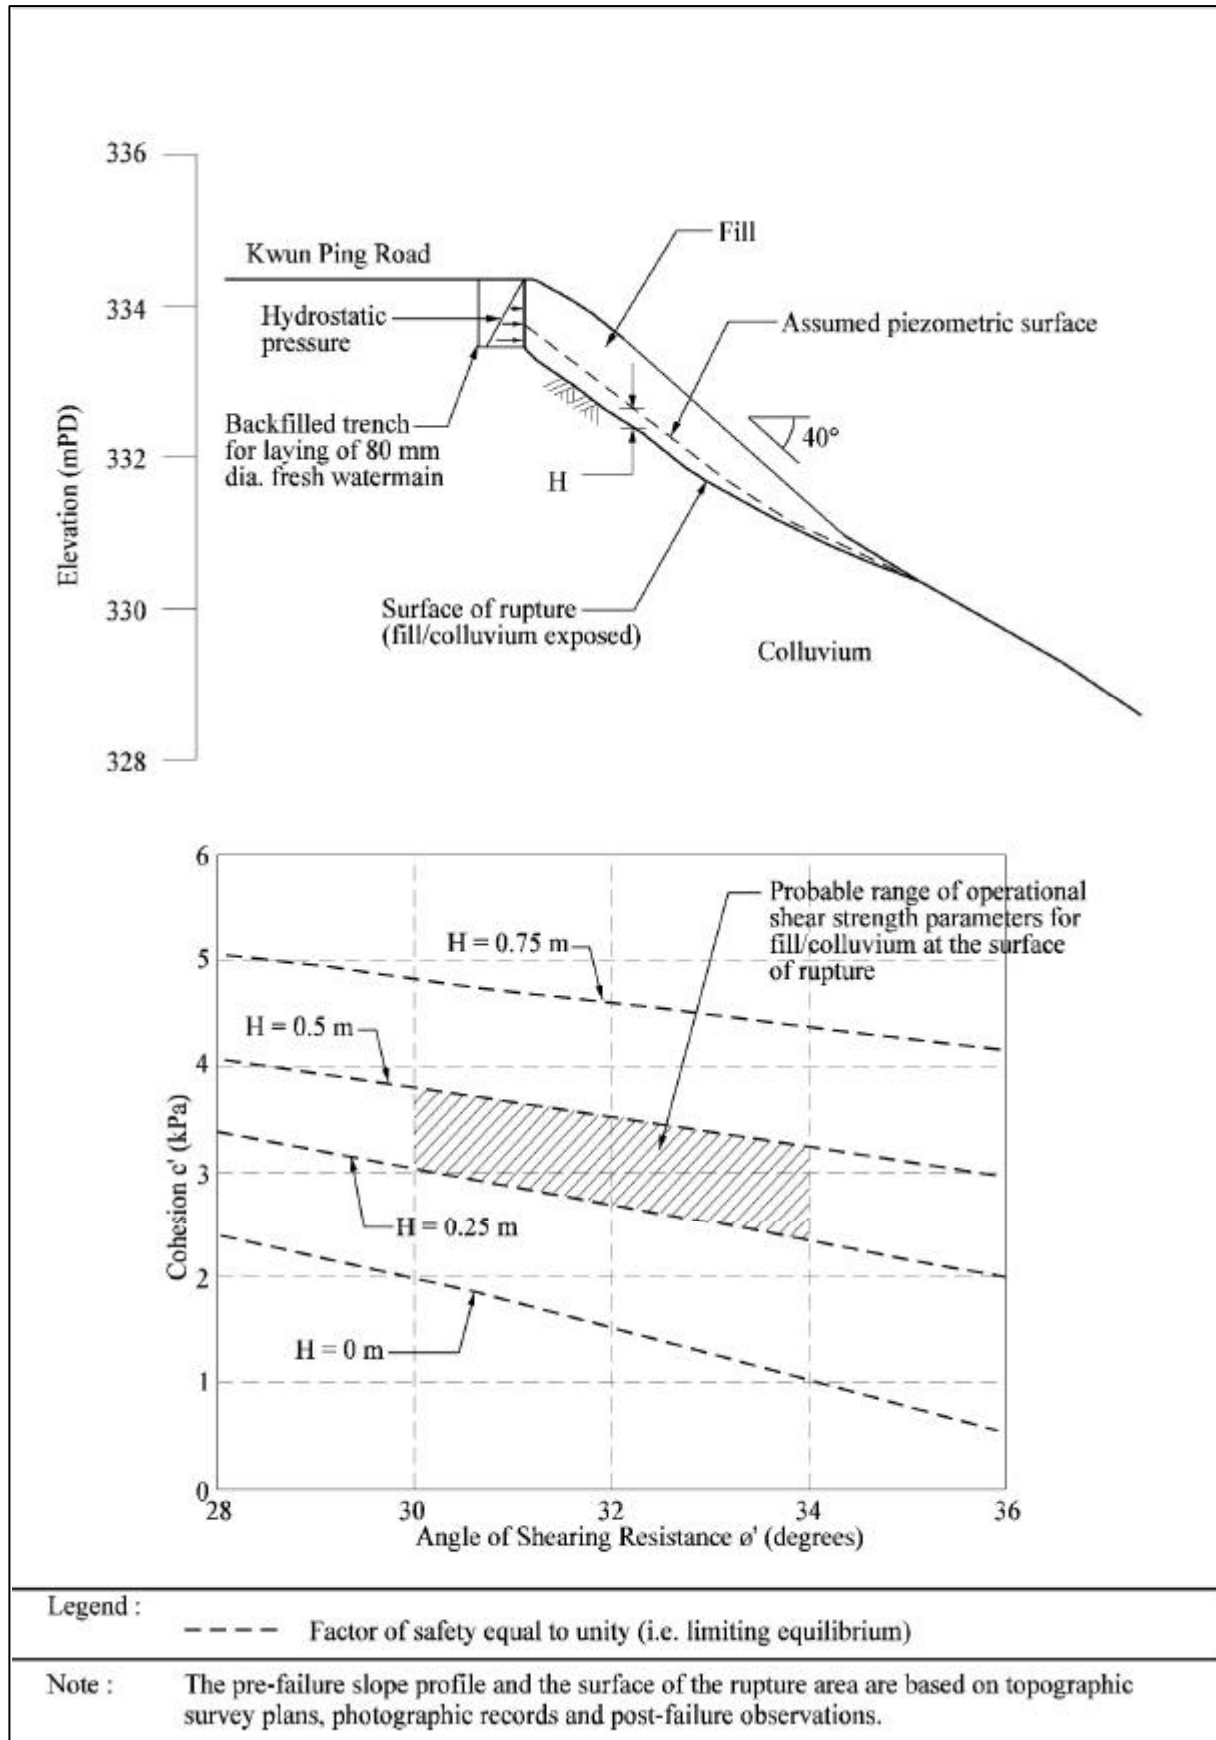
Figure 10 - Summary of Sensitivity Analyses

The results of the analyses are presented in Figure 10. These indicate that the development of a transient groundwater pressure corresponding to a piezometric level of about 0.5 m above the surface of rupture would be sufficient to initiate failure in the slope.

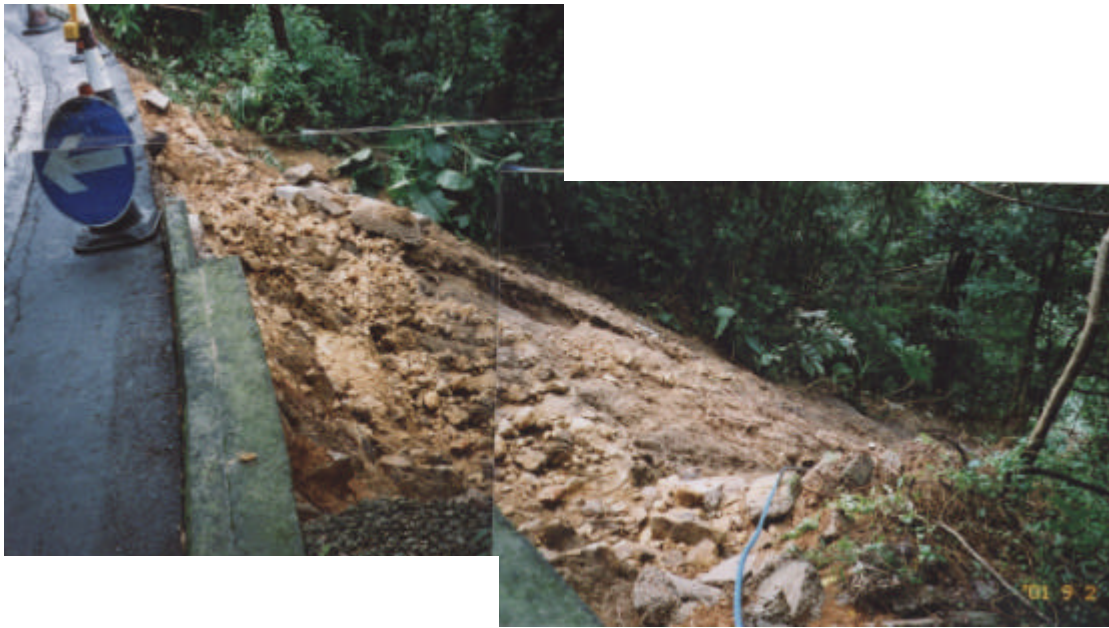
Plate 1 - General View of the Landslide Site
(Photograph taken on 2 September 2001 by GEO)

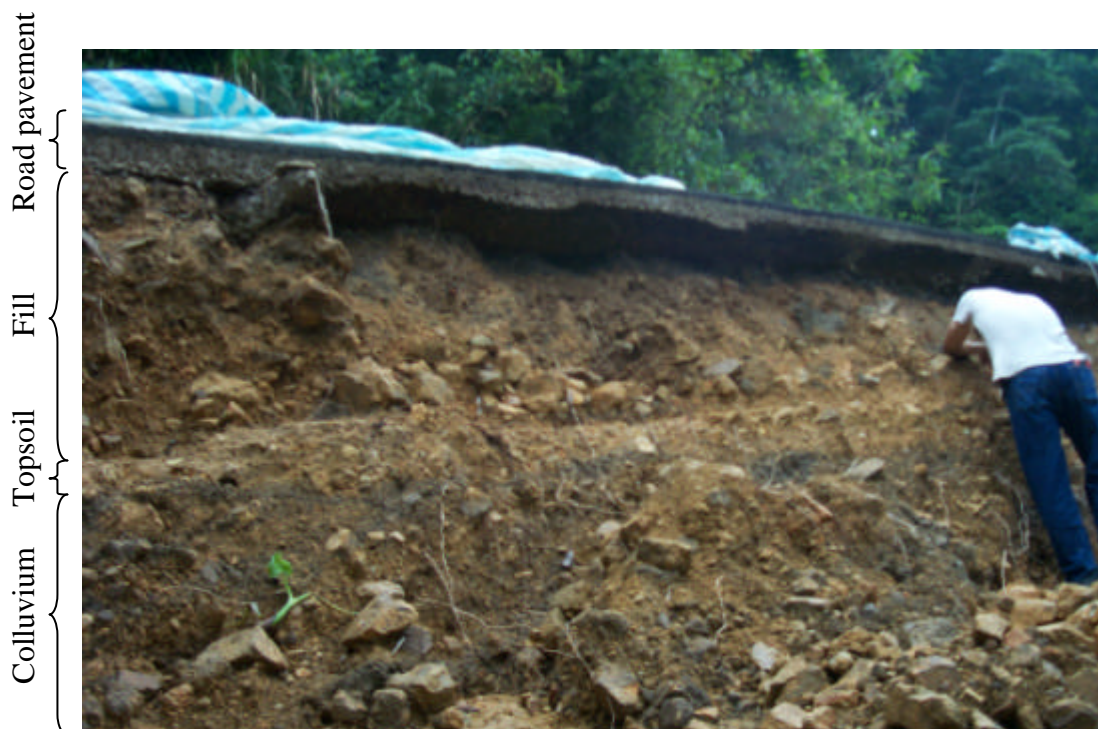
Plate 2 - Collapse of Sub-grade below Kwun Ping Road
(Photograph taken on 10 September 2001)

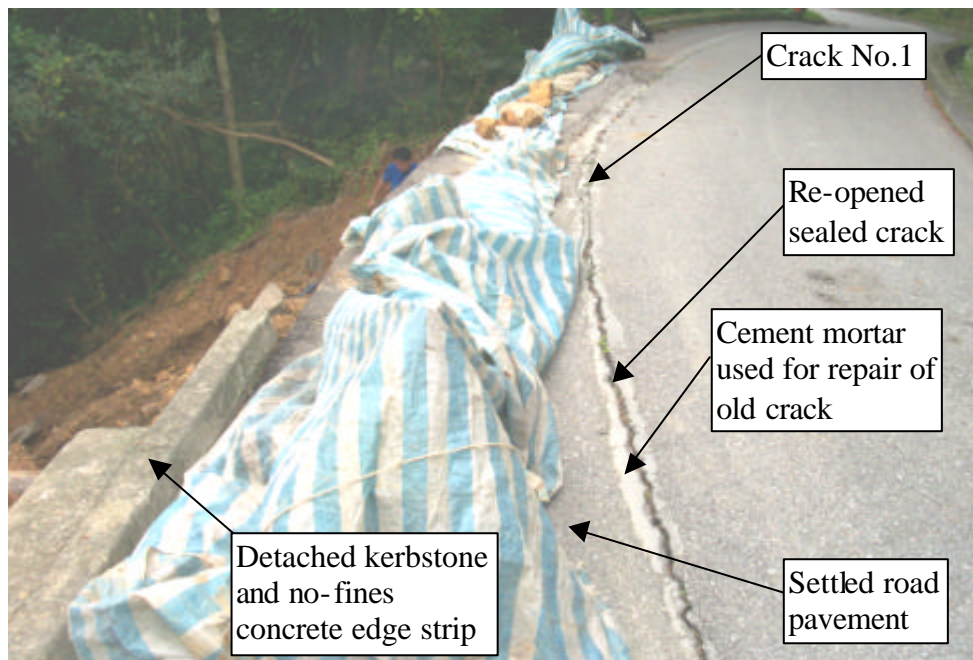
pavement above the landslide main scarp had settled about 30 mm (Plate 3). It appears that the east edge of this settled strip was delineated by an old crack (being part of a crack designated as crack No. 1 in this report, see Section 4.2), which was sealed with cement mortar for an extent of about 23 m, along the west edge of the road (Plate 3). During the inspection on 10 September 2001, MGSL observed that the crack had re-opened.

Plate 3 - View from Road Showing Re-opened Sealed Crack No.1, Settled Road Pavement, Detached Kerbstone and No-fines Concrete Edge Strip
(Photograph taken on 10 September 2001)

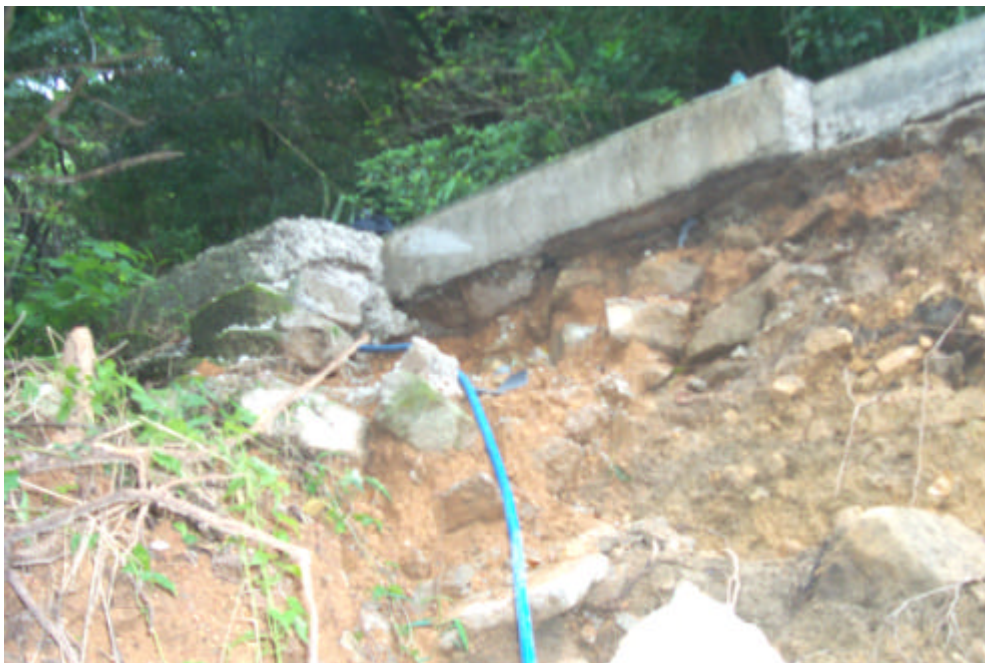
Plate 4 - View of a Section of Collapsed No-fines Concrete Edge Strip and Kerbstone
(Photograph taken on 10 September 2001)

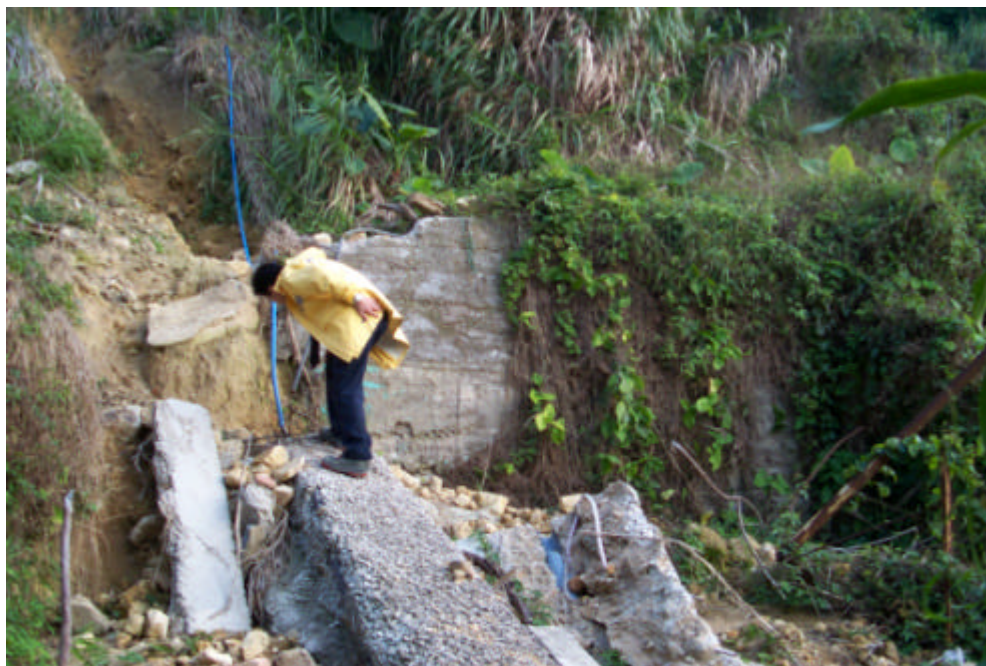
Plate 5 - View Showing Damaged Concrete Retaining Wall behind Area
with Remains of Squatter Units
(Photograph taken on 21 January 2002)

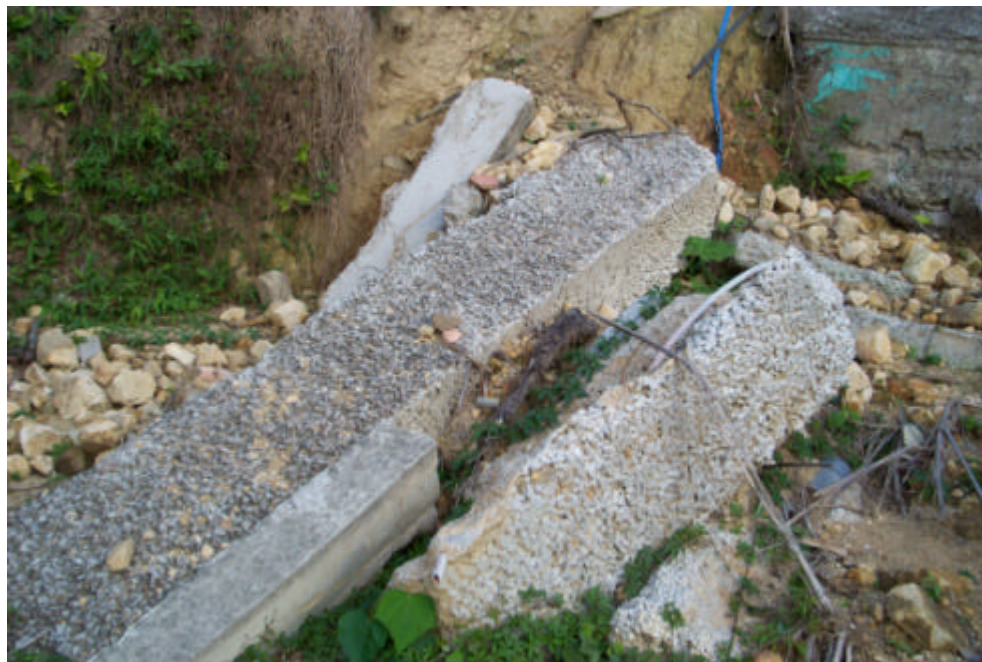
Plate 6 - View Showing Fragments of Displaced No-fines Concrete Edge
Strips
(Photograph taken on 21 January 2002)

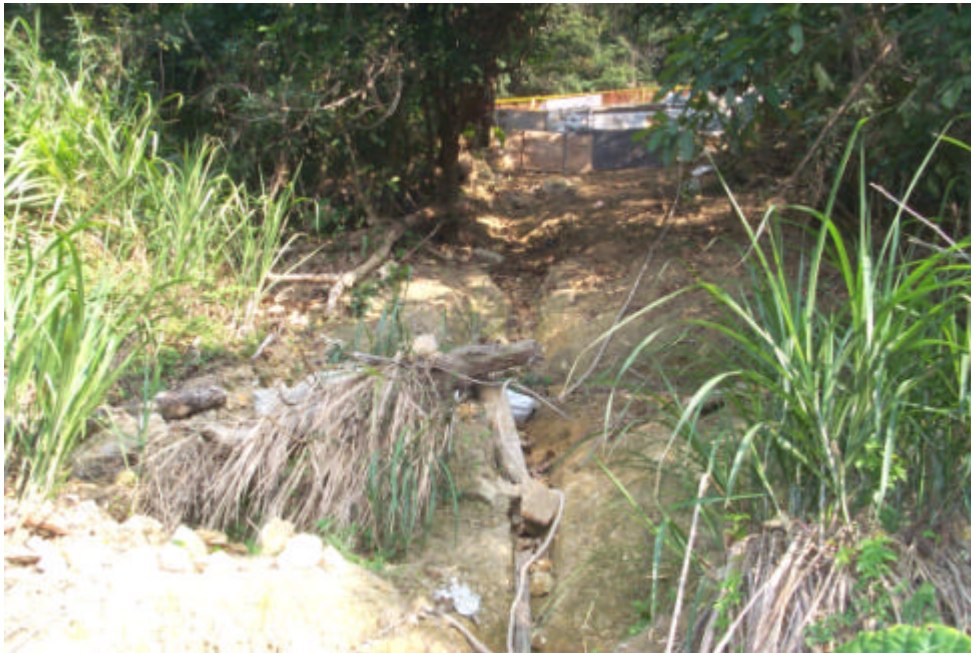
Erosion gullies with a maximum depth of 0.5 m were observed along the debris trail, where vegetation and fallen trees were aligned in the direction of flow of the landslide debris (Plate 7). Broken segments of the concrete kerbstone and no-fines concrete edge strip (up to between 2 m and 3 m long) were deposited about 45 m from the roadside. No signs of past instability or signs of significant deterioration of the other small fill slopes and the hillside in the close vicinity of the landslide were observed during MGSL's inspections. The landslide debris did not appear to be channelised as there are no natural drainage lines in the vicinity of the landslide site.

Plate 7 - View of the Landslide Site from Below Showing Disturbed Vegetation on the Debris Trail
(Photograph taken on 22 January 2002)

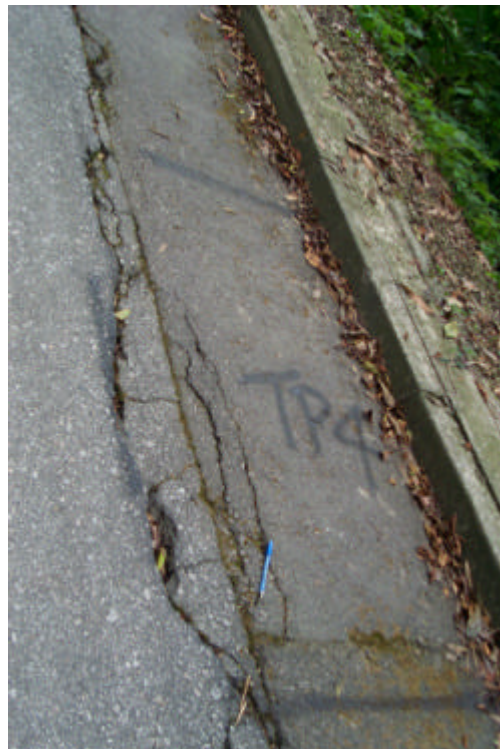
Plate 8 - View of Crack No. 1 Observed above Landslide Scar on Western Side of Kwun Ping Road
(Photograph taken on 13 December 2001)

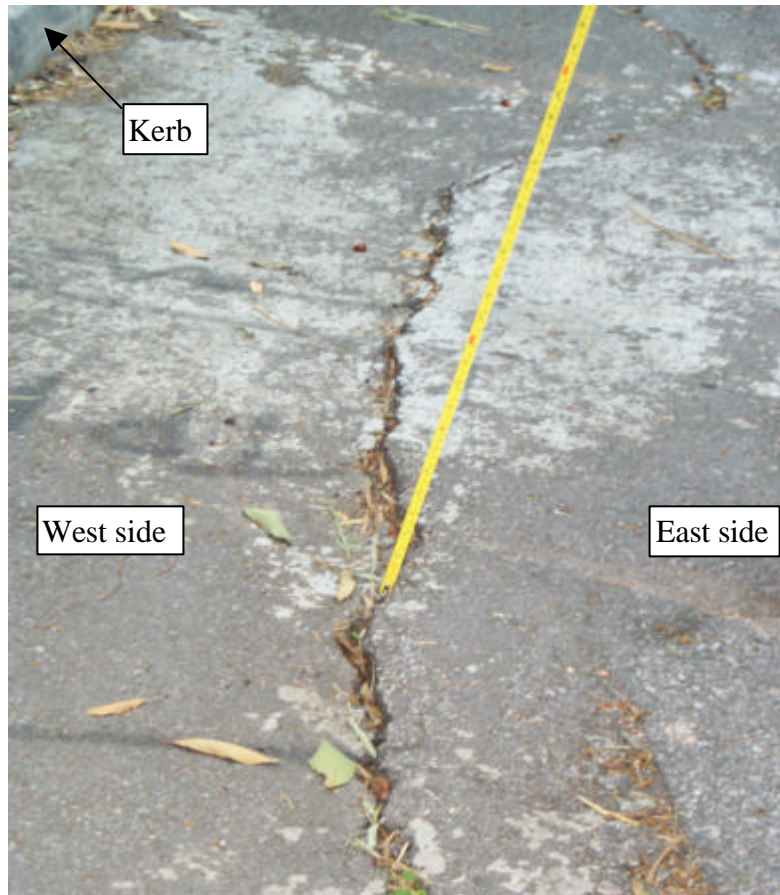
Plate 9 - Differential Settlement of Road Pavement across Crack No. 1
(Photograph taken on 4 January 2002)

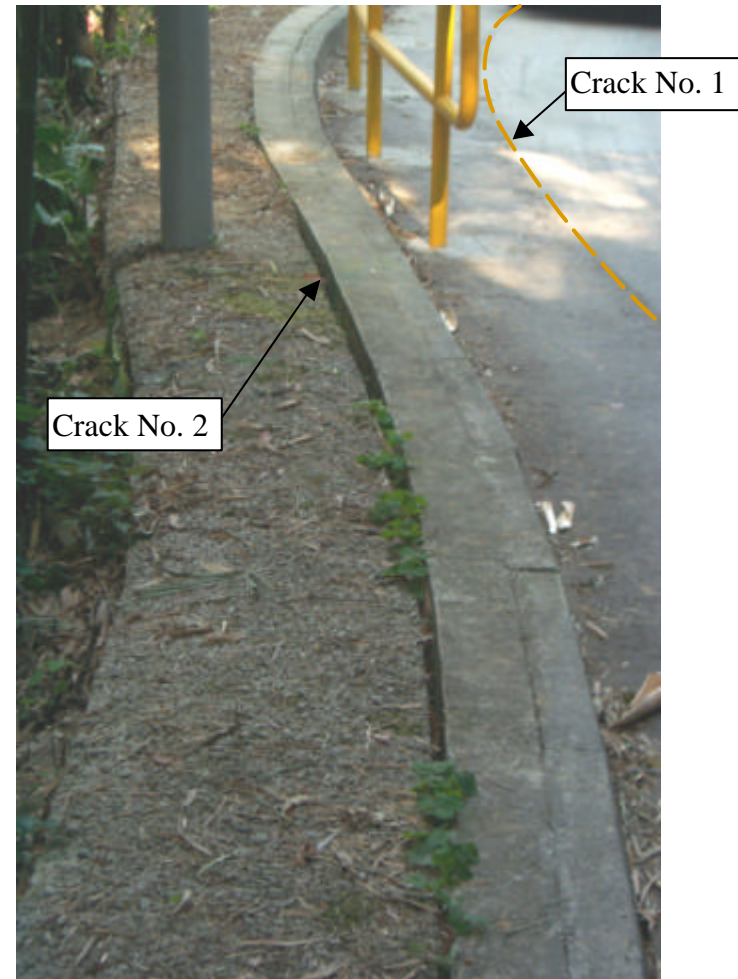
Crack No. 2 was discontinuous and occurred between the no-fines concrete edge strip and the concrete road kerb (Plate 10). About 10 m to the south of the subject landslide site, the width of the opening and the downhill differential movement were consistently about 30 mm (Plates 11 and 12). Approximately 10 m to 15 m to the north of the subject landslide site, the width ranged from 10 mm to 25 mm and the settlement was up to some 40 mm on the west side of the crack. Crack No. 3 was located along the inner edge of a passing bay and exhibited minor settlement, whereas Cracks Nos. 4 to 8, were aligned across the road.

Plate 10 - Differential Settlement along Kerb/No-fines Concrete Edge Strip
(Photograph taken on 4 January 2002)

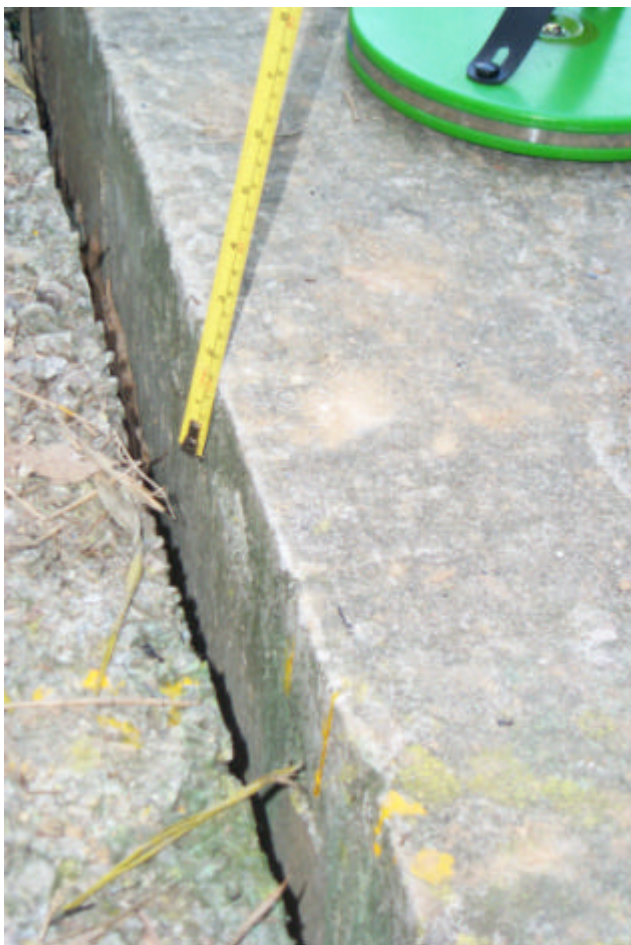
Plate 11 - Differential Settlement about 30 mm
across Crack No. 2
(Photograph taken on 4 January 2002)

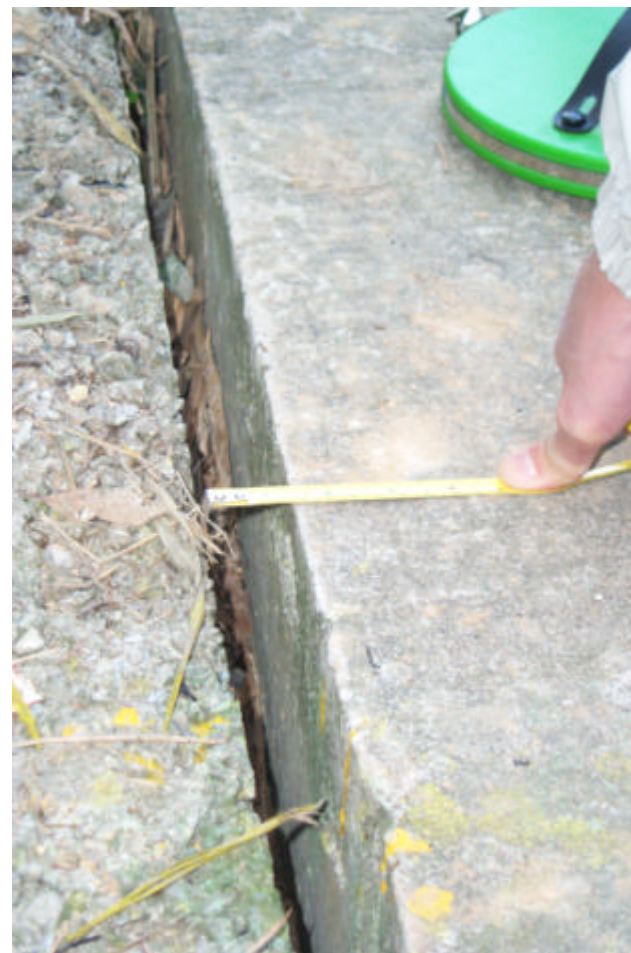
Plate 12 - Width of Gap about 35 mm across
Crack No. 2
(Photograph taken on 4 January 2002)
