**DETAILED STUDY OF
THE SEPTEMBER 2001
LANDSLIDE ON THE HILLSIDE
BELOW KWUN PING ROAD,
NORTH OF TSZ WAN SHAN**

GEO REPORT No. 153

Maunsell Geotechnical Services Ltd.

**This report was originally produced in December 2002
as GEO Landslide Study Report No. LSR 10/2002**

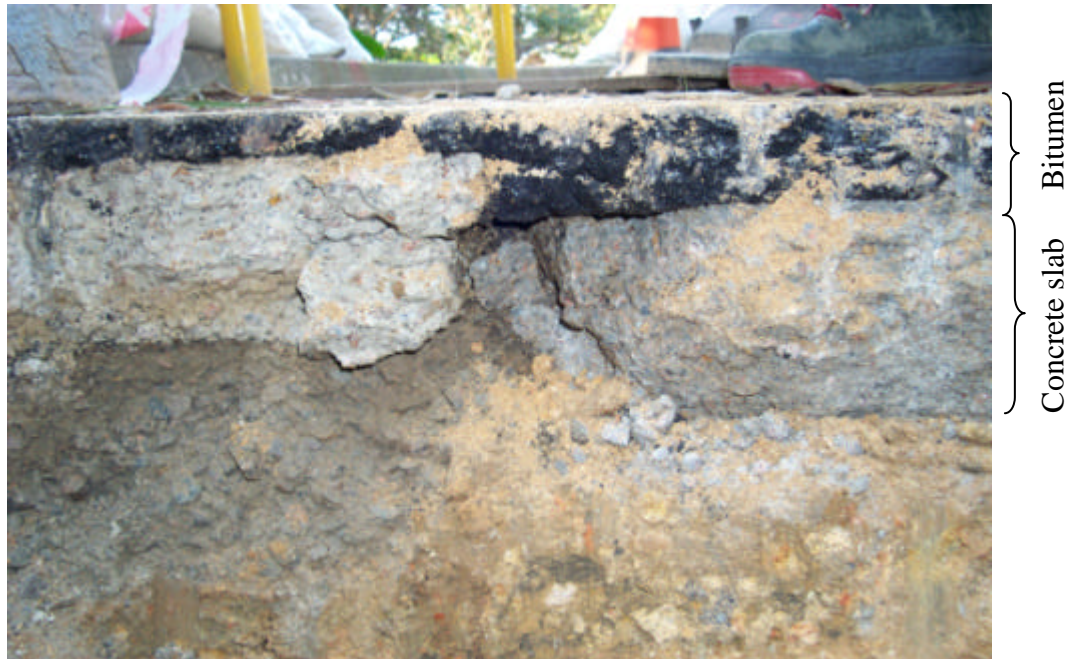
Plate 13 - View Showing a Typical Section through the Road Pavement in Trial Pit No. TP3
(Photograph taken on 21 January 2002)

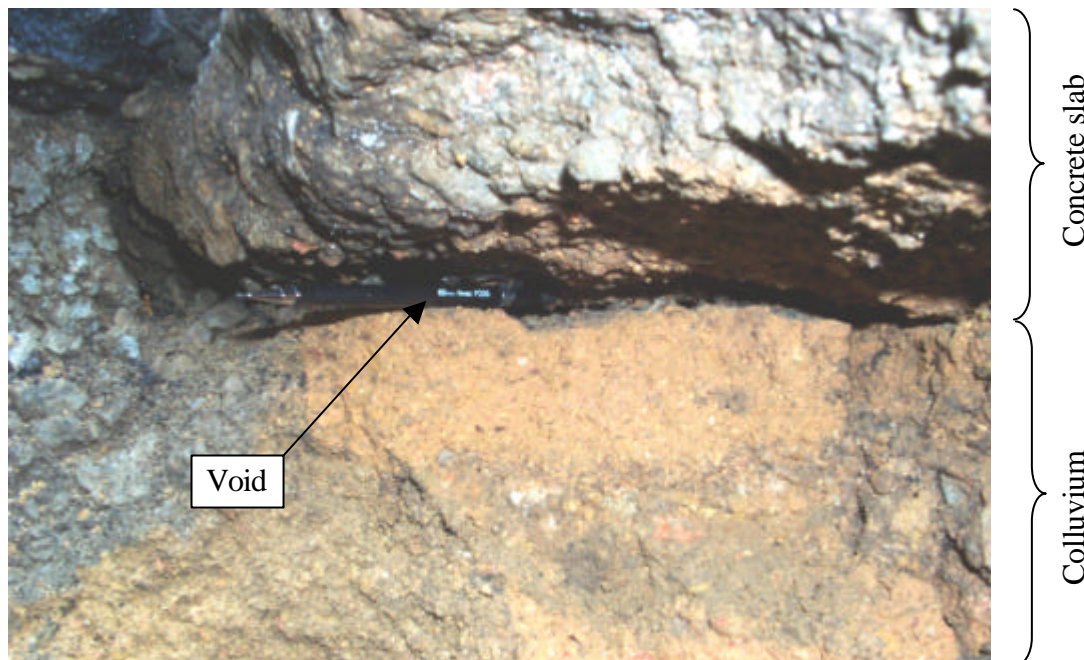
A discontinuous void (up to about 20 mm wide) between the underside of the concrete road pavement and the underlying fill was observed at the location of trial pit No. TP2 (Plate 14). In trial pit No. TP6, Crack No. 1 was found to extend through the bitumen and concrete pavement of Kwun Ping Road (about 200 mm depth), terminating at the top of the subgrade (Plate 15).

Plate 14 - View of Void between Sub-grade and Underside of Concrete Road Pavement in Trial Pit No. TP2
(Photograph taken on 21 January 2002)

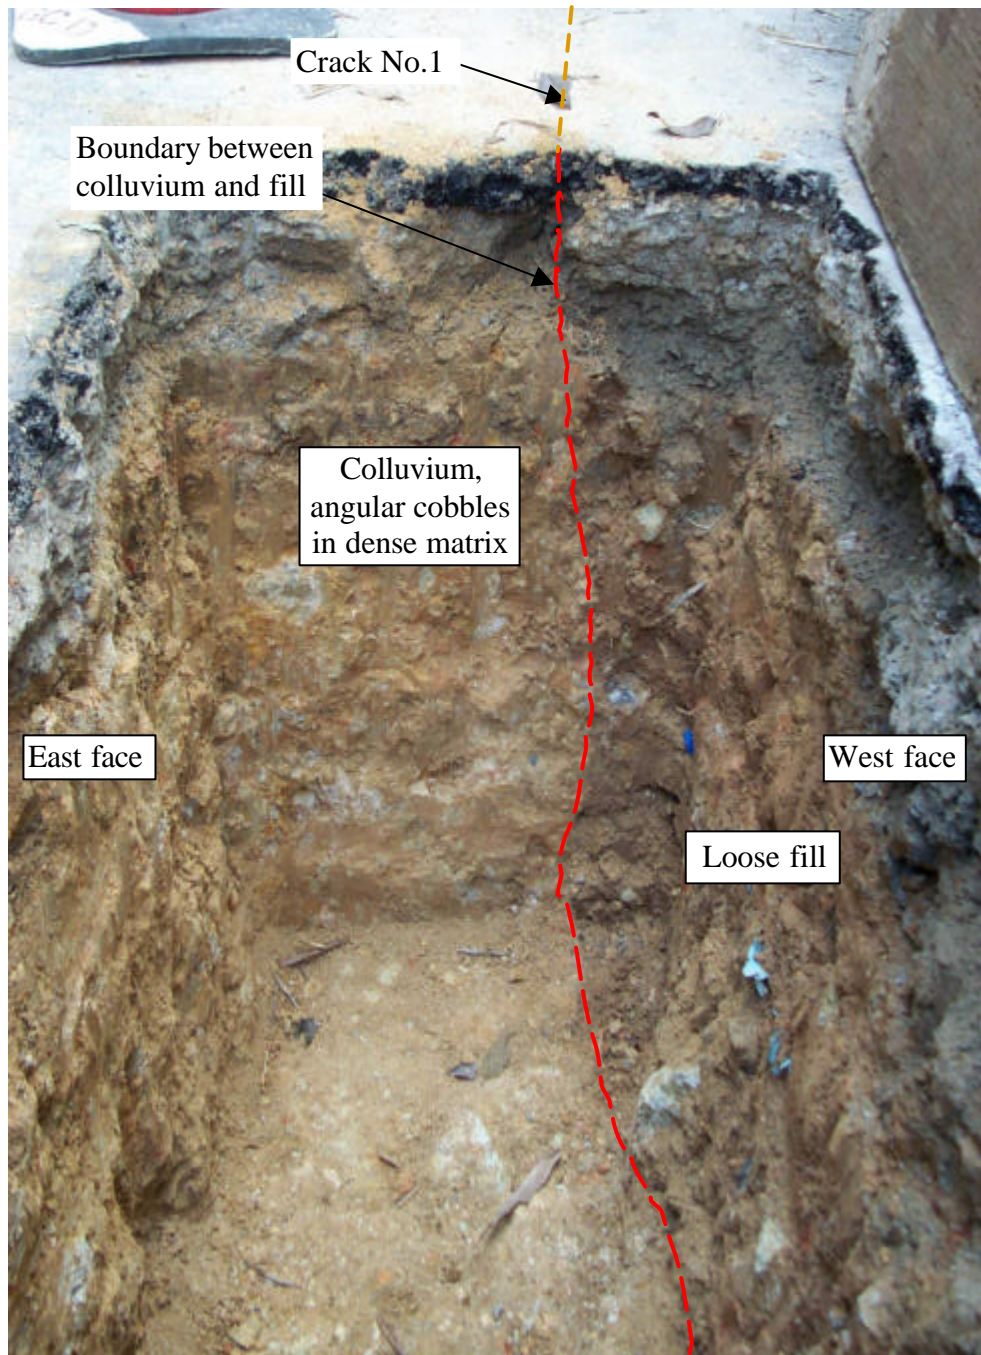
Plate 15 - General View of Trial Pit No. TP6
(Photograph taken on 10 January 2002)
