DETAILED STUDY OF THE 1 SEPTEMBER 2001 DEBRIS FLOW ON THE NATURAL HILLSIDE ABOVE LEI PUI STREET

GEO REPORT No. 154

Maunsell Geotechnical Services Ltd.

This report presents the findings of an investigation into the landslide (GEO Incident No. 2001/09/0057), which occurred on 1 September 2001 above Lei Pui Street, Shek Lei Estate, Kwai Chung. The debris flow was triggered by a landslide involving about 250 m³ of rock and soil on the steep natural hillside above a 25 m high cliff. The landslide debris and entrained material with an estimated maximum volume of 780 m³ was deposited mainly within the lower part of the hillside and an active construction site, situated about 10 m above Lei Pui Street. About 50 m³ of outwash material was deposited on Lei Pui Street and the Shek Lei Estate. The landslide demolished two squatter structures which had been vacated about two hours before the event and Lei Pui Street was closed for 3 days. No casualties were reported.

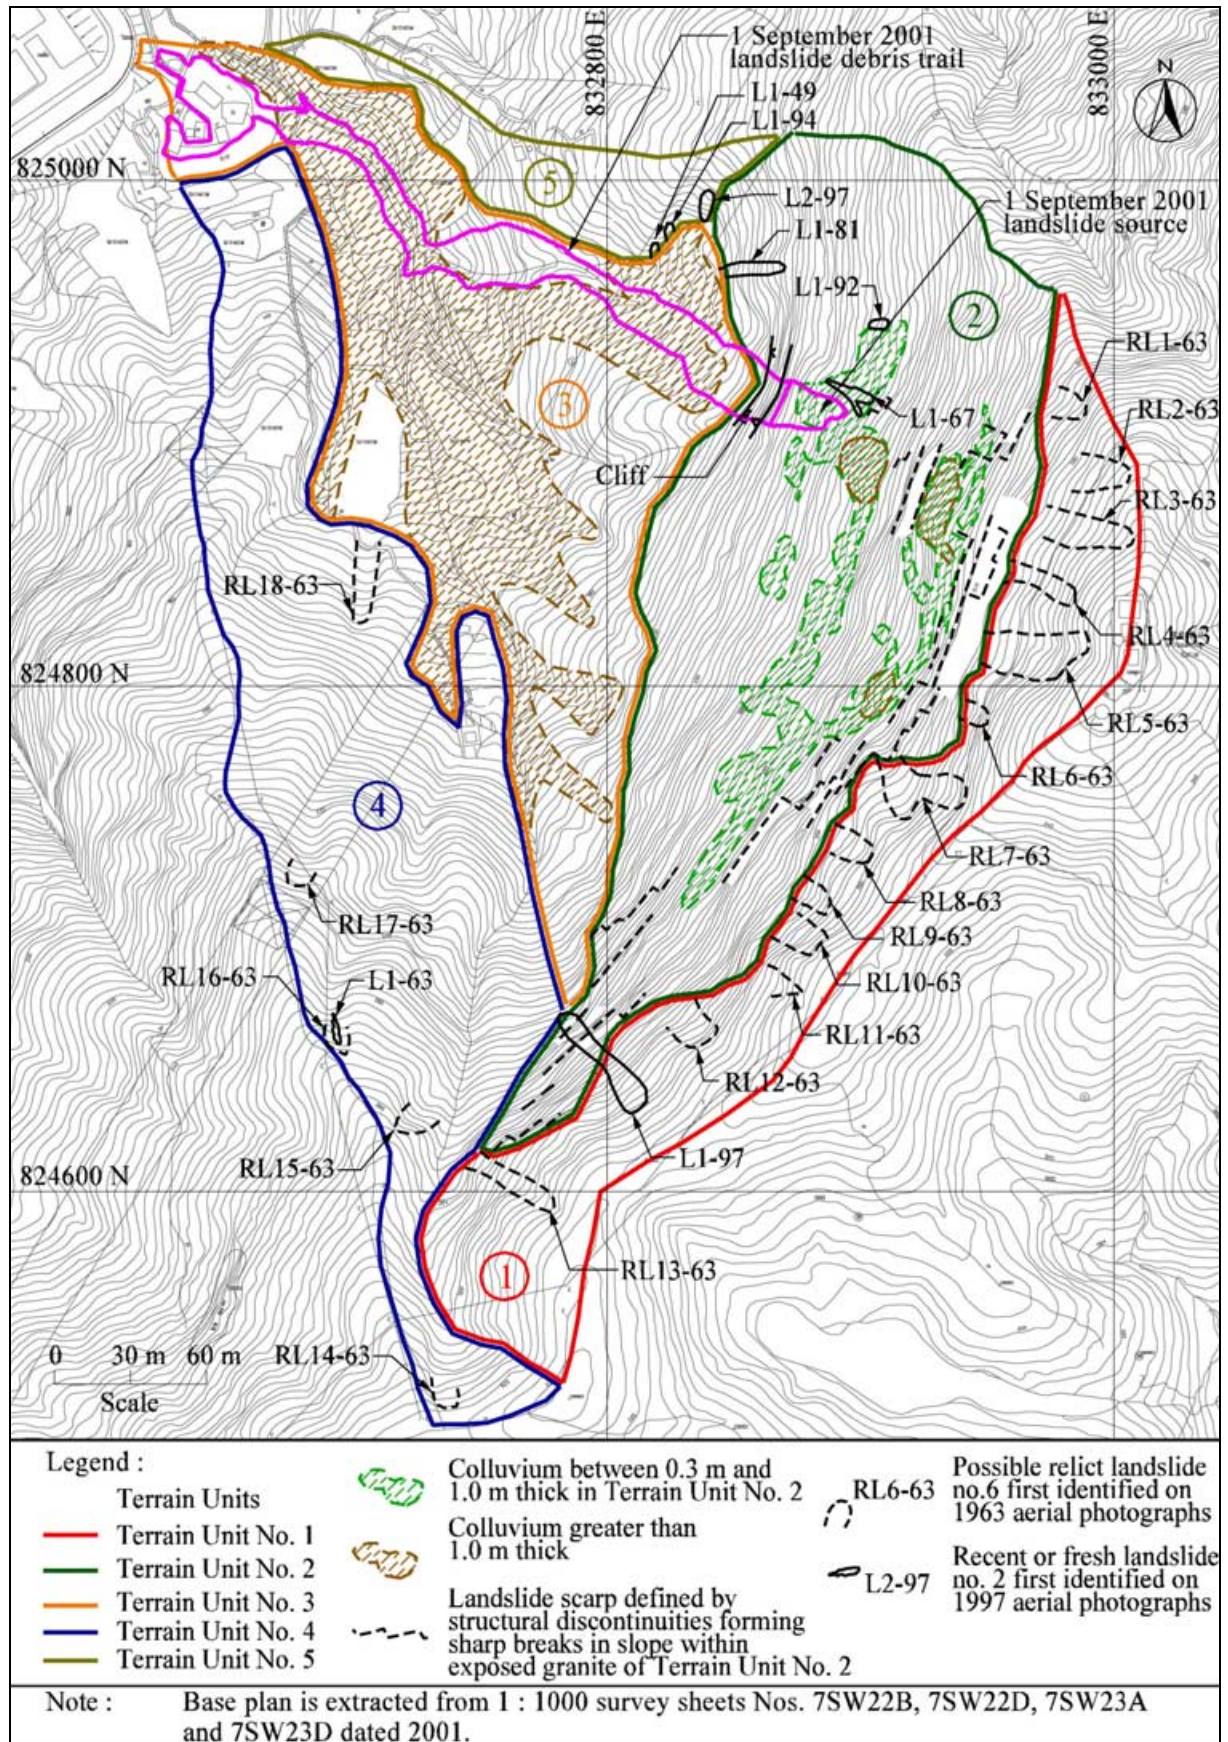
Figure 15 - Landslides and Geomorphology Inferred from API and Field Mapping

The Set 2 joints have been identified as being a contributing factor to the 1 September 2001 landslide in that they form overhanging release surfaces cutting directly across the strike of the sheeting joints (see Figure B1, Appendix B and Plate 25). Site observations indicate that these joints are frequently open near the ground surface indicating that movements have taken place. Based on examination of low-level aerial photographs, many of the rock cliffs contain large-scale blocks that are separated by tension cracks orientated in a similar direction to the Set 2 joints. Mapping of the rock face above the 1 September 2001 landslide source also confirms the dilated nature of the steeper portions of the rock cliffs (Plate 26). From the above observations, it is inferred that many of the cliffs mark the scarps of structurally controlled instability that have failed by a combination of toppling and sliding, and that many of the remaining scarps can be regarded as being potentially unstable. The API carried out for the SW study (see Section 3.2) also identified an extensive joint-controlled relict landslide, which extends across the series of cliffs in the upper portion of Terrain Unit 2 (Figure 7) and broadly corresponds to the main belt of structurally controlled relict instability identified in Figure 15.

As a consequence of the relict landslides in Terrain Unit 1 and the unstable nature of the cliffs in Terrain Unit 2, the flatter-lying ledges within Terrain Unit 2 are partially covered with colluvium (Figure 15). The most extensive and thickest areas of colluvium include the area above the 1 September 2001 landslide source (Plate 5). Large colluvial boulders (up to 2.5 m by 1.5 m) were found lying close to the edge of a ledge above the landslide source area that are being undermined by erosion of the underlying loose, sandy colluvium (located in the lower lobe of colluvium indicated in Plate 5). Clast-supported colluvium (talus) can also be found resting on an overhung sheeting joint directly beneath the landslide source (Figure 8). Erosion by the landslide has exposed a section through the colluvium, which reveals loose, clast-supported, angular cobbles, boulders and gravel in a subordinate matrix of silty sand (talus).

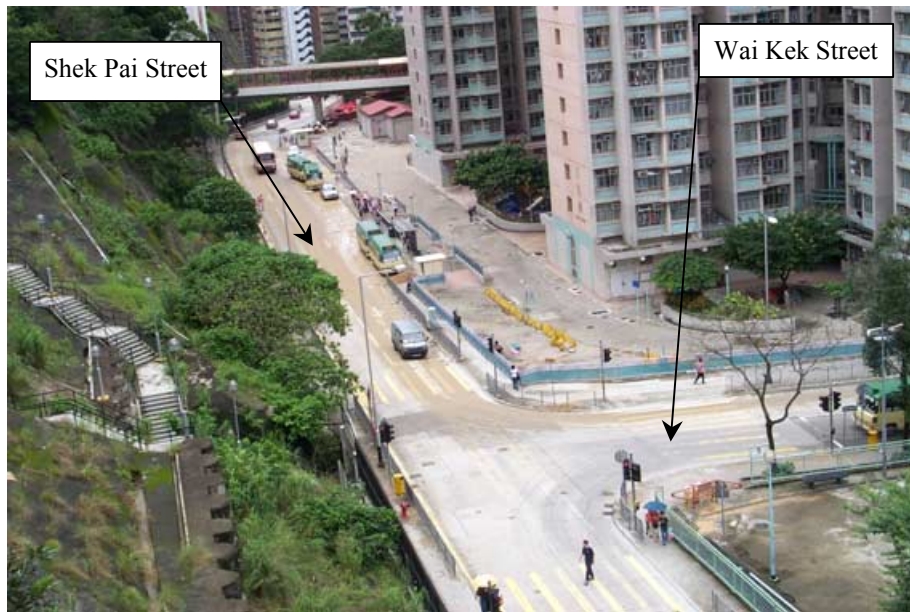
Plate 2 - Outwash Material along Shek Pai Street and Wai Kek Street
(Photograph taken on 2 September 2001)

About 50 m³ of outwash consisting of silty sand and gravel (with only occasional cobbles and boulders up to 300 mm across found within 100 m of the active construction site) entered Lei Pui Street and continued along Shek Pai Street and into open areas of Shek Lei Estate (Figure 2 and Plate 2).

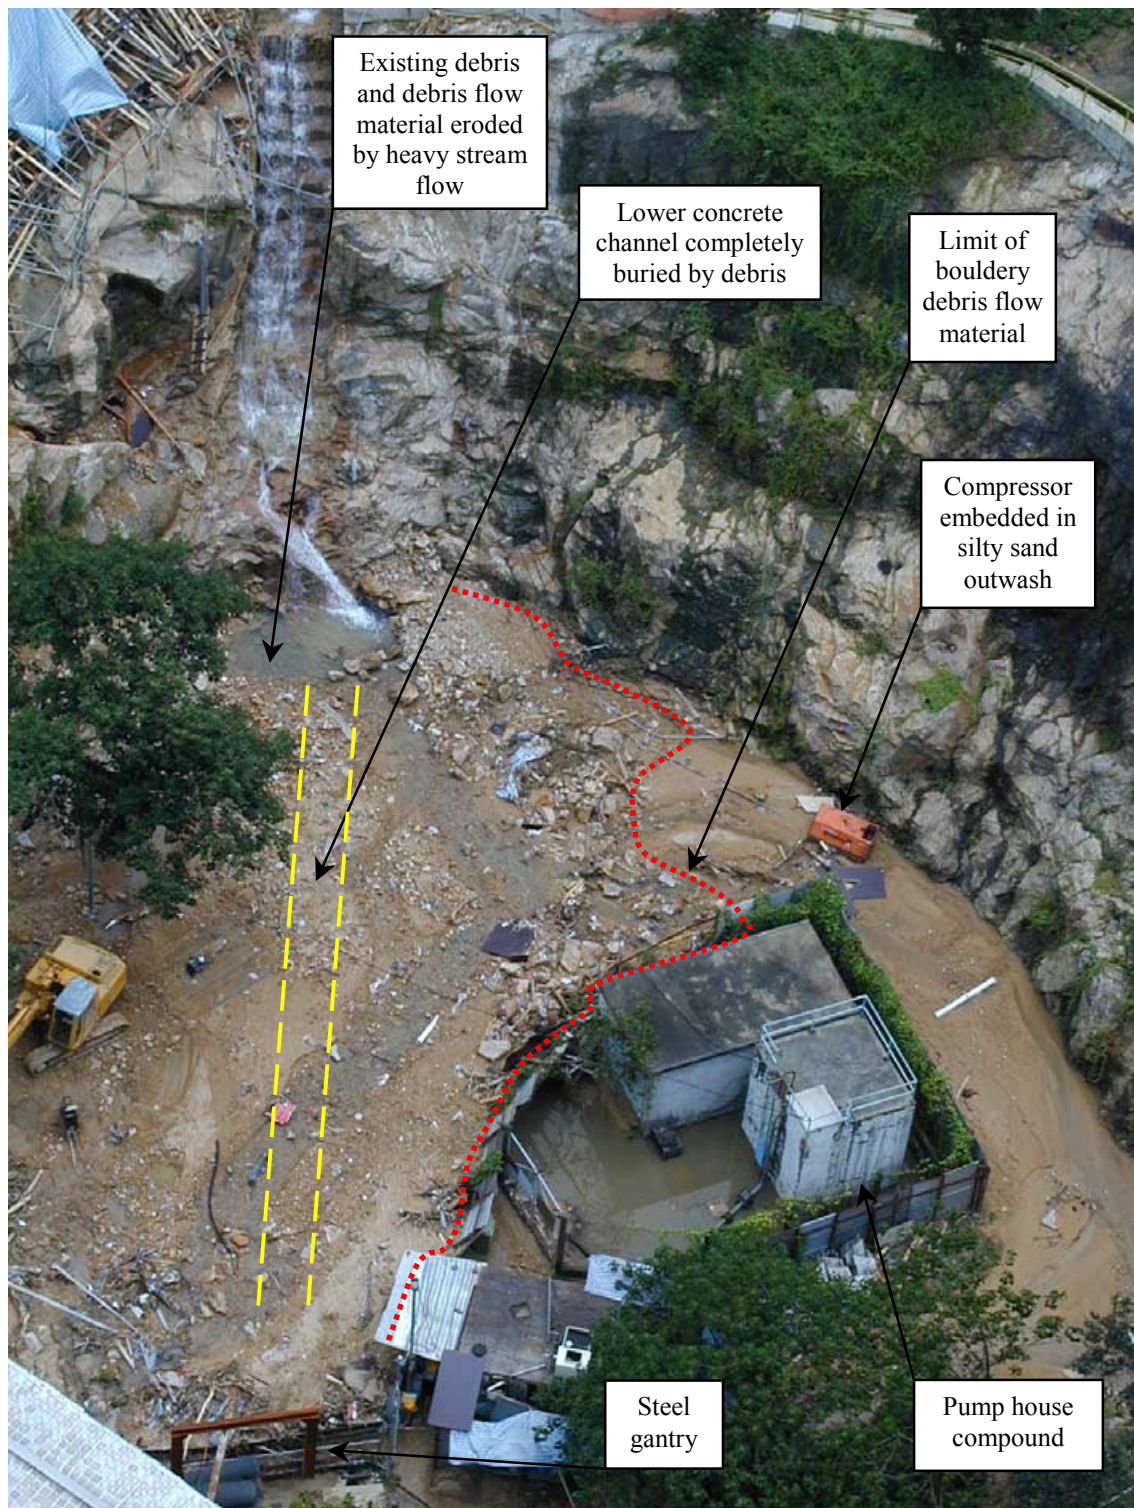
Plate 13 - Oblique Aerial View of Active Construction Site
(Photograph taken on 5 September 2001)

The extent and nature of the debris flow material, which reached the active construction site, are shown in Plates 13 to 15. The lower concrete drainage channel constructed across the floor of the active construction site was completely infilled and buried by debris. The debris came to rest against the hoardings on the east and north sides of the WSD compound around the pump house and against the fences in front of the footbridge and steel gantry, resulting in minor buckling of the supports, with the most severe damage concentrated at the corner of the pump house compound. The hoardings are similar in construction to those alongside the upper reinforced concrete channel with the addition of light, steel-angle diagonal bracings (Plate 11). The perimeter fence of the pump house compound was just within the line of hoardings and was supported by 200 mm square reinforced concrete posts at 3 m centres.

The debris front material deposited immediately behind the fences and footbridge comprised (in terms of volume) approximately 60% to 70% boulders and cobbles, about 15% tree fragments and construction debris, and about 15% to 25% sandy gravel with organic material (Plate 15). The trial pits excavated within the quarry site revealed coarse, remoulded debris up to 600 mm deep with about 65% cobbles and boulders. Similar material was found to have infilled the concrete drainage channel, across the floor of the active construction site. Finer sands and silts with less than 25% cobbles and boulders were deposited around the periphery of the debris front within the quarry, partly engulfing a compressor and excavator up to 300 mm in depth (Drawing No. 1 and Plate 13). The total debris accumulation in the active construction site was about 530 m³.

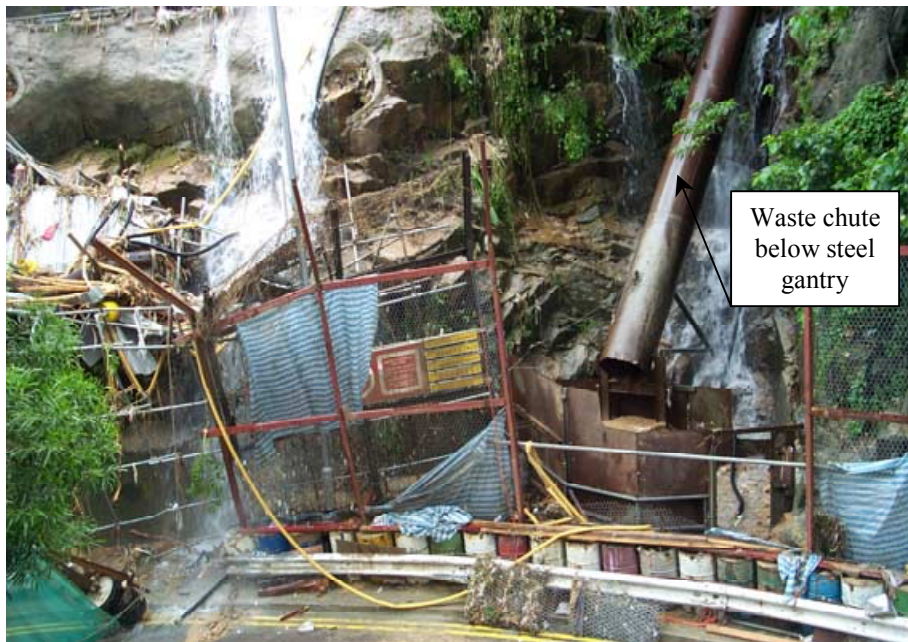
Plate 16 - Deformed Temporary Fence on Lei Pui Street
below the Active Construction Site
(Photograph taken on 2 September 2001)

Below cut slope No. 7SW-C/C182, minor deposition of fine and occasional coarse material was observed, with about 3 m³ of coarse debris being trapped behind the temporary fence at the toe of the slope along Lei Pui Street (Plate 16). One panel of the chain-link

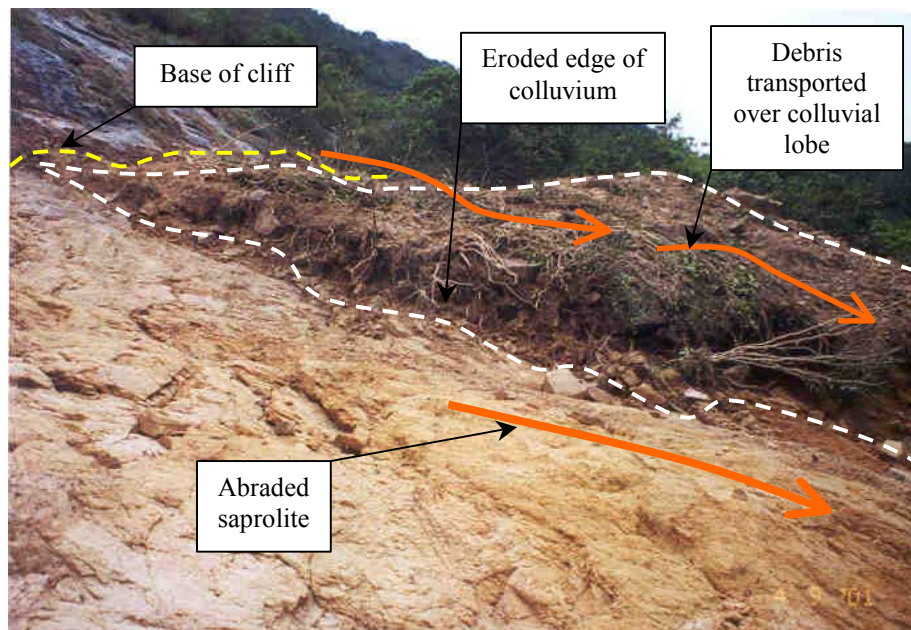
Plate 19 - Erosion of Colluvium and Saprolite at Base of Cliff
(Photograph taken on 4 September 2001)

At the toe of the rock cliff, the gradient of the slope decreases to approximately 40°, where colluvial deposits overlie completely decomposed and highly decomposed granite (Plate 19). The upper edge of the colluvium is less than 0.3 m thick and this material overlies a similar thickness of completely decomposed granite (CDG). The colluvium is clast supported (talus) with approximately equal proportions of angular cobbles and boulders of slightly to moderately decomposed granite and up to 25% silty sand and gravel. The lack of decomposition of the cobble and boulder clasts and their 'loose' nature (being easily excavated by a hand pick), indicates that the colluvium is relatively recent.

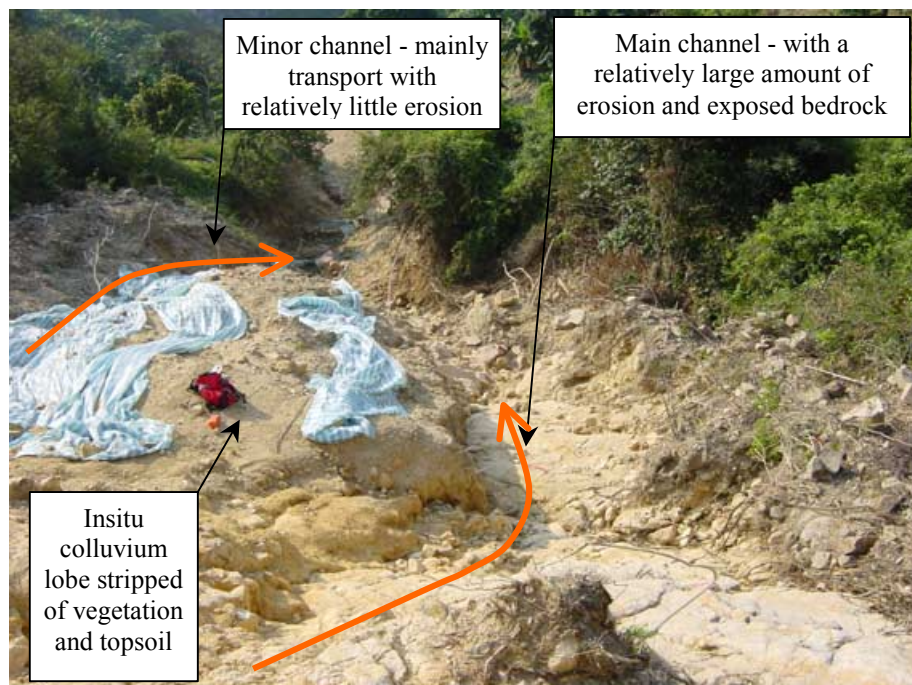
Plate 20 - Bifurcation around Colluvial Lobe
(Photograph taken on 4 September 2001)

Between Chainages 70 and 115, the gradient along the drainage line decreases to about 1 in 1.7 (about 30°), and the thickness of eroded colluvial deposits increases. Along this section of the trail the erosion channel bifurcates into two channels, a main channel on the north side and a minor channel on the south side (Plates 20 and 21). Bedrock is exposed in the main channel with up to 2.2 m thickness of loose, bouldery colluvial deposits being freshly exposed along the north side of the channel in a sub-vertical bank. Recent colluvium was exposed in the base of the south channel. Two minor ephemeral drainage lines at the same locations as these erosion channels are visible on the 1963 aerial photographs. The approximate shapes of the pre-existing drainage lines were taken into account, when calculating the volumes of erosion caused by the September 2001 debris flow.

A lobe of recent colluvium between the two channels extended between Chainages 77 and 102. Debris was transported over the lobe with minor surface erosion and flattening of vegetation taking place and subsequent deposition of a thin layer of fine debris. Along the flanks of the trail, zones of transportation between 1 m and 4 m wide were observed together with localised deposits of coarse, remoulded debris and loose boulders along the periphery (Plates 20 and 21). At about Chainage 85, an ephemeral drainage line converges with the north erosion channel. At this location, several large boulders up to 1.5 m across accumulated from the September 2001 event. Large boulders of similar dimensions and a colluvial "levee" from previous events were also present. One newly displaced boulder, about 2.5 m across, was located at Chainage 85. This boulder was too large to have been part of the relatively thin granite slabs from the landslide source, and it probably originated from a previous landslide. The volume of material eroded between Chainages 70 and 102 was approximately 260 m³.

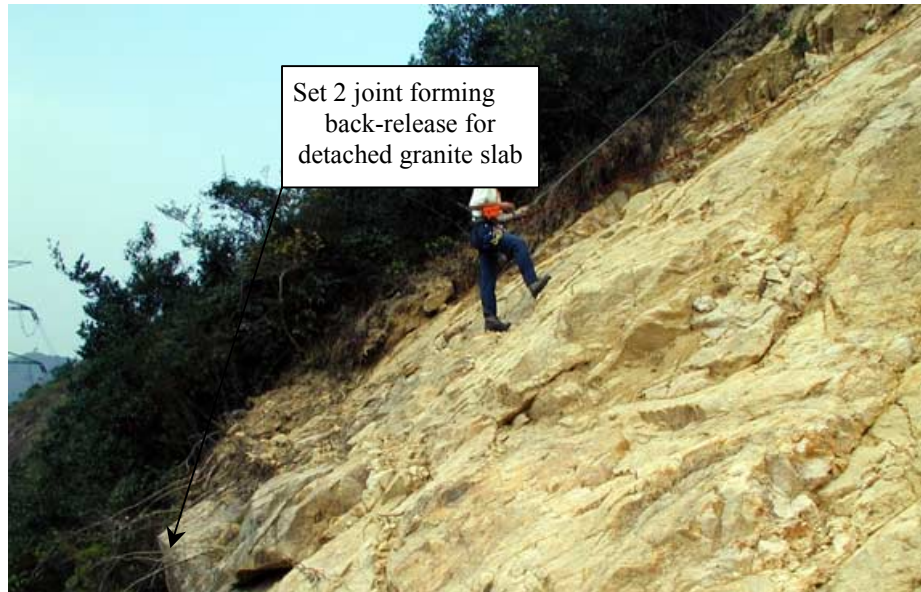
Plate 27 - View of the Floor and Lower Right Flank of the Source Area
(Photograph taken on 21 October 2001)

A general view of the floor of the lower surface of rupture is shown in Plate 27. The source floor is defined by stress-relief joints that dip between 31° and 44° in a west to west-northwest direction and the exposed joint surfaces are rough and undulating. Several light to dark grey-brown patches of silty sand joint infill were observed adhering to the floor of the landslide source at local, steeply-inclined joints striking across the floor. Joint infill contains abundant rootlets and is probably the result of washing in of fines into dilations caused by progressive, downhill movement of the rock slabs over many years. Some of the sub-vertical Set 2 joints, which penetrate the source floor, are dilated by up to 30 mm (Plate 28).

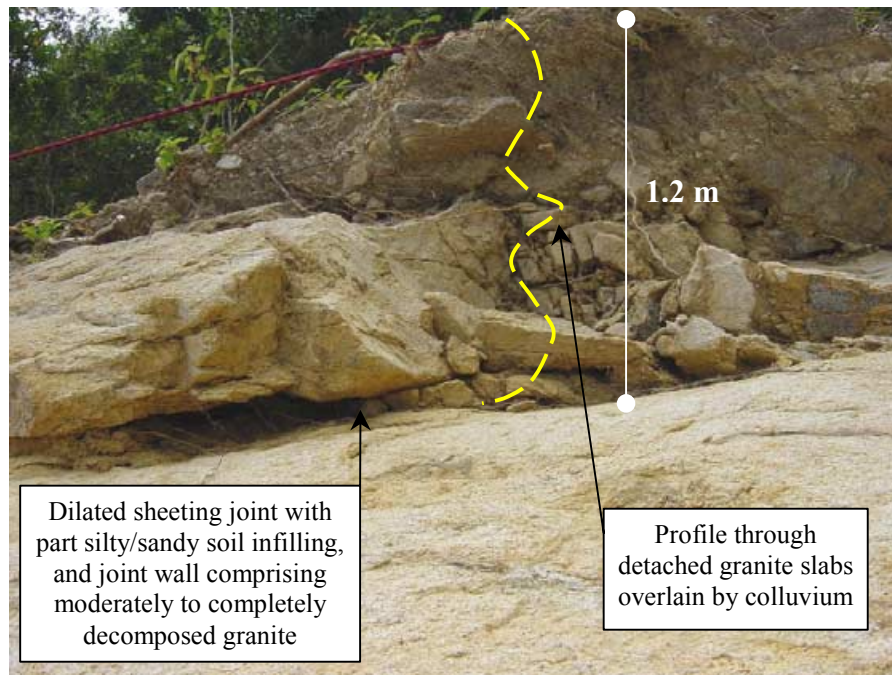
Plate 29 - View of Dilation and Infilling of Sheeting Joints in Right Flank of Source Area
(Photograph taken on 21 October 2001)

Colluvium up to 0.6 m thick is exposed along the north flank (Plate 29) and the crown of the landslide scar, but the south flank has only an intermittent colluvial cover of less than 250 mm in thickness. The colluvium is clast-supported (talus) with abundant tree roots and is composed of sub-angular boulders and cobbles in a 15% to 20% loose, gravelly silty sand matrix, with a maximum boulder size of 400 mm.

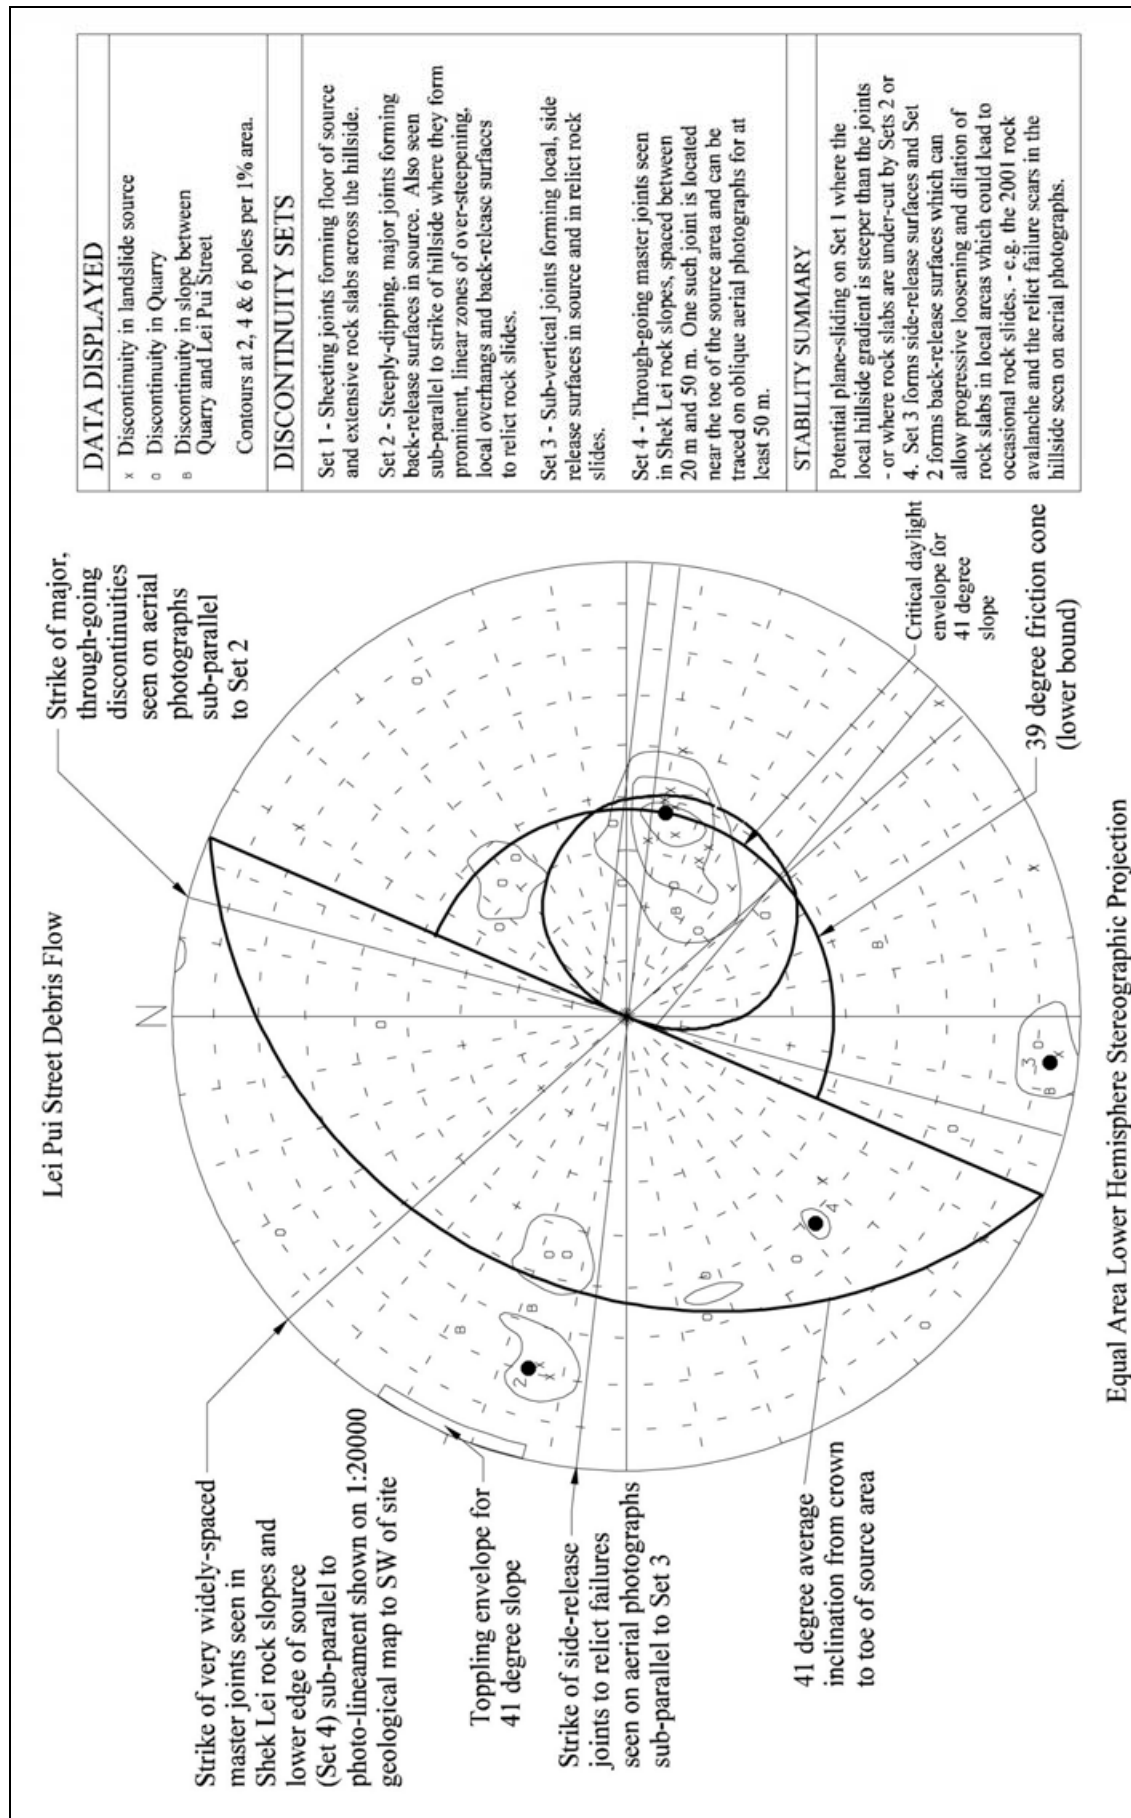
Figure B1 - Stereoplot of Joint Sets and Kinematic Stability Assessment of the Landslide Source Area

The geomorphology and stability of the hillside in Terrain Unit 2 is heavily influenced by the underlying rock structure. Figure B1 in Appendix B shows a stereoplot and kinematic stability assessment of the joint sets mapped within the site. The main findings of this assessment are that the Set 1 sheeting joints are adversely orientated for stability with regard to planar sliding and that the Set 2 joints are adversely orientated for stability with regard to toppling failure and may form release surfaces and potential tension cracks, which allow plane sliding. The sub-vertical Set 3 and Set 4 joints also strike at a high angle to the strike of the Set 1 and Set 2 joints and may form lateral release surfaces, allowing slabs of rock to detach from the rock outcrops. These main structural controls on the stability of the hillside are illustrated in Plate 25. The API has shown that the main structural patterns evident near the source area are consistent throughout the full extent of the hillside in which the rock structure is visible.
