# **REVIEW OF LANDSLIDES IN 2001**

**GEO REPORT No. 155**

**T.T.M. Lam, H.W. Sun & K.K.S. Ho**

**GEOTECHNICAL ENGINEERING OFFICE  
CIVIL ENGINEERING AND DEVELOPMENT DEPARTMENT  
THE GOVERNMENT OF THE HONG KONG  
SPECIAL ADMINISTRATIVE REGION**

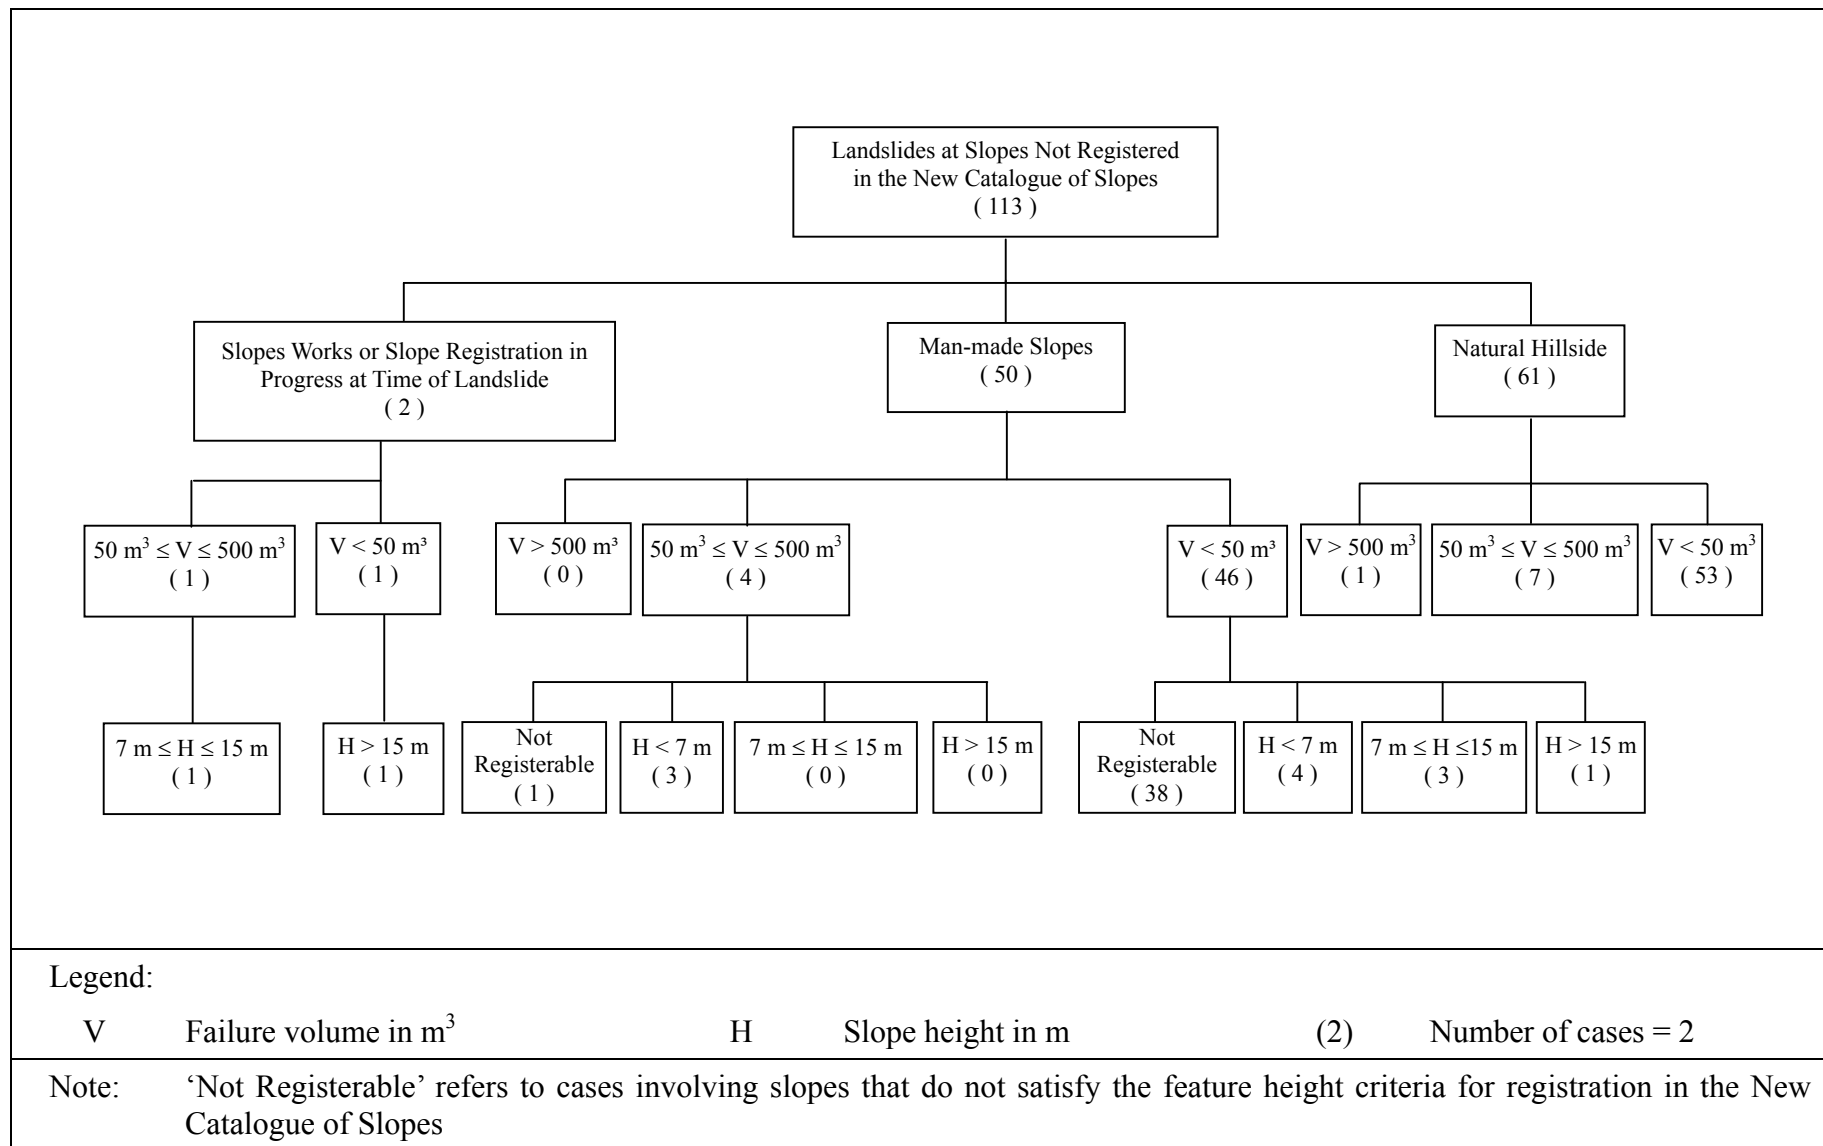
Figure 1 - Breakdown of Landslides at Unregistered Slopes in 2001

A total of 113 out of the 214 genuine landslides occurred on slope features that were unregistered at the time of failure. A breakdown of these 113 incidents is given in Figure 1.
