**DETAILED STUDY OF THE
22 MAY 2002 ROCKFALL
INCIDENT ON SLOPE
NO. 11NE-A/C284 AT
SHATIN PASS ROAD
TSZ WAN SHAN**

GEO REPORT No. 156

Halcrow China Limited

**This report was originally produced in October 2002
as GEO Landslide Study Report No. LSR 9/2002**

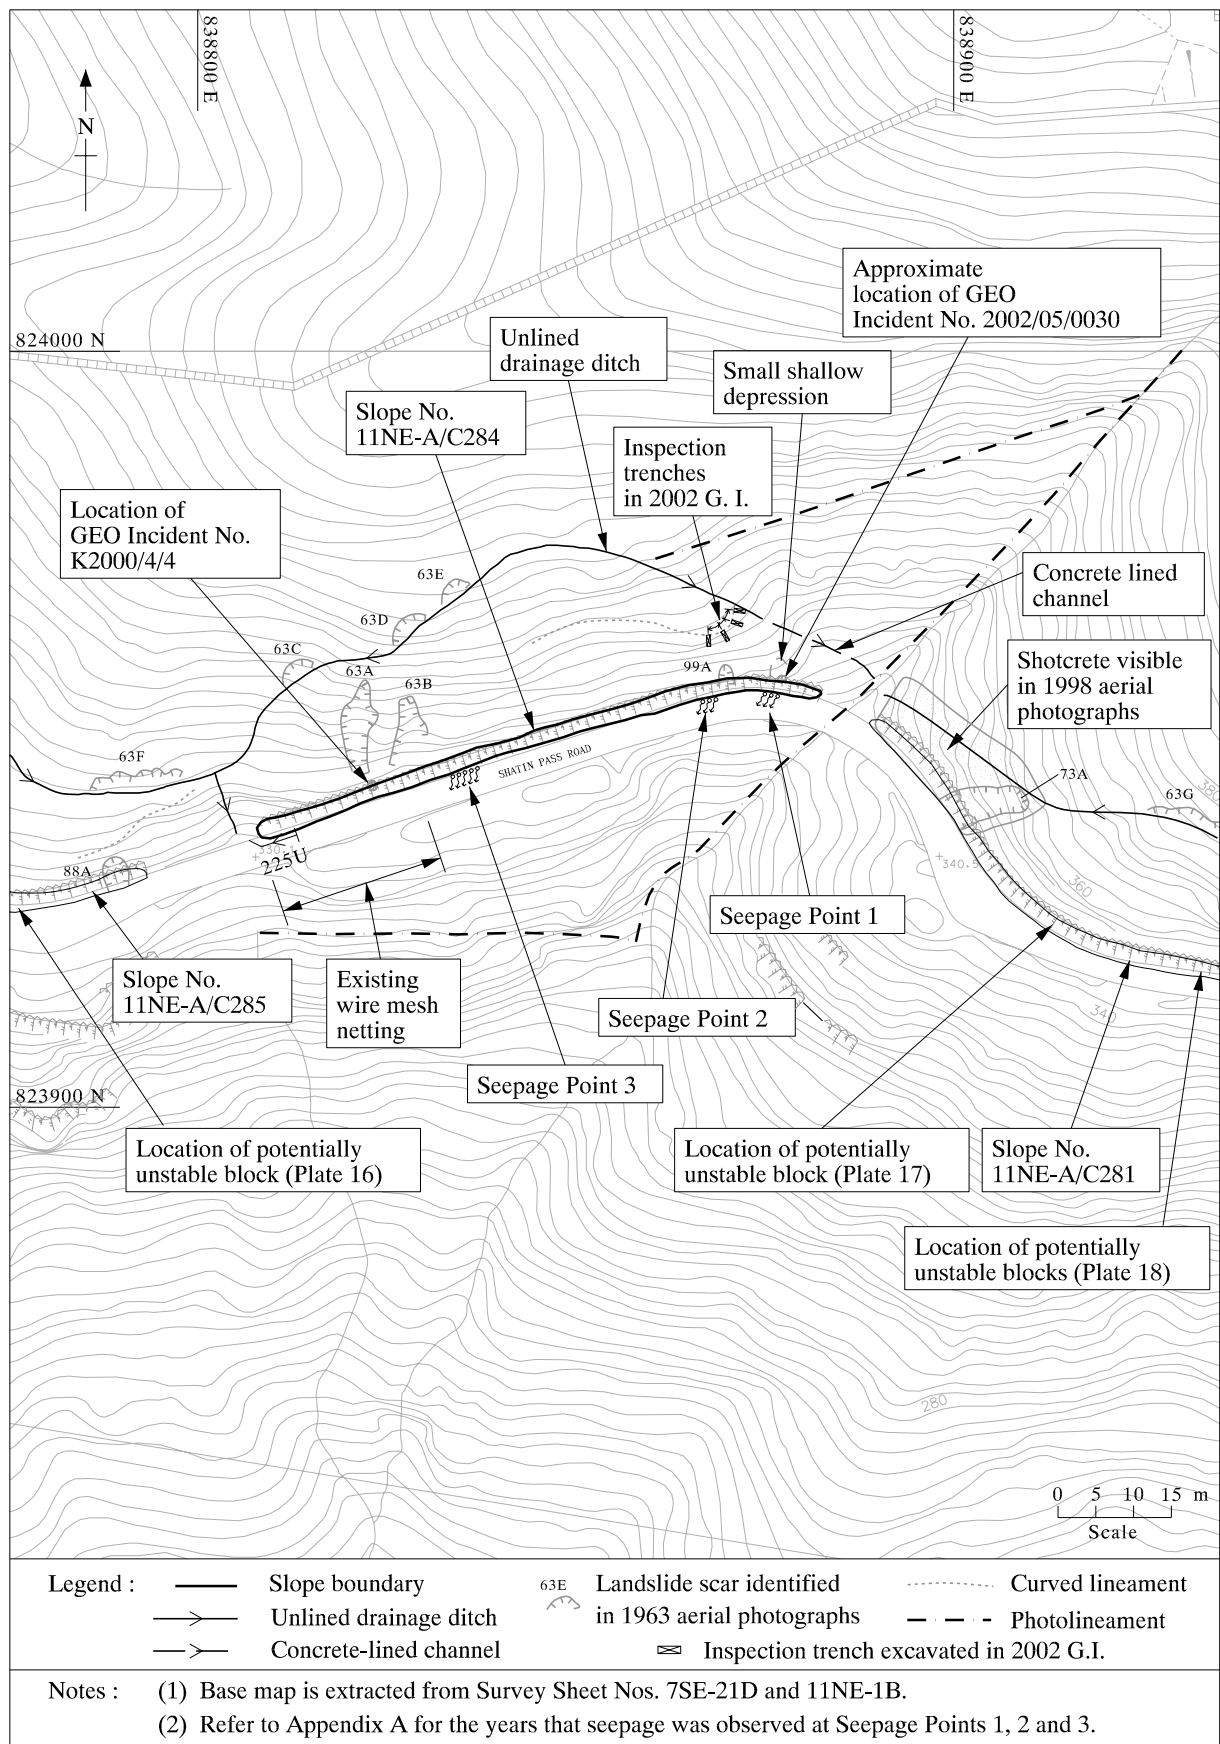
Figure 2 - Site Layout Plan and Key Observations

Site observation by HCL in May 2002 revealed that the wire mesh netting at the western portion of the slope (Figure 2) was hanging loosely in places over the rock surface. The fixing of the wire mesh is different from that presented in CED Standard Drawing No. C2205A. Two loose blocks of approximately 0.7 m wide each were observed over the upper half of the central portion of the slope (Plate 15). At the central and eastern portions of the slope, several sub-vertical joints dipping into the slope were observed near the slope toe,

which are liable to induce toppling failures. Weak to moderately strong seepage was observed at Seepage Points 1, 2 and 3 as shown in Figure 2, where seepage had been frequently observed in the aerial photograph interpretation.

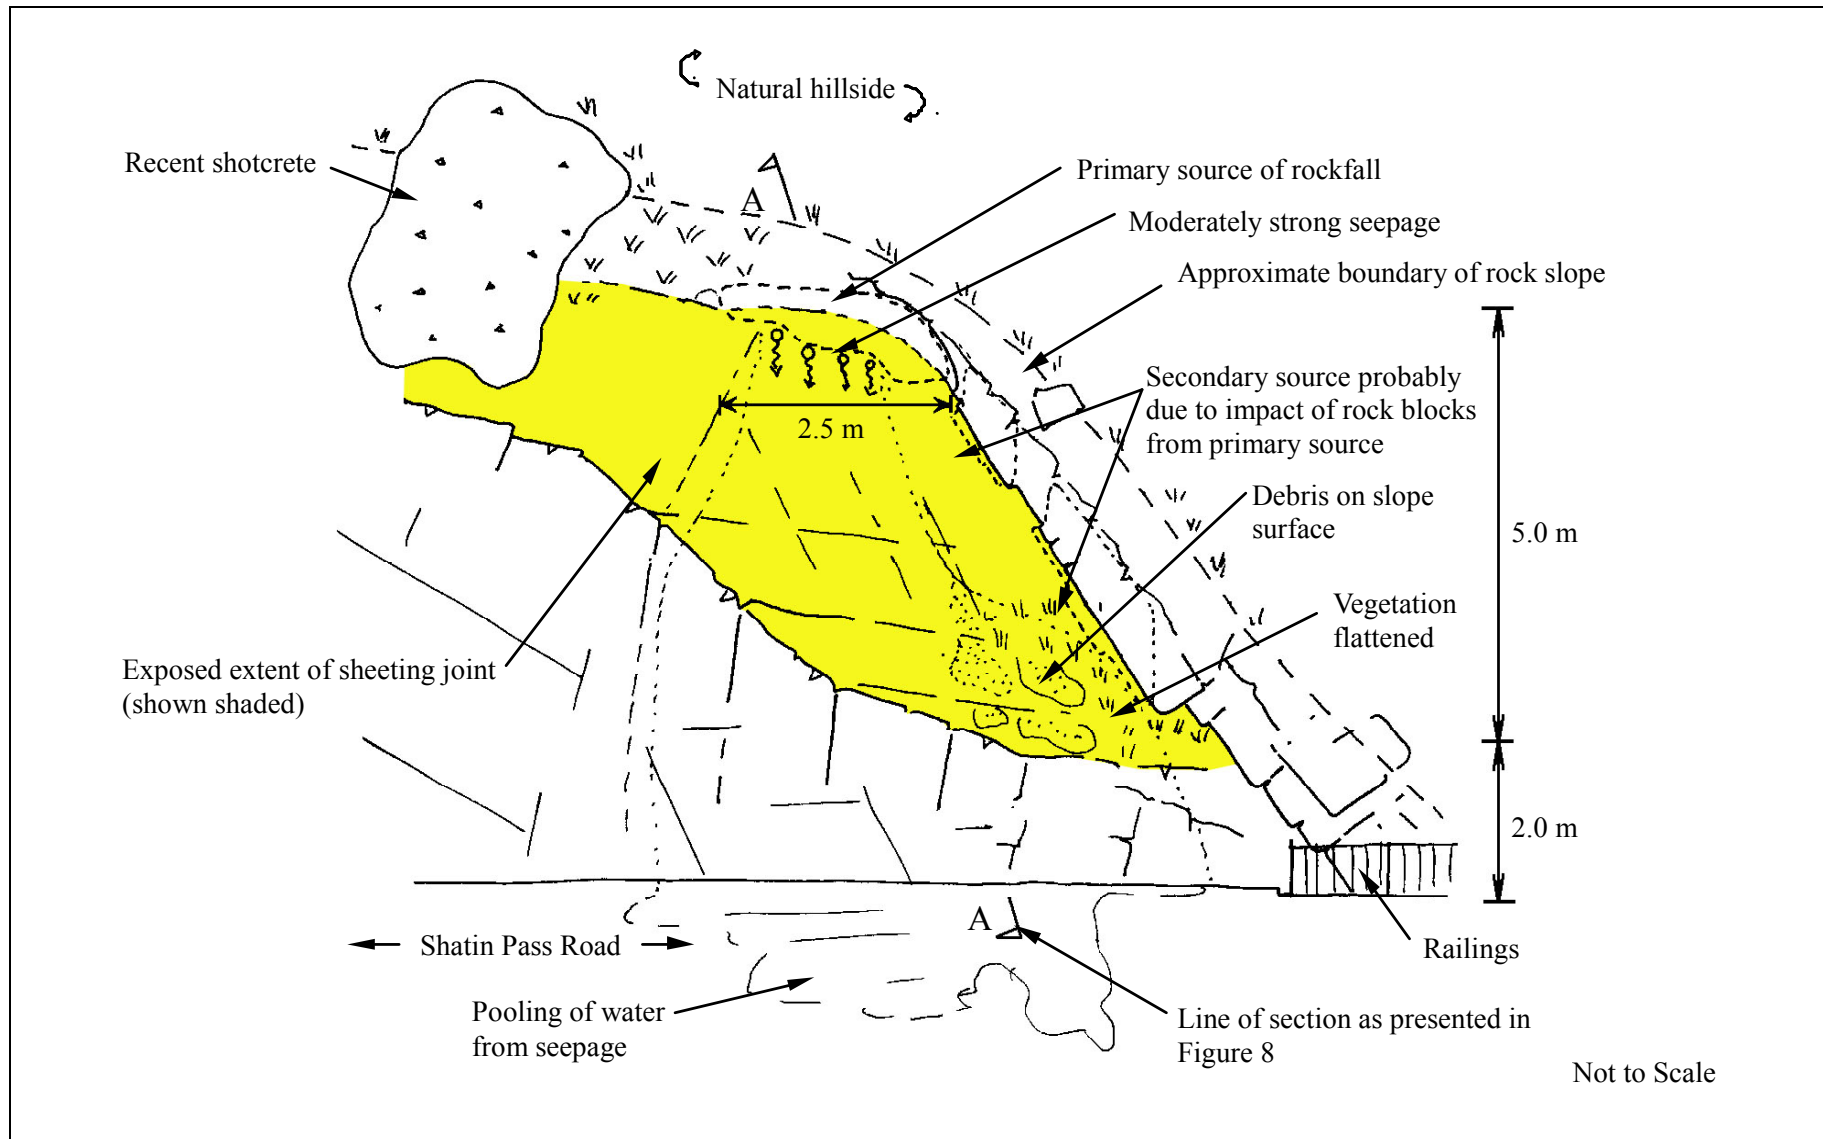
Figure 7 - Front Elevation of Slope No. 11NE-A/C284 at the 22 May 2002 Rockfall Location

HCL inspected the site on a number of occasions between 24 May 2002 and 3 July 2002. The source of the rockfall was located at about 7 m to 8 m above the toe of slope No. 11NE-A/C284 (Figures 7 and 8). As indicated in photographs taken before and after the May 2002 rockfall incident by the SIRST inspection team and HCL respectively (Plates 6 and 10), the primary source of the failure was a series of rock blocks located close to the crest of the cut slope. After detachment of the series of rock blocks originating from the primary source, the debris appears to have dislodged some other thin slab-like rock blocks located below and to the east of the primary source, resulting in a minor secondary failure (Figure 7 and Plate 2). The total volume of the rock blocks and debris is about 7 m³.

of about 64° to 68° out of the slope, which is probably a sheeting joint. The surface of the joint was planar, stepped and with a lateral persistence of about 10 m (Figures 7 & 8 and Plate 11). The sheeting joint extends beneath a series of potentially unstable rock blocks with an approximate volume of 30 m³ located at the far eastern end of the slope (Plates 12 to 14). A sub-vertical joint set with a typical orientation of 70°-90°/240°-260° was observed at the eastern portion of the back scarp (Plate 11). The site inspection by HCL revealed that part of the “open joint” (see Section 7) recorded in the MGSL’s EI report could still be observed at the eastern portion of the back scarp (Plates 10 and 13). The nature of this “open joint” is unusual and the possible modes of formation include concentrated subsurface flow within the sheeting joint, washout of a mineral infill or mineralised vein, or prolonged movement along the joint.

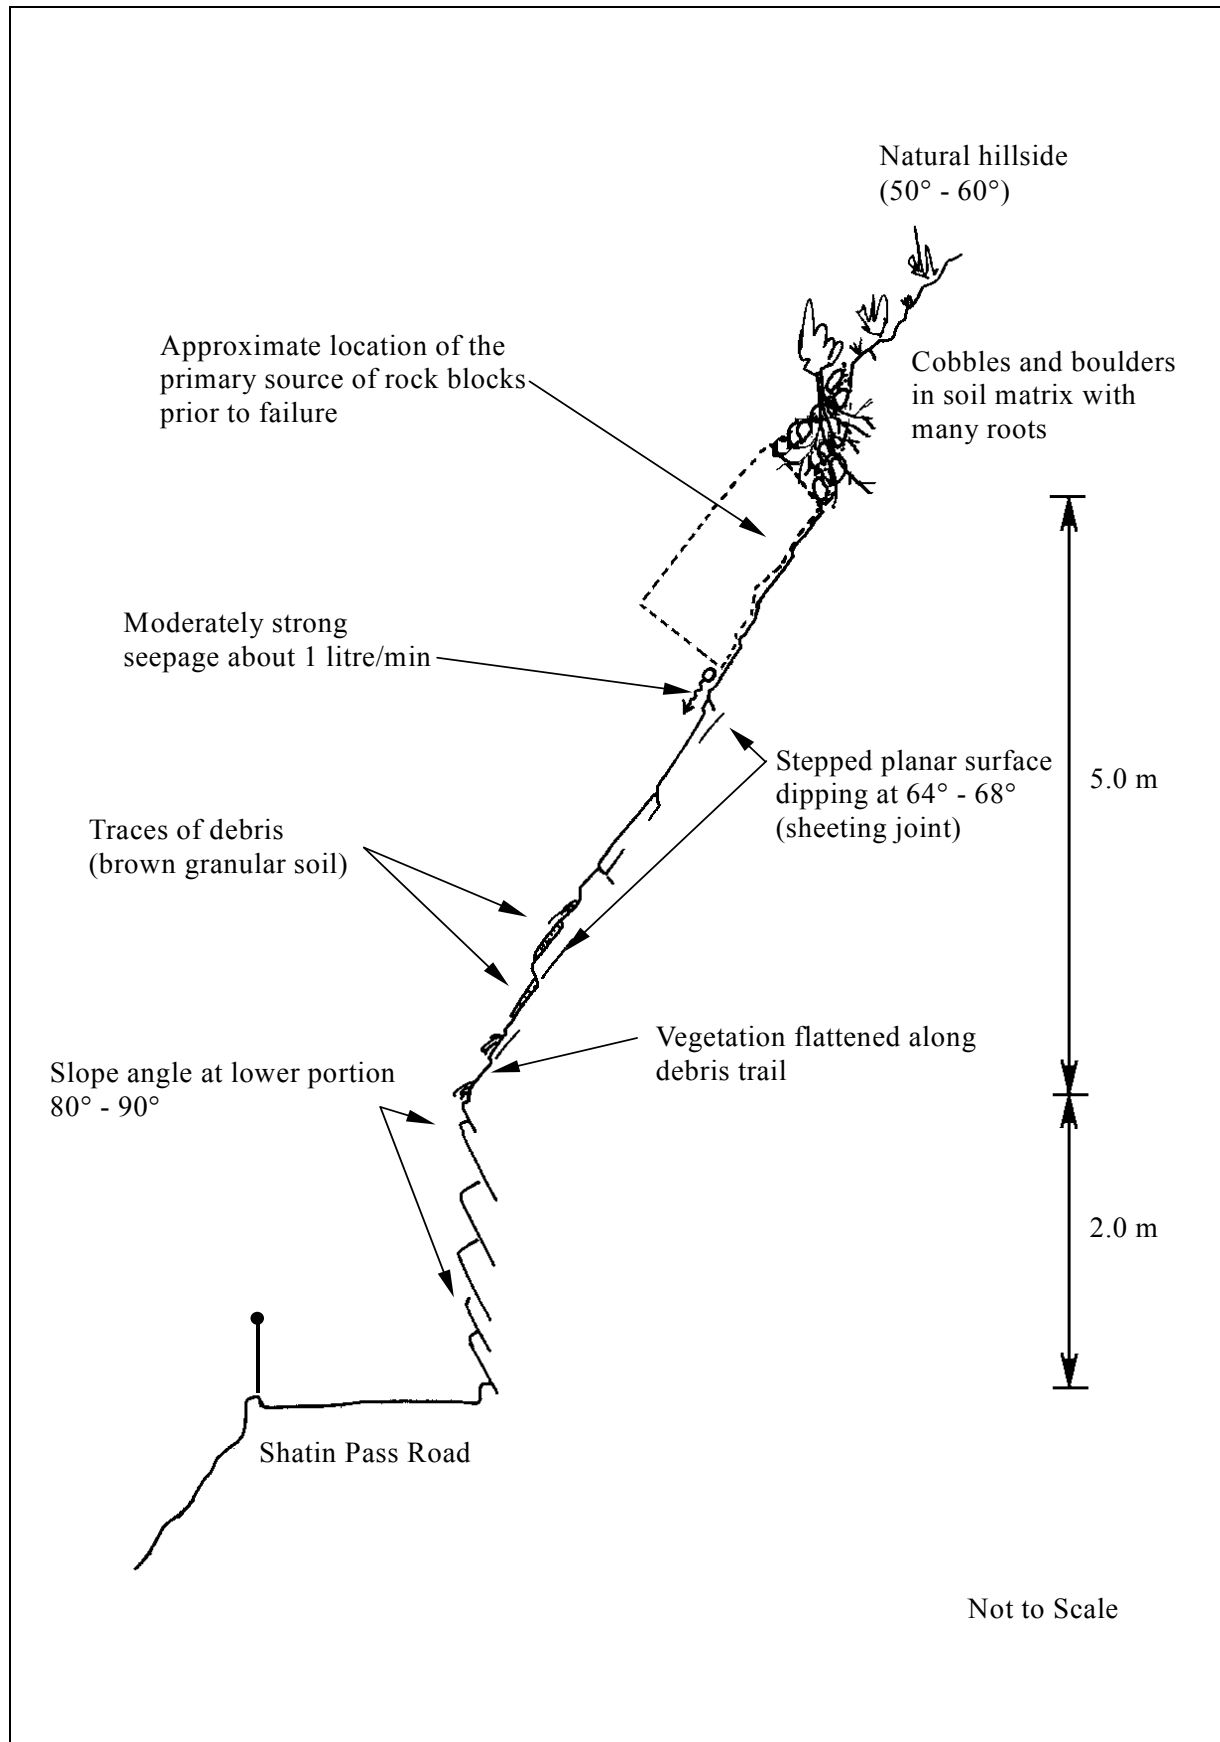
Figure 8 - Section A-A of the 22 May 2002 Rockfall

The height of the rock slope at the location of the failure was about 8 m (Figure 8), with the upper portion of the slope inclined at angles of about 64° to 68° and the lower portion inclined at angles of about 80° to 90°. The slope was cut into strong, light pinkish grey, moderately to slightly decomposed, medium-grained granite with generally closely spaced joints. The basal release joint plane beneath the detached rock blocks was inclined at angles

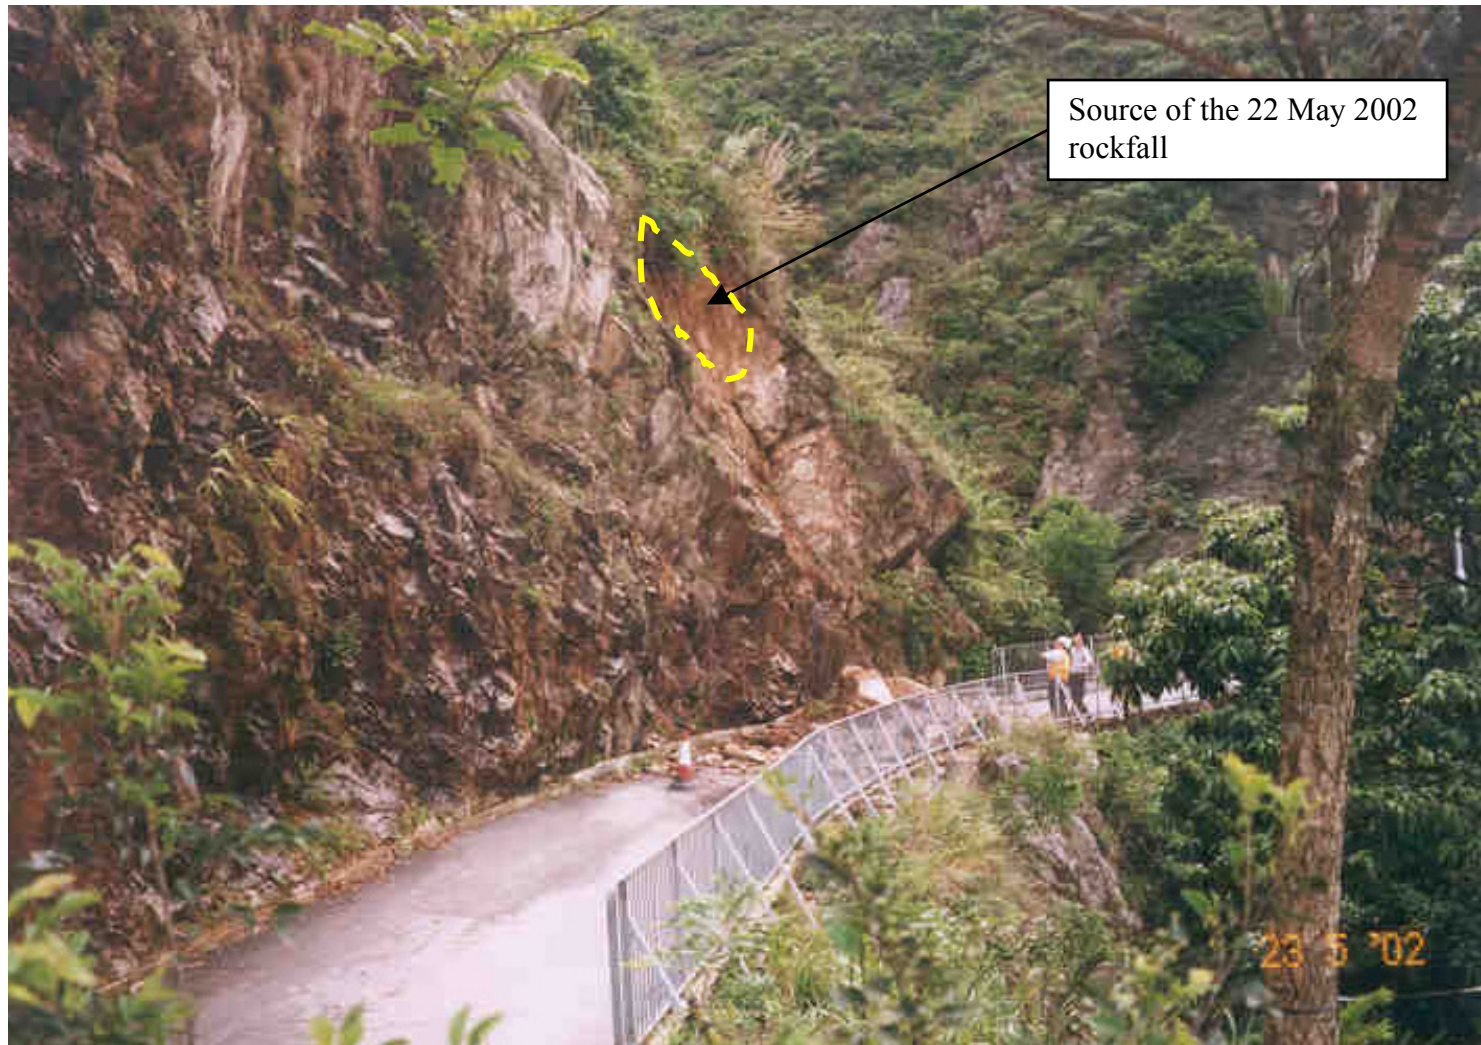
The primary source of the failure was a series of rock blocks located close to the crest of the cut slope (Plate 7). After detachment of the series of rock blocks originating from the primary source of failure, the debris appears to have dislodged some other thin slab-like rock blocks located below and to the east of the primary source, resulting in a minor secondary failure. The incident involved a planar sliding failure along an adversely orientated steeply dipping basal release surface, which is probably a sheeting joint. The joint dips at about 64° to 68° out of the slope and is laterally persistent for about 10 m (Plate 2 and Figures 7 and 8). The detachment of rock blocks in May 2002 may have been the result of progressive deterioration of the rock slope, as indicated by the opening up of the sheeting joint probably due to past movement and washout of a mineral infill or a mineralised vein. Root action associated with unplanned vegetation would also have been a contributory factor to the rockfall incident.

Source of the 22 May 2002
rockfall

Plate 1 - General View of the 22 May 2002 Rockfall (Photograph taken on 23 May 2002 by GEO)

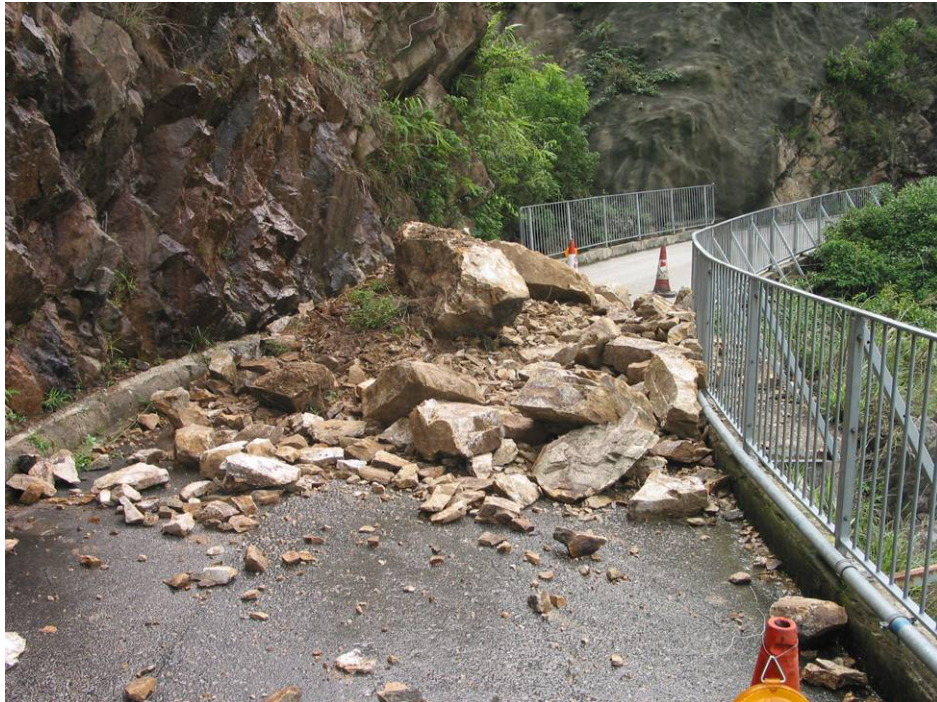
Plate 3 - General View of Landslide Debris Deposited on Shatin Pass Road
(Photograph taken on 23 May 2002 by GEO)

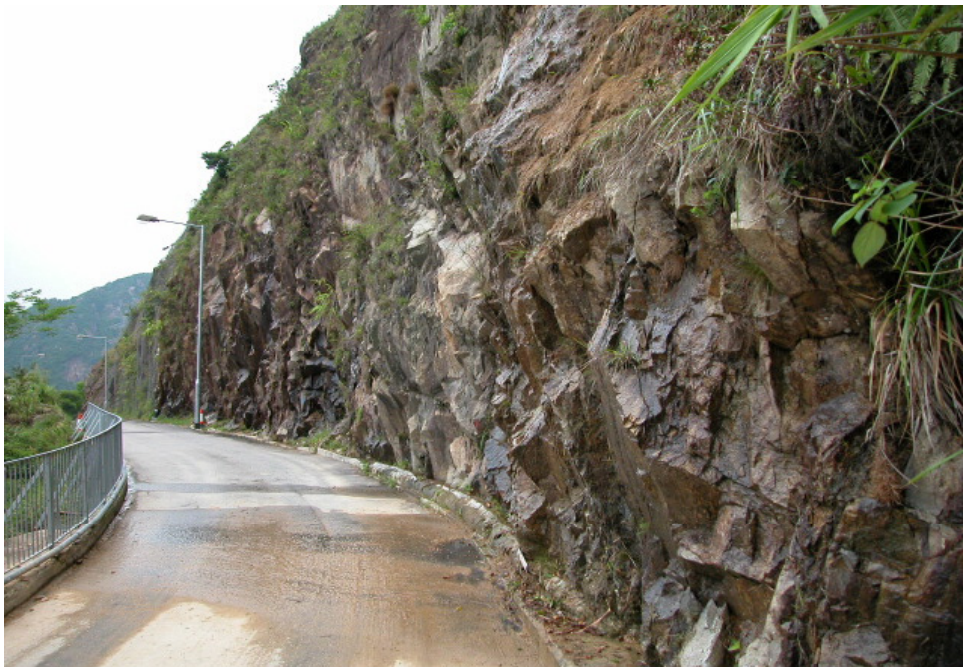
Plate 4 - View of the Western Portion of Slope No. 11NE-A/C284
(Photograph taken on 24 May 2002 by HCL)

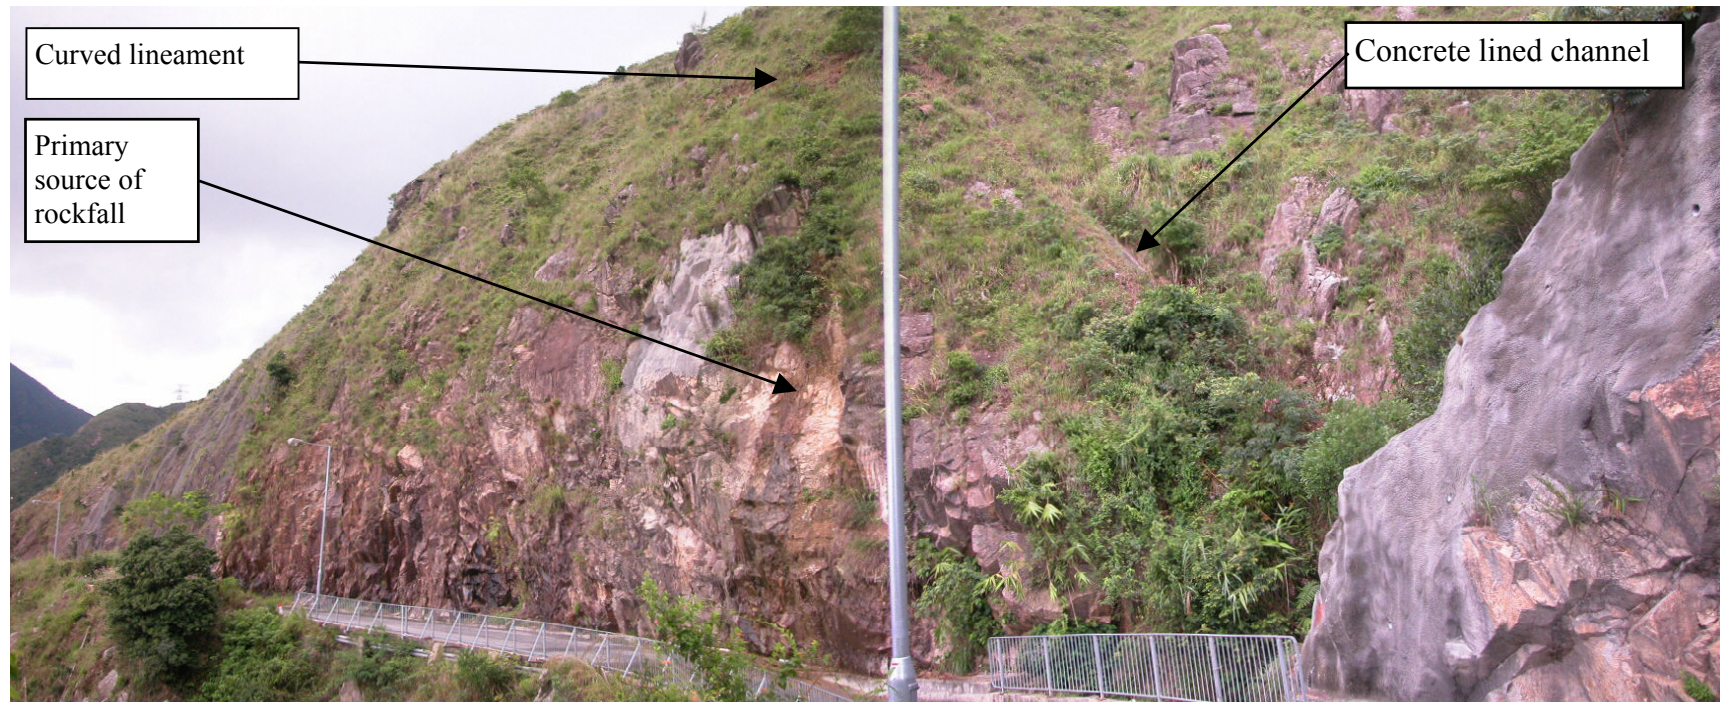
Plate 5 - View of the Eastern Portion of Slope No. 11NE-A/C284 (Photograph taken on 3 July 2002 by HCL)

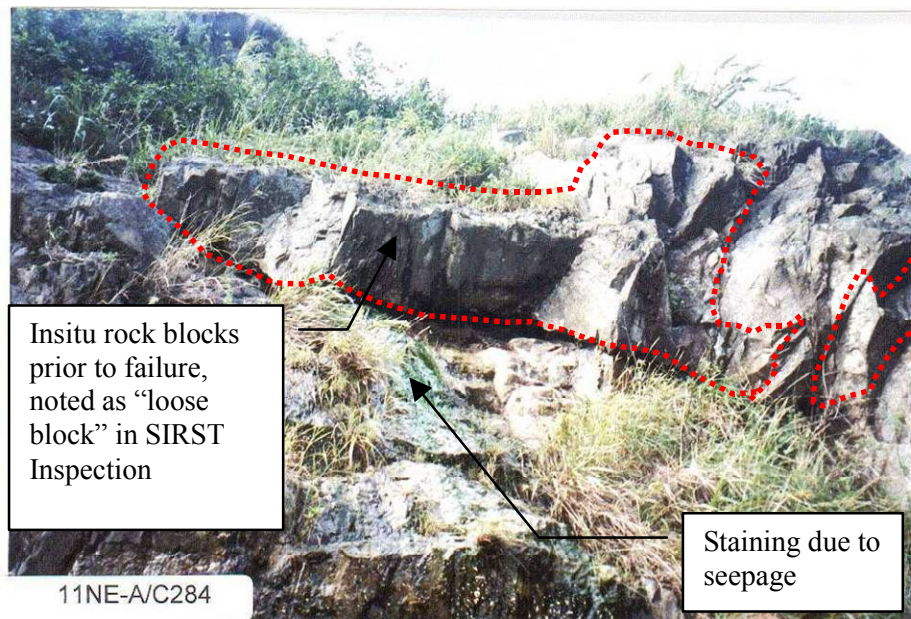
Plate 6 - View of the Location of the May 2002 Rockfall in 1996
(Photograph taken on 26 September 1996 during SIRST Inspection)

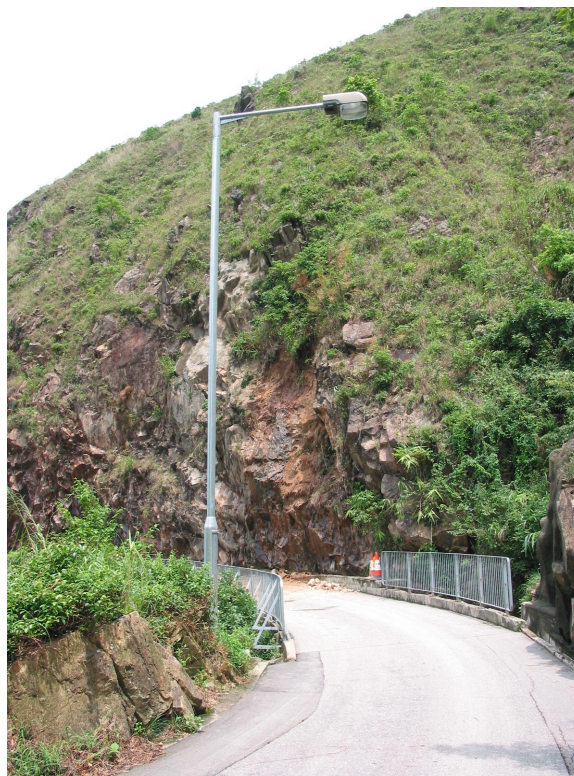
As indicated in the “Record of Slope and Retaining Wall” attached to the EI report, reference was made to a memo dated 10 April 2000 issued by the GEO District Division to HyD regarding the 2000 rockfall, which noted that “Landslide and/or other movement has continuously been occurring in the slopes along Shatin Pass Road and Jat’s Incline. This indicates that these slopes involve complex geological and groundwater conditions”. Also, a patch of the shotcrete of 3 m by 4 m was observed near the slope crest in the vicinity of the May 2002 rockfall as shown in the Record Photograph V5 (reproduced as Plate 7) in the EI report.

Plate 7 - General View of the Eastern End of Slope No. 11NE-A/C284
(Photograph taken on 11 May 2001 during MGSL Inspection)

Following the inspection, maintenance works comprising the provision of wire mesh netting for the exposed rock surface over the central and eastern portions of the slope, removal of loose rock debris at the slope toe, sealing up of open joints in the rock slope and provision of local surfacing to prevent ingress of water were recommended by MGSL to HyD in November 2001. According to HyD, the maintenance works recommended by MGSL was “not an urgent recommendation” and they “planned to carry out the works recommended by MGSL together with the annual routine maintenance works for the slope”. The maintenance works recommended by MGSL and the annual routine maintenance works for 2002 had not been carried out at the time of the incident. In addition, the EI report recommended that a “Low Priority Stability Assessment” be carried out for the slope. HyD noted that the slope “has consequence category of 3 (i.e. negligible consequence)” and the “Low Priority Stability Assessment” had not been implemented at the time of the May 2002 rockfall incident.

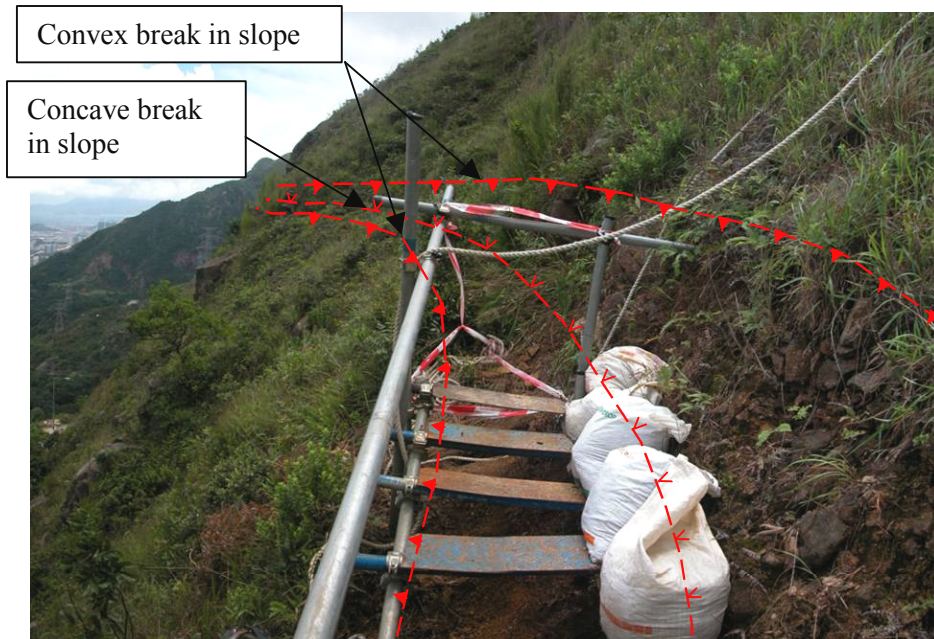
The 25 m curved lineament as identified in the 1963 aerial photographs was inferred as a possible tension crack based on API. Ground truthing and ground investigation, consisting of vegetation clearance and the excavation of shallow inspections trenches, were carried out to verify the actual origin of the curved lineament. The findings of ground investigation and detailed site inspection suggest that the curved lineament is probably an abandoned access path instead of a tension crack. This demonstrates the importance of using ground investigation to corroborate the findings of API.

Plate 8 - View of the Curved Lineament Located Above Slope No. 11NE-A/C284 (Photograph taken on 14 June 2002 by HCL)

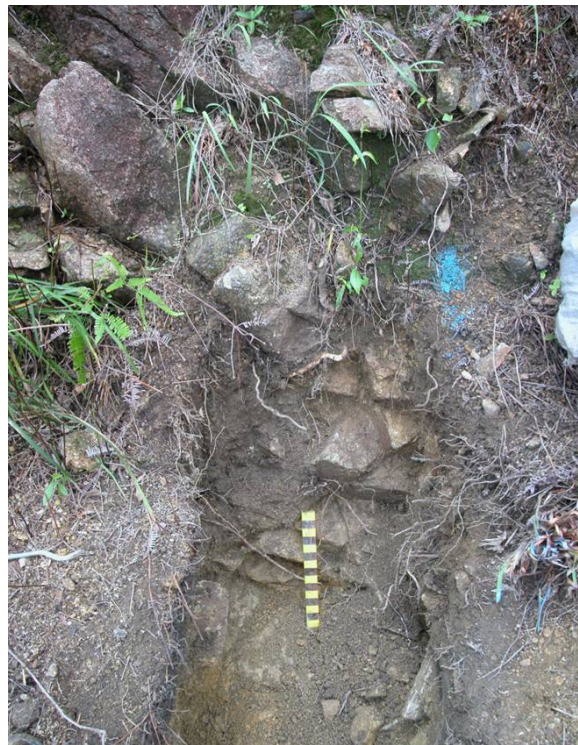
Plate 9 - Inspection Trench Across Curved Lineament Showing Exposed Rock on Side and Base of Trench (Photograph taken on 17 June 2002 by HCL)

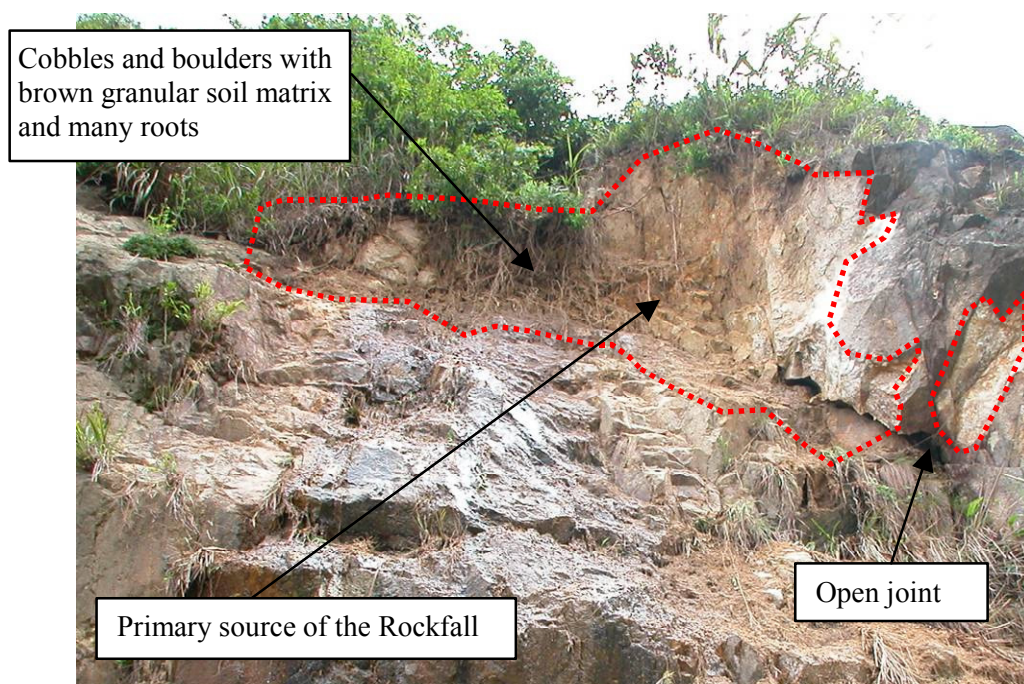
An accumulation of cobbles and boulders in a soil matrix comprising dark brown silty sand and many shrub roots were exposed at the upper portion of the back scarp of the May 2002 rockfall (Plate 10). The confinement to the soil matrix was removed following the May 2002 rockfall. A moderately strong seepage with a flow rate of about 1 litre/minute and 2 litre/minute was observed from the base of the soil matrix (Plate 2) on 24 May 2002 and on 30 May 2002 respectively. It is noted that the rainfall recorded by raingauge No. K07 between the two visits was about 3 mm.

Plate 10 - View of the Source of the Rockfall (Photograph taken on 24 May 2002 by HCL)

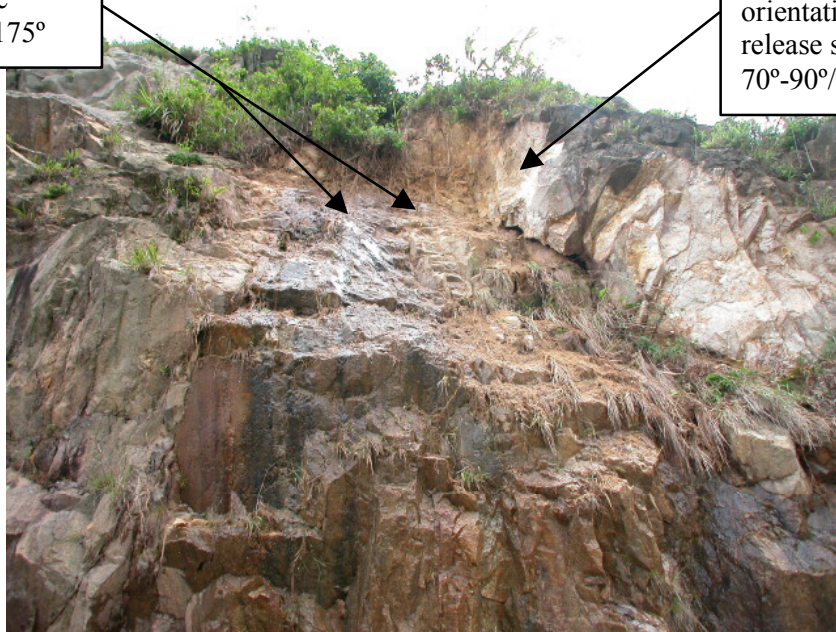
Approximate
orientation of basal
release surface
64°-68°/165°-175°

Approximate
orientation of side
release surface
70°-90°/240°-260°

Plate 11 - View of the Source of the Rockfall Showing the
Orientations of Principal Release Surfaces
(Photograph taken on 24 May 2002 by HCL)

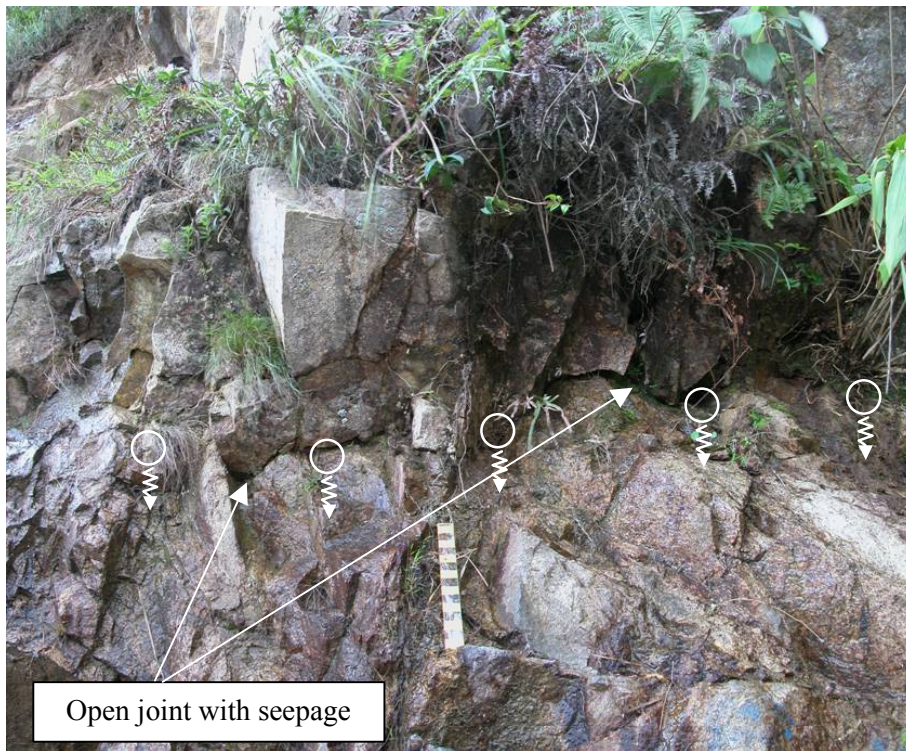
Open joint with seepage

Plate 12 - Detailed View of an Open Joint Daylighting Below
a Series of Large Potentially Unstable Blocks
(Photograph taken on 14 June 2002 by HCL)

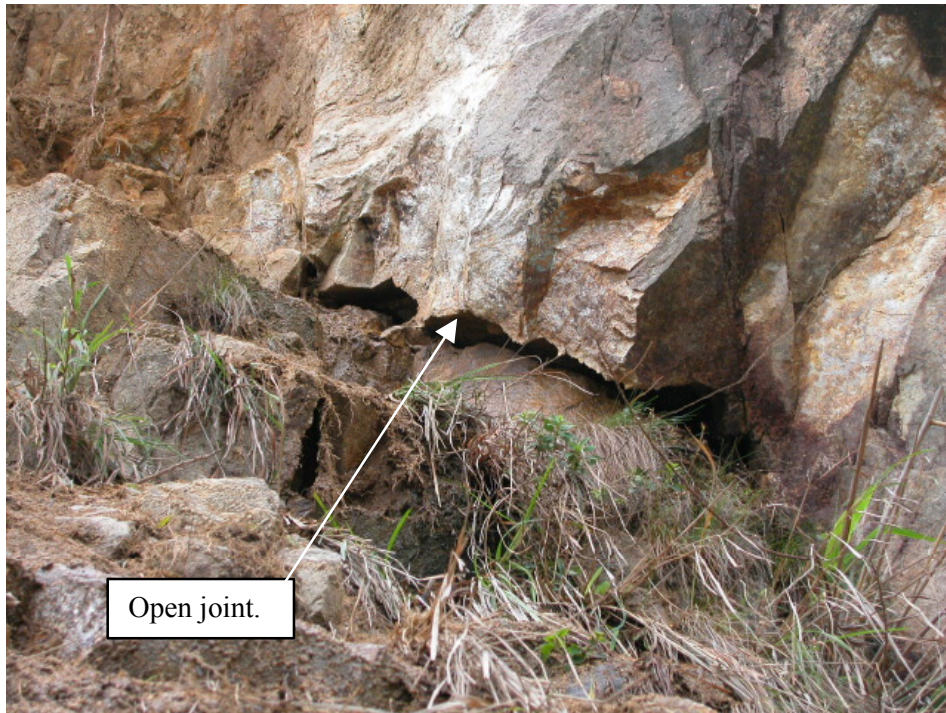
Plate 13 - Detailed View of Open Joint Adjacent to the Source of the Rockfall
(Photograph taken on 24 May 2002 by HCL)

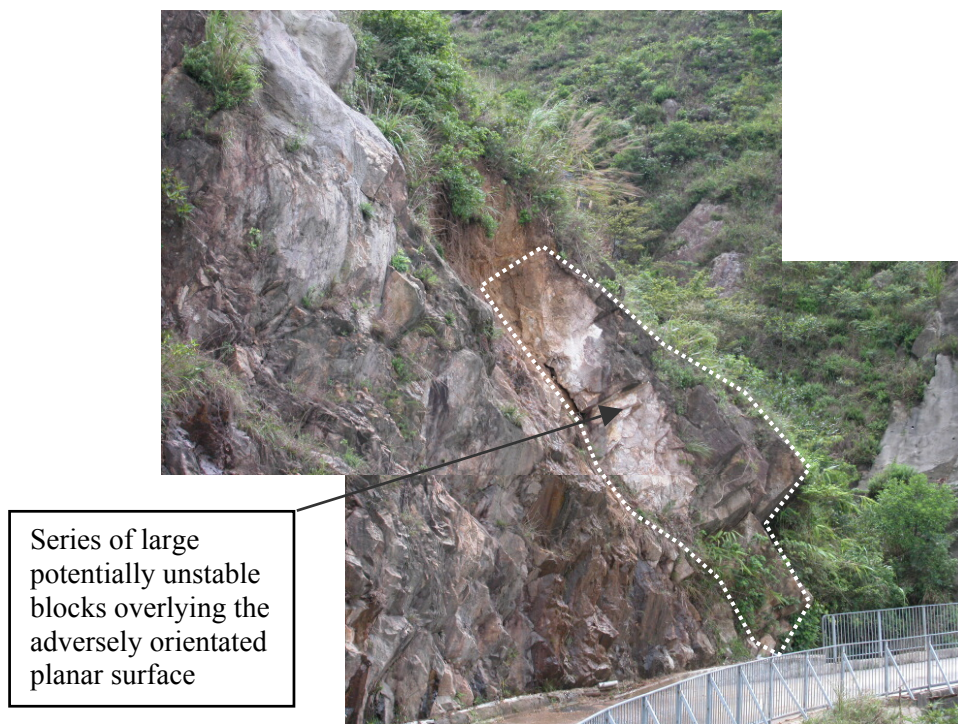
Based on the API, slope No. 11NE-A/C284 was formed before 1949. The adversely orientated sheeting joint identified following the May 2002 rockfall extends beneath a series of potentially unstable rock blocks, with an approximate volume of 30 m³, located at the far eastern end of the slope (Plate 14). Failure of these rock blocks could potentially result in some damage to the reinforced concrete bridge below. Also, the pocket of cobbles and boulders in a sandy matrix at the crest of the back scarp exposed by the May 2002 rockfall is

Plate 14 - View of the Eastern Portion of Slope No. 11NE-A/C284 Showing a Series of Large Potentially Unstable Blocks (Photograph taken on 24 May 2002 by HCL)

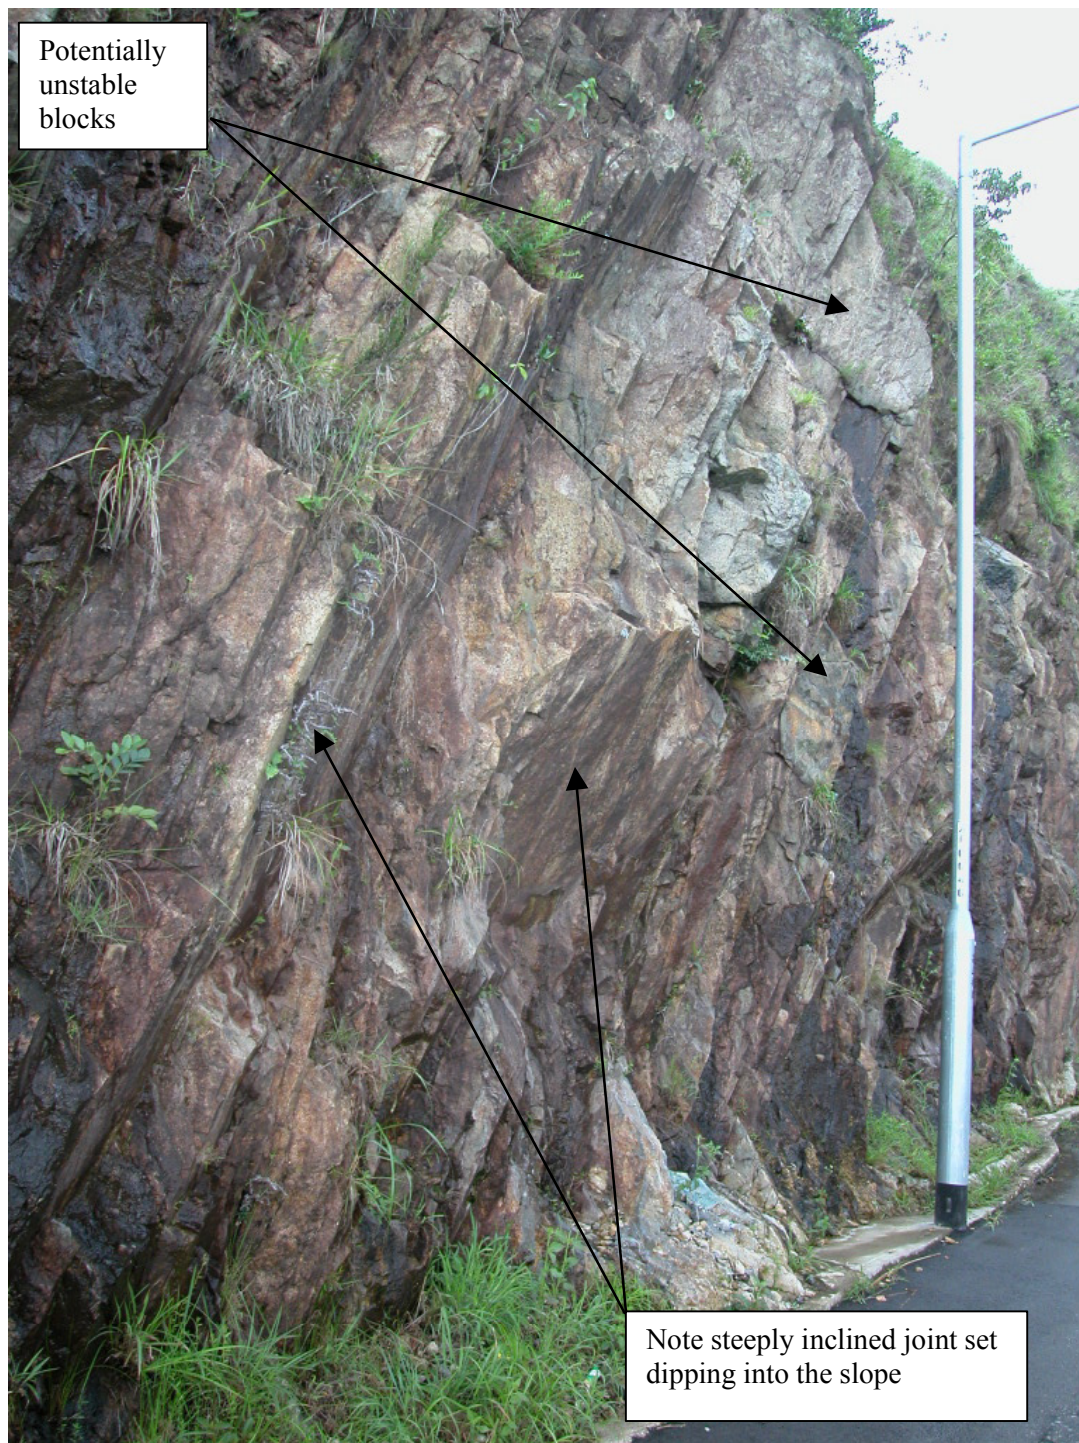
Along the central and eastern portions of the subject slope, there are adversely orientated joints with a potential toppling failure mode (see Plate 15). Two loose blocks of approximately 0.7 m wide were observed at the central portion of the slope (Plate 15). Given progressive deterioration, the loose blocks and the adversely orientated rock blocks may become more vulnerable to rain-induced failures. At the time of HCL's inspection in May 2002, no signs of an incipient major failure on slope No. 11NE-A/C284 were observed.

Plate 15 - View of Potentially Unstable Blocks Located at the Central Portion of Slope No. 11NE-A/C284 (Photograph taken on 3 July 2002 by HCL)

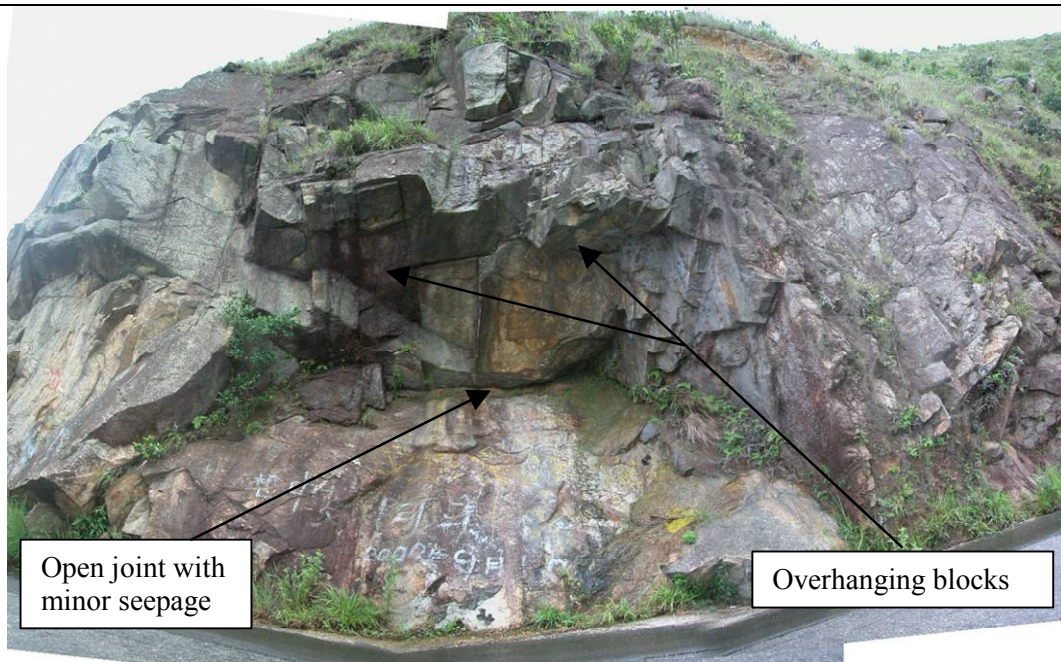
Plate 16 - View of Overhanging Blocks Located at the Central Portion of Slope No. 11NE-A/C285 (Photograph taken on 3 July 2002 by HCL)

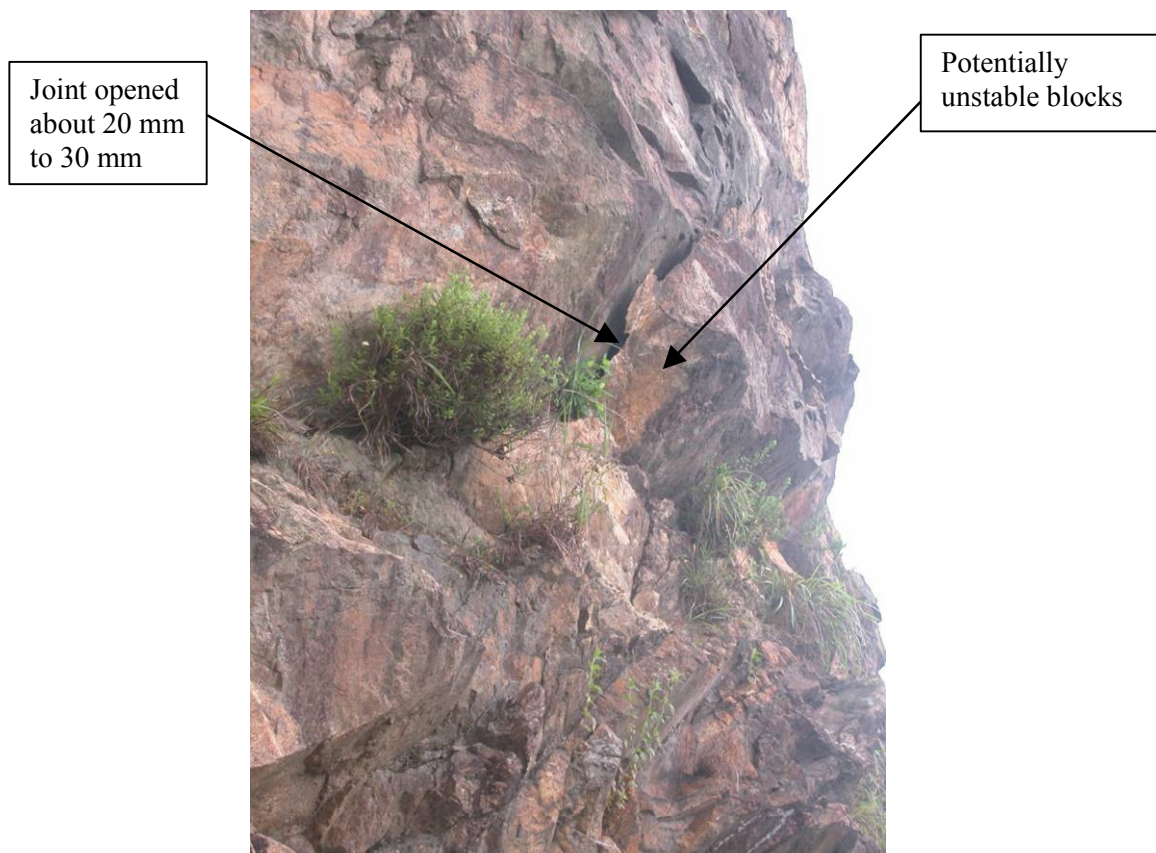
Plate 17 - View of Potentially Unstable Block Located at the Central Portion of Slope No. 11NE-A/C281 (Photograph Taken on 3 July 2002 by HCL)
