**DETAILED STUDY OF THE
22 MAY 2002 ROCKFALL
INCIDENT ON SLOPE
NO. 11NE-A/C284 AT
SHATIN PASS ROAD
TSZ WAN SHAN**

GEO REPORT No. 156

Halcrow China Limited

**This report was originally produced in October 2002
as GEO Landslide Study Report No. LSR 9/2002**

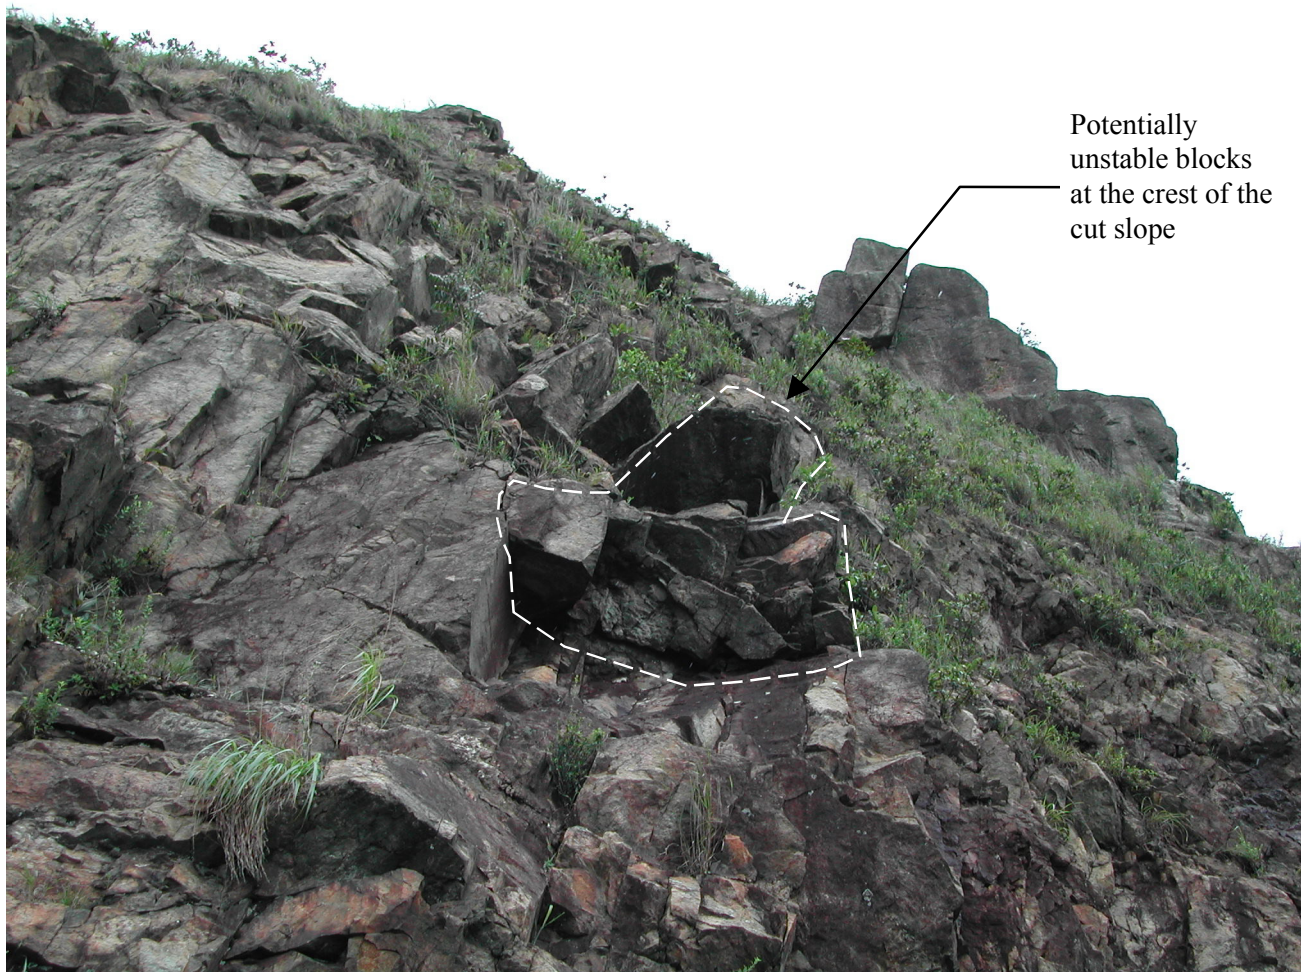
Plate 18 - View of Potentially Unstable Blocks Located at the Crest of Slope No. 11NE-A/C281
(Photograph taken on 23 July 2002 by HCL)
