**DETAILED STUDY OF  
THE 23 MARCH 2002  
ROCKFALL INCIDENT  
AT SLOPE NO. 11NW-A/C61  
AT CASTLE PEAK ROAD,  
KWAI CHUNG**

**GEO REPORT No. 157**

**Maunsell Geotechnical Services Limited**

**GEOTECHNICAL ENGINEERING OFFICE  
CIVIL ENGINEERING AND DEVELOPMENT DEPARTMENT  
THE GOVERNMENT OF THE HONG KONG  
SPECIAL ADMINISTRATIVE REGION**

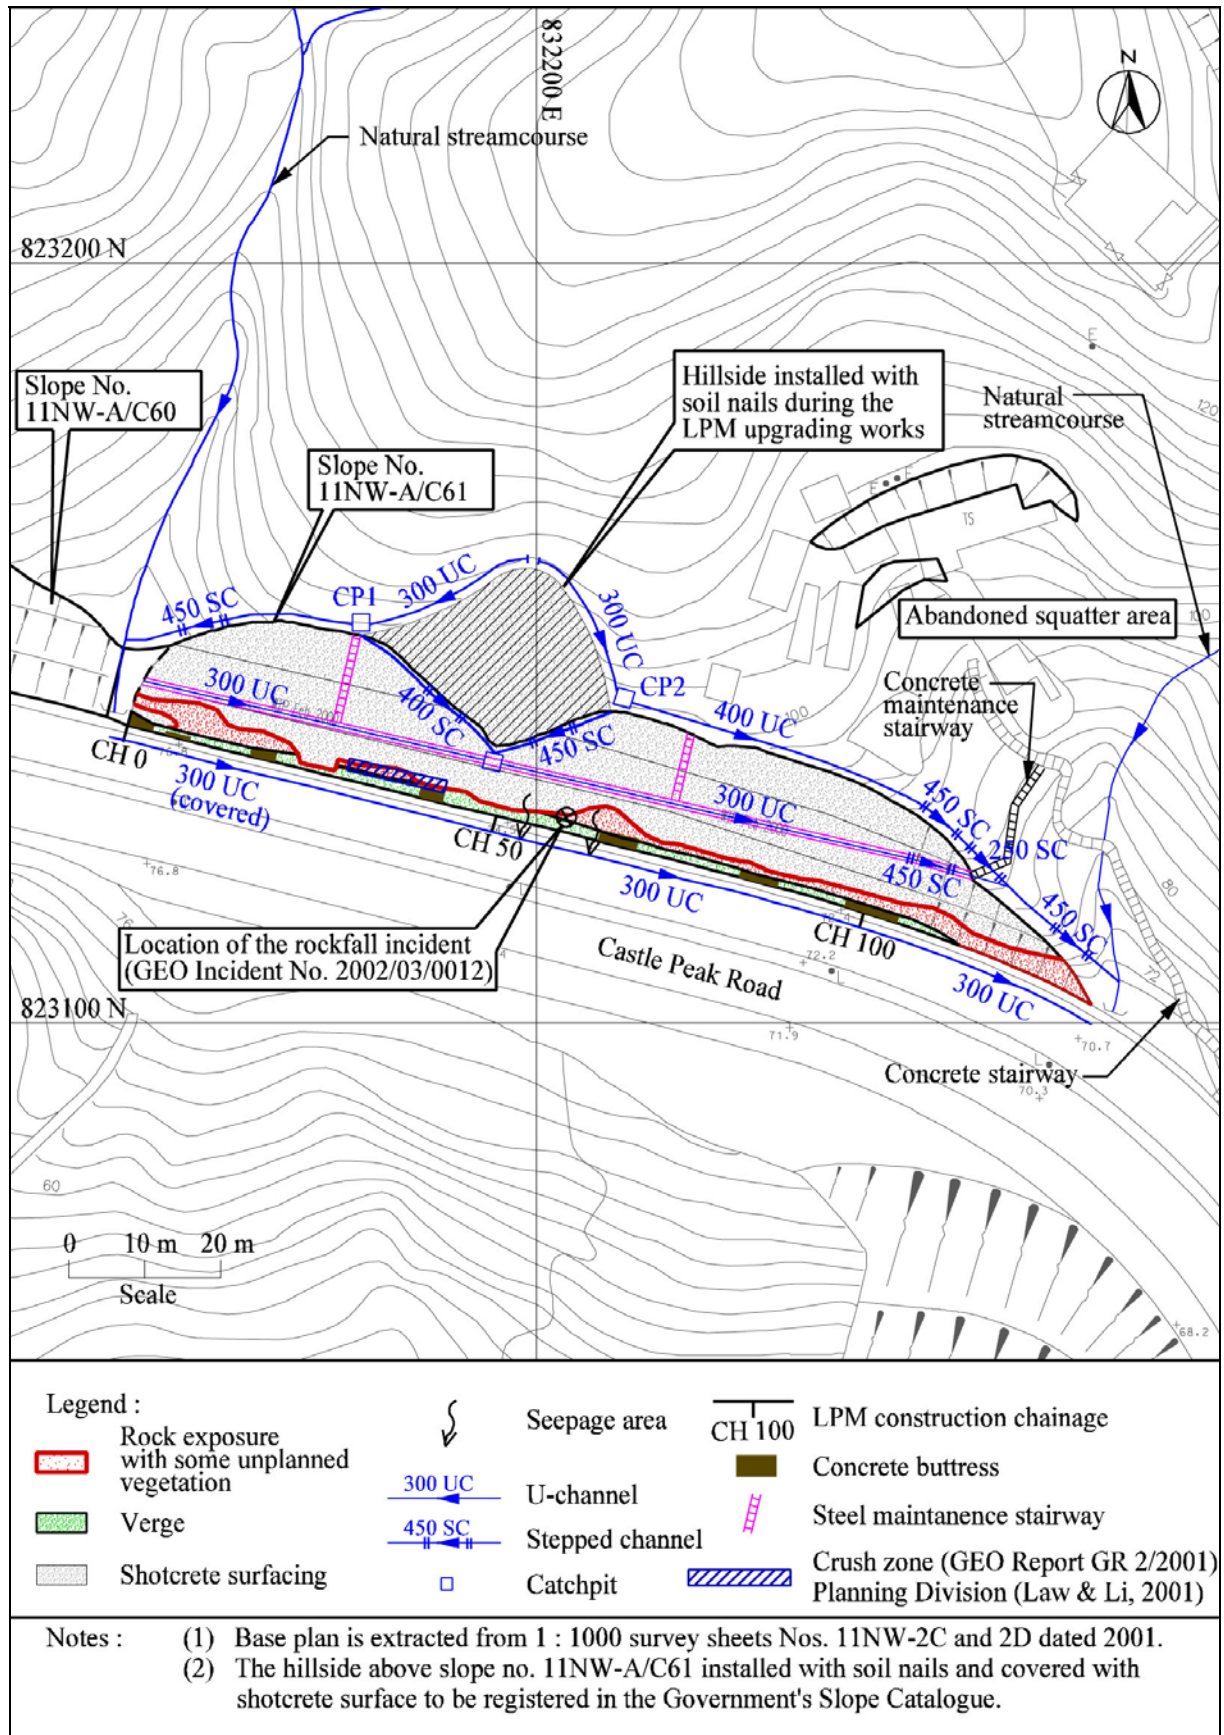
Figure 2 - Field Observations Following the Rockfall

At about 10:15 a.m. on 23 March 2002, when the Amber Rainstorm Warning was hoisted, the rockfall (GEO Incident No. 2002/03/0012) occurred approximately 60 m from the western end of slope No. 11NW-A/C61 (Figure 2), adjacent to Castle Peak Road, Kwai Chung. Most of the rockfall debris, which had an estimated failure volume of 0.1 m<sup>3</sup>, fell from the upper part of the rock cut portion (about 10 m from the slope toe) onto the footpath at the toe of the slope (Plate 1). The remainder of the debris fell onto the road (Plate 2) causing the temporary closure of one lane of the road. No casualties were reported as a result of the incident.

Following the incident, MGSL inspected the site on 27 March 2002 and carried out a rock joint discontinuity survey on 19 April 2002. The location of the source of the rockfall was established by comparing stereopairs of photographs taken by MCL before and after completion of the LPM works with photographs taken after the rockfall incident (Plates 6, 7 and 8). The detached rock block appears to have originated from just below the interface between the shotcreted soil portion and the exposed rock cut portions of the slope, some 10 m above the toe. The detached rock block was about 0.6 m wide by 0.6 m long and between about 0.15 m and 0.2 m thick, with a failure volume of about 0.1 m<sup>3</sup>.

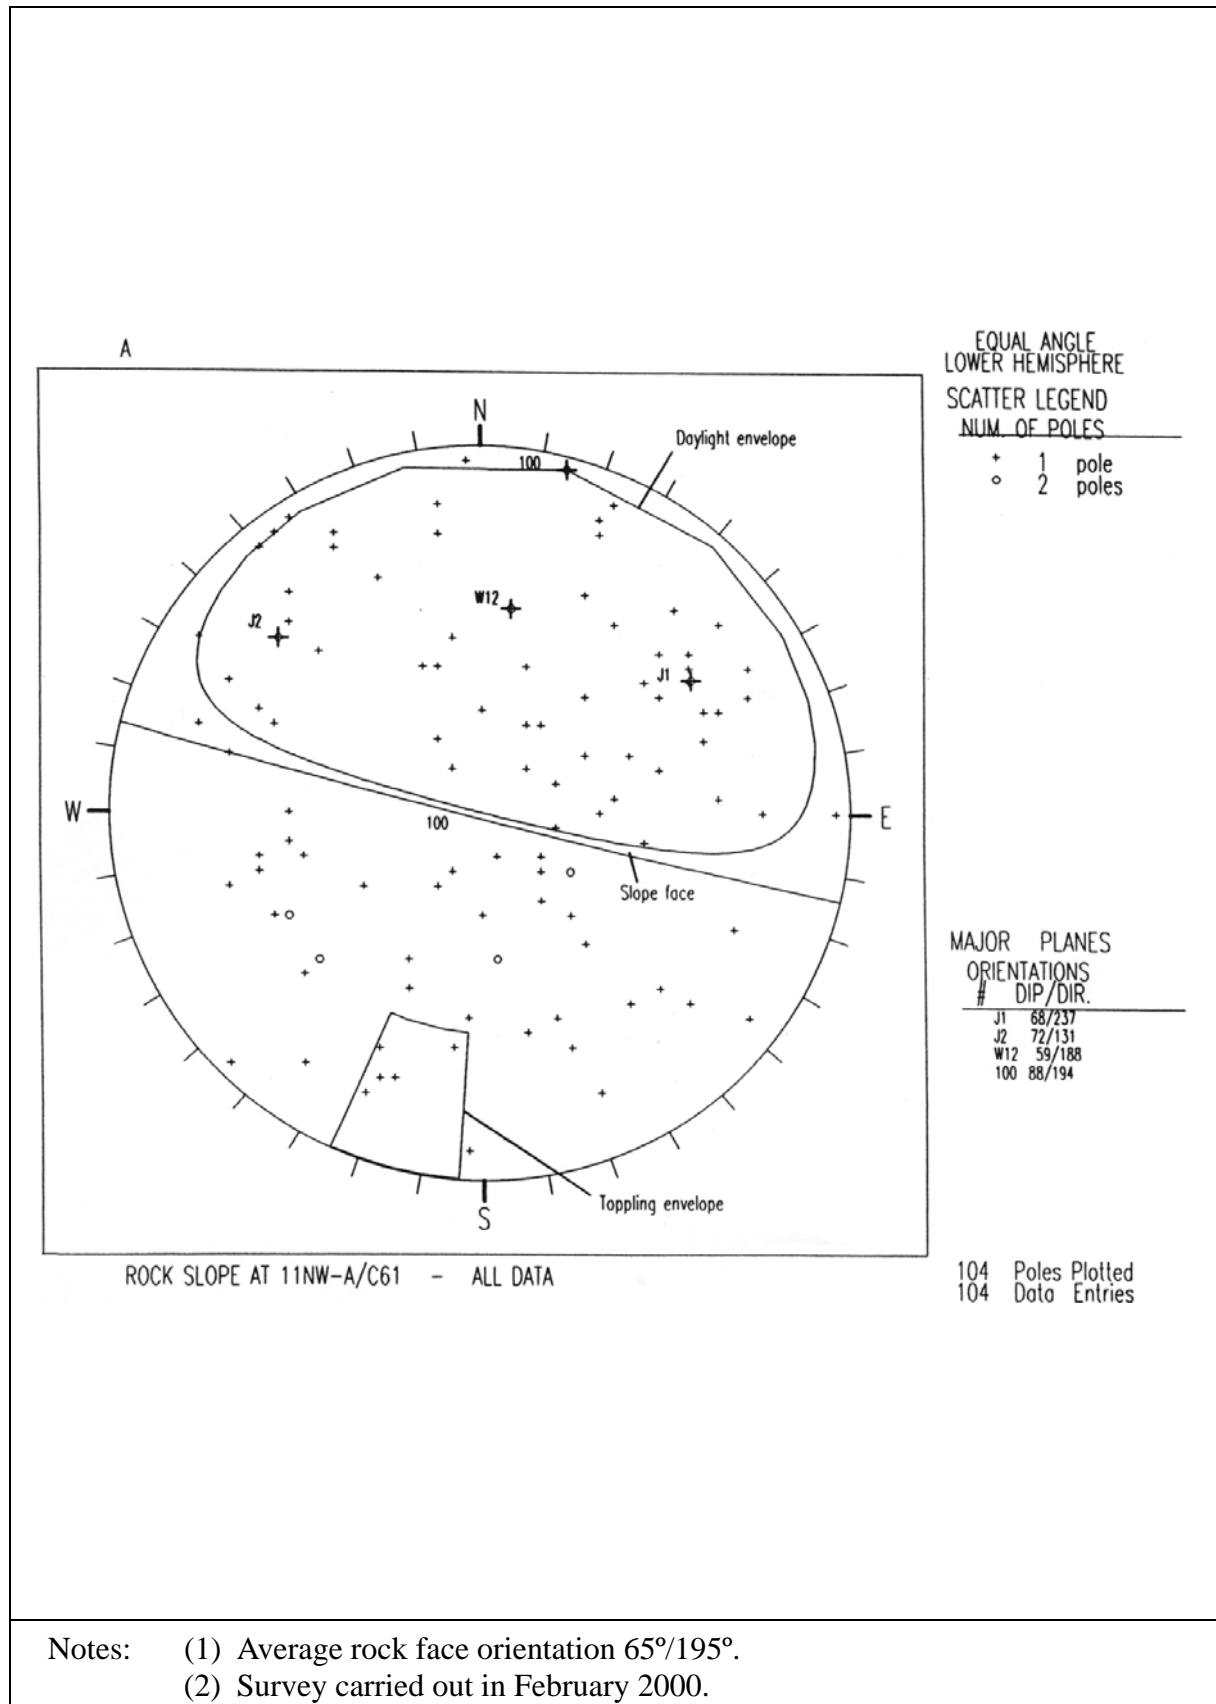
Figure 6 - MCL Stereoplot of the Entire Rock Portion of Slope No. 11NW-A/C61  
(Extracted from MCL Stage 3 Report No. S3R 206/97)

After the removal of the dense unplanned vegetation covering the rock cut portion of slope No. 11NW-A/C61, MCL carried out a detailed rock joint discontinuity survey (Figure 6) in early February 2000. MCL concluded that, while rock joints could give rise to planar and toppling failures, large-scale wedge failures were unlikely. The rock joint discontinuity survey indicated the dip and dip direction only of the joint planes with no further information given as to the condition of the rock joint surfaces. According to MCL’s working sketches of the rock face, locations of unstable blocks, overhanging faces and potential wedge or planar failure were identified. There is no mention in the Stage 3 Study Report of the “crushed zone”, which daylights the rock cut face with a dip angle of 18°, as documented by Law & Li (2001).

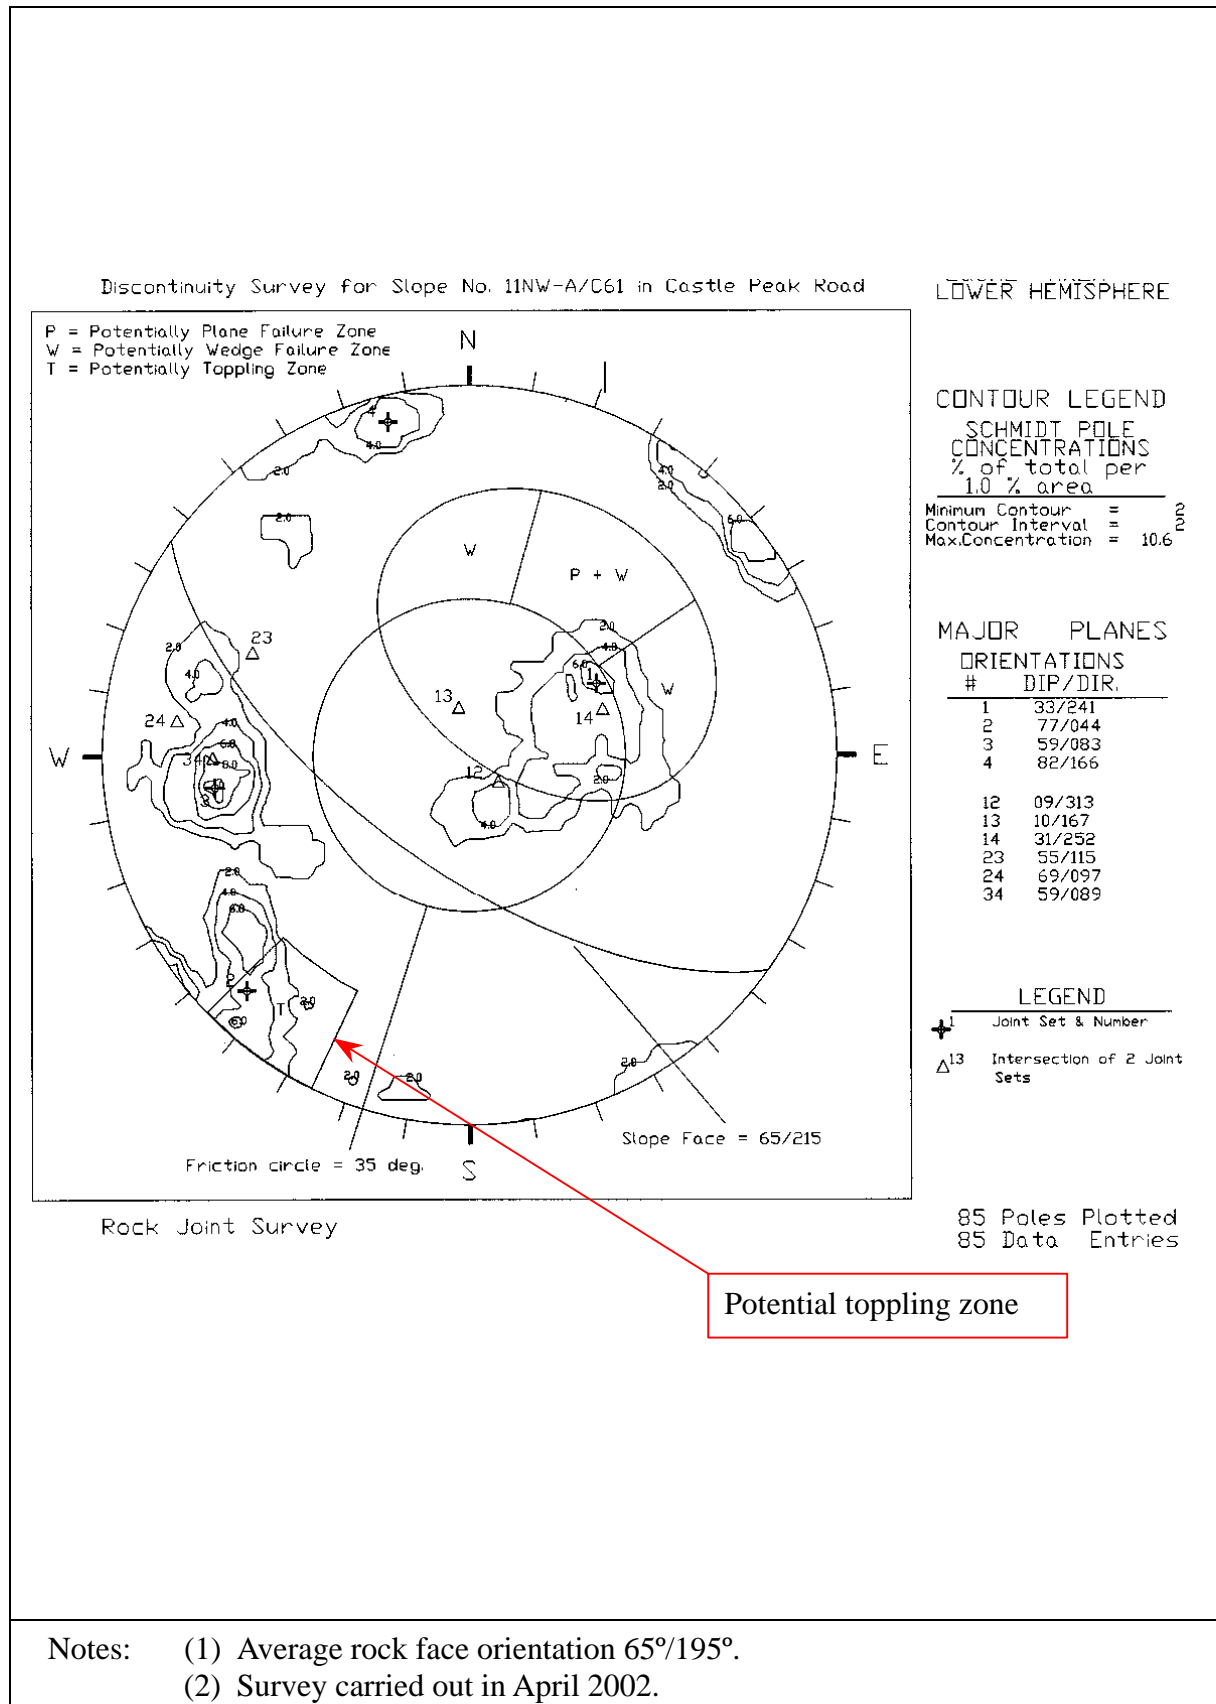
Figure 7 - MGSL Stereoplot of Rock Portion of Slope No. 11NW-A/C61 in the Vicinity of the Rockfall Incident

Results of rock joint mapping carried out by MGSL presented in a stereoplot (Figure 7) indicates the potential for toppling failure and a low potential for sizeable wedge and planar failures. The combination of sub-vertical and adversely inclined joints, which are closely spaced, would give rise to the potential for local failures. MGSL's mapping of the rock face indicated that no sizeable failures were apparent and locally planar, wedge or toppling potential was minor for unrestrained rock blocks.

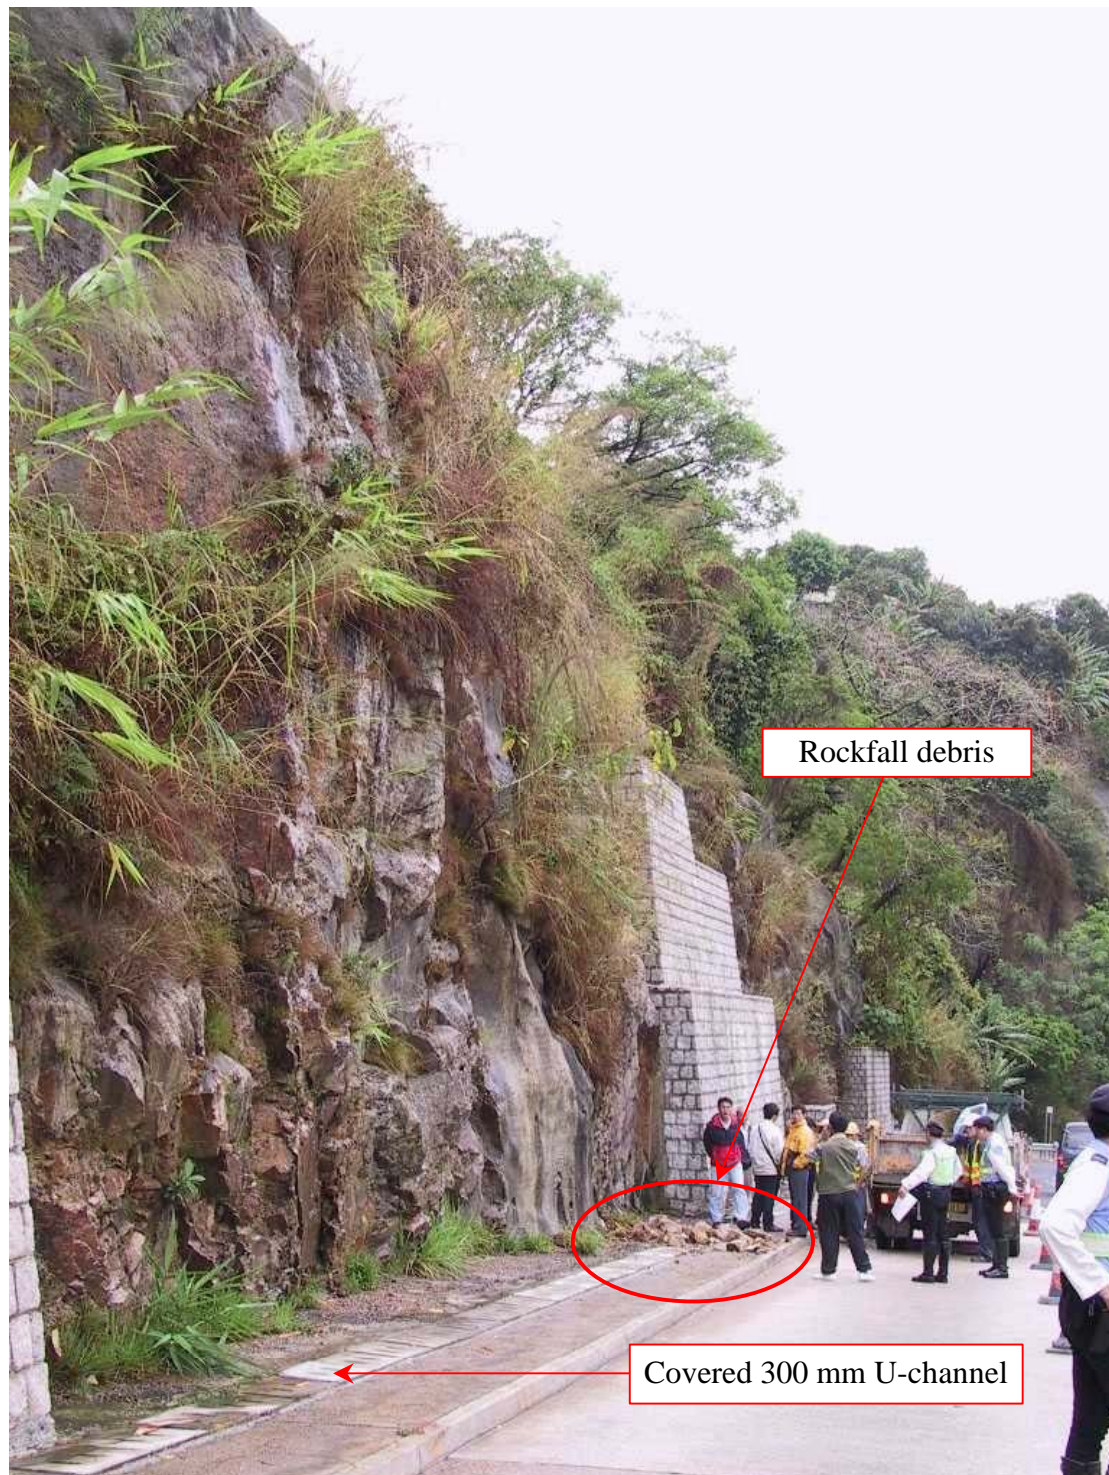
Plate 1 - View of Slope No. 11NW-A/C61 Looking East Showing Debris on the Footpath  
(Photograph taken by GEO on 23 March 2002)

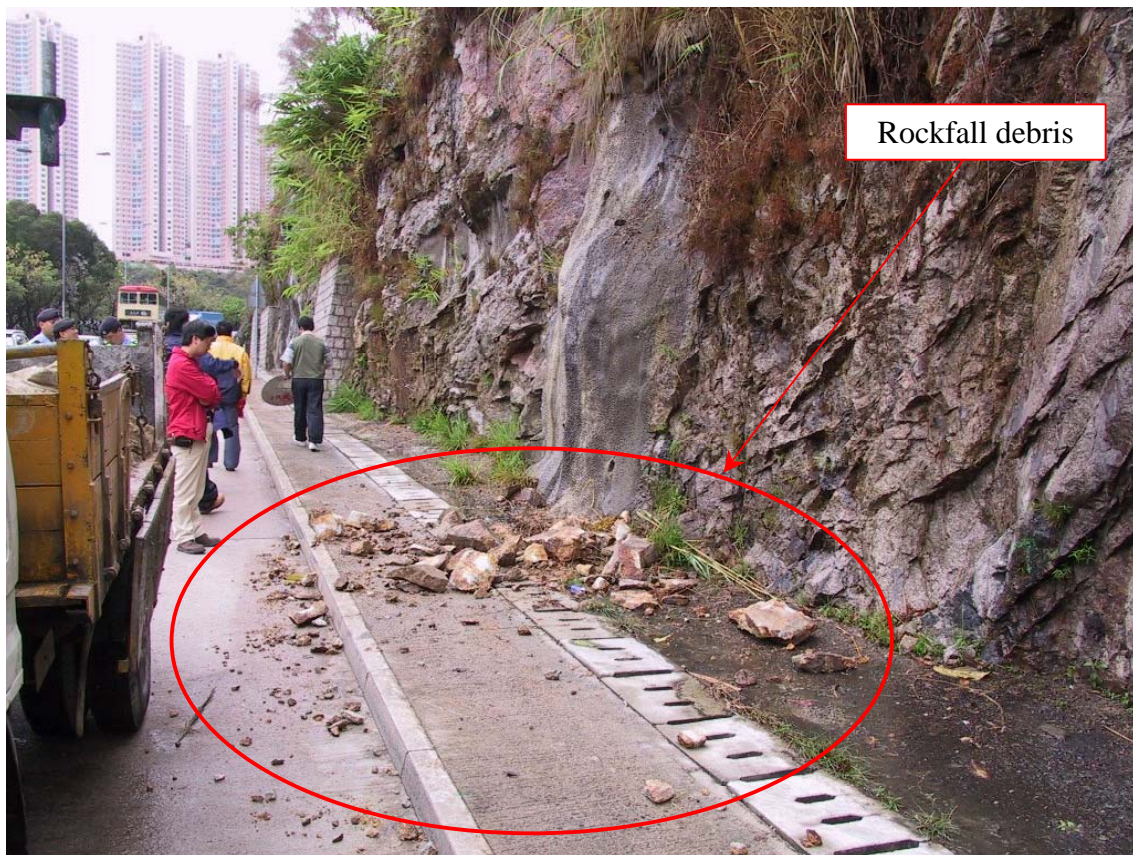
Plate 2 - View of Slope No. 11NW-A/C61 Looking West Showing Rockfall Debris  
(Photograph taken by GEO on 23 March 2002)

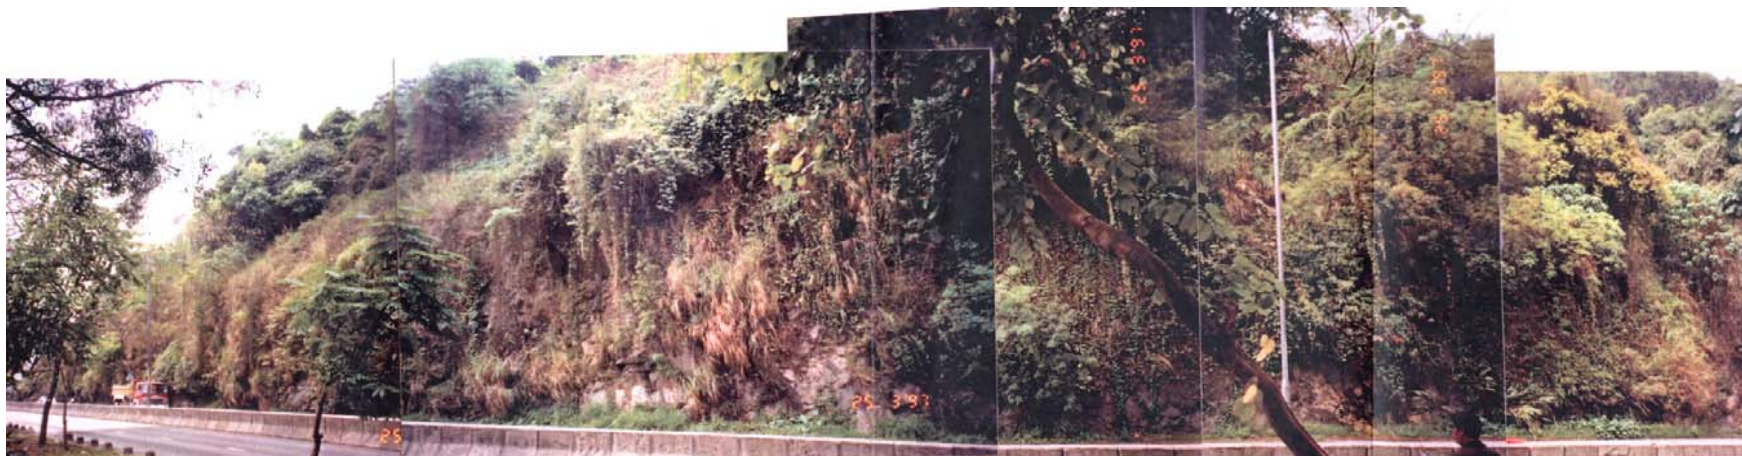
MCL inspected the slope between March and October 1997. Since the face of the rock portion was covered with dense unplanned vegetation comprising small trees, shrubs and grass (Plate 3), only the lowest 2 m of the rock cut portion of slope No. 11NW-A/C61 could be inspected. MCL reported that “A number of unstable blocks with potential wedge, toppling, and locally, plane failure were identified”. MCL also observed seepage and dampness on the exposed rock cut portion of the slope between May and October 1997 and in January 1998 and February 1998. The Stage 3 Study Report did not record any observation of the landslide scar identified by B&P in 1977.

The rock slope portion was covered with dense unplanned vegetation comprising trees and shrubs prior to LPM works (Plate 3). Unplanned vegetation comprising tall grass and small shrubs had quickly re-established on the upper rock portion some six months after completion of LPM works (Plate 7). The presence of unplanned vegetation may have been a contributing factor to the failure.

Plate 3 - View of Slope No. 11NW-A/C61 Showing Unplanned Vegetation on the Rock Cut Portion in 1997  
(Photograph taken by Mott Connell Ltd on 25 March 1997)

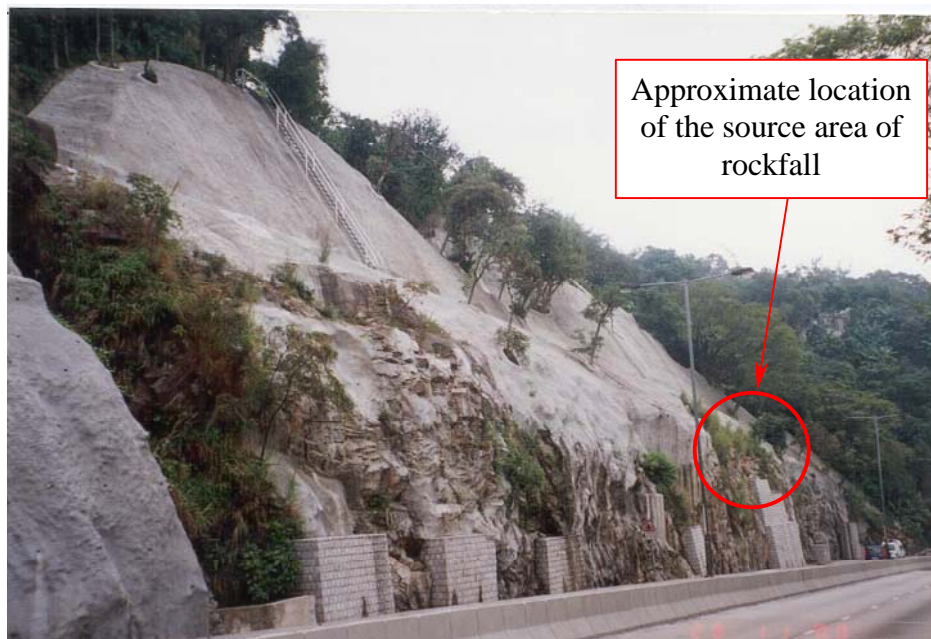
Following the completion of the slope upgrading works under the LPM Programme at the end of June 2000, routine maintenance inspection (RMI) by HyD on the 28 November 2000 recommended follow-up actions comprising removal of overgrown vegetation from the slope (Plate 4) and clearing blocked channels and catchpits. According to HyD’s record, the recommended works were carried out by HyD in December 2000. The next RMI on 6 December 2001 (before the March 2002 rockfall) indicated that no follow-up action was recommended as a result of the inspection (Plate 5).

Plate 4 - View of Slope No. 11NW-A/C61 in November 2000 during a Routine Maintenance Inspection (Photograph taken by Highways Department on 28 November 2000)

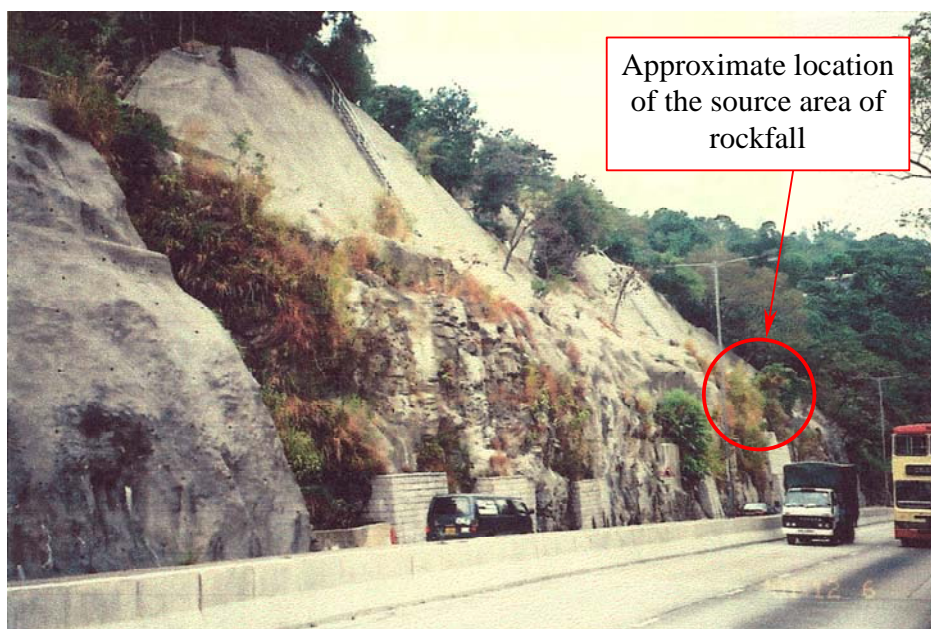
Plate 5 - View of Slope No. 11NW-A/C61 in December 2001 during a Routine Maintenance Inspection (Photograph taken by Highways Department on 6 December 2001)

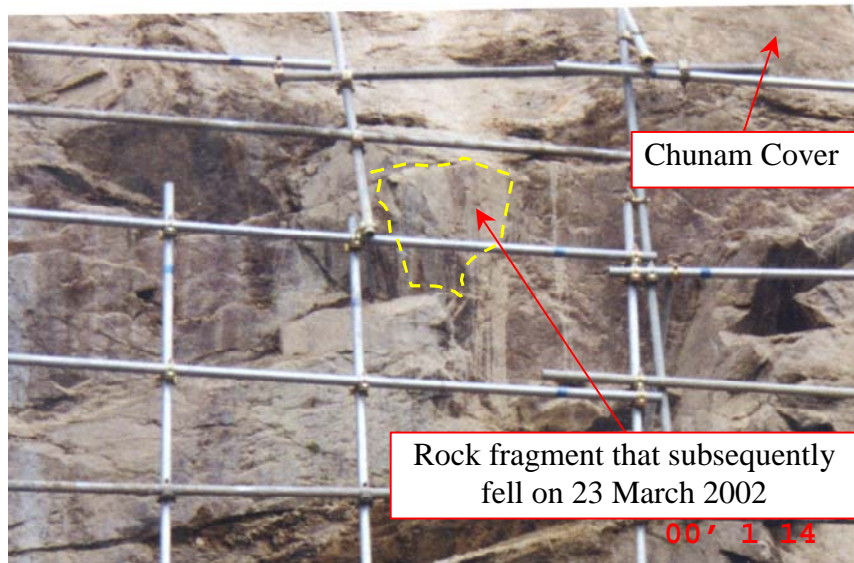
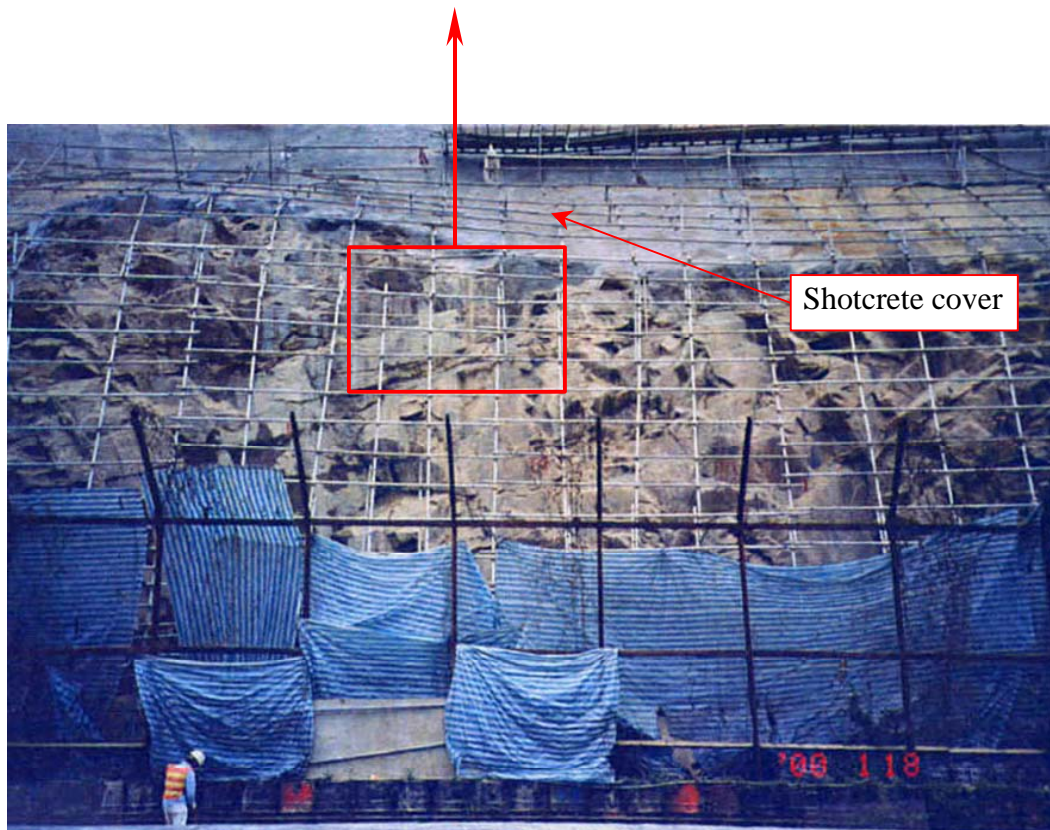
MGSL noted that unplanned vegetation comprising tall grass and small shrubs had quickly re-established on the slope (since the removal of vegetation as part of the slope upgrading works in January 2000, see Plate 6), particularly on the upper rock portion of the slope, by examination of photographs taken by MCL in July 2000 (Plate 7). No signs of blockage of the surface drainage system on the berms or slopes were observed by MGSL's inspection in March 2002. There were no indications to suggest that the berm drainage system had overtopped during heavy rainfall. MGSL's observation in the vicinity of the source area of the March 2002 rockfall also confirmed that the shotcrete cover of the slope was generally in a good condition and no significant cracks were present at the interface between the shotcrete cover and the 300 mm U-channel at the berm.

The source of the rockfall was located just below the interface of the newly shotcreted soil portion (previously covered with chunam, see Plate 6) and the exposed rock cut portion below where locally a set of adversely orientated joints and unplanned vegetation provided the potential for toppling of marginally stable blocks. The detachment of the rock blocks, which occurred shortly after a period of moderate rainfall, was probably caused by the development of cleft water pressure in the sub-vertical joints behind the rock blocks, which had probably been exacerbated by the gradual opening up of the rock joints as a result of progressive deterioration. The progressive deterioration of the rock face was possibly promoted by root action due to unplanned vegetation, which apparently had quickly spread across the slope following the upgrading works.

Plate 6 - View of Slope No. 11NW-A/C61 during LPM Works (Photographs taken by Mott Connell Ltd on 14 and 18 January 2000)

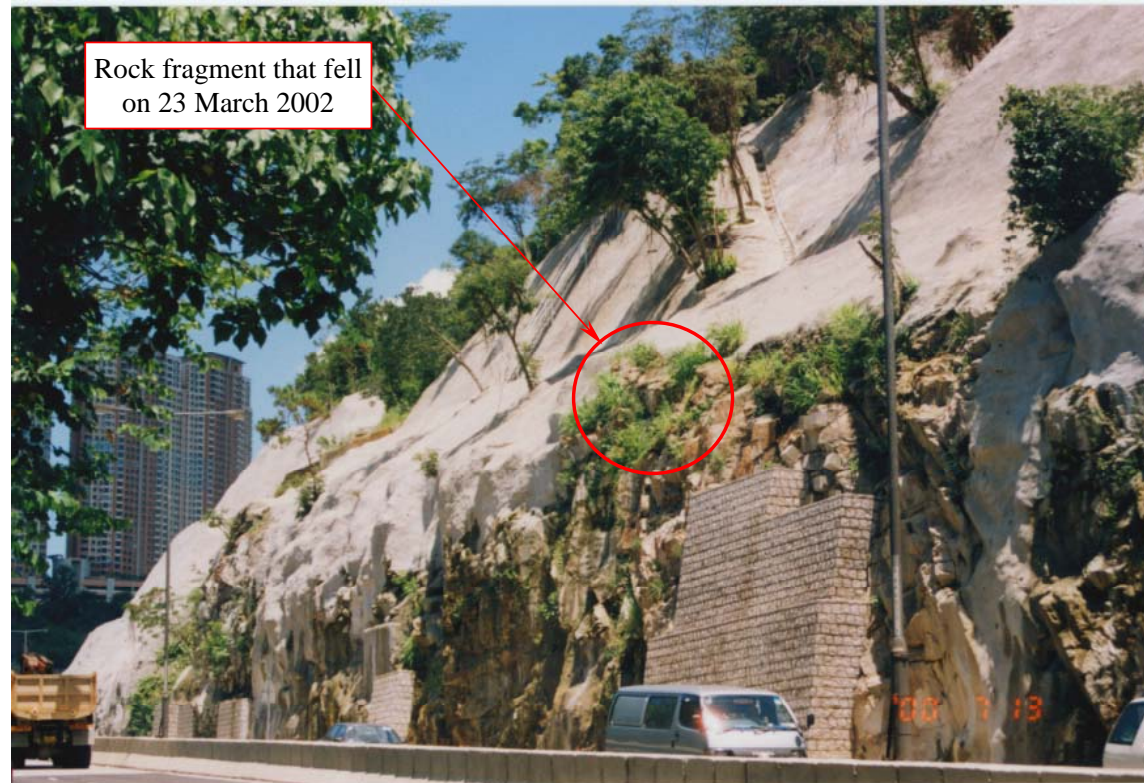
Plate 7 - View of Slope No. 11NW-A/C61 Showing Some Unplanned Vegetation immediately after Completion of LPM Works  
(Photograph taken by Mott Connell Ltd on 13 July 2000)

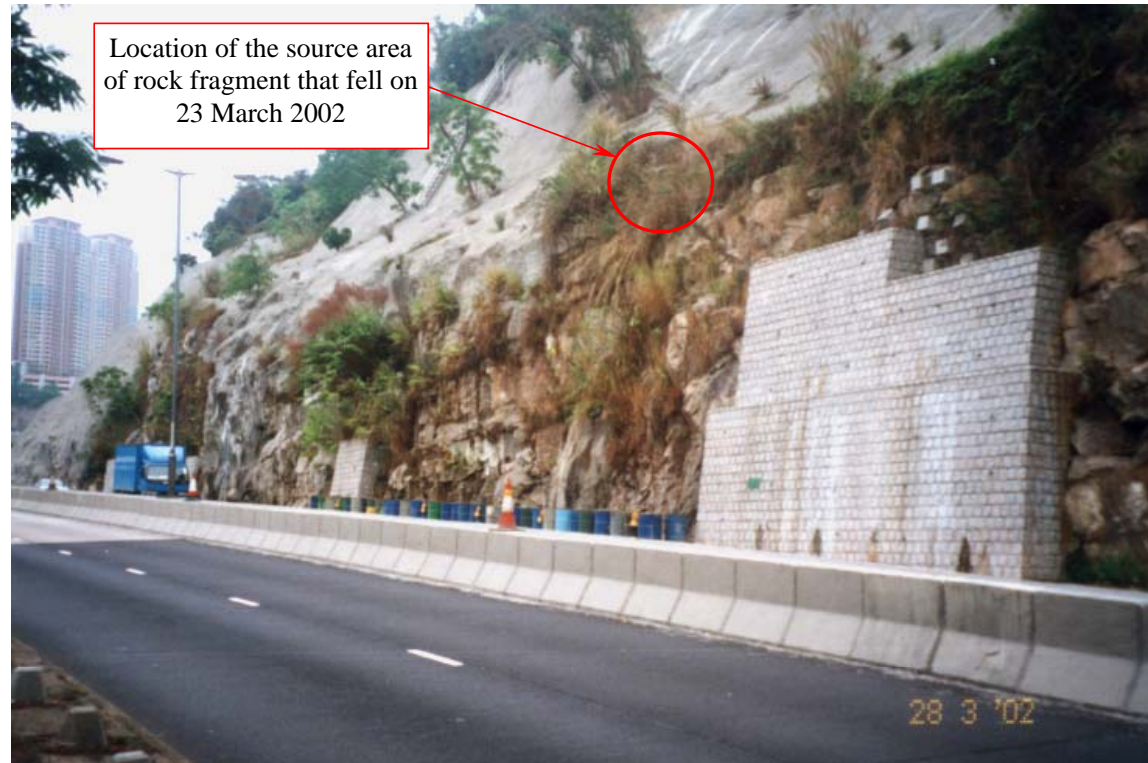
Plate 9 - View of Slope No. 11NW-A/C61 Showing Growth of Unplanned Vegetation on the Rock Portion  
(Photograph taken on 28 March 2002)
