**DETAILED STUDY OF
THE 10 AUGUST 2002
LANDSLIDE INCIDENT
ON A CUT SLOPE AT
VICTORIA ROAD, HONG KONG**

GEO REPORT No. 158

Halcrow China Limited

**GEOTECHNICAL ENGINEERING OFFICE
CIVIL ENGINEERING AND DEVELOPMENT DEPARTMENT
THE GOVERNMENT OF THE HONG KONG
SPECIAL ADMINISTRATIVE REGION**

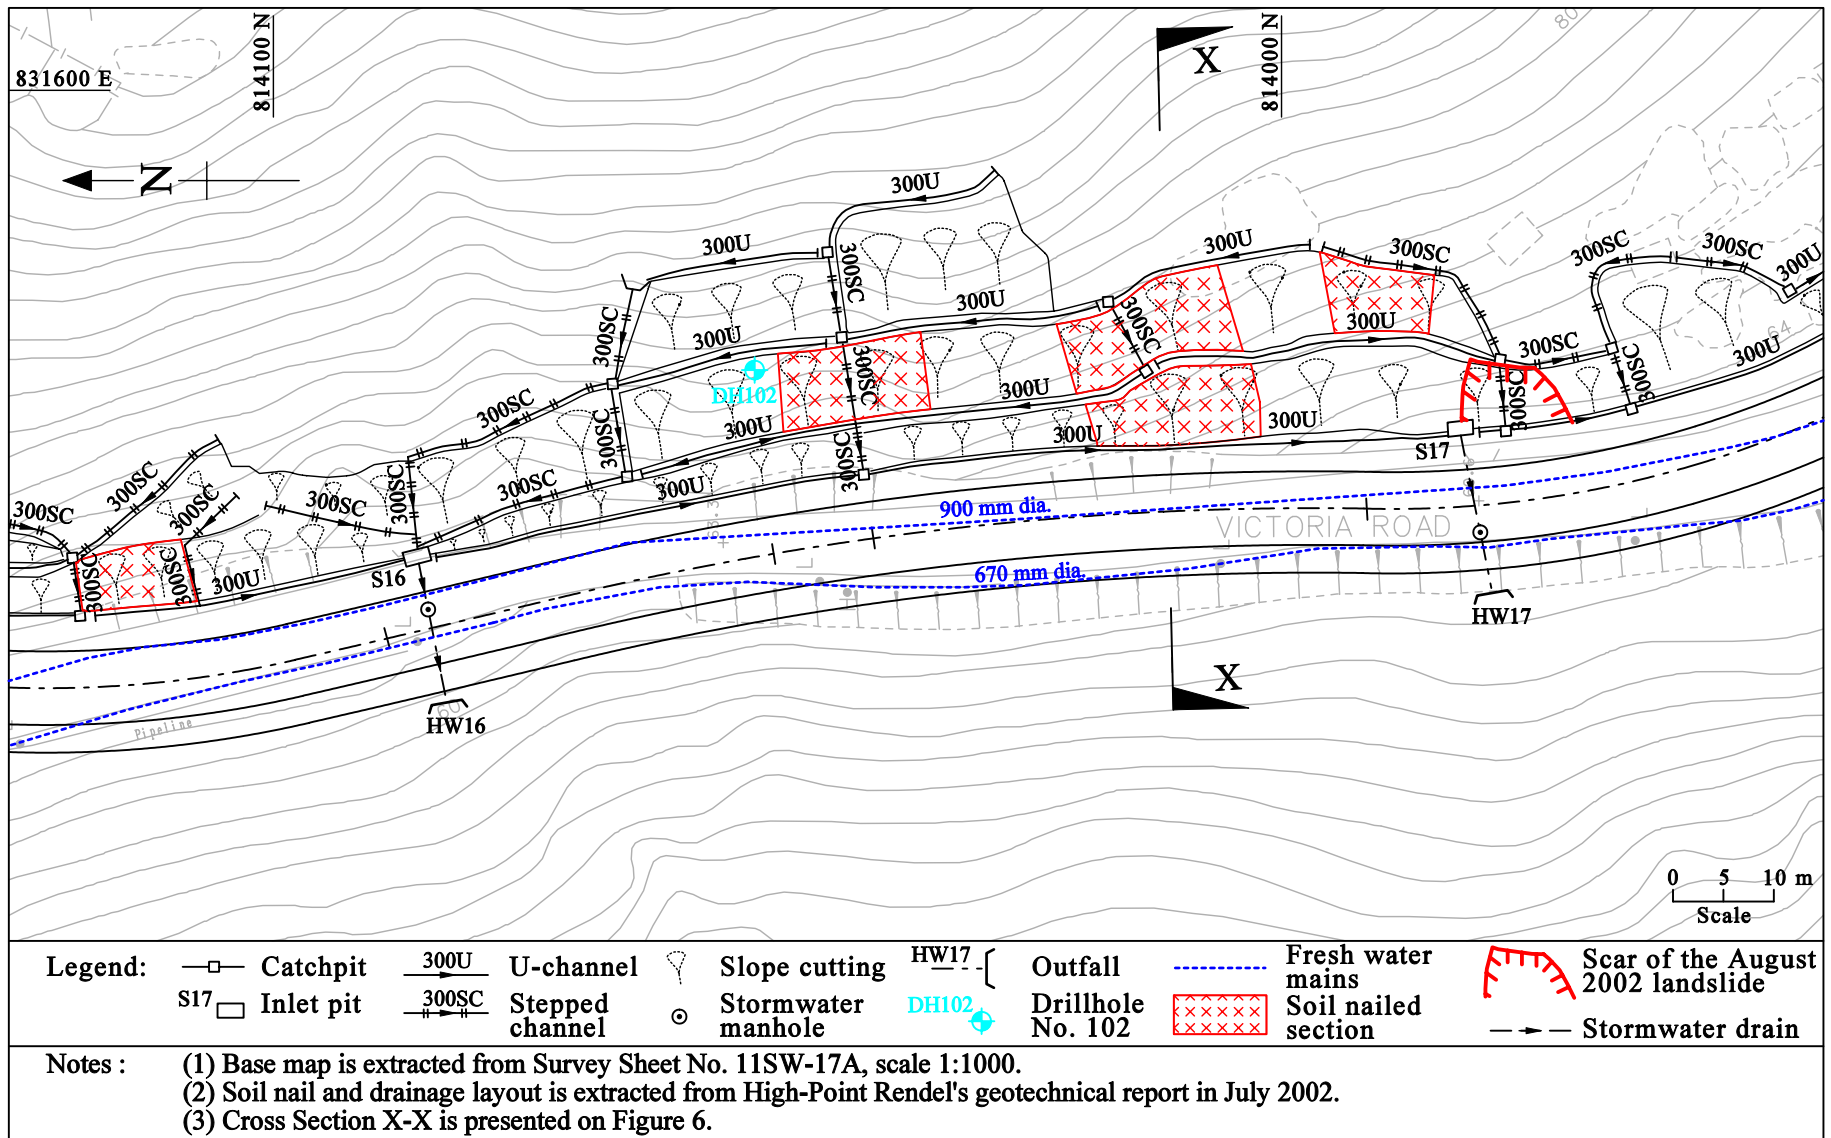
Figure 2 - General Layout Plan of Drainage Provisions and Soil Nailing Works in the July 2002 Geotechnical Report

According to the report, no soil nails were provided to the failed section of the August 2002 landslide (Figure 2) and no stability analysis was carried out to check the FoS of the section (which has a maximum height of 5.5 m). It was not stated in the report whether the failed section comprised soil or rock. Based on the correspondence between the consultant and the contractor in May 2000 (see Section 4.3), the consultant appeared to be aware that the section that subsequently failed on 10 August 2002 comprised entirely soil material.

Surface drainage system for the subject slope comprises U-channels and stepped channels with catchpits at the intersection points. The proposed drainage layout plan is shown in Figure 2. The construction of surface drainage system commenced in August 2001. HPR noted in the progress summary for the period November 2001 to May 2002 that the “outstanding works included the installation of hand railing along the berm channel, construction of toe channel and catchpits” and that “No work was carried out due to priority being given to the adjacent carriageway works”, whereas the summary for the period June 2002 to July 2002 noted that the above outstanding works “to be commenced by 26 July 2002”.

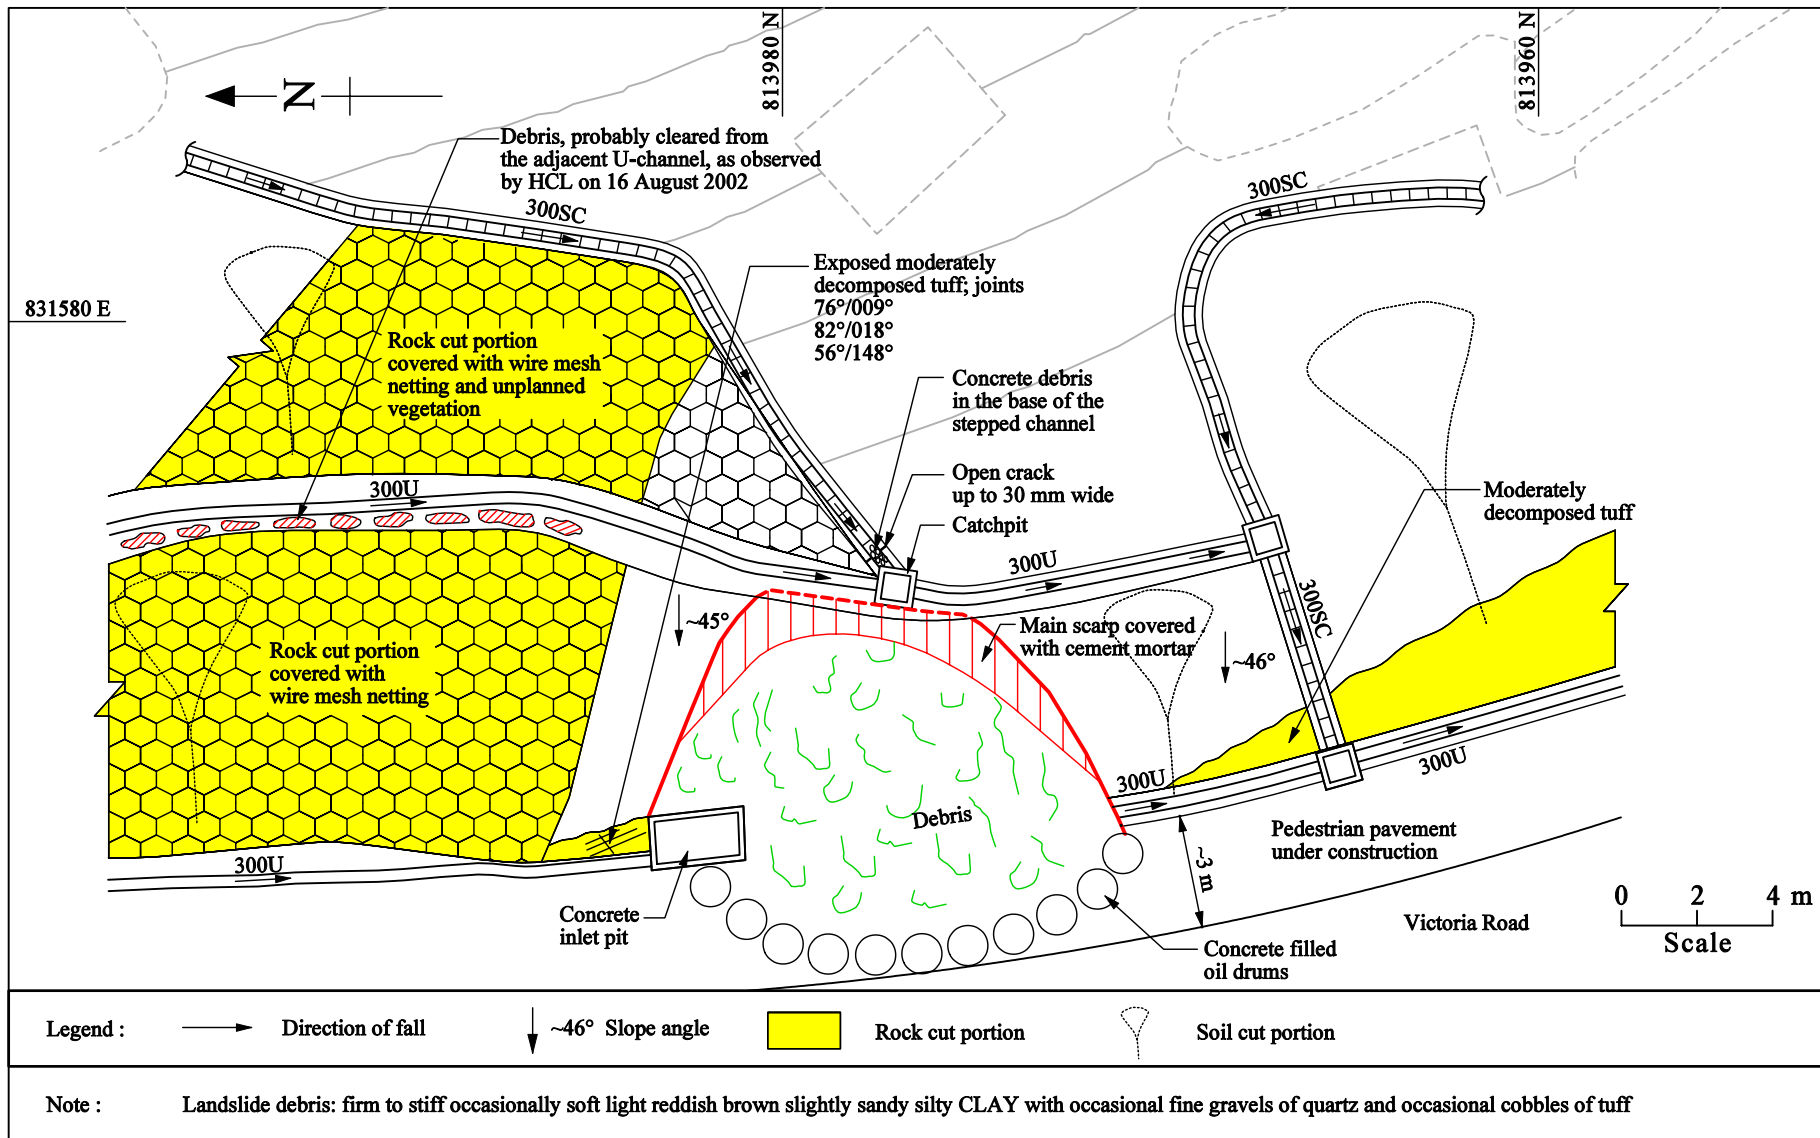
Figure 7 - Plan of the Landslide Scar

The landslide involved about 80 m^3 of debris from a landslide scar with a width of about 11.5 m and a length of 10.5 m (Figure 7). The typical depth of the failure was about 1.5 m (maximum 2 m thick) as revealed in trial pits (see Section 6.2 below). The debris travelled a maximum distance of about 2.7 m from the slope toe position over the incomplete pedestrian pavement, with a corresponding travel angle of about 40° (inclination of the line joining the distal end of the debris and the crest of the landslide scarp). The debris comprised firm to stiff, occasionally soft, light reddish brown slightly sandy silty clay with

About 3 m to the north of the scar of the 2002 landslide is a sharp interface between soil and rock that runs sub-parallel to the northern edge of the landslide scar (dipping at about $80^{\circ}/015^{\circ}$, see Figure 7) in the lowermost slope batter (Plate 3). The rock exposed is a strong moderately decomposed tuff (MDT) (Plate 4) within which there is a prominent set of medium spaced joints dipping steeply approximately towards the north (i.e. into the slope) and are not adverse. The rock portion was covered with steel wire mesh netting (Plate 18). The upper soil portion was observed to have been soil nailed, with the nail heads connected by means of concrete beams of about 300 mm wide by 200 mm deep (Plate 19). No soil nails were installed in the soil cut portion involved in the 2002 landslide as per the HPR's design drawing.

At the time of HCL's inspection on 16 August 2002, the main scarp of the landslide had been covered with cement mortar. As a result of the displacement of the failed ground mass, a section of the concrete apron along the first berm above the backscarp had been undermined (Plate 7), and construction waste comprising broken ceramic pipes and pieces of plastic was observed at the underside of the apron (Plate 8). Slight seepage was observed over the soil surface (Plate 9) beneath a catchpit located above the landslide backscarp (Figure 7). The mortar adjacent to the exposed soil surface was also damp.

The catchpit located above the backscarp is at the intersection point of the U-channel along the first berm and a stepped channel running from east to west (from uphill) towards the landslide scar (Figure 7). Cracks up to 30 mm wide were observed on the side wall of the stepped channel (Plate 10). A small amount of concrete debris was also observed at the base of the catchpit (Plate 5) and stepped channel (Plate 11). Just to the north of the 2002 landslide, debris comprising construction waste and fallen leaves had been placed on the concrete apron alongside the U-channel on the first berm (Plate 12). It is considered that the observed debris had probably been cleaned out from the adjacent U-channel after the landslide. Other sections of the U-channels on the slope (Figure 8) were observed to have been fully blocked with debris, which was primarily construction waste comprising broken concrete, no-fines concrete and brick fragments (Plates 13 and 14).

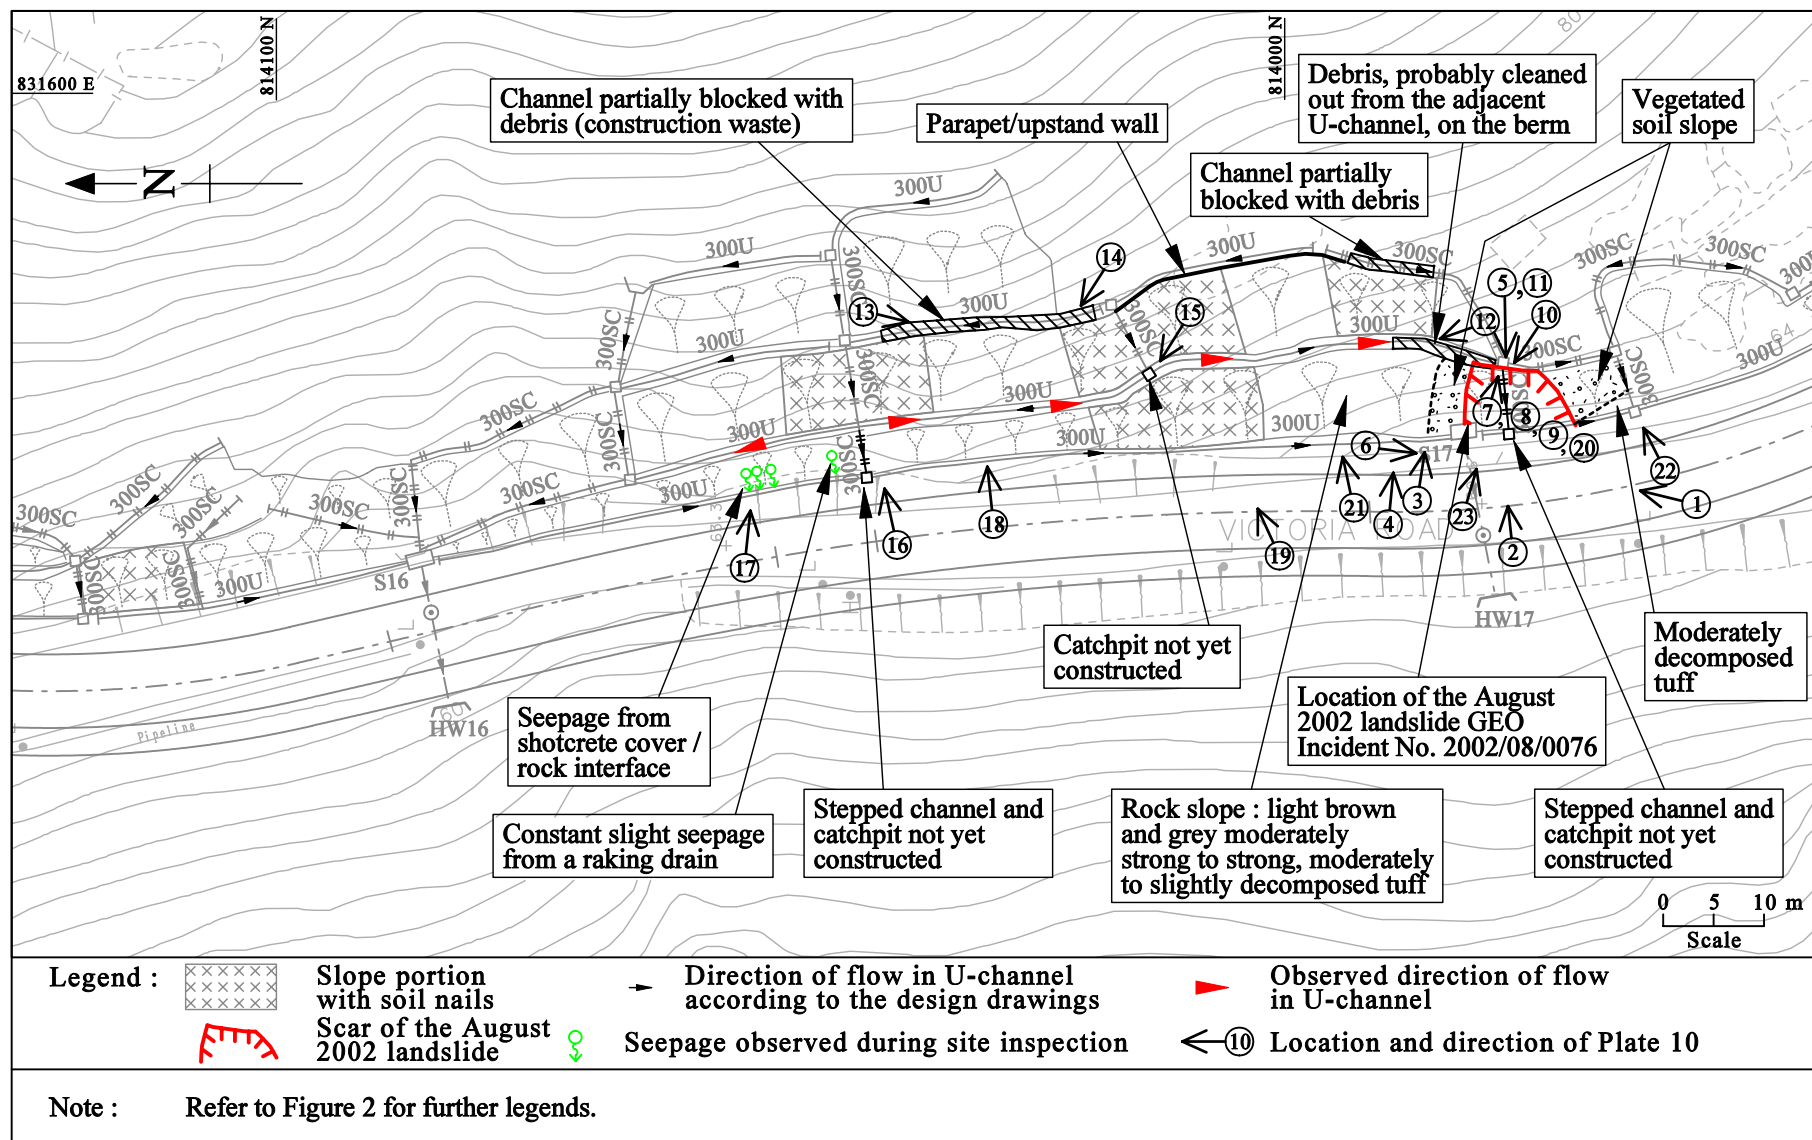
Figure 8 - Site Observations in the Vicinity of the Landslide

Observations of the drainage flow paths along the U-channels for the southern half of the slope indicate that the majority of the water collected in the U-channels would drain towards the location of the 2002 landslide (Figure 8). In particular, the U-channel along the first berm was noted to be draining a section of about 100 m in length towards the catchpit located above the backscarp of the 2002 landslide. An indication of the observed drainage flow path as compared with the drainage layout plan attached to HPR's July 2002 detailed geotechnical design report is presented in Figure 8.

During the field inspection by HCL in August and September 2002, seepage was observed at several locations at the lowest batter of the subject slope (Figure 8 and Plates 16 and 17).

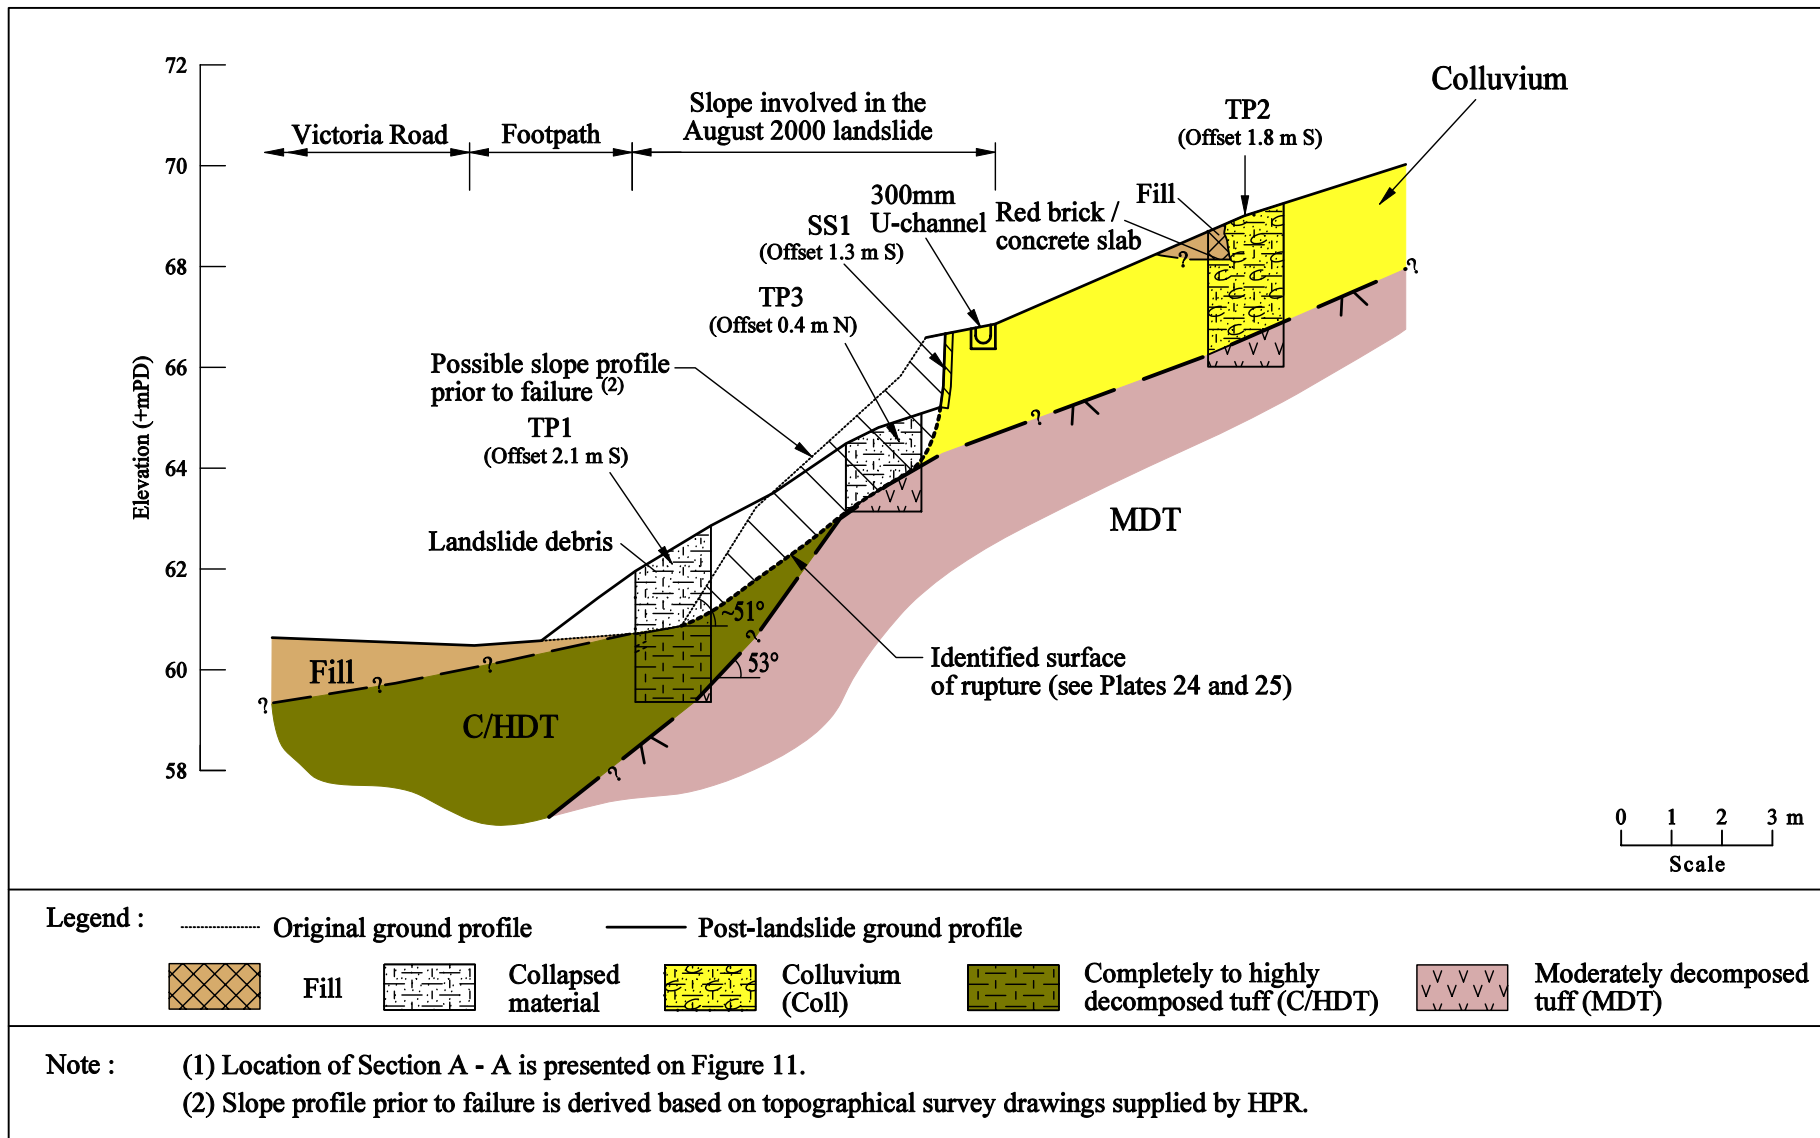
Figure 9 - Geological Section A - A through the Landslide

It is apparent that colluvium, up to 2 m thick, was present at the location of the 2002 landslide. The underlying solid geology at the landslide location was confirmed by ground investigation to be a fine ash tuff. The tuff is weathered more deeply at the location of the landslide than at the surrounding area, which is consistent with the geological setting that the failure location is in the vicinity of a natural drainage line. Geological Section A-A through the 2002 landslide is shown in Figure 9.

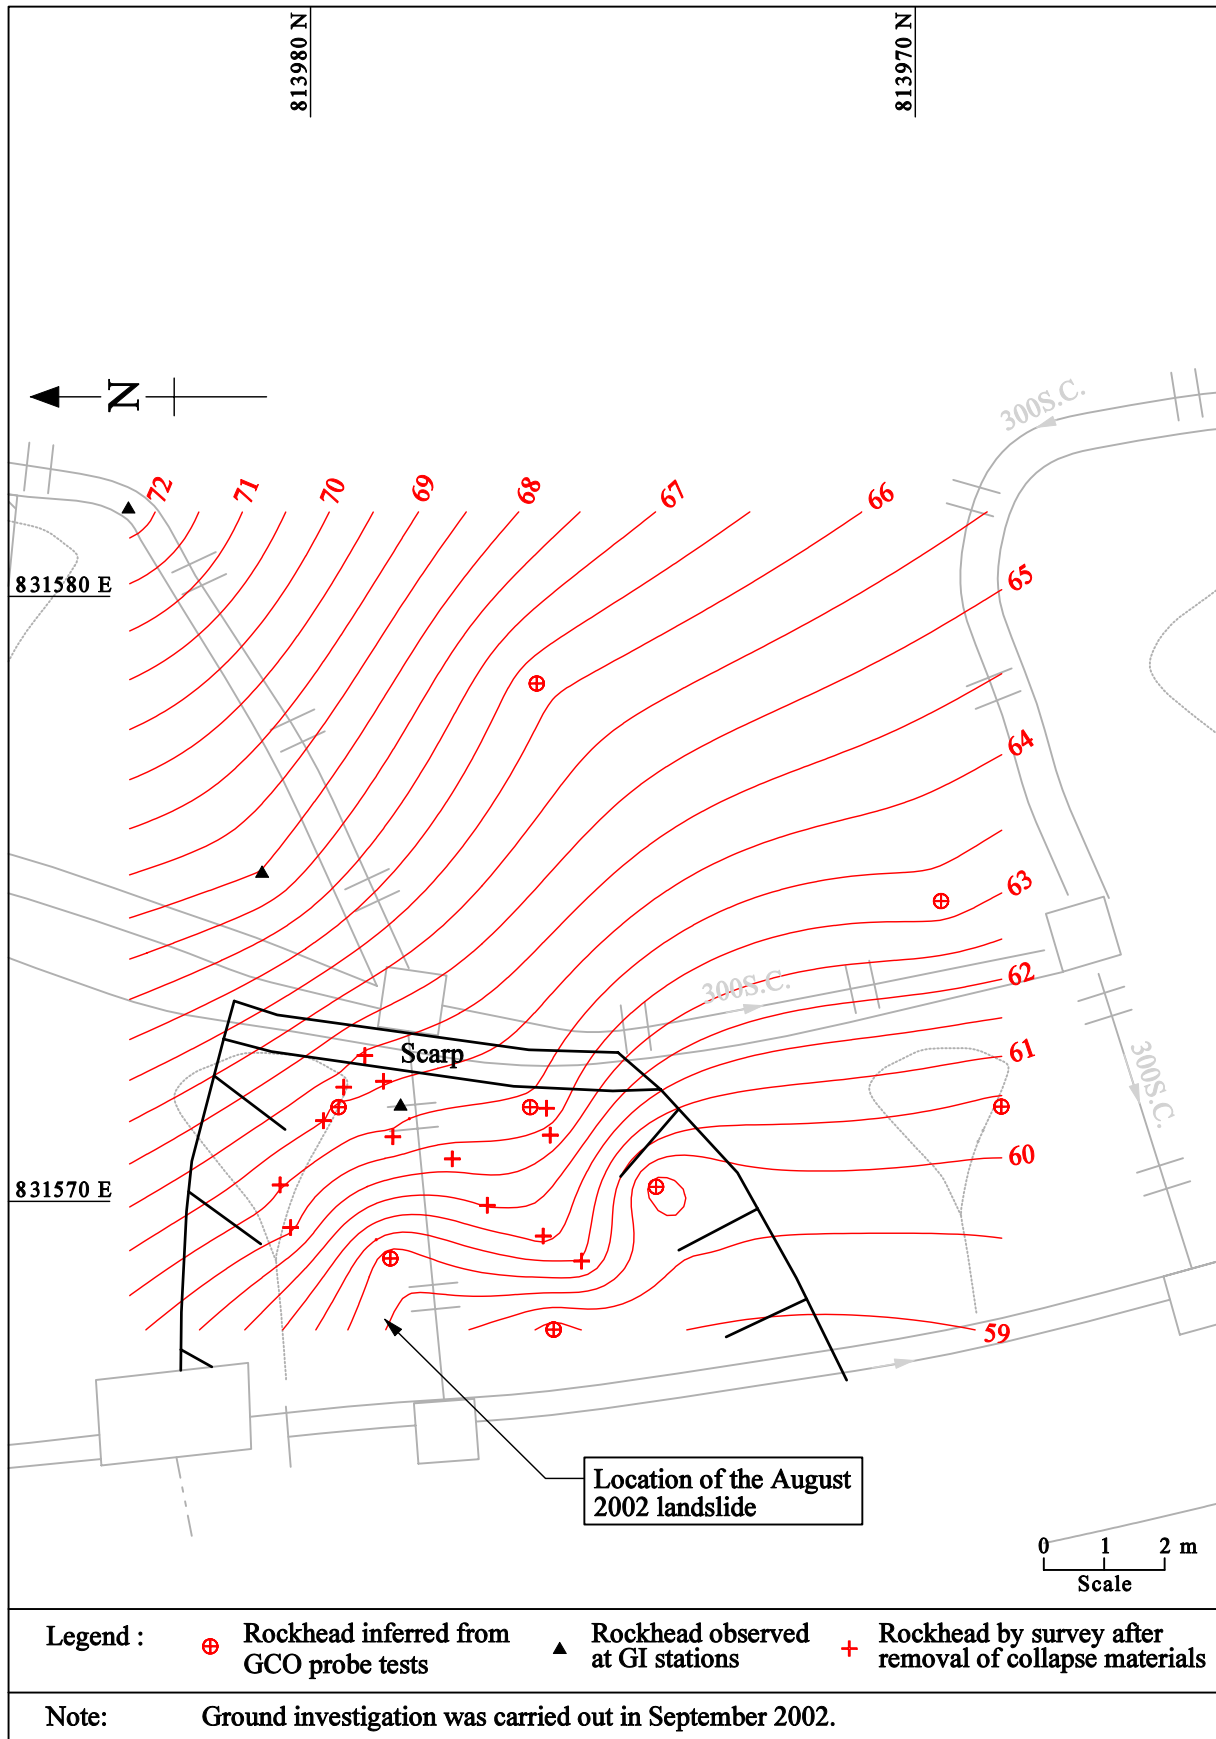
Figure 10 - Inferred Rockhead Contours at the Landslide Site

As part of the repair works to the failed slope, the landslide debris, together with the underlying CDV, was completely removed by the contractor and the rockhead was exposed. HCL carried out an inspection of the exposed rockhead surface (Plate 23) on 30 December 2002. The bedrock surface can be seen to be undulating and generally dipping towards the road at about 50° as depicted in Figure 9. A plot of rockhead contour based on various measurements taken from the rock exposed and from observations in trial pits (see Section 6) is presented in Figure 10.

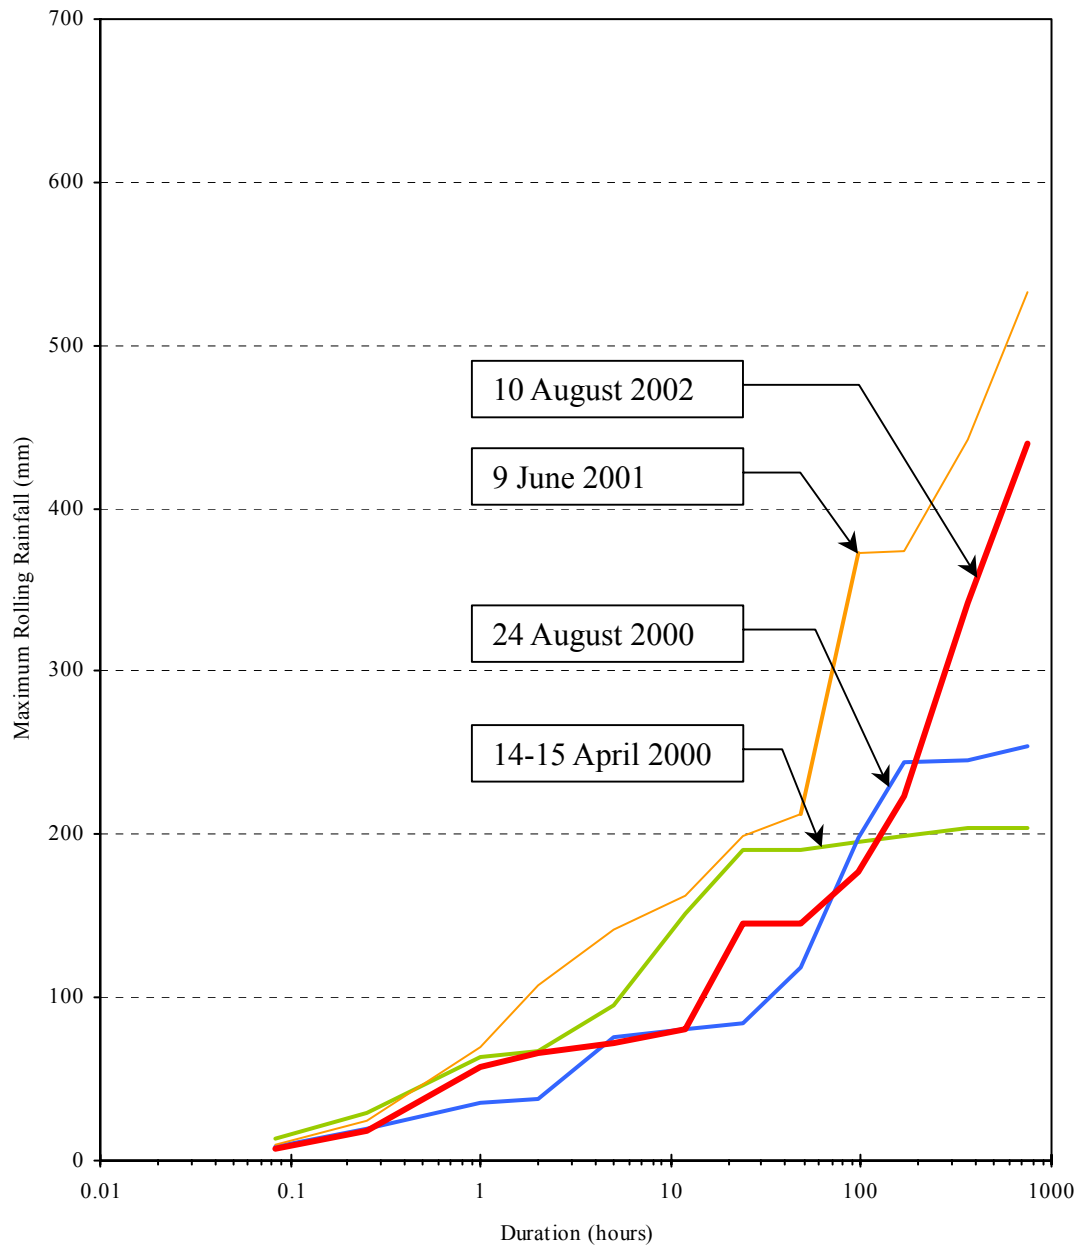
Figure 13 - Maximum Rolling Rainfall at GEO Raingauge No. H03 for Major Rainstorms between April 2000 and August 2002

A comparison of the maximum rolling rainfall of the 10 August 2002 rainstorm with that of the past major rainstorms recorded by the raingauge No. H03 after the completion of the subject slope formations works in May 2000 (Figure 13). It is noted that the 10 August 2002 rainstorm was not the most critical rainstorm experienced by the subject slope after the completion of slope formation works in May 2000. The rainstorm on 9 July 2001 was more severe than that of the 10 August 2002 rainstorm for all durations considered (viz. 5 minutes to 31 days).

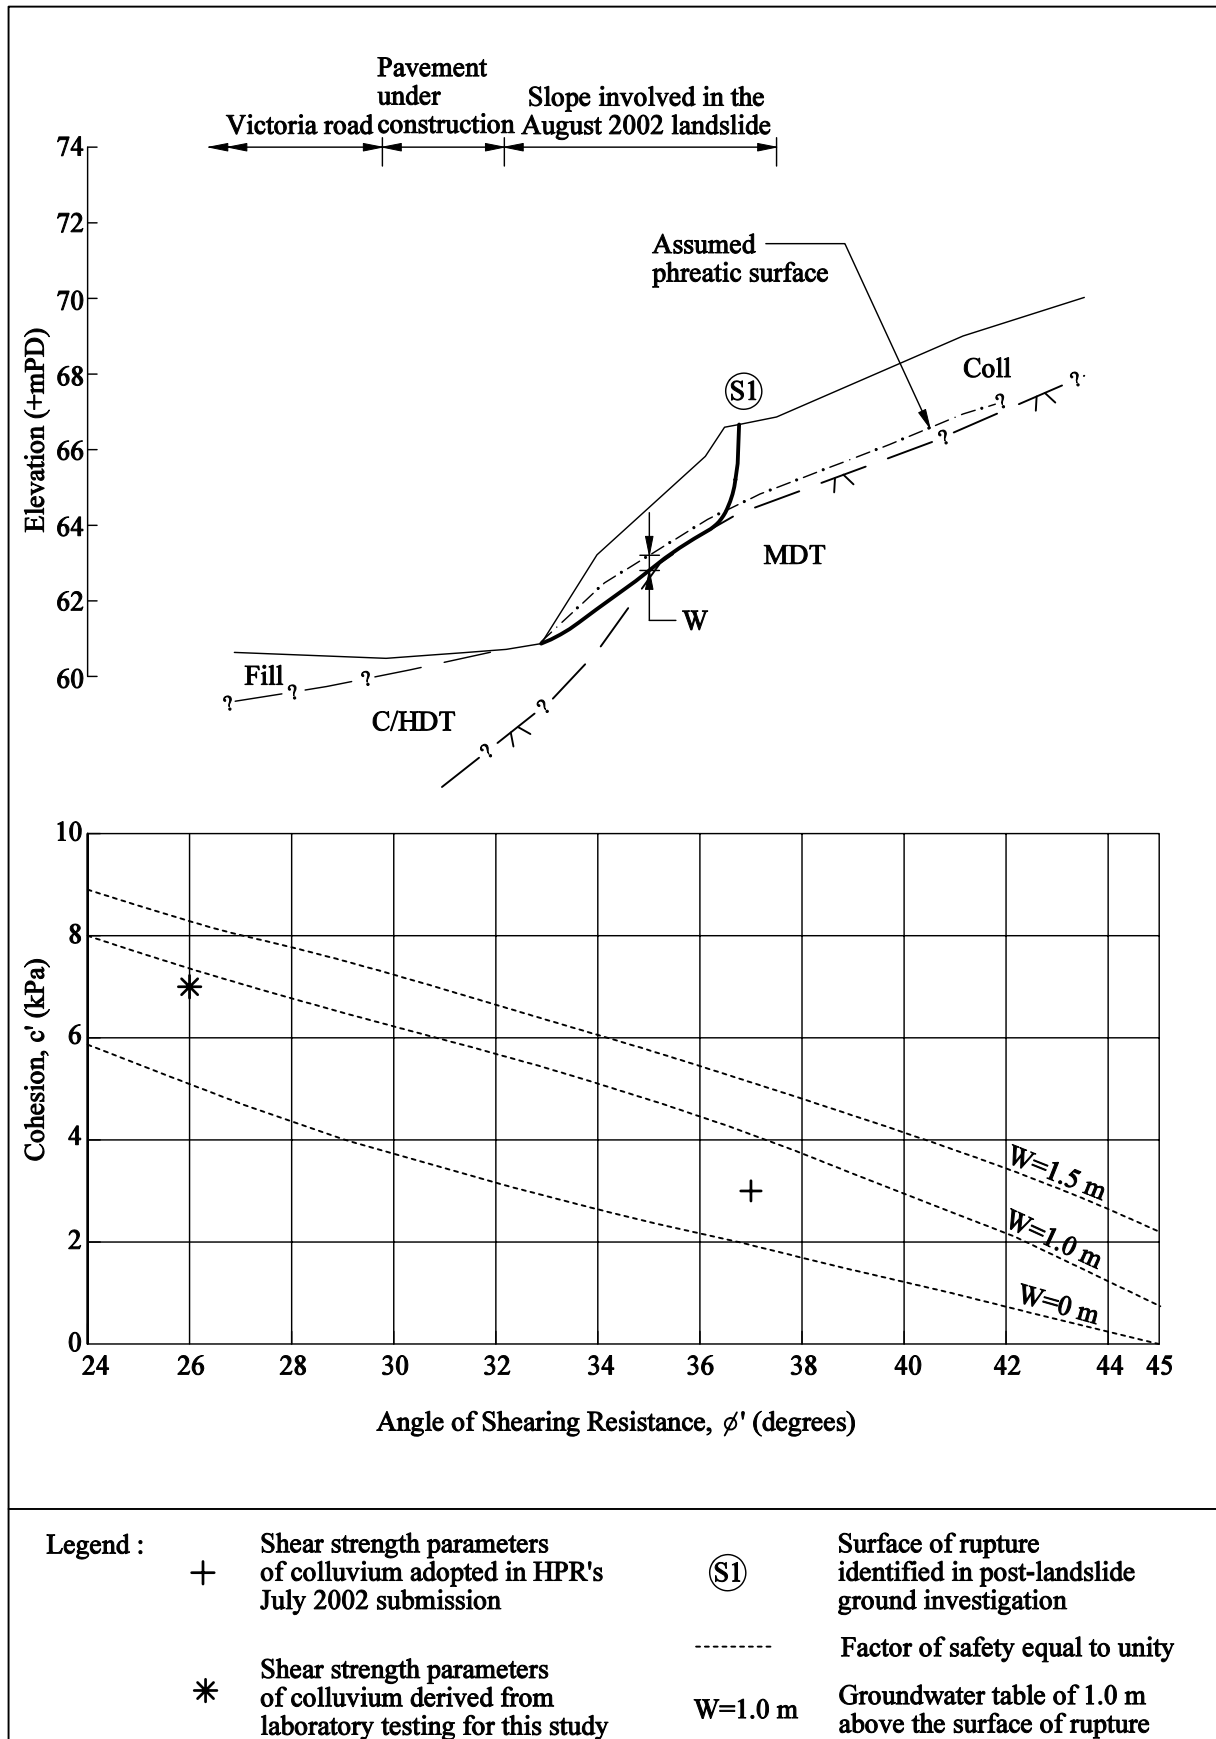
Figure 14 - Summary of Sensitivity Analyses

The results of the analyses are presented in Figure 14 in the form of c' versus ϕ' for different water levels above the surface of rupture. The shear strength parameters for colluvium adopted in HPR's interpretative report in 1997 are also indicated in Figure 14. The results of the stability analyses revealed that with HPR's design parameters, the development of a transient water pressure corresponding to a water level of 1.0 m above the

surface of rupture would have been sufficient to initiate slope failure.

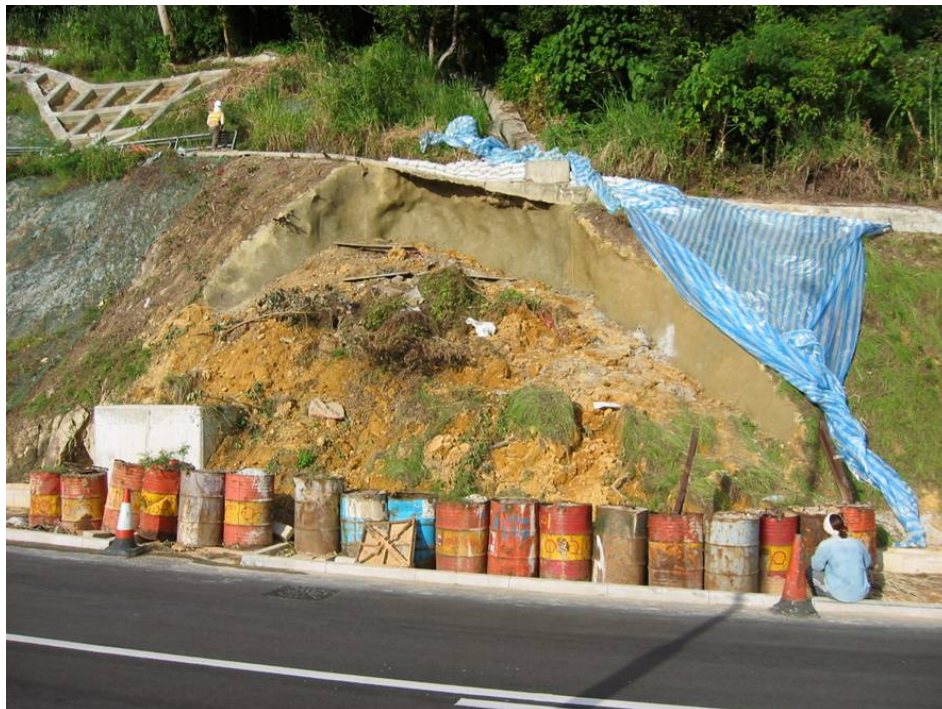
Plate 2 - View of the Failed Portion of the Subject Slope
(Photograph taken on 16 August 2002)

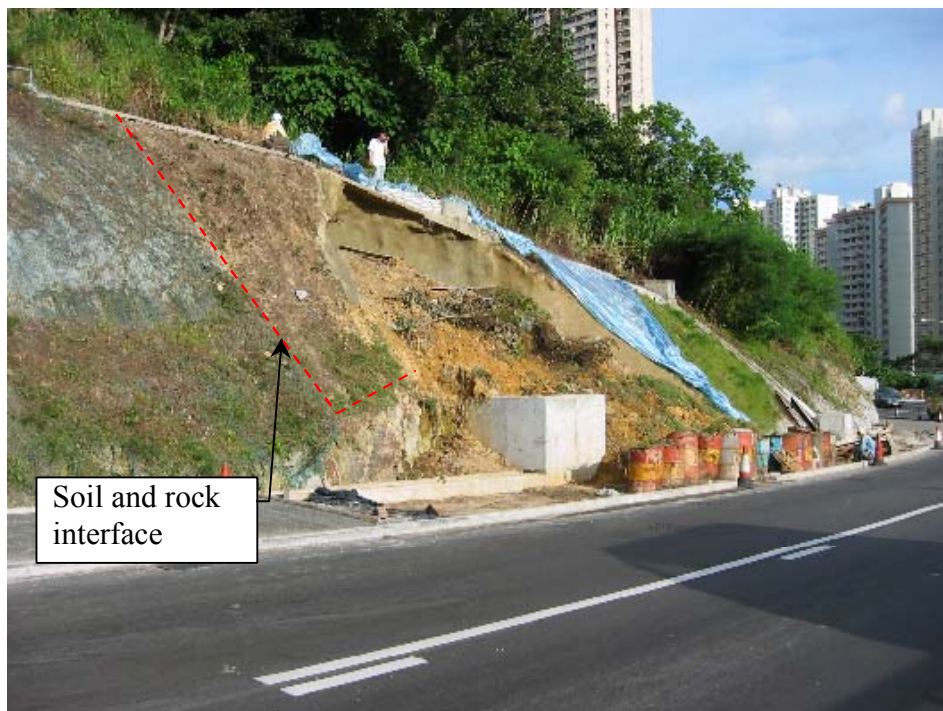
Plate 4 - Interface between Soil and Rock about 3 m to the North of the Landslide
(Photograph taken on 16 August 2002)

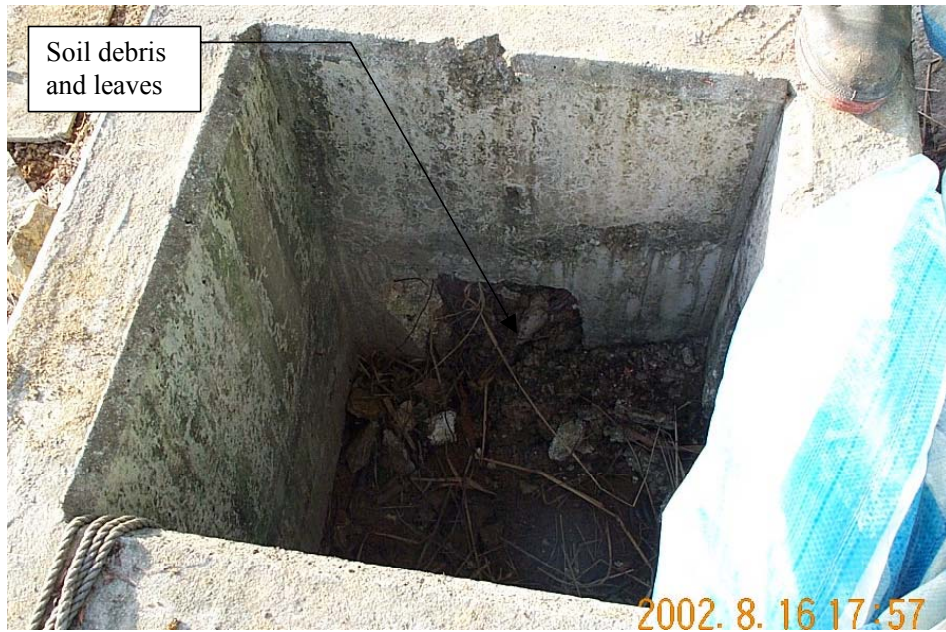
Plate 5 - View of the Catchpit above the 2002 Landslide
(Photograph taken on 16 August 2002)

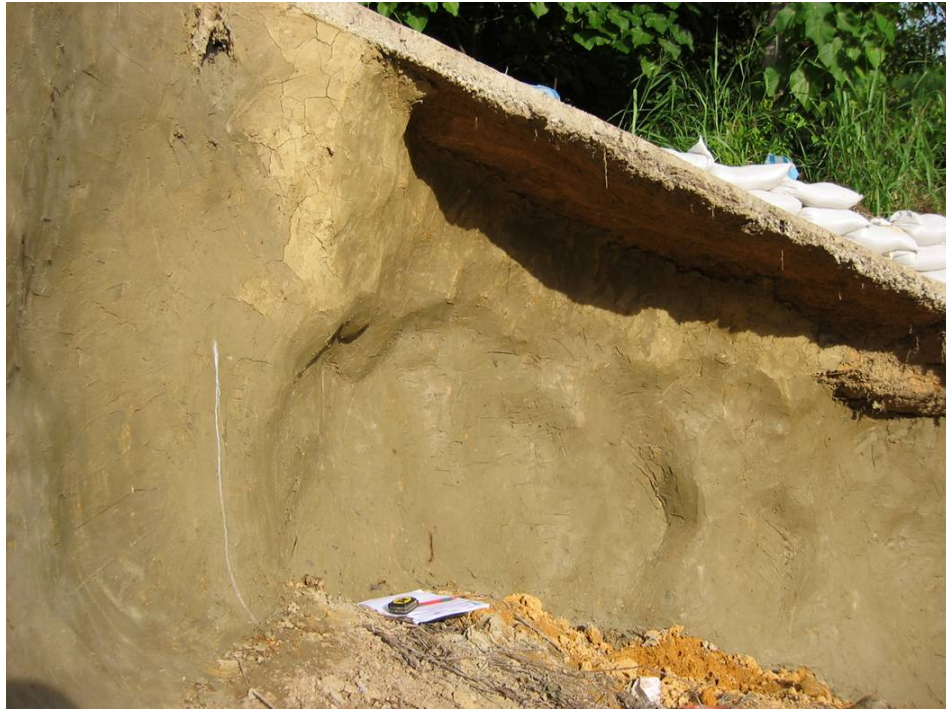
Plate 7 - Back Scarp (Covered with Cement Mortar) and Undercut Concrete Berm
(Photograph taken on 16 August 2002)

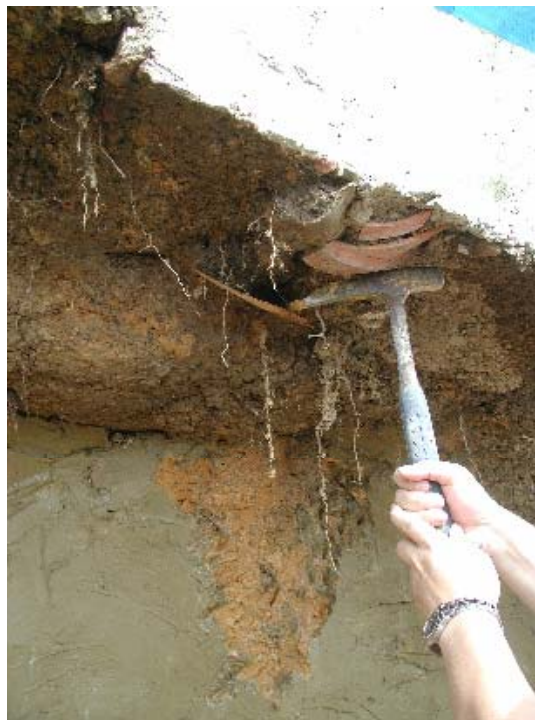
Plate 8 - Broken Ceramic Pipes and Pieces of Plastic beneath the Concrete Berm
(Photograph taken on 19 August 2002)

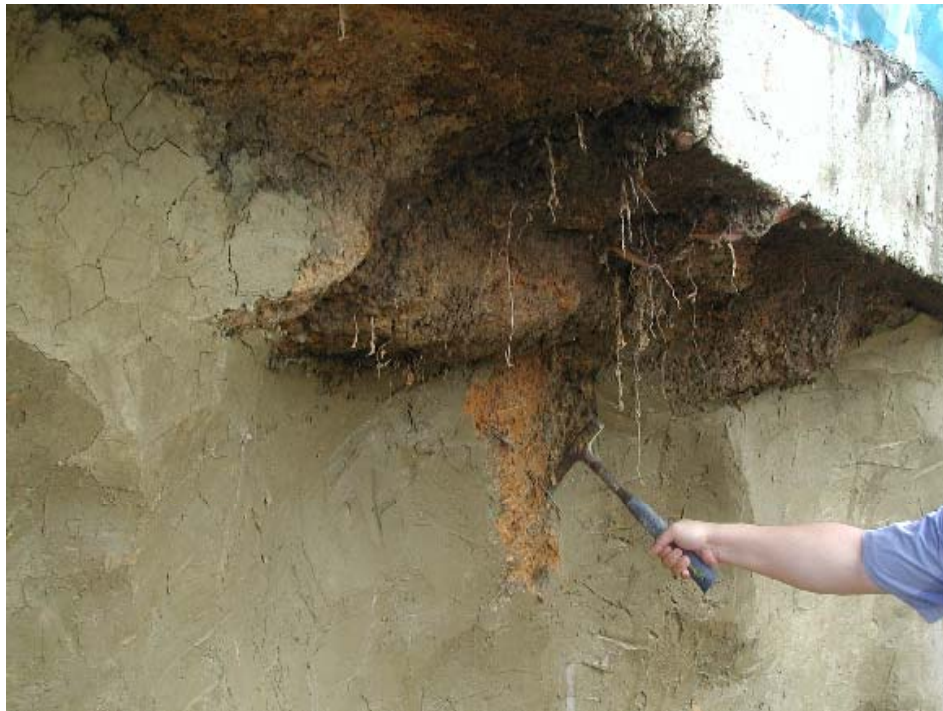
Plate 9 - Slight Seepage from Soil Surface in the Scarp
(Photograph taken on 19 August 2002)

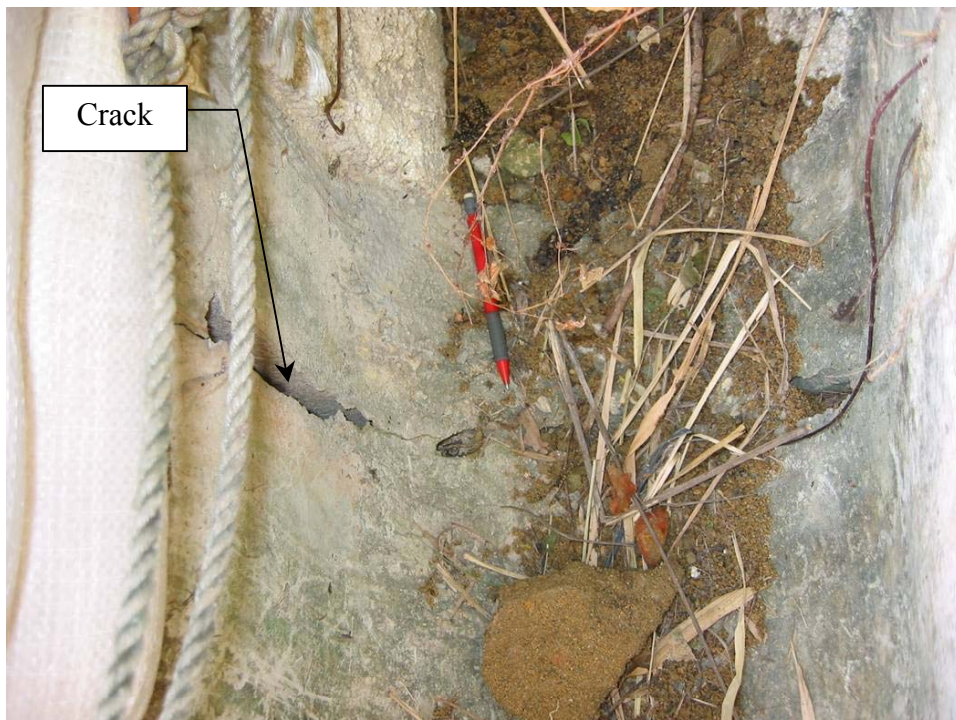
Plate 10 - Cracks up to 30 mm Wide along Construction Joints
(Photograph taken on 16 August 2002)

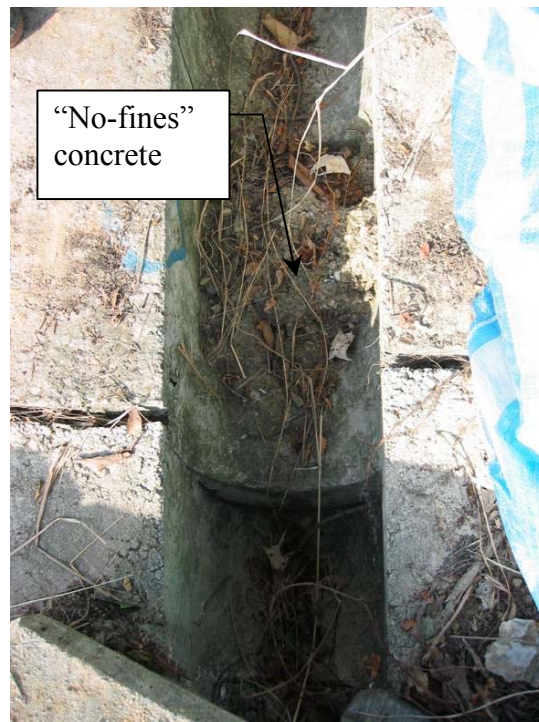
Plate 11 - "No-fines" Concrete in Stepped Channel (Photograph taken on 16 August 2002)

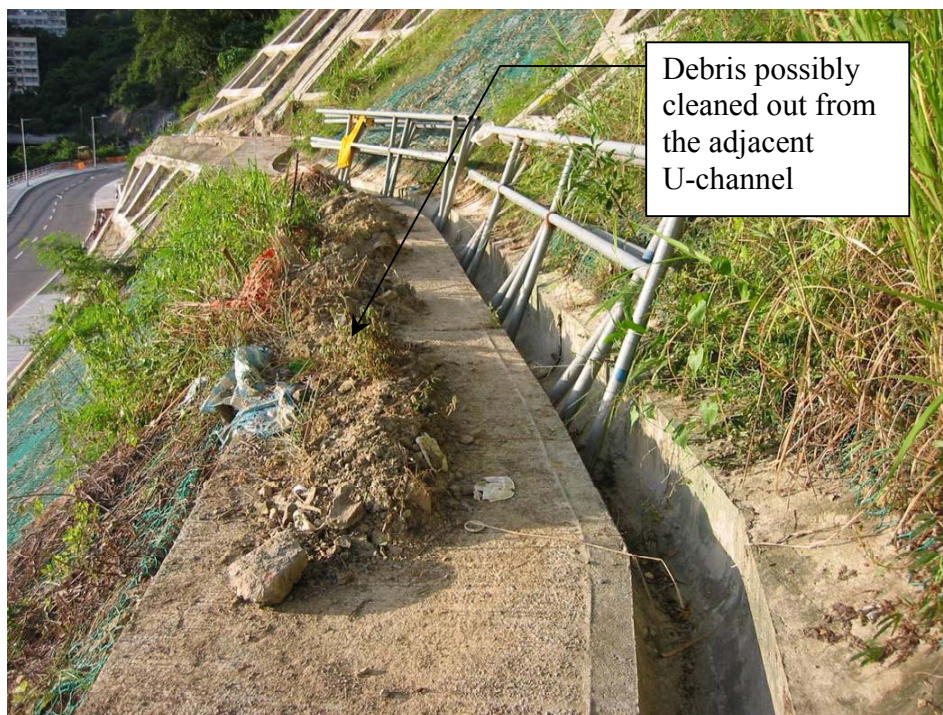
Plate 12 - Debris on the Concrete Berm (Photograph taken on 16 August 2002)

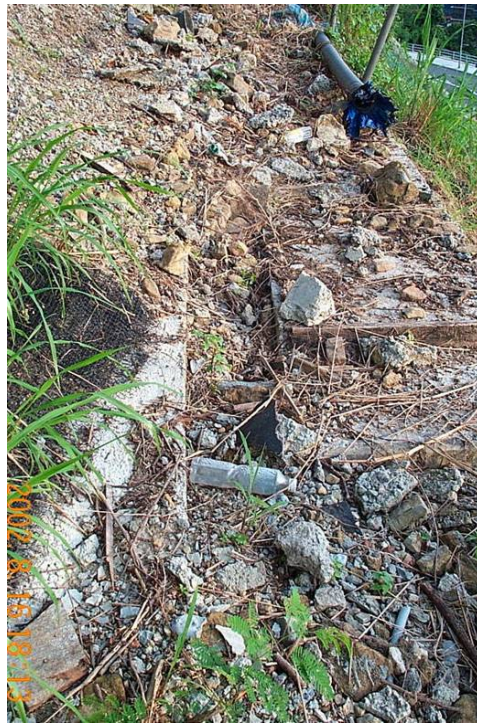
Plate 13 - Construction Waste Blocking a U-channel along the Second Berm
(Photograph taken on 16 August 2002)

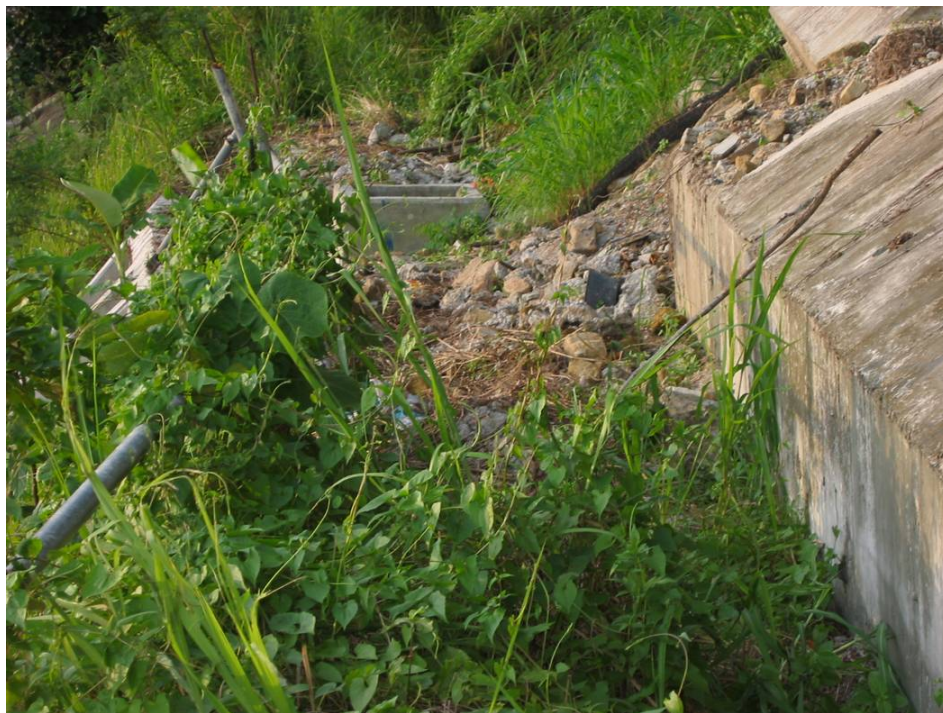
Plate 14 - View of the Blocked U-channel along the Second Berm
(Photograph taken on 16 August 2002)
