**DETAILED STUDY OF
THE 10 AUGUST 2002
LANDSLIDE INCIDENT
ON A CUT SLOPE AT
VICTORIA ROAD, HONG KONG**

GEO REPORT No. 158

Halcrow China Limited

**GEOTECHNICAL ENGINEERING OFFICE
CIVIL ENGINEERING AND DEVELOPMENT DEPARTMENT
THE GOVERNMENT OF THE HONG KONG
SPECIAL ADMINISTRATIVE REGION**

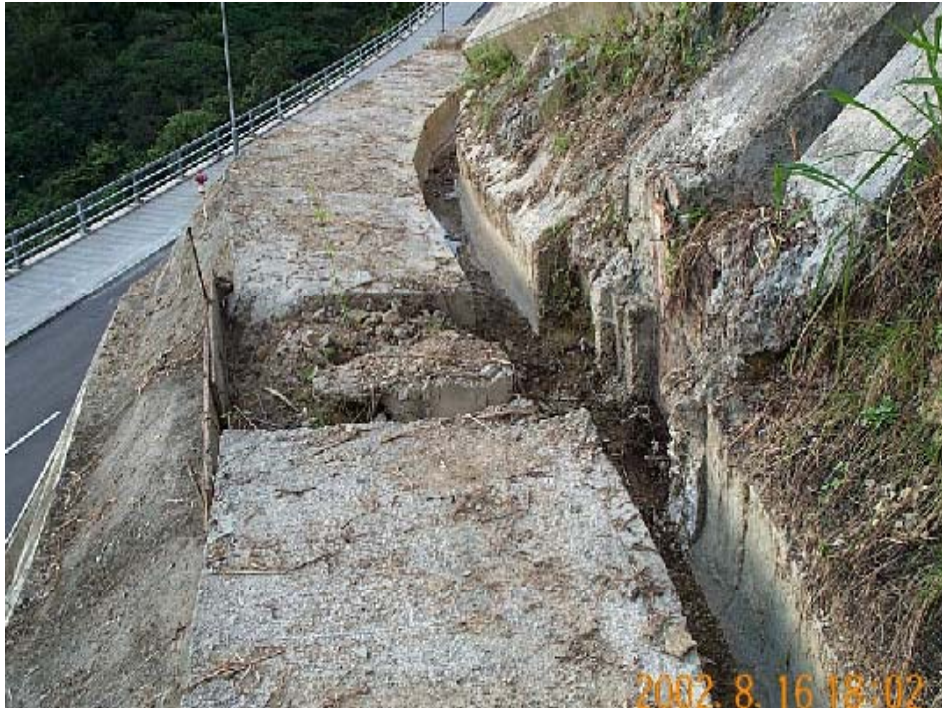
Plate 15 - Catchpit Yet to be Constructed on the First Berm
(Photograph taken on 16 August 2002)

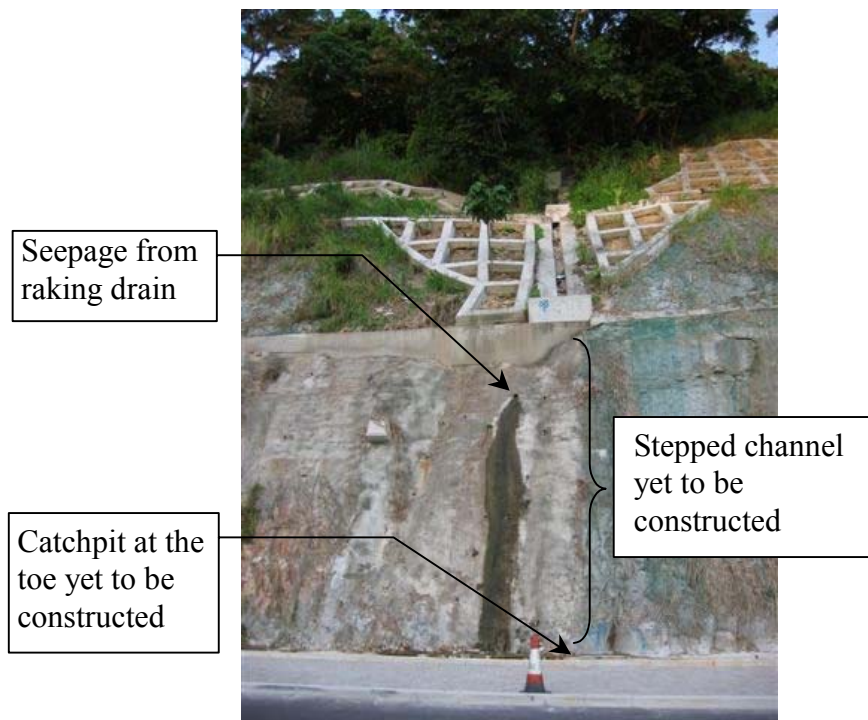
During the field inspection by HCL in August and September 2002, seepage was observed at several locations at the lowest batter of the subject slope (Figure 8 and Plates 16 and 17).

Plate 16 - Seepage from a 80 mm Diameter Raking Drain in the First Batter
(Photograph taken on 16 August 2002)

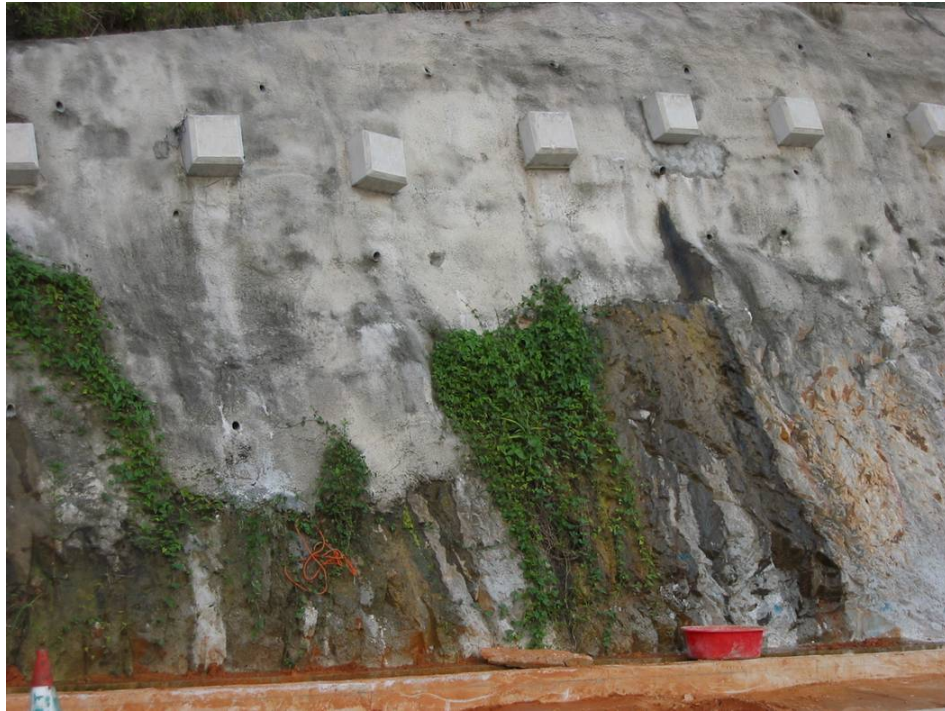
Plate 17 - Extensive Seepage below Shotcrete and above Exposed Rock
(Photograph taken on 16 August 2002)

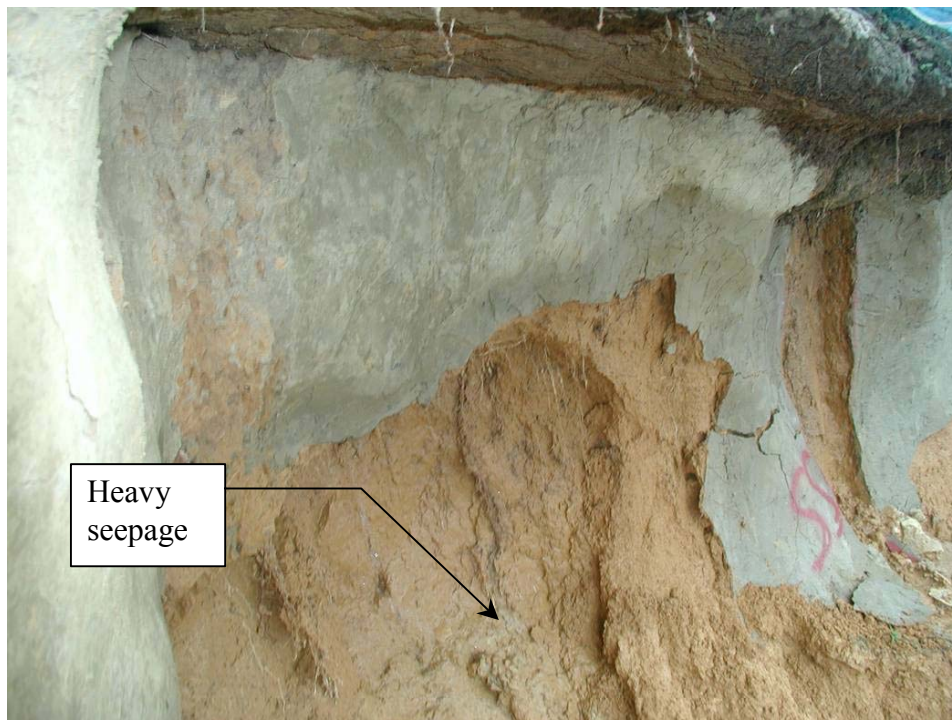
During rainstorms on 16 and 17 September 2002, field inspections were carried out by HCL. A heavy constant seepage of water was observed, at about 1 m below the crest of the main scarp, emerging from between the cement mortar applied to the scarp and the newly exposed soil (Plate 20). Surface water carried by the U-channel was also observed to be overtopping the first berm at about 20 m to the north of the 2002 landslide location during a rainstorm on 17 September 2002 (Plate 21).

Plate 20 - Heavy Seepage from Soil below Cement Mortar Cover during a Rainstorm
(Photograph taken on 16 September 2002)

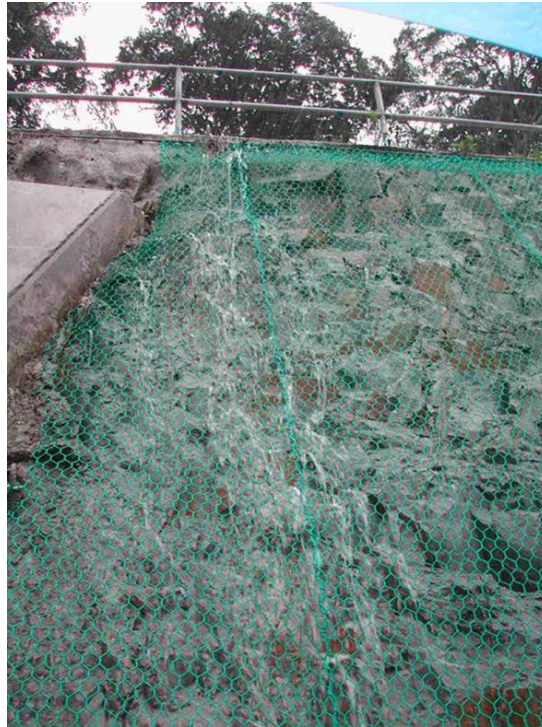
Plate 21 - Water Over-topping the First Berm during a Rainstorm
(Photograph taken on 17 September 2002)

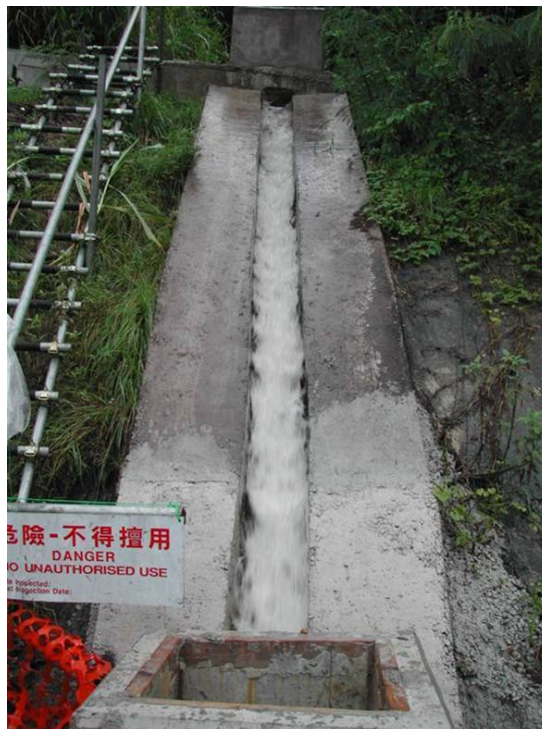
Plate 22 - Heavy Flow of Water in the Stepped Channel to the South of the 2002
Landslide during a Rainstorm (Photograph taken on 17 September 2002)

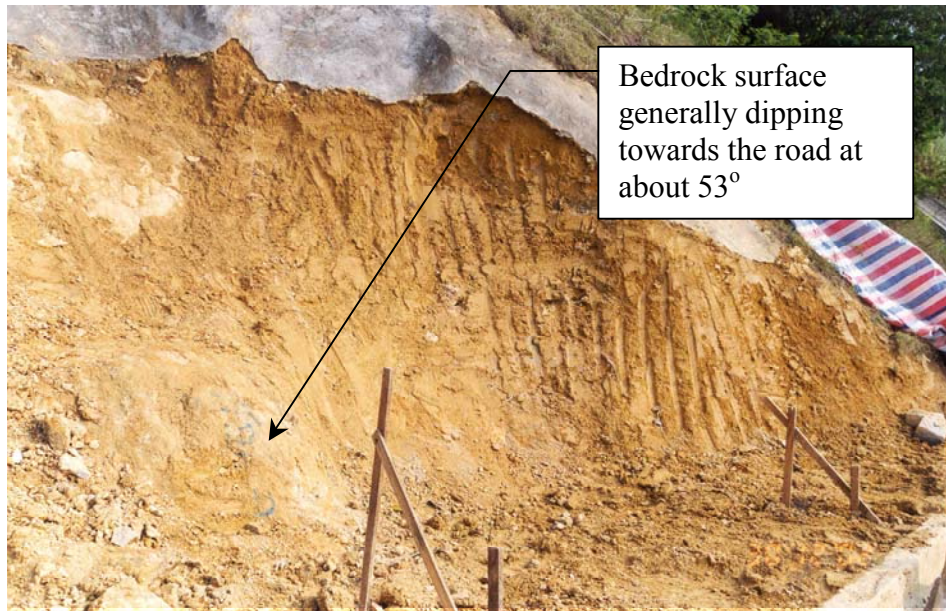
As part of the repair works to the failed slope, the landslide debris, together with the underlying CDV, was completely removed by the contractor and the rockhead was exposed. HCL carried out an inspection of the exposed rockhead surface (Plate 23) on 30 December 2002. The bedrock surface can be seen to be undulating and generally dipping towards the road at about 50° as depicted in Figure 9. A plot of rockhead contour based on various measurements taken from the rock exposed and from observations in trial pits (see Section 6) is presented in Figure 10.

Plate 23 - View of the Landslide Area after Removal of Debris
(Photograph taken on 30 December 2002)

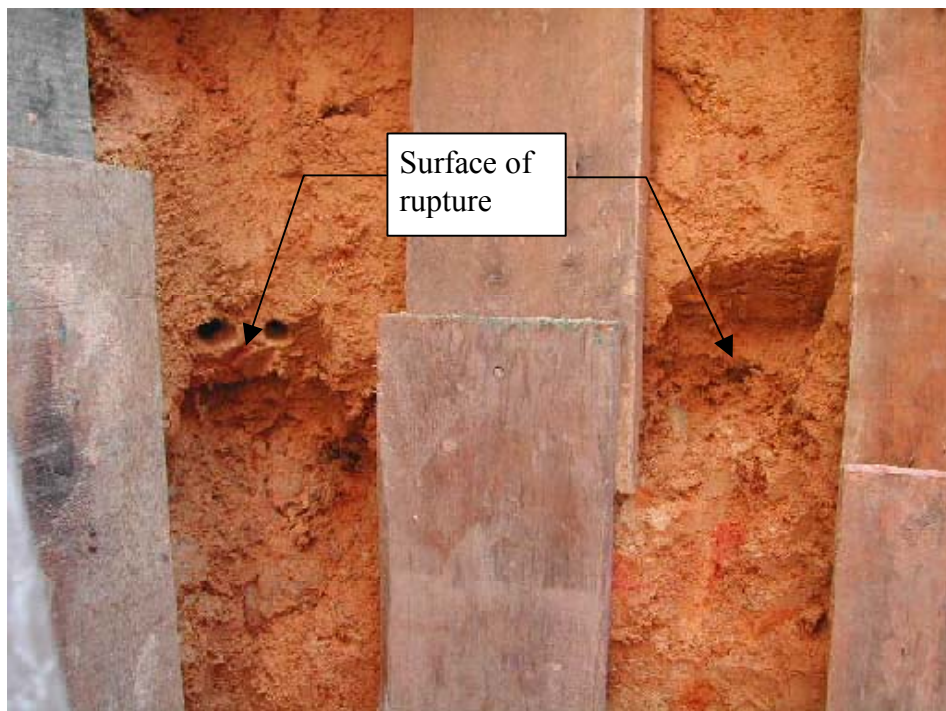
The surface of rupture was marked by the presence of a thin layer of very soft, light reddish brown, slightly sandy silty clay that ran predominantly along the interface between

the colluvium and in-situ weathered tuff, as observed in trial pit Nos. TP1 (Plate 24) and TP3 (Plate 25), and partly within the colluvium as observed in trial pit No. TP4.

Plate 24 - Surface of Rupture at Interface between Colluvium and CDT in Trial Pit No. TP1
(Photograph taken on 5 September 2002)

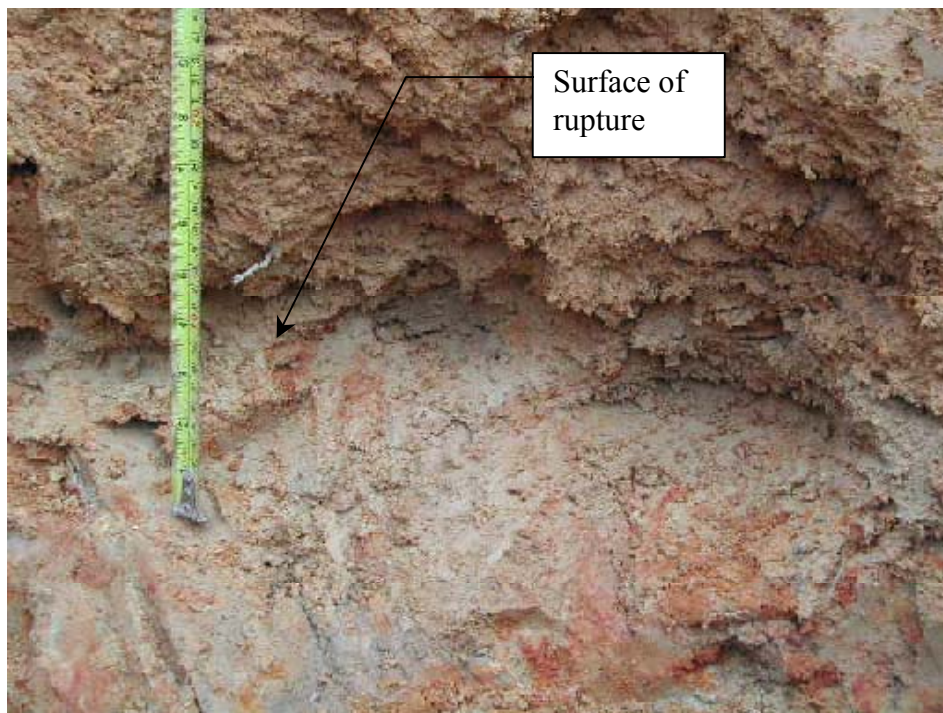
Plate 25 - Surface of Rupture at Interface between Colluvium and H/MDT in Trial Pit No. TP3
(Photograph taken on 5 September 2002)

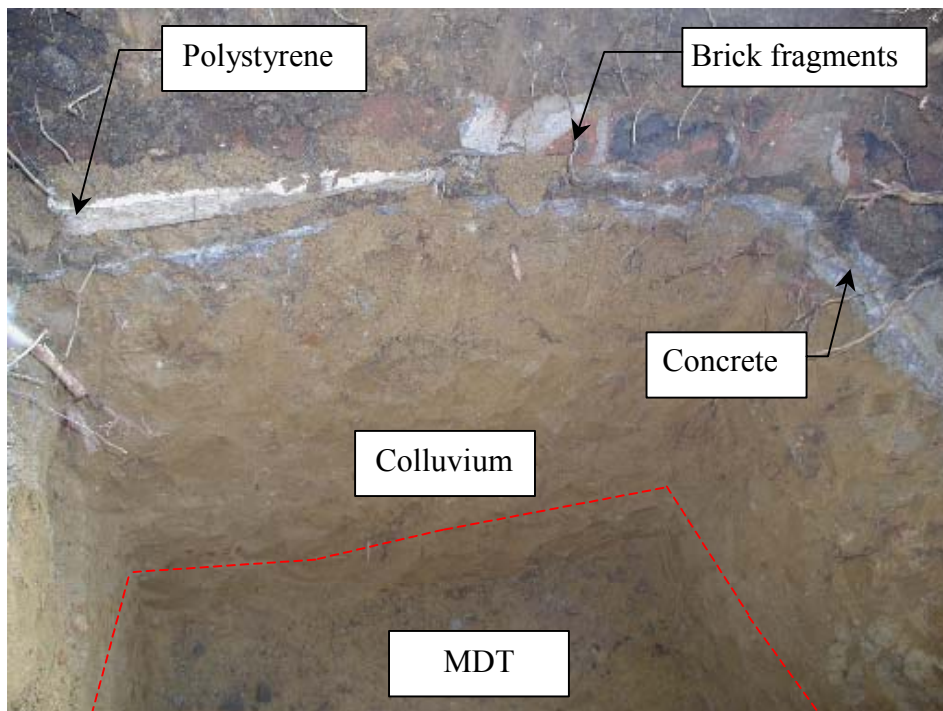
To the east (uphill) of the scarp outside the landslide site (trial pit No. TP2), colluvium was found to be overlain by localised fill of about 0.5 m thick (Plate 26), which may be the remains of the single-storey squatter hut identified in the 1983 aerial photographs (see Section 2.5 and Appendix A). The colluvium exposed in trial pit No. TP2 comprised stiff, light reddish brown slightly sandy silty clay with occasional cobbles and boulders of HDT and some roots, with a maximum thickness of about 2.5 m. As indicated in slope strip No. SS2 to the north of trial pit No. TP2, MDT was observed (Plate 27) to be directly below the fill (Appendix B).

Plate 26 - Fill Containing Brick Fragments, Concrete and Polystyrene Exposed in Trial Pit No. TP2
(Photograph taken on 5 September 2002)

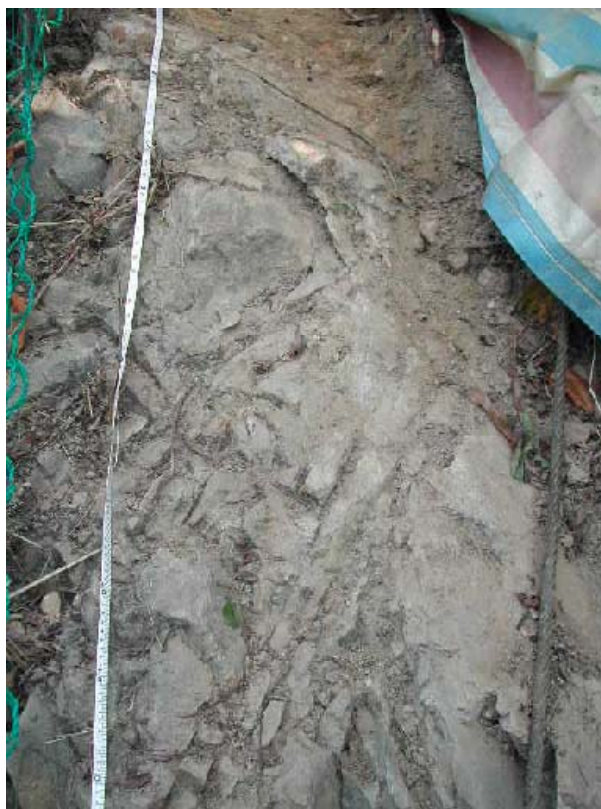
Plate 27 - Moderately Decomposed Tuff Exposed in Slope Strip No. SS2 between 1.4 m and 6.6 m (Photograph taken on 5 September 2002)

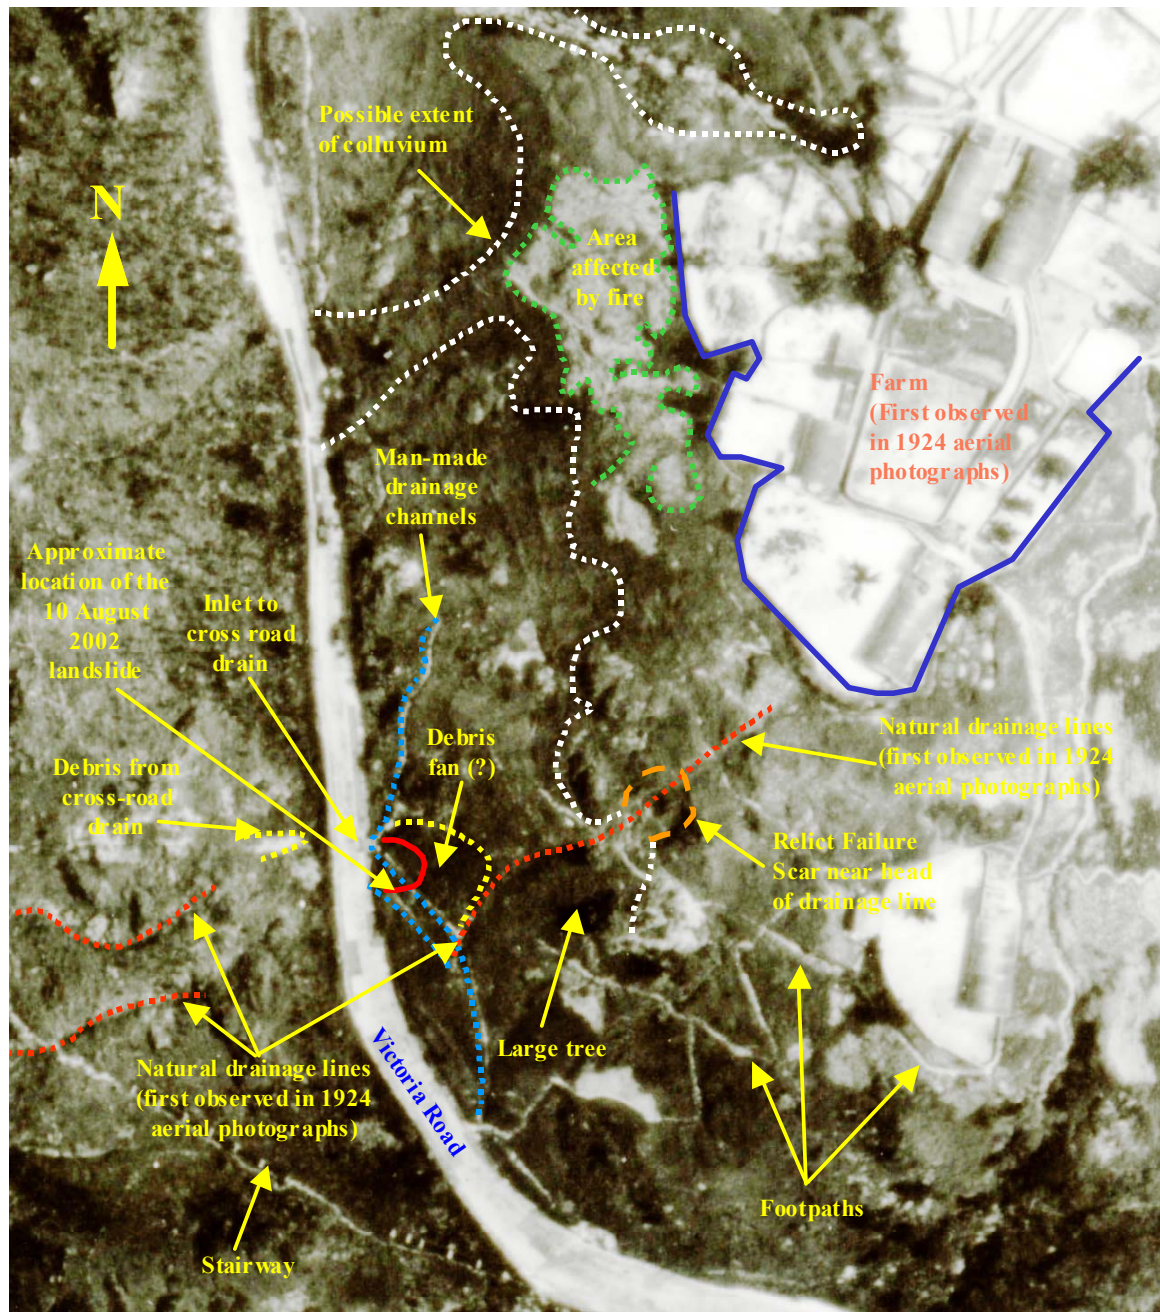
Plate A1 - Extract from 1949 Aerial Photograph (6010, 81A/127) 8600'

By 1949, two drainage channels directly above a roadside cut slope on the east side of the road are observed, with the channels appearing to drain towards and into an inlet pit at the approximate location of the 2002 landslide (Plate A1). The inlet pit on the eastern side of the road connects to a cross-road drain that outlets at the western side of the road and a possible debris fan is observed on the western side of the road at about the location of the probable cross-road drain outlet (Plate A1).

In the 1949 aerial photographs, a possible colluvial debris fan is observed at a location immediately above (east of) the 2002 landslide, which probably fans out from a natural drainage line about 10 m to 15 m to the south of the 2002 landslide (Plate A1).
