**DETAILED STUDY OF
THE 1 SEPTEMBER 2001
LANDSLIDE ON SLOPE
NO. 11NE-B/FR249 BELOW
NO. 56 DENON TERRACE,
TSENG LAN SHUE, SAI KUNG**

GEO REPORT No. 159

Maunsell Geotechnical Services Limited

**This report was originally produced in May 2003
as GEO Landslide Study Report No. LSR 3/2003**

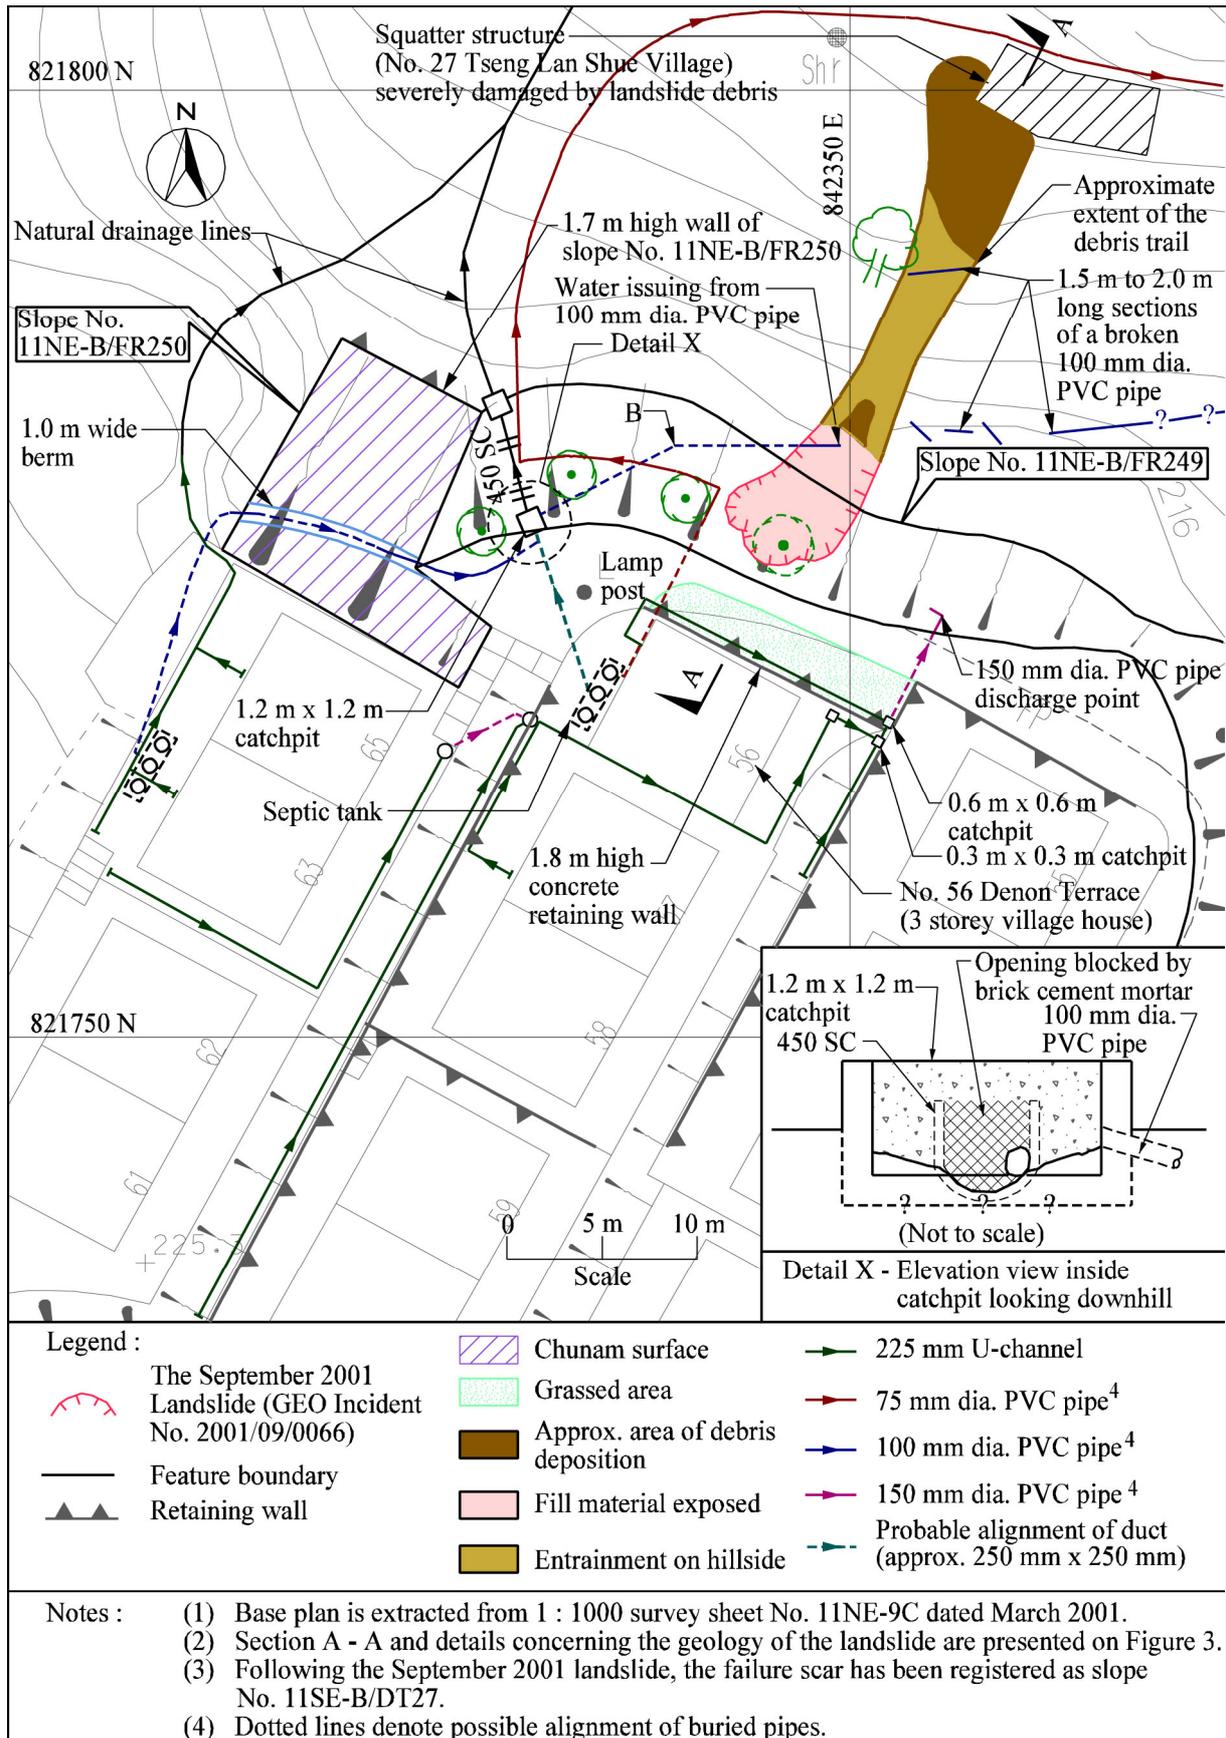
Figure 2 - Site Observations

The landslide occurred on a portion of slope No. 11NE-B/FR249 and the natural hillside below (Figure 2 and Plate 1). The landslide scar was found to be stepped, about 5 m wide by 12 m long (measured on the slope) with a maximum depth of about 1.5 m and comprising two individual (an upper and a lower) spoon-shaped scars of comparable size. The surface of rupture extended from the crest of slope No. 11NE-B/FR249 and went beyond its toe by about 2 m into the densely vegetated natural hillside below, which is inclined at about 30°. The main scarp of the landslide was inclined at about 60° to the horizontal and the materials exposed on the surface of rupture was fill and comprised generally orangish brown mottled grey sandy clayey silt with some fine to coarse gravel-sized rock fragments and rootlets (Plate 14).

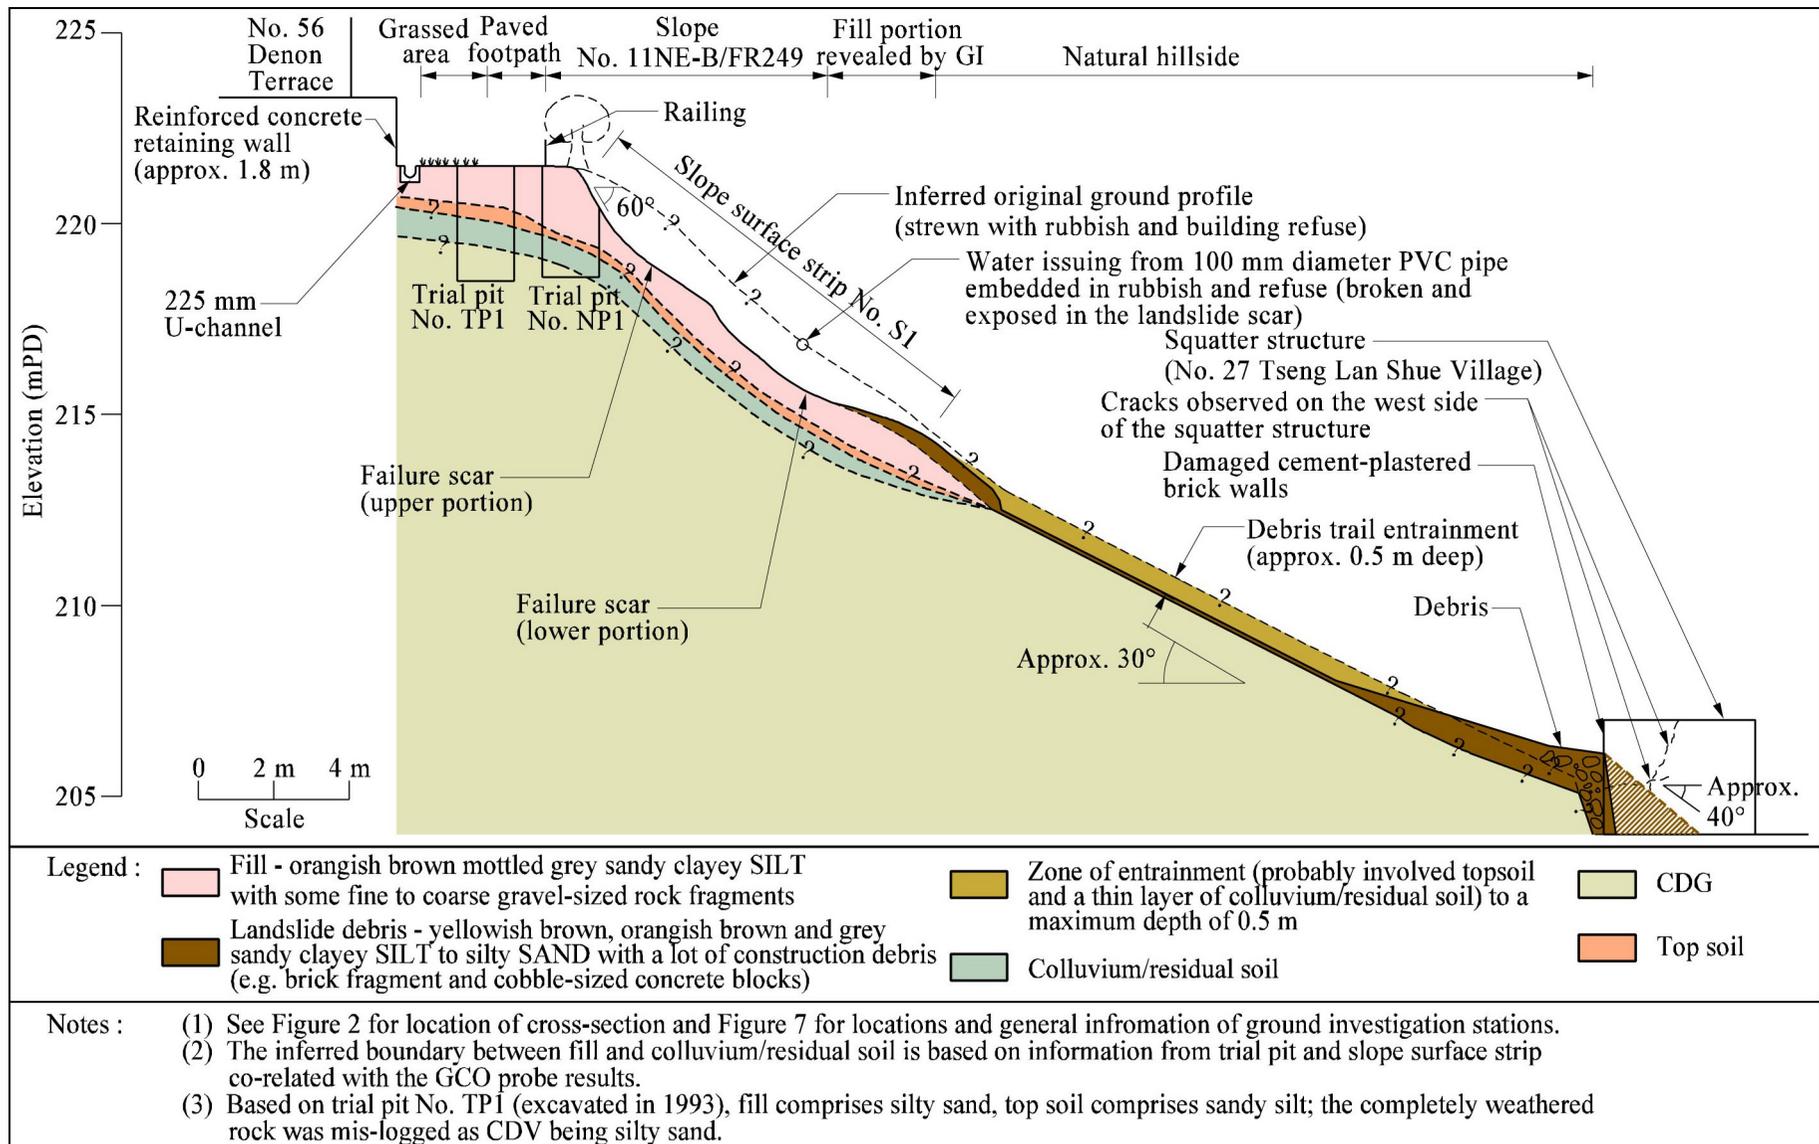
Figure 3 - Geological Section A - A through the Landslide

Based on the results of ground investigation and field mapping, the layer of fill overlying slope No. 11NE-B/FR249 extends at least 2 m below the toe of the 5 m high slope No. 11NE-B/FR249, into the natural hillside below (Figure 3). Taking into account also findings from API on the extent of the fill, the total height of the fill slope was about 9 m. The layer of fill was about 2 m in thickness and in general comprised (probably loose) orangish brown sandy clayey silt with some sub-angular fine to coarse gravel-sized rock fragments. A layer of old topsoil up to 200 mm thick, comprising medium dense greyish brown clayey silty fine to coarse sand, was present below the fill layer. A 0.6 m thick layer of residual soil and colluvium, comprising stiff to very stiff light brown clayey sandy silt, was present below the layer of topsoil. The underlying insitu material was found to be completely decomposed granite (CDG), which comprised extremely weak light yellow mottled red and white silty fine to coarse sand. A geological cross-section through the landslide site is shown in Figure 3.

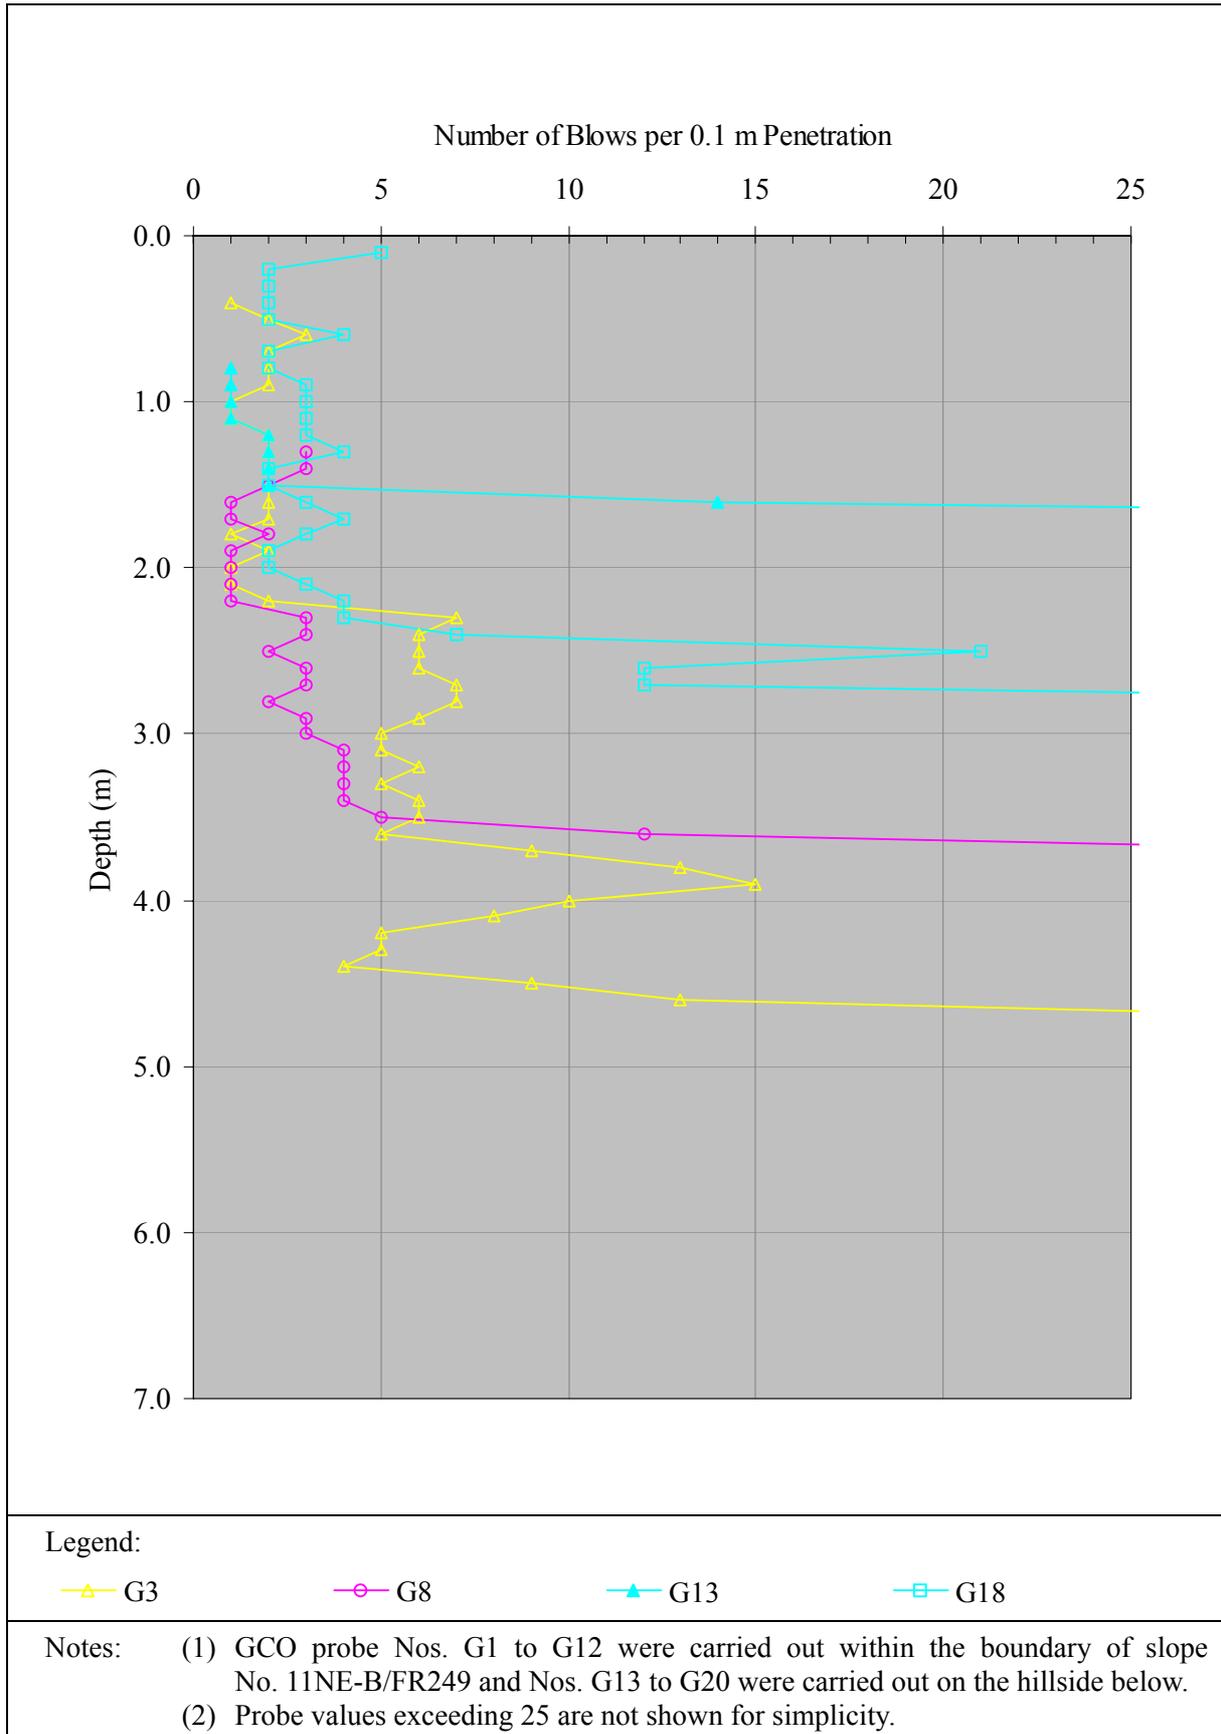
Figure 8 - Results of GCO Probe Tests Carried Out Inside the Landslide Scar

Most of the GCO probe values recorded within the top 2 m were between 0 and 5 blows (indicating the presence of probably loose material) and probe values exceeding 20 were generally recorded between 2 m and 4 m below ground surface (Figures 8 and 9). The results of GCO probe tests carried out on slope No. 11NE-B/FR249 do not show much difference from those obtained from tests conducted on the natural hillside below. In summary, the GCO probe test results indicate that the fill of the slope adjacent to the landslide scar was generally loose.

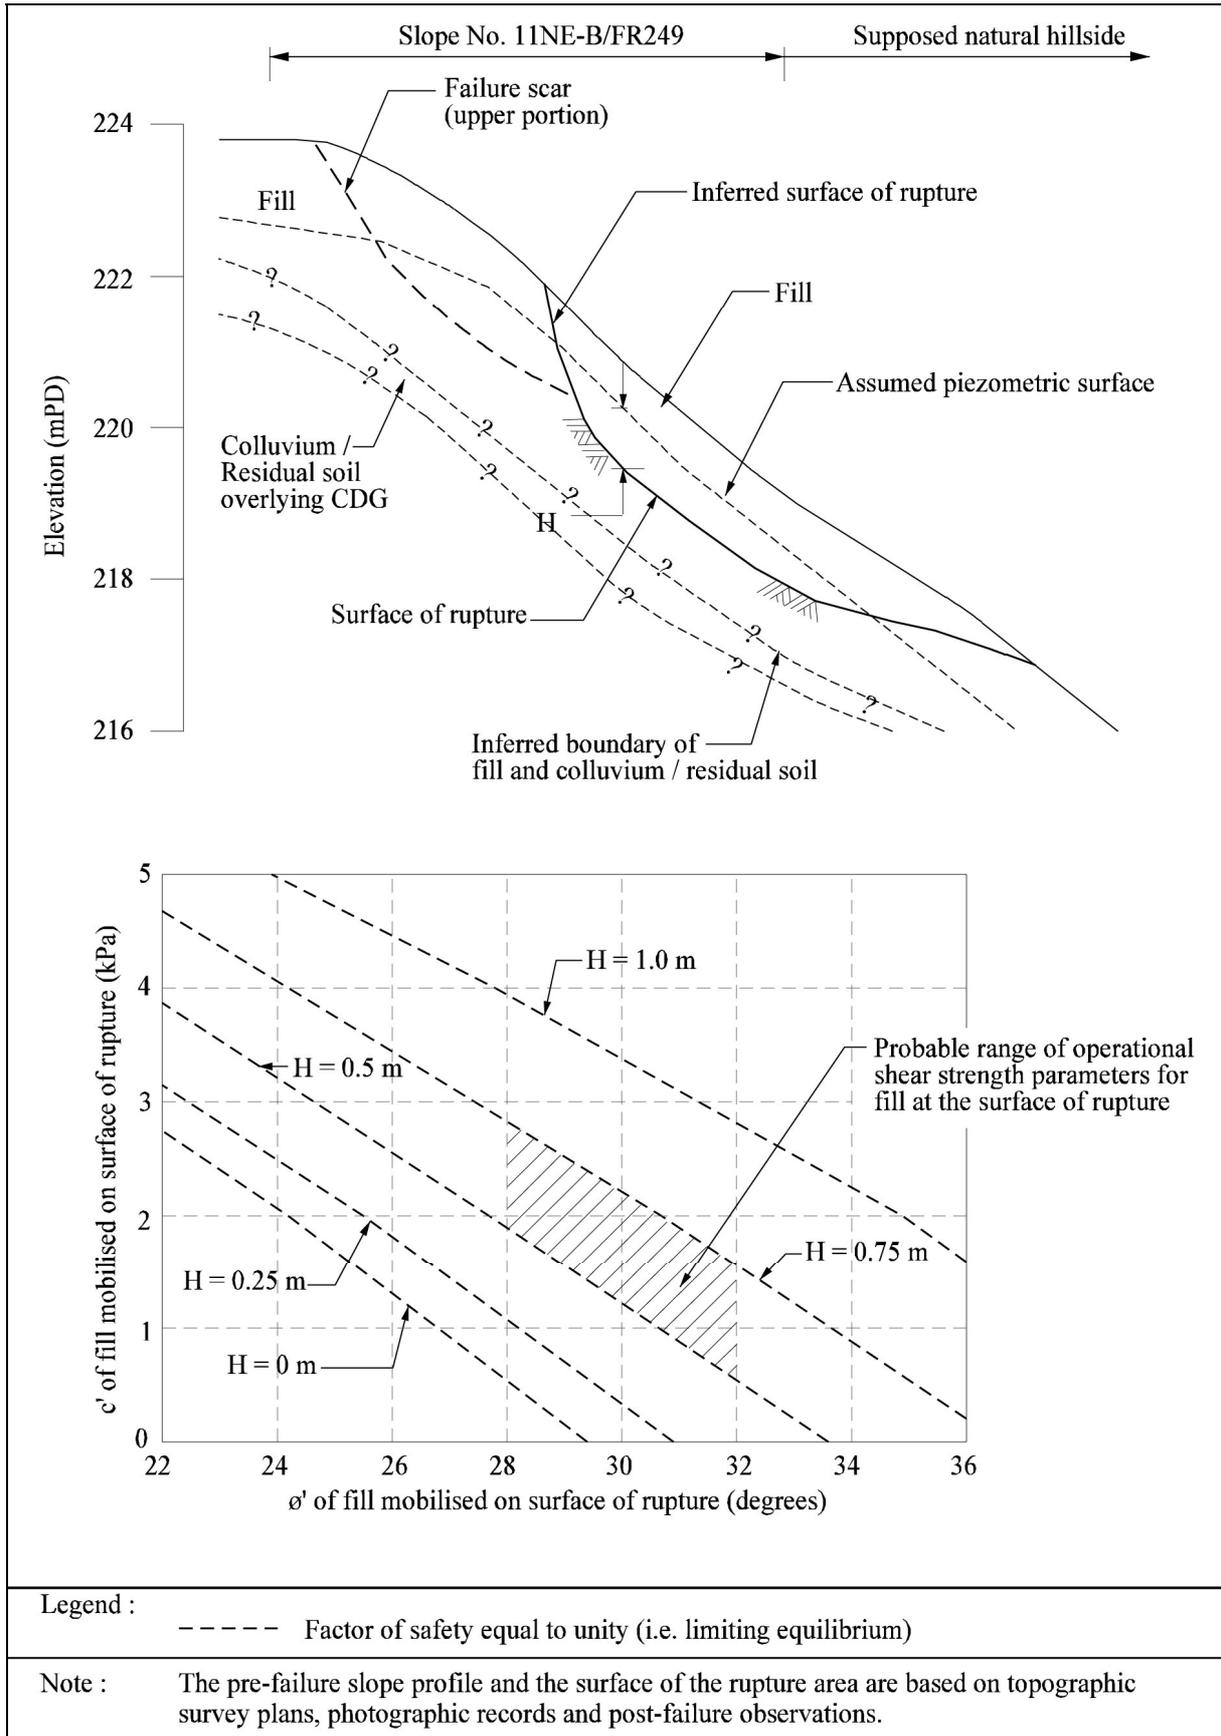
Figure 12 - Summary of Sensitivity Analyses

The results of the analyses are presented in Figure 12. These indicate that the development of a transient groundwater pressure corresponding to a piezometric level of about 0.5 m above the surface of rupture would have been sufficient to initiate failure in the slope.

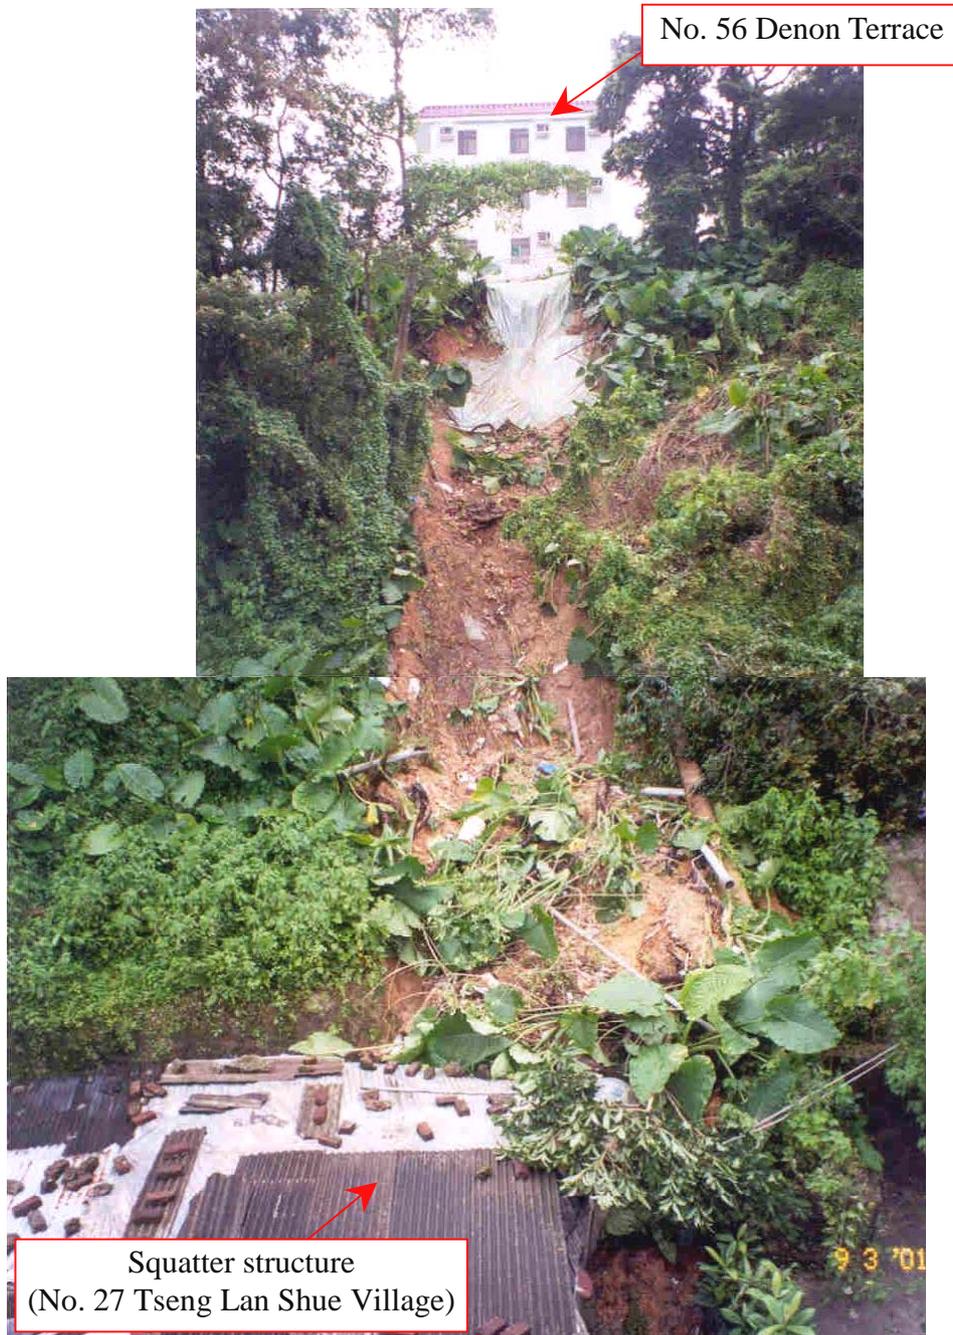
Plate 1 - General View of the Landslide Site (Photograph taken on 3 September 2001)

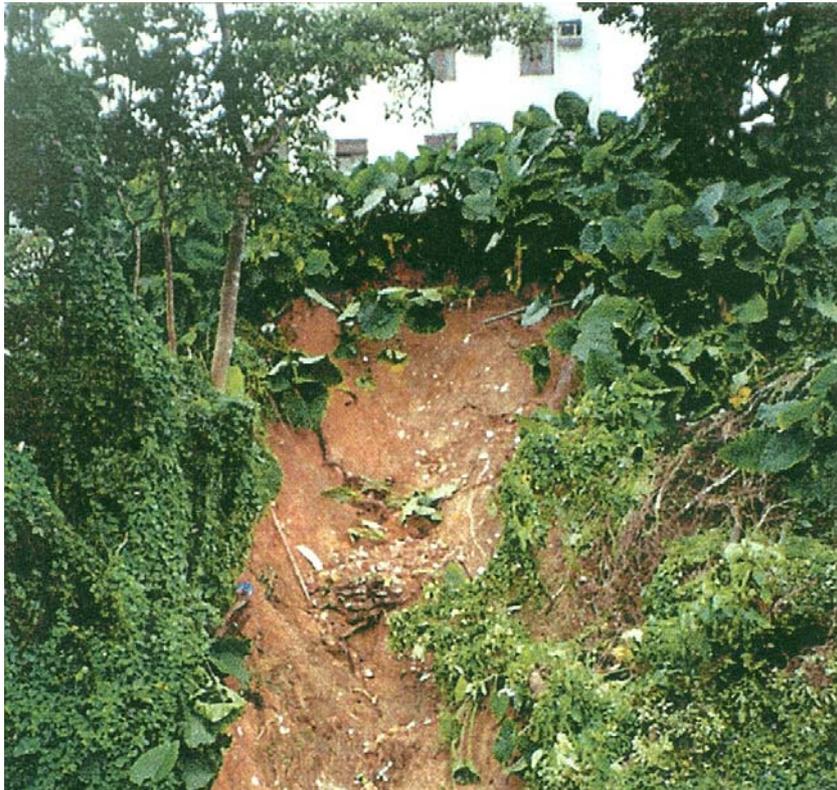
Plate 14 - General View of the Landslide Scar
(Photograph taken by GEO on 3 September 2001)

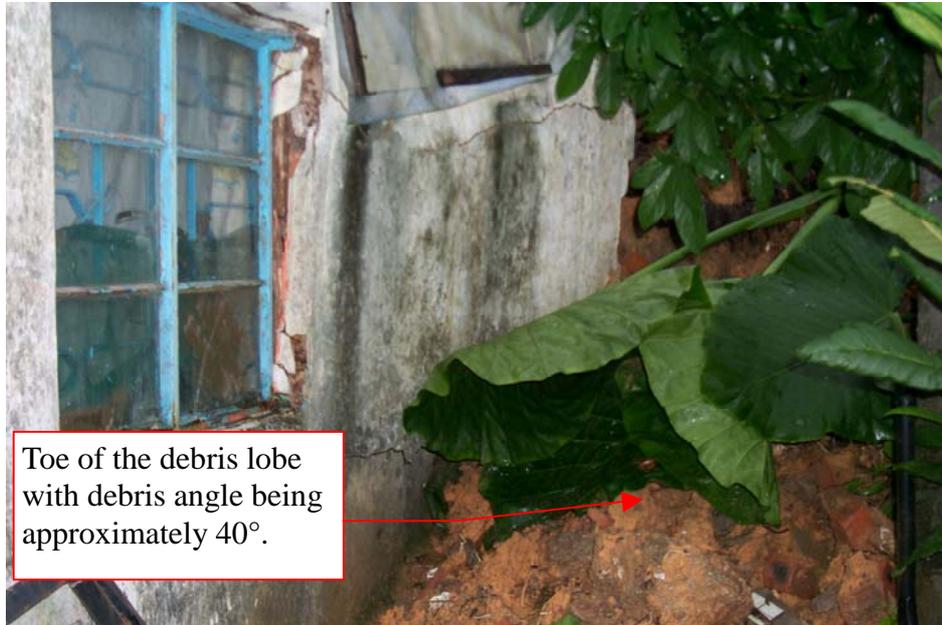
No field evidence of very fast movement of the landslide debris could be identified in post-failure observations by MGSL. The absence of any splash marks of debris on the wall of the squatter structure may suggest that the debris was not particularly wet and mobile at the time of impact; nevertheless, the squatter structure was severely damaged by the landslide debris.

Plate 15 - View of Severely Damaged Wall of Squatter Structure (No. 27 Tseng Lan Shue Village) (Photograph taken on 3 September 2002)

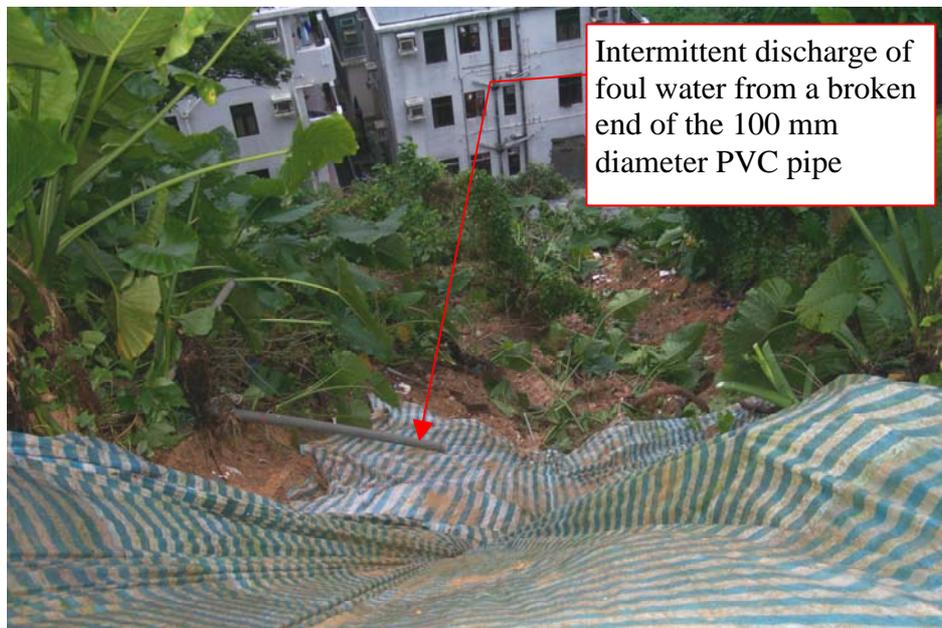
The partial saturation of the slope caused by the intermittent discharge of foul water from the 100 mm diameter damaged PVC pipe, which is located at about 1 m above the toe of the lower portion of the landslide scar and connected to the overflows from the septic tanks at Denon Terrace, was probably a key contributory factor to the landslide at the lower portion of the failure area. Coupled with this, the ingress of additional surface water through the grassed area above the landslide site could also have contributed to the failure. In addition, the presence of refuse and construction debris on the slope surface would have promoted water ingress into the slope by interrupting direct surface runoff.

Plate 16 - View of the 100 mm Diameter PVC Pipe at the Landslide Site (Photograph taken on 3 September 2001)

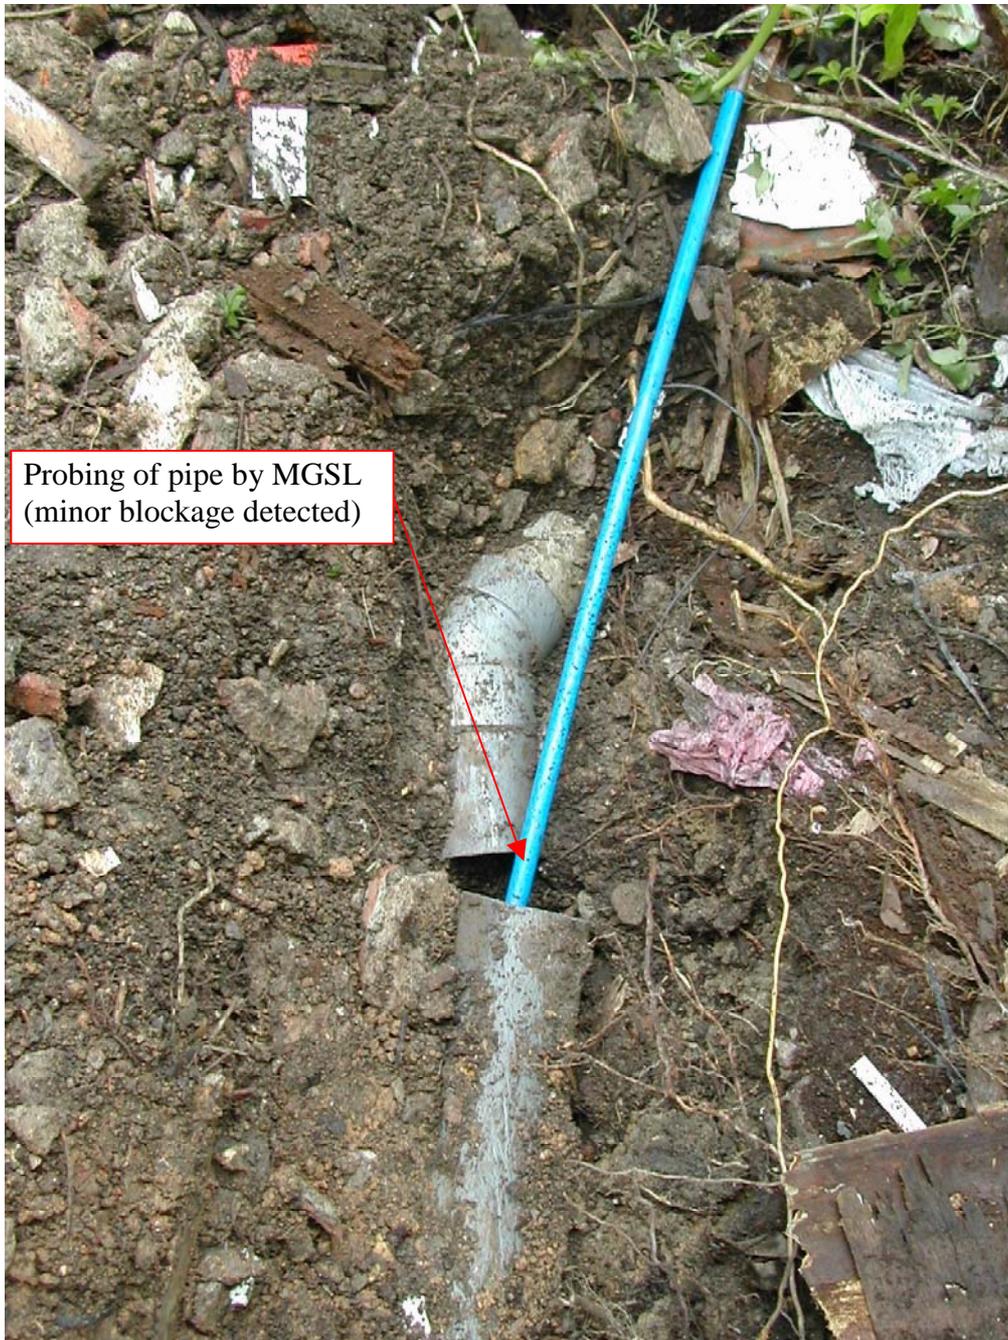
During MGSL's site inspections in September 2001 and December 2001, the 100 mm diameter PVC pipe connected to the 1.2 m by 1.2 m catchpit near the west end of slope No. 11NE-B/FR249 was found to be broken and discharging water with an unpleasant odour from the end of one of its broken sections, onto the natural hillside on the west side of the landslide scar (Figure 2 and Plate 16). Immediately to the northeast of the landslide scar, there were several 1.5 m to 2 m long sections of the broken 100 mm diameter pipe on the natural hillside partly covered by a steel folding gate. These broken sections of pipe were found to be randomly orientated. Detailed inspection of these sections of PVC pipe revealed that more than 50% of the cross-section was blocked by leaves and silt indicating that the pipe was possibly broken before the 1 September 2001 landslide incident. Following the subsequent site inspection and field works, the PVC pipe was found to have been separated at the joint (Point B in Figure 2) on a 120° bend (Plate 17) about 6 m from the breakage point and it was partly blocked with soil.

Sewage pipes connecting to the nearby septic tanks at Denon Terrace, including one 75 mm and one 100 mm diameter PVC pipes, were partly laid on, and partly embedded within, the north end of slope No. 11NE-B/FR249. Evidence of prolonged intermittent leakage onto the slope at a location about 1 m above the toe of the landslide scar due to damage of the 100 mm diameter sewage pipe were seen in post-landslide inspections by MGSL in September and December 2001. Based on the field observations and given that the slope was strewn with construction debris it is possible that the pipe was damaged some time before the September 2001 landslide.

Plate 17 - View of the 100 mm Diameter PVC Pipe Separated at the Joint
(Photograph taken on 24 September 2002)

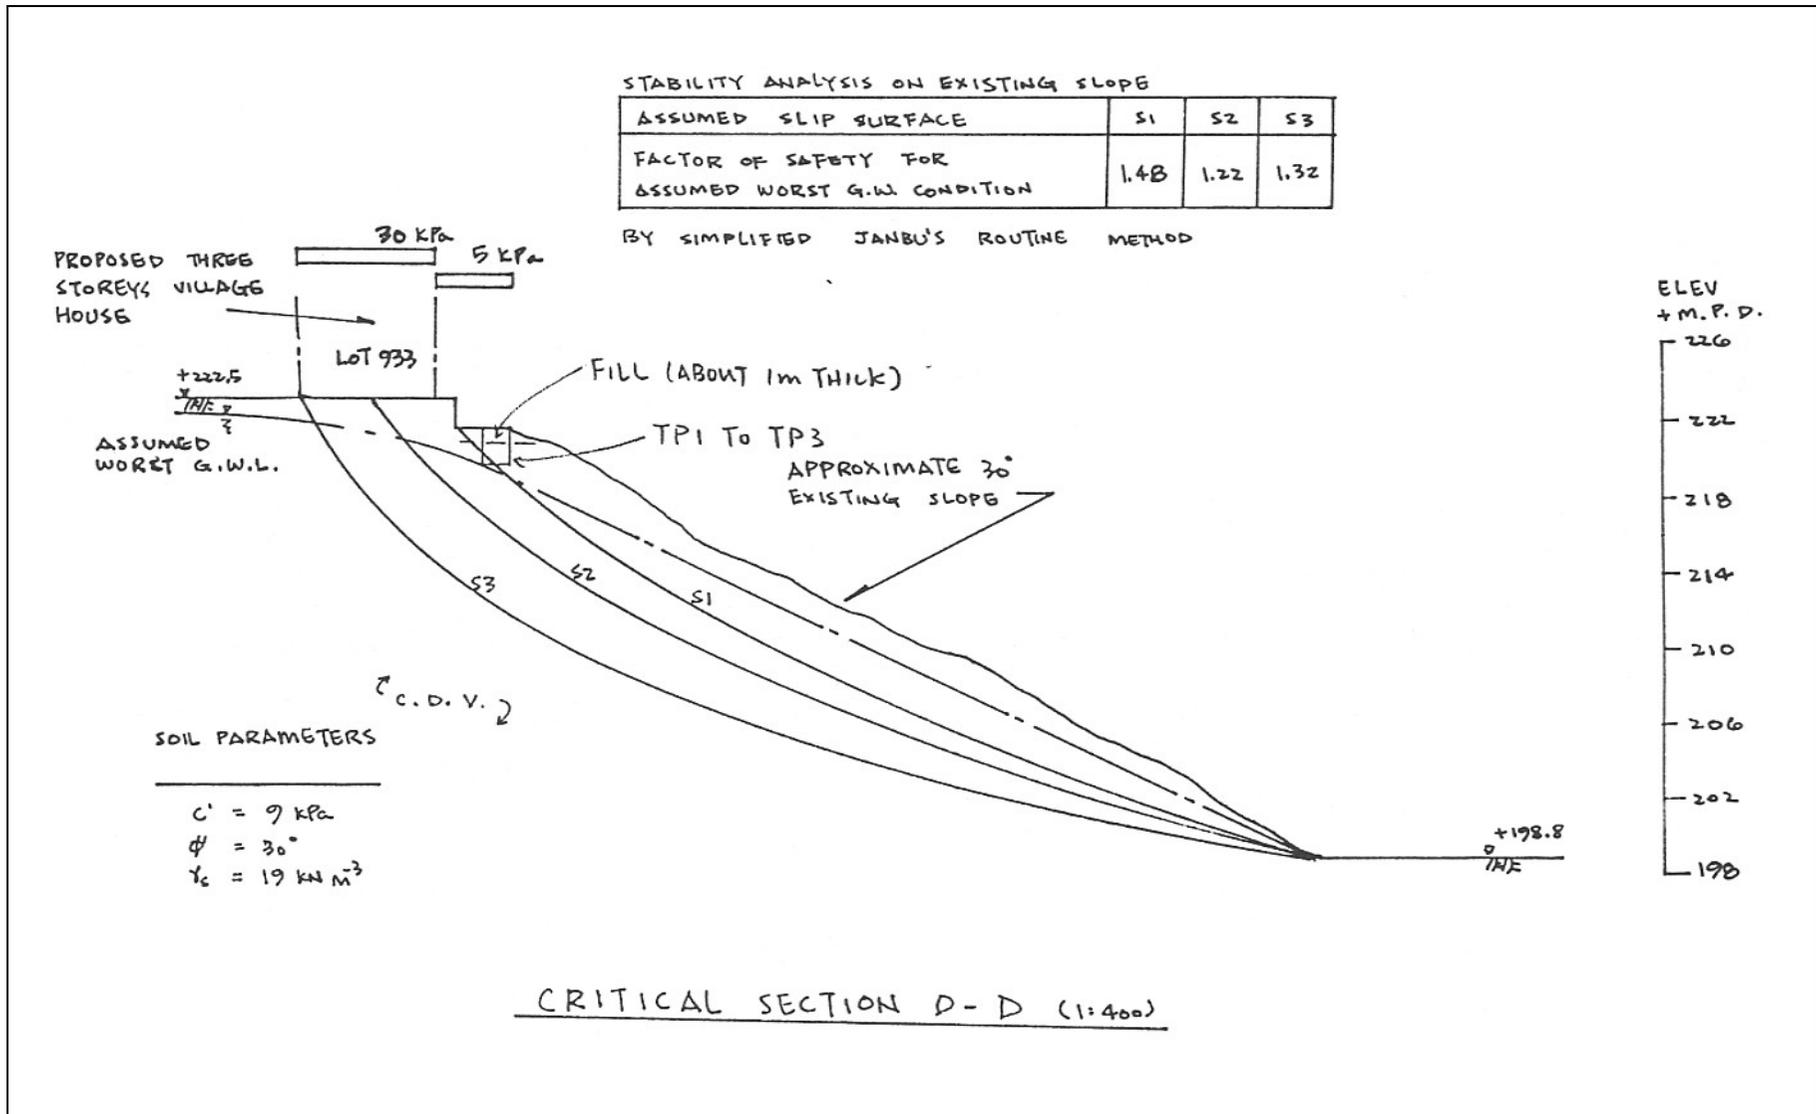
Figure B2 - Stability Assessment of Slope No. 11NE-B/FR249 (Extracted from Site Formation Re-submission Report for No. 56 Denon Terrace)

The stability of the section of slope corresponding to the failure site was assessed as part of the submission of site formation plans to the BD in 1993 for the development of No. 56 Denon Terrace. In the slope stability analysis submitted to the BD, the presence of the fill material revealed during the ground investigation was modelled as a 1 m thick horizontal layer of fill at the slope crest and the groundwater table was assumed to be between 1 m and 2.5 m below ground surface. The site formation plans were checked and accepted by the GEO in November 1993. It is noted that the geological model assumed in the above stability analysis was not representative of the actual ground conditions in that the fill stratum was not properly delineated and considered.

stability was previously assessed in 1993 and the geotechnical submission was accepted by the GEO. The geological model assumed in the stability analysis was not representative of the actual ground conditions in that the fill stratum was not considered.
