**DETAILED STUDY OF  
THE 16 SEPTEMBER 2002  
LANDSLIDE ON SLOPE  
NO. 11NE-D/C18 AT  
CHA KWO LING TSUEN,  
FAN WA STREET, LAM TIN**

**GEO REPORT No. 160**

**Maunsell Geotechnical Services Limited**

**This report was originally produced in August 2003  
as GEO Landslide Study Report No. LSR 7/2003**

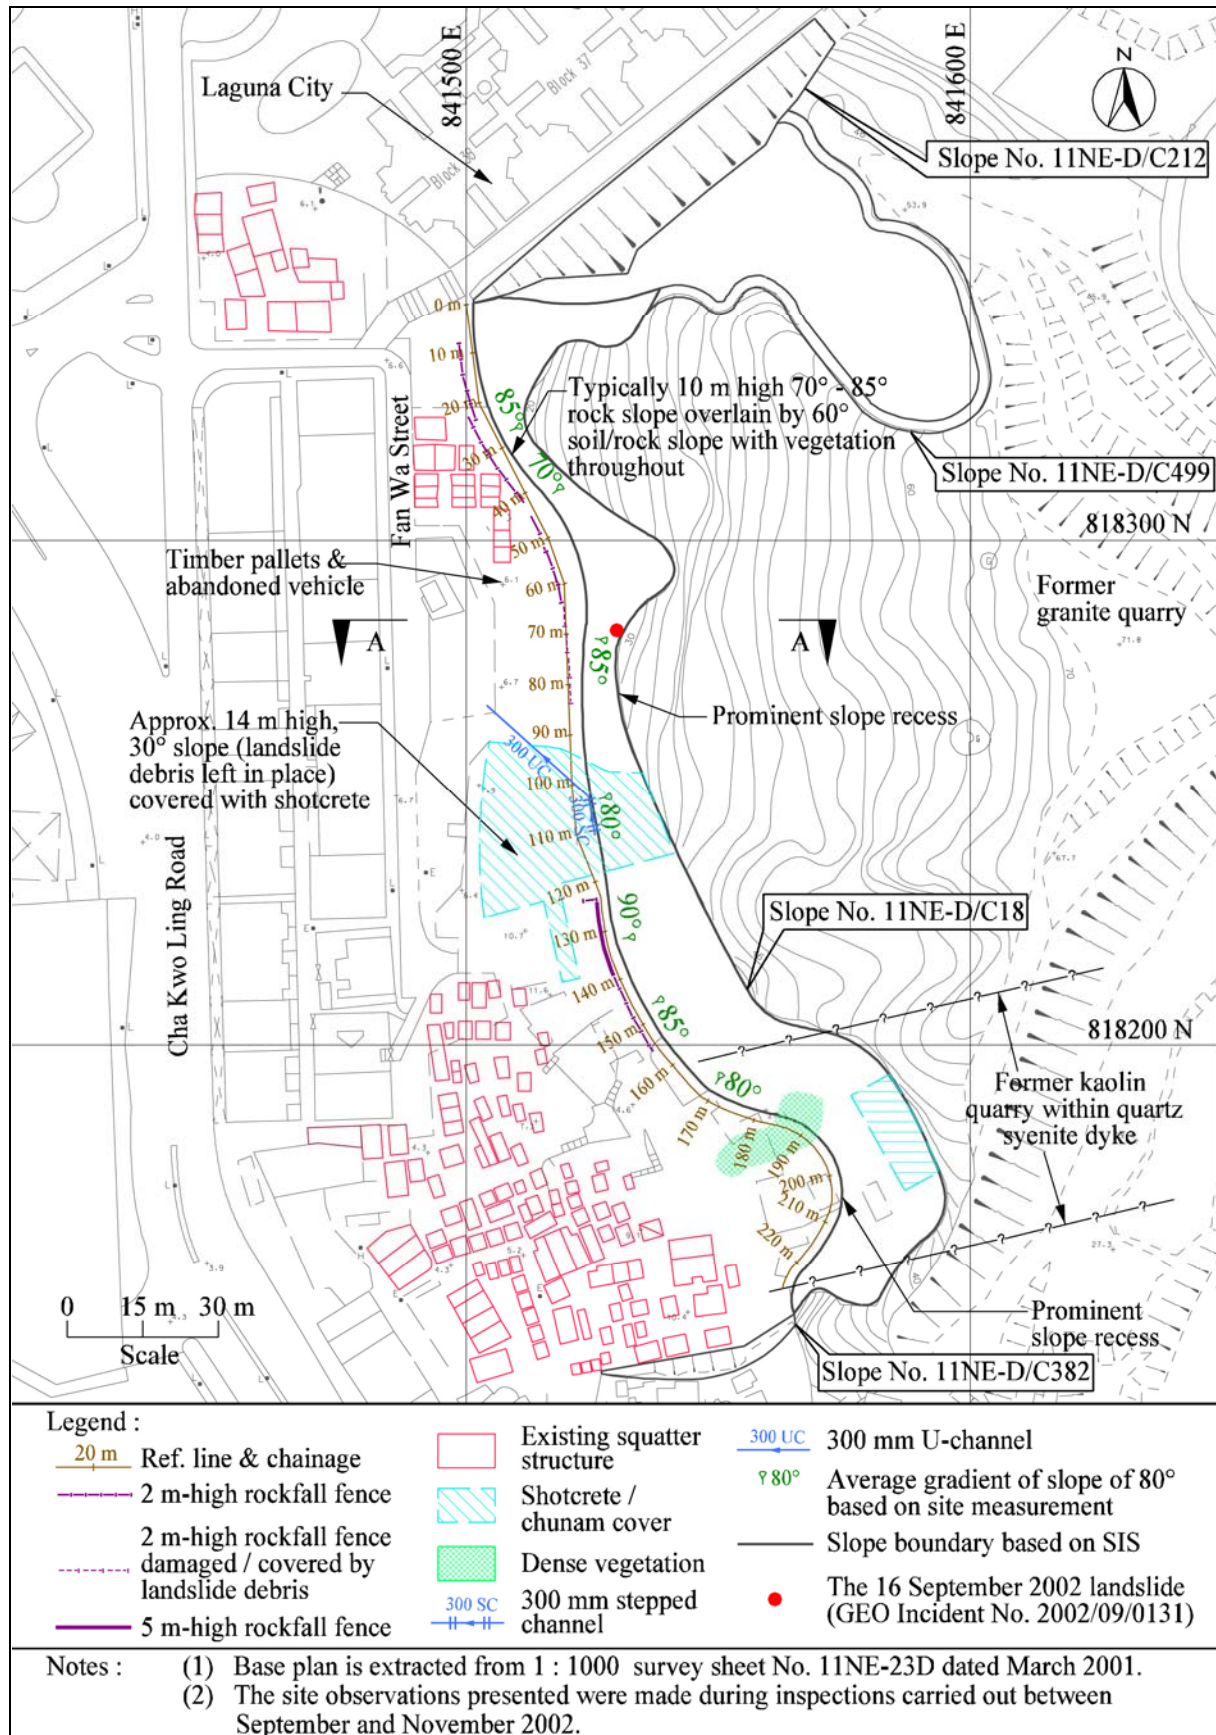
Figure 2 - Site Observations

The landslide occurred in the central portion of slope No. 11NE-D/C18 (i.e. Area 2) during heavy rainfall and involved the failure of an estimated volume of 30 m<sup>3</sup> of soil and rock material detached from the upper part of the slope, at an elevation of approximately 25 mPD (Figure 2).

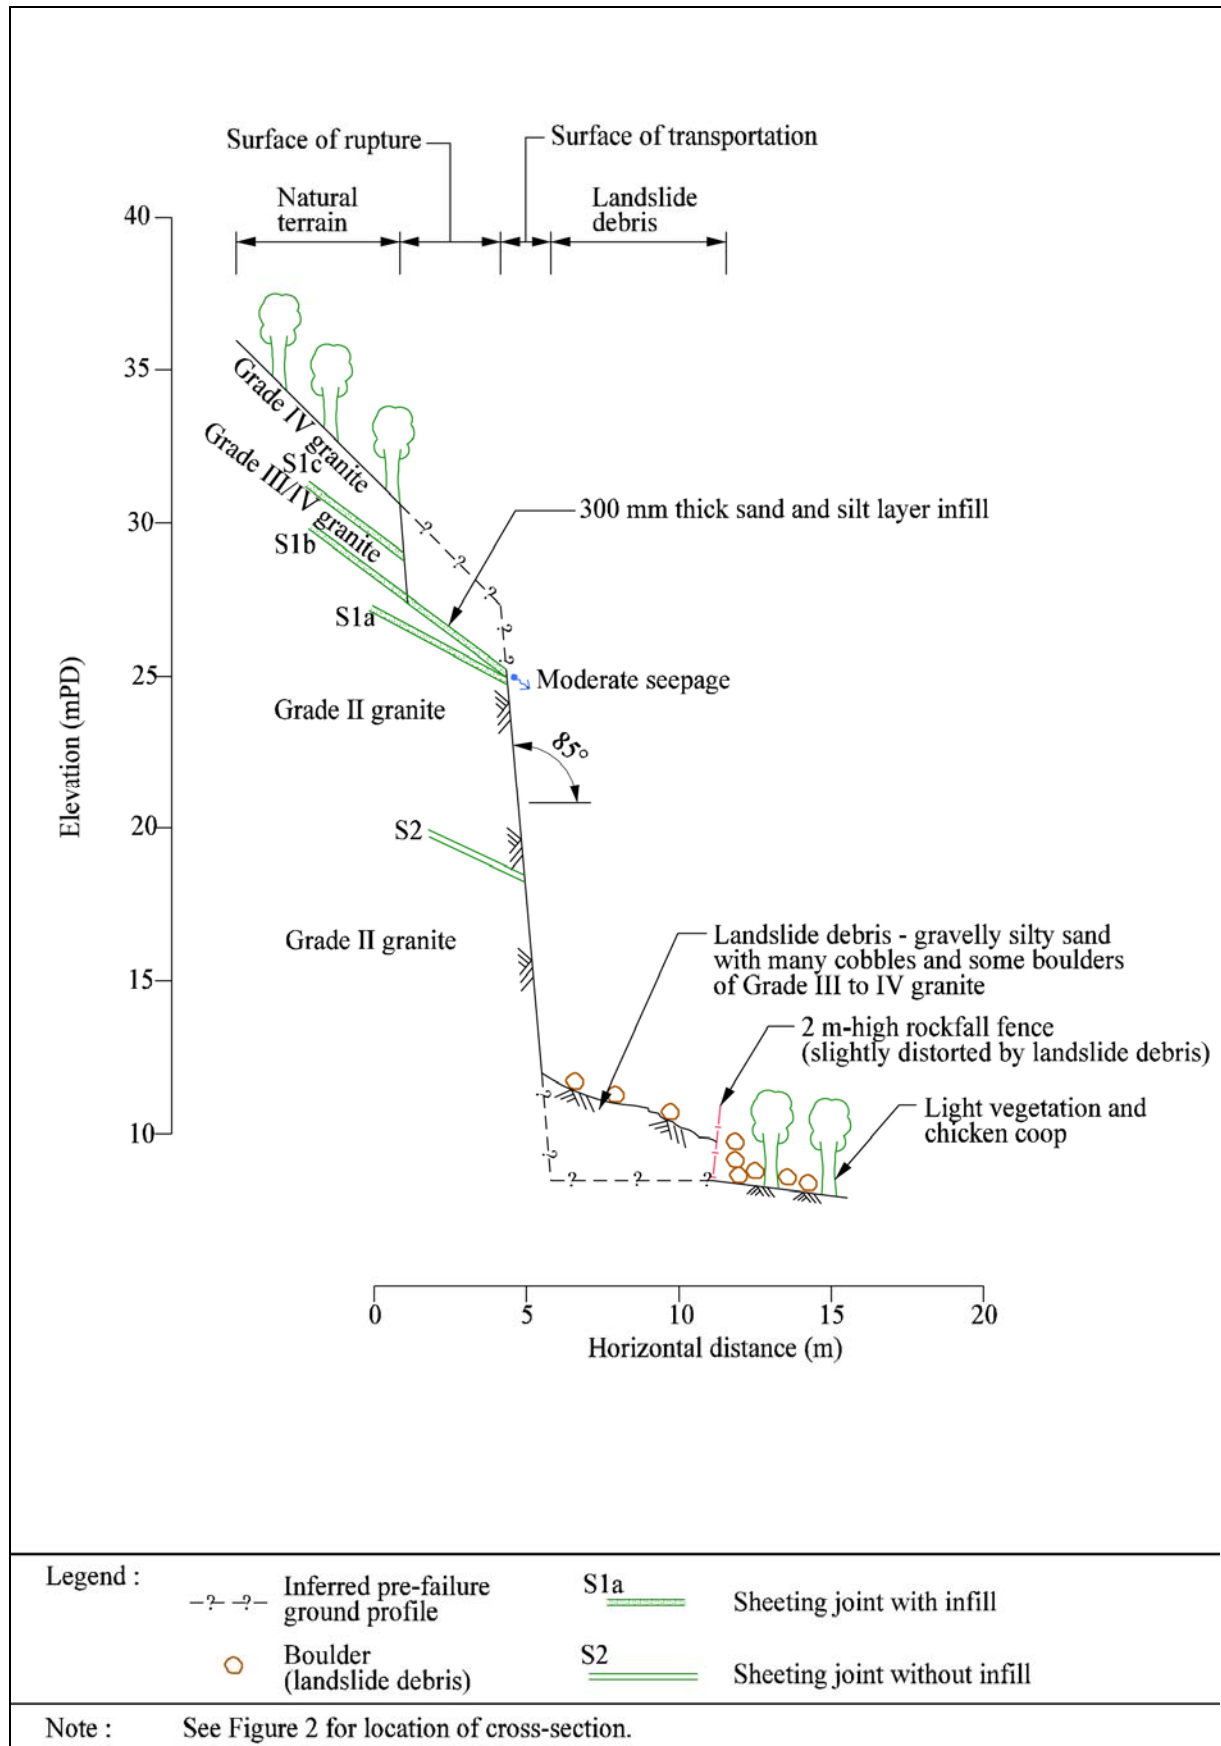
Figure 10 - Cross-Section A-A through the Landslide Site

MGSL carried out several inspections of the slope as part of this study in the period between September 2002 and November 2002. The surface of rupture comprised a steep (approximately 80°) main scarp and a relatively planar basal surface dipping adversely out of the slope at an angle of approximately 35° (Figure 10 and Plate 8).

The scar floor was found to comprise three undulating joints (S1a, S1b, S1c) dipping out of the slope face with a dip angle ranging from 25° to 35° (Figure 10 and Table 3) that extend across the full width of the scar (Plate 10). These joints are inferred to be sheeting joints, primarily due to their rough, undulating nature (typical of defects created by tensile stress-relief forces) and similarity in orientation to the slope of the original hillside. The sheeting joints contain insitu, completely decomposed granite up to 300 mm thick. A

sheeting joint, S2, similar to joint S1a in orientation but with only slightly decomposed walls and tight aperture, was observed about 6 m below the landslide scar (i.e. about 10 m above the slope toe) at the location of Section A-A, see Figure 10 and Plate 10.

Due to the steepness of the rock cut face (about 85°) below the source, the failure debris, which was about 30 m<sup>3</sup> in volume, was directed downward onto the relatively flat ground at the slope toe (Plate 1). Further debris travel was constrained by the 2 m-high rockfall fence located approximately 5 m beyond the slope toe (Plate 11). The stanchions and wire-mesh fencing were distorted away from the slope at an angle of approximately 10° to the vertical (Figure 10).

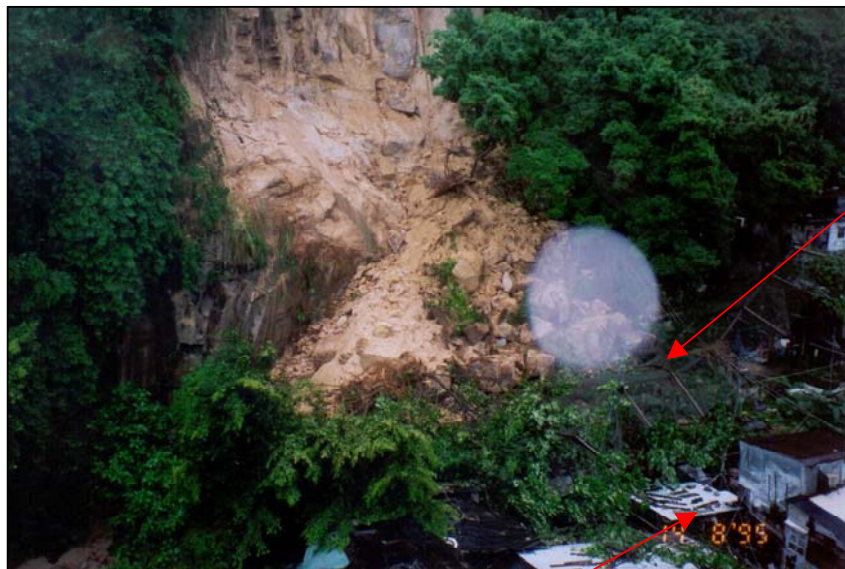
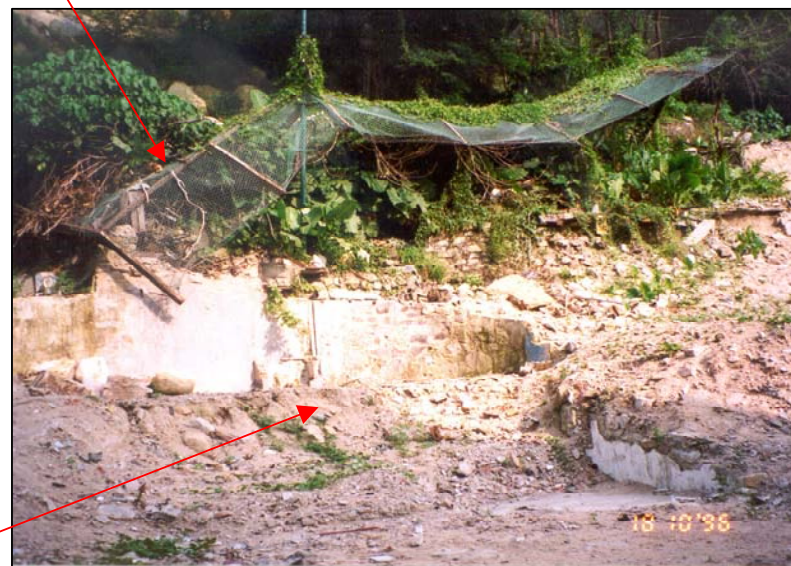
Plate 5 - View Showing the Mitigating Effects of the Rockfall Fence During a Previous Landslide  
(Photographs taken by GEO on 14 August 1995 and 18 October 1996)

Squatter structures immediately below the rockfall fence were relatively unscathed by the large-scale failure

The 1995 major landslide (GEO Incident No. K95/8/7) with estimated volume of up to 1,000 m<sup>3</sup>, which destroyed a portion of the 5 m-high rockfall fence

Squatter structures cleared by October 1996

Following the major landslide on the slope on 12 August 1995 (GEO incident No. K95/8/7), urgent repair works to the failure were carried out by HyD between November 1996 and January 1997. The landslide scar was shotcreted and the destroyed section of the rockfall fence (about 60 m long) was removed, which was not reconstructed as the squatters

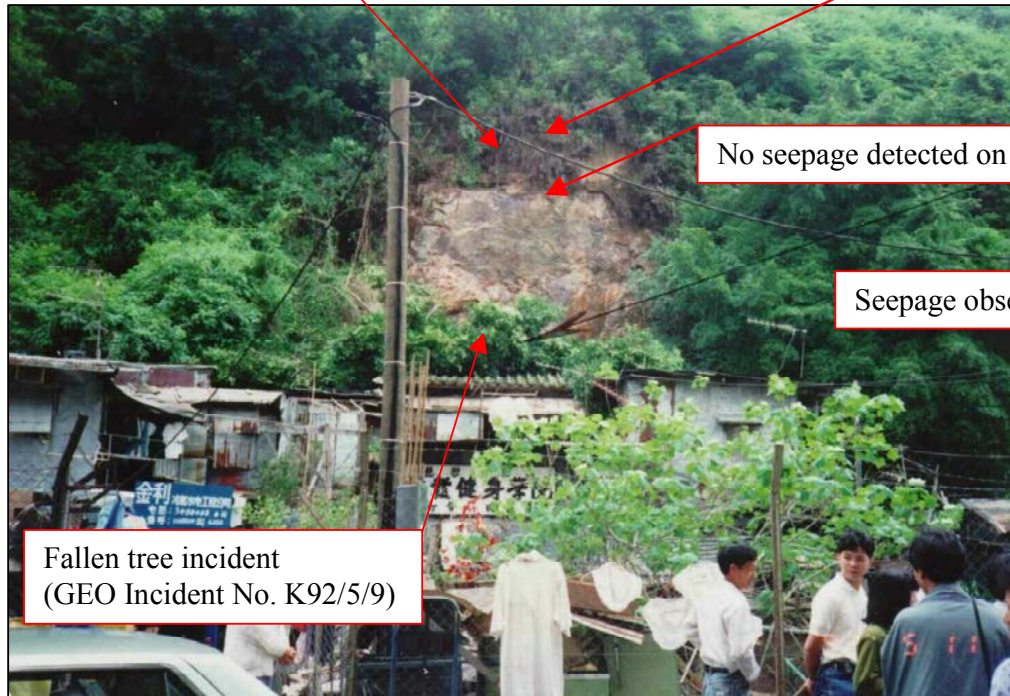
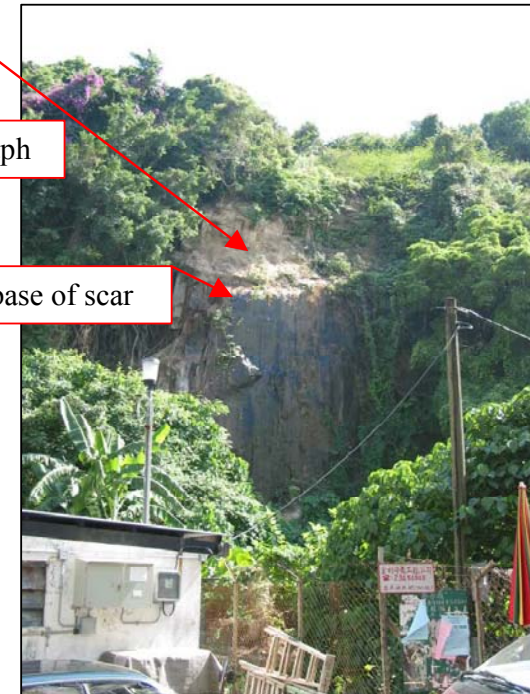
Plate 6 - Pre-Failure and Post-Failure Terrain at the Landslide Location  
(Photographs taken by GEO in May 1992 and by MGSL in November 2002)

Pre-failure steep face  
and vegetation growth

Location of the subsequent 16 September 2002 Landslide

Fallen tree incident  
(GEO Incident No. K92/5/9)

No seepage detected on photograph

Seepage observed at base of scar

(a) Photograph taken by GEO in May 1992 showing  
the pre-failure view of the landslide site

(b) Photograph taken by MGSL in November 2002  
showing the post-failure view of the landslide site

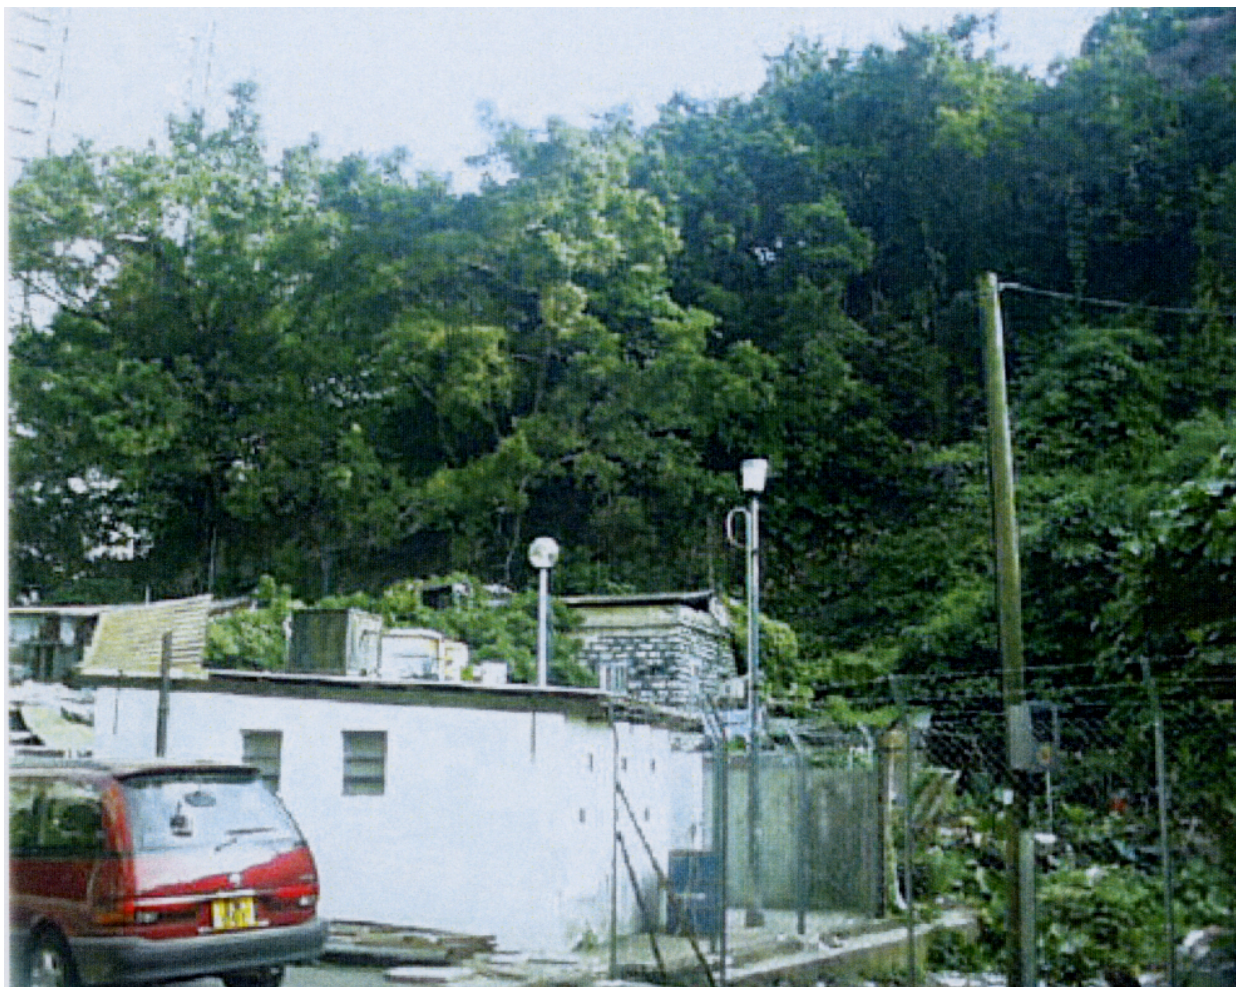
Plate 7 - View of Slope No. 11NE-D/C18 (Photograph taken by the Lands D on 19 December 1999)

On 15 December 1999, Halcrow Asia Partnership (HAP) carried out an Engineer Inspection (EI) of slope No. 11NE-D/C18 on behalf of the Lands D (Plate 7) under Agreement No. CE 48/98. No signs of distress were noted during the EI. The overall state of maintenance of the subject slope was diagnosed as “Poor”. The recommendations by HAP are as follows: “Consideration should be given to the removal of squatters (Category 2) at the toe of the feature [identified by HAP] as they are vulnerable to landslips, especially during periods of heavy rain. If the squatters cannot be removed prior to the next raining season, minimal non-structural preventive maintenance work should be undertaken. In the meantime, provision of warning (Dangerous Hillside) Sign - boards erected at the toeline of the slope is recommended. Furthermore, it is recommended to update the SIRST records to reflect the change in consequence-to-life category of feature”.

The December 1999 EI report also recommended routine maintenance works (including unblocking surface channels and removing undesirable vegetation, etc.) and preventive maintenance works (including provisions of surface drainage channels and a slope crest channel).

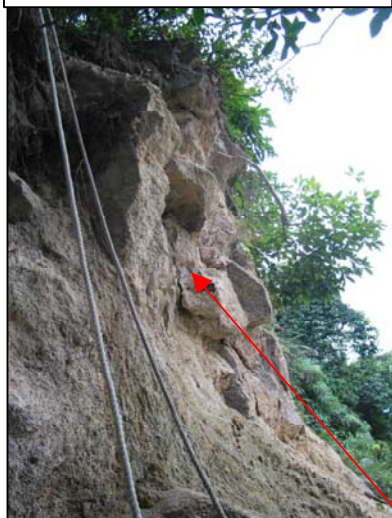
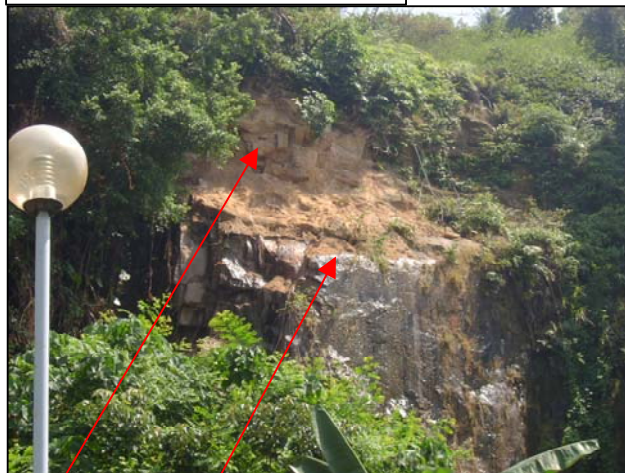
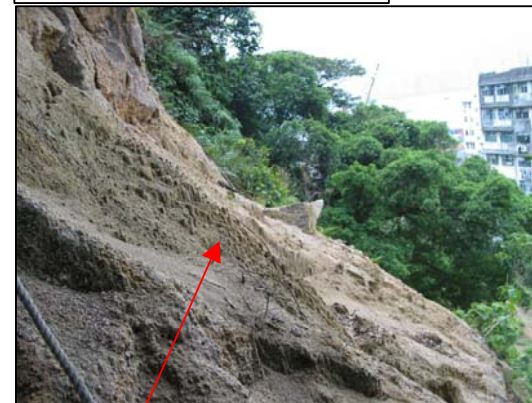
Plate 9 - View of the Surface of Rupture (Photograph taken on 27 November 2002)

Constant moderate seepage was seen issuing from sheeting joint S1a (Figure 10 and Plate 9) at the time of inspecting the landslide. No seepage was observed from and above sheeting joint S1b (the entire surface of rupture being dry) or from the rock joints below the landslide scar, or within the slope recess to the north.

Dry, partially weathered granite  
(PW 30/50 to PW 50/90)  
observed in main scarp

Constant seepage at the base of  
the landslide scar

About 200 mm thick layer of dry  
saprolitic soils overlying the floor  
of the surface of rupture

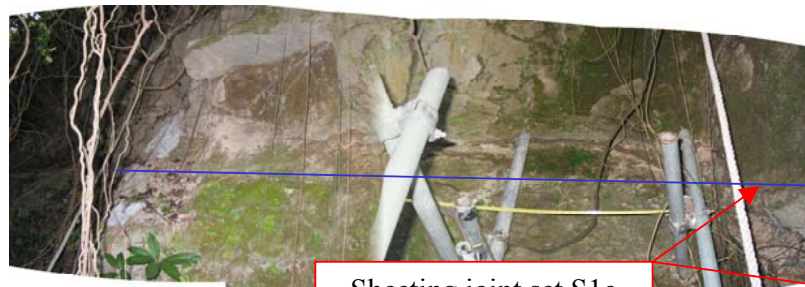
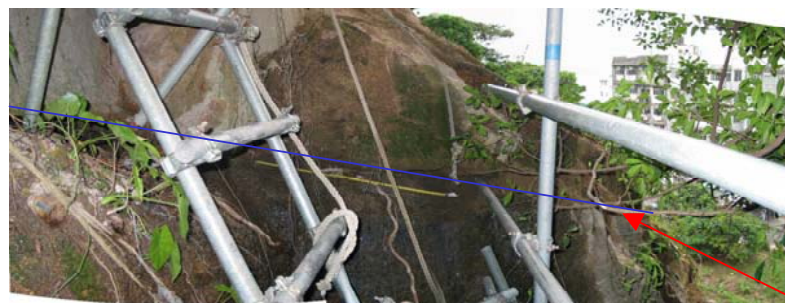
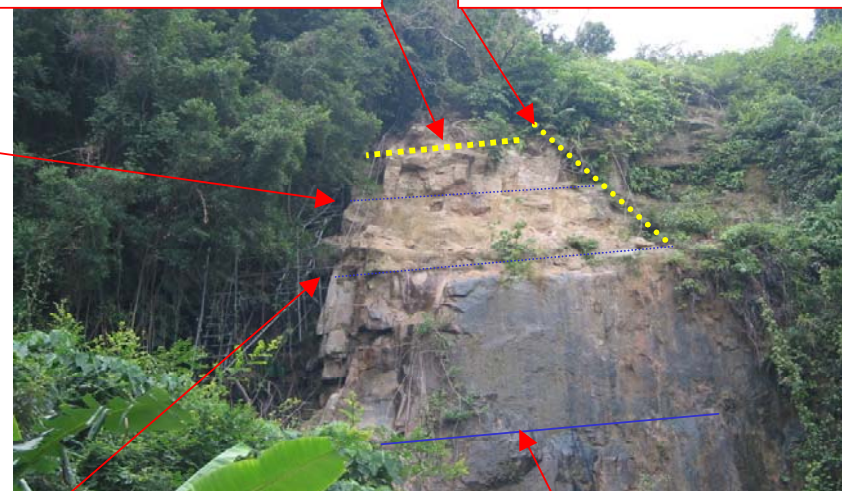
Plate 10 - View Showing the Main Structural Controls at the Landslide Source  
(Photographs taken on 27 November 2002)

Sheeting joint set S1c

Sheeting joint set S1a

Steeply dipping joint set J2 forming back release surface to the 16 September 2002 landslide

Steeply dipping joint set J1 forming side release surface to the 16 September 2002 landslide

Sheeting joint S2

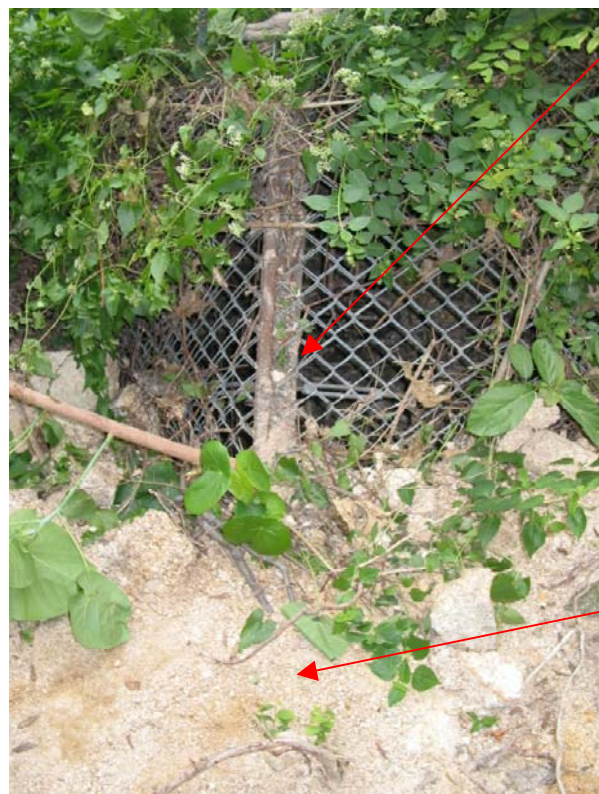
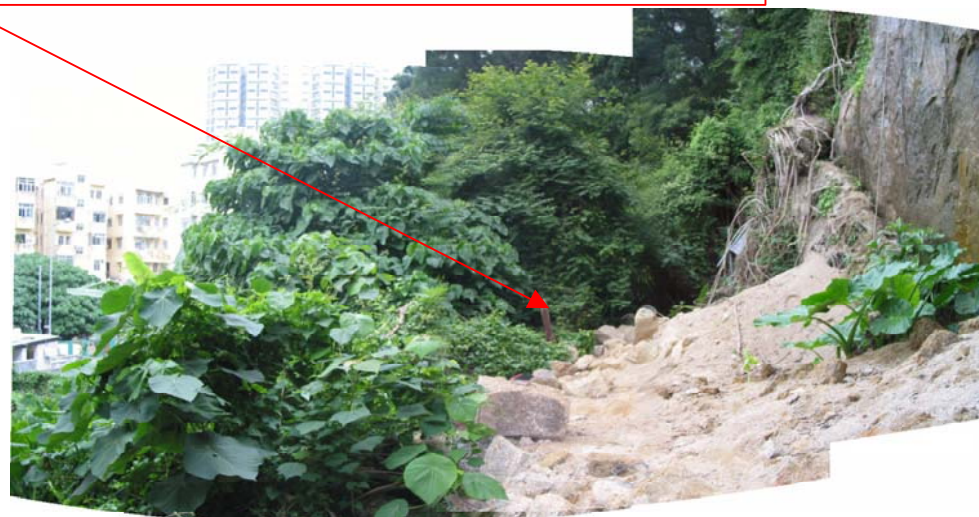
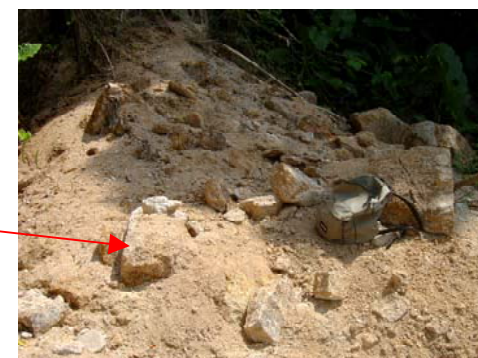
Plate 11 - View of the Landslide Debris (Photographs taken on 27 November 2002)

The surface of transportation of the failure debris, which comprised very strong, pinkish grey, slightly decomposed (Grade II) granite, showed signs of mild abrasion but there appeared to be virtually no erosion or entrainment of the surface. Some failure debris had travelled down the recess immediately north of the landslide scar and bifurcated at a tree stump (the tree was probably knocked down by the landslide debris) close to the slope toe (Plate 1). The landslide debris comprised fine to coarse gravelly, slightly silty sand with many cobbles and some boulders of highly to moderately decomposed granite (Grade III to IV).

Landslide debris contained by the existing rockfall fence

Landslide debris comprising Grade IV granite with cobbles and some boulders of Grade III granite

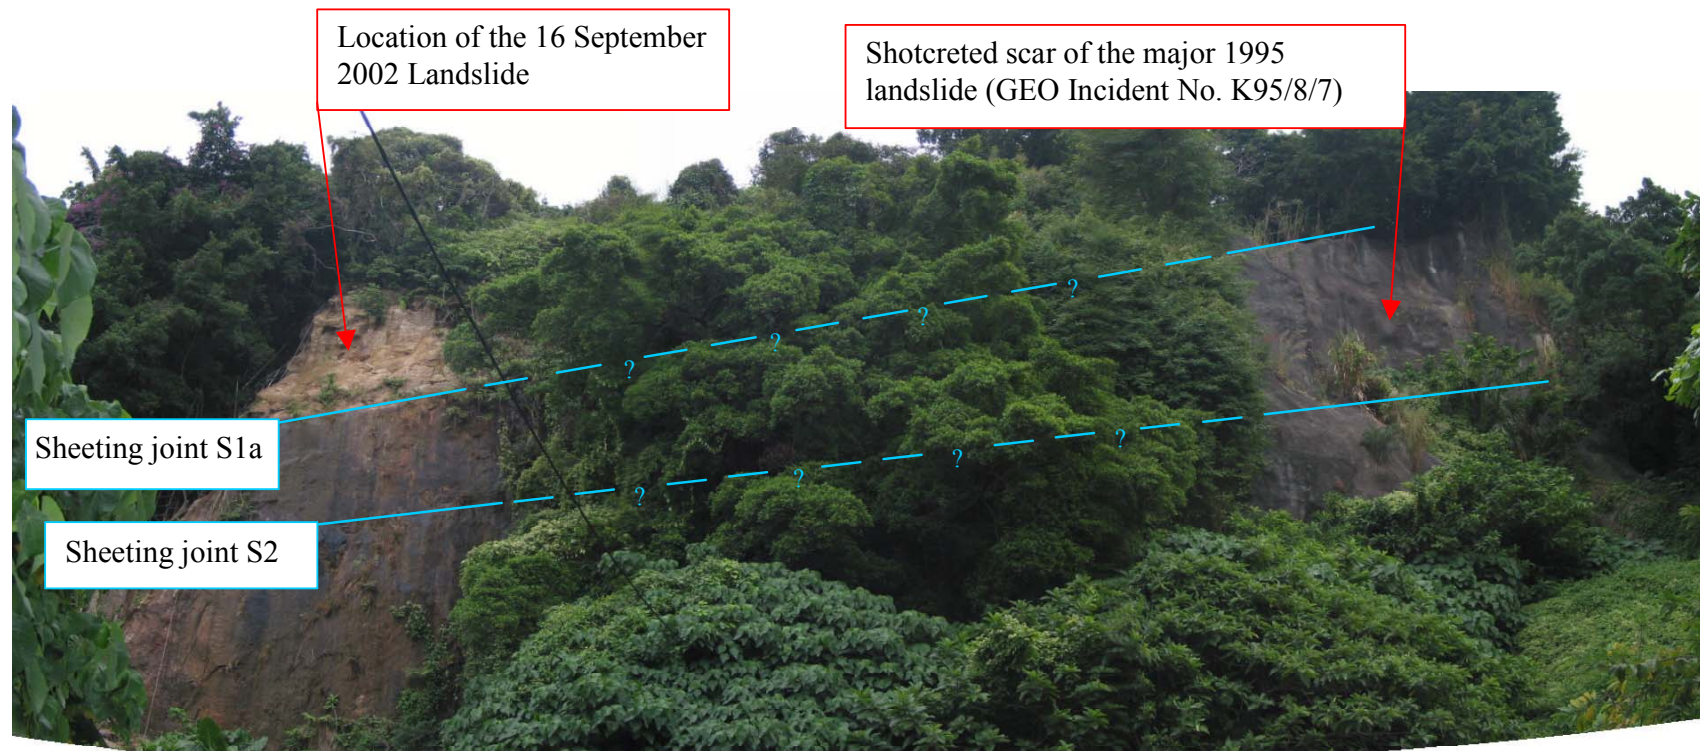
Plate 12 - View of the Sheeting Joints in Area 2 (Photograph taken on 27 November 2002)

Rock joints of similar characteristics to the three undulating sheeting joints (S1a, S1b and S1c) form part of a distinct zone of similarly orientated geological features (designated composite sheeting joint zone S1) that along with sheeting joint S2 at the location of the 16 September 2002 landslide (Figure 10) can also be identified at the location of the 1995 major landslide (which is to the south of the 2002 landslide and now obscured by shotcrete). Based on a critical review of the post-failure photographs of the 1995 landslide, a discontinuity or zone of discontinuities with similar orientation to that of sheeting joint zone S1 outcrops near the crest of the 1995 landslide area whilst the base of the 1995 landslide scar

is characterised by an outward dipping surface with an orientation similar to that of joint S2 (Plate 12). Owing to limited access and the presence of dense vegetation cover, the persistence of these sheeting joints in areas between the locations of the 1995 and 2002 landslides cannot be assessed in detail. Given the nature and characteristics of sheeting joints, the presence of these sheeting joints between these two locations cannot be ruled out. A joint with similar orientation was also observed in the north, where it extended at least 20 m into the prominent recess and where a joint similar to joint S1a was observed to be 'open' in places due to washout of the completely decomposed granite infill. Further sheeting joints could also be seen near the north end of the subject slope, where they occur at lower elevations.

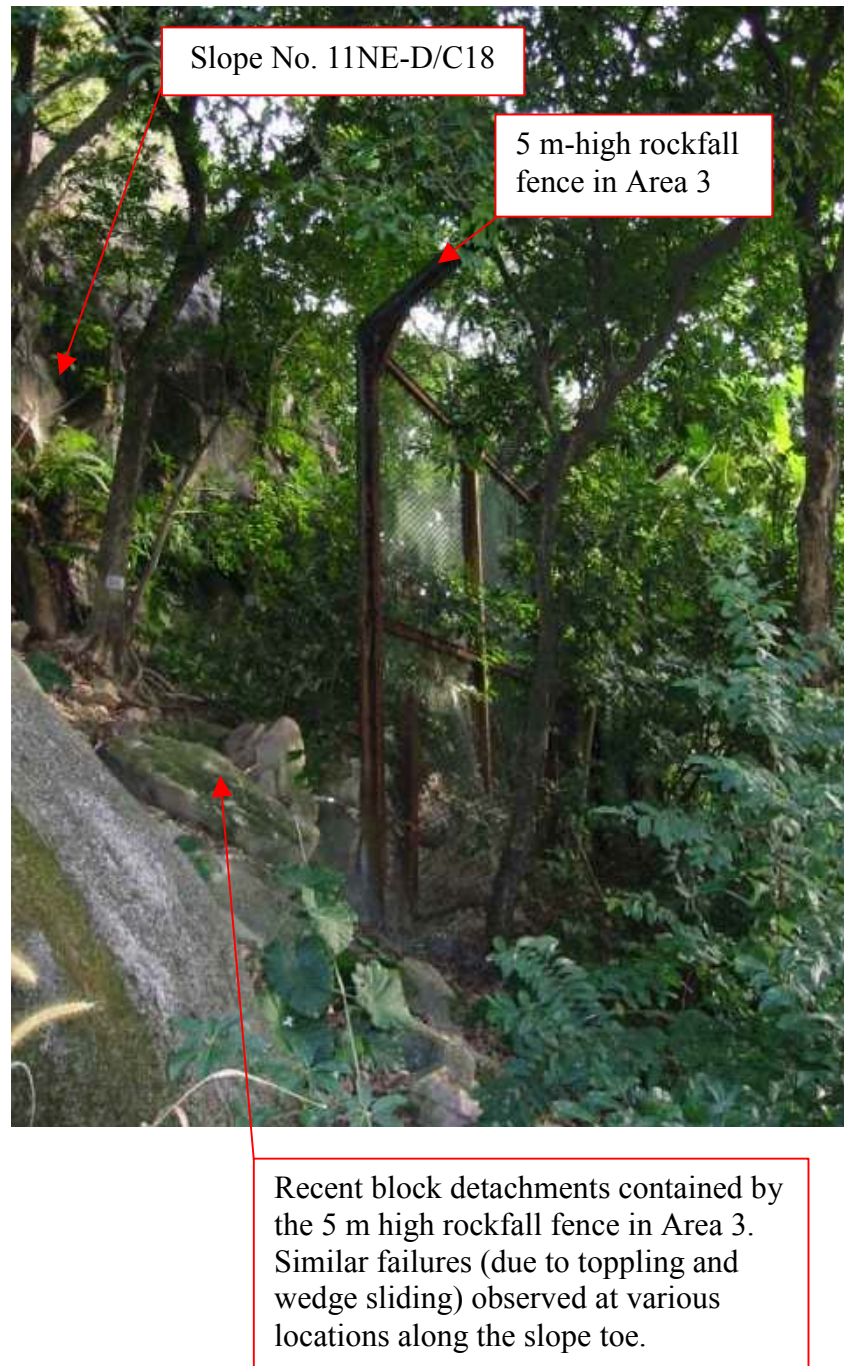
Plate 14 - View Showing Typical Small-scale Failures Contained by the Rockfall Fence  
(Photograph taken on 10 October 2002)

The rock joint system J1 to J3 observed at the 2002 landslide was also found over the remainder of slope No. 11NE-D/C18. These main structural controls are consistent throughout the full extent of the slope. Joints of each set, together with random joints, occurred as minor joints (generally tight, closely to medium spaced, not persistent) and also probably as persistent major joints (tight or extremely narrow and medium to widely spaced). Incipient small-scale failures, associated with the interaction of joints J1 and J2, were observed in slope Areas 2 and 3. These failures were particularly prevalent at the junction of slope Areas 2 and 3. There was evidence that vegetation root growth was also contributing to small-scale block failure (Plate 13). In Area 3, the recently detached small rock blocks were contained by the rockfall fence (Plate 14). In Area 2, where the rockfall fence was removed along with squatter structures, some rock blocks had generally come to rest within about 4 m of the slope toe.
