**DETAILED STUDY OF THE
28 NOVEMBER 2002
ROCKFALL ABOVE
YIP HING STREET,
WONG CHUK HANG**

GEO REPORT No. 164

Halcrow China Limited

**This report was originally produced in October 2003
as GEO Landslide Study Report No. LSR 9/2003**

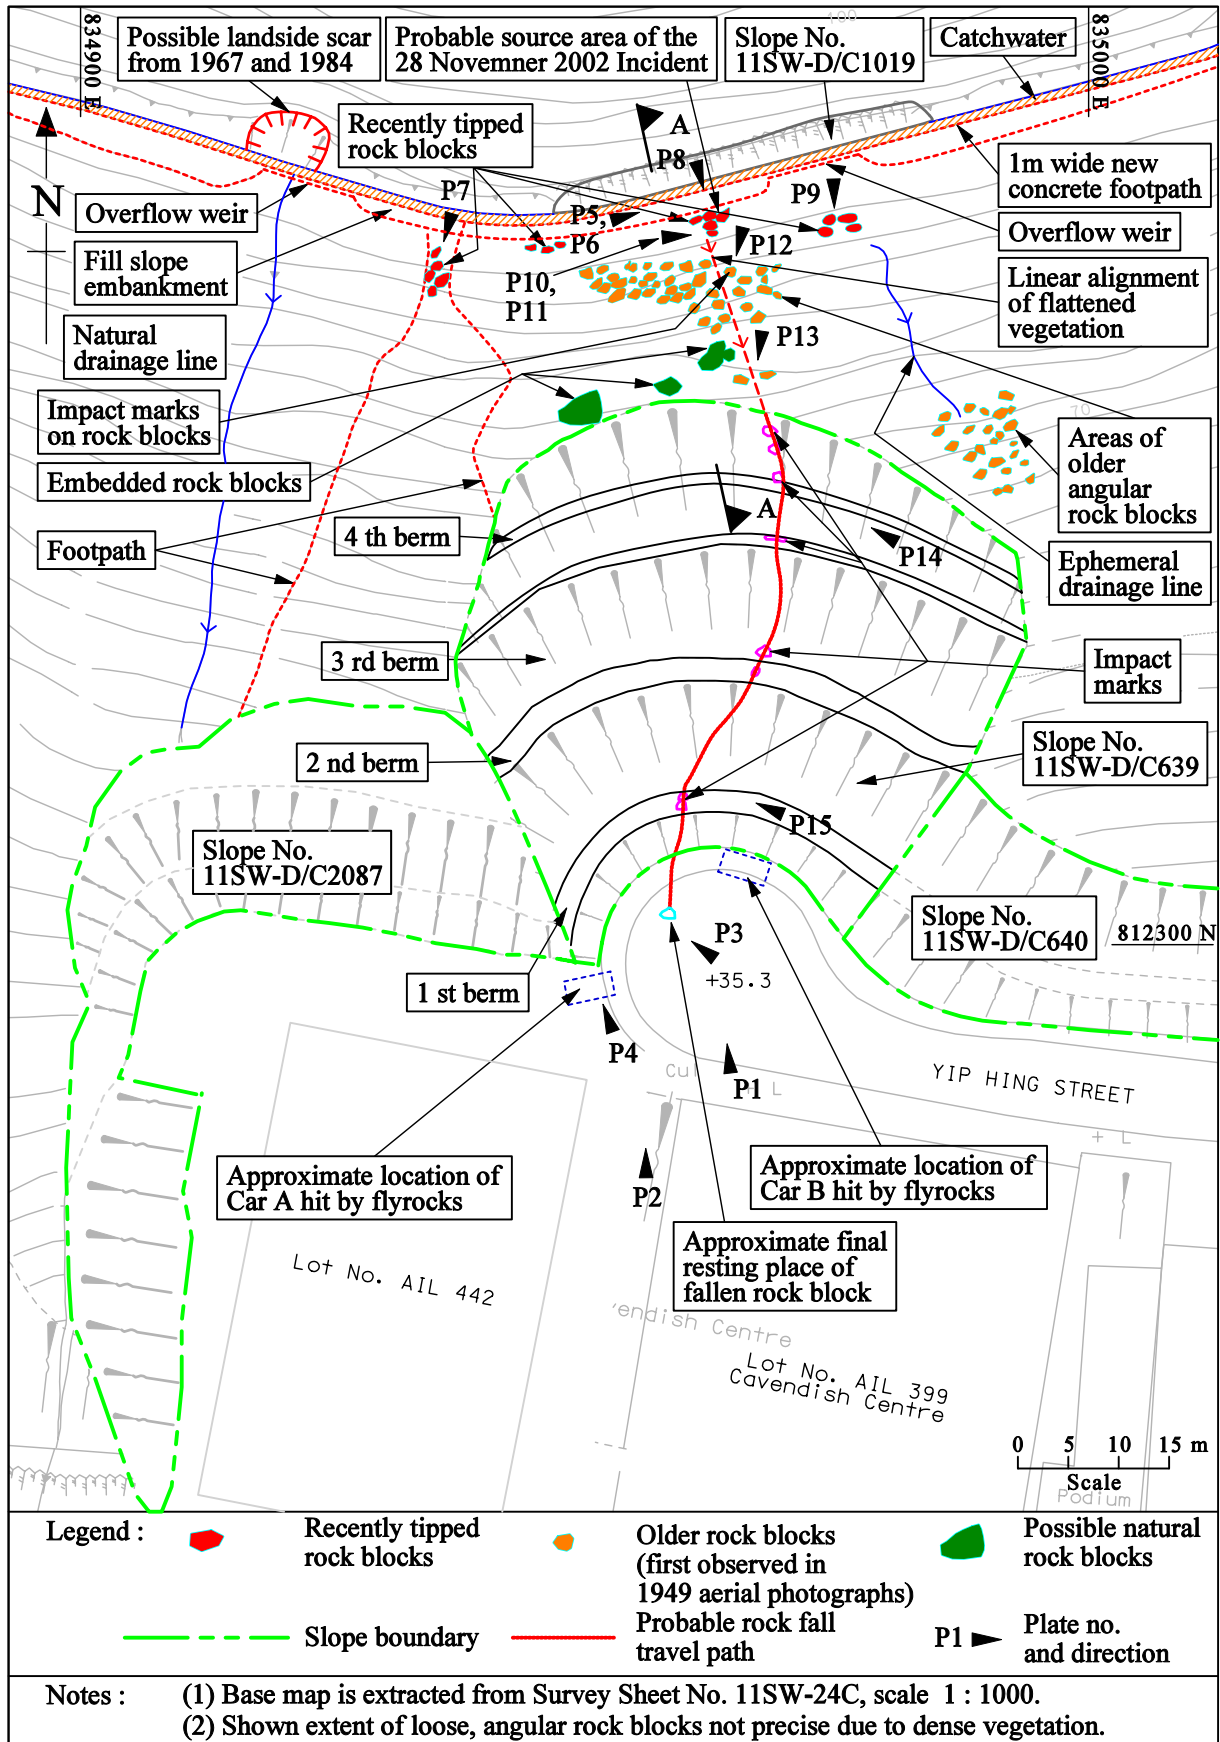
Figure 2 - Site Plan

The rockfall involved a single rock block that fell from the hillside at an elevation of about 85 mPD. The rock block travelled (bounced and rolled) over the hillside along an approximately linear path towards the crest of slope No. 11SW-D/C639. The rock block bounced down the slope, impacting the hard surface cover of the slope and the berms as it descended, before coming to rest on Yip Hing Street at the slope toe at an elevation of 35.3 mPD (see Figure 2 and Plate 2).

Detailed site inspections have identified recent impact marks in the form of damaged tree branches below a younger-looking rock block cluster on the hillside below the catchwater access footpath (see Figure 2 and Plate 11). It is not certain whether these impact marks were created by blocks other than the fallen rock block or not. Further downhill, other recent impact marks are also indicated by the presence of fresh rock flour and local loss of lichen cover on some of the older-looking rock blocks (see Plate 12). Downslope of the above older-looking rock block cluster, vegetation was observed to have been flattened along an essentially linear path that leads to the crest of cut slope No. 11SW-D/C639 (see Plate 13). The linear path is consistent/in-line with the impact marks observed on the hard cover and the berm slabs of the cut slope (Plates 14 and 15). No impact marks were observed on the catchwater channel and the catchwater access path. Based on the inspections, the likely trajectory of the fallen rock block, which is fairly well defined by the impact marks, is shown in Figure 2 and Plate 2.

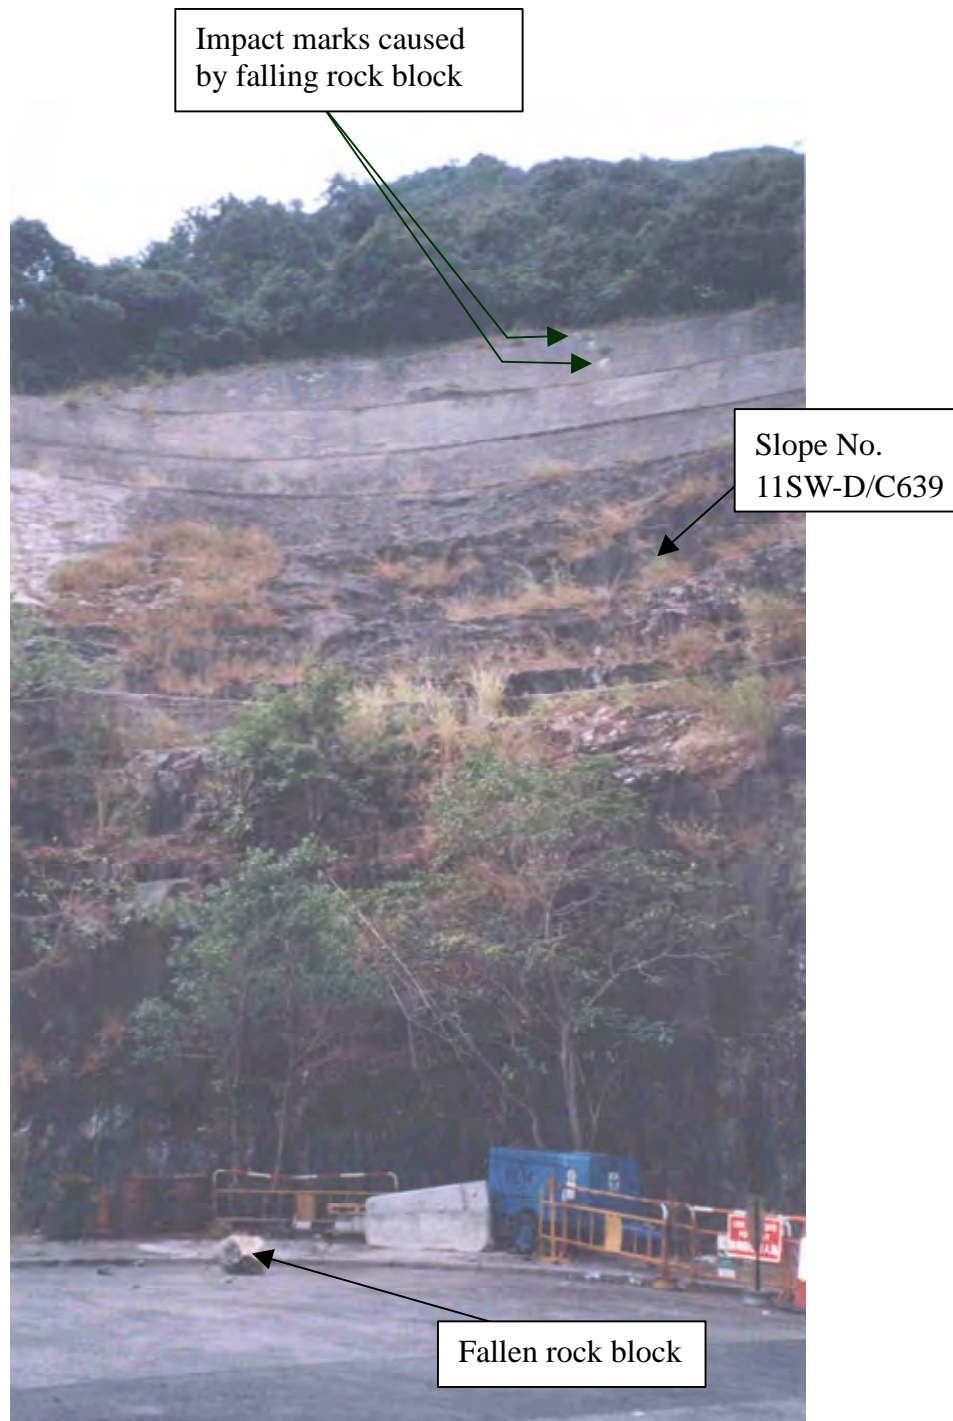
Plate 1 - View of Slope No. 11SW-D/C639 with the Fallen Rock Block at the Slope Toe
(Photograph taken by GEO on 28 November 2002)

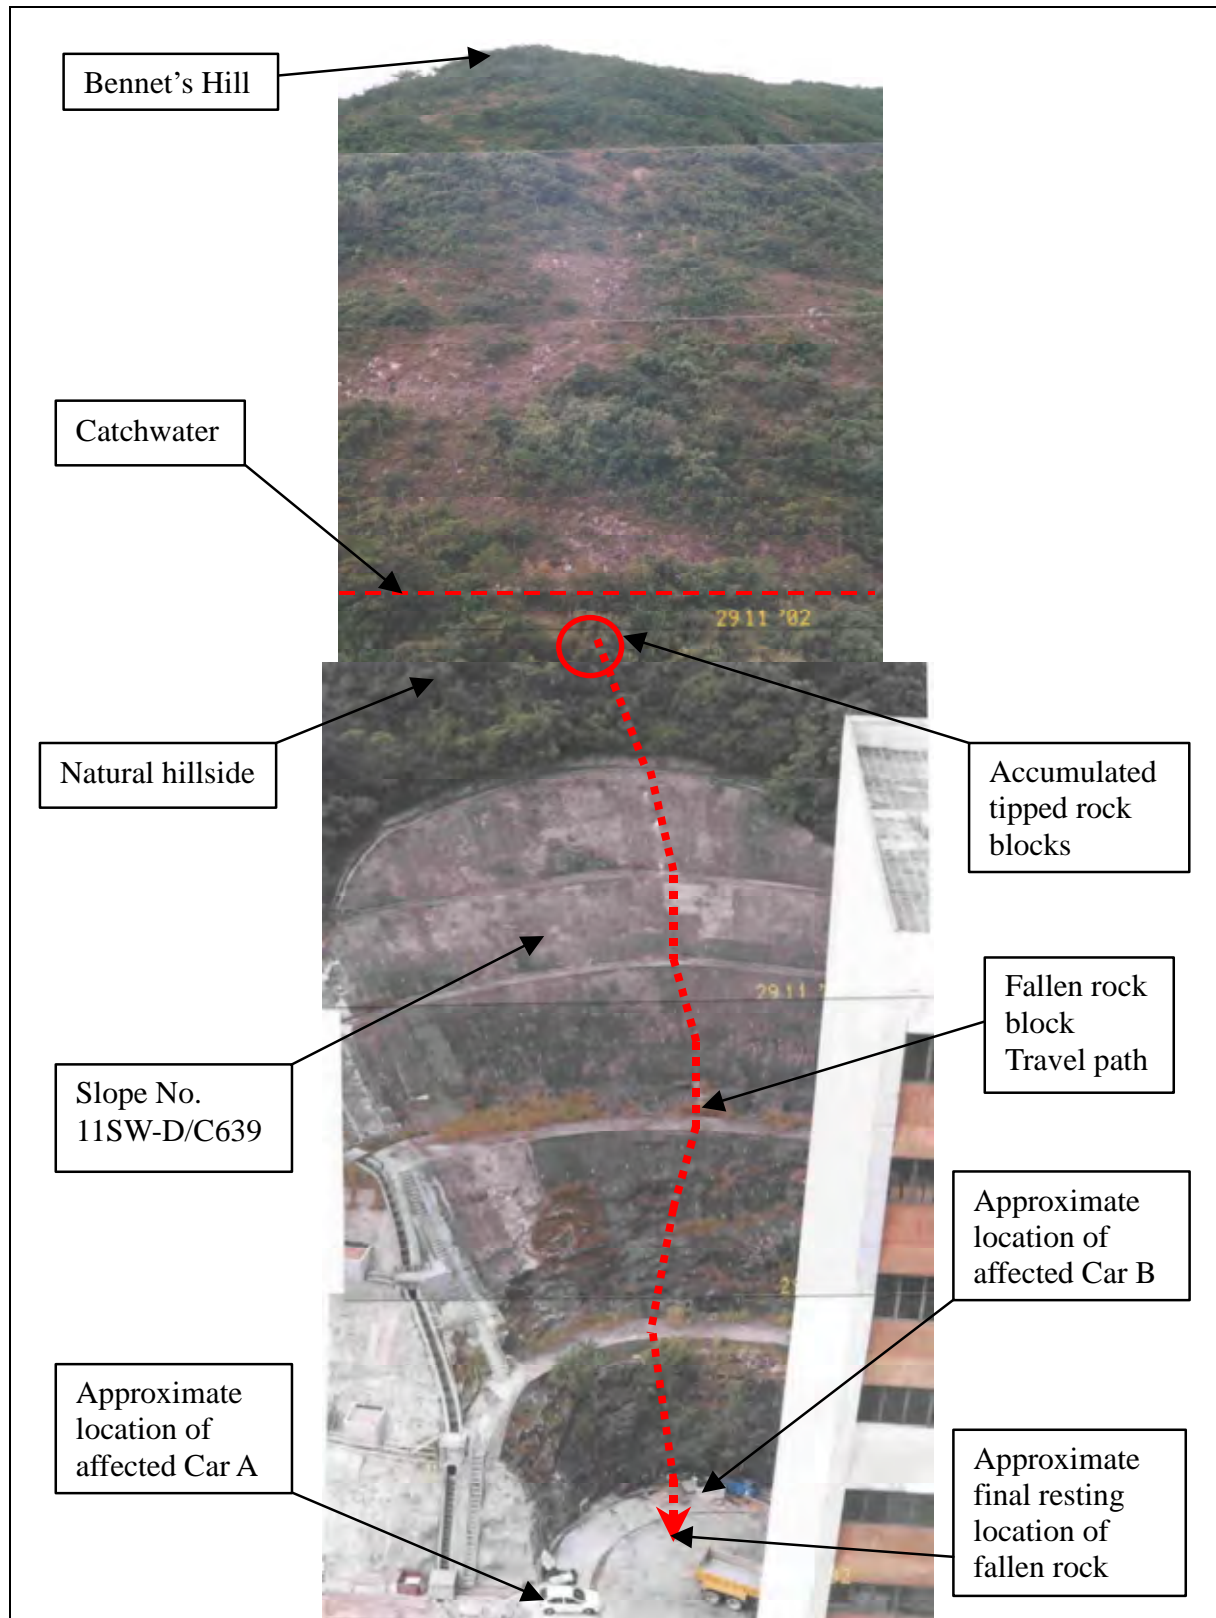
Plate 2 - A General View of the Path taken by the Fallen Rock Block
(Photograph taken by GEO on 29 November 2002)

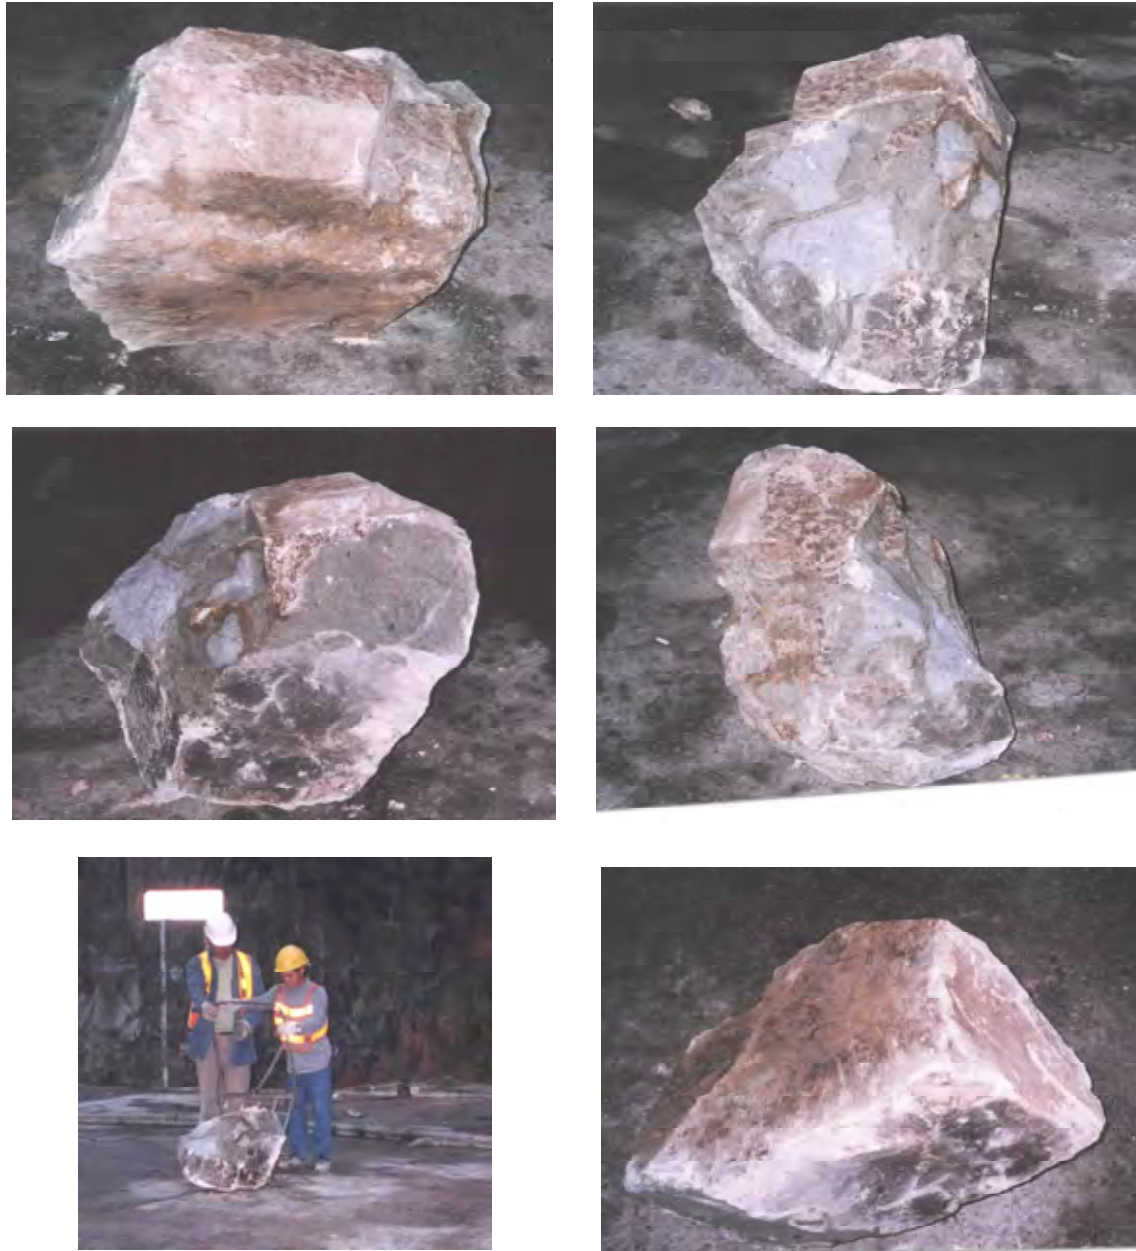
Plate 3 - Close-up Views of the Fallen Rock Block
(Photographs taken by GEO on 28 November 2002)

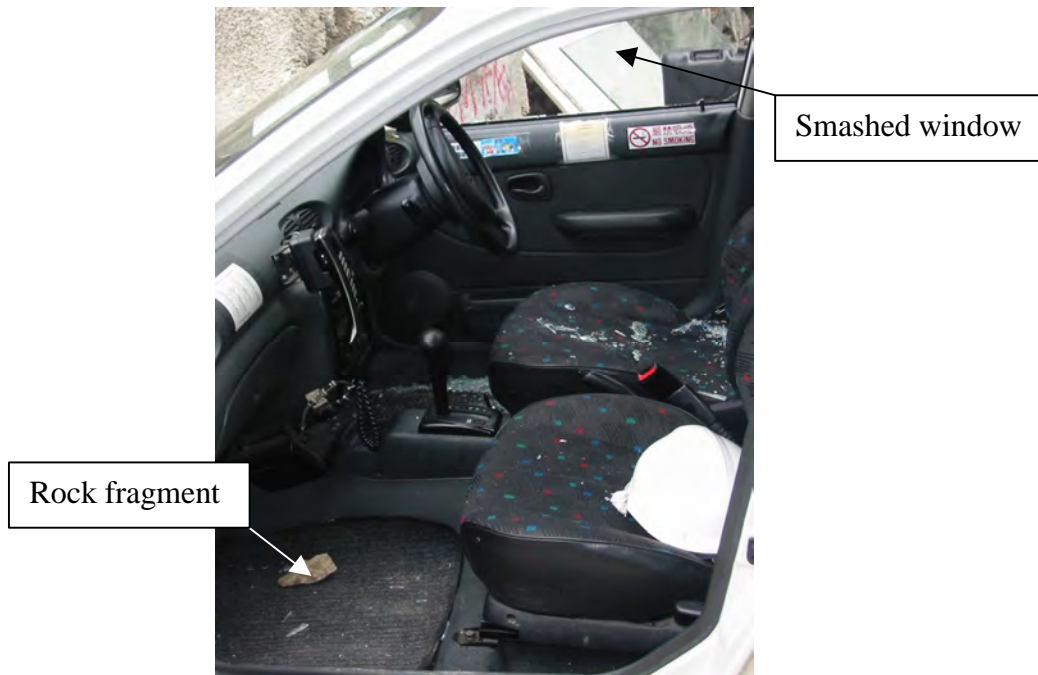
Plate 4 - View of the Affected Car A (Photograph taken by the Driver of Car A on 28 November 2002)

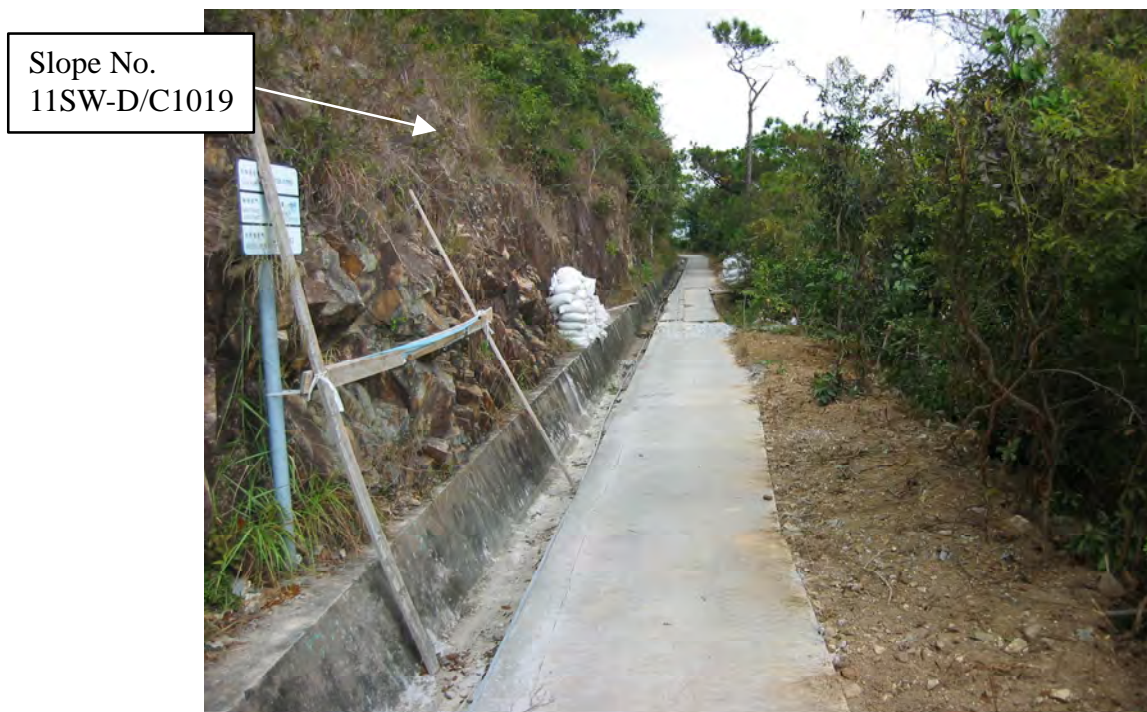
An inspection of the rock (fine ash vitric tuff) cut slope (No. 11SW-D/C1019) uphill of the catchwater channel (see Figure 2 and Plate 5) did not reveal any freshly broken surfaces that might be signs of detachment of rocks. When compared with the WSD's record photograph taken in October 2002 (Plate 6), it would appear that the rock cut slopes had been recently cleared of unplanned vegetation. In the same record photograph, stockpiling of what appears to be material stored in white sacks can be seen along the downhill side of the footpath.

Plate 5 - View of the Catchwater and Slope No. 11SW-D/C1019 (Photograph taken on 5 December 2002)

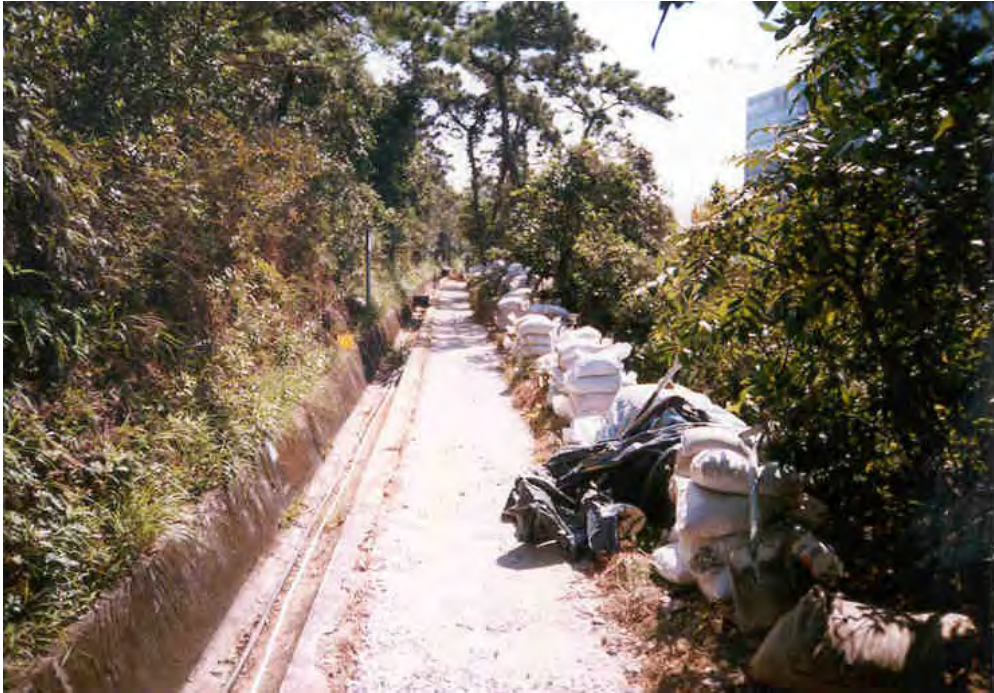
Plate 6 - View of Construction Works along the Catchwater
(Photograph taken by WSD in October 2002)

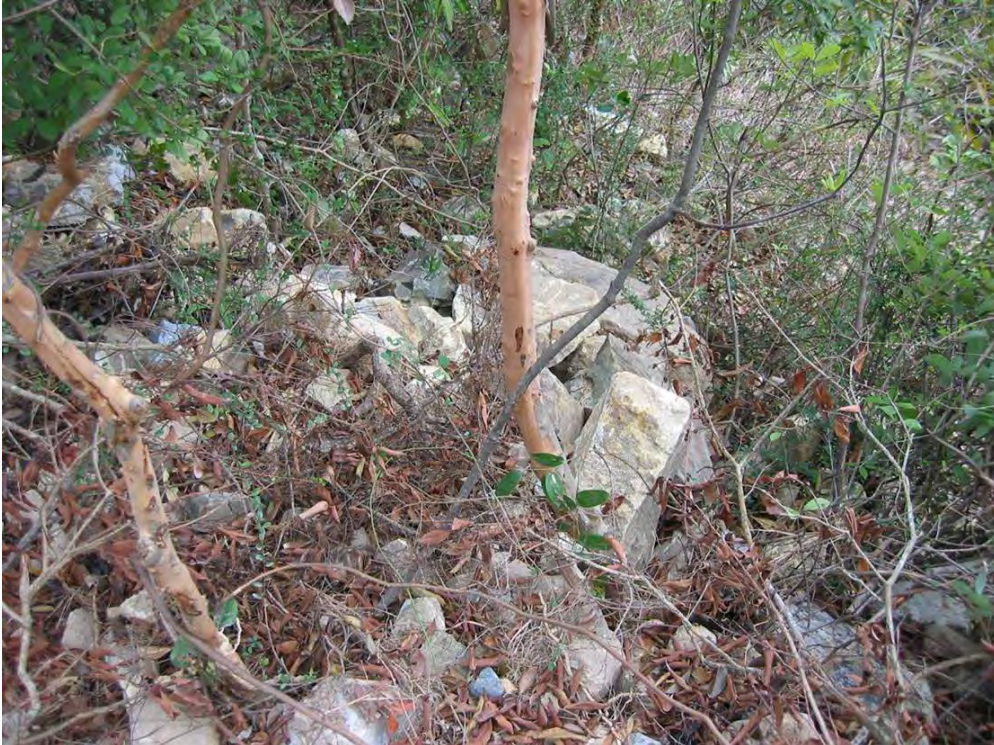
Plate 7 - Rock Blocks on the Natural Hillside below the Catchwater
(Photograph taken on 5 December 2002)

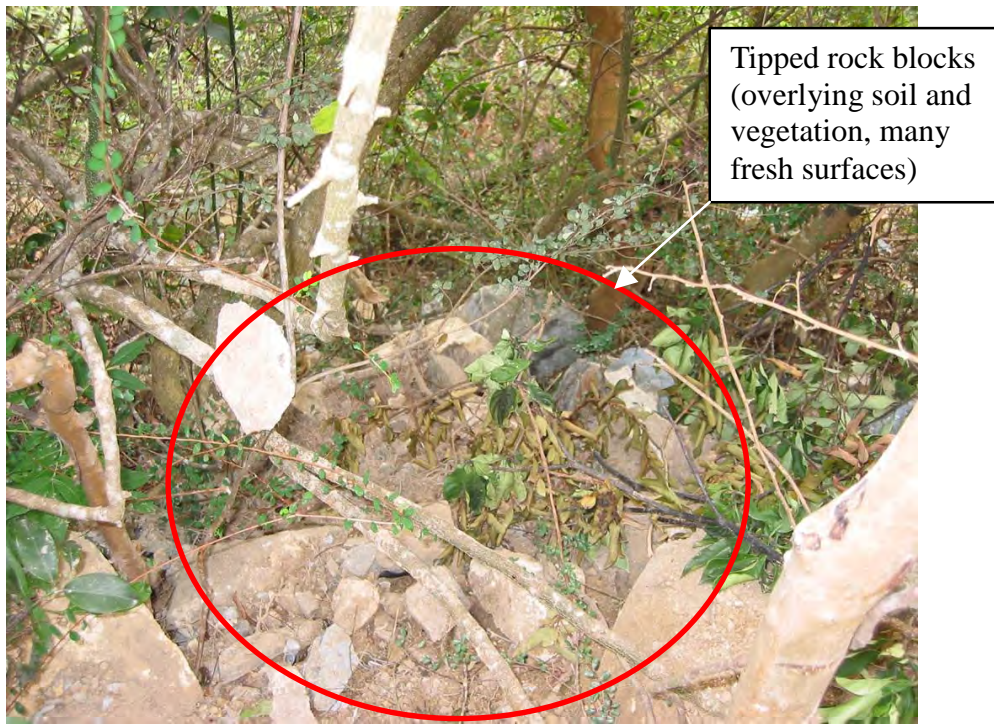
Plate 8 - Tipped Rock Blocks on the Hillside below the Catchwater
(Photograph taken on 5 December 2002)

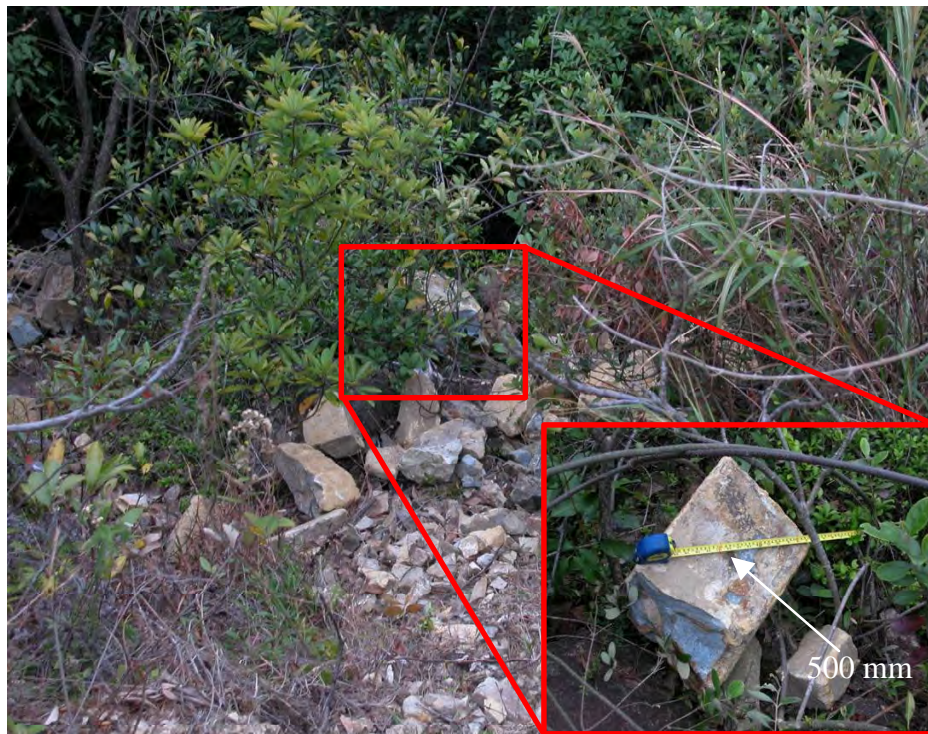
Plate 9 - Tipped Rock Blocks up to 0.5 m across below the Catchwater
(Photograph taken on 14 February 2003)

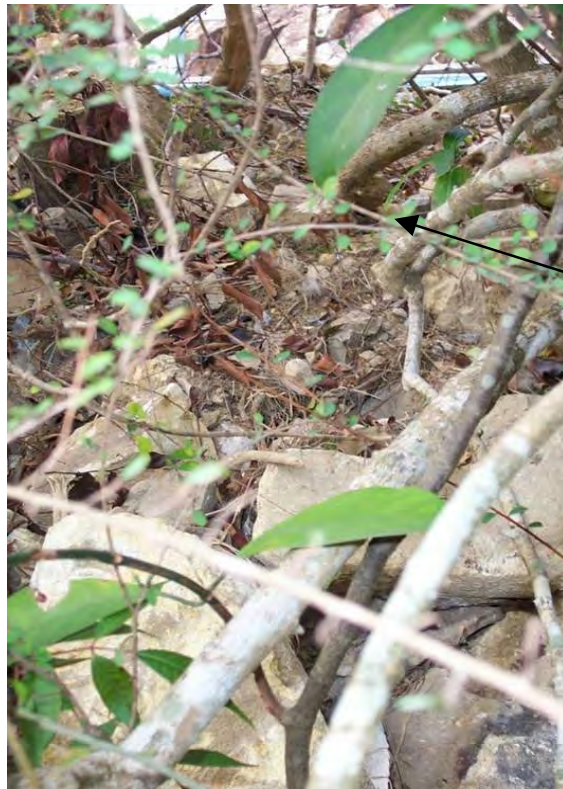
Damaged and
flattened
vegetation
(see Plate 8)

Plate 10 - Tipped Rock Blocks above the Probable Path of the Fallen Rock Block
(Photograph taken on 30 January 2003)

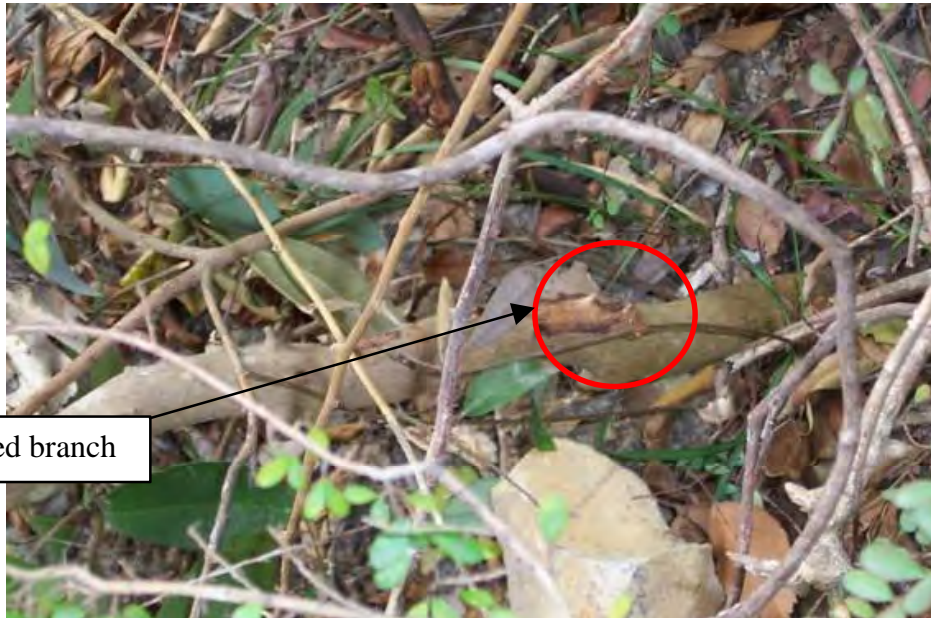
Damaged branch

Plate 11 - Damage to the Vegetation (Photograph taken on 30 January 2003)

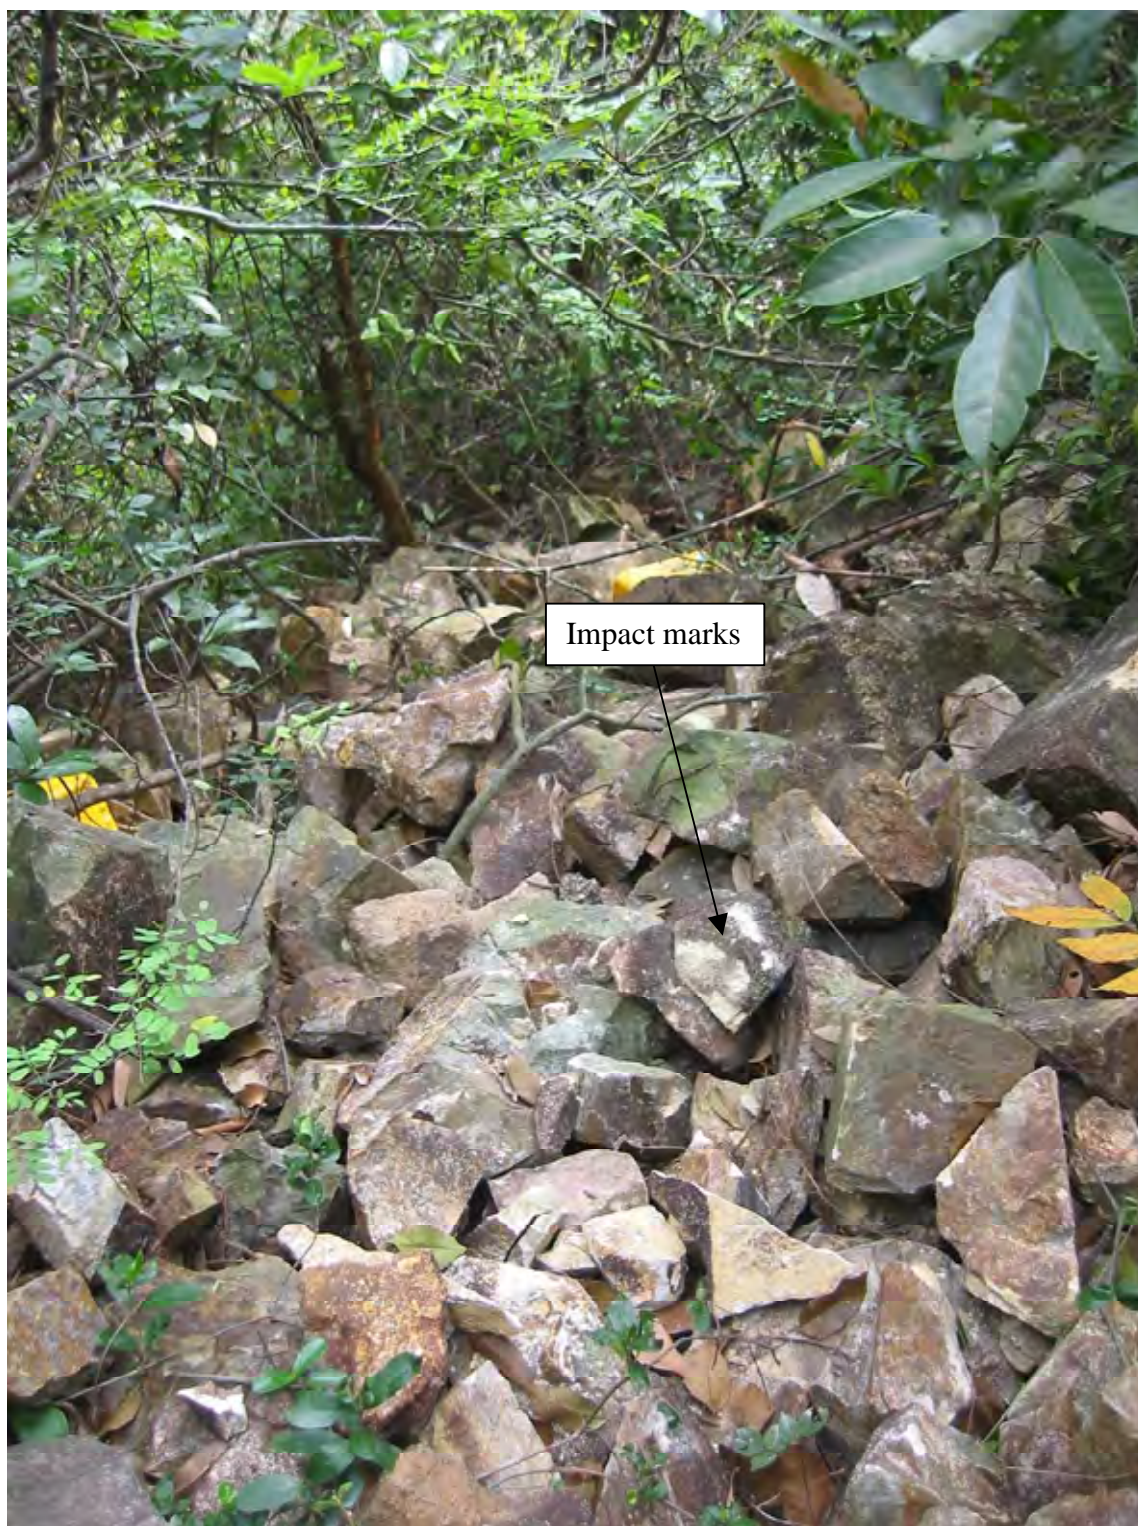
Plate 12 - View of Impact Marks on Rock Blocks
(Photograph taken on 5 December 2002)

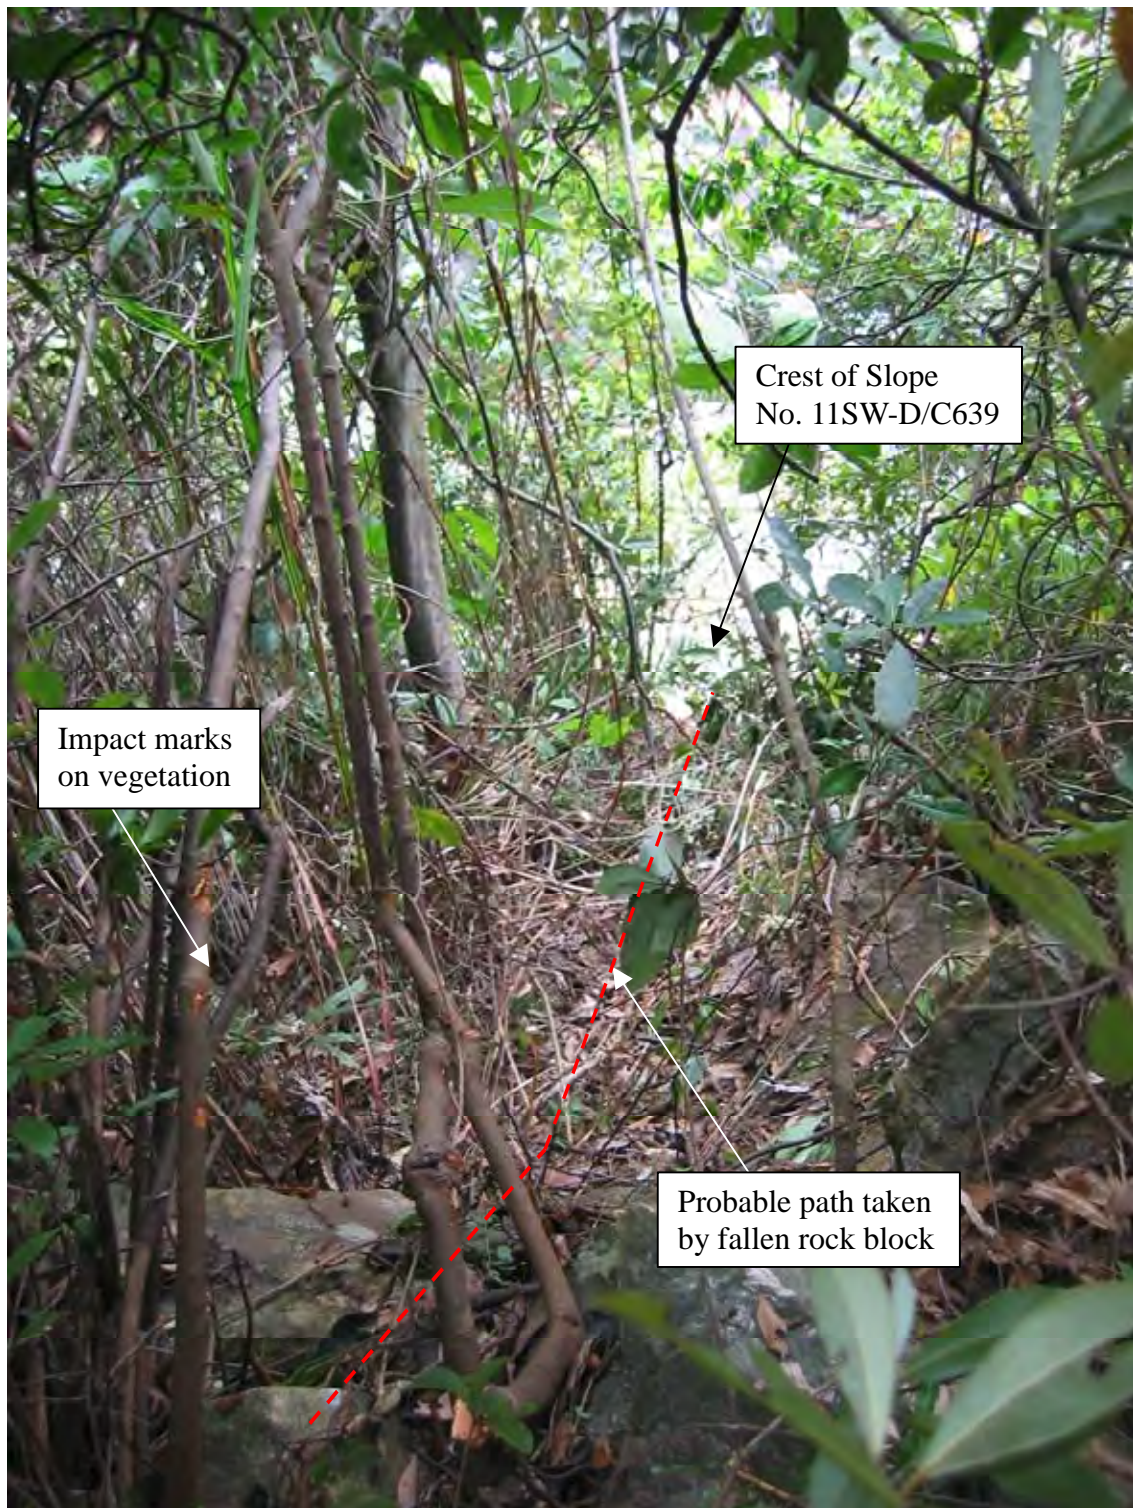
Plate 13 - View of the Impact Marks on Vegetation and Probable Path taken by Fallen Rock Block (Photograph taken on 30 January 2003)

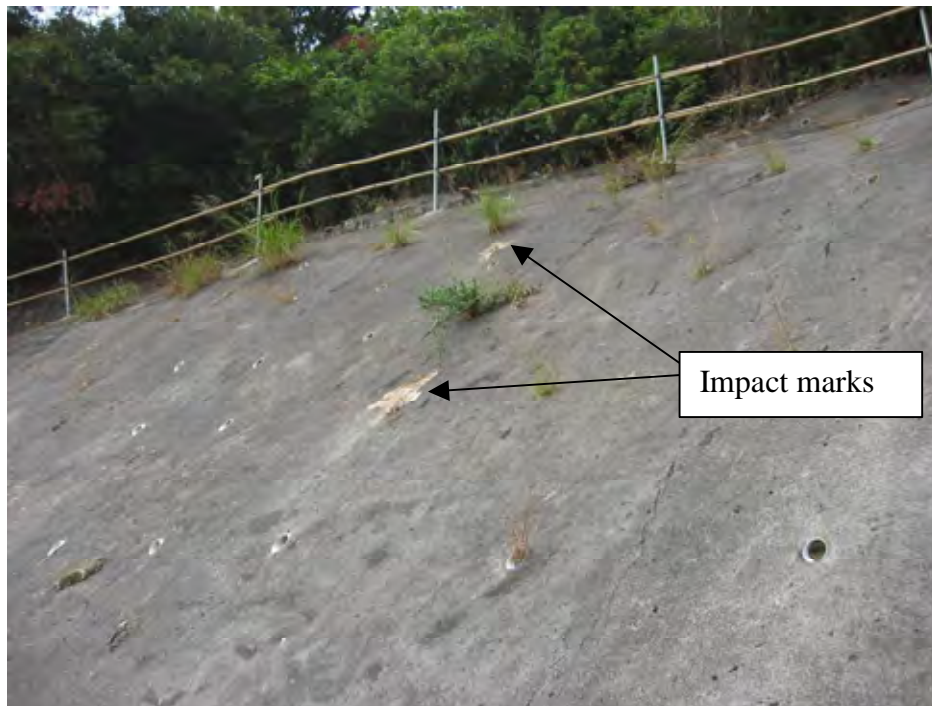
Plate 14 - View of the Impact Marks on Uppermost Slope Batter of Slope No. 11SW-D/C639 (Photograph taken on 5 December 2002)

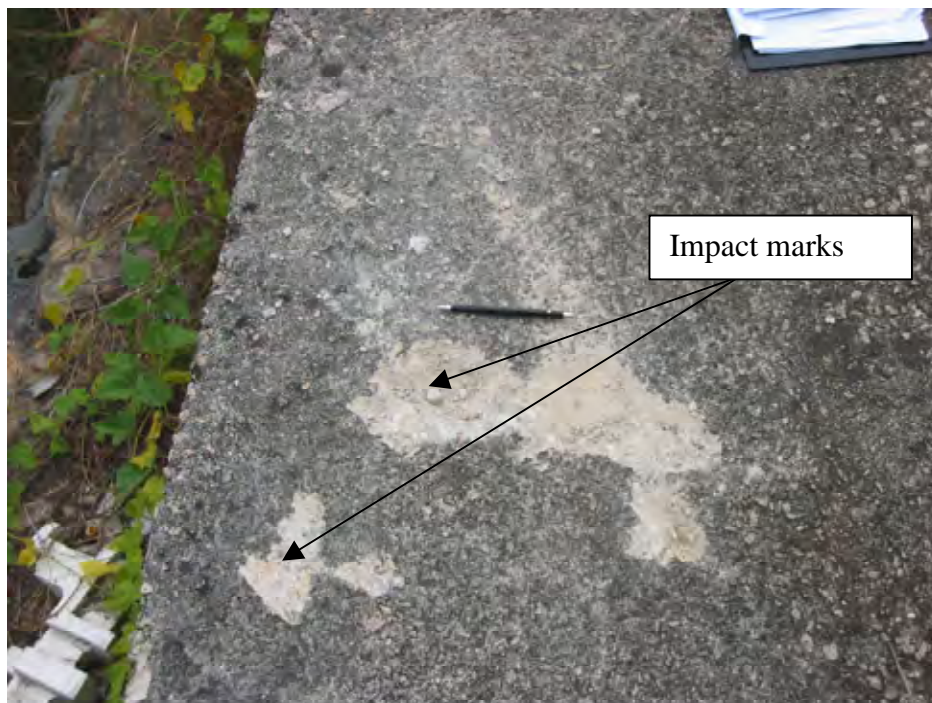
Plate 15 - View of the Impact Marks on Lowermost Berm of Slope No. 11SW-D/C639 (Photograph taken on 5 December 2002)

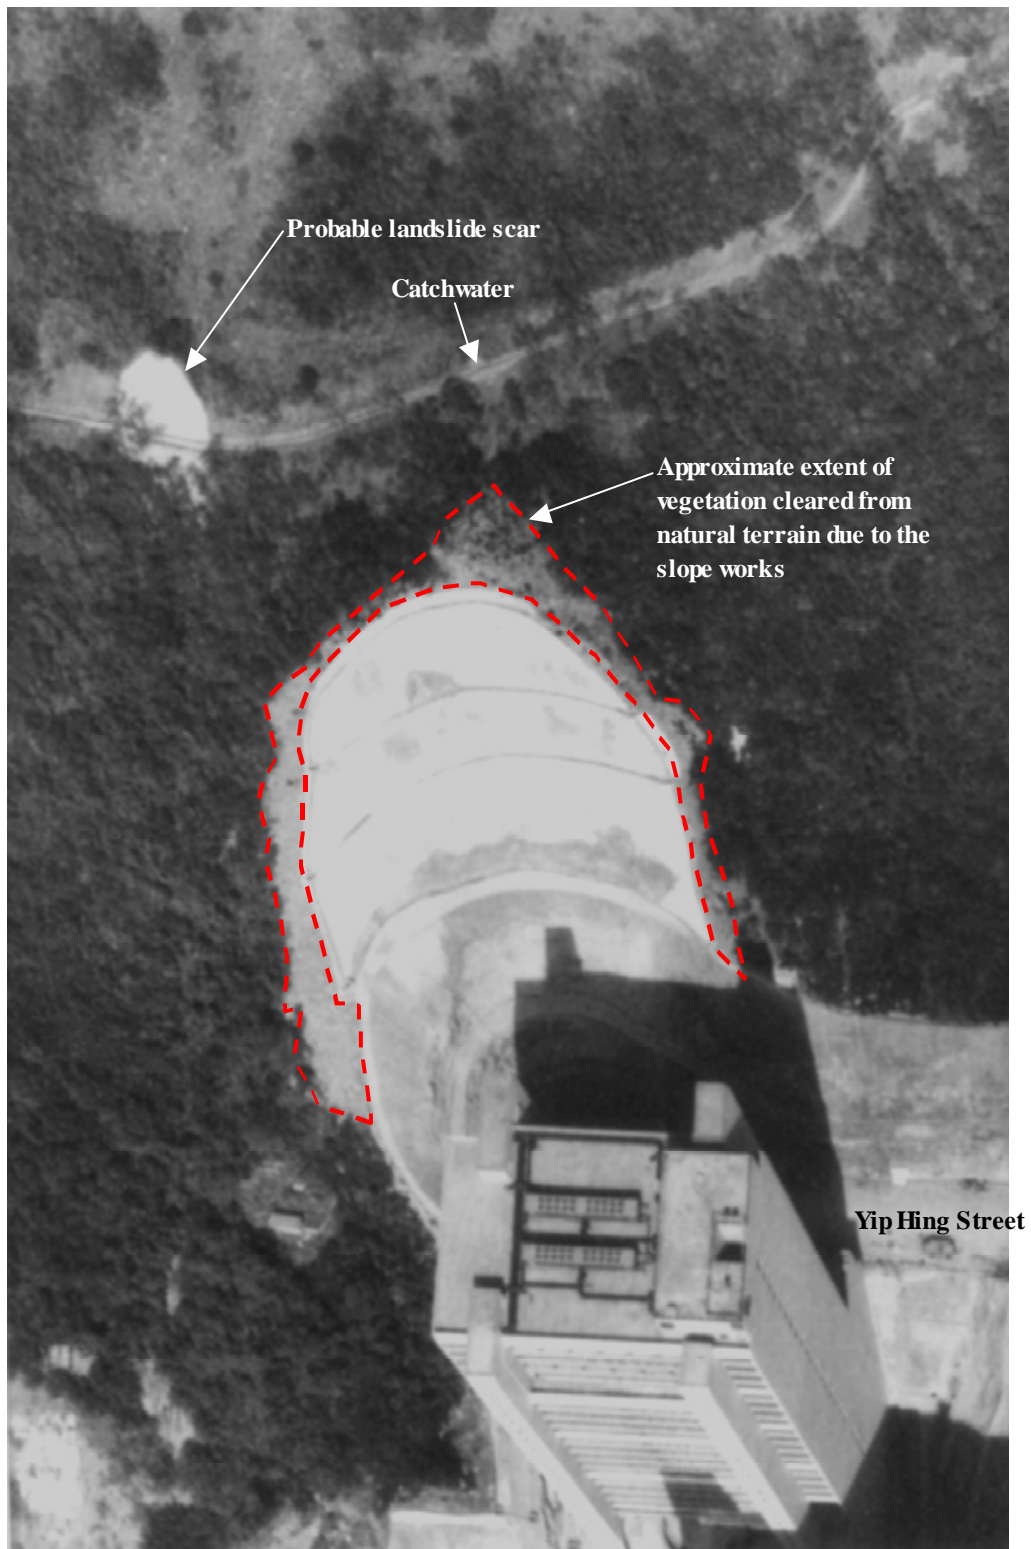
Plate A5 - 1984 Aerial Photograph of the Site

A possible landslide scar was observed in the 1984 aerial photographs (Plate A5) near cut slope No. 11SW-D/C1019 along the northern side of the catchwater. The south-facing 58 m high (about 23 m above and 35 m below the level of Yip Hing Street) cut slope No. 11SW-D/C2087 (Figure 2), adjacent to the western lower end of cut slope No. 11SW-D/C639, was formed between 1998 and 1999. Between 1999 and 2002 the site remained essentially unchanged.
