# **GEOLOGICAL CHARACTERISATION OF THE LAI PING ROAD LANDSLIDE**

**GEO REPORT No. 166**

**N.P. Koor & S.D.G. Campbell**

**GEOTECHNICAL ENGINEERING OFFICE  
CIVIL ENGINEERING AND DEVELOPMENT DEPARTMENT  
THE GOVERNMENT OF THE HONG KONG  
SPECIAL ADMINISTRATIVE REGION**

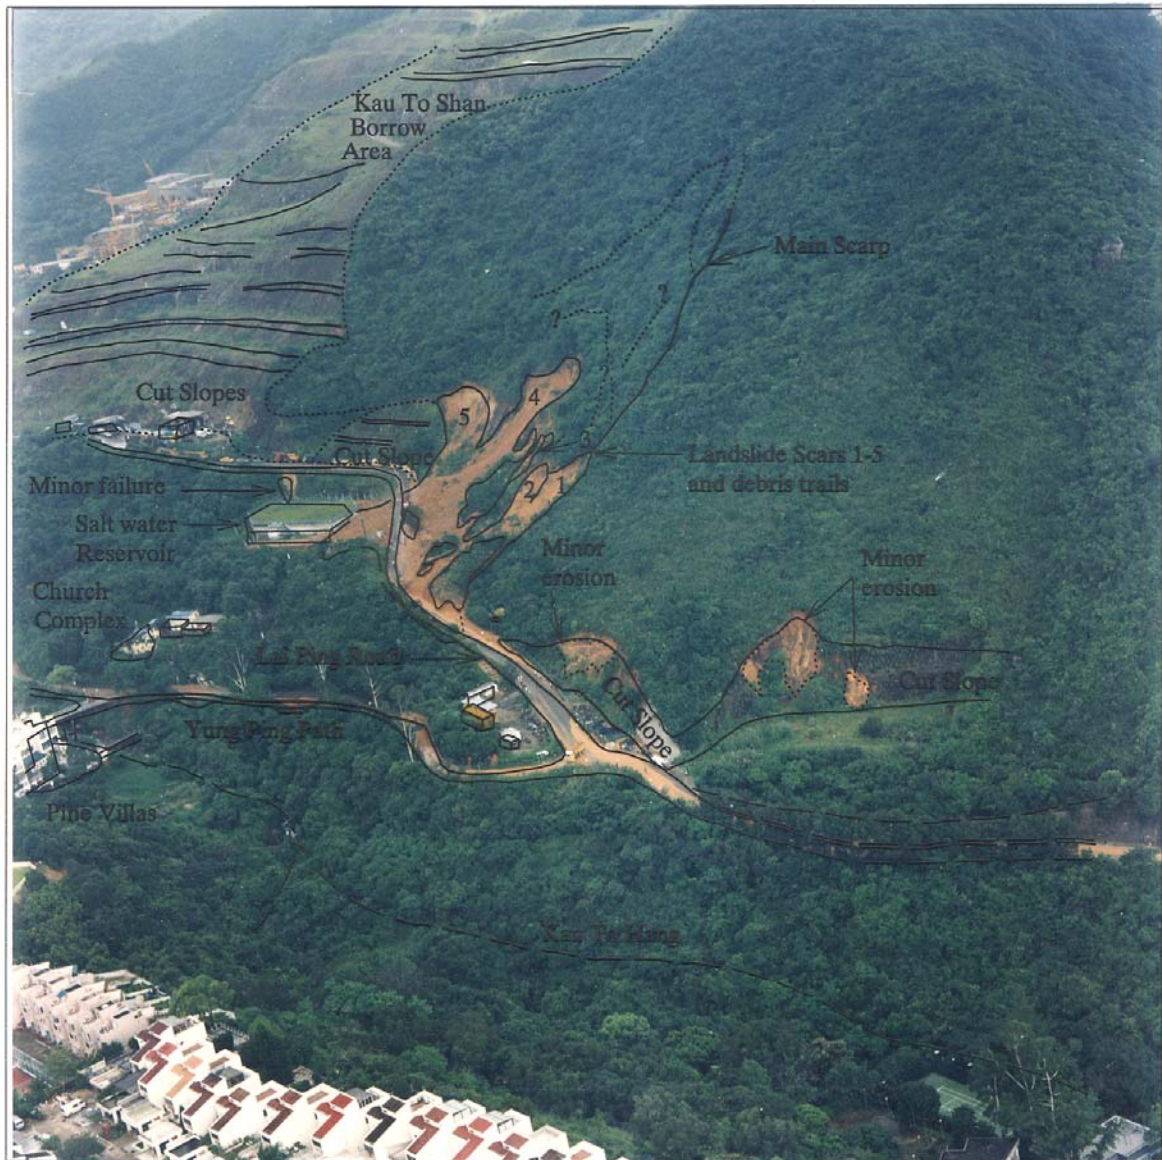
Plate 1 - Oblique Aerial View of Lai Ping Road Landslide Site from the South, Annotated to Show Landslide Scars 1-5, the Approximate Location of the Main Scarp, the Extent of the Debris, Locations of other Minor Failures, the Kau To Shan Borrow Area, the Church Complex and Other Structures (Taken on 4/7/97)

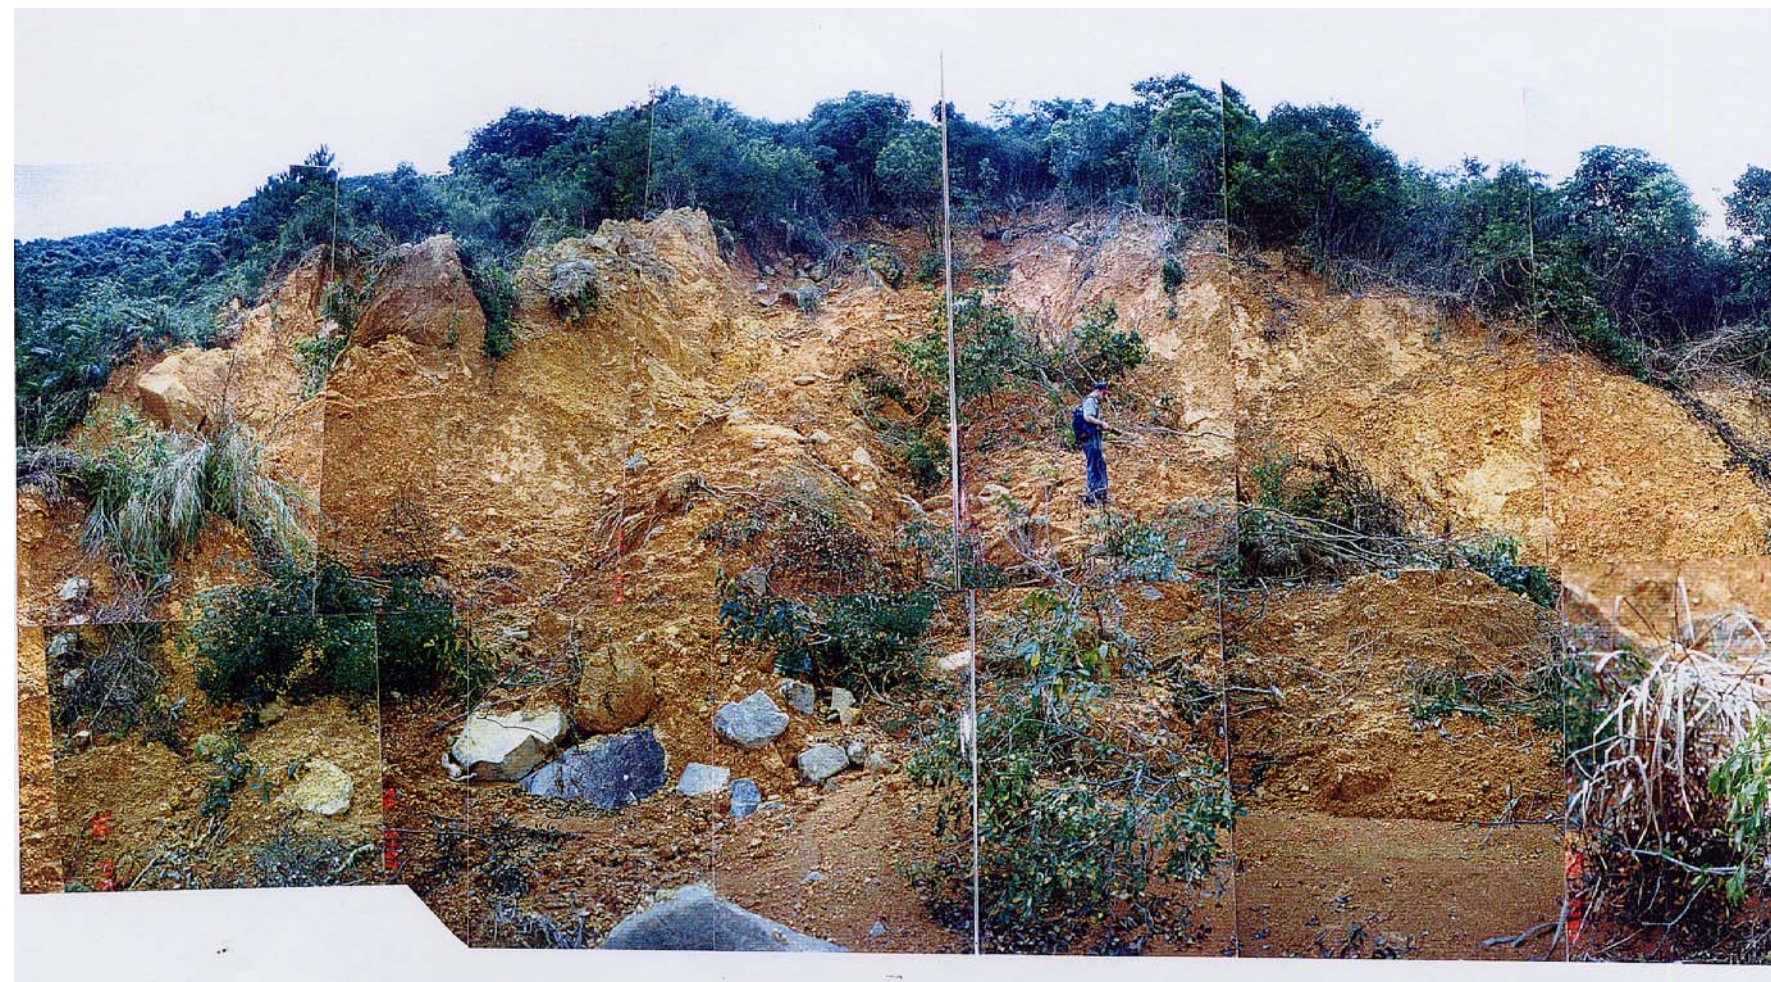
(a) Landslide scar 1 (Plate 11) has its toe within the original cut slope and its crown within quasi-natural terrain, 20 m to the east of the cut slope (Figure 1). The main scarp is generally trapezoidal in plan, being 13 m wide at the crown, 25 m wide at the toe and 52 m long. At the crown, the main scarp is sub-vertical and about 1.5 m high and is intersected by tension cracks that continue up-slope. The left hand flank of the main scarp is up to 5 m high and inclined at 45°. The right hand flank is up to 4 m high and ranges from sub-vertical to inclined at 45°. The landslide occurred in mainly residual soil grading to completely decomposed tuff in places. Pods of rhyolite dyke are also present (Drawing No. EG 499). Planar slickensided surfaces of rupture are present within the gully eroded surface below the crown of the slide (Plate 12 & Drawing No. EG 499). The slickensides indicate a direction of landslide movement towards 190° at an inclination of between 32° and 45°.

Plate 11 - View of Landslide Scar 1 Looking Up Towards the Main Scarp (Plate Location shown on Drawing EG503) (Taken on 30/7/97)

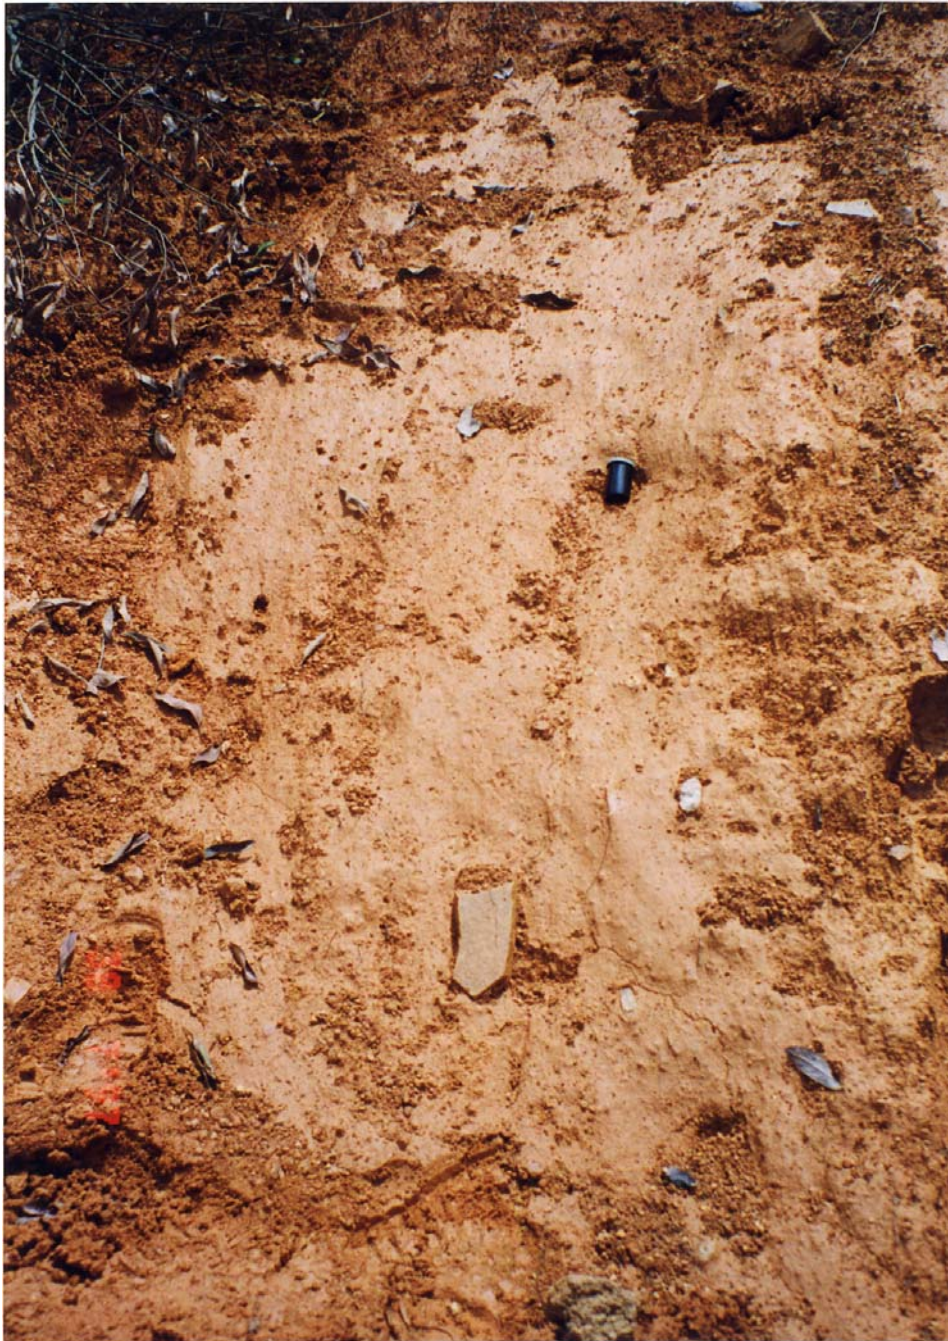
Plate 12 - Planar Slickensided Surface of Rupture Exposed below the Crown of Landslide Scar 1 (Plate Location Shown on Drawing EG503) (Taken on 30/7/97)

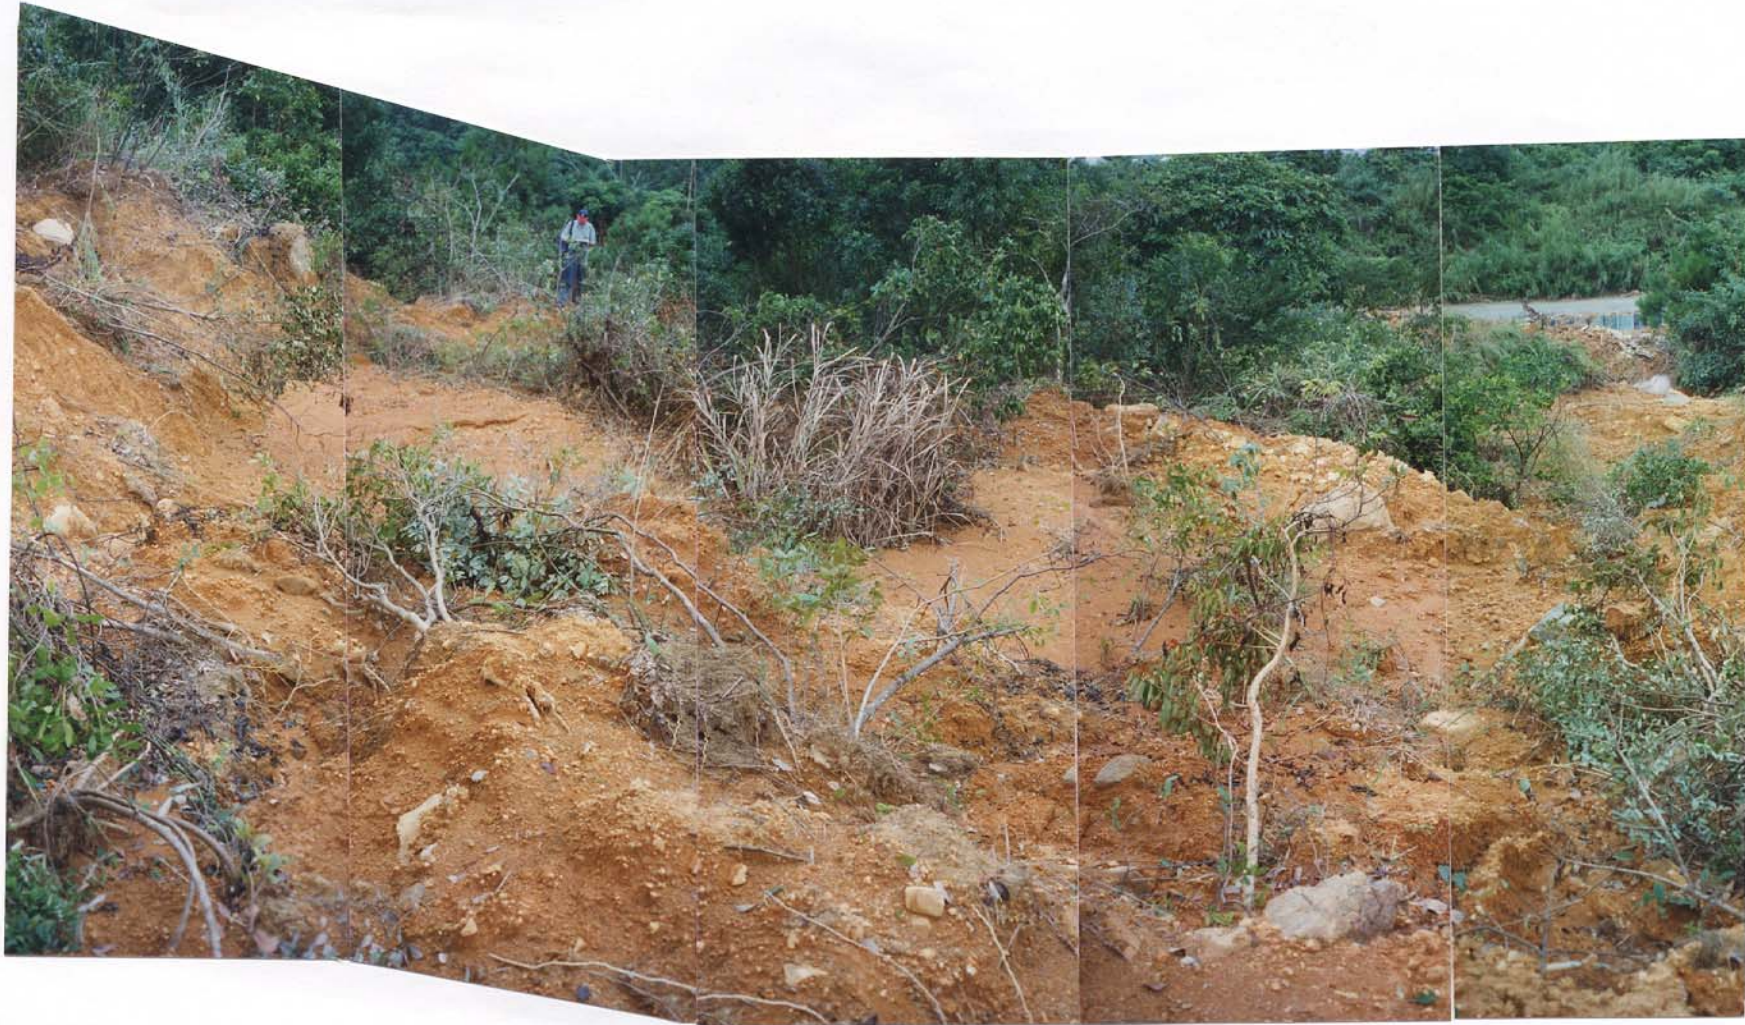
Plate 13 - Flat Area of Deposition and Debris Mound in Area Up-Slope of the Intact Debris Raft in Landslide Scar 1 (Plate Location Shown on Drawing EG503) (Taken on 30/7/97)

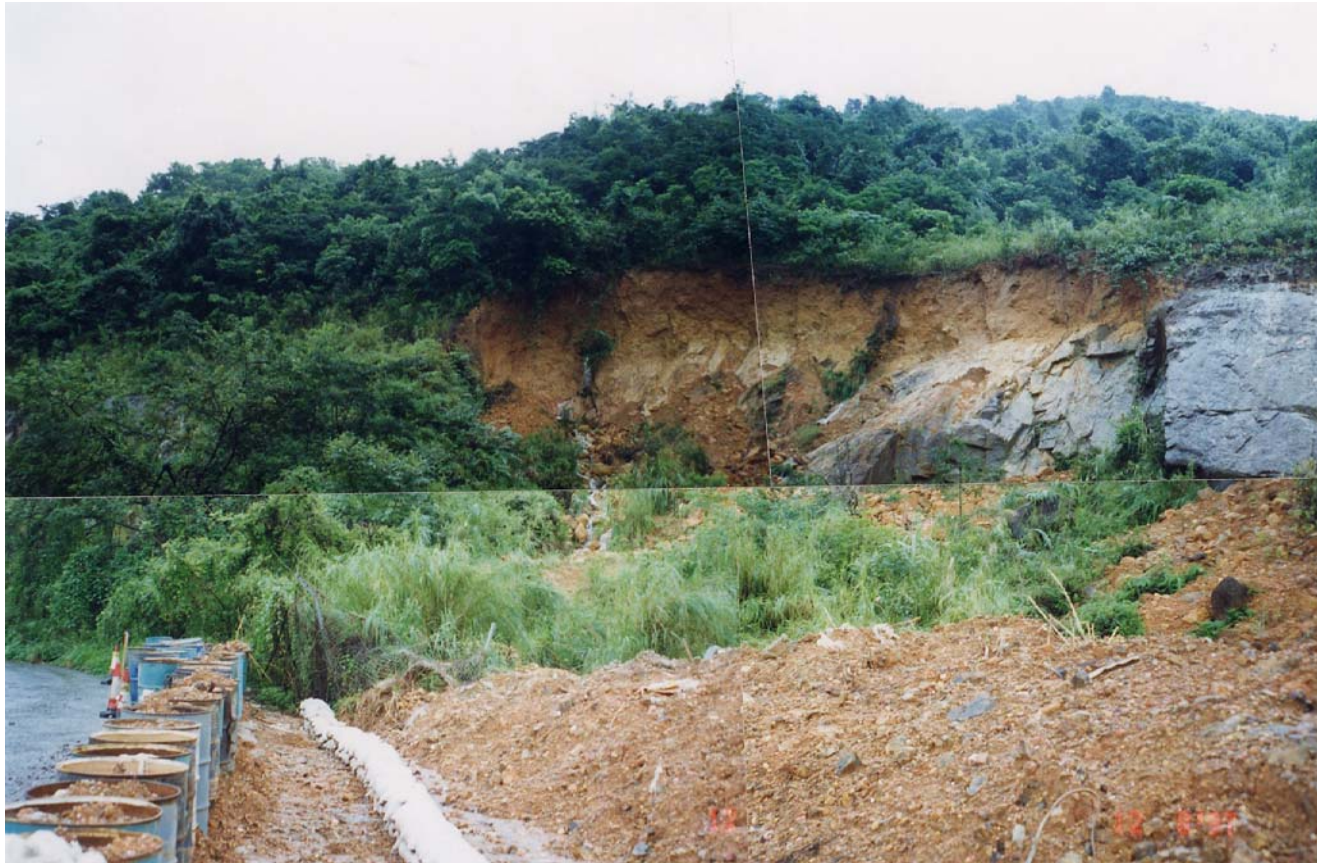
Plate 21 - View of Landslide Scar 4 & 4A (Plate Location Shown on Drawing EG503)  
(Taken on 12/8/97)

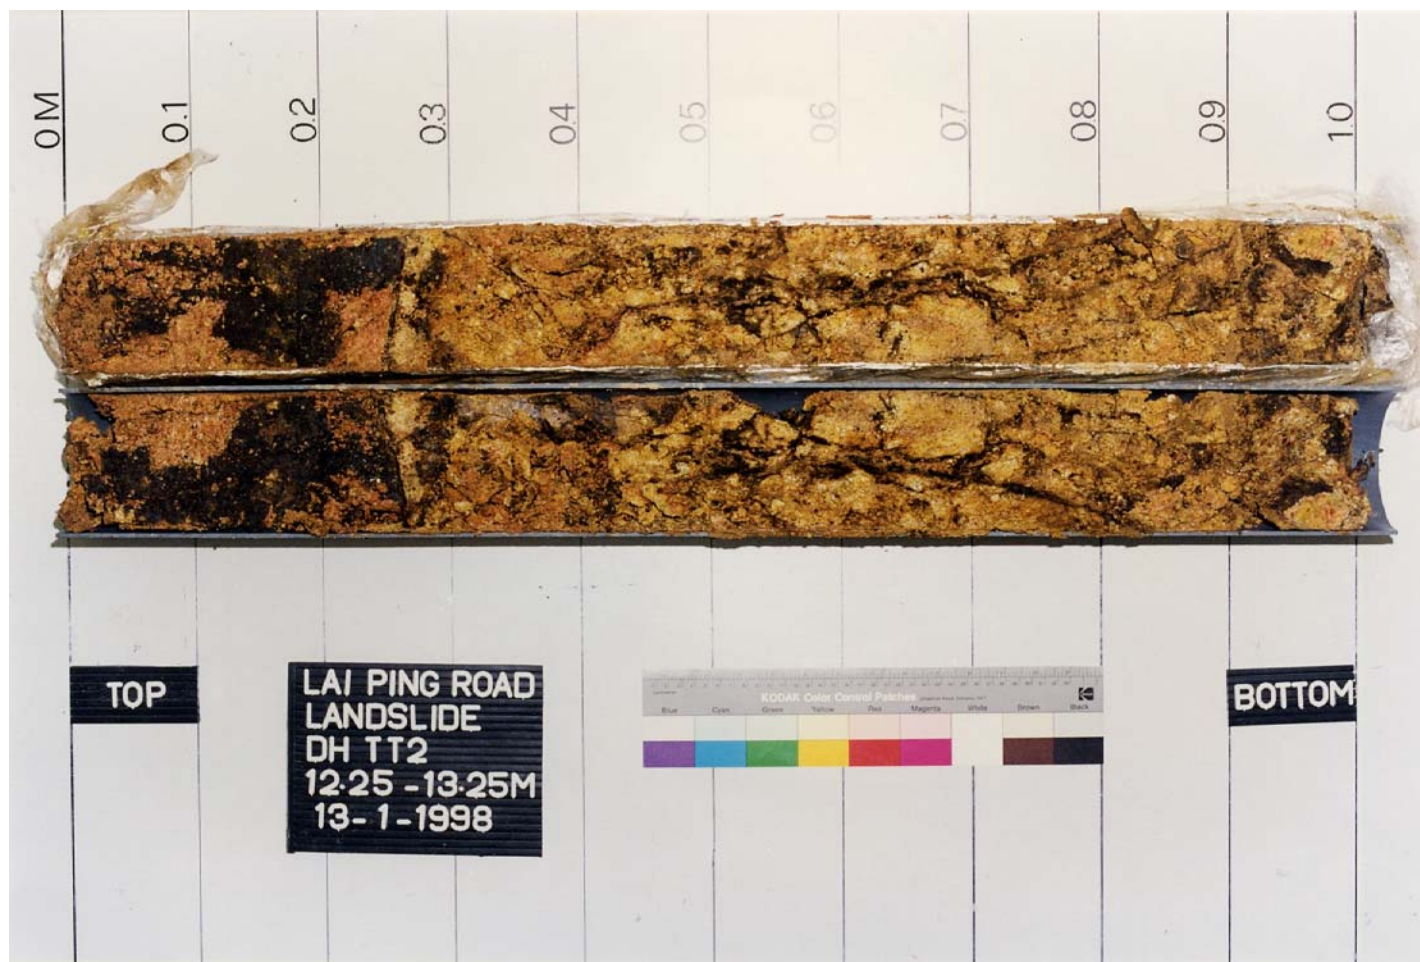
Plate 32 - Split 4CMLC Core from Drillhole TT2 Showing Sub-Vertical Relict Joints with Much Manganiferous Staining on the Joint Surface and within the Rock Fabric (Taken on 31/1/98)
