**REPORT ON THE
DEBRIS FLOW AT
SHAM TSENG SAN TSUEN
OF 23 AUGUST 1999**

**FINDINGS OF
THE INVESTIGATION**

GEO REPORT No. 169

Fugro Maunsell Scott Wilson Joint Venture

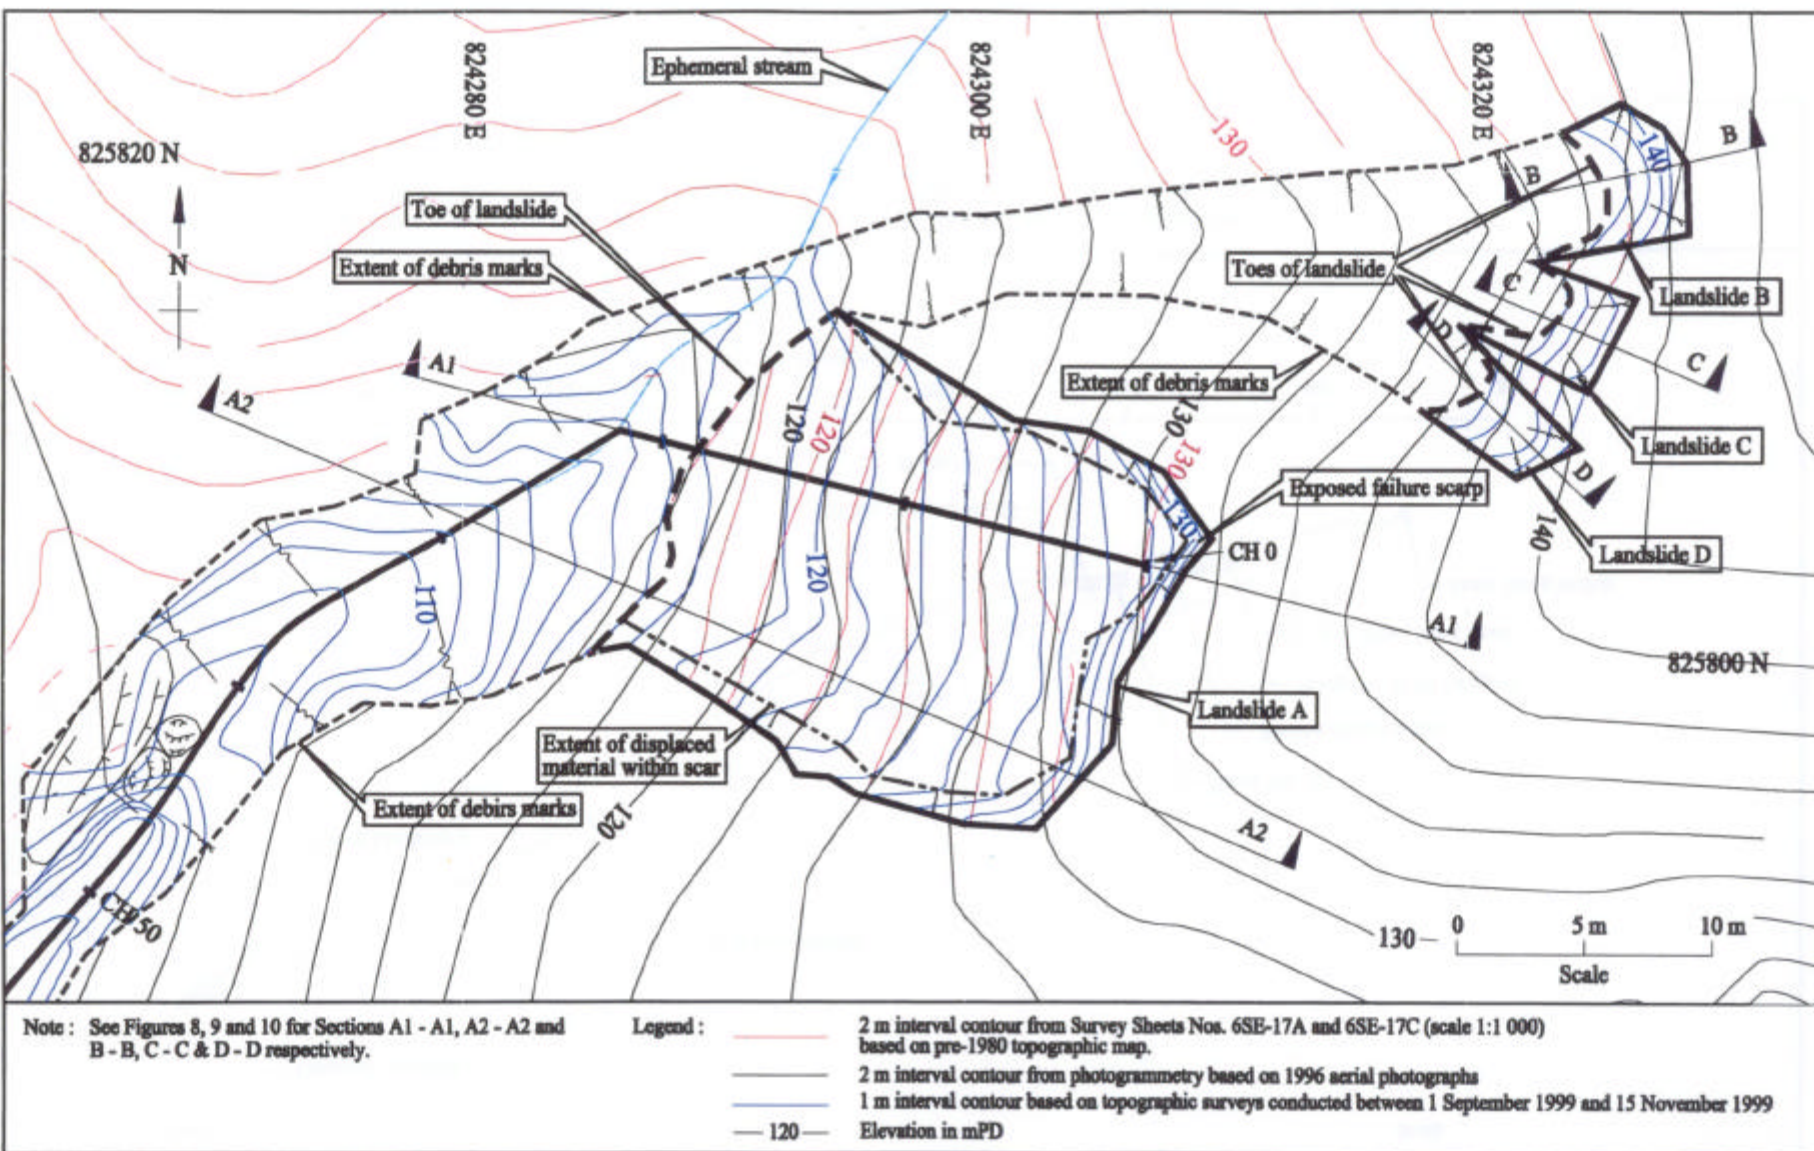
Figure 7 - Pre-failure and Post-failure Topographical Plan of the Landslides

Figure 7 shows the topographic contours derived from the 1:1000 scale topographic map of the area (which was based on pre-1980 mapping) and contours derived from photogrammetric analysis of the 1996 aerial photographs taken after the hillfire had burnt off the vegetation cover. The differences in the elevations derived from the different sources (Figure 13) may be due to the hillfire reducing the height of vegetation cover to a greater extent near the less sheltered ridge line, or accuracy of the different techniques adopted for the two surveys. It is not certain whether the differences between the two sets of contours could be partly attributed to any progressive slope movements at the site of Landslide A.

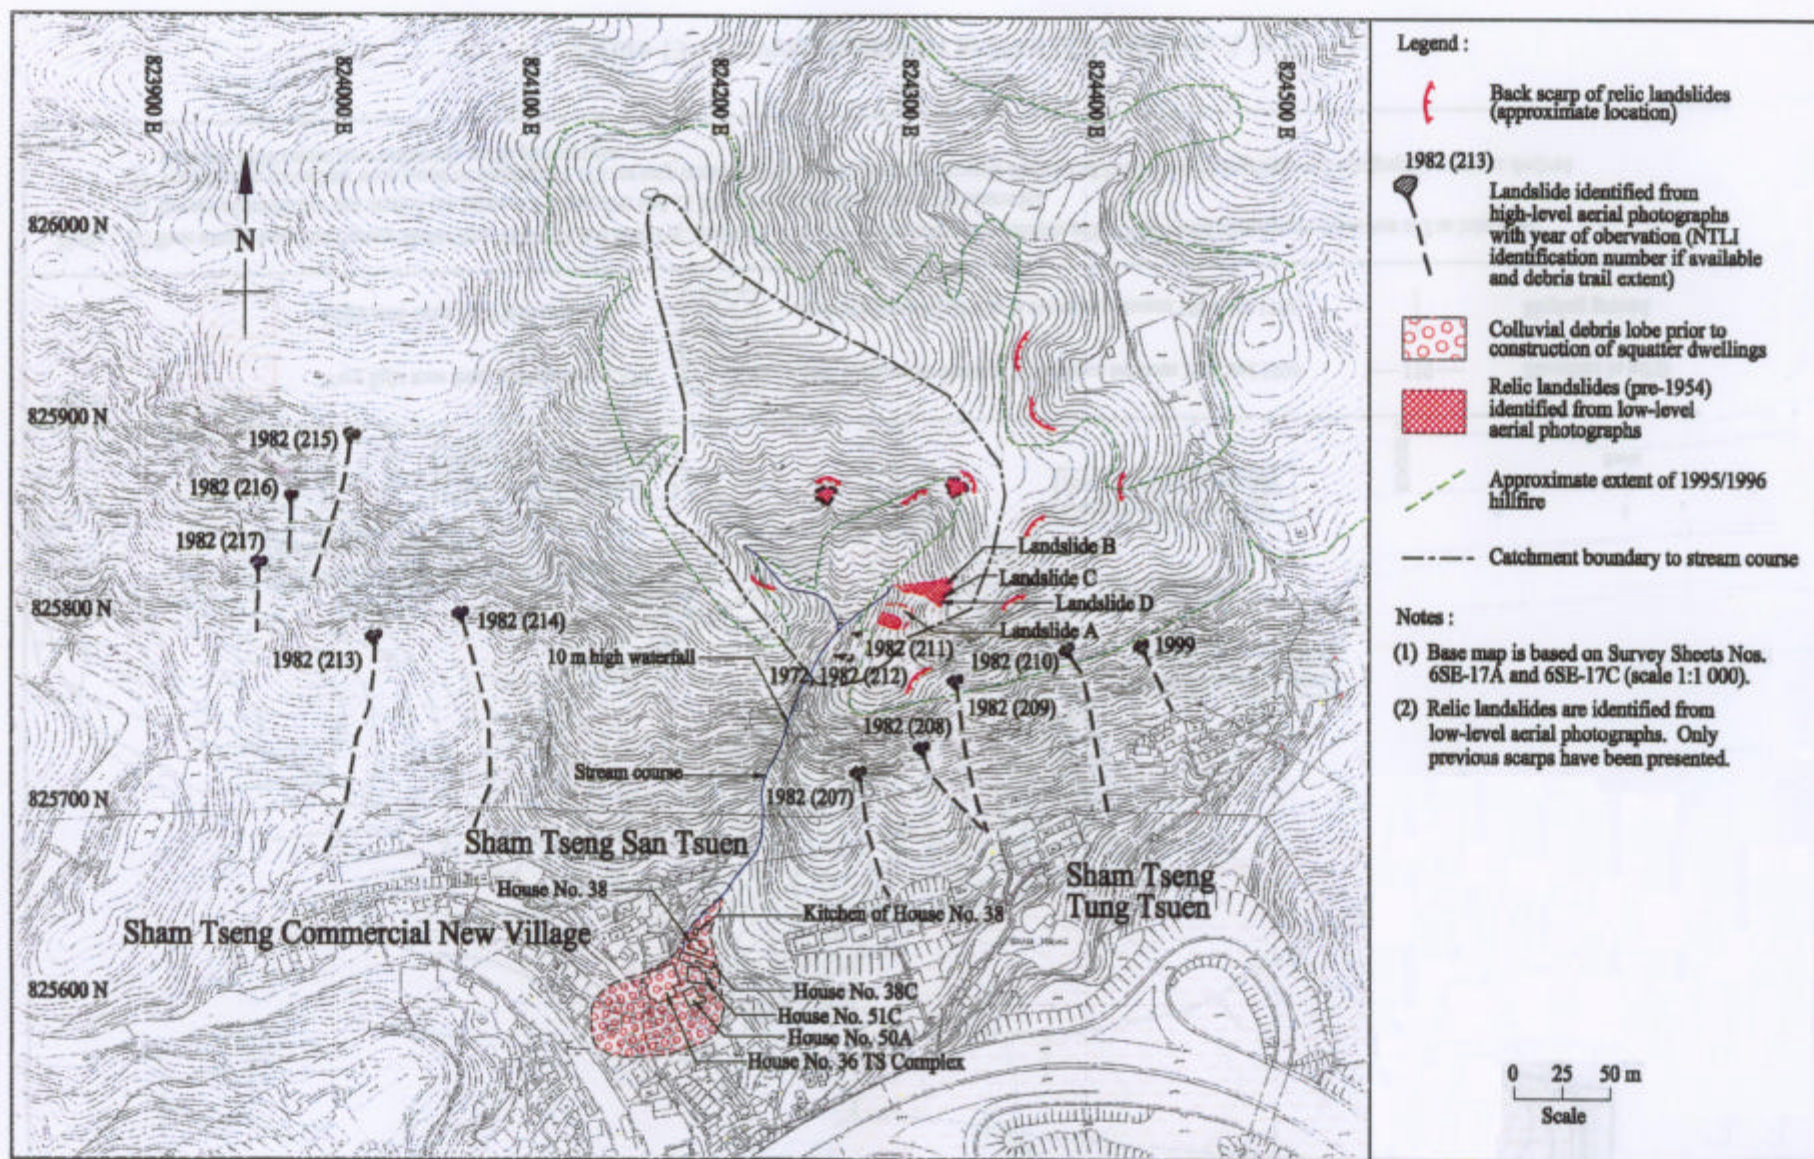
Figure 12 - Previous Instability at the Natural Hillside above the Sham Tseng Squatter Villages

Topographic depressions, probably representing relic landslides, can be identified on the 1963 low-level aerial photographs at the locations of Landslides A to D (Figure 12). There was a complete vegetation cover of grass and small bushes on these relic landslide scars at this time. The absence of visible scars on the 1954 high altitude aerial photographs probably indicates a failure at least 30 to 35 years prior to 1954, having regard to the likely rate of re-vegetation of the scars (Evans et al, 1997). The locations of the previous landslides in the vicinity of the 1999 landslide sites are shown in Figure 12.

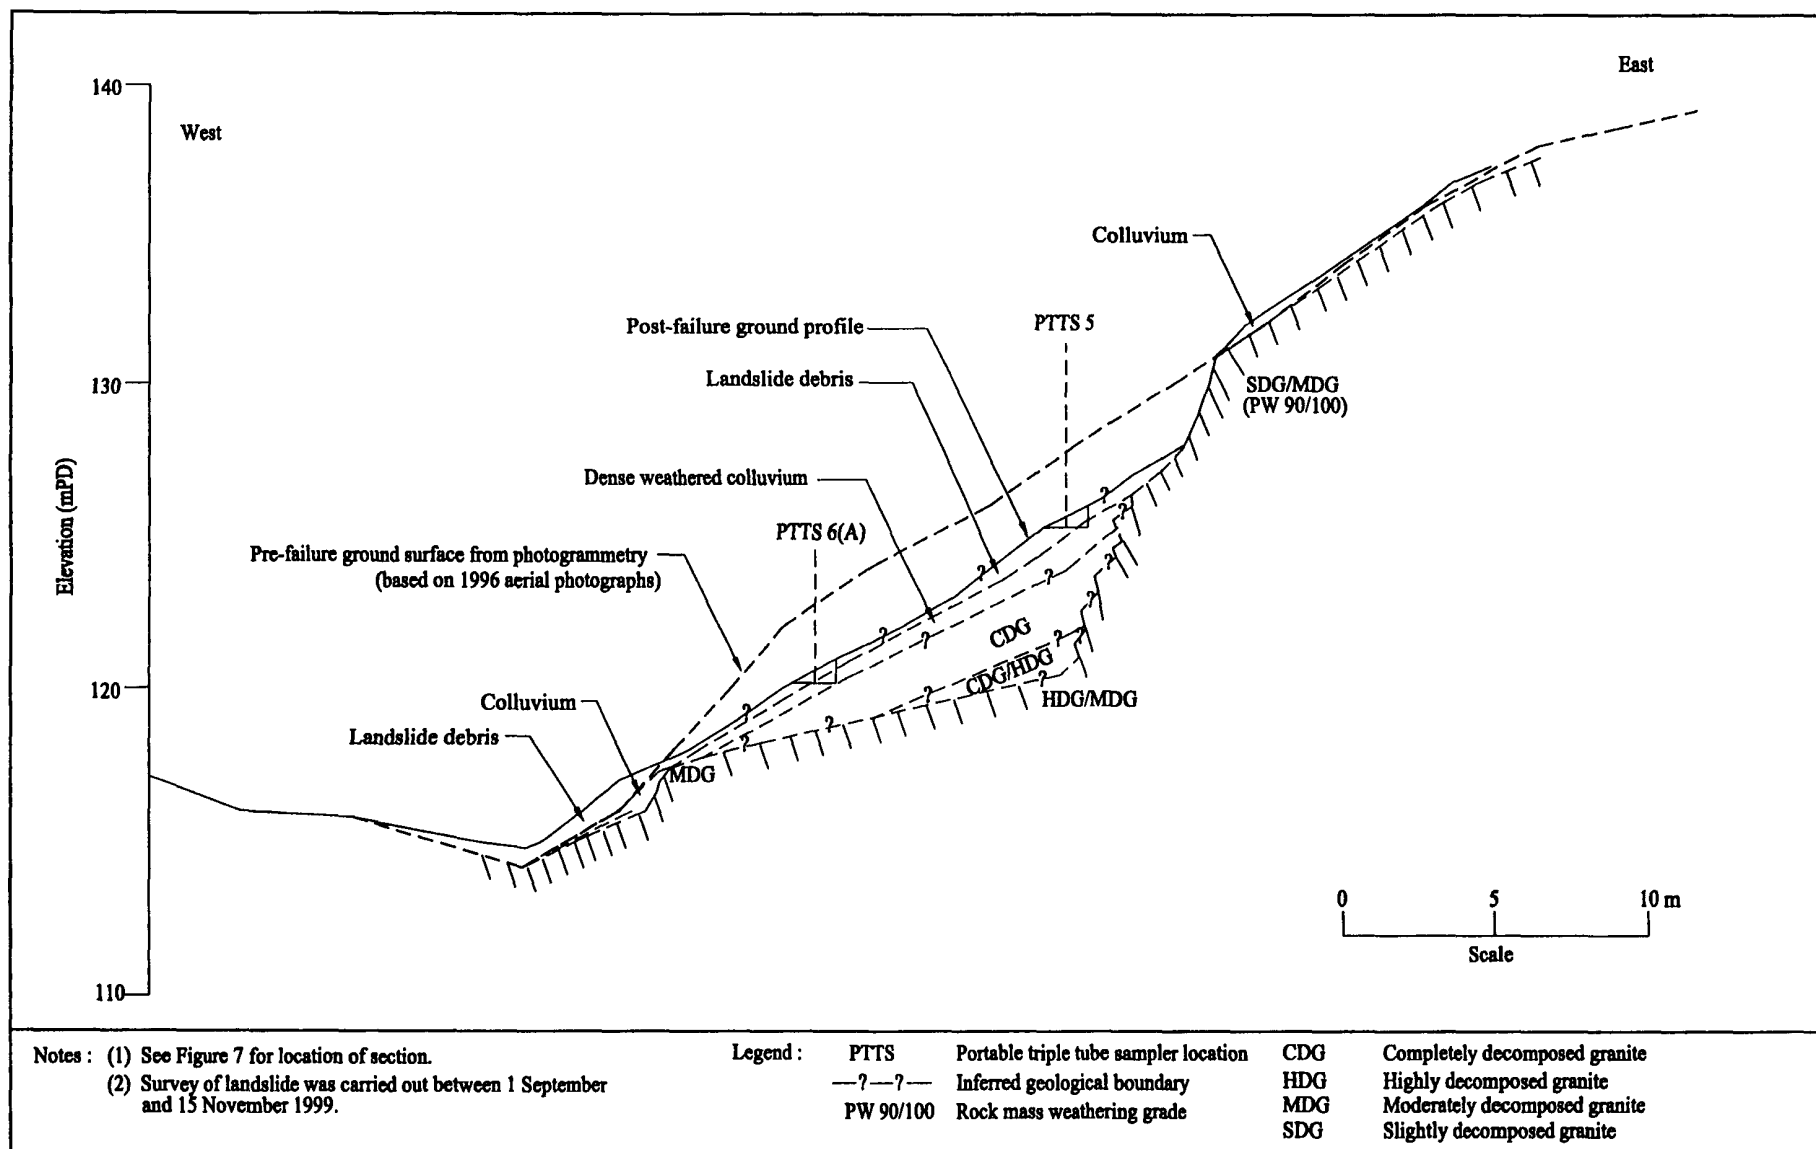
Figure 18 - Geological Section A1 - A1 Through Landslide A

Geological sections through Landslide A are shown in Figures 18 and 19. These indicate that the rockhead (taken to be the upper surface of PW 30/50 or better material) below the main scarp is steeply inclined at a roughly similar angle to that of the exposed scarp. The depth of superficial and completely to highly decomposed material is up to 8 m below the 1999 pre-failure ground surface. No fault or major discontinuity can be seen at the steeply inclined rockhead surface.

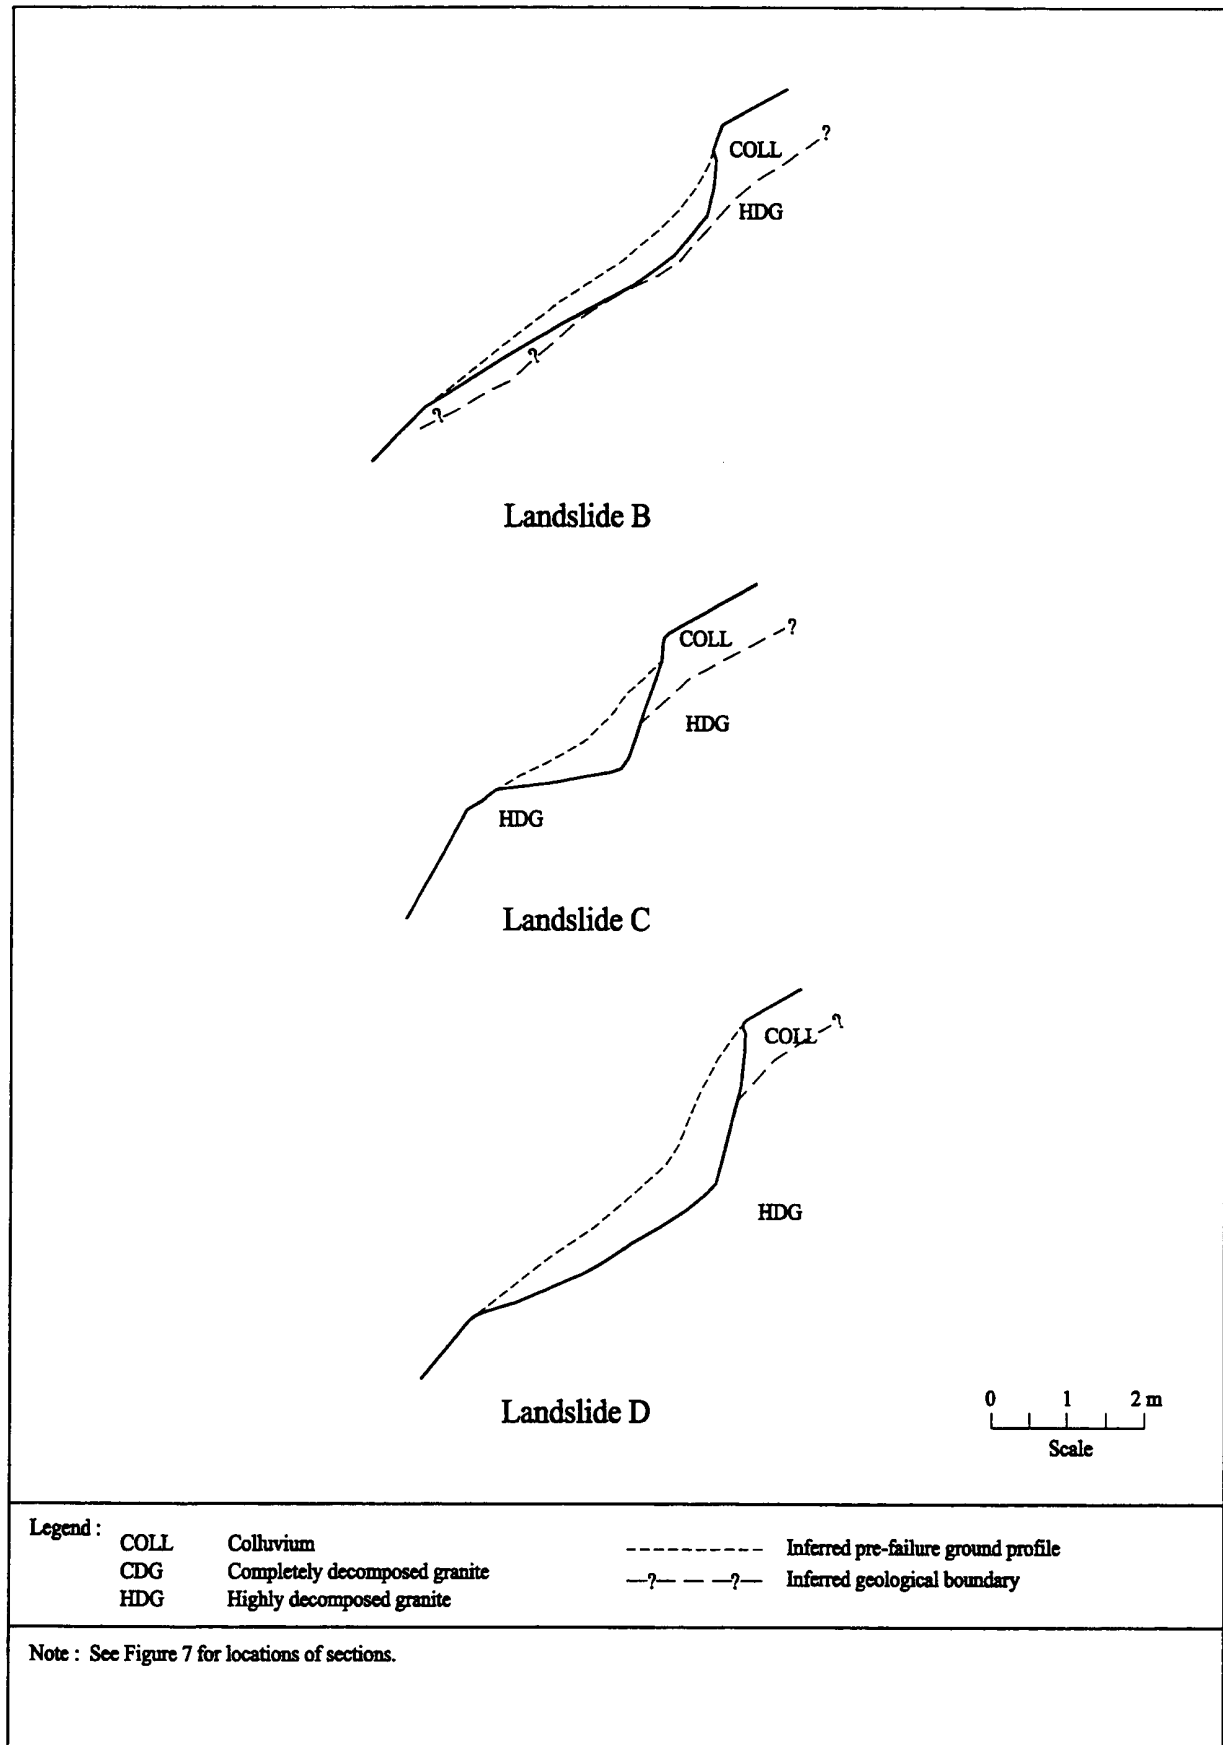
Figure 20 - Geological Sections Through Landslides B, C and D

At the smaller Landslides B to D (Figure 20), loose to medium dense colluvium containing cobbles and boulders of CDG/HDG overlies completely and highly decomposed fine to medium-grained granite, which is locally intruded by sub-vertical, completely to highly decomposed medium and fine-grained granite dykes striking 260° . Small 'holes' up to 50 mm diameter (rootholes) are present within the colluvium in the scarps. Localised downslope erosion below these holes was noted when first inspected on 27 August 1999, indicating seepage had occurred. In the northern part of the scarp of Landslide B, a prominent iron-stained joint orientated sub-parallel to the post-failure ground surface (with dip and dip direction of $54^{\circ}/290^{\circ}$) forms the base of most of the scar. As indicated in Figure 20, the lower part of the rupture surfaces have formed either at or slightly below the interface between the colluvium and insitu decomposed granite, whereas the upper part lies mainly within the colluvium.

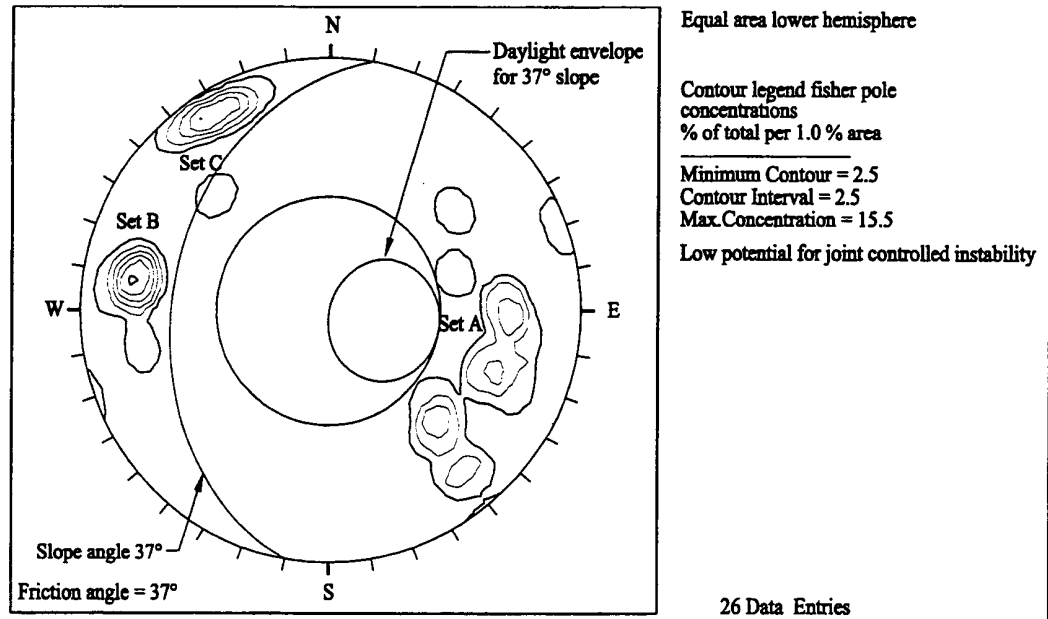
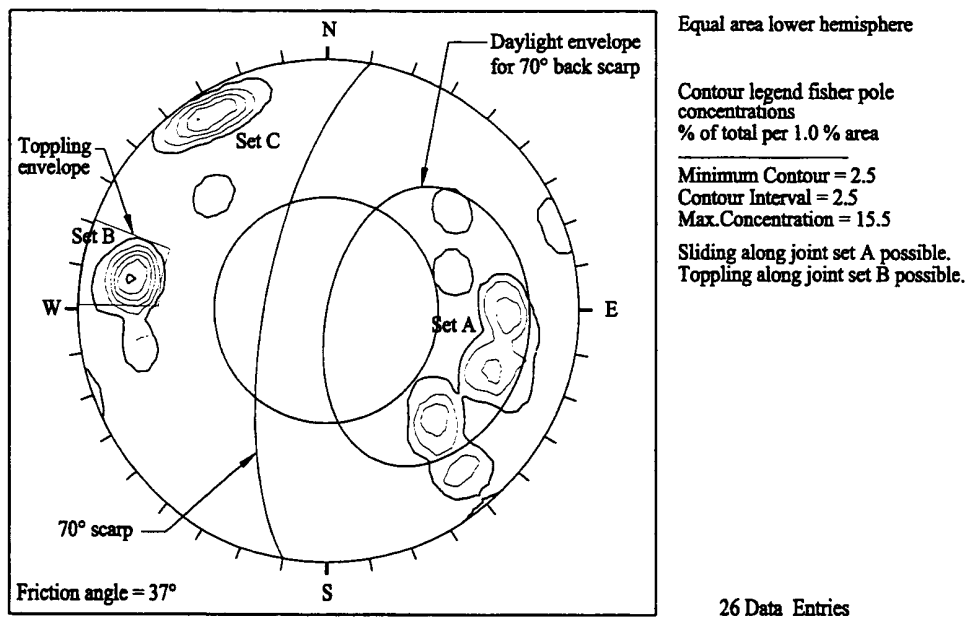
Figure 21 - Stereographic Assessment of Potential Joint-controlled Instability at Landslide A

The contoured stereographic projections shown in Figure 21 indicate that the Set A joints are not unfavourably orientated with respect to kinematic sliding of the pre-failure ground profile (approximately 37°), but they would be unfavourable with respect to the stability of the steep back-scarp (approximately 70°) following possible initial failures. The Set B joints, striking parallel to the failed slope at Landslide A, are unfavourable with respect to toppling as they form steeply-dipping weak planes.

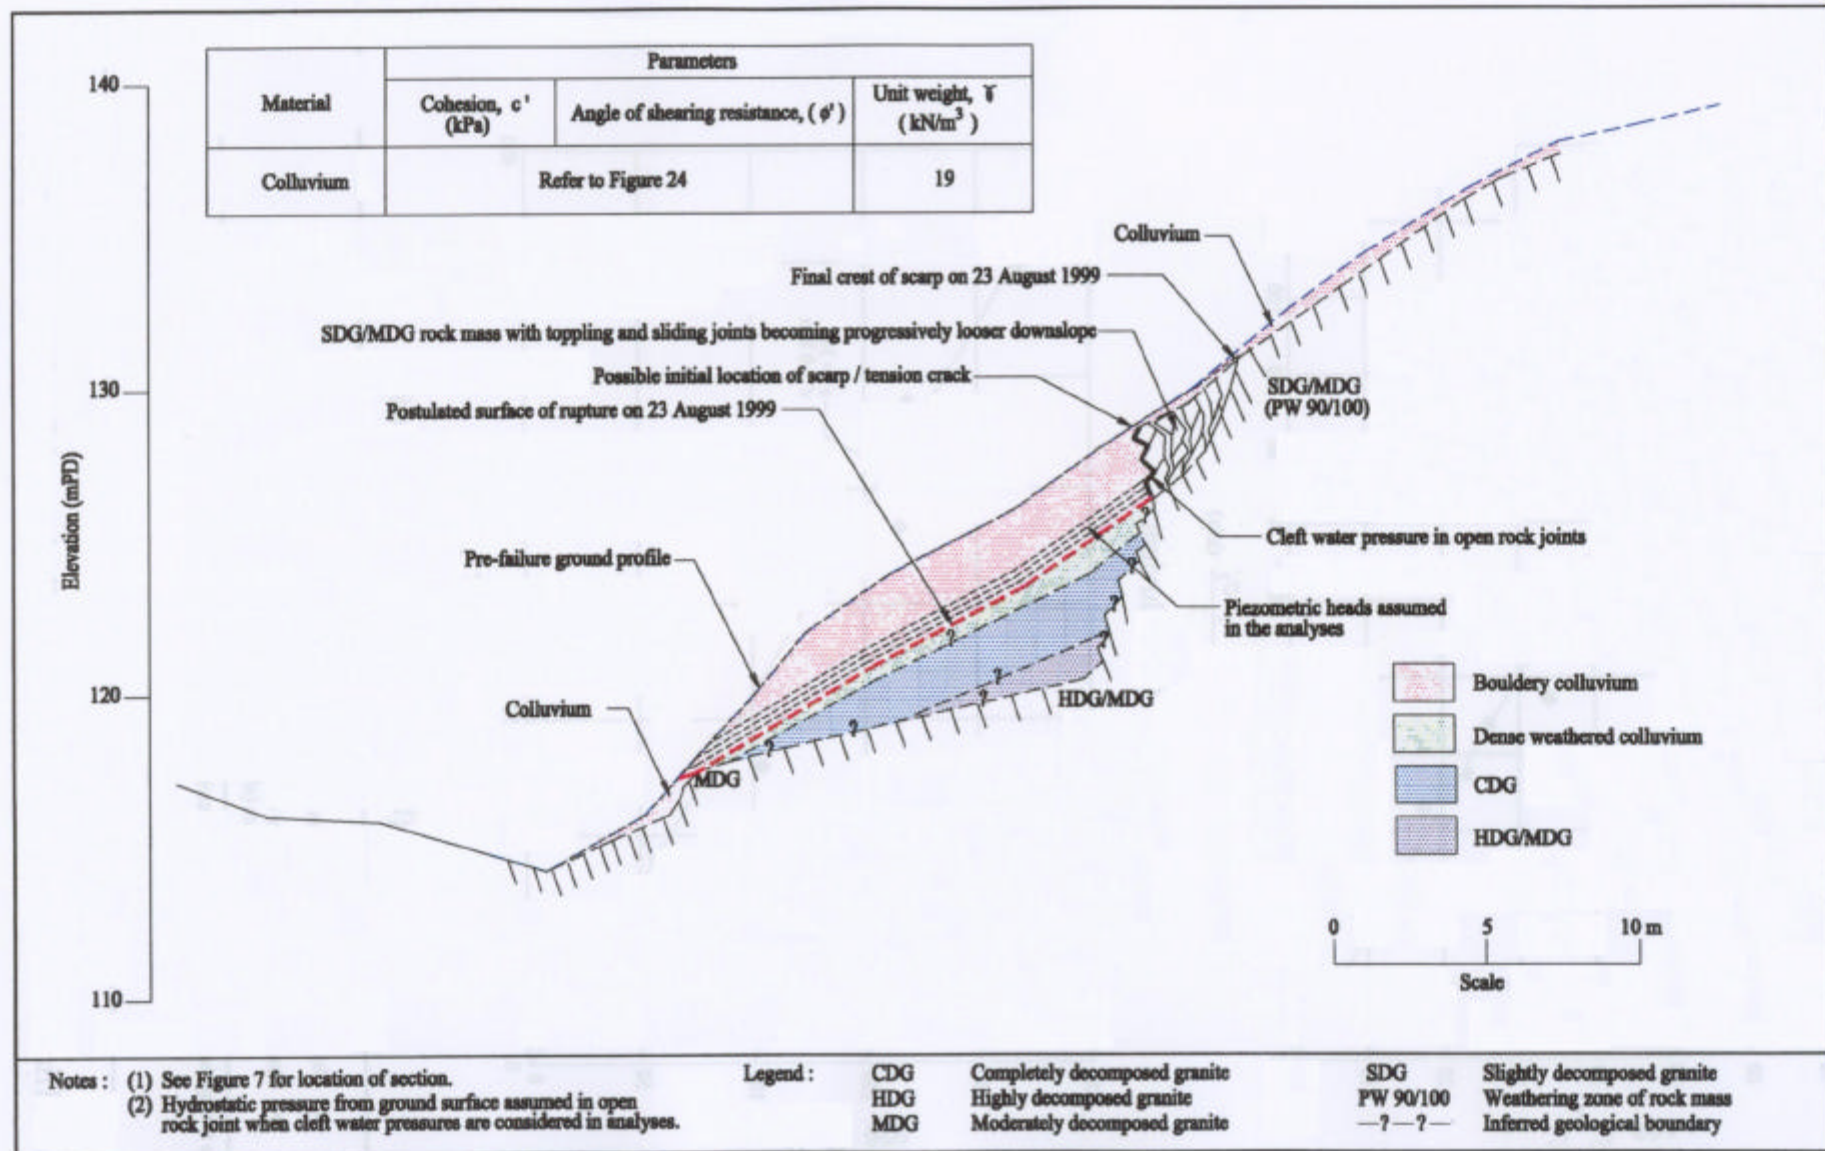
Figure 22 - Stratigraphical Section A1 - A1 Through Landslide A

The postulated surface of rupture of the main part of Landslide A is shown in Figure 22. Near the southern flank of the scar, the inferred initial upper part of the rupture surface was formed in the thin, surface colluvium and the underlying CDG. However, the majority of the area of the surface of rupture was formed along the interface between the surface colluvium and the underlying, dense weathered colluvium.

In the central part of the main scarp of Landslide A, it is inferred that the upper part of the rupture surface passed through the interface between the surface colluvium and the PW 50/90 rock mass (Plate 20), and then passed along the interface between the surface colluvium and the underlying dense weathered colluvium. As shown in Figure 22, the

rupture surface near the northern flank of the scar lies at the base of the surface colluvium which overlies the dense weathered colluvium. The toe of the landslide was constrained by the presence of an insitu outcrop of moderately decomposed granite.

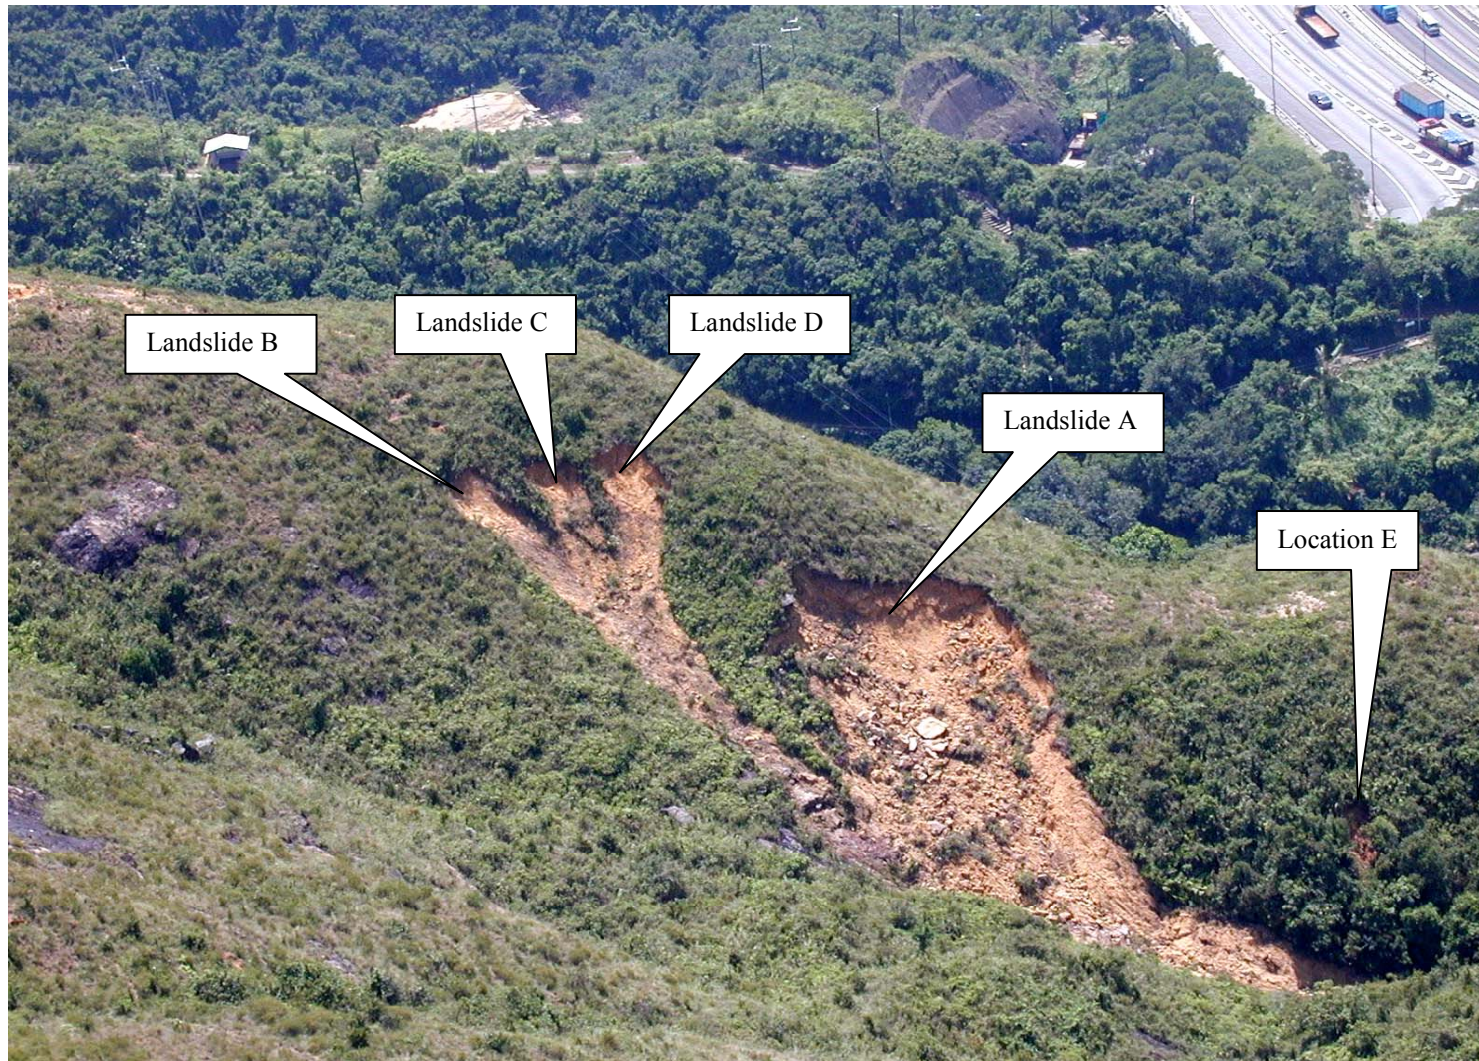
Plate 2 - Oblique Aerial View of the Landslide Sites (Photograph Taken on 26 August 1999)

A photograph of the debris flow source areas on the natural hillside is shown in Plate 2. Plans of the natural hillside failures, debris trail and the damaged dwellings are shown in

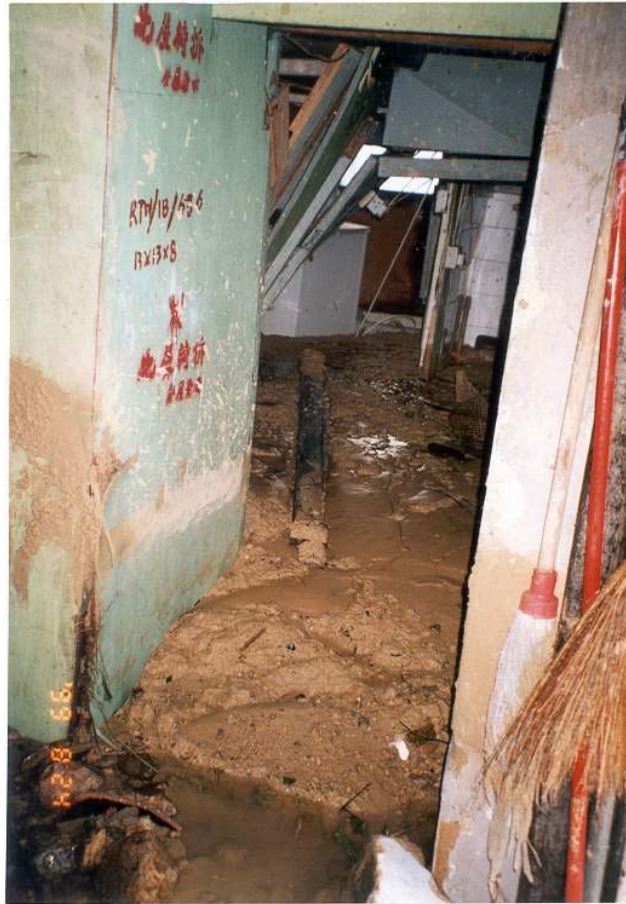
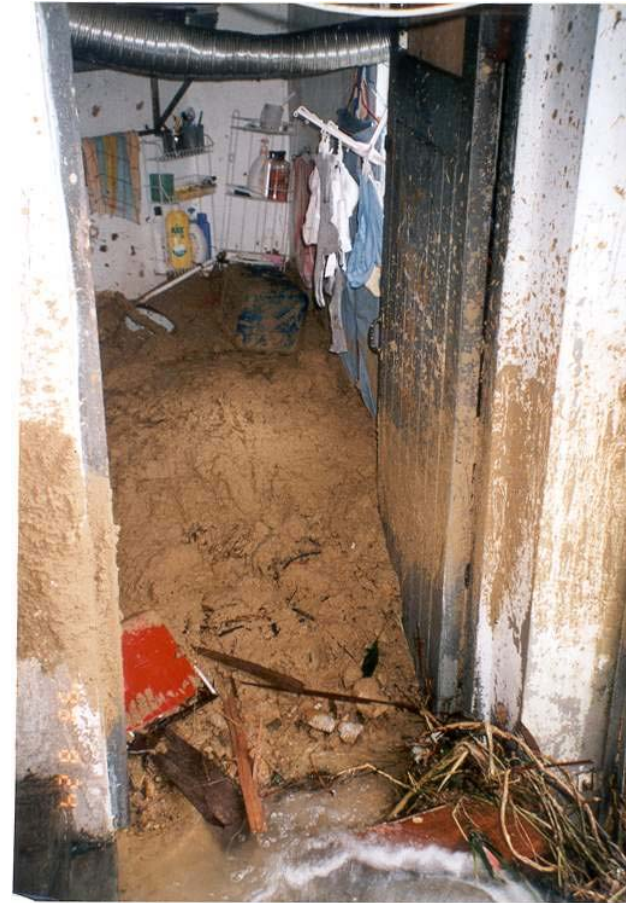
Plate 16 - Slurry-like Debris Inside the House No. 36TS Complex (Photographs Taken on 24 August 1999)

The remaining material of the debris front and debris flow body breached the wall to the House No. 36TS Complex and infilled several dwellings with debris up to about 1 m deep (Plates 16 and 17). The infill material within the upstream half of the complex is similar in grading and consistency to the upper layer of debris within the nullah. However, only rare boulders less than 400 mm in length could be found beyond the mid-point of the complex. It is inferred that the coarse material comprising the debris front was largely exhausted by deposition in the nullah, although some boulders managed to locally penetrate the external walls of the House No. 36TS Complex. The finer debris penetrated the complex and became largely arrested by the internal walls of the structure. The increasingly finer and thinner material deposited within the lower half of the complex and down Sham Hong Road is probably mainly outwash material transported by subsequent overland flow.

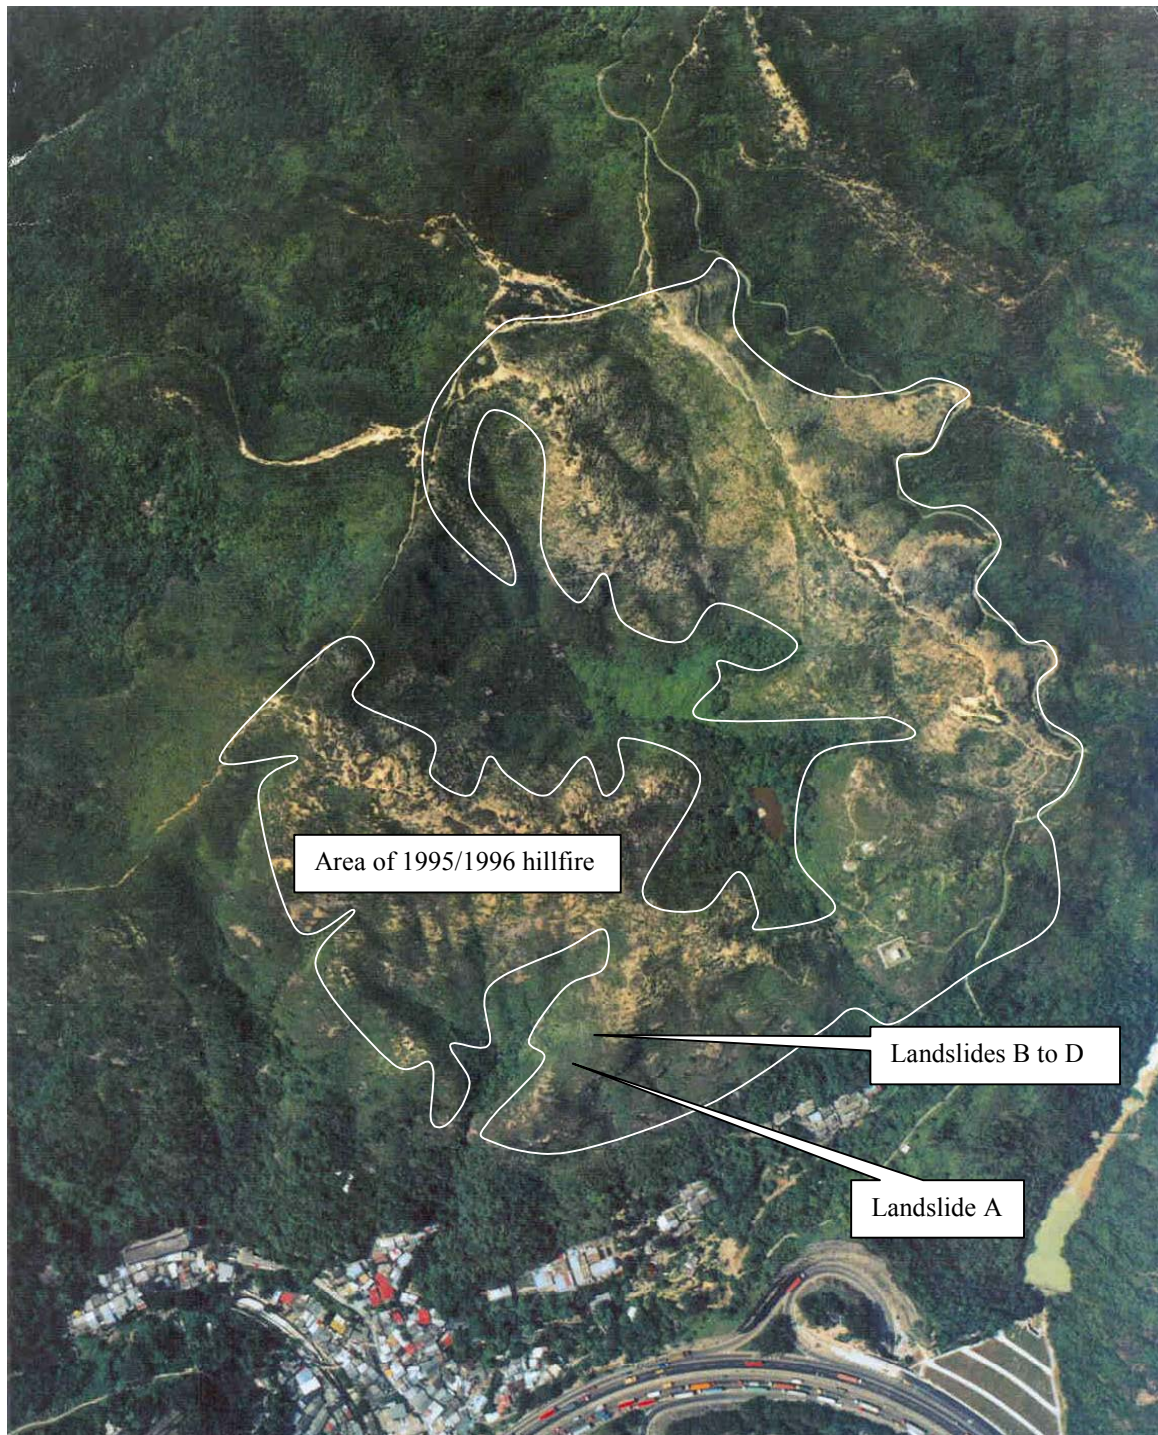
Plate19 - Aerial Photograph Showing Approximate Extent of 1995/1996 Hillfire
(Photograph Ref. No. CN14226 ; Taken on 12 June 1996)

Examination of the June 1996 aerial photographs indicates that the sites of Landslides A to D were affected by an extensive hillfire, probably in the 1995/1996 dry season. The hillfire removed much of the vegetation cover (comprising shrubs and grass) from the landslide source areas and charred the full depth of the thin (< 200 mm thick) topsoil, as evidenced in the post-failure ground investigation. The extent of the hillfire is shown in Figure 12 and Plate 19.

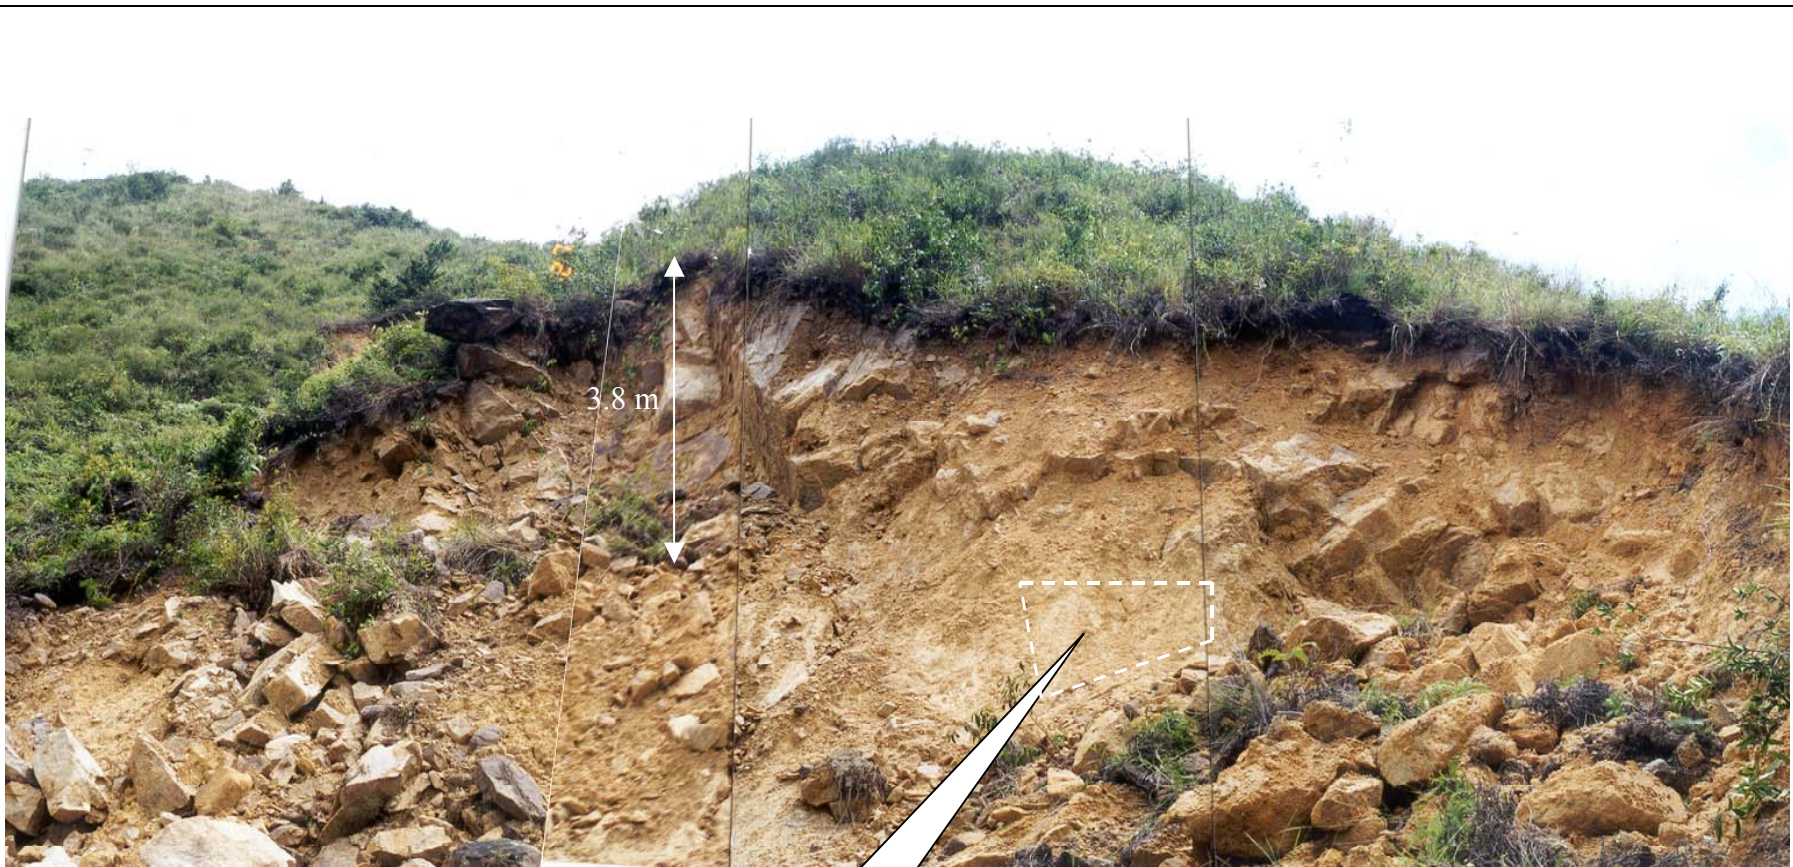
Plate 20 - View of Main Scarp of Landslide A Showing Disturbed Insitu Rock with Local Surface of Rupture in CDG in Central Portion (Photograph Taken on 27 August 1999)

Except for the small rupture surface shown in Plate 20, no planar surface of rupture has been identified in the scar and in the cores taken by the portable sampler. A smooth, slickensided rupture surface is unlikely to have been produced because of the coarse nature of the surface colluvium which formed the majority of the failed mass.

Local surface of
rupture dipping 50°

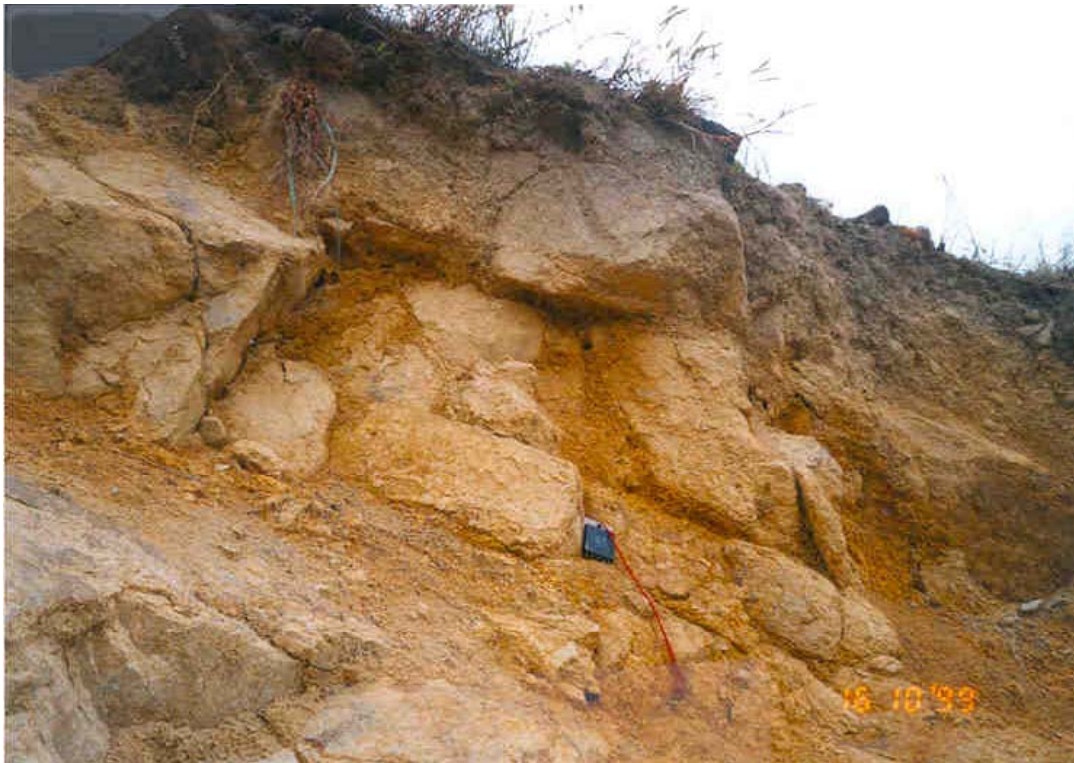
Plate 21 - Details of Adversely Orientated Open and Partially
Infilled Joints in Main Scarp of Landslide A
(Photograph Taken on 16 October 1999)

The rock mass is disturbed in the main scarp of Landslide A. The Set B joints are open or infilled with very silty gravelly sand which has been washed in, down to a depth of about 3.5 m below ground surface (Plates 21 to 23). The disturbed fabric is evidence of past movement of the slope which may be attributed to progressive opening-up of the rock mass, possibly promoted by the disturbance caused by the previous instability. During heavy rain, the Set B joints are likely to be wholly or partially filled with water that would give rise to cleft-water pressure acting on the rear of any potentially unstable soil or rock mass.

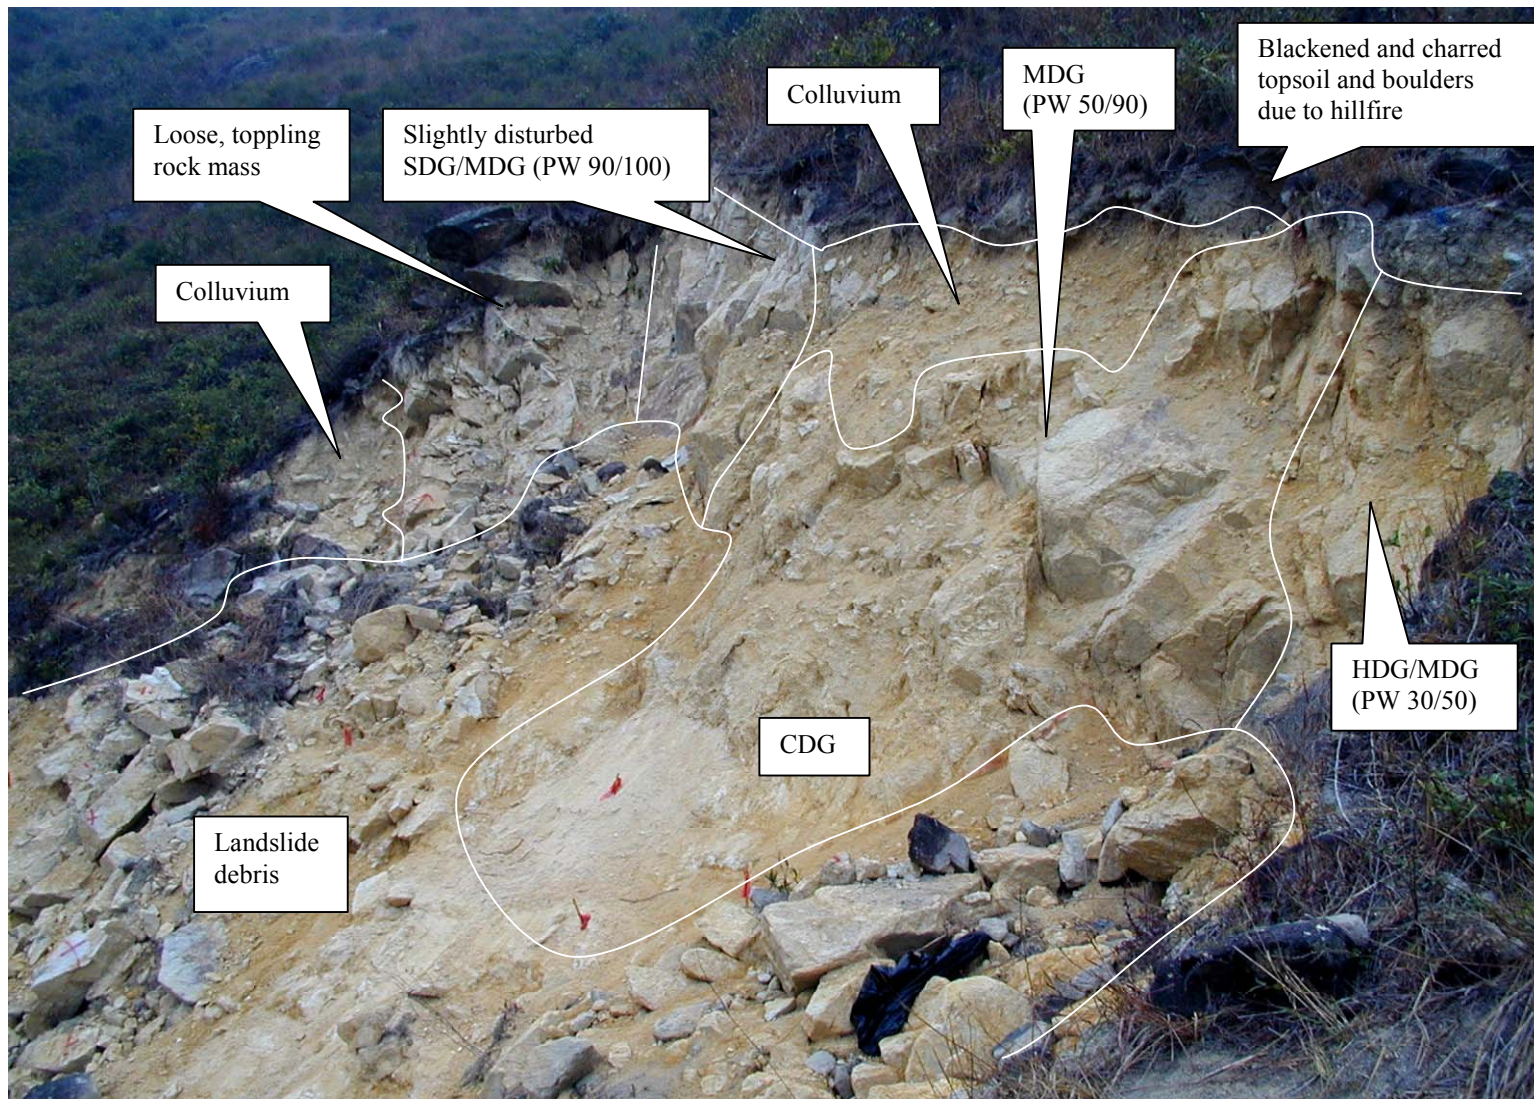
Plate 26 - Details of Main Scarp and Upper Portion of Northern Flank of Landslide A (Photograph Taken on 16 December 1999)

In the central portion of the main scarp of Landslide A, colluvium up to 0.4 m thick overlies PW 50/90 medium-grained granite (Plate 26), whereas CDG overlies the lower part of the PW 50/90 rock mass. When first examined on 27 August 1999, a planar surface about 1 m² in area, dipping at about 50° downslope, was present in the lower part of the CDG (Plate 20). About 50 mm thickness of remoulded soil was present on the surface, which is inferred to be part of the initial surface of rupture. This surface was about 2 m in front of the final main scarps on either side, and may be evidence of secondary failures of the over-steepened scarp following the main failure.

Plate 26 and Figure 22 show the geology of the northern portion of the main scarp and the northern flank of Landslide A. The main scarp is formed in a disturbed rock mass of slightly to moderately decomposed (PW 90/100) fine-grained granite, overlain by up to 0.3 m thickness of colluvium which contains slightly to moderately decomposed clasts. The rock mass becomes progressively looser downslope due to sliding on the Set A joints and toppling on the Set B joints and grades into colluvium of up to about 2.5 m thick (Figure 22 and Plate 26). This colluvium contains moderately weathered clasts and overlies up to 0.5 m thickness of dense weathered colluvium (Plate 27).
