**REPORT ON THE
DEBRIS FLOW AT
SHAM TSENG SAN TSUEN
OF 23 AUGUST 1999**

**FINDINGS OF
THE INVESTIGATION**

GEO REPORT No. 169

Fugro Maunsell Scott Wilson Joint Venture

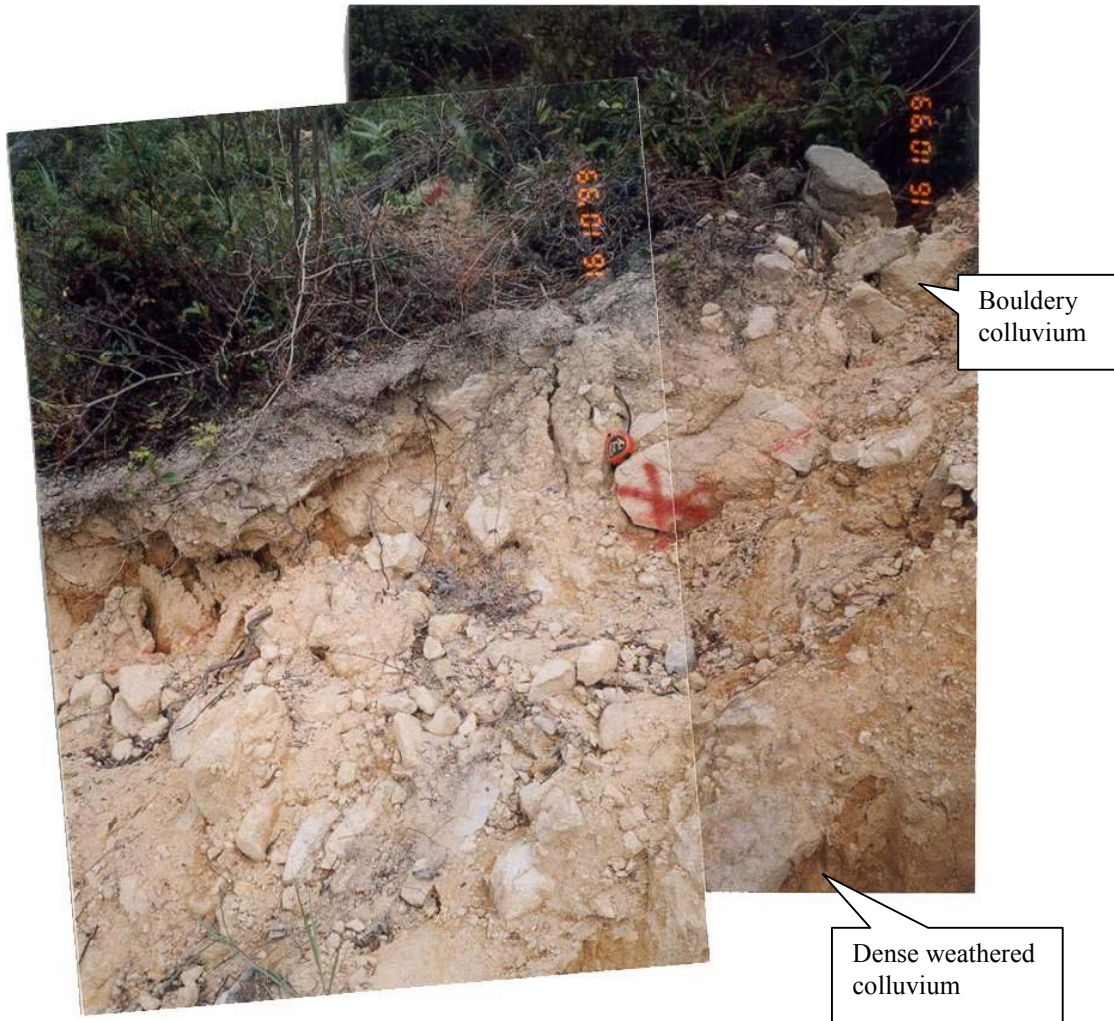
Plate 27 - Details of Surface Colluvium Overlying Dense Weathered Colluvium
in Middle Portion of Northern Flank of Landslide A
(Photograph Taken on 16 October 1999)

Plate 26 and Figure 22 show the geology of the northern portion of the main scarp and the northern flank of Landslide A. The main scarp is formed in a disturbed rock mass of slightly to moderately decomposed (PW 90/100) fine-grained granite, overlain by up to 0.3 m thickness of colluvium which contains slightly to moderately decomposed clasts. The rock mass becomes progressively looser downslope due to sliding on the Set A joints and toppling on the Set B joints and grades into colluvium of up to about 2.5 m thick (Figure 22 and Plate 26). This colluvium contains moderately weathered clasts and overlies up to 0.5 m thickness of dense weathered colluvium (Plate 27).
