REVIEW OF NOTABLE LANDSLIDE INCIDENTS DURING SLOPE WORKS

GEO REPORT No. 171

H.W. Sun & H.M. Tsui

**GEOTECHNICAL ENGINEERING OFFICE
CIVIL ENGINEERING AND DEVELOPMENT DEPARTMENT
THE GOVERNMENT OF THE HONG KONG
SPECIAL ADMINISTRATIVE REGION**

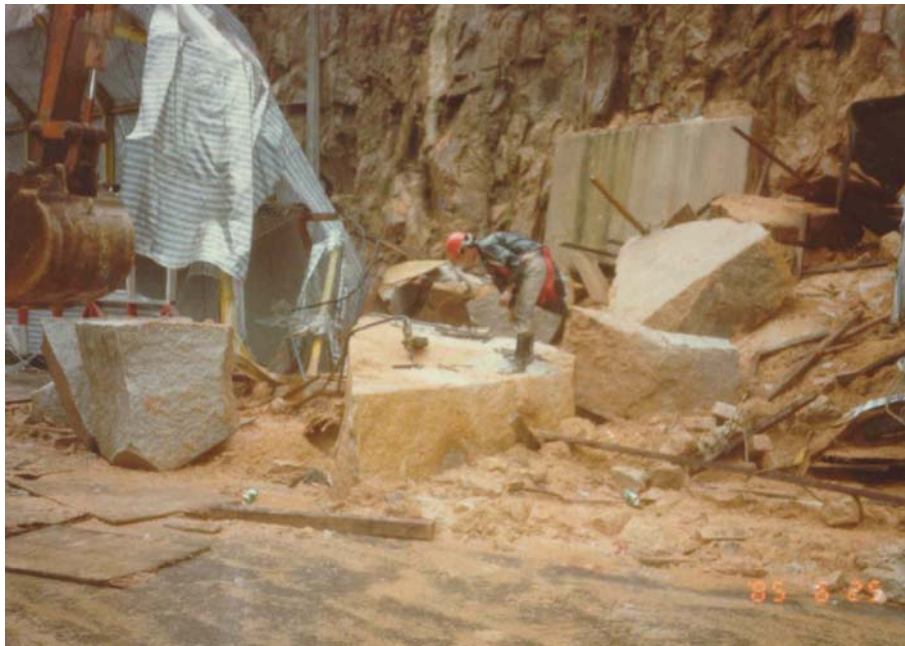
Plate 7 - The 25 June 1985 Incident at King's Road, Hong Kong

This incident involved an LPM site supervised by GEO in-house staff. The landslide occurred soon after heavy rainfall at about 8:00 a.m. on 25 June 1985 at a soil/rock cut slope above the busy road. At the time of the incident, trimming works were being carried out near the crest of the slope for the construction of a retaining wall (which was being built in panels). The failure occurred suddenly and involved planar sliding of granite rock blocks along adversely orientated joints which were partly coated with kaolin (see Plate 5). The slipped mass, comprising large rock fragments up to 5 m³, demolished a 7 m long section of the safety fence at the slope toe along King's Road (see Plates 6 and 7). The total volume of debris was estimated to be about 70 m³ and fortunately there were no casualties.

Note: Fallen rock blocks were broken up into smaller pieces prior to removal

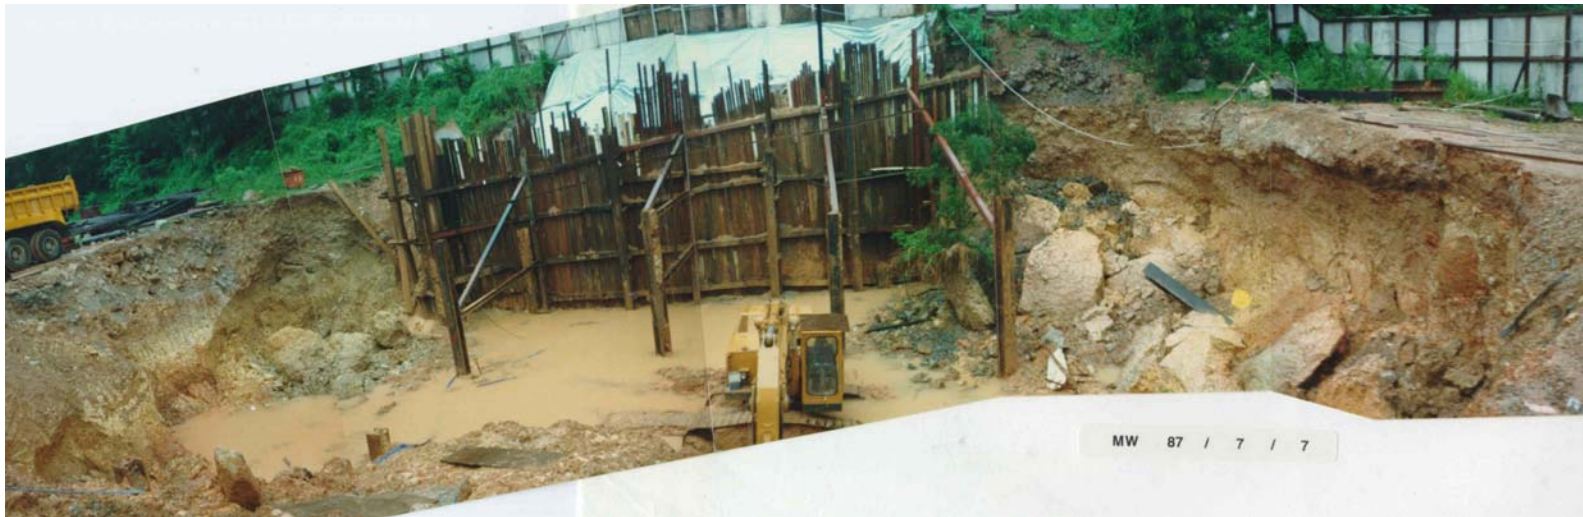
Plate 9 - The 27 July 1987 Incident at Wai Tsuen Road, Tsuen Wan

The incident occurred on a private building construction site and involved the failure of a 6 m high unsupported excavation for pile cap construction during rainfall at a time when eight workers were working in the excavation (see Plate 9). The workers were installing planking to the temporary cut as a precautionary measure because of the heavy rainfall preceding the failure. The failure (about 45 m³) occurred on a 45° steep temporary slope in granitic saprolite and trapped two workers who were subsequently rescued by firemen. The two workers suffered injuries as a result of the incident. Another worker who had escaped injury in the collapse was injured when he went to assist with the rescue. About four hours after the first failure, the north-western face of the excavation also collapsed, releasing about 30 m³ debris and resulting in temporary closure of the road above and beyond the construction site.

In the subsequent report by the contractor, it was noted that six days before the failure, the soil near the toe of the temporary cut in completely decomposed granite was observed to have been “severely disturbed” by prolonged heavy rainfall. The report stated that the infiltration and seepage of rainwater had caused the soil near the toe to flow outwards “like a liquid” followed by “slumping” of the upper part of the cut. Because of the above

Note: The failure occurred on a 6 m high unsupported excavation for pile cap construction

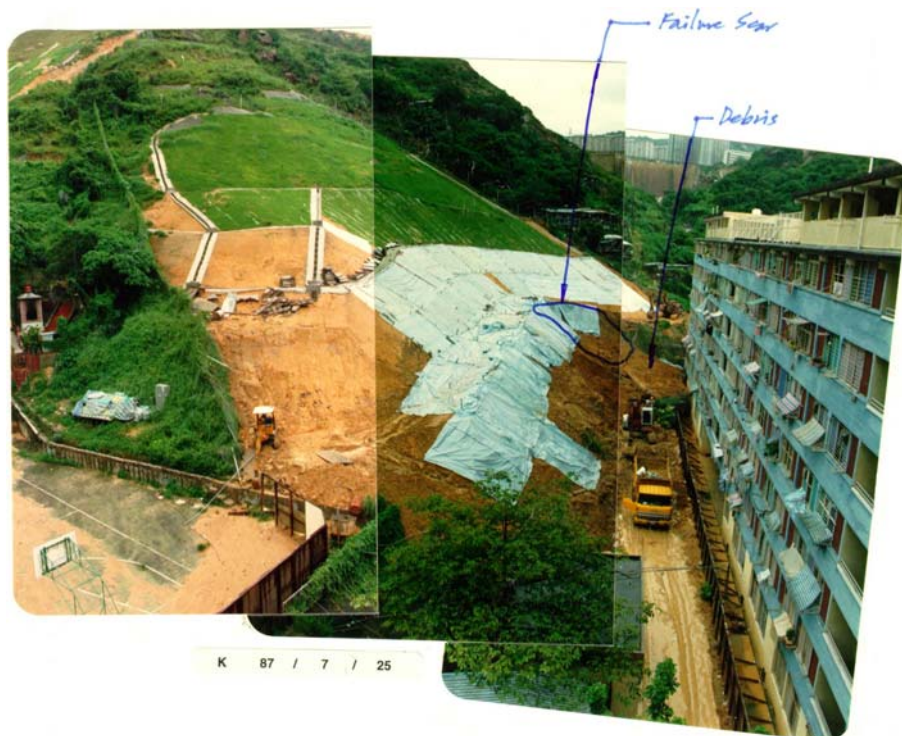
Plate 10 - The 30 July 1987 Incident behind Block 10, Jordan Valley Estate

The landslide occurred at about 2:30 a.m. during heavy rainfall and involved excavated materials which had been placed on the lower batter of a soil cut slope behind Block 10 of Jordan Valley Estate to form a temporary access ramp. Slope upgrading works involving trimming back the existing cut slope were being carried out by the Housing Department and the works were supervised by a consultant engineering firm. The debris, with a volume of about 300 m³, caused the hoarding and safety fence at the toe of the cut slope to partially collapse and then came to rest against the first floor of the public housing block below (see Plates 10 to 12). Part of the external building wall and some of the windows and doors of several flats on the ground floor were damaged in the incident and some “soil mud” was washed into two of the ground floor flats. No casualties were reported but 20 flats of the housing block were temporarily evacuated.

Note: General View of the Landslide

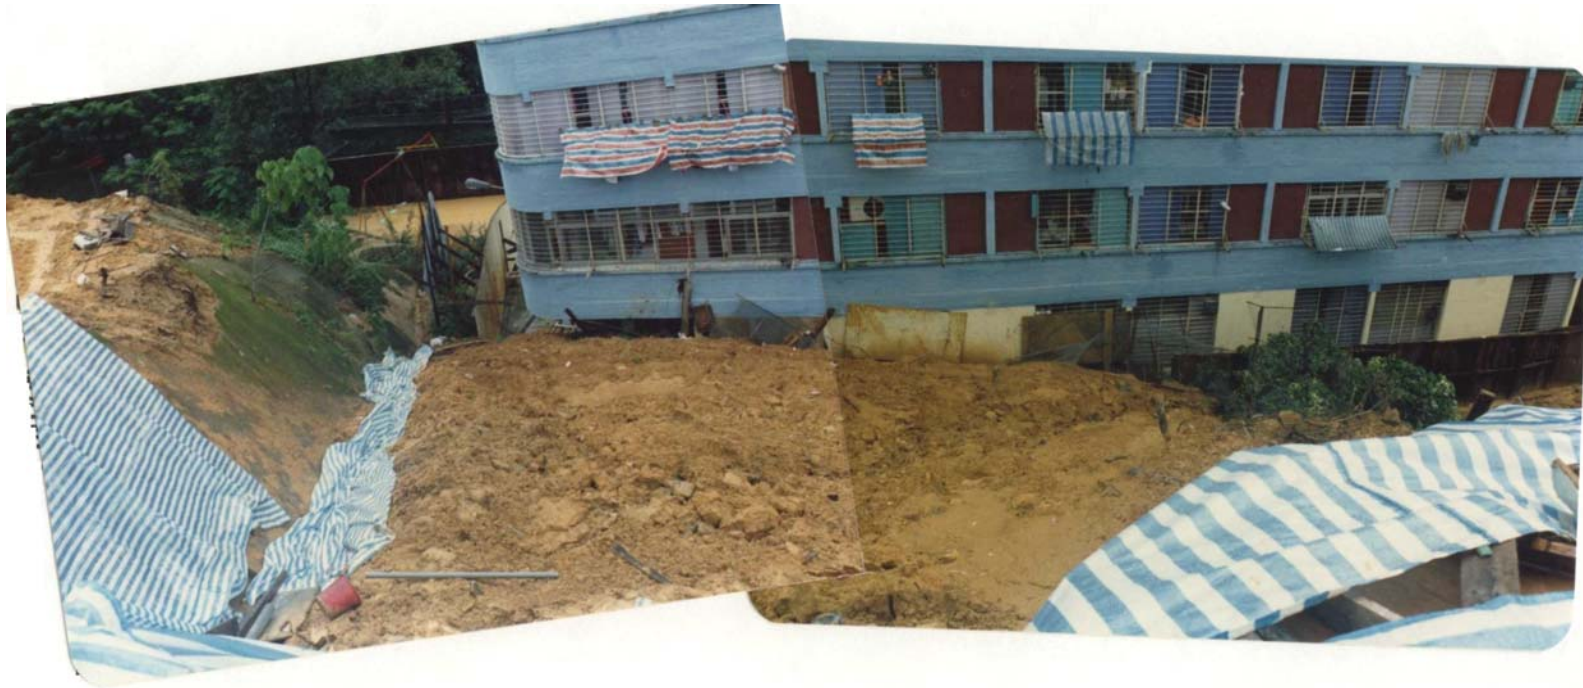
Plate 11 - The 30 July 1987 Incident behind Block 10, Jordan Valley Estate

Note: The debris (about 300 m³) damaged the hoardings and safety fence and came to rest against the housing block. Part of the external building wall, windows and doors of several flats were damaged.

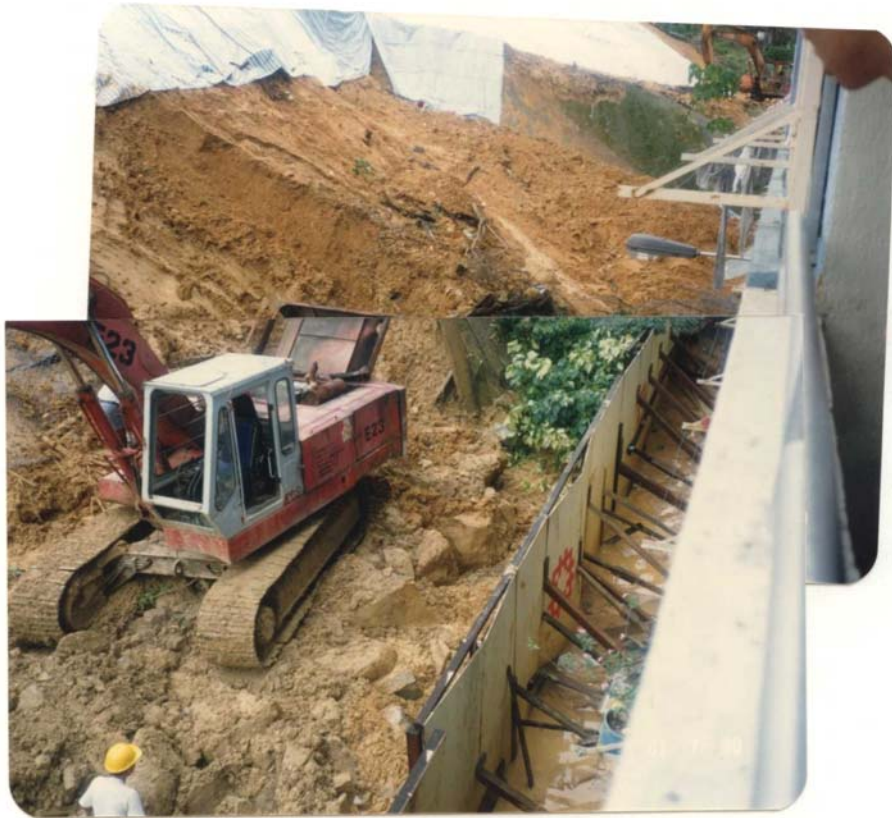
Plate 12 - The 30 July 1987 Incident behind Block 10, Jordan Valley Estate

Note: A close-up view of the damaged hoardings and safety fence at the toe of the cut slope

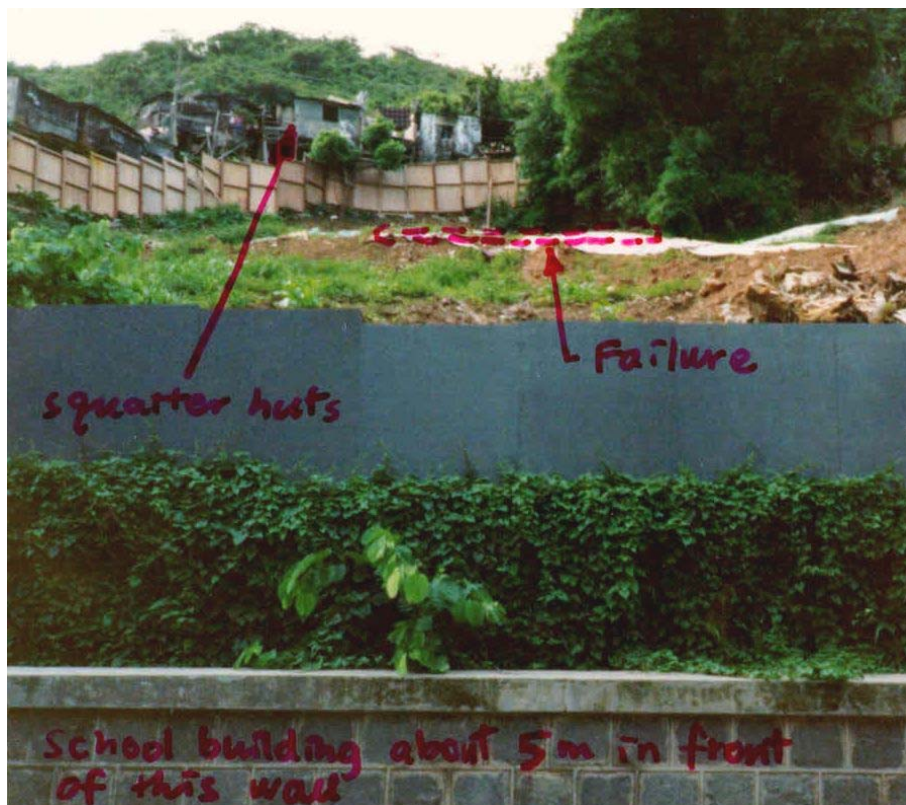
Plate 13 - The 28 June 1988 Incident at North of Island Road Government School

The first major failure occurred after prolonged rainfall from 23 to 27 June 1988. Prior to the first failure, the site works included stripping of the pre-existing dense surface vegetation cover, excavation of two trial pits, cutting for access and excavation for a cut-off drain. About 100 m³ of debris slid downhill and a 17 m long tension crack developed on the slope face near to the slope crest. As a result of this failure, ten squatter dwellings at the slope crest near the tension crack were permanently evacuated (see Plate 13). After this failure, it was considered by the designer that it was impractical to proceed with the construction of the cut-off drain and consequently the design was revised, involving excavation and replacement of the upper 3 m of material from the slope surface by rockfill, in stages.

Note: Ten huts at the crest near a 17 m long and up to 1 m deep tension crack were permanently evacuated.

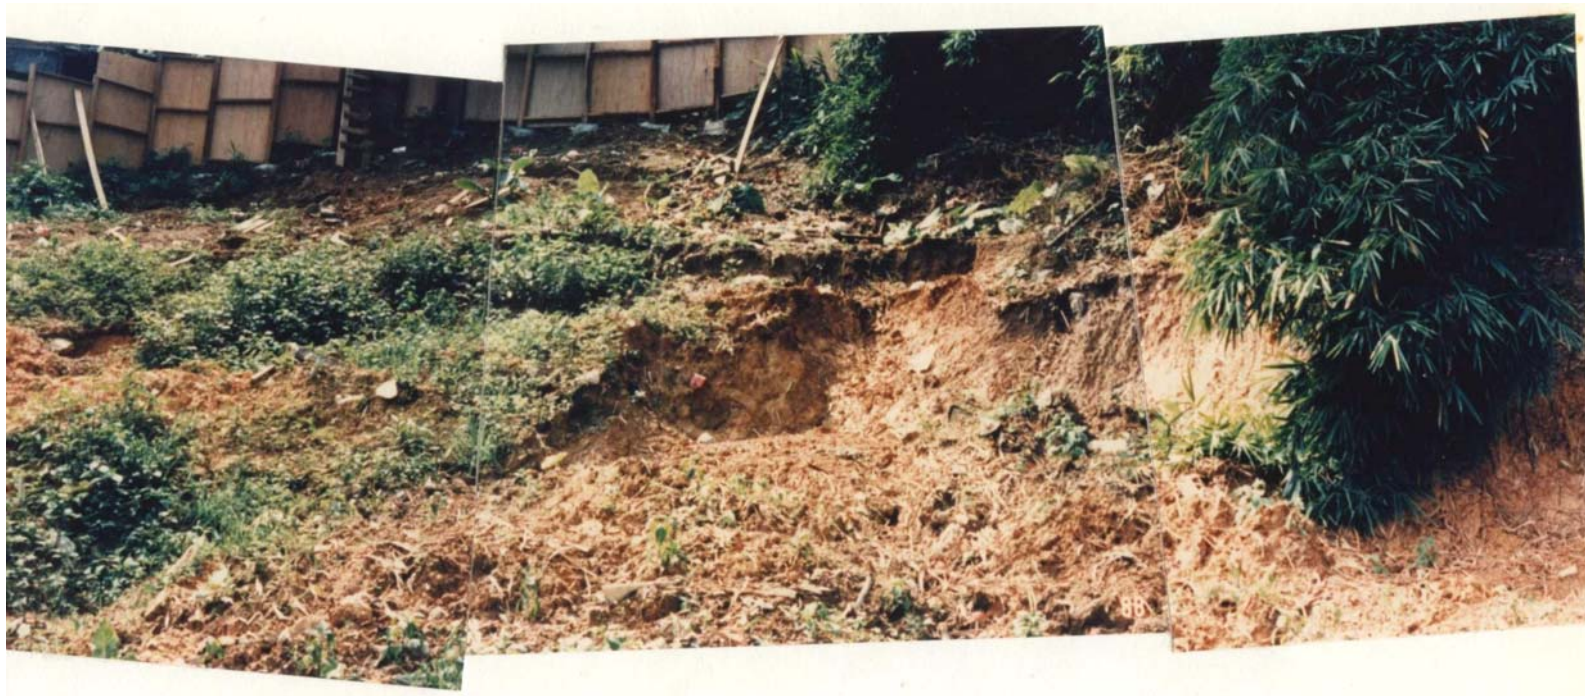
Note: A 17 m long and up to 1 m deep tension crack developed on the slope face near the crest

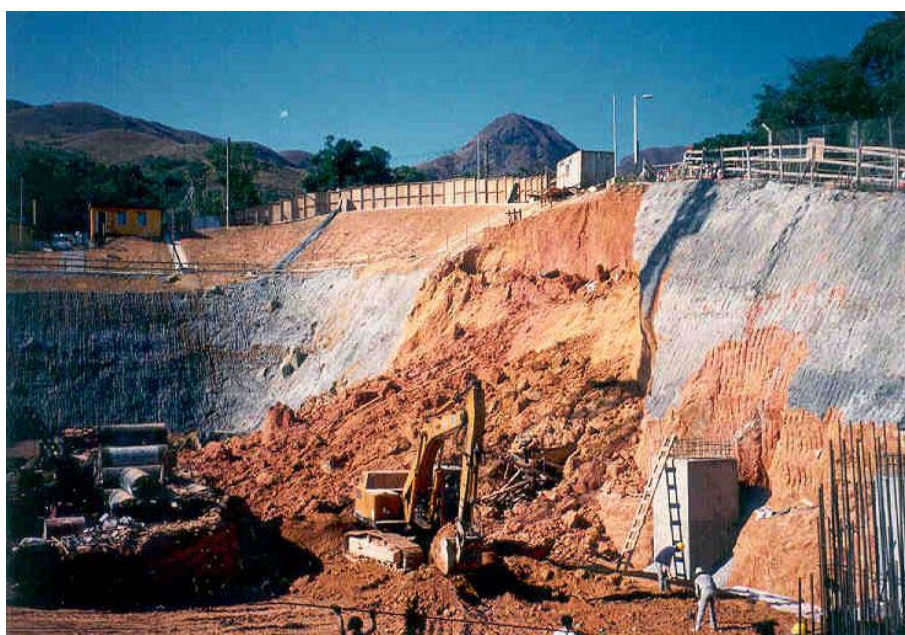
Plate 23 - The 10 January 1990 Incident at Po Lo Che Service Reservoir Site, Sai Kung

Note: General view of the landslide

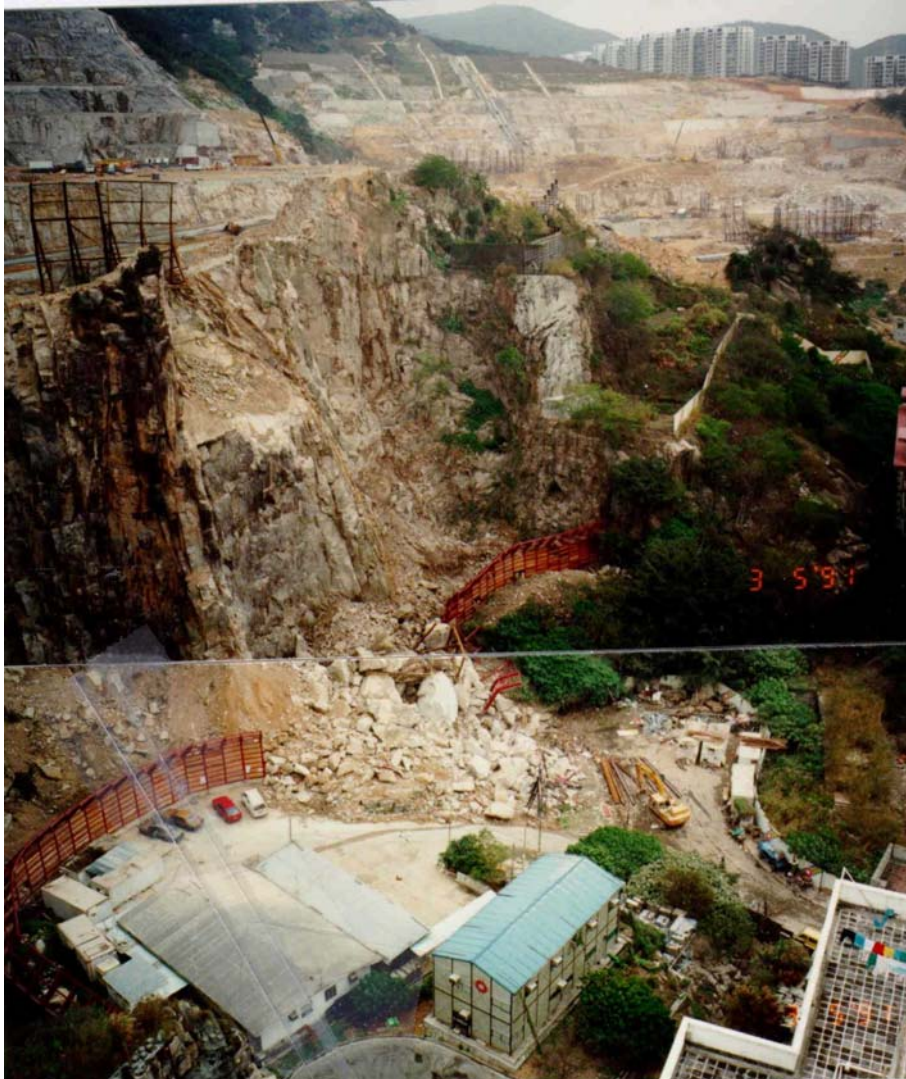
Note: Major failure of a disused rock quarry face overlooking Hoi Ching Street
(about 2,000 m³ of rock)

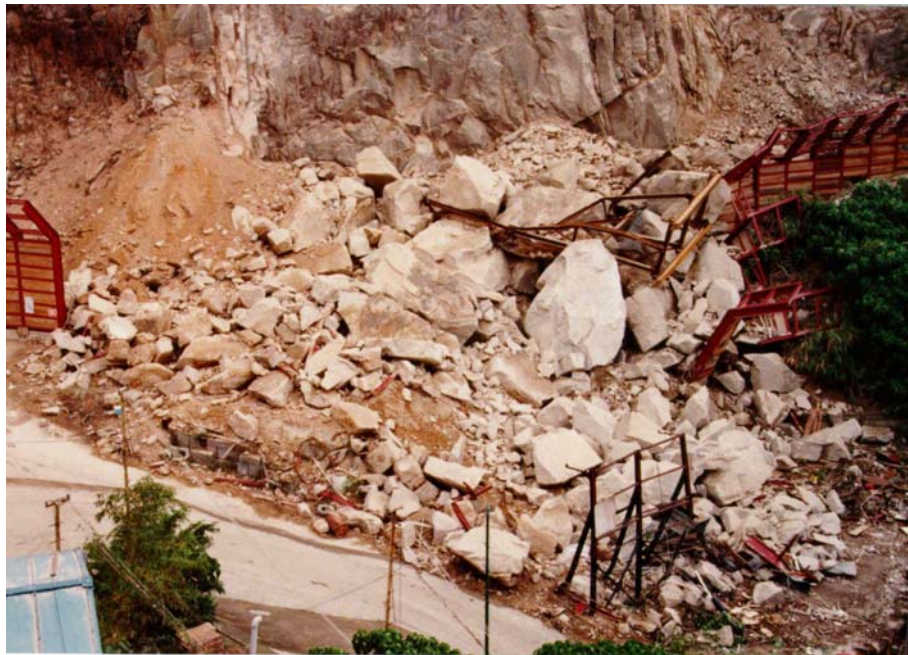
Note: All landslide debris landed within the construction site boundary

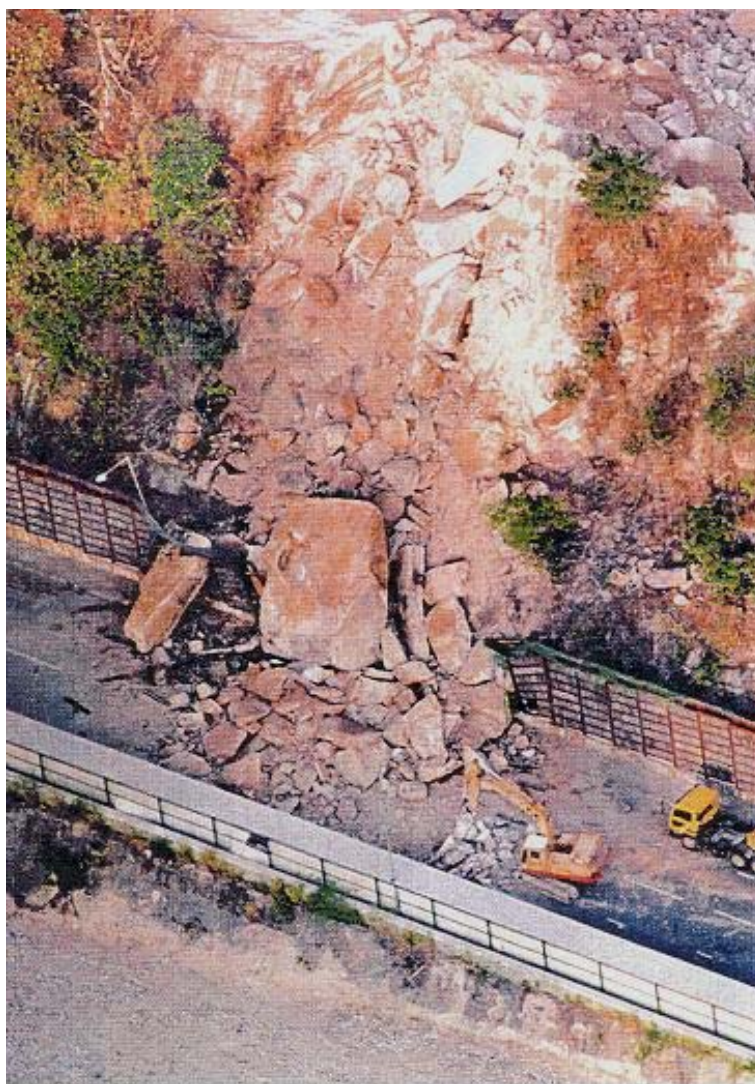
Note: General view of the landslide

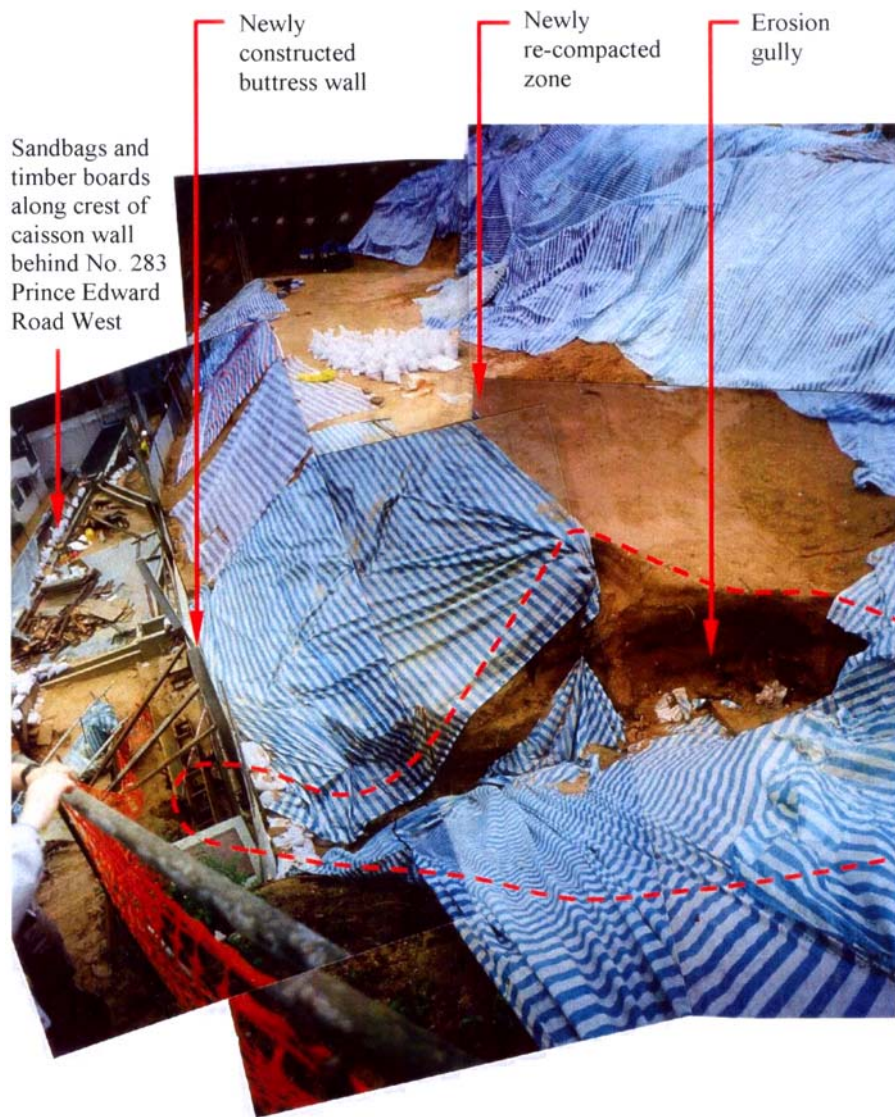
Plate 39 - The 3 April 2000 Incident behind No. 279 Prince Edward Road West

Note: A major erosion gully caused by concentration surface water flow

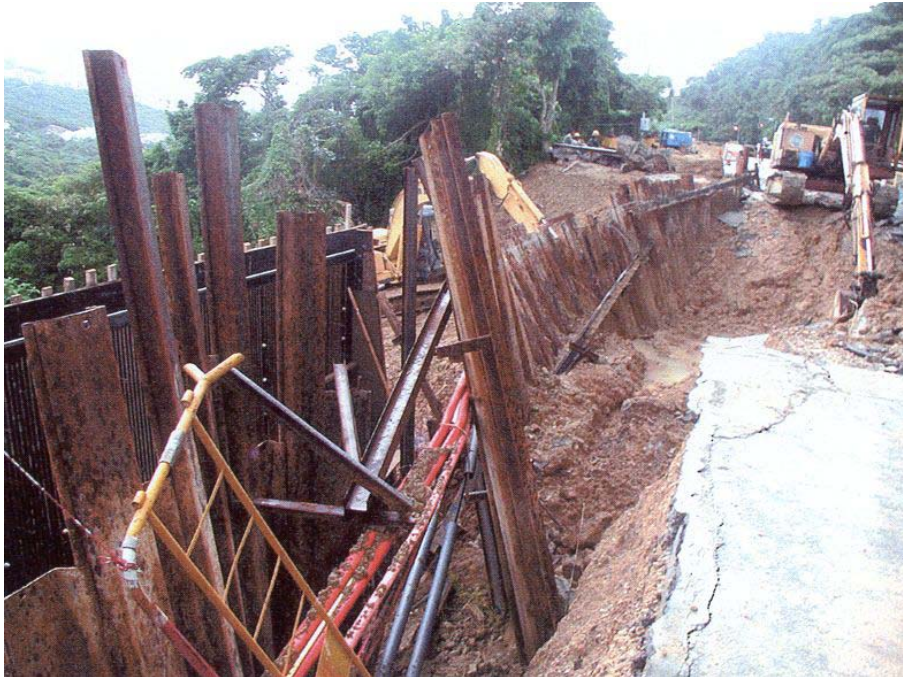
Note: Significant deformation and tilting of a portion of sheet pile wall
