# **REVIEW OF LANDSLIDES IN 2002**

**GEO REPORT No. 172**

**T.H.H. Hui, T.T.M. Lam & H.W. Sun**

**GEOTECHNICAL ENGINEERING OFFICE  
CIVIL ENGINEERING AND DEVELOPMENT DEPARTMENT  
THE GOVERNMENT OF THE HONG KONG  
SPECIAL ADMINISTRATIVE REGION**

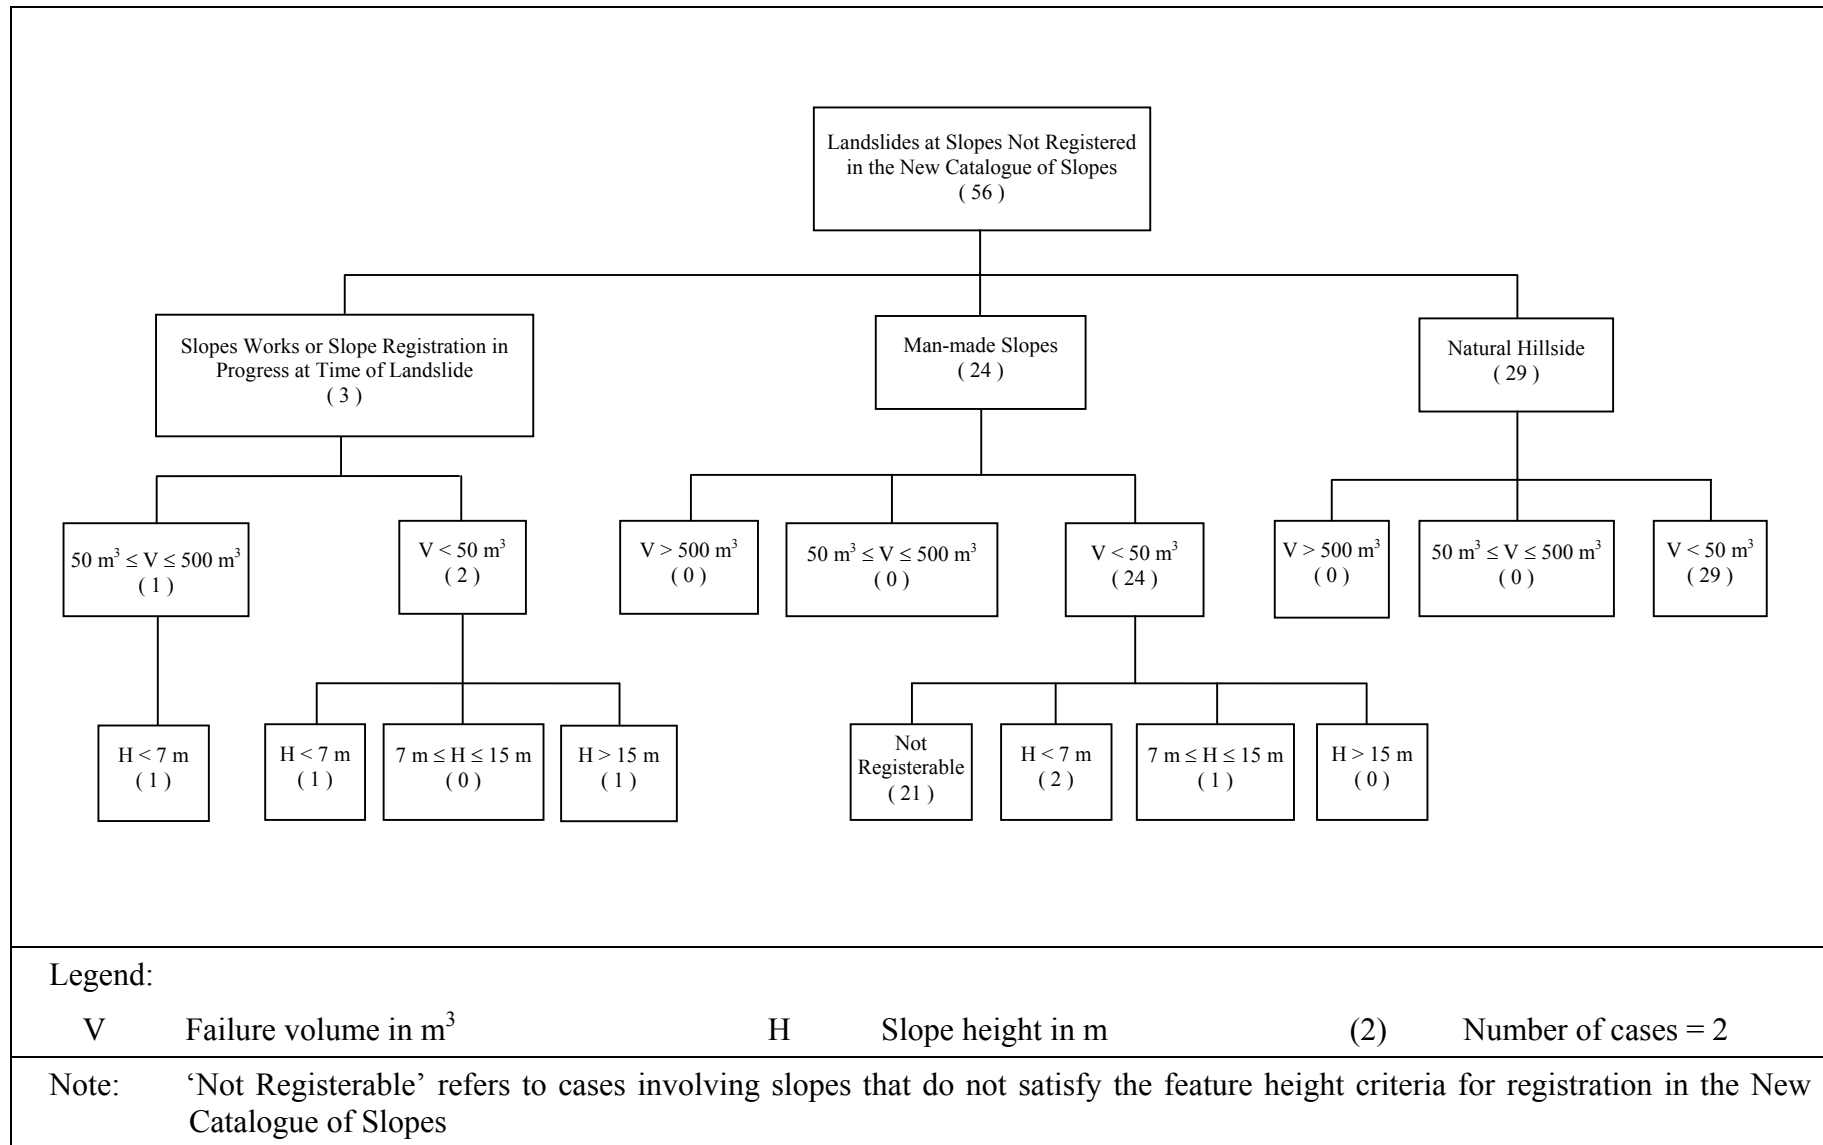
Figure 1 - Breakdown of Landslides on Unregistered Slopes in 2002

A total of 56 out of the 138 genuine landslides occurred on slope features that were unregistered at the time of failure. A breakdown of these 56 incidents is given in Figure 1.

Of the 56 incidents, 21 landslide incidents (i.e. about 38%) involved small man-made slope features which do not satisfy the slope registration criteria and 29 landslide incidents (i.e. about 52 %) occurred on natural hillsides that are not registered in the New Catalogue of Slopes because they are not man-made slope features. One of the landslide incidents involved a cut slope where slope works were in progress at the time of failure and hence it was not yet ready for registration.

The remaining five landslide incidents (i.e.  $56 - 21 - 29 = 6$ ) involved slope features that satisfy the registration criteria but were not registered in the New Catalogue of Slopes at the time of slope failure. Of these five failures, three involved slopes which were being registered but the process was not yet completed when the failures occurred.
