DETAILED STUDY OF THE COASTAL LANDSLIDE AT SHEK KOK TSUI, LAMMA ISLAND

GEO REPORT No. 173

MAUNSELL GEOTECHNICAL SERVICES LIMITED

**This report was originally produced in October 2003
as Landslide Study Report No. LSR 10/2003**

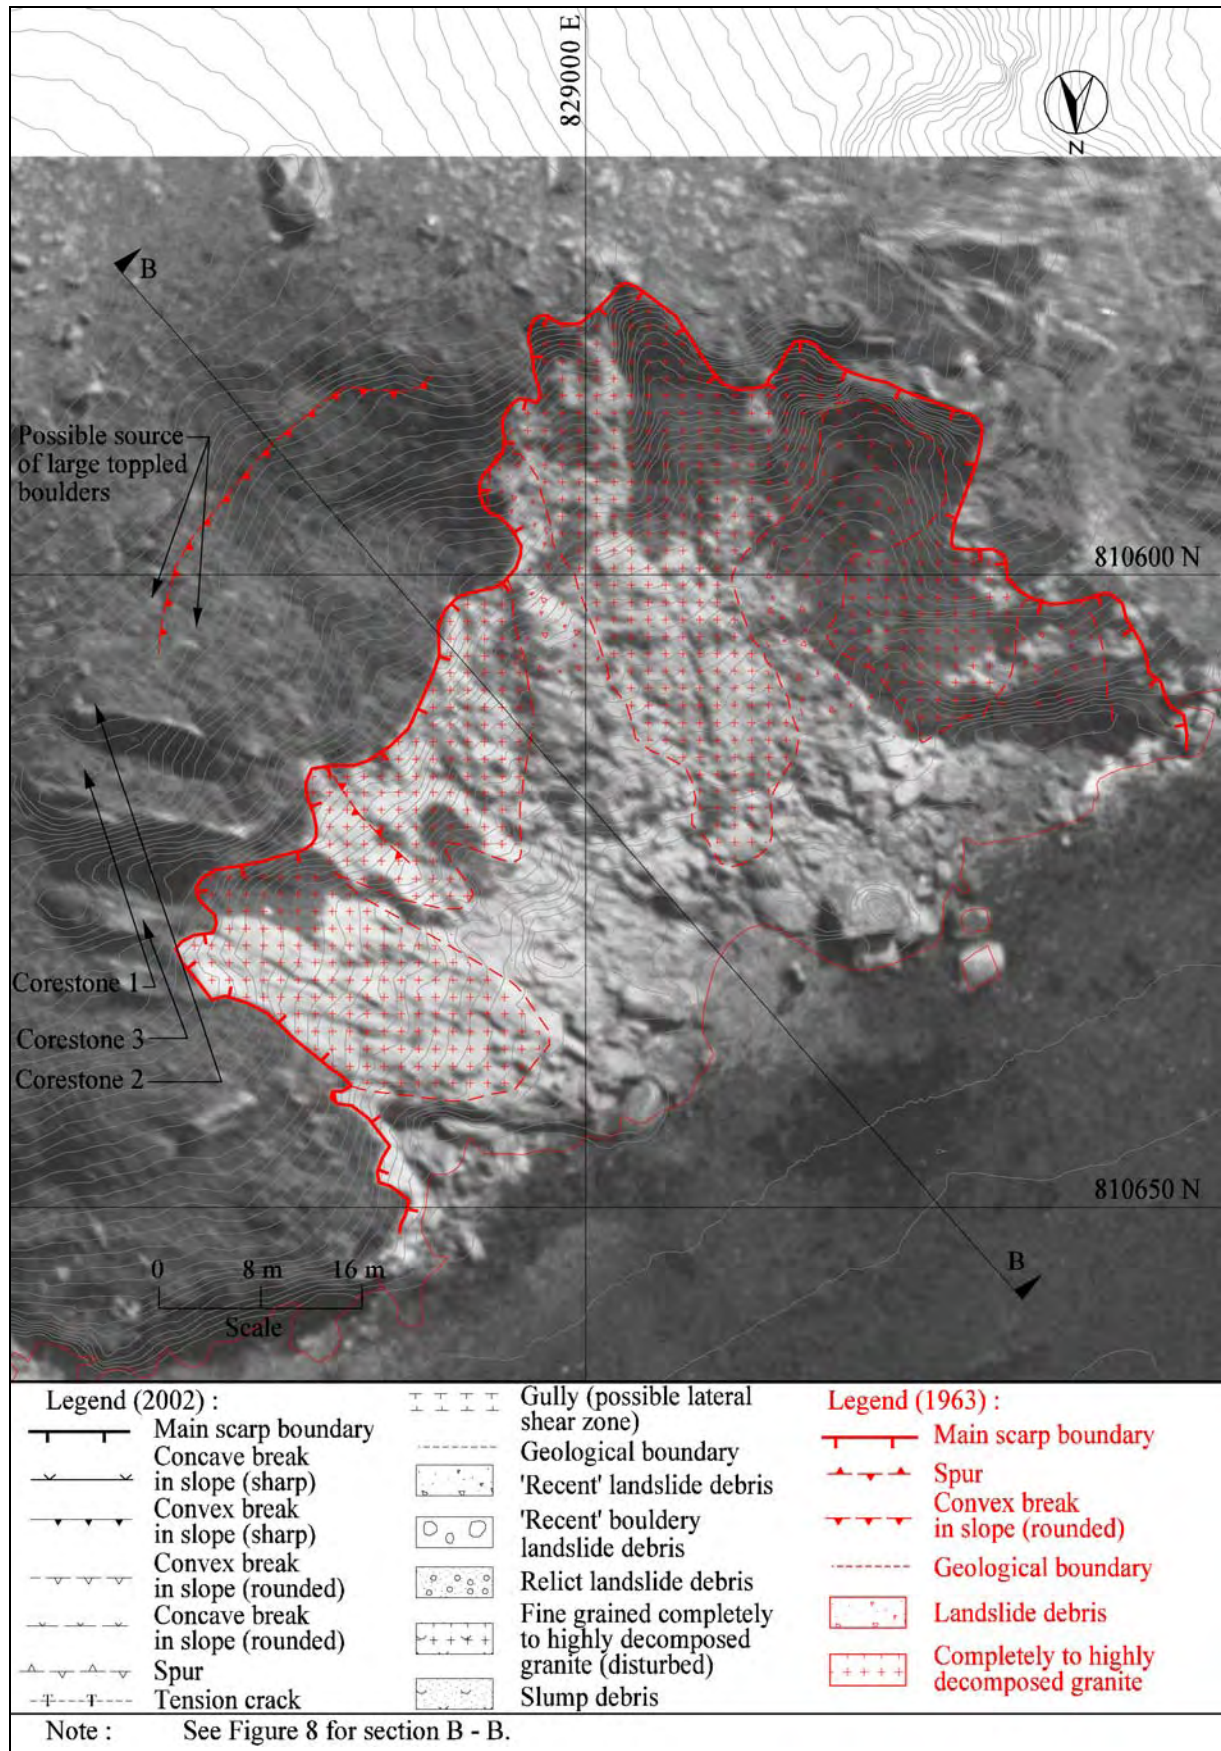
Figure 5 - Orthorectified Image (1963)

The first available low altitude aerial photographs with good resolution were taken in 1963. The details observed from the 1963 aerial photographs are shown in Plate A2 and an orthorectified plan, which is based on the 1963 photographs, is shown in Figure 5. The 1963 aerial photographs show very clearly large-scale instability within the landslide site. Figure 5 shows that in plan the scar was approximately 60 m wide and 50 m long. Although the shape of the scar in 1963 was similar to that visible on the 1945 photographs, some deterioration (in terms of retrogressive development of instabilities retreating uphill) of the landslide site may have occurred between 1945 and 1963. The high reflectivity of all the materials within the landslide scar on the 1963 photographs suggests relatively recent instability at that time. MGSL estimate from the 1963 aerial photographs, based on photogrammetry, that the landslide scar was about 40 m long by 65 m wide with an estimated depth of about 10 m,

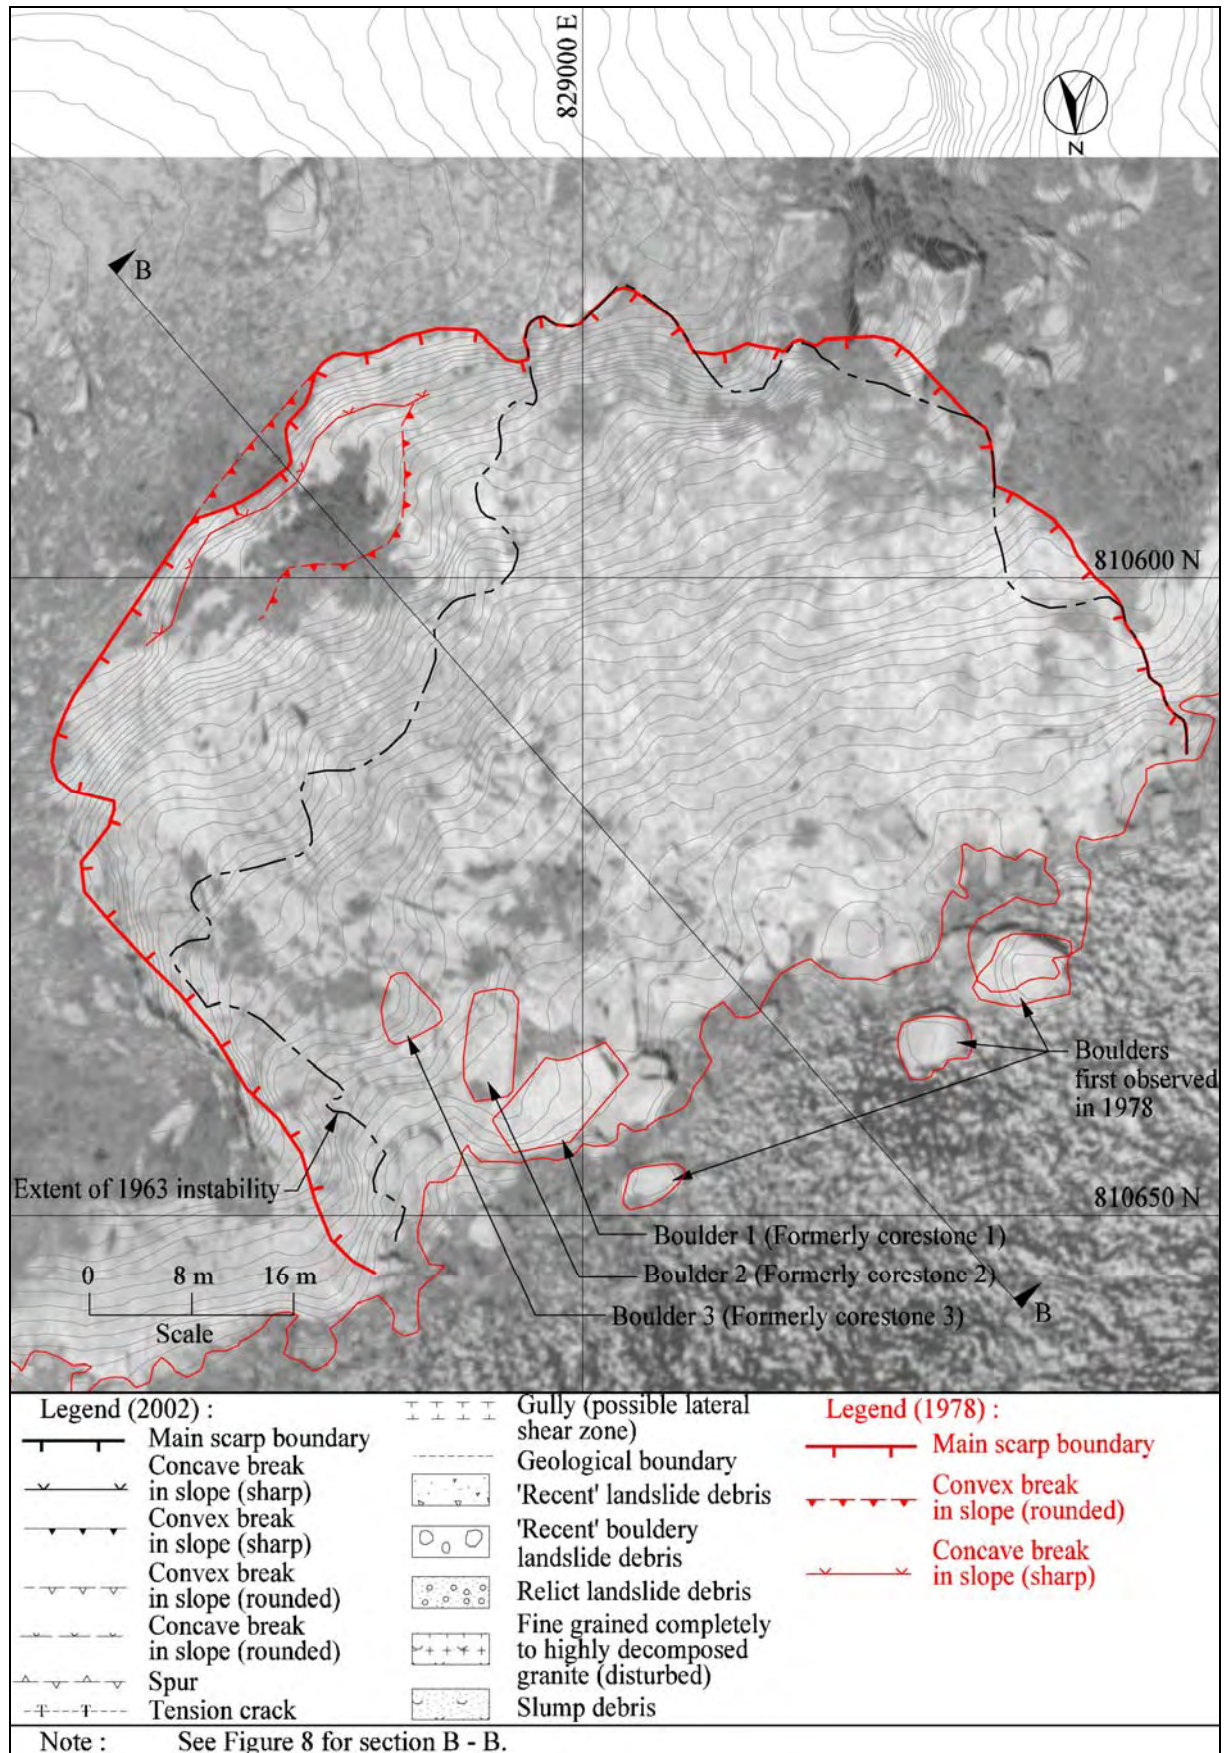
Figure 6 - Orthorectified Image (1978)

By 1973, high altitude aerial photographs indicate a significant enlargement of the 1963 landslide scar plan area by approximately 20%. The July 1978 aerial photographs are the first subsequently available low altitude photographs (although the colour tone of the photographs is poor), from which further significant deterioration of the landslide scar is clearly visible (Figure 6).

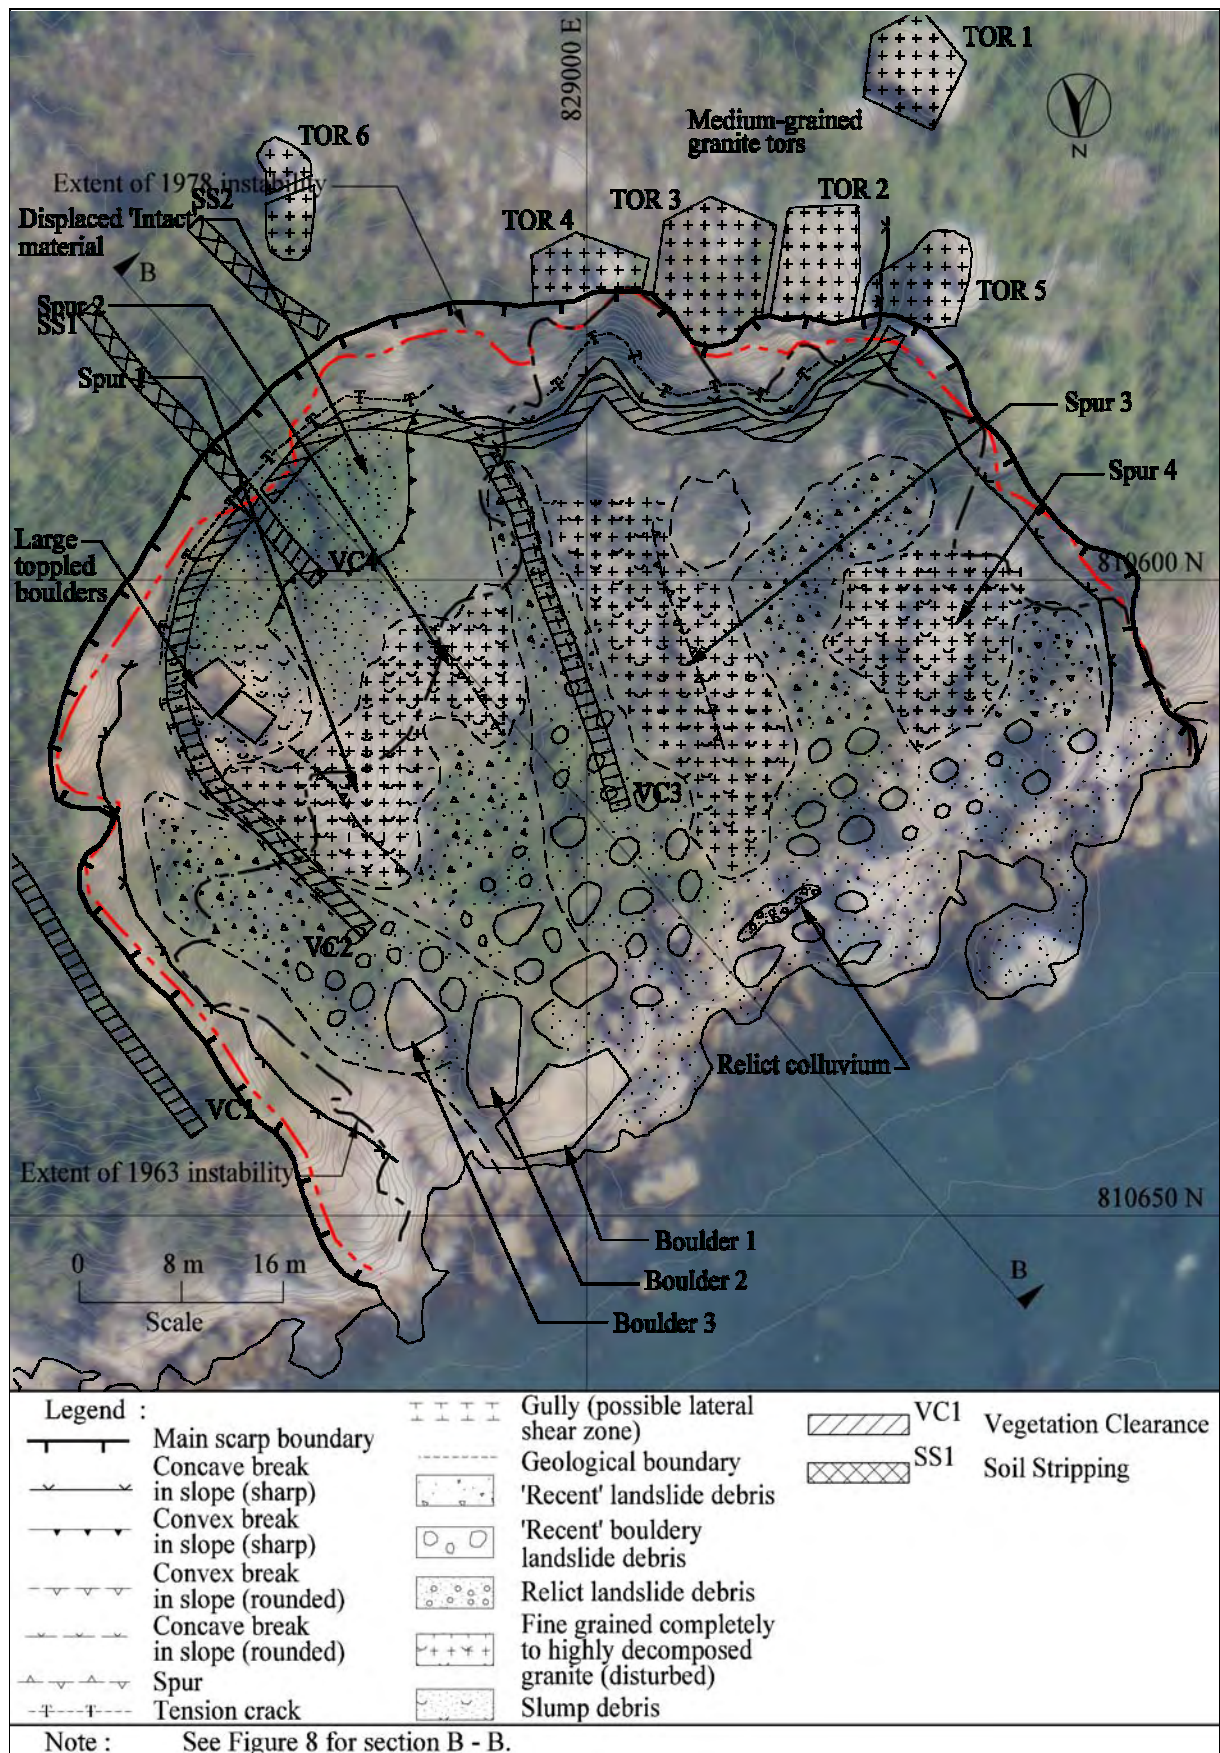
Figure 7 - Orthorectified Image (2002)

The 2002 aerial photographs show the present-day extent of the landslide scar (Figure 7). Apart from changes in the vegetation and perhaps some minor degradation and erosion, there is little change from the 1978 photographs. A detailed description of the landslide site is given in Section 4.

In February and March 2003, a limited ground investigation comprising two surface strips (Nos. SS1 and SS2) and four vegetation clearance strips (Nos. VC1 to VC4) were carried out by Gammon Skanska Ltd., under the supervision of MGSL, for general characterisation of the materials and identification of the locations of possible instability or distress. It was not possible to carry out any drilling owing to the GI Contractor's concerns about safety. The locations of the surface strips were selected to primarily investigate the presence of potential tension cracks or other forms of distress within the ground slope above the crown of the main scarp, and also to characterise the nature of surface materials exposed. The vegetation clearance strips were located above the east flank, along the base of the main scarp and up the central portion of the landslide site, in order to facilitate investigation of inferred recent instability. The locations of the surface strips and vegetation clearance strips are shown in Figure 7.

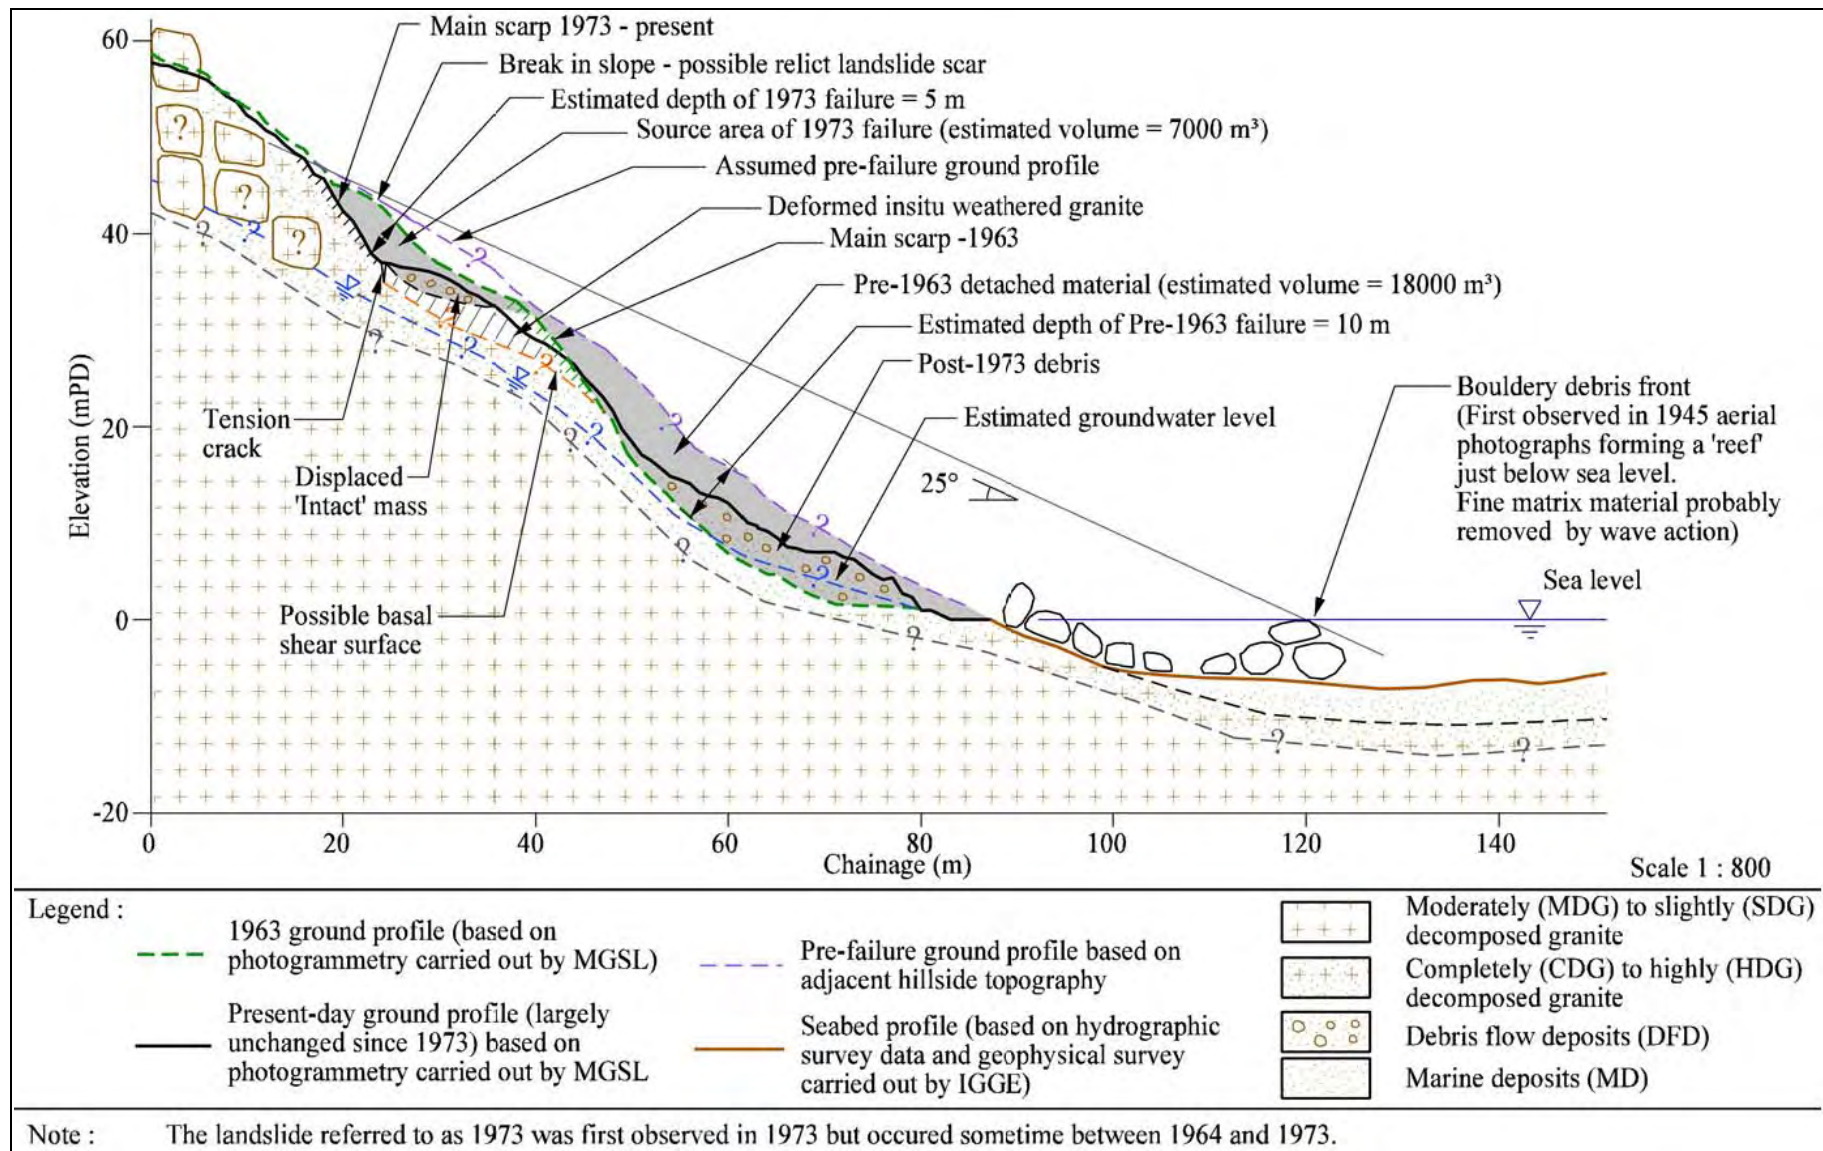
Figure 8 - S Section B-B Through Landslide Site

The background groundwater table was inferred to be relatively low (i.e. >5 m below ground level) as no seepage could be observed anywhere within the landslide scar during the site visits in both winter and summer months (Figure 8). Although no site visits were made immediately after heavy rainfall it is possible that at such times transient elevation of groundwater levels could occur within the saprolite above rockhead or a more complicated groundwater regime (with possible perching or damming) may exist in the southwest portion of the main scarp due the effects of very large corestones within a saprolite matrix. The catchment above the main scarp is relatively small with an area of approximately 1,500 m².

During the field mapping, joint measurements were taken from exposures around the landslide site (i.e. the fine-grained and medium-grained megacrystic granite types). The field observations and measurements indicated that there were differences in the sub-vertical joint orientations and significant increases in the joint spacing between the two granite types (i.e. different structural domains). Also, most of the structurally controlled failure had taken place within discontinuities of the medium-grained megacrystic granite (see Section 4.5) comprising relict joints within completely to highly decomposed granite. Thus, an analysis of the joints within this material was undertaken to assess whether failure would have been kinematically feasible (Figure 9) and what type of initial failure was likely to have occurred in the estimated pre-failure hillside (Figure 8) and during later retrogressive landslides.

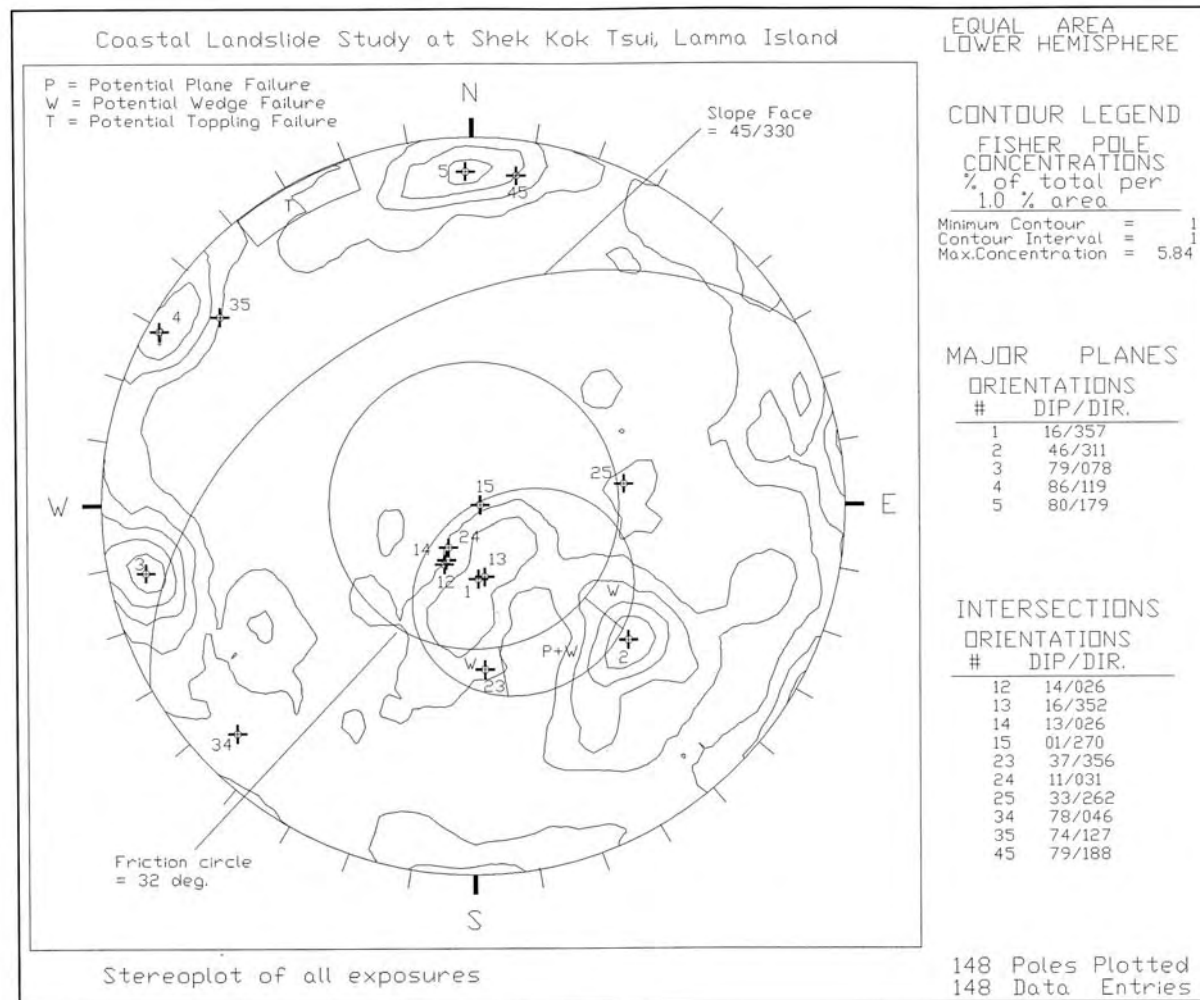
Figure 9 - Kinematic Analysis

The analysis indicates the possibility of both planar and wedge type failures (Figure 9). Some of the major joint sets define back-release surfaces of the main scarp such as joint set No. 5 ($80^{\circ}/179^{\circ}$) and joint set No. 4 ($86^{\circ}/119^{\circ}$) as shown in Figure 9. Within the medium-grained granite, a shallow-angle joint set (joint set No. 1) orientated at about $16^{\circ}/357^{\circ}$ forms a planar failure surface, and joint set No. 3 ($79^{\circ}/078^{\circ}$) forms a side-release surface. Instability of large corestones and tors has occurred in the upper scar area, possibly

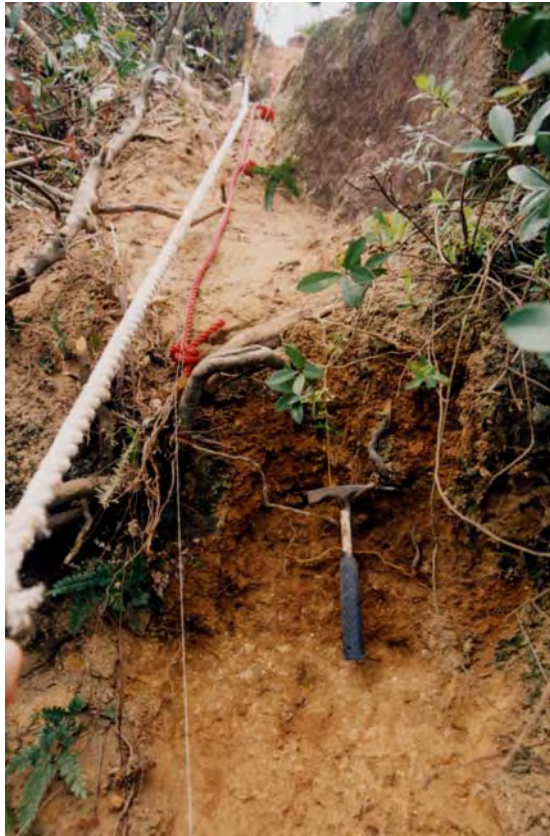
Surface strips Nos. SS1 and SS2 did not reveal any evidence of potential instability such as tension cracks, back scarps or subsidence above the main scarp area. Within the main scarp, a minor scarp (approximately 0.5 m in height) was observed along surface strip No. SS1, approximately 5 m from the base of the main scarp (Plates 7 and 8). This is located in an area of the main scarp that is relatively shallow at approximately 50° and may be a localised feature since it could not be traced laterally for more than 10 m. The materials encountered along both surface strips consisted predominantly of granitic topsoil and slopewash material.

Plate 7 - View of a Minor Scarp (0.5 m in Height)
Immediately above the Main Scarp Along
Surface Strip SS1 (Photograph taken on
11 March 2003)

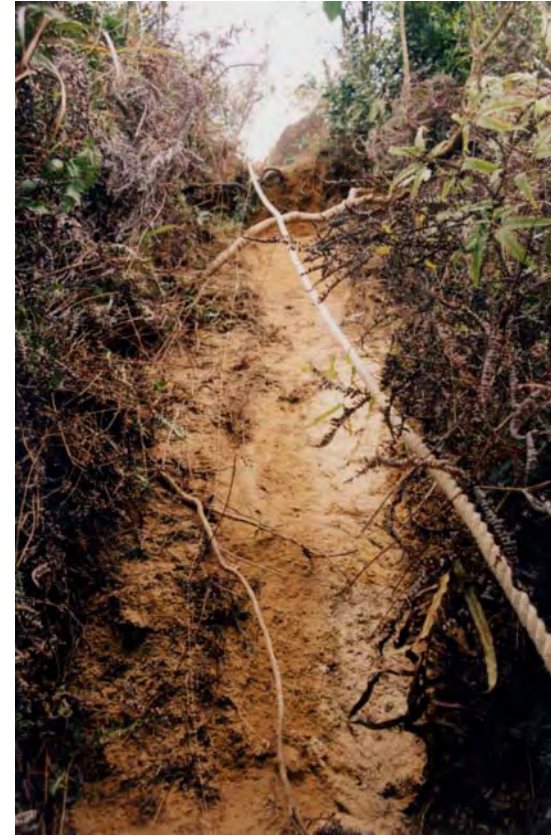
Plate 8 - View Upslope of Surface Strip SS1 from
the Base of the Main Scarp Towards the Minor
Scarp shown in Plate 7 (Photograph taken on
11 March 2003)

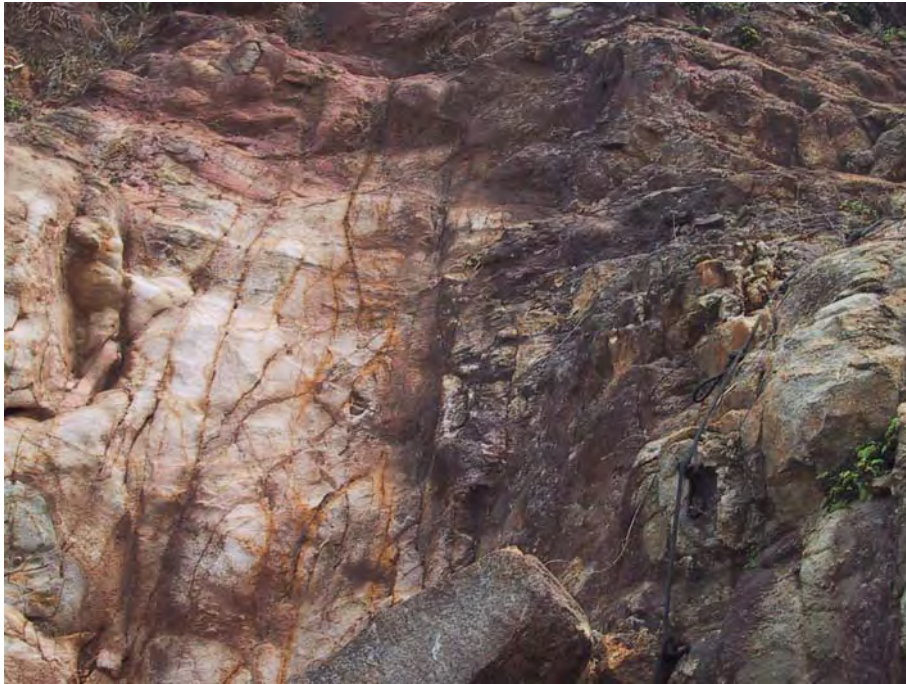
Plate 9 - View of Insitu Fine-grained Granite at the Lower Eastern Flank of the Main Scarp (Photograph taken on 10 March 2003)

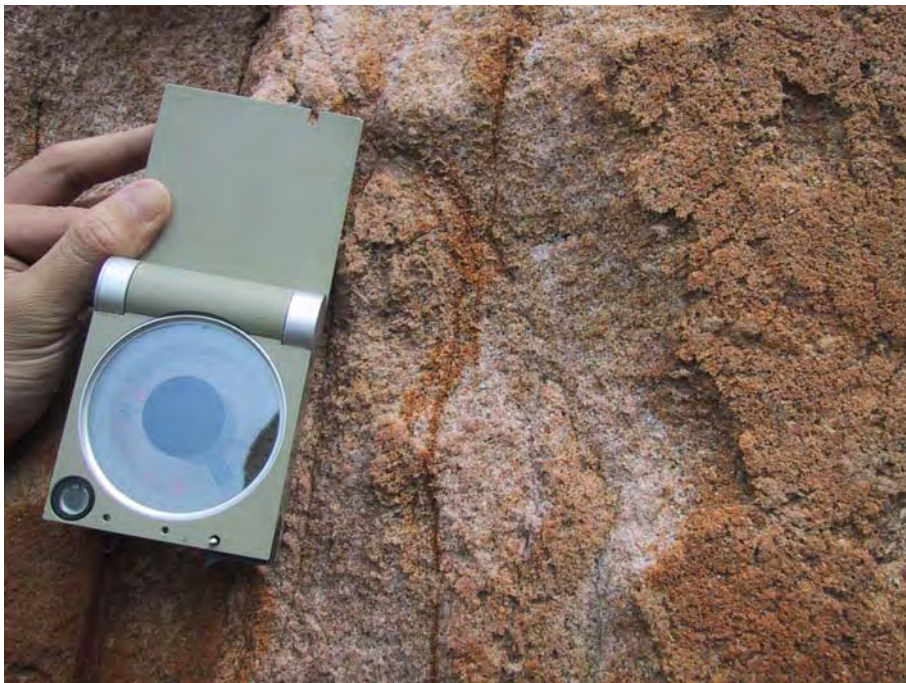
Plate 10 - Close-up View of Insitu Fine-grained Granite as Shown in Plate 9 (Photograph taken on 10 March 2003)

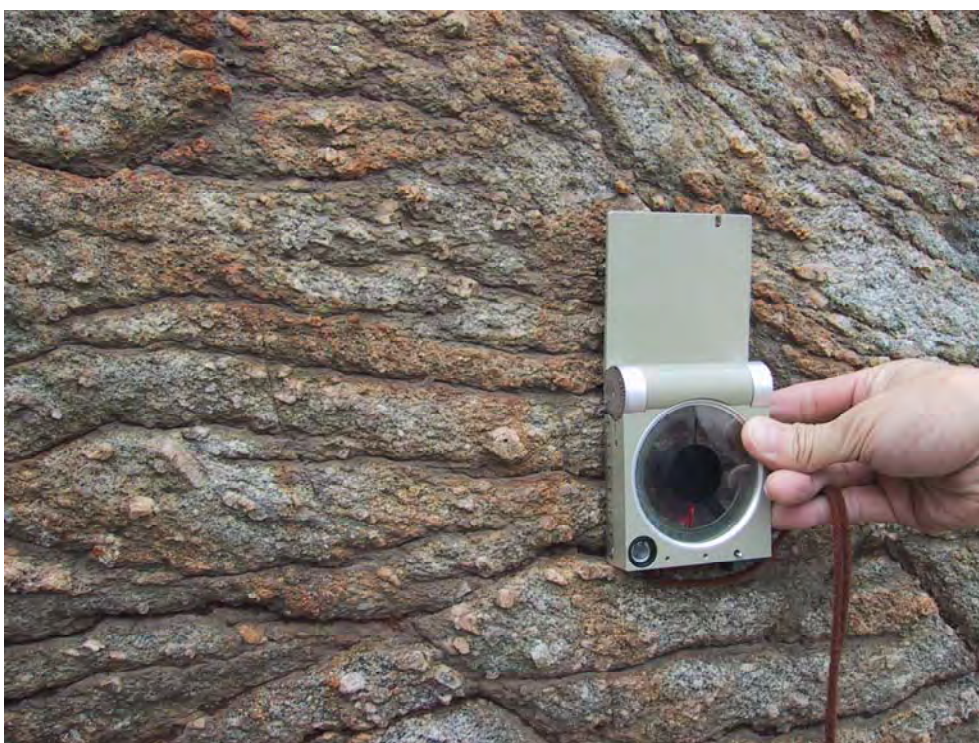
Plate 11 - Close-up View of Insitu Megacrystic Granite at the Lower Eastern Flank of the Main Scarp (Photograph taken on 10 March 2003)

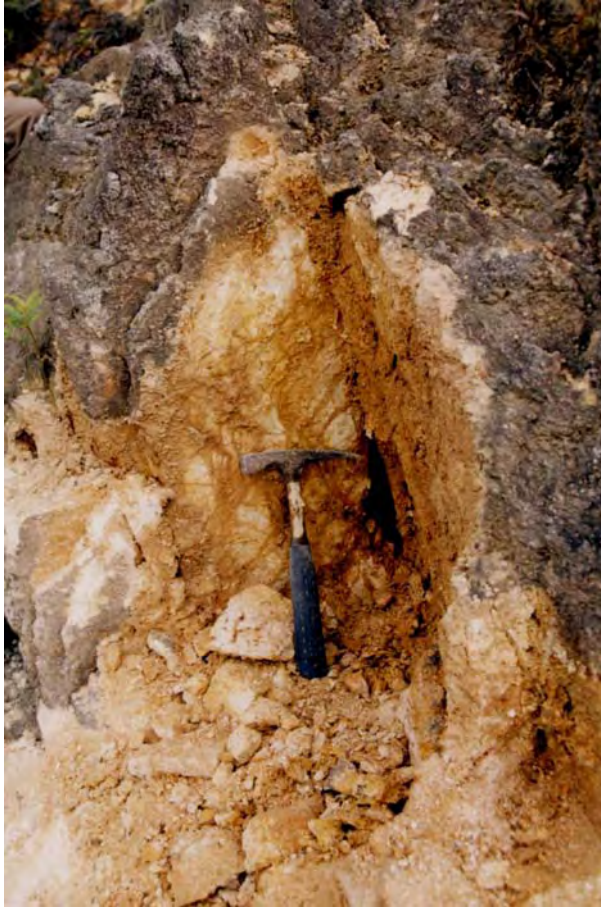
As no exposed shear surfaces can be seen within the landslide scar, it is possible that the movement observed within the tension cracks could be associated with the local deformation observed within the weathered granitic rock mass of spurs Nos. 1 and 2.

Plate 13 - View of Deformed Rock Mass Within Spur
No. 1. Showing Dilation and Voids
(Photograph taken on 18 March 2003)

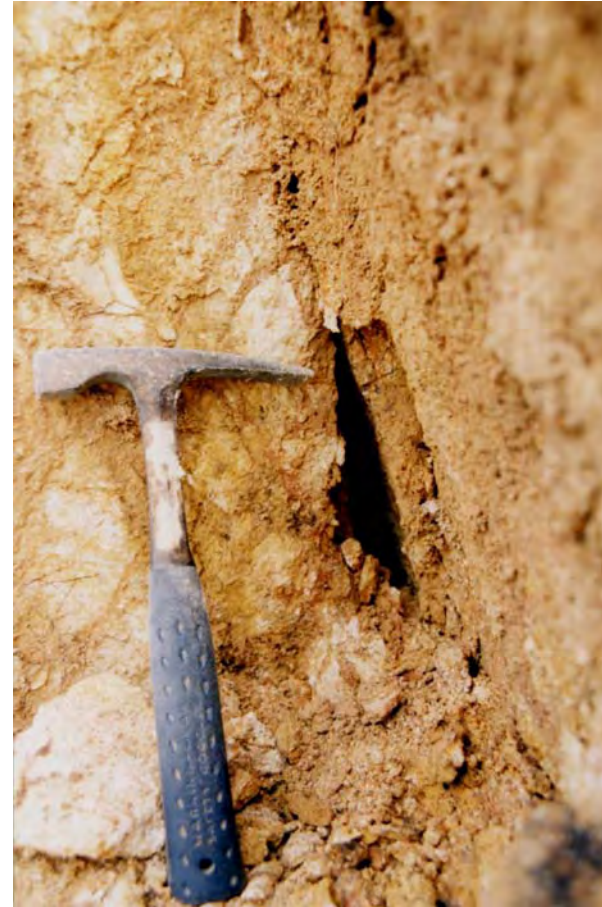
Plate 14 - Close-up View of Deformed Rock Mass with
Voids and Kaolin Coated Joint Surfaces
(Photograph taken on 18 March 2003)

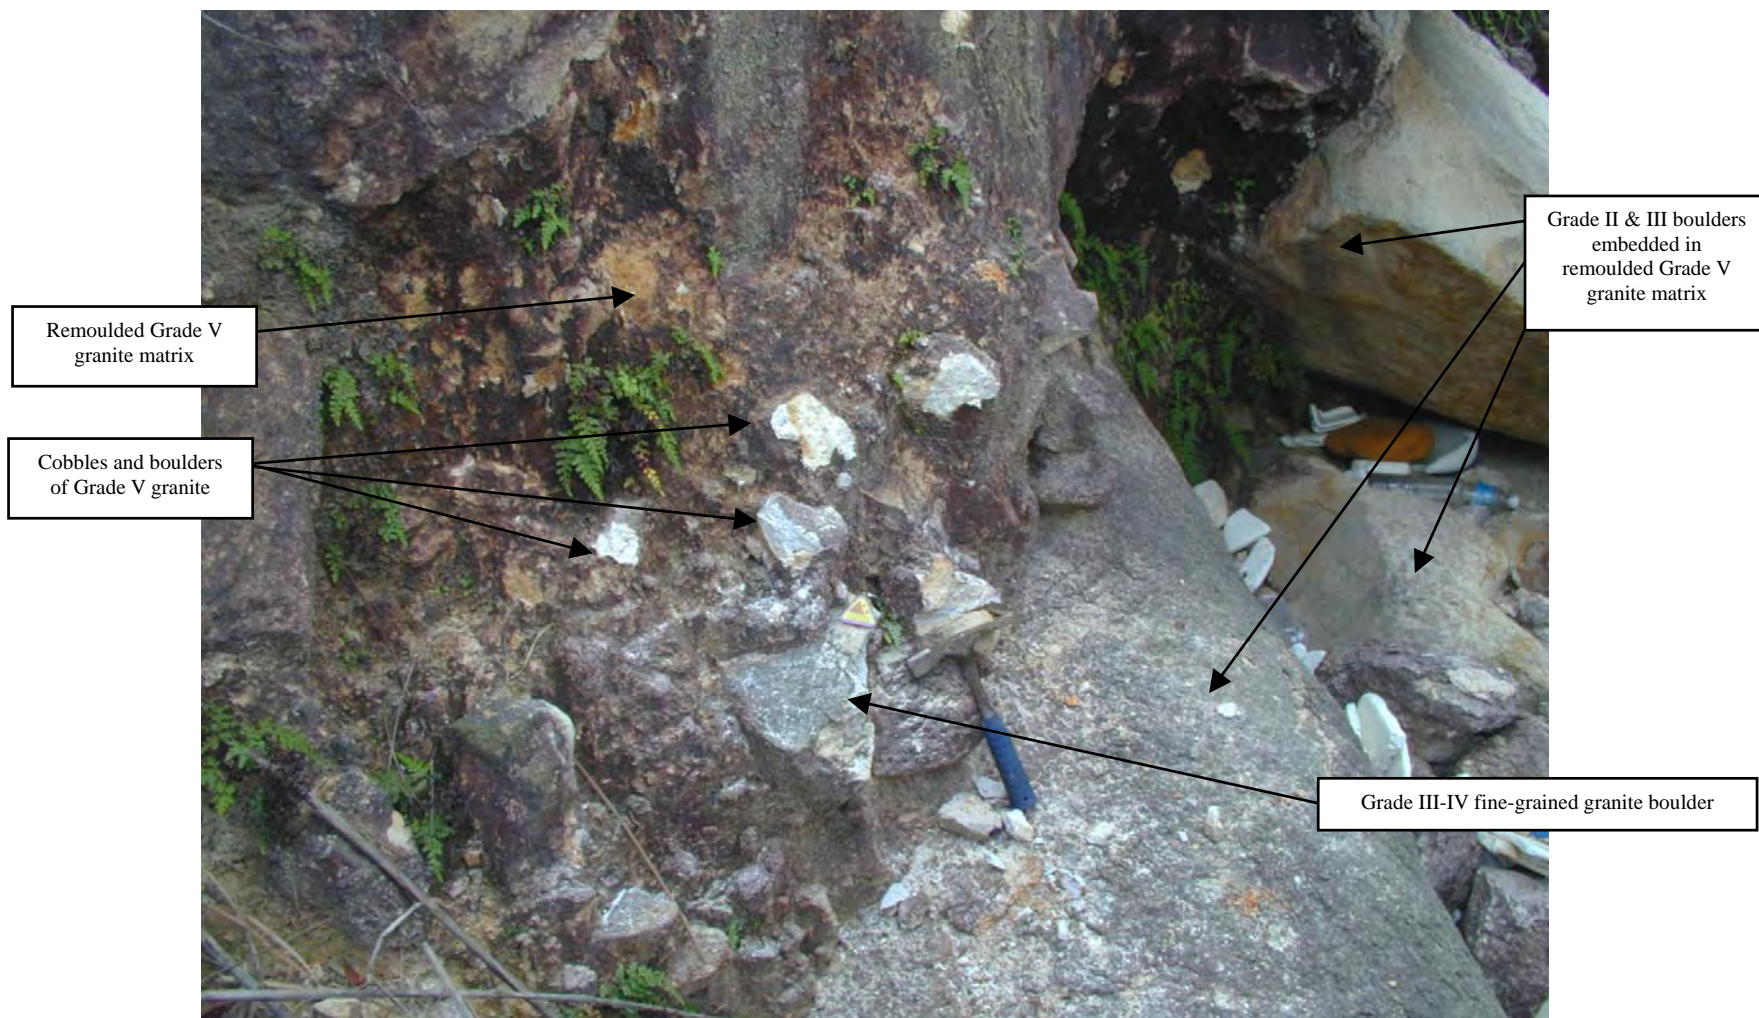
Plate 16 - Relict Colluvium Near the Toe of the Landslide Scar (Photograph taken on 5 December 2001)

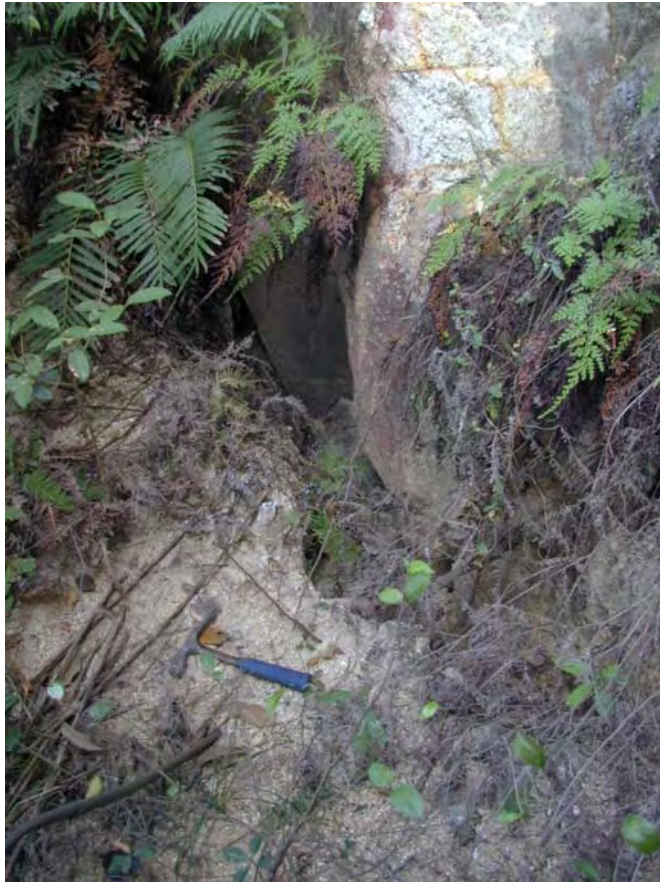
A similar situation exists where tension cracks are found at the base of the main scarp below tors Nos. 2, 3 and 4. Here there is a tension crack of similar size (i.e. about 0.3 m wide and 0.5 m deep) and deformation in the weathered granite spurs below. However, below tor No. 3 an approximately 1 m wide strip has subsided by up to about 0.5 m to produce a graben-like feature.

Plate 17 - Tension Crack Along the Base of the Main Scarp below Tor No. 3 (Photograph taken on 5 December 2001)

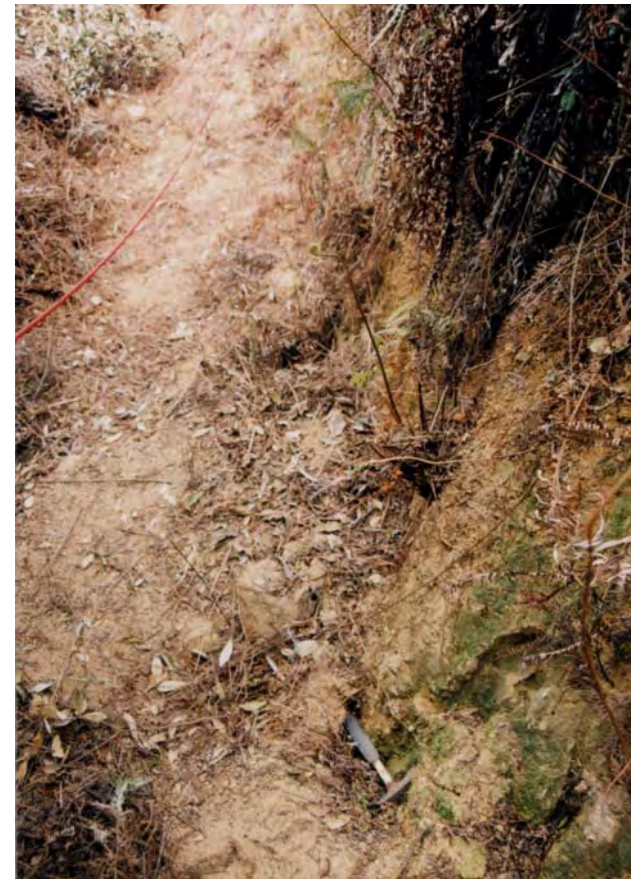
Extensive tension cracks over a distance of about 70 m were observed along the base of the central and western portions of the main scarp, at the base of tors Nos. 2, 3, 4 and 5, and along the base of the main scarp above spurs Nos. 1 and 2 (Figure 7 and Plates 17 and 18). The tension cracks are up to about 0.3 m wide and displaced vertically by up to approximately 0.5 m. In most cases they appear to be relatively recent from the fresh appearance of the soil within the tension crack and lack of degradation. Incised 'gully' features, up to about 0.2 m wide and 0.5 m deep, were found adjacent to vegetation clearance strips Nos. VC2 and VC3, descending the landslide scar on either flank of spurs Nos. 1 and 2.

Plate 18 - Tension Crack Along the Base of the Main Scarp below Surface Strip SS1 (Photograph taken on 5 December 2001)

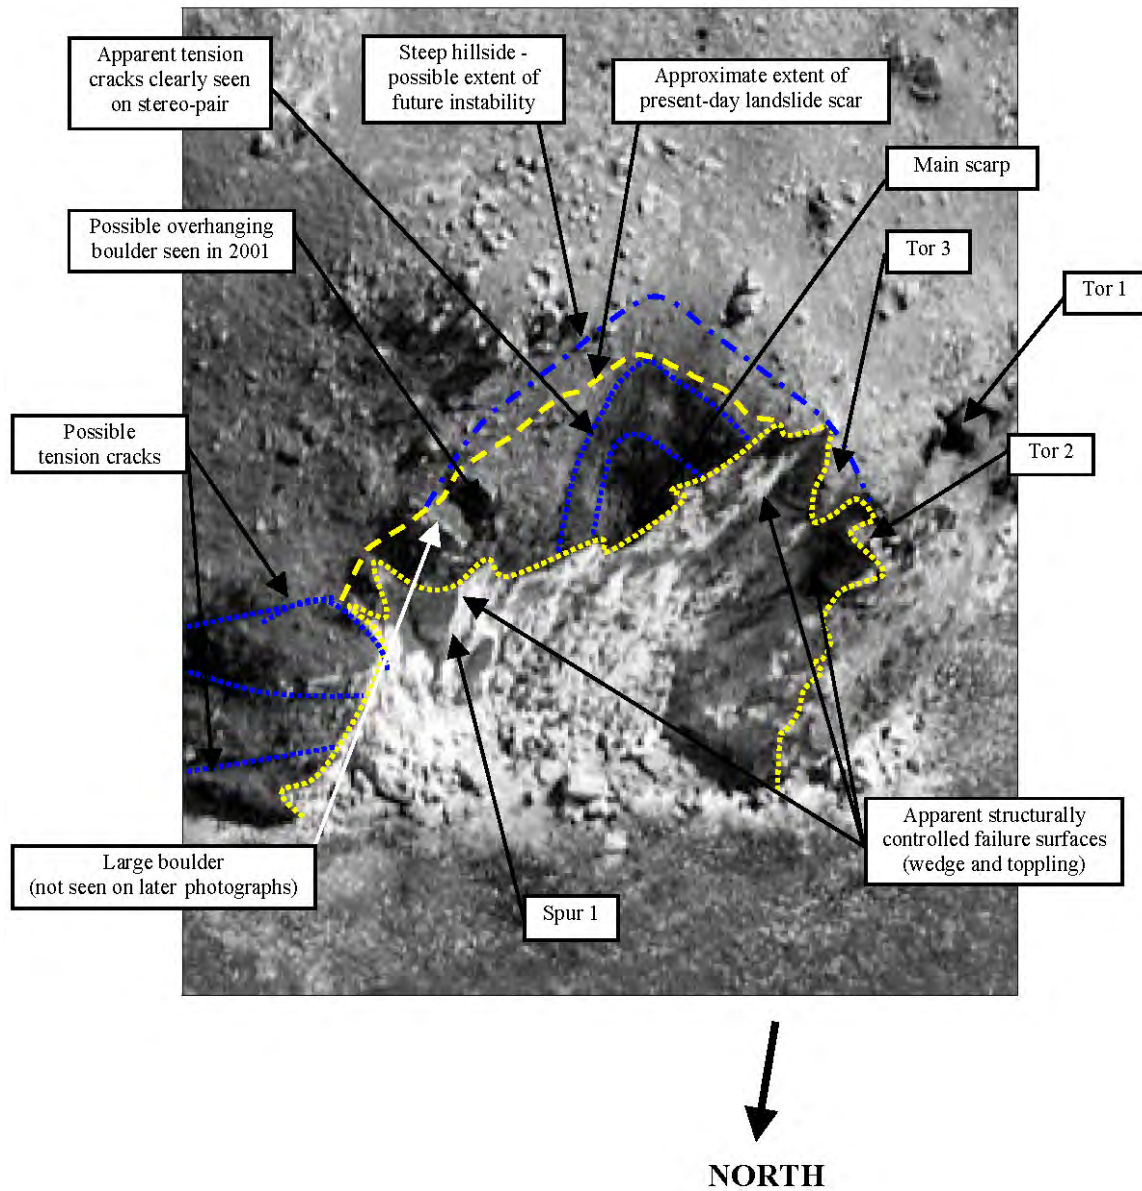
Plate A2 - API Observations of Landslide Area From 13 February 1963
Stereo-photographs

Apparent tension cracks can be seen in the 1963 photographs at the approximate location of the present main scarp. This indicates that this portion of the hillside was probably only marginally stable in 1963 due to loss of lateral and toe support as a result of the previous landsliding. The 1978 photographs indicate further instability along the line of the present-day main scarp and some areas above spur No. 2 appear to have slid down as intact rafts or slumping of material based on the presence of areas of vegetation within the scar. The depth of failure estimated from the 1978 photographs is still fairly deep at about 5 m perpendicular to the ground surface. The depth of failure surface was probably controlled by a combination of extremely widely spaced joint sets and the deeply weathered profile within the landslide site, together with the significant loss of toe support.

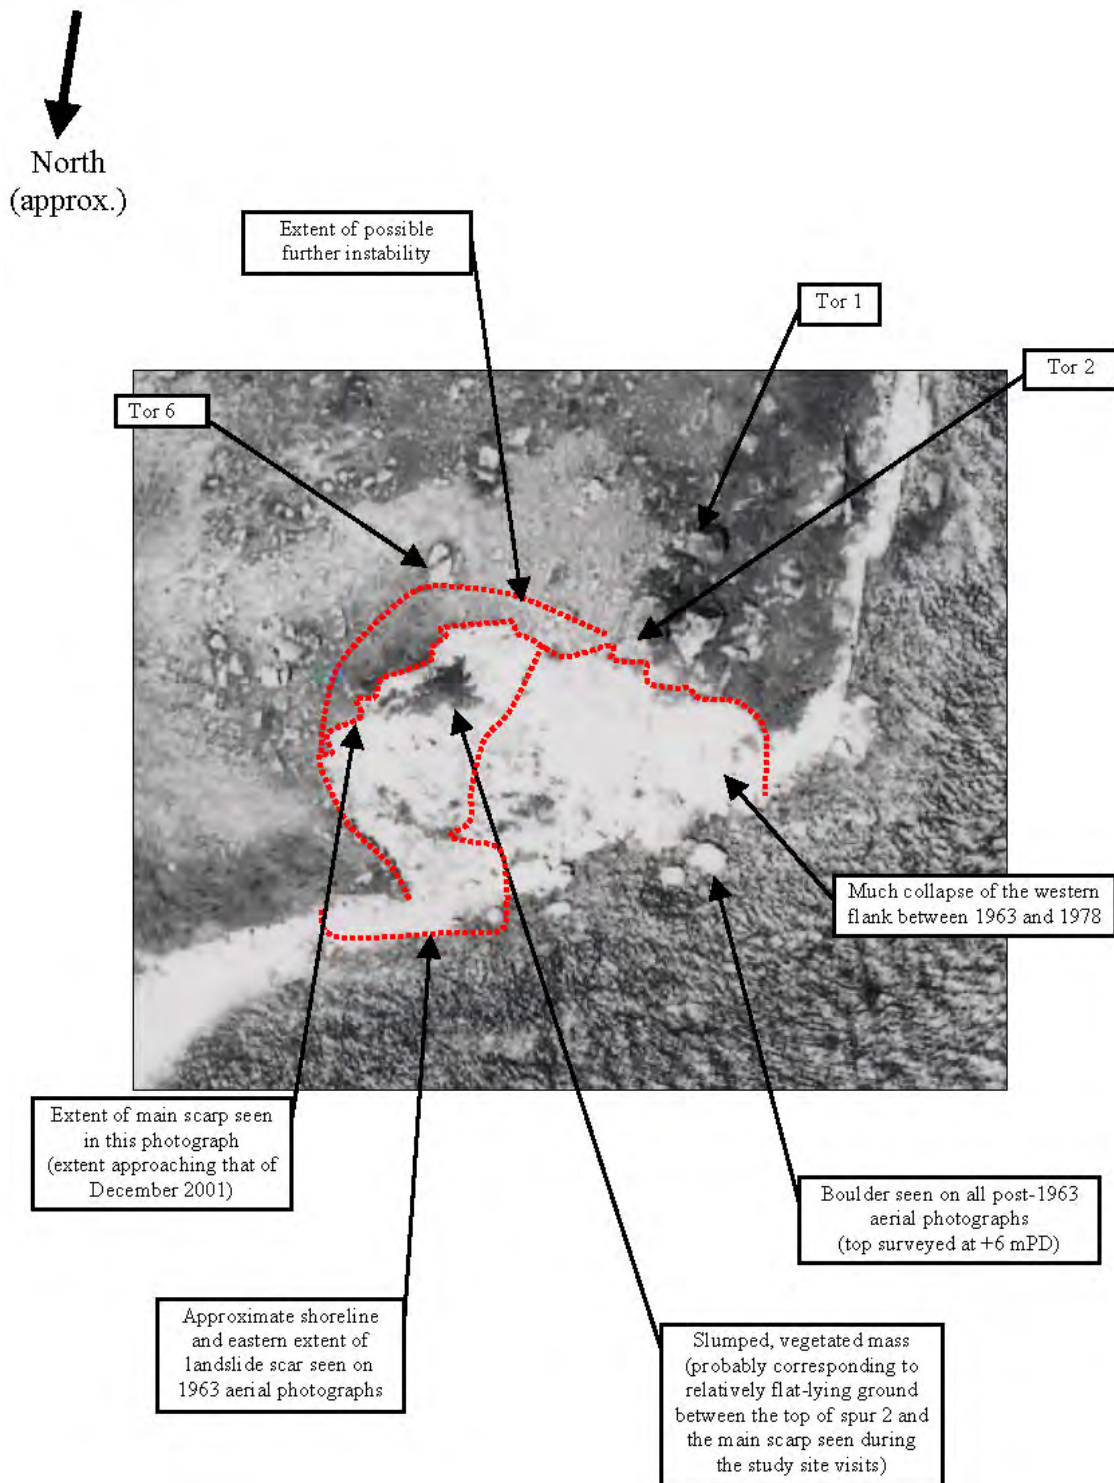
Plate A3 - API Observations of Landslide Area From 5 July 1978
Stereo-photographs

YEAR	OBSERVATIONS
1976	No observable changes.
1978	The 5 July 1978 photographs are low level and confirm the extent of the main scarp enlargement being similar to the present-day outline (Plate A3). The ground between the 1963 main scarp and the present-day main scarp (tension cracks of 1963) has apparently slumped vertically several metres. This area is relatively flat-lying, thickly vegetated and was observed on site to lie between the crest of Spur 2 and the base of the main scarp. A vegetated mass, surrounded by bare soil, in a similar position can be seen on the 1978 photographs. The large intact spurs of apparently insitu decomposed granite appear to be undisturbed with no bulging, cracking or distortion, suggesting little possibility of deep seated movement taking place underneath.
1979	No observable changes.
1984	No observable changes.
1993	<p>The 2 November 1993 photograph indicates very strongly that there is a structural geological control on the instability of the hillside. The main scarp of the landslide is shown clearly to follow three main structural trends of sub-vertical discontinuities, one of which (striking E-W) forms the back release surface for the large granite tors within the western flank. Other main structural trends (striking N-S) shown in the photograph indicate side release surfaces for the tors. Similar structural trends are repeated within the degraded large relict landslide scar approximately 70 m to the west, and within a small degraded landslide scar 30 m to the southwest. Other lower angle joint sets were observed from the site reconnaissance visit which initially indicate possible toppling or wedge sliding failure possibilities.</p> <p>The hillside to the south of the present-day main scarp contains distinctly more large corestone-bearing ground than that to the west, which generally coincides with the area of medium grained granite as shown in the published 1:20 000 geological map (HKGS Map Sheet 14). It is possible that the conditions of placement of this granite, including cooling and crystal growth, may have been favourable for the very wide, persistent, orthogonal joint development leading to the eventual formation of the large corestones.</p> <p>The dominant discontinuity trends are N-S, E-W, and NW-SE. A number of lineations that may represent major, sub-vertical discontinuities and/or tension cracks can be seen striking across the slope and through the East and West flanks, extending across the natural hillside on either side. A N-S trending fault is inferred passing within 30 m of the east flank of the landslide.</p>
