REPORT ON THE SHEK KIP MEI LANDSLIDE OF 25 AUGUST 1999

GEO REPORT No. 181

**Fugro Maunsell Scott Wilson Joint Venture
&
Professor J. B. Burland**

**GEOTECHNICAL ENGINEERING OFFICE
CIVIL ENGINEERING AND DEVELOPMENT DEPARTMENT
THE GOVERNMENT OF THE HONG KONG
SPECIAL ADMINISTRATIVE REGION**

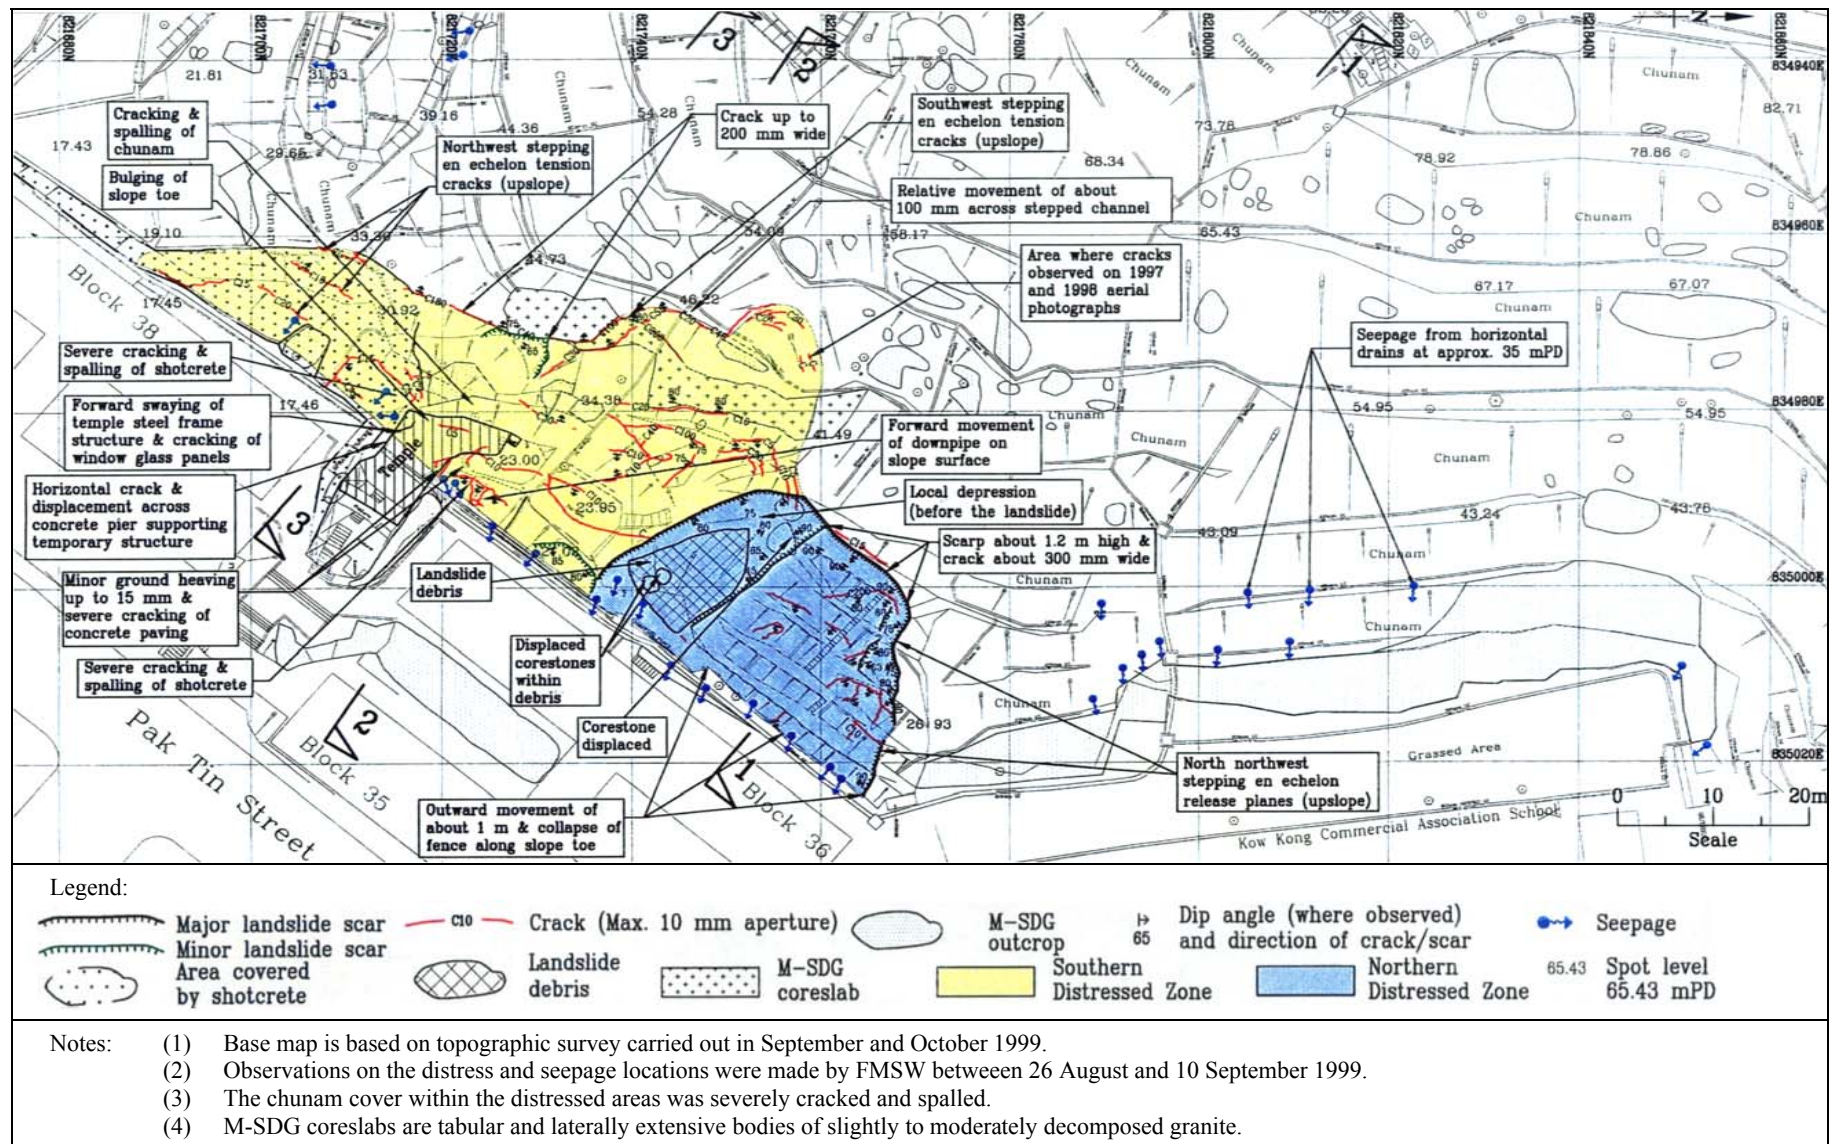
Figure 3 - Plan of the Landslide

A crack up to about 300 mm wide, 1.5 m deep and 18 m long was noted between the main scarp and the displaced material, and several cracks up to 150 mm wide together with minor scarps were observed on the displaced slope surface (Figure 3). The main scarp extended southwards behind a large corestone (about 2 m across) and into a local depression on the slope surface (Figure 3 and Plate 6).

Seepages were observed along the toe of the slope and within the lower area of the local depression in the southern portion of the northern distressed zone (Figure 3).

The western margin of the southern distressed zone was characterised by a series of northwest stepping (upslope) en echelon tension cracks (Figure 3). The crest of the distressed area was denoted by the uppermost, recently-activated cracks observed on the chunam cover. Here the cracks were up to 50 mm wide and vertical displacement of up to 50 mm was noted, and about 50% of the cracks exhibited a relative downward displacement on the upslope side.

Cracks up to 12 m long and 20 mm wide and generally orientated north-south to northeast-southwest were observed on the shotcreted surface of the slope toe opposite the northern portion of Block No. 38 (Figure 3). Similar cracks were noted in and beneath the chunam cover, to the north of the temple. Here, cracks up to 200 mm wide were noted,

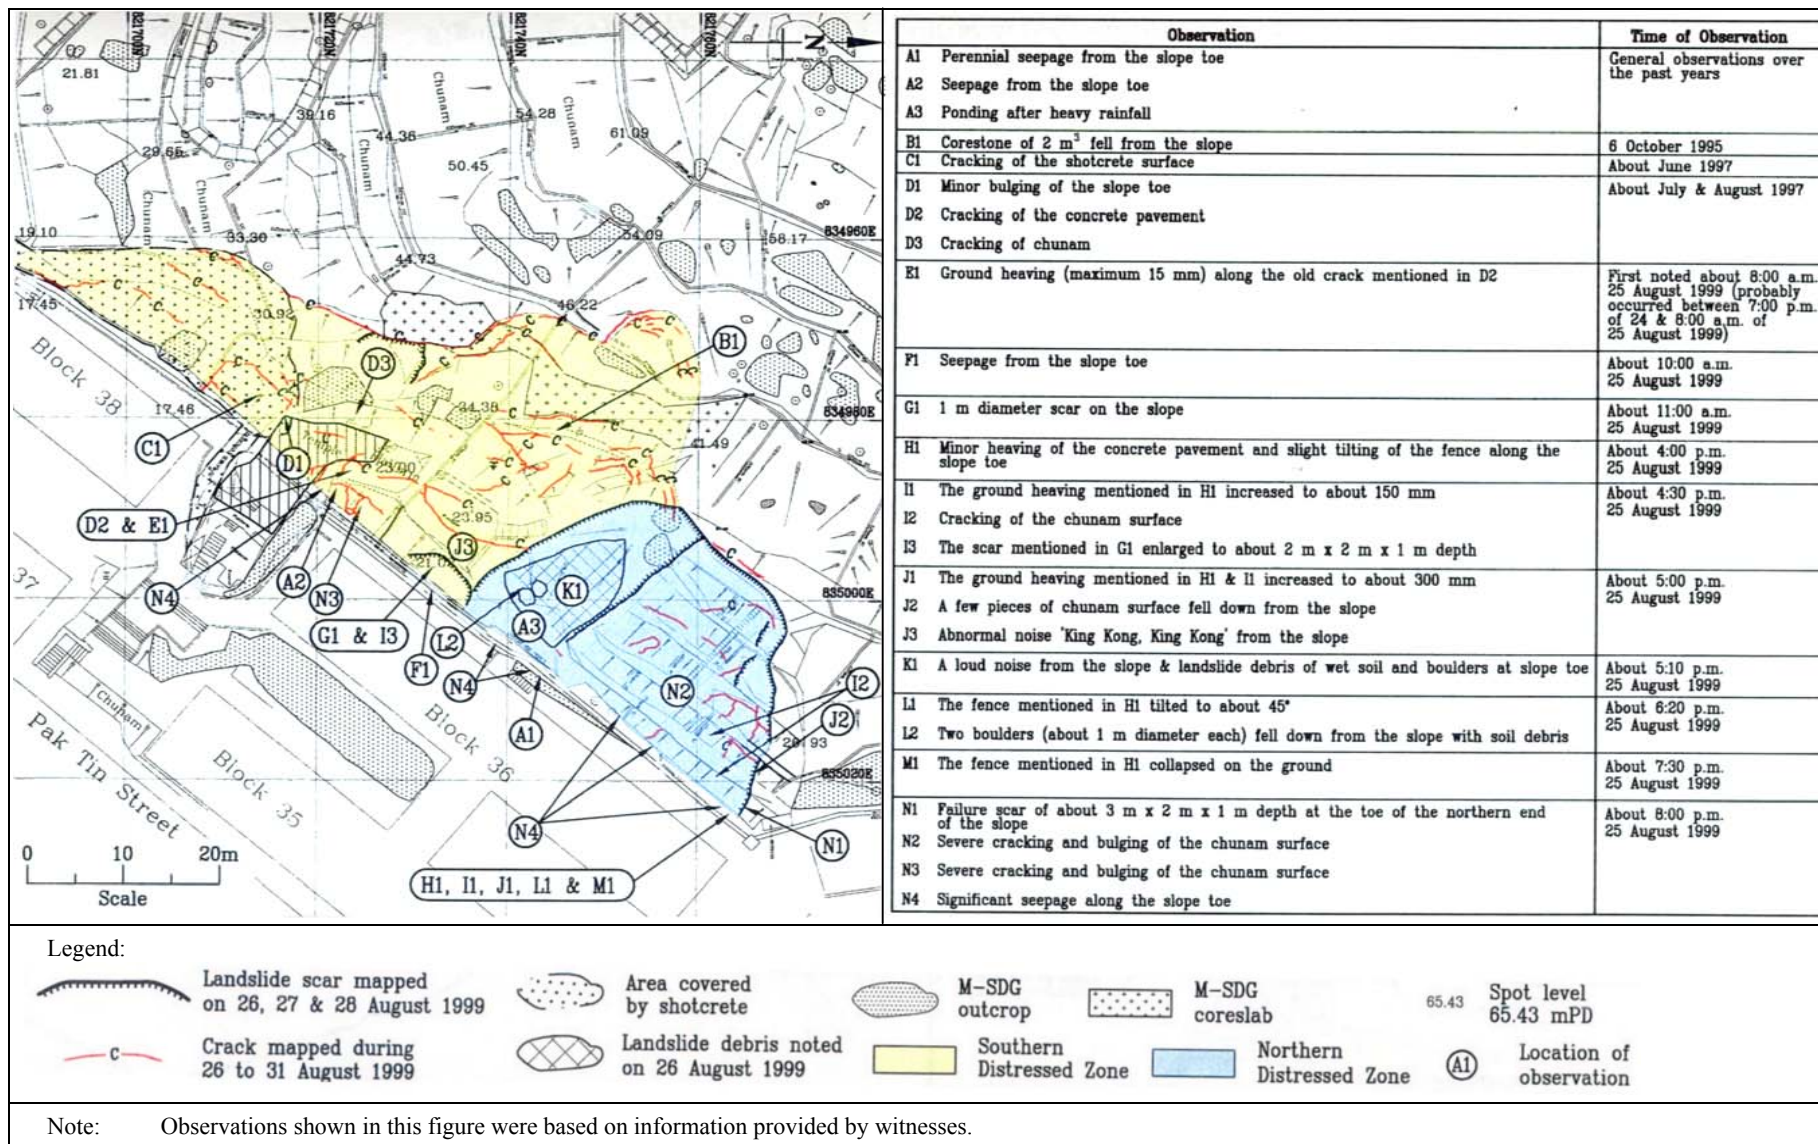
Figure 4 - Key Observations Made on and before 25 August 1999

Perennial seepage from the toe at the central portion of slope No. 11NW-B/C90 was noted by the residents of Shek Kip Mei Estate and personnel of the temple over the past years prior to the landslide (Figure 4).

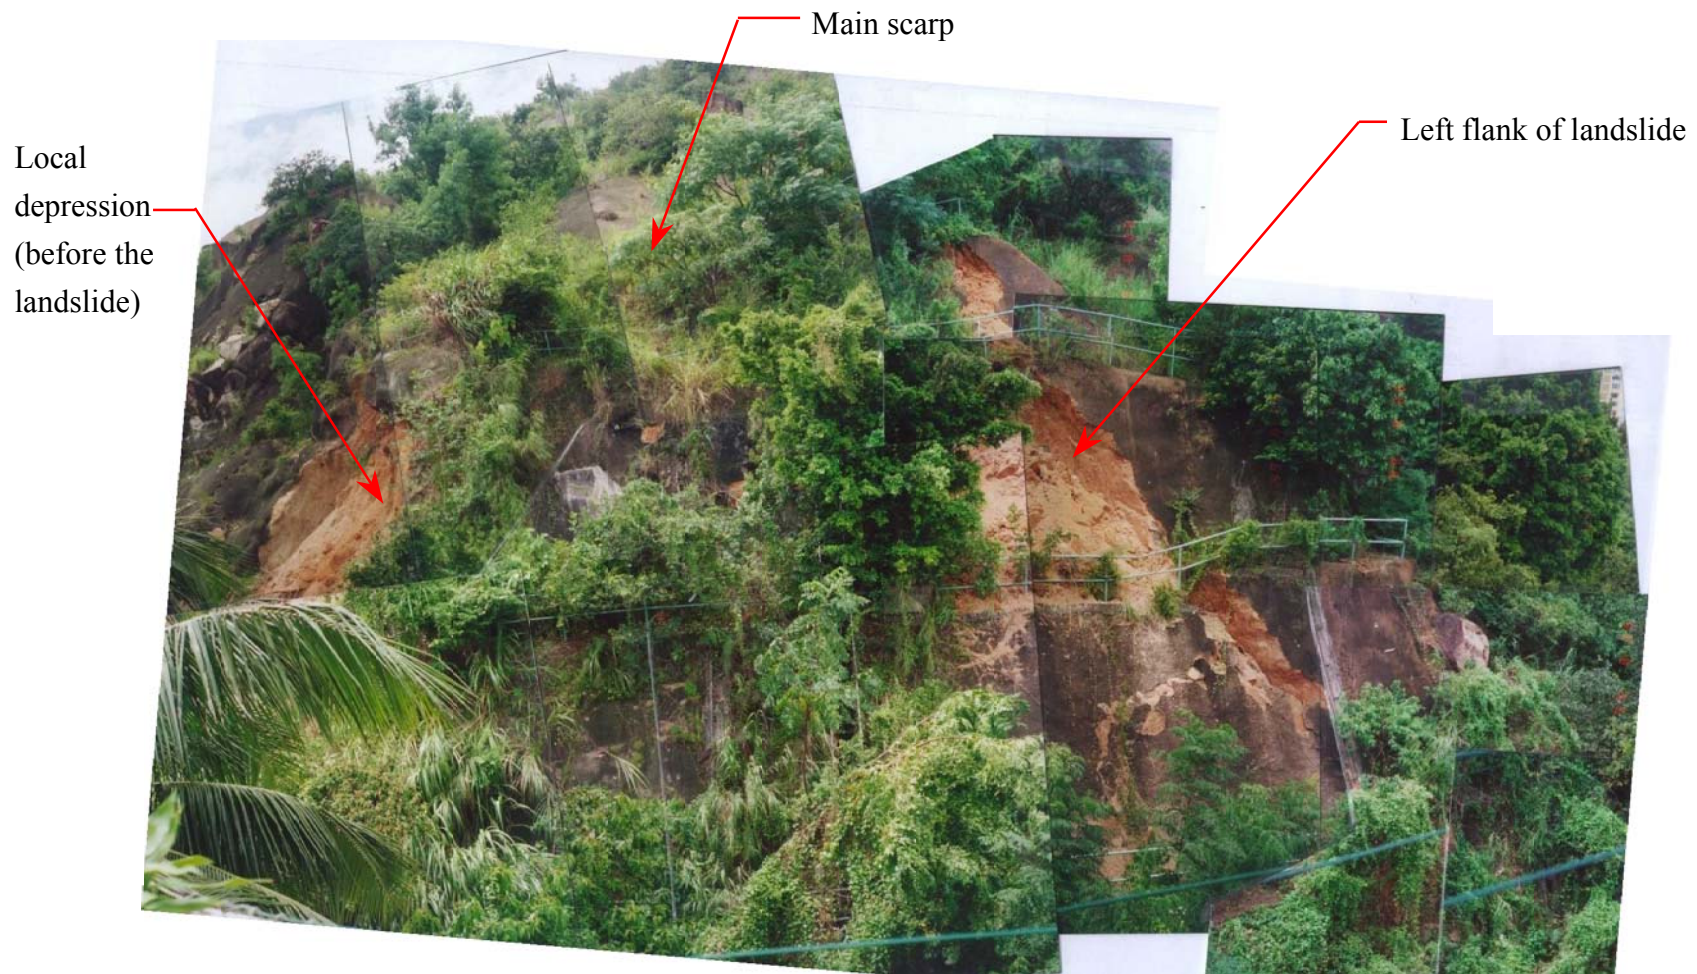
In the northern distressed zone, the landslide scar was about 37 m wide, 31 m long and comprised essentially intact debris, which had been displaced downwards at the crest of the scar by up to about 1.2 m (Plates 6 and 7) and horizontally at the slope toe by about 1 m (Plate 8). The maximum depth of the landslide was estimated to be up to about 8 m, and the estimated volume of the debris was about 2500 m³. The displaced material was mainly covered with cracked chunam and comprised medium to coarse-grained completely decomposed granite (CDG) with some moderately to slightly decomposed corestones. Apart from localized collapse of debris and corestones, the majority of the displaced material had a limited mobility and remained on the slope.

Plate 6 - General View of the Northern Distressed Zone (Photograph Taken on 26 August 1999).
See Figure 34 for location.

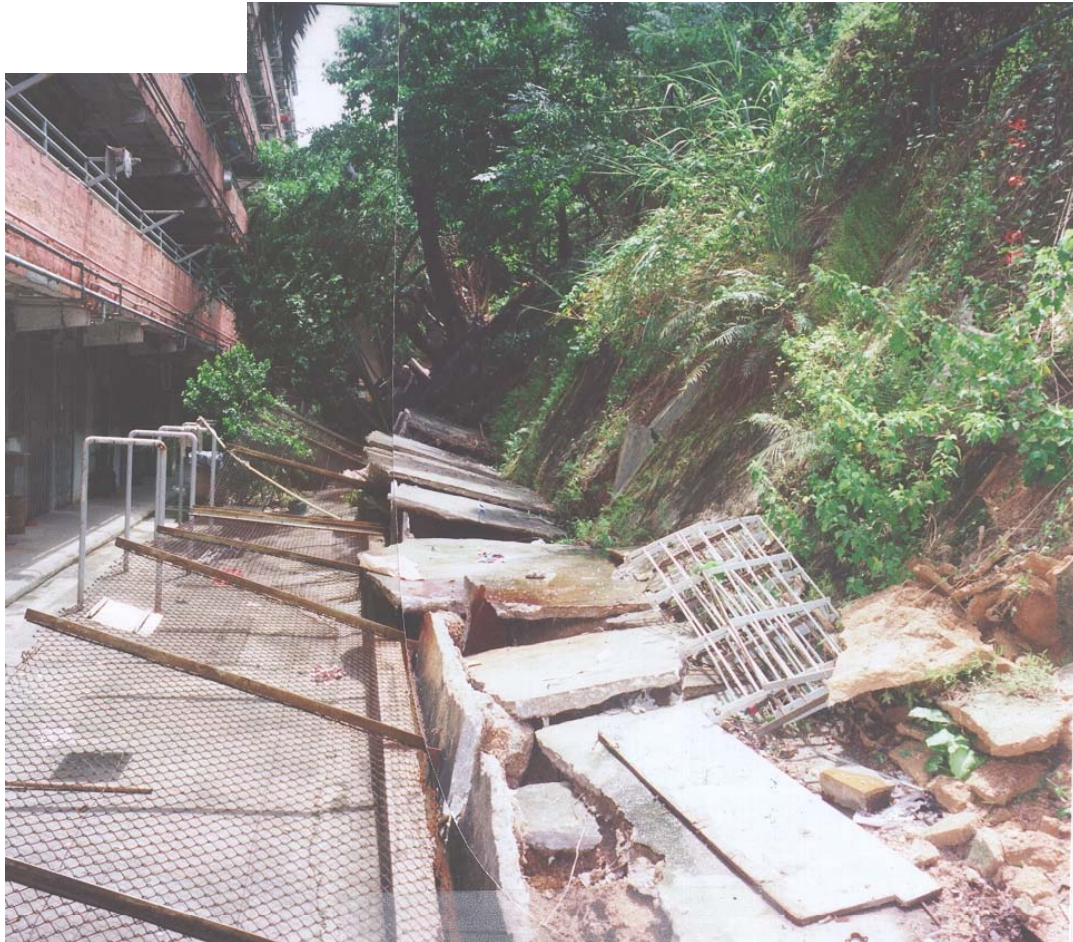
The movement of the displaced material, which was principally downwards along the face of the slope, caused an outward displacement of the concrete pavement in front of the slope toe. This in turn pushed over a steel wire chain link fence into a sub-horizontal position (Figure 3 and Plate 8). Several trees tilted and toppled at the slope toe as a result of the displacement.

Plate 8 - Slope Toe of the Northern Distressed Zone (Photograph Taken on 26 August 1999). See Figure 34 for location.

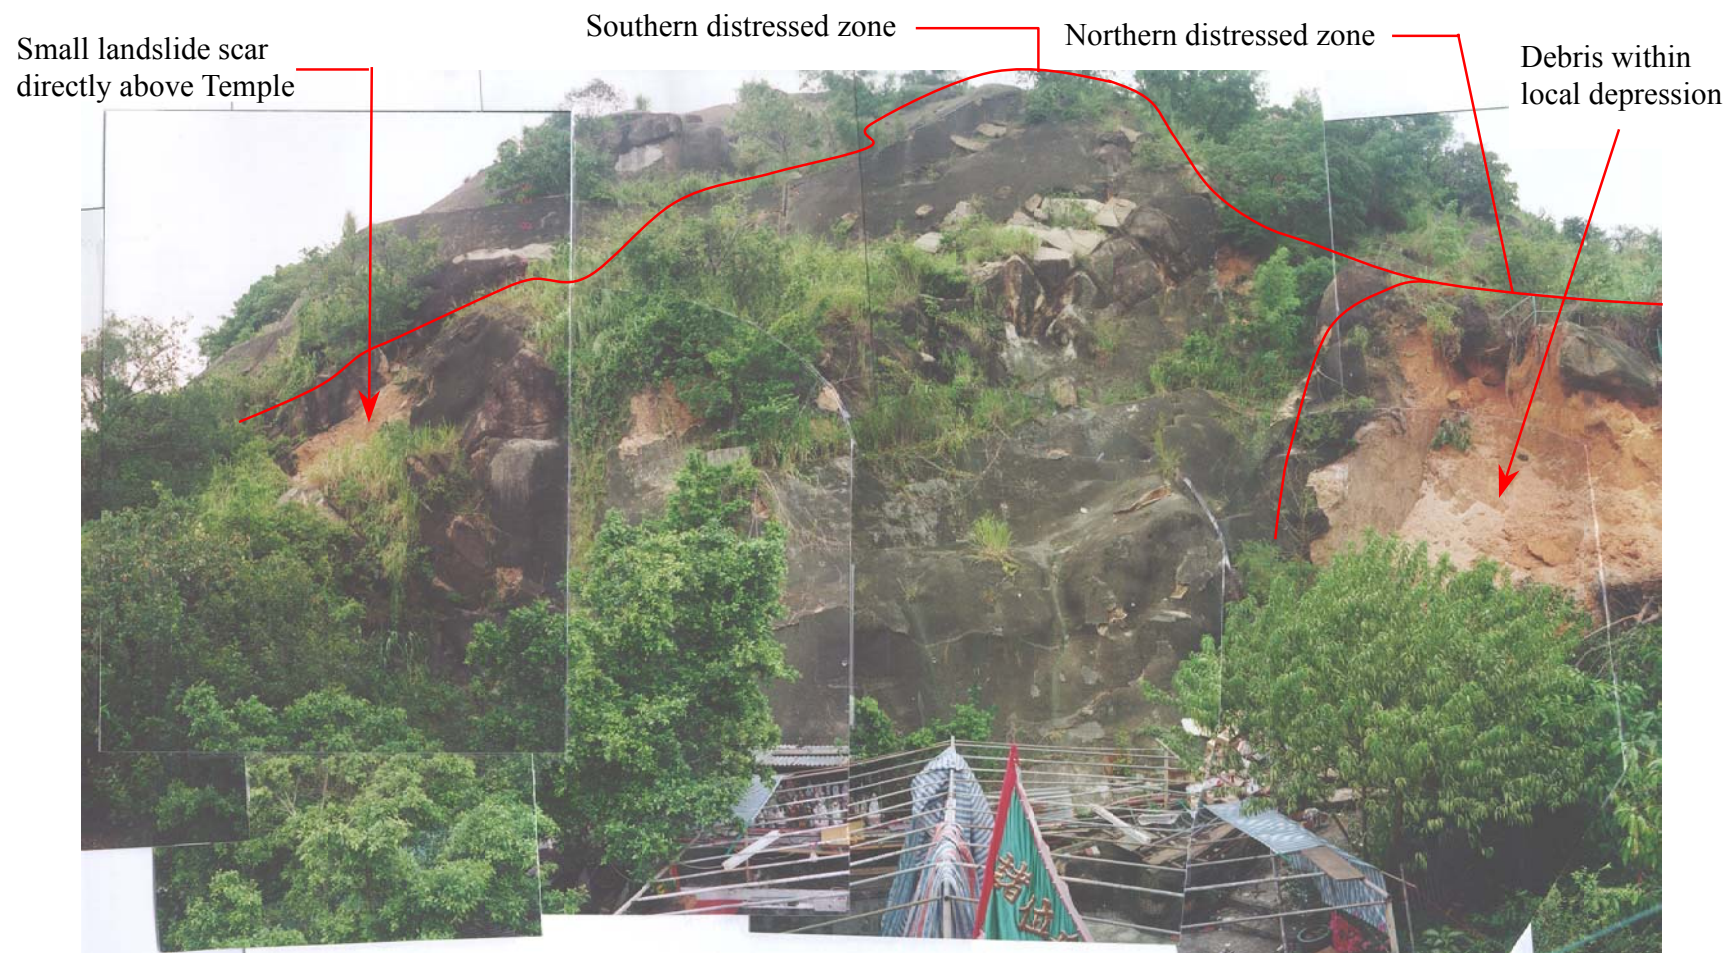
Within the area of the local depression, up to 0.5 m thick of loose debris, comprising mainly silty sand, was noted covering vegetation on the slope surface (Plate 9). Several corestones had been displaced from the upper portion of the scar (Figure 3), coming to rest within the dense, unplanned vegetation towards the toe of the slope. There was also evidence of surface erosion, probably related to the lower end of a gully, which had generally been lined with chunam, feeding surface runoff directly into the depression. Release planes along the right flank of the scar included relic joint sets dipping at 75° to 80° towards east southeast (Figure 3 and Plate 9), some of which were coated with kaolin and a black-brown deposit likely to comprise manganese and iron oxides (referred to as manganese oxide in this report). The left flank comprised north northwest stepping (upslope) en echelon release planes dipping at 50° to 75° towards the southeast and south southeast (Figure 3).

A small landslide scar, characterised by shallow (up to about 200 mm) detachment of chunam and soil, was observed on the slope directly above the temple (Plate 9). Another small landslide scar was observed on the slope between the 1.8 m-high brick toe wall opposite the southern portion of Block No. 36 and the concrete platform to the north-east of the temple (Plate 16). The toe wall itself exhibited only minor cracking.

Plate 9 - View of the Distressed Slope above the Platform to the Northeast of the Temple
(Photograph Taken on 26 August 1999). See Figure 34 for location.

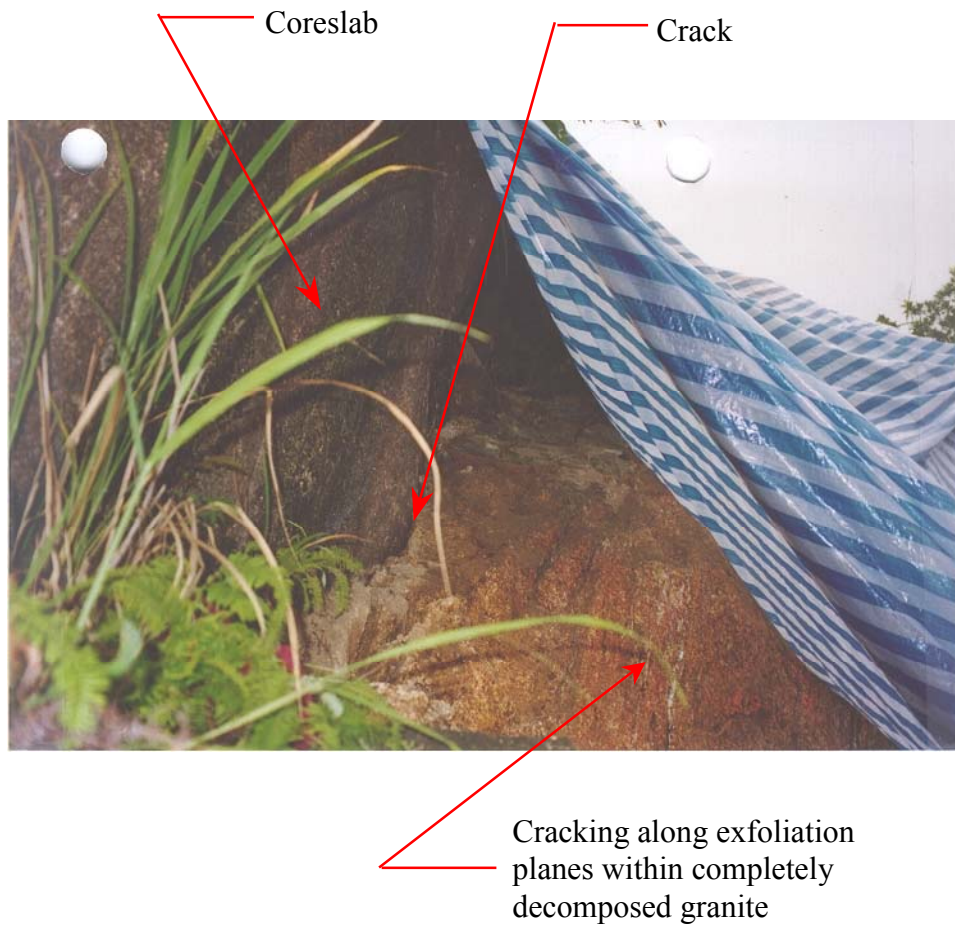
Plate 10 - Crack along the Downslope Side of the Coreslab (Photograph Taken on 1 September 1999). See Figure 34 for location.

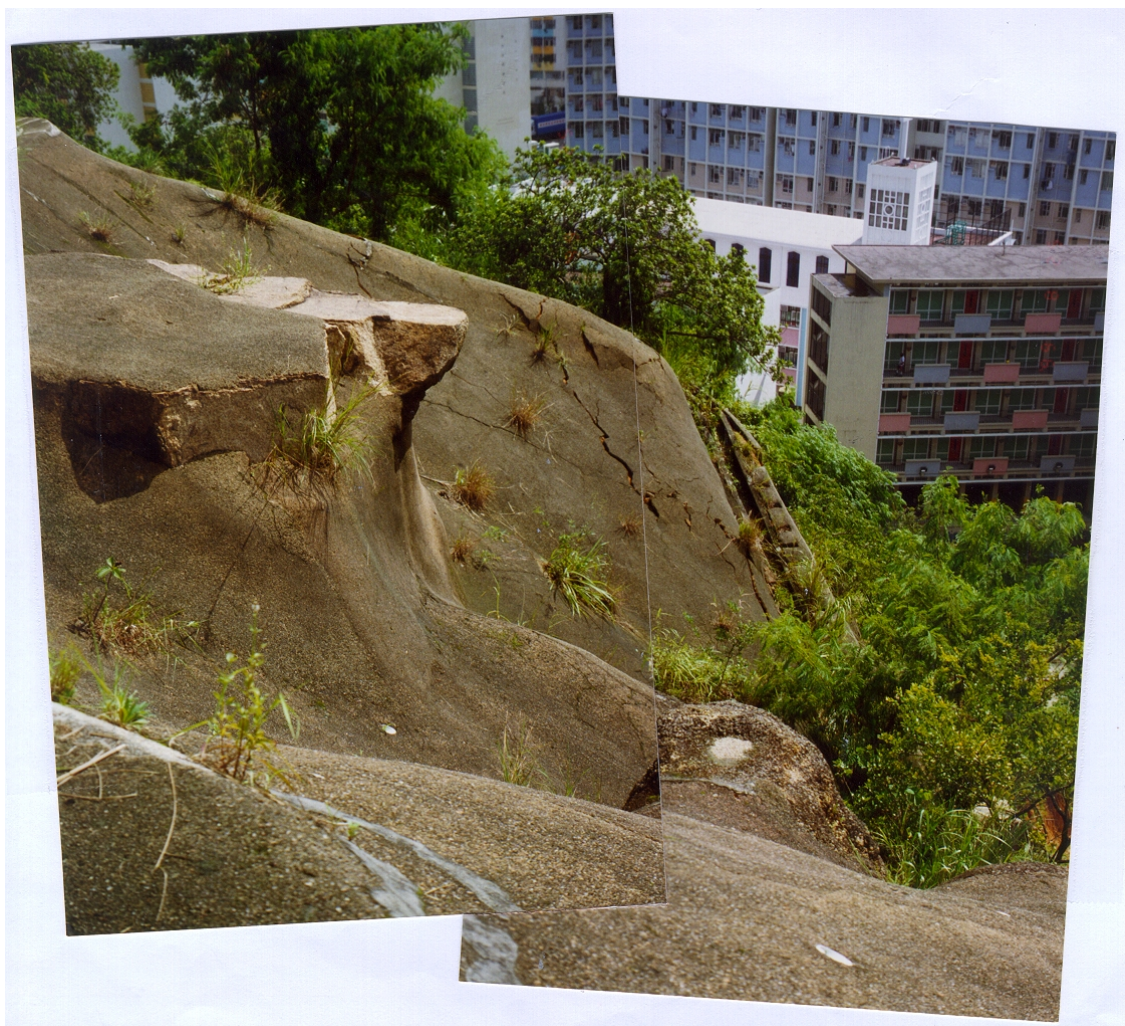
Plate 11 - Crest of the Southern Distressed Zone (Photograph Taken on 26 August 1999). See Figure 34 for location.

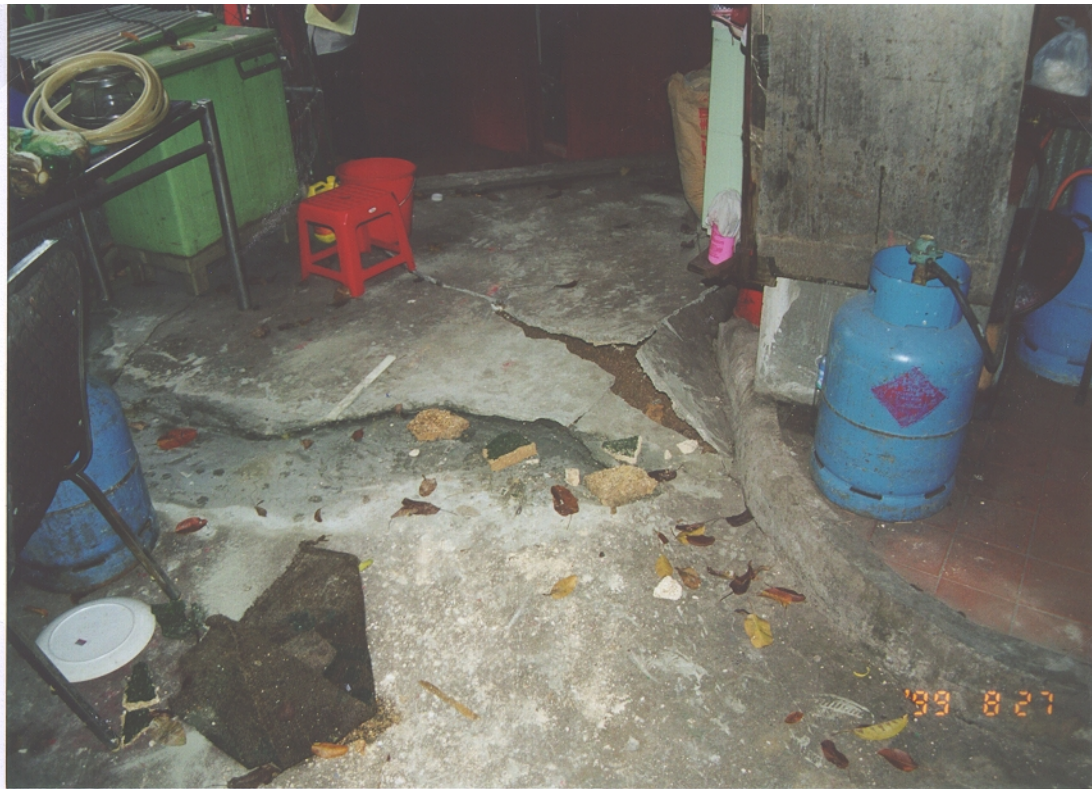
Cracking and heaving were observed on the concrete platform located to the north-east of the temple (Plate 13). In addition, minor displacement (up to 5 mm) was noted along a horizontal crack across a concrete pier supporting the temple structure (Figure 3 and Plate 14). The temple structure also showed signs of deformation, most notably on the southern side where glass window frames had tilted, the upper parts of the frame moving from northwest to southeast up to 85 mm (Plate 15).

Plate 13 - Cracking and Heaving in the Concrete Platform to the Northeast of the Temple (Photograph Taken on 27 August 1999). See Figure 34 for location

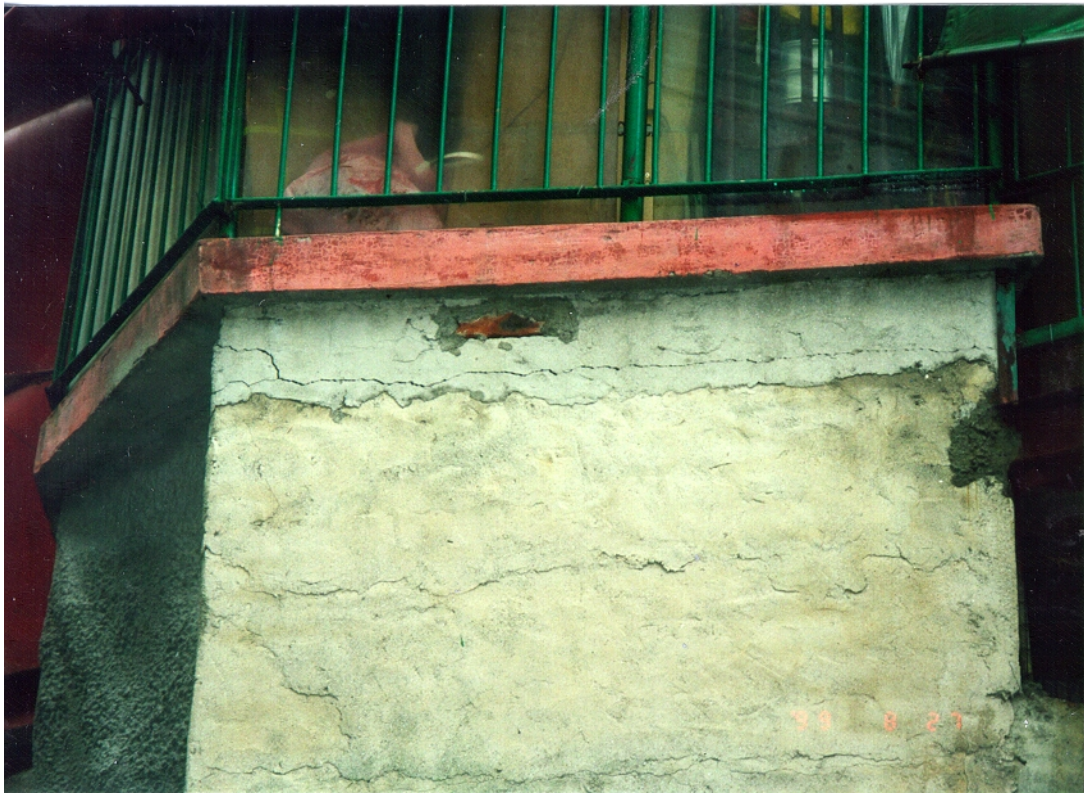
Plate 14 - Horizontal Crack in a Concrete Pier Supporting the Temple Structure (Photograph Taken on 27 August 1999). See Figure 34 for location

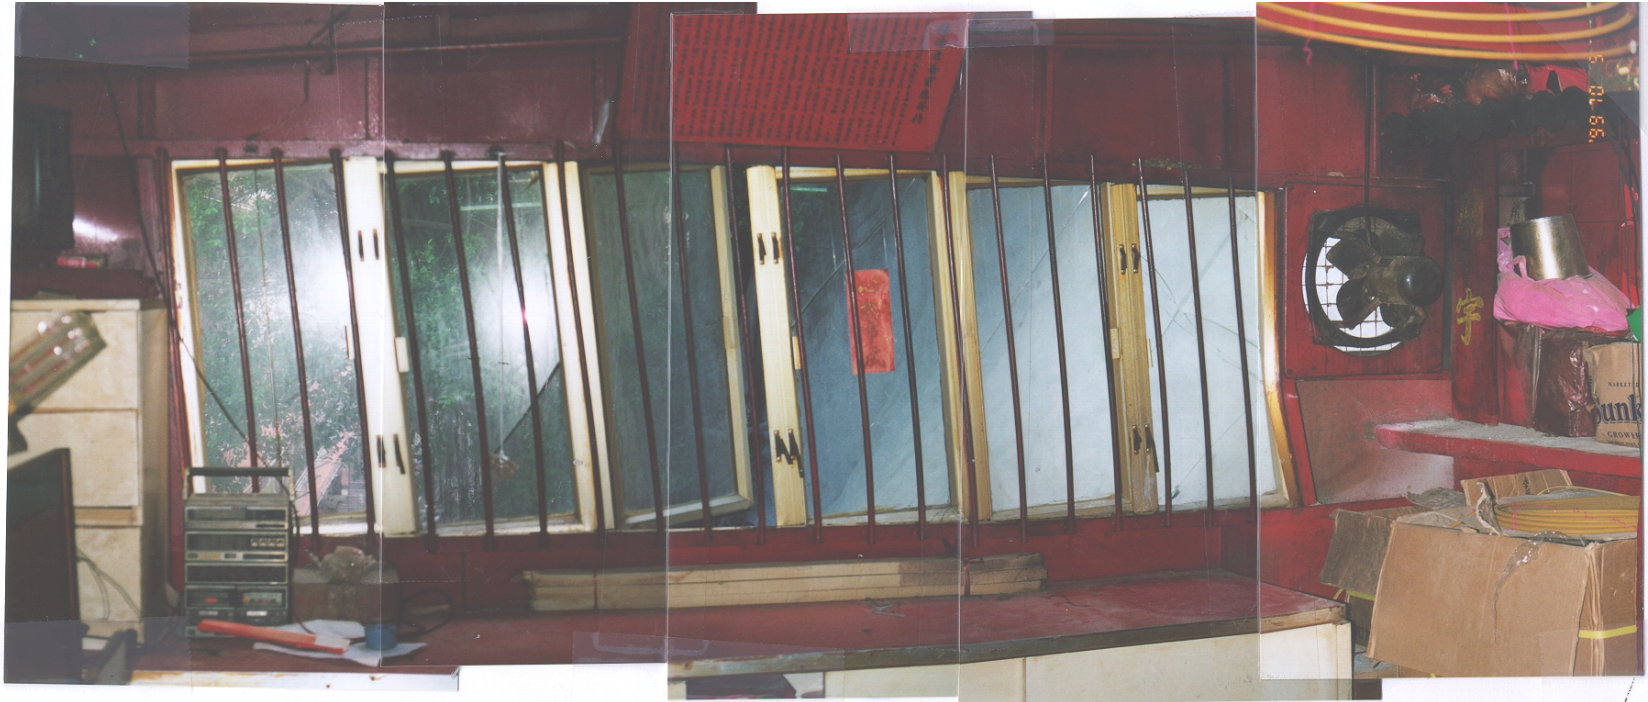
Plate 15 - Tilting of the Window Frames at the Temple (Photograph Taken on 9 October 1999).
See Figure 34 for location.

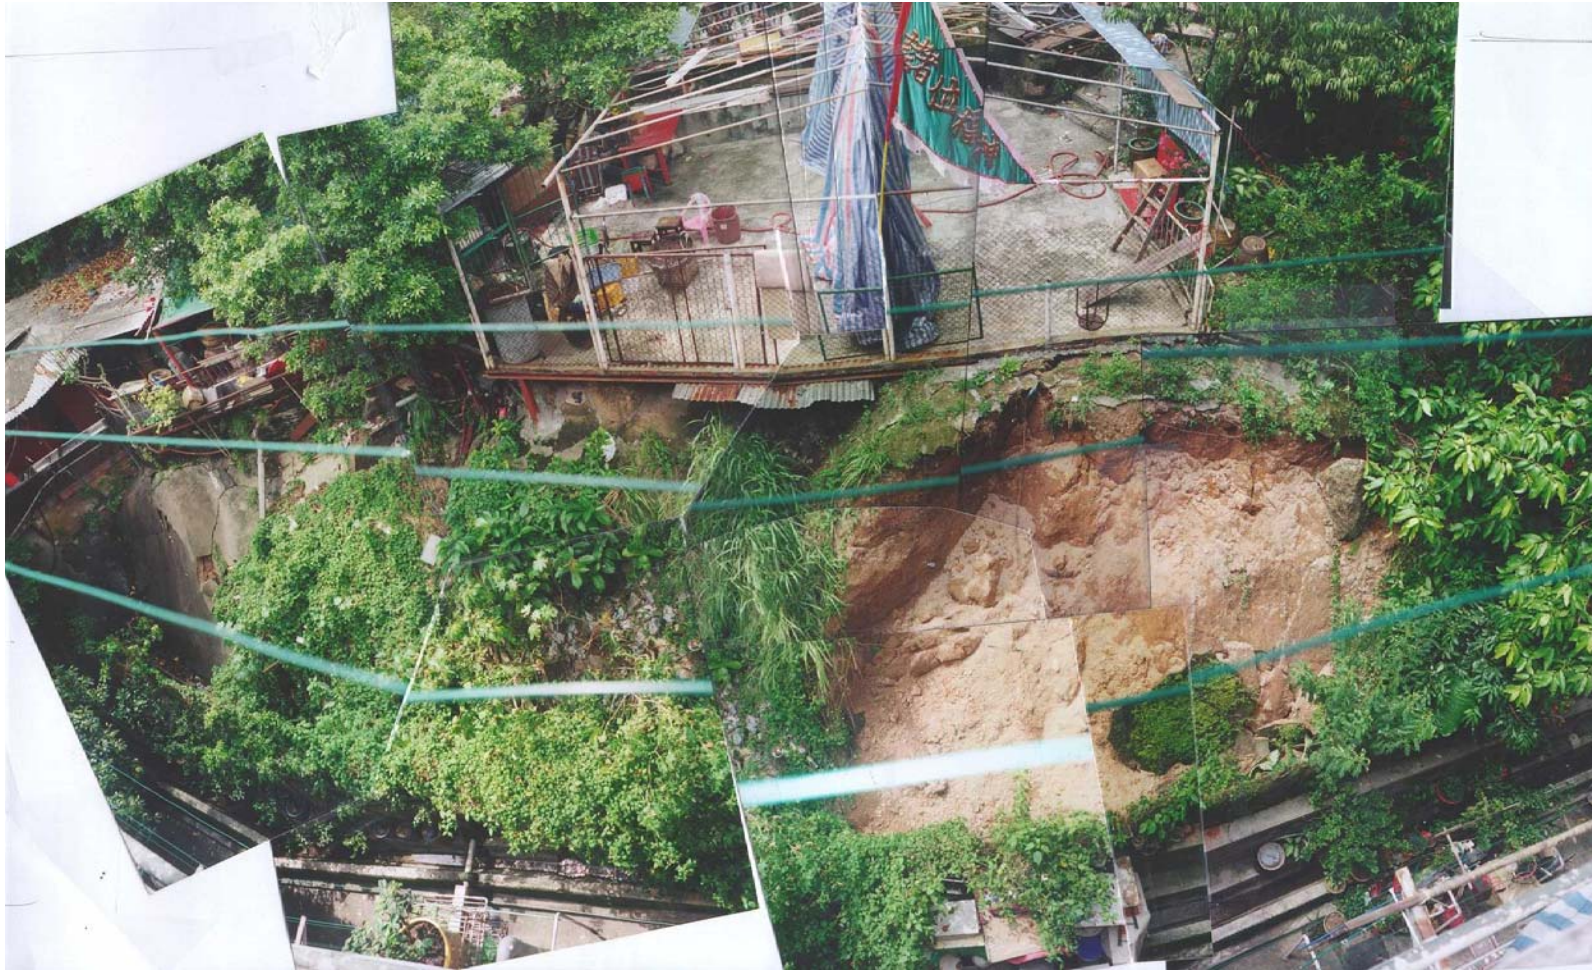
Plate 16 - View of the Distressed Slope below the Platform to the Northeast of the Temple
(Photograph Taken on 26 August 1999). See Figure 34 for location.

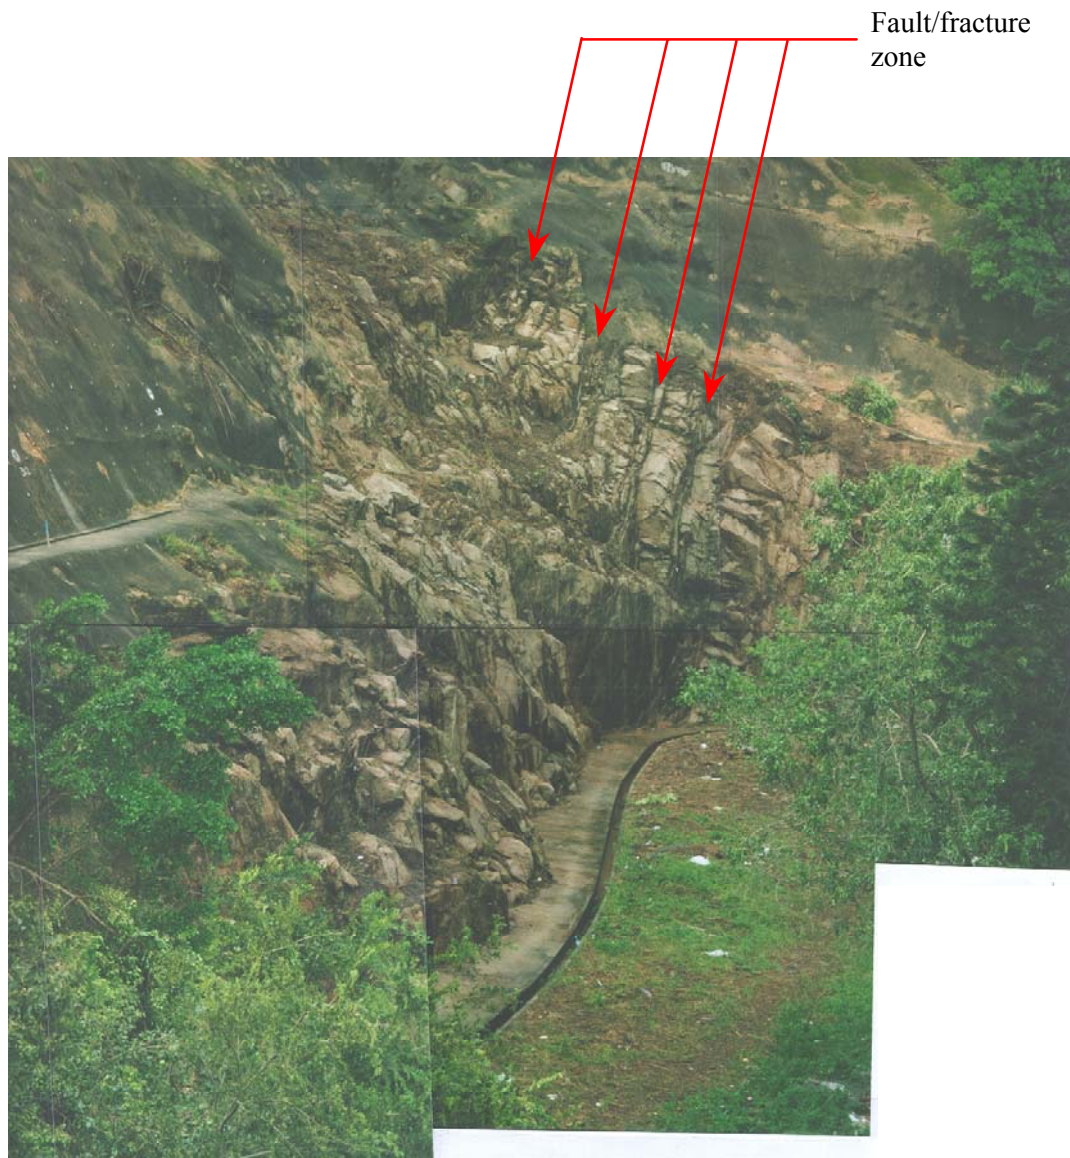
Plate 19 - Fault/Fracture Zone at the Lower Part of Slope No. 11NW-B/C91
(Photograph Taken on 15 September 1999). See Figure 34
for location.

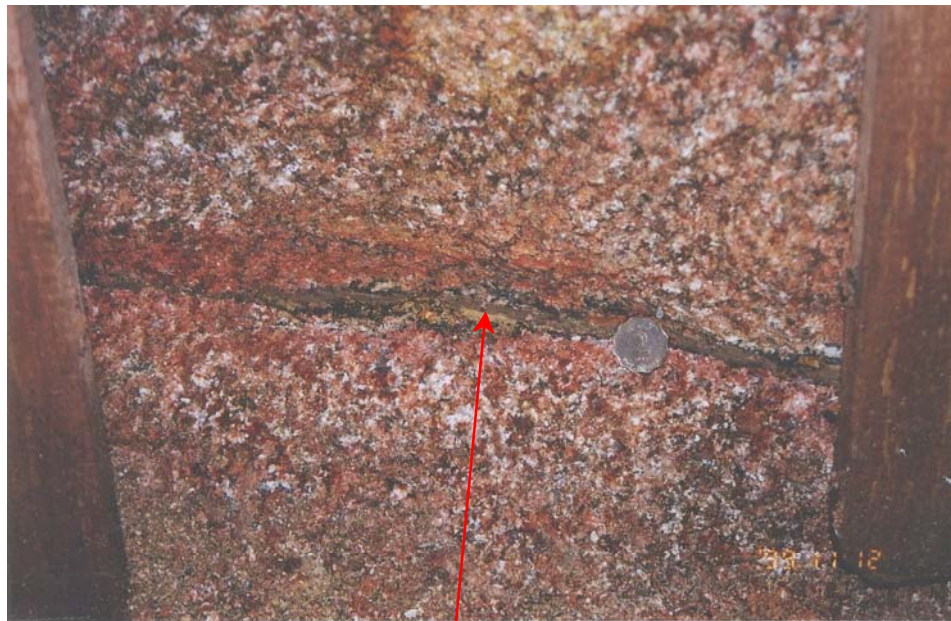
Plate 20 - Slip Surface along a Silty Clay Layer at Trial Trench No. TT1A at the Toe of the Northern Distressed Zone (Photograph Taken on 12 November 1999). See Figure 34 for location.

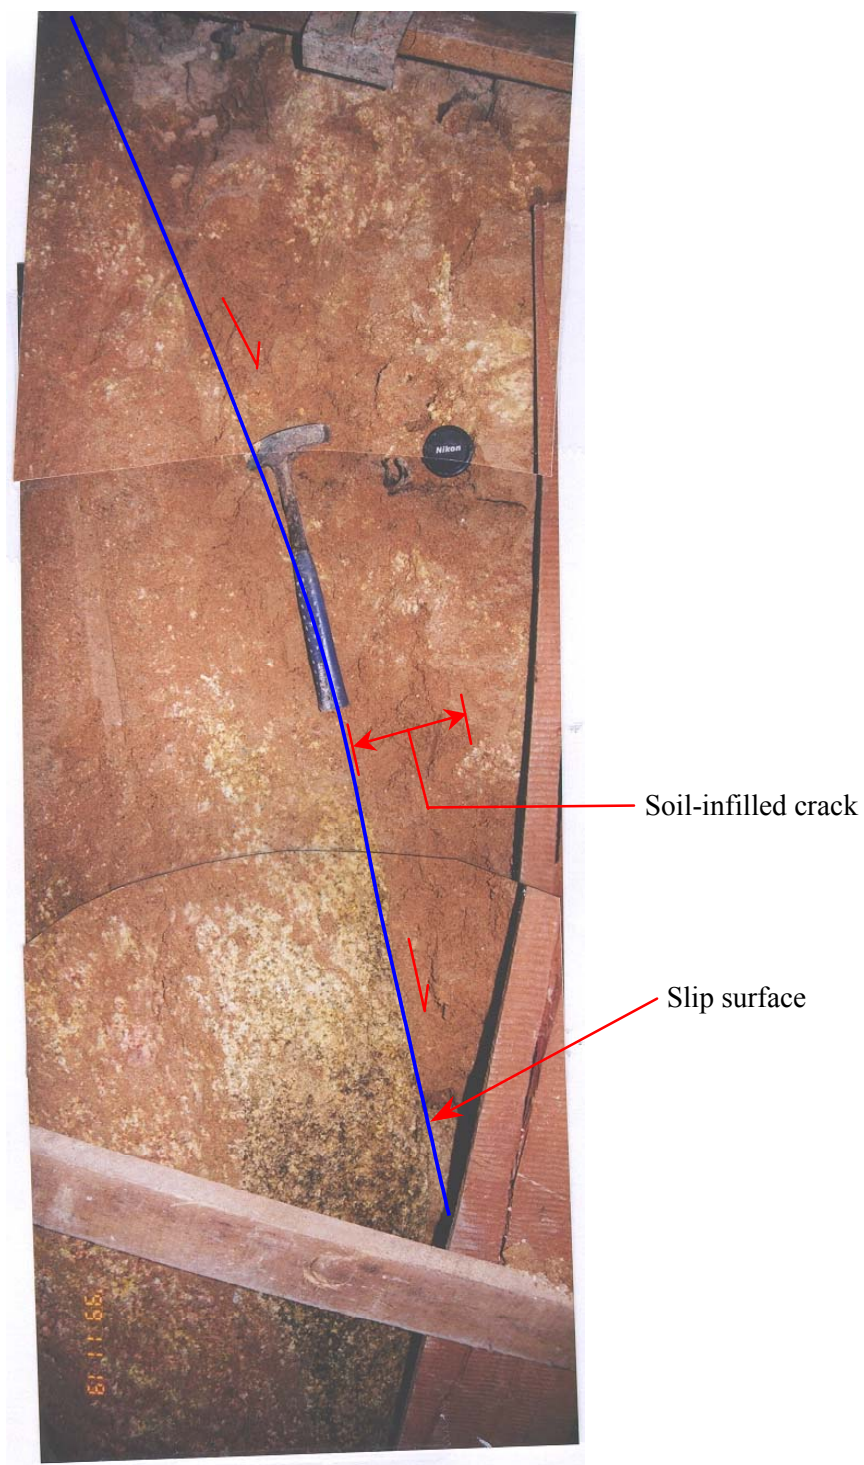
Plate 21 - Slip Surface along a Soil-infilled Crack at the Top of the Displaced Ground Mass at Trial Trench No. TT1 at the Northern Distressed Zone (Photograph Taken on 19 November 1999). See Figure 34 for location.

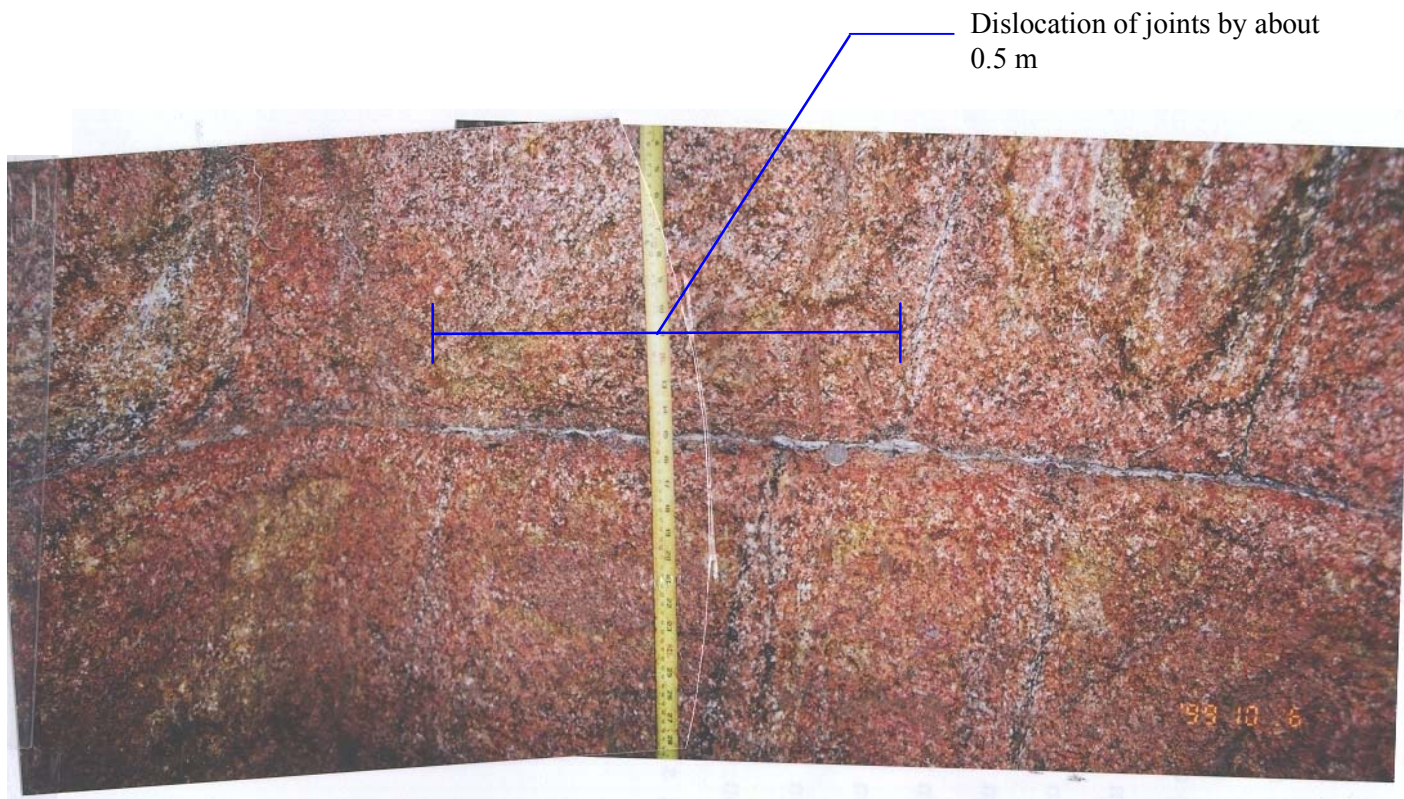
Plate 22 - Dislocated Sub-vertical Discontinuities Infilled with Kaolin and Manganese Oxide Deposits on the Northeast Face of Trial Pit No. AP6 at the Toe of the Southern Distressed Zone (Photograph Taken on 6 October 1999). See Figure 34 for location.

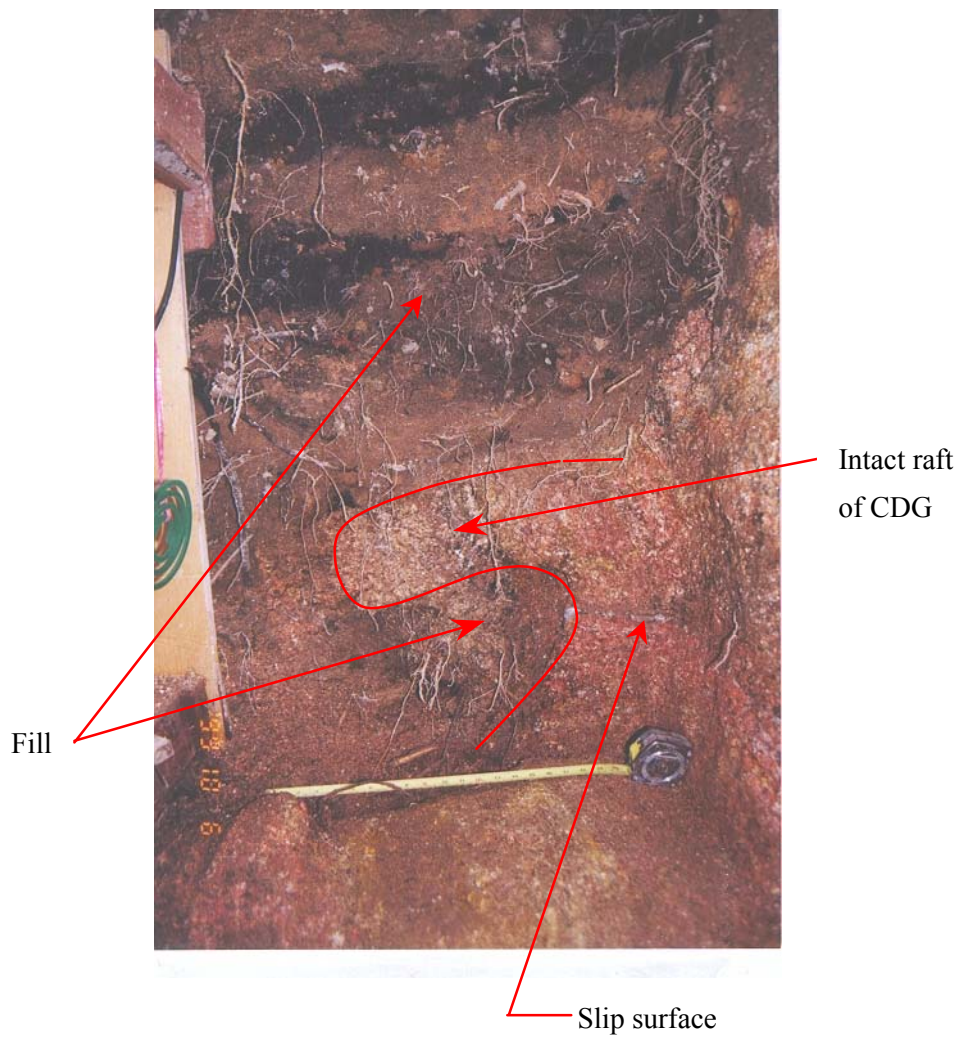
Plate 23 - Intact Raft of CDG over Fill on the Southwest Face of Trial Pit No. AP6 at the Toe of the Southern Distressed Zone (Photograph Taken on 6 October 1999). See Figure 34 for location.
