REPORT ON THE SHEK KIP MEI LANDSLIDE OF 25 AUGUST 1999

GEO REPORT No. 181

**Fugro Maunsell Scott Wilson Joint Venture
&
Professor J. B. Burland**

**GEOTECHNICAL ENGINEERING OFFICE
CIVIL ENGINEERING AND DEVELOPMENT DEPARTMENT
THE GOVERNMENT OF THE HONG KONG
SPECIAL ADMINISTRATIVE REGION**

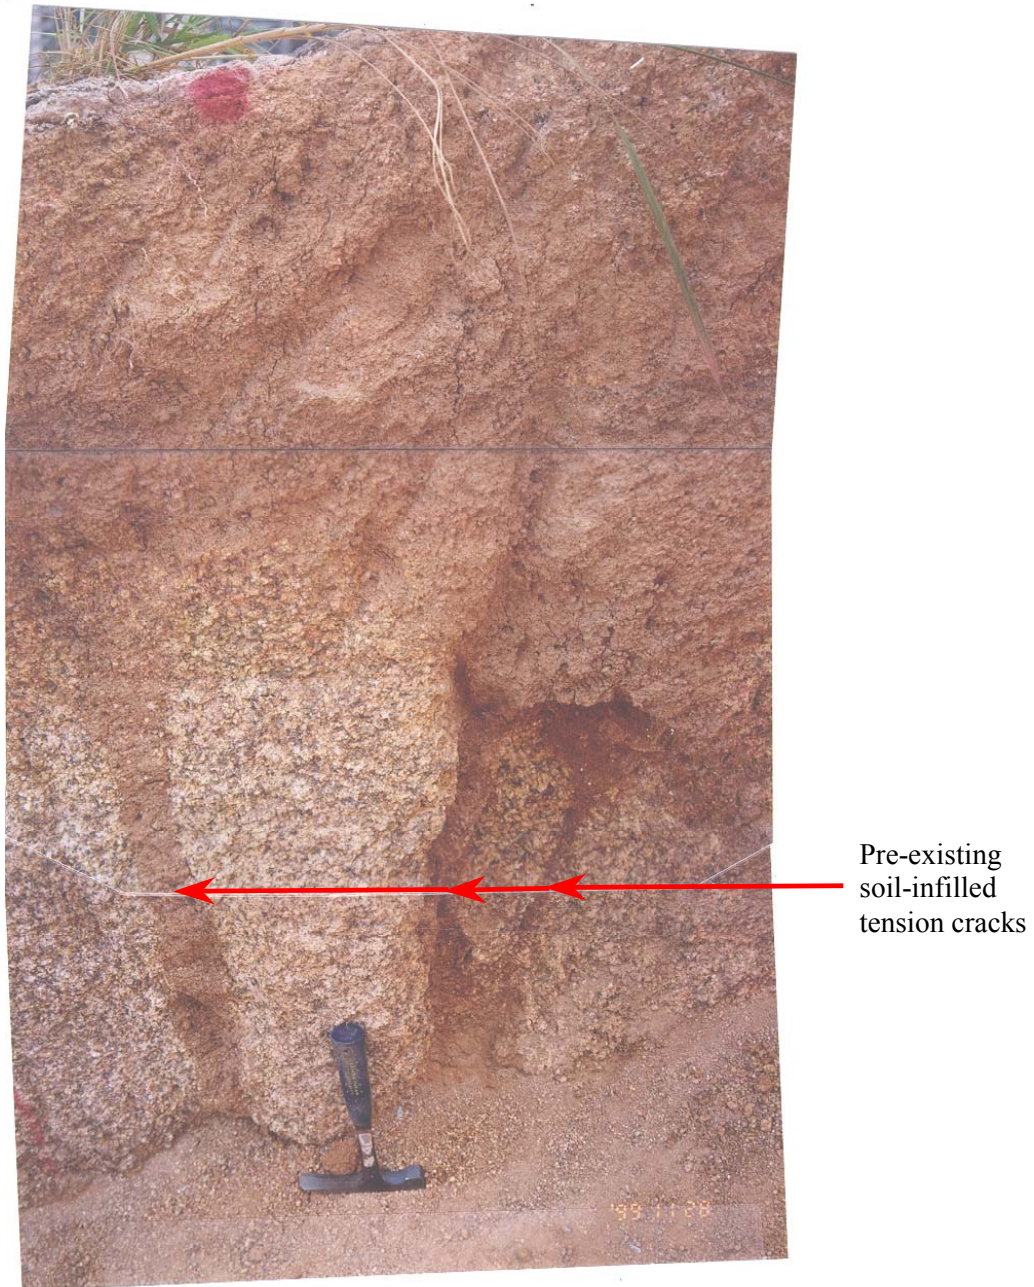
Plate 26 - Pre-existing Soil-infilled Tension Cracks at Trial Trench No. TT3 at the Crest of the Southern Distressed Zone (Photograph Taken on 28 November 1999). See Figure 34 for location.

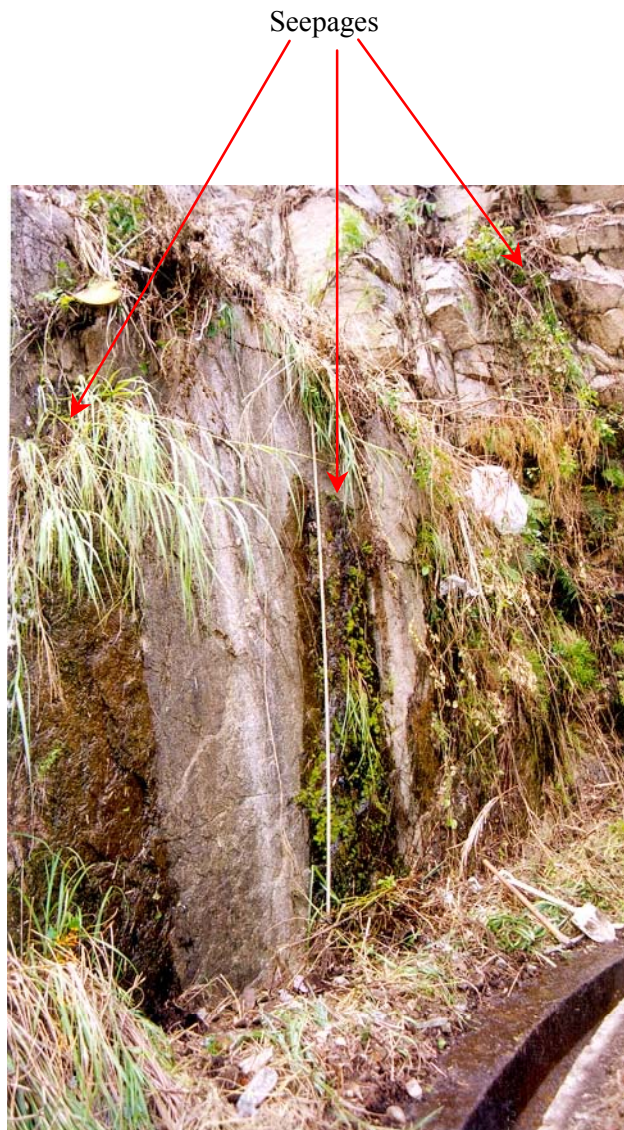
Plate 27 - Seepage at the Rock Outcrop at the Toe of Slope No. 11NW-B/C91.
(Photograph Taken on 8 September 1999). See Figure 34 for location.

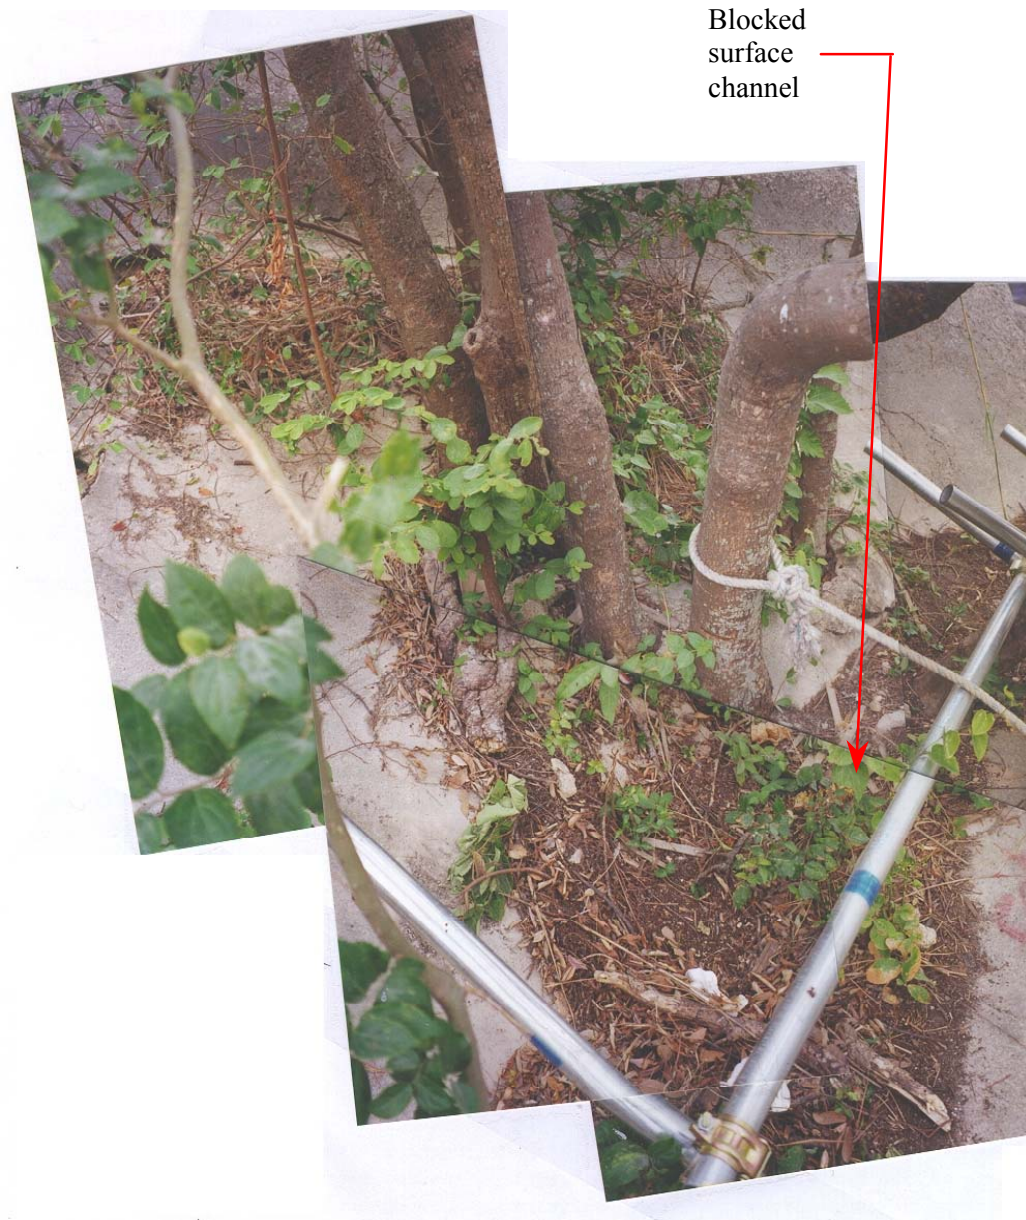
Plate 29 - Unplanned Tree Blocking Surface Channel (Photograph Taken on 9 November 1999). See Figure 34 for location.

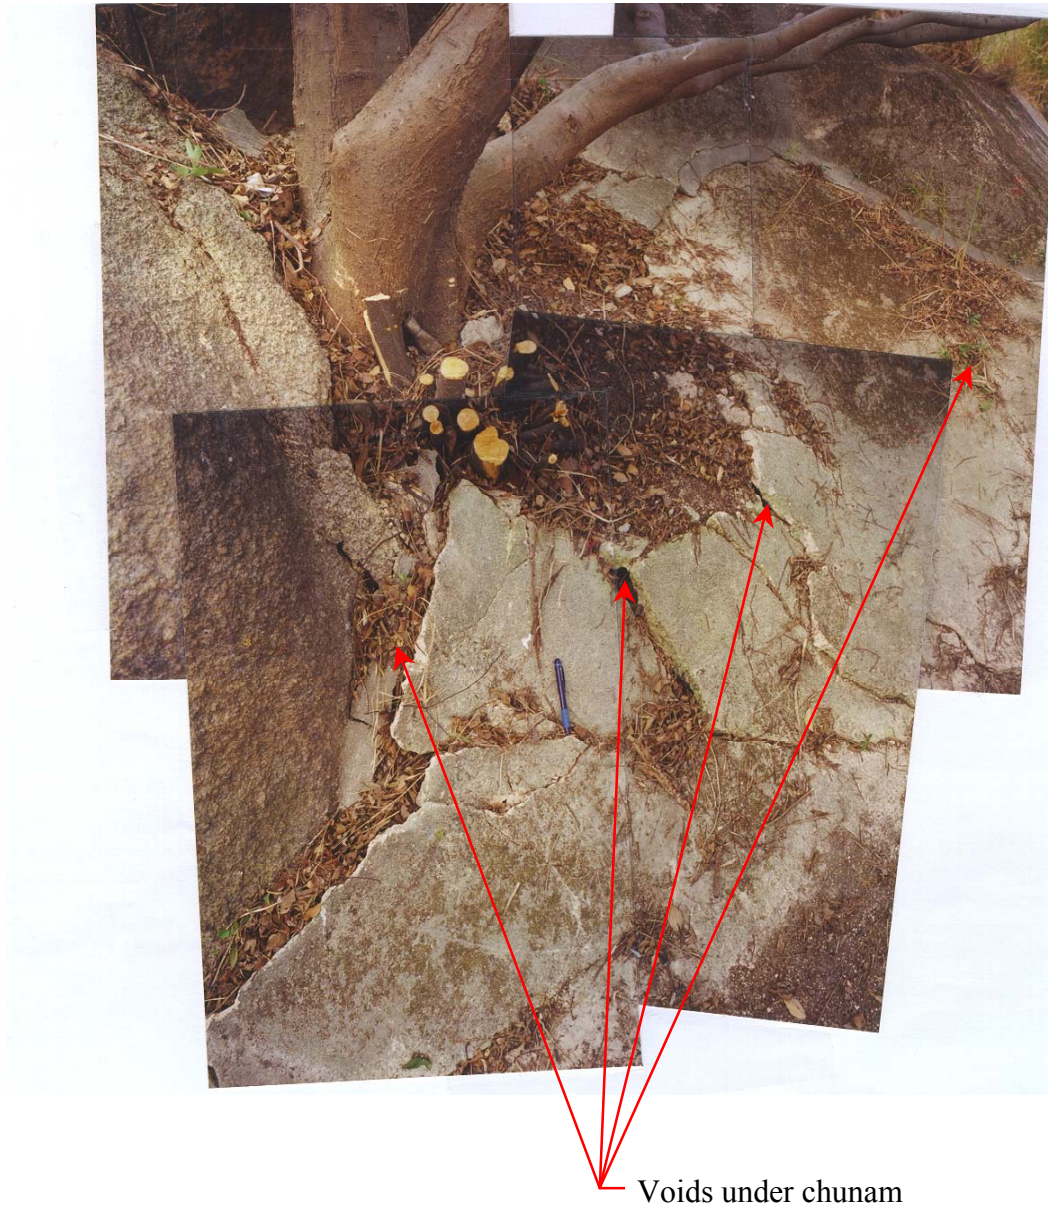
Plate 30 - Disrupted Chunam at Location of Unplanned Vegetation on Slope No. 11NW-B/C90 (Photograph Taken on 11 November 1999). See Figure 34 for location.

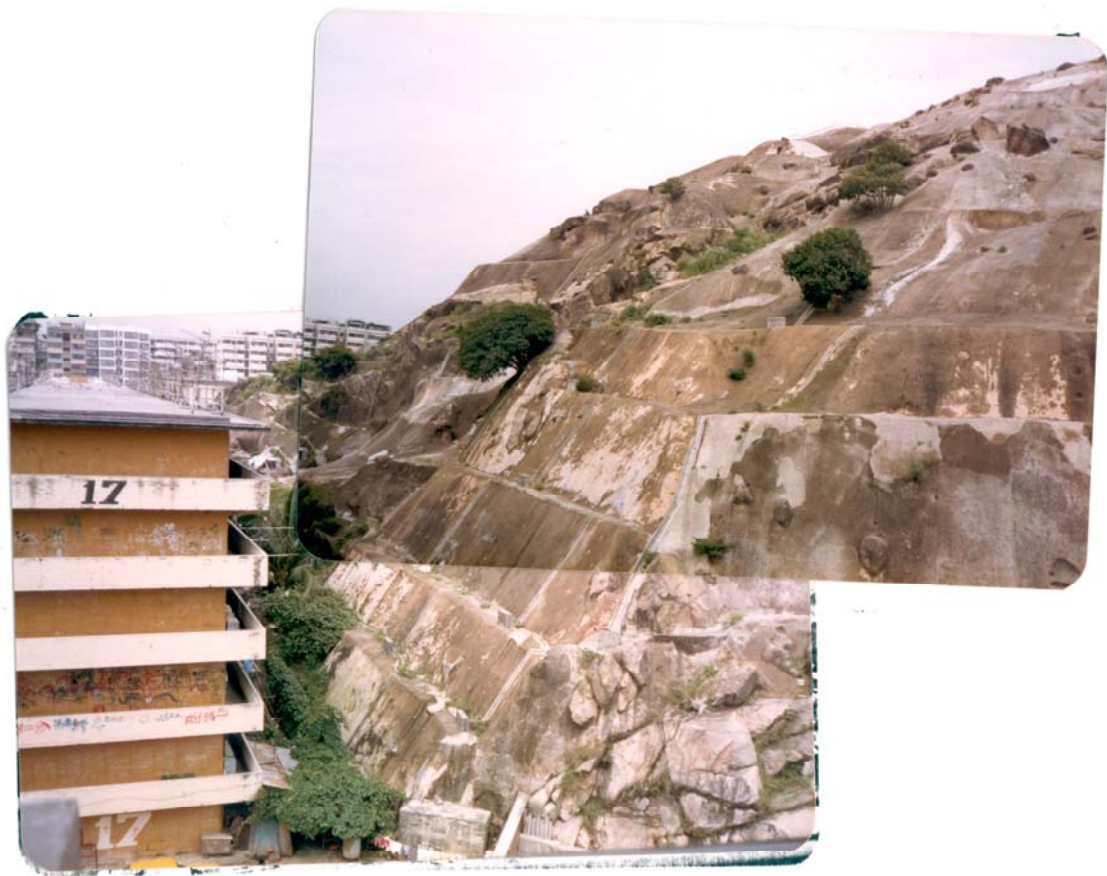
Plate A3 - General View of the Northern Portion of Slope No. 11NW-B/C90
Taken on 4 June 1982 (Reproduced from B&P, 1982).
Note patches of repaired chunam on the slope surface.

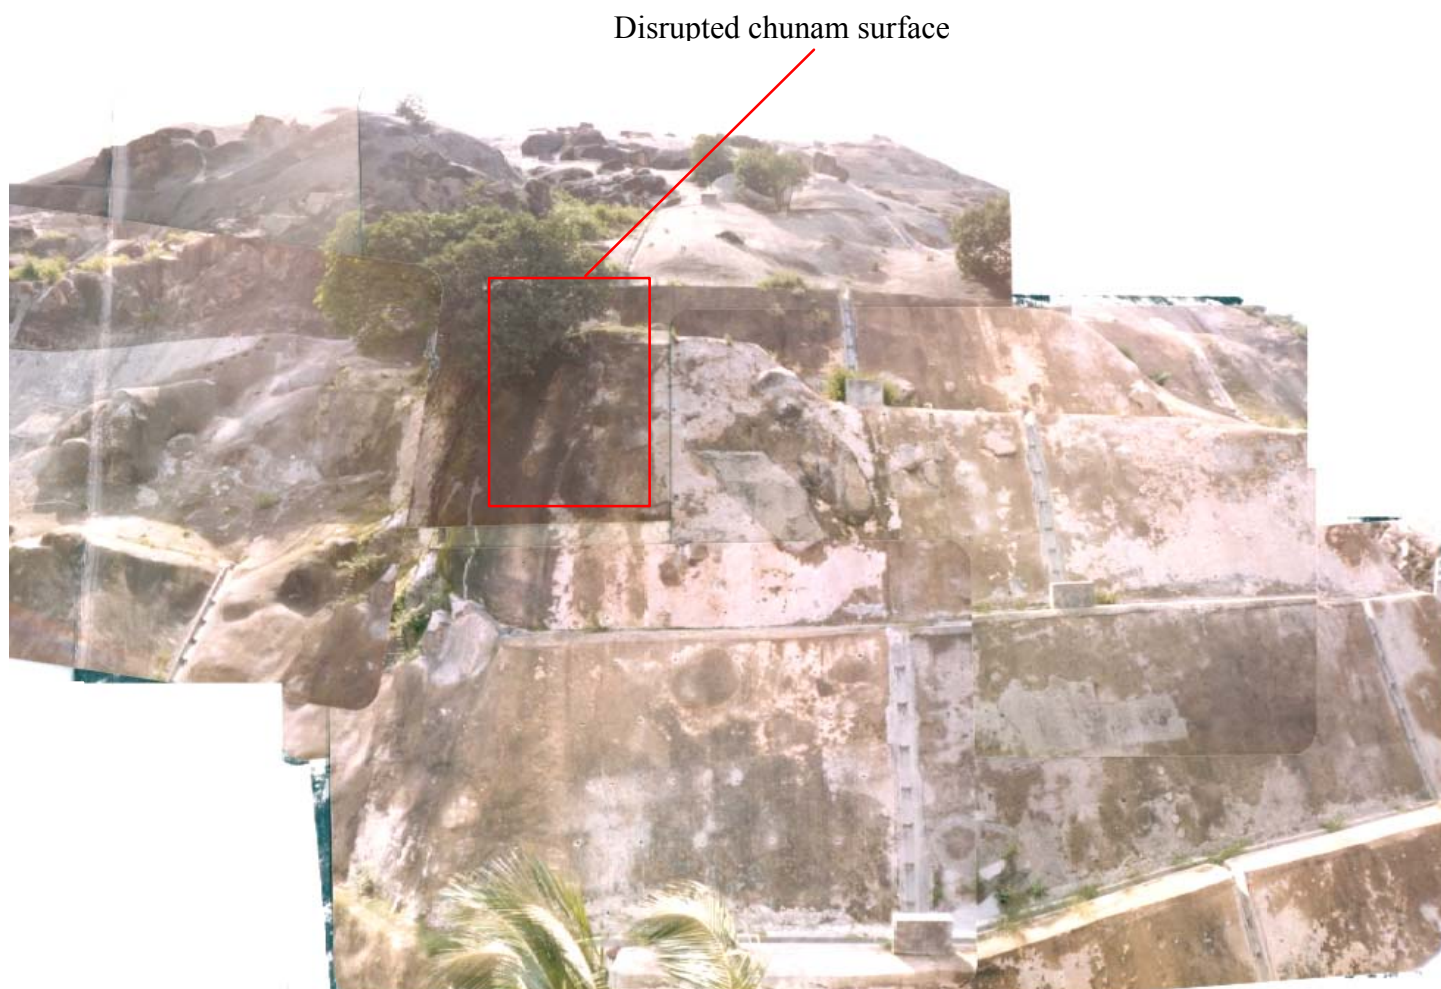
Plate A4 - General View of the Northern and Central Portions of Slope No. 11NW-B/C90 Taken on 4 June 1982 (Reproduced from B&P, 1982). Note the disrupted chunam, patches of repaired chunam and chunam with dark tone on the slope surface.

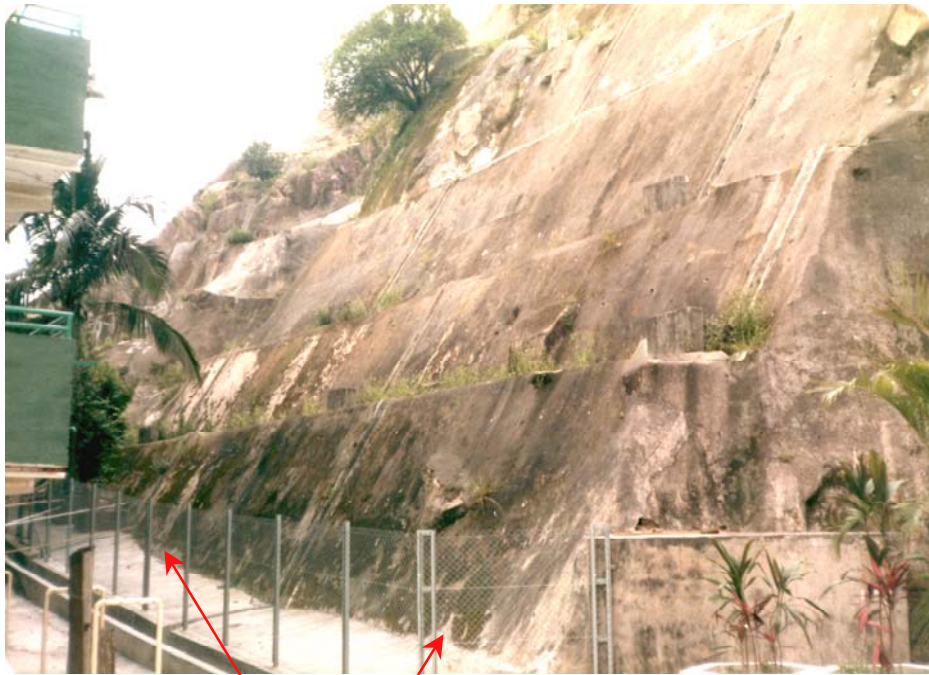
Plate A5 - General View of the Lower Northern Portion of Slope No. 11NW-B/C90 Taken on 15 June 1984 (Reproduced from B&P, 1984). Note the repaired chunam along the toe and on the slope.

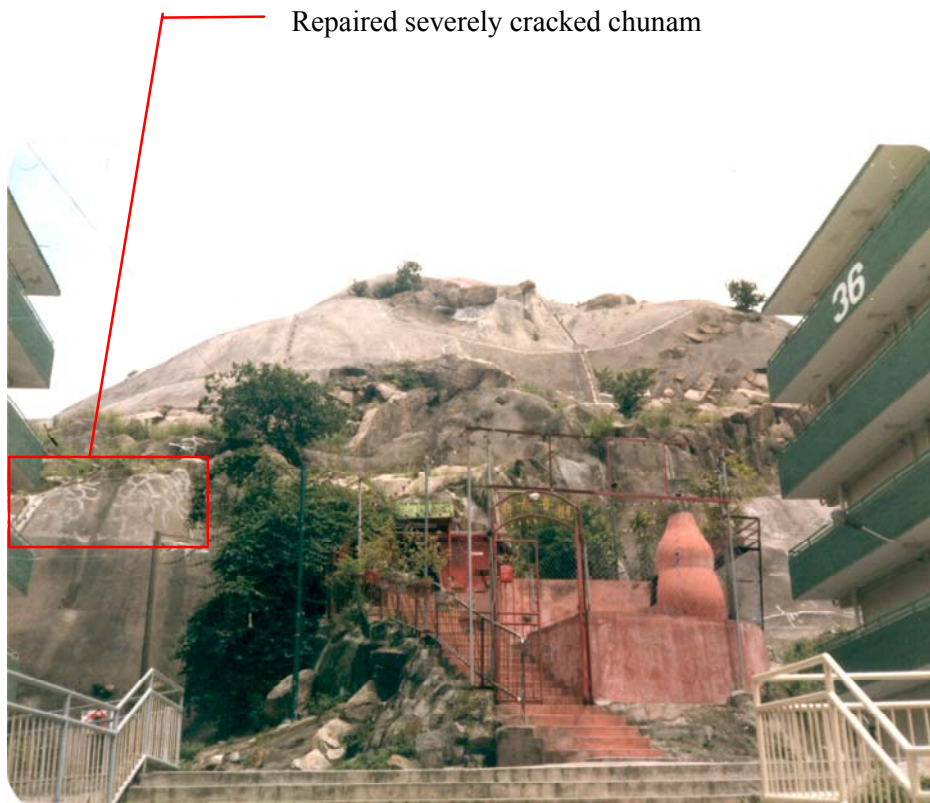
Plate A6 - General View of the Central Portion of Slope No. 11NW-B/C90 Taken on 15 June 1984 (Reproduced from B&P, 1984). Note the repaired severely cracked chunam above the approximate location of the relict slip surface observed in trial trench No. TT6 excavated after the 1999 Landslide (see Section 6.3 and Figure 25)

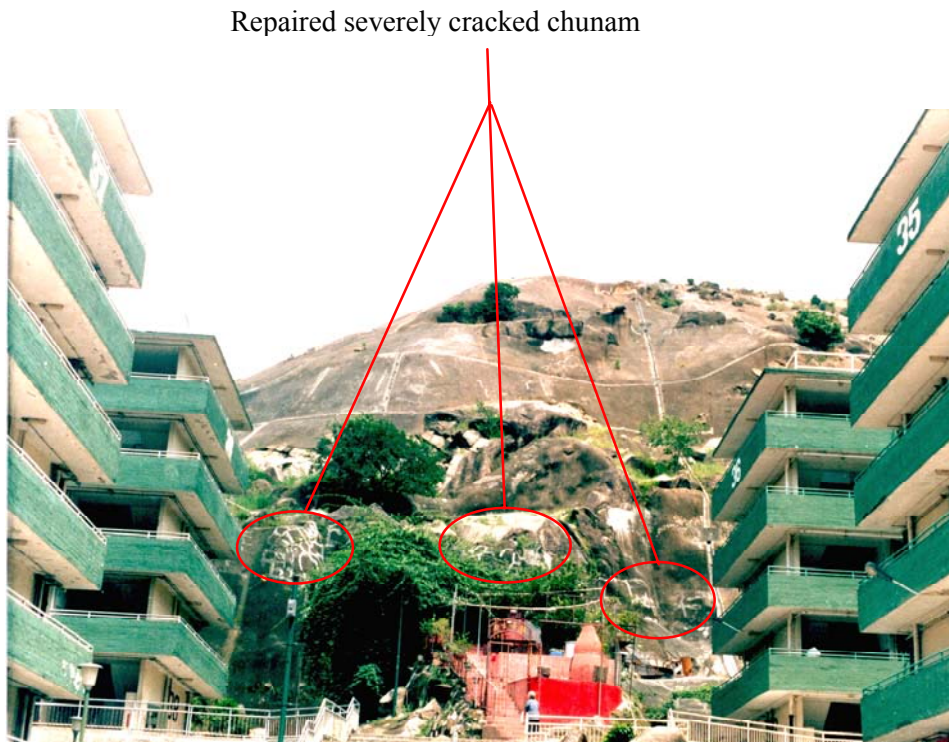
Plate A7 - General View of the Central Portion of Slope No. 11NW-B/C90 Taken on 14 August 1986 (Reproduced from Dames & Moore, 1986). Note the repaired severely cracked chunam above the approximate location of the relict slip surface observed in trial trench No. TT6 excavated after the 1999 Landslide (see Section 6.3 and Figures 23 and 25)

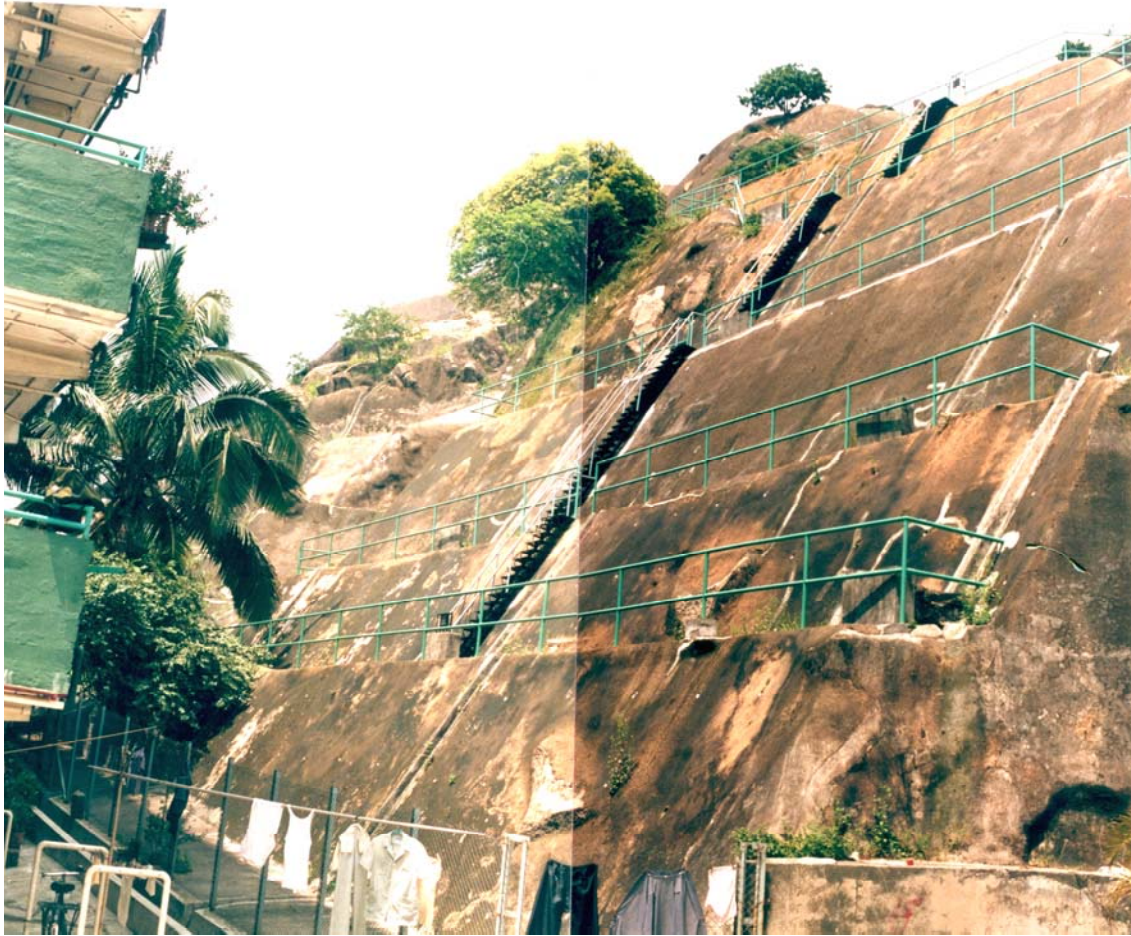
Plate A8 - General View of the Lower Northern Portion of Slope No. 11NW-B/C90 Taken on 14 August 1986 (Reproduced from Dames & Moore, 1986). Note the repaired chunam and sealed cracks on the slope.

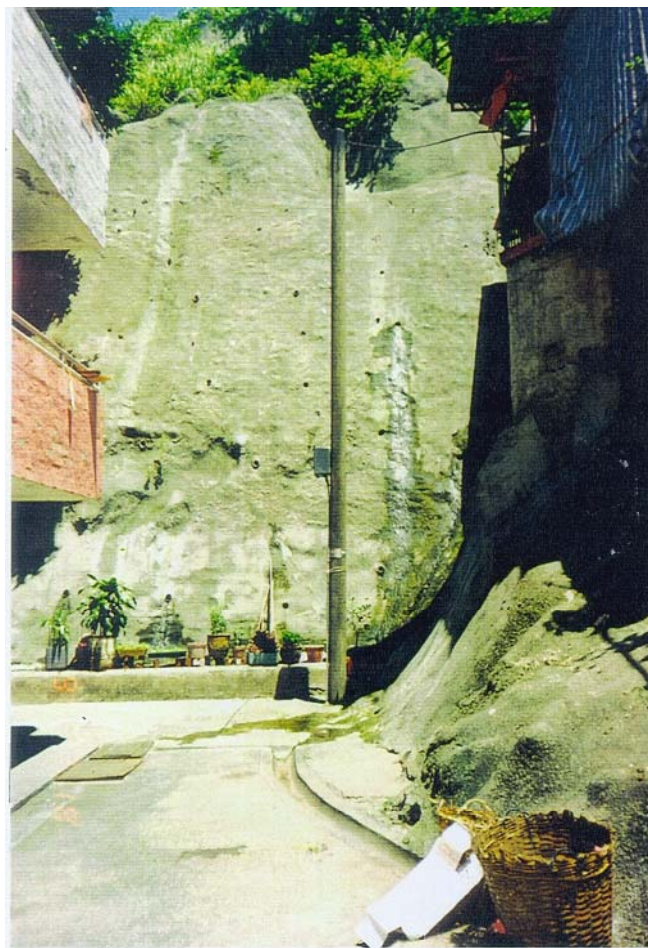
Plate A9 - View of the Lower Central Portion of Slope No. 11NW-B/C90 South of the Temple Taken on 18 July 1995 (Reproduced from Greg Wong & Associates, 1995). Note the seepage at the approximate location of the persistent infilled discontinuity observed in trial trench No. TT6 excavated after the 1999 Landslide (see Section 6.3 and Figure 25)

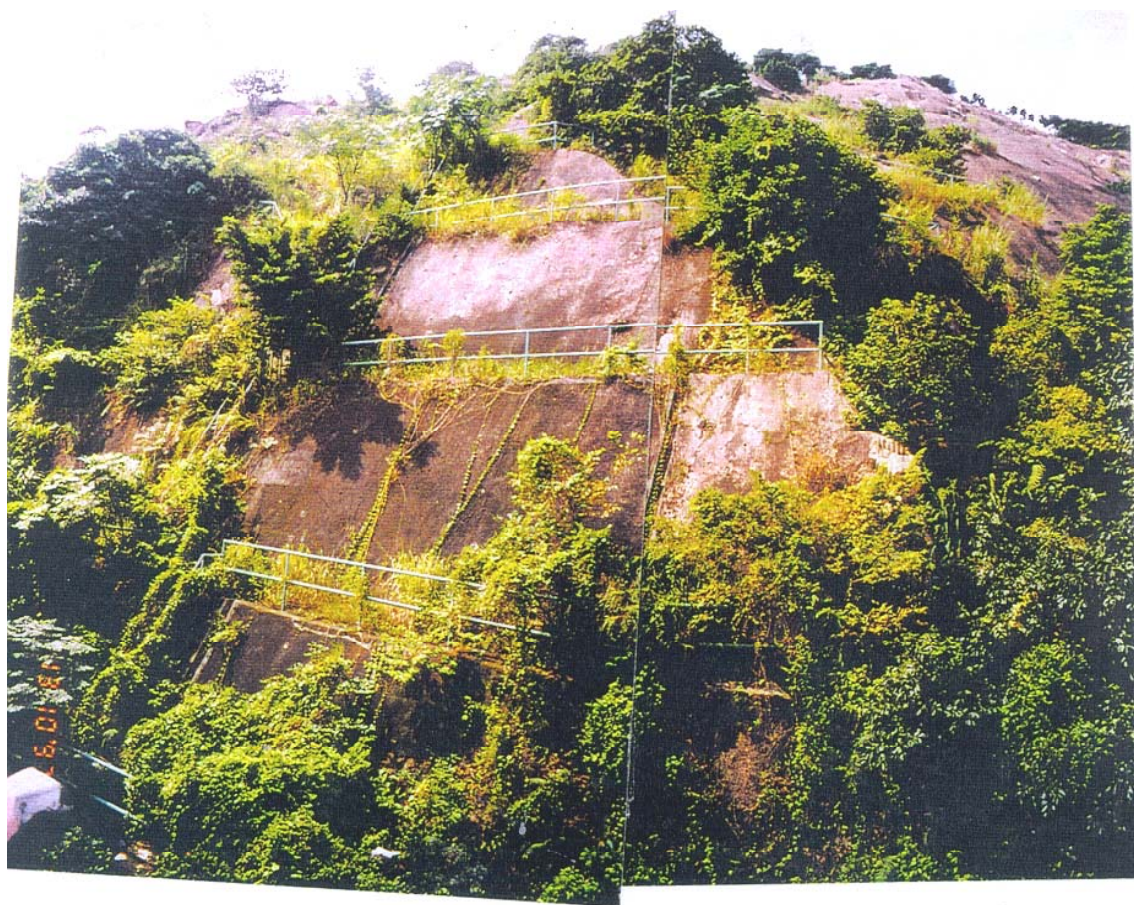
Plate A10 - General View of the Northern Portion of Slope No. 11NW-B/C90 Taken on 13 October 1997 (Reproduced from Atkins China Ltd., 1997). Note the extent of chunam with dark tone and dense unplanned vegetation on the slope.

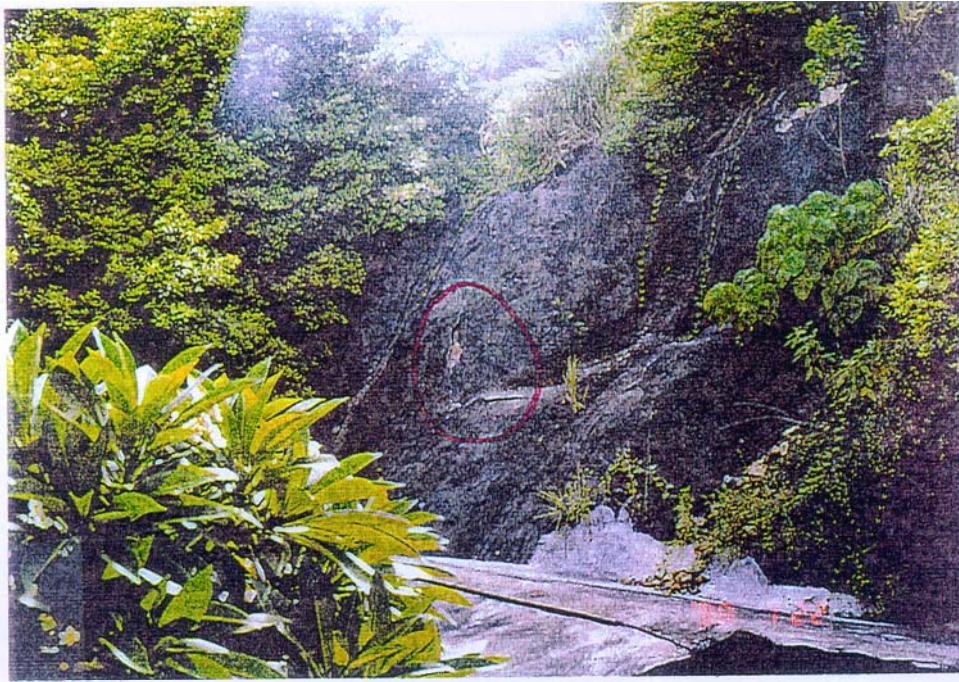
Plate A11 - Cracked Chunam on the Central Portion of the Slope above the Temple Taken on 22 July 1998 (Reproduced from Atkins China Ltd., 1998). Note that these cracks were also observed after the 1999 Landslide and appeared to have opened up.
