PERFORMANCE ASSESSMENT OF GREENING TECHNIQUES ON SLOPES

GEO REPORT No. 183

B.L.S. Lui & Y.K. Shiu

**GEOTECHNICAL ENGINEERING OFFICE
CIVIL ENGINEERING AND DEVELOPMENT DEPARTMENT
THE GOVERNMENT OF THE HONG KONG
SPECIAL ADMINISTRATIVE REGION**

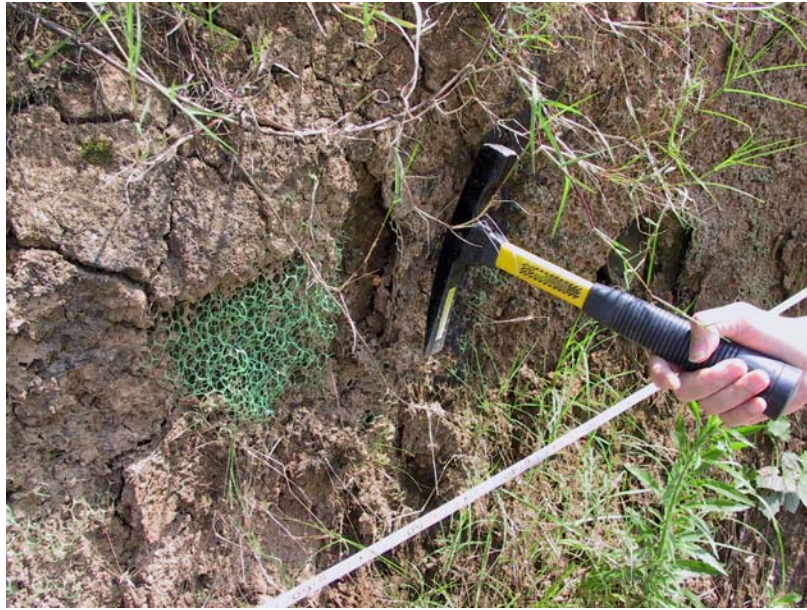
Plate 1a

Observations: Cracks and drying up of mulch/soil mix
Slope No.: 6NE-D/C55
Location: Route Twisk
Date of Inspection: 22 May 2003

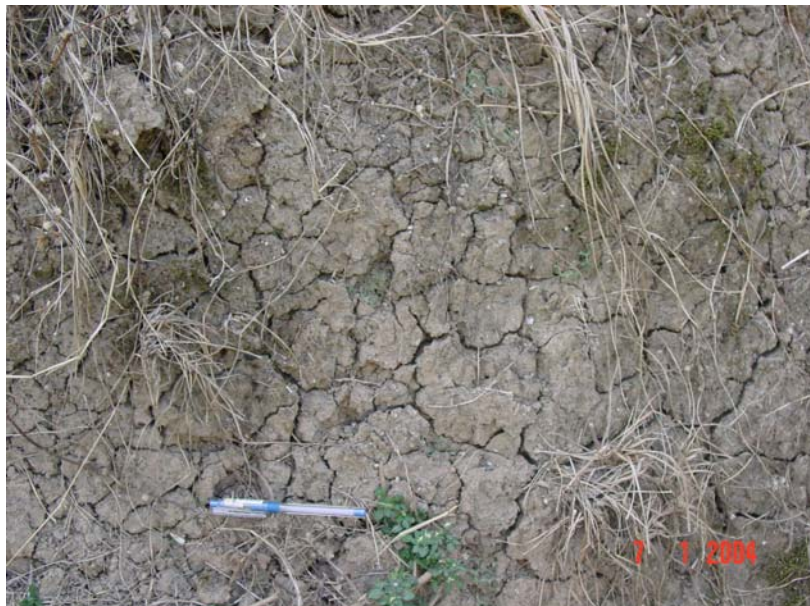
Plate 1b

Observations: Widespread cracks on mulch/soil mix
Slope No.: 3NE-D/C104
Location: Bride's Pool Road
Date of Inspection: 7 January 2004

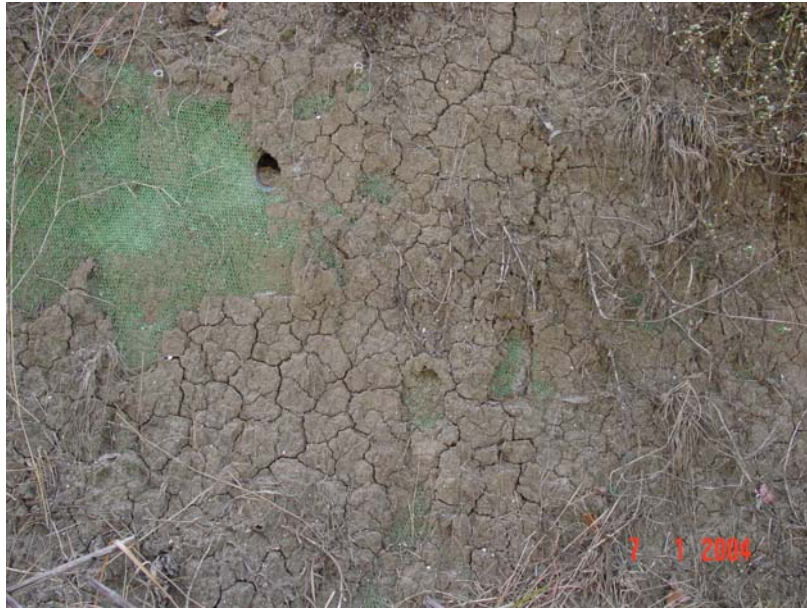
Plate 1c

Observations: Widespread cracks on mulch/soil mix
Slope No.: 3NE-D/C104
Location: Bride's Pool Road
Date of Inspection: 7 January 2004

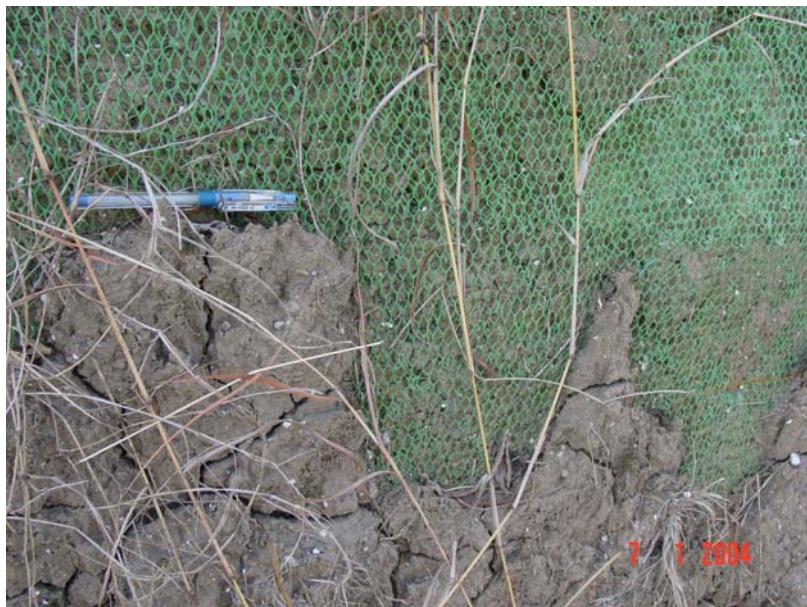
Plate 1d

Observations: Detachment of mulch/soil mix, exposing the erosion control mat which is embedded in the mulch/soil mix
Slope No.: 3NE-D/C104
Location: Bride's Pool Road
Date of Inspection: 7 January 2004

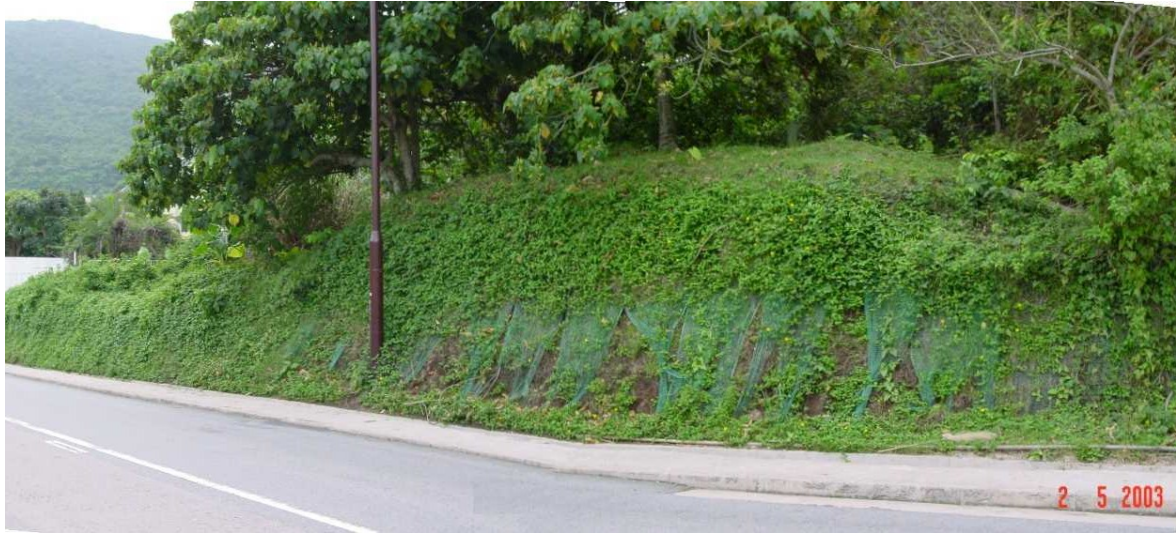
Plate 3a

Observations: Difference in vegetation coverage on upper and lower parts of slope
Slope No.: 8SW-B/C95
Location: Tai Mong Tsai, Sai Kung
Date of Inspection: 2 May 2003

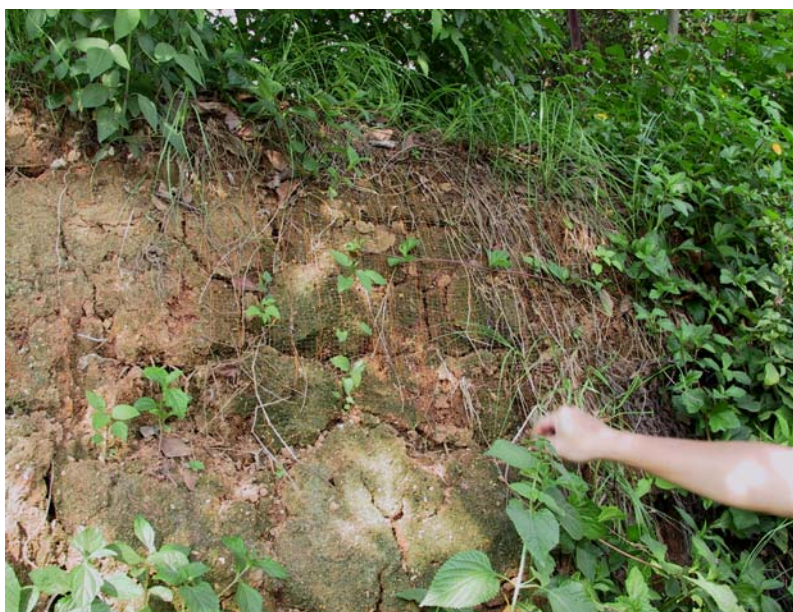
Plate 4a

Observations: Surface cracking
Slope No.: 6SE-B/C256
Location: Route Twisk
Date of Inspection: 22 May 2003

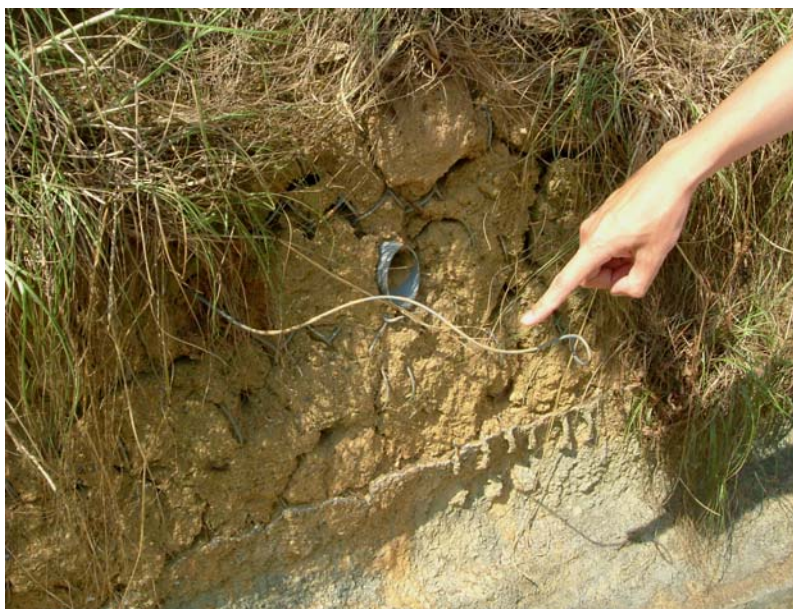
Plate 4b

Observations: Surface cracking
Slope No.: 11SE-C/C33
Location: Wong Nai Chung Gap Road
Date of Inspection: 25 October 2003

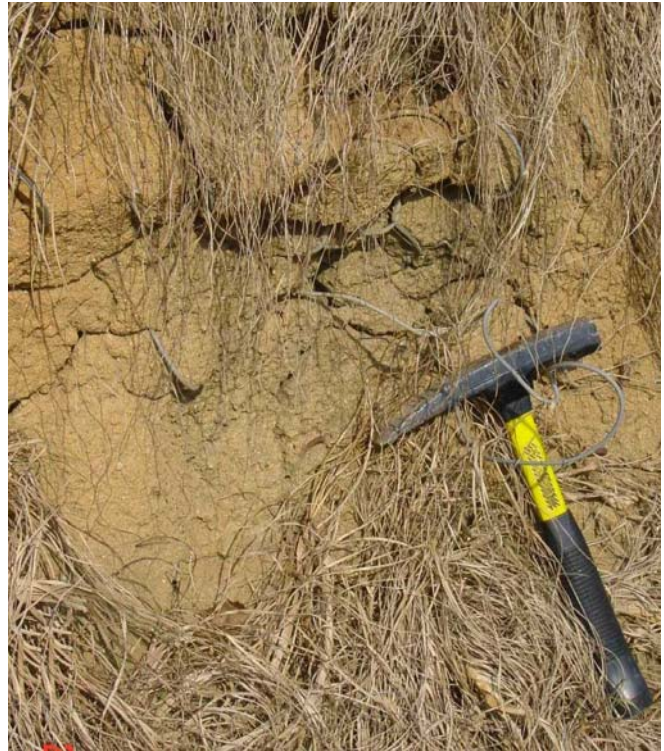
Plate 4c

Observations: Cracks on mulch/soil mix, exposing the wire mesh
Slope No.: 11SW-D/C105
Location: Deep Water Bay Road
Date of Inspection: 17 December 2003

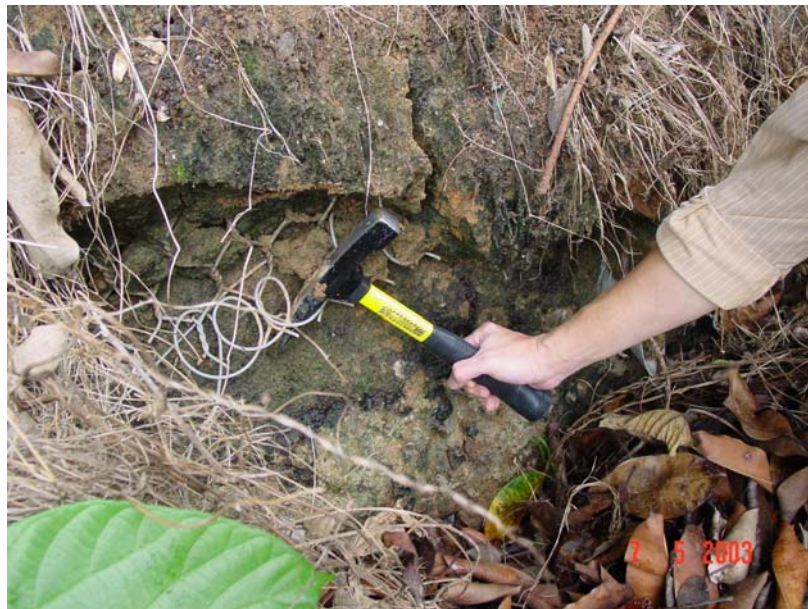
Plate 4d

Observations: Unsupported at toe
Slope No.: 11NW-D/C90
Location: Homantin
Date of Inspection: 7 May 2003

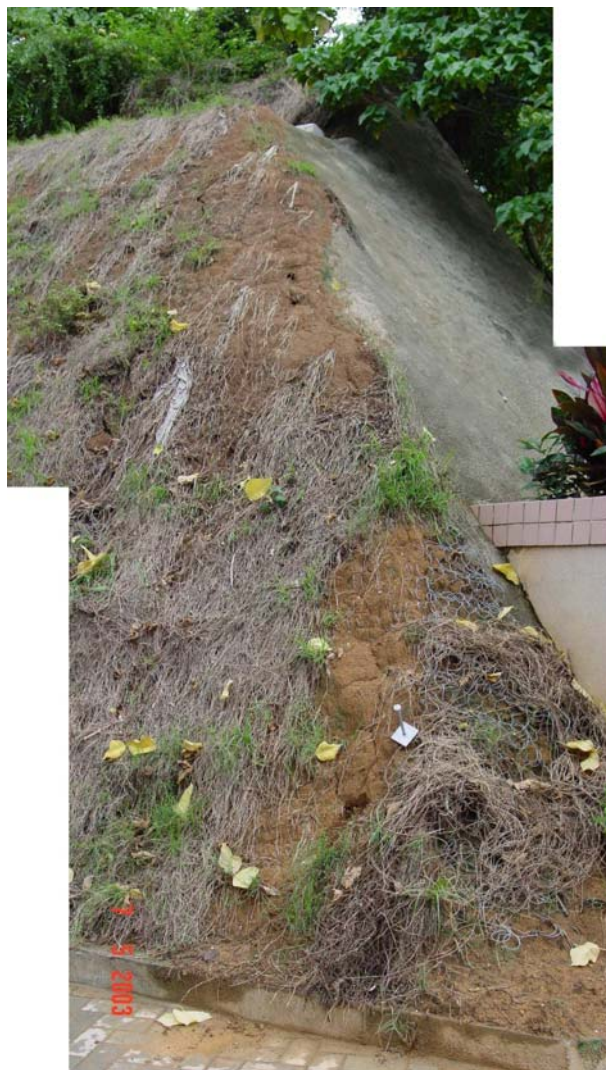
Plate 5b

Observations: Surface erosion
Slope No.: 11NW-D/C90
Location: Homantin
Date of Inspection: 7 May 2003

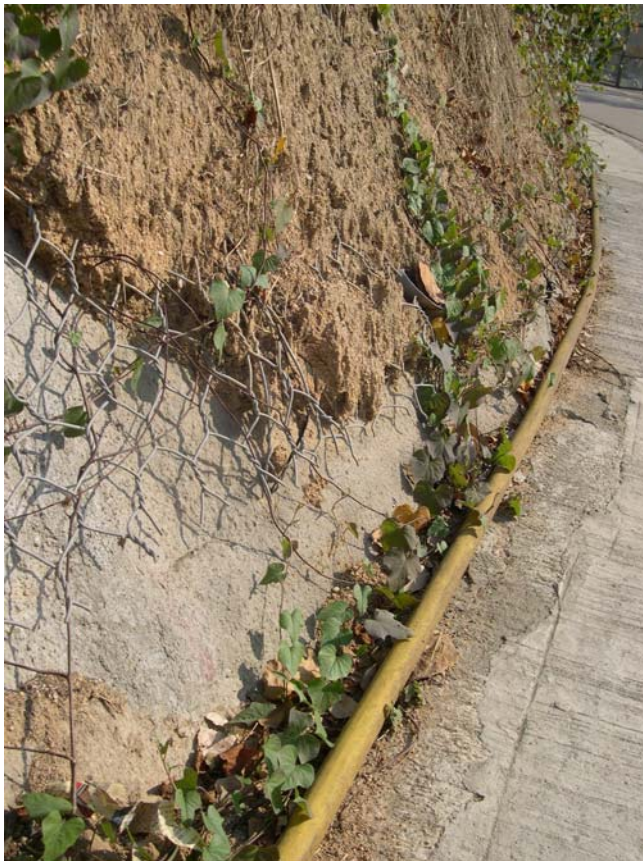
Plate 6e

Observations: Erosion and detachment
of mulch/soil mix,
exposing wire mesh
Slope No.: 11NW-A/C123
Location: Caldecott Road
Date of Inspection: 16 December 2003

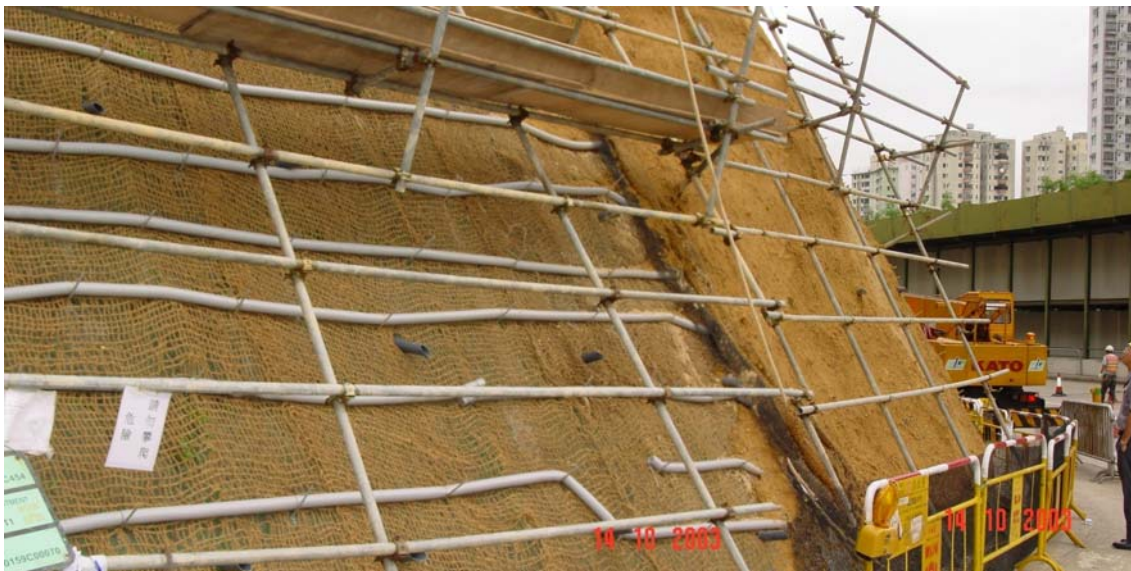
Plate 7b

Observations: Horizontal support within the soil mix in the form of PVC pipes
Slope No.: 11NW-D/C131
Location: Chung Hau Street, Homantin
Date of Inspection: 14 October 2003

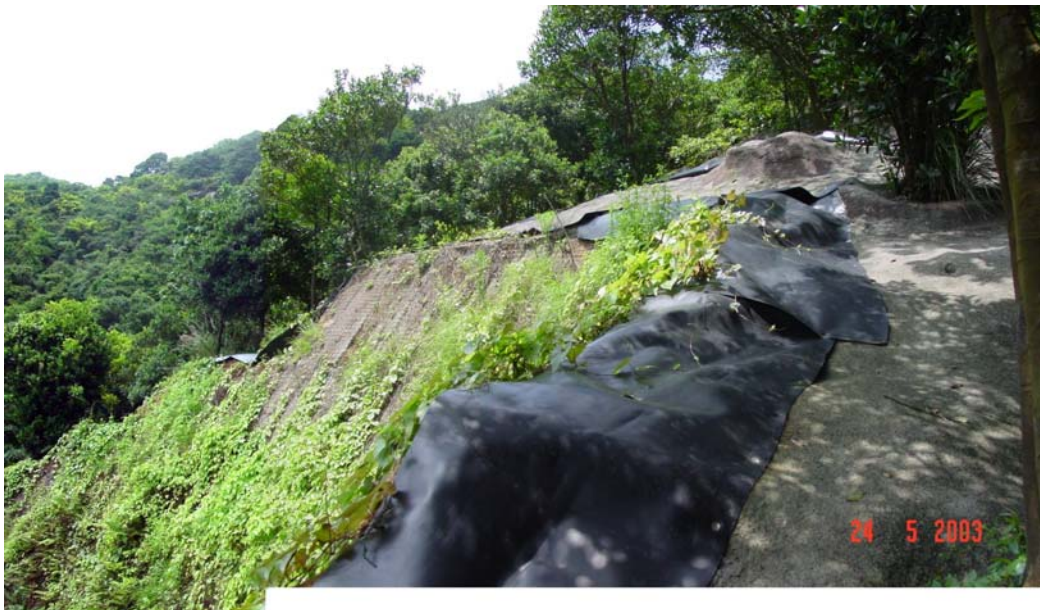
Observations:	Surface erosion
Slope No.:	11SE-A/C487
Location:	Mount Parker Road
Date of Inspection:	24 May 2003

Plate 9 - Protection of Erosion at Crest of Slopes with Soil Panel

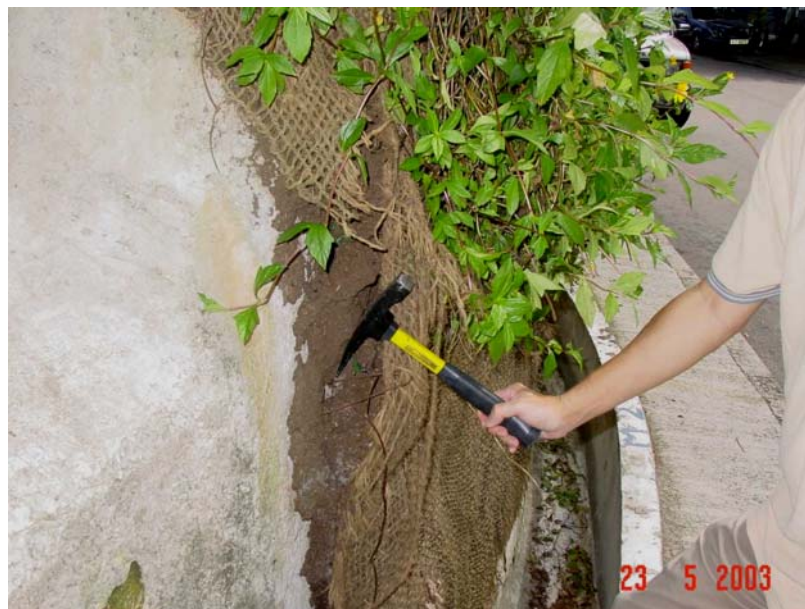
Plate 10b

Observations: Inadequate anchorage of erosion control mat at edge of system
Slope No.: 11SE-C/C166
Location: Mount Butler
Date of Inspection: 23 May 2003

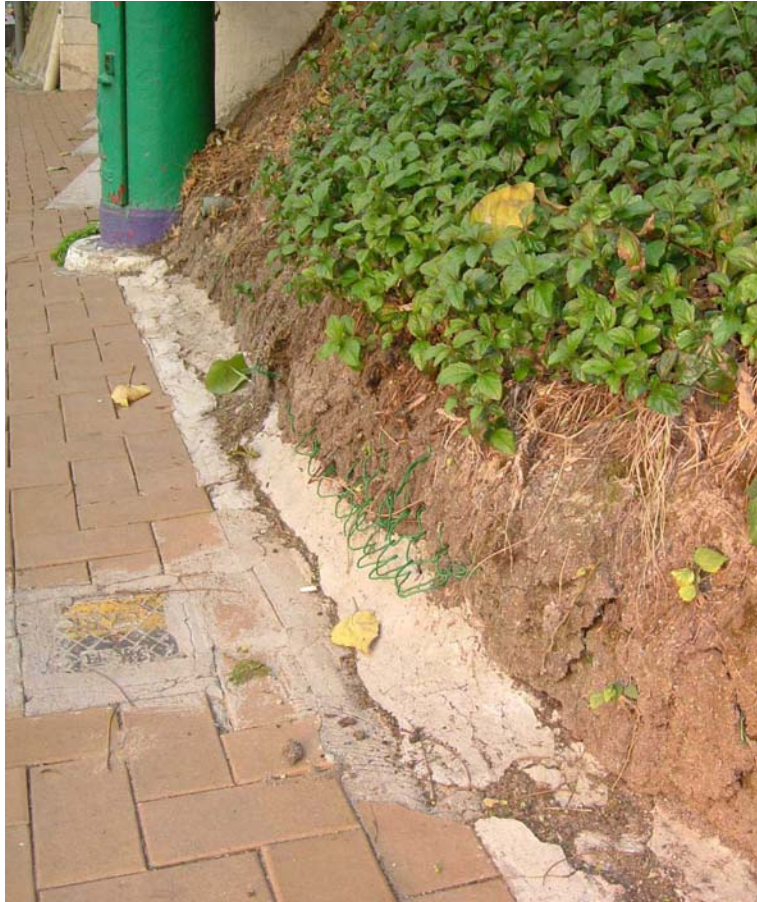
Plate 10c

Observations:	Erosion along slope toe
Slope No.:	11SW-A/C138
Location:	Pokfulam Road
Date of Inspection:	27 December 2003

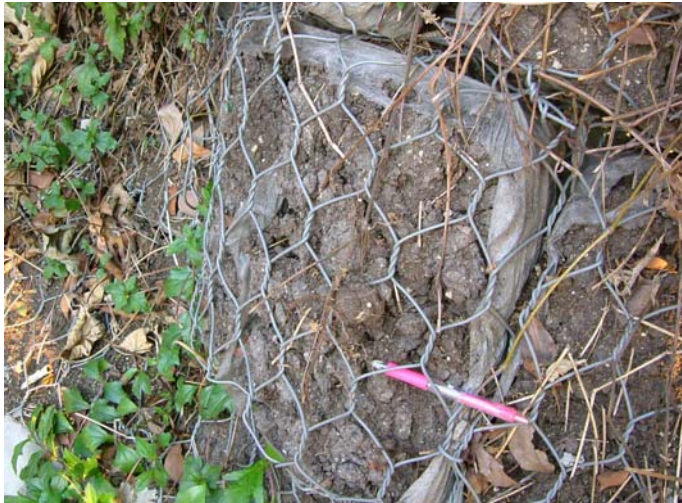
Plate 13a

Observations: Cracks and disintegration of the mulching blocks
Slope No.: 11SW-A/C139
Location: Pokfulam Road
Date of Inspection: 27 December 2003

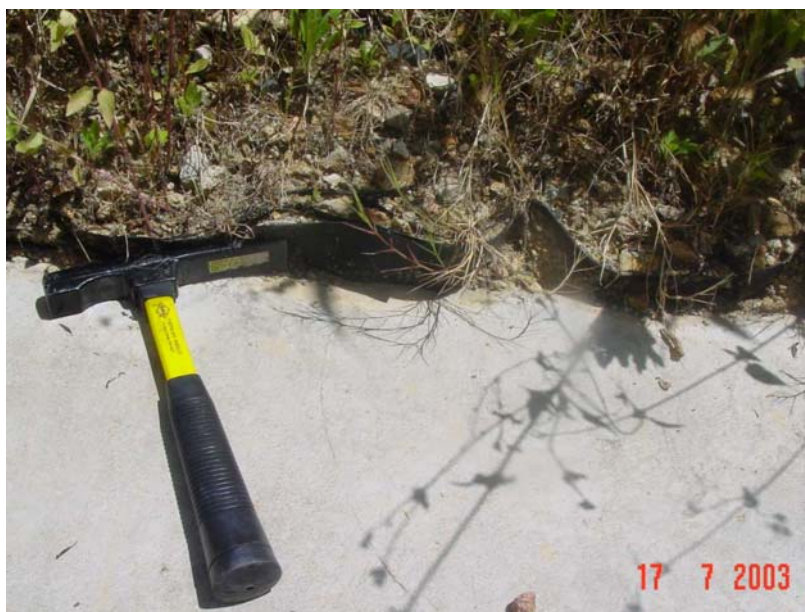
Plate 14a

Observations:	Unsupported system of Terra Cell
Slope No.:	11NE-D/C815
Location:	Tiu Keng Leng
Date of Inspection:	17 July 2003

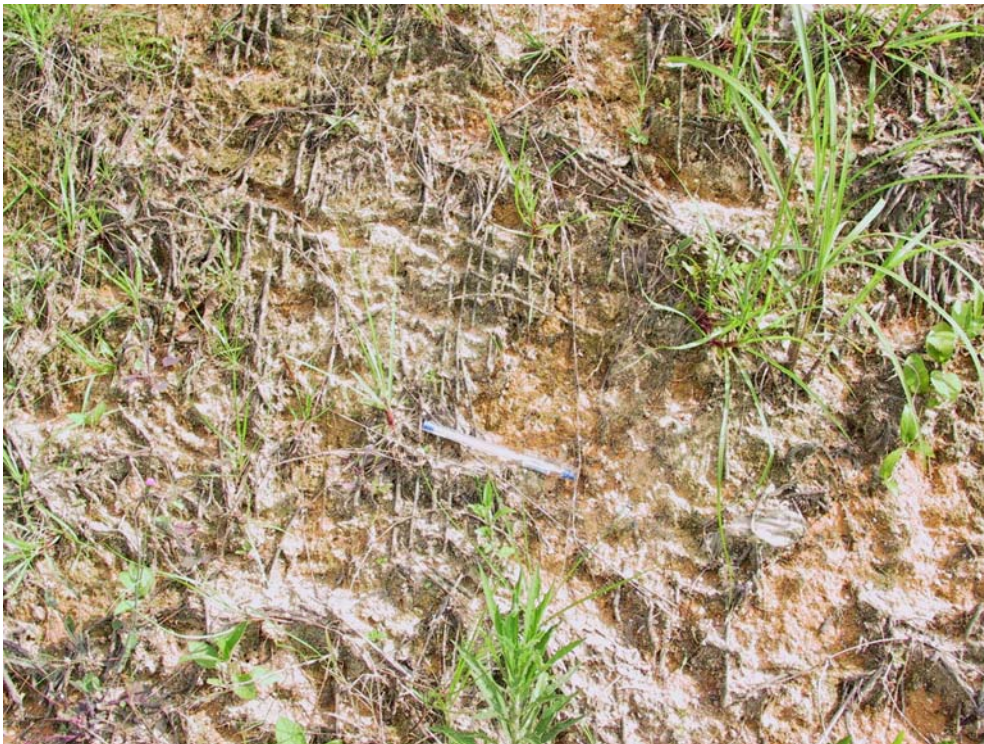
Slope No.: 6SE-D/C212
Location: Route Twisk
Date of Inspection: 22 May 2003

Plate 18 - Degradation of Soil Saver on a Slope

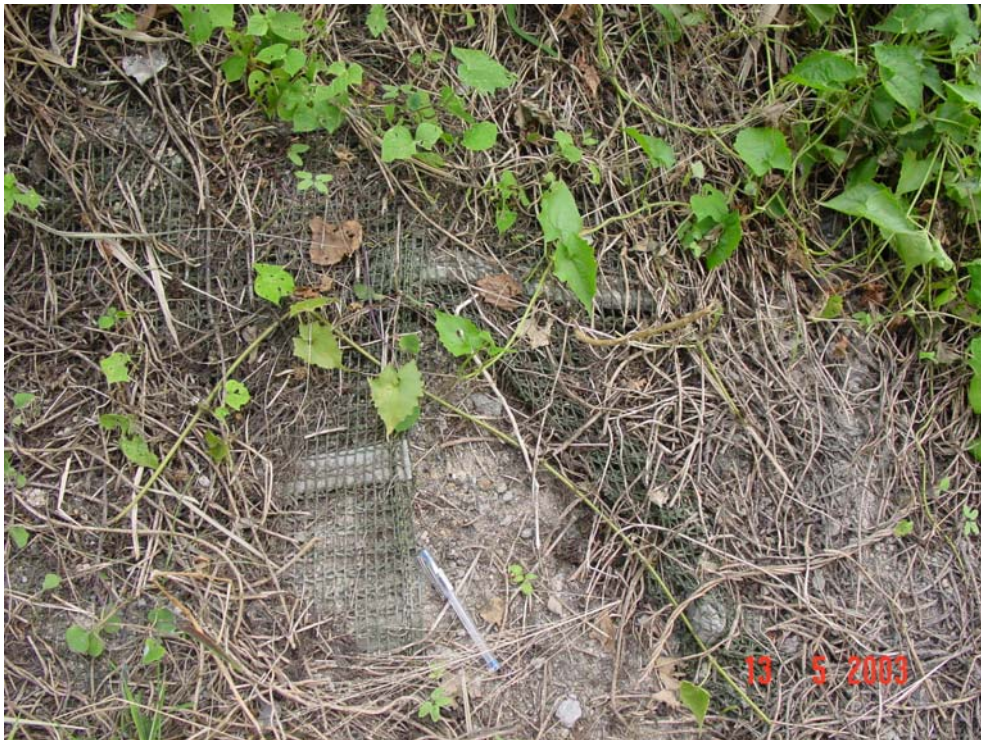
Slope No.: 11NW-A/C159
Location: Kwai Tai Road, Kwai Chung
Date of Inspection: 13 May 2003

Plate 19 - Inadequate Anchorage of Kangaroo Mat on a Slope

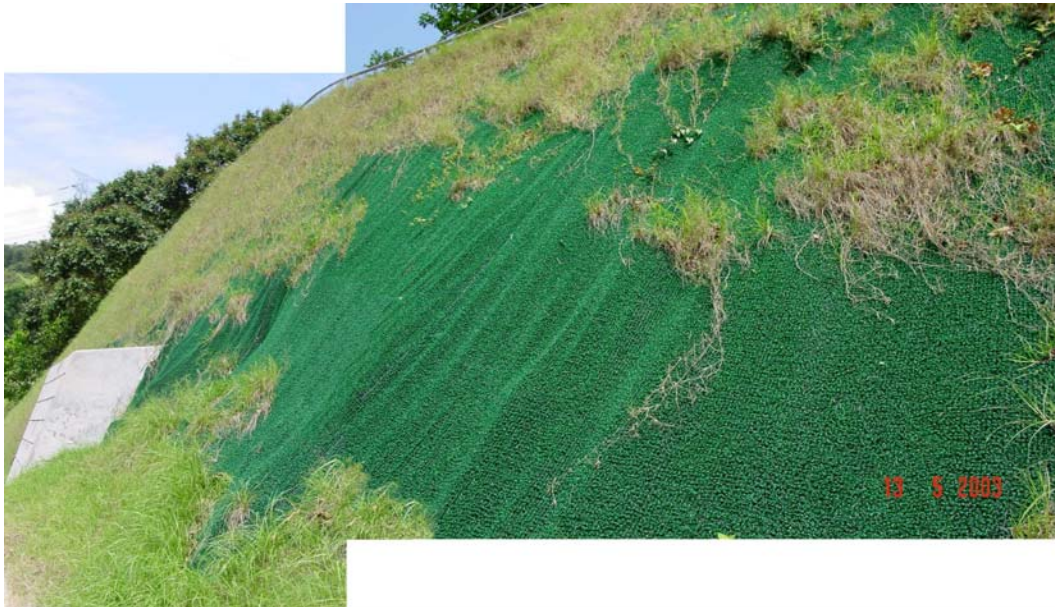
Plate 20b

Observations: Miramat TM8 not conforming to surface profile
Slope No.: 7SW-C/C180
Location: Shek Lei Estate
Date of Inspection: 13 May 2003

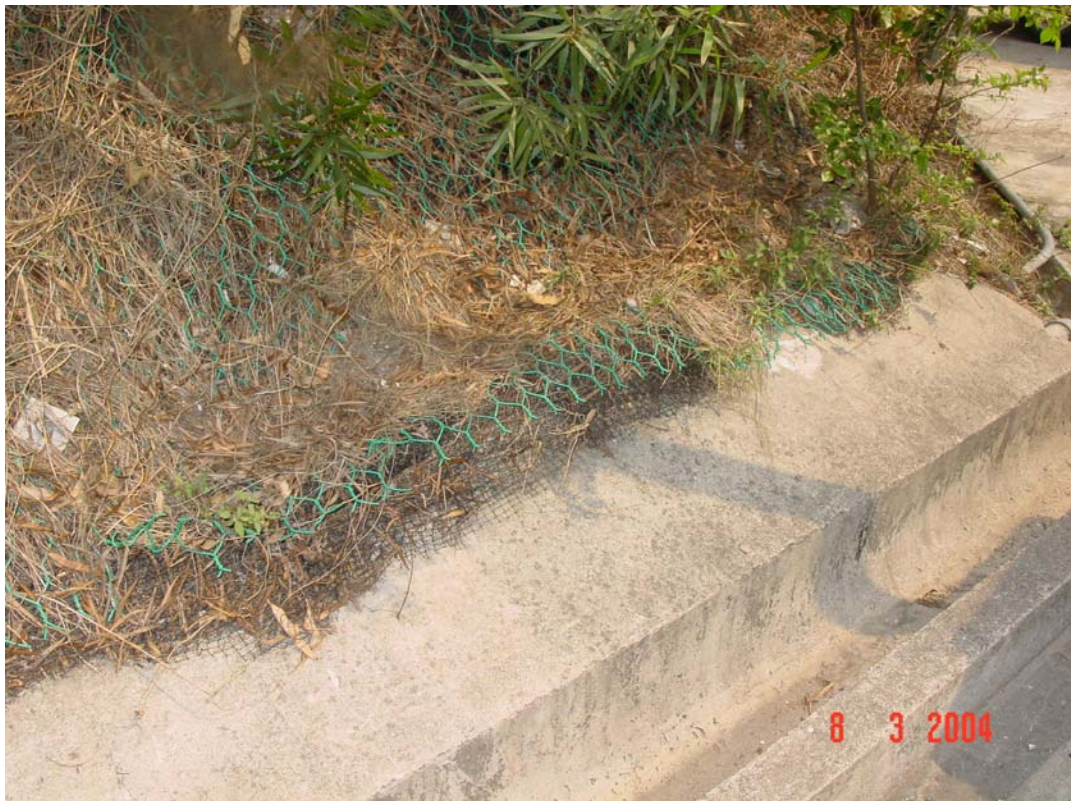
Slope No.: 6SE-C/C28
Location: Tsing Lung Tau
Date of Inspection: 8 March 2004

Plate 24 - Steel Wire Mesh and Multimat not Securely Anchored at Slope Toe
