# **REVIEW OF LANDSLIDES IN 2003**

**GEO REPORT No. 184**

**GEOTECHNICAL ENGINEERING OFFICE  
CIVIL ENGINEERING AND DEVELOPMENT DEPARTMENT  
THE GOVERNMENT OF THE HONG KONG  
SPECIAL ADMINISTRATIVE REGION**

**This report was originally produced in October 2004  
as GEO Landslide Study Report No. LSR 5/2004**

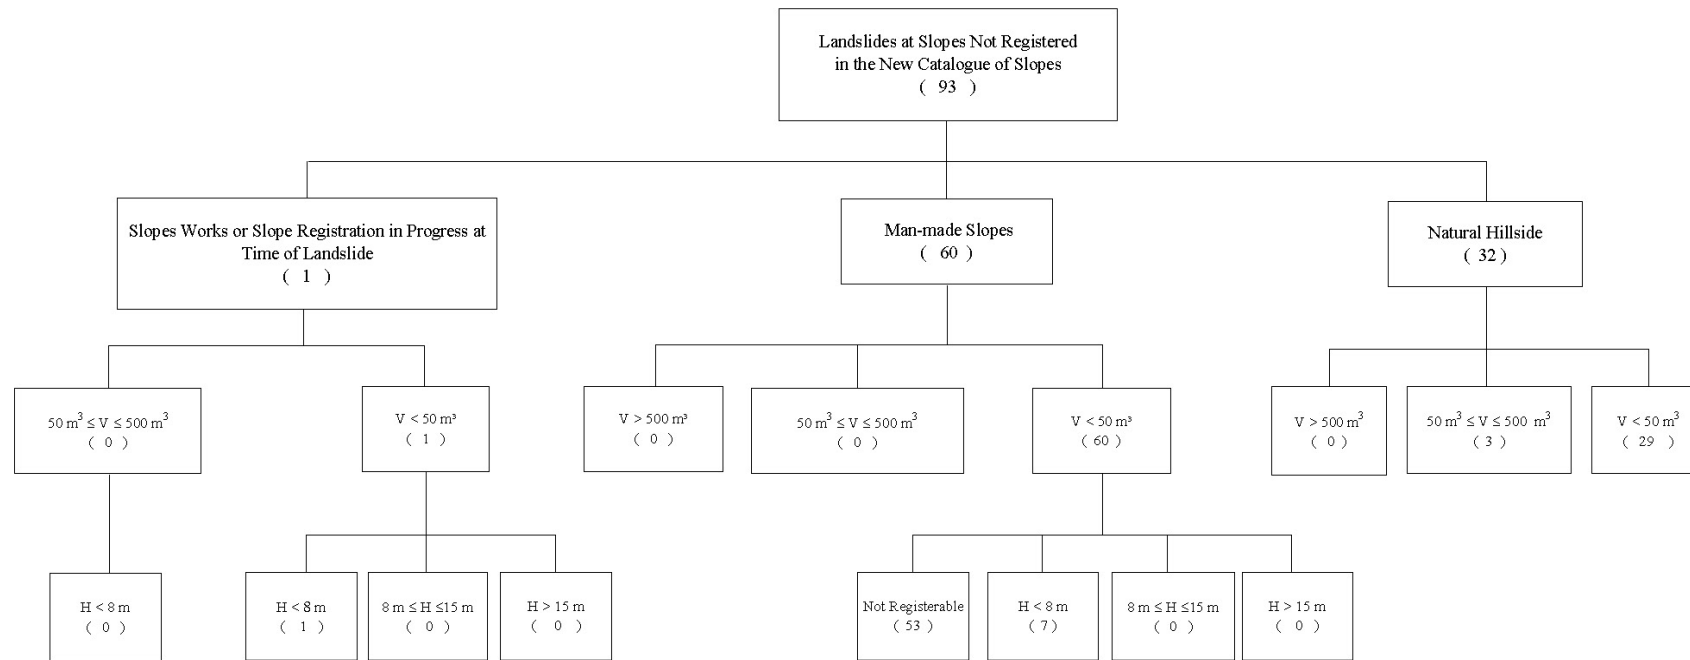
Figure No.		Page No.
1	Breakdown of Landslides at Unregistered Slopes in 2003	46

The remaining seven incidents involved features that satisfy the slope registration criteria but were not registered in the New Catalogue of Slopes at the time of the failure (see Figure 1 for details).
