**DETAILED STUDY OF THE  
5 MAY 2003 AND 13 JUNE 2003  
LANDSLIDES ON  
SLOPE NO. 6NE-B/C8  
FAN KAM ROAD, PAT HEUNG**

**GEO REPORT No. 190**

**Maunsell Geotechnical Services Limited**

**This report was originally produced in February 2004  
as GEO Landslide Study Report No. LSR 1/2004**

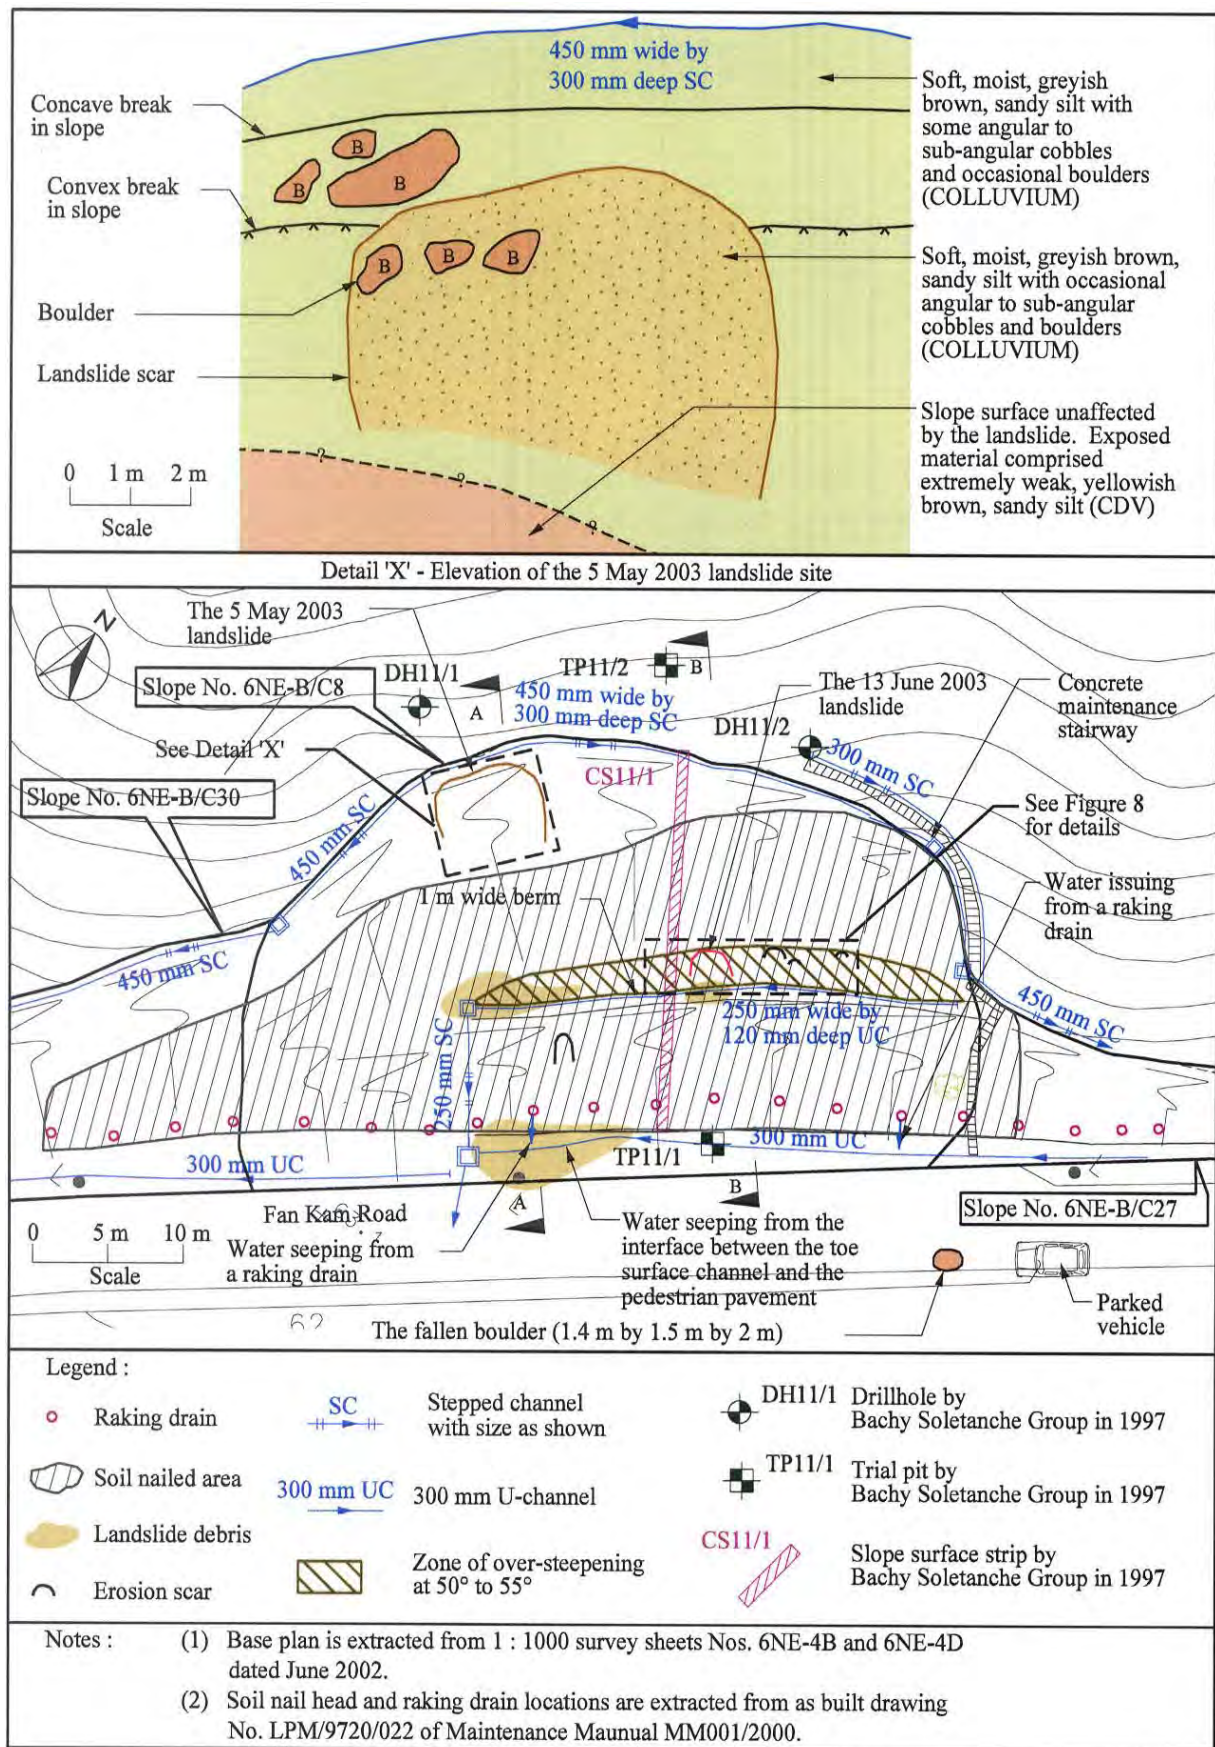
Figure 2 - Site Observations

The landslide scar was about 7.2 m wide by 5 m long by a maximum 1 m deep and the crown of the scar was about 1 m below the slope crest (Figure 2 and Plate 11). A geological cross-section through the landslide scar is shown in Figure 3. The material exposed on the landslide scar was colluvium comprising soft greyish brown, sandy silt with cobbles and boulders of coarse ash tuff, which constitutes about 15% to 20% by volume of the slope-forming material. No erosion pipes were observed on the landslide scar.

Landslide debris comprising material similar to that exposed on the landslide scar was found to have been deposited on the berm and in the 300 mm U-channel along the toe of the slope below the landslide scar, both over a length of about 7 m (Figure 2 and Plate 5). Some of the debris reached as far as the northeast bound lane of Fan Kam Road (Figure 2).

An erosion scar was observed on the lower batter of the slope below the northeast side of the 5 May 2003 landslide scar (Figure 2 and Plate 12). This erosion scar was possibly formed by concentrated surface water flow from overspilling of the berm U-channel after it became blocked by the landslide debris derived from the 5 May 2003 landslide (see Figure 2 and Plate 5).

During inspections on 6 and 18 August 2003, water was observed to be issuing from a raking drain located close to the northeast end of slope No. 6NE-B/C8 (Figure 2 and Plate 13) and seepage was observed from another raking drain located directly below the 5 May 2003 landslide scar (Figure 2). During an inspection on 6 August 2003, water was observed to be seeping from the interface between the toe channel and the pedestrian pavement near the 250 mm stepped channel (Figure 2 and Plate 13).

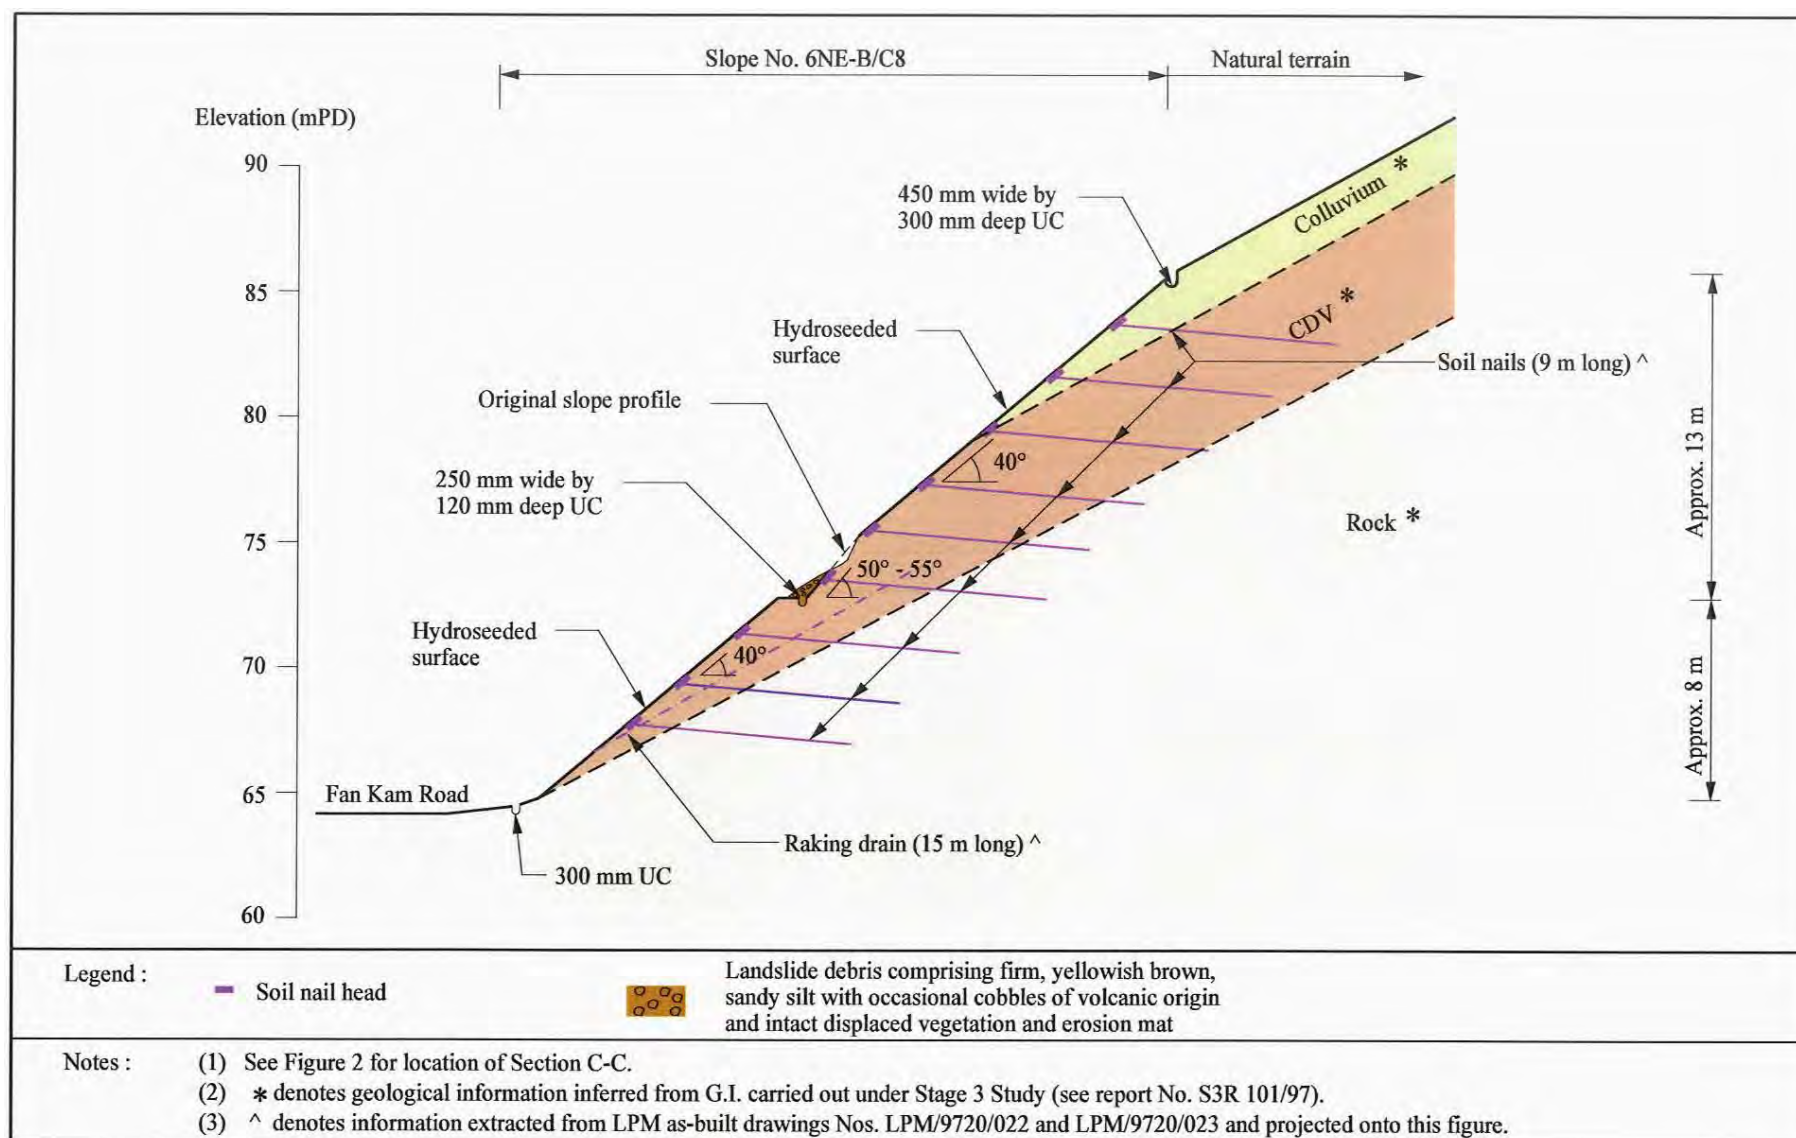
Figure 4 - Section B-B through the 13 June 2003 Landslide Site

Detailed engineering geological mapping of the landslide scar was carried out by MGSL. The result of the mapping is presented in Figure 9 and a geological cross-section through the landslide scar is shown in Figure 4. The material exposed on the scar was extremely weak, yellowish brown, completely decomposed coarse ash tuff comprising sandy silt with occasional cobbles. No signs of seepage were observed on the landslide scar.

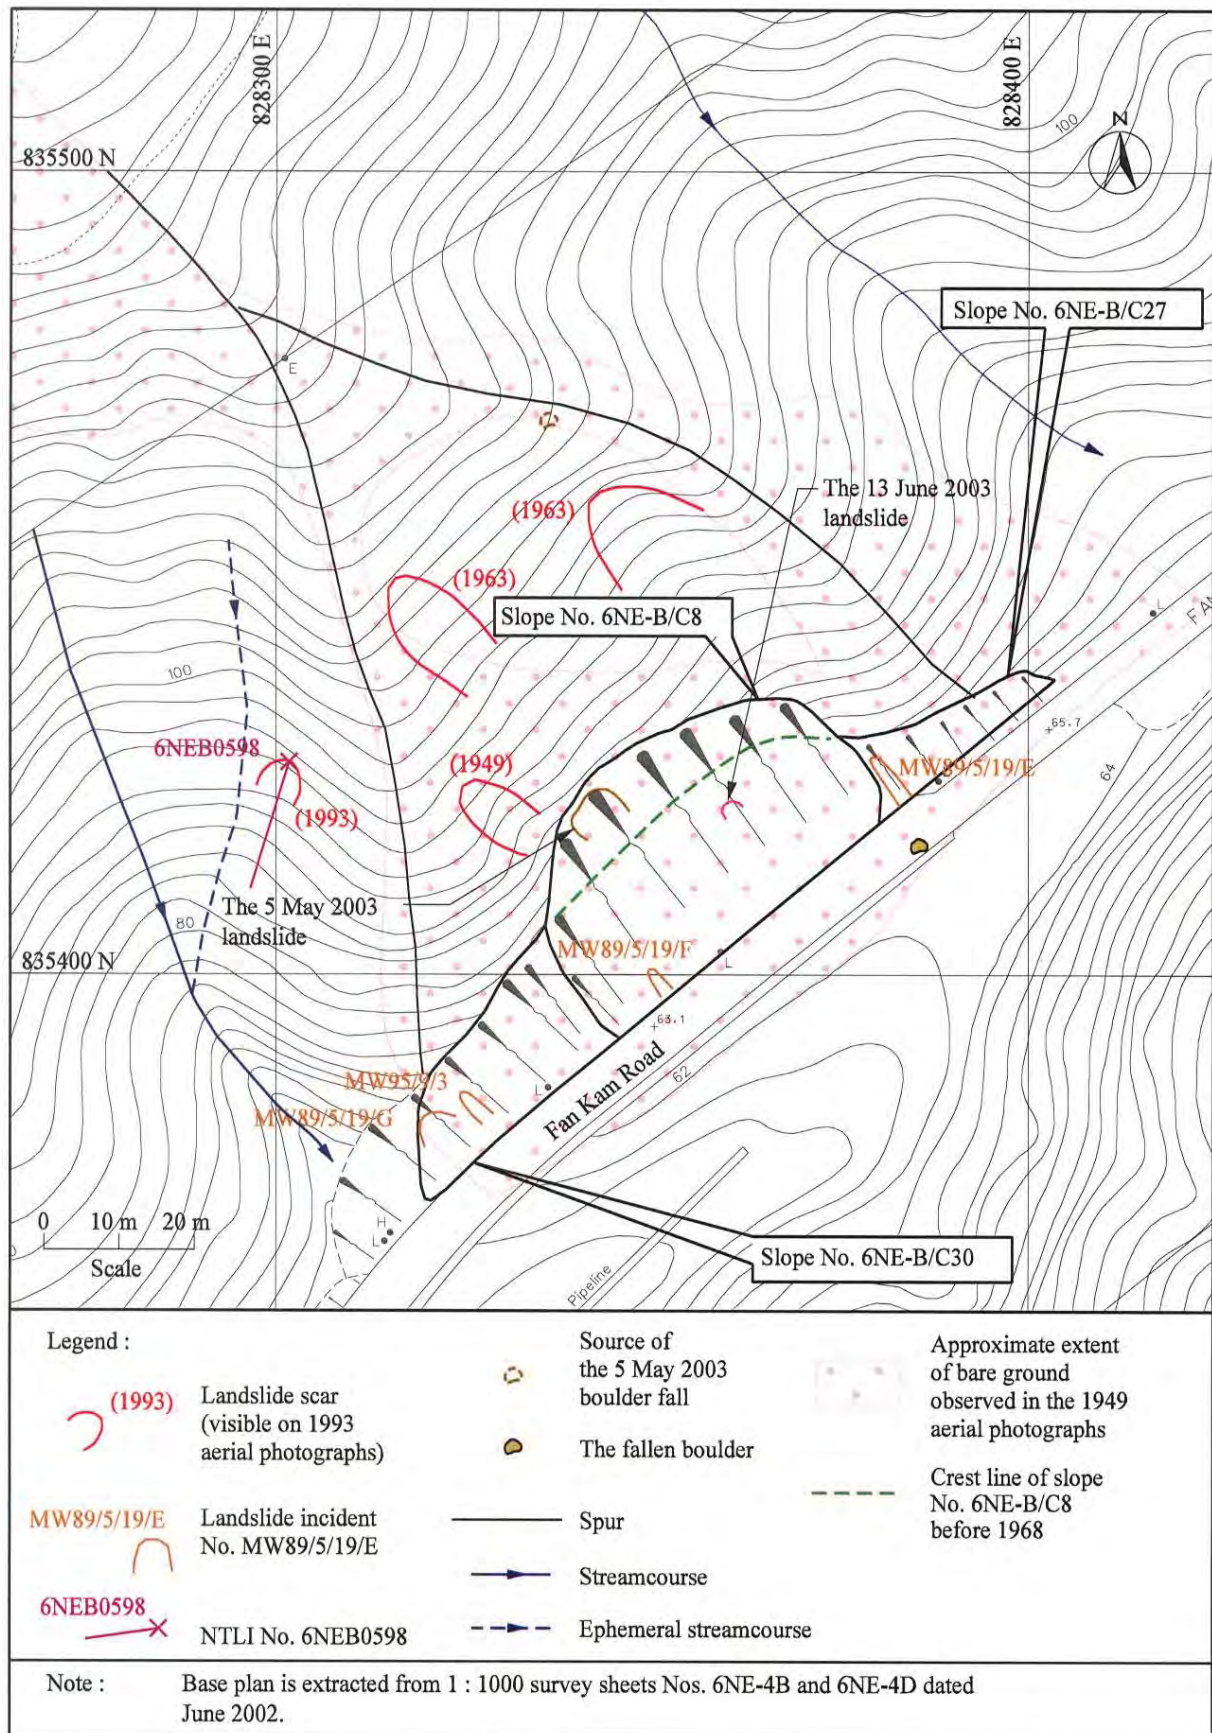
Figure 7 - Past Instability

On the 1949 aerial photographs, a relict landslide scar is visible just above the crest line of the present-day slope No. 6NE-B/C8 within the shallow depression (see Section 2.5 and Figure 7). On the 1963 aerial photographs, two possible degraded relict landslide scars are visible within the depression between the two spurs, about 15 m above the crest of the cut slope (Figure 7).

In May 1989, a cluster of minor landslides (Incident No. MW89/5/19) occurred on a number of cut slopes along Fan Kam Road, including a small failure near the toe of slope No. 6NE-B/C8 (Figure 7). According to the GEO’s landslide incident report, the landslide scar was about 2 m wide by 0.75 m deep. The volume of the failure was not recorded. The pedestrian pavement of Fan Kam Road was closed temporarily as a result of the landslides. The incident report noted that “Groundwater”, “Infiltration” and “Strong Wind on trees” were the possible causes of failure.

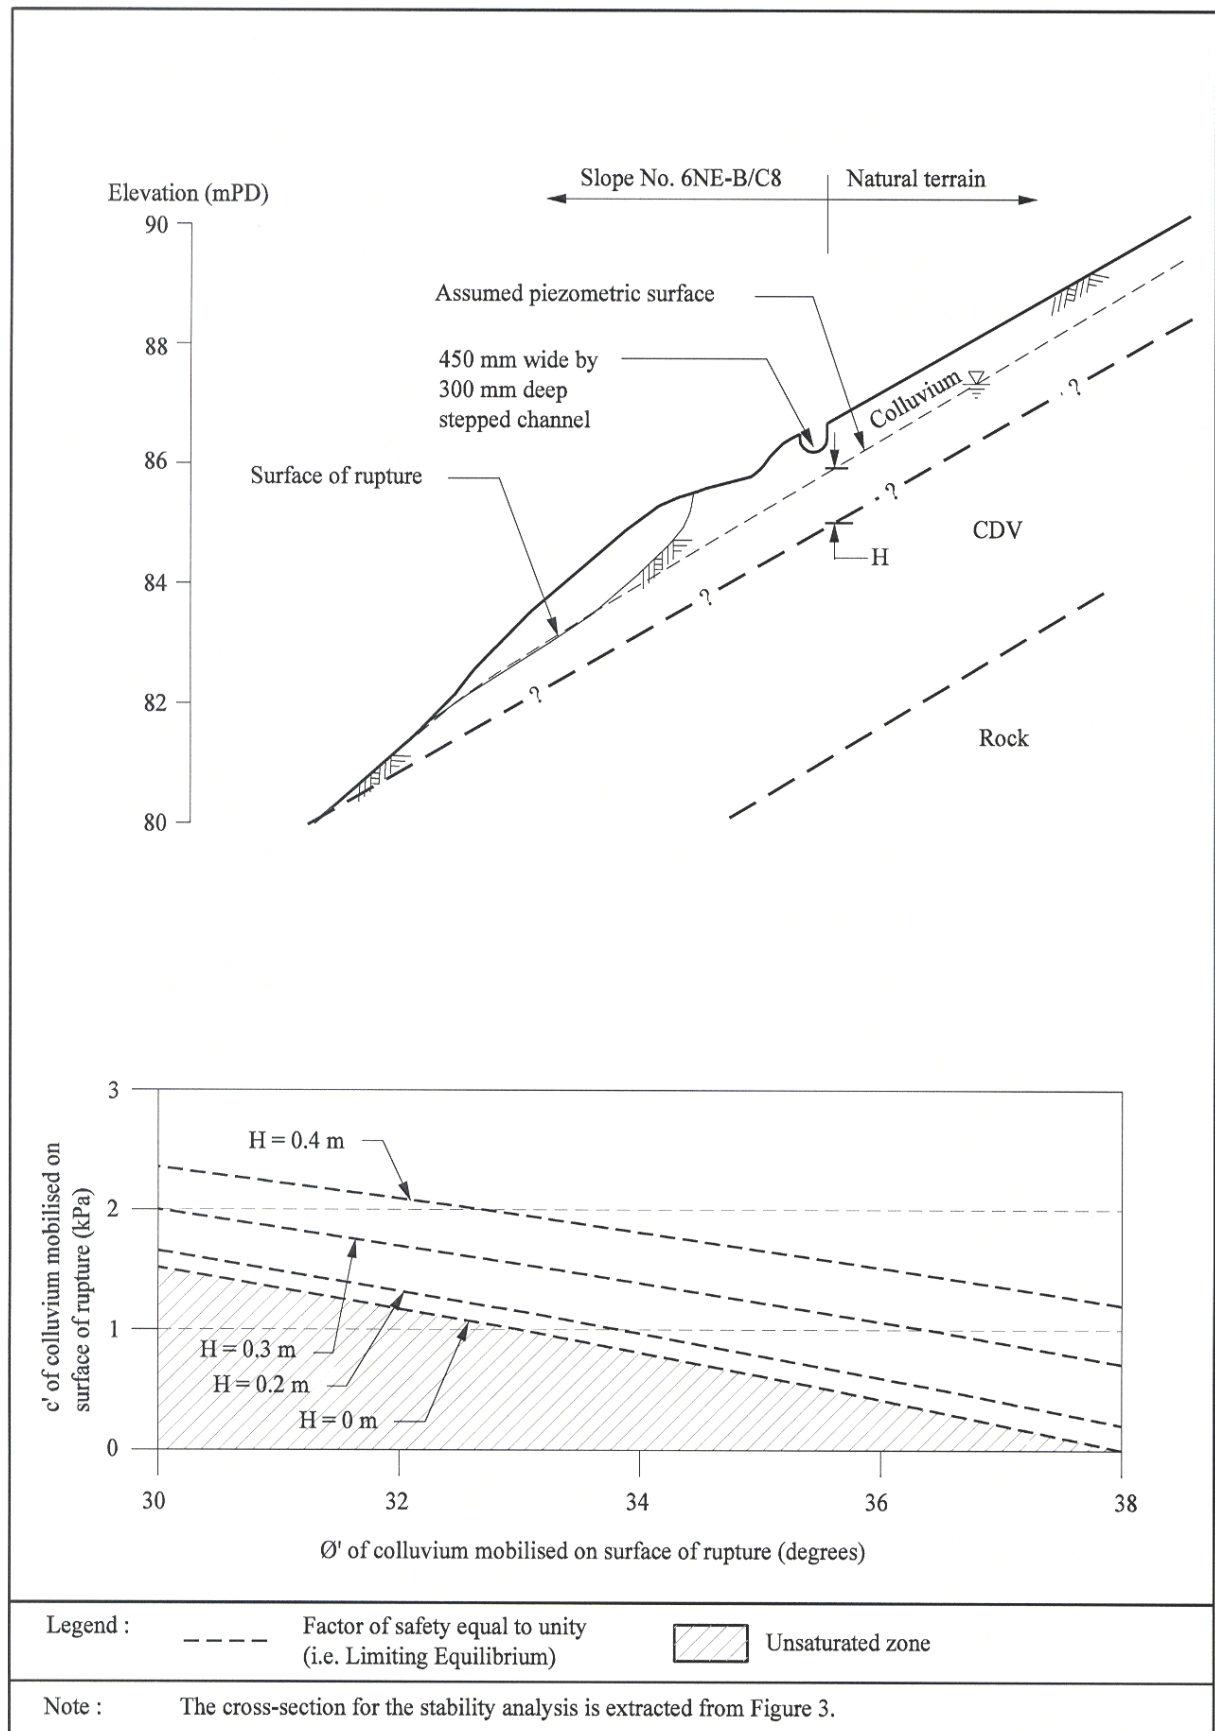
Figure 12 - Summary of Sensitivity Analyses

The results of the stability analyses are presented in Figure 12. If the shear strength parameters of colluvium are taken to be  $c' = 0$  kPa and  $\phi' = 35^\circ$ , the calculated FOS would fall below unity. For the probable range of mass shear strength parameters for the colluvium, the analyses suggest that failure could occur upon near saturation of the colluvium (possibly with a small amount of residual suction in the ground mass) or build-up of a small transient groundwater pressure (possibly with a low  $c'$  value and/or some residual suction in the ground mass). The analyses confirm the vulnerability of the steep, unsupported slope portion to failure in colluvium.

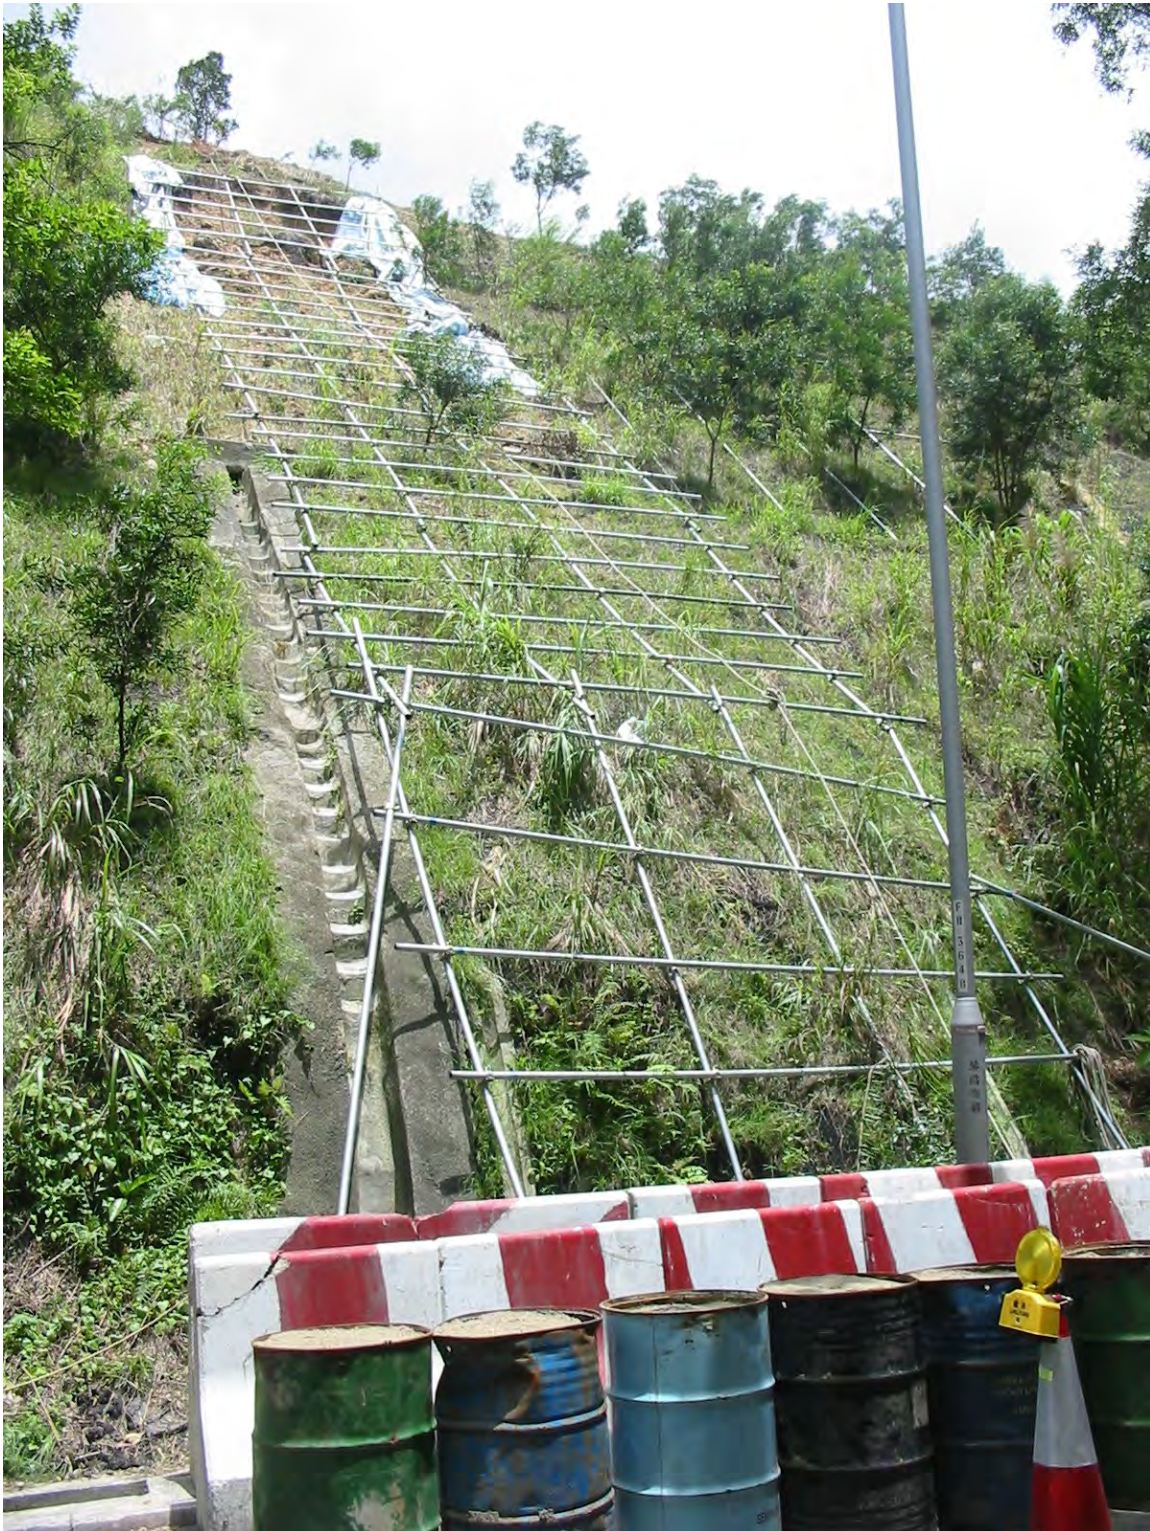
Plate 1 - General View of the 5 May 2003 Landslide on Slope No. 6NE-B/C8  
(Photograph taken on 16 May 2003)

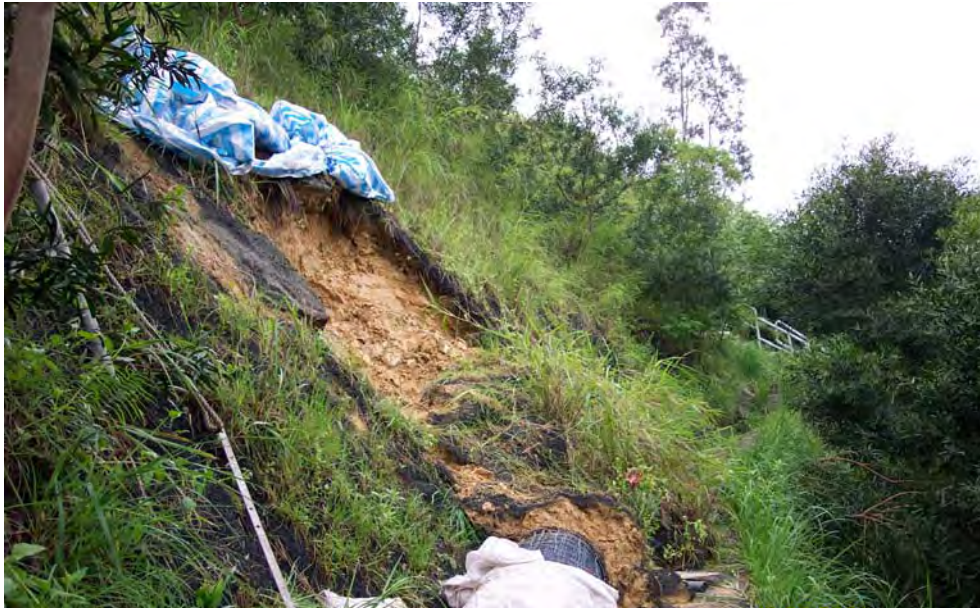
At about 2:00 p.m. on 13 June 2003 during moderate rainfall, a landslide with a failure volume of about 3 m<sup>3</sup> (Incident No. 2003/06/0126), occurred on slope No. 6NE-B/C8 at about 10 m above slope toe (Figure 2 and Plate 2). The landslide debris was deposited on the slope berm below the failure and Fan Kam Road was not affected by the incident.

Plate 2 - View of the 13 June 2003 Landslide on Slope No. 6NE-B/C8  
(Photograph taken on 14 June 2003)

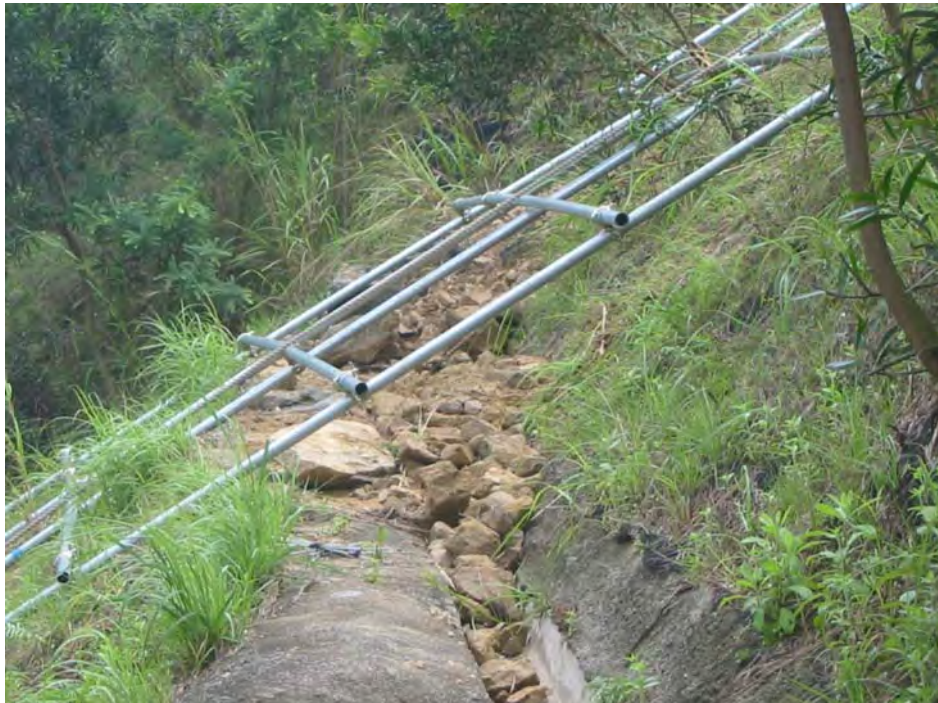
Plate 5 - View of the 1 m Wide Berm on Slope No. 6NE-B/C8  
(Photograph taken on 6 May 2003)

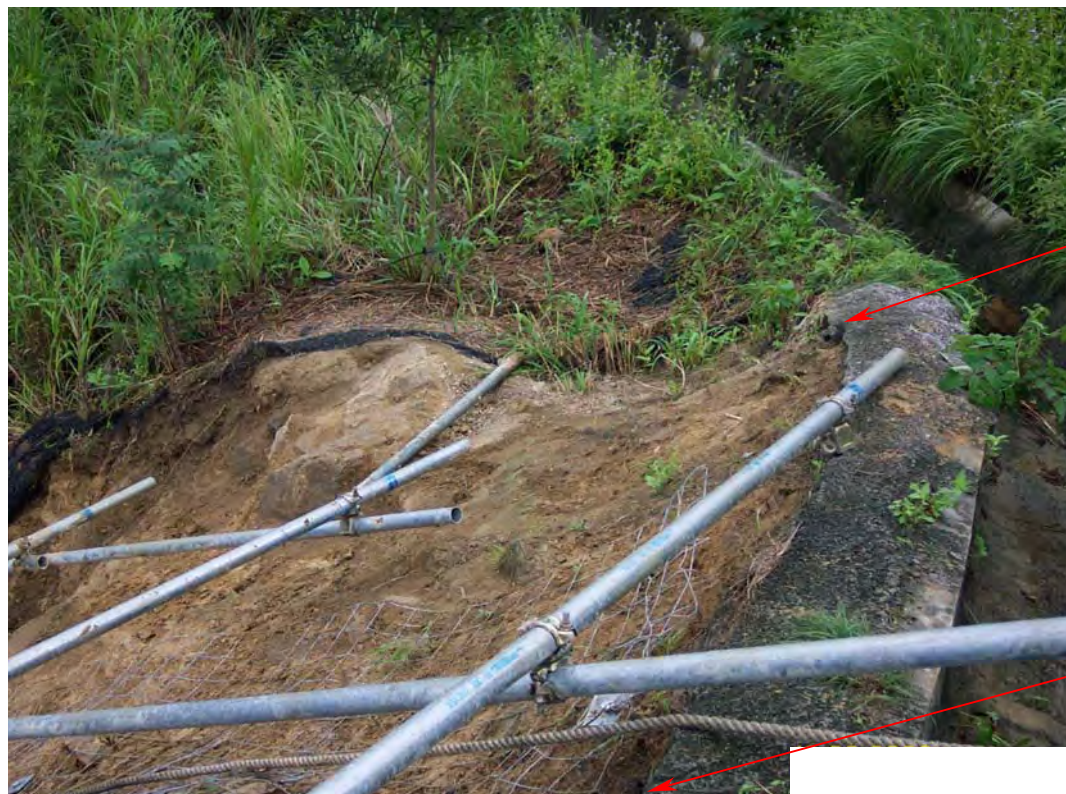
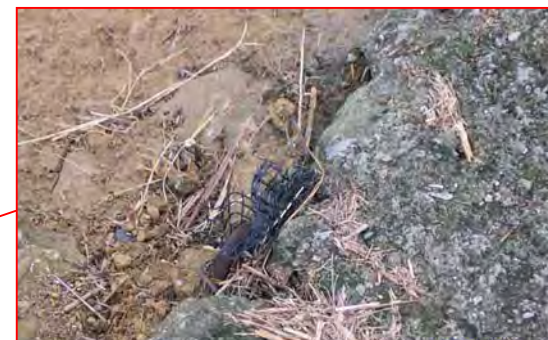
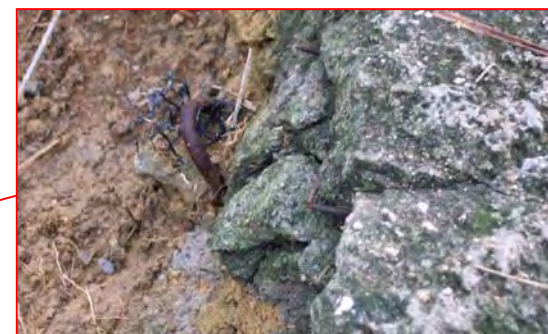
Remnants of the erosion control mat could be found in places around the periphery of the landslide scar (Plate 6). The erosion control mat was fixed to the slope by pins spaced at about 1 m centres vertically (measured on the slope face) and between 0.5 m and 1 m horizontally. The upper edge of the mat was not embedded beneath the concrete apron of

Plate 6 - View of Remnants of Erosion Control Mat around the Crest of the 5 May 2003 Landslide Site  
(Photograph taken on 14 June 2003)

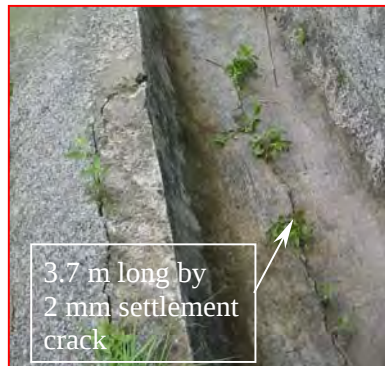
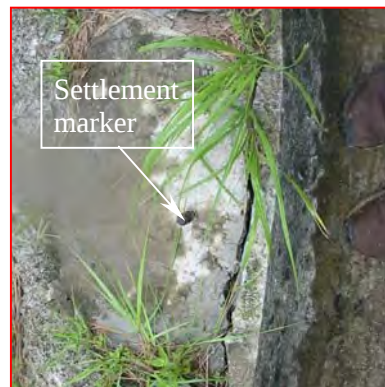
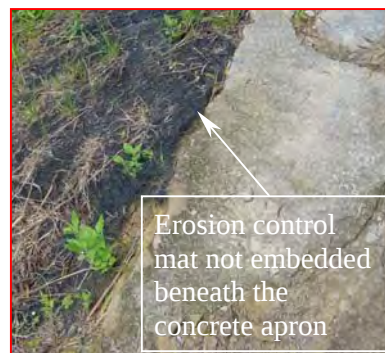
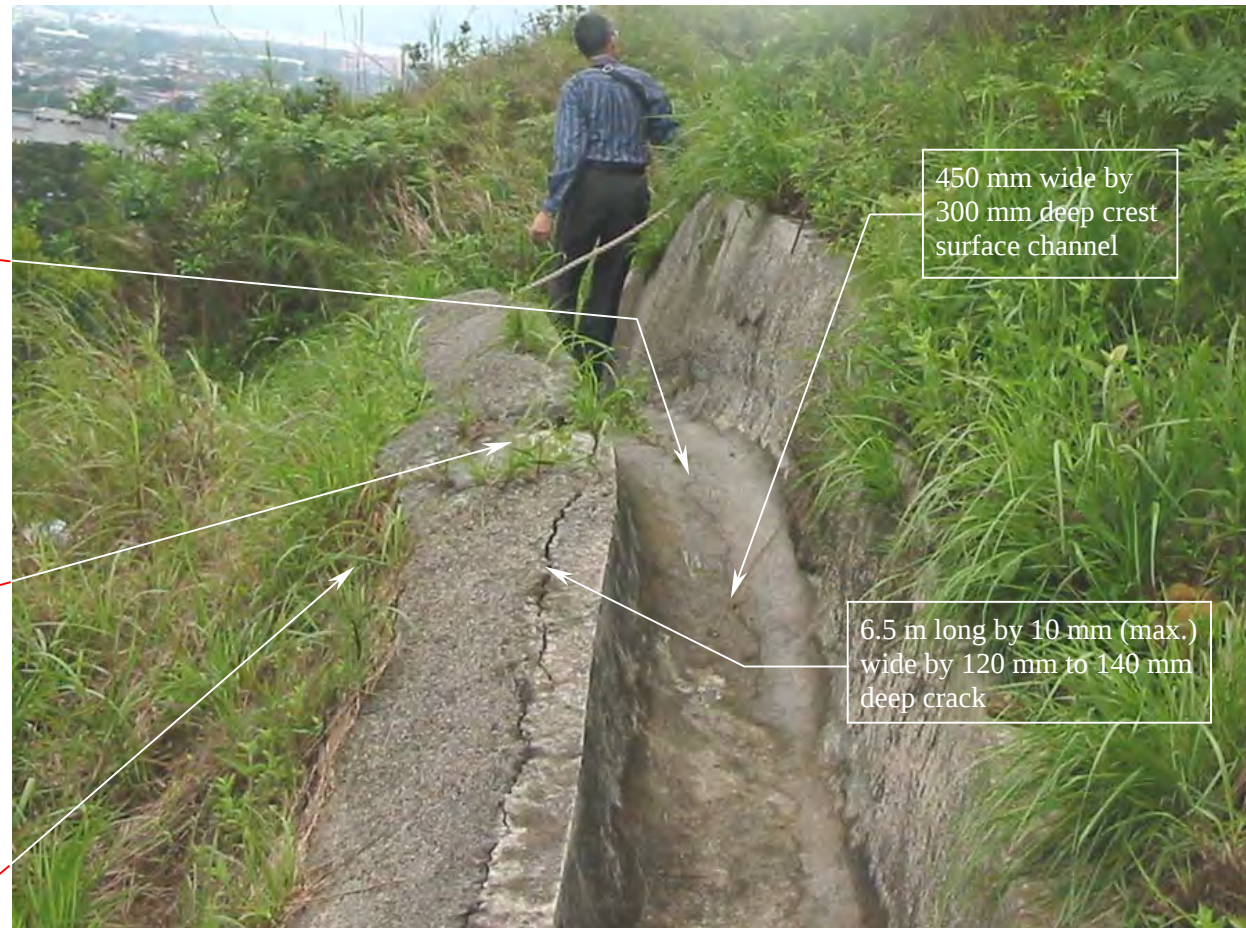
the crest surface channel (Plate 7). With the exception of the 50° to 55° steep portion of the upper batter of the slope (see Section 5.2), the erosion control mat was found to rest tightly against the slope surface.

An approximately 6.5 m long by 10 mm (maximum) wide and 120 mm to 140 mm deep crack was found at the interface between the crest surface channel and the adjoining concrete apron (Plate 7). Also, an approximately 3.7 m long, up to 2 mm wide crack, with a level difference of about 2 mm across itself, was found along the crest channel (Plate 7).

Plate 7 - View of the Surface Drainage Channel along the Crest of  
Slope No. 6NE-B/C8 (Photograph taken on 6 May 2003)

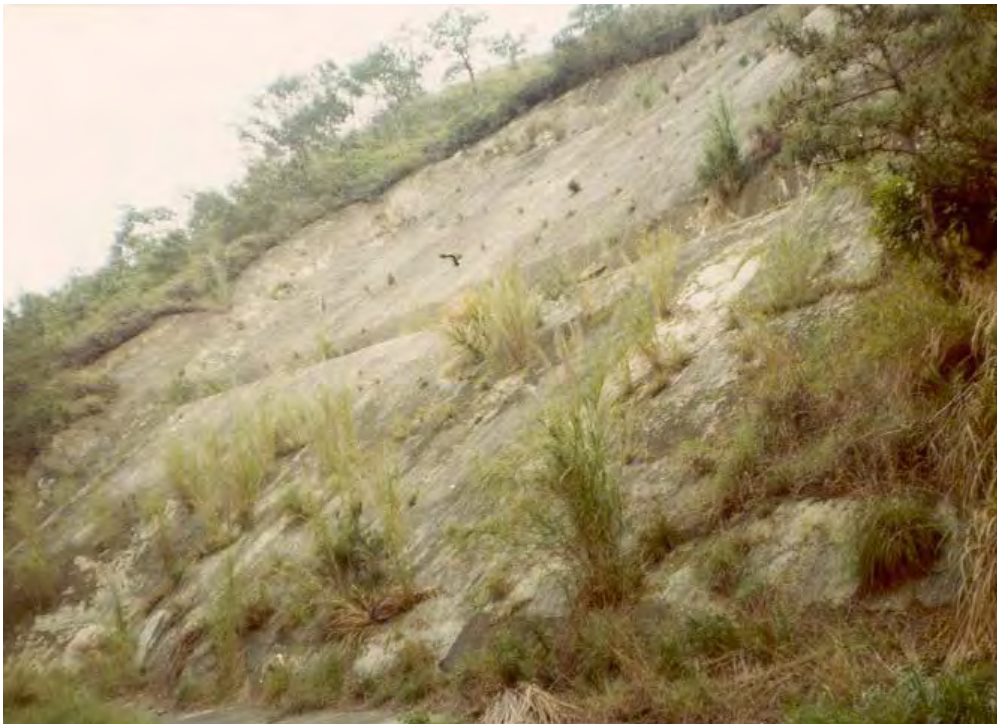
Binnie & Partners (Hong Kong) (B&P) were commissioned by the Geotechnical Control Office (GCO, renamed GEO in 1991) to prepare, inter alia, the 1977/78 Slope Catalogue under the project entitled "Phase I Re-appraisal of Cut and Natural Slopes and Retaining Walls". The B&P's fieldsheet on the inspection carried out in April 1978 recorded the following: "previous failure likely" (Plate 8) and "cracks in chunam".

Plate 8 - General View of Slope No. 6NE-B/C8 in 1978 (Photograph taken by Binnie & Partners (Hong Kong) on 18 April 1978)

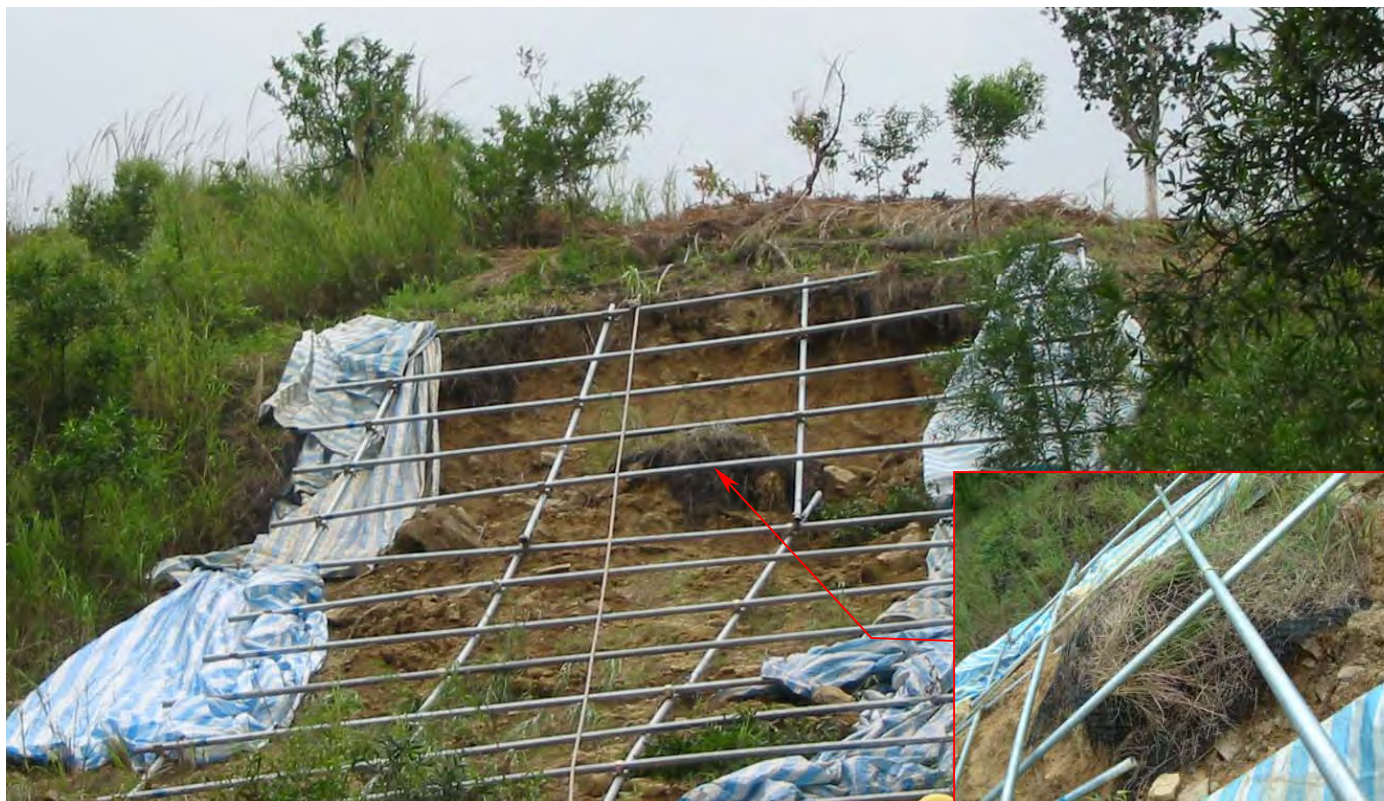
Plate 11 - Close-up View of the 5 May 2003 Landslide (Photograph taken on 16 May 2003)

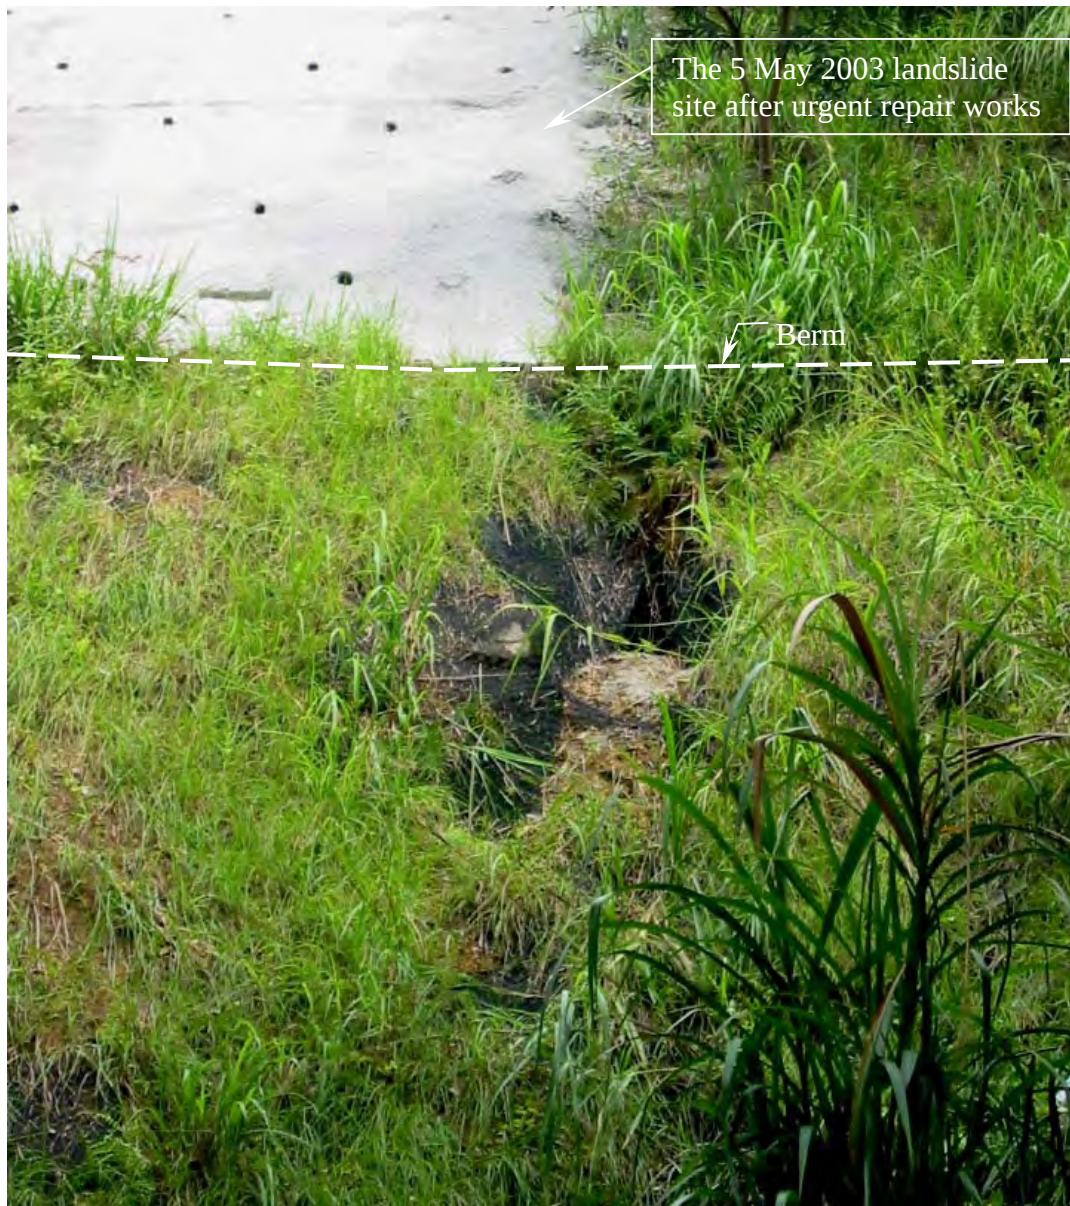
Plate 12 - View of the Erosion Scar on the Lower Batter of Slope No. 6NE-B/C8  
(Photograph taken on 14 June 2003)

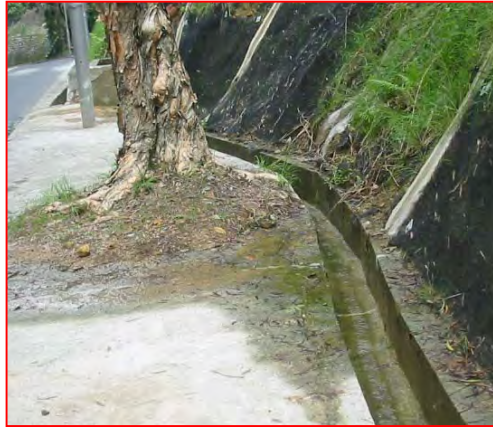
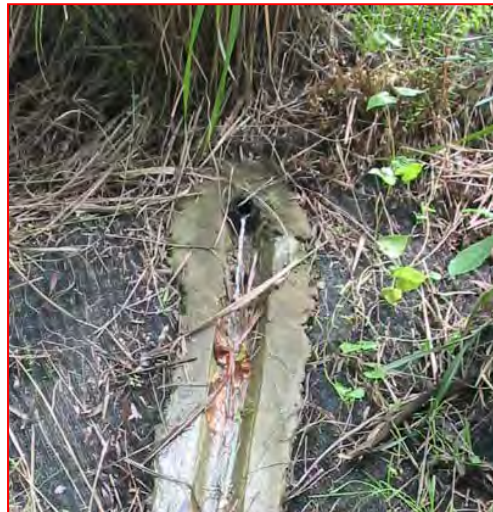
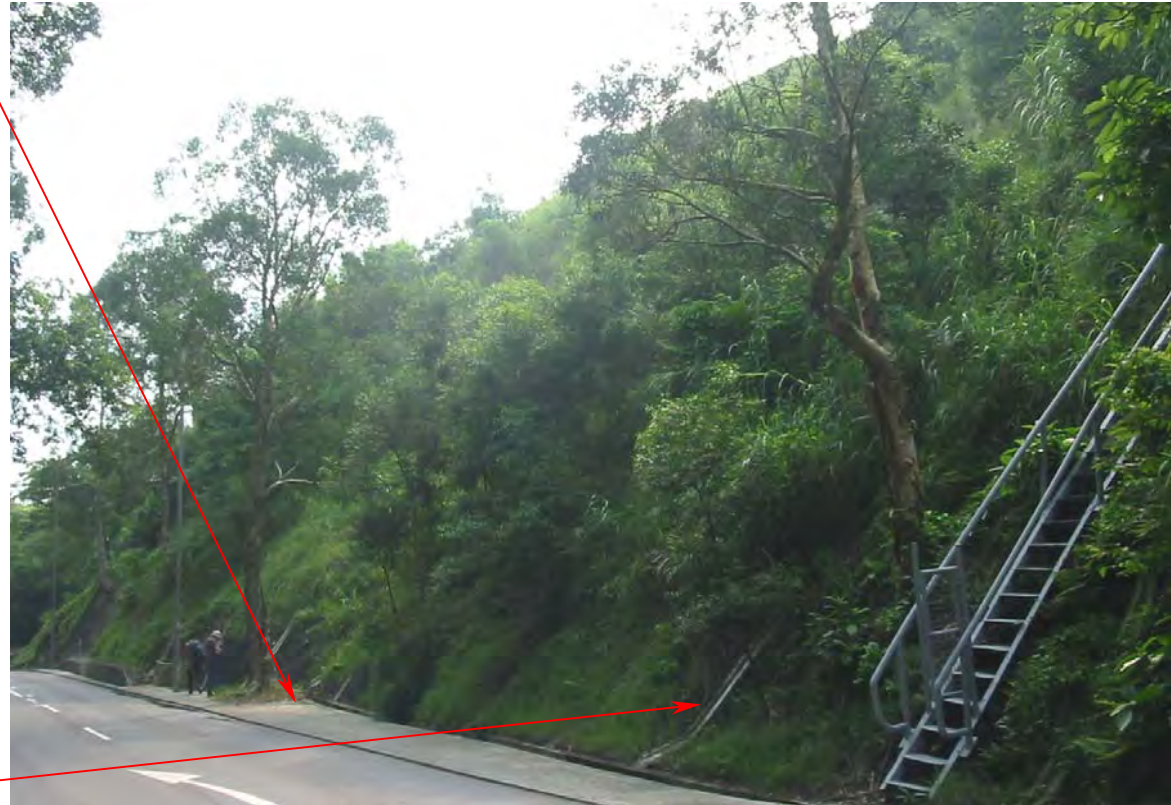
Plate 13 - View of Water Flowing from a Raking Drain and Seeping from the Interface between the Toe Surface Channel and the Pedestrian Pavement  
(Photograph taken on 6 August 2003)

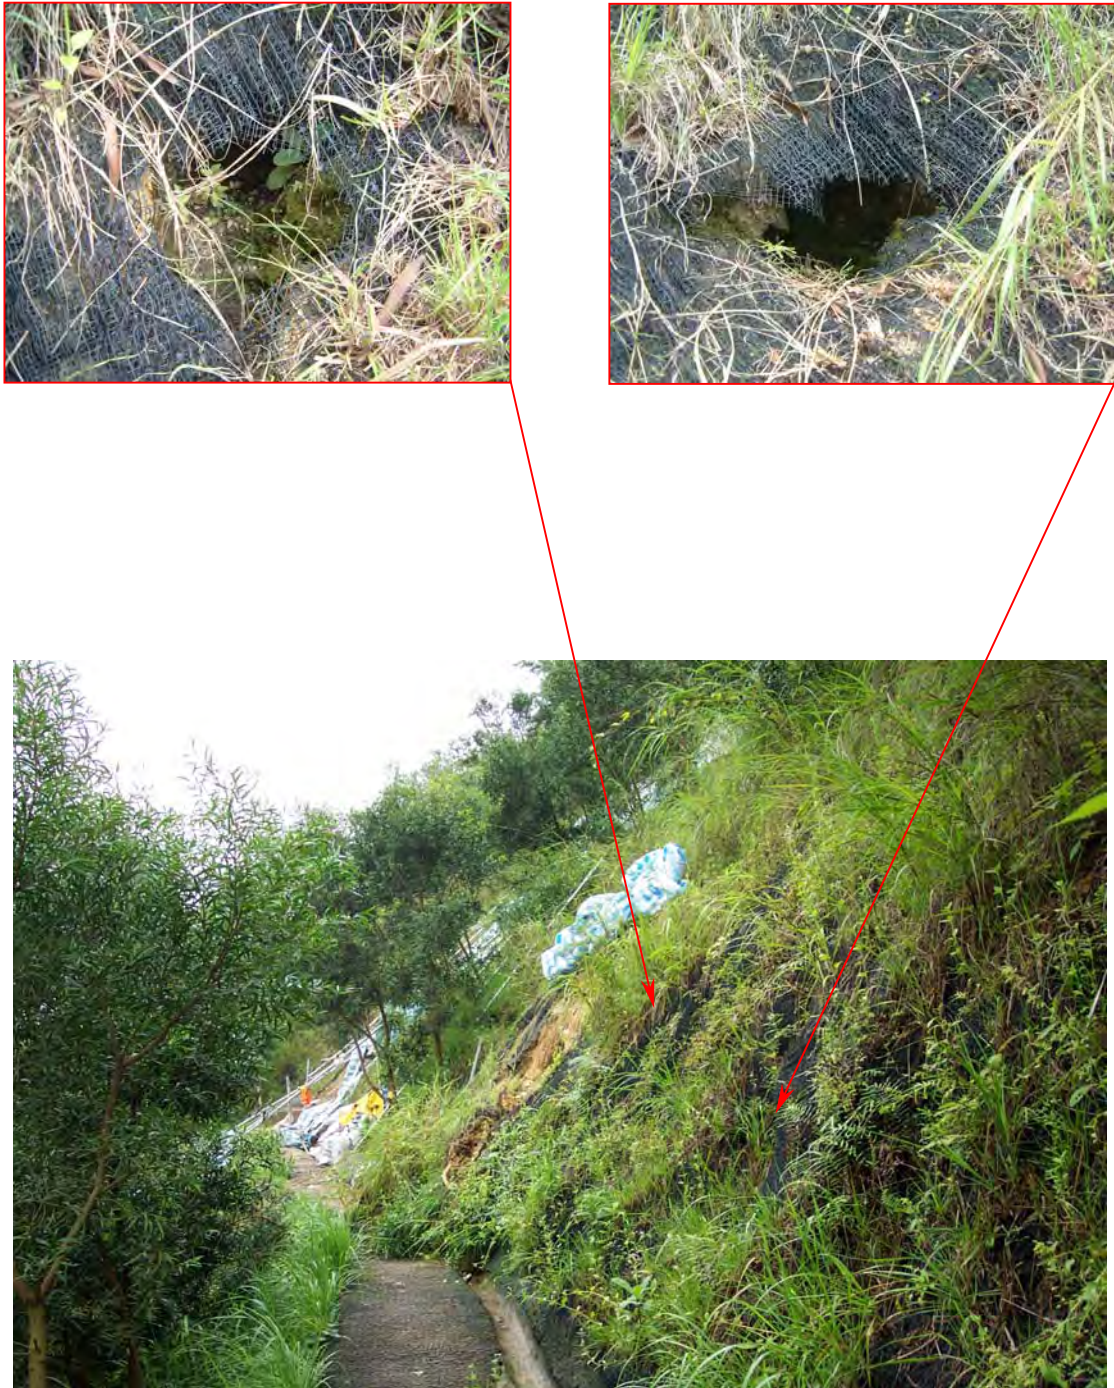
Plate 15 - View of the Erosion Scars on Slope No. 6NE-B/C8 above the Berm  
(Photograph taken on 14 June 2003)
