**DETAILED STUDY OF THE  
5 MAY 2003 AND 13 JUNE 2003  
LANDSLIDES ON  
SLOPE NO. 6NE-B/C8  
FAN KAM ROAD, PAT HEUNG**

**GEO REPORT No. 190**

**Maunsell Geotechnical Services Limited**

**This report was originally produced in February 2004  
as GEO Landslide Study Report No. LSR 1/2004**

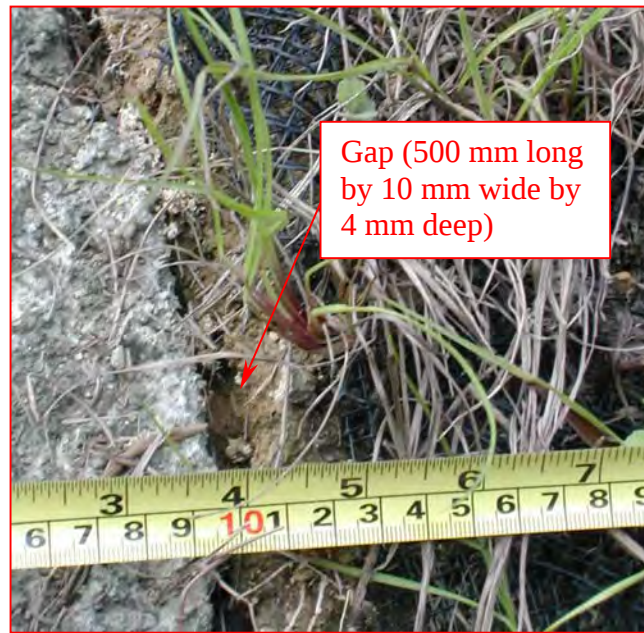
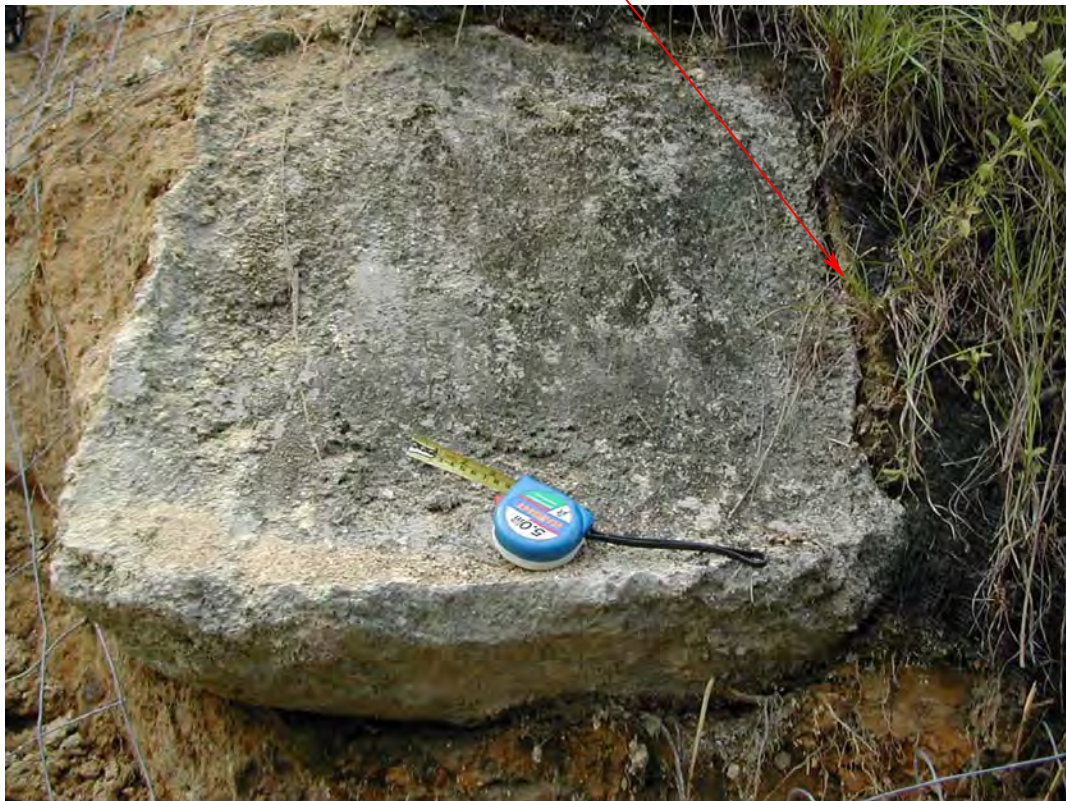
Plate 16 - Close-up View of a Gap between a Soil Nail Head and the Slope at the 13 June 2003 Landslide Site (Photograph taken on 19 June 2003)

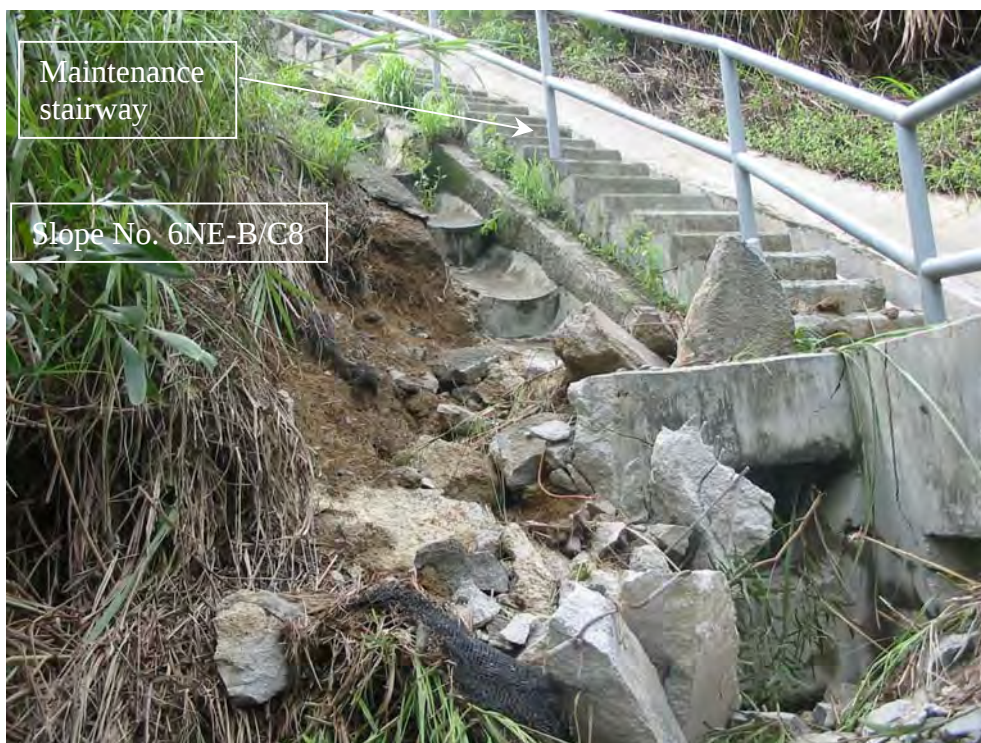
Plate A9 - View Showing a Catchpit Damaged by the Fallen Boulder  
(Photograph taken on 6 May 2003)

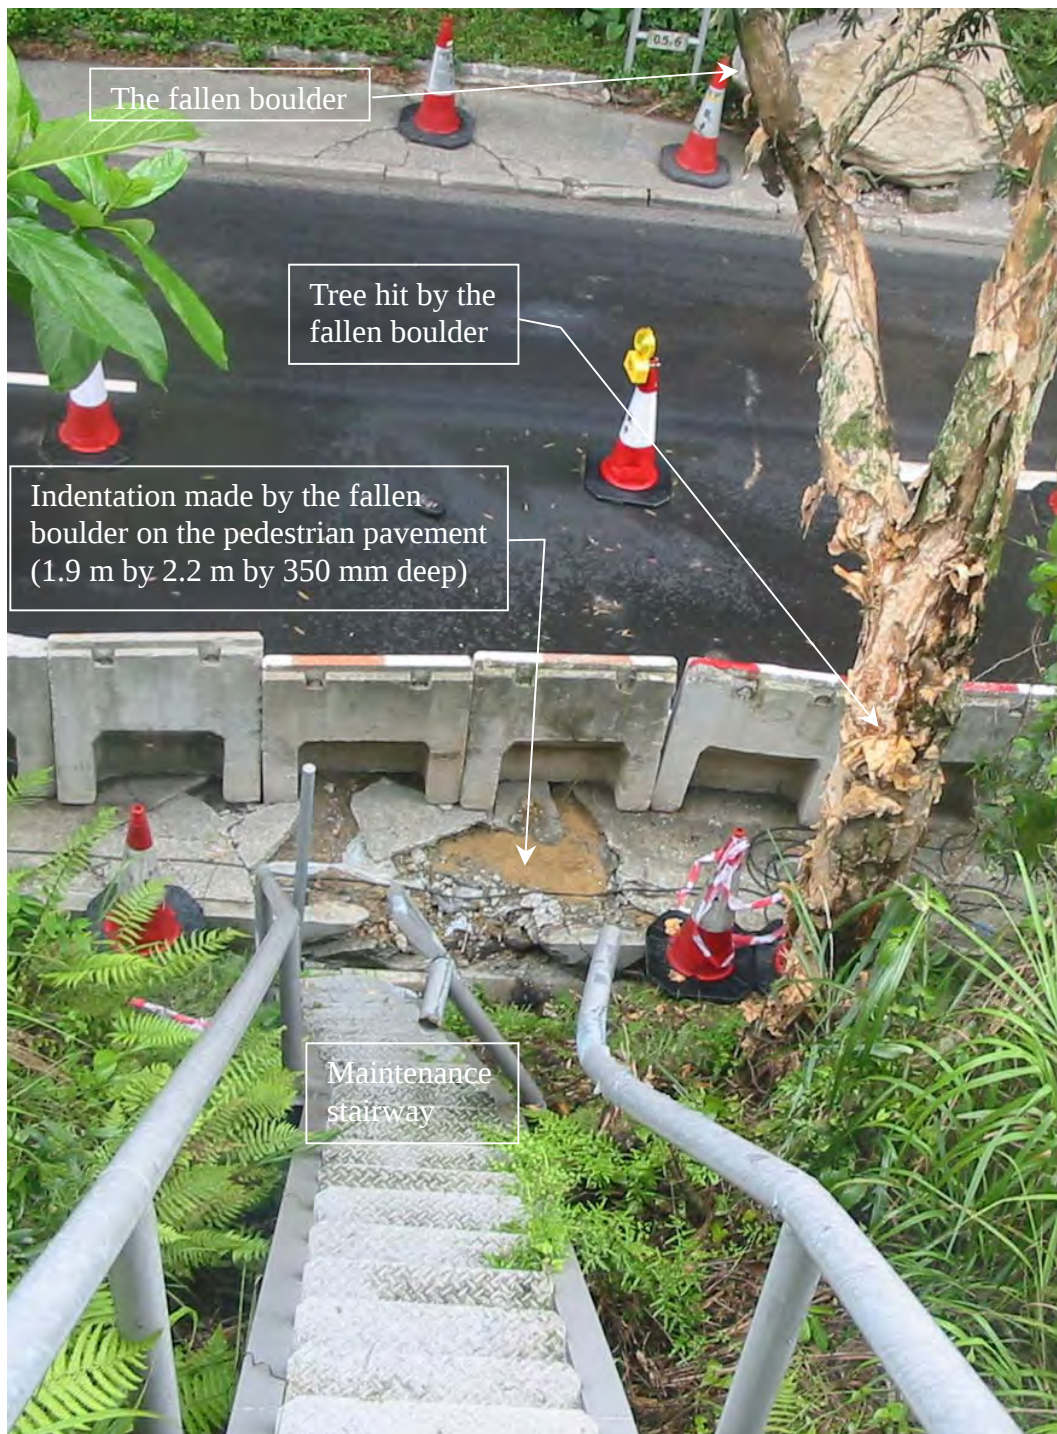
Plate A10 - View of the Maintenance Stairway and Pedestrian Pavement Damaged by the Fallen Boulder (Photograph taken on 6 May 2003)
