**DETAILED STUDY
OF THE 6 JUNE 2003
ROCKFALL INCIDENT ON
SLOPE NO. 11NE-C/C71
AT KUNG LOK ROAD
KWUN TONG**

GEO REPORT No. 192

T.H.H. Hui

**GEOTECHNICAL ENGINEERING OFFICE
CIVIL ENGINEERING AND DEVELOPMENT DEPARTMENT
THE GOVERNMENT OF THE HONG KONG
SPECIAL ADMINISTRATIVE REGION**

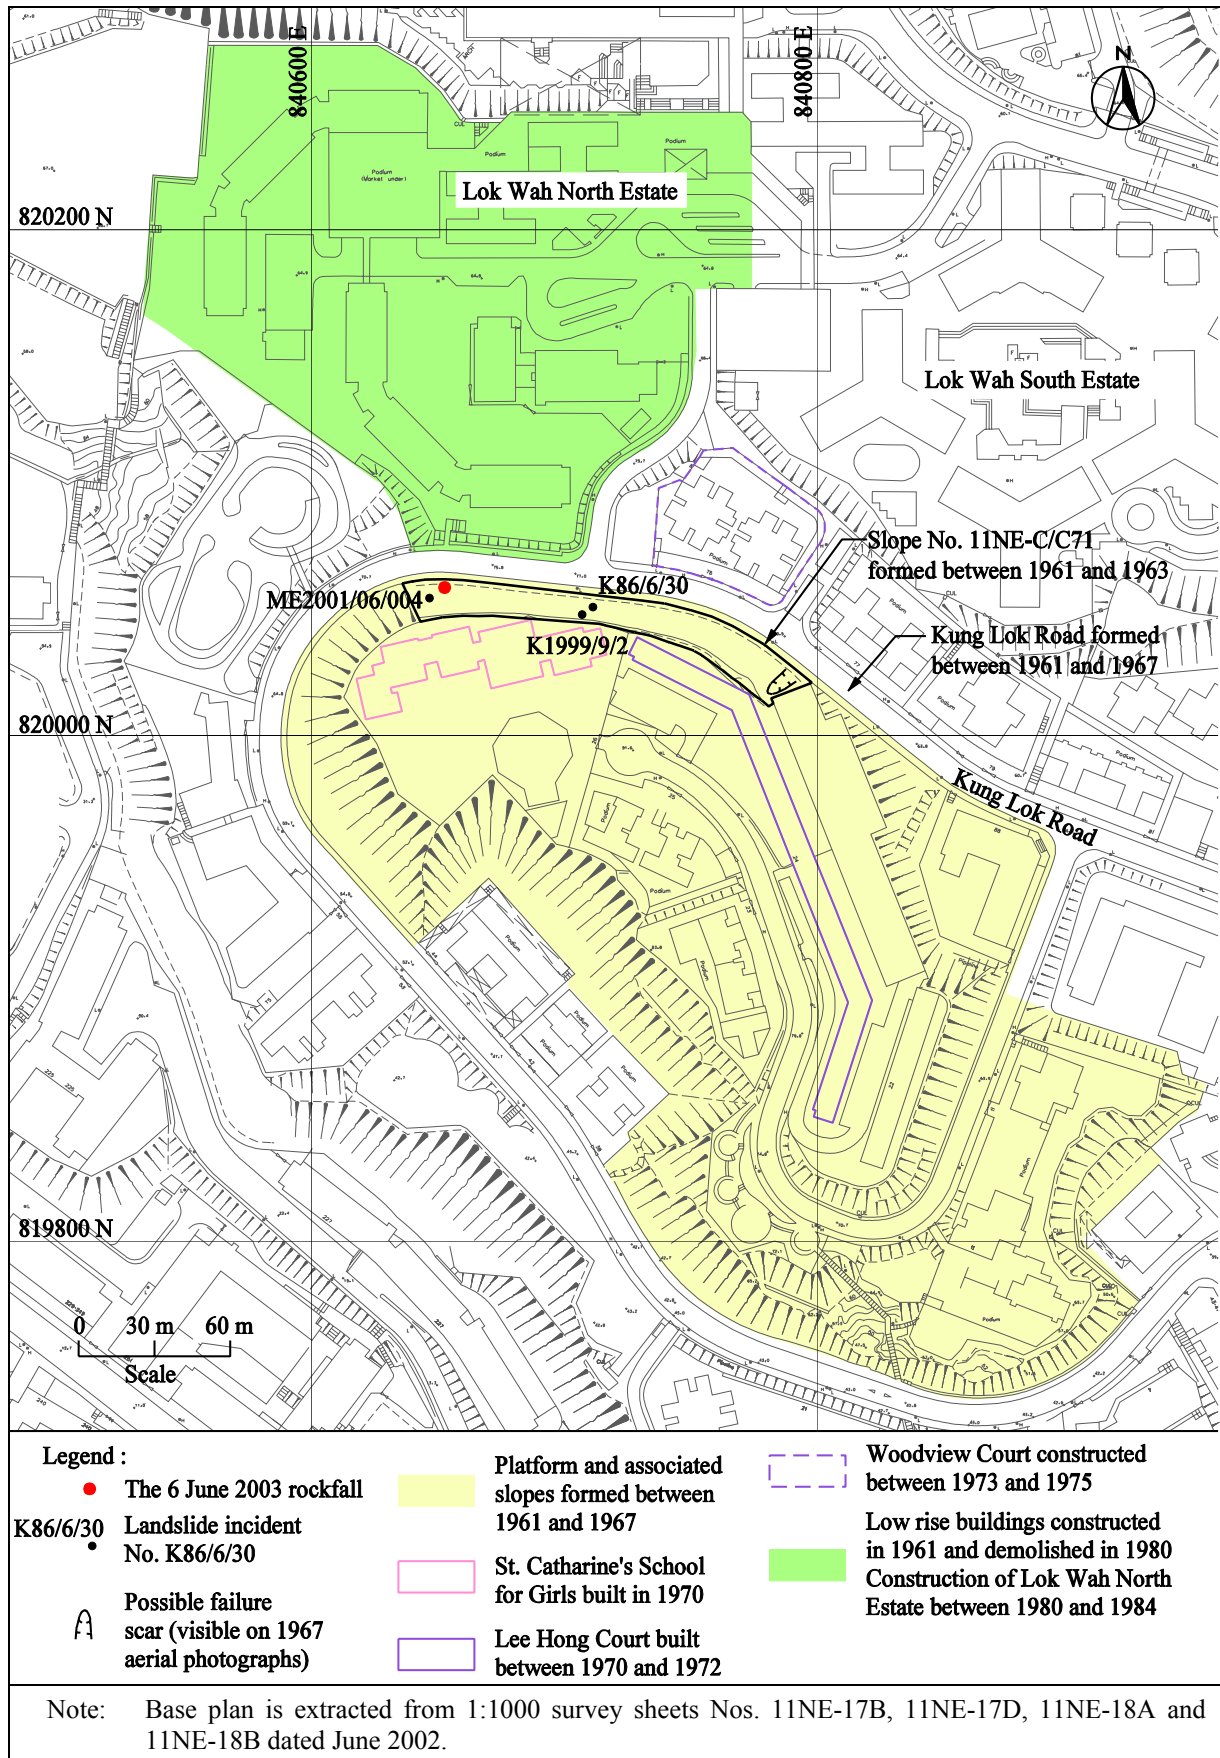
Figure 5 - History of Site Development and Past Instabilities

On the 1967 aerial photographs, an approximately 5 m wide gully feature can be observed originating just below the slope crest on the eastern side of slope No. 11NE-C/C71 (Figure 5). Since most of the adjacent cut slopes had been formed before 1967, this gully was probably a failure or erosion scar.

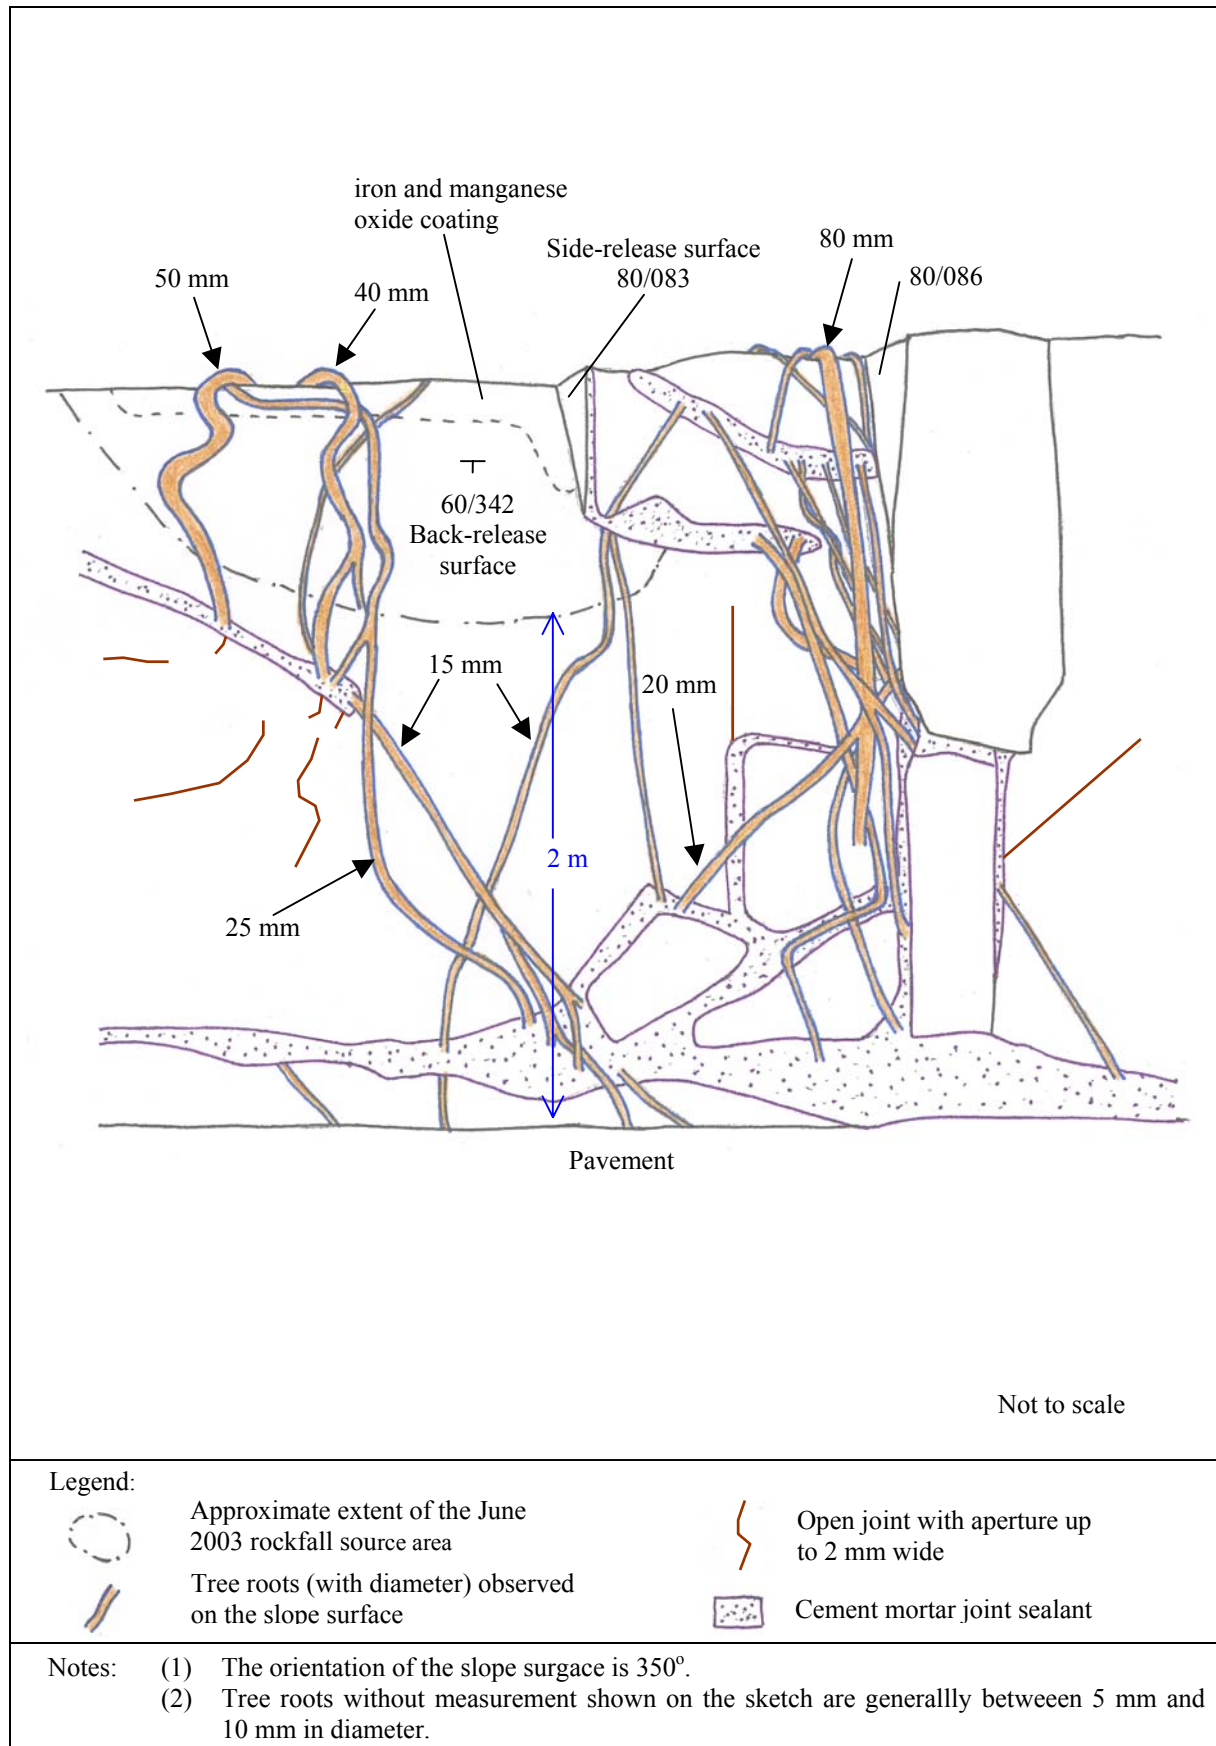
Figure 6 - Sketch of the June 2003 Rockfall Scar

The exposed back-release surface within the upper part of the rockfall was steeply dipping ($>60^\circ$) and clean, apart from local iron and manganese oxide staining. In contrast, the lower part of the back-release surface was slightly wavy with dip angle of generally less than 60° (see Plate 4). Thus, the overall dip angle of the back-release surface (about 60°) daylights with respect to the adjacent rock mass, which has a slope aspect of approximately $65^\circ/350^\circ$. Numerous tree roots between 15 mm and 50 mm in diameter were exposed on the back-release surface (Plate 5). The June 2003 rockfall appears to have involved a planar failure of a rock block with a dilated sub-vertical release surface, and blast-induced fractures probably formed the back-release and side-release surfaces of the June 2003 rockfall. Remnants of cement mortar infilling were observed on the rock surface alongside the edge of the source of the June 2003 rockfall (Figure 6 and Plate 5).

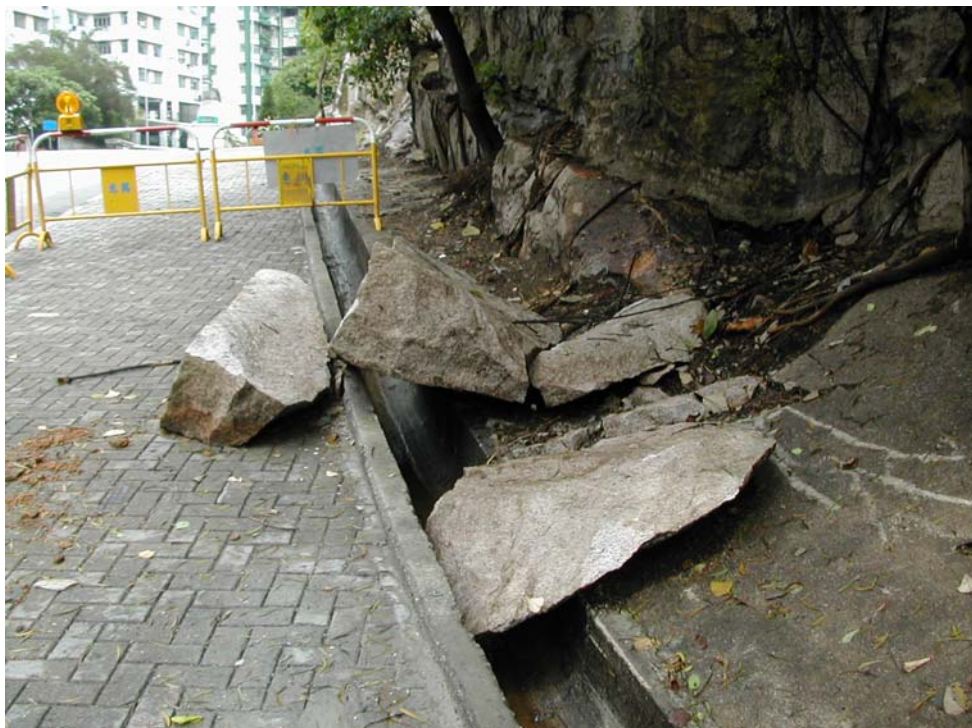
Plate 3 - View of the Detached Granite Blocks from the 6 June 2003 Rockfall
(Photograph taken on 7 June 2003)

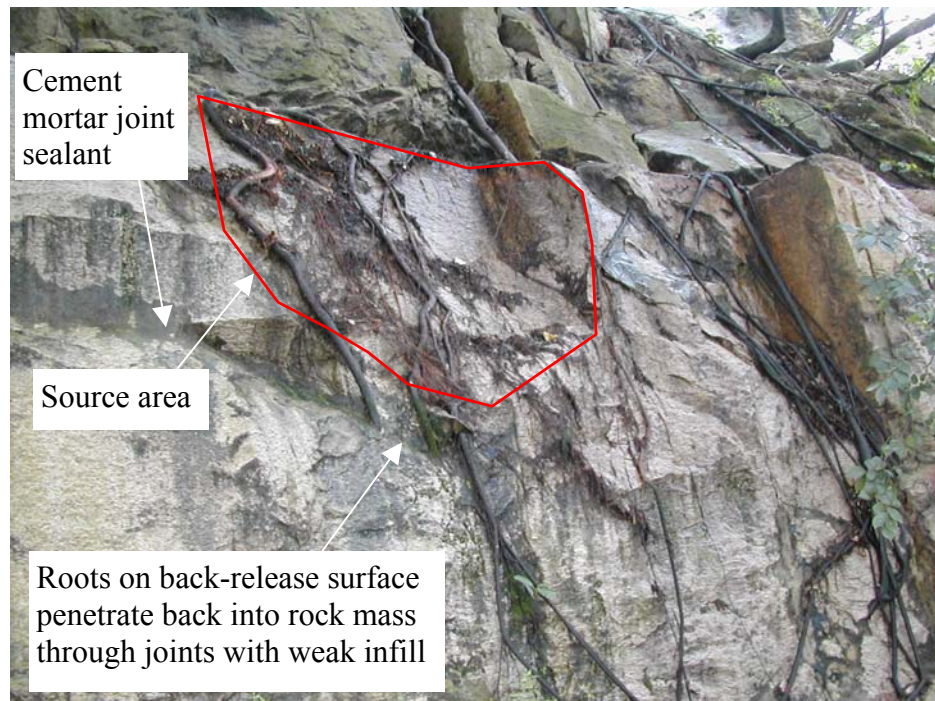
Plate 4 - View of the Source Area of the 6 June 2003 Rockfall
(Photograph taken on 7 June 2003)

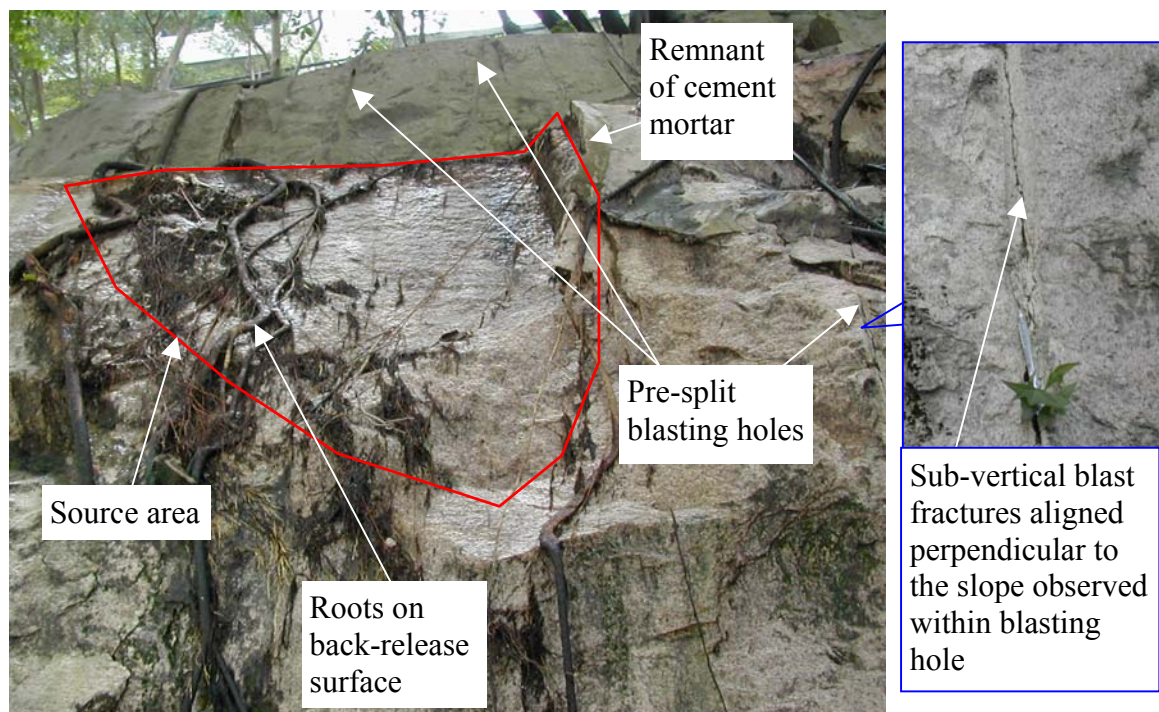
drillholes parallel to the slope surface. Sub-vertical blast-induced minor fractures were observed to be aligned perpendicular to the slope face in some of these drillholes (Plate 5).

Site inspection carried out on 7 June 2003 noted slight seepage along the exposed surfaces of the 6 June 2003 rockfall source (Plate 5) and elsewhere on the rock slope. Subsequent inspections revealed continuous minor seepage, particularly at the eastern portion of the slope, and moss-covered surfaces within the weathered bands of the sub-vertical joint set No. J1.

Plate 5 - Close-up View of the Source Area of the 6 June 2003 Rockfall
(Photograph taken on 17 June 2003)

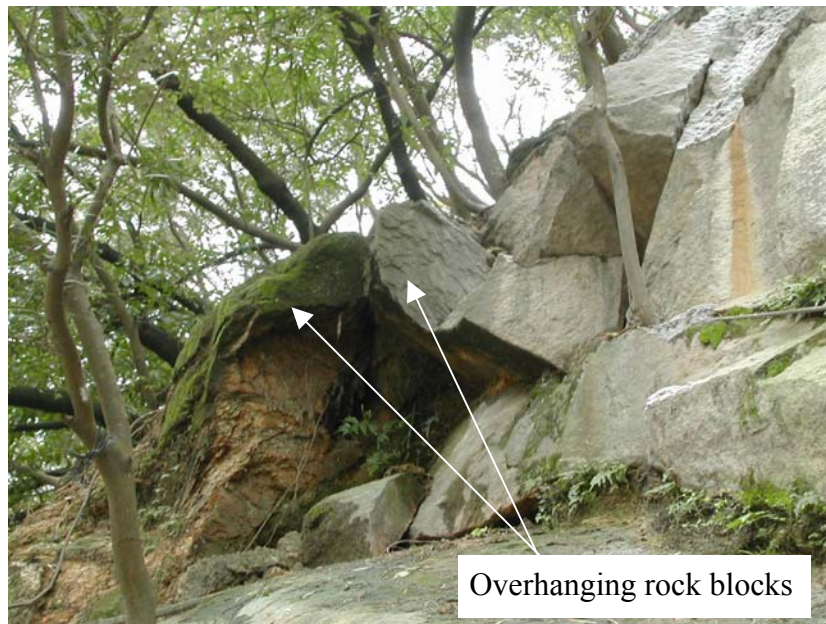
Plate 6 - Basal Joint Along Joint Set No. J1
(Photograph taken on 17 June 2003)

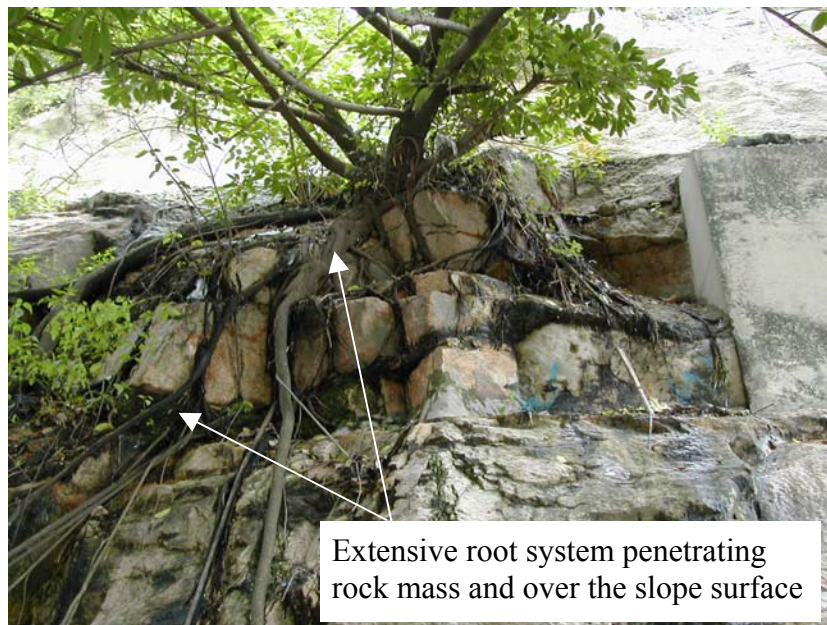
Plate 7 - View Looking South at Another Large Example of the *F. virens*
Tree Species Located at the Western Portion of the Subject Slope
(Photograph taken on 21 October 2003)

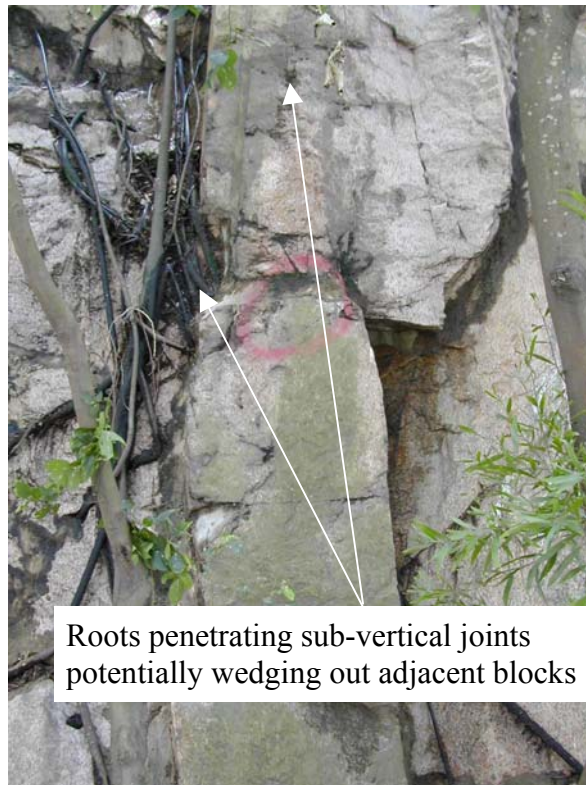
Plate 8 - Roots Penetrating Open Sub-vertical Joints at the Eastern Portion of the Subject Slope Creating Potentially Unstable Rock Blocks
(Photograph taken on 17 June 2003)

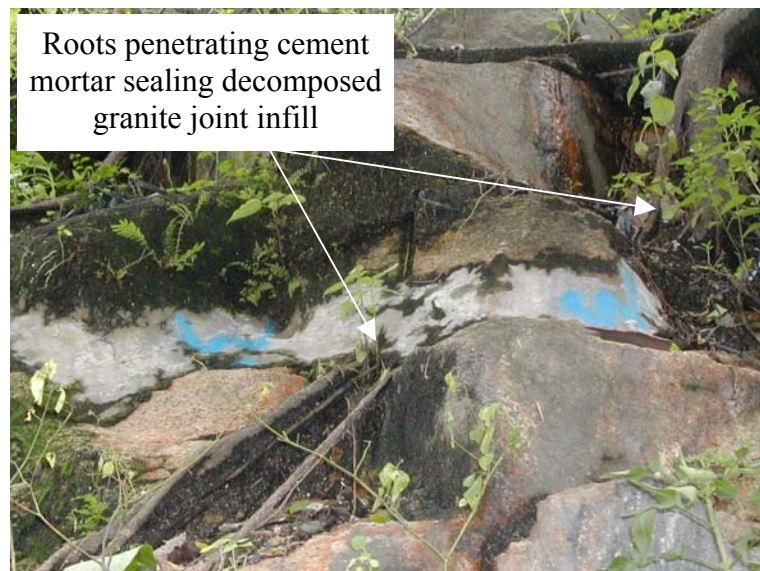
Without safe access (e.g. scaffolding), it was not possible to examine closely large areas of the steep slope. Nonetheless, some potentially unstable, overhanging rock blocks were observed at the western portion of the rock face (Plate 6). Several rock blocks with the potential for being progressively destabilised by tree root action were observed (Plates 7 and 8). Also, several joints were observed to have been sealed with cement mortar with little or no drainage provision (Plate 9).

Plate 9 - Wide Sub-horizontal Joints Sealed with Cement Mortar to Prevent Erosion of Weak Weathered Granite Infill Material
(Photograph taken on 17 June 2003)

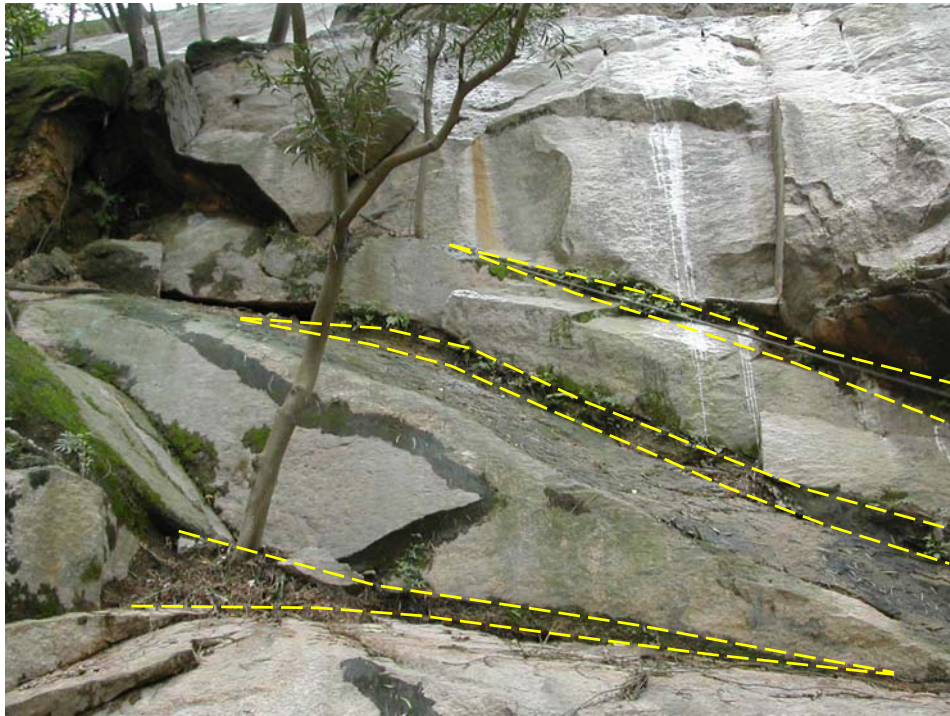
Plate 10 - Weathered Joint Infill along Sheeting Joints (Joint Set No. J1)
(Photograph taken on 17 June 2003)

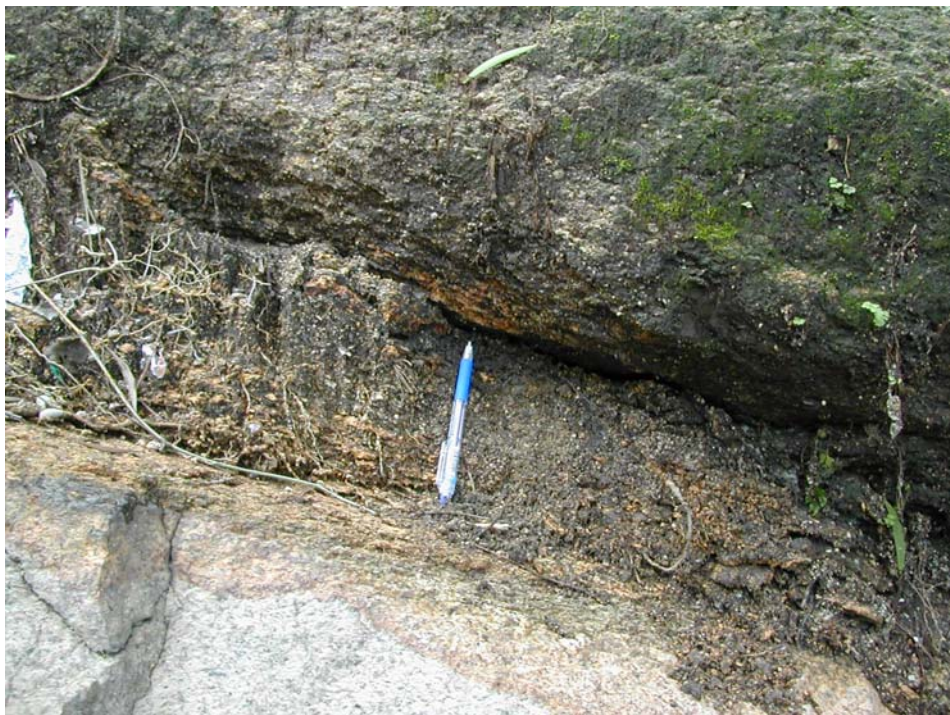
Plate 11 - Close-up View of Weathered Joint Infill up to 150 mm Thick
along A Sheeting Joint (Joint Set No. J1)
(Photograph taken on 21 October 2003)

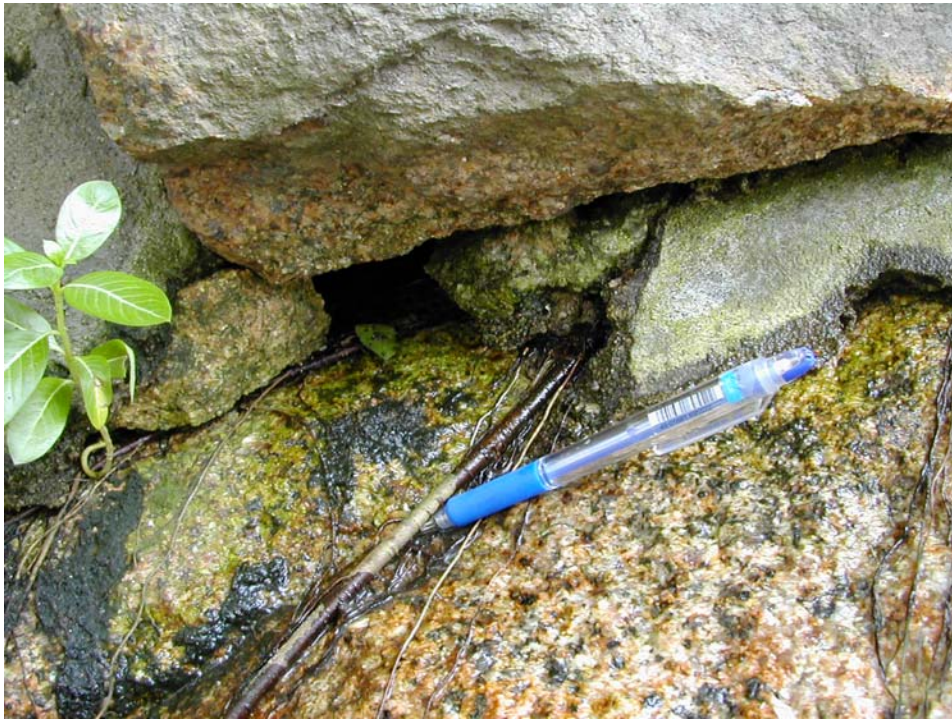
Plate 12 - Close-up View of Seepage at the Eastern Portion of the Rock Slope
(Photograph taken on 17 June 2003)

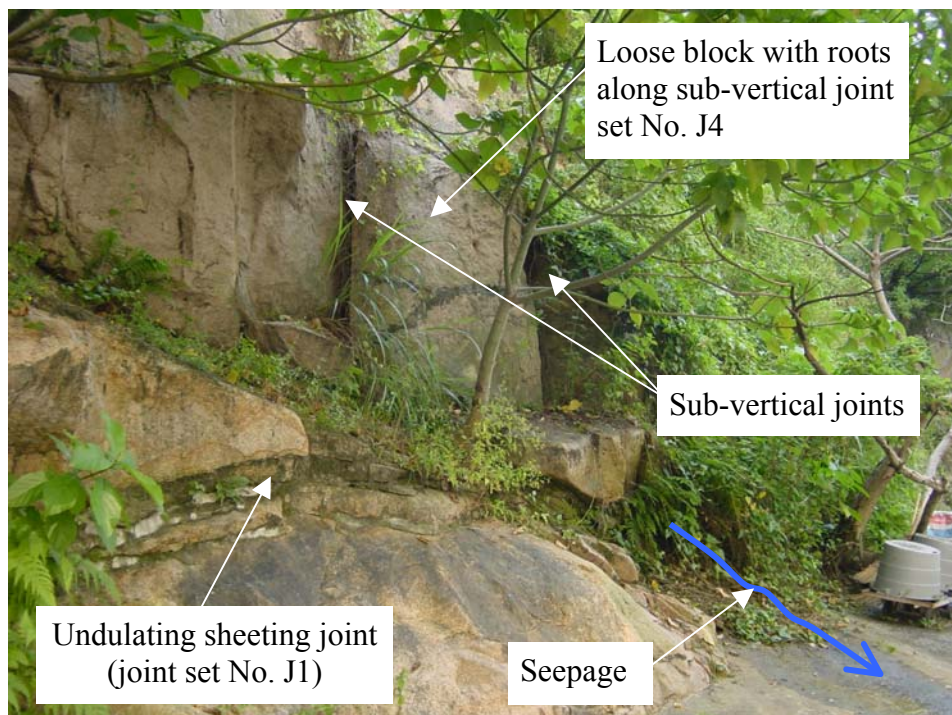
Plate 13 - Seepage Observed at Intersection of Sheeting Joint (Joint Set No. J1)
and Persistent Sub-vertical Joint (Joint Set No. J3)
(Photograph taken on 21 October 2003)

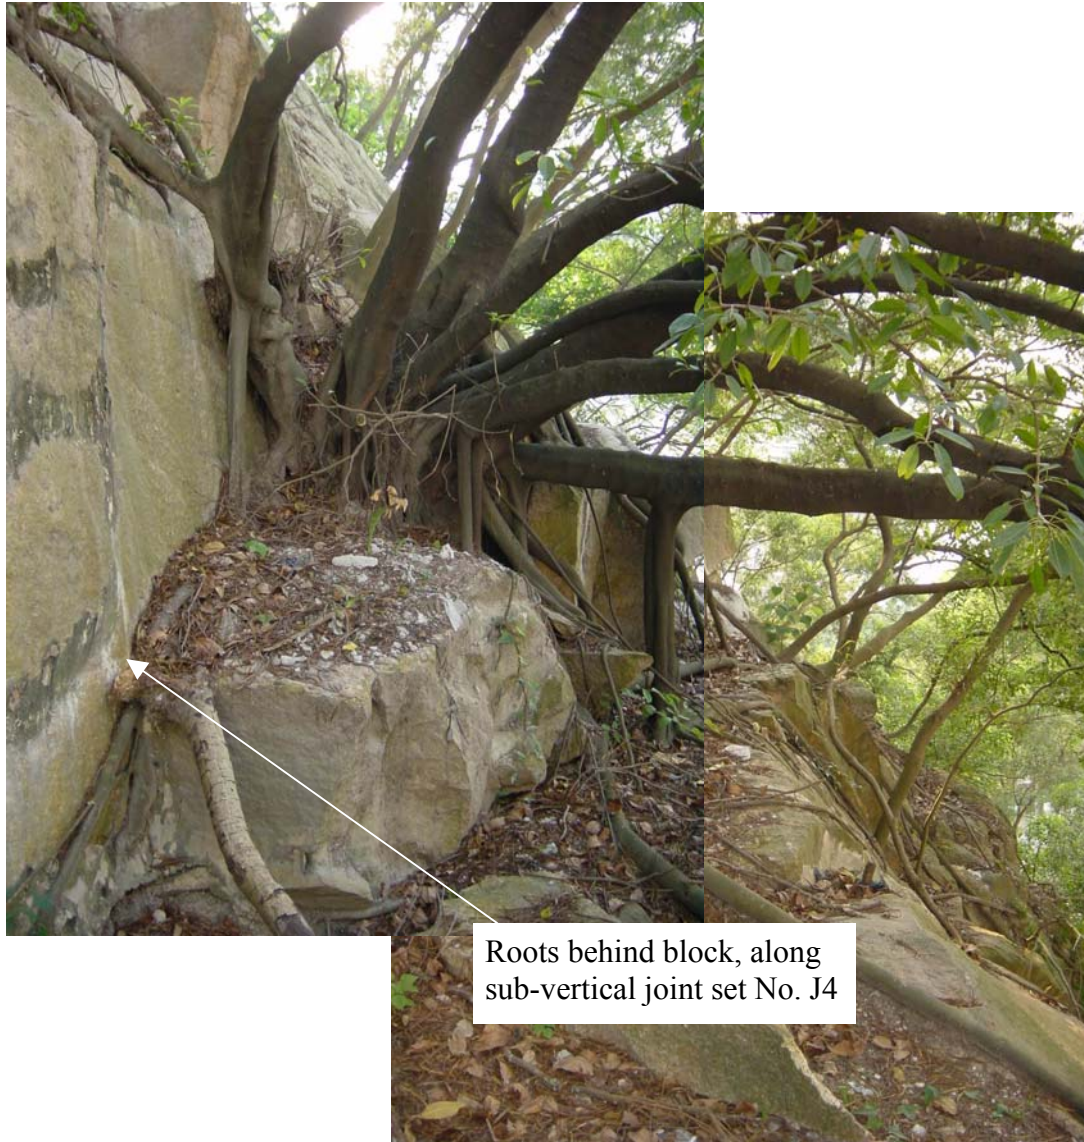
One relatively mature (about 7 m high) example of *F. virens* was seen to be growing approximately 8 m above the source area of the June 2003 rockfall (Plate 14). The roots of this tree were up to 100 mm in diameter and were growing over the rock surface, including the exposed surface of the June 2003 rockfall source (where the roots were up to 50 mm in diameter, see Plate B8 in Appendix B). The roots of this species were also observed in other rock joints on the slope (Appendix B). Based on the API, this tree became established over a period of approximately 10 years.

Plate 14 - View Looking West at the Large *F. virens* Tree Species Whose Extensive Root System Probably Contributed to the 6 June 2003 Rockfall (Photograph taken on 21 October 2003)

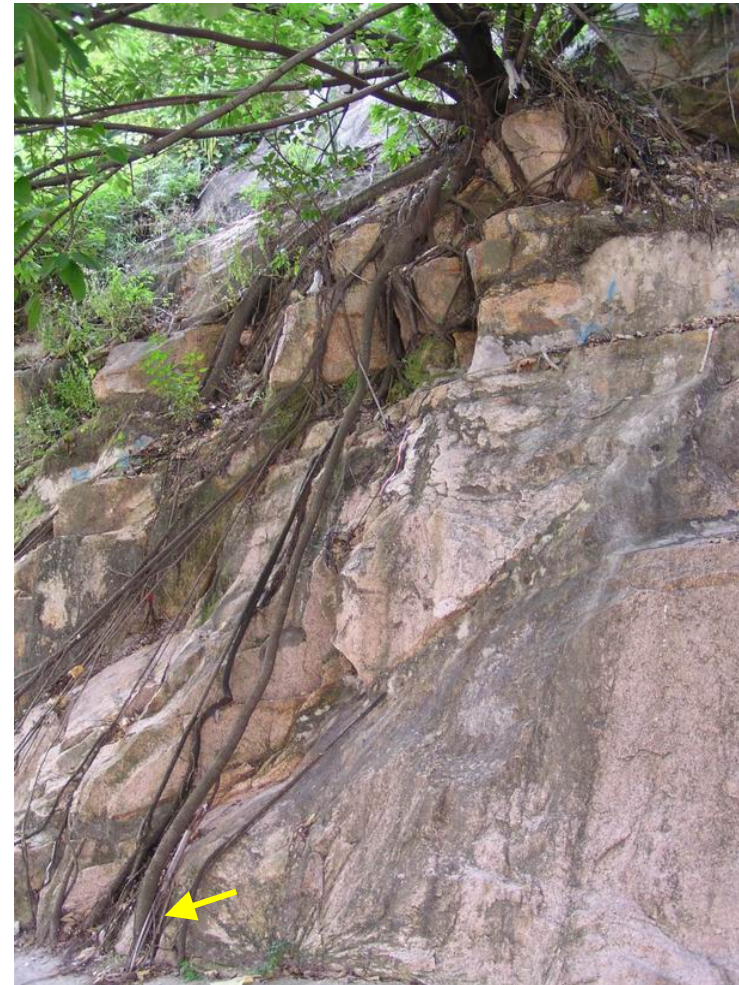
One relatively large *F. virens* was recorded on slope No. 11NE-C/C71 growing approximately 7 m above the 6 June 2003 rockfall area. The roots of this tree were observed growing over the rock surface, extending to the base of the slope. Roots were also observed in rock joints on the slope (Plates B2 to B6).

Plate B2 - *Ficus virens* var. *sublanceolata* (Exposed root systems extending to base of slope)

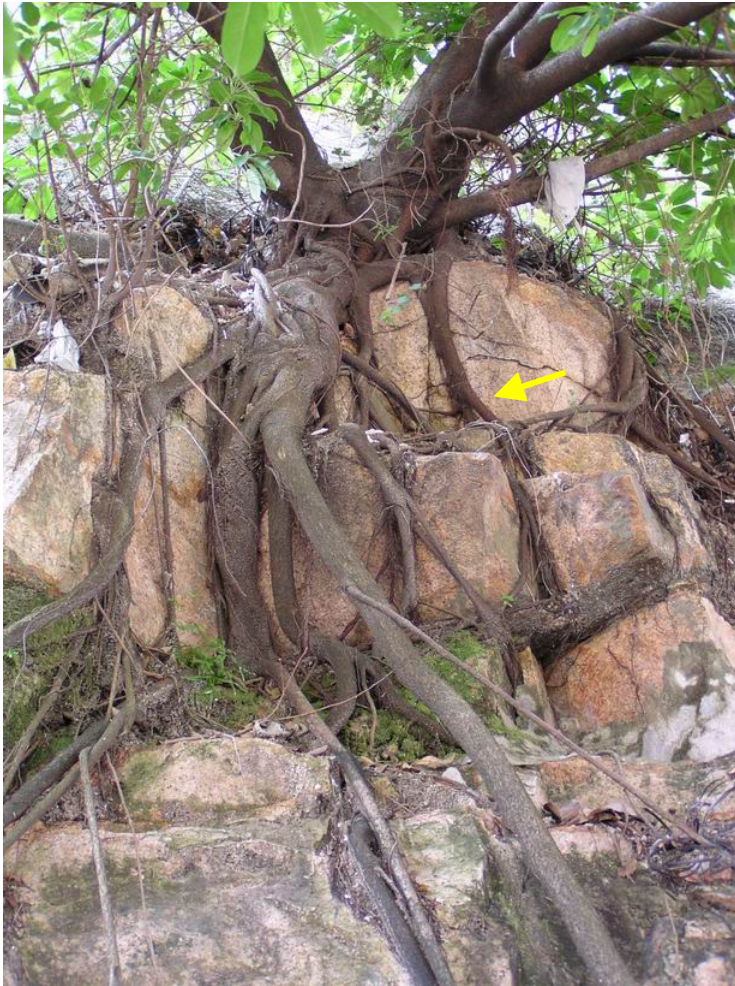
Plate B3 - *Ficus virens* var. *sublanceolata* (Root system growing over rock face and in rock joints)

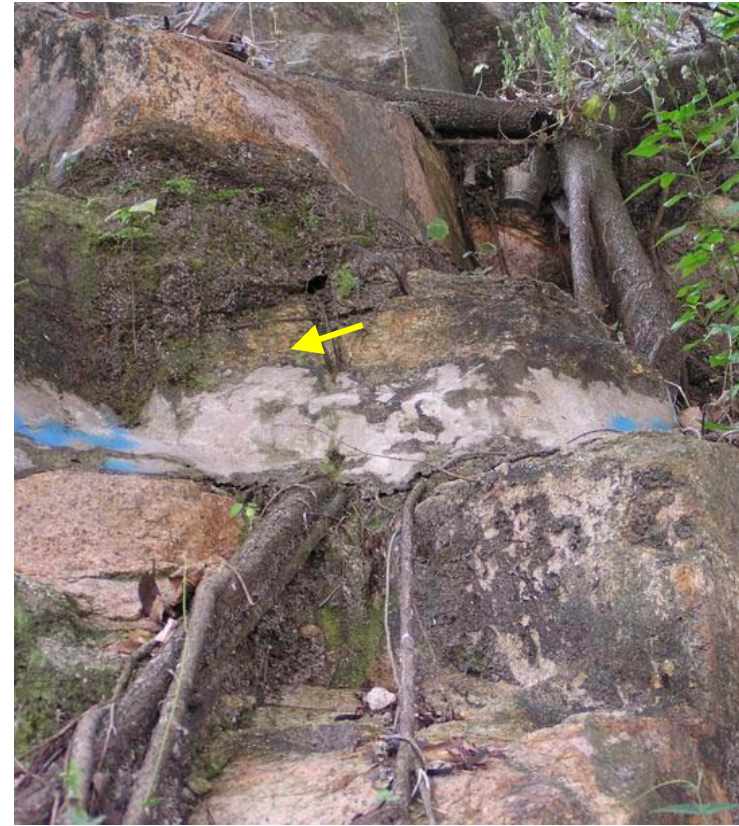
Plate B4 - *Ficus virens* var. *sublanceolata* (Root emerging from a concrete covered rock joint)

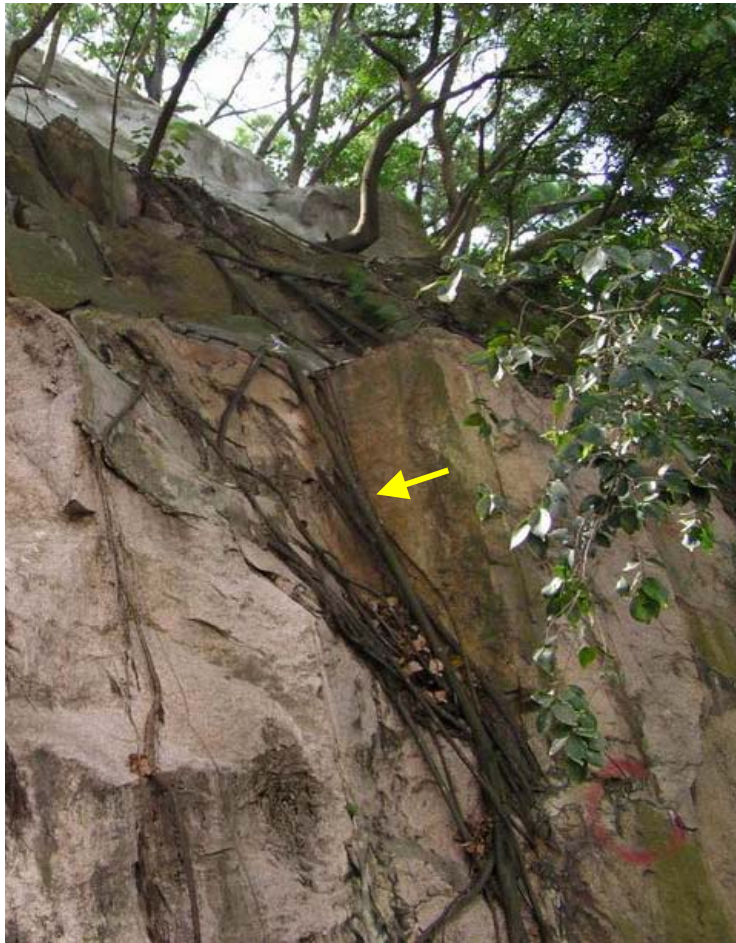
Plate B5 - *Ficus virens* var. *sublanceolata*
(The 6 June 2003 rockfall area - View 1)

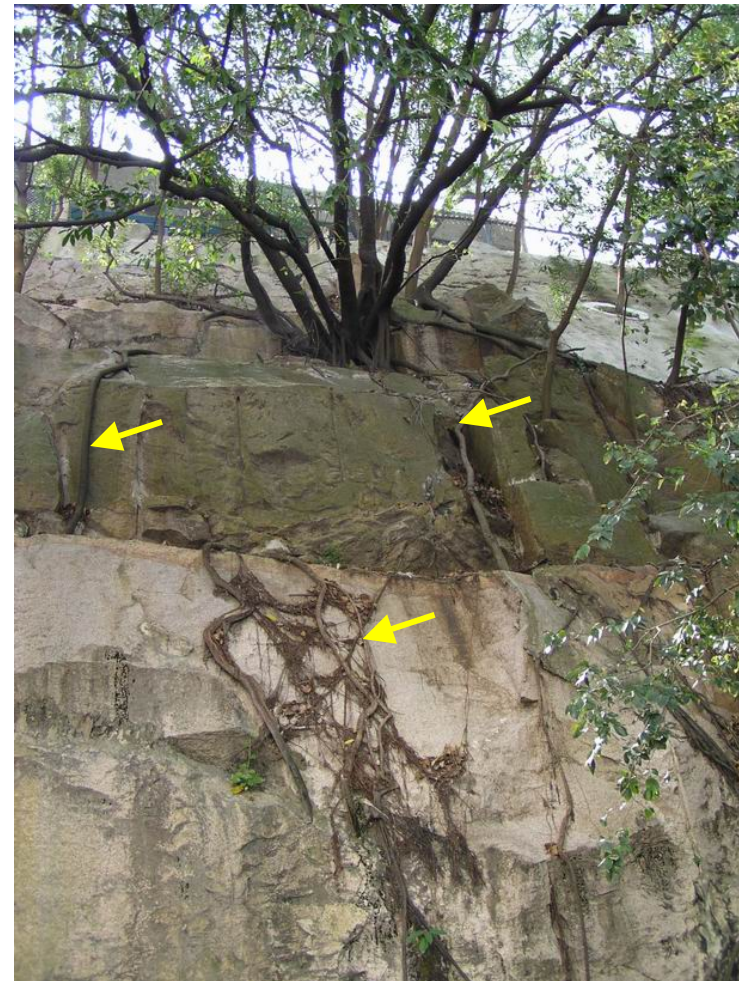
Plate B6 - Root systems extended from *Ficus virens*
var. *sublanceolata* (The 6 June 2003
rockfall area - View 2)
