**THE 5 MAY 2003
DEBRIS FLOW AT
KAU LUNG HANG SHAN
TAI PO**

GEO REPORT No. 196

Maunsell Geotechnical Services Limited

**This report was originally produced in February 2005
as GEO Landslide Study Report No. LSR 2/2005**

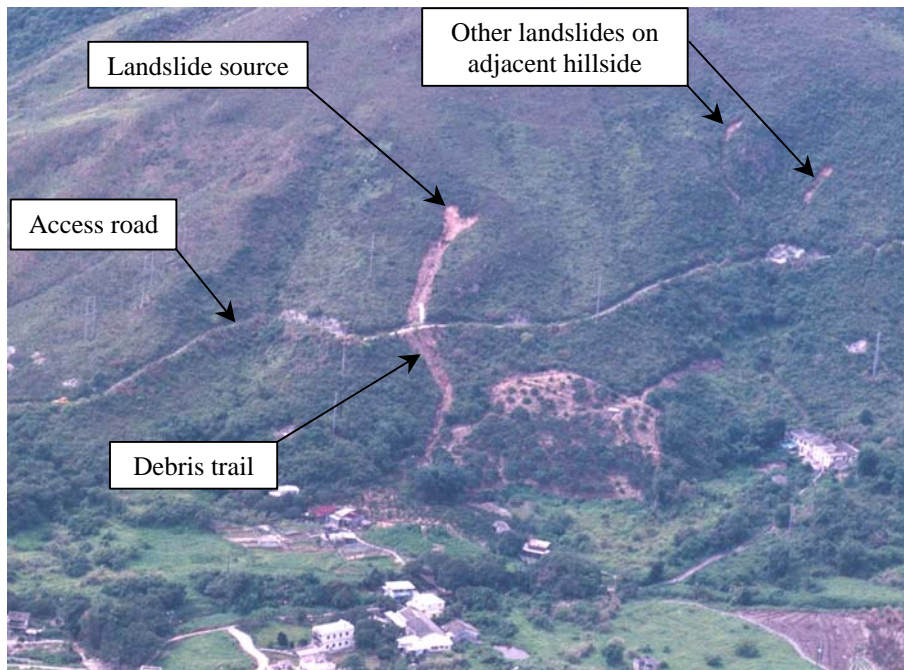
Plate 1 - Oblique Aerial View of the 5 May 2003 Debris Flow
(Photograph taken by GEO on 16 May 2003)

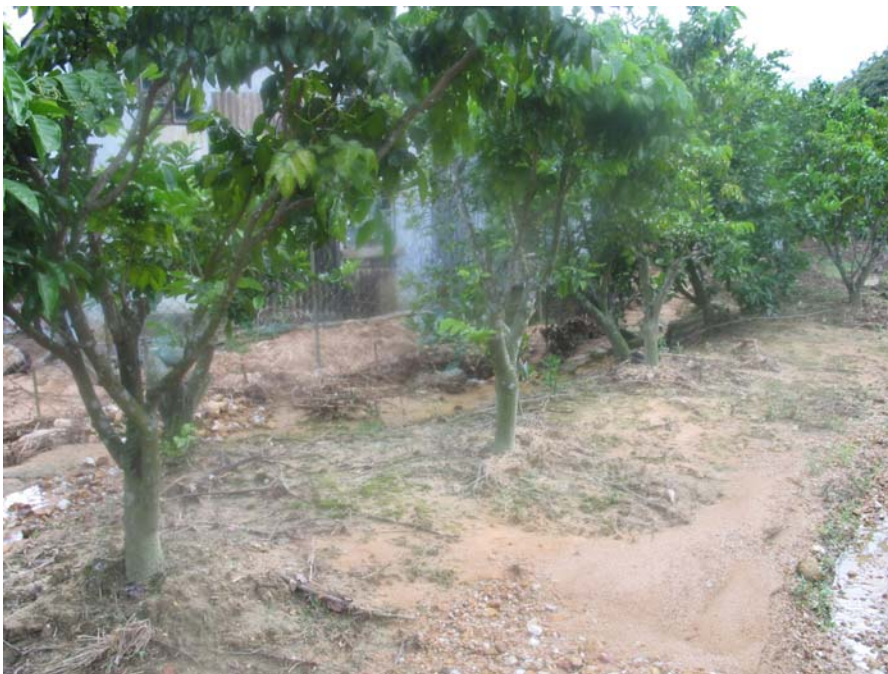
Plate 2 - View of Deposition of Fluvial Outwash at the Boundary of the
Private Village Houses (Photograph taken on 12 May 2003)

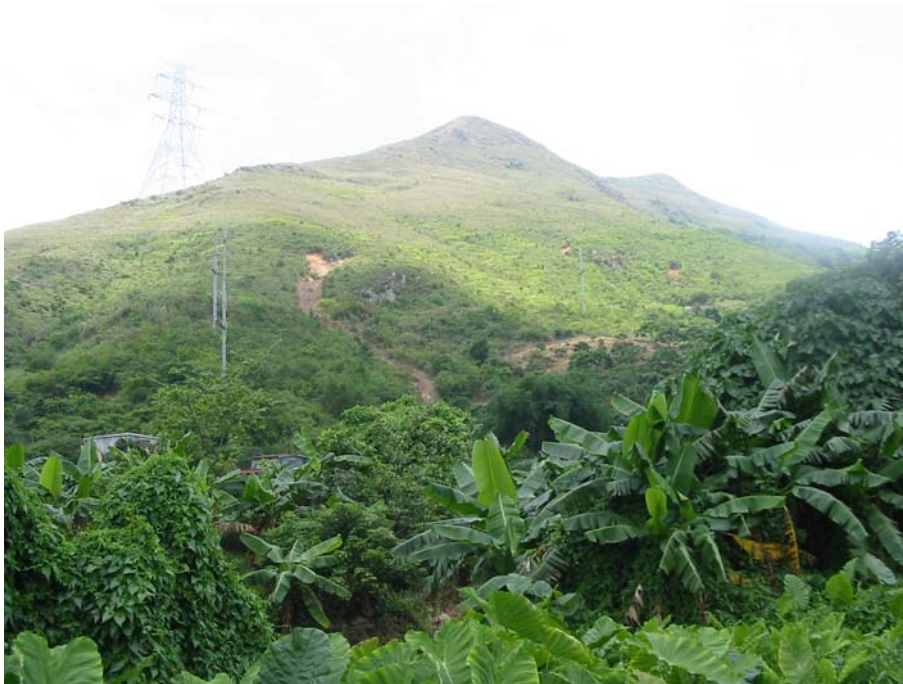
A longitudinal section and a cross-section through the landslide source area are given in Figure 5, and longitudinal and cross-sections through the debris trail are shown in Figure 6 and Appendix B. These sections show the observed surface and interpreted sub-surface geology. Materials encountered within the landslide scar have been classified as one of nine material types (MT) and are described in Appendix B. To avoid repetition, materials designations (viz. MT1 to MT9) have been used where appropriate in this report. The estimated volumes of material entrained and deposited along the path of the landslide are shown in Table 1 and Appendix B, and detailed descriptions of the landslide source and debris trail are presented in the following Sections. General views of the landslide source and trail are shown in Plates 3 and 4.

Plate 3 - View of the Landslide from Kau Lung Hang Village
(Photograph taken on 12 May 2003)

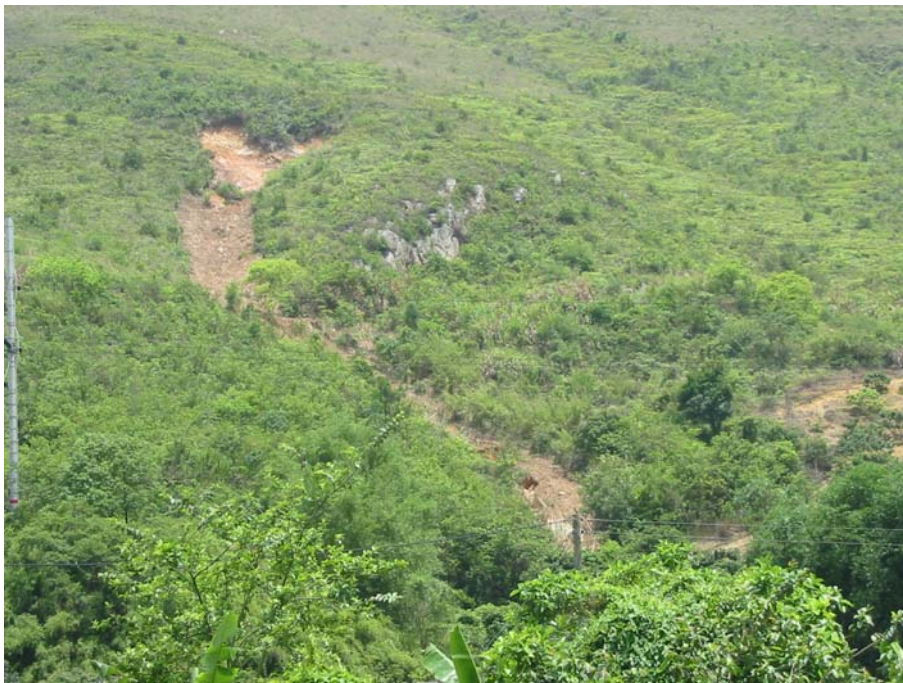
Plate 4 - View of the Source Area and the Debris Trail
(Note the rock outcrop to the southeast of the source area.
Photograph taken on 12 May 2003)

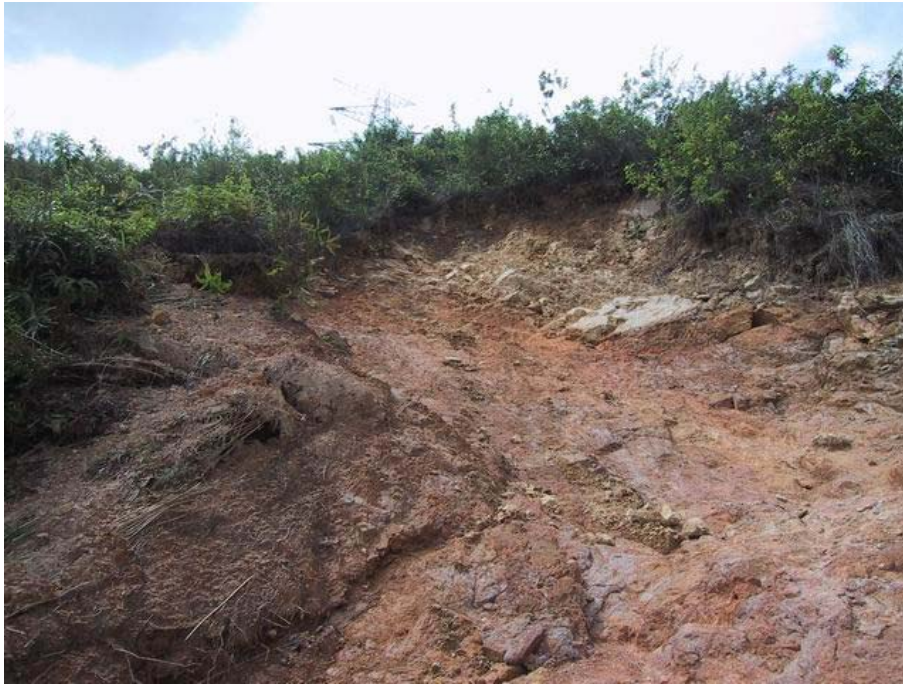
Plate 5 - View of the Western Portion of the Main Scarp
(Note the lithology change - HDV/MDV with overlying
metamorphosed siltstone. Photograph taken on 9 May 2003)

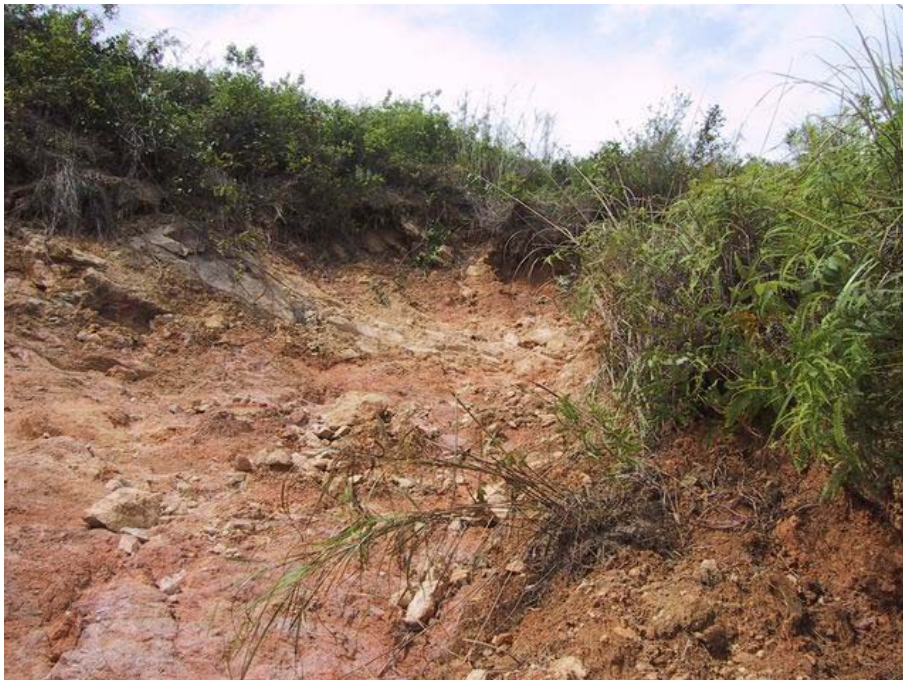
Plate 6 - View of the Eastern Portion of the Main Scarp
(Note the persistent band of metamorphosed siltstone.
Photograph taken on 16 May 2003)

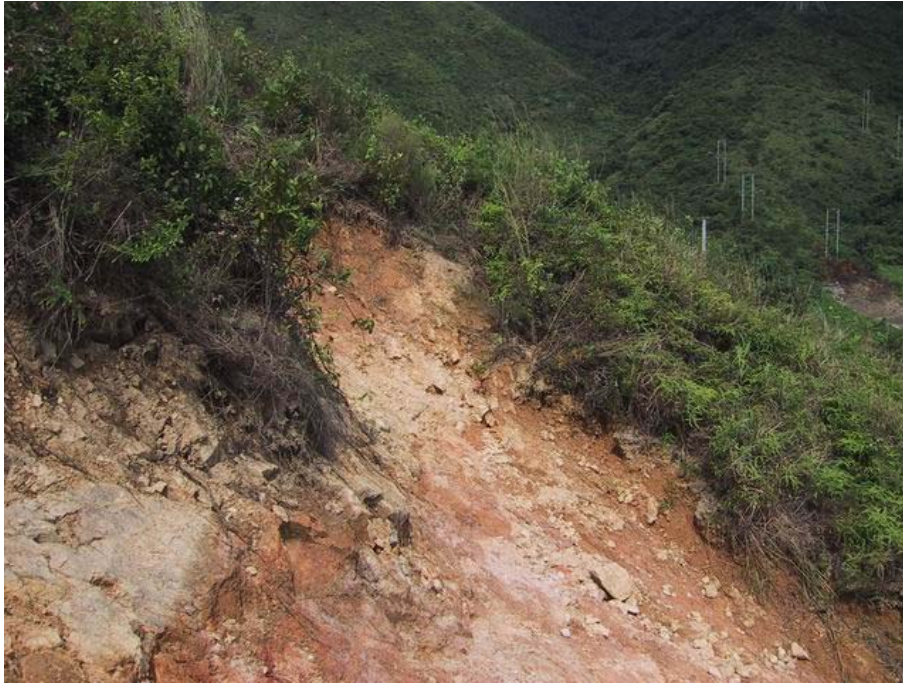
General views of the eastern and western flanks of the main scarp of the May 2003 landslide are shown in Plates 7 and 8 respectively. These Plates also show that the thickness of colluvium is up to about 1 m and that it occupies the flanks and overlies the completely to highly decomposed tuff on the floor of the source area. An area of colluvium in the western flank has had the surface vegetation stripped off only, without complete detachment. This colluvial mass is considered potentially unstable as it is vulnerable to direct rainfall infiltration and overlies the undulating joint-controlled surface of rupture (Plate 9). The steep upper source floor area consists of moderately and highly strong, light grey mottled orange brown tuff, with clasts of light purplish grey mudstone/siltstone (material MT6). The central source floor area comprises moderately weak to moderately strong, light pinkish grey, completely to highly decomposed coarse ash tuff (material MT5). Below this material, there was a second narrow (about 0.5 m) band of material type MT5 where a small break in slope had formed (Plate 10). Extensive quartz veins are exposed within the tuff of the upper source floor, possibly alluding to evidence of hydrothermal alteration and therefore consequent resistance to weathering. The material in the centre of the main scarp that did not detach (thus leading to the 'Y' shape source area) and comprised moderately decomposed tuff with locally wide joint spacing, which may explain its increased resistance to weathering.

Plate 7 - View of the Eastern Flank of the Source Area
(Note the relatively clean surface of rupture with
overlying colluvium exposed at the scarp.
Photograph taken on 16 May 2003)

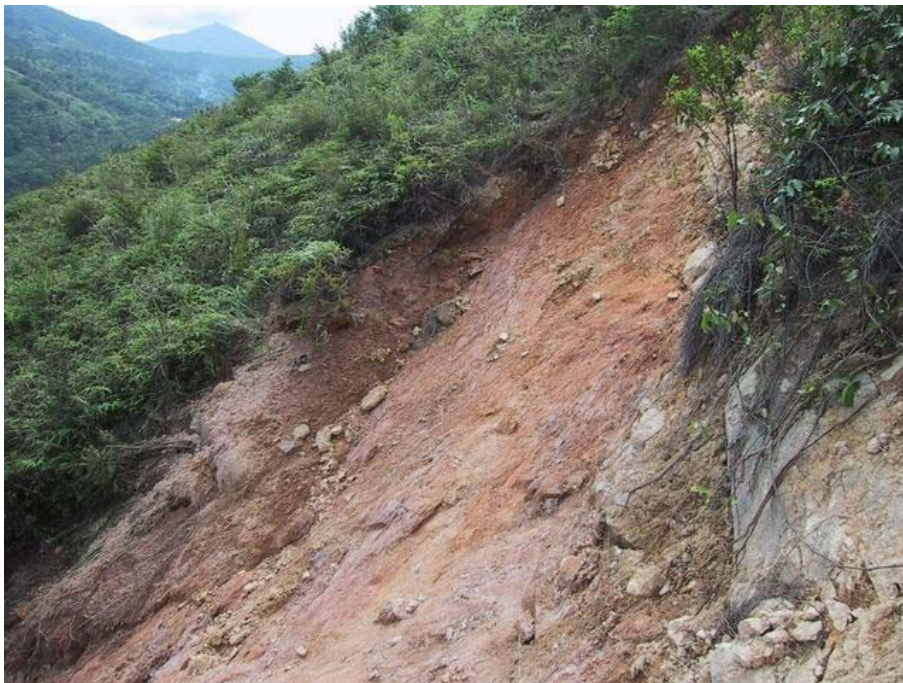
Plate 8 - View of the Western Flank of the Source Area
(Relatively clean surface of rupture with overlying colluvium
exposed at the scarp. Photograph taken on 16 May 2003)

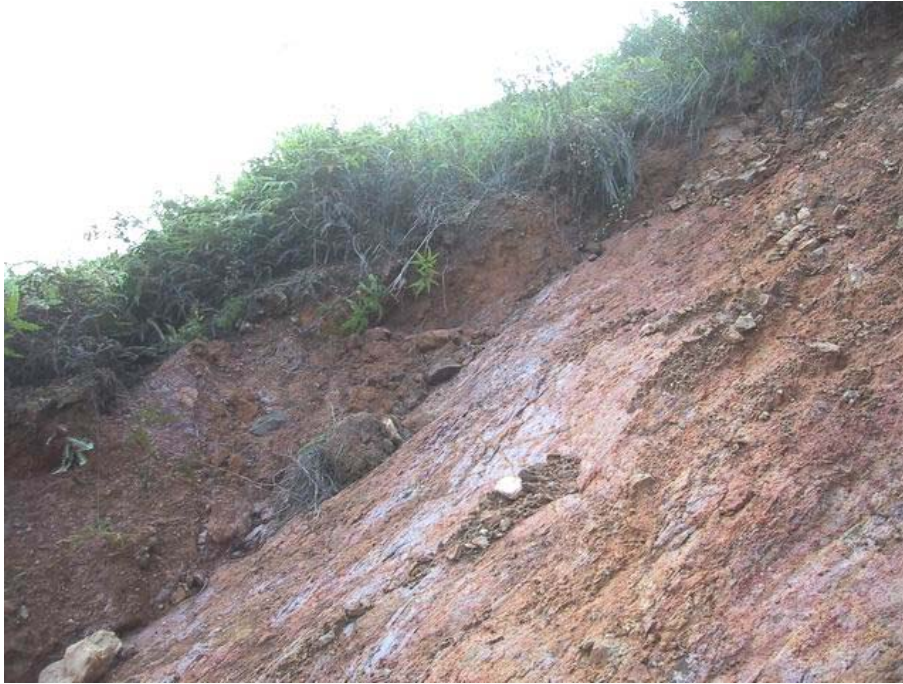
Plate 9 - View of Potentially Unstable Colluvium
at the Western Flank of the Source Area
(Note the undulating joint surface.
Photograph taken on 9 May 2003)

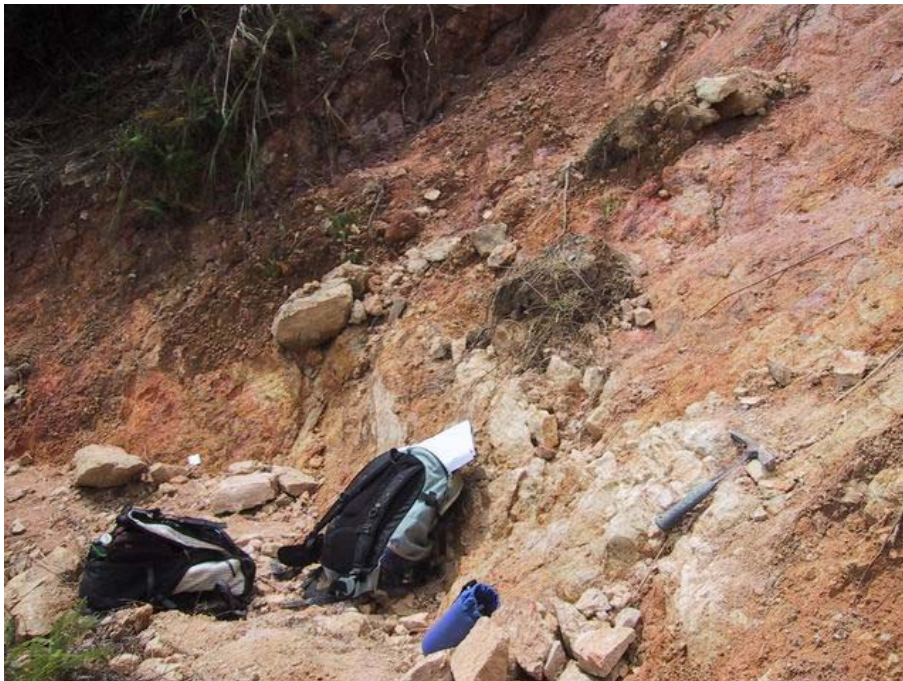
Plate 10 - View of Break in Slope Within the Source Area
(Roughly parallel to the band of lighter rock (MT6) found
high in the source area. Photograph taken on 16 May 2003)

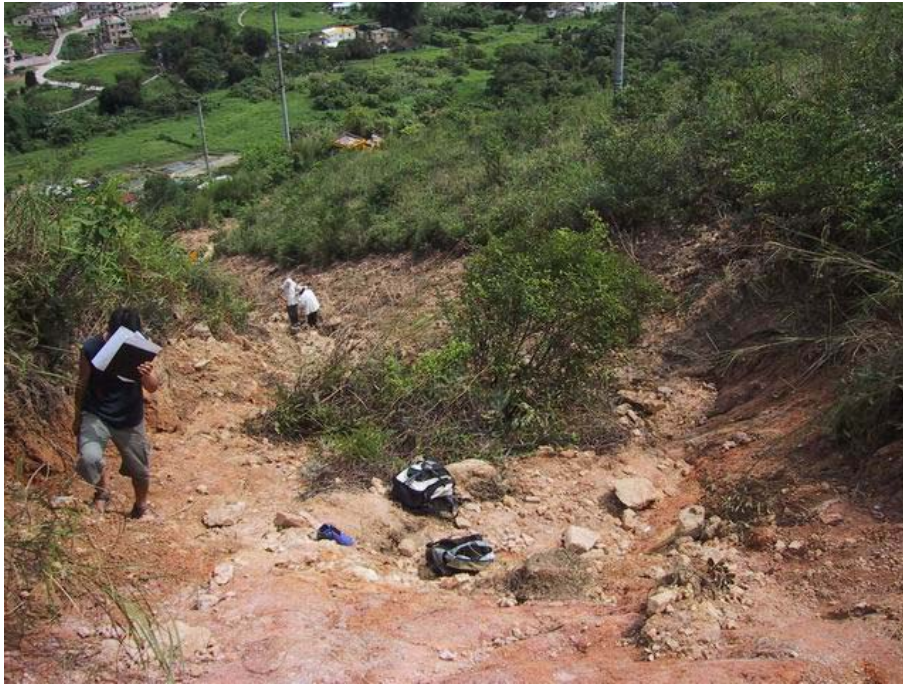
Plate 11 - View Looking Downslope from the Source Area
(Note the displaced vegetated intact debris raft at centre.
Photograph taken on 16 May 2003)

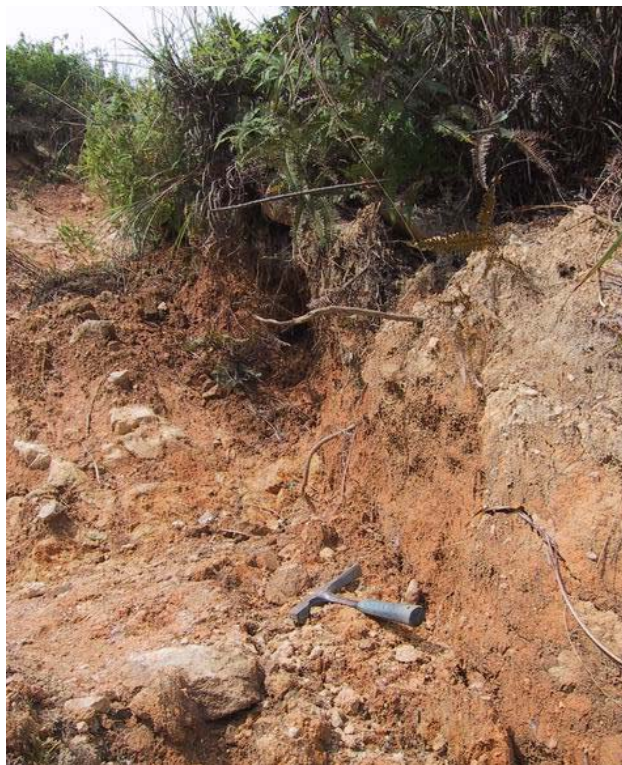
A number of tension cracks, primarily within the colluvium, could be seen in the flanks of the source area (between 20 mm and 300 m wide, 3 m to 5 m long, see Drawing No. 1 and Plates 12 to 14). These were probably associated with the recent instability since the cracks were free of vegetation and could not be traced more than a few metres from the flanks of the source area.

Plate 12 - View of the Eastern Flank of the Landslide Source Area
(Note a tension crack (~20 mm wide) to the right of the
hammer. Photograph taken on 16 May 2003)

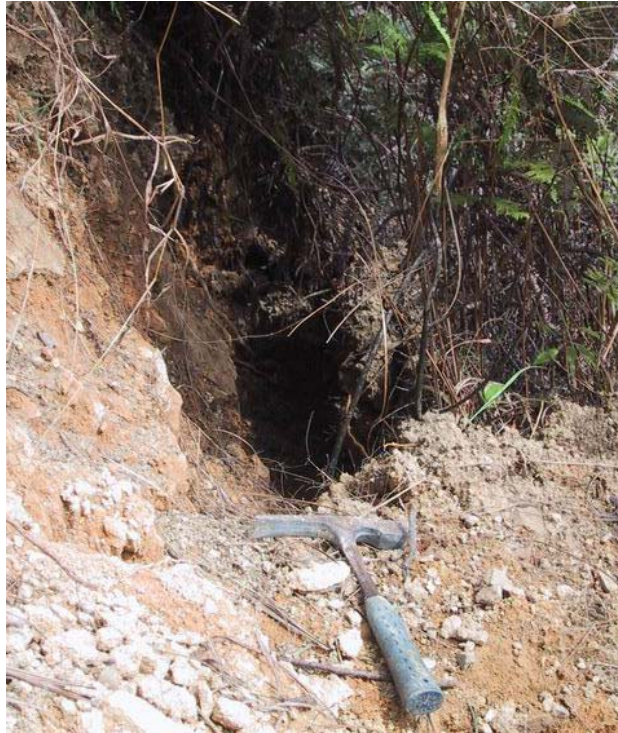
Plate 13 - View of Tension Crack on the Eastern
Flank of the Source Area
(Photograph taken on 16 May 2003)

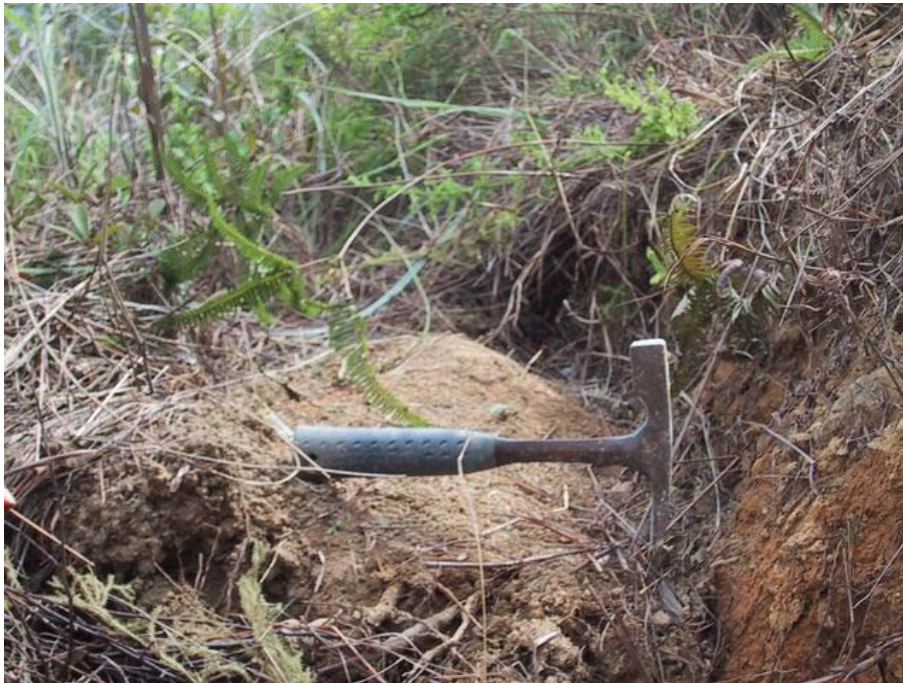
Plate 14 - View of Tension Crack on the
Western Flank of the Source Area
(Photograph taken on 16 May 2003)

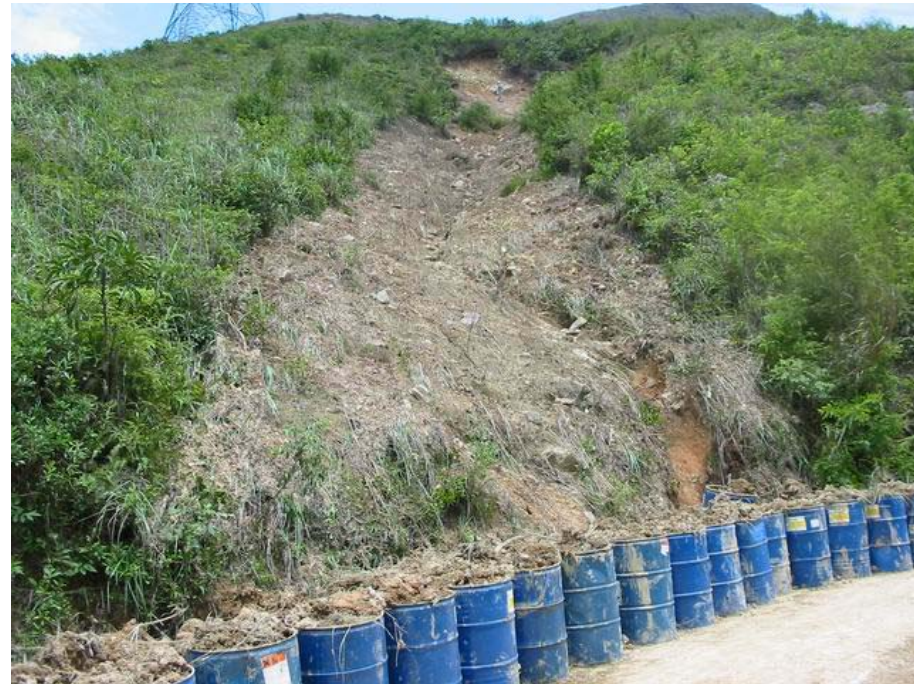
Plate 16 - View of the Debris Trail and Source
Area from the Access Road
(Note the incised gully on the right side.
Photograph taken on 16 May 2003)

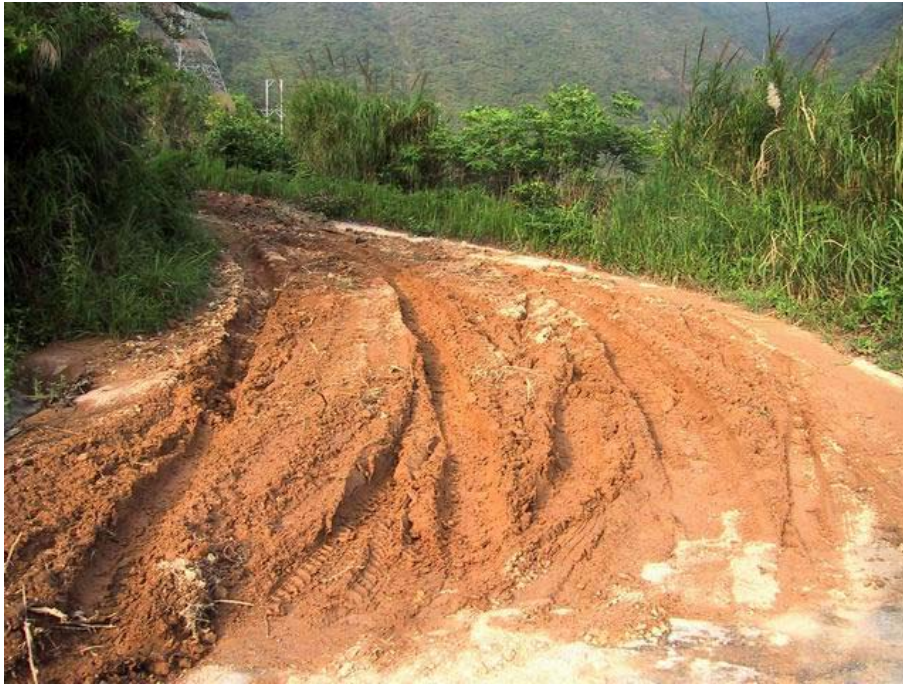
Plate 17 - View of the Landslide Debris Washed Down the Access Road by Subsequent Overland Flow
(Photograph taken on 9 May 2003)

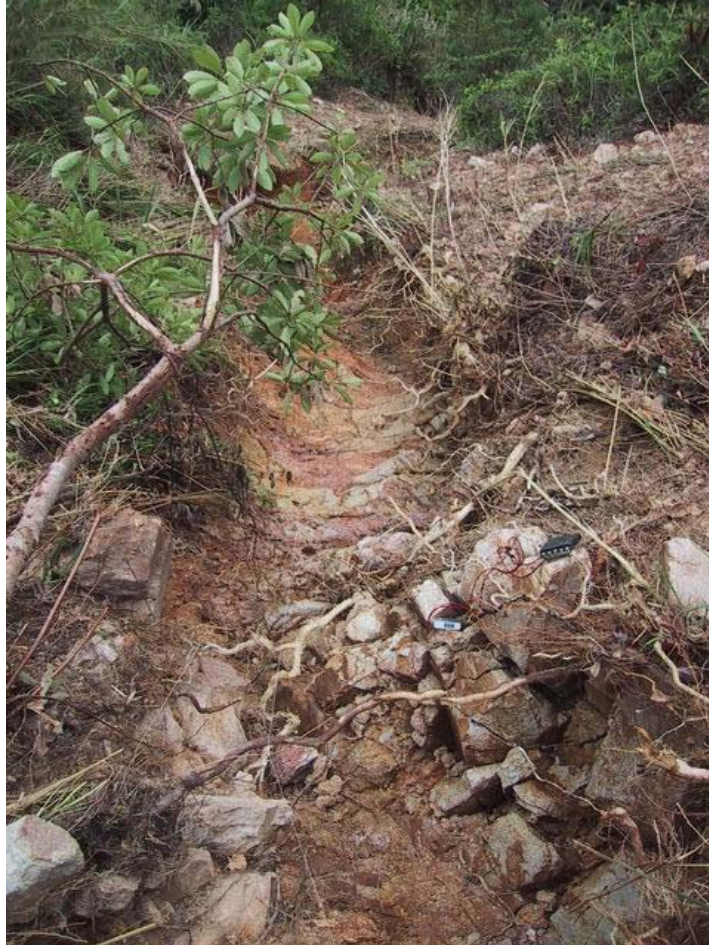
The incised gully resulted in the erosion of about 36 m³ of material although this was probably the result of subsequent water erosion (see Section 4.5) rather than during the main landslide event (Plates 21 & 22). The erosion gully extended from chainage CH 75 to CH 132 and generally exposed moderately decomposed (material MT6) tuff (Plate 23) and completely to highly decomposed (material MT5) tuff in the substrate (see cross sections 9 to 14 in Figures B3 & B4), and has a maximum width and depth of about 2.8 m and 3.2 m respectively. Several minor post-event stream flank failures were observed due to probable undercutting by surface water in the lower drainage line (Plate 24). At about chainage CH 88, a failure occurred in the eastern flank of the drainage line (Plate 25) exposing colluvium (material MT3) overlying completely decomposed coarse ash tuff (material MT4).

Plate 21 - View of the Deeply Incised Gully Directly Below the Access Road
(Gradual change from MDT to CDT within the gully. Photograph taken on 16 May 2003)

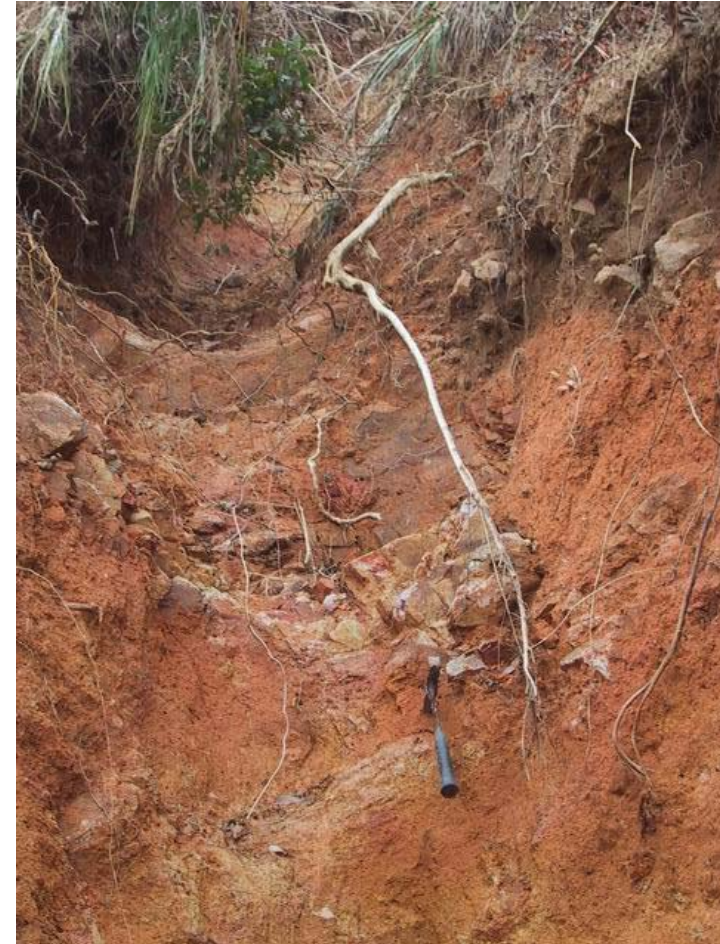
Plate 22 - View of the Incised Gully Near the Access Road
(Insitu MDT and CDT exposed within the gully with colluvium exposed at the flanks. Photograph taken on 16 May 2003)

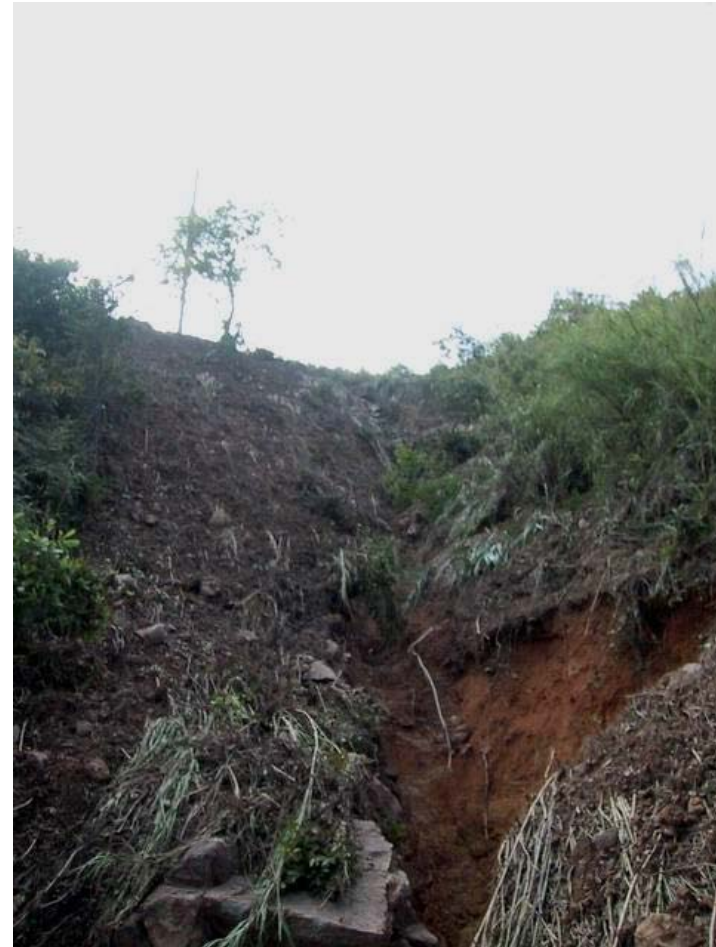
Plate 24 - View Looking Upslope from Chainage CH 82
(Note the minor failure of the eastern flank of the drainage line. Photograph taken on 9 May 2003)

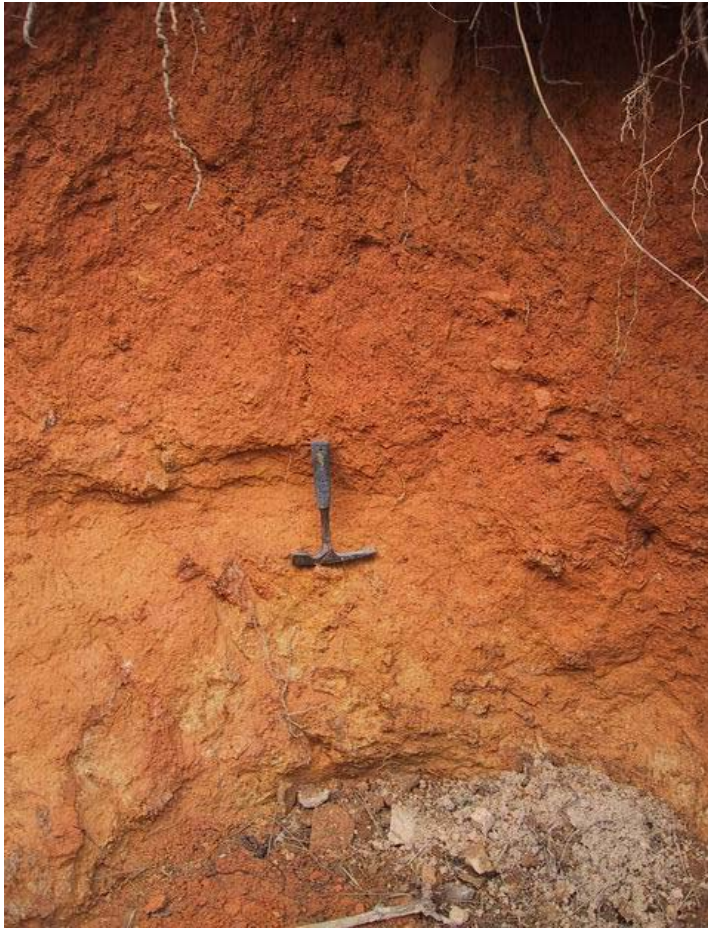
Plate 25 - View of the Failure Eastern Flank of the Drainage Line at Chainage CH 88 (Hammer denotes the contact between colluvium and completely decomposed coarse ash tuff. Photograph taken on 16 May 2003)

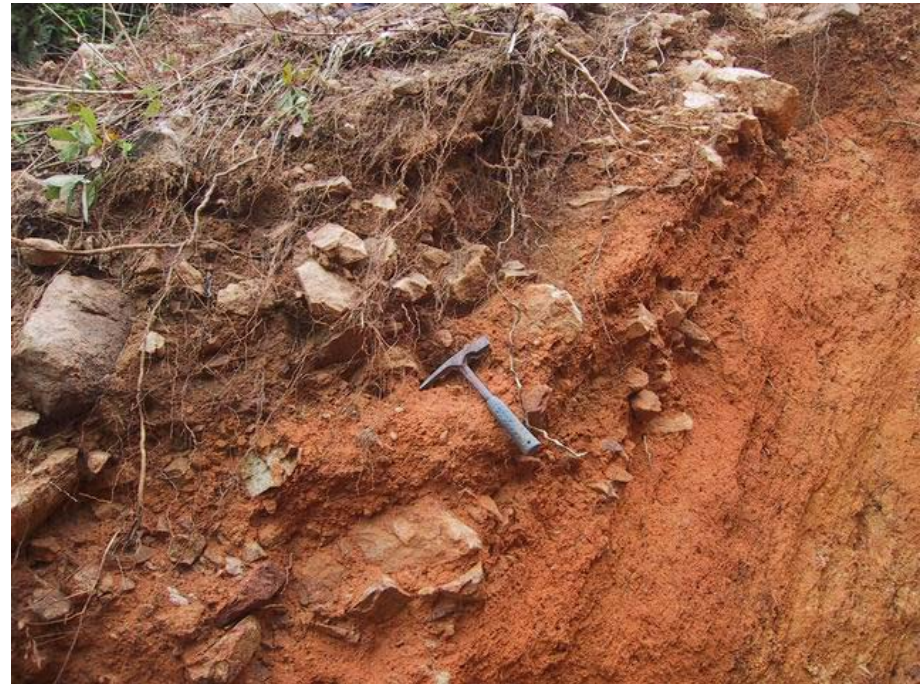
On the western flank of the debris trail at chainage CH 88, colluvial layers were observed within the incised erosion gully with a distinct contrast in the clast and matrix properties, possibly indicating different ages of deposition (Plate 26). Further down the debris trail, between chainages CH 120 and CH 125, other well-defined vertical profiles were observed within the erosion gully flanks (Plates 27 to 30) generally exposing variable colluvium and occasionally exposing the underlying metamorphosed siltstone (Plate 27).

Plate 26 - View of Varying Ages of Colluvium at the Western Flank of the Failure within the Drainage Line at Chainage CH 88
(Photograph taken on 16 May 2003)

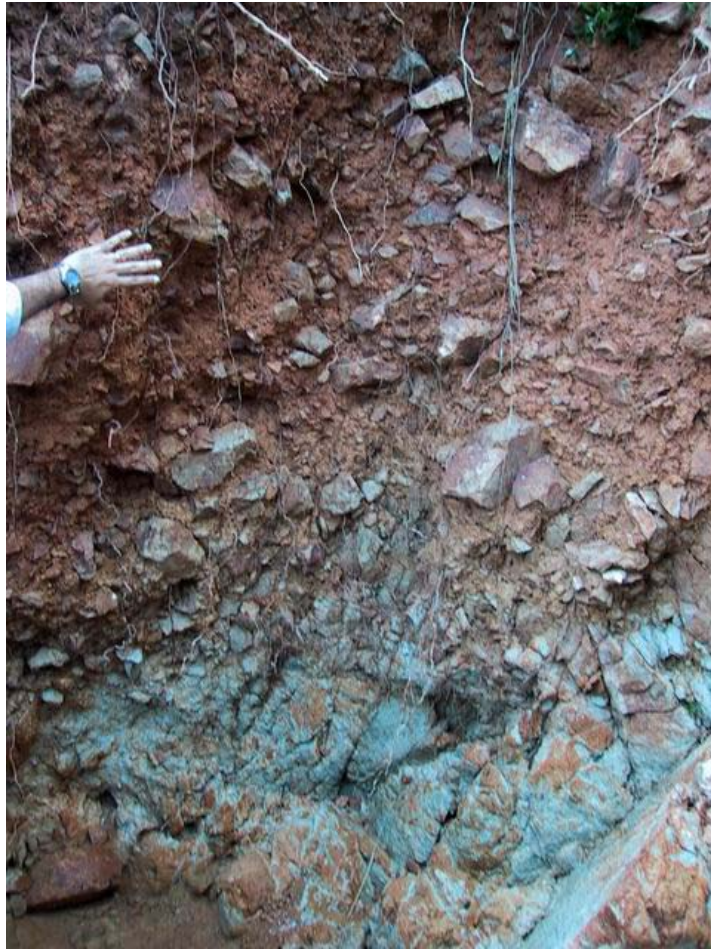
Plate 27 - View of Colluvium Overlying Insitu
Metamorphosed Siltstone at Chainage CH 120
(Photograph taken on 9 May 2003)

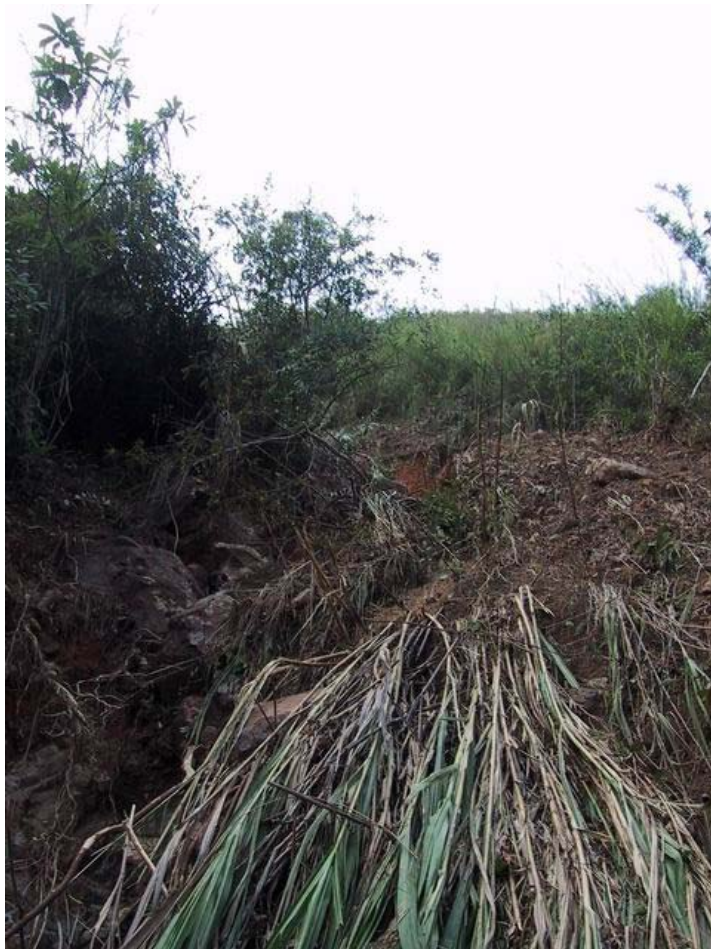
Plate 31 - View Uphill Towards the Access Road
(Note the bent and damaged grass and
vegetation. Photograph taken on 9 May 2003)

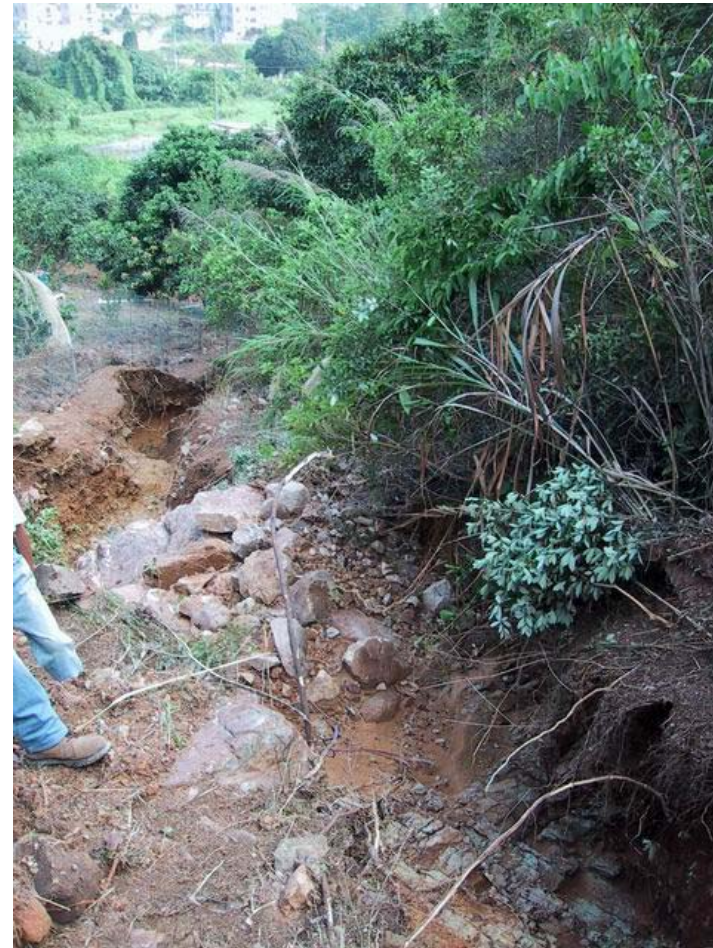
From approximately chainage CH 110 to CH 135, the lower debris trail slope angle decreases rapidly from about 24° to 10° where the trail widens out to form the debris fan and outwash deposits (Plate 32). Near chainage CH 130, alluvial deposits were found in the substrate of the debris trail (Plates 33 and 34). Evidence of debris height was provided by the accumulation of vegetation debris around trees along the flank of the trail.

Plate 32 - View Looking Downslope at Chainage CH 110
(Photograph taken on 9 May 2003)
