**THE 25 AUGUST 2003
ROCKFALL ON SLOPE NO.
7SW-C/C362 AT ROUTE TWISK
NEAR TSUEN KAM
INTERCHANGE TSUEN WAN**

GEO REPORT No. 200

Maunsell Geotechnical Services Limited

**GEOTECHNICAL ENGINEERING OFFICE
CIVIL ENGINEERING AND DEVELOPMENT DEPARTMENT
THE GOVERNMENT OF THE HONG KONG
SPECIAL ADMINISTRATIVE REGION**

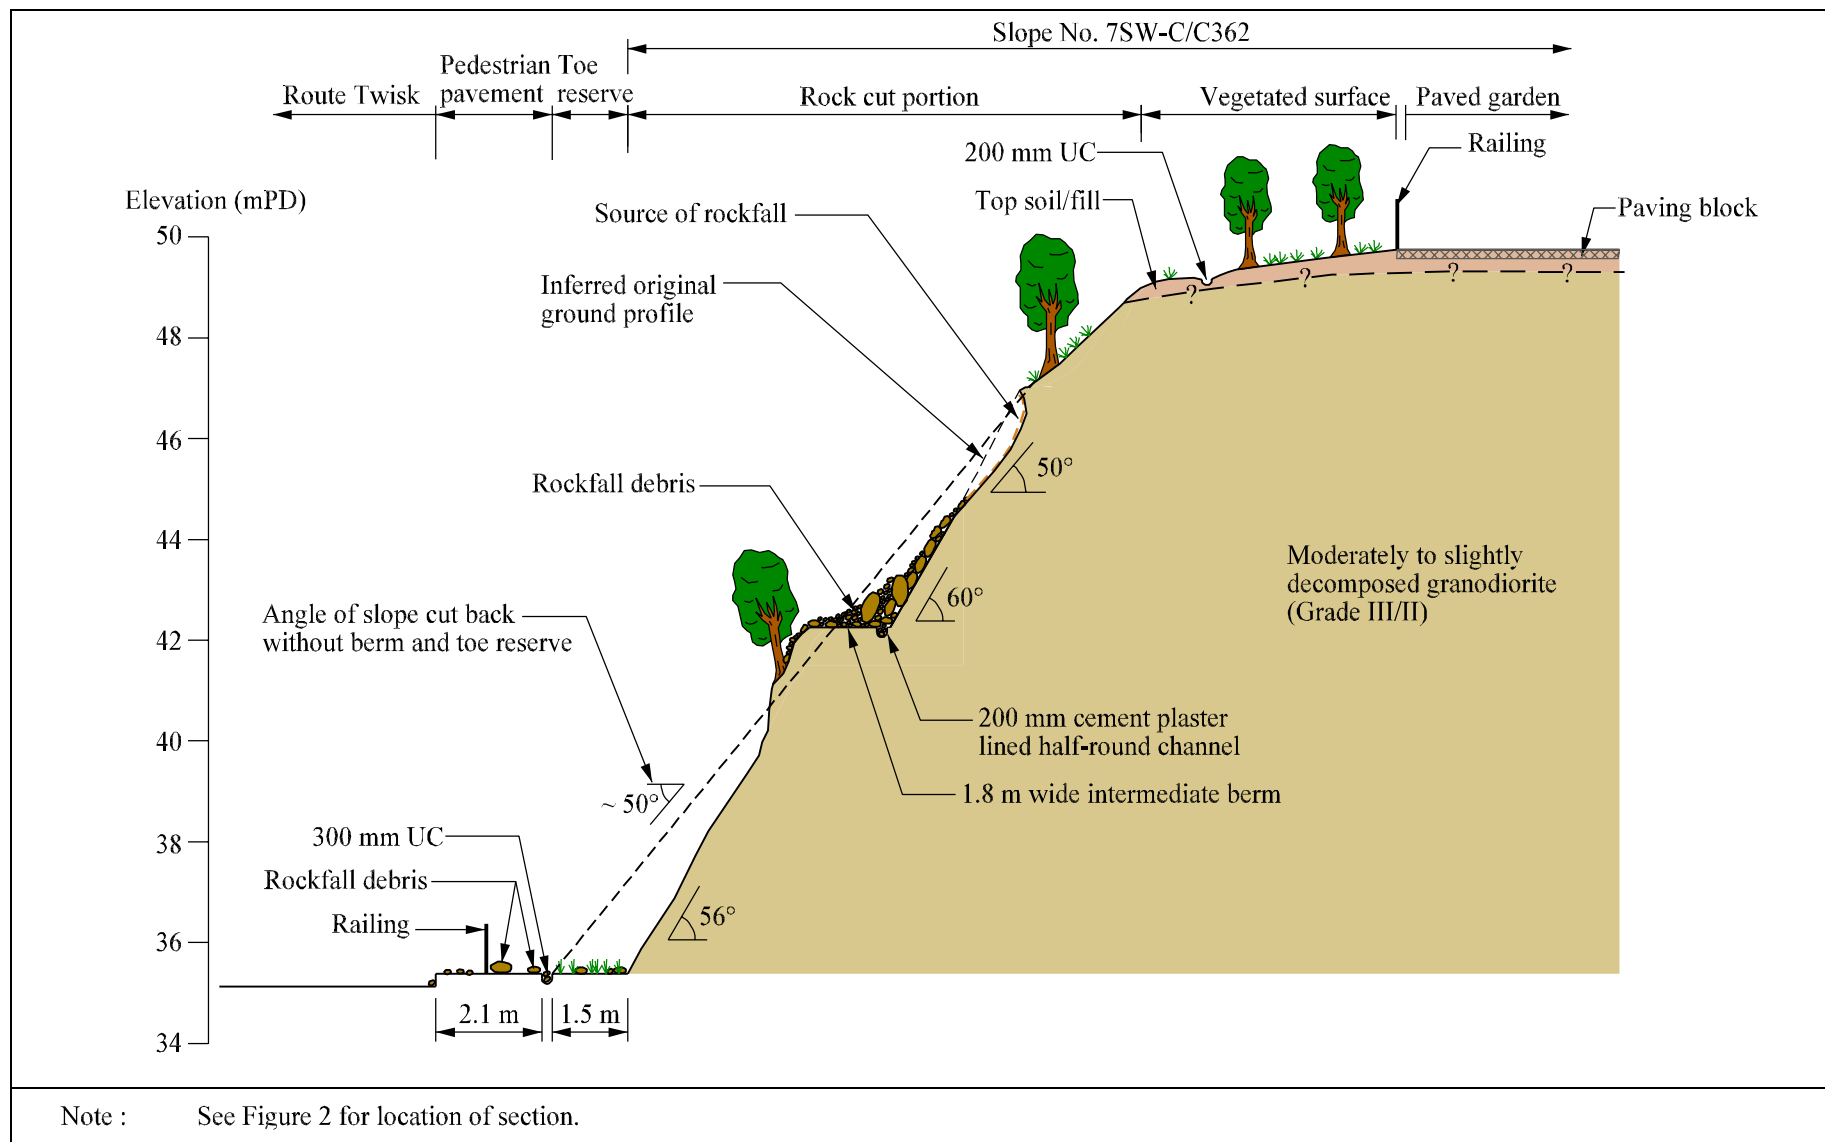
Figure 3 - Section through the August 2003 Rockfall Source

A section of the rock cut at the central portion of the subject slope, which is about 20 m long (where the August 2003 rockfall is located), is inclined locally at an angle of about 60° at the second batter. The widths of the intermediate berm and the toe 'reserve zone' immediately below the source area of the August 2003 rockfall are about 1.8 m and 1.5 m respectively (Figure 3).

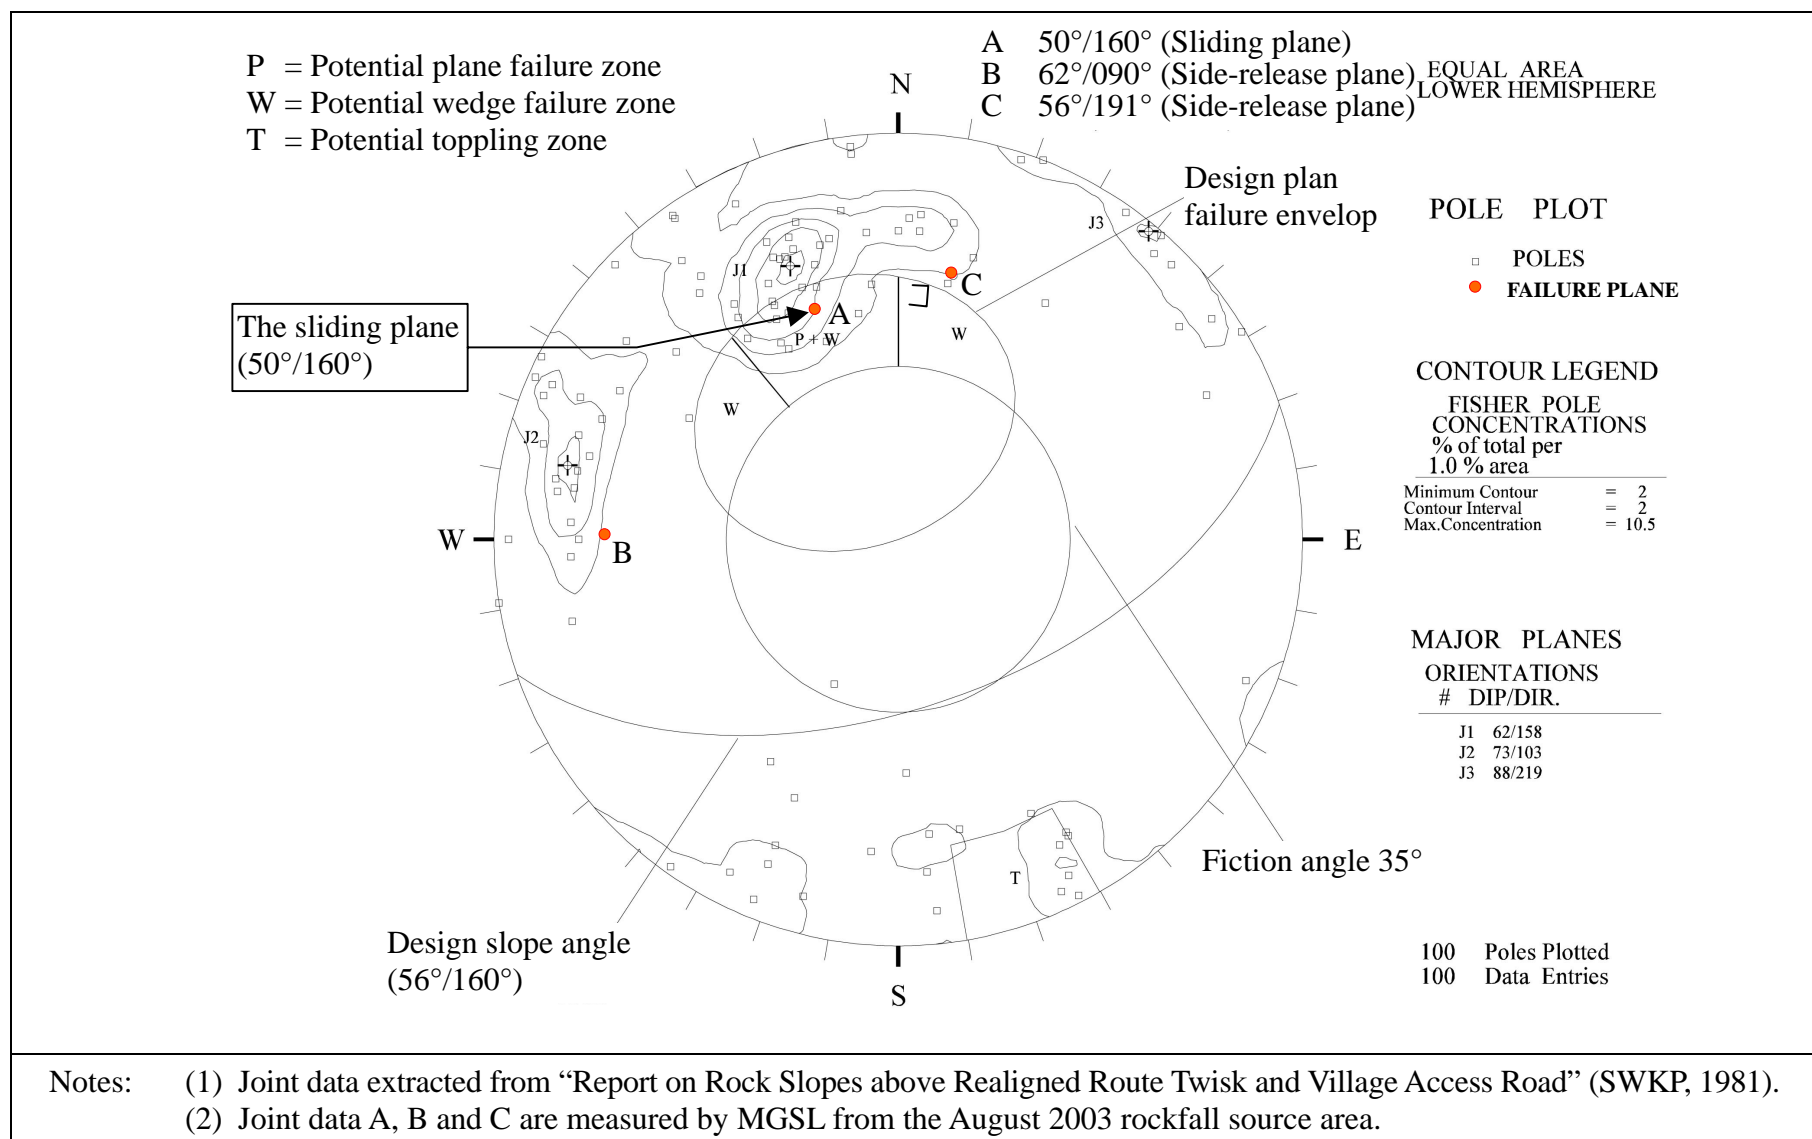
Figure 5 - Kinematic Analysis by Scott Wilson Kirkpatrick & Partners in 1981

A contoured stereoplot of the rock joint data was generated by SWKP (reproduced as Figure 5). The joint friction angle with “an allowance for roughness is assessed from visual inspection as 35°”. The report noted from the stereoplot that “only a small section [of a major joint] is within 20° of the slope face direction. There is therefore only a low probability of planar joints daylighting in the rock face”. The report also noted that a toppling failure mode was not likely owing to the “blocky nature of the rock”.

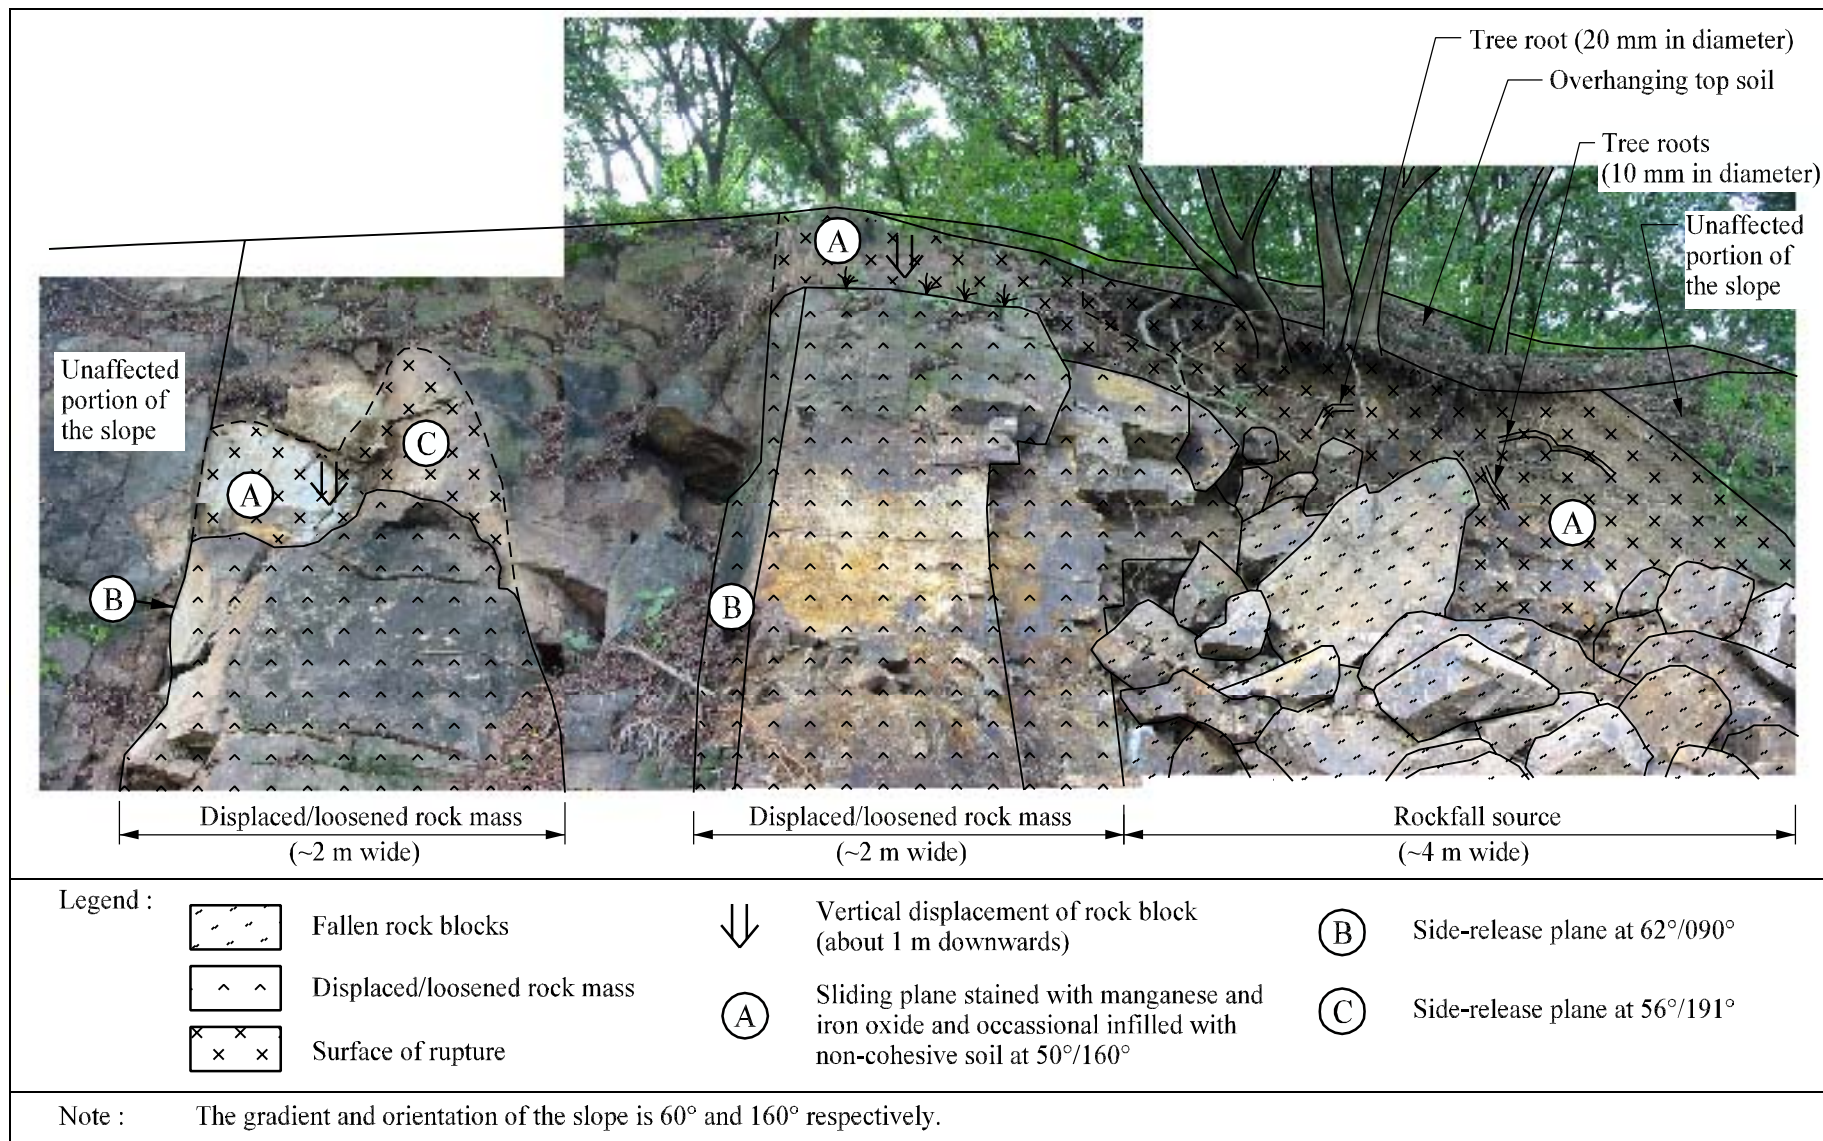
Figure 6 - The Source Area of the August 2003 Rockfall

The rockfall involved the detachment of about 8 m³ of rock blocks and the displacement of a further 8 m³ of rock fragments. The failure scar was approximately 5 m long by 8 m wide by 0.4 m deep (Figure 6 and Plate 1). The fallen rock blocks, with a maximum size of about 0.2 m³, mostly landed on the intermediate berm (about 1.8 m wide at this point, see Figure 3) and some came to rest against a tree below the failure scar. Some rock debris (<0.5 m³ in volume) was deposited on the 1.5 m wide ‘reserve zone’ and the 2.1 m wide pedestrian pavement at the slope toe (Plate 2). As a result of the rockfall, a section of the pedestrian pavement directly in front of the slope toe was temporarily closed. It is noted that no fence (e.g. chain link fence) has been provided to cordon off the ‘reserve zone’ and that it can be accessible by general public.

The back-release surface of the rockfall source is inclined at an angle of about 50° (see Figure 6). The materials exposed at the source comprised moderately strong, light greenish grey, moderately decomposed coarse-grained granodiorite with iron and manganese oxide stained joints that were occasionally infilled with non-cohesive soil. The August 2003 rockfall appears to have involved a planar failure of rock blocks along a steep release surface (50°). It is noted that the rock section (about 20 m long) in the vicinity of the source of the rockfall is inclined locally at an angle of about 60°, whilst the other slope sections are dipping at about 56°.

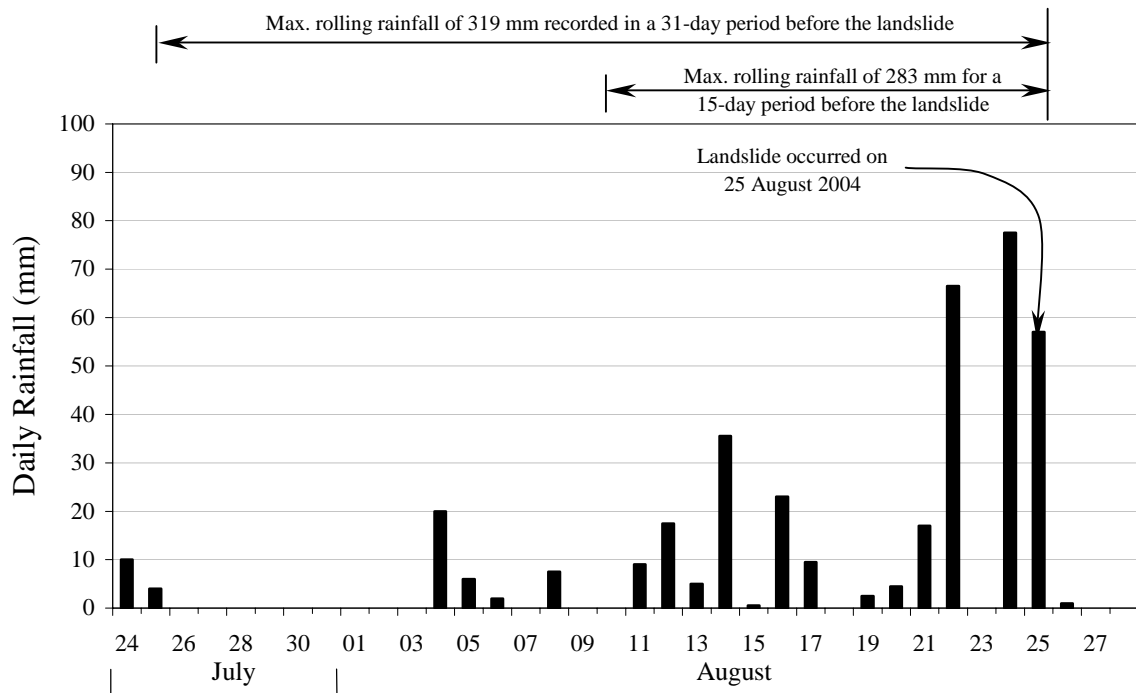
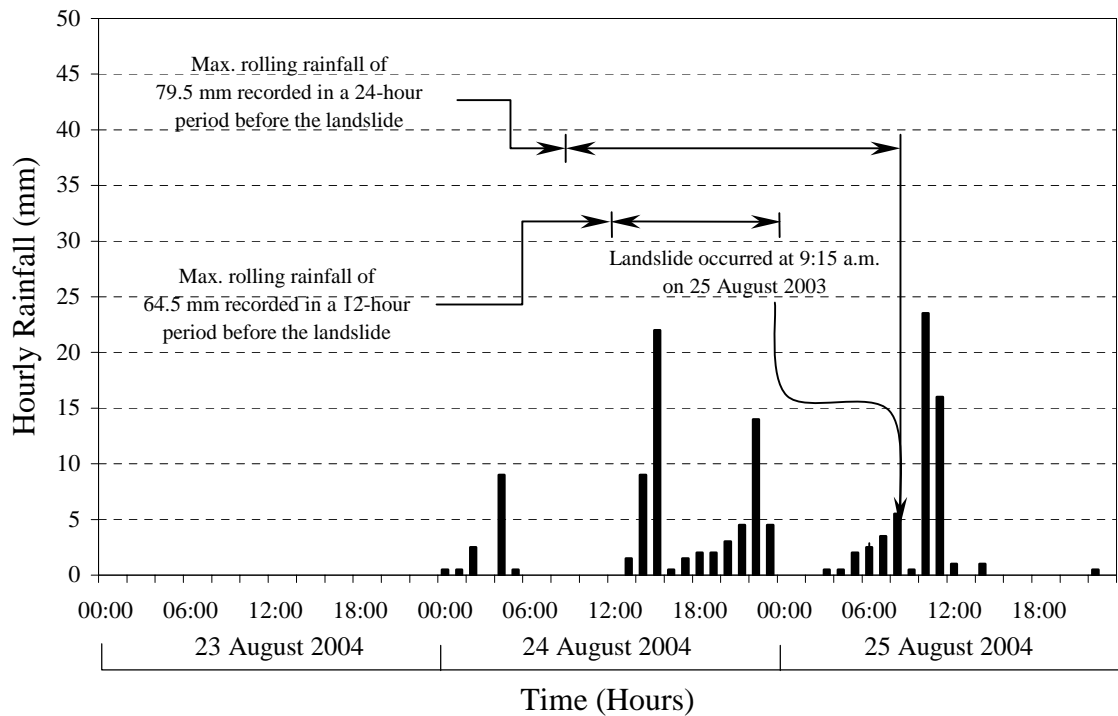
Figure 7 - Daily and Hourly Rainfall Recorded at GEO Raingauge No. N03

The 25 August 2003 rockfall involved the detachment and displacement of a total of 16 m³ of rock blocks along a steep rock joint (50°) on an engineered soil/rock cut. The rockfall was probably triggered by light rainfall, with the maximum hourly and 24-hour rolling rainfall of 8 mm and 80 mm respectively preceding the rockfall (Figure 7).

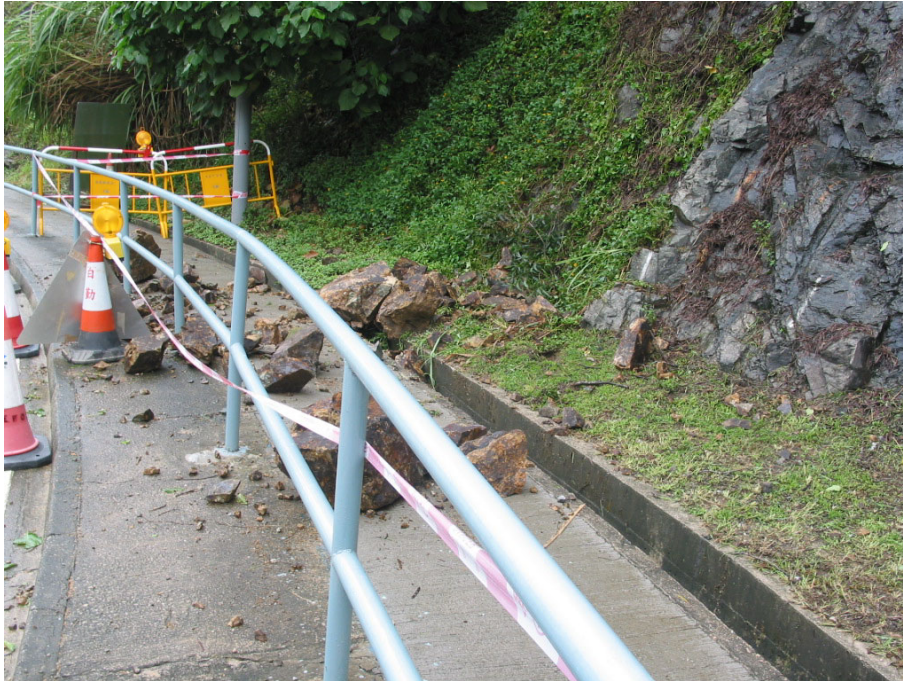
Plate 1 - The 25 August 2003 Rockfall at Slope No. 7SW-C/C362
(Photograph taken on 26 August 2003)

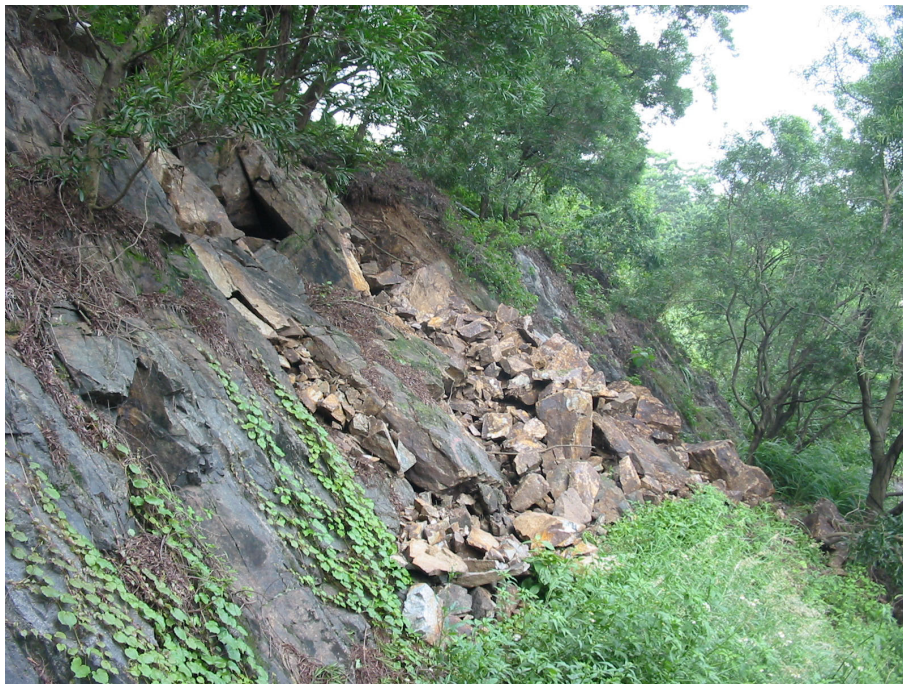
Plate 2 - View of the Rock Blocks Deposited on the
Pedestrian Pavement along Route Twisk
(Photograph taken on 25 August 2003)

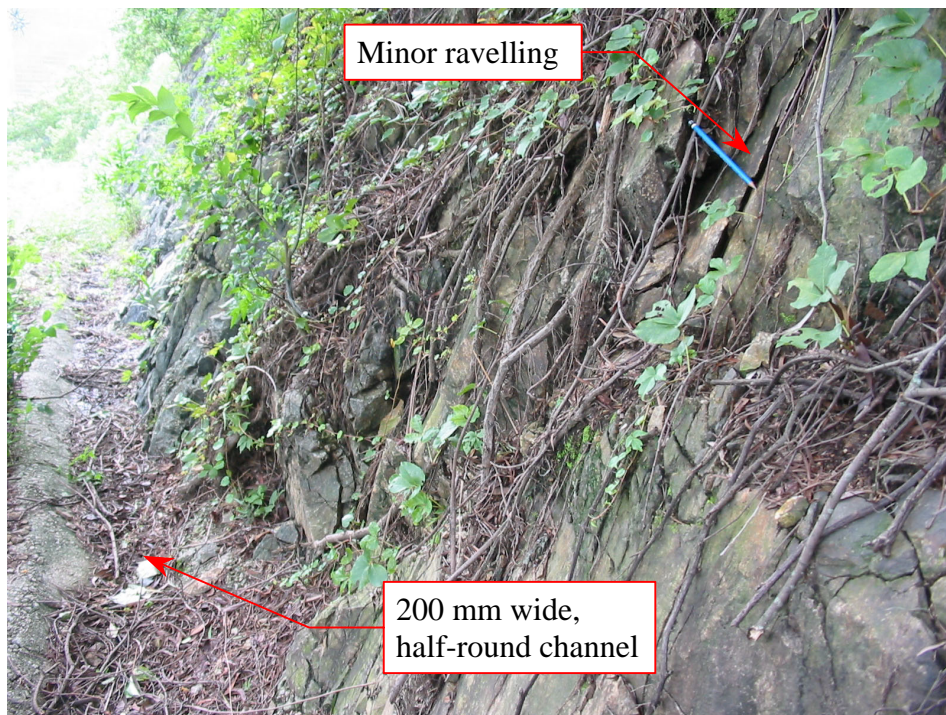
Both the crest channel and half-round berm channel in the vicinity of the August 2003 rockfall were almost completely blocked with vegetation (Plates 5 and 6). Also, a section of the crest channel (about 8 m long) was completely buried by soil of up to about 0.3 m thick and covered extensively with tree roots (Figure 2 and Plate 10). No signs of seepage were observed on slope No. 7SW-C/C362 during MGSL's inspections.

Plate 5 - View of the Half-round Channel along the Berm of the Rock Portion
(Photograph taken on 26 August 2003)

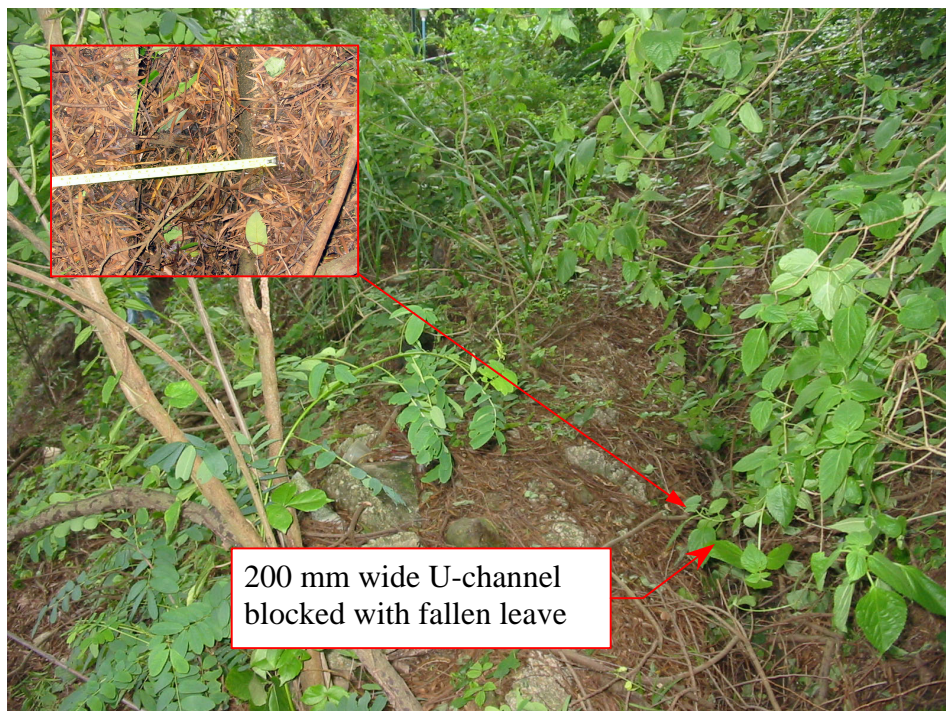
Plate 6 - View of the U-channel at the Crest of the Rock Portion
(Photograph taken on 26 August 2003)

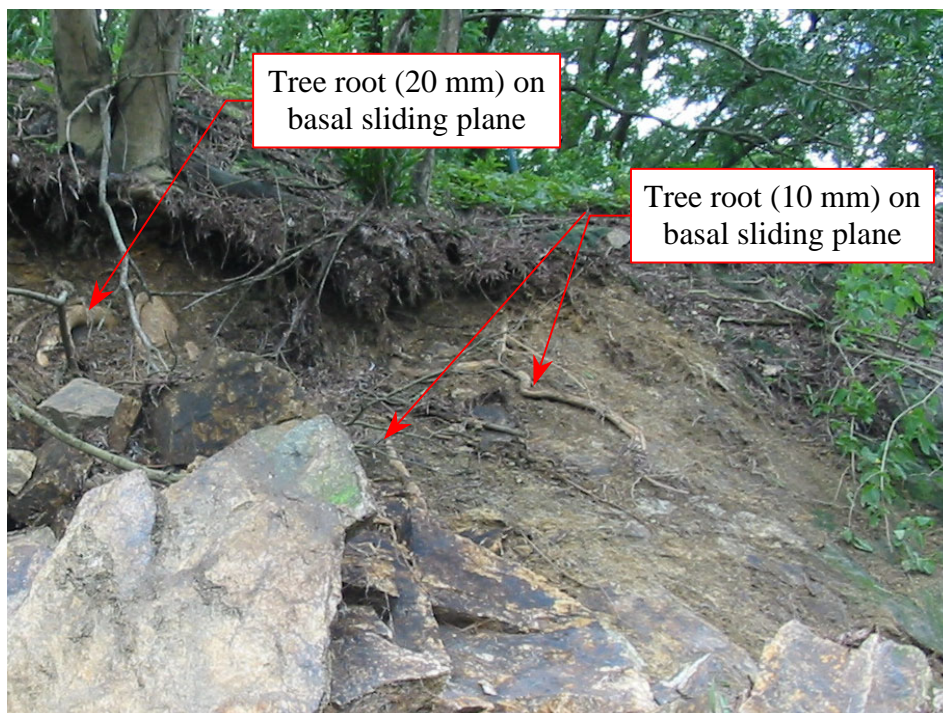
Tree roots of 10 mm to 20 mm diameter were exposed within the upper part of the source of rockfall (Plates 5 and 9), suggesting that the rock joint of concern had been subjected to root jacking action prior to the failure. The rockfall was probably caused by water ingress into a possibly dilated steep rock joint, resulting in the build-up of transient cleft water pressure behind rock blocks. According to the post-failure observations, both the crest and berm channels on the subject slope were probably completely blocked with vegetation at the time of the rockfall (Plates 5 and 6). Overflow of surface water probably resulted in concentrated water ingress into the dilated rock joints that involved in the August 2003 rockfall.

Plate 9 - Tree Roots Exposed within the Source of Rockfall
(Photograph taken on 26 August 2003)

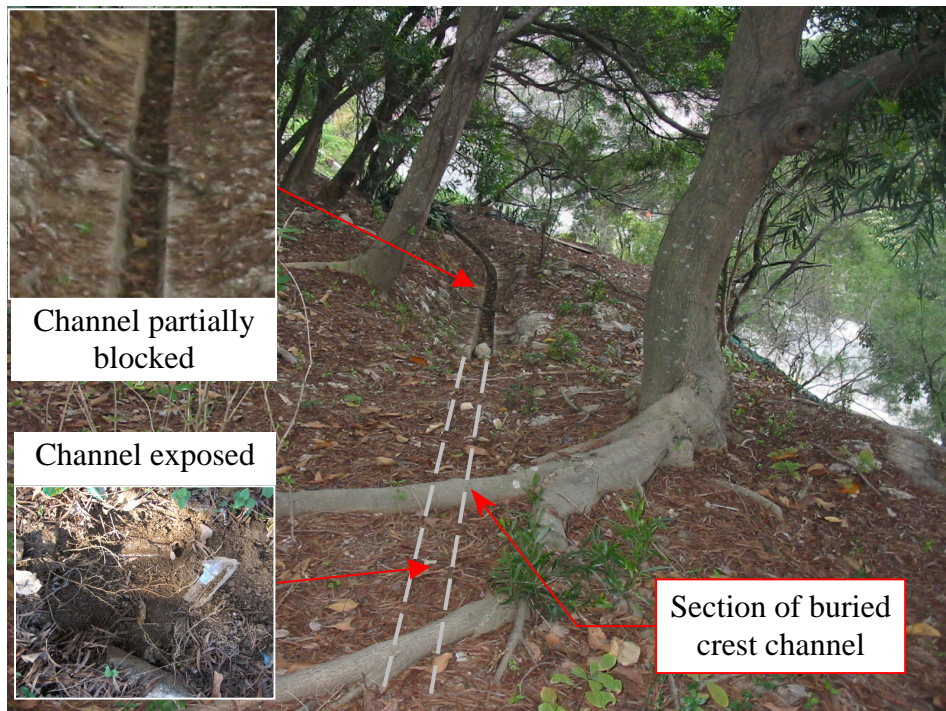
Plate 10 - View of the Buried Crest Channel above the Rockfall Source
(Photograph taken on 17 March 2005)

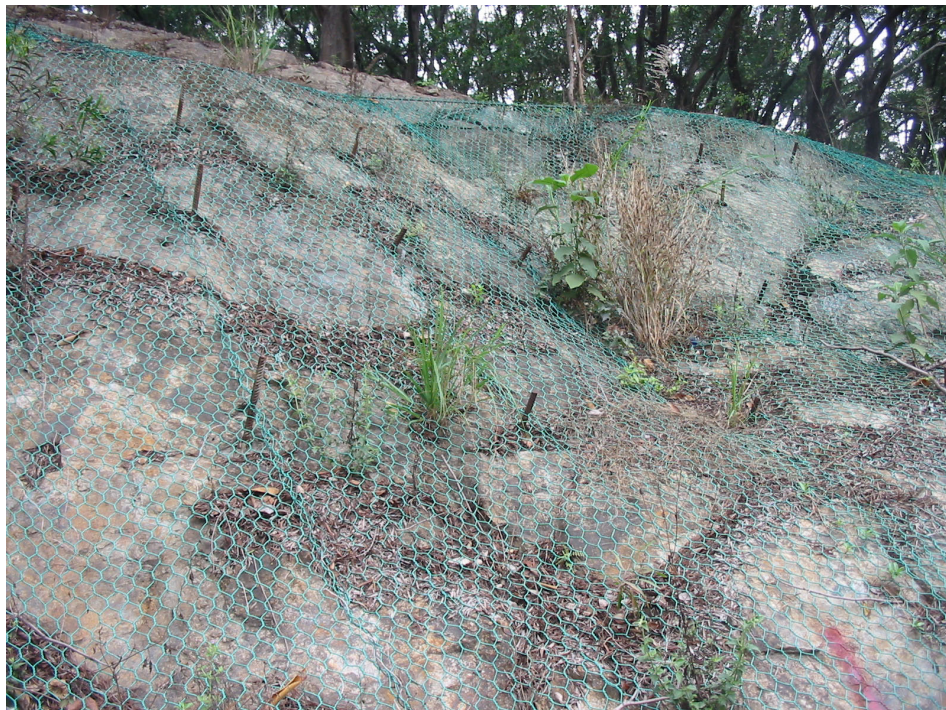
Plate 11 - View of the Pattern Rock Dowels Installed in the
Vicinity of the August 2003 Rockfall Source
(Photograph taken on 17 March 2005)

Site inspection by MGSL in March 2005 revealed that the slope remedial works as recommended by the GEO and Arch SD for the August 2003 rockfall, which comprised removal of loose rock blocks, vegetation clearance, installation of pattern rock dowels (Plate 11) and provision of wire mesh netting at selected areas (with the potential for minor raveling failures), were completed (Plate 12).

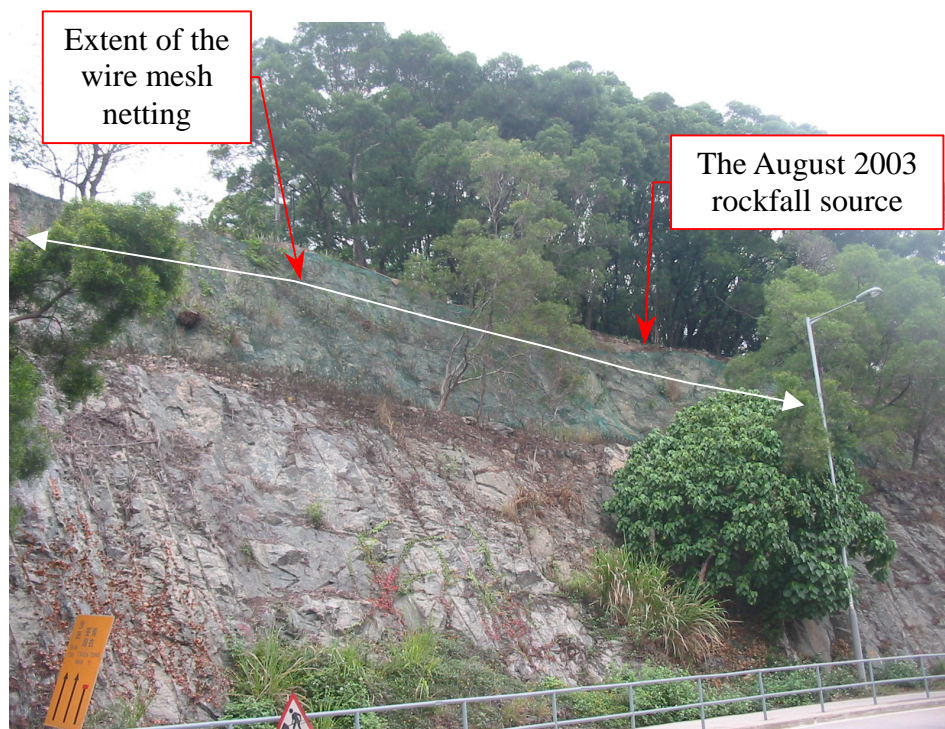
Plate 12 - View of the Area of the August 2003
Rockfall after the Slope Remedial Works
(Photograph taken on 17 March 2005)

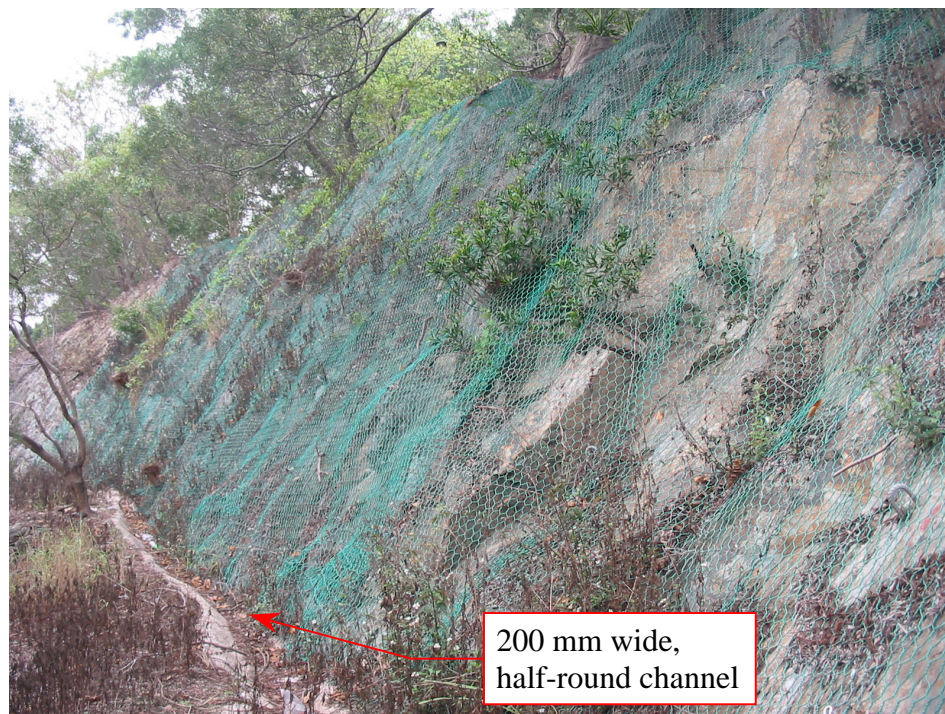
Plate 13 - View of the Rock Mesh Netting and the Berm Channel after
the Slope Remedial Works (Photograph taken on 17 March 2005)
