REVIEW OF THE JUNE 2004 WASHOUT INCIDENT ON SLOPE NO. 10SW-D/C97 AT ADDICTION TREATMENT CENTRE, HEI LING CHAU

GEO REPORT No. 201

Fugro Scott Wilson Joint Venture

**This report was originally produced in May 2005
as GEO Landslide Study Report No. LSR 6/2005**

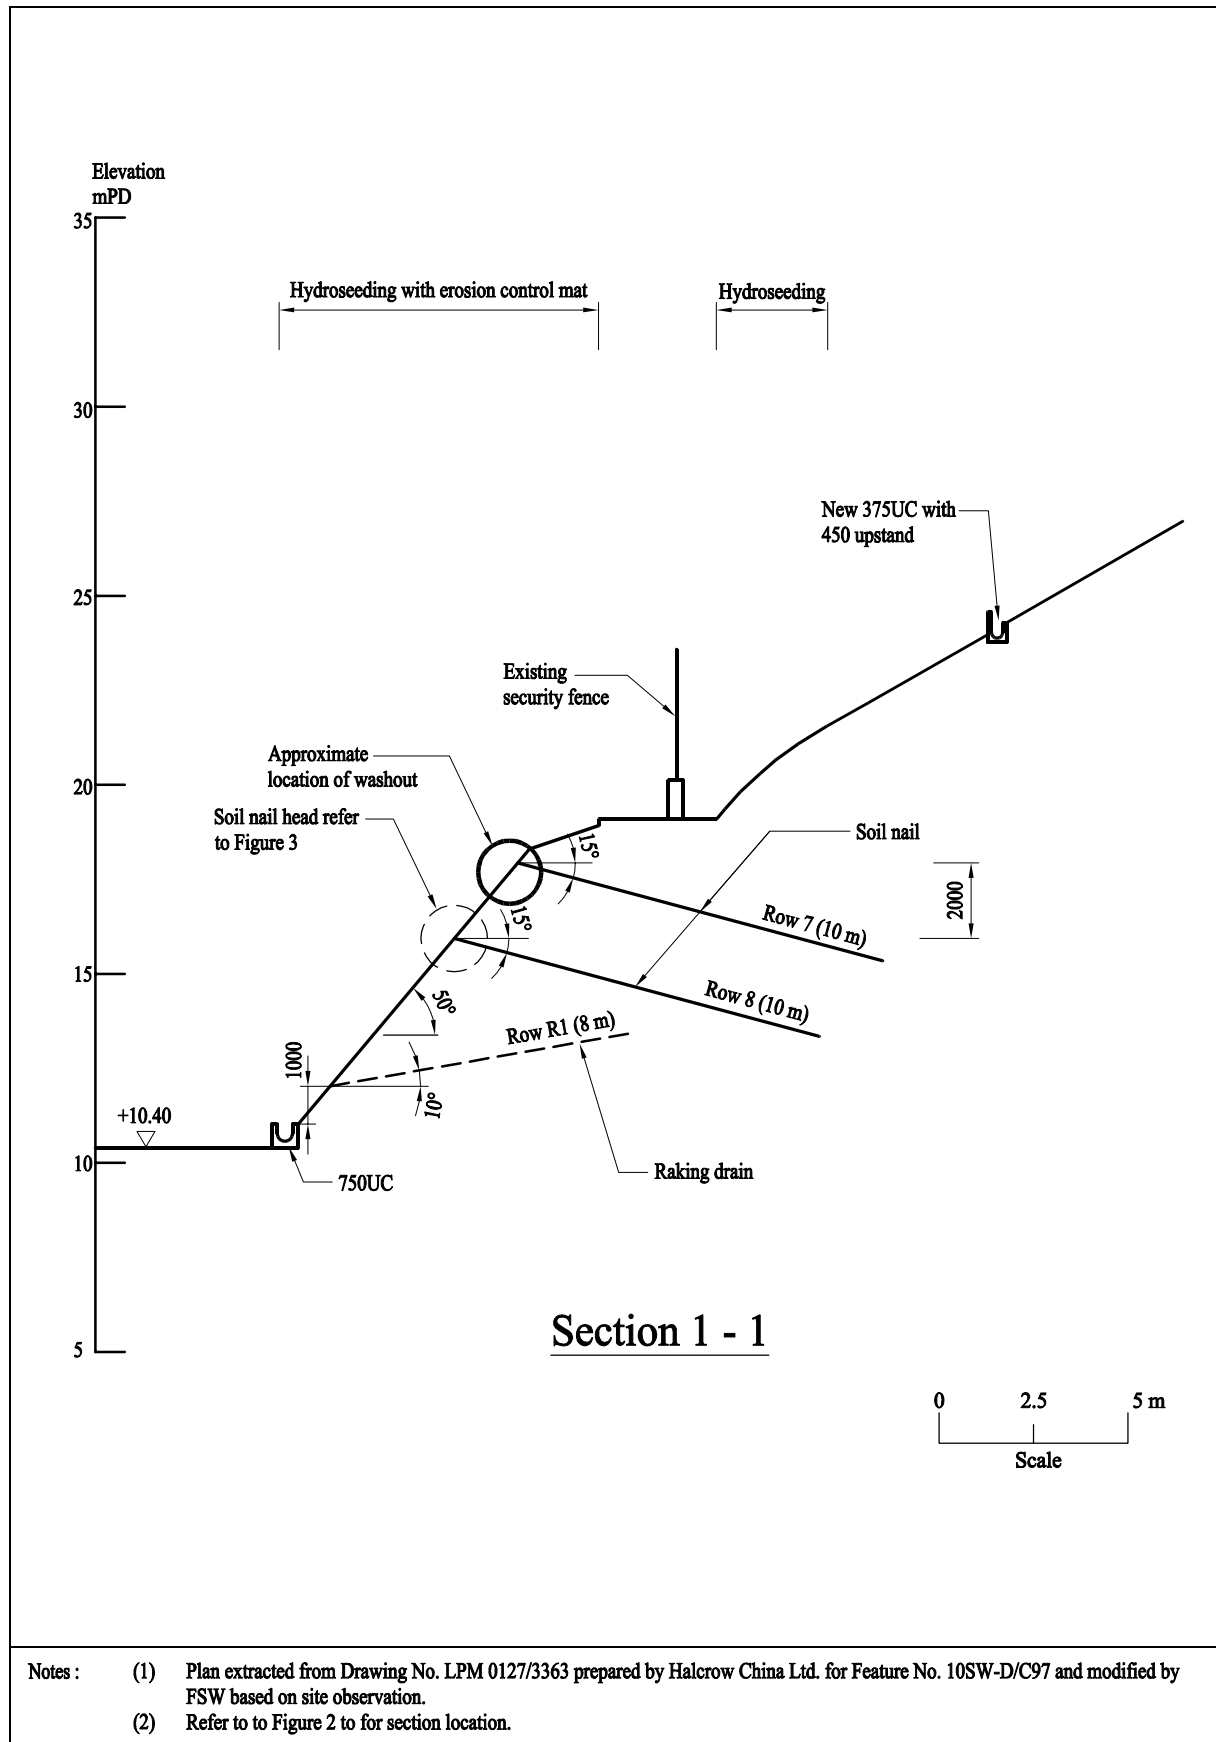
Figure 4 - Cross-section through Slope No. 10SW-D/C97 at the Washout Location

The June 2004 washout (Plate 4) occurred at a soil nail head located in the central portion of the slope (see Figure 2), about 7.5 m above the slope toe. A cross-section through

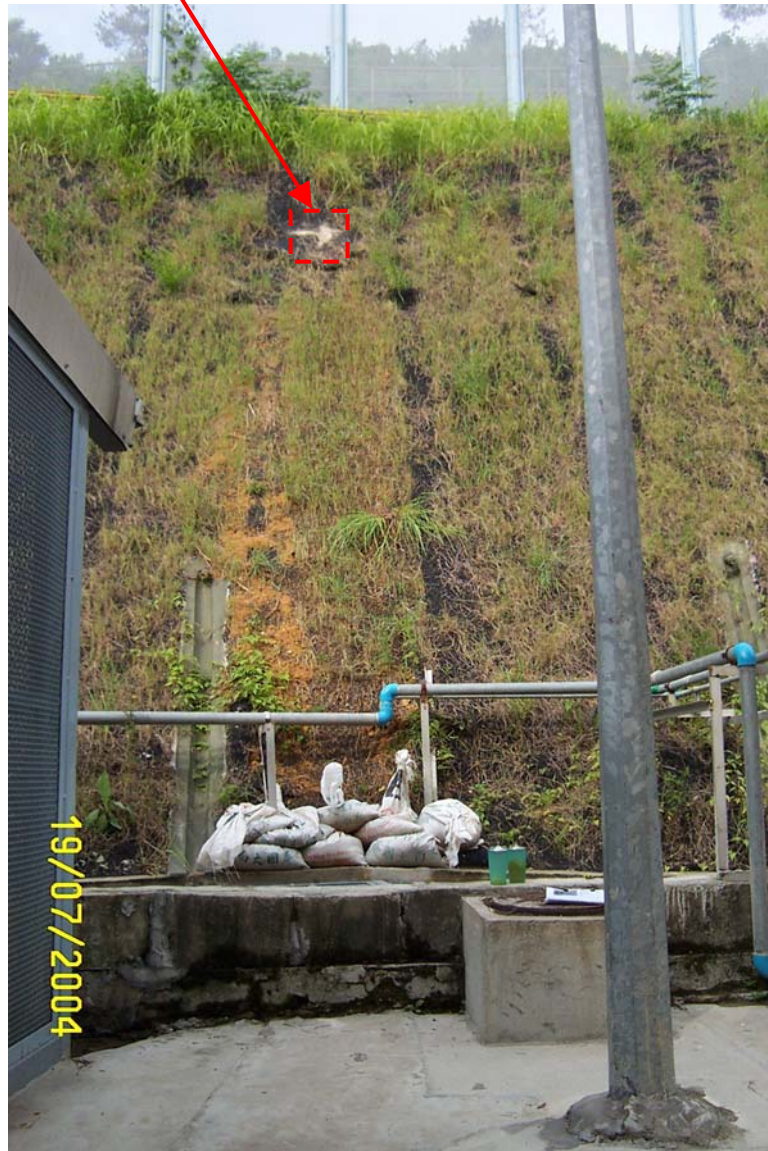
The dimensions of the washout source area are of the order of 0.6 m x 0.6 m. The washout involved the soil nail head backfill material within a depth of around 0.1 m below the slope surface, exposing the nail head beneath. Debris from the washout deposited on the slope face and was carried down to the drainage channel at the slope toe.

Approximate extent of the washout scar

Plate 4 - General View of the Washout Scar on Slope No. 10SW-D/C97
(Photograph taken on 19 July 2004)

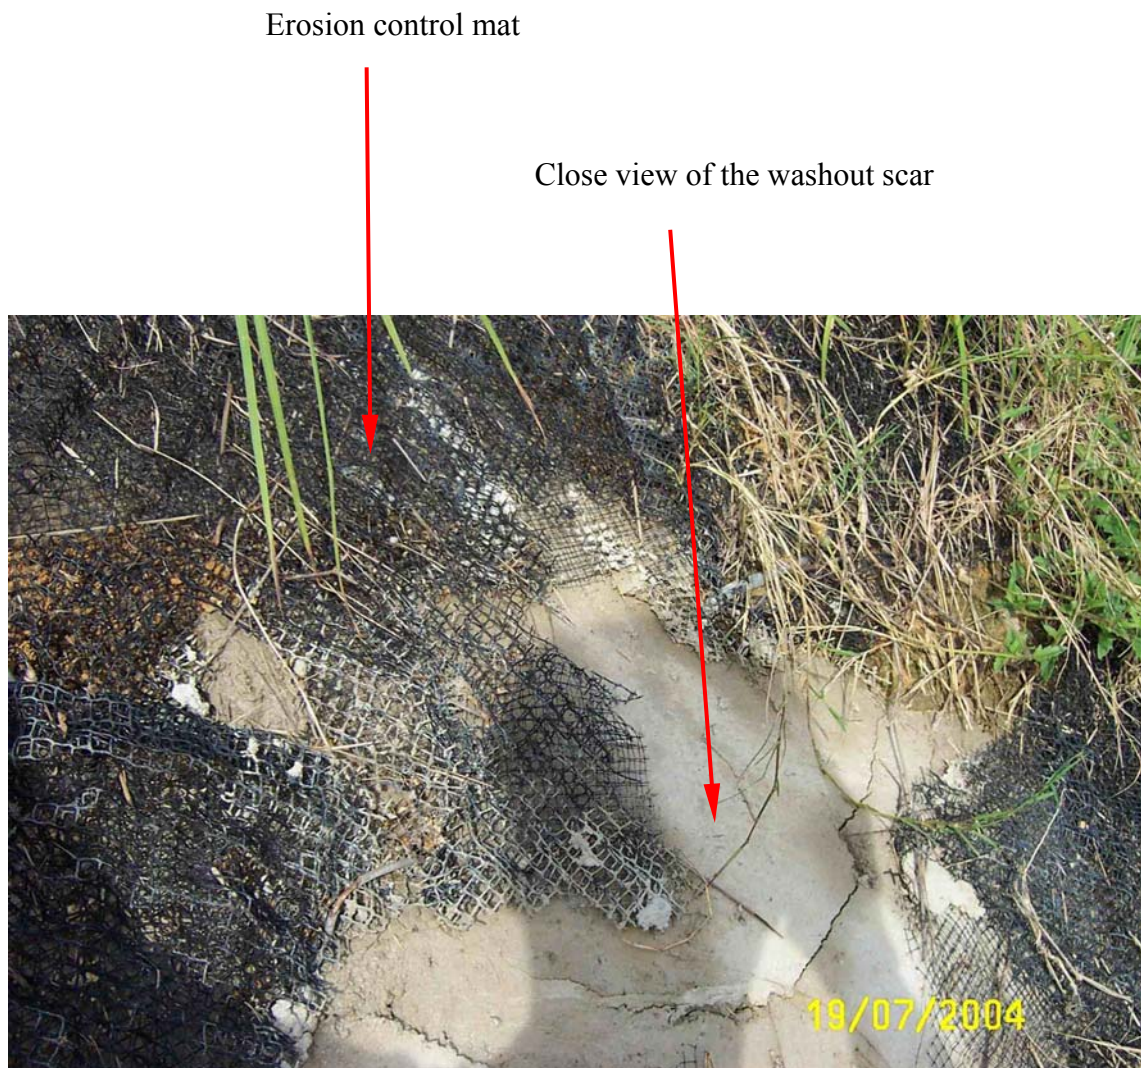
FSW inspected the slope on 19 July 2004. By this time, the washout scar had been reinstated with cement mortar (Plate 5), covering the exposed nail head. The majority of debris from the incident had been cleared, with only traces present near the slope toe. No obvious signs of seepage or distress were observed on the subject cut slope.

Plate 5 - Close View of the Repaired Washout Scar at Slope No. 10SW-D/C97
(Photograph taken on 19 July 2004)

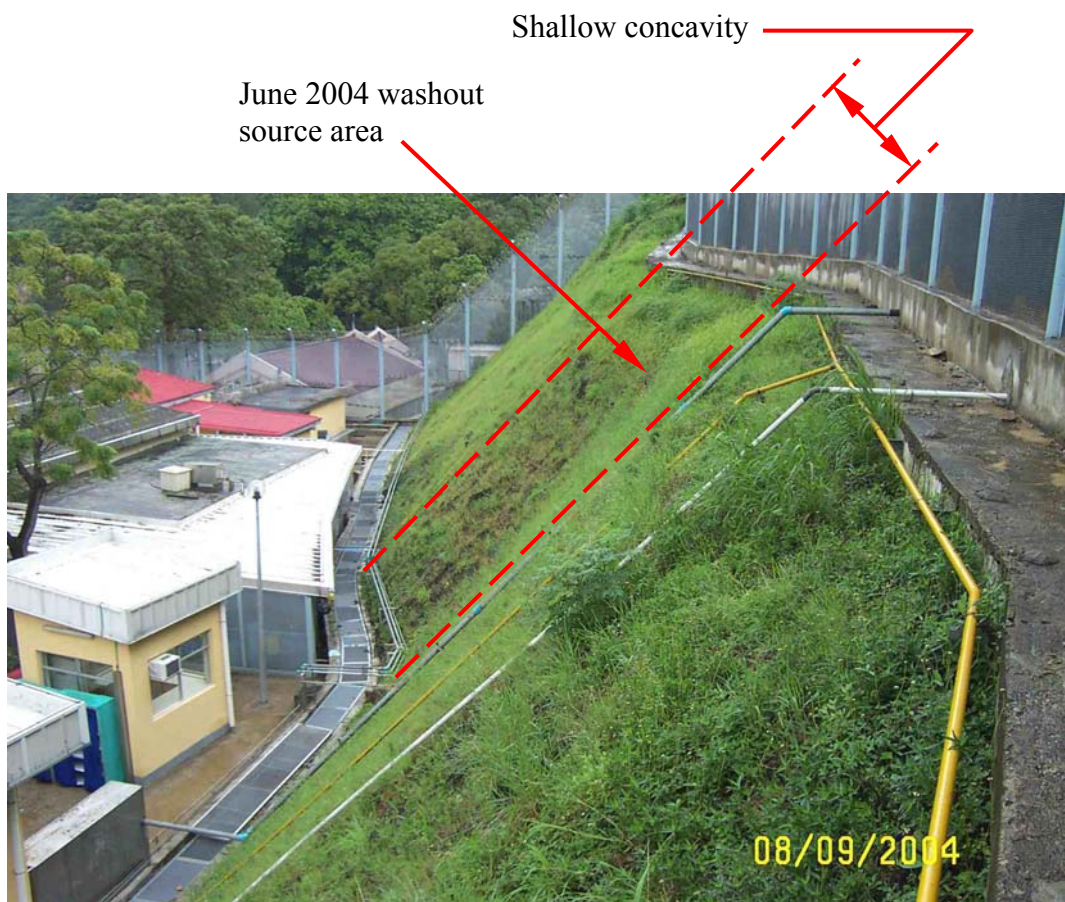
The slope face at the location of the washout scar incorporates a shallow concavity extending from the crest to the toe of the slope (Plate 6), which is followed by the alignments of the security fence footing at the slope crest and the toe drainage channel. No obvious signs of distress or movement were observed in the general area immediately beyond the crest of the cut slope. The 375 mm U-channel located upslope from the crest berm was found to be in good condition and no signs of blockage were observed. The arrangement of this channel provides an effective cut-off from any surface runoff generated by the hillside above.

Plate 6 - View North along Crest Towards Location of the June 2004 Washout at Slope No. 10SW-D/C97 (Photograph taken on 8 September 2004)

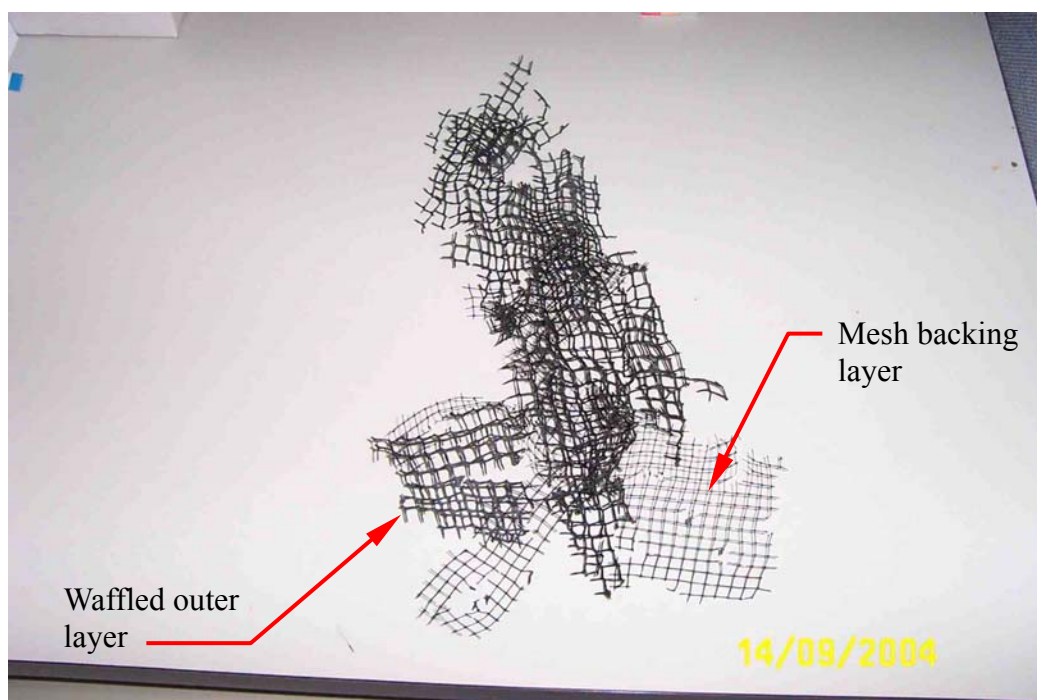
Plate 7 - Fragment of Erosion Control Mat Recovered from Toe of Slope No. 10SW-D/C 97 Showing Multiple Cuts

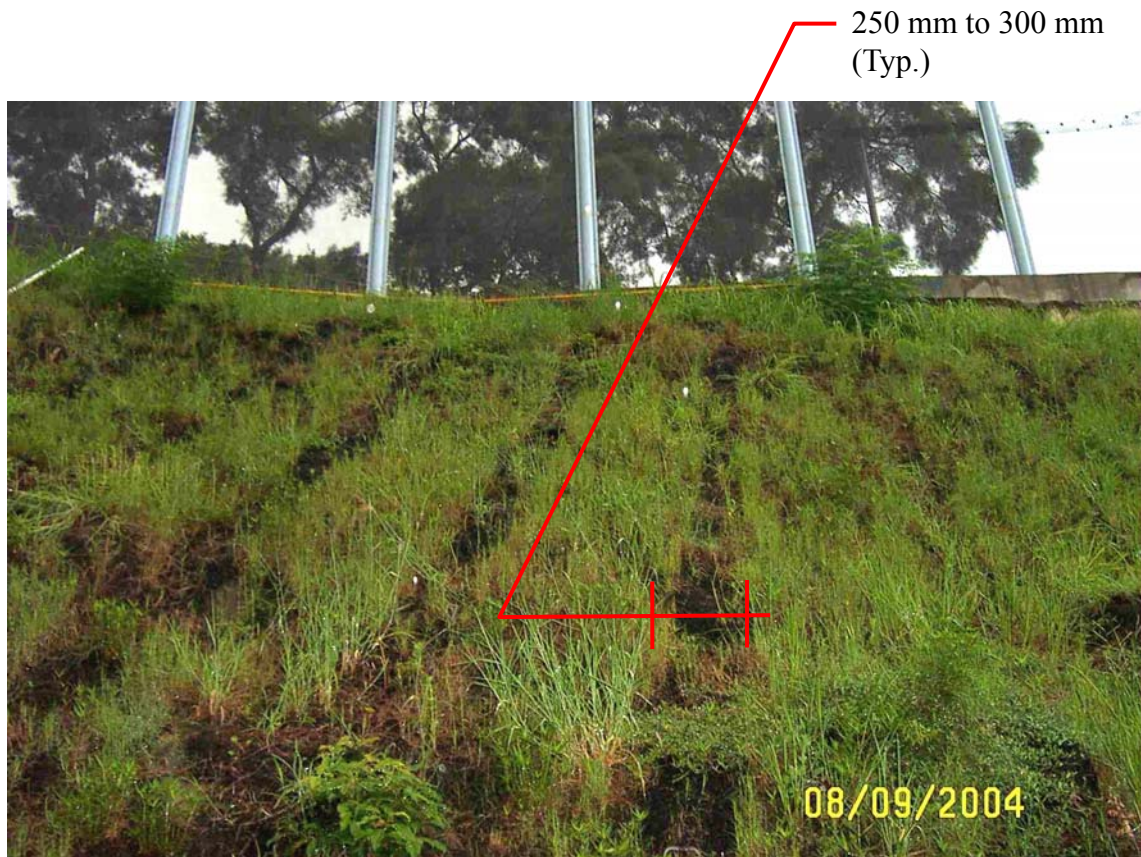
The lap between adjacent strips of erosion control mat (Plate 8) was relatively uniform and about 250 mm to 300 mm in width. Laps generally appeared to have been adequately stapled to the slope face.

Plate 8 - General View of Central Portion of Slope Face from Toe Showing Typical Lap of Adjacent Sheets of Erosion Control Mats at Slope No. 10SW-D/C97 (Photograph taken on 8 September 2004)

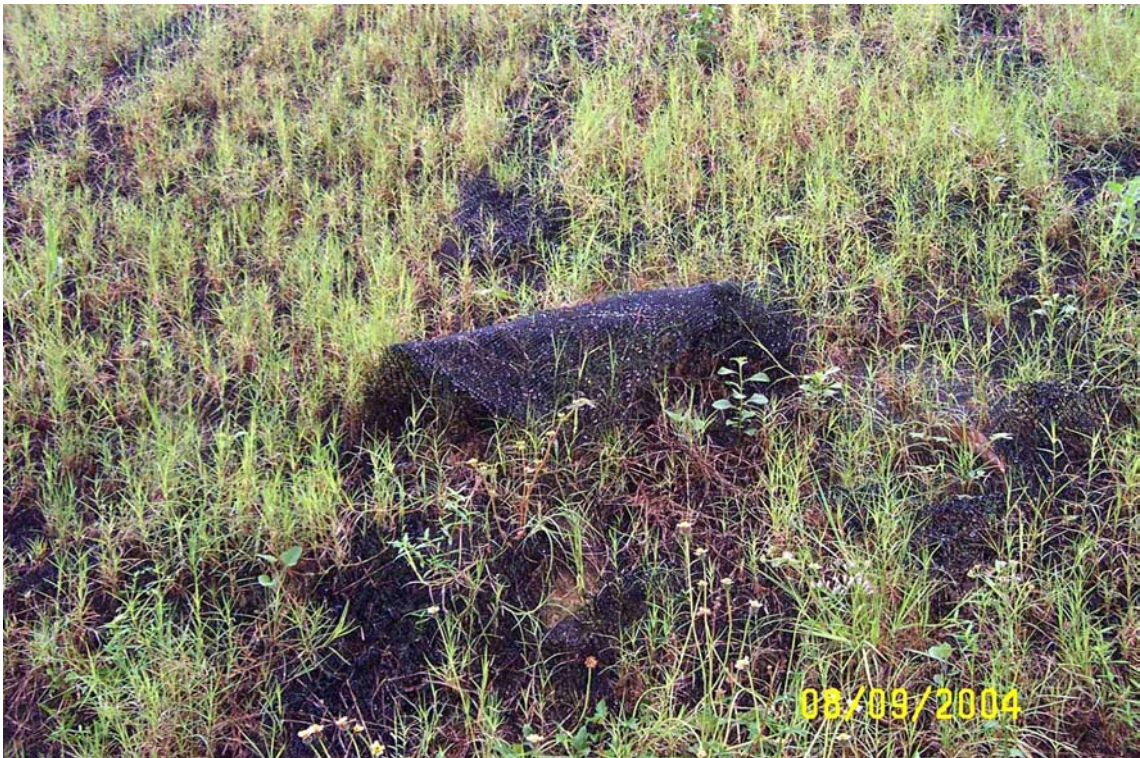
The erosion control mat appeared to have been cut in many locations, with loose flaps hanging down exposing the slope face (Plate 9). In a number of areas, the outer layer of the erosion control mat was completely absent, with only the finer mesh net backing layer remaining (Plate 10). At numerous locations, particularly where only the backing layer was present, the erosion control mat was torn over small areas around 100 mm in diameter

Plate 9 - Example of Erosion Control Mat having been Cut and Loose Flap
Hanging Down Slope Face of Slope No. 10SW-D/C97
(Photograph taken on 8 September 2004)

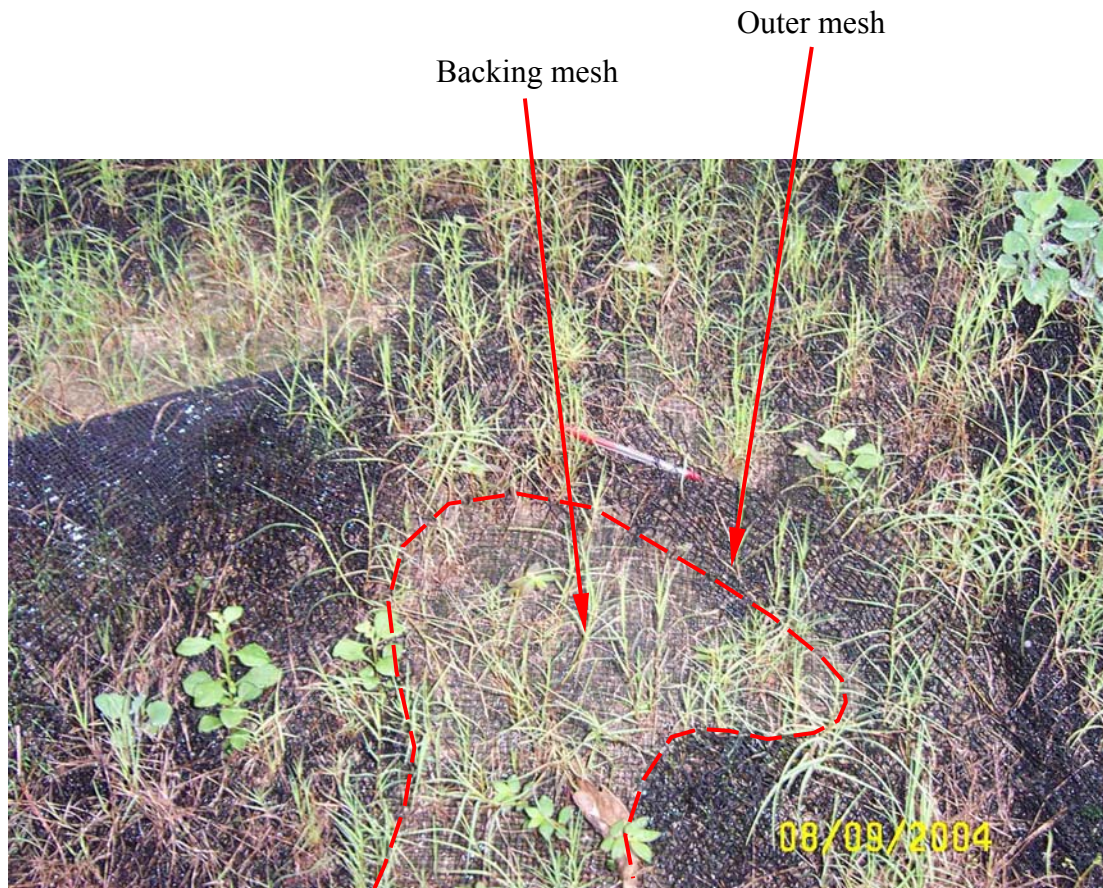
Plate 10 - Example of Location with Outer Layer of Erosion Control Mat having been Removed, Leaving only Backing Mesh in Place at Slope No. 10SW-D/C97 (Photograph taken on 8 September 2004)

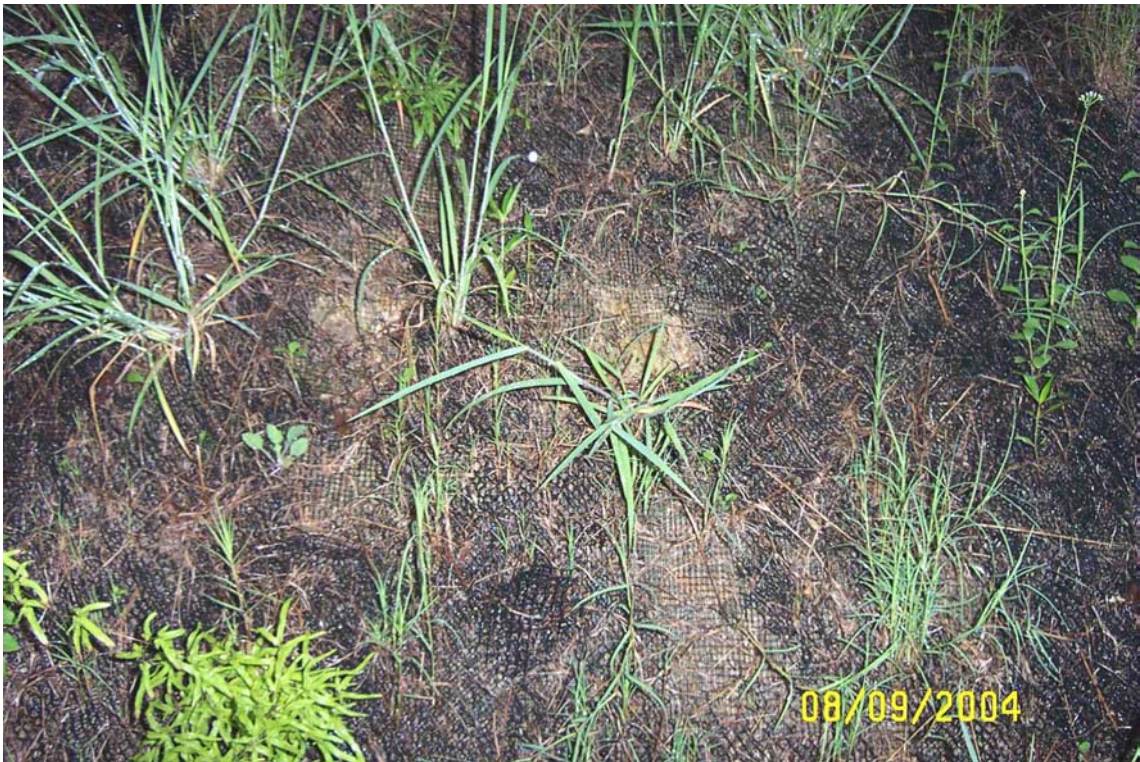
(Plate 11), which can be interpreted as the damage from pedestrian access to the slope face during vegetation trimming works.

Plate 11 - Example of Location where Backing Mesh has been Torn to Expose Slope Face of Slope No. 10SW-D/C97 (Photograph taken on 8 September 2004)

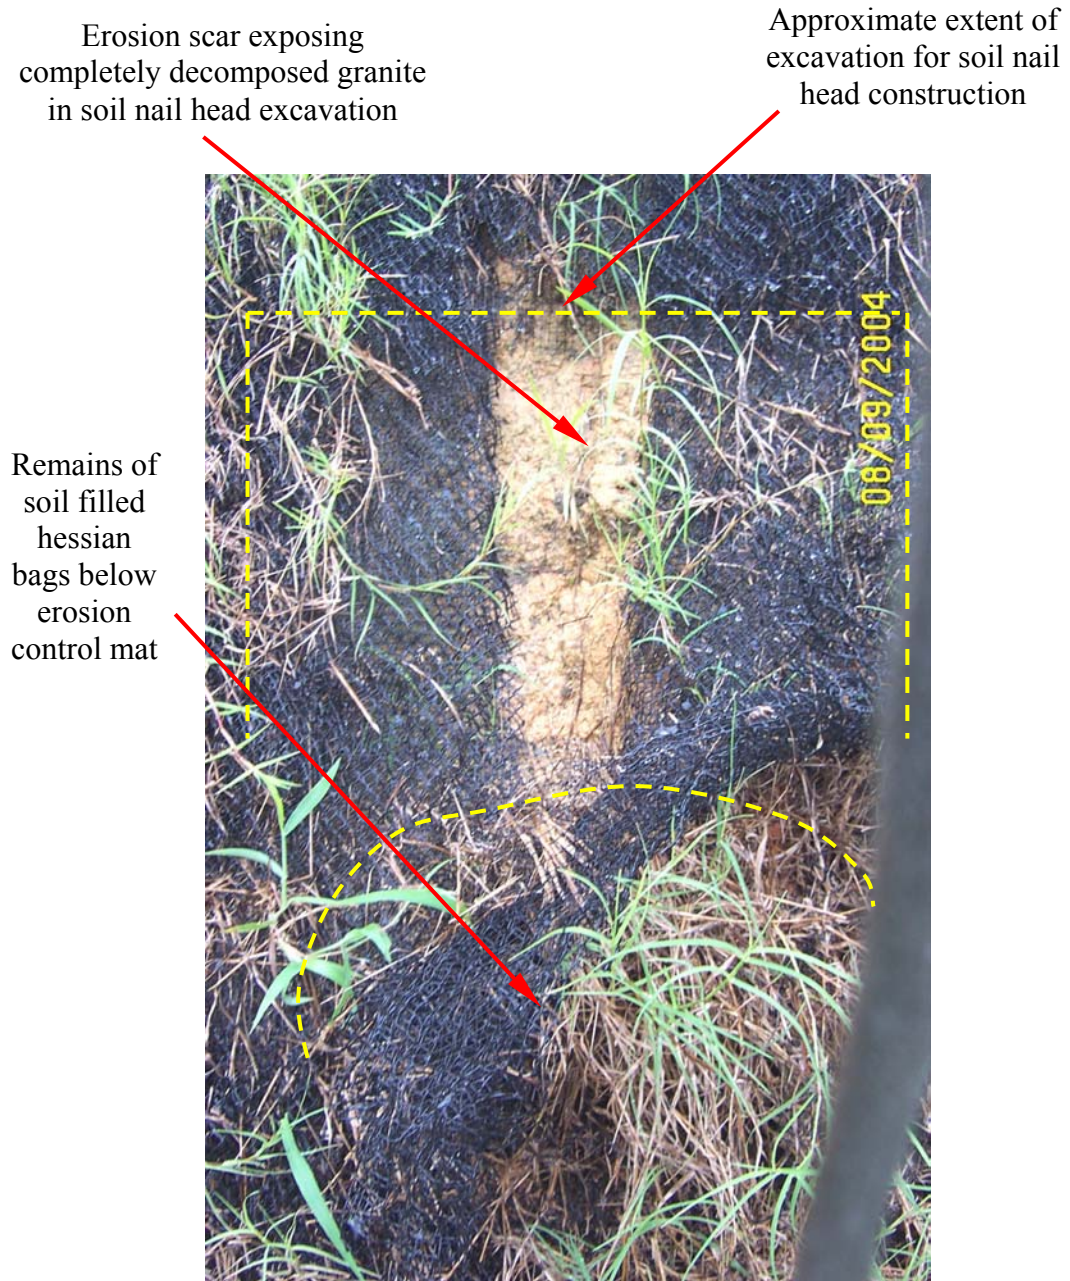
A soil nail head below the one at which the June 2004 washout occurred, and at which the erosion control mat had also been cut was inspected in detail by FSW. A small erosion scar was observed in the upper portion of the area (Plate 12). The remains of the soil-filled hessian bags were identified, and a piece of Hessian was removed (Plate 13), which proved to have rotten and was easily broken up by hand.

Plate 12 - Soil Nail Head below the Location of June 2004 Washout Showing Erosion Control Mat having been Cut and Erosion Scar at Slope No. 10SW-D/C97 (Photograph taken on 8 September 2004)

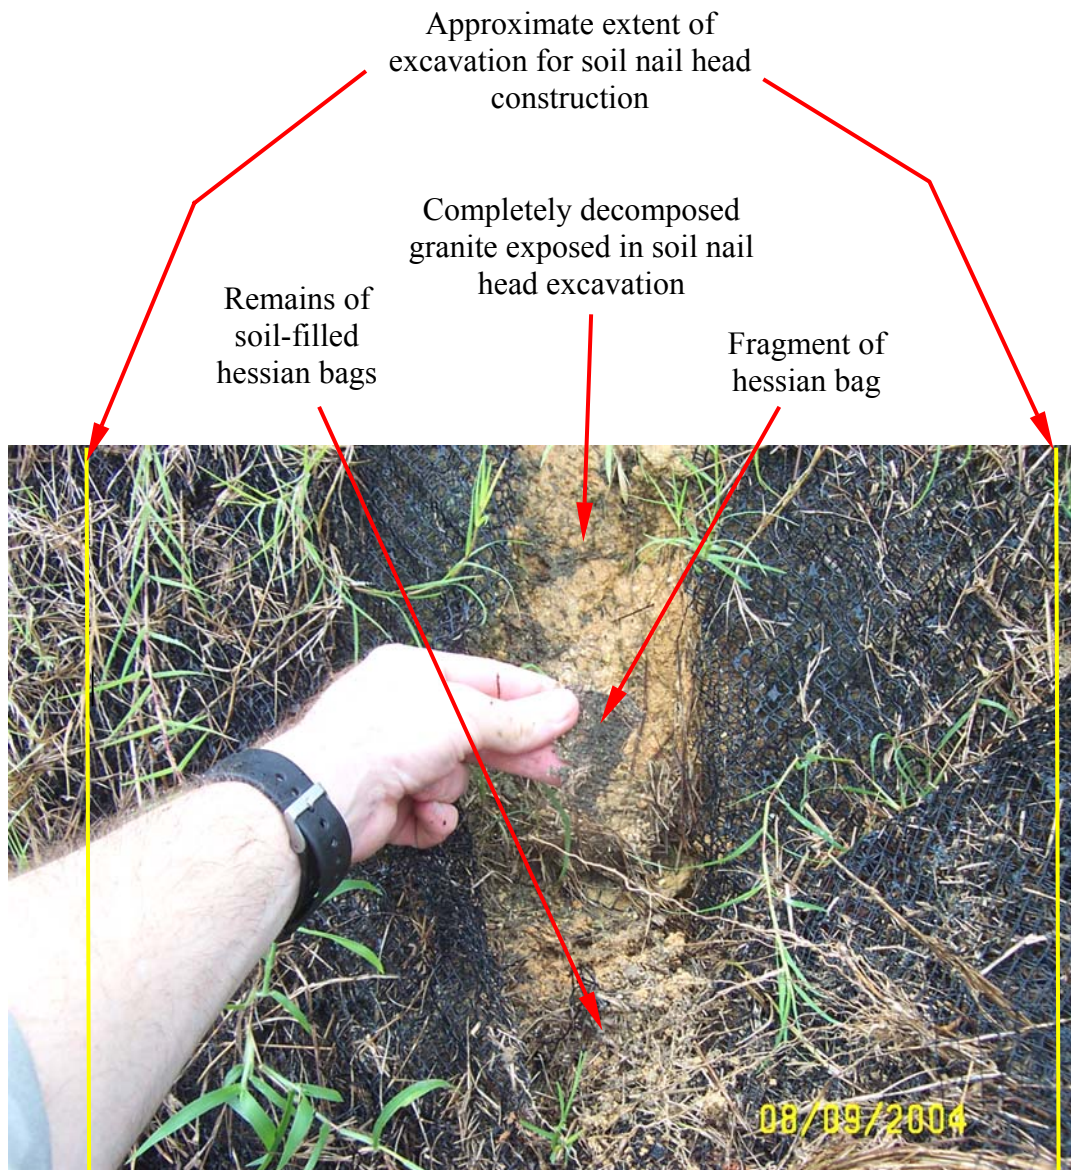
Plate 13 - Fragment of Rotten Hessian Sack Recovered from Beneath Erosion Control Mat at Slope No. 10SW-D/C97 (Photograph taken on 8 September 2004)

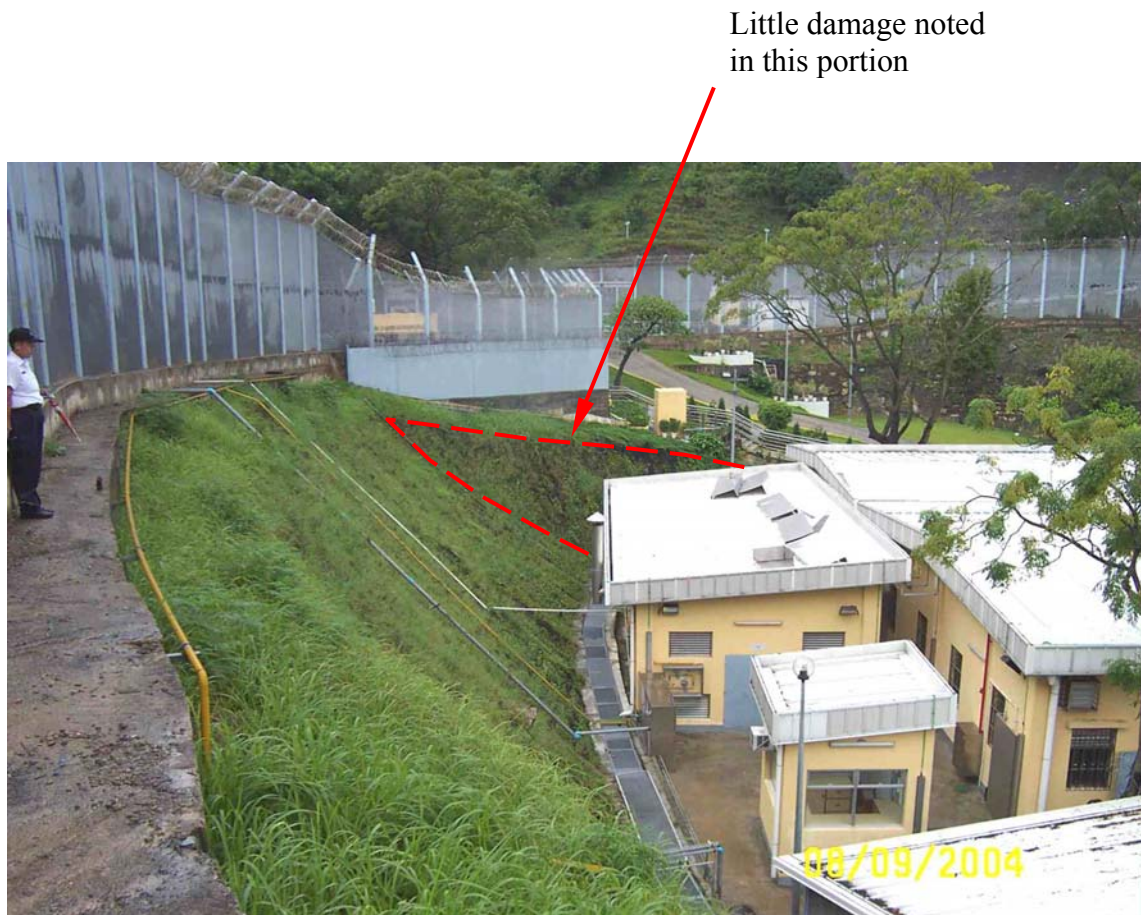
Little damage or disturbance to the erosion control mat was observed at the extreme southern end of the slope (Plate 14), where the slope height reduces and the slope angle increases, probably sufficiently to prevent foot access to the slope face.

Plate 14 - View South Along Slope Crest Indicating Steeper Southern Portion of Slope No. 10SW-D/C97 where Little Damage to Erosion Control Mats (Photograph taken on 8 September 2004)

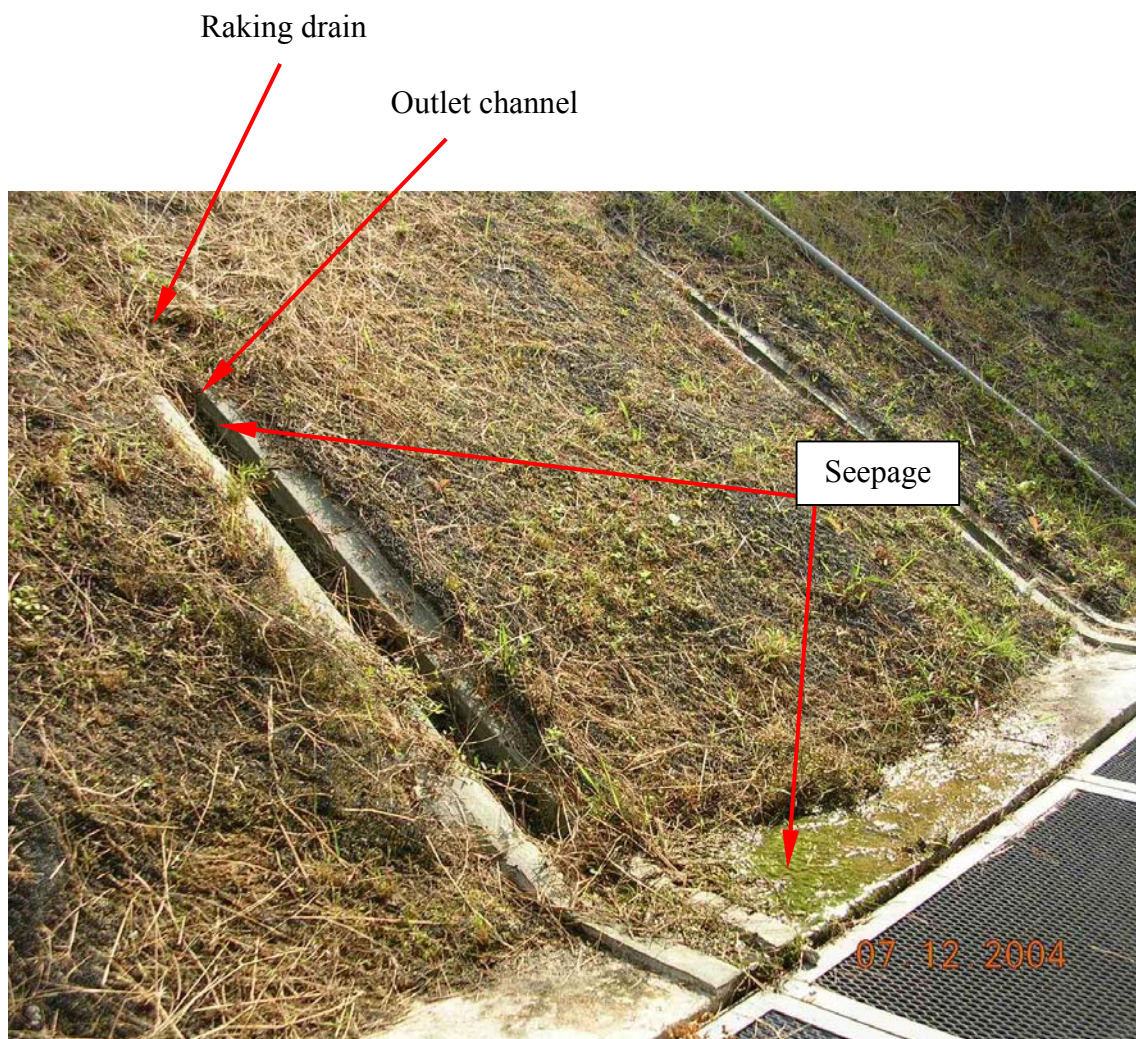
At the time of the 7 December 2004 inspection, seepage was observed from the raking drains at the southern end of the feature and at various locations of the slope toe (Plate 15).

Plate 15 - Seepage at Southern End of Slope No. 10SW-D/C97
(Photograph taken on 7 December 2004)

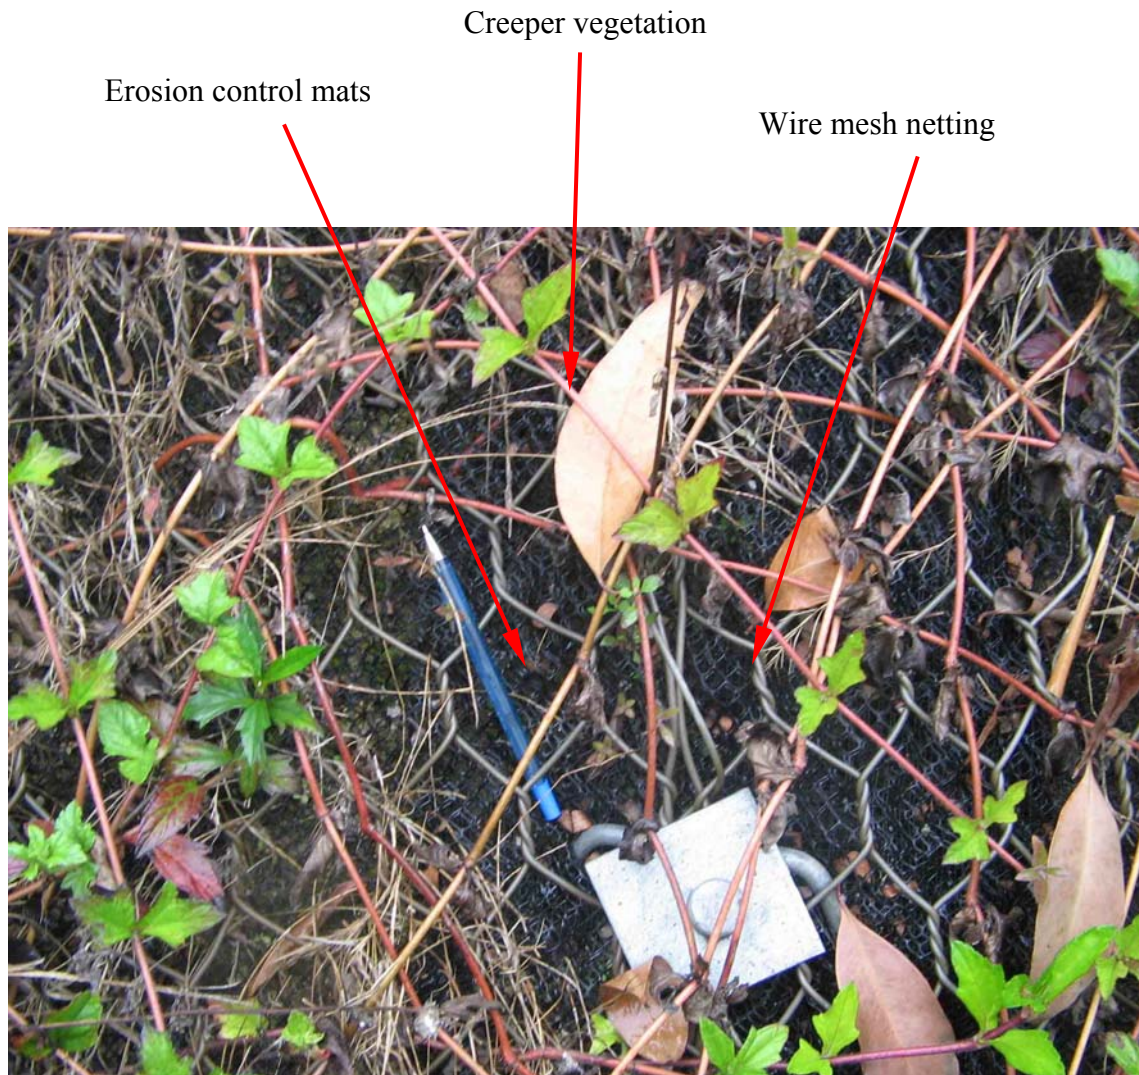
Slopes Nos. 10SW-D/C27, 10SW-D/C35 and 10SW-D/C139 (Plates 16, 17 and 18) incorporate a wire mesh netting lying over the erosion control mat. This appeared to have provided a barrier against trimming tools and mitigated the abrasive effects of pedestrian access, as in all cases, the erosion control mat was found to be in good condition, with no obvious signs of damage (Plates 19, 20 and 21).

Plate 19 - Close View of Wire Mesh Netting Overlying Erosion Control Mat on Slope No. 10SW-D/C27 (Photograph taken on 11 March 2005)

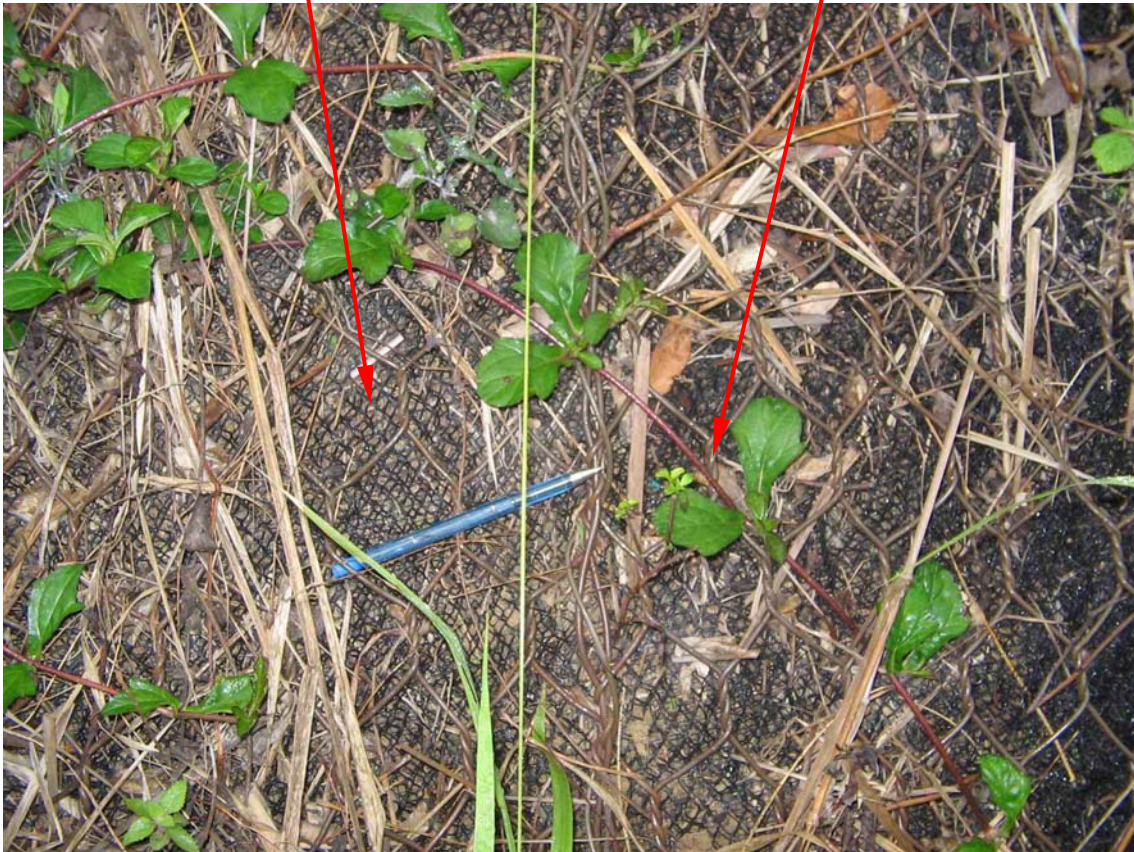
Plate 20 - Close View of Wire Mesh Netting overlying Erosion Control Mat
on Southwesterly Facing Portion of Slope No. 10SW-D/C35
(Photograph taken on 11 March 2005)

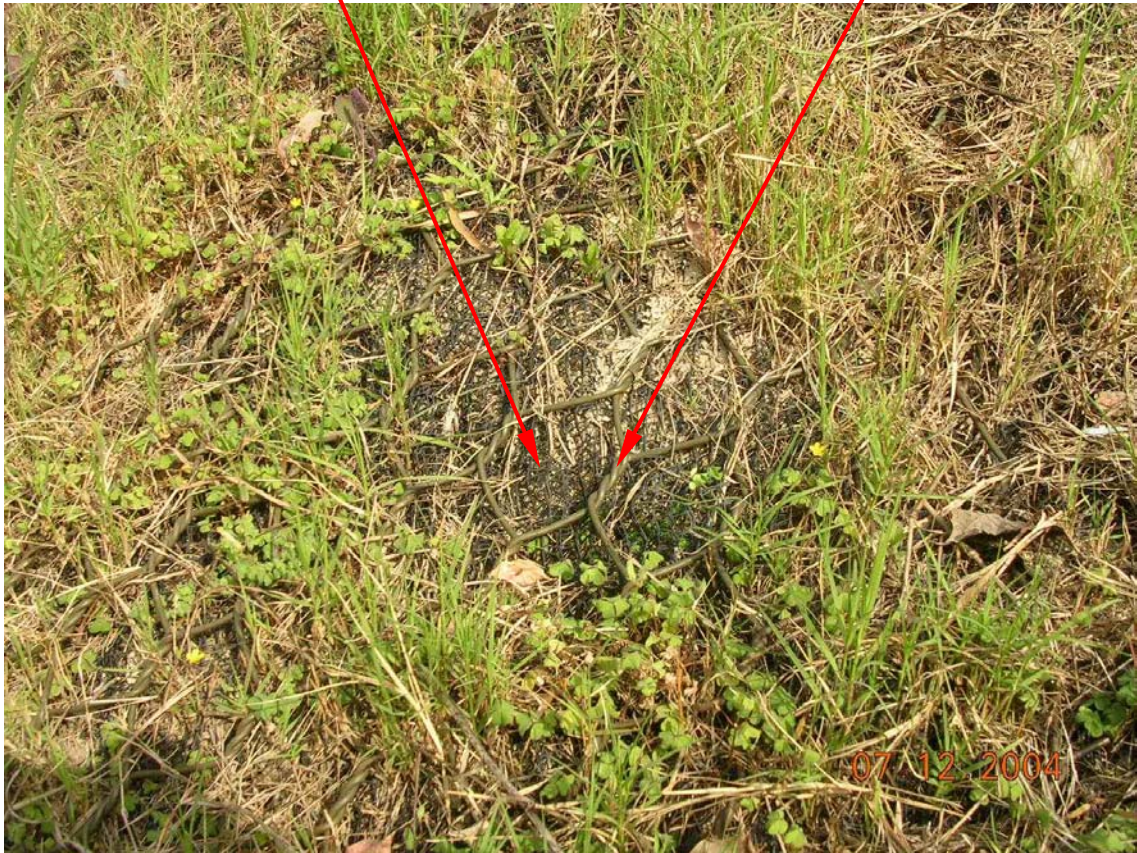
Plate 21 - Close View of Wire Mesh Netting Overlying Erosion Control Mats
on Slope No. 10SW-D/C139 (Photograph taken on 7 December 2004)

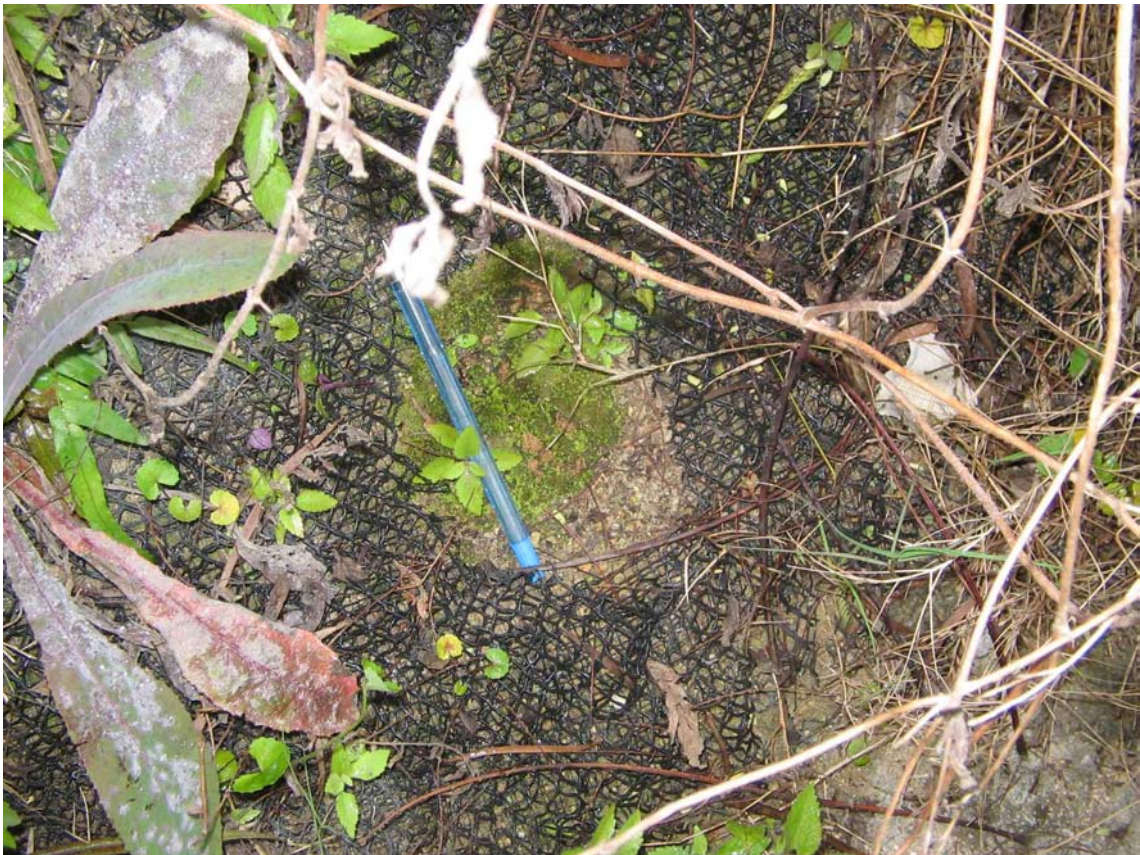
The erosion control mats on slopes Nos. 10SW-D/C28, 10SW-D/C101 and 10SW-D/C102 (Plates 22, 23 and 24), which did not incorporate wire mesh netting, all showed signs of having been cut after placement (Plates 25, 26 and 27), although to a lesser extent than that observed on slope No. 10SW-D/C97 where the June 2004 landslide incident occurred. A factor in the condition of the erosion control mat for these slopes appeared to be the choice of different vegetations, as the 'creeper' type vegetation cover applied to the upper batter of slope No. 10SW-D/C28 and also slope No. 10SW-D/C27 (Plates 28 and 19 respectively) formed a network of stems on the erosion control mat that did not appear to be removed during vegetation trimming (underway on slope No. 10SW-D/C28 at the time of inspection by FSW in March 2005), whilst the grass cover on the lower batter of slope No. 10SW-D/C28 and slope No. 10SW-D/C102 had been trimmed down to the erosion control mat.

Plate 25 - Isolated Location on Lower Batter of Slope No. 10SW-D/C28 where Erosion Control Mat has been Cut (Photograph taken on 11 March 2005)

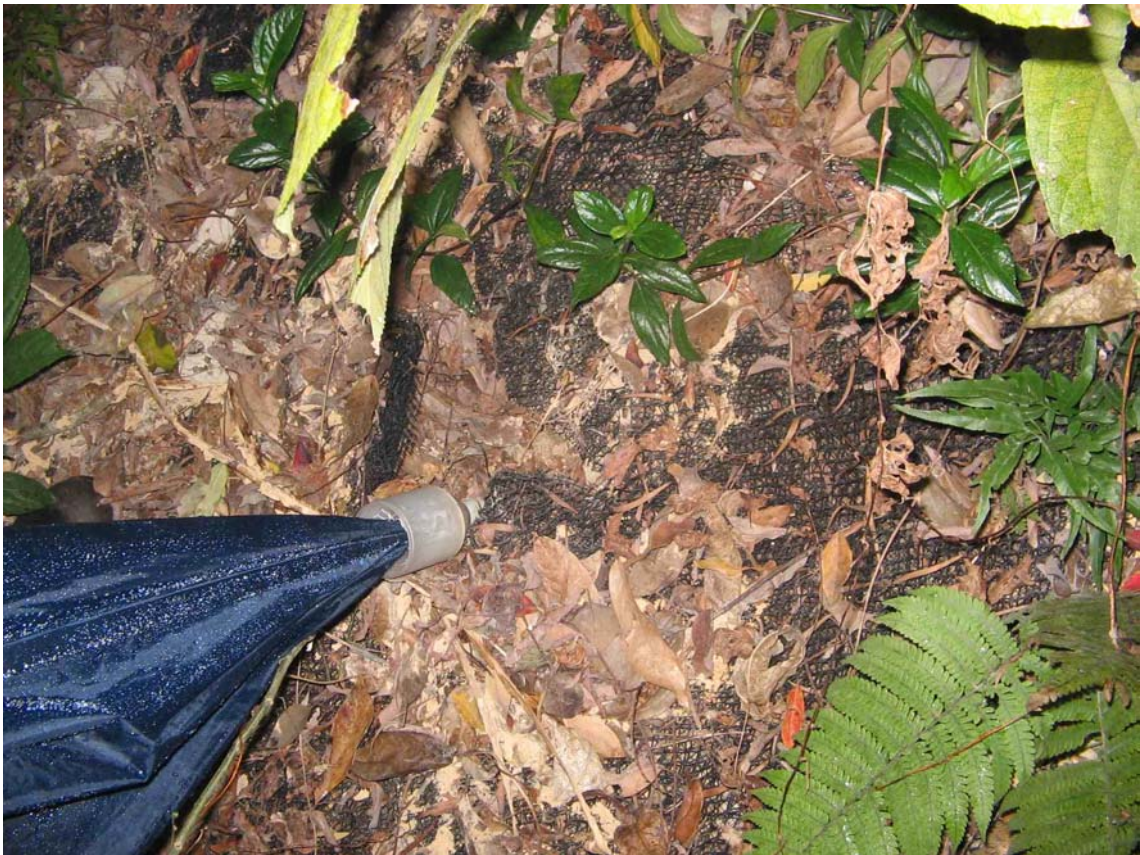
Plate 26 - Example of Erosion Control Mat having been Cut on Slope No. 10SW-D/C101
(Photograph taken on 11 March 2005)

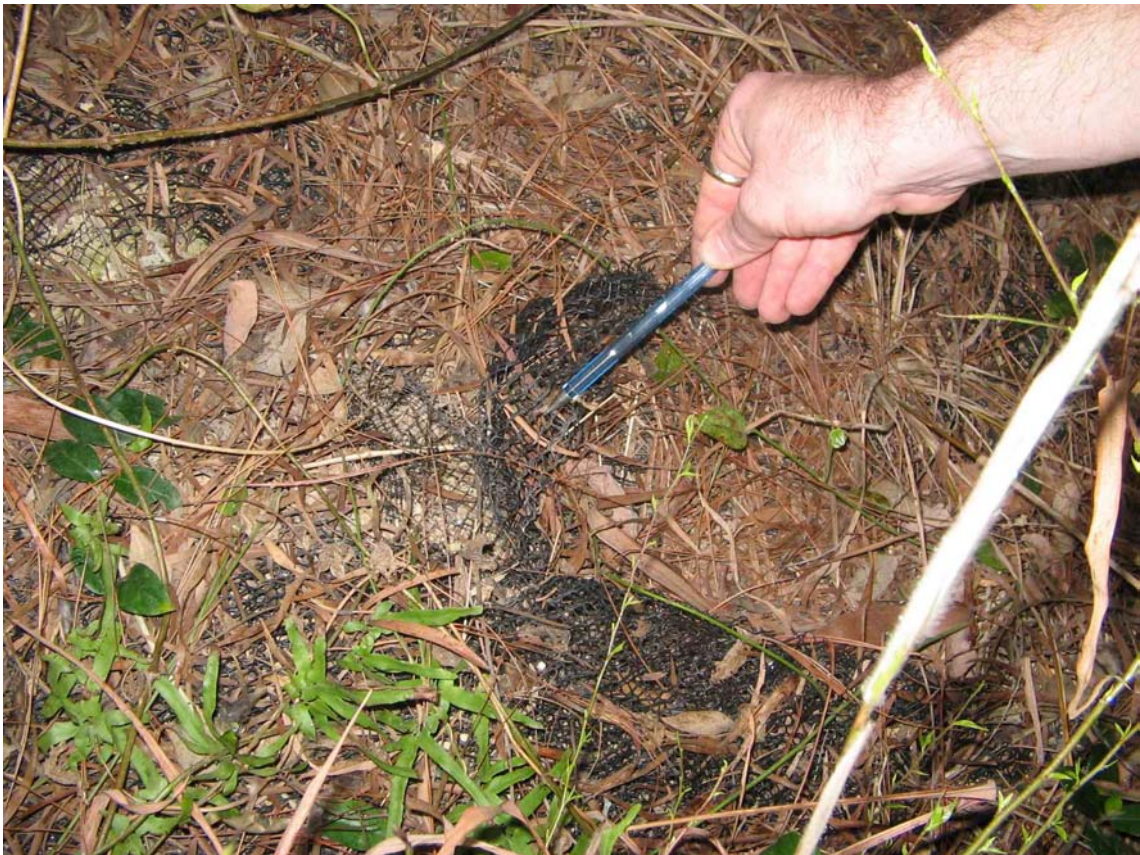
Plate 27 - Example of Erosion Control Mat having been Cut on Face of
Slope No. 10SW-D/C102 (Photograph taken on 11 March 2005)
