REVIEW OF THE JUNE 2004 WASHOUT INCIDENT ON SLOPE NO. 10SW-D/C97 AT ADDICTION TREATMENT CENTRE, HEI LING CHAU

GEO REPORT No. 201

Fugro Scott Wilson Joint Venture

**This report was originally produced in May 2005
as GEO Landslide Study Report No. LSR 6/2005**

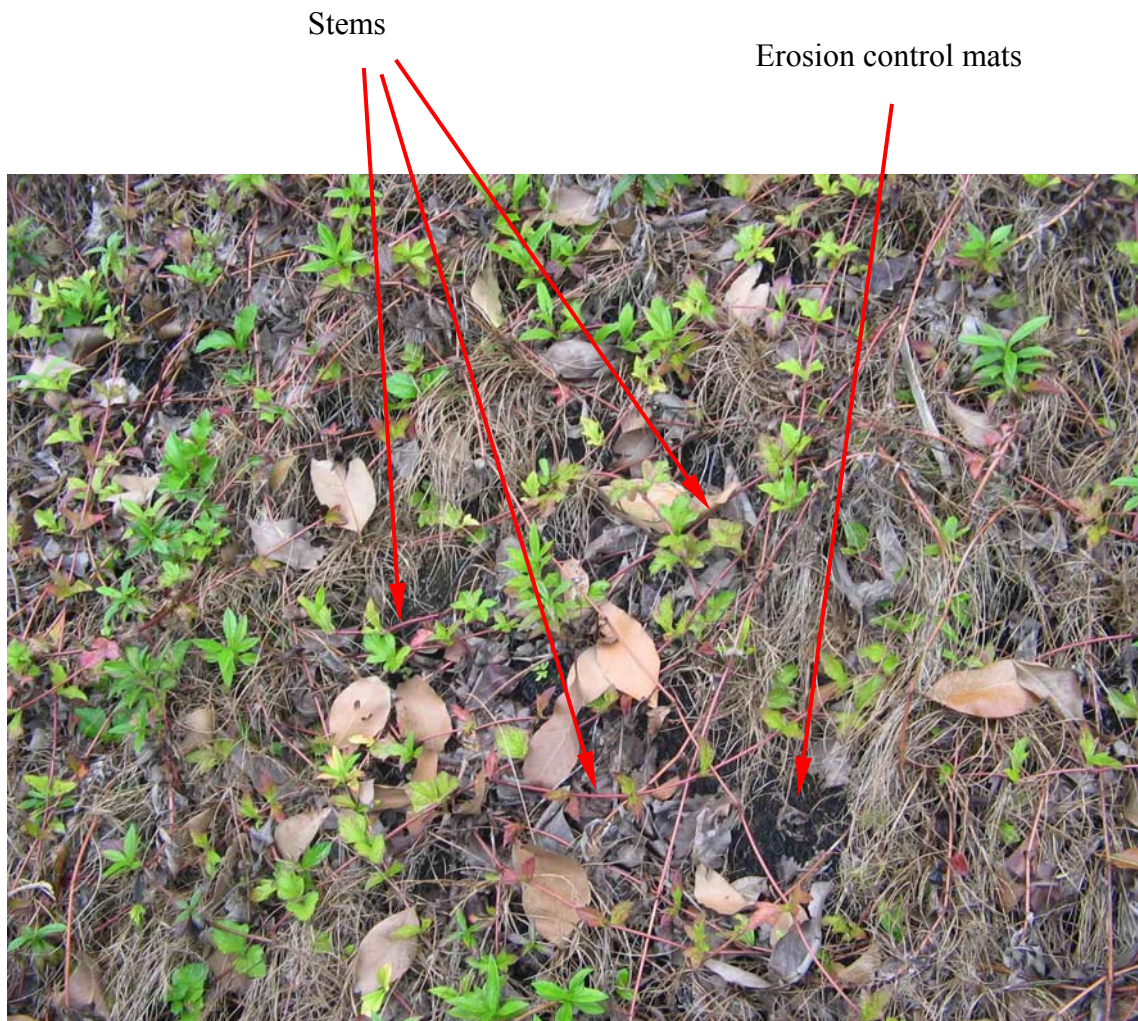
Plate 28 - Creeper Vegetation on Upper Batter of Slope No. 10SW-D/C28
forming Networks of Stems Covering Erosion Control Mat
(Photograph taken on 11 March 2005)

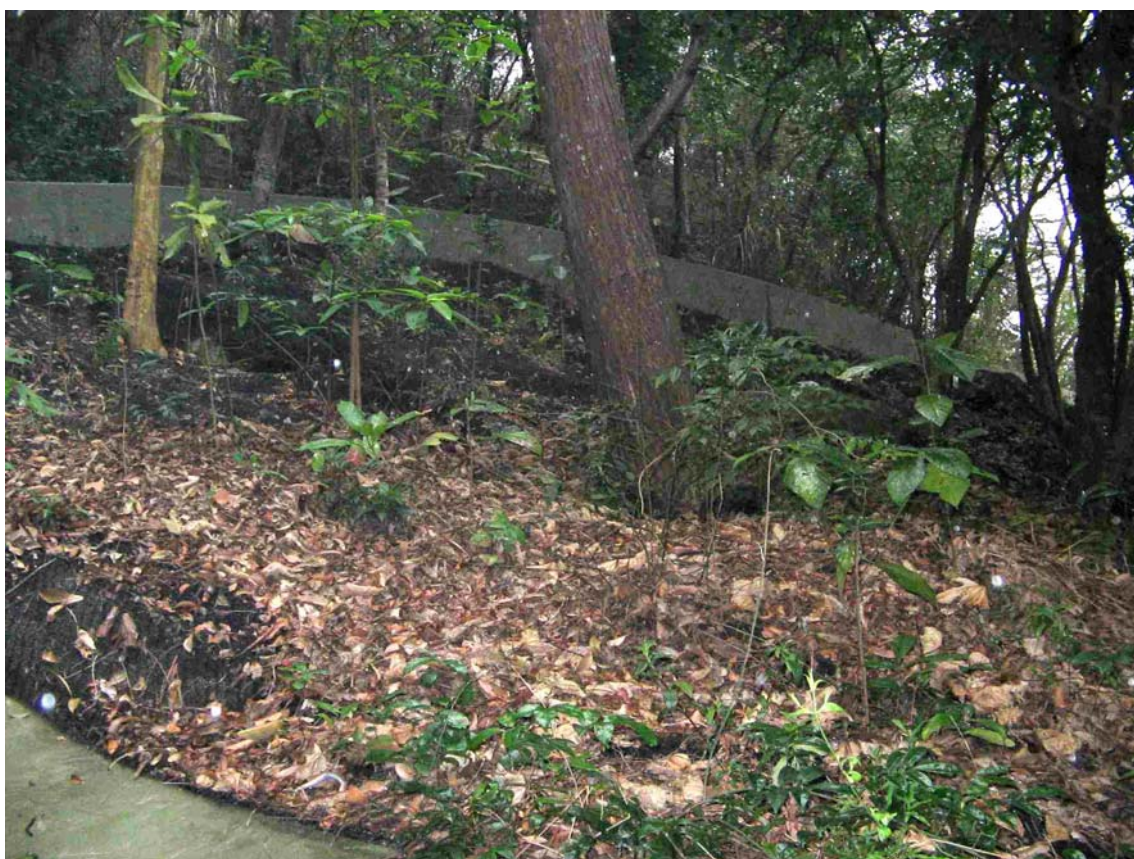
face of slope No. 10SW-D/C101 (Plates 23 and 29), which appeared to be hindered by the extensive tree cover and resulting leaf litter, as well as the gap between the erosion control mat and the underlying ground surface over significant areas. These two features probably further limited the amount of sun light reaching the slope face and reduce vegetation growth.

Plate 29 - Northeastern Portion of Slope No. 10SW-D/C101 where Establishment of Ground Cover Vegetation Limited by Tree Canopy and Leaf Litter
(Photograph taken on 11 March 2005)

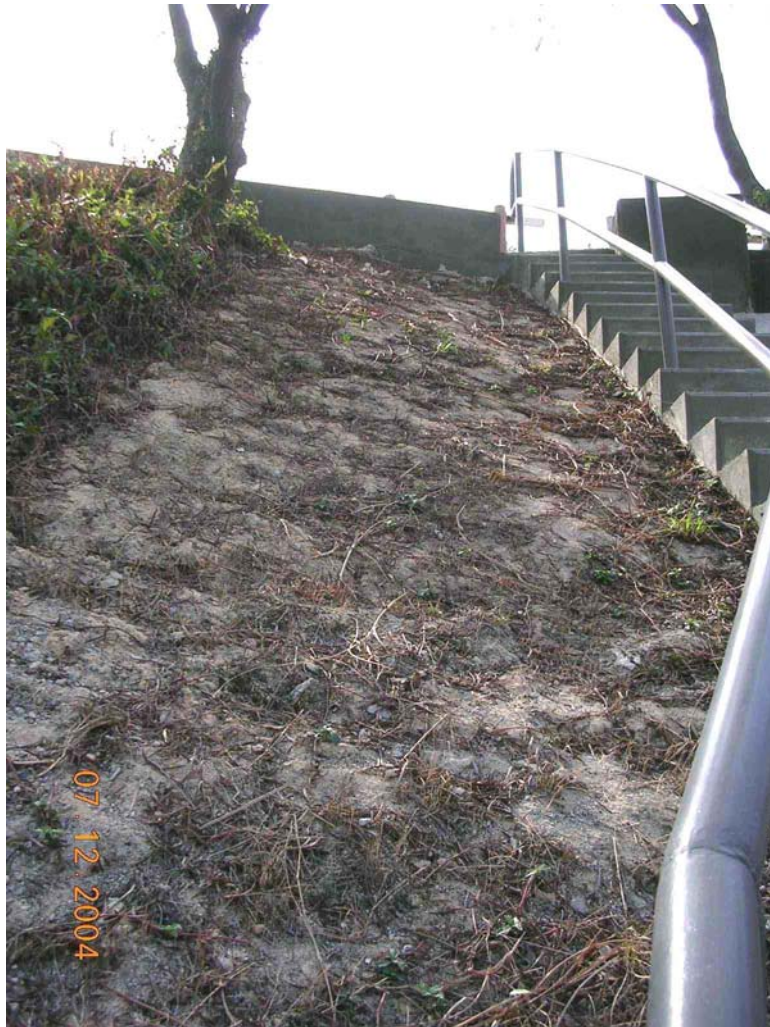
At the time of the inspection by FSW of slope No. 10SW-D/F55 in December 2004, which did not incorporate wire mesh netting or erosion control matting at the slope face, the majority of the slope face had recently undergone vegetation trimming (Plate 30). A small portion of the eastern end of the feature retained a dense cover of grass and creeper vegetation (Plate 31). A number of areas on the slope face were completely stripped of vegetation, exposing the topsoil below (Plates 32 and 33).

Plate 32 - View of Area of Exposed Ground on Face of Slope No. 10SW-D/F55 following Recent Vegetation Trimming (Photograph taken on 7 December 2004)

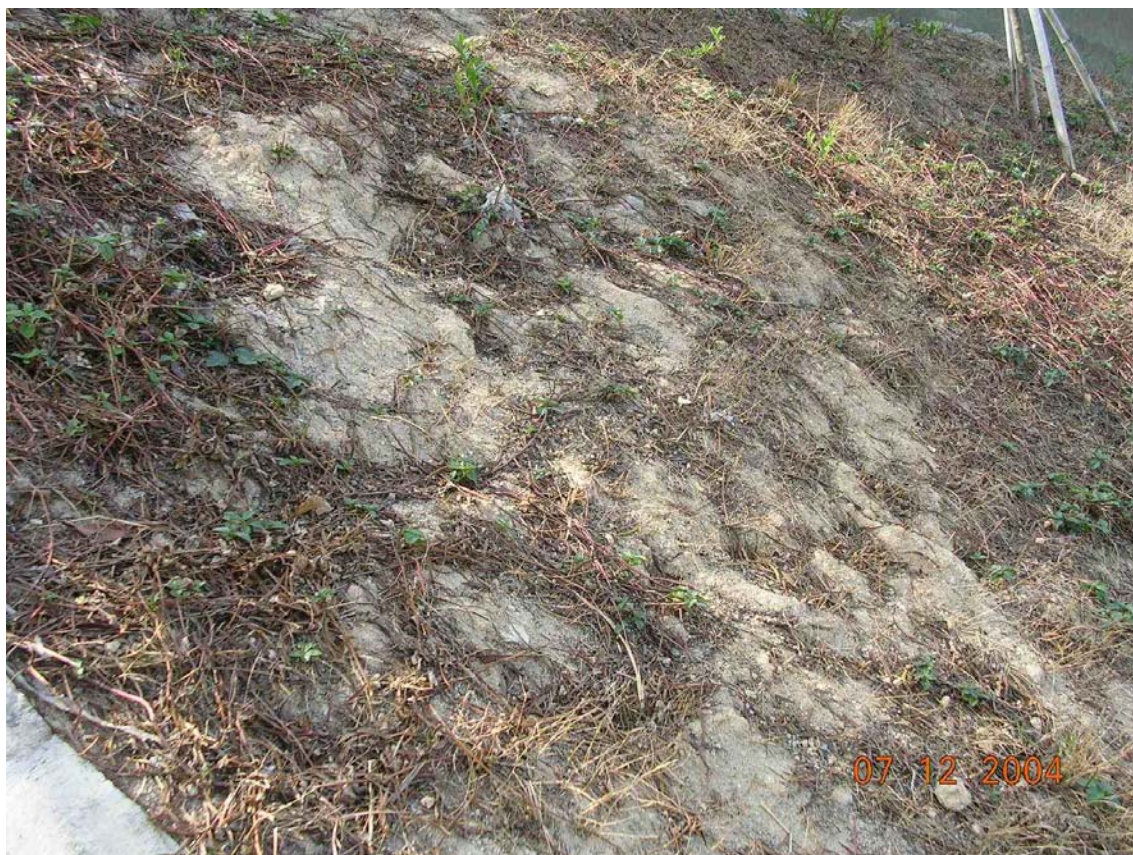
Plate 33 - Close View of Area of Exposed Ground on Face of Slope No. 10SW-D/F55 following Recent Vegetation Trimming (Photograph taken on 7 December 2004)
