STUDY OF DISTRESS ON SLOPE NO. 11SW-D/FR1 BELOW STUBBS ROAD HAPPY VALLEY

GEO REPORT No. 204

Fugro Scott Wilson Joint Venture

**GEOTECHNICAL ENGINEERING OFFICE
CIVIL ENGINEERING AND DEVELOPMENT DEPARTMENT
THE GOVERNMENT OF THE HONG KONG
SPECIAL ADMINISTRATIVE REGION**

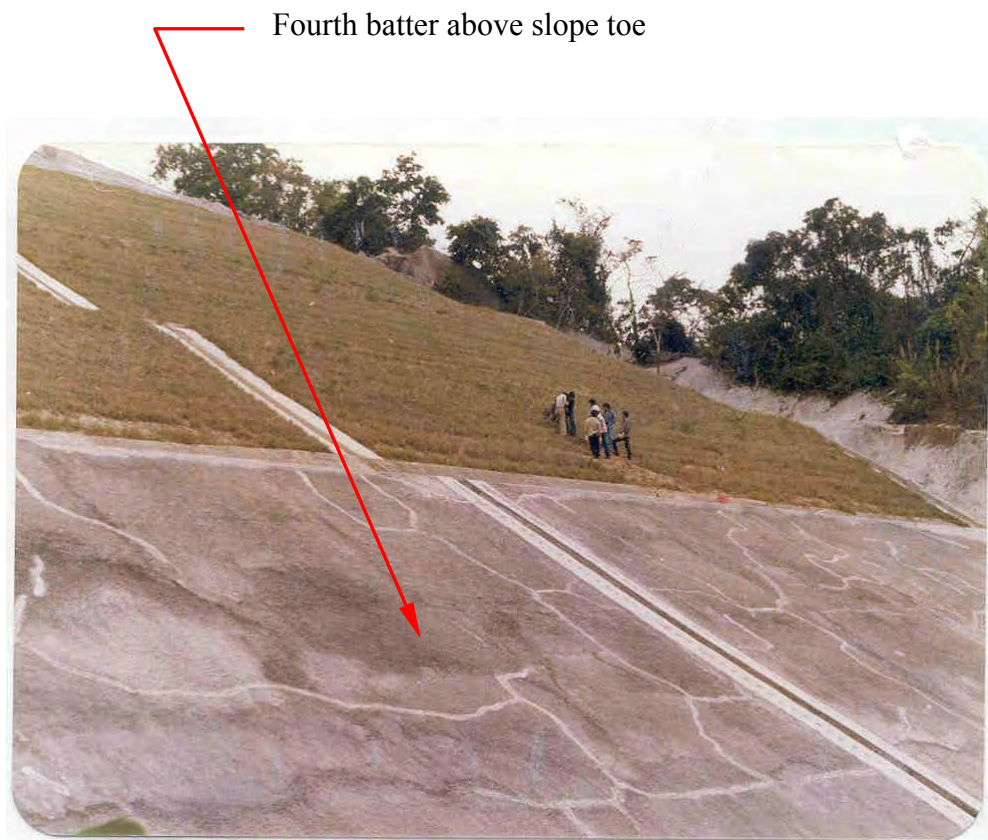
Cracking of the shotcrete on the fourth batter above the slope toe can be seen in close view from record photographs in a report by McFarlane (1980), which were taken in connection with the monitoring of tensiometers by the Geotechnical Control Office (GCO, renamed GEO in 1991), see Plate 9. A laterally extensive crack present in the shotcrete surfacing of the fourth batter above the slope toe is also seen in the 1981 aerial photographs. The 1982 and 1983 aerial photographs show that the crack on the fourth batter had become more prominent, with the development of additional cracking and discernible bulging of the shotcrete cover (Plate 10). Cracking was also observed on the third batter above the slope toe during the same period.

Plate 9 - View Northwest across Fourth Batter above Slope Toe showing Extensive Cracking on Shotcreted Surface in 1980

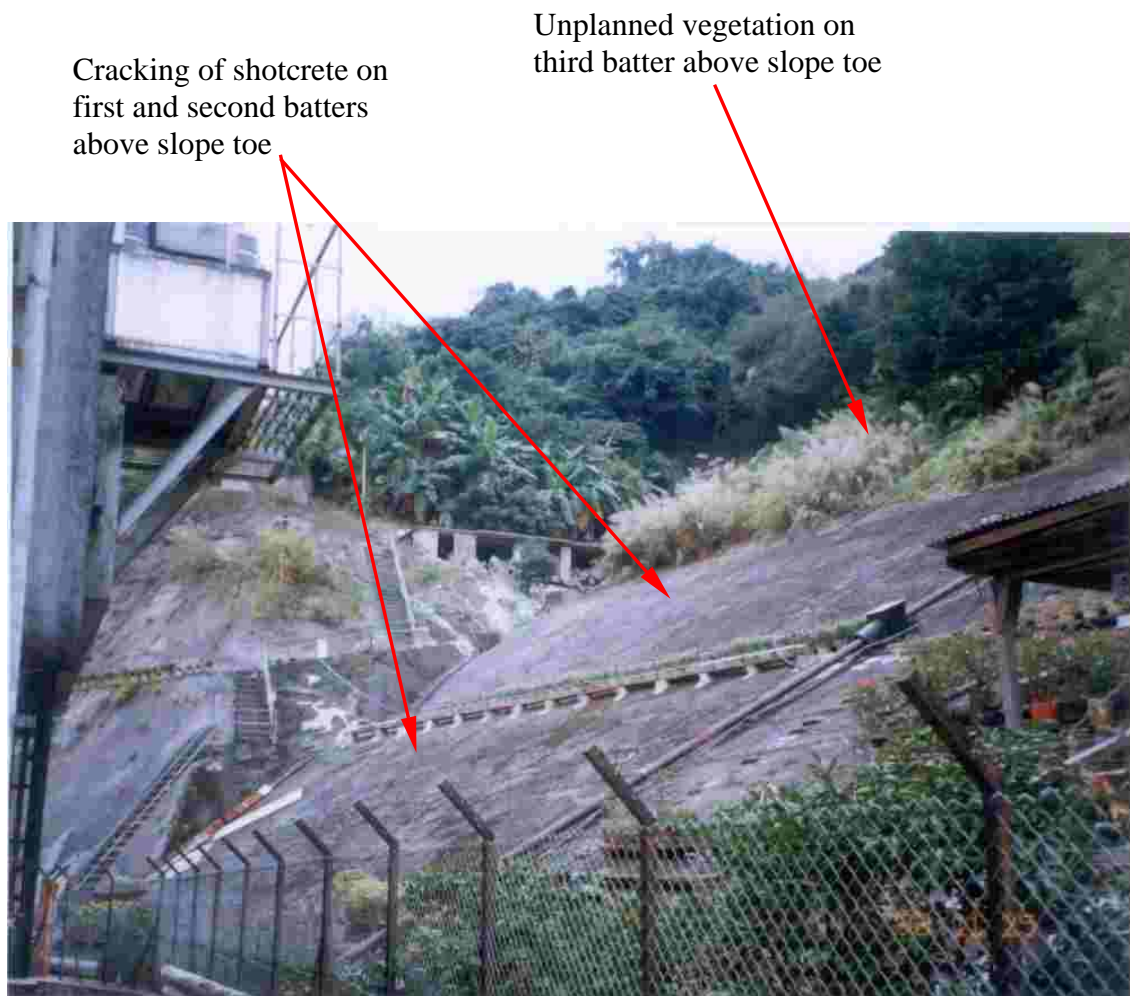
The records of the 1998 inspection (Plate 13) indicate similar observations to the 1995 inspections and noted that no follow-up action was necessary, except that cracking of the toe retaining wall was reported (Plate 14).

Plate 13 - View South across Lower Batters of Slope No. 11SW-D/FR1 (Photograph taken by Highways Department on 25 November 1998)

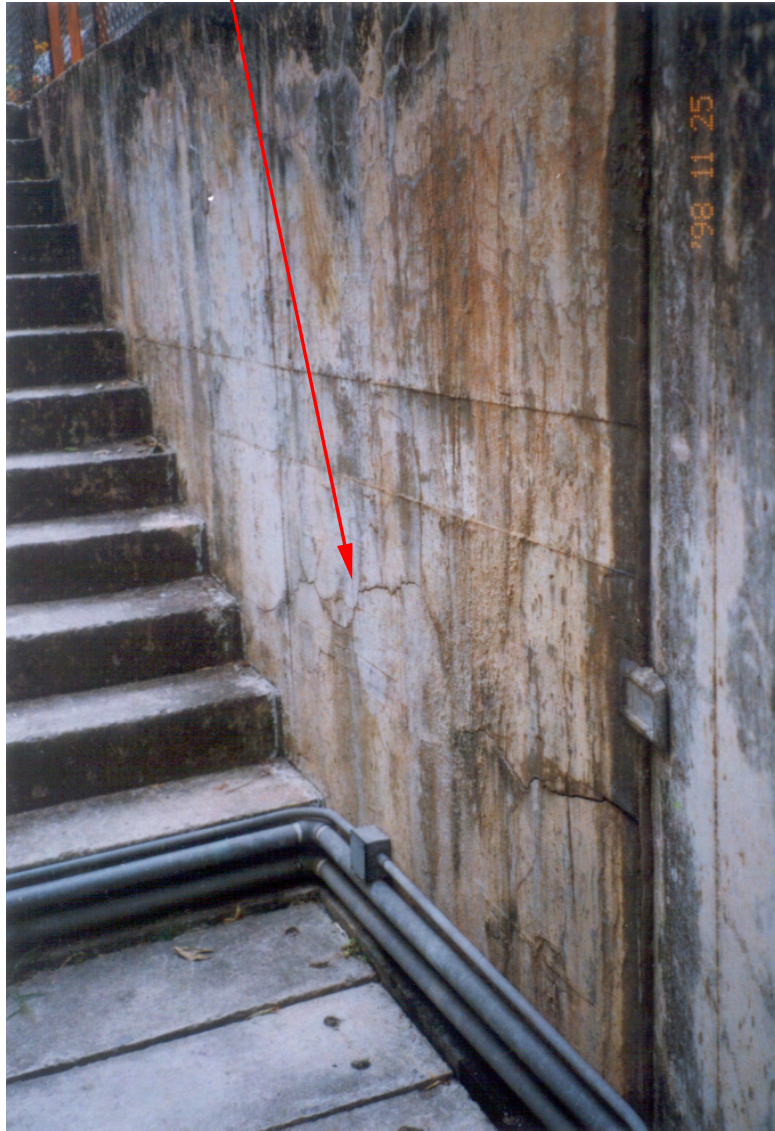
Cracking in mass concrete gravity retaining wall

Plate 14 - Cracking in Mass Concrete Gravity Retaining Wall near Access Stairs
(Photograph taken by Highways Department on 25 November 1998)

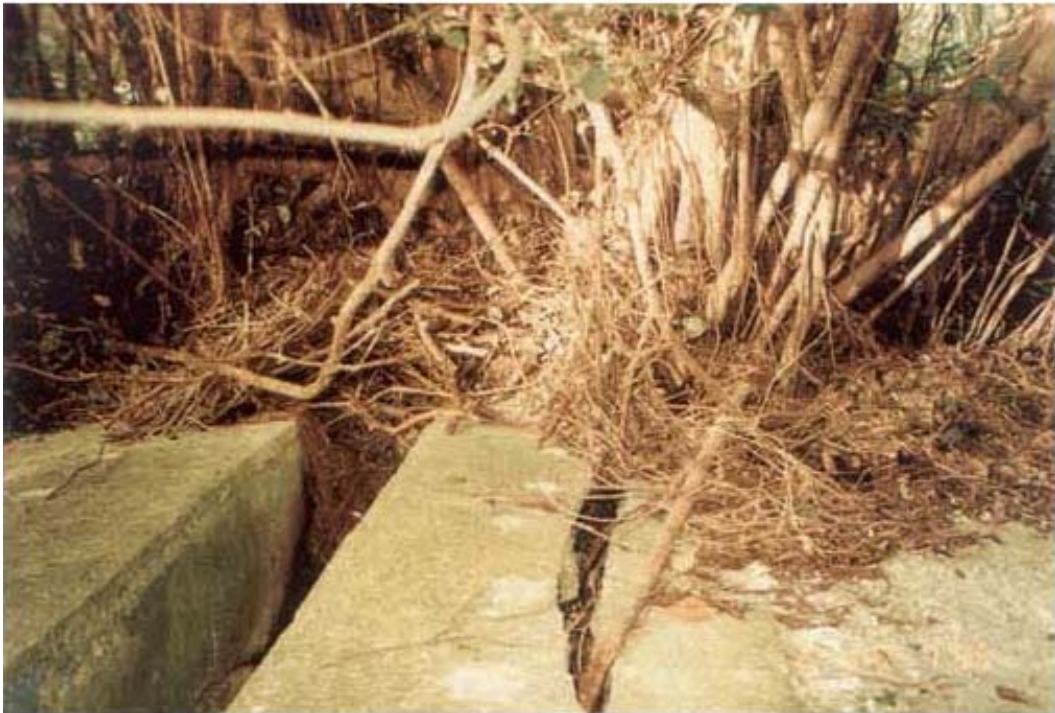
Plate 15 - View Down Stepped Channel on 4th Batter above Slope Toe Showing Severe Cracking between Channel Apron and Adjacent Shotcrete and Growth of Unplanned Vegetation (Photograph taken by Maunsell Geotechnical Services in July 1999)

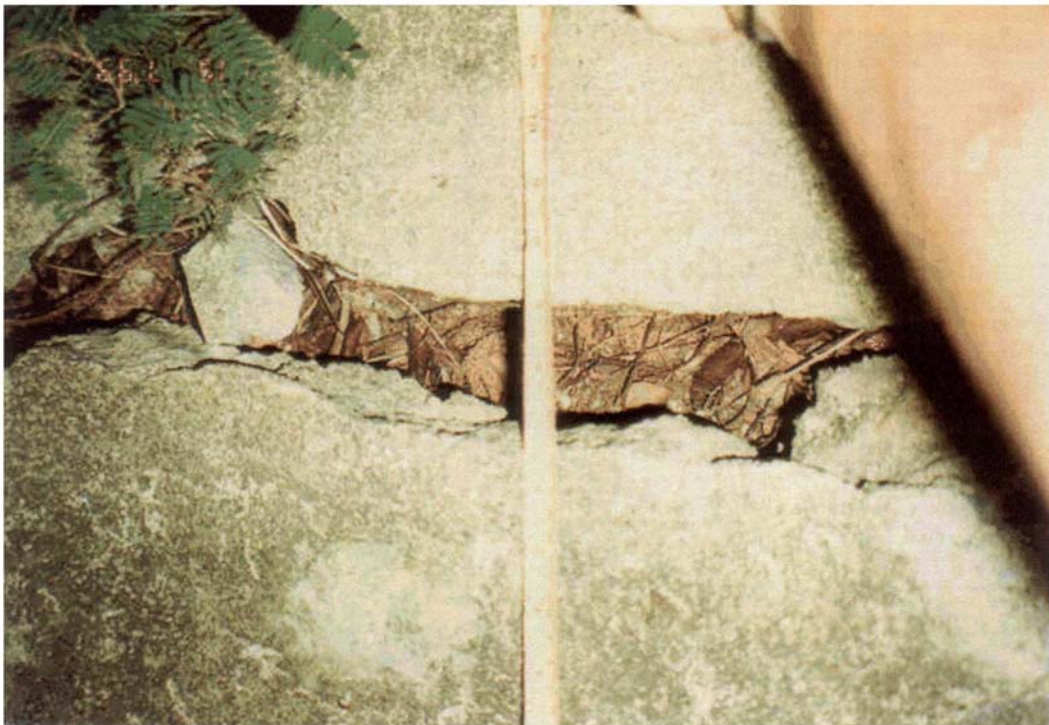
Plate 16 - Close View of Cracking between Stepped Channel Apron and Shotcrete on 4th Batter above Slope Toe (Photograph taken by Maunsell Geotechnical Services in July 1999)

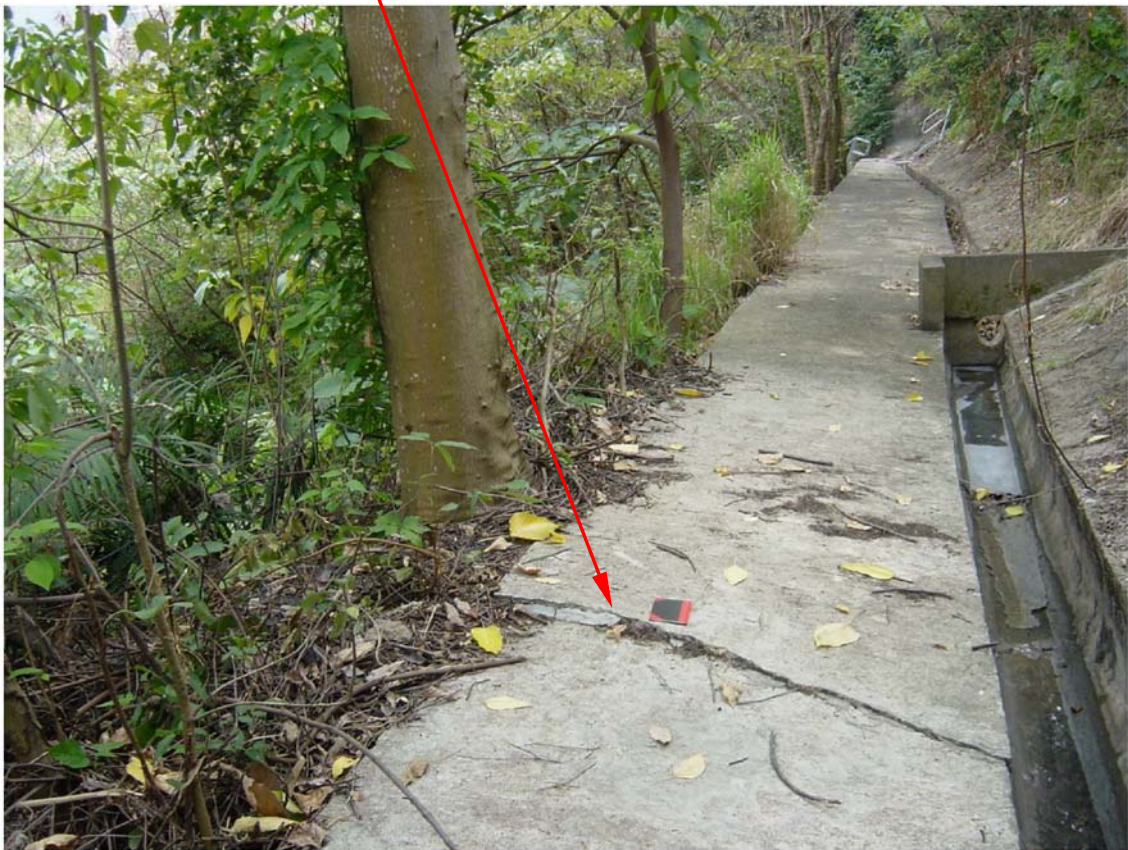
Transverse crack

Plate 17 - Typical Example of Transverse Crack in Berm Slab
(Photograph taken on 28 February 2004)

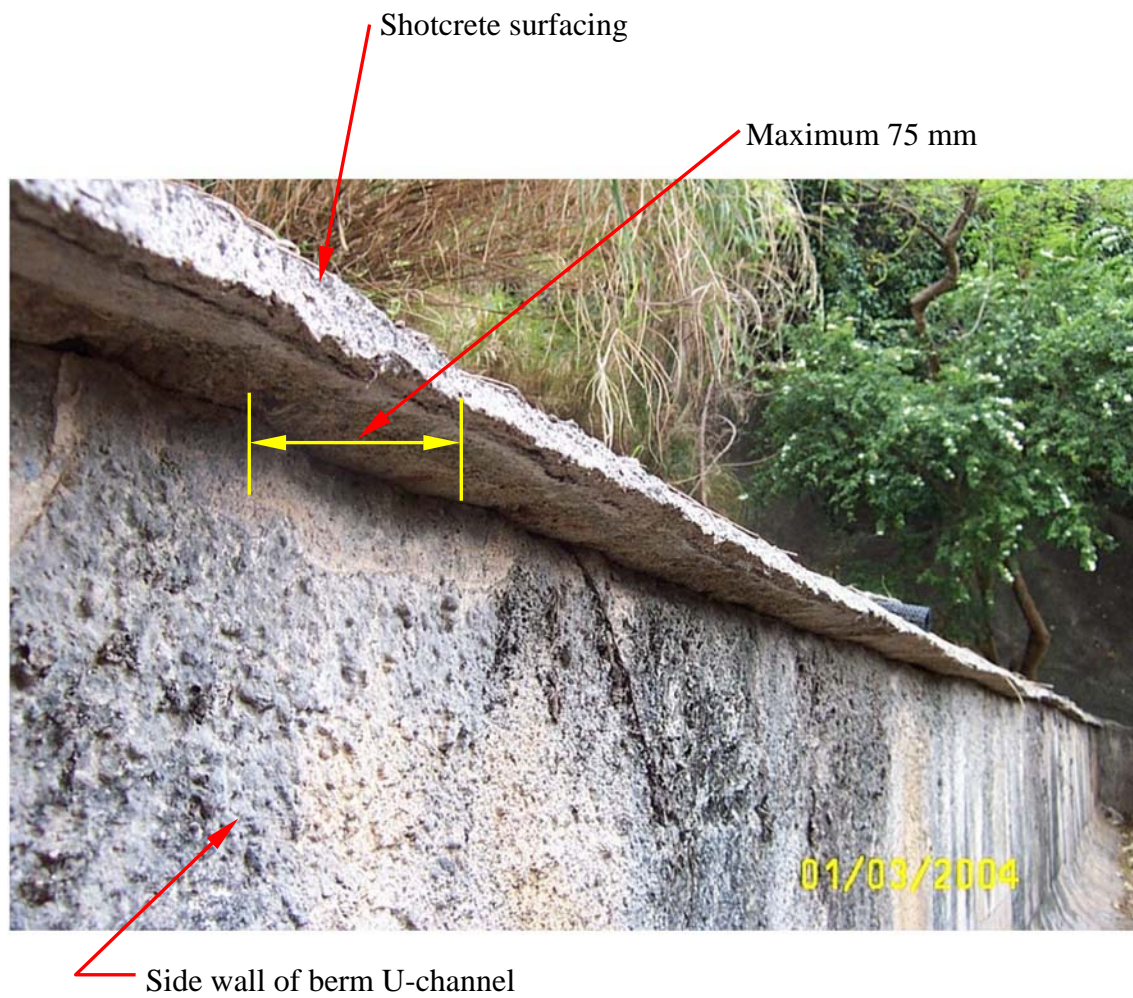
Plate 18 - Example of Shotcrete Surfacing Overhanging Berm U-channel
(Photograph taken on 1 March 2004)

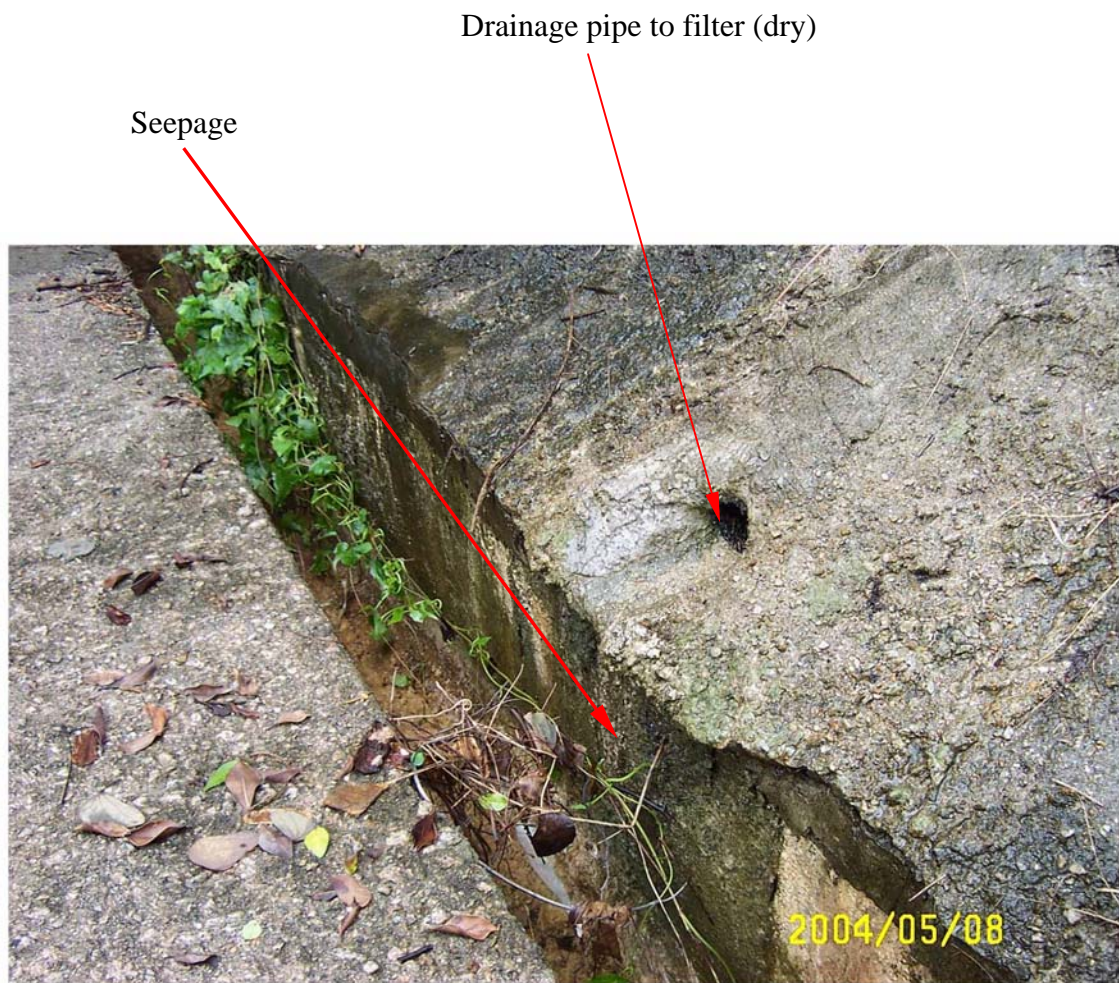
Plate 19 - Seepage Observed Flowing from Beneath Shotcrete Surfacing Following Light Rainfall on 8 May 2004 (Photograph taken on 8 May 2004)

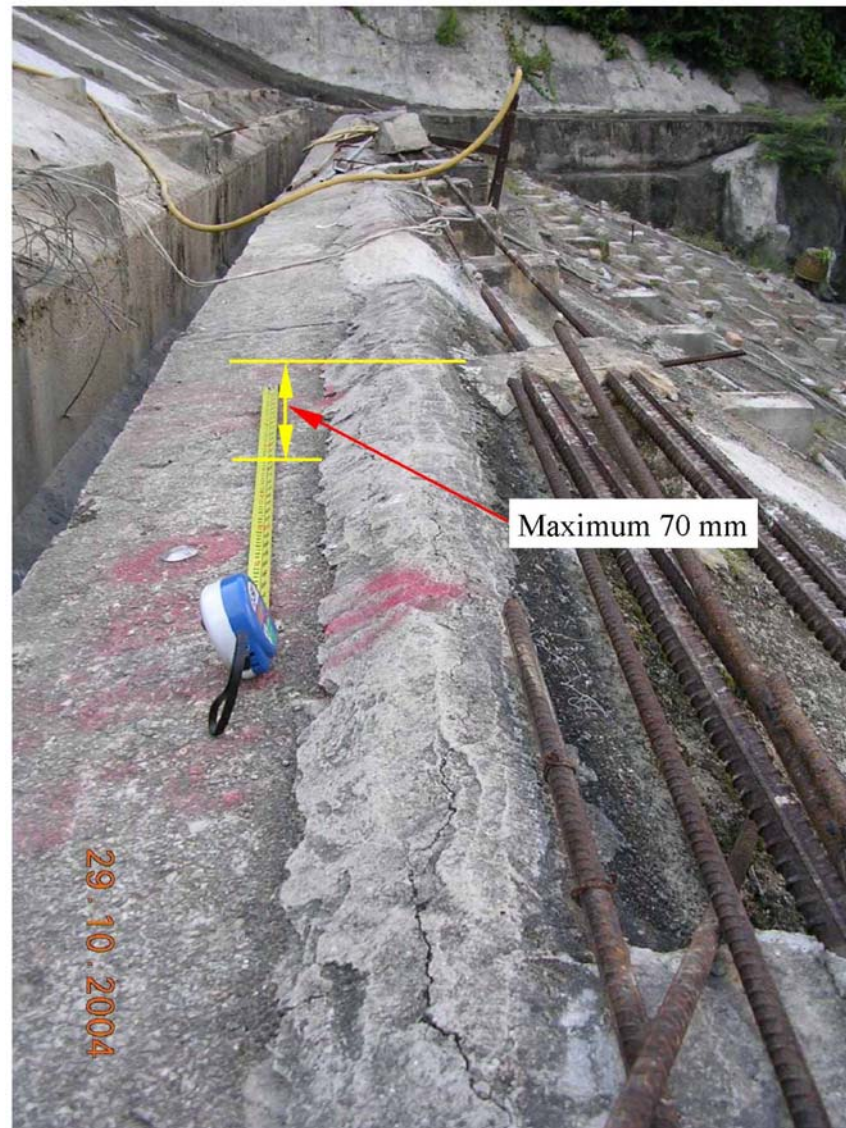
Plate 20 - Lip Formed at Crest of First Batter above Slope Toe through Differential Movement between Shotcrete and Berm Slab
(Photograph taken on 30 August 2004)

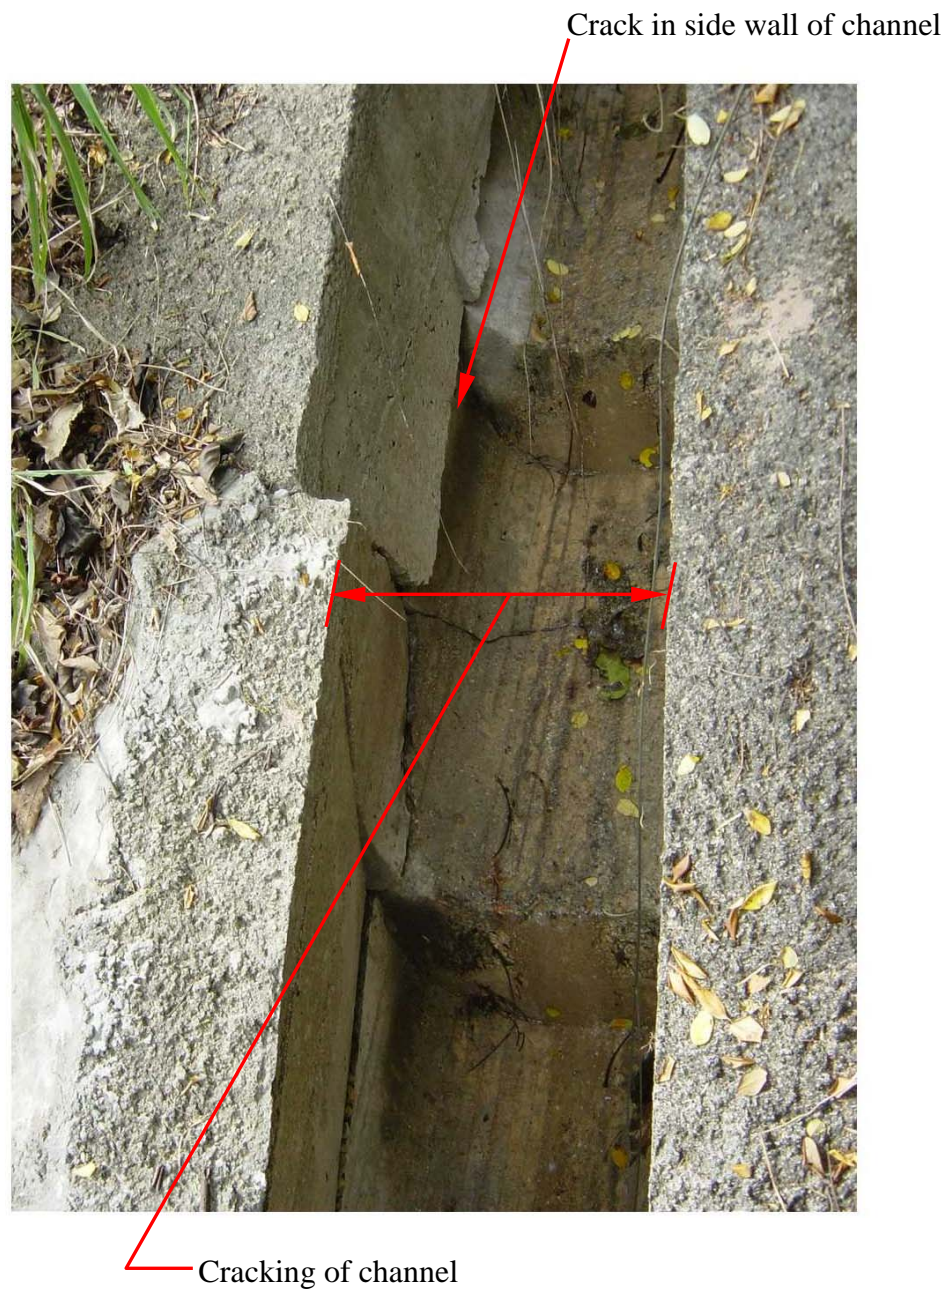
Plate 21 - Example of Cracked and Crushed Stepped U-channel
(Photograph taken on 28 February 2004)

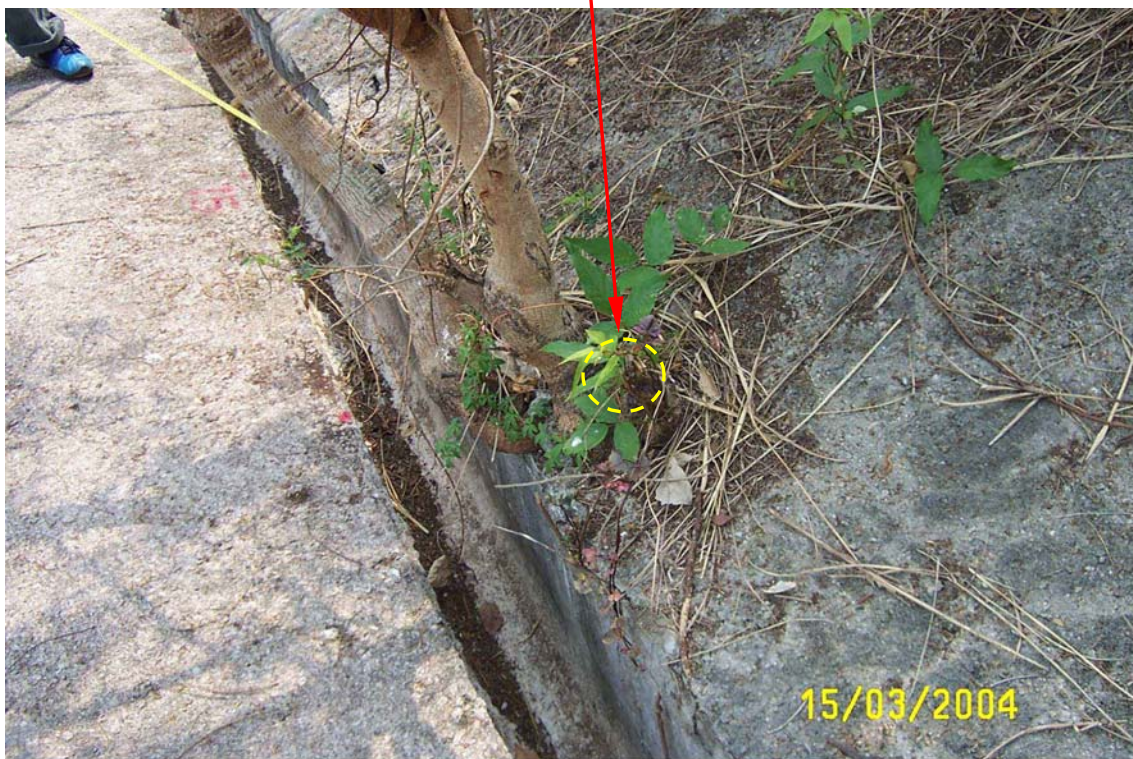
Outlet of 75 mm
diameter drainage pipe

Plate 22 - Example of Blocked 75 mm Diameter Drainage Pipe Exploited by
Unplanned Vegetation (Photograph taken on 15 March 2004)

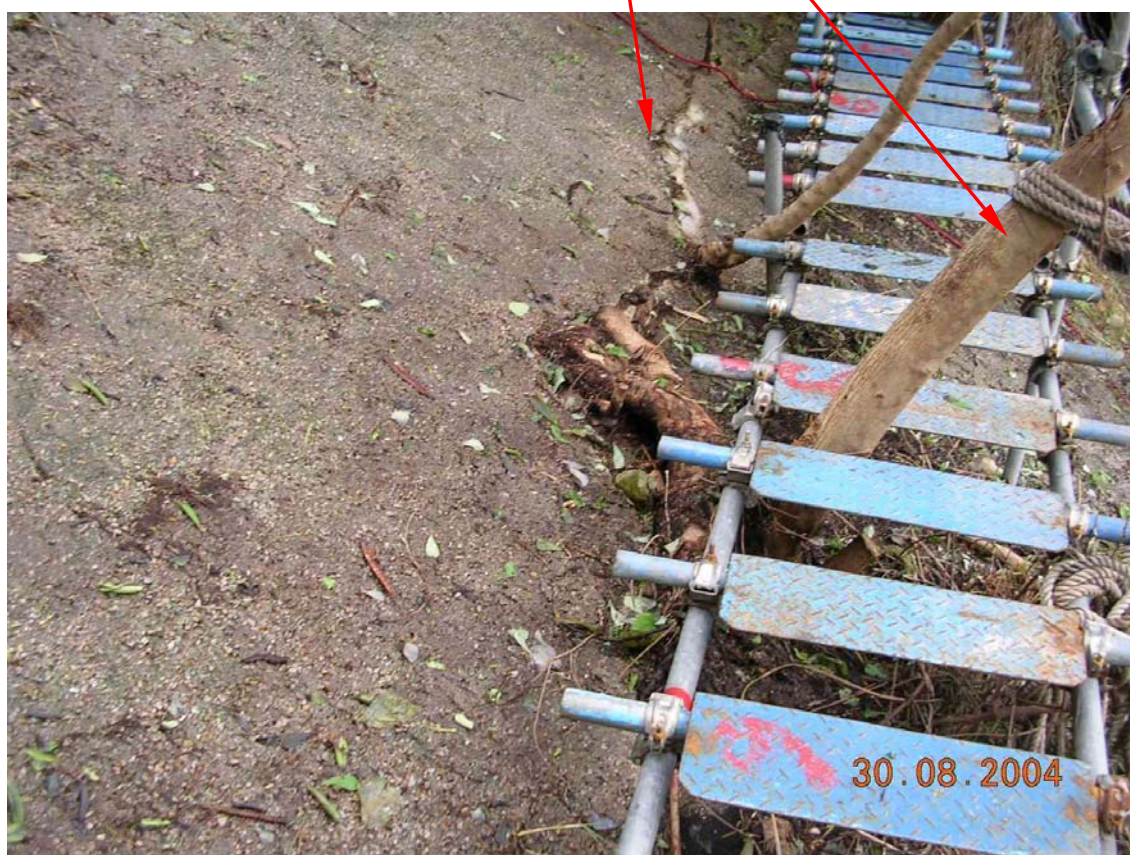
Crack in shotcrete surfacing
dating from 1981 - 1983

Unplanned
vegetation

Plate 23 - Example of Unplanned Vegetation Exploiting Cracks in Shotcrete Surfacing
on Third Batter above Slope Toe (Photograph taken on 30 August 2004)

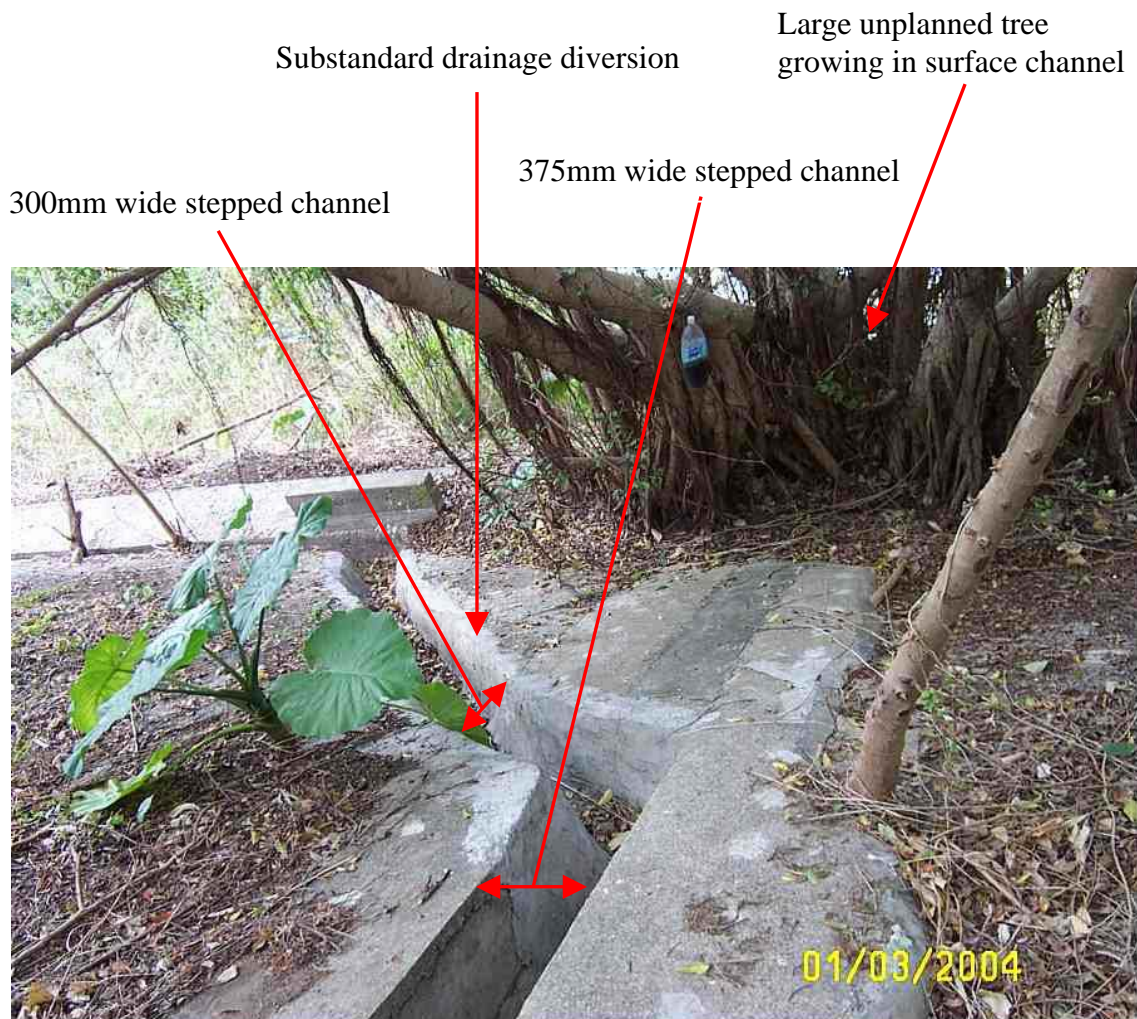
Plate 24 - Unplanned Vegetation Blocks Surface Drainage System
(Photograph taken on 1 March 2004)

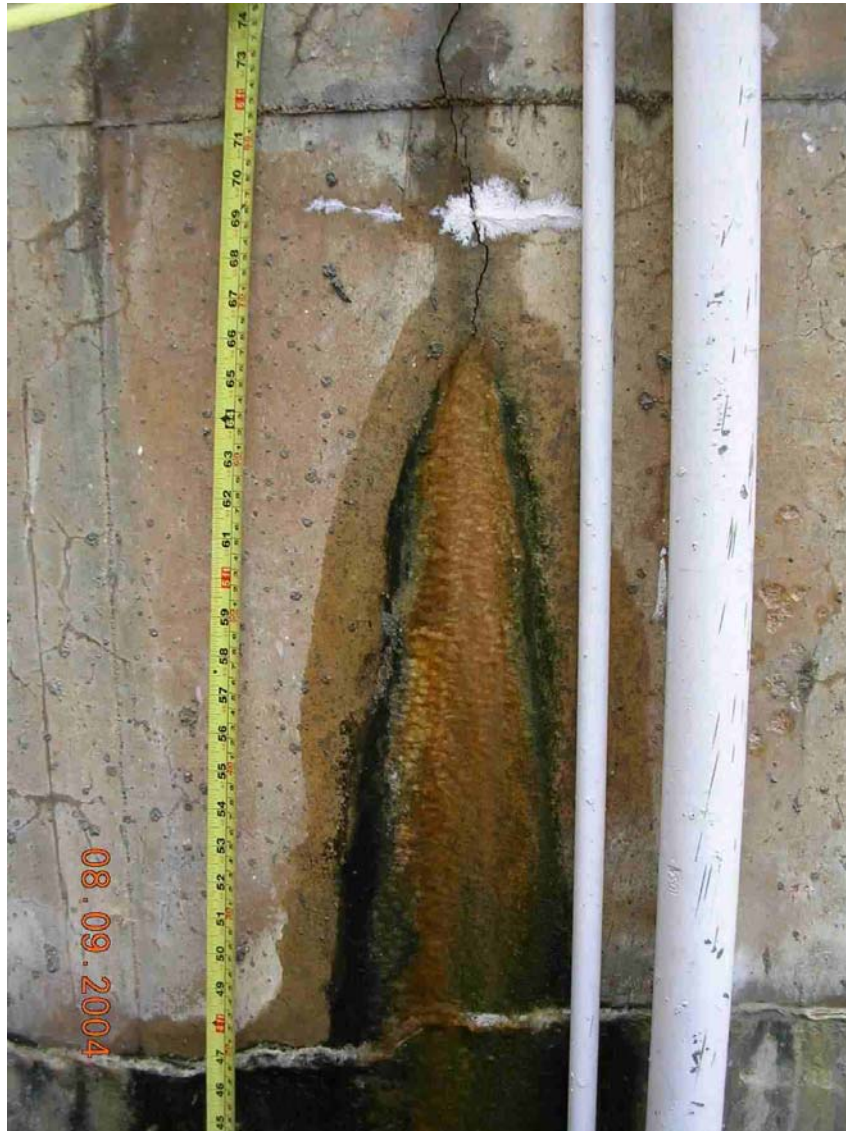
Plate 25 - Sustained Seepage Observed Issuing from Crack in Mass Concrete Gravity Retaining Wall (Photograph taken on 8 September 2004)

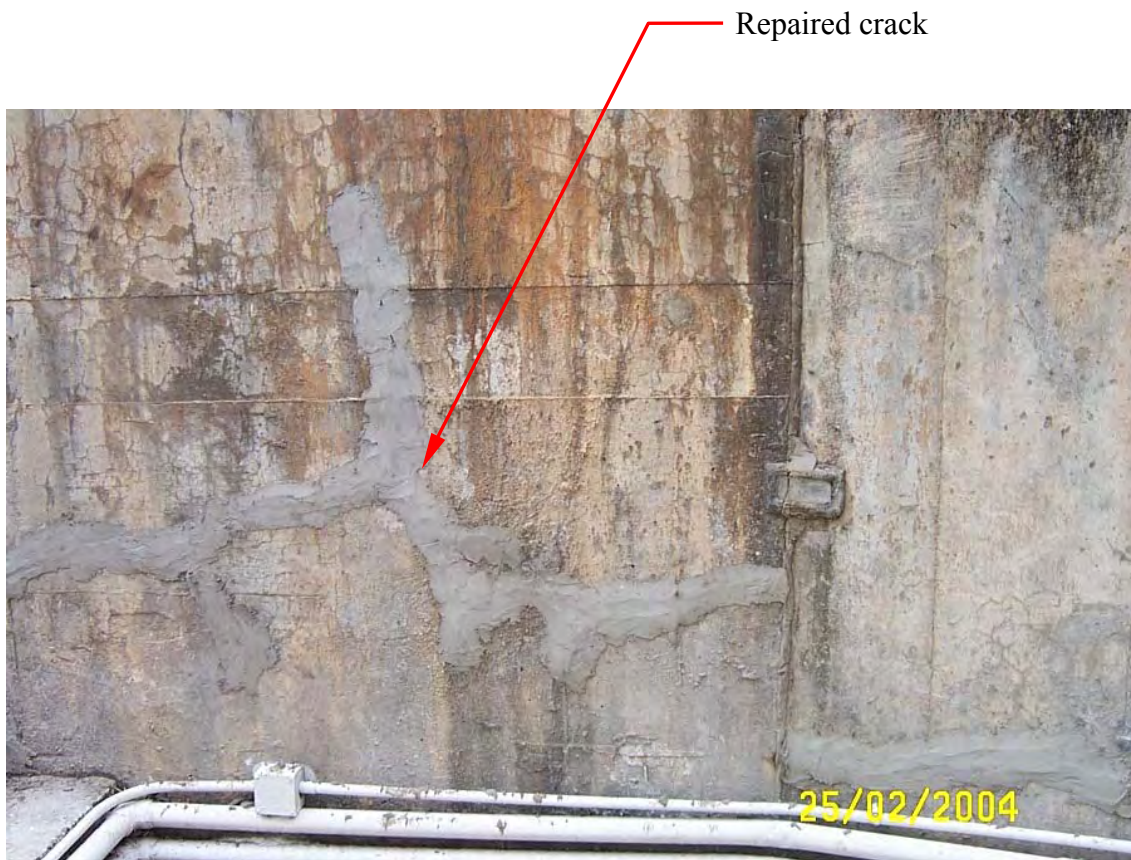
Plate 27 - Example of Repaired Cracking in Mass Concrete Gravity Retaining Wall
(Photograph taken on 25 February 2004)

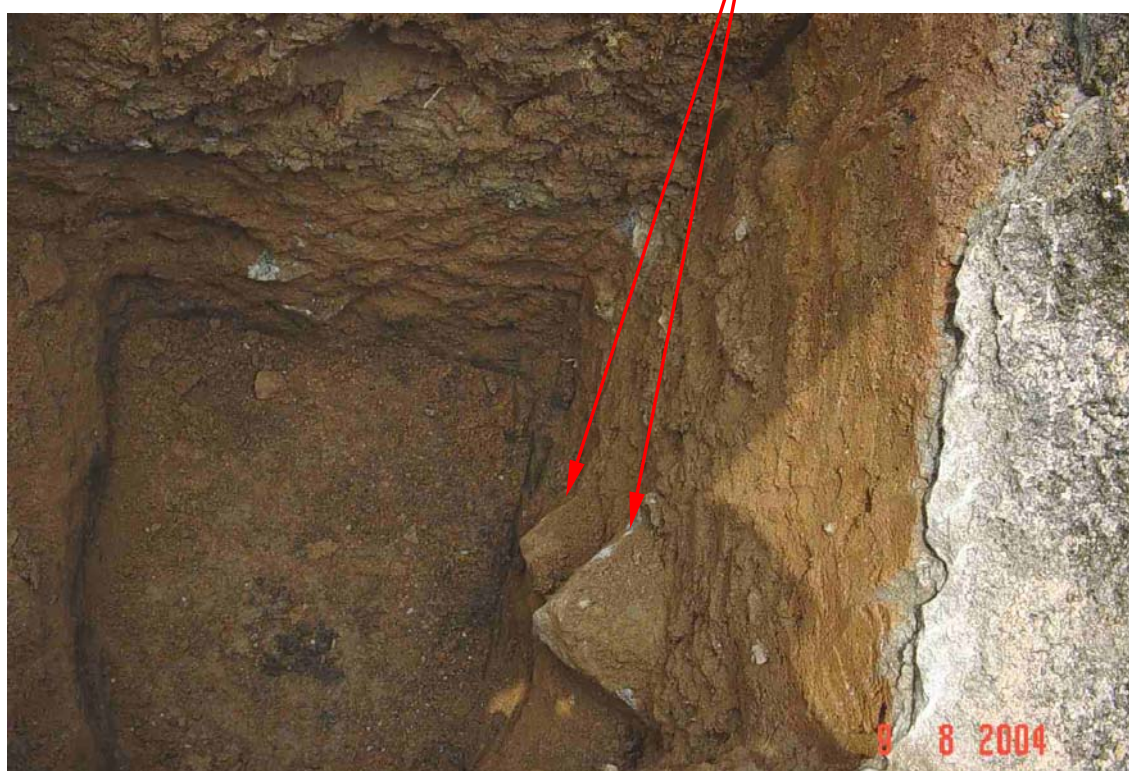
Oversize rock blocks
exposed in face of trial pit

Plate 28 - Example of Rock Blocks Exposed within Compacted Fill Layer in
Trial Pit TP4 (Photograph taken on 9 August 2004)

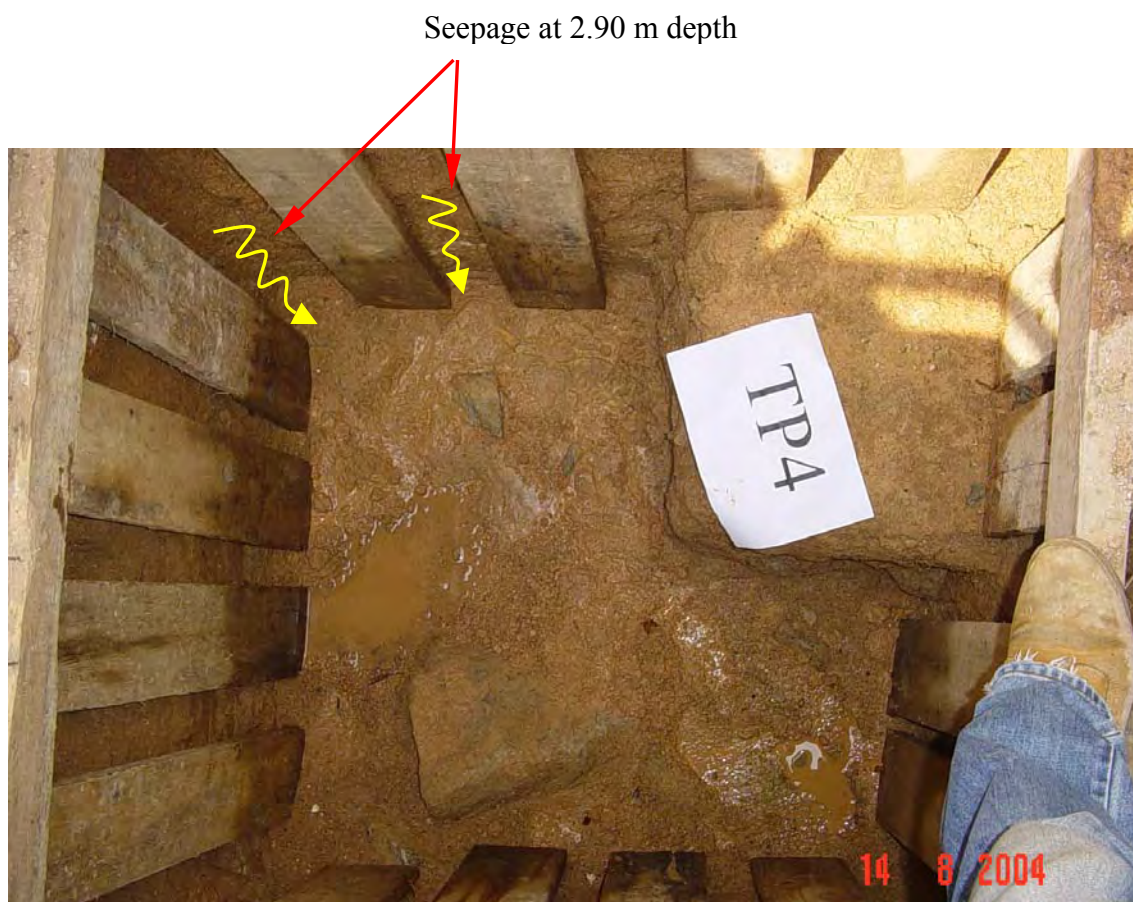
Plate 31 - Seepage Observed in Trial Pit TP4 during Excavation
(Photograph taken on 14 August 2004)

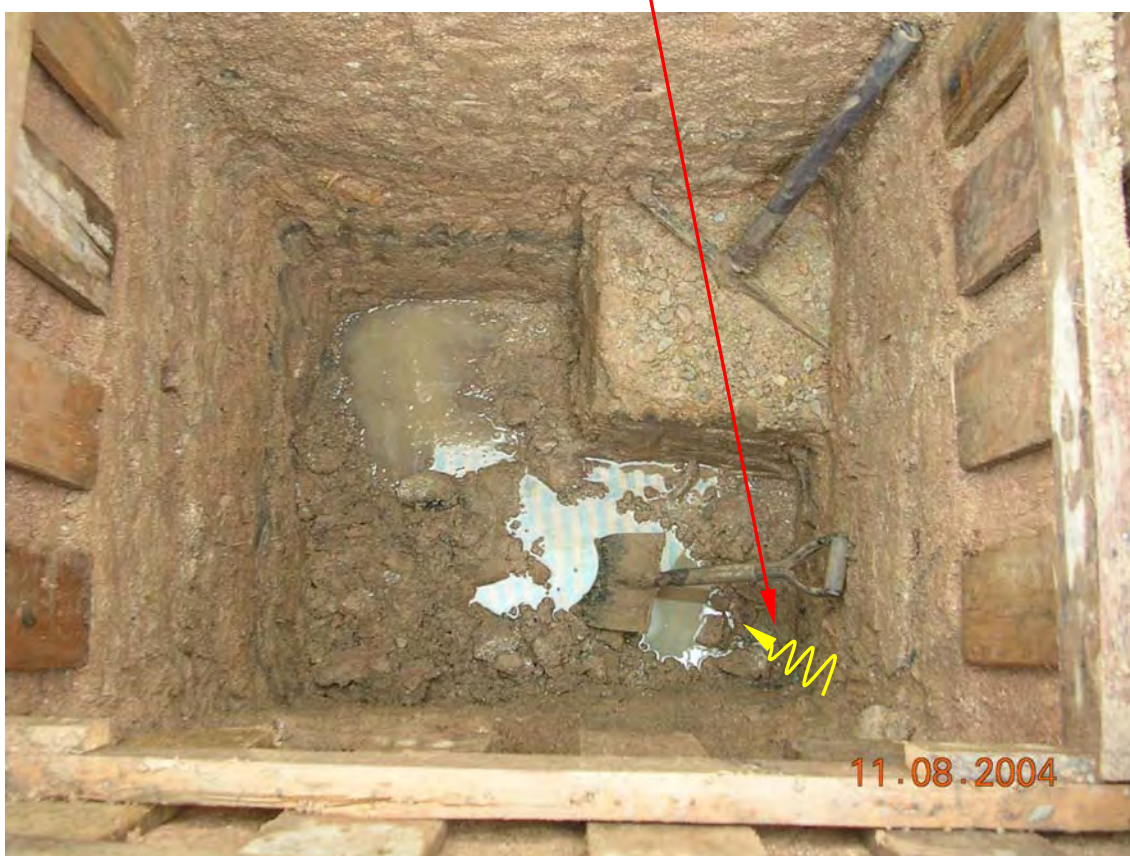
Seepage at 2.70 m depth

Plate 32 - Seepage Observed in Trial Pit TP5 during Excavation
(Photograph taken on 11 August 2004)

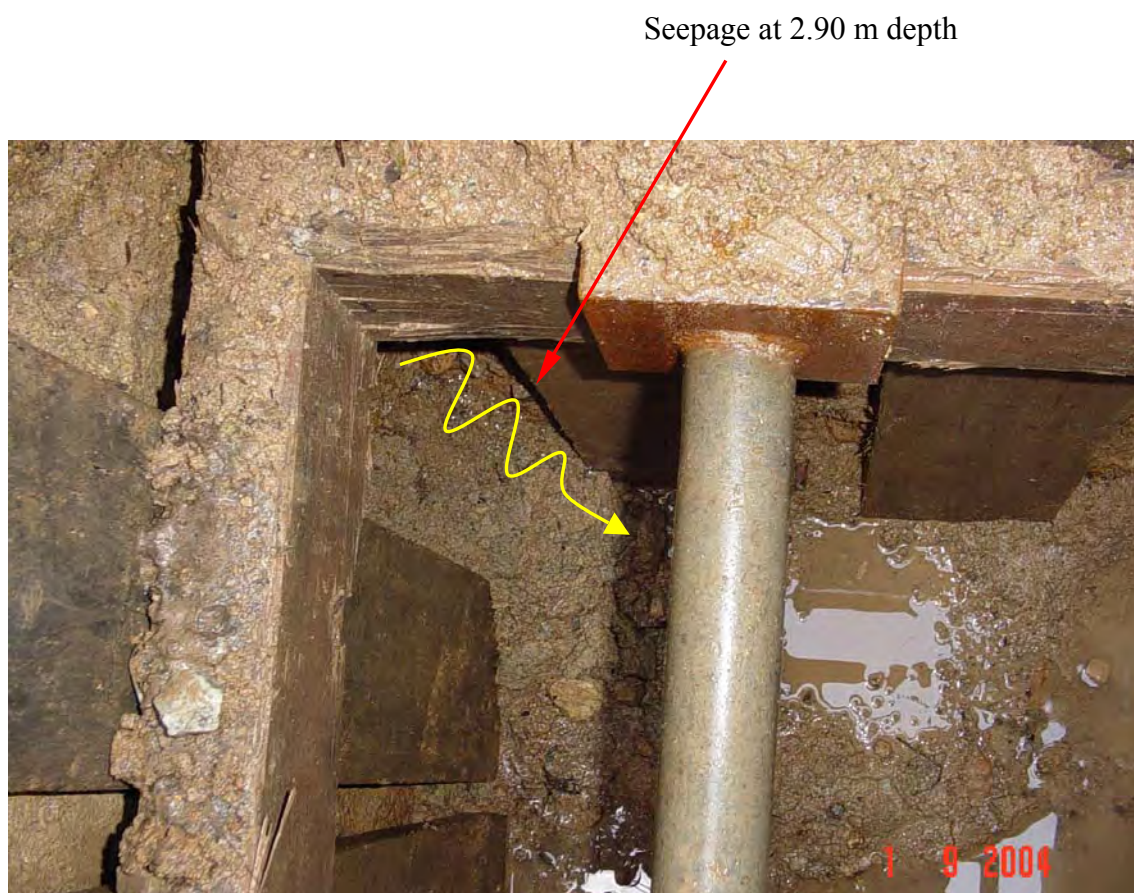
Plate 33 - Seepage Observed in Trial Pit TP6 during Excavation
(Photograph taken on 1 September 2004)

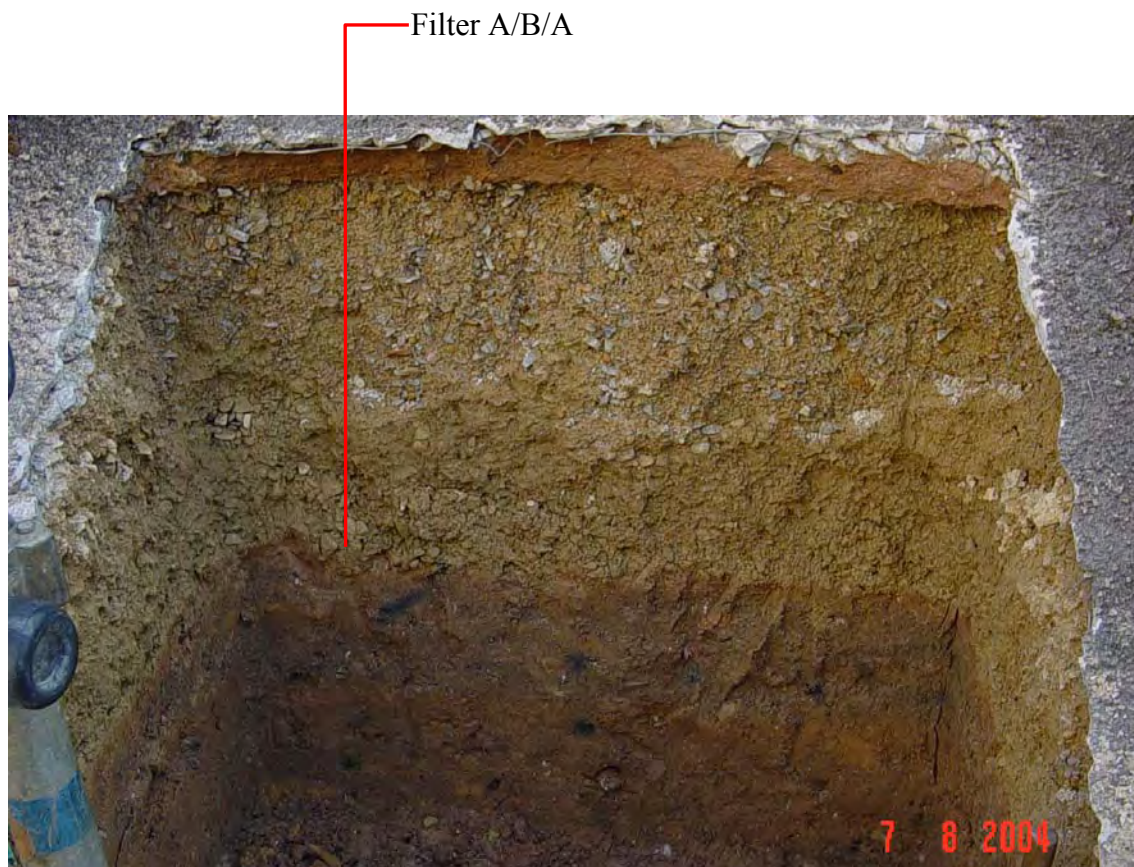
Plate 34 - Close View of Filter A/B/A Arrangement Exposed in Trial Pit TP5
Showing Lack of Definition between Individual Filter Layers
(Photograph taken on 7 August 2004)

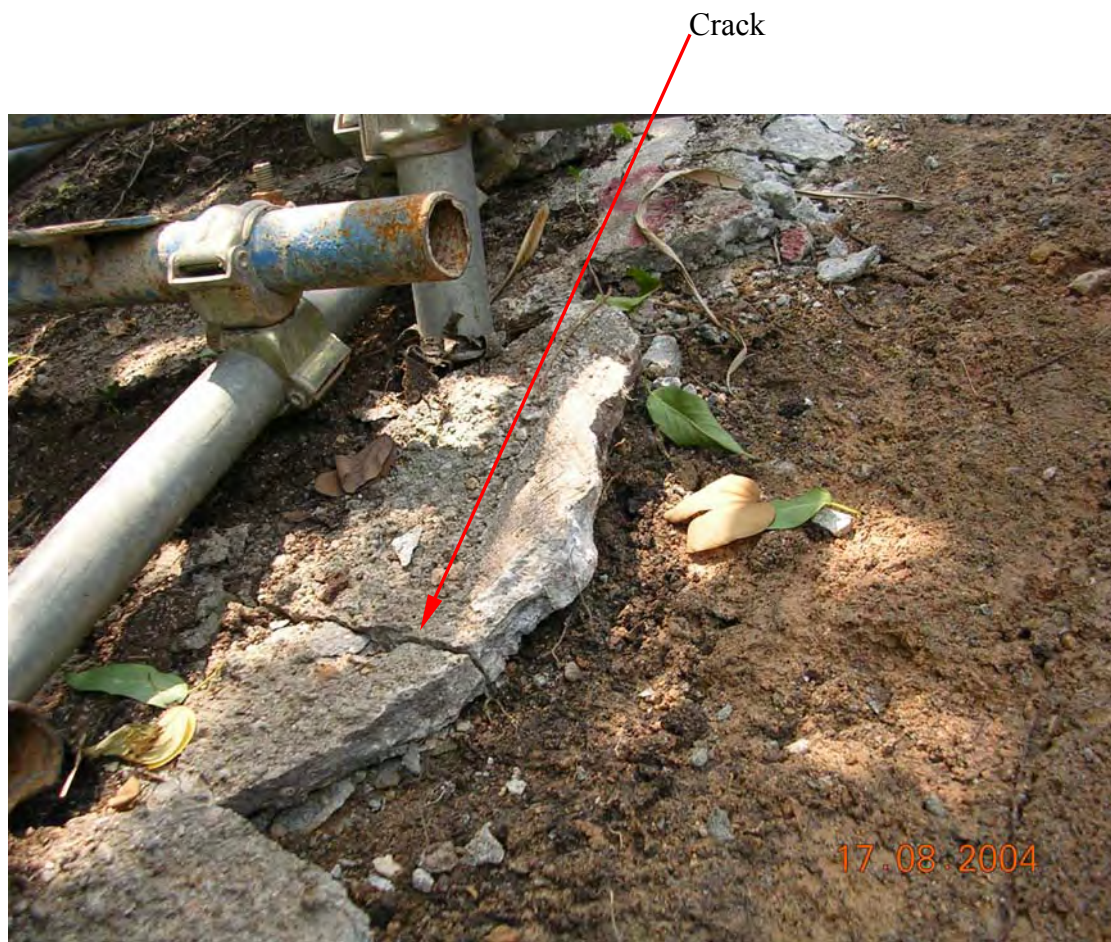
Plate 35 - Example of Surface Strip (CS1) across Cracking in Shotcrete
(Photograph taken on 17 August 2004)

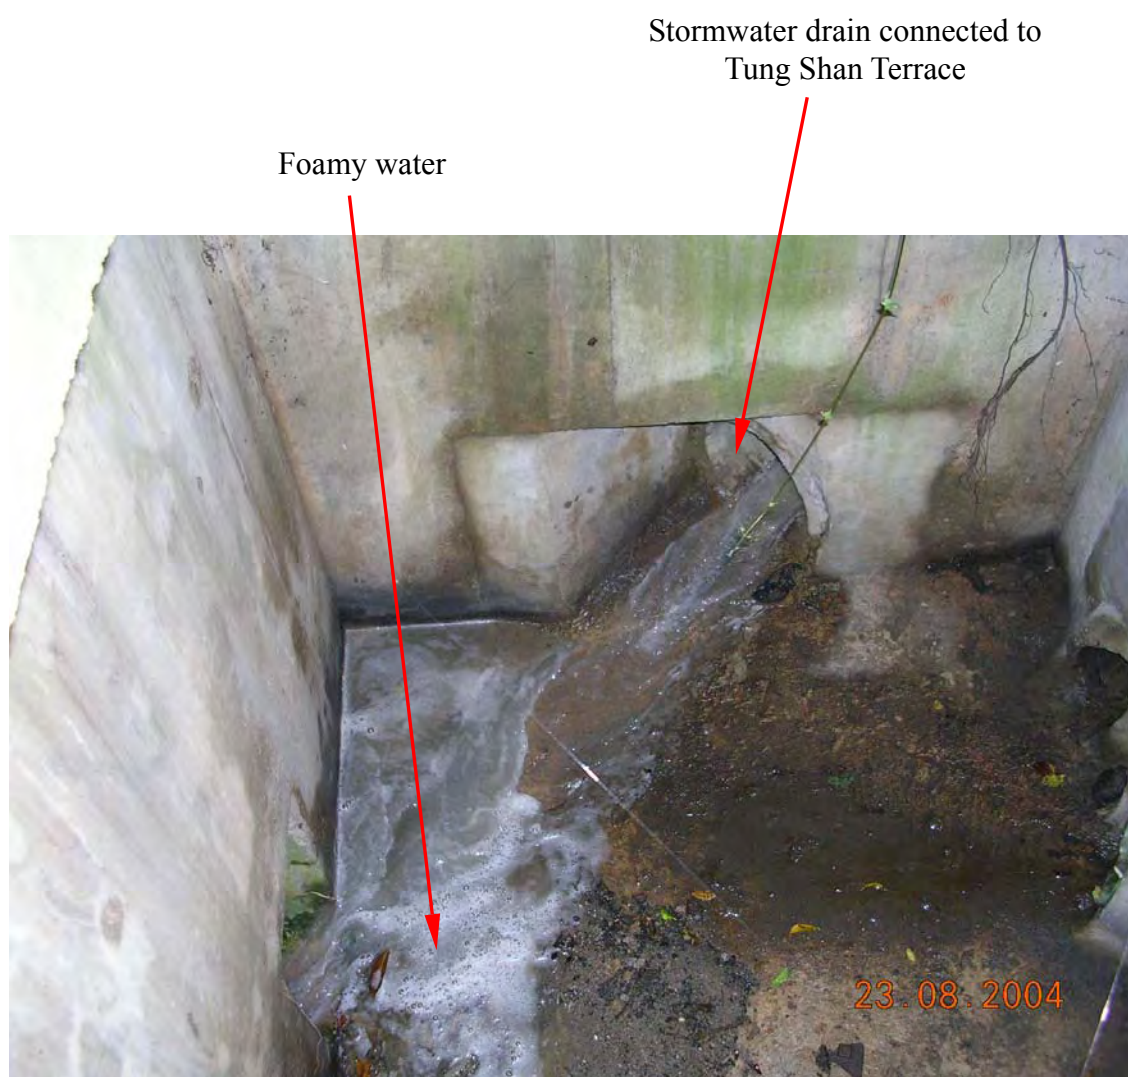
Plate 38 - Anomalous Flow of Foamy Water Observed at Stormwater Outlet Entering Surface Drainage System of Slope No. 11SW-D/FR1 at Slope Crest
(Photograph taken on 23 August 2004)
