# **VOLUME 3: DETAILED STUDY OF SELECTED NATURAL TERRAIN LANDSLIDES AT CLOUDY HILL**

**HALCROW CHINA LIMITED**

**This report was originally produced in July 2003  
as GEO Landslide Study Report No. LSR 6/2003**

**Landslide Investigation Consultancy Agreement No. CE 2/2000**  
**Landslide Reconnaissance Field Proforma – Cloudy Hill**

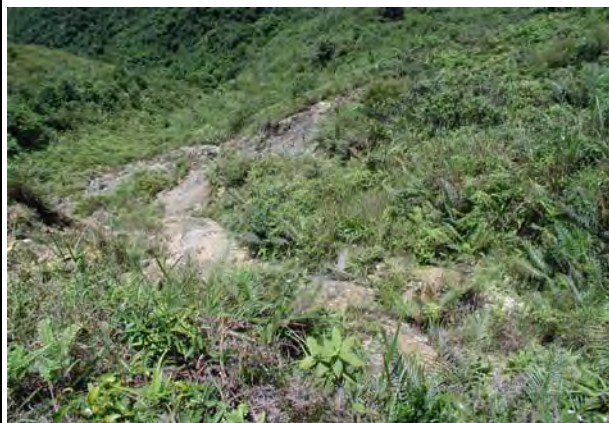
Photo. No. P8090027 Date 09/08/01 (Looking W)

Very steep, access very difficult (possibly 1993 landslide)

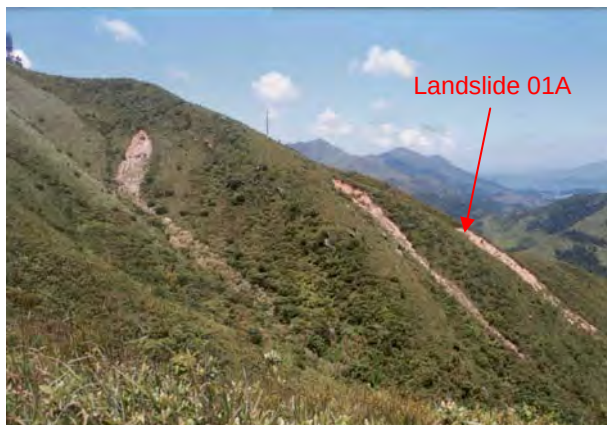
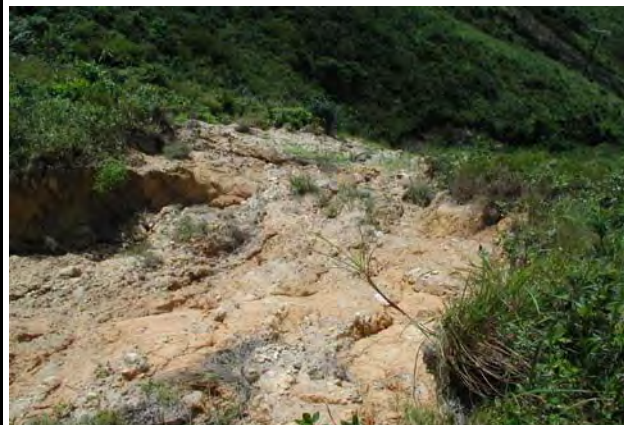
Photo. No. CH01ABCNK Date 09/08/01 (Looking E)      Photo. No. P8090002 Date 08/09/01 (Looking S)

Many pipes approximately 30 mm diameter      Some quartz Veins  
 Much post-failure gullying

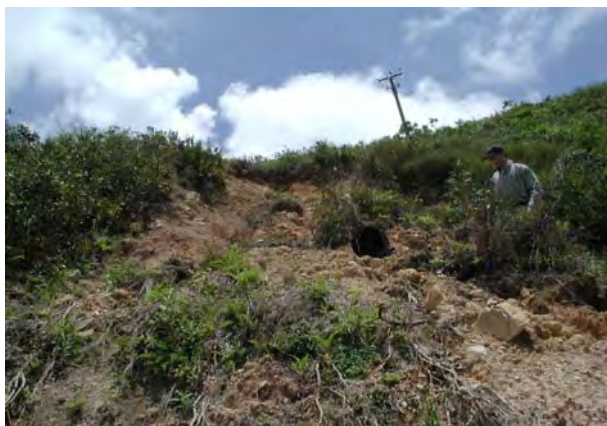
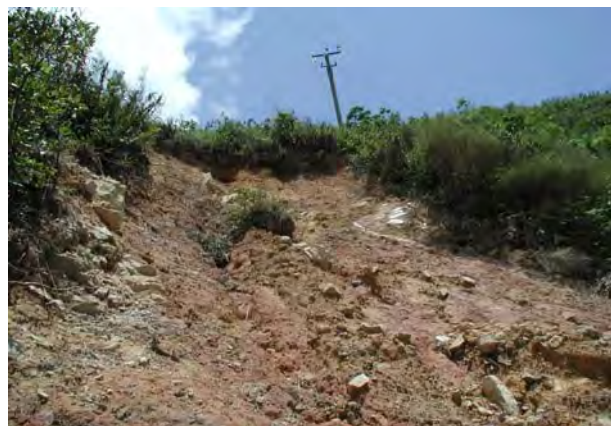
Numerous quartz veins over surface of rupture  
Controlled by local thick deposits of colluvium

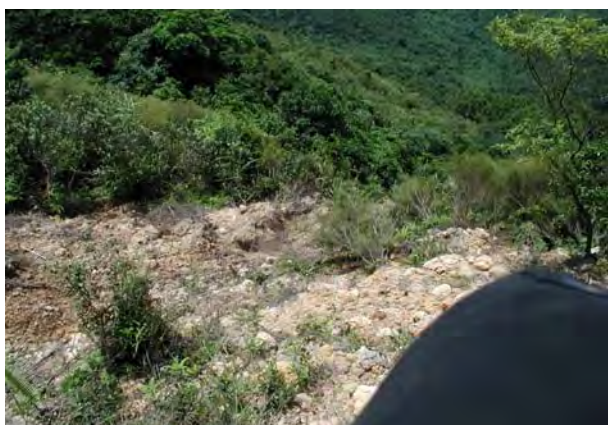
Photo. No.P8090020 Date 09/08/01(Looking W)

Step observed near toe of landslide is possible crown of previous landslide

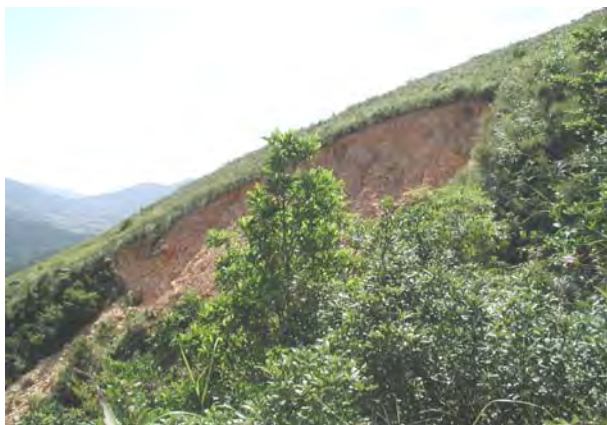
Photo. No.P8090044 Date 09/08/01 (Looking W)

Widening of very large (150 m x 100 m x 5 m) pre-existing failure  
Potential hazard to developments at base of drainage channel
