REVIEW OF SLOPE SURFACE DRAINAGE WITH REFERENCE TO LANDSLIDE STUDIES AND CURRENT PRACTICE

GEO REPORT No. 210

T.H.H. Hui, H.W. Sun & K.K.S. Ho

**GEOTECHNICAL ENGINEERING OFFICE
CIVIL ENGINEERING AND DEVELOPMENT DEPARTMENT
THE GOVERNMENT OF THE HONG KONG
SPECIAL ADMINISTRATIVE REGION**

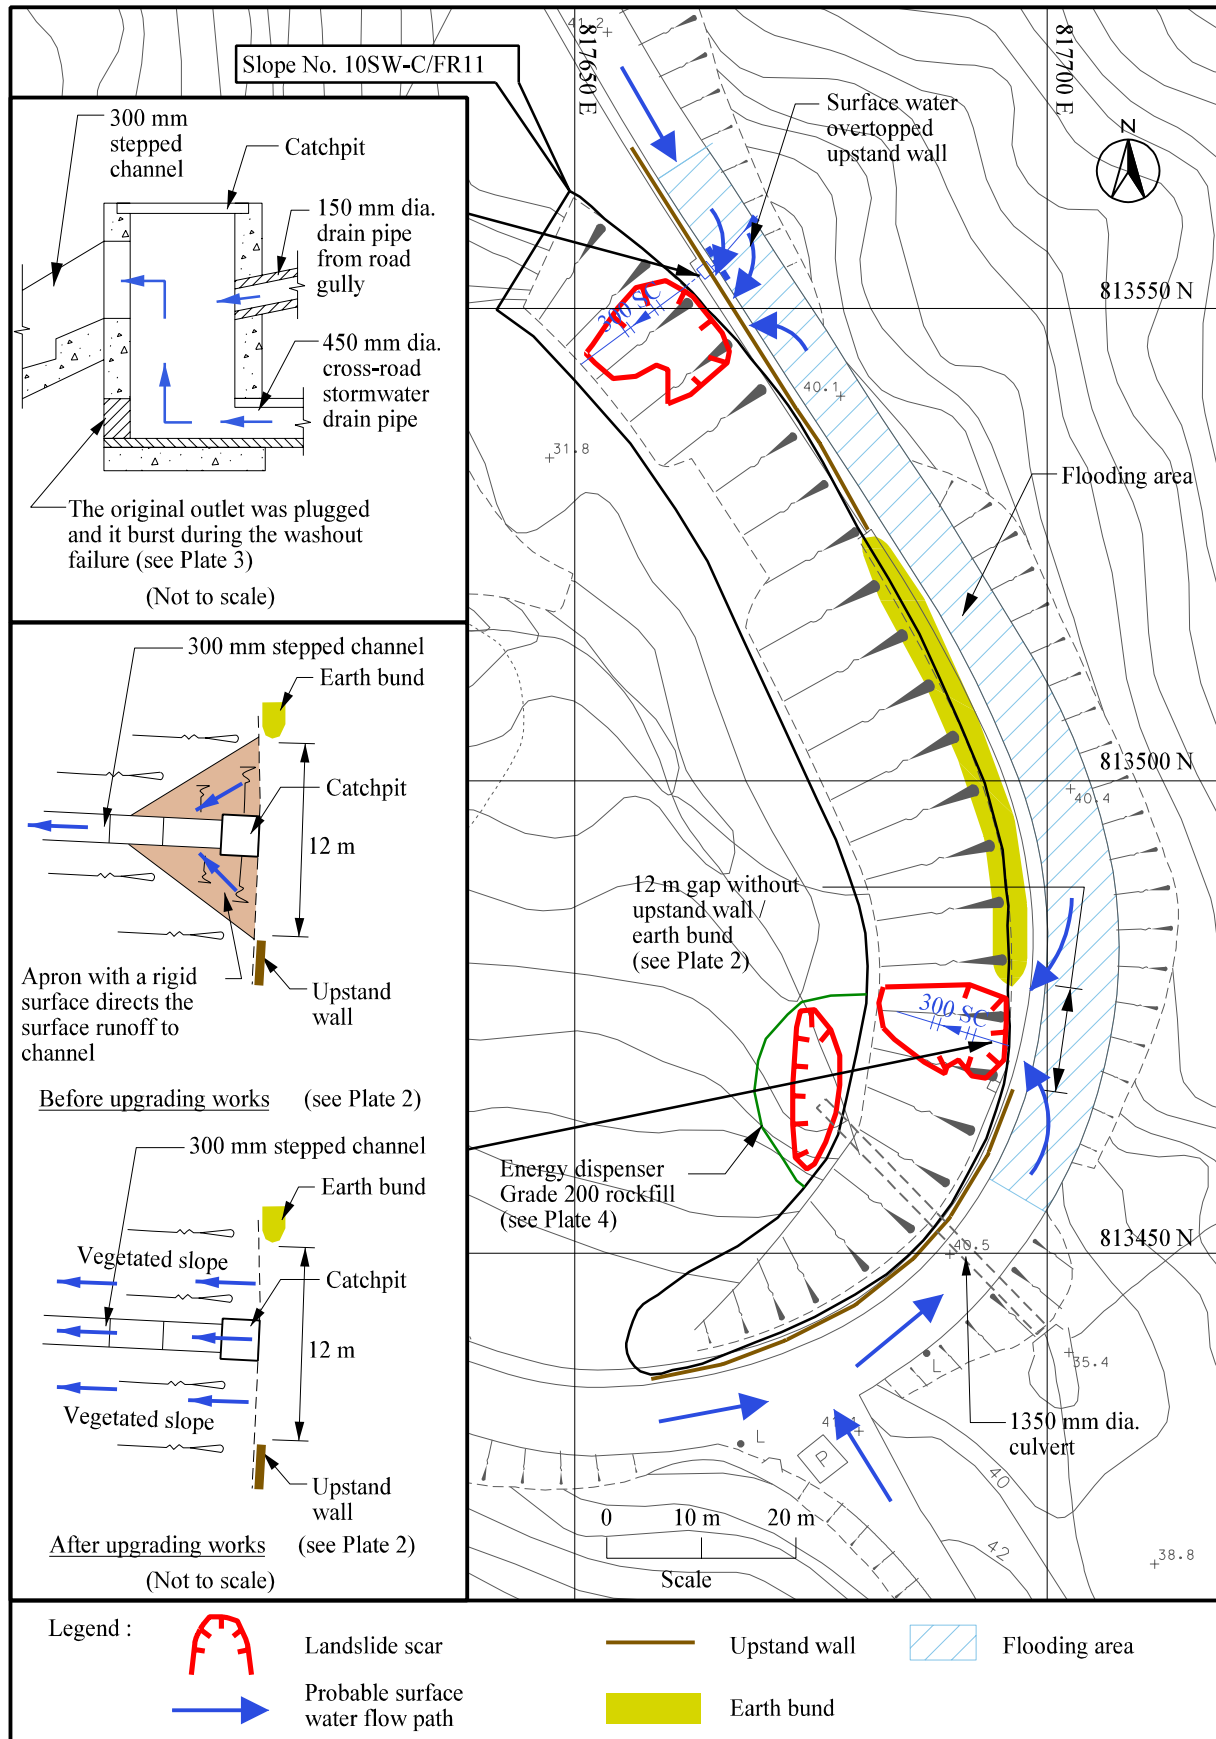
Figure 1 - The 5 May 2003 Washout Failures on an Upgraded Fill Slope below South Lantau Road

The situation was exacerbated by poor detailing and probably inadequate review conducted during the construction of the slope drainage system (see Figure 1). One of the failure scars coincided with the location of a previous concrete apron below a low point of the road at the crest, which was downhill of an opening in the crest upstand wall that, in effect, served as an overflow system. As part of the slope upgrading works, the slope, including the concrete apron, was filled up and provided with a vegetated cover but the opening in the upstand wall at the crest was maintained. During heavy rainfall in May 2003 shortly after completion of slope upgrading works, the road above the slope crest was flooded. As a consequence, concentrated discharge occurred through the opening in the upstand wall, which resulted in severe erosion of the vegetated slope (see Figure 1 and Plate 2).

The other failure scar coincided with the outlet to an existing 450 mm diameter cross-road stormwater culvert, which was plugged during the slope upgrading works. As part of the slope upgrading works, additional rockfill was placed on the slope behind a newly constructed toe retaining wall, and the pre-existing catchpit was correspondingly extended upward such that the raised outlet was connected to the new 300 mm stepped channel on the elevated slope surface. As a result of this detailing, the water flow from the cross-road culvert leading to this catchpit was expected to bend round and travel upward before discharging onto the slope drainage channel. Such a connection detailing probably reduced the discharge capacity of the system significantly, as evidenced by the observation of uncontrolled overflow of stormwater directly onto the carriageway from the catchpit located on the opposite side of the road. The overflow was discharged onto the subject fill slope, resulting in severe erosion.

This incident highlights the importance of giving due attention to the environmental setting of the site in the design and detailing of slope drainage provisions, in particular the proper detailing of the connections between cross-road culverts and the slope drainage provisions. A comprehensive assessment of all the potential hazards affecting the performance of the slope surface drainage provisions should be undertaken, especially for vulnerable sites with an adverse environmental setting and a history of problems associated with surface water overflow.

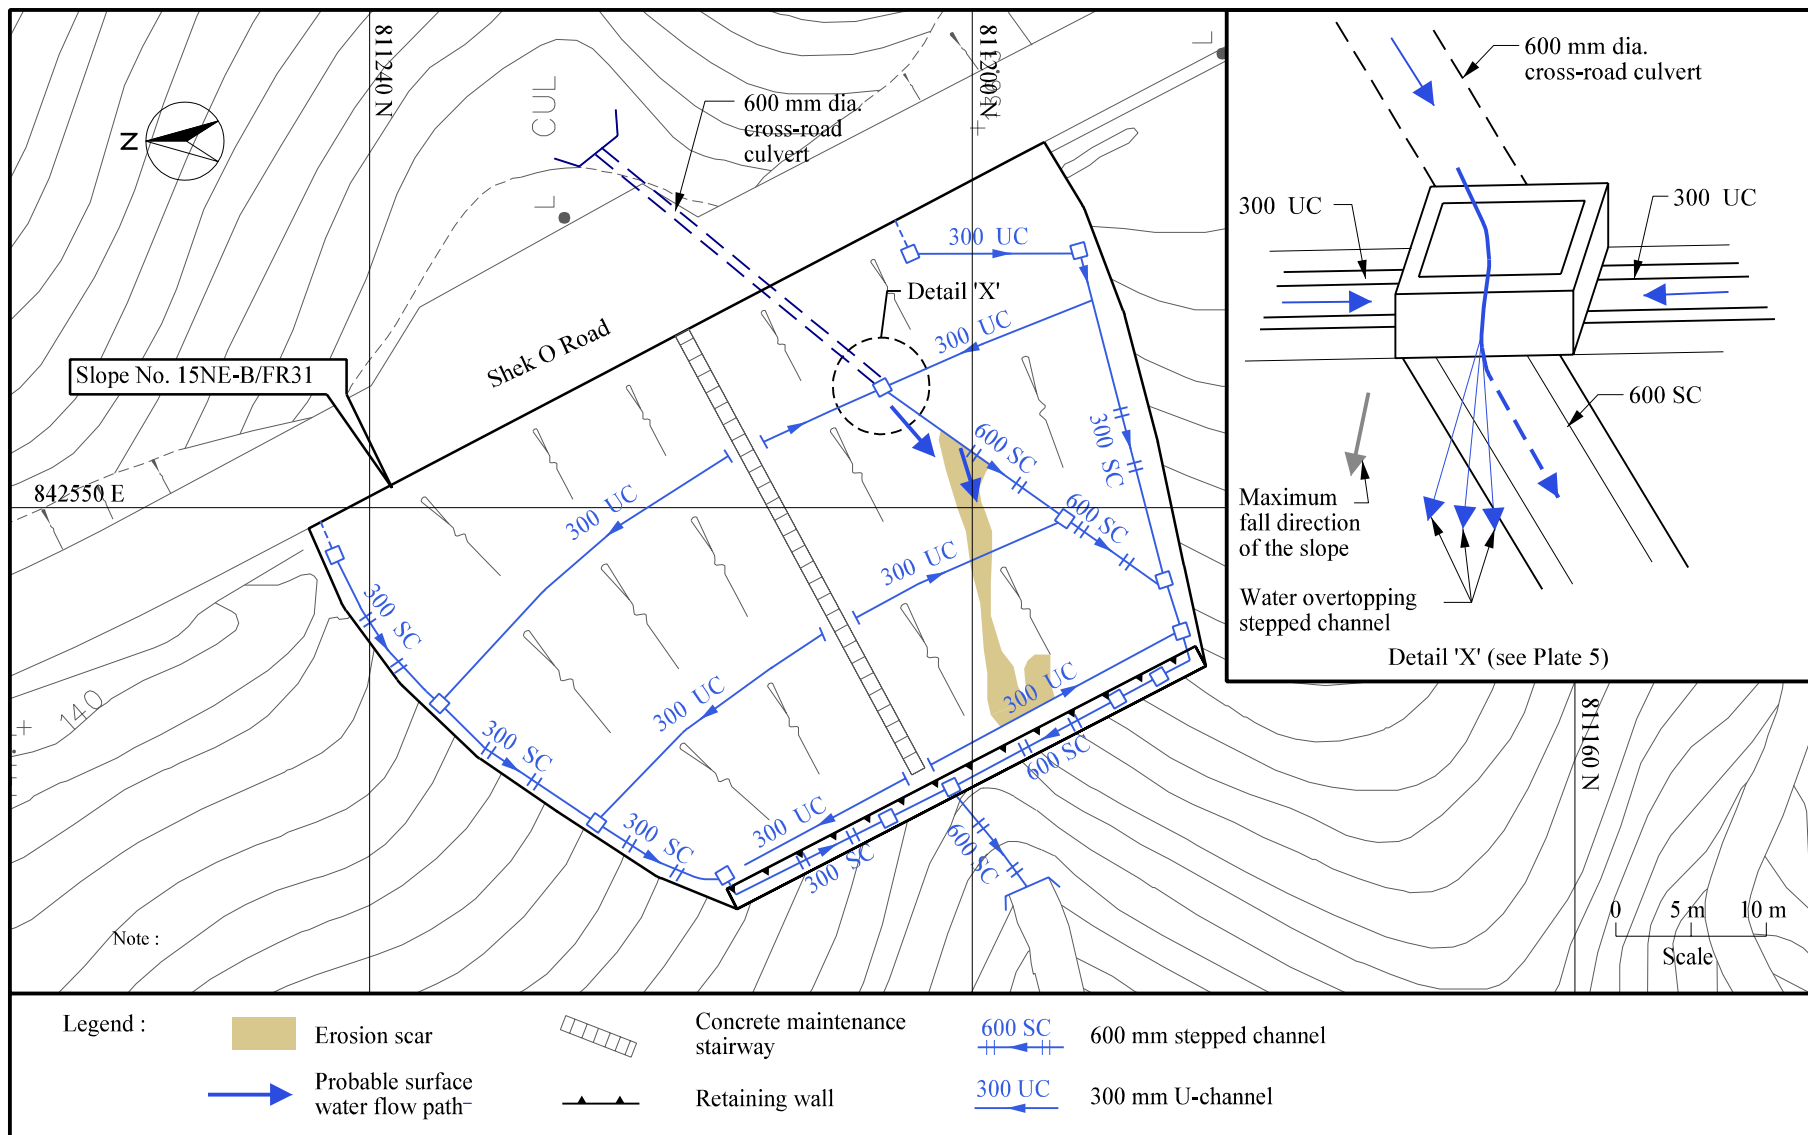
Figure 2 - Slope Distress on an Upgraded Fill Slope below Shek O Road near Lan Nai Wan, Shek O

This case involved a minor washout failure ($< 5 \text{ m}^3$), which occurred on a newly upgraded fill slope. It transpired that this was a repeated problem since completion of the slope upgrading works. The erosion was observed during intense rainfall to be caused by significant overspilling from a stepped channel that runs obliquely down the slope face at about 30° . The principal cause of the overflow was due to a sudden change in the flow directions between the outlet of a cross-road culvert and a stepped channel on the slope (see Figure 2 and Plate 5).

The follow-up study (FSWJV, 2005) established that overspilling from the stepped channel was probably a result of the poor detailing of the catchpit/stepped channels, together with an under-estimation of the potential adverse effects of abrupt changes in the directions of surface water flow. Inadequate depth of the downslope side of the stepped channel, and lack of precautionary measures at the vulnerable location (such as provision of elevated sidewalls to the channel on the downslope side of the catchpit), may also have contributed to the uncontrolled overspilling.

This incident serves to highlight the importance of paying due attention to proper detailing of slope drainage provisions and appropriate amendment of the detailing on site during slope works to suit the actual site conditions.

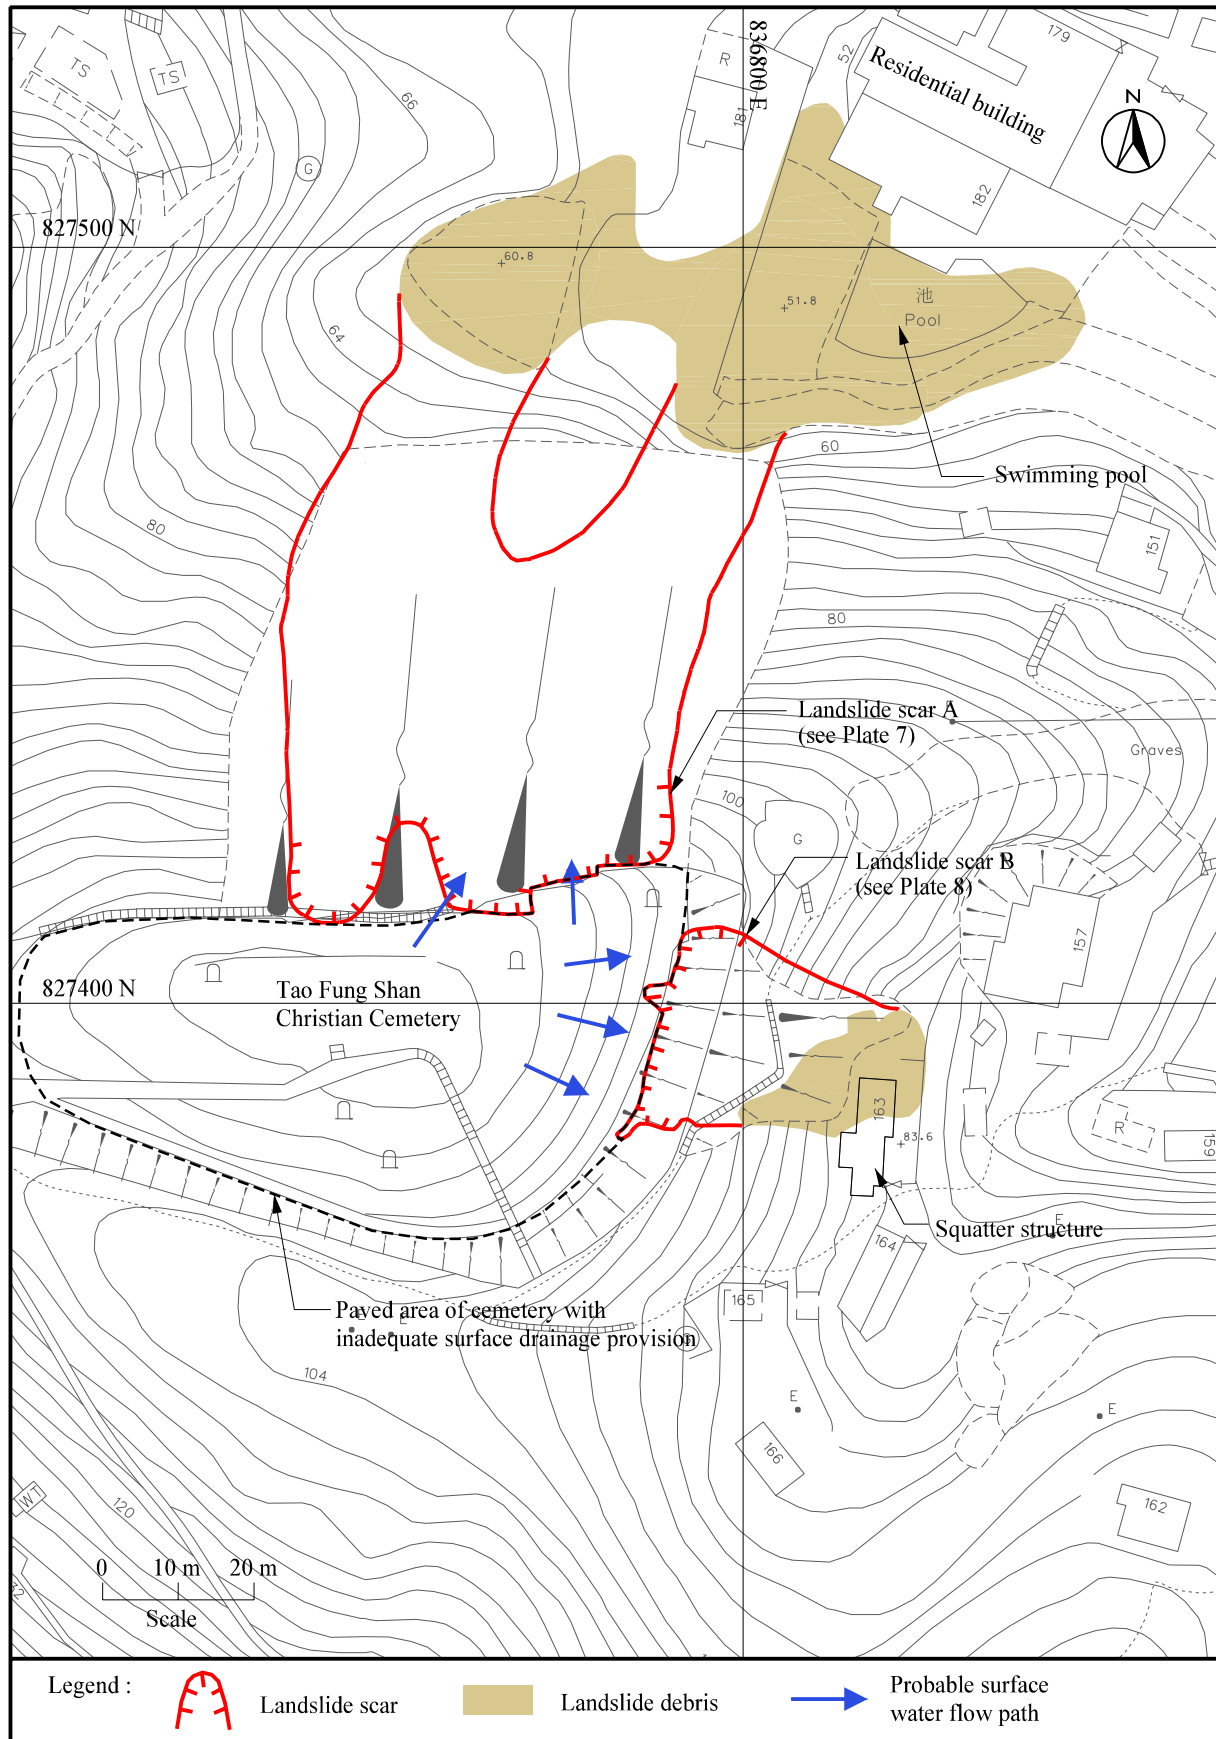
Figure 4 - The 2 July 1997 Landslides below Tao Fung Shan Christian Cemetery, Sha Tin

This case involved two major landslides (with a total volume of about 1,300 m³), which affected two non-engineered man-made slopes within a cemetery. Several abandoned buildings were severely damaged as a result of the landslides (see Figure 4 and Plates 7 and 8). No casualties were reported but a registered squatter structure with outstanding NDC recommendation was demolished by landslide debris and casualty was narrowly avoided in this 'near-miss' incident as the squatter structure happened to be unoccupied at the time.

The follow-up study (HAP, 1998c) revealed that the hilltop development above the source areas of the landslides was paved shortly before the failures. Illegal earthworks involving the construction of a substandard retaining wall, together with inadequate surface drainage provisions within the hilltop development leading to uncontrolled and concentrated surface runoff onto the downhill slopes, were the key contributory factors to the landslides.

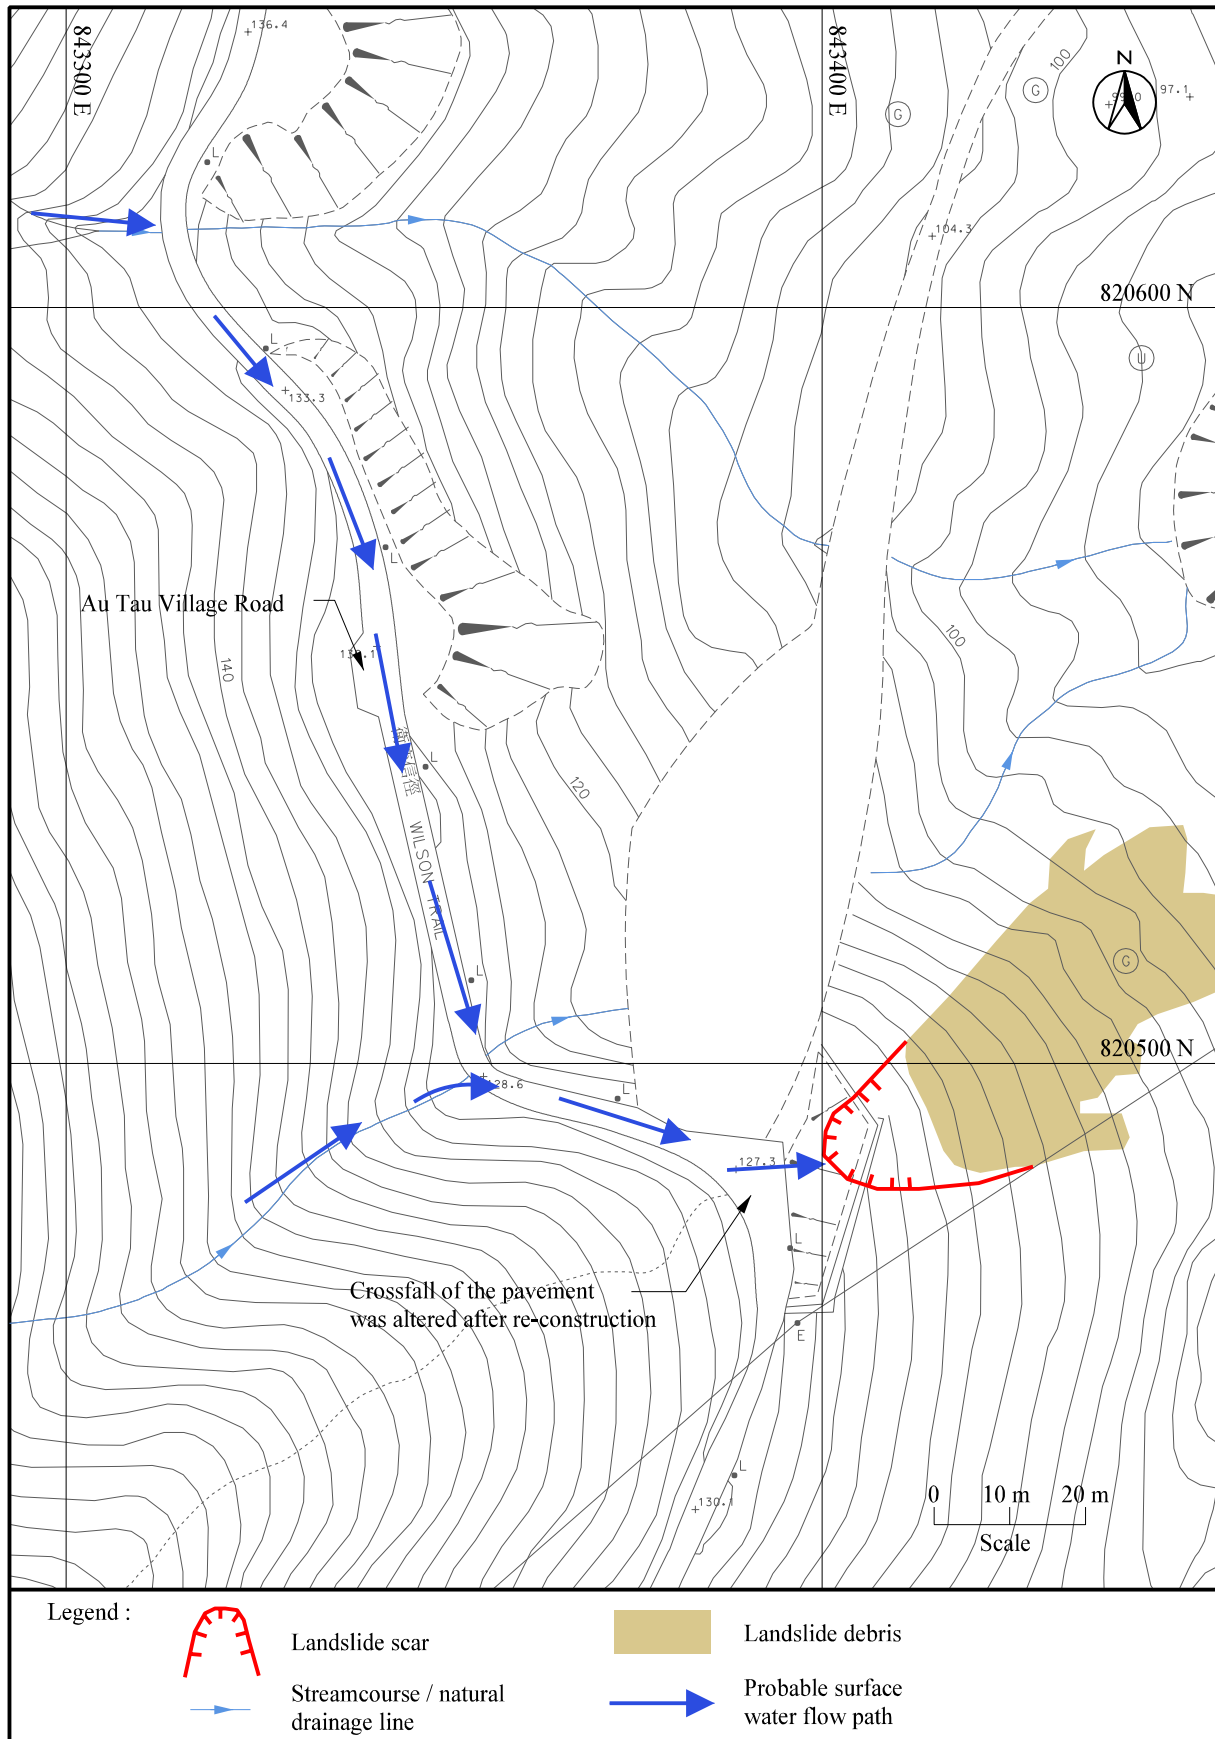
Figure 5 - The 9 June 1998 Landslide on a Fill Slope below Au Tau Village Road, Tseung Kwan O

This incident comprised a major landslide (about 170 m³) involving the failure of an old fill slope below a minor access road (see Figure 5 and Plate 9). Uncontrolled overtopping of surface water from the access road at slope crest was diagnosed as a key contributory factor to the landslide (FSWJV, 1999).

The access road had no surface drainage provisions and the pavement was reconstructed about three months before the landslide. During the reconstruction works, the crossfall of the pavement was altered. This, together with the road geometry, probably resulted in surface runoff being directed along the road towards the landslide site. Ponding of surface water was observed on the road after the landslide. Flows from the nearby streamcourses could also have played a contributory role in providing a possible additional source of water onto the road (see Figure 5). Overtopping of surface water from the crest area directly onto the loose fill below the road probably promoted surface erosion and concentrated water ingress into the ground mass resulting in the major landslide.

This incident highlights the potential impact of adverse changes in the environmental condition of the upslope area, which could convey additional surface water towards the downhill area resulting in a slope failure.

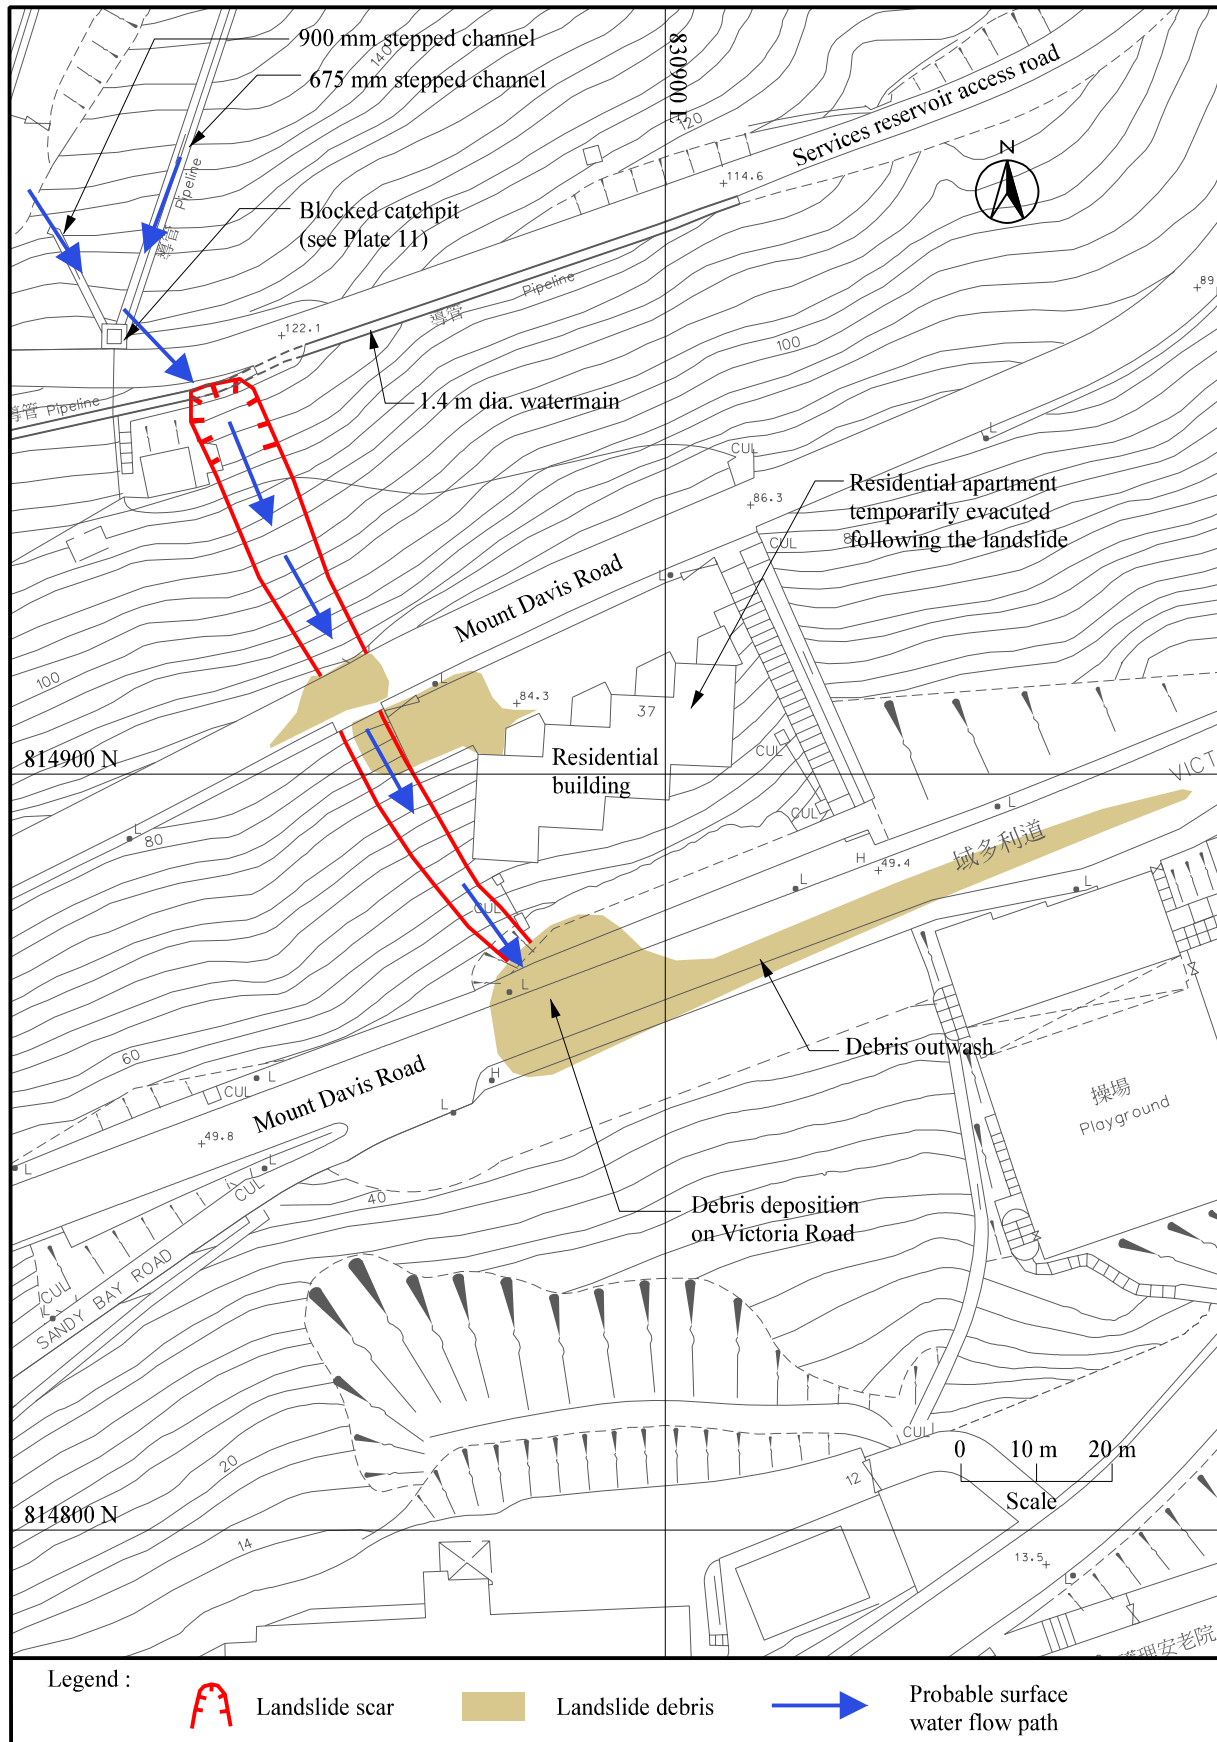
Figure 7 - The 24 August 1999 Landslide on a Hillside above Mount Davis Road

This incident comprised a major landslide (about 200 m³) that occurred on a hillside below Mount Davis Road. The landslide debris travelled narrowly missed a residential building block in the downhill area. Following the failure, the occupants of the affected building block were evacuated temporarily. The landslide debris undermined a 1.4 m diameter pressurised watermain at the crown of the failure scar, which is an important trunk main for supplying potable water to the Hong Kong south areas (see Figure 7 and Plate 11).

The follow-up study (FMSWJV, 2000a) established that the landslide was associated with the blockage of several catchpits along an access road directly above the landslide source area. This probably resulted in uncontrolled discharge of surface runoff from the fairly sizeable catchment above, and overspilling of surface water near a road bend probably led to concentrated water ingress into the hillside below, resulting in the major failure. Inadequate and poorly maintained surface water drainage provisions along the access road, together with lack of an upstand on the downhill side of the access road, were the probable key contributory factors to the landslide.

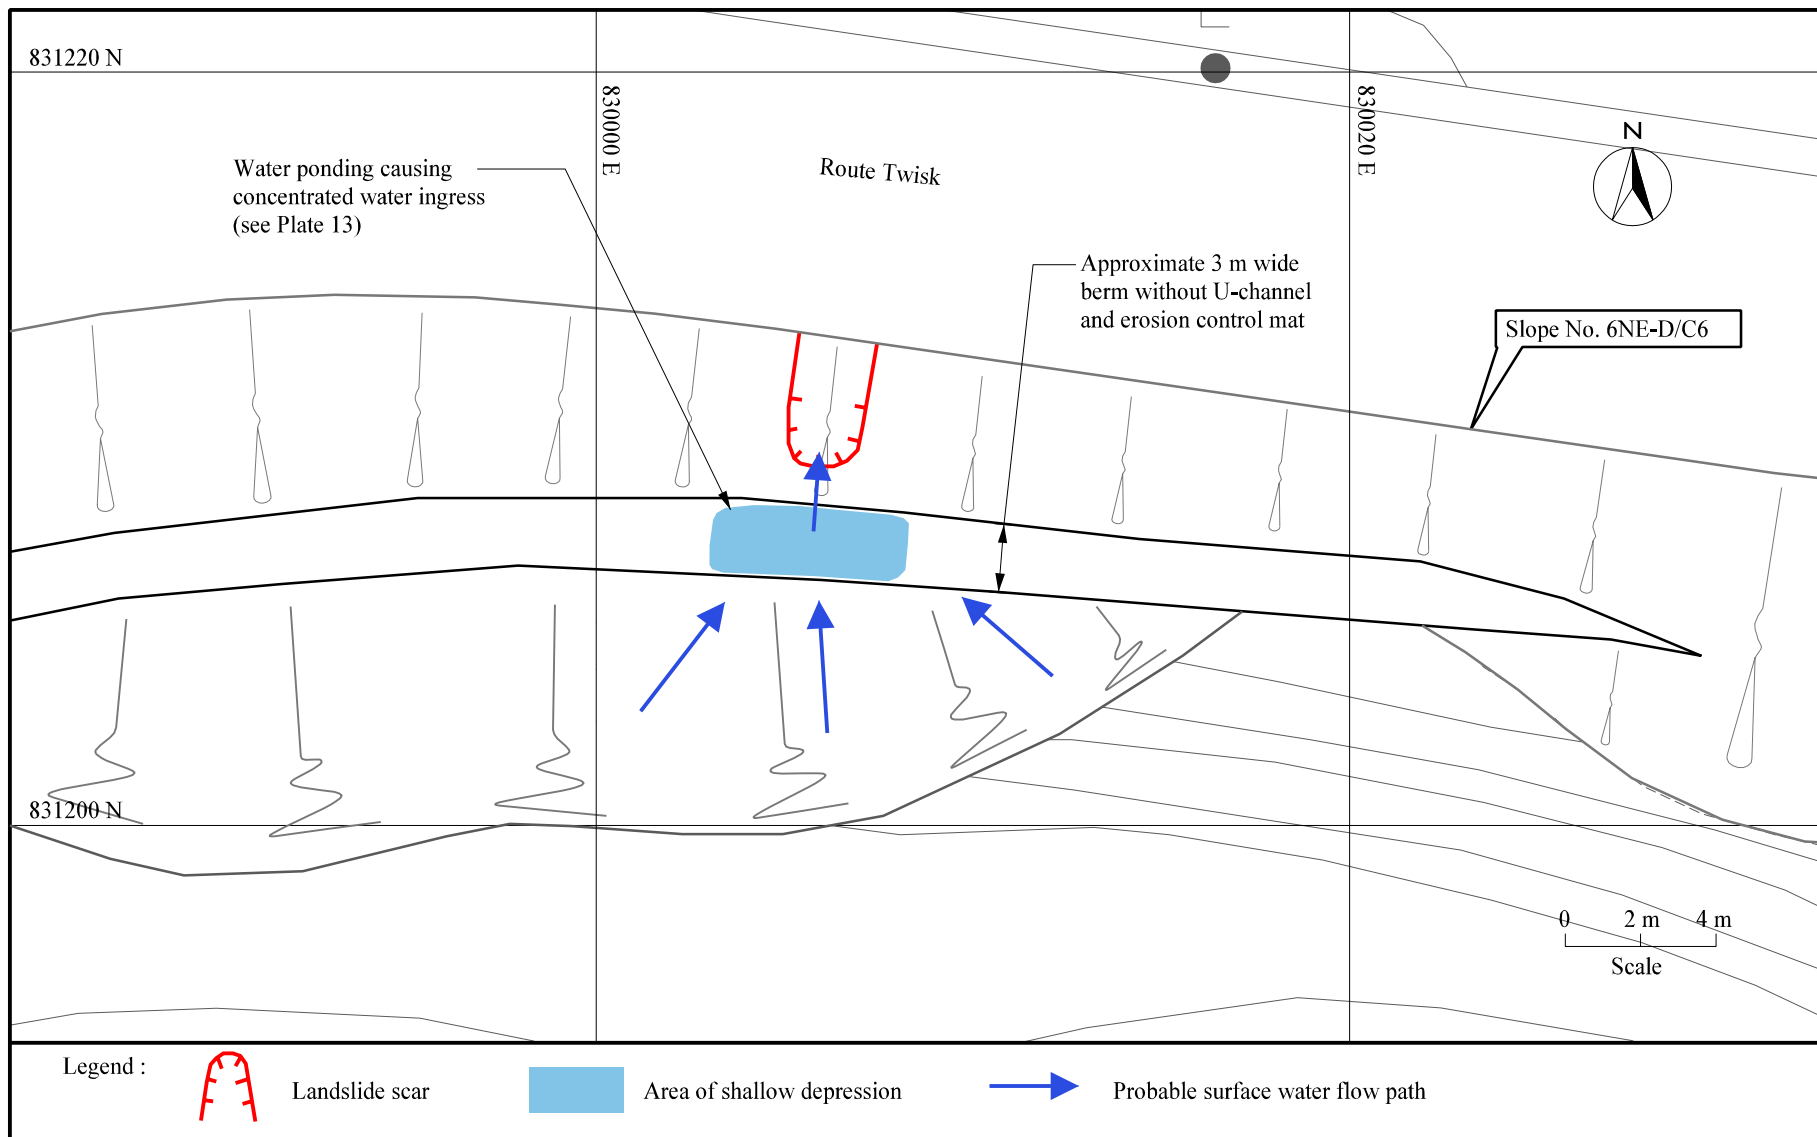
Figure 9 - The June 2001 Landslide on an Upgraded Cut Slope at Route Twisk

This incident involved a minor landslide (about 3 m³) that occurred on a newly upgraded soil cut slope. As part of the slope upgrading works, the pre-existing hard surface cover was replaced with a vegetated cover (see Figure 9 and Plate 13). No surface drainage channel was provided on a 3 m wide vegetated berm above the location of the landslide to intercept potential surface runoff from the upper slope batter.

The follow-up study (Hui, 2002) established the presence of a local shallow depression on the vegetated berm directly above the landslide source area. Enhanced and concentrated water ingress into the ground mass from this local low point was probably a key contributory factor to the failure.

This incident serves as a reminder of the need to provide adequate drainage provisions, particularly for slope works involving replacement of a hard surface cover with a vegetated cover, and to properly treat local depressions on a vegetated slope, which are liable to lead to concentrated water ingress.

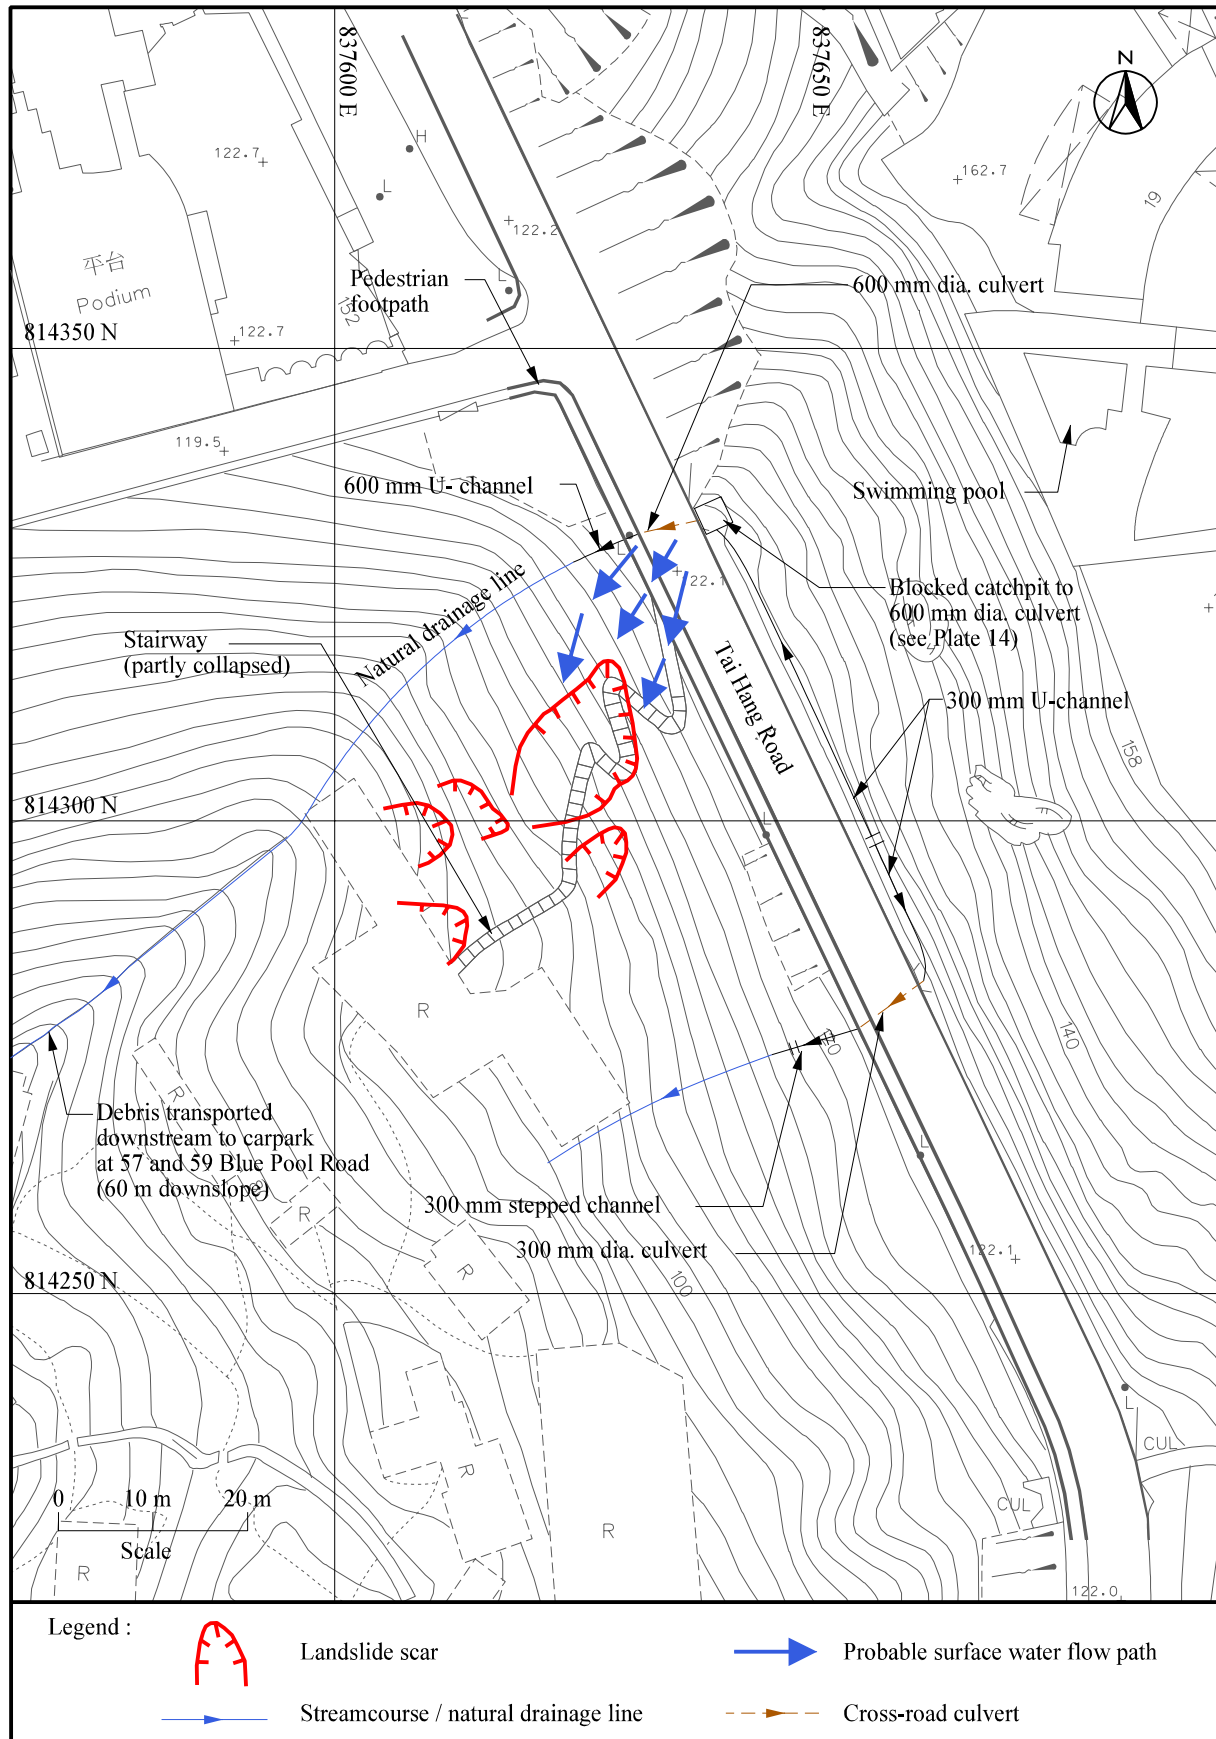
Figure 10 - The 24 August 2000 Landslides on Disturbed Terrain below Tai Hang Road

This case involved a total of five landslides (failure volumes ranging from 10 m³ to 250 m³) that occurred on disturbed terrain (comprising a cleared squatter area) below Tai Hang Road. Most of the landslide debris was deposited on a natural drainage line and the outwash material was carried downslope to a carpark of a private residential building at the toe of the hillside (see Figure 10 and Plate 14).

The follow-up study (FMSWJV, 2002b) established that overflow of surface runoff resulted from a blocked roadside catchpit (probably due to debris from a minor landslide in the uphill catchment) at Tai Hang Road above the crest of the landslide sites. This led to uncontrolled overspilling of surface water onto the downhill slope and significant water ingress into the landslide sites, resulting in the failures. The section of Tai Hang Road above the landslides is relatively flat and susceptible to flooding and no upstand wall had been provided along the edge of the footpath above the landslide sites to prevent uncontrolled overtopping.

This incident serves as a reminder that an adverse environmental setting is conducive to uncontrolled discharge of surface runoff from a road onto the slope below, which is liable to cause major landslides that can impact on developments further downhill, especially if the debris reaches a drainage line.

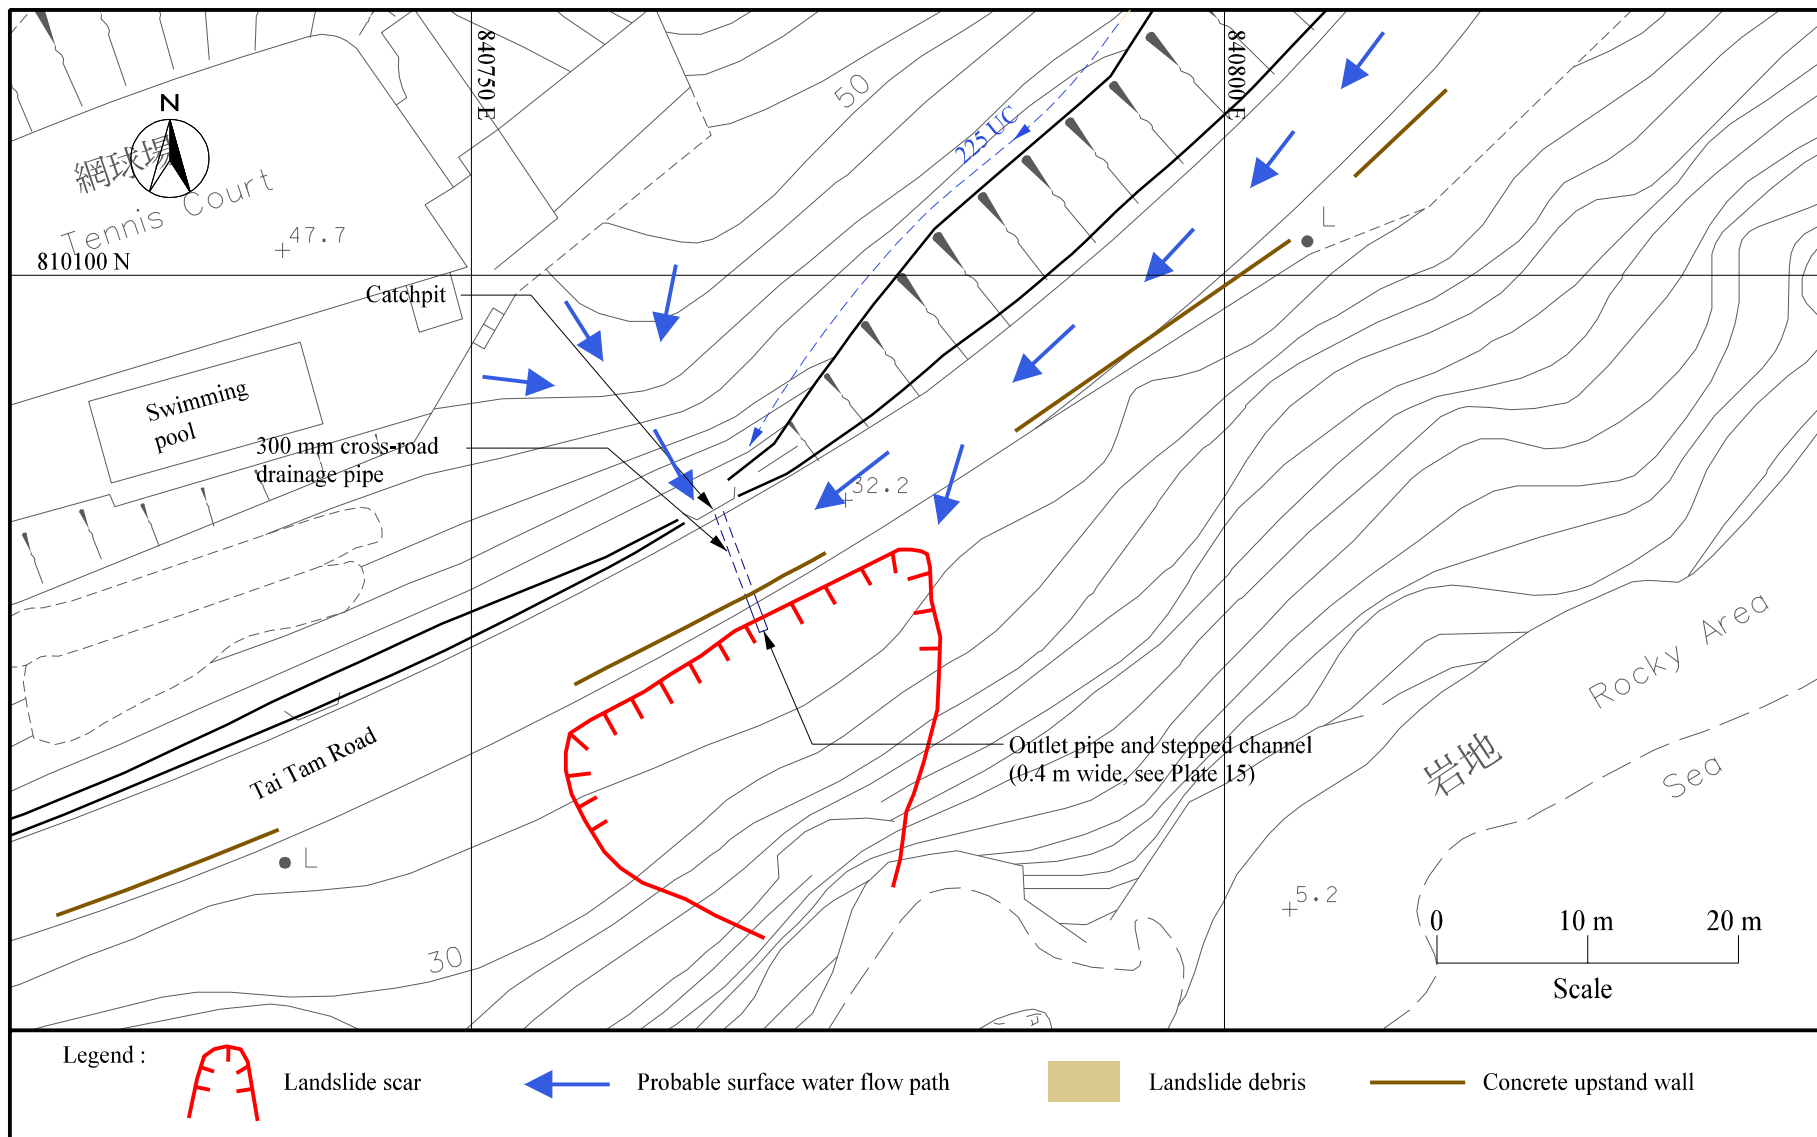
Figure 11 - The 24 August 2000 Landslide on a Hillside below Tai Tam Road

This case involved a major landslide (about 700 m³) that occurred on a hillside below Tai Tam Road (see Figure 11 and Plate 15). No casualty or significant damage to property was caused in the incident.
