REVIEW OF SLOPE SURFACE DRAINAGE WITH REFERENCE TO LANDSLIDE STUDIES AND CURRENT PRACTICE

GEO REPORT No. 210

T.H.H. Hui, H.W. Sun & K.K.S. Ho

**GEOTECHNICAL ENGINEERING OFFICE
CIVIL ENGINEERING AND DEVELOPMENT DEPARTMENT
THE GOVERNMENT OF THE HONG KONG
SPECIAL ADMINISTRATIVE REGION**

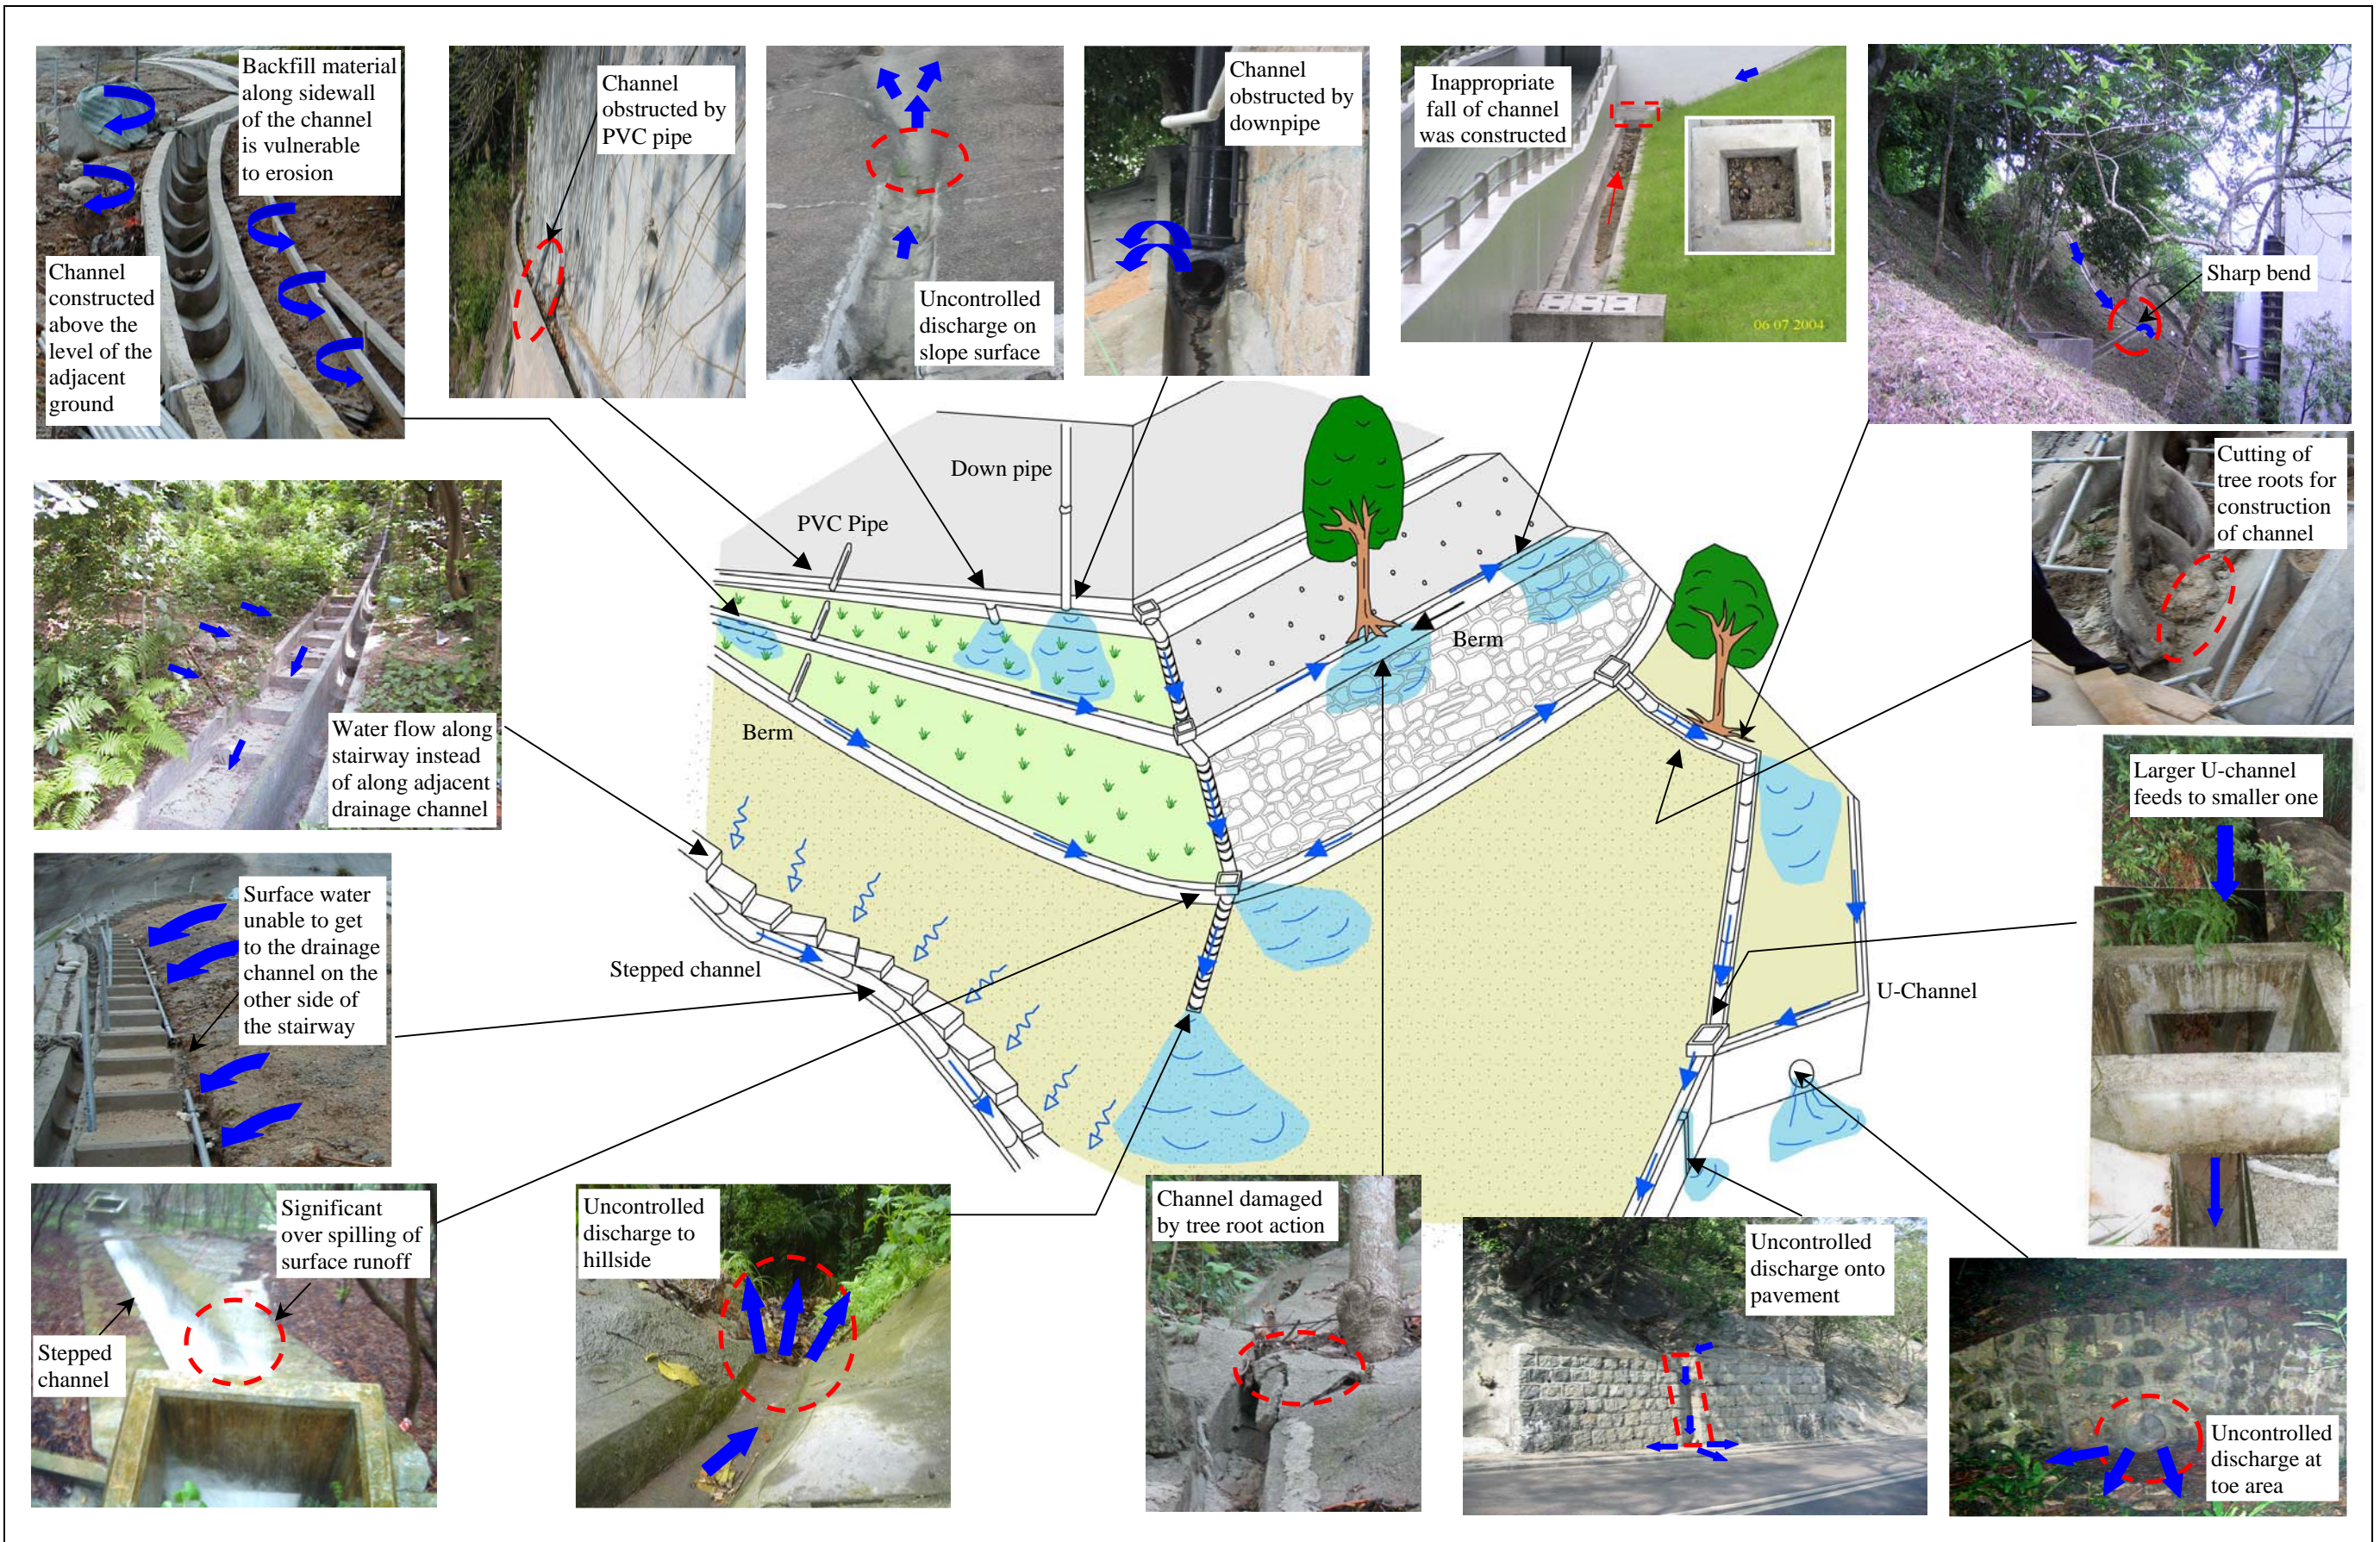
Figure 14 - Some Examples of Inadequate Attention to Drainage Detailing

Observations have been made of the detailing of slope drainage provisions in landslide inspections, slope maintenance inspections as well as site visits made during heavy rainstorms. These field inspections have highlighted some examples of inadequate detailing or construction of surface drainage provisions, notwithstanding the extensive guidance given in various publications. Some of these examples (see also Figure 14) include the following:

- (a) presence of sharp bends in drainage channels with no catchpits or baffle walls provided to control potential splashing,
- (b) inadequate capacity of downstream drainage provisions to cater for the discharge from the slope (e.g. large channels discharging into smaller-sized channels), hence resulting in overflow,

- (e) inadequate construction of drainage channels with the tops of the sidewalls being above the adjacent ground level (possibly due to over-excavation of the channel width, under-excavation of the channel depth, use of formworks to minimise concrete wastage and subsequent use of soil fill to make up the surrounding ground), hence lead to erosion along the side of the channel,

- (h) drainage channels constructed close to mature trees necessitating removal of some tree roots, with the attendant risk of causing adverse impact on the tree health condition as well as possible damage to the channels by tree root action in due course,

- (i) trees planted too close to drainage channels, hence a risk of causing damage to the channels due to tree root growth,
- (j) undersized drainage channels that can lead to splashing, hence erosion of the vegetated slope surface alongside the drainage channels,

- (l) inappropriate detailing of trash grill/debris screens at drainage inlets, which are liable to lead to turbulent flow and splashing,
- (m) inadequate protection of the headwalls at inlets to cross-road culverts against water ingress into the road embankment, leading to wetting up of the ground and potential subsurface erosion and ground movement (hence possible cracking of the culverts and consequential leakage which can affect the downhill slope),

- (n) inadequate number of drainage discharge points provided,
- (o) undersized catchpits that can be prone to blockage,
- (p) presence of a concrete stairway adjoining drainage channel, that is liable to act as an interceptor and prevent surface runoff from getting into the channel,

- (q) poor detailing at the connection between the existing road/stormwater drainage provisions and the slope drainage systems, and
- (r) absence of crest channels or inadequate sizing of crest channels for slopes with sizeable surface catchments.

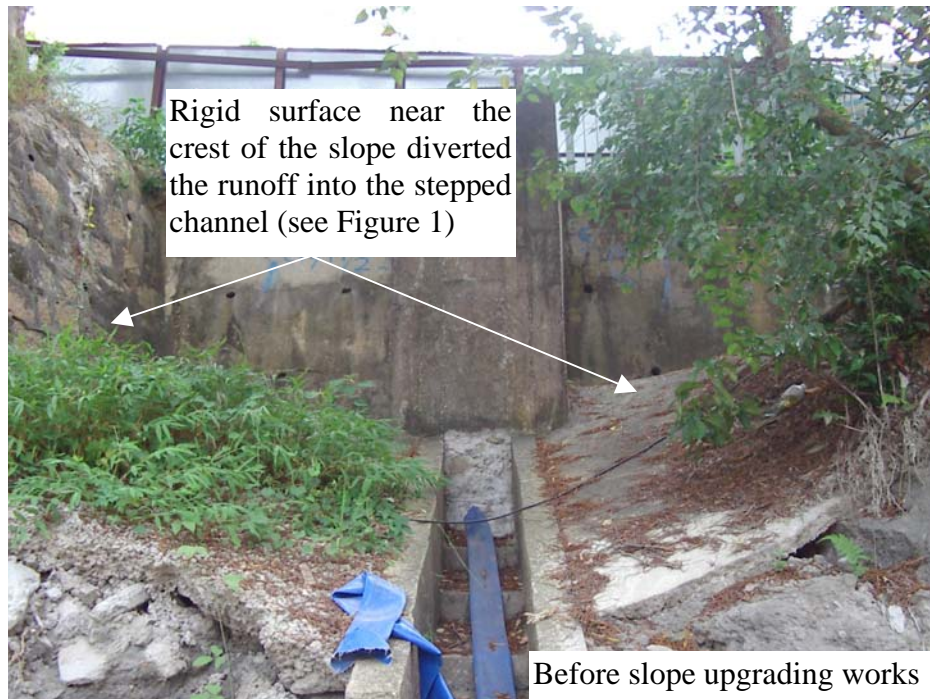
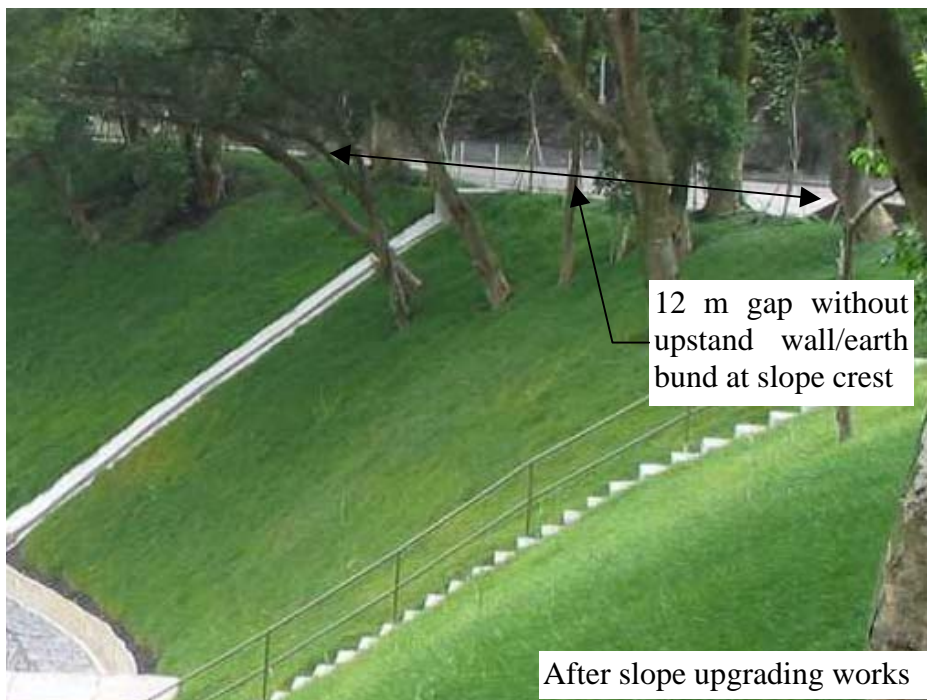
The situation was exacerbated by poor detailing and probably inadequate review conducted during the construction of the slope drainage system (see Figure 1). One of the failure scars coincided with the location of a previous concrete apron below a low point of the road at the crest, which was downhill of an opening in the crest upstand wall that, in effect, served as an overflow system. As part of the slope upgrading works, the slope, including the concrete apron, was filled up and provided with a vegetated cover but the opening in the upstand wall at the crest was maintained. During heavy rainfall in May 2003 shortly after completion of slope upgrading works, the road above the slope crest was flooded. As a consequence, concentrated discharge occurred through the opening in the upstand wall, which resulted in severe erosion of the vegetated slope (see Figure 1 and Plate 2).

Plate 2 - Surface Drainage System Before and After the Slope Upgrading Works at Scar A of the 5 May 2003 Washout Failures below South Lantau Road

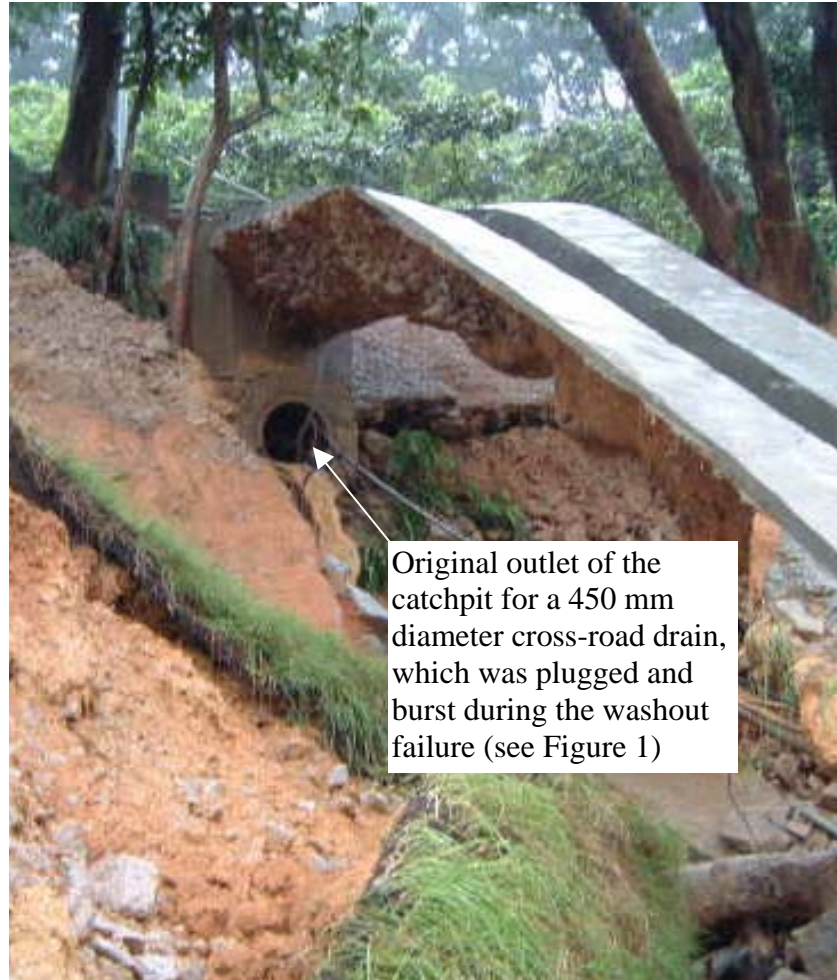
Plate 3 - The Catchpit at the Crest of Scar B of the 5 May 2003 Washouts at South Lantau Road

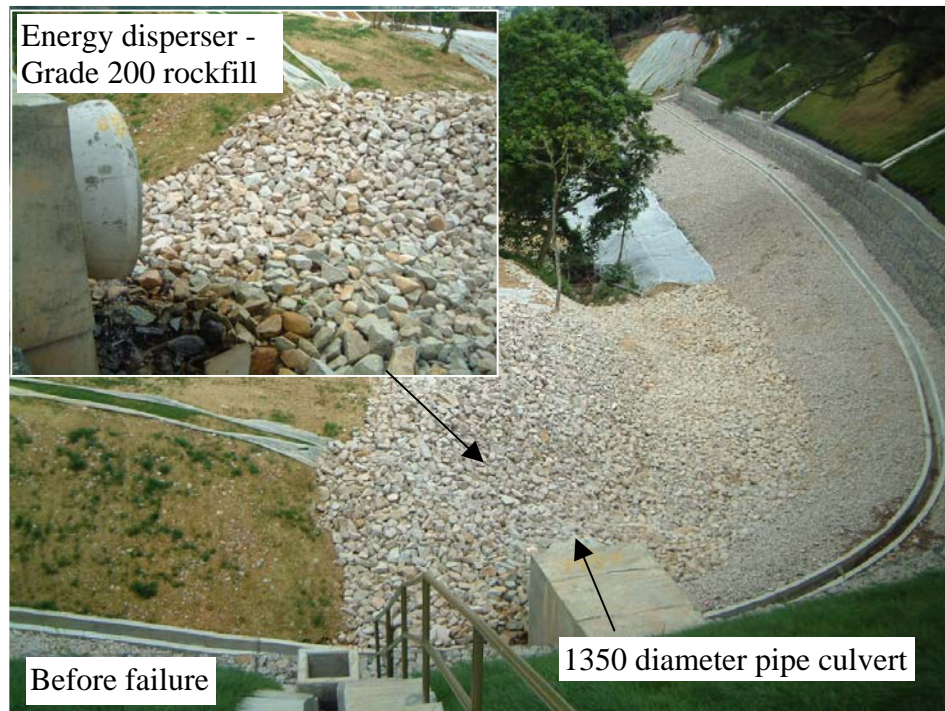
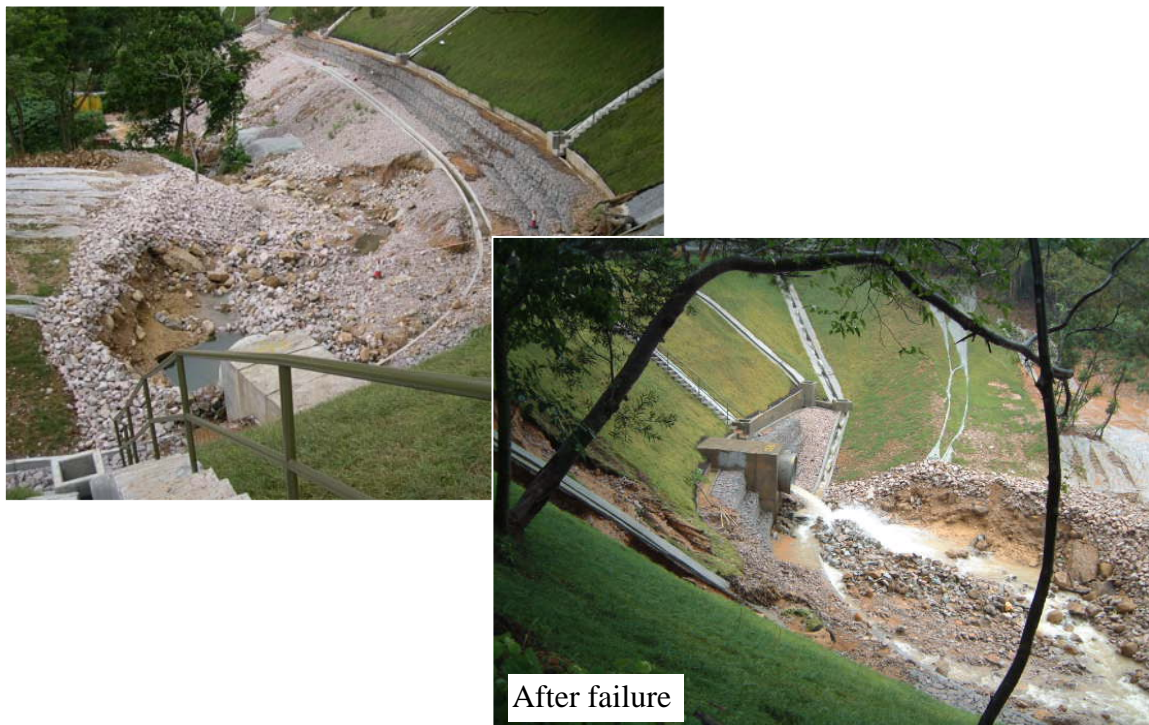
Plate 4 - The Energy Disperser for a 1350 mm Diameter Pipe Culvert and Erosion during the 5 May 2003 Washouts at South Lantau Road

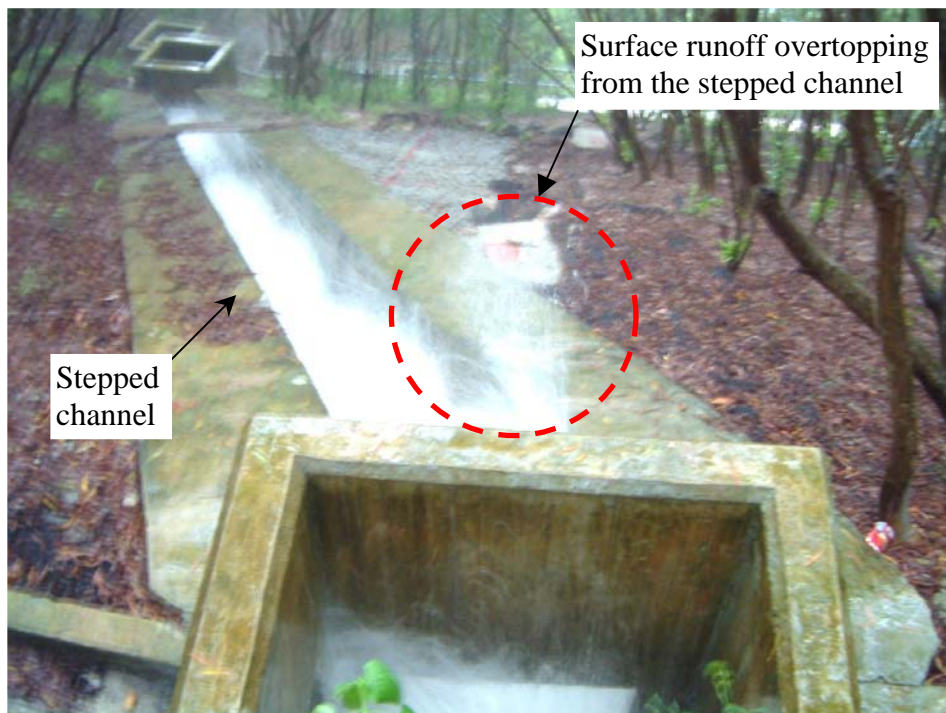
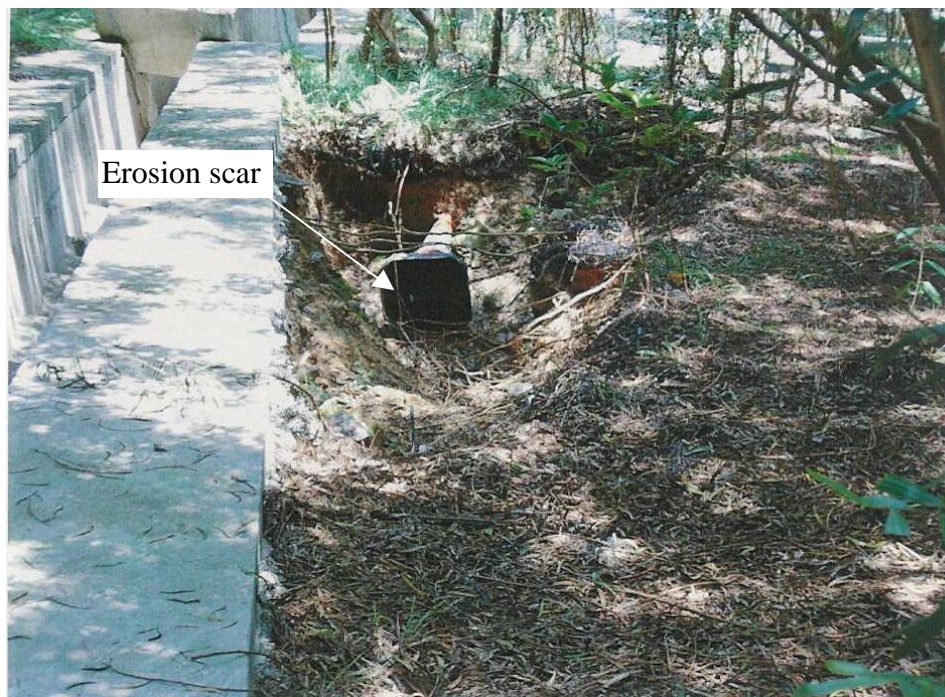
This case involved a minor washout failure ($< 5 \text{ m}^3$), which occurred on a newly upgraded fill slope. It transpired that this was a repeated problem since completion of the slope upgrading works. The erosion was observed during intense rainfall to be caused by significant overspilling from a stepped channel that runs obliquely down the slope face at about 30° . The principal cause of the overflow was due to a sudden change in the flow directions between the outlet of a cross-road culvert and a stepped channel on the slope (see Figure 2 and Plate 5).

Plate 5 - Slope Distress and Erosion on a Fill Slope below Shek O Road near Lan Nai Wan, Shek O

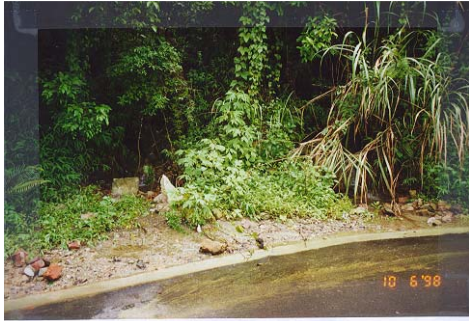
Overflow from streamcourse

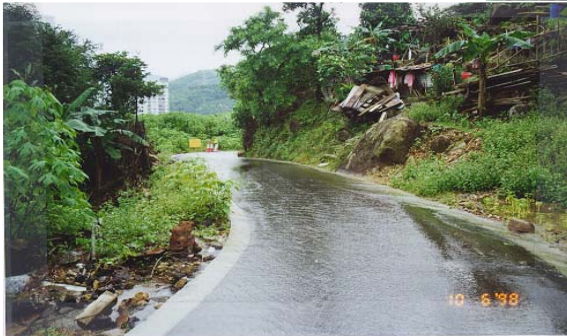
Surface water flow towards landslide scar

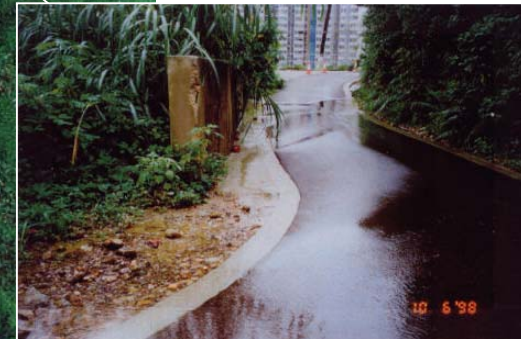
Surface water flow along road

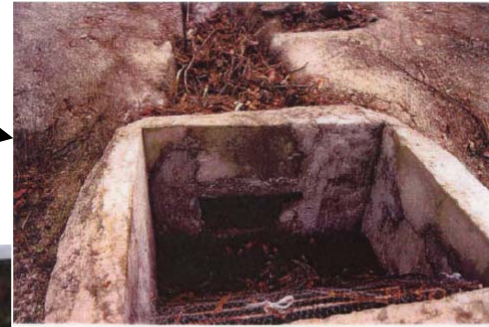
Blocked catchpit 50 m from landslide
