**DETAILED STUDY OF THE  
20 AUGUST 2005 LANDSLIDE  
ON SLOPE NO. 11SW-D/C543  
ABOVE MIDDLE GAP ROAD  
WANCHAI GAP**

**GEO REPORT No. 211**

**FUGRO SCOTT WILSON JOINT VENTURE**

**This report was originally produced in November 2006  
as GEO Landslide Study Report No. LSR 8/2006**

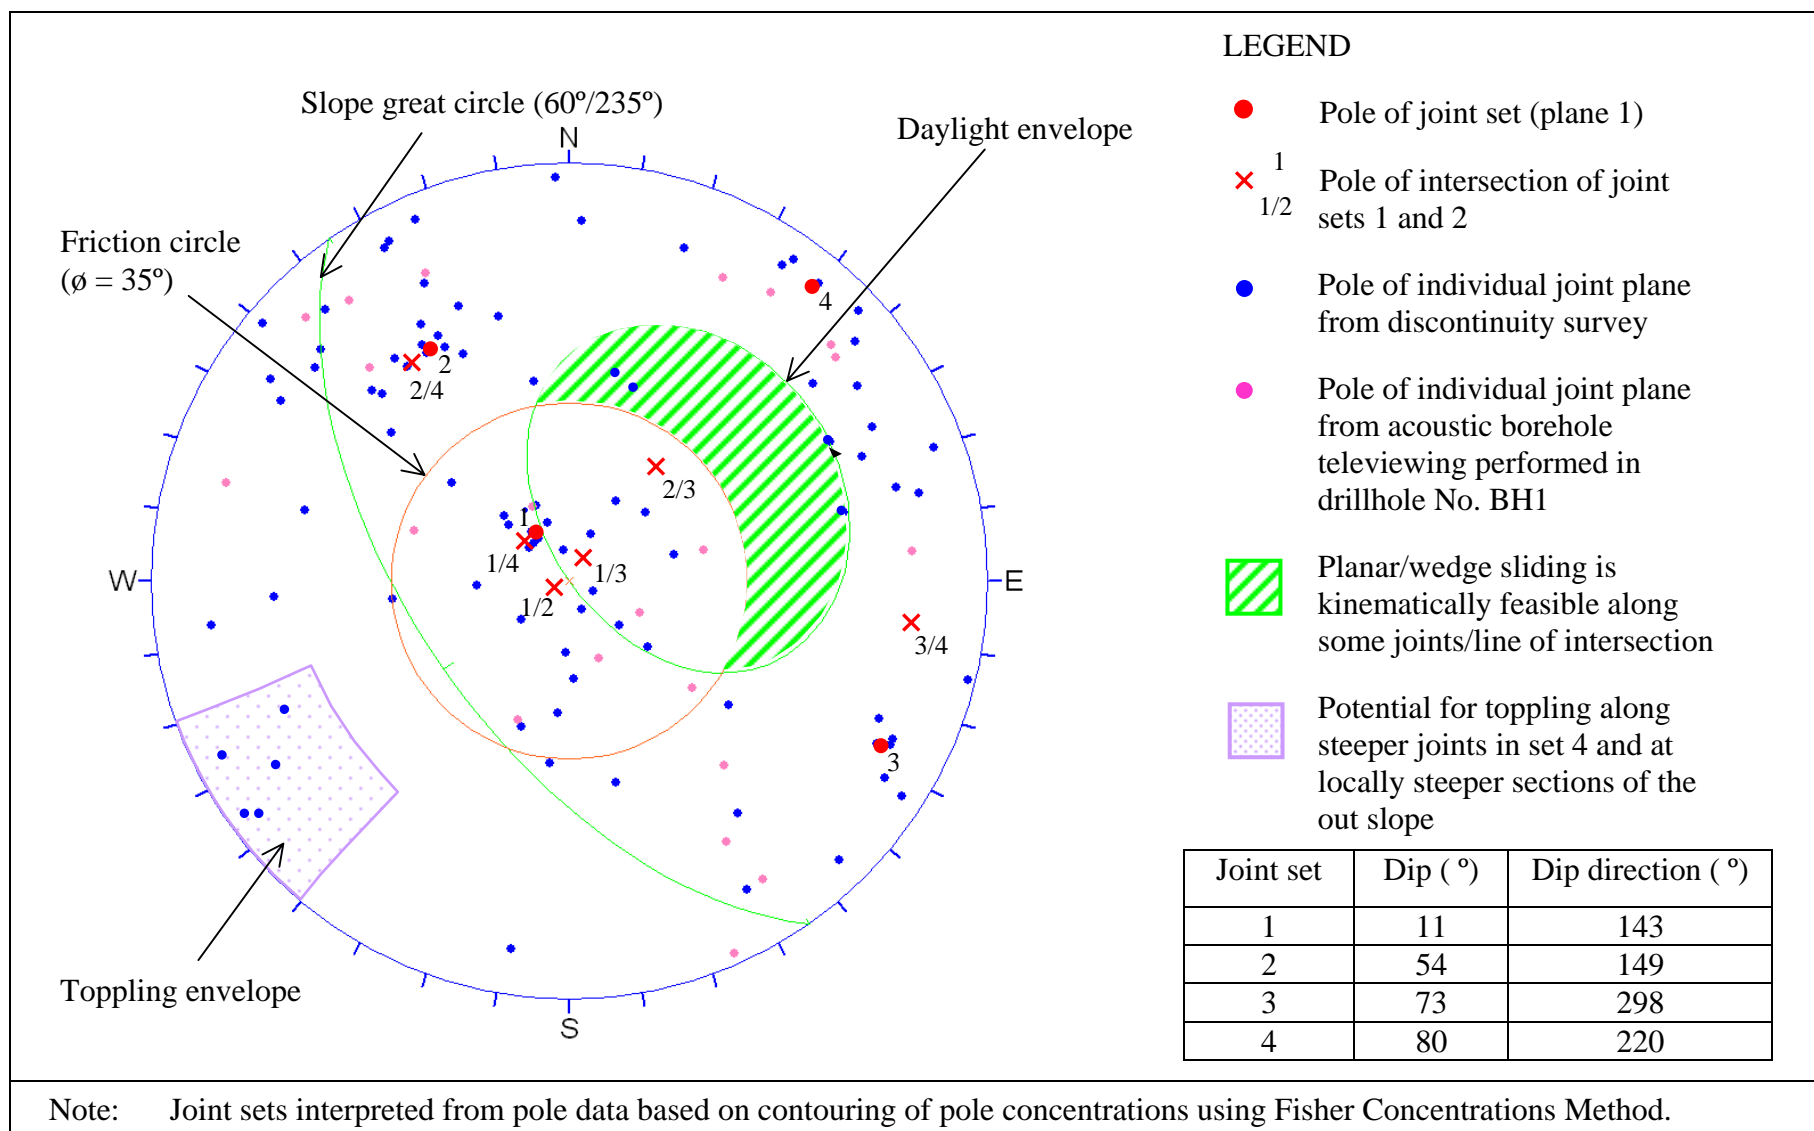
Figure 11 - Stereographic Projection of Discontinuity Survey Data

The results of the discontinuity survey, presented in Figure 11, indicate that the highly decomposed fine ash tuff incorporates relict structures with scattered orientations. Nevertheless, these have been characterised into three main joint sets with dip/dip direction of 11°/143° (Joint Set 1), 54°/149° (Joint Set 2) and 73°/298° (Joint Set 3). An additional Joint Set 4 (80°/220°) has been included to represent the rest of the fewer and scattered joint data for the kinematic admissibility analysis. The results of kinematic admissibility analyses indicate that a wedge failure along the intersection of Joint Sets 2 and 3 is feasible for a cut slope face orientation of similar dip and dip direction to that of slope No. 11SW-D/C543 (60°/235°). Local daylighting joint orientations form potential planar sliding failures and toppling failures.

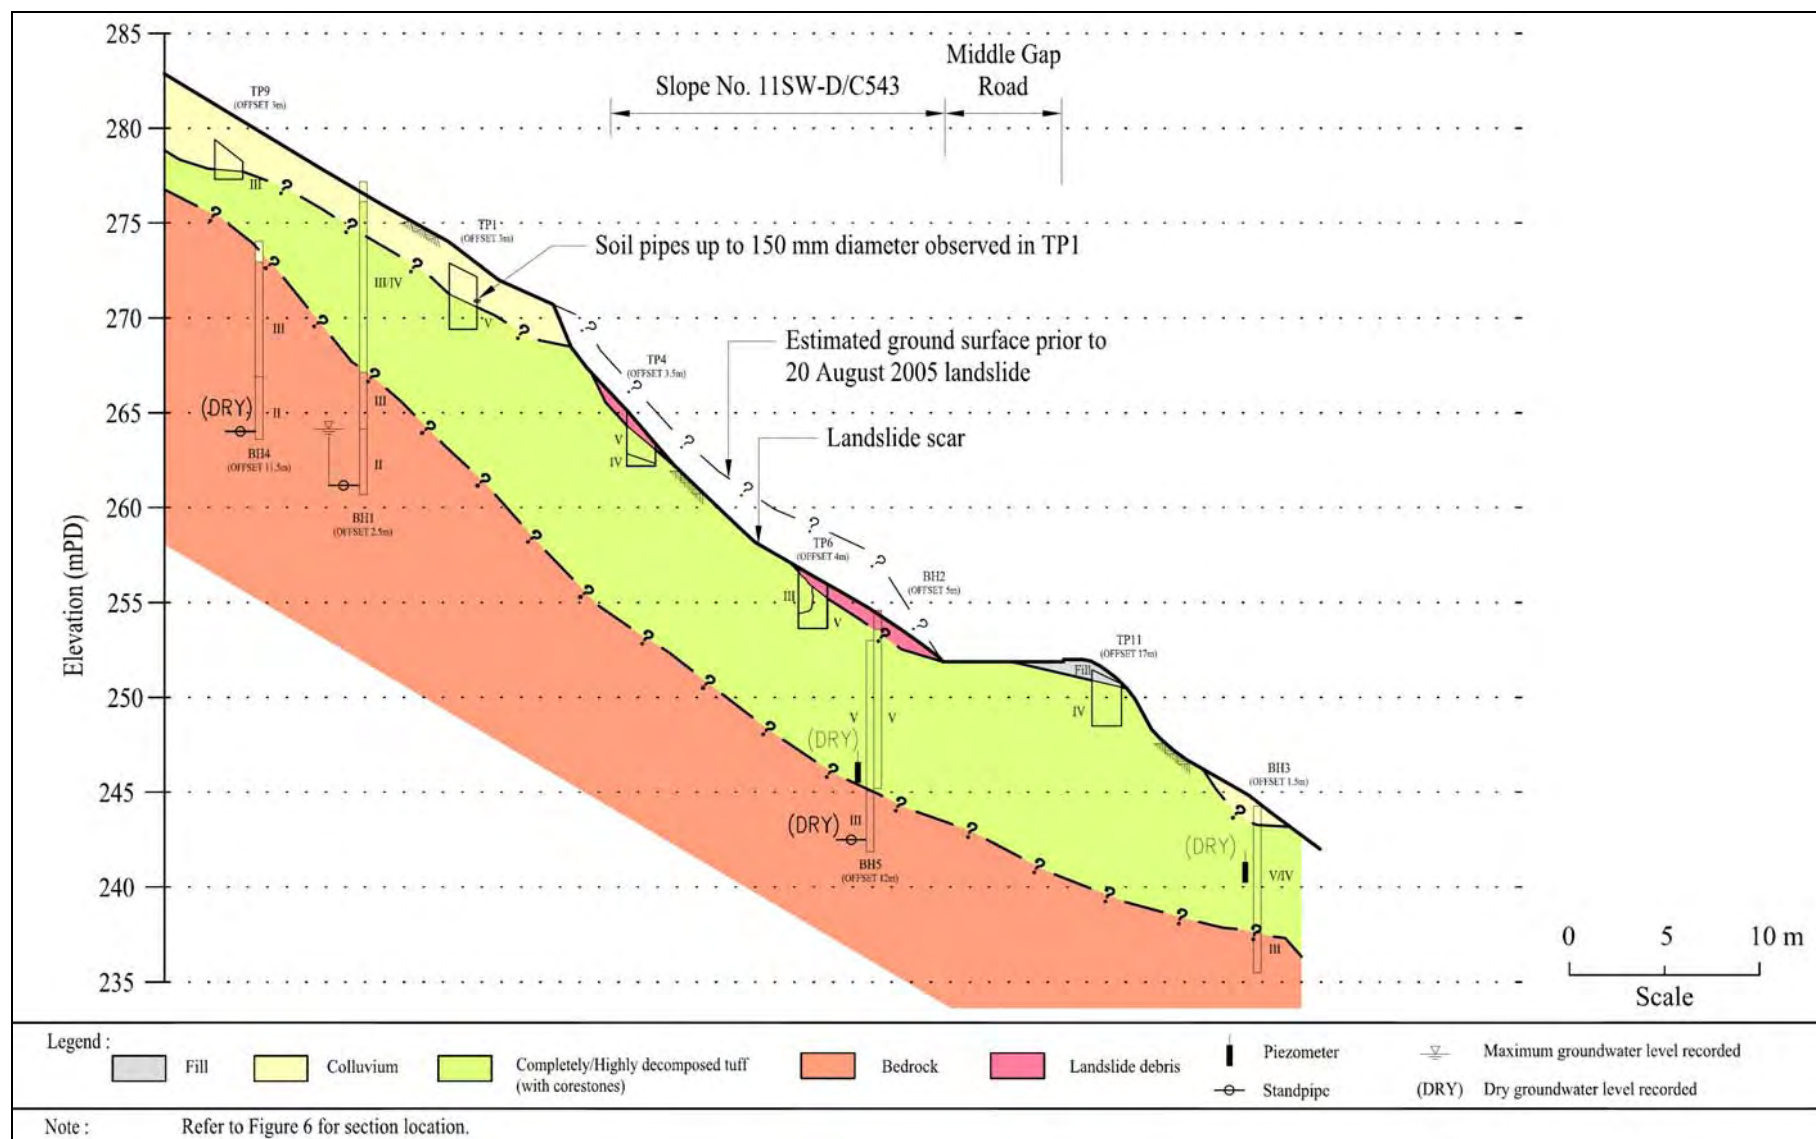
Figure 12 - Geological Profile (Section A - A)

The information provided by the current site-specific ground investigation is in general agreement with that from the geological map. The local hillside above the landslide scar is underlain by around 8 m to 9 m of completely to highly decomposed tuff, described as light to dark yellowish brown, firm to stiff, sandy silt with some angular, fine to medium gravel with relict joints stained with limonite and manganese. Bedrock comprising slightly to moderately decomposed tuff is located at about 10 m below ground surface. A thin (about 1 m to 2 m thick) layer of material that has been interpreted as colluvium/residual soil/disturbed insitu material (collectively referred to as colluvium hereinafter), described as firm to stiff, yellowish brown, slightly sandy clayey silt with some angular to sub-angular, medium to coarse gravel, cobbles and boulders of weak to moderately strong tuff, overlies the completely decomposed tuff. This stratum was distinguished from the completely decomposed tuff by the state of weathering of the cobble and boulder-sized corestones, which were completely decomposed, whilst the corestones within the completely decomposed tuff were highly to moderately decomposed. A geological profile is presented in Figure 12.

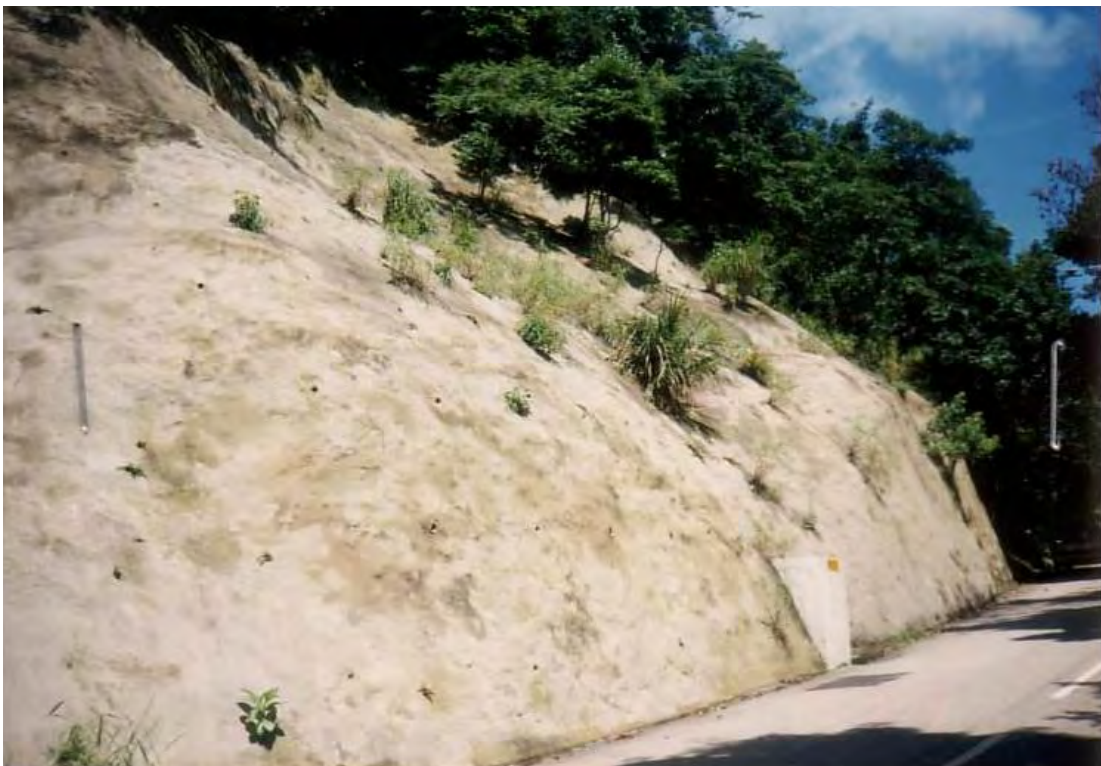
Plate 6 - Record Photograph of Slope No. 11SW-D/C543 Taken in June 1994  
(Photograph taken by Highways Department on 23 June 1994)

The inspection records for the 1994 RMI indicated that the condition of slope No. 11SW-D/C543 was satisfactory (Plate 6), and no maintenance works were required.

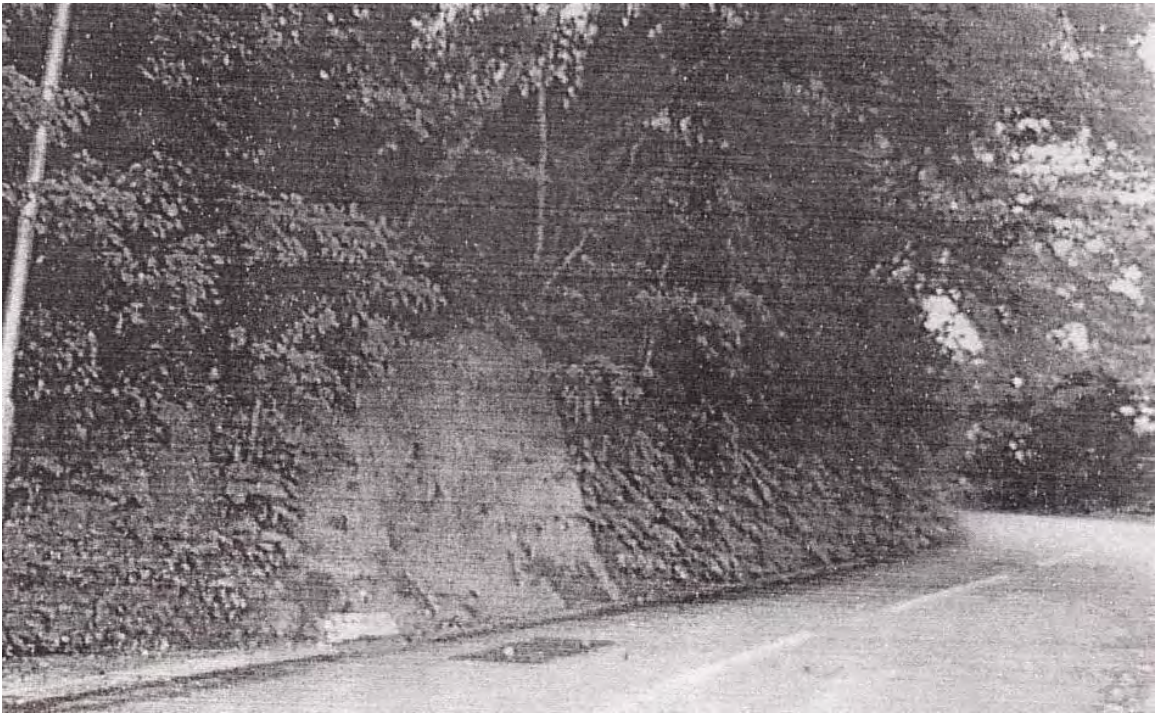
Plate 7 - Record Photograph of the Northern End of Slope No. 11SW-D/C543  
Taken in June 1995

The June 1995 inspection completed by FMR identified evidence of a past failure at the northern end of the slope (Plate 7), an upslope extension of the crest line from the location shown on the record plan, which was possibly a result of slope failure, and chunam cover over an old failure scar at the southern end of the slope, which appear to be broadly consistent with the observations made by FSW from aerial photographs (Section 3.2). FMR also observed that the northern 7 m of the feature had no hard surface cover. The inspection records noted that "Failures have occurred on the slope up to 6 m long and 3 m deep resulting in steep (> 70°) back scarps which are > 2 m high, now covered with shotcrete". However, the locations of these failures were not provided in the records. Routine maintenance works comprising the removal of vegetation from surface drainage channels, weepholes, catchpits and sandtraps, were recommended. A stability assessment and "Major Works", which were not elaborated, were recommended in view of the slope failures.

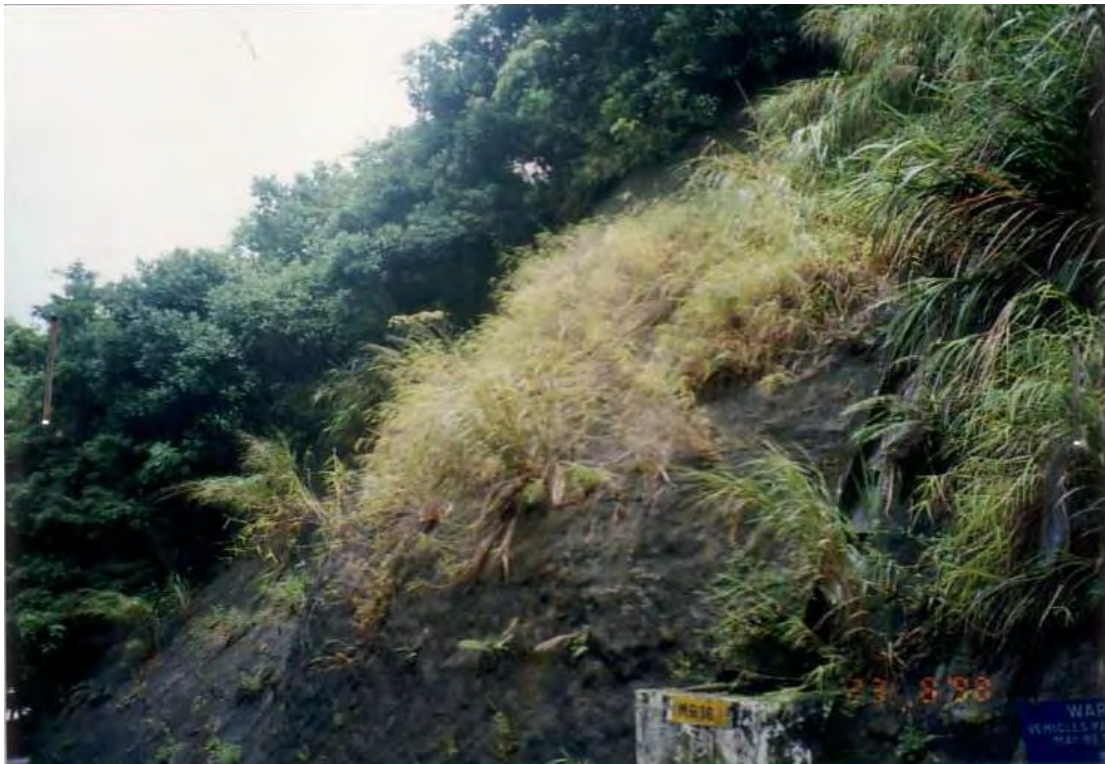
Plate 9 - Record Photograph of Slope No. 11SW-D/C543 Taken in August 1998 (Photograph taken by Highways Department on 23 August 1998)

The inspection records for the August 1998 RMI indicated that action was required in respect of repair of cracked/damaged surface cover, removal of debris and vegetation from the slope surface and clearance of weepholes (Plate 9). These works were reported to have been completed in October 1998. Another Works Order was issued in December 1998 for repair of the slope with about 100 m<sup>2</sup> of 75 mm thick reinforced shotcrete.

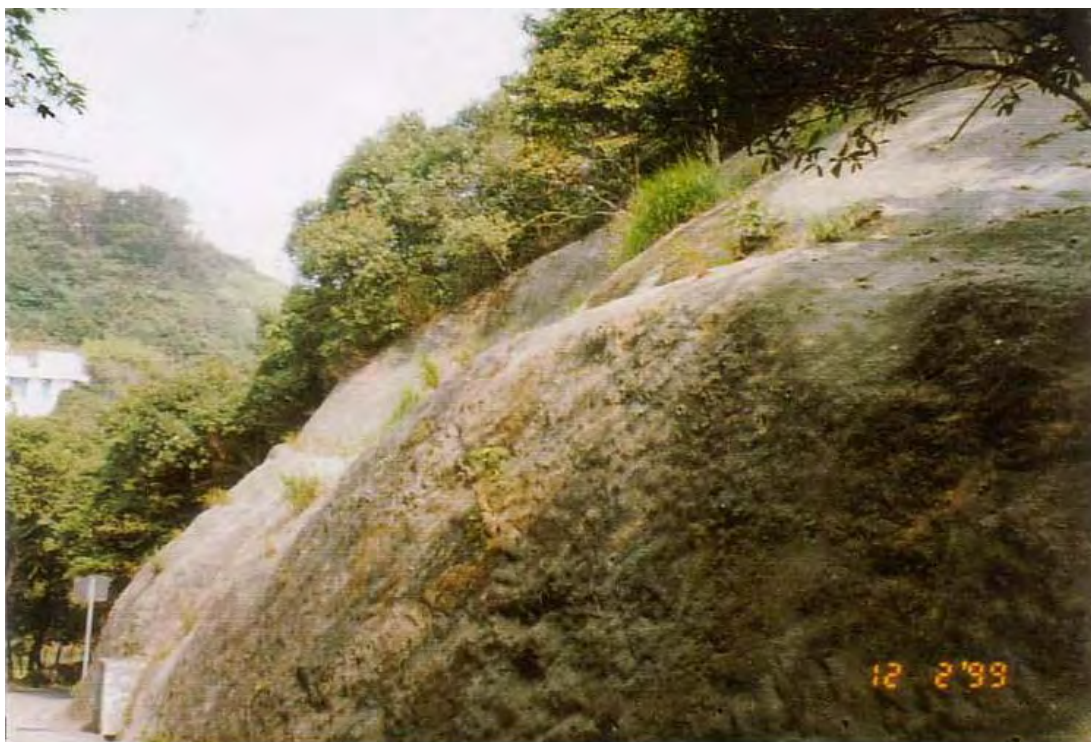
Plate 10 - Record Photograph of Slope No. 11SW-D/C543 Taken in February 1999  
(Photograph taken by Maunsell Geotechnical Services Ltd. on  
12 February 1999)

Records from the February 1999 EI completed by MGS indicated that the rigid surface cover was in fair condition (Plate 10), and that weepholes, U-channels and catchpits were partially blocked with vegetation. Erosion and washout was reported at the northwestern end of the slope. Minor works were recommended in relation to the clearance of surface channels, catchpits and weepholes, the repair of cracked/damaged surface channels and rigid surface cover, and the regrading and repair of eroded areas. A recommendation was also made for a revision to the feature boundary shown on the record plans, as well as a stability assessment on the basis that the same recommendation made by FMR in 1995 had not been implemented.

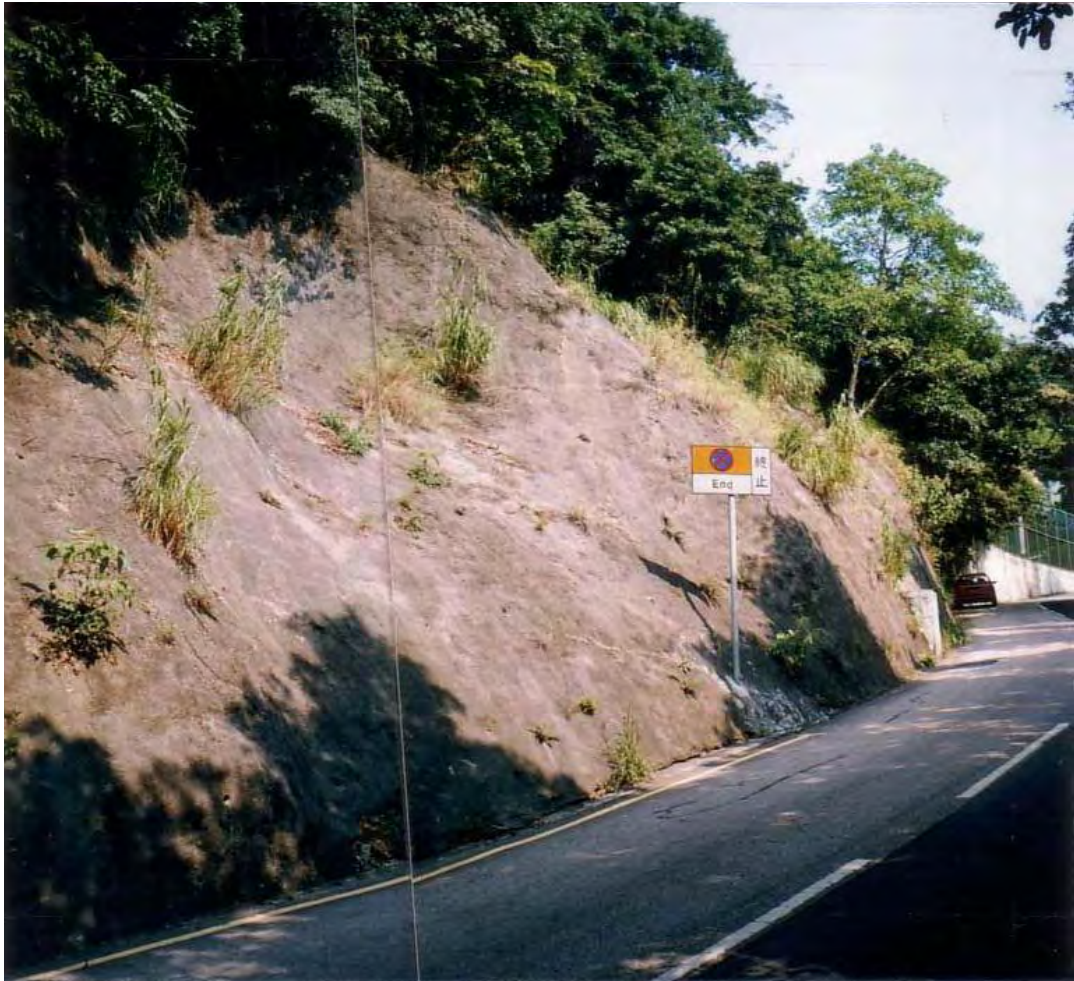
Plate 11 - Record Photograph of Slope No. 11SW-D/C543 Taken in August 1999  
(Photograph taken by Highways Department on 15 August 1999)

The August 1999 RMI recorded recommendations for clearance of surface drainage and weepholes, removal of surface debris and vegetation from the slope face and repair of cracked surface cover (Plate 11). The November 2000 RMI recorded similar recommendations, with the addition recommendation of repair of cracked drainage channels. HyD Records indicate that a Works Order for routine maintenance works was issued in January 2001, which included removal of unplanned vegetation from the slope face, clearance of debris from surface channels and catchpits, removal of defective surface cover (approximately 2 m<sup>2</sup>), application of cement rendering to the slope surface (about 22 m<sup>2</sup>), and clearance of weepholes.

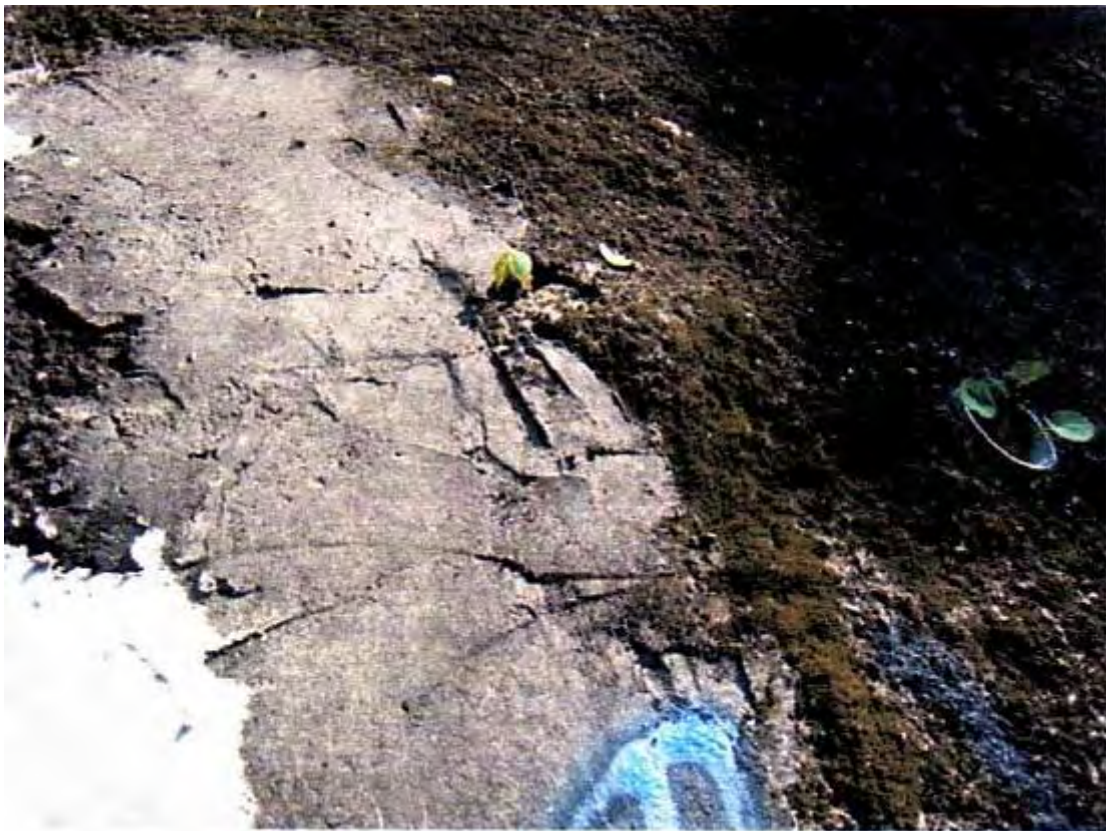
Plate 15 - Record Photograph of Slope No. 11SW-D/C543 Taken in October 2004

The October 2004 RMI recorded recommendations for clearance of surface drainage and weepholes, removal of surface debris and vegetation from the slope face, together with repair of cracked drainage channels and surface cover (Plate 15). HyD records indicate that these works were completed in October 2004.

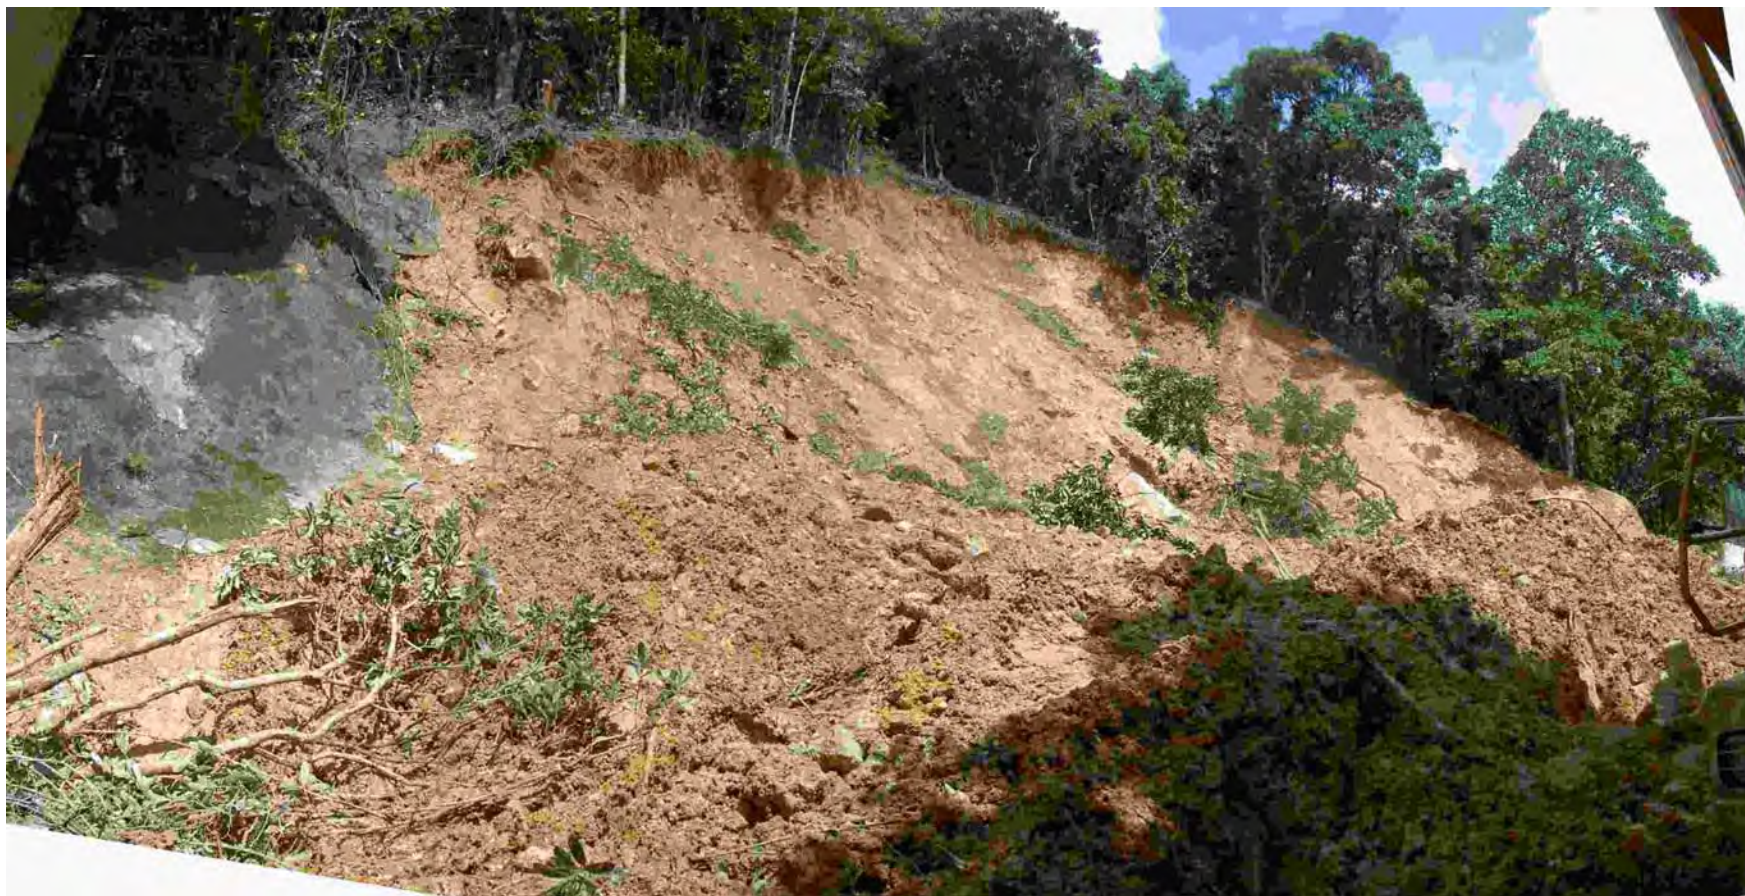
Plate 16 - General View of 20 August 2005 Landslide Scar above Middle Gap Road

The landslide affected the full height of cut slope No. 11SW-D/C543 and extended over the major portion of the slope face (Plate 16). The landslide scar measured approximately 40 m in width at the slope toe and extended an estimated 2 m to 3 m into the hillside above the slope crest that had been modified by previous landslides. Landslide debris comprising soil, cobbles, boulders, trees and broken shotcrete with an estimated volume of about 400 m<sup>3</sup> was deposited on Middle Gap Road and Mount Cameron Road, part of which spilled over into a natural drainage line below Mount Cameron Road.

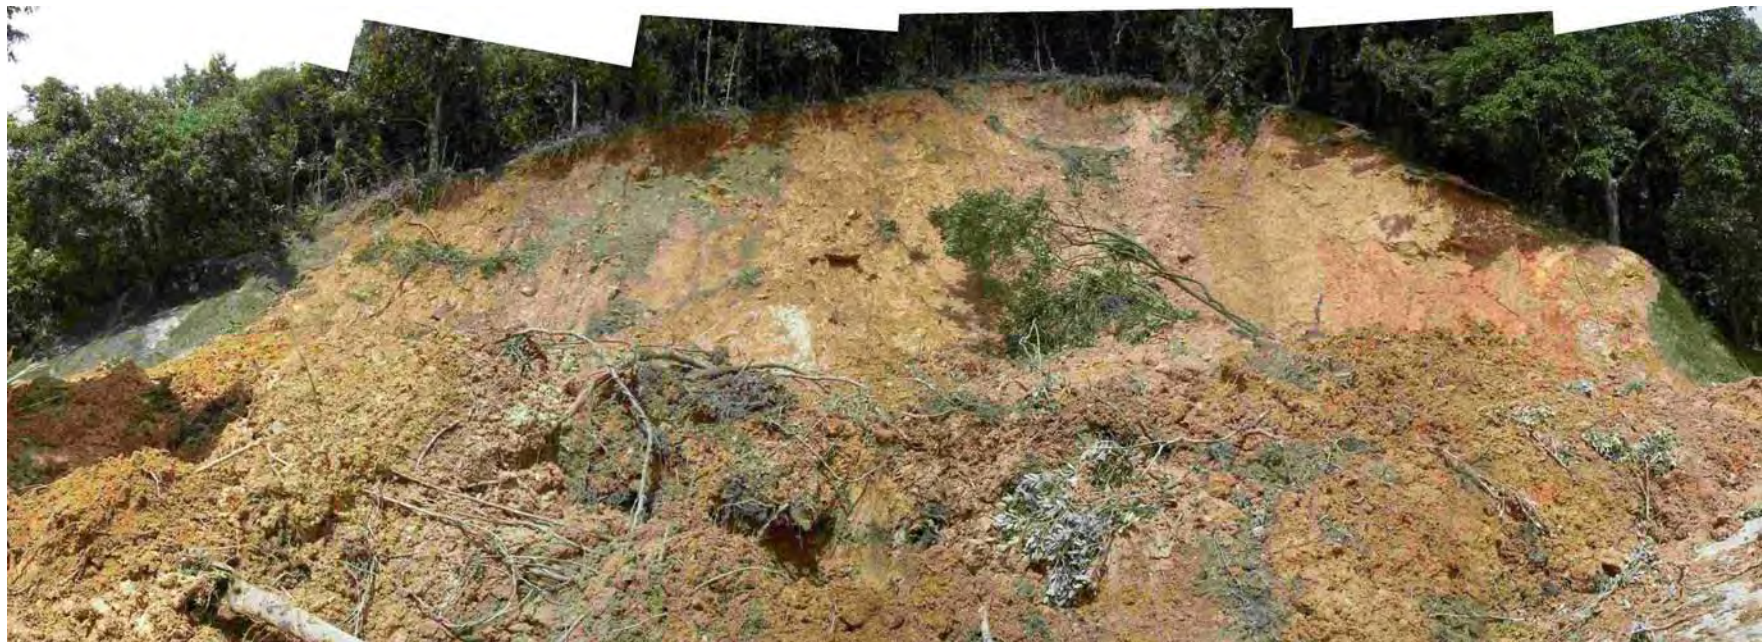
Plate 17 - General View of Surface of Rupture of the 20 August 2005 Landslide

The surface of rupture was undulating and slightly blocky in the central portion and inclined at an angle of about 55°, daylighting at or slightly above the slope toe (Plate 17). Material exposed in the scar comprised predominantly highly to completely decomposed fine ash tuff with corestones. Zones of kaolinisation of the parent rock were also observed. The failure partially exploited adversely orientated relict joint surfaces (see Section 7.3).

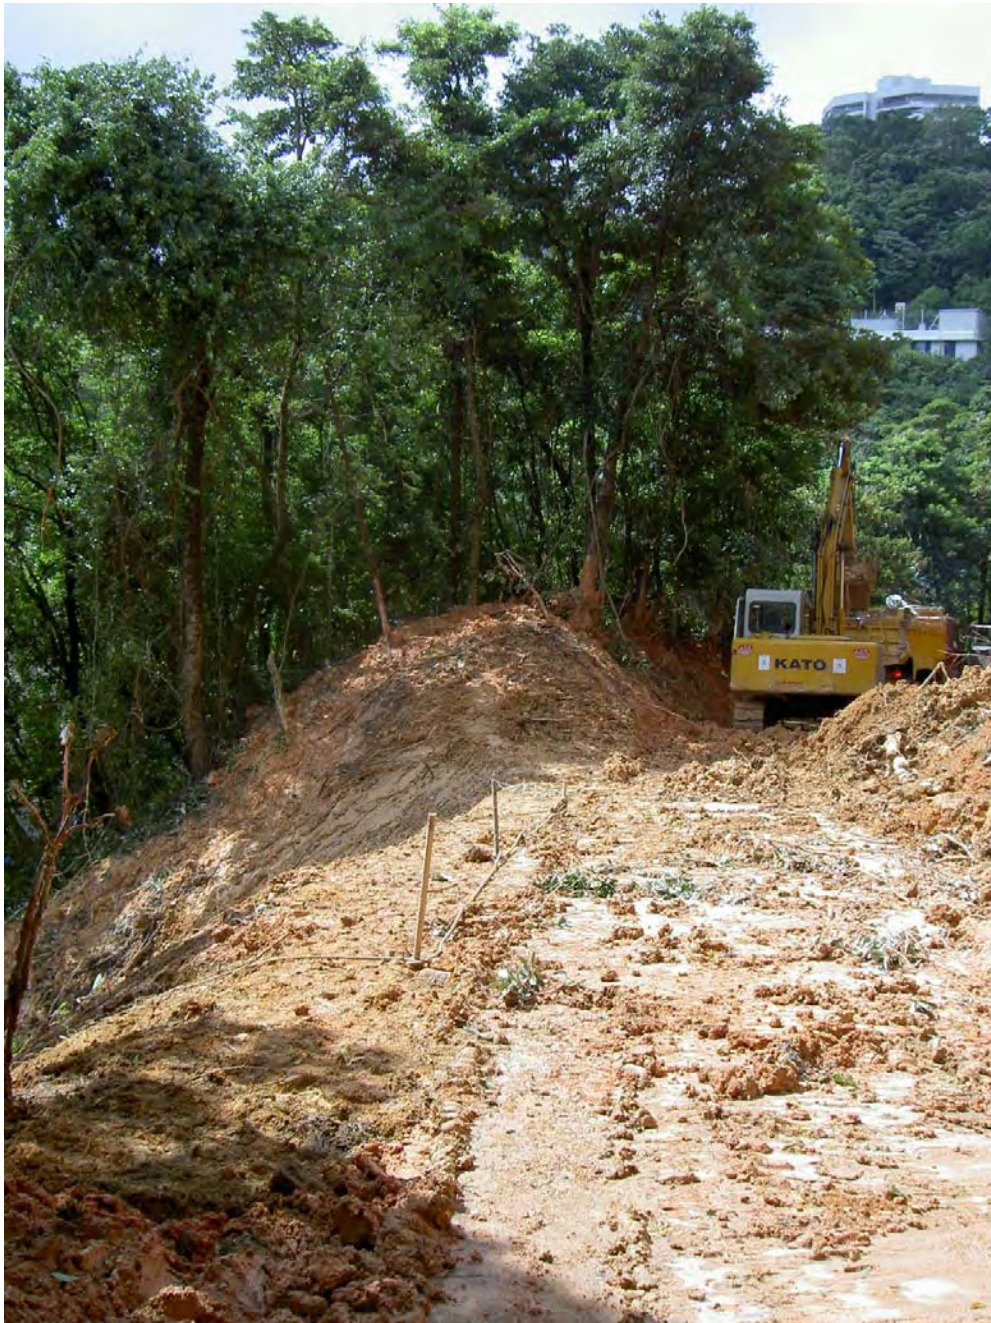
Plate 22 - View West across Middle Gap Road Showing Debris Mound  
Contained by Small Cutting

The northern margin of the debris mound on Middle Gap Road had been contained to some extent by the small cutting on the western side of the carriageway (Plate 22). Debris in this area was generally less disturbed than the material observed further downslope and contained a number of agglomerations of a light grey/buff coloured kaolin-like material (Plate 23). The debris on Mount Cameron Road included broken shotcrete from the hard surface cover of slope No. 11SW-D/C543.

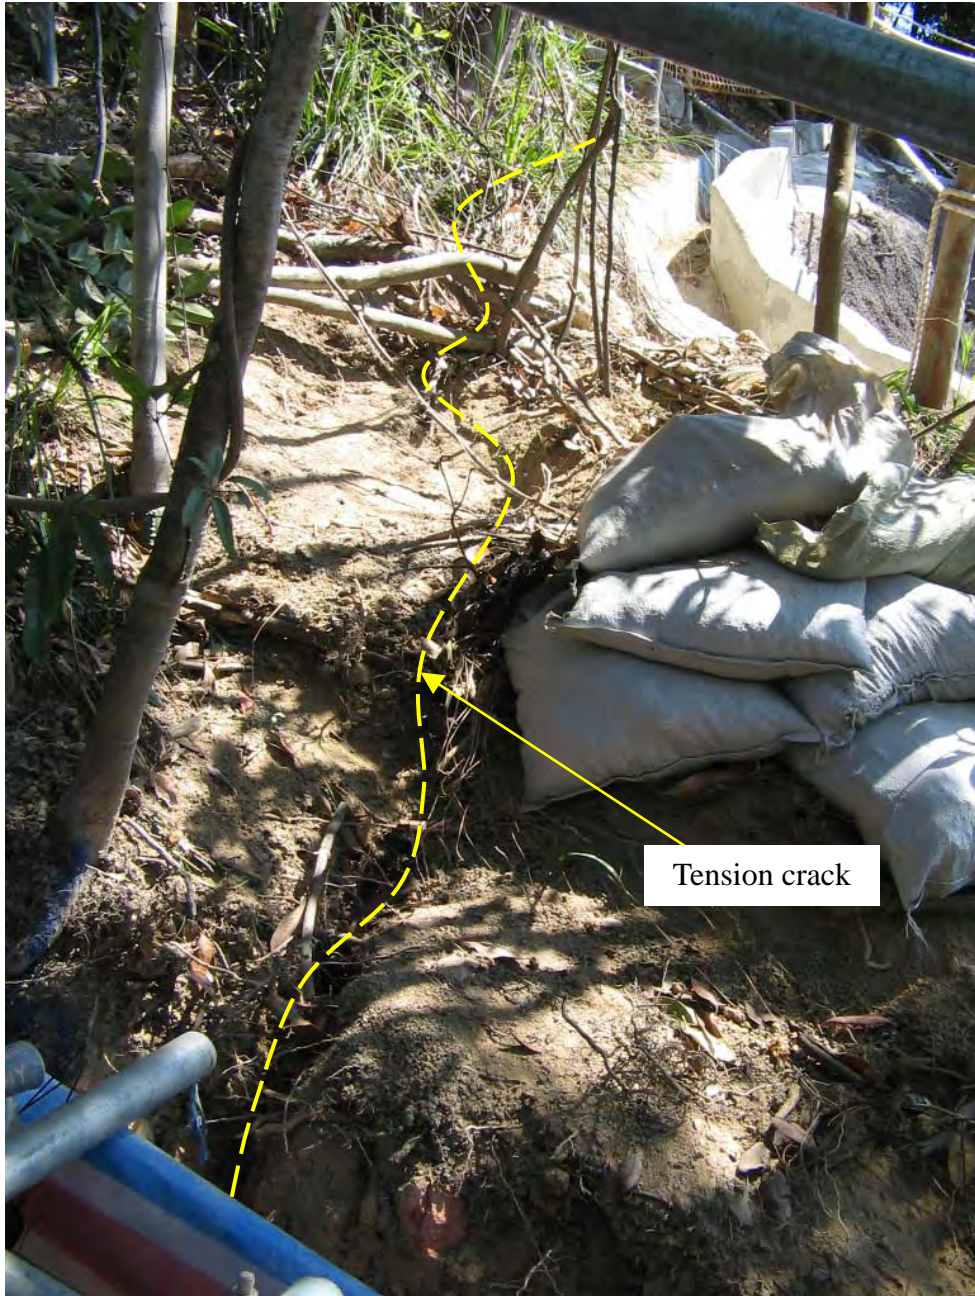
Plate 30 - Tension Crack Identified in Vegetation Strip VS3 behind Main Scarp  
(Photograph taken on 21 February 2006)

- (c) A tension crack about 100 mm wide and extending to the northwest of the crown of the landslide scar was identified in vegetation strip VS3 (Figure 9 and Plate 30). This feature was traced back to the north flank of the landslide scar, about 1.5 m from the crown, and was interpreted as recent and associated with the August 2005 landslide, representing the upper margin of a displaced, but not completely detached, ground mass.

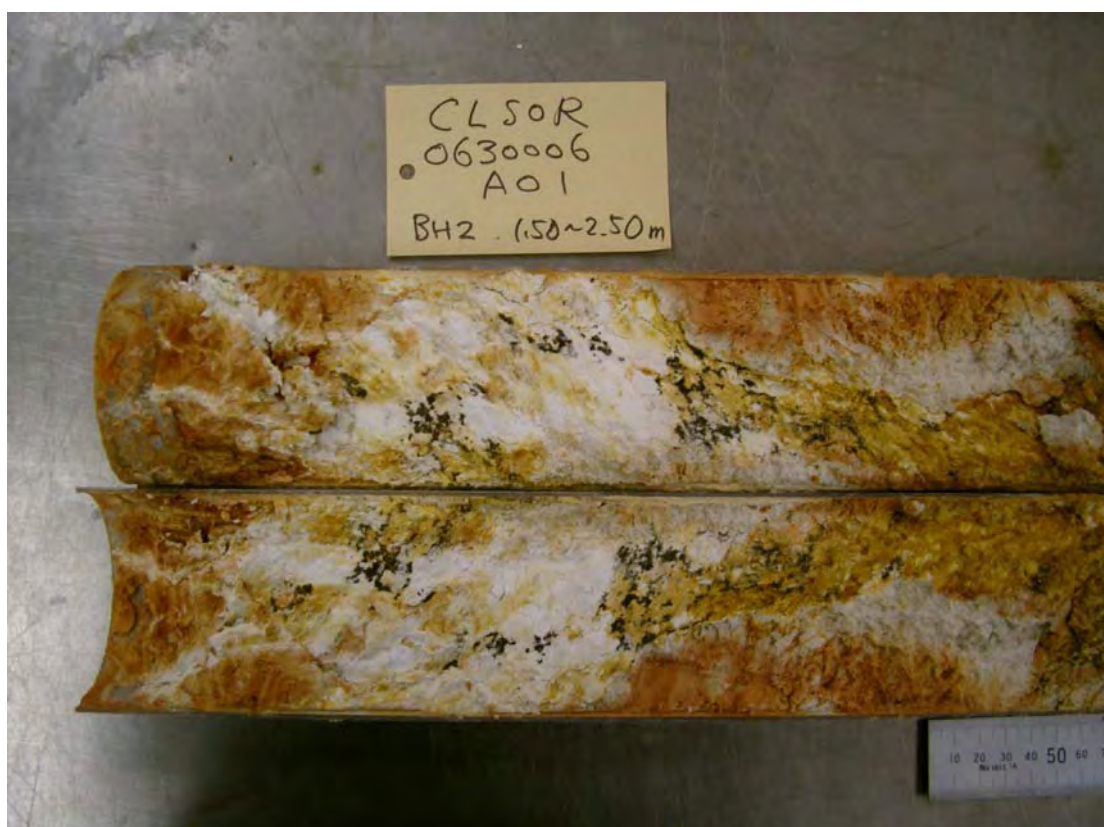
Plate 34 - Deposition of White and Buff Kaolin and Black Manganiferous Infills in Relict Joints (Photograph taken on 26 April 2006)

- (e) Extensive kaolinisation of the decomposed tuff, described as light grey, slightly sandy clayey silt with occasional fine gravel with limonite and manganese stained in relict joints, was identified in the lower portion of the scar in trial pits TP5 and TP6, being most distinct in TP5 (Plate 31), which was broadly consistent with the locations identified during the field mapping of the scar (Section 5.2.2). Kaolinisation was also observed to some extent in TP4, situated higher in the scar, though to a much lesser extent and in combination with deposition in relict joints (Plate 32). Mazier samples recovered from drillholes BH2 and BH5 in the lower slope portion also indicated localised kaolinisation of the tuff, ranging in thickness from 0.2 m to 0.5 m (Plate 33). White and buff kaolin of up to 5 mm thick and black mangiferous infills were commonly observed in relict joints (Plate 34).

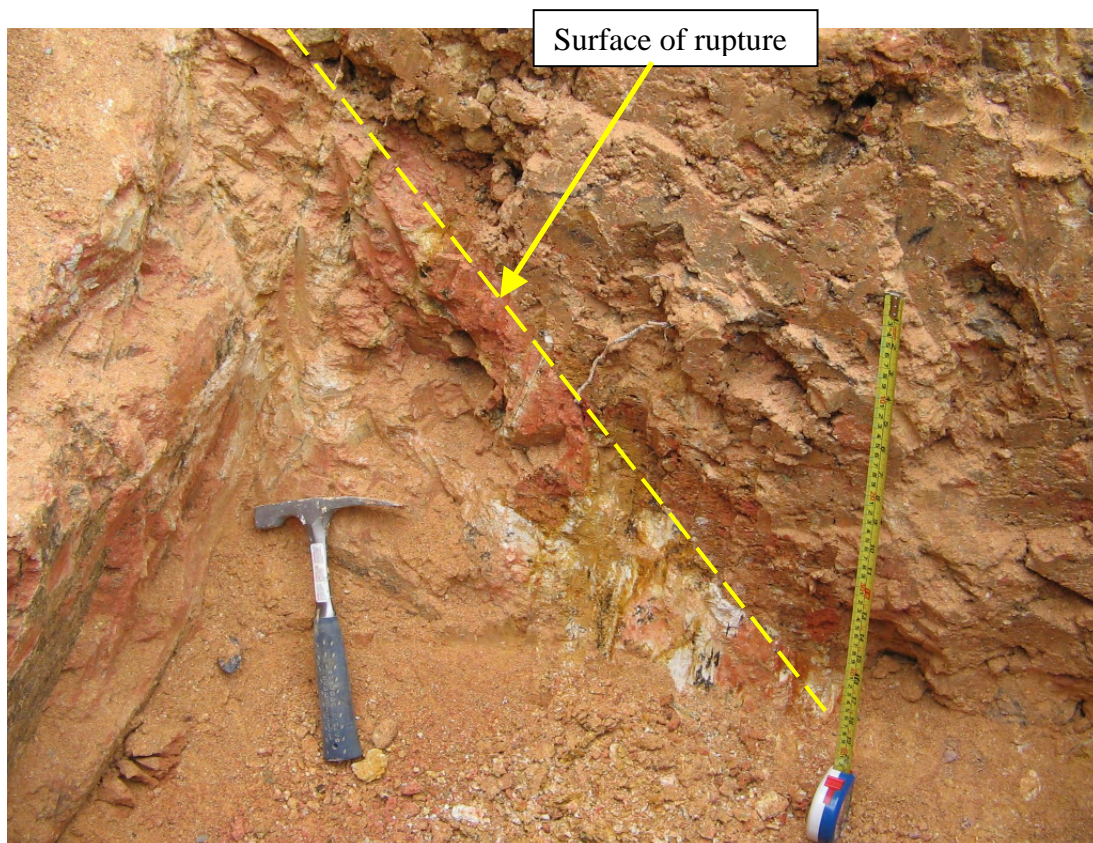
Plate 35 - Landslide Debris above Surface of Rupture in Trial Pit TP6  
(Photograph taken on 11 February 2006)

- (f) Landslide debris of up to 1 m thick remaining within the landslide scar was identified in TP6 above the surface of rupture (Plate 35).
- (g) The ground between Middle Gap Road and Mount Cameron Road indicated a thin (about 1m thick) layer of fill immediately below ground surface underlain by a highly to completely decomposed tuff similar to that encountered above the landslide scar.
