**REVIEW OF
THE 20 AUGUST 2005
DEBRIS FLOOD AT
LO WAI, TSUEN WAN**

GEO REPORT No. 212

Maunsell Geotechnical Services Limited

**This report was originally produced in October 2006
as GEO Landslide Study Report No. LSR 5/2006**

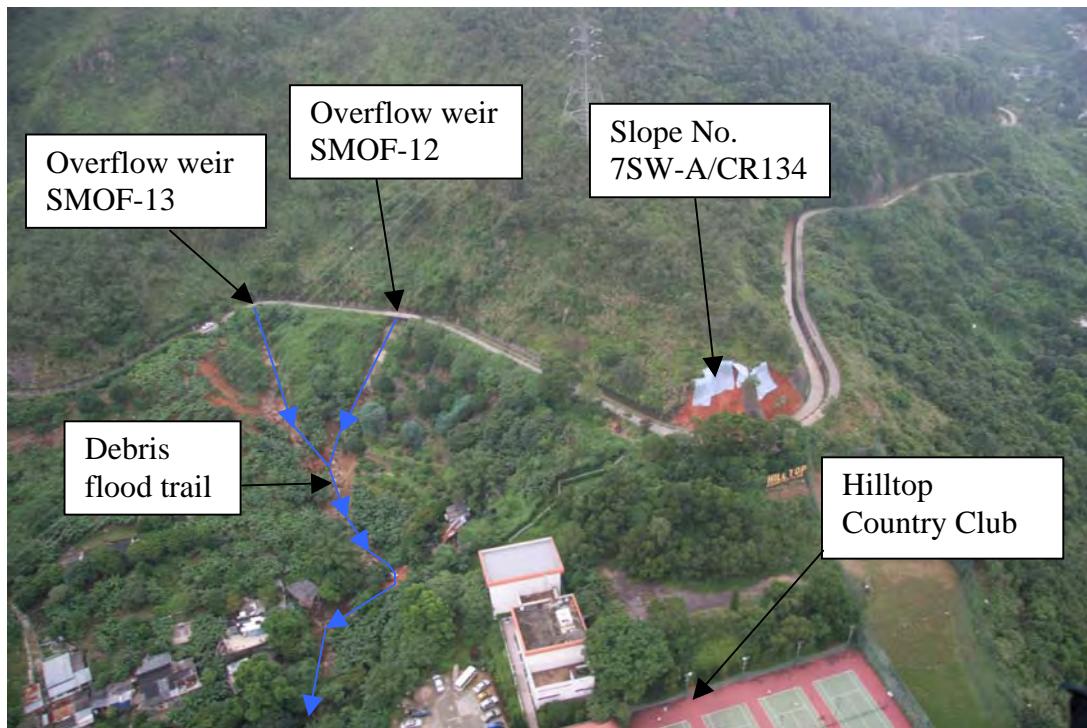
Plate 1 - Oblique Aerial View of Shing Mun Catchwater
and Landslides at Slope No. 7SW-A/CR134
(Photograph taken on 22 August 2005)

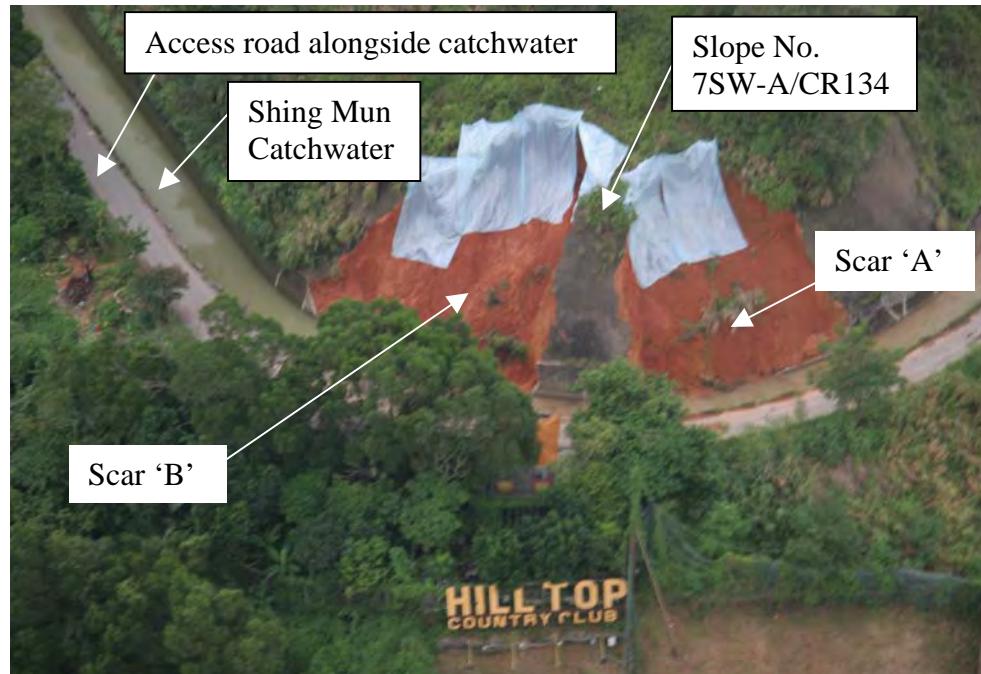
Plate 10 - Oblique Aerial View of Landslides
on Slope No. 7SW-A/CR134
(Photograph taken on 22 August 2005)

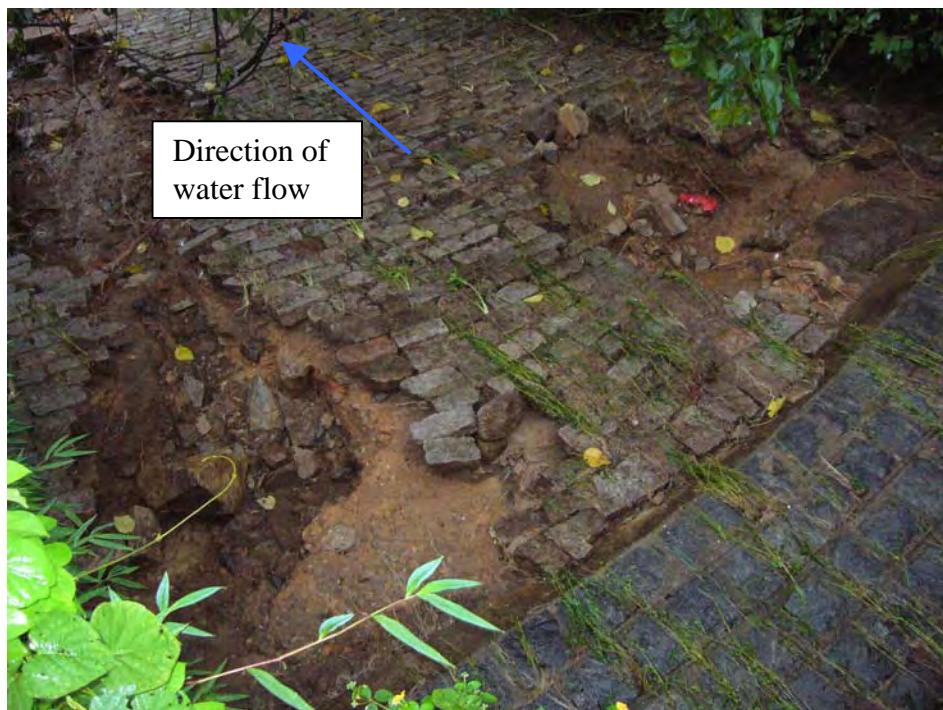
Plate 11 - Dislodged Masonry Facing Blocks at
Spillway below Overflow Weir SMOF-13
(Photograph taken on 25 August 2005)

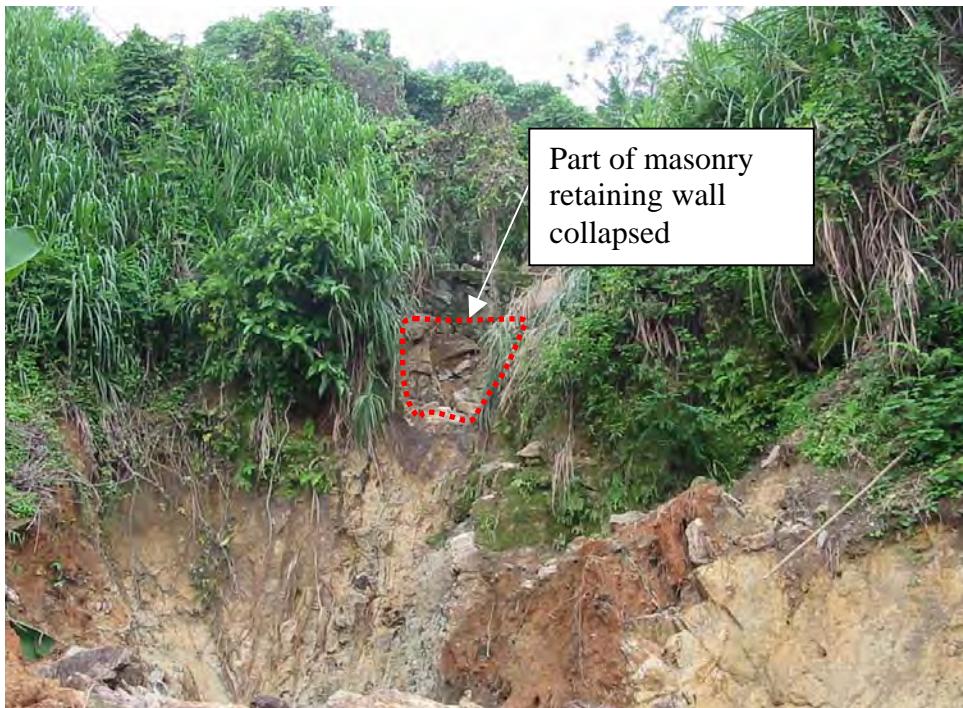
Plate 13 - Collapse of Part of a Masonry Wall below the Spillway (Below Overflow Weir SMOF-13)
(Photograph taken on 25 August 2005)

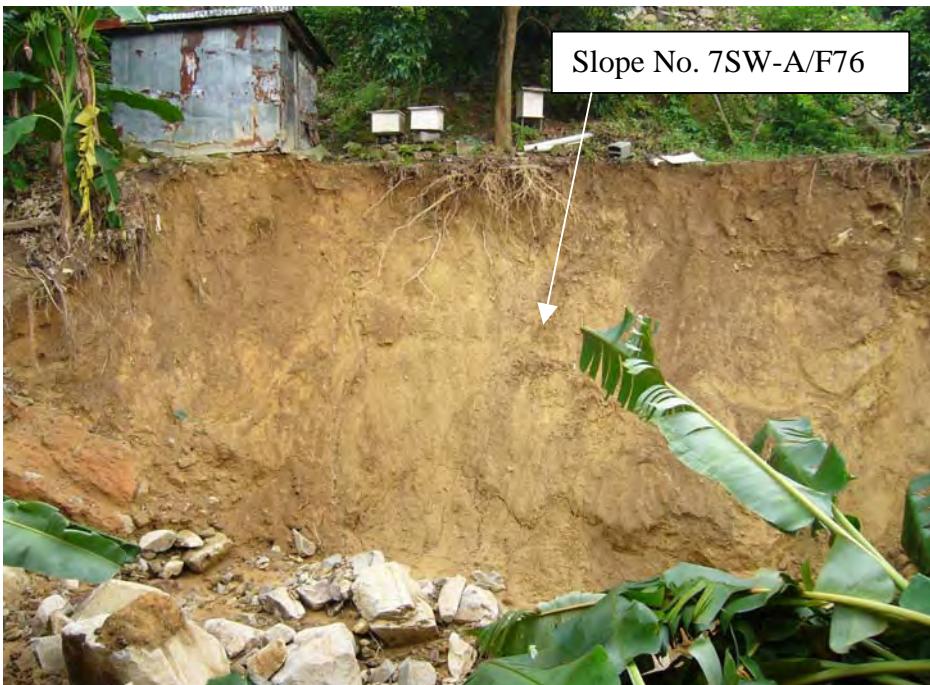
Plate 22 - View of Undercutting of Slope No. 7SW-A/F76 near Squatter
Structure No. RTW/4AD/124 at Approximate Chainage CH 48
(Photograph taken on 25 August 2005)

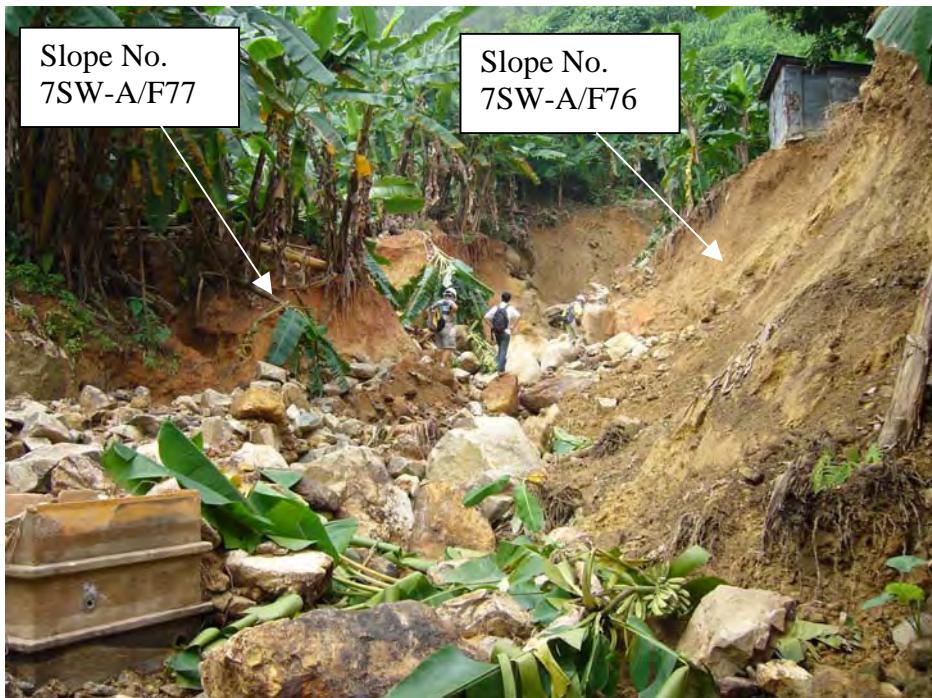
The undercutting of slopes Nos. 7SW-A/F76 and 7SW-A/F77 led to a series of landslides at these slopes. The debris, including domestic refuse, tree branches and other detritus, was deposited at the slope toes. One of these landslides (Incident No. 2005/08/0402), with an estimated failure volume of 40 m³, undermined squatter structures No. RTW/4AD/119, which is situated at the crest of slope No. 7SW-A/F77. One of the

Plate 25 - Erosion of Slopes Nos. 7SW-A/F76 and 7SW-A/F77
Caused by Debris Flood at Approximate Chainage CH 66
(Photograph taken on 25 August 2005)

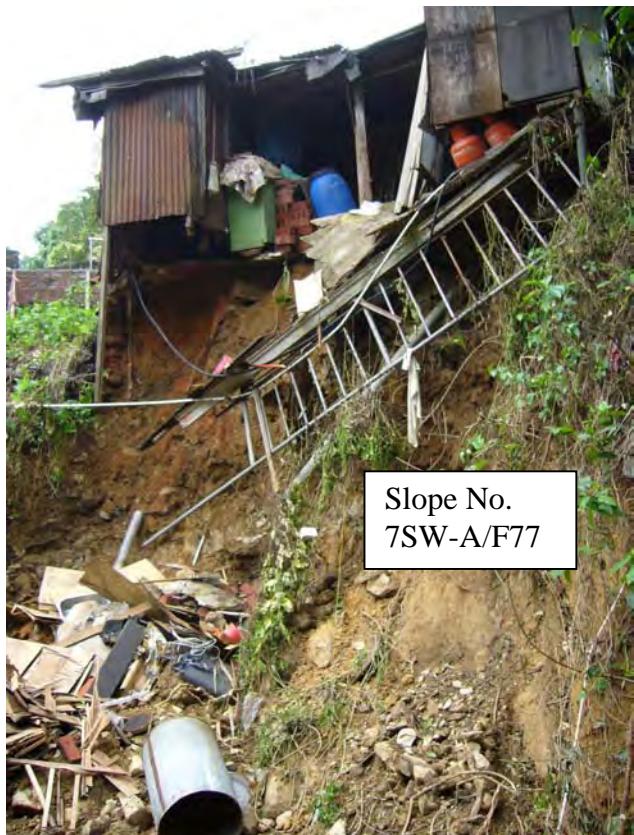
In the debris flood incident, squatter structure No. RTW/4AD/125 partly collapsed, squatter structure No. RTW/4AD/126 completely collapsed and squatter structure No. RTW/4AD/119 was undermined. The rear of squatter structure No. RTW/4AD/115 was damaged and the nearby pier of the footbridge was dislocated by the debris flood. The pier had taken most of the impact force of the debris flood, resulting in only minor damage to part of squatter structure No. RTW/4AD/115 (i.e. it was a ‘near-miss’ case).

Plate 29 - View of Undermining of Squatter Structure No. RTW/4AD/119 above Slope No. 7SW-A/F77 (Photograph taken on 25 August 2005)

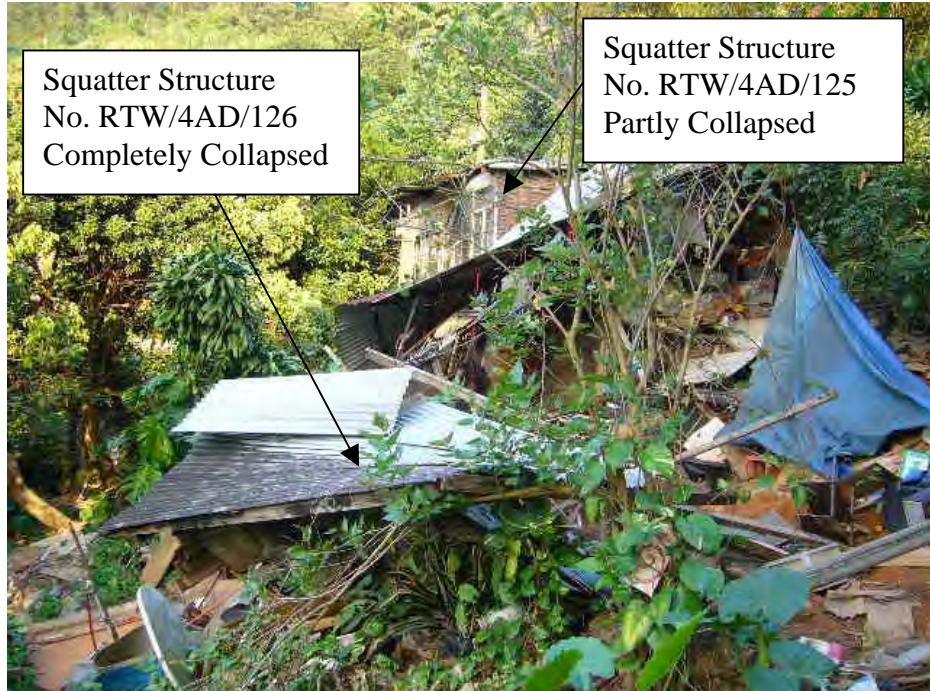
witnesses reported that a portion of slope No. 7SW-A/F76 failed on the morning of 20 August 2005 (Incident No. 2005/8/0348), which led to the collapse of squatter structures Nos. RTW/4AD/125 and RTW/4AD/126 that were situated at the crest of slope No. 7SW-A/F76.

Plate 30 - Collapses of the Squatter Structures Nos. RTW/4AD/125 and RTW/4AD/126 (Photograph taken on 16 November 2005)

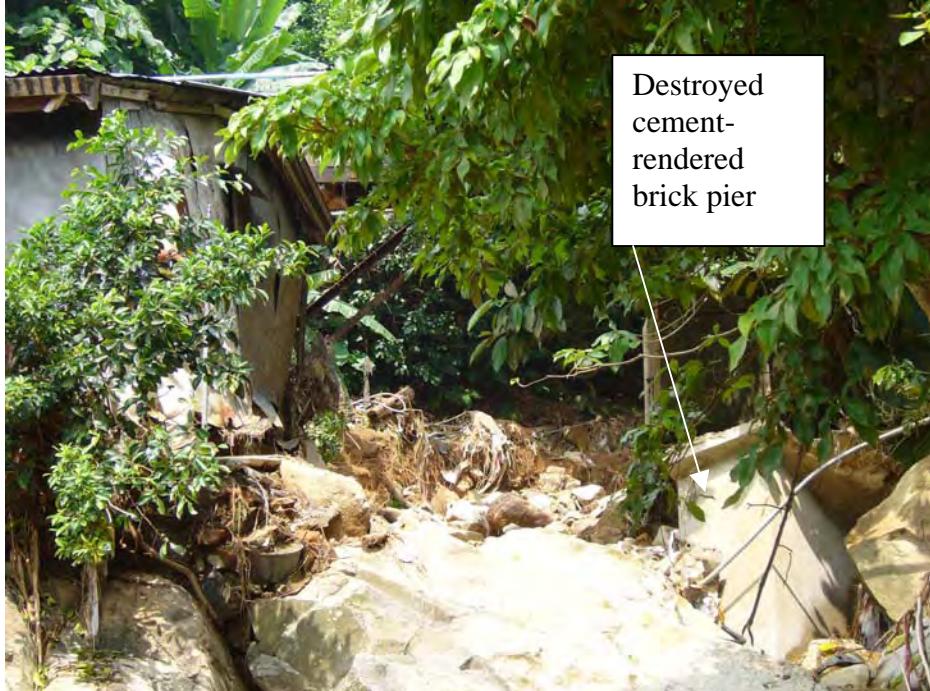
At chainage CH 190, the debris flood destroyed a cement-rendered brick pier which provided support to the footbridge near Lung Mo Temple. The debris flood swept the destroyed pier downstream. Squatter structure No. RTW/4AD/115 is located immediately adjacent to the original position of the footbridge pier. The structure suffered only minor damage since the pier had probably taken most of the impact force, leaving only minor damage to the squatter structure (i.e. a ‘near-miss’ case).

Plate 32 - View of Destroyed Brick Pier Located
Approximately 10 m Downstream of Footbridge
(Photograph taken on 25 August 2005)

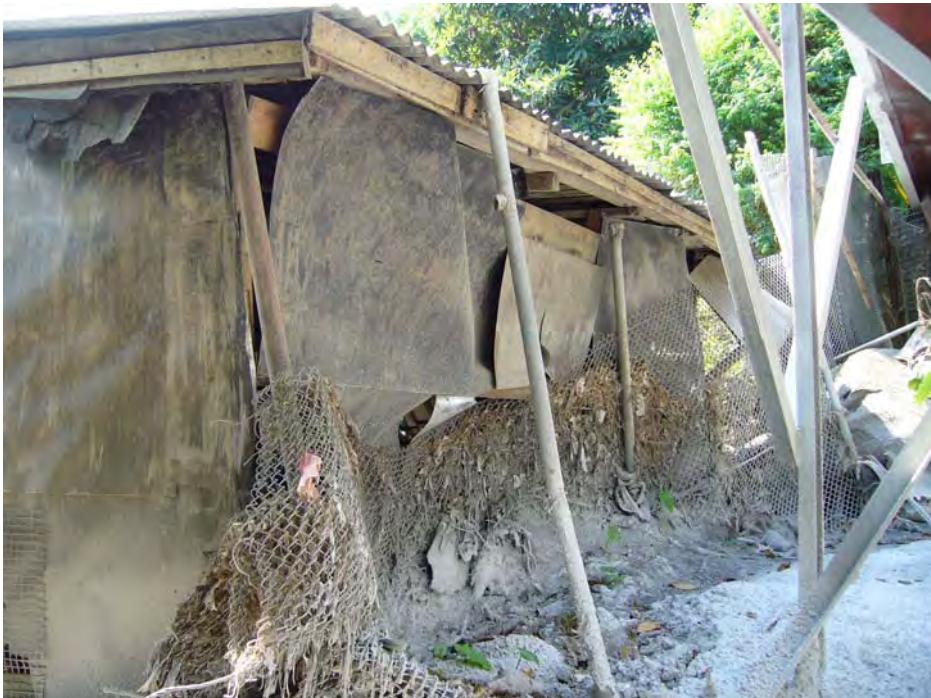
Plate 36 - View of Damage Caused by Debris Flood to
Rear of Squatter Structure No. RTW/4AD/115
(Photograph taken on 22 September 2005)

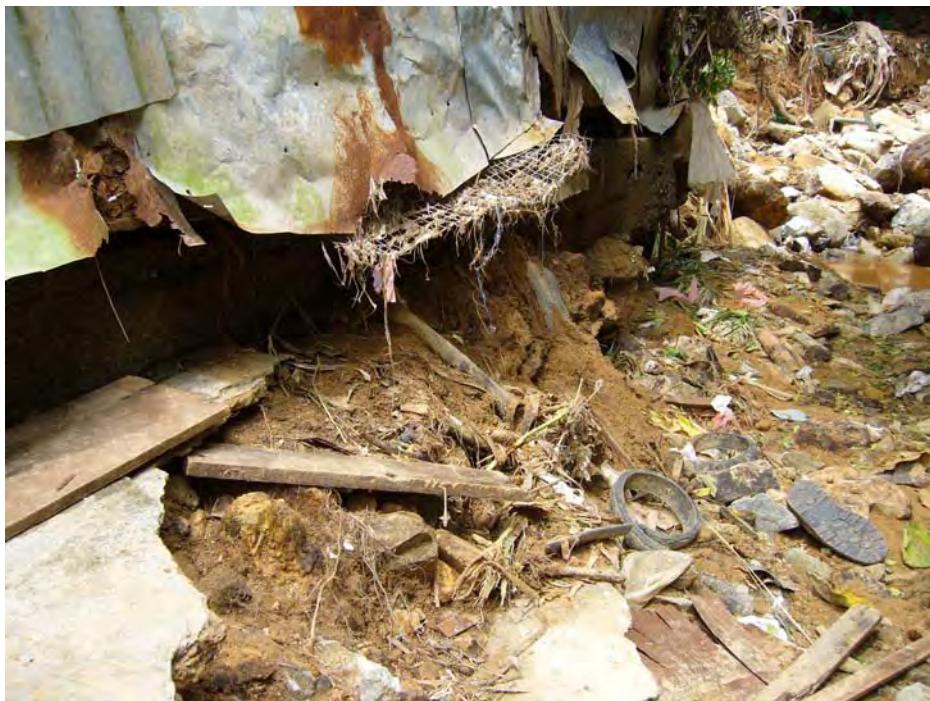
Plate 37 - View of Debris Deposition and Undermining
of Squatter Structure No. RTW/4AD/115
(Photograph taken on 25 August 2005)

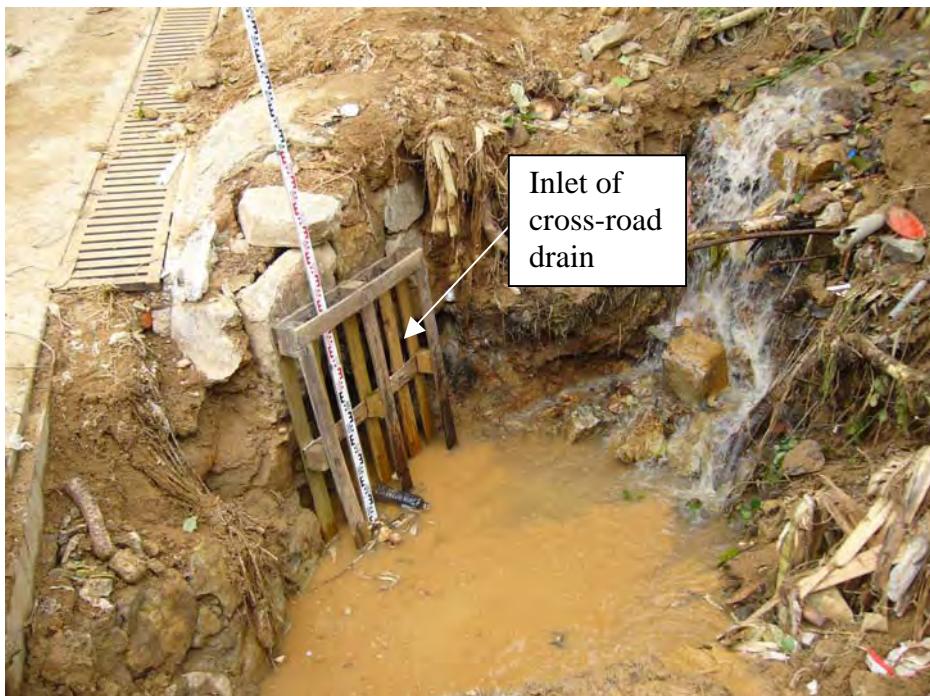
Plate 38 - View of Blocked Cross-road Drain (After Clearance)
(Photograph taken on 25 August 2005)

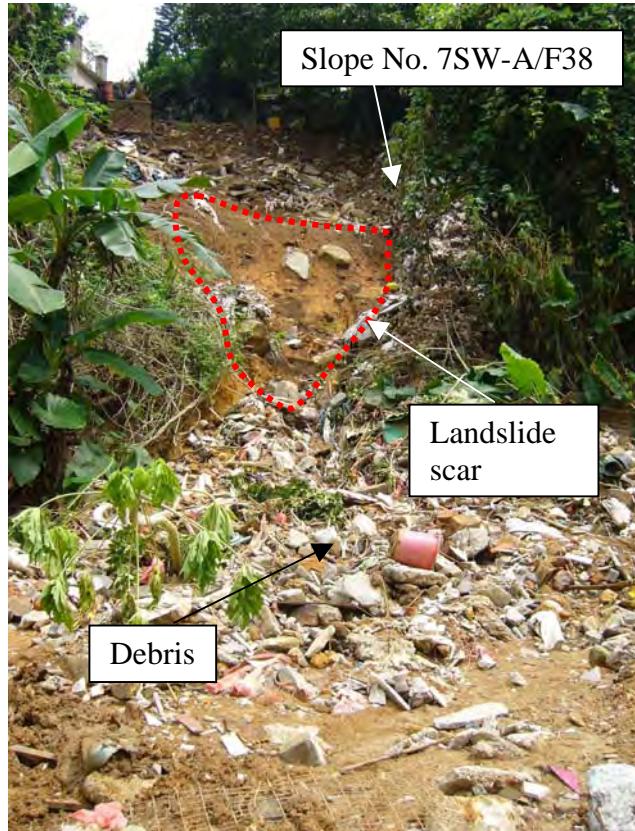
Plate 40 - View of Landslide at
Slope No. 7SW-A/F38
(Photograph taken on
25 August 2005)

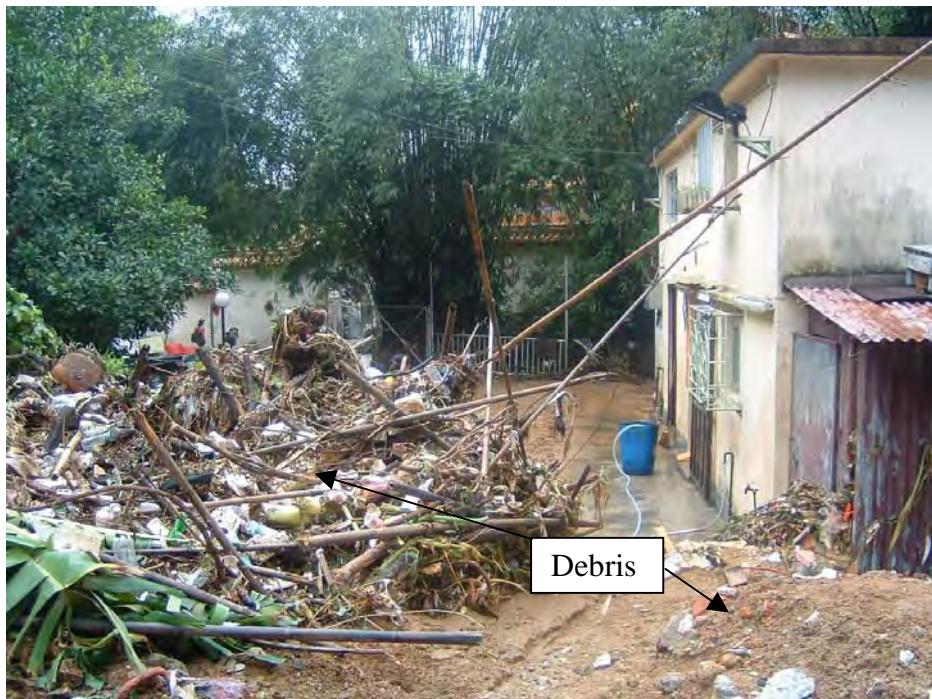
Plate 41 - View of Debris and Refuse Deposited in
Front Yard of Village House No. 200
(Photograph taken on 21 August 2005)

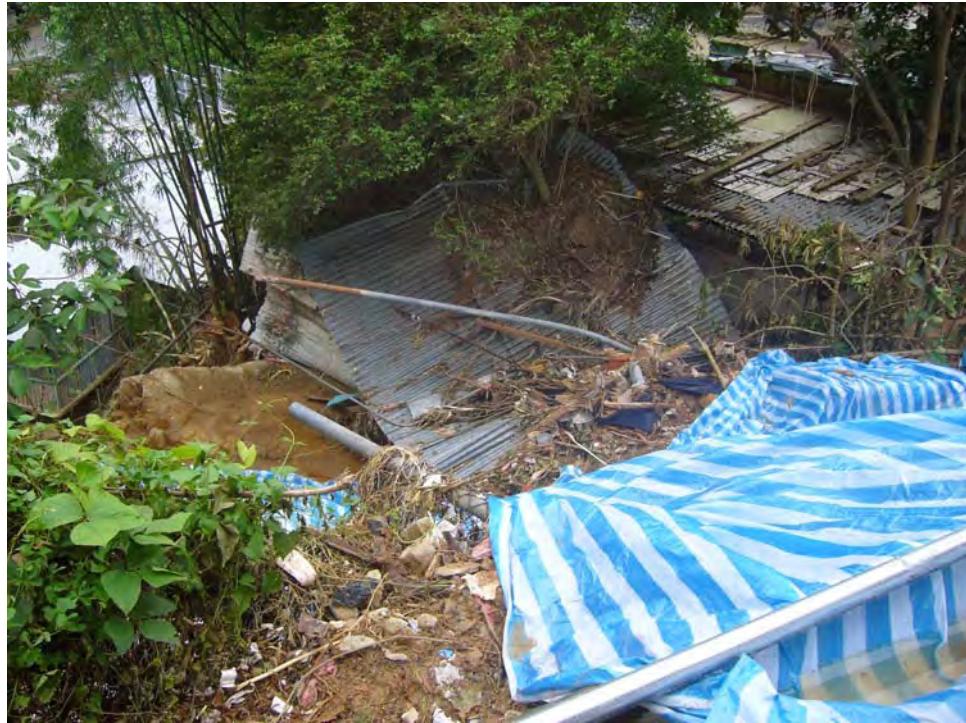
Plate 45 - A Vacated Village House at the Toe of
Slope No. 7SW-A/CR132 was Damaged
(Photograph taken on 25 August 2005)

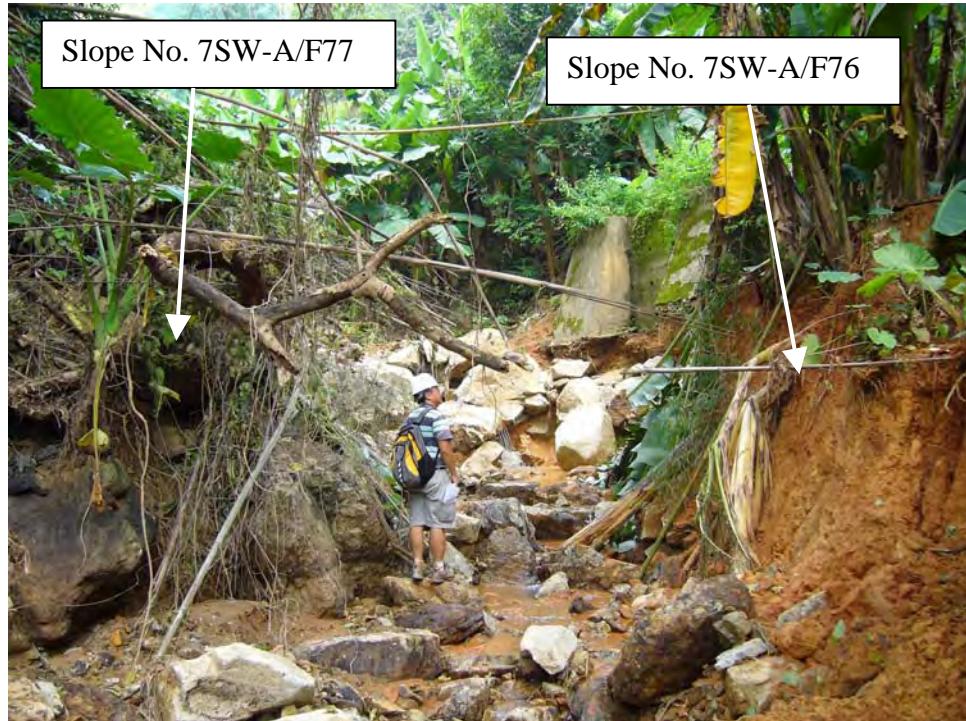
Plate 46 - Possible Location of 'Dam Break'
(Photograph taken on 25 August 2005)
