**REVIEW OF THE  
11 AUGUST 2005 LANDSLIDE  
BELOW BLOCK J OF PRINCESS  
MARGARET HOSPITAL,  
KWAI CHUNG**

**GEO REPORT No. 213**

**Maunsell Geotechnical Services Limited**

**This report was originally produced in November 2006  
as GEO Landslide Study Report No. LSR 7/2006**

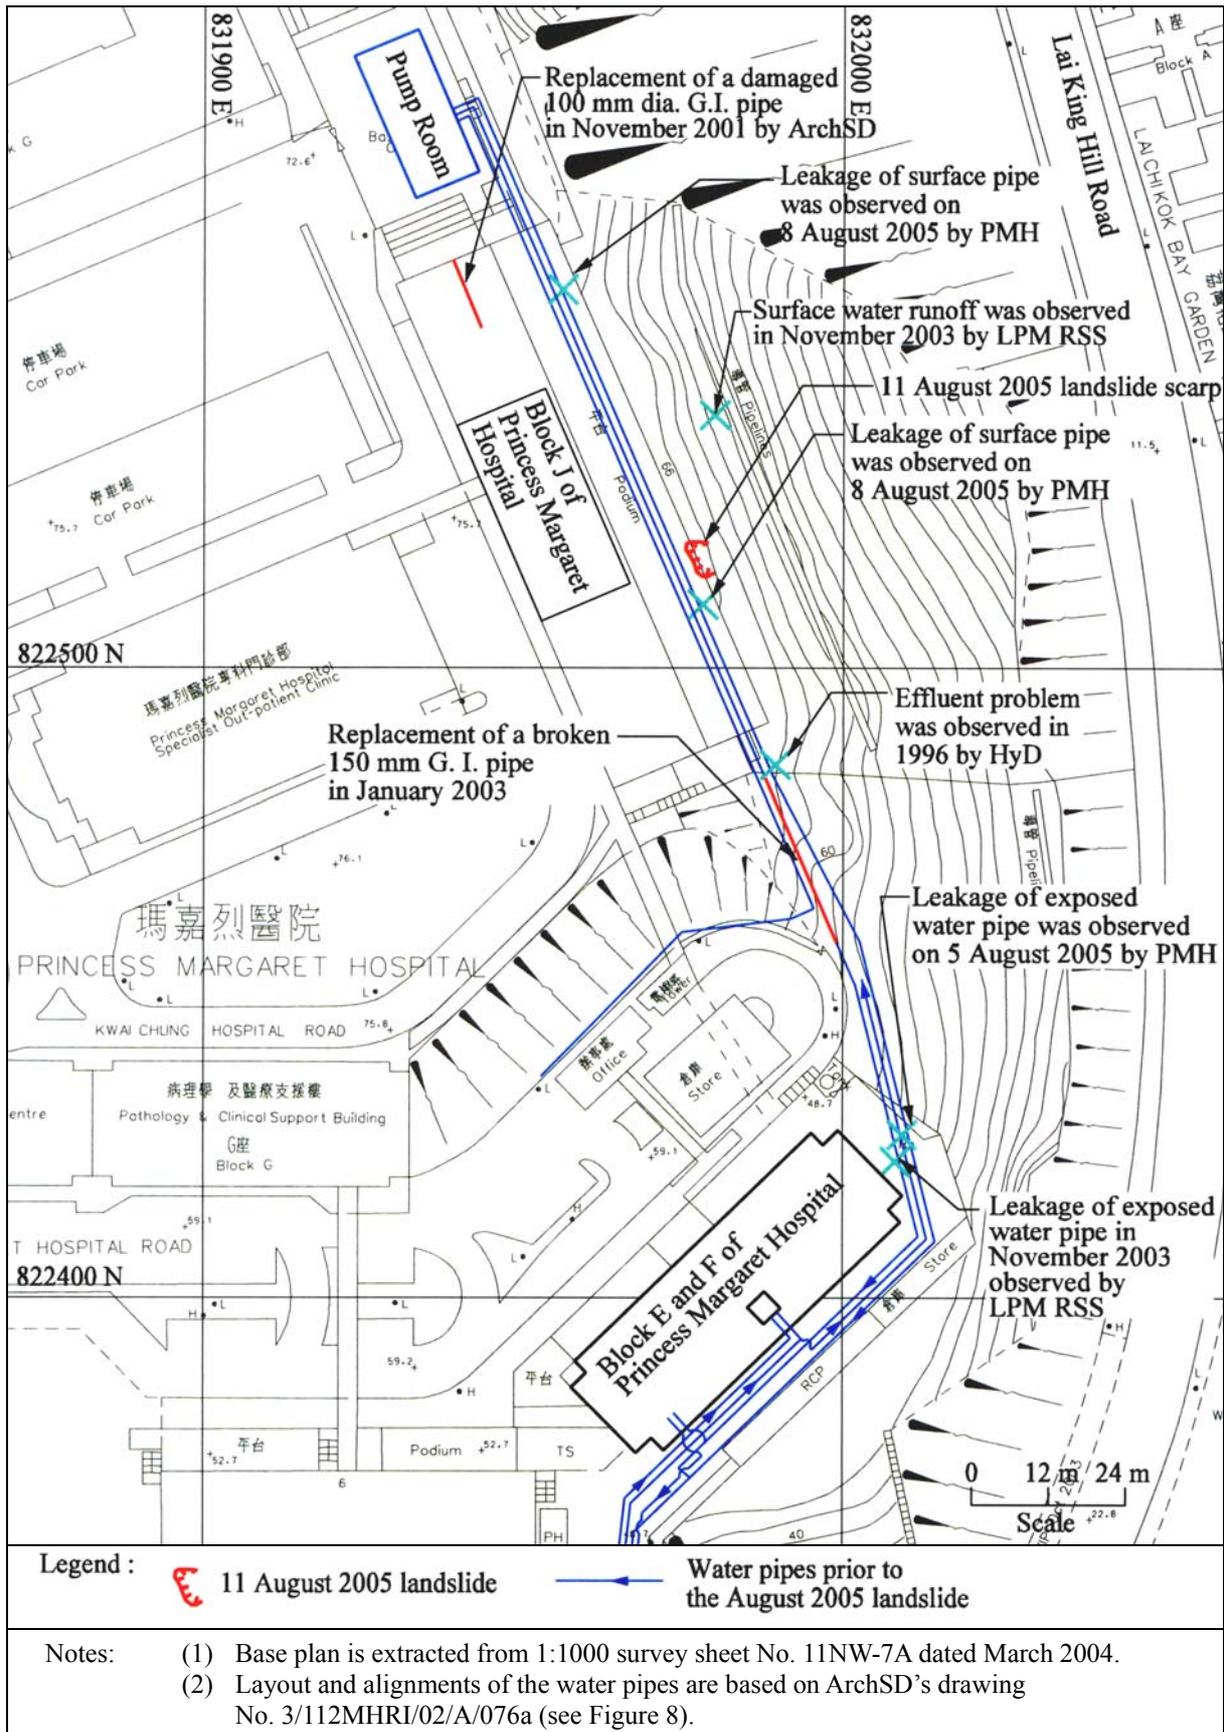
Figure 5 - Locations of Recorded Leakage in Water-carrying Services Prior to the August 2005 Landslide

According to a series of HyD's memoranda to Arch SD during the period of 1998 to 2003, there had been repeated complaints of effluent emanating from the hillside below Block J of PMH and in the vicinity of slope No. 11NW-A/C49 (Figure 5). HyD notified Arch SD in their memorandum dated 9 December 1998 that "seepage of dark stained water was found on the above slope" and believed that "the dark stained water comes from the buried pipe from PMH". They also mentioned in the same memorandum that "In fact, leakage problem previously occurred from such buried pipe in 1996". On 4 February 1999, HyD sent another memorandum to Arch SD stating "According to our recent inspection, seepage of dark stained water was still found on the above slope". Arch SD noted in their reply memorandum dated 20 July 2001 to HyD that "we had cleared the blockage of the sewer pipes every time you informed us but it blocked again". On 19 July 2002, HyD sent another memorandum to Arch SD stating "no response has been given by you so far". In response to HyD's queries, Arch SD pointed out in their memorandum of 22 July 2002 that "we had already rectified the defect every time" when they received HyD's advice. During the course of the present study, records of the rectification works to the sewer pipe could not be located by Arch SD.

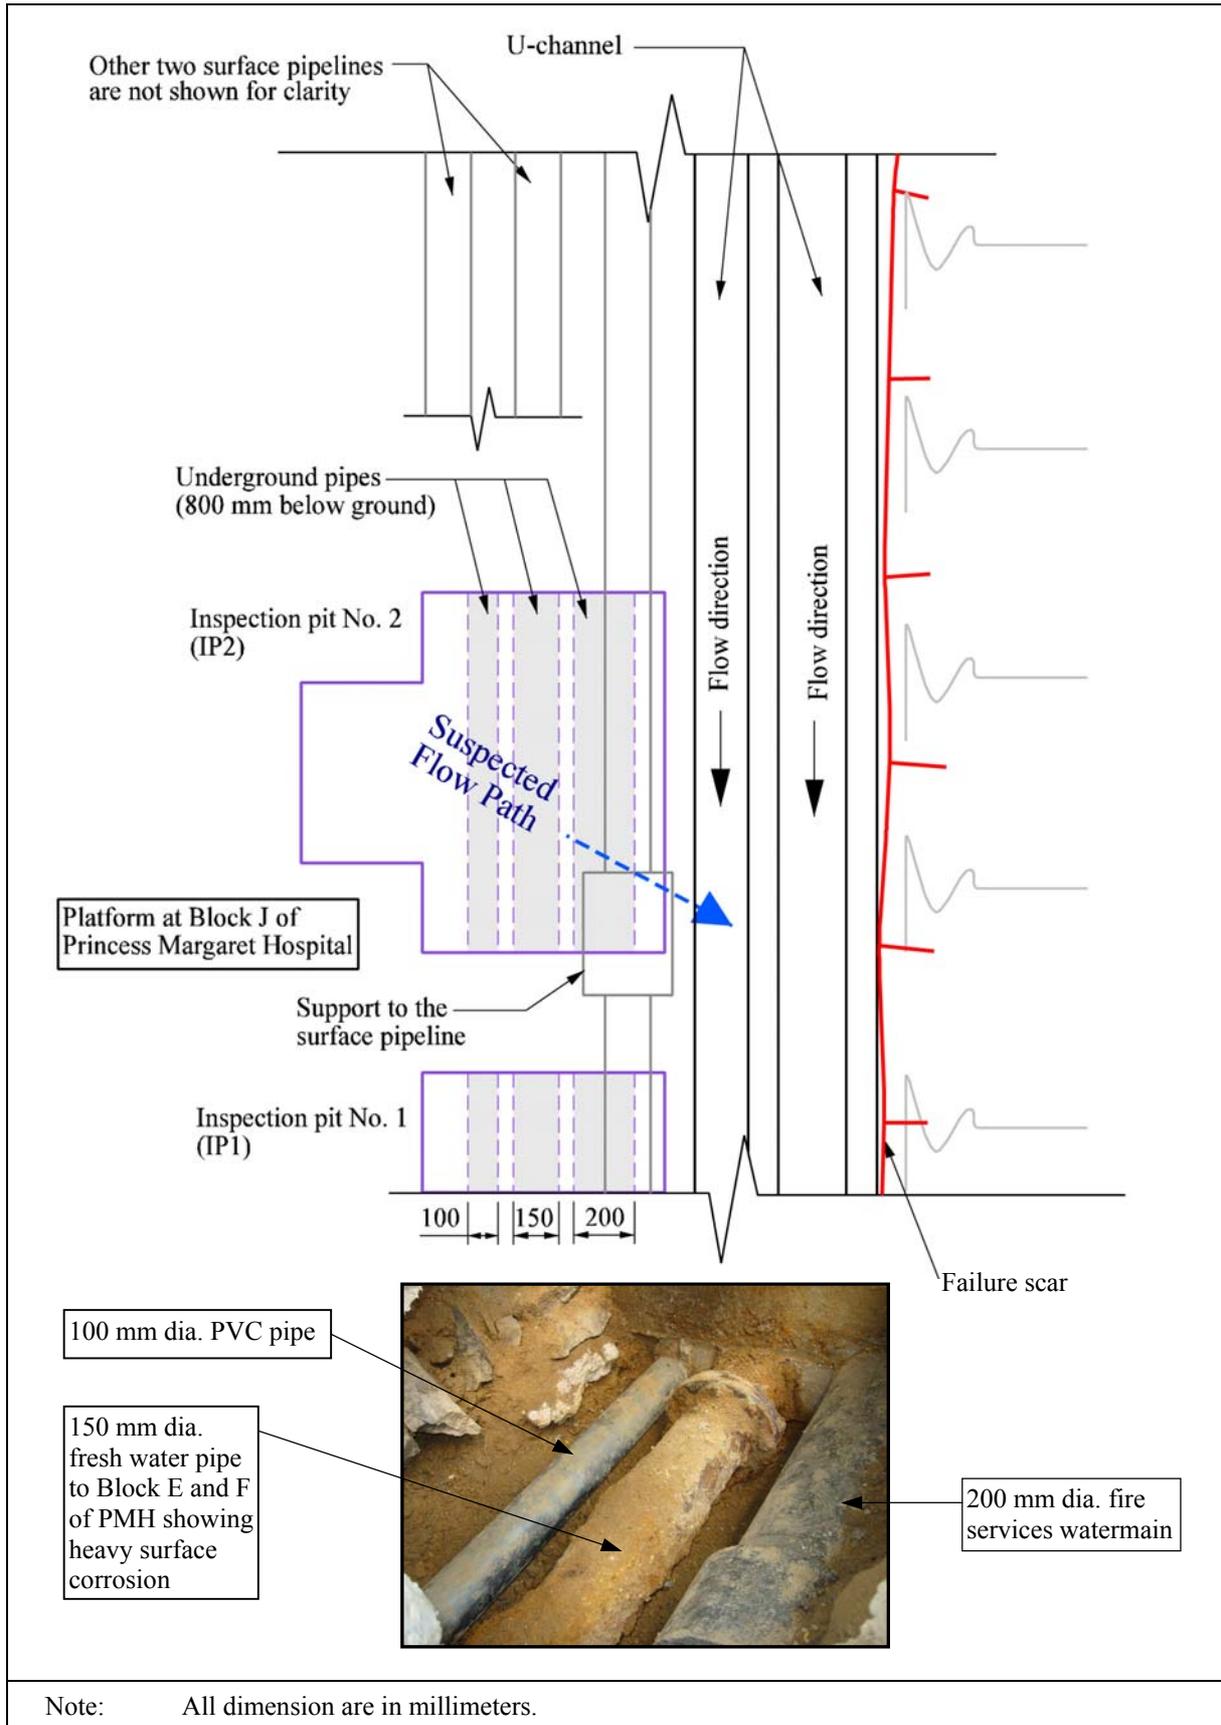
Figure 6 - Observations in Inspection Pits Nos. IP1 and IP2

Three underground pipes were found at a depth of about 800 mm in Inspection Pits Nos. IP1 and IP2 (Figure 6 and Plate 8). Based on the drawings provided by Arch SD and post-failure site observations, the three underground pipes included a 150 mm diameter G.I. water pipe, which supplied fresh water to Blocks E and F of PMH, a 200 mm diameter fire services watermain and an unrecorded 100 mm diameter uPVC pipe. The surface of the 150 mm diameter G.I. water pipe was found severely corroded (Plate 7).

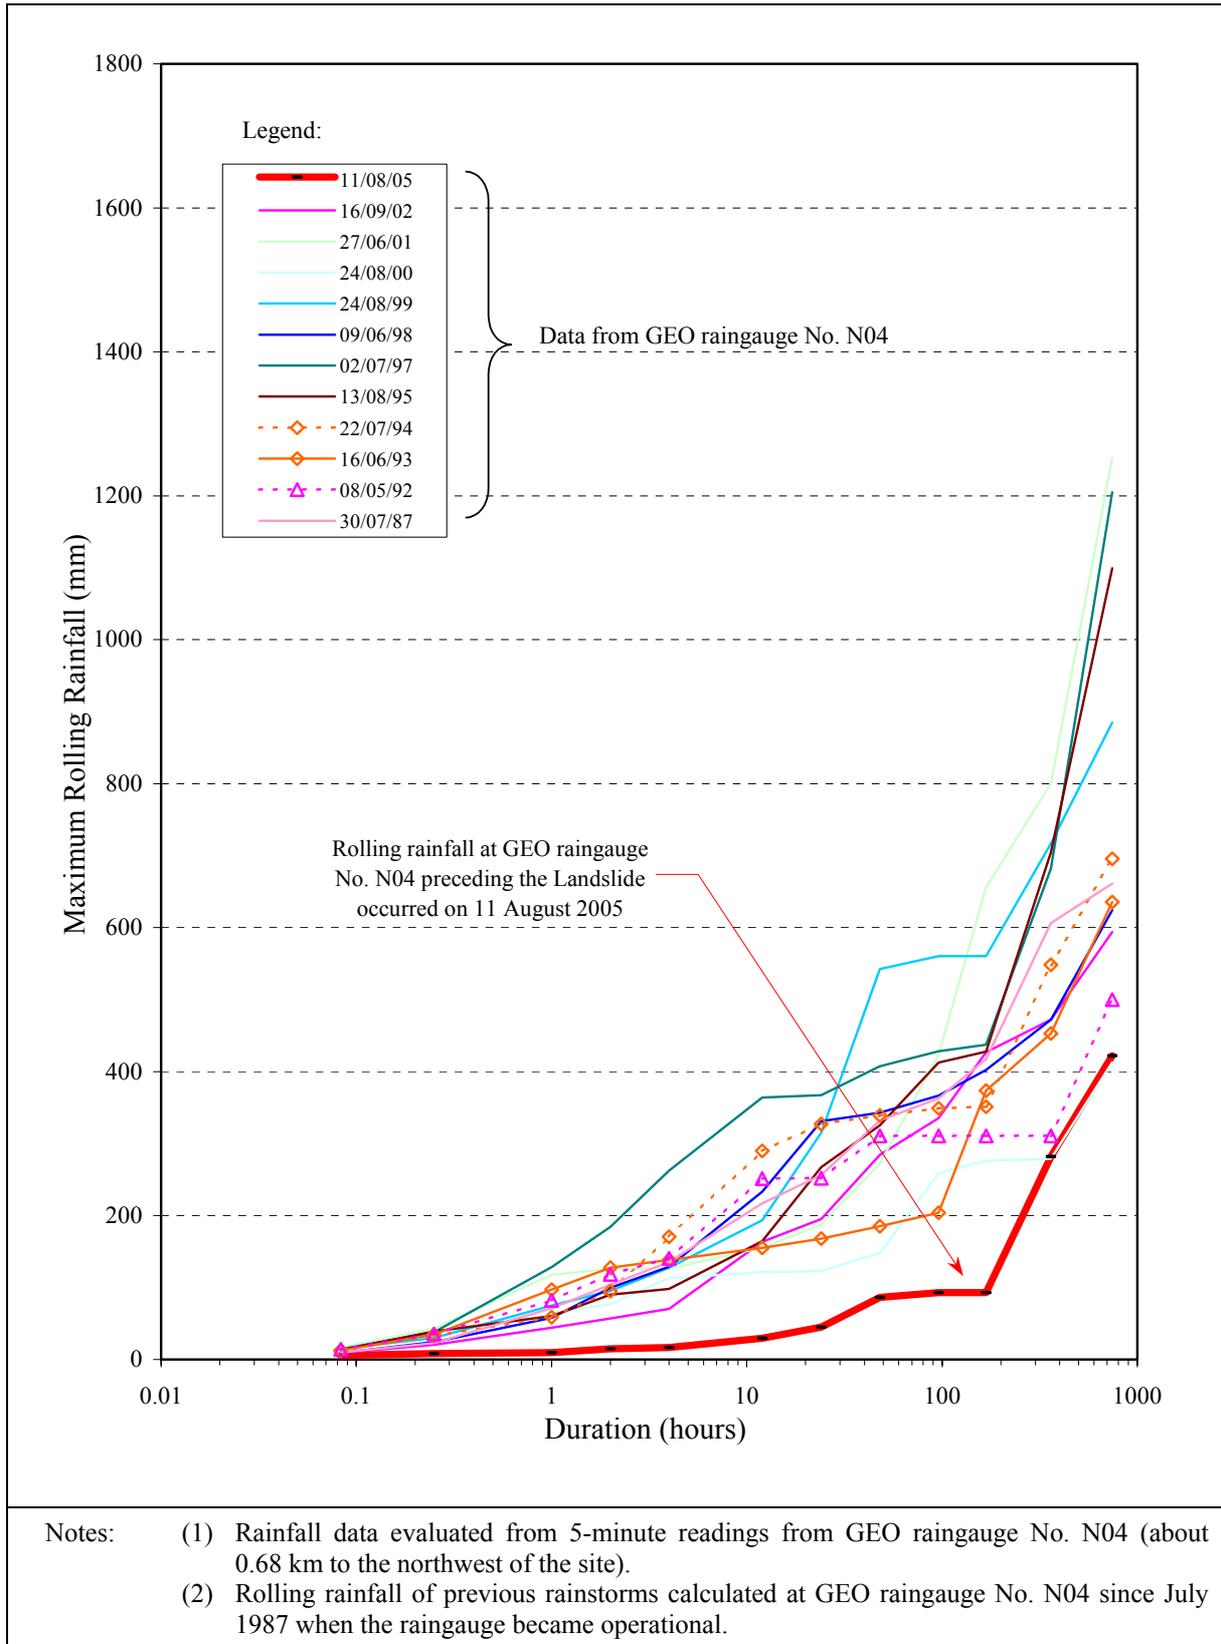
Figure 11 - Maximum Rolling Rainfall for Previous Major Rainstorms at GEO Raingauge No. N04

The maximum rolling rainfall for the 11 August 2005 incident has been compared with the past major rainstorms recorded by raingauges No. N04 between 1987 and 2002 (Figure 11). It is noted that the rainfall on 11 August 2005 is much less severe than the previous major rainstorms.

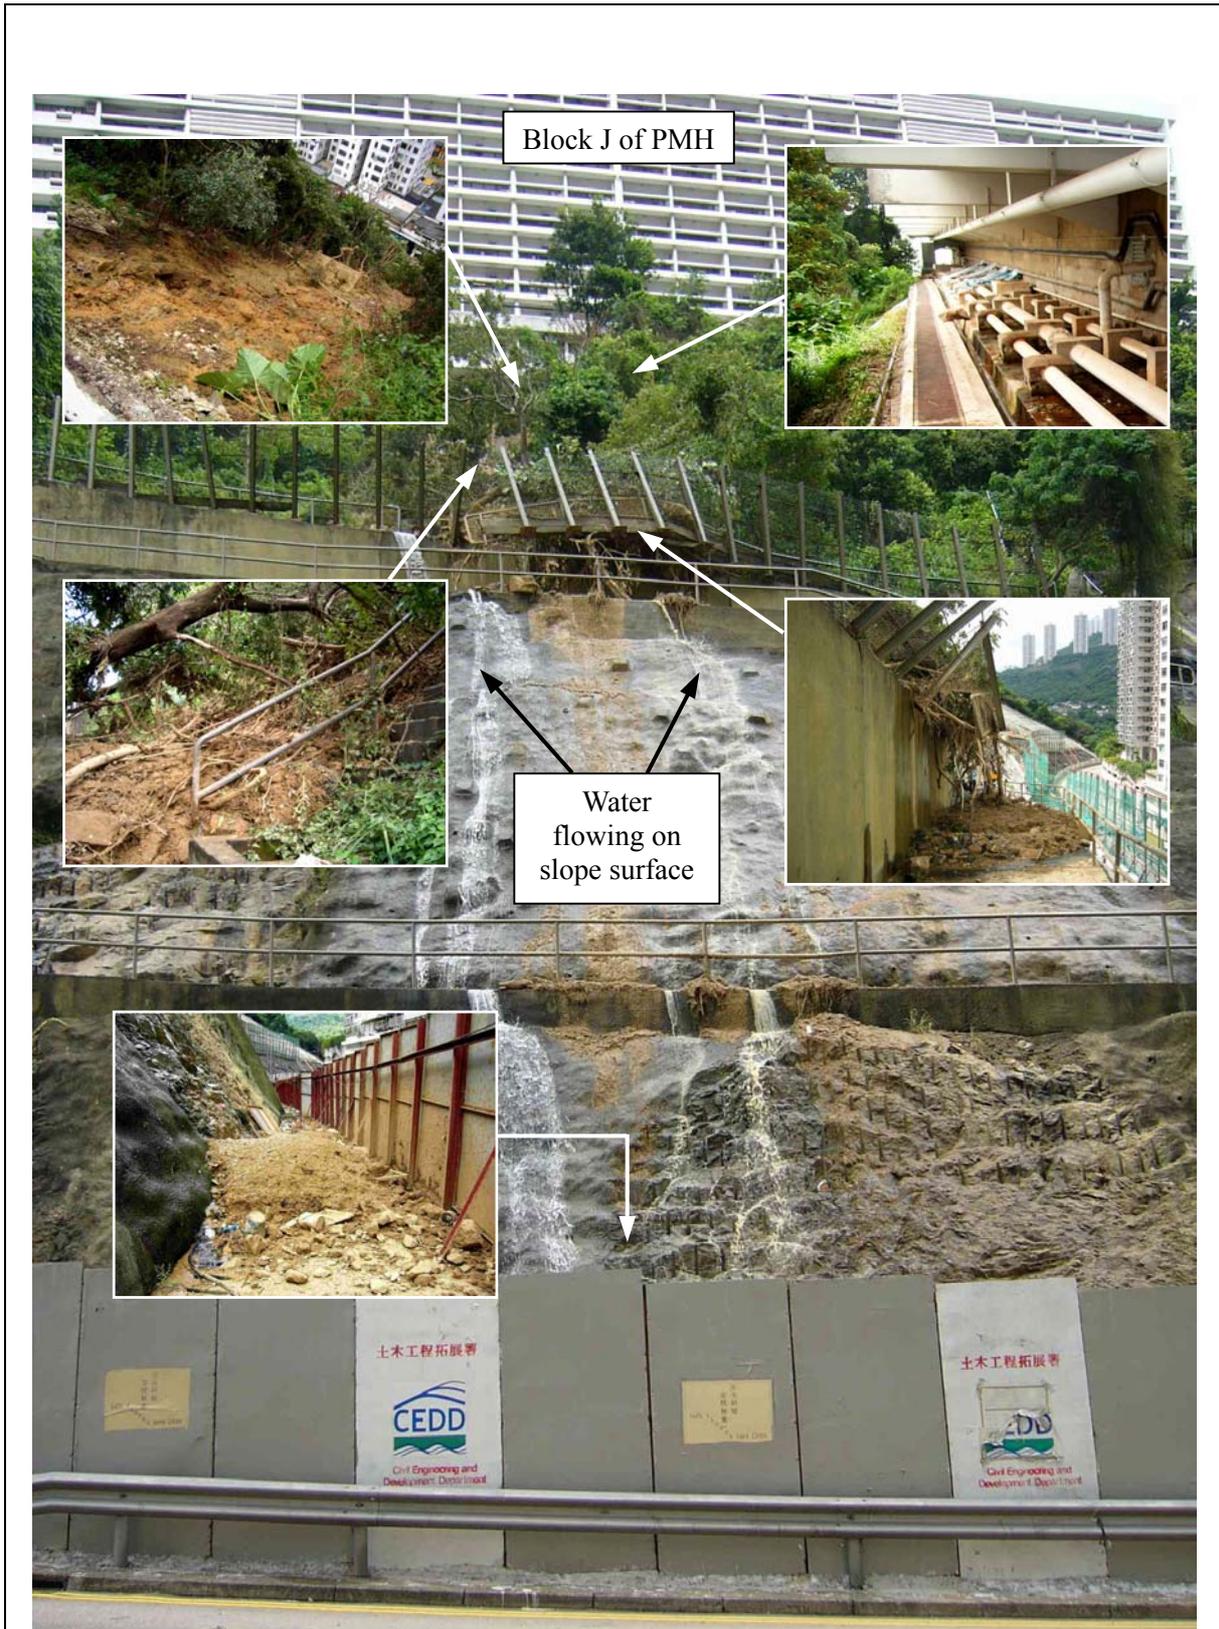
Plate 1 - General Views of the Landslide (Photographs taken on 11 August 2005)

The landslide occurred at about 5:00 a.m. on 11 August 2005. No Rainstorm Warning or Landslip Warning was in effect at the time. The landslide involved a shallow failure where the source area was about 5 m wide by 15 m long with a maximum depth of about 1 m. About 15 m<sup>3</sup> of landslide debris detached from the vegetated hillside below Block J of PMH. The landslide debris, which comprised mainly residual soil, fill, colluvium and mature trees with a girth up to about 500 mm, eroded the soil portion of slope No. 11NW-A/C49 and exposed several soil nail heads installed on the slope along the debris trail, which measured about 5.3 m in width, 50 m in length and maximum 0.2 m in depth.

During the post-failure inspection by MGSL at about 11:00 a.m. on 11 August 2005, it was noted that significant water flow, which was in general clear, was emanating from the main scarp of the landslide, just below Block J of PMH (Plate 1). At the time, the staff of PMH present at the landslide site were attempting to close the pipe valves in the pump house to the north of Block J (Figure 5). The water flow from the main scarp eventually stopped when one of the pipe valves was turned off by the staff of PMH at around noon that day. The PMH staff noted that the water flow was probably due to leakage from a buried fresh water pipe (i.e. the 150 mm diameter pipe with heavy corrosion as subsequently exposed in the inspection pits as discussed below) connecting to Blocks E and F of PMH. This leaky fresh water pipe was later disconnected and abandoned, as confirmed in PMH's letter dated 28 October 2005. According to Arch SD, the fresh water supply to Blocks E and F comprised a "dual pipes system" and the water supply would not be affected by turning off the valve of either one of the two water pipes.

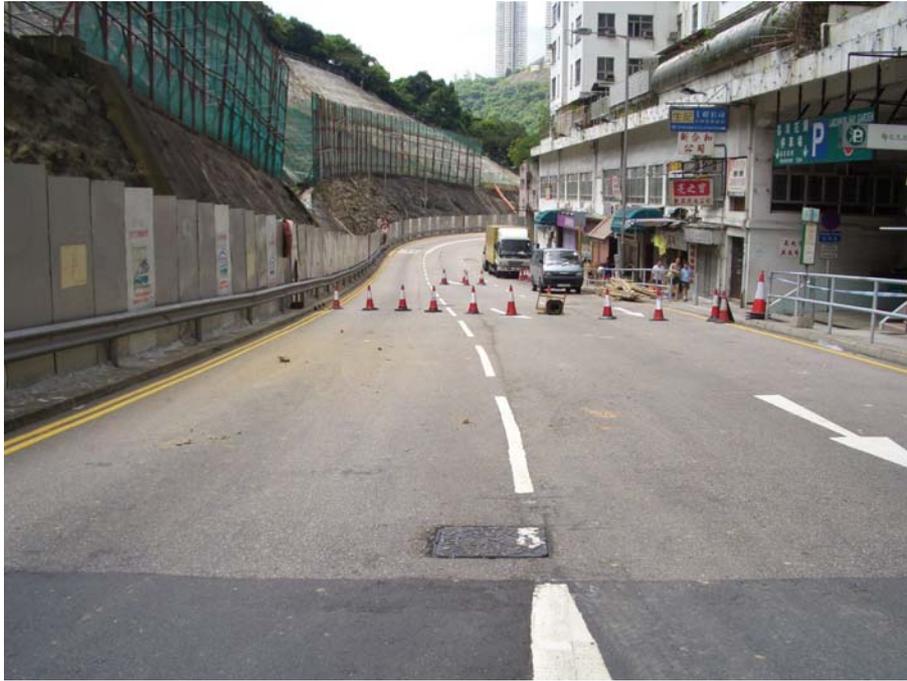
Plate 2 - Lai King Hill Road Temporarily Closed (Photograph taken on 11 August 2005)

Most of the landslide debris was deposited on the slope berms at the northern end of slope No. 11NW-A/C49. While some of the landslide debris came to rest at the toe of slope No. 11NW-A/C49 against the hoarding for the adjacent LPM site, a few small rock blocks and a small amount of soil debris overtopped the hoarding and were deposited on Lai King Hill Road, making a travel angle of about 35°. A stretch of the fence along the coping of the retaining wall at about mid-height of slope No. 11NW-A/C49 was severely damaged, and part of it was left over-hanging (Plate 1). As a result, Lai King Hill Road was temporarily closed (Plate 2) and no casualties were reported.

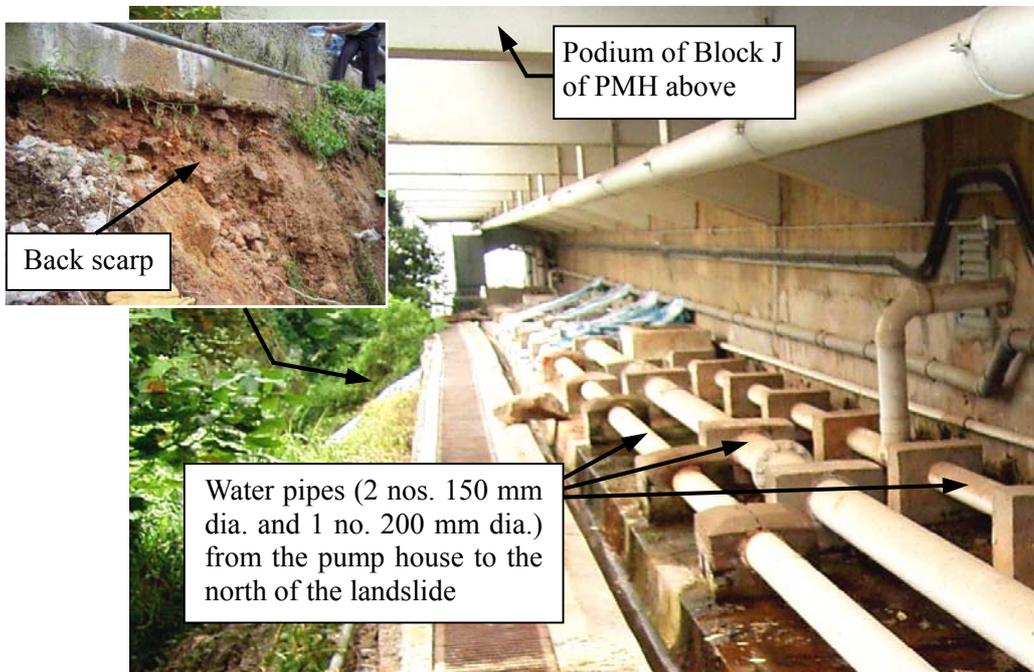
Plate 3 - Exposed Pipes Located at the Crest of Landslide (Photograph taken on 12 August 2005)

The hillside where the August 2005 landslide occurred is located just below a small concrete platform, which is underneath an elevated deck of the podium at Block J of PMH (Plate 3). Three exposed ductile iron pipes (two of 150 mm in diameter and one of 200 mm in diameter), which are supported by concrete haunches, run along the concrete platform. Another ductile iron pipe (150 mm in diameter) is suspended from the elevated podium deck. There are also two surface U-channels (one is a 300 mm UC with cast iron grating and the other is a 225 mm open channel) alongside the edge of the concrete platform.

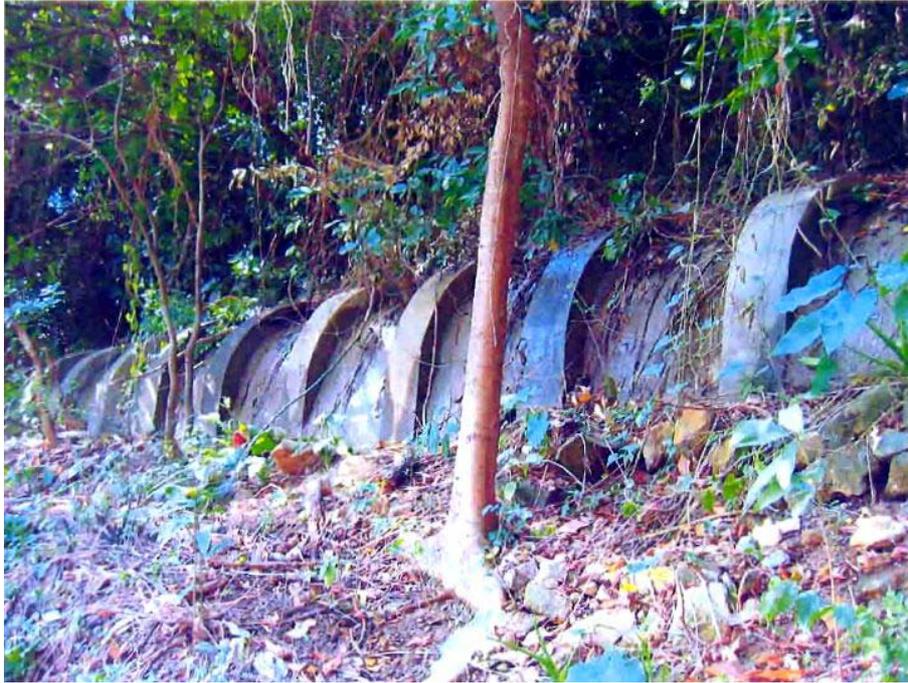
Plate 4 - View of the Abandoned 1.2 m dia. Pipeline above Slope No. 11NW-A/C49  
(Photograph taken in November 2003 by LPM RSS)

A 1.2 m diameter abandoned pipe is present at about 13 m below the landslide scarp, just above the crest of the northern portion of slope No. 11NW-A/C49 (Figures 2 and 3 and Plate 4). Further downhill, a retaining wall, which is approximately 45 m long and up to 2.5 m high, is located immediately above the rock cut portion of the slope (Figures 2 and 3). Lai Chi Kok Bay Garden is located on the downhill side of Lai King Hill Road, opposite to the landslide site.

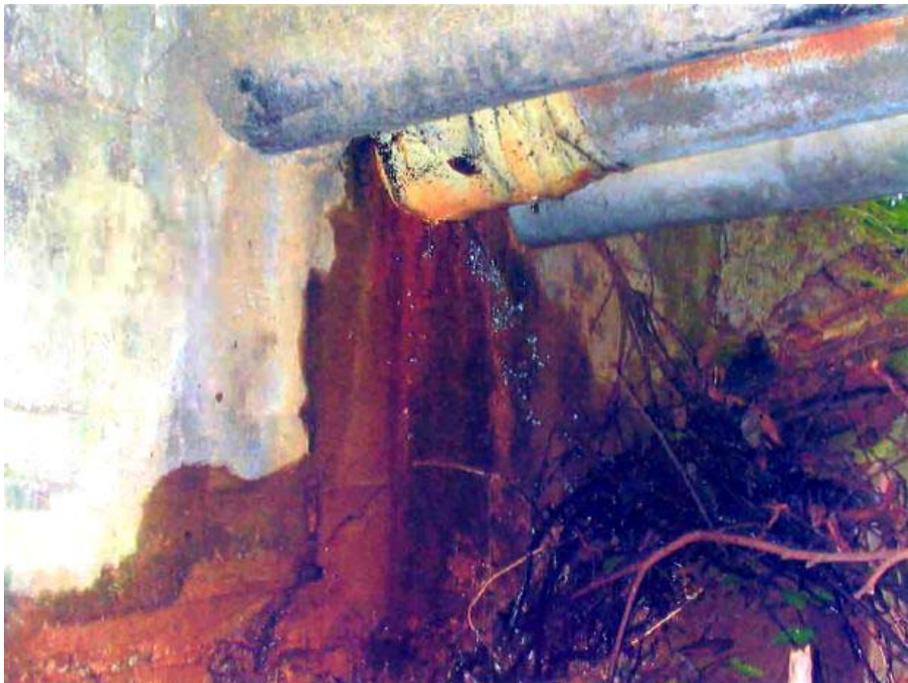
Plate 5 - Leakage of Exposed Water Pipe at the Southern End of Slope No. 11NW-A/C49  
(Photograph taken in November 2003 by LPM RSS)

In November 2003, during the course of LPM upgrading works for slope No. 11NW-A/C49, the resident site staff (RSS) of the LPM works noted and reported to the then Works Division (renamed LPM Division 3 in July 2004) of the GEO that seepage was observed on the slope surface above the abandoned 1200 mm diameter concrete pipe (Plate 4) and leakage was found at the exposed water supply lines (not known as fresh water or salt water supply) at the southern end of slope No. 11NW-A/C49 (Figure 5 and Plate 5). The LPM RSS advised that it had not been raining on the day of the inspection. On

10 December 2003, the Works Division of the GEO forwarded the above site observations to Arch SD, and recommended that repair works should be carried out. No information showing Arch SD's response can be located in Arch SD and GEO, and it is uncertain whether Arch SD had dealt with the leaky pipe. Six additional raking drains were installed immediately above the abandoned 1200 mm diameter concrete pipe under the LPM works.

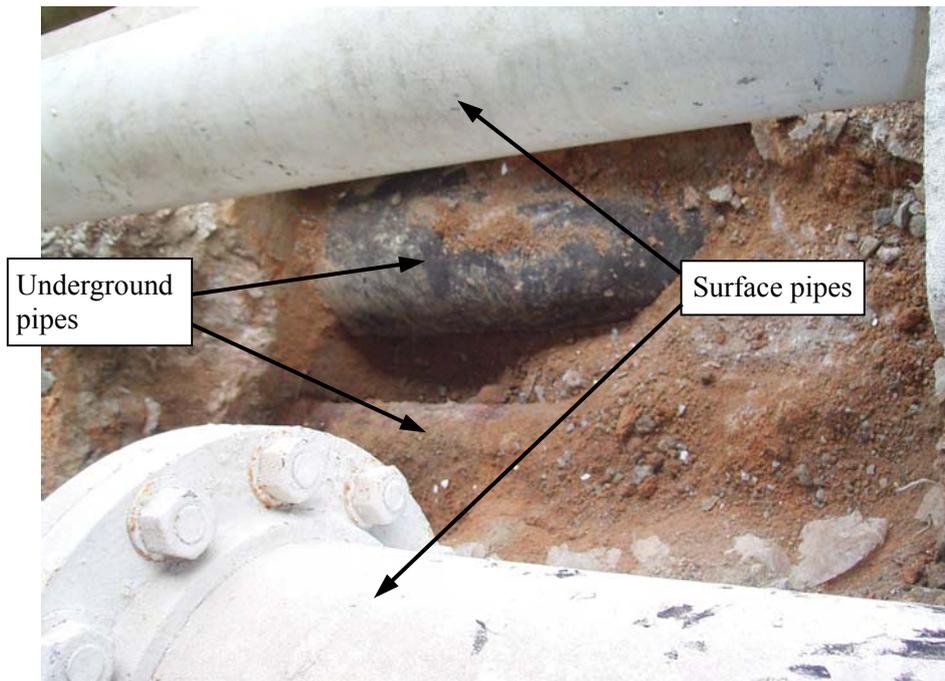
Plate 6 - Underground Pipes Exposed in Inspection Pit No. P5 Excavated by EMSD  
(Photograph taken on 12 August 2005)

After the landslide, the EMSD, the prevailing maintenance agent to PMH, excavated five inspection pits (Nos. P1 to P5) (Figure 4) on the platform at the crest of the landslide scar on 12 August 2005 to identify and inspect the buried services. Three pipes (one is a 150 mm diameter heavily corroded steel pipe, one is a 200 mm diameter steel pipe and the remaining one is a 100 mm diameter uPVC pipe) were exposed in the pits at a depth of about 200 mm (Plates 6 and 7). No leakage or evidence of void or soil pipe was observed in the inspection pits. No leakage check or closed-circuit television (CCTV) survey of the buried pipes was

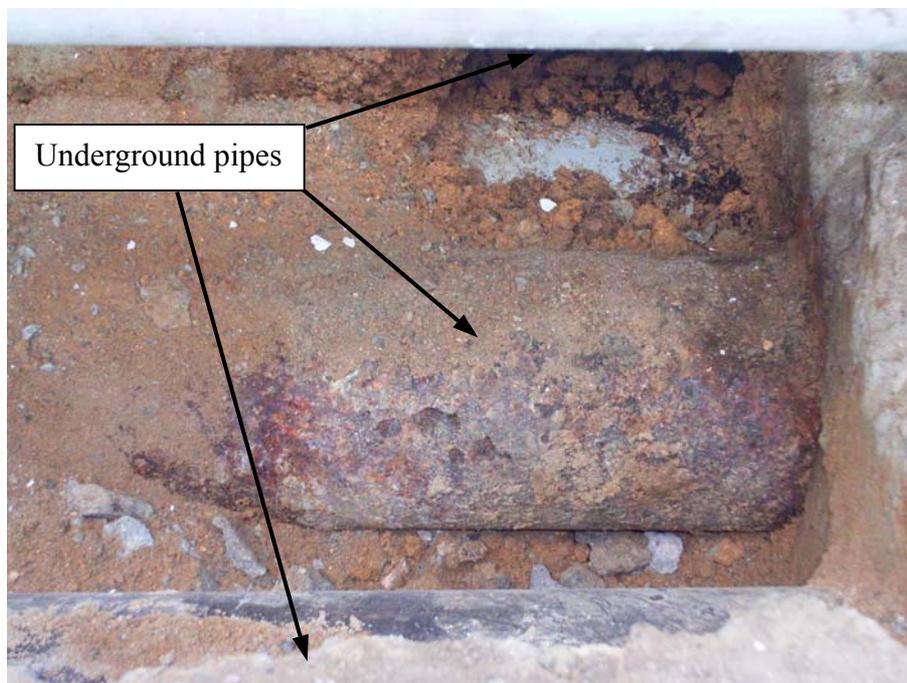
Plate 7 - Close-up View of the Underground Pipes Exposed in Inspection Pit No. P5 Excavated  
by EMSD (Photograph taken on 12 August 2005)

As a result, the leaky part(s) of the subject buried pipe could not be located in full. Based on the information collected from Arch SD and PMH together with the post-failure inspections, the leaky pipe was likely to be the severely corroded fresh water pipe exposed in the inspection pits, which supplied fresh water to Blocks E and F of PMH.

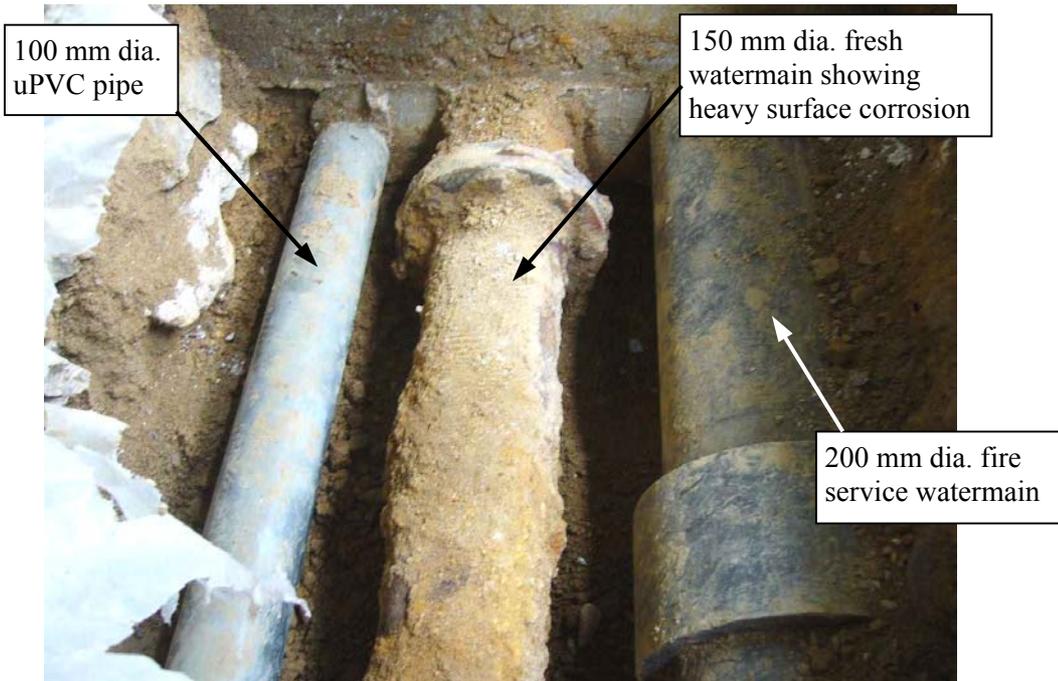
Plate 8 - Underground Pipes Exposed in Inspection Pit No. IP1 Excavated by LIC's Stand-by GI Contractor (Photograph taken on 27 March 2006)

As revealed from the inspection pits formed by the ground investigation (GI) contractor for Agreement No. CE 15/2004 (GE), Inter Pacific Limited, following the August 2005 landslide (Section 6.2), there are three utility pipes buried at about 800 mm below ground at the concrete platform behind the landslide scarp. The pipes include one severely corroded 150 mm diameter steel pipe, which is suspected to be leaking, one 200 mm diameter galvanised mild steel pipe, which is probably the fire services pipe, and one 100 mm diameter uPVC pipe (Plate 8).

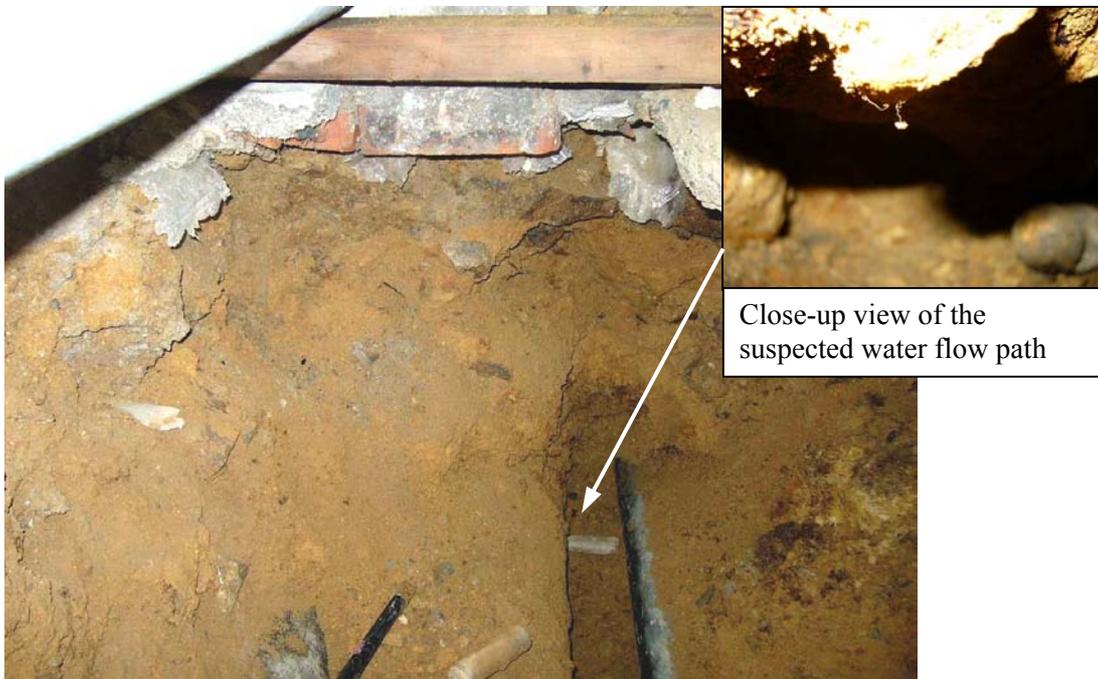
Plate 9 - The Opening of the Suspected Water Flow Path in Inspection Pit No. IP2 Excavated by LIC's Stand-by GI Contractor (Photograph taken on 27 March 2006)

In Inspection Pit No. IP2, a soil pipe about 20 mm high by 150 mm wide, which extended in a direction towards the landslide site, was found near the 150 mm diameter water pipe (Plates 9 and 10).
