**DETAILED STUDY OF THE
20 AUGUST 2005 LANDSLIDE
AT BOWEN ROAD ABOVE
NO. 120 KENNEDY ROAD**

GEO REPORT No. 214

FUGRO SCOTT WILSON JOINT VENTURE

**GEOTECHNICAL ENGINEERING OFFICE
CIVIL ENGINEERING AND DEVELOPMENT DEPARTMENT
THE GOVERNMENT OF THE HONG KONG
SPECIAL ADMINISTRATIVE REGION**

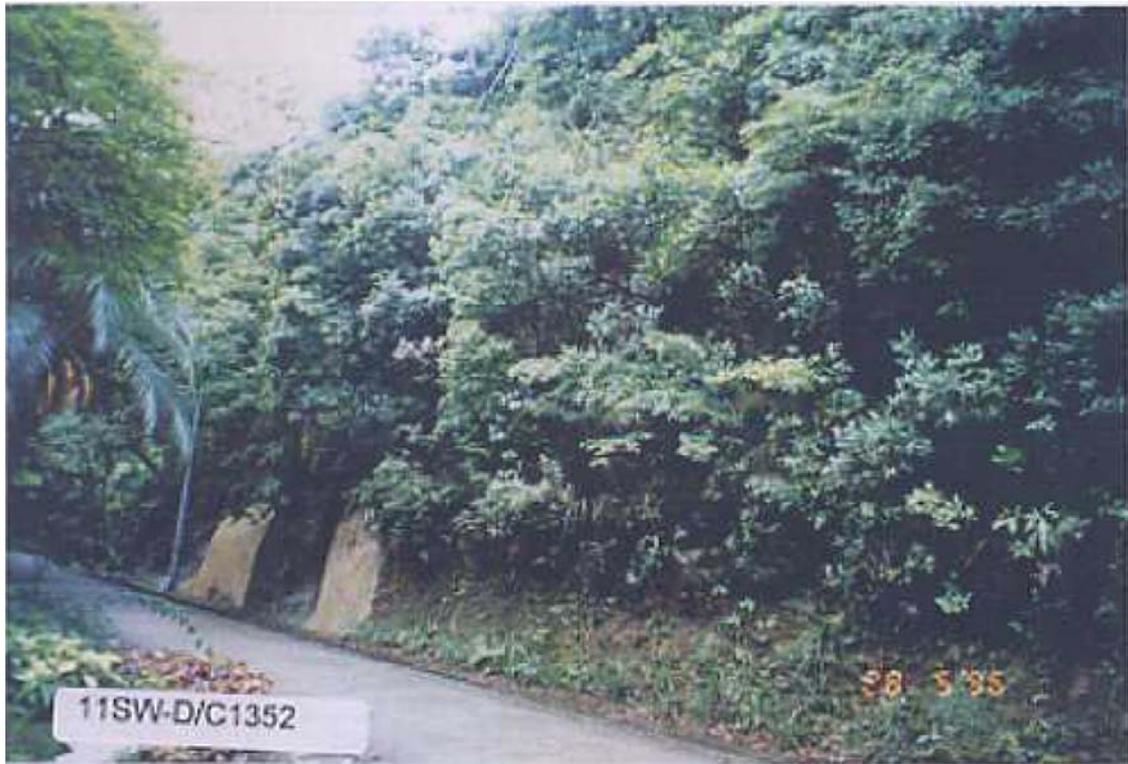
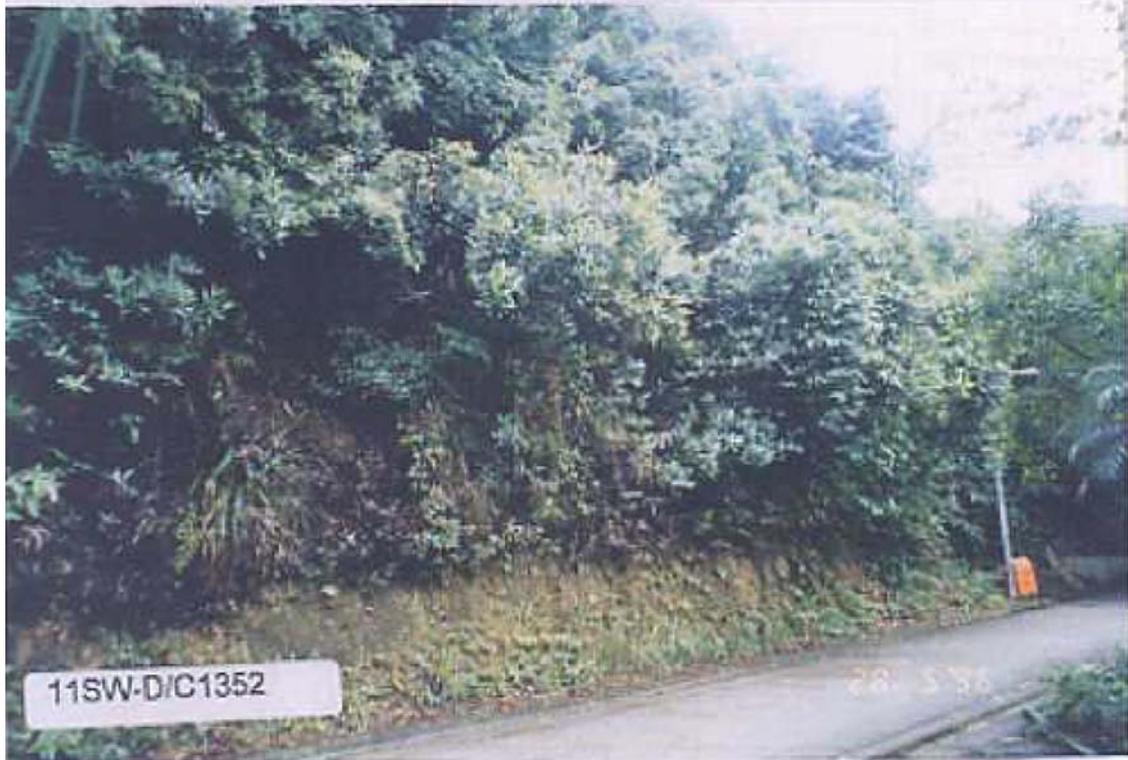
Plate 3 - Record Photographs of Slope No. 11SW-D/C1352 Taken in May 1996

In April 1996, Slope No. 11SW-D/C1352 was inspected under the "Systematic Identification and Registration of Slopes in the Territory" (SIRST) project initiated by the GEO. The SIRST field sheet indicates an 8 m high (maximum) soil cut slope inclined at about 70° (maximum) with 15% of the surface covered by chunam, 45% by vegetation and 40% having bare soil. No seepage or signs of distress were observed and the slope was recorded as being in a 'fair' condition. The consequence-to-life category of the slope was rated as '2'. The priority ranking score (referred to as the CNPCS score) was not recorded at this time. Photographs of the slope taken in May 1996 are shown in Plate 3.

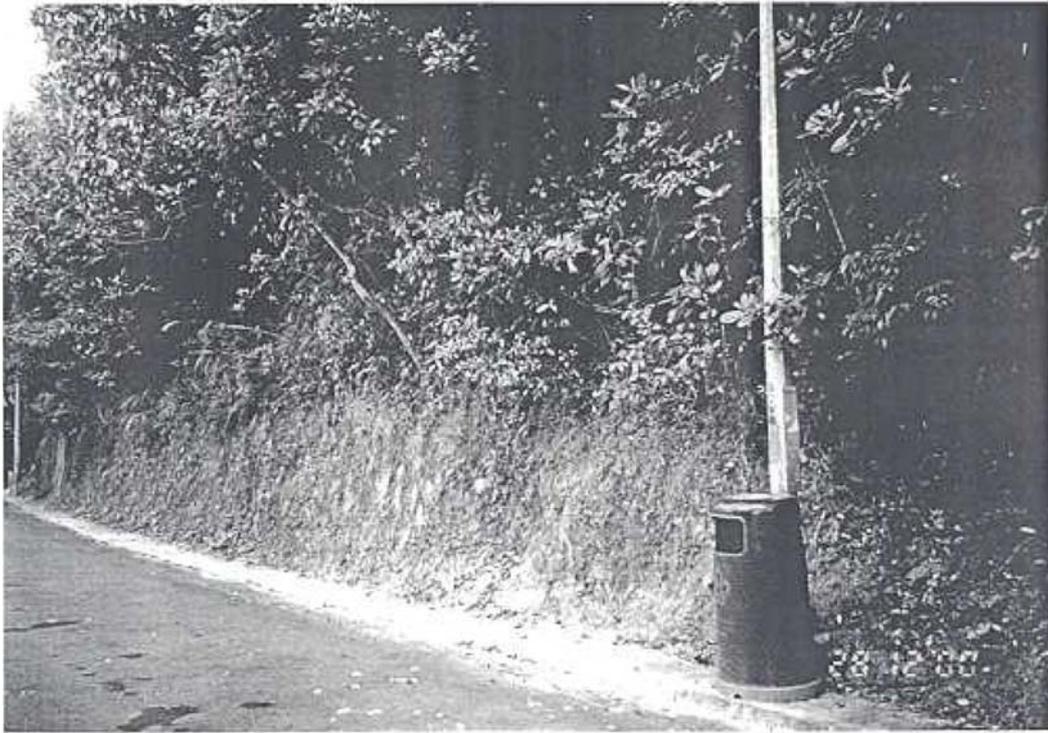
Plate 5 - Record Photograph of Slope No. 11SW-D/C1352 Taken in December 2000

The inspection records for the December 2000 (Plate 5), November 2001 (Plate 6) and January 2002 RMI's indicated that no specific follow-up actions had been recommended.

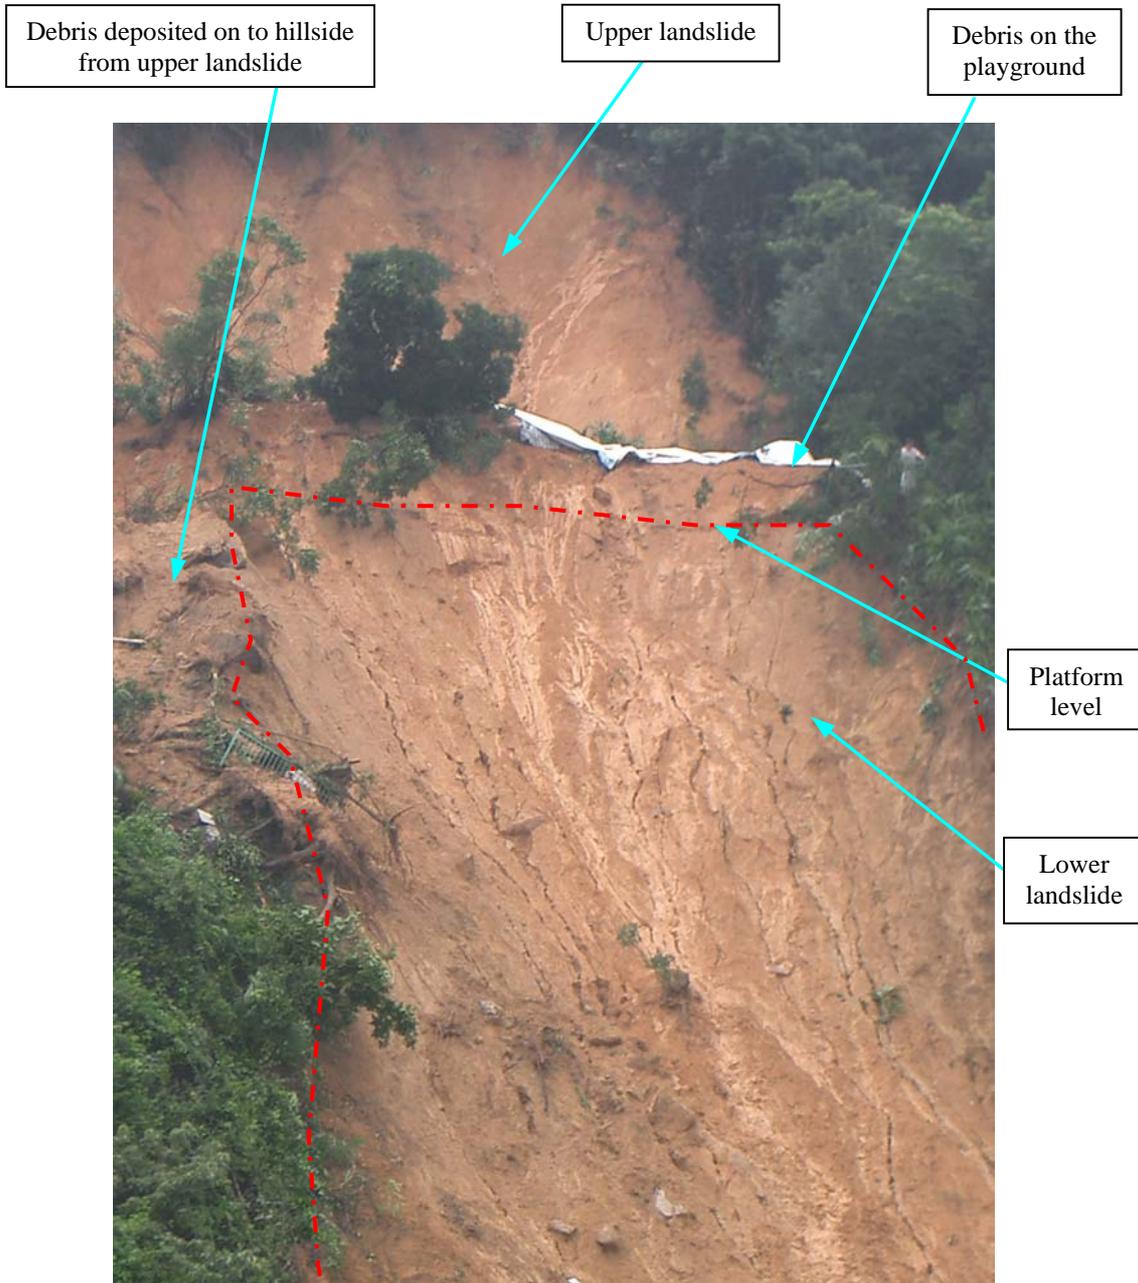
Plate 7 - Main Scarp and Source Area of the Lower Landslide below the Playground (Photograph Taken on 21 August 2005)

The crest of the lower landslide scar is located immediately below the playground. The postulated extent of the source area for the lower landslide is shown in Figures 2 and 3 and in Plate 7. The source area was relatively concave in shape (Plate 7) and the surface of rupture was relatively planar and steep (40° to 45°).

The main scarp of the lower landslide comprises about 2 m thick loose fill, which formed part of the playground on Bowen Road. The postulated extent of the fill prior to the failure is shown in Figures 4, 7 and 8. Below the main scarp, the scar was covered with about 1m thick, soft, clayey debris and fill, which contained deep gullies formed by surface runoff on the scar during the heavy rain following the landslide. Below this material, the original ground surface had been stripped of vegetation and topsoil, and comprised CDG and locally highly decomposed granite (HDG) with corestones.

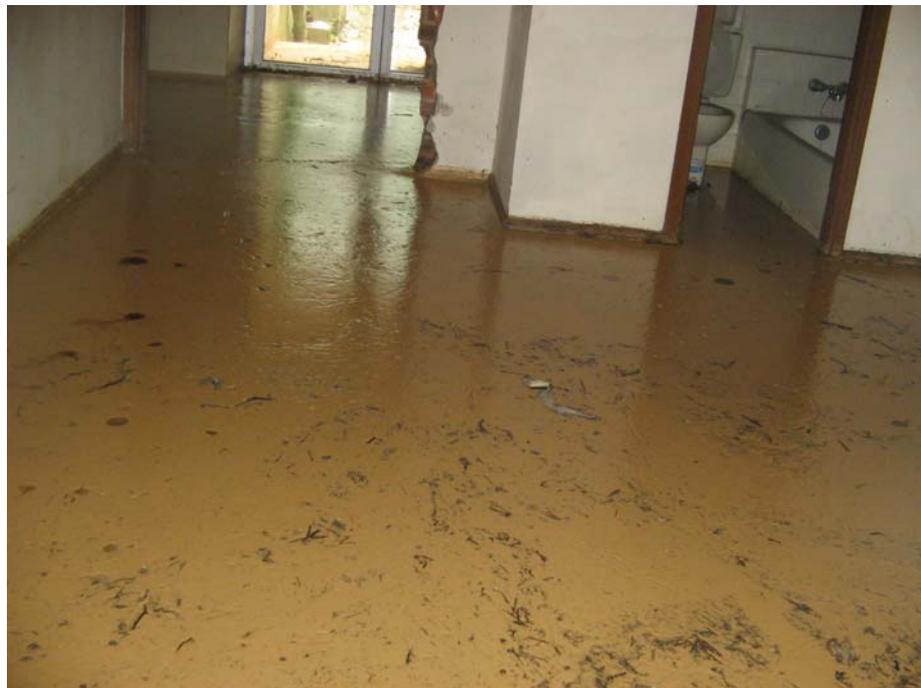
Plate 16 – Fine-grained Silty Outwash Debris (10 mm to 20 mm deep) Deposited within Ground Floor Apartment at No. 120 Kennedy Road (Photograph Taken on 6 September 2005)

The landslide debris comprised wet, soft, fine to coarse sand becoming finer and predominantly silty further from the source. Outwash debris was also present on the ground floor of No. 120 Kennedy Road (Plate 16), which was unoccupied at the time of failure. The travel angle (Wong & Ho, 1996) of both the upper and lower landslide debris (not including outwash debris beyond the rear wall of No. 120 Kennedy Road) is about 37° and the travel distance of the lower landslide debris was about 90 m.

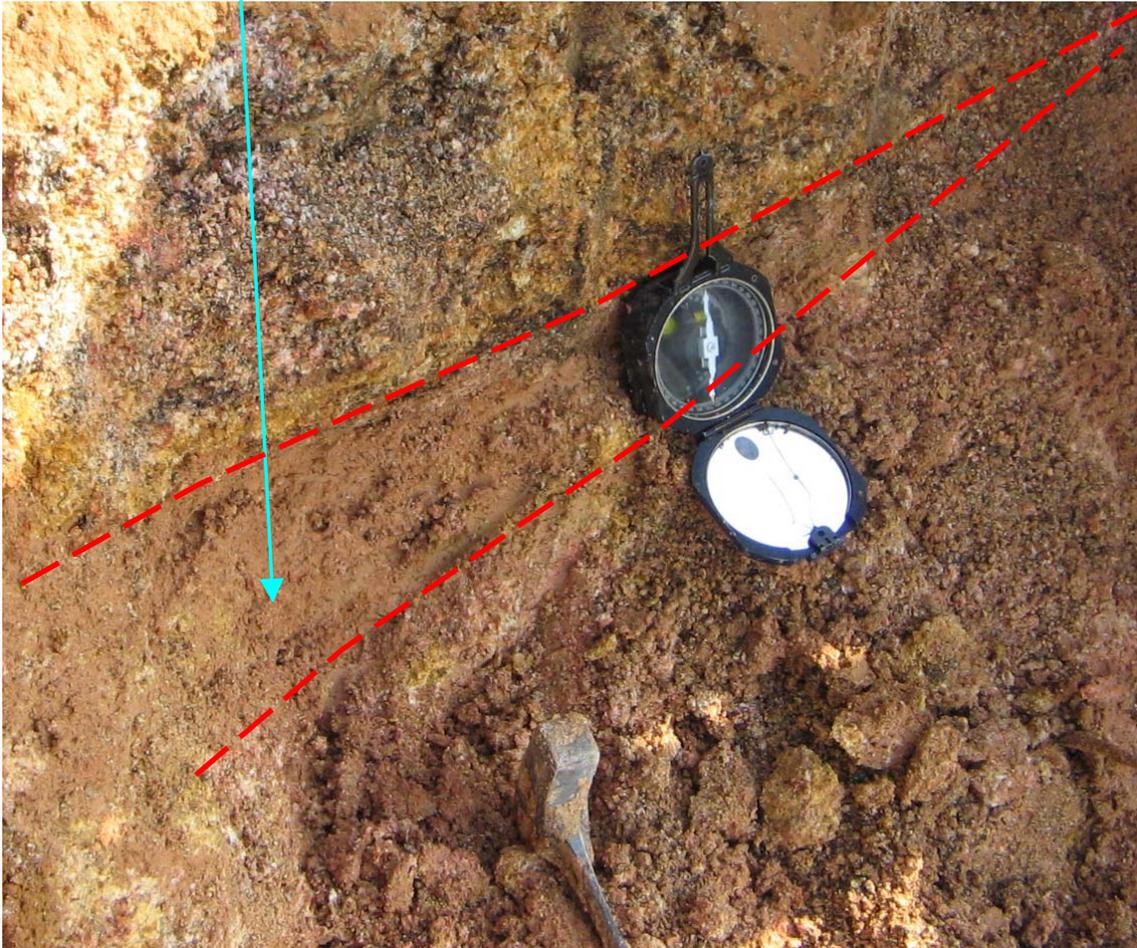
Plate 17 – Clay-infilled Relict Joints within CDG at the Toe of Upper Landslide
(Photograph Taken on 24 August 2005)

discontinuities were observed to have had a controlling influence on the landslide. In addition, there was no evidence of any clay-rich layers along the surface of rupture. However, clay infill materials (up to 100 mm thick) were observed along highly persistent, medium spaced, relict joints dipping into the slope at 45° towards the mid to lower portion of the east flank of the scar (Plate 17). In addition, a 300 mm to 500 mm thick zone of clay-rich, disturbed CDG was noted dipping out of the scar at about 25° located about 4 m below the main scarp near the western flank (Plate 18). The lateral extent of this zone is uncertain. This zone could have influenced the failure of the upper portion, and its presence suggests previous slope deformation in the upper part of the scar, which could have been associated with landslide DT1-1949 observed from API (Section 3.3). The clay-rich layers could have influenced the hydrogeology of the slope by forming less-permeable barriers to groundwater flow, leading to the formation of local perched groundwater conditions.

100 mm thick clay
layer dipping into
the slope

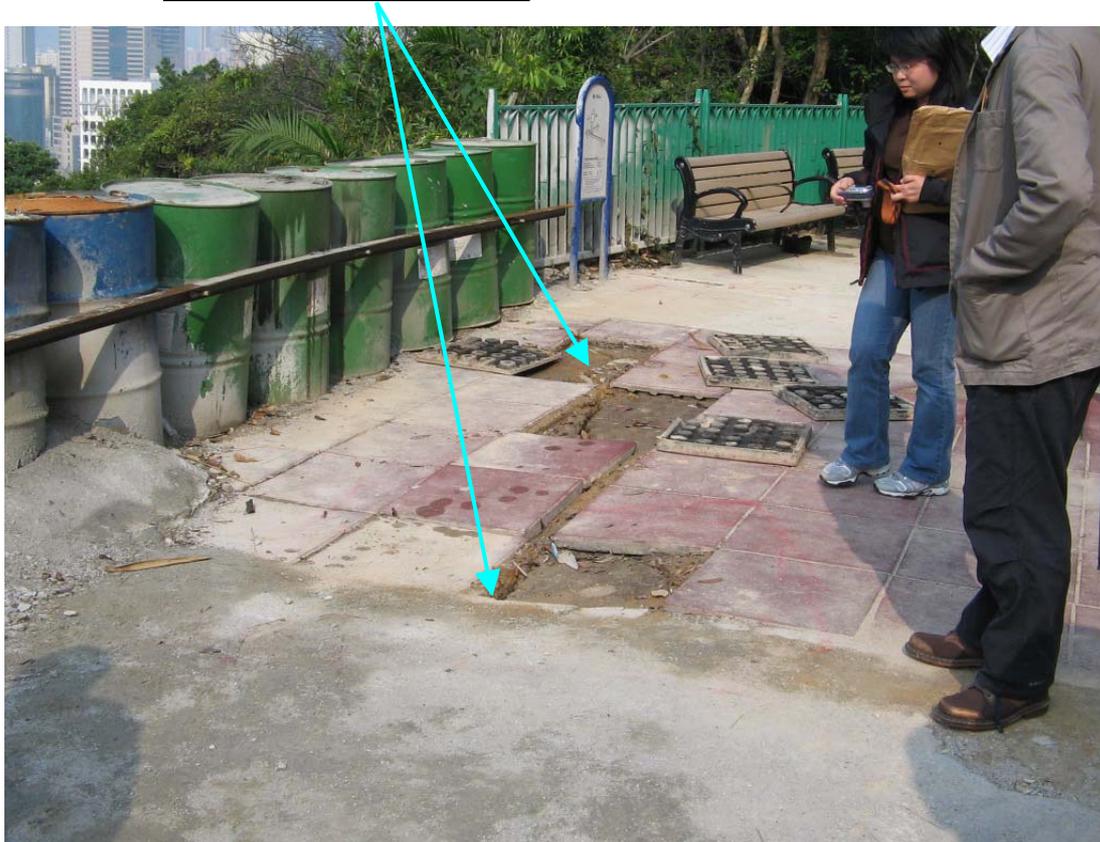
Plate 19 - Tension Crack on the Playground (Photograph Taken on 8 March 2006)

A tension crack up to about 6 m long, 60 mm wide and 0.6 m deep (see Section 7.3) was observed on the east section of the playground in January 2006, after the completion of the emergency slope works (see Section 10). The tension crack is shown in Figures 2, 4 and 7 and in Plates 19 and 20. The timing of the development of the tension crack is not certain as the playground was covered with landslide debris and subsequently covered by construction materials and equipment following the August 2005 landslides.

The tension crack observed on the platform adjacent to Bowen Road (Figures 2 and 7, and Plates 19 and 20) was further investigated by trial pit TP8 (Plate 23), together with slope surface strips SS2a and SS2b. At each location, the crack was noted to be within fill and was poorly developed as compared with the crack observed at ground surface. In trial pit TP8, the crack was observed up to about 0.6 m depth at the rear of a concrete block. The crack was about 30 mm wide and comprised some loose soil infill.

Tension crack below rubber
mats on playground

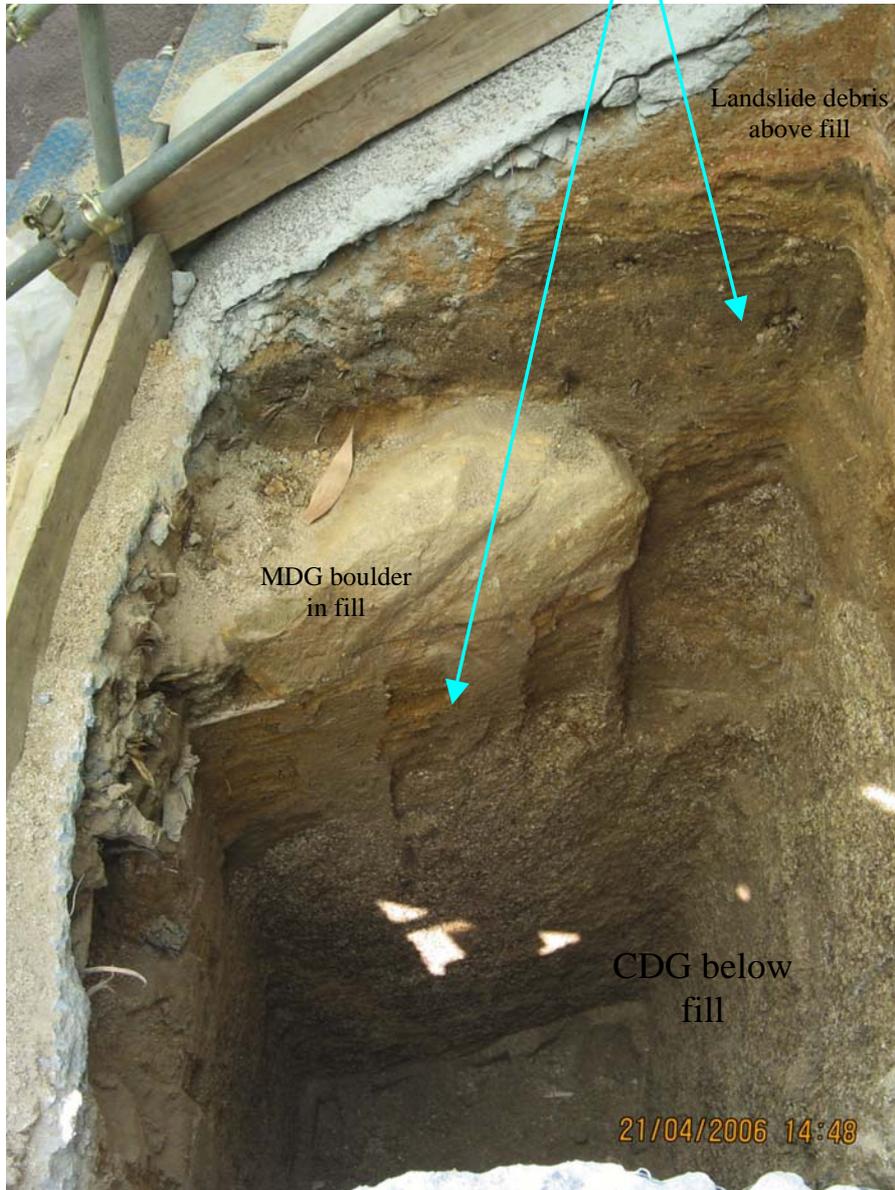
Plate 22 - Layered Fill with Granite Boulder above CDG in Trial Pit No. TP6
(Photograph Taken on 21 April 2006)

Layered fill located on depositional area of the lower landslide scar, about 50 m horizontal distance from Bowen Road
