**DETAILED STUDY OF
THE 20 AUGUST 2005
LANDSLIDE ON SLOPE NO.
11NE-A/C153 AT PING TING
ROAD, NGAU CHI WAN**

GEO REPORT No. 215

T.M.F. Lau & K.K.S. Ho

This report presents the findings of a review of a landslide (Incident No. 2005/08/0299) that occurred at the rock portion of a 47 m high soil/rock cut slope No. 11NE-A/C153 at Ping Ting Road, Ngau Chi Wan, at about 2:37 a.m. on 20 August 2005. The landslide involved the detachment of a total of about 36 m³ of rock blocks and soil, and the displacement of a rock wedge, about 12 m wide and 14 m high. Both lanes of Ping Ting Road were temporarily closed. No casualties were reported as a result of the landslide.

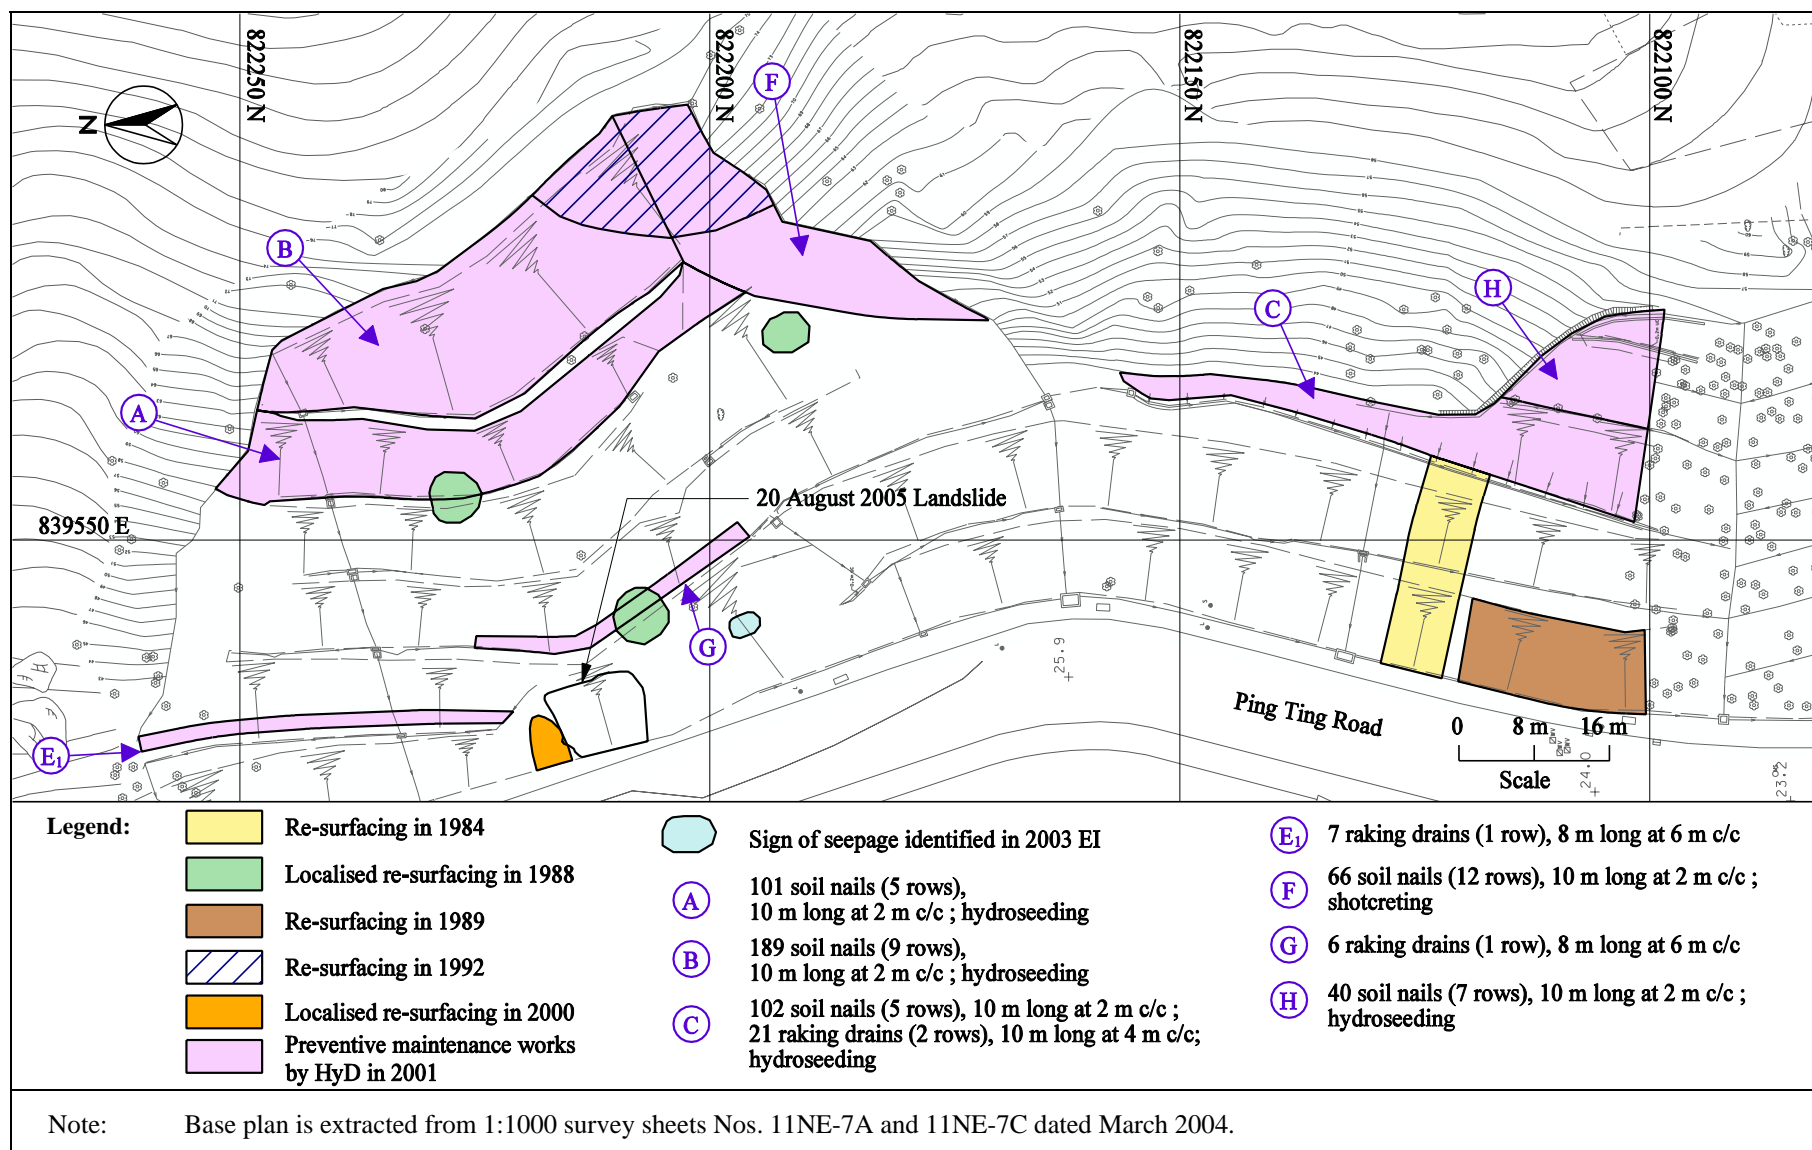
Figure 8 - Previous Works Carried Out at the Northern Part of Slope No. 11NE-A/C153

Based on the API, the northern part of the slope was stripped and re-surfaced with shotcrete in 1988 and 1996. Re-surfacing of parts of the slope had been carried out between 1984 and 2001 (Figure 8). It was also noted that a small local area immediately adjacent to the 2005 landslide was re-surfaced, probably between February 2000 and September 2000 (Figure 8 and Plate 11). To date, no records relating to this re-surfacing could be found.

In 2001, HyD carried out preventive maintenance works, which were broadly in accordance with those recommended in the 1999 EI (Section 5.4). Based on HyD’s records, the works comprised the installation of 498 Nos. of 10 m long soil nails, at 2 m and 1 m centre-to-centre spacing horizontally and vertically, at the two uppermost soil cut batters of the northern part of slope No. 11NE-A/C153. Most of the original hard cover on the slope surface where soil nails were installed was removed and replaced with hydroseeding. The preventive maintenance works also included the installation of 13 Nos. 8 m long raking drains at 6 m centres above the lowermost berm of the northern part of the slope (Figure 8).

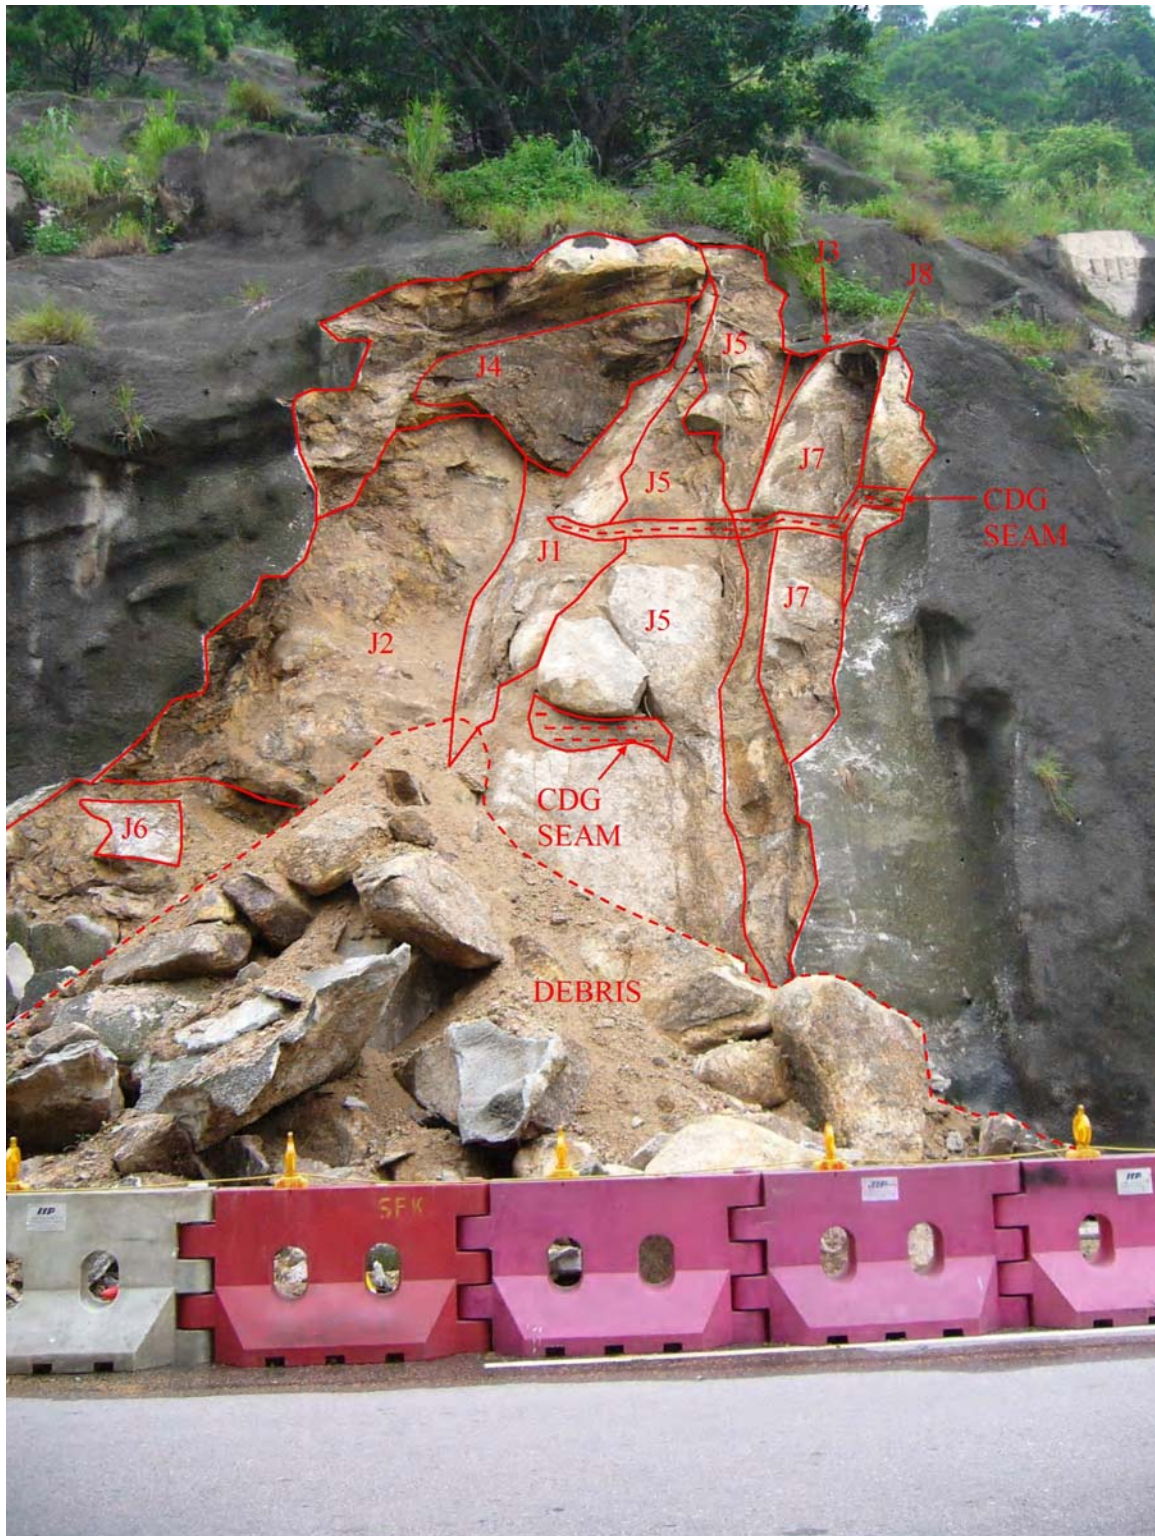
Figure 9 - Rock Joint Mapping of Landslide Scar

The rock joints exposed within the landslide scar were mapped and their orientations measured on 25 August 2005 (Figure 9), and a kinematic analysis was carried out. In the analysis, a friction angle of 35° was adopted for the rock joints taking cognizance of the presence of very thin coating of limonite in the joints. The stereoplot of the rock joints indicates that two of three joint sets identified fall just within the daylighting envelope for wedge failure (Figure 10).

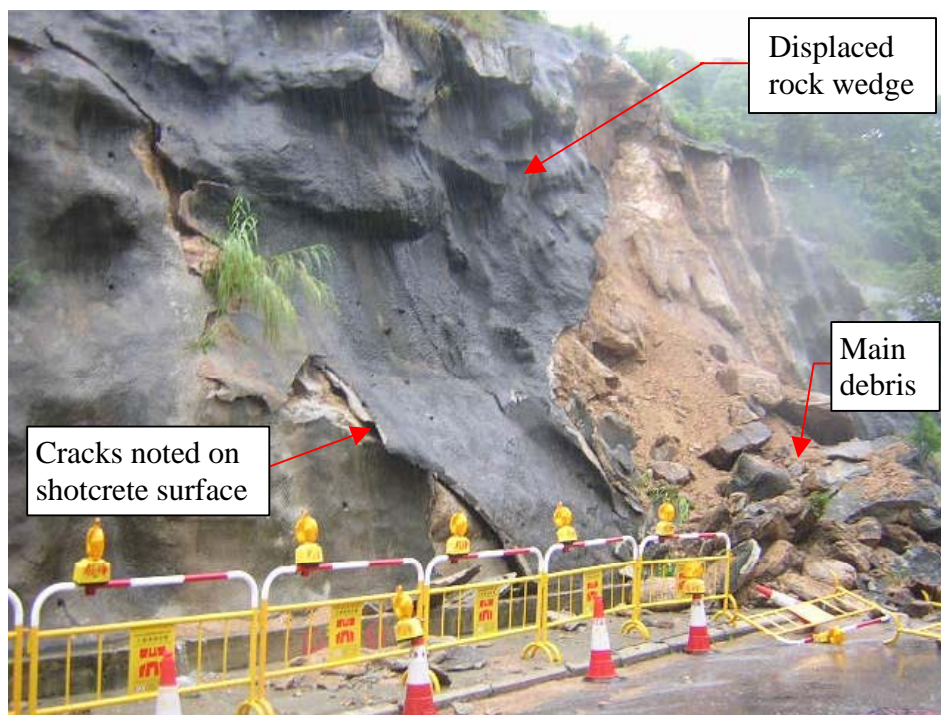
Persistent cracking of the shotcrete surface adjacent to the landslide scar was also observed (Plate 1). The pattern of shotcrete cracking indicated that movement had occurred within a rock wedge about 12 m wide (at the top) and about 14 m high. Seepage from the nearby weepholes and cracked shotcrete surface was observed (Plate 13). The raking drains located above the lowermost batter and to the north of the landslide scar also show significant seepage (Plate 14).

Plate 1 - View of the 20 August 2005 Landslide on Slope No.11NE-A/C153 Looking Southeast (Photograph taken on 20 August 2005)

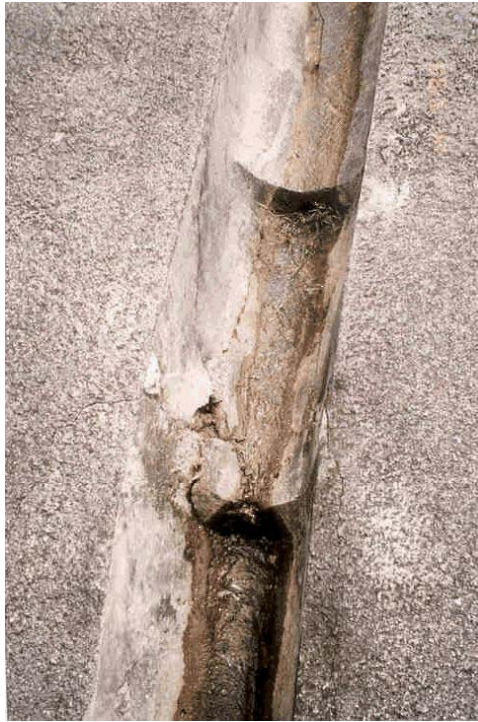
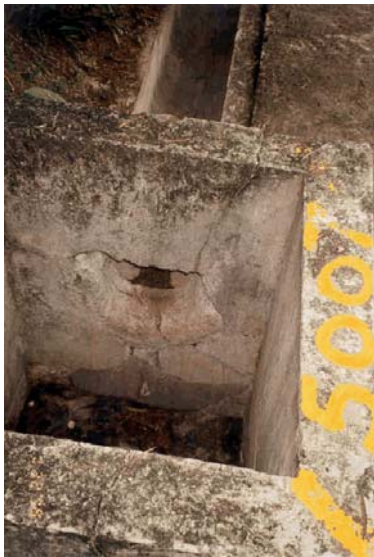
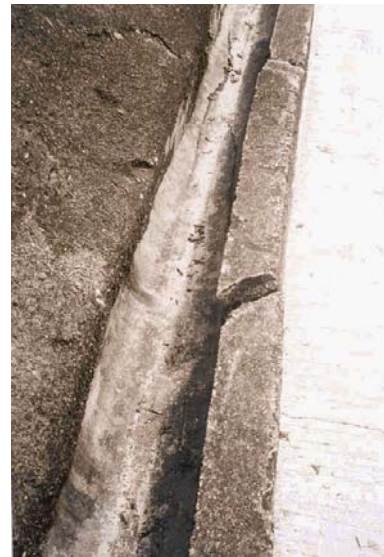
Cracked stepped channel and seepage

Cracked catchpit

Cracked channel at slope toe

Plate 9 - Some of the Slope Defects Identified in
1999 EI (Extracted from the 1999 EI
Report for Slope No. 11NE-A/C153)

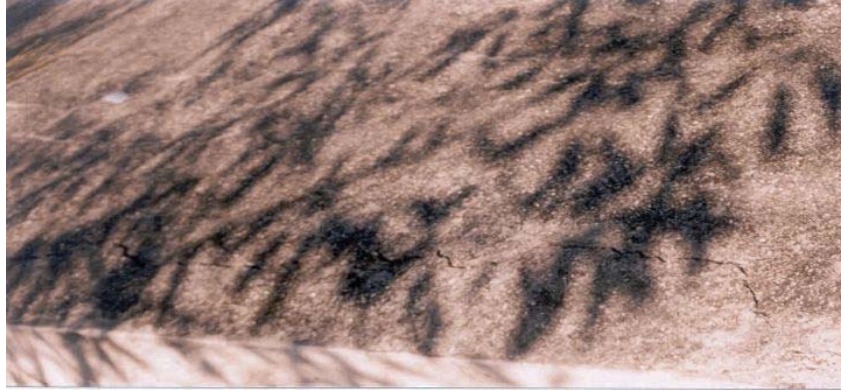
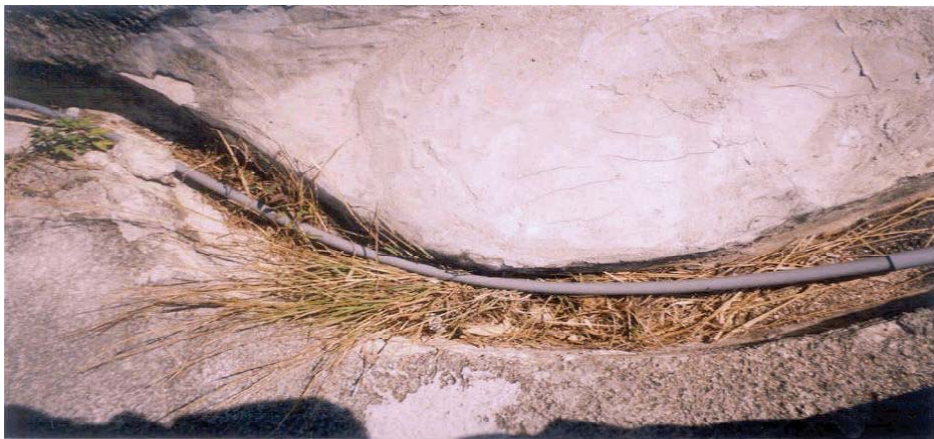
In January 2003, MGSL carried out a further EI of the slope for HyD. Defects observed on slope included "cracked surface cover", "blocked channel & weephole", "undermined channel due to erosion or wash-out", "rubbish on the feature surface", "undesirable vegetation on rigid surface", "damaged channel" and "cracked surface cover with signs of seepage". The EI consultant reported no recent movement, no tension cracks

at the crest but recent seepage was noted. Some of the identified slope defects are shown in Plate 10. The overall state of maintenance was classified as “1”, i.e. the overall state of maintenance of the slope was considered to be satisfactory in general. The routine maintenance works were considered to be satisfactorily carried out and no routine maintenance works were recommended. The EI report indicated that no stability assessment or upgrading works has been carried out previously on the slope (based on a file search by MGSL) and a stability assessment was therefore recommended.

Cracked surface cover

Blocked channel

Plate 10 - Some of the Slope Defects Identified in
2003 EI (Extracted from the 2003 EI
Report for Slope No. 11NE-A/C153)

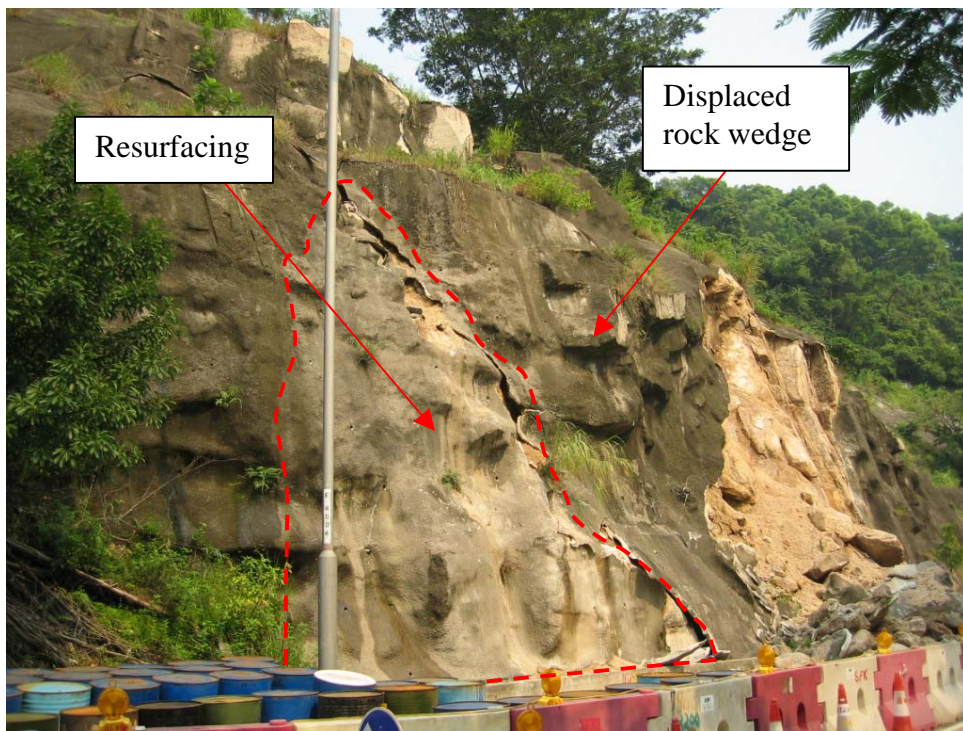
Plate 11 - View of Localised Re-surfacing Immediately
Adjacent to the Displaced Rock Wedge
(Photograph taken on 31 August 2005)

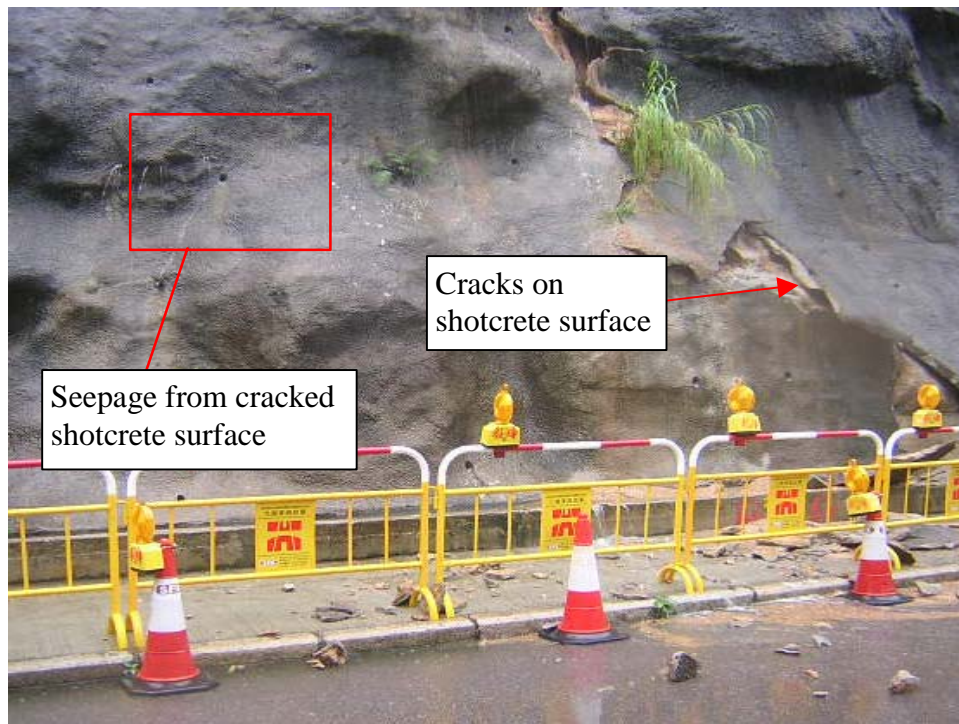
Plate 13 - Seepage from Cracked Shotcrete
(Photograph taken on 20 August 2005)

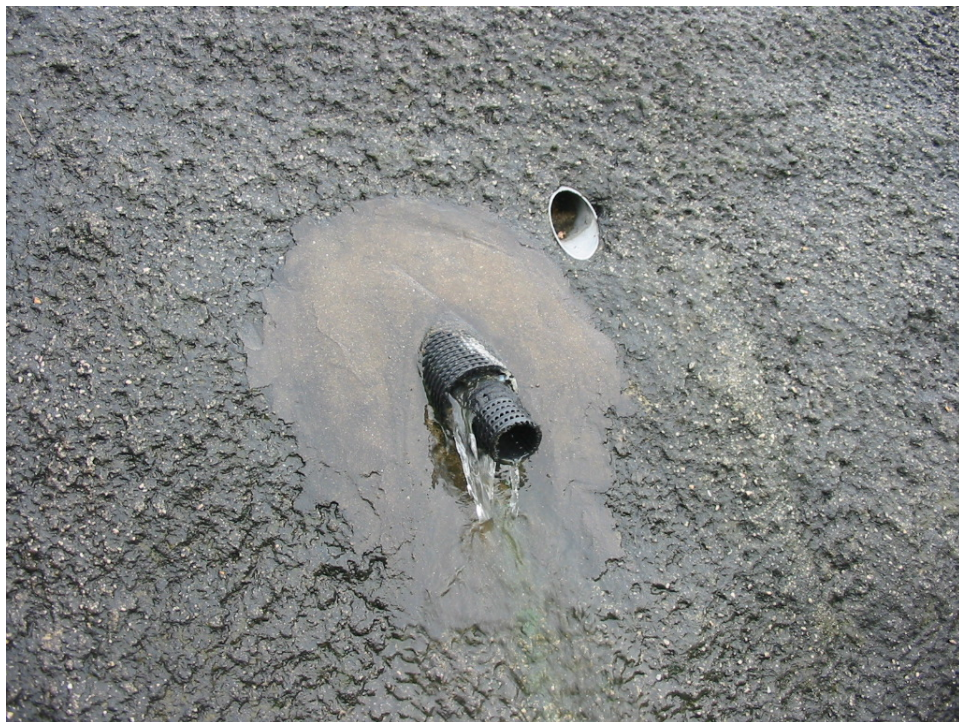
Plate 14 - Seepage from Raking Drain above the Lowest Batter
of the Northern Part of Slope No. 11NE-A/C153
(Photograph taken on 24 August 2005)

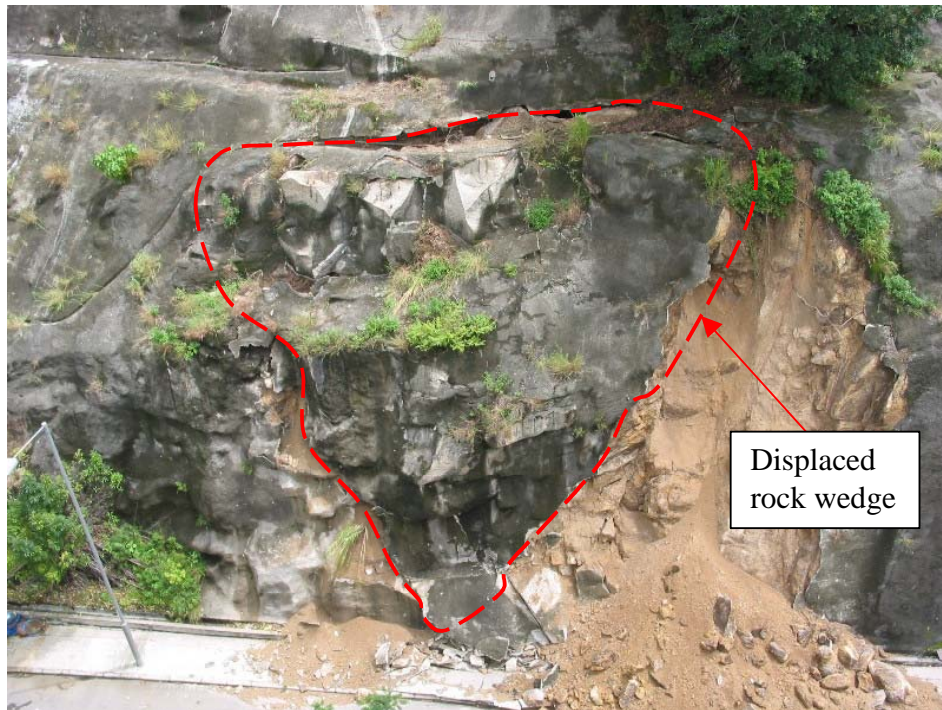
The unstable rock wedge, as defined by the persistent cracking in the shotcrete, had displaced further with significant widening (up to about 0.5 m) of the cracks (Plate 15). MGSL observed a sub-vertical tension crack, about 0.5 m wide and more than 1 m deep, at the top of the displaced rock wedge (Plate 16). The back-release surface of the rock wedge was steeply inclined (almost sub-vertical) and by inference, based on the observed exposed joint surfaces, the wedge appeared to be approximately 4 m deep. Another 10 m³ of debris

Plate 15 - General View of Displaced Rock Wedge on
Northern Part of Slope No. 11NE-A/C153
(Photograph taken on 13 September 2005)

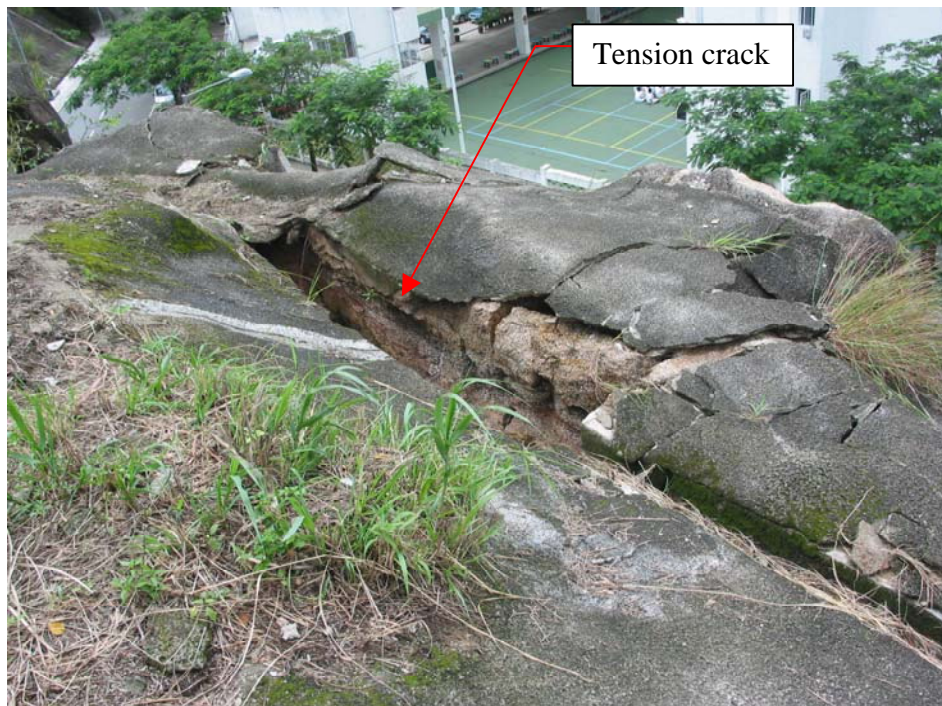
Plate 16 - Tension Crack at Top of the Displaced Rock Wedge
(Photograph taken on 13 September 2005)

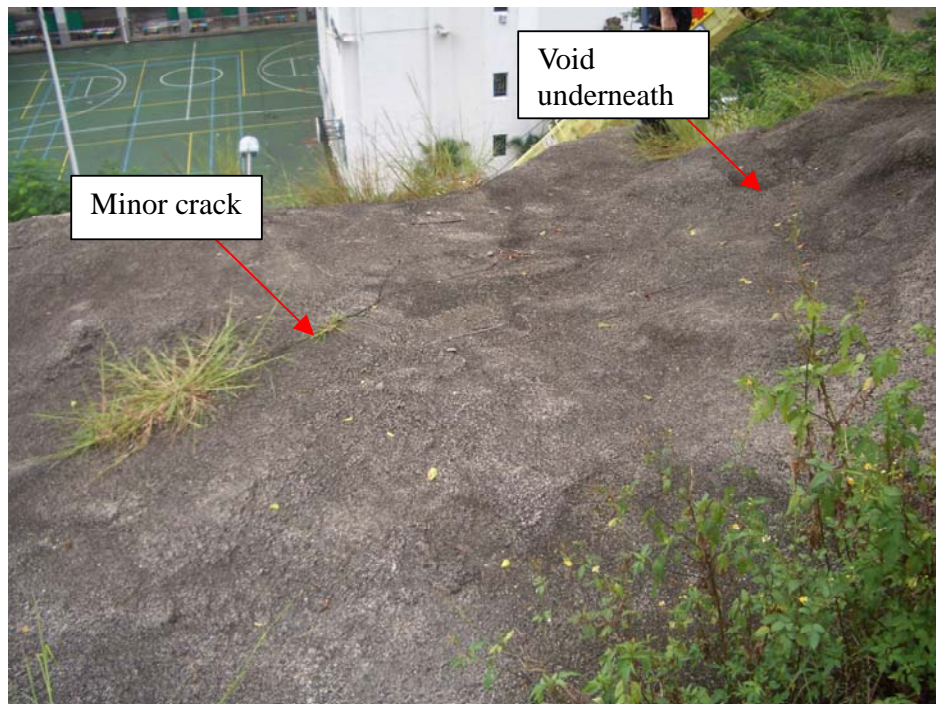
Beneath the shotcrete surface, a suspected void about 2 m wide by 1 m long was identified near the top of the displaced rock wedge (Plate 17). Several old cracks, about 2 mm wide, were also observed on the shotcrete surface above the displaced rock wedge (Plate 18). Debris and vegetation were found in these cracks, which suggest that the cracks had existed for quite some time.

Plate 17 - Void near the Top of Displaced Rock Wedge
(Photograph taken on 14 September 2005)

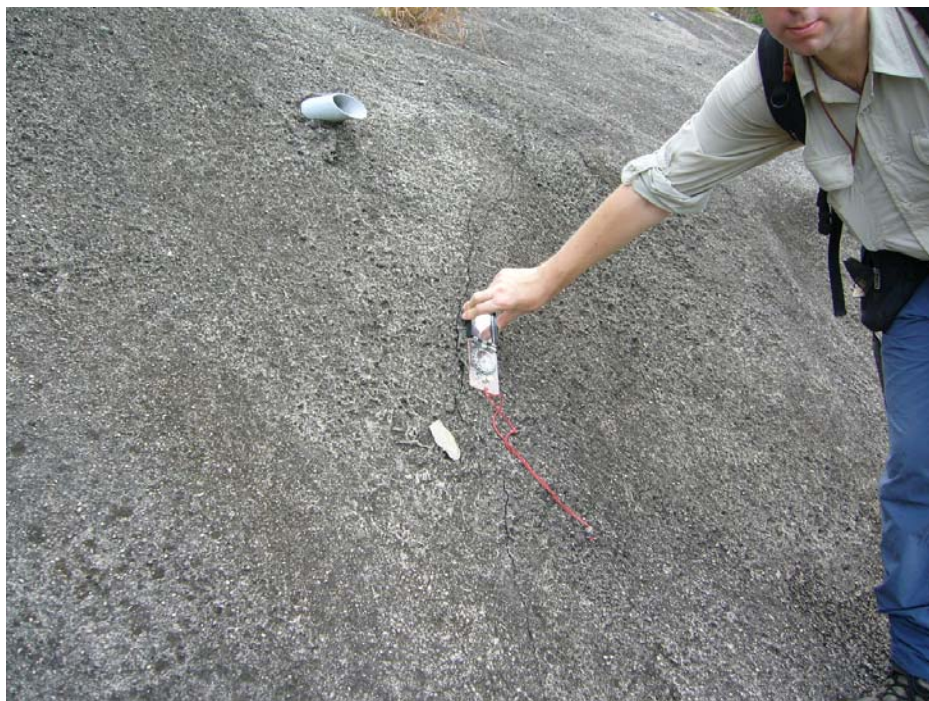
Plate 18 - Cracked Shotcrete Surface above the Displaced Rock Wedge
(Photograph taken on 14 September 2005)

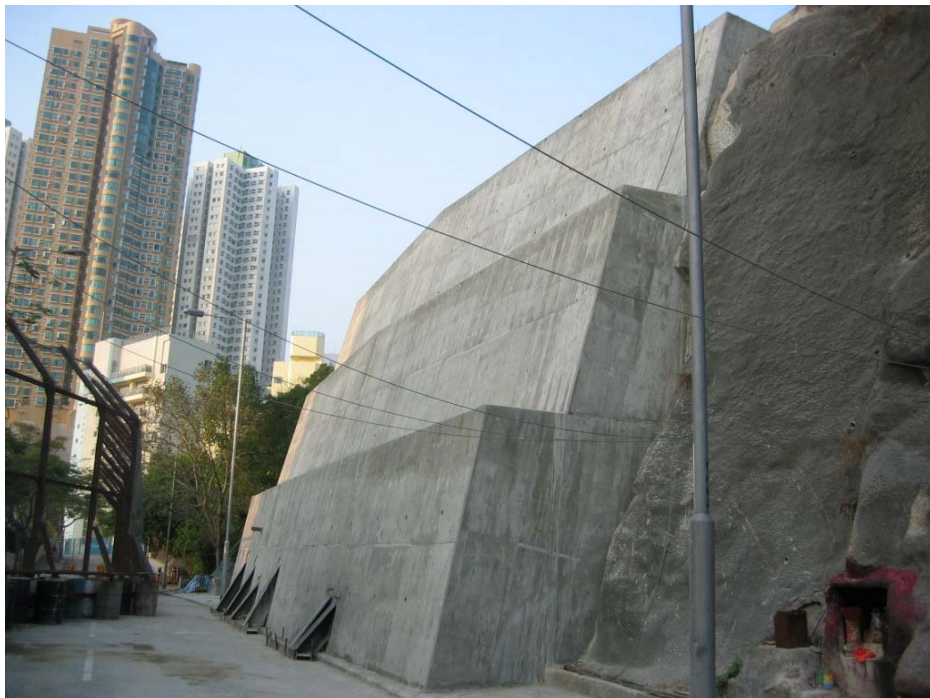
Plate 20 - General View of Urgent Repair Works as
at 1 February 2006 Looking Northeast

Between 13 and 16 September 2005, HyD carried out emergency works at the recommendation of the GEO, including the removal of landslide debris and loose rock blocks, to allow re-opening of the northbound lane of Ping Ting Road. During the emergency works, some of the loose rock blocks were observed to exhibit further displacement. Struts were erected by HyD to support the overhanging rock blocks (Plate 19). In mid-September 2005, the Mainland East Division of the GEO advised HyD to construct a mass concrete buttress to support the displaced rock wedge. The buttress was completed by the end of January 2006 (Plate 20).
