**REVIEW OF THE 21 AUGUST 2005
LANDSLIDE ON SLOPES
NOS. 7SE-B/C195 AND 7SE-B/C131
AND THE DISTRESSED HILLSIDE
ABOVE SLOPE NO. 7SE-B/C122 AT
MA ON SHAN UPPER VILLAGE**

GEO REPORT No. 216

Maunsell Geotechnical Services Limited

**This report was originally produced in December 2006
as GEO Landslide Study Report No. LSR 16/2006**

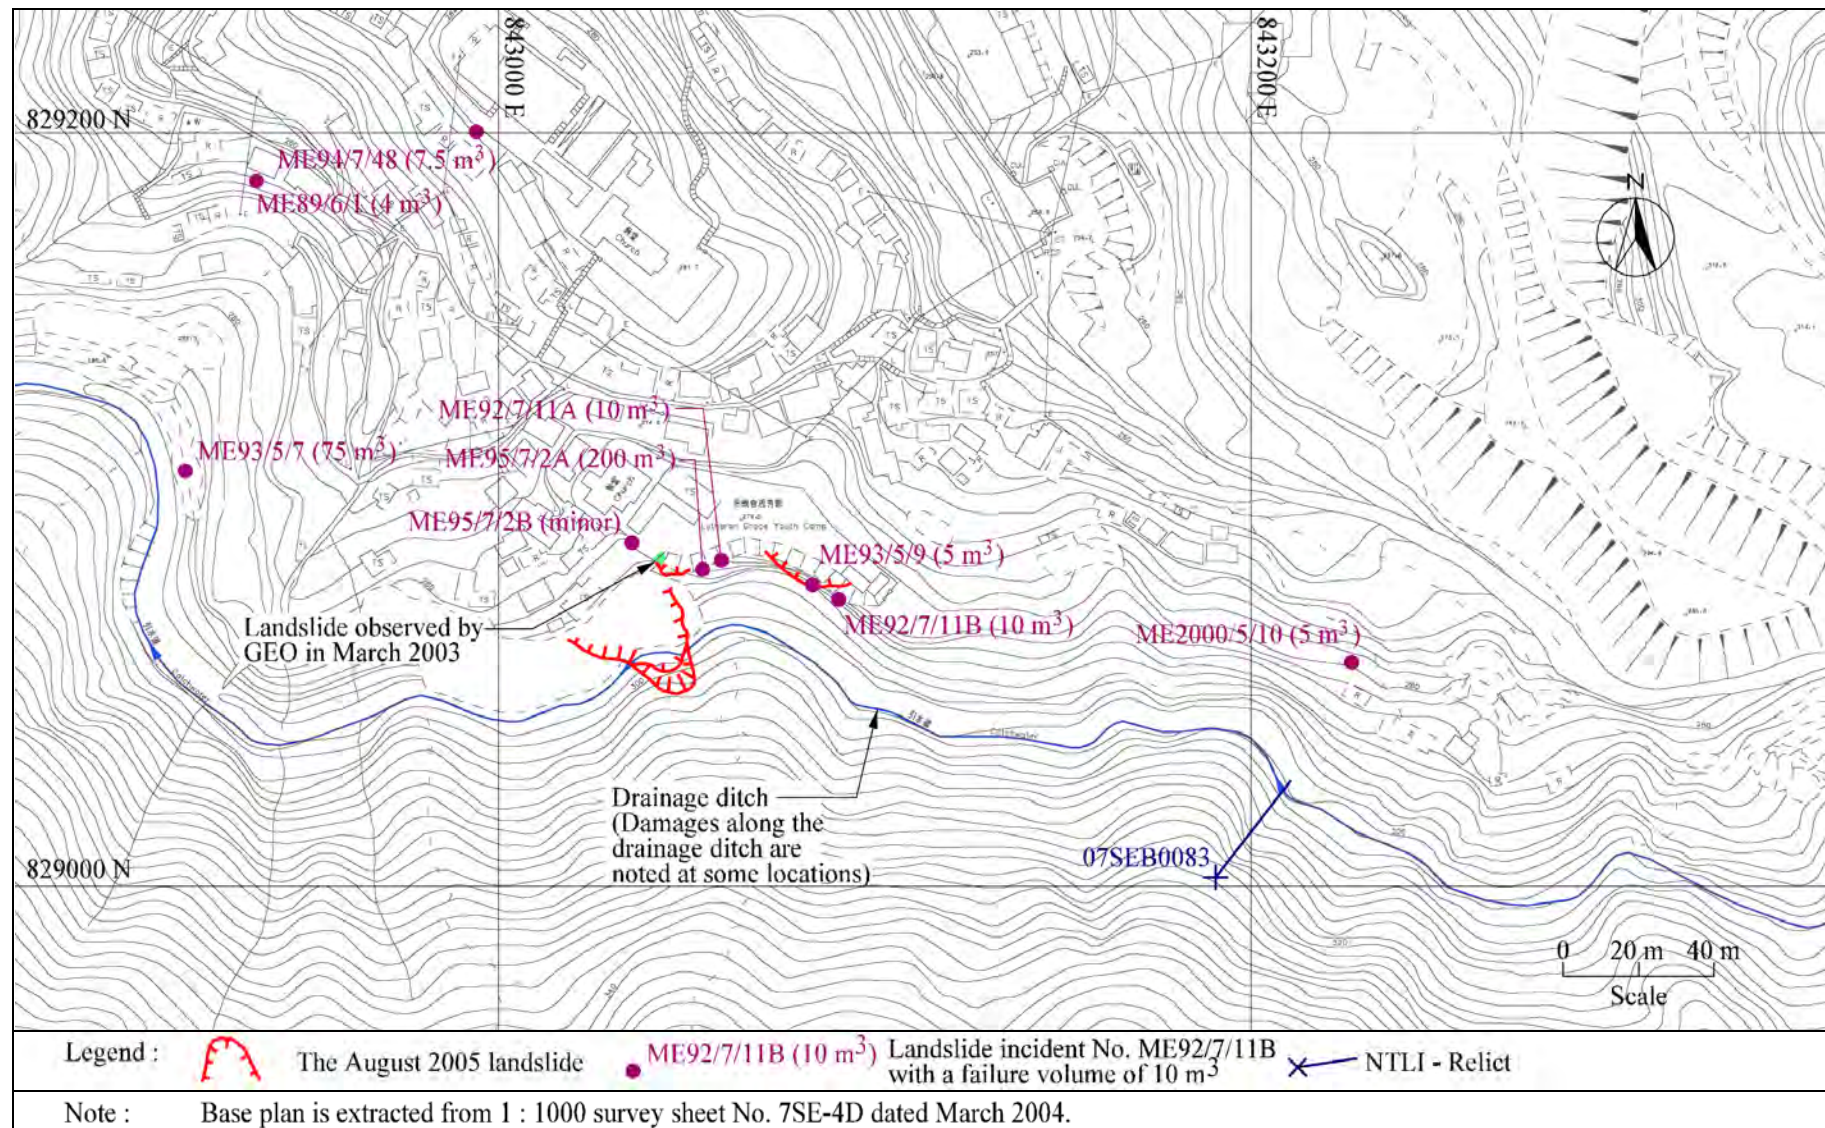
Figure 5 - Past Instability

According to the landslide database and file records, four previous landslide incidents occurred on slope No. 7SE-B/C122 (Figure 5). No past instability record could be found for slopes Nos. 7SE-B/C195 and 7SE-B/C131.

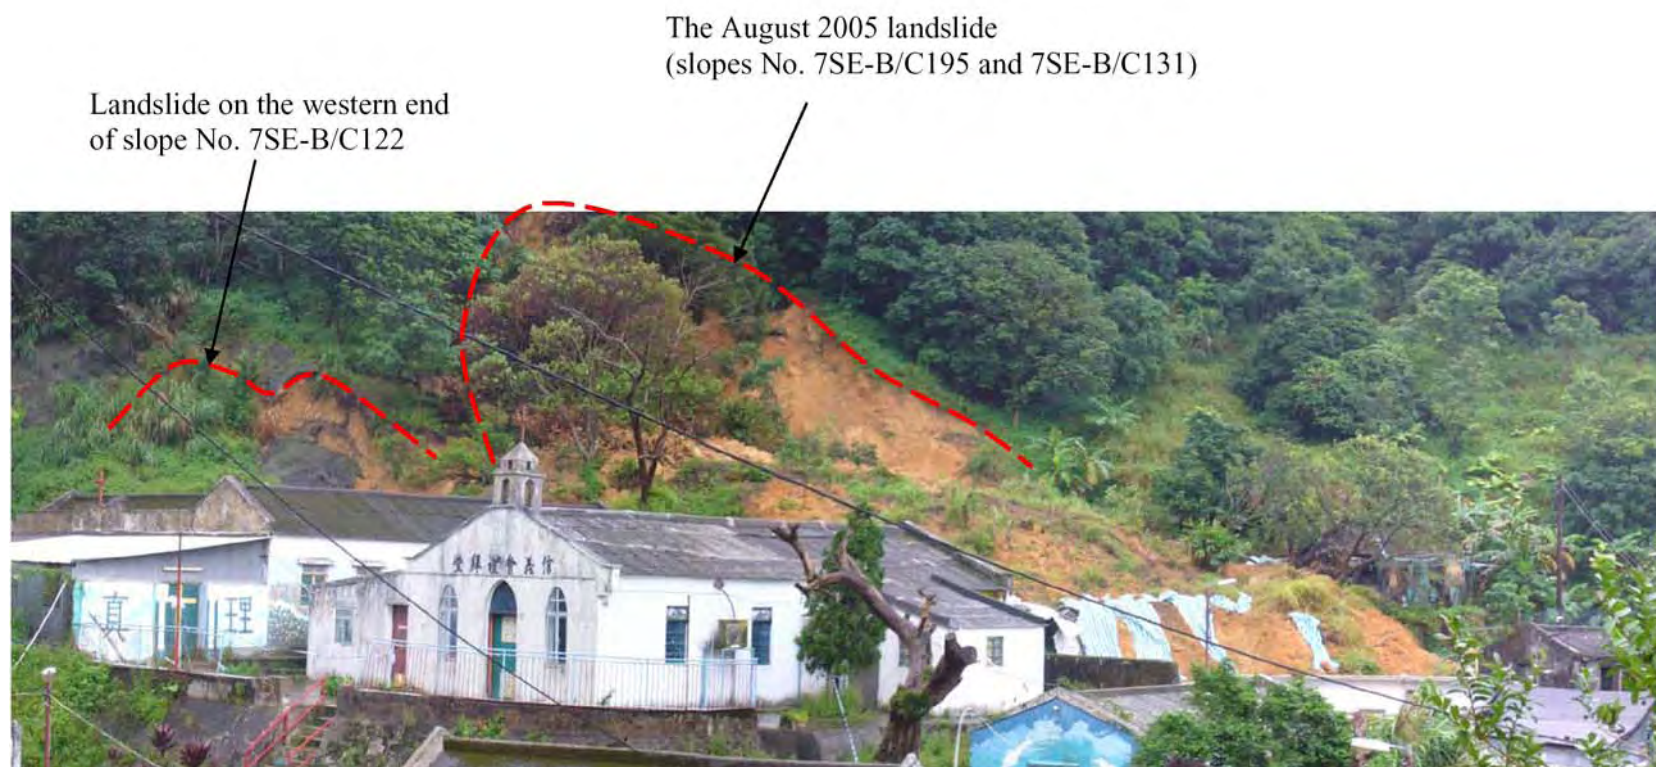
Plate 1 - General View of the August 2005 Landslide (Photograph taken on 21 October 2005)

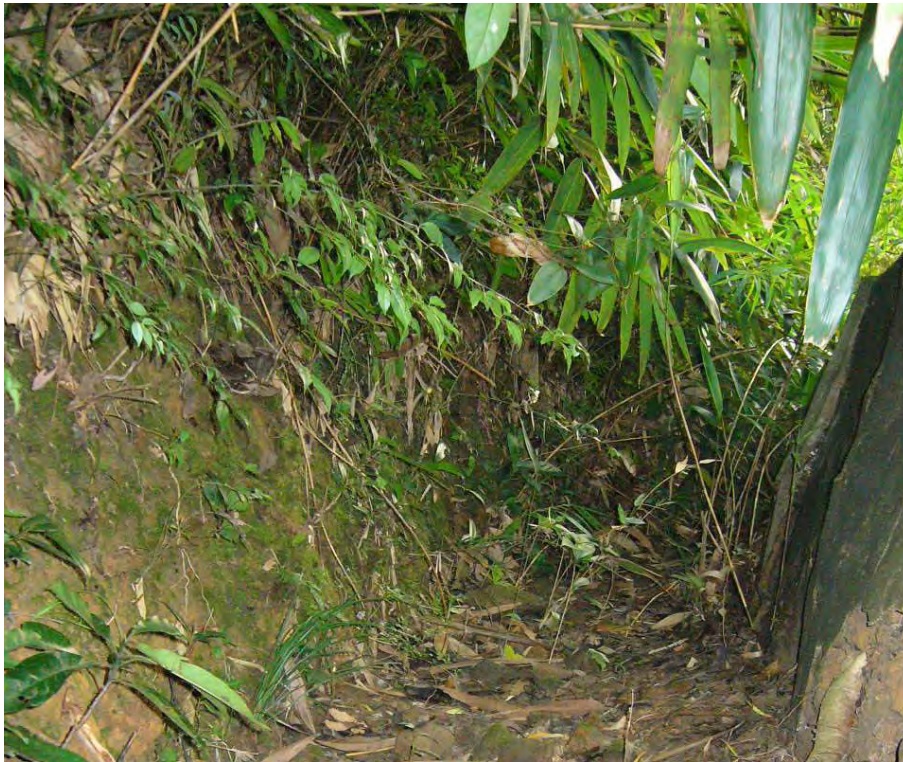
The drainage ditch is partly unlined, with some portions of the sidewalls covered by chunam and stone facing on the downhill side. The drainage ditch is generally cut into the hillside with the upper face comprising exposed soil and the invert lined with rock rubble (Plate 2). At some locations, a mortared-rubble retaining structure has been constructed on the downhill side to support the drainage ditch. No weirs or spillways are present along the drainage ditch. During inspection, several rock blocks and other debris were observed in the drainage ditch indicating the absence of regular maintenance. However, limited vegetation was growing in the drainage ditch, which suggests that some water has flowed along the ditch on a regular basis. At several locations in the vicinity of the ditch, there are some old landslides. It is not clear if any of the old landslides would have affected the function of the ditch in conveying runoff from the uphill area.

Plate 2 - General View of the Drainage Ditch (Photograph taken on 21 September 2005)

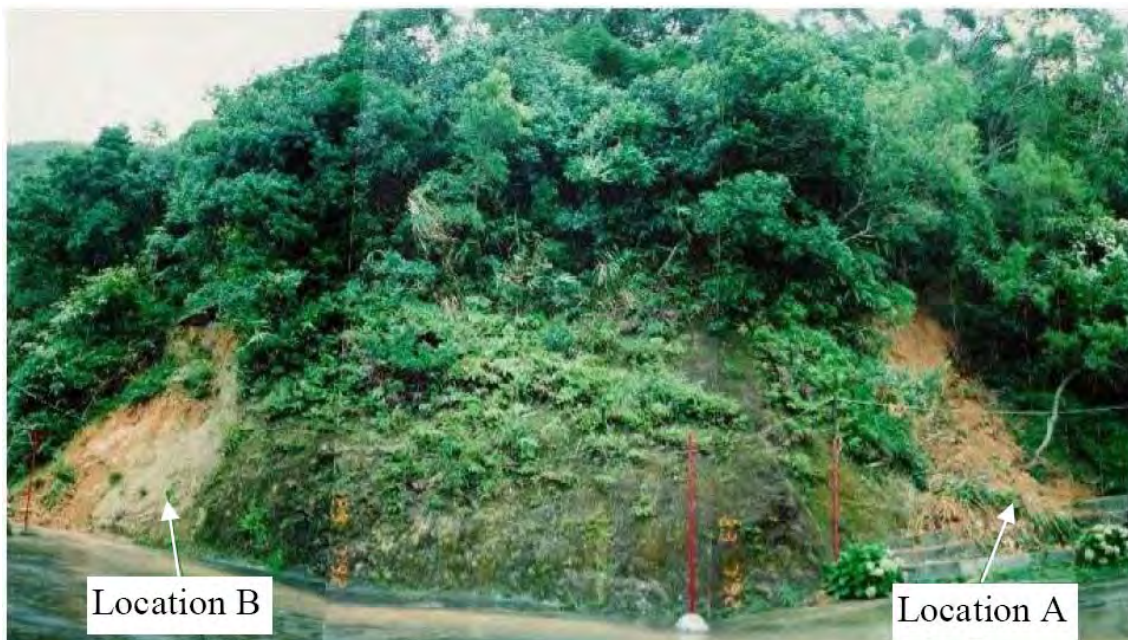
On 21 June 1992, two minor landslides (Incident No. ME92/7/11, with a failure volume at both locations estimated to be about 10 m³) occurred on slope No. 7SE-B/C122 (see Figure 5 and Plate 3). One of the landslides buried part of the staircase along the slope toe and the other knocked over a lamppost at the slope toe. The Incident Report indicated that the failure material was colluvium and the possible causes of failure were "erosion" and "blockage of drains".

Plate 3 - General View of the Landslide Incident No. ME92/7/11 at Slope No. 7SE-B/C122 (Photograph taken on 23 July 1992 as extracted from Incident Report)

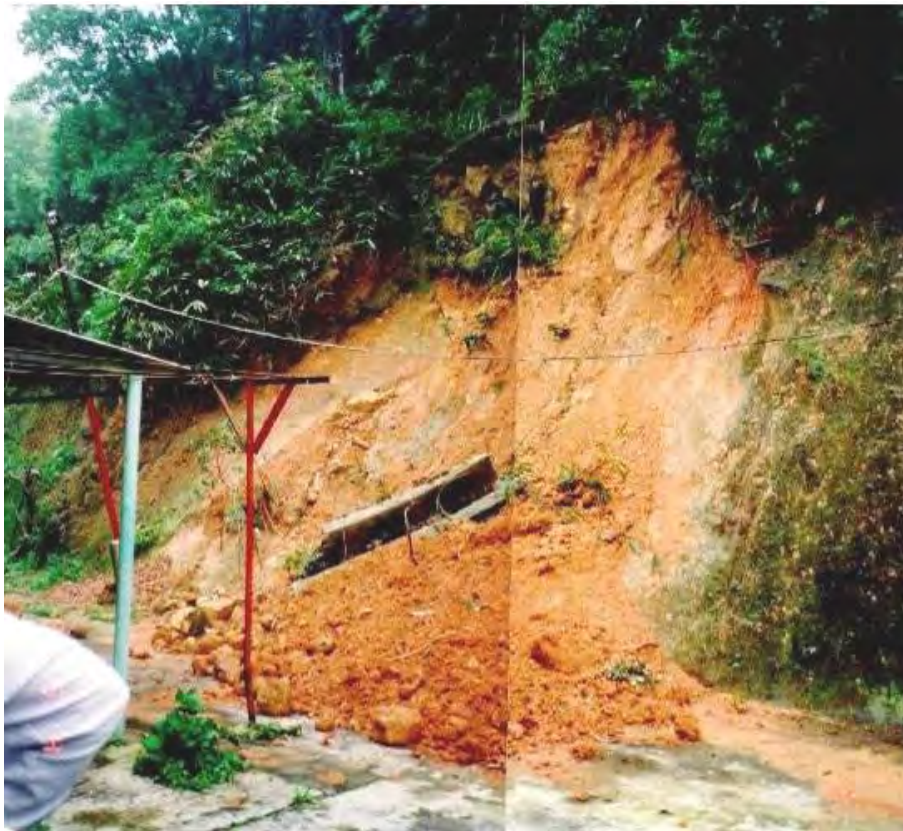
On the morning of 1 May 1993, a minor landslide (Incident No. ME93/5/9, with a failure volume of about 5 m³) occurred at the eastern portion of slope No. 7SE-B/C122 (Figure 5 and Plate 4). The Incident Report stated that the failure material was "residual soil" and the possible causes of failure included "infiltration", "rupture of water mains/drains"

Plate 4 - View of Landslide Incident No. ME93/5/9 at Slope No. 7SE-B/C122
(Photograph taken on 4 May 1993 as extracted from Incident Report)

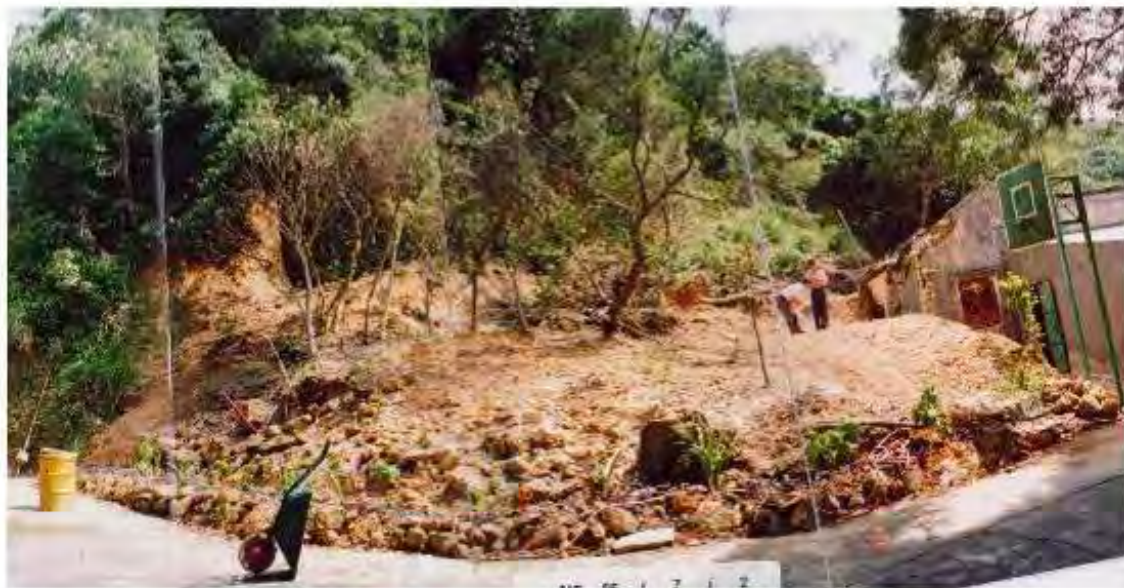
On 7 July 1995, a landslide with a volume of 200 m³ (Incident No. ME95/7/2, Location A) and a minor landslide (Incident No. ME95/7/2, Location B) were reported to the GEO. It was reported that the slope failed in July 1994. The Incident Report shows that the size of the major landslide was about 25 m wide by 9 m long (Plate 5). The debris spilled onto the basketball court east of the Youth Camp knocking down part of the external wall to dormitory No. 6. The Incident Report indicated that a “bare slope surface” was observed. The material involved in the failure was weathered rock and the possible cause of failure was “infiltration”.

Plate 5 - View of Landslide Incident No. ME95/7/2 (Location A) at Slope No. 7SE-B/C122
with a Failure Volume of about 200 m³ (Photograph taken on 10 July 1995 as
extracted from Incident Report)

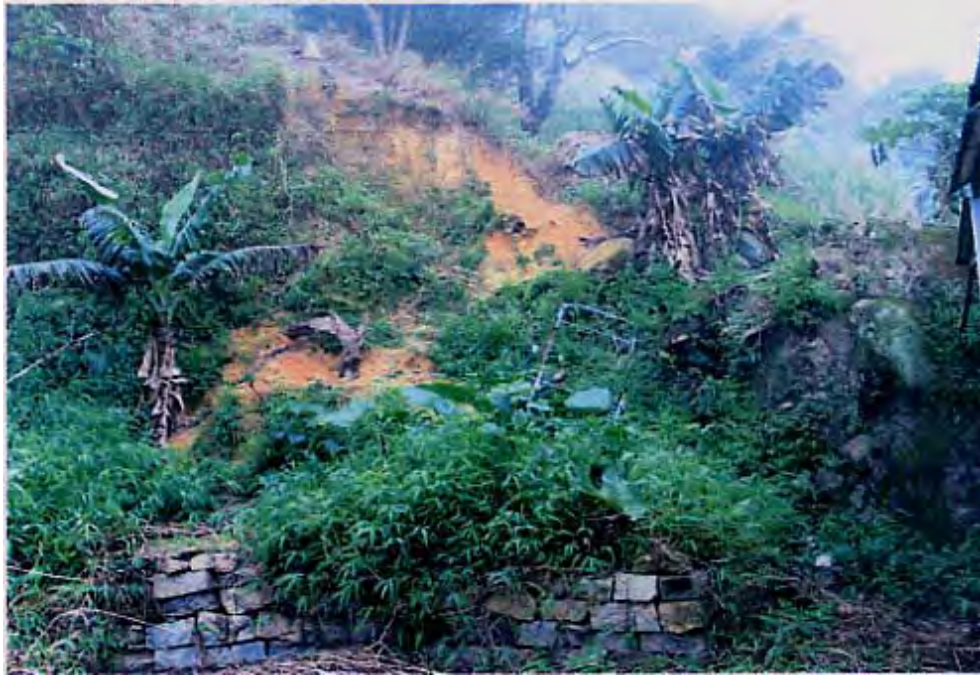
Following a regular review of slopes under the maintenance of STT with Warning Letters issued to the tenants (see Section 4.3), the Mainland East (ME) Division of the GEO visited slope No. 7SE-B/C122 on 4 March 2003 and observed a minor landslide scar at the western end of the slope (Figure 5 and Plate 6). This landslide had not been recorded in the GEO’s landslide database and the exact date of the failure is unknown. Based on the record photographs, the size of the landslide was about 8 m wide by 6 m high and the GEO noted the following: “Signs of wash-out were observed at various locations of the feature”.

Plate 6 - View of the Landslide Observed by GEO in March 2003 on the Western Portion of Slope No. 7SE-B/C122 (Photograph taken on 4 March 2003 as extracted from GEO inspection record)

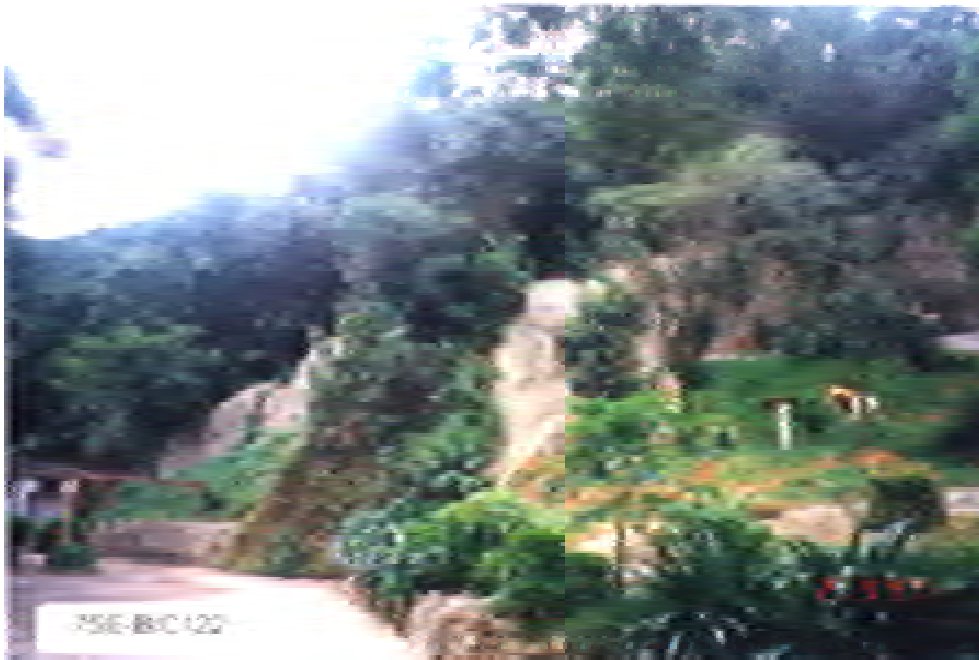
Slope No. 7SE-B/C122 was inspected by the SIRST consultant, BCL, on 2 August 1997. The inspection record noted that the slope surface was in fair condition with no signs of seepage. The consequence-to-life category was assessed to be “1”. A photograph taken on 2 September 1997 for the Stage 1 Study is shown in Plate 7.

Plate 7 - View of Slope No. 7SE-B/C122 in 1997 after Temporary Remedial Works (Photograph taken on 2 September 1997 as extracted from Stage 1 Report)

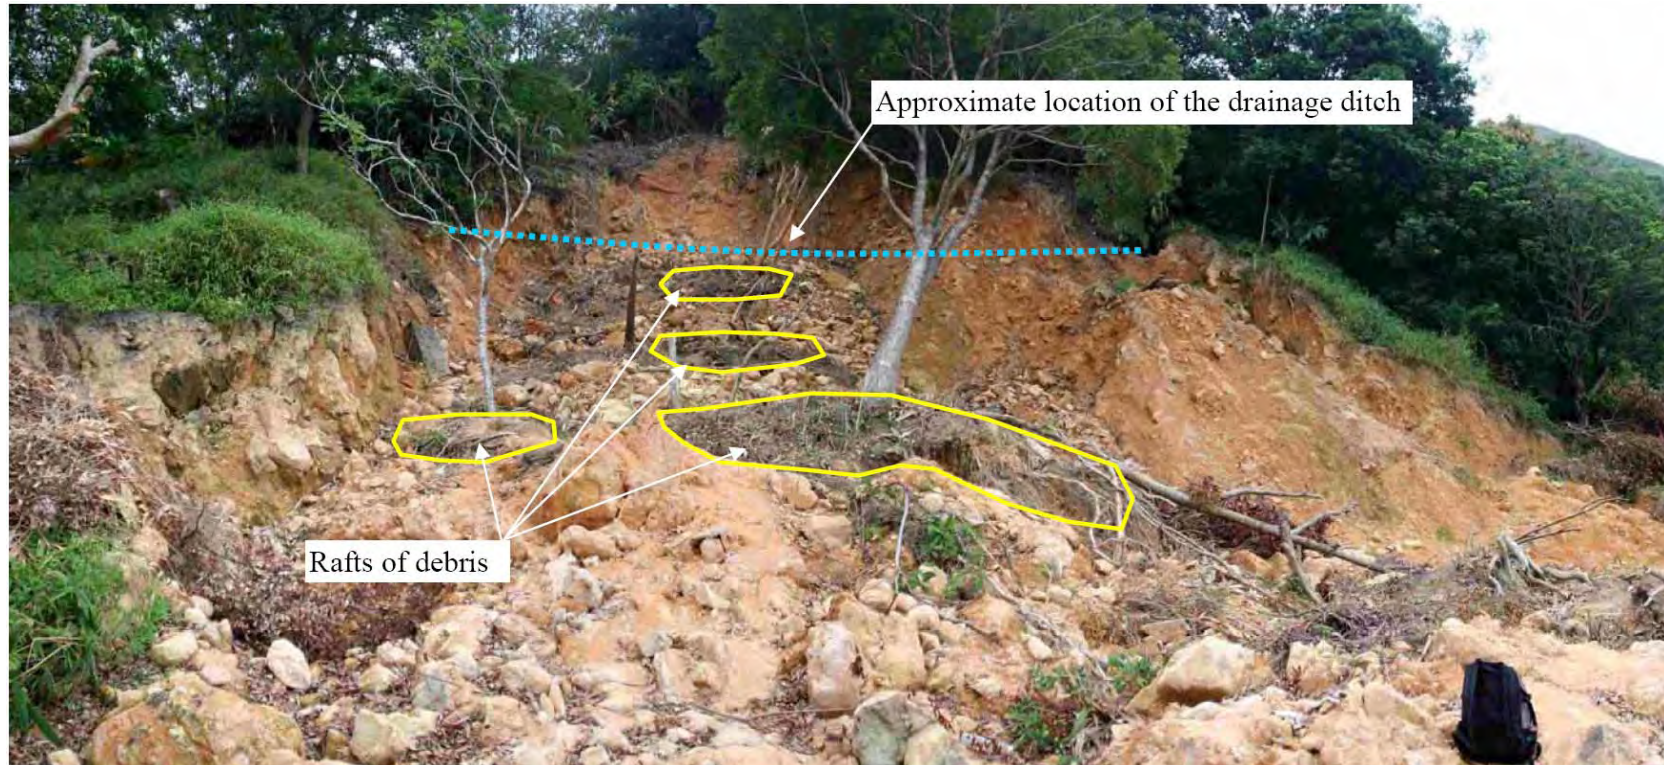
Plate 8 - View of the August 2005 Landslide from Toe Showing Local Rafts of Debris and Approximate Location of the Drainage Ditch
(Photograph taken on 21 October 2005)

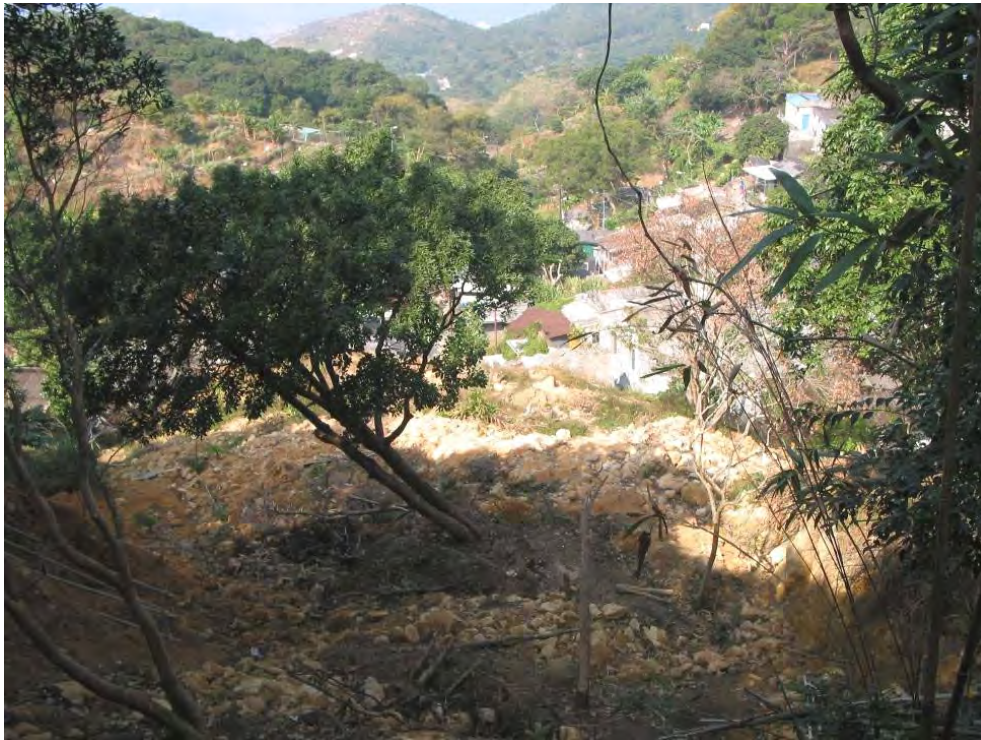
Plate 9 - View of Debris Lobe from the Crest of the August 2005 Landslide
(Photograph taken on 2 December 2005)

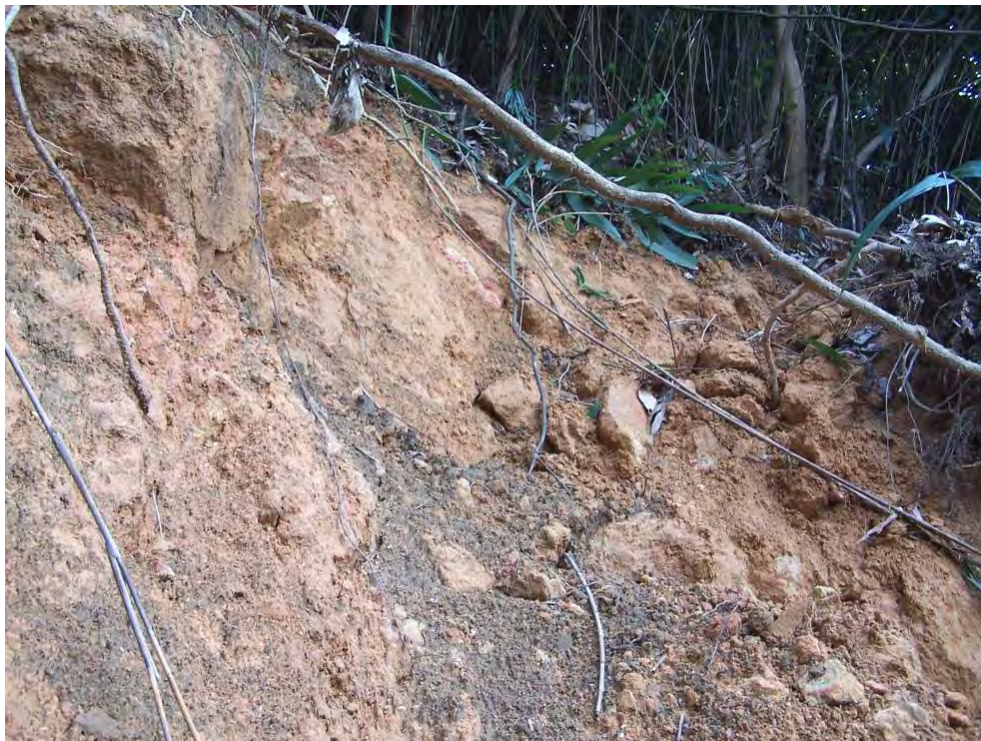
Plate 10 - View of the Main Scarp of the August 2005 Landslide
(Photograph taken on 23 August 2005)

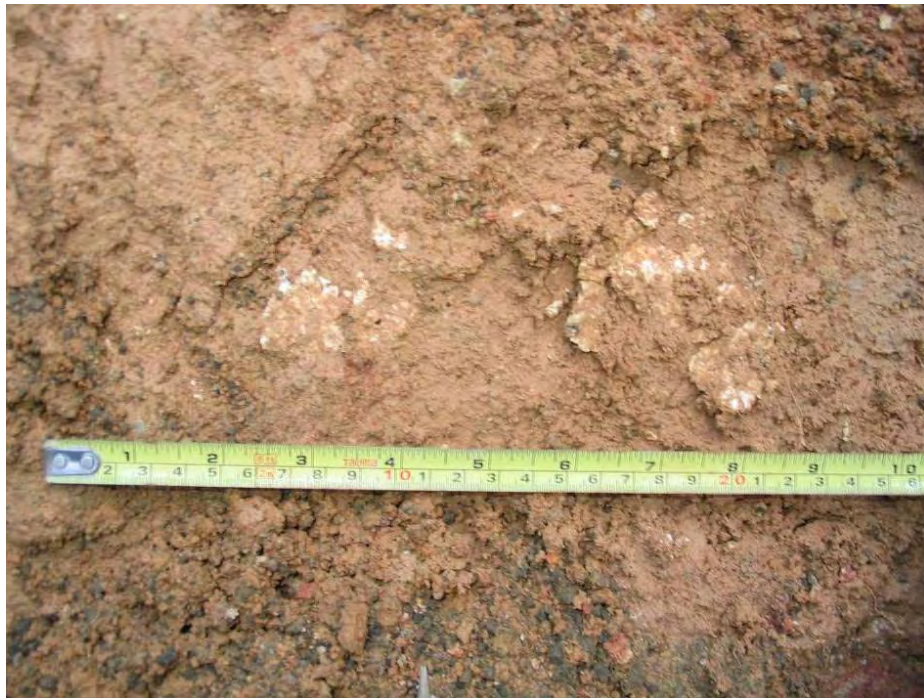
Plate 11 - Localised Kaolin Deposits on the Failure Surface
(Photograph taken on 23 August 2005)

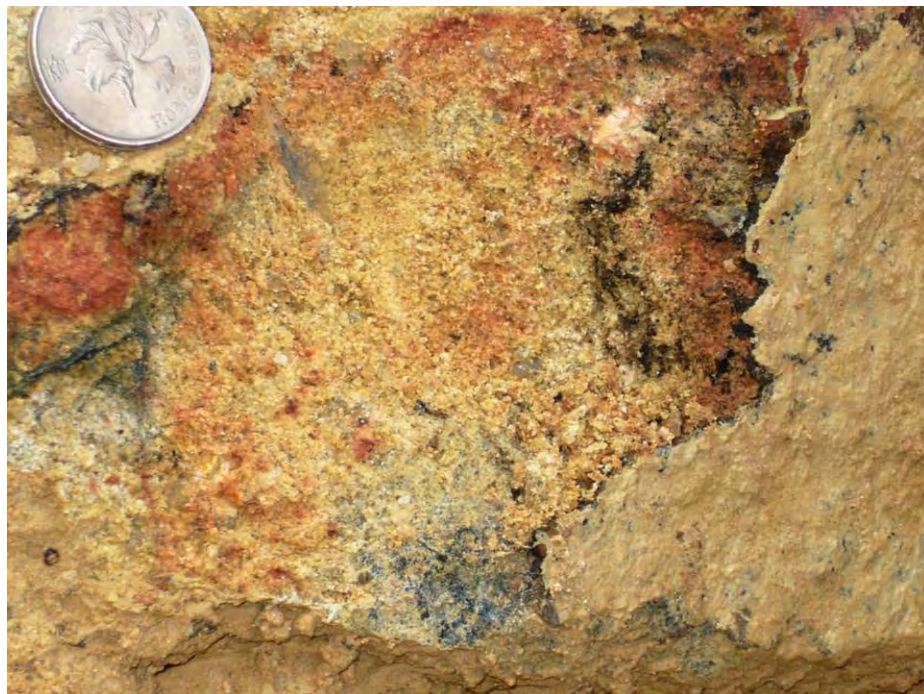
Plate 12 - Close up View of the Kaolin and Manganese Coated Joint
(Photograph taken on 30 September 2005)

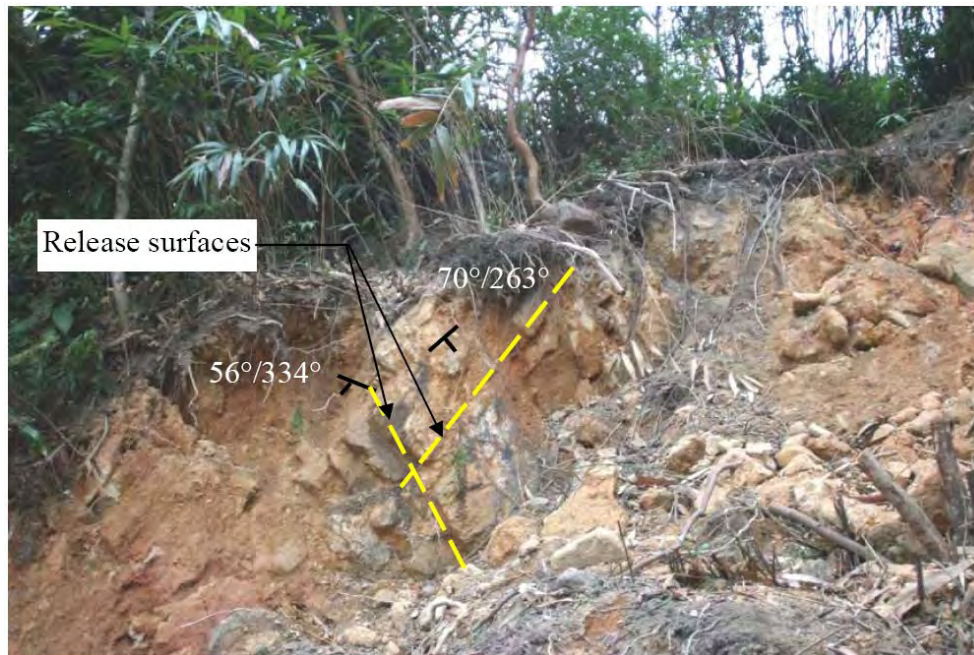
Plate 13 - Release and Unfavourable Joints on Eastern Flank of the Landslide
(Photograph taken on 2 December 2005)

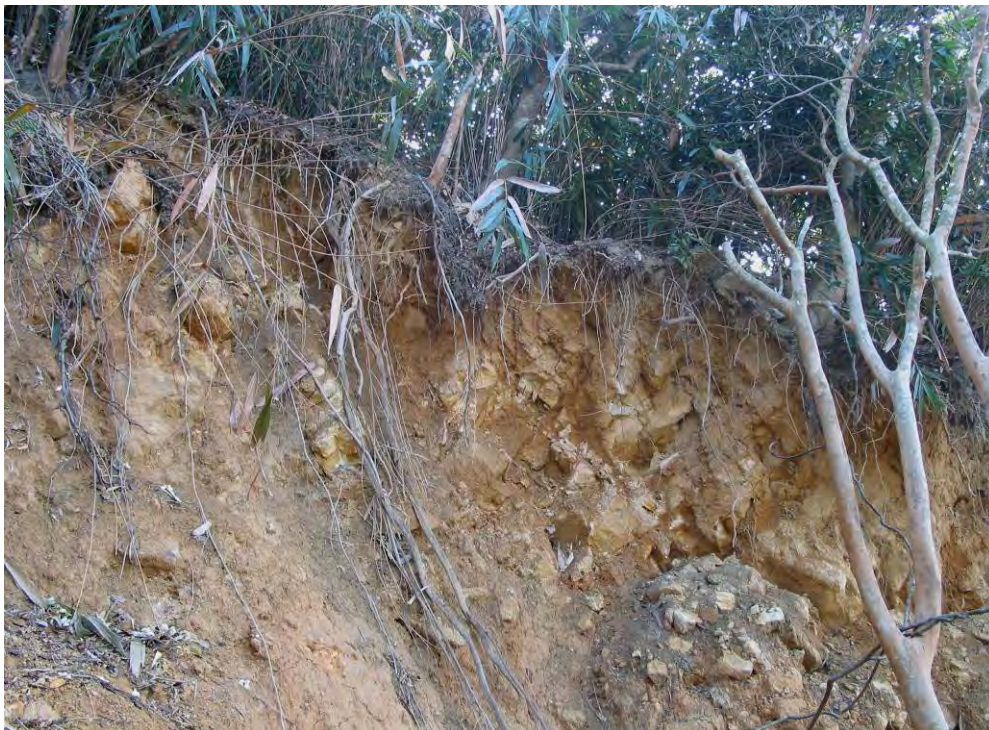
Plate 14 - Western Flank of the August 2005 Landslide
(Photograph taken on 2 December 2005)

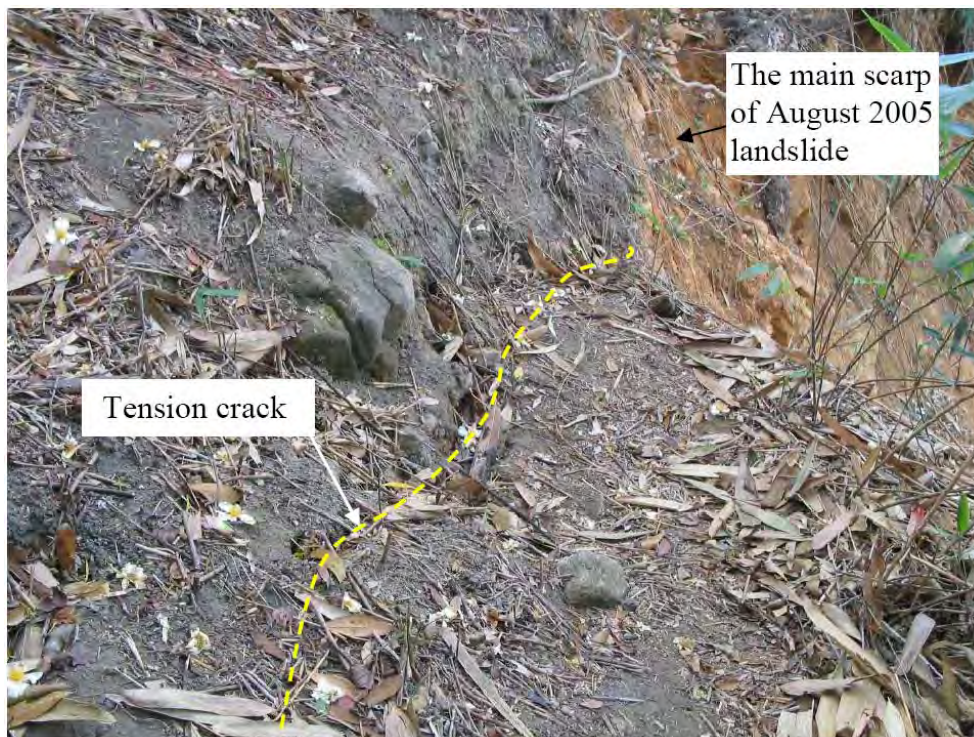
Plate 15 - Tension Crack Extending to the Main Scarp of the August 2005 Landslide from the Distressed Hillside (Photograph taken on 2 December 2005)

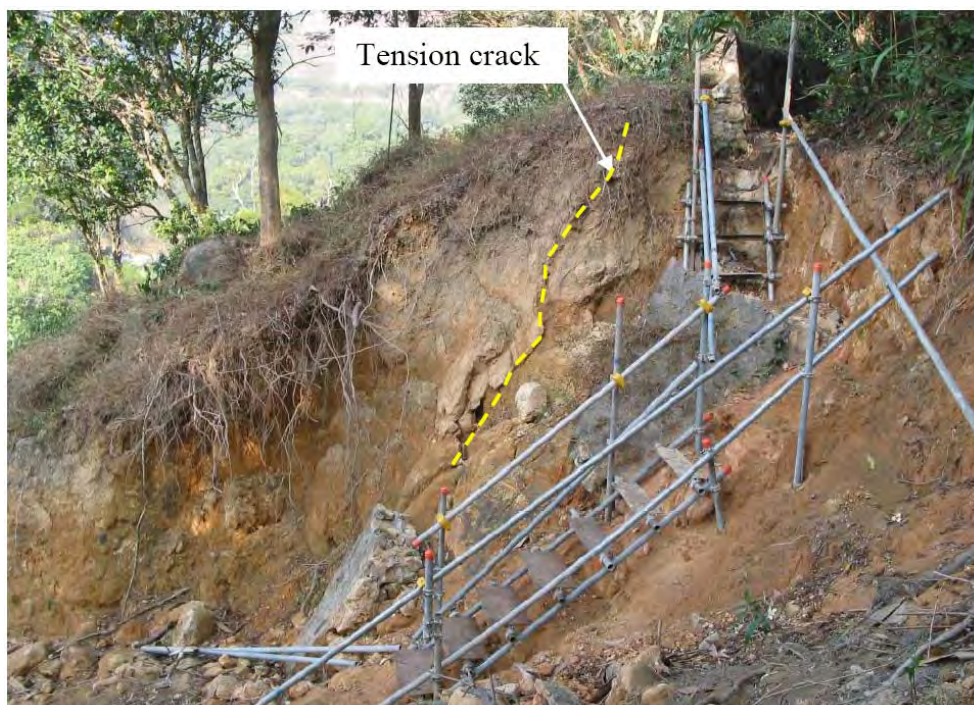
Plate 16 - Tension Crack Exposed on the Eastern Flank of the August 2005 Landslide (Photograph taken on 2 December 2005)

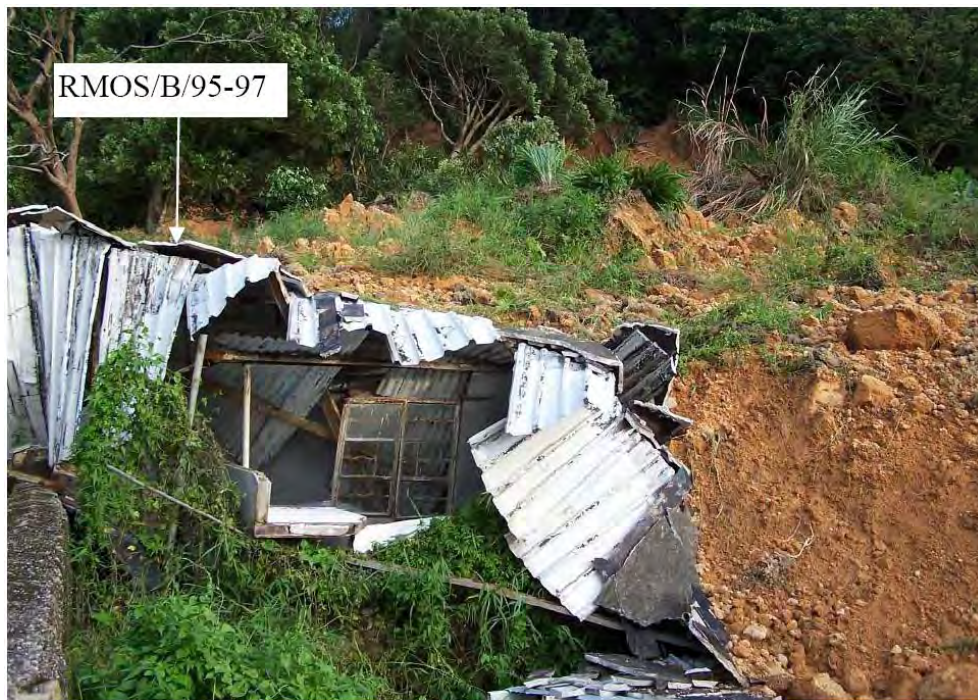
Plate 17 - Destroyed Registered Squatter Structures Nos. RMOS/B/95 97 on Eastern Margin of the Debris Lobe (Photograph taken on 23 August 2005)

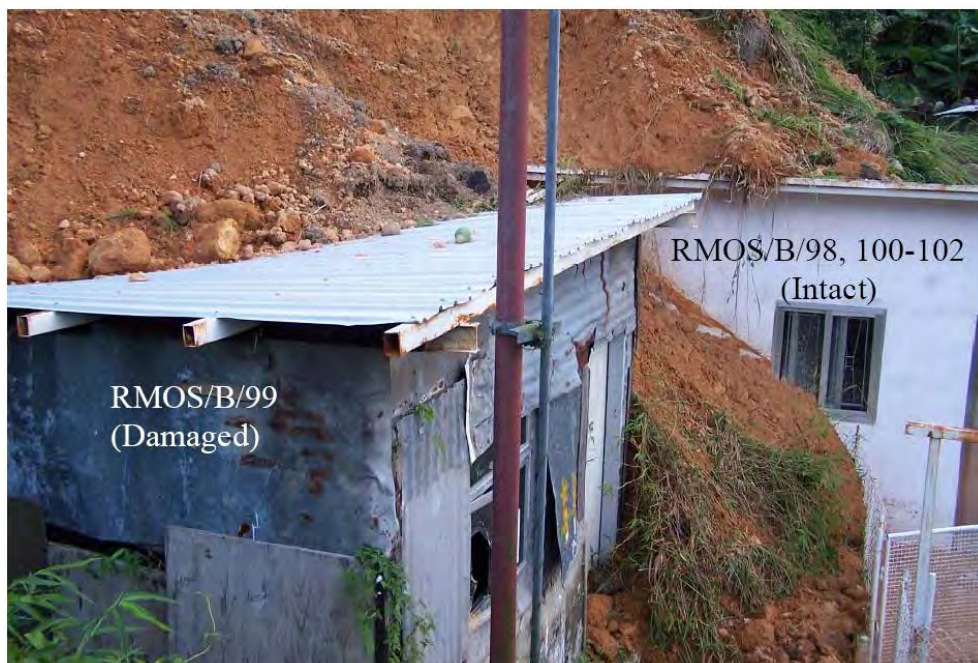
Plate 18 - Partly Buried and Damaged Registered Squatter Structures Nos. RMOS/B/98-102 at Northern Margin of the Debris Lobe (Photograph taken on 23 August 2005)

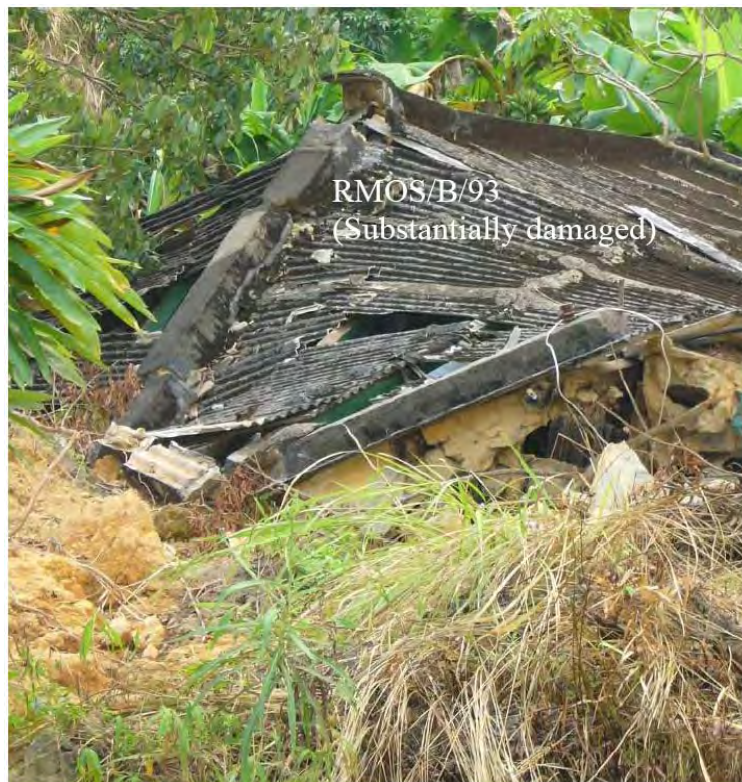
Plate 19 - Substantially Damaged Registered Squatter Structure No. RMOS/B/93 on Western Margin of the Debris Lobe (Photograph taken on 23 August 2005)

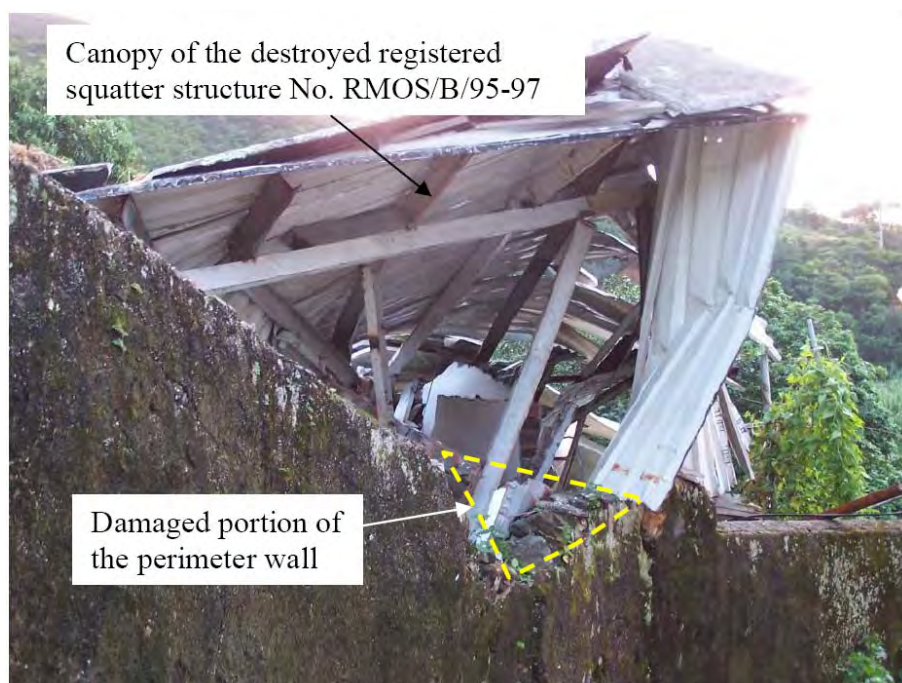
Plate 20 - Partially Damaged Perimeter Wall of the Lutheran Grace Youth Camp (Photograph taken on 23 August 2005)

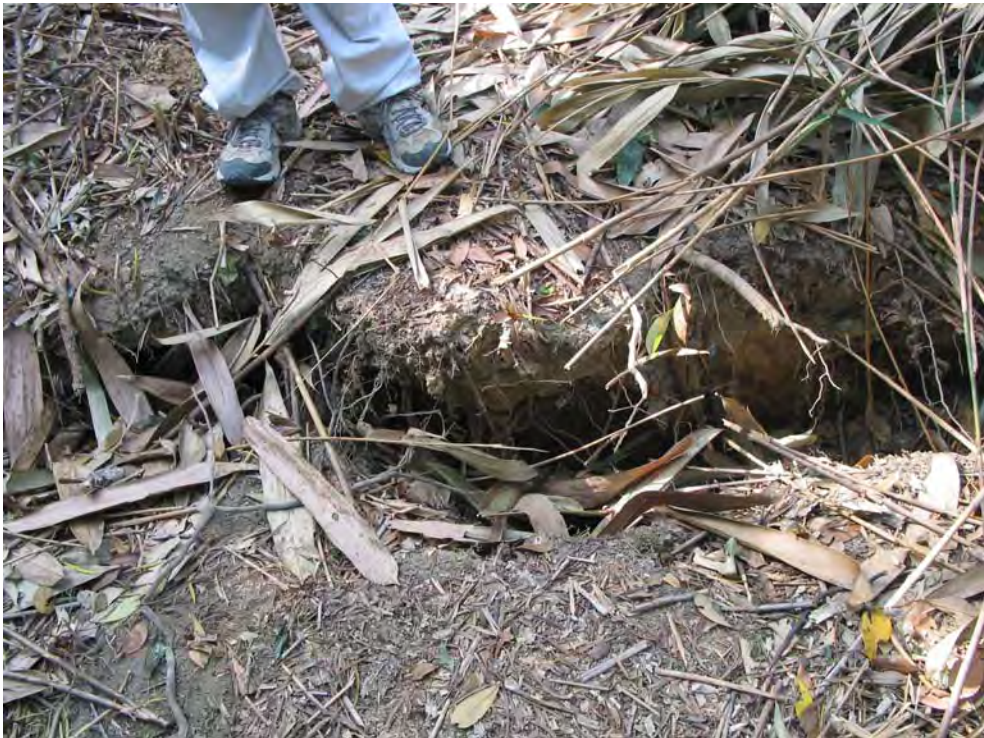
Plate 21 - Tension Crack within the Distressed Hillside
(Photograph taken on 2 December 2005)

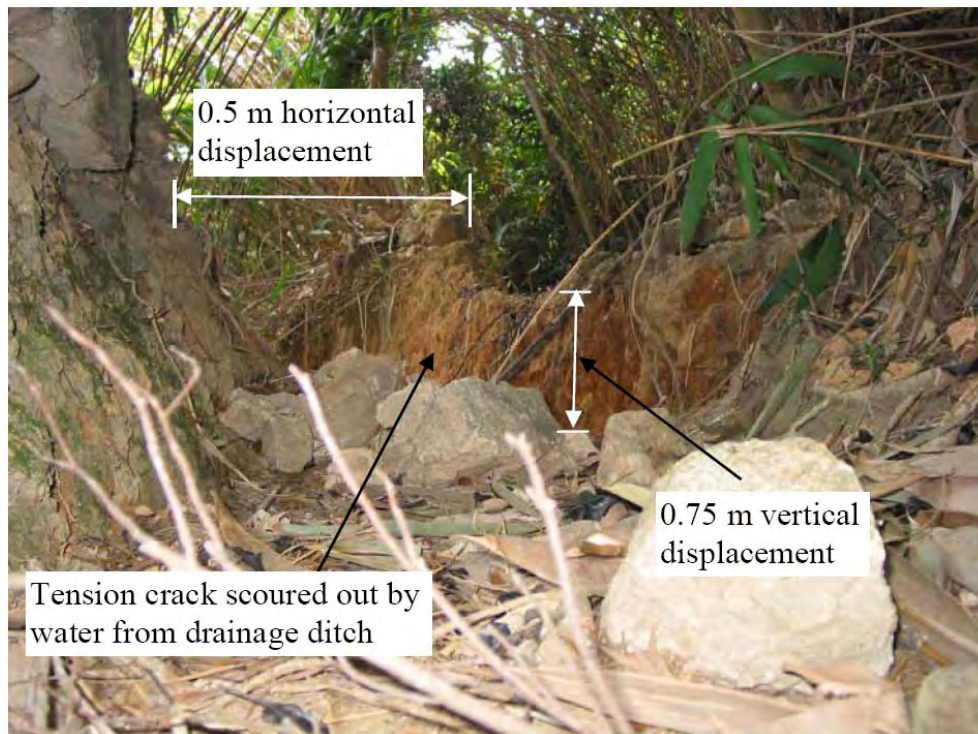
Plate 22 - Displacement of Drainage Ditch across Tension Crack
(Photograph taken on 2 December 2005)

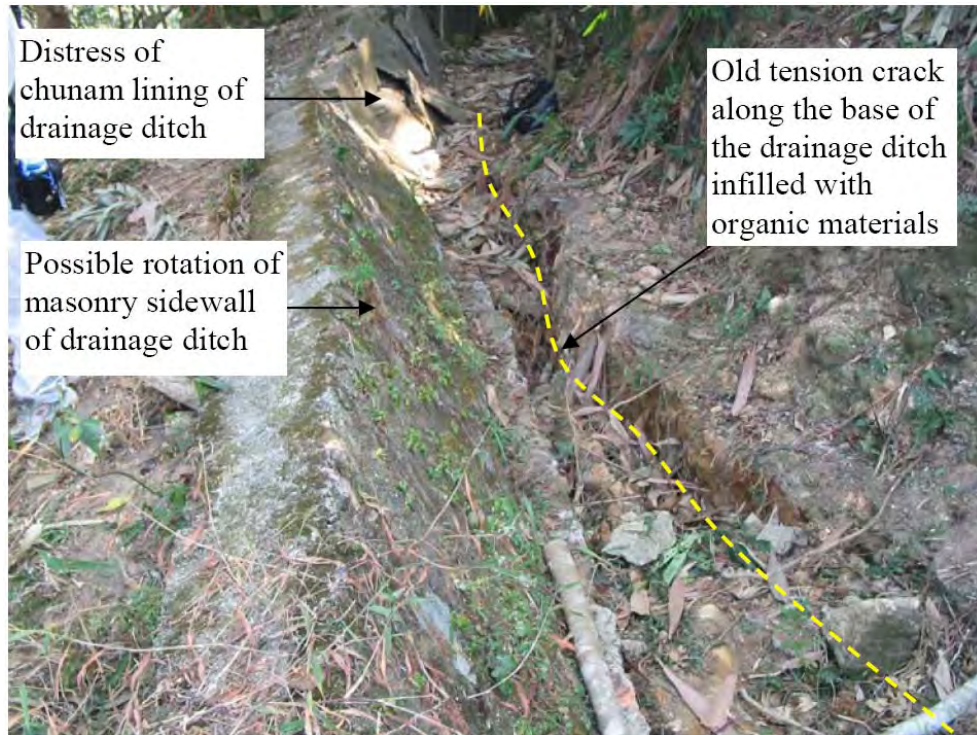
Plate 23 - Tension Crack along Base of the Drainage Ditch and Rotation/Distress of Drainage Ditch Sidewall (Photograph taken on 2 December 2005)

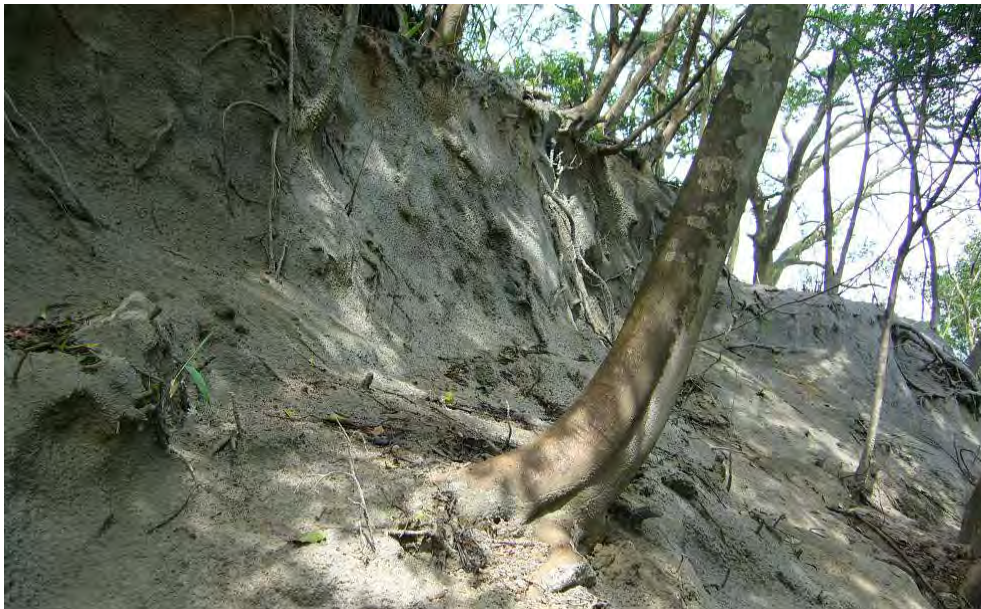
Plate 24 - Deformed Tree within the Distressed Hillside (Photograph taken on 4 June 2006)

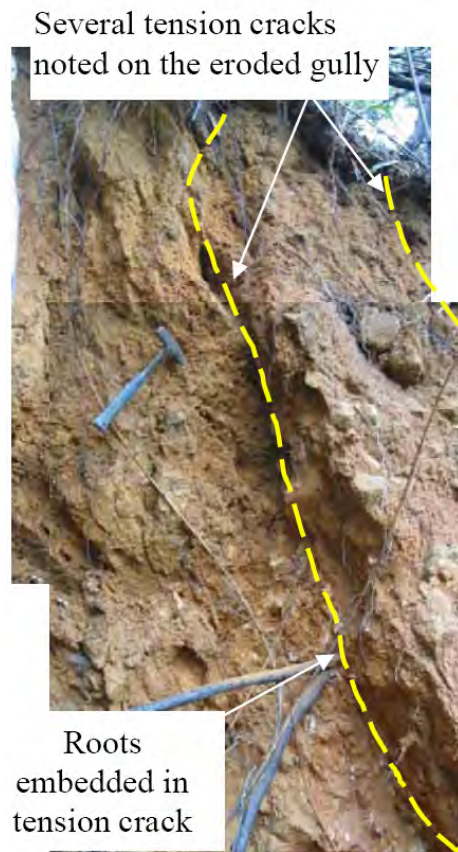
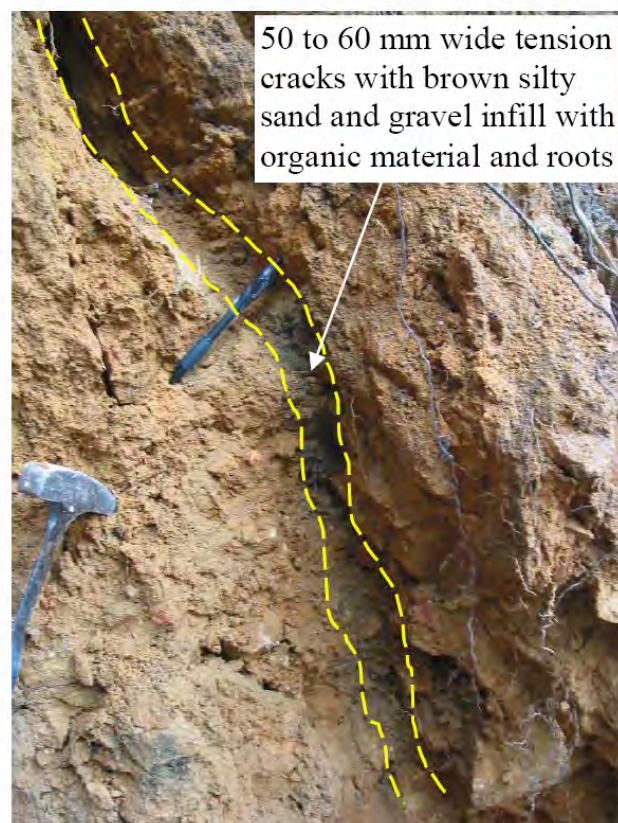
Plate 25 - Pre-existing Tension Cracks in the Washed-out Gully on the Eastern Edge of the Distressed Hillside (Photograph taken on 24 March 2006)

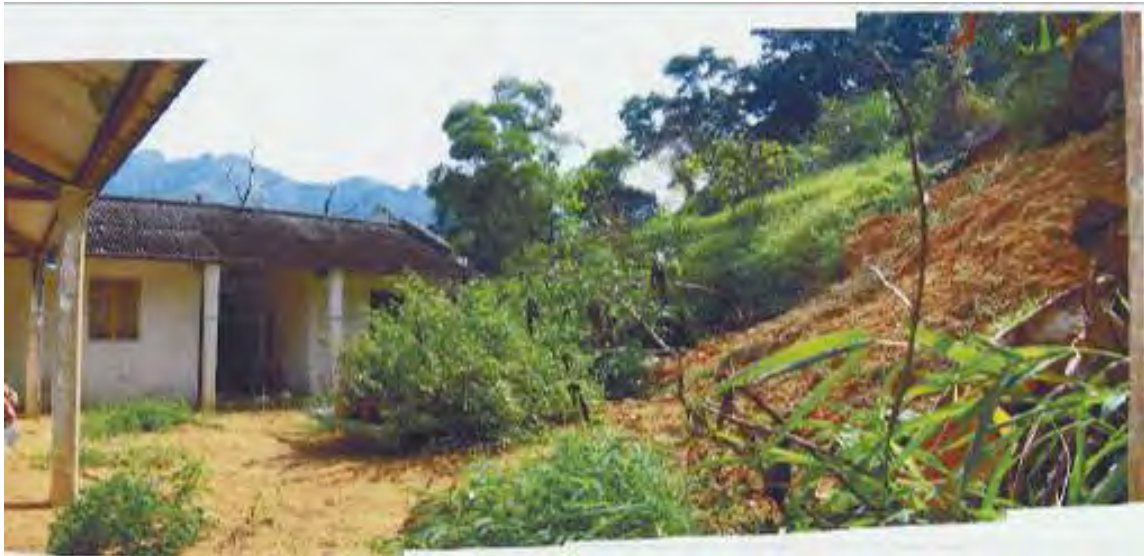
Plate 26 - View of the August/September 2005 Landslide on the Western Portion of Slope No. 7SE-B/C122 (Photograph taken by GEO on 22 September 2005)
