**REVIEW OF THE 21 AUGUST 2005
LANDSLIDE ON SLOPES
NOS. 7SE-B/C195 AND 7SE-B/C131
AND THE DISTRESSED HILLSIDE
ABOVE SLOPE NO. 7SE-B/C122 AT
MA ON SHAN UPPER VILLAGE**

GEO REPORT No. 216

Maunsell Geotechnical Services Limited

**This report was originally produced in December 2006
as GEO Landslide Study Report No. LSR 16/2006**

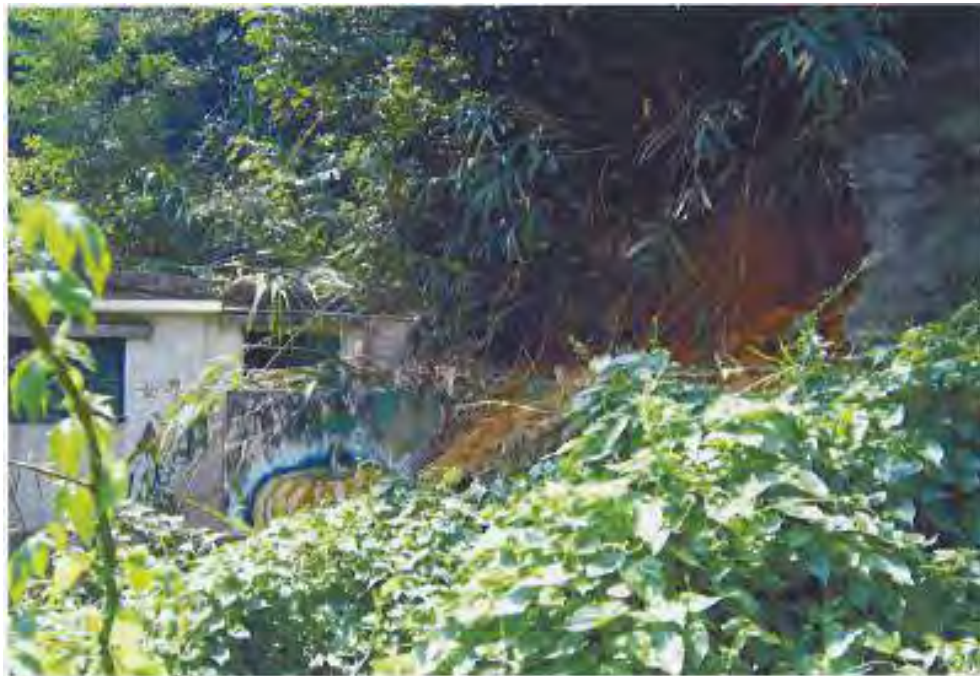
Plate 27 - View of the August/September 2005 Landslide on the Eastern Portion of Slope No. 7SE-B/C122 (Photograph taken by GEO on 22 September 2005)

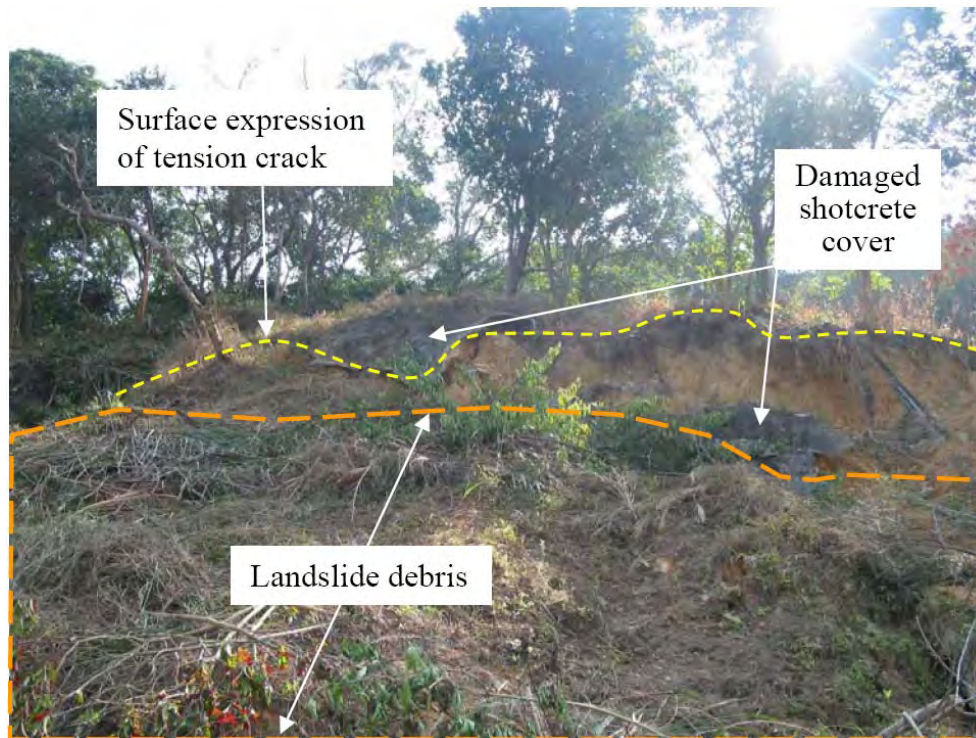
Plate 28 - Tension Cracks and Associated Landslide at the Toe of Slope No. 7SE-BC122
(Photograph taken on 2 December 2005)

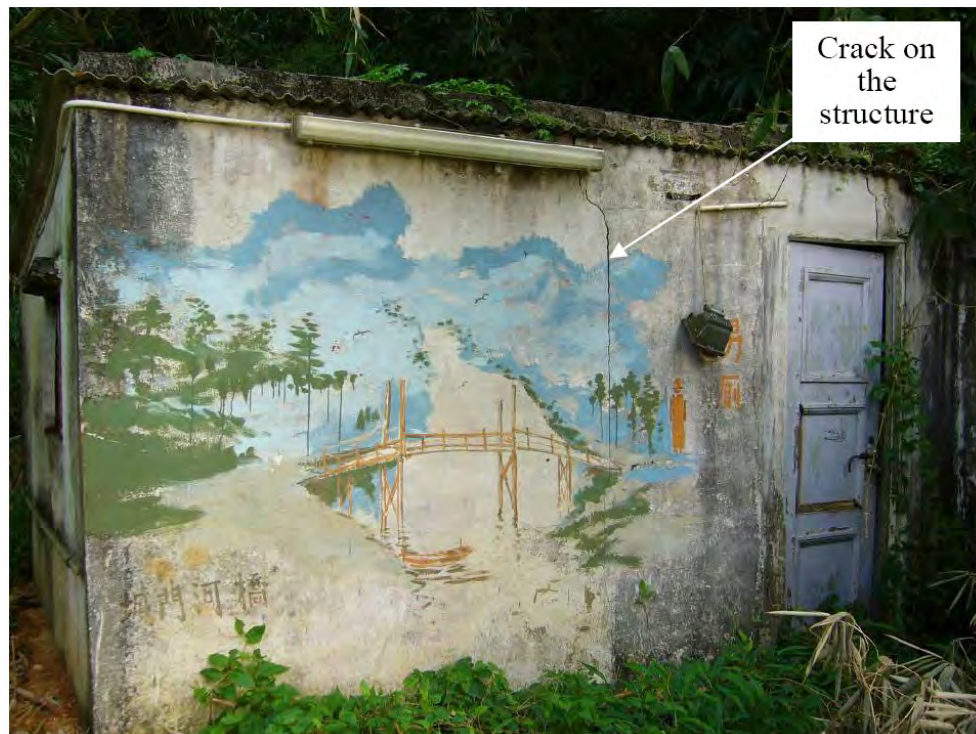
Plate 29 - Crack Observed on the Toilet/Shower Structure
(Photograph taken on 14 October 2005)

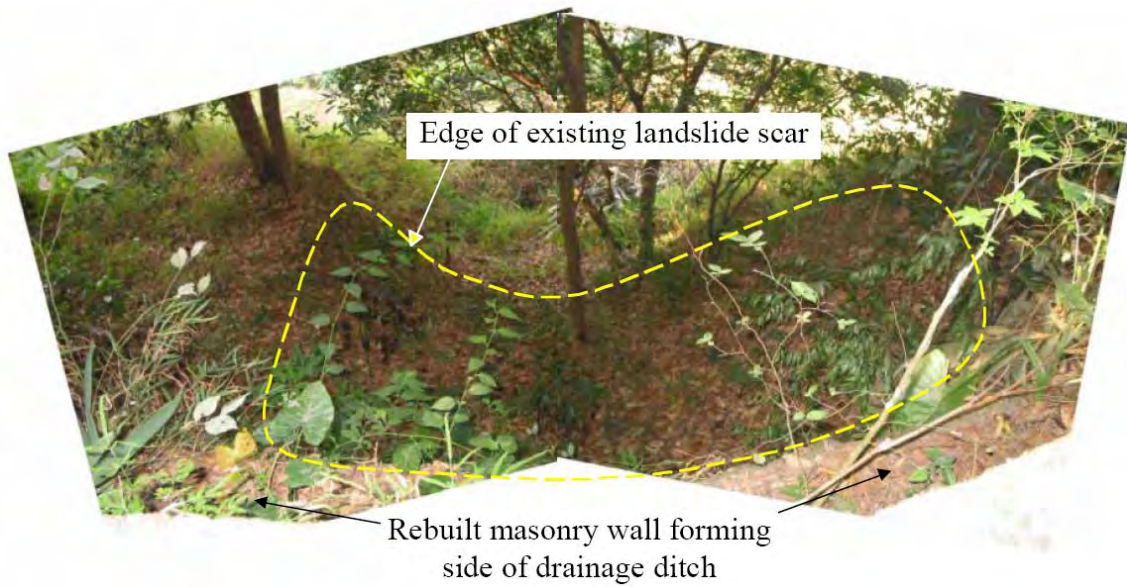
Plate 30 - Existing Landslide Scar to the West of the August 2005 Landslide
(Photograph taken on 2 December 2005)

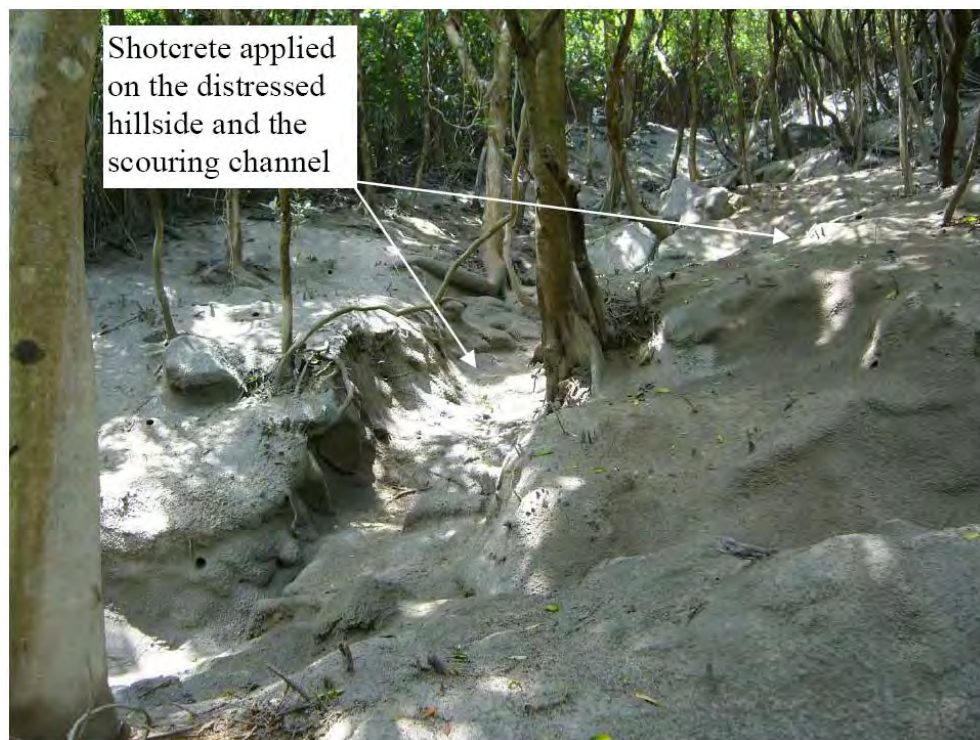
Plate 31 - Urgent Repair Works on the Upper and Eastern Portion of the Distressed Hillside
(Photograph taken on 4 June 2006)

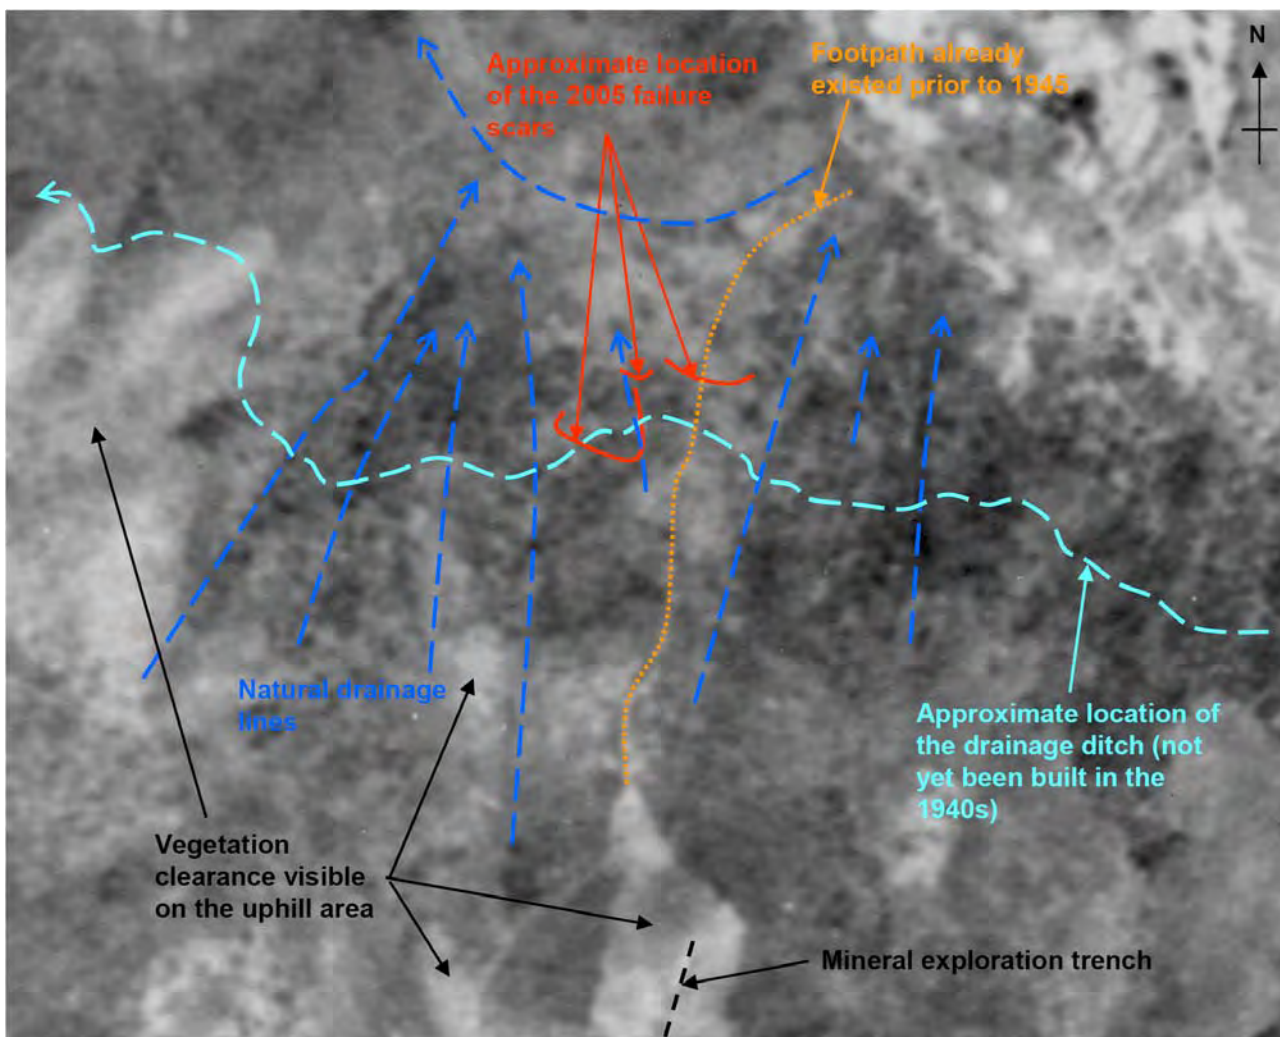
Plate A1 - Aerial Photograph Interpretation (1949 Photograph)

- The landslide site was a natural terrain prior to 1949.
- The hillside was sparsely to moderately vegetated with shrubs and small trees.
- Some vegetation clearance was evident to the south and west of the hillside.
- Major natural drainage lines are identified in the vicinity of the landslide site and they are mainly draining from south to north.
- Some possible mineral exploration trenches were noted on the hillside.
- A footpath had been built prior to 1945 along the ridgeline where one of the 2005 landslide on slope No. 7SE-B/C122 occurred.
- The 2005 failure scar is located on a minor ridgeline.

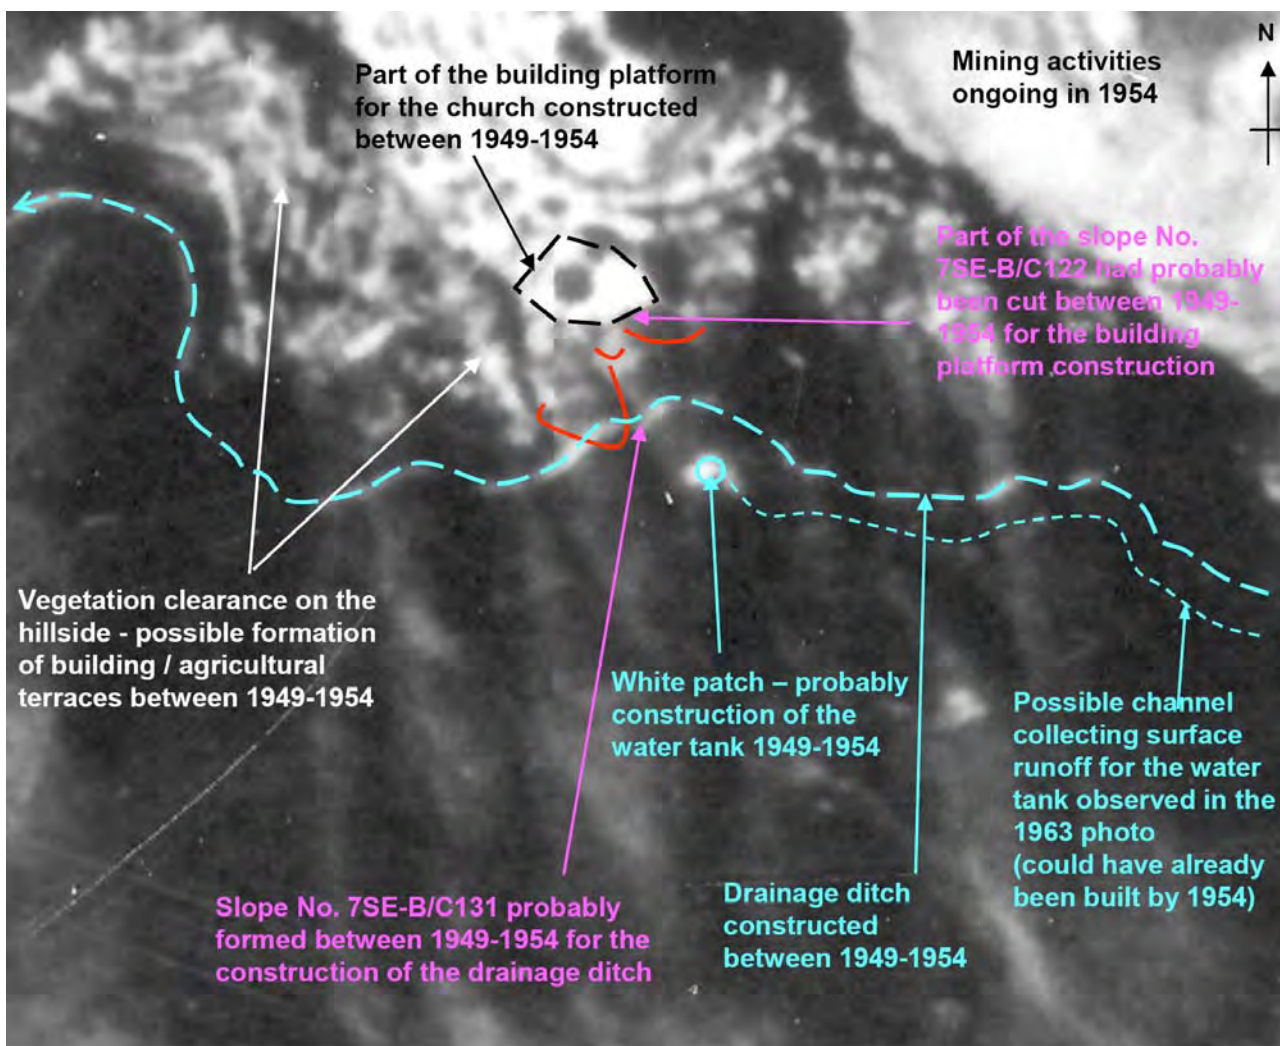
Plate A2 - Aerial Photograph Interpretation (1954 Photograph)

- Photos are blurred and details of the landslide site were not clearly visible.
- The drainage ditch had been built at some time between 1949 and 1954. Slope No. 7SE-B/C131 probably formed in association with the construction of the drainage ditch.

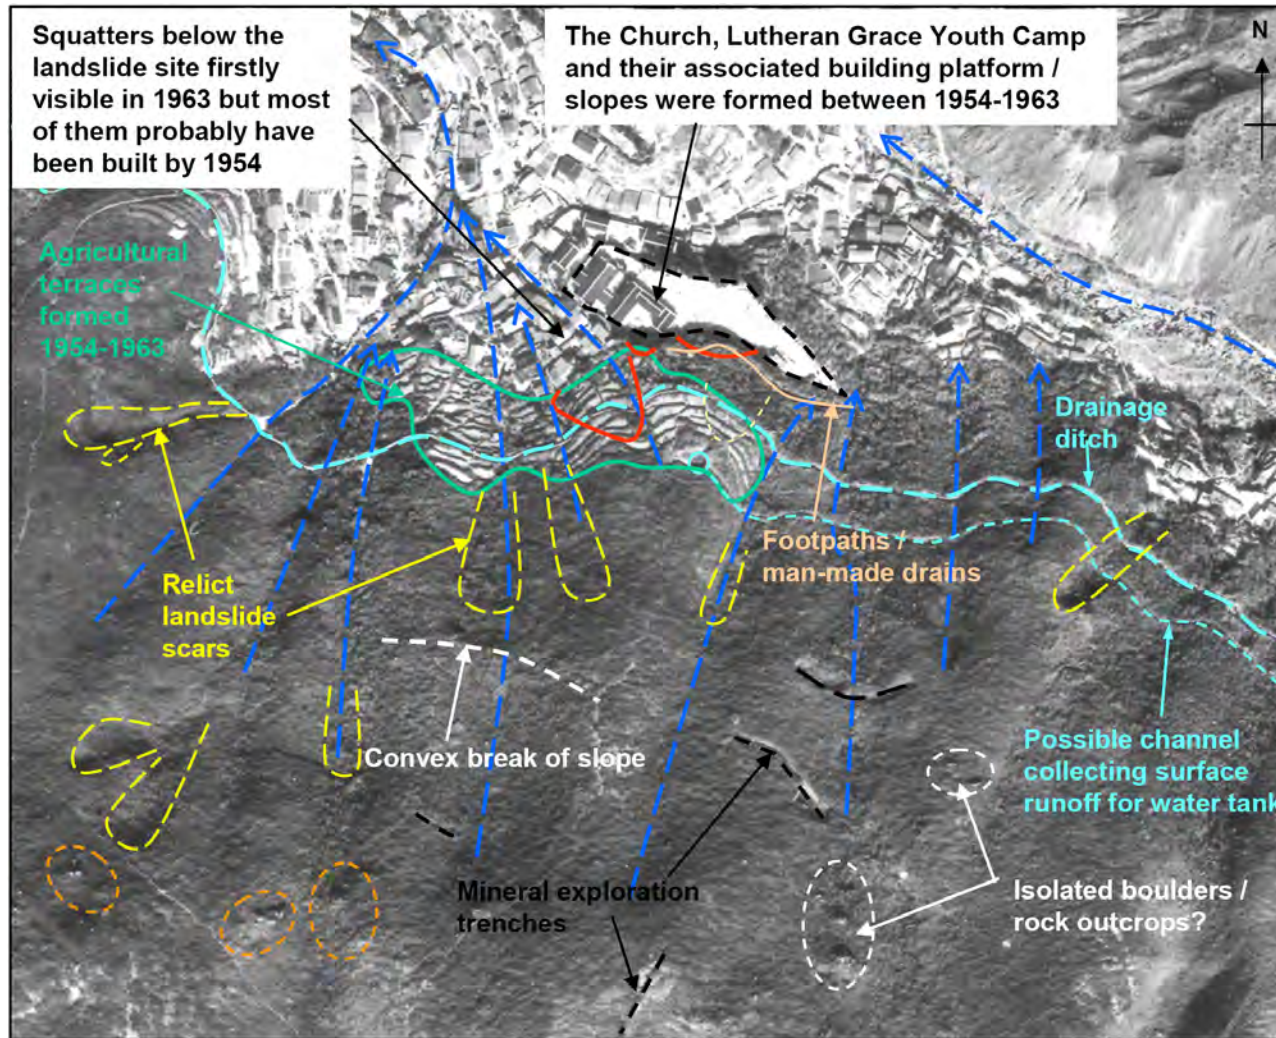
Plate A3 - Aerial Photograph Interpretation (1963 Photograph)

- The Ma On Shan Upper Village has reached its full development.
- All the squatter dwellings below the 2005 landslide site appeared to have been constructed by 1963.

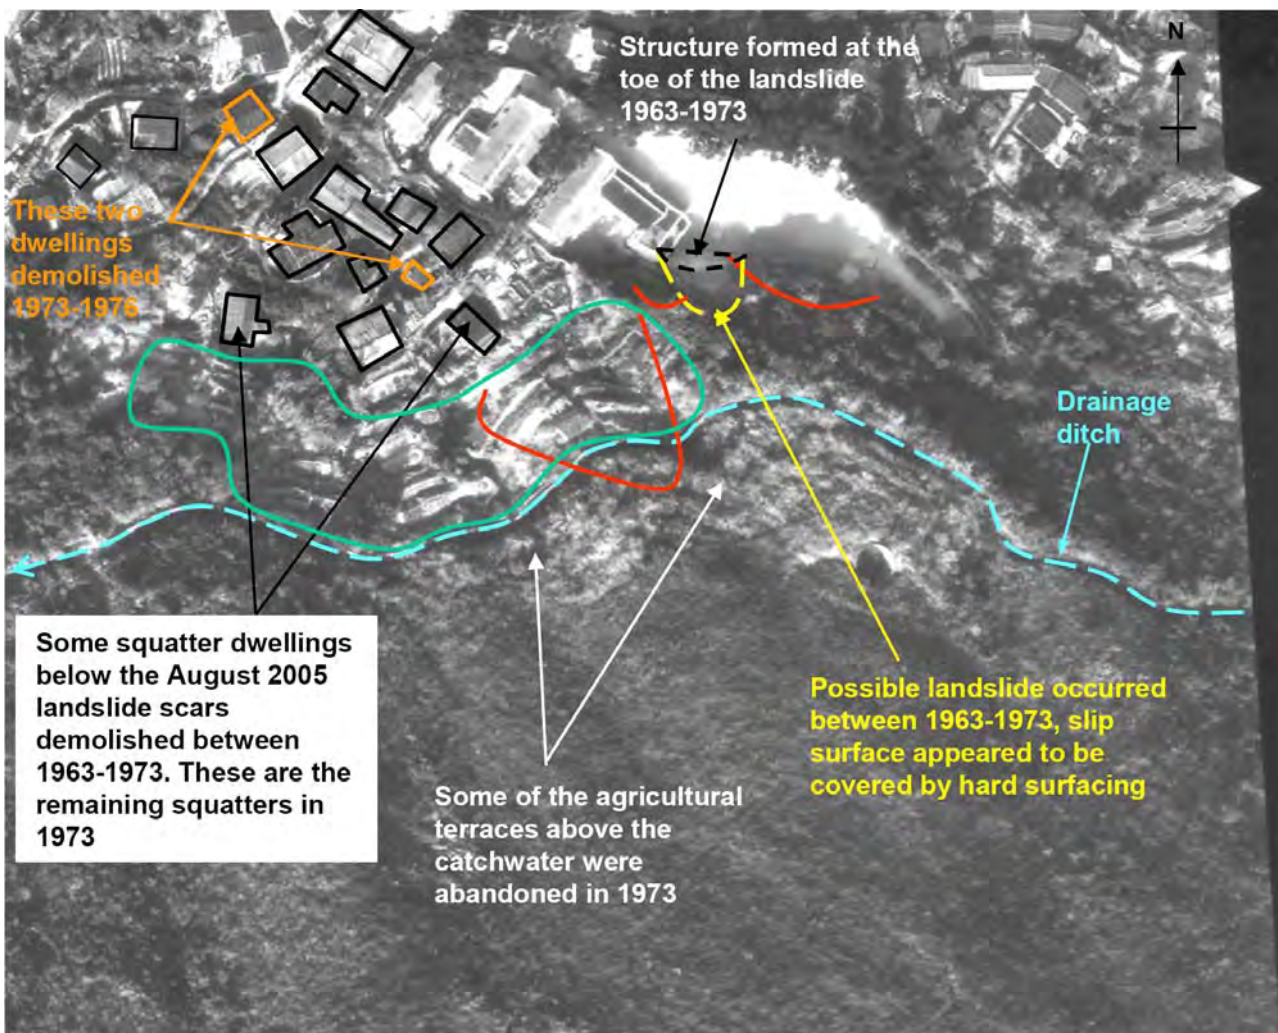
Plate A4 - Aerial Photograph Interpretation (1973 Photograph)

- Some squatter dwellings below the 2005 landslide scars were demolished between 1963 and 1973 and the remaining squatter structures in 1973 were highlighted in the scanned image.
- Two more dwellings below the 2005 main landslide scar were demolished between 1973 and 1976.
- Most of the agricultural terraces above the drainage ditch were found to be abandoned in 1973.
- Some vegetation clearance was noted to the south and above the August 2005 landslide site in the 1976 photos.
- A significant depression, possibly a landslide scar, was noted at the western portion of slope No. 7SE-B/C122. The landslide was estimated to be 8 m wide by 8 m long with 1 m to 2 m deep. The slip surface appeared to have been covered by some hard surfacing.
- A structure of about 1 m high had been formed along the toe of this landslide scar.

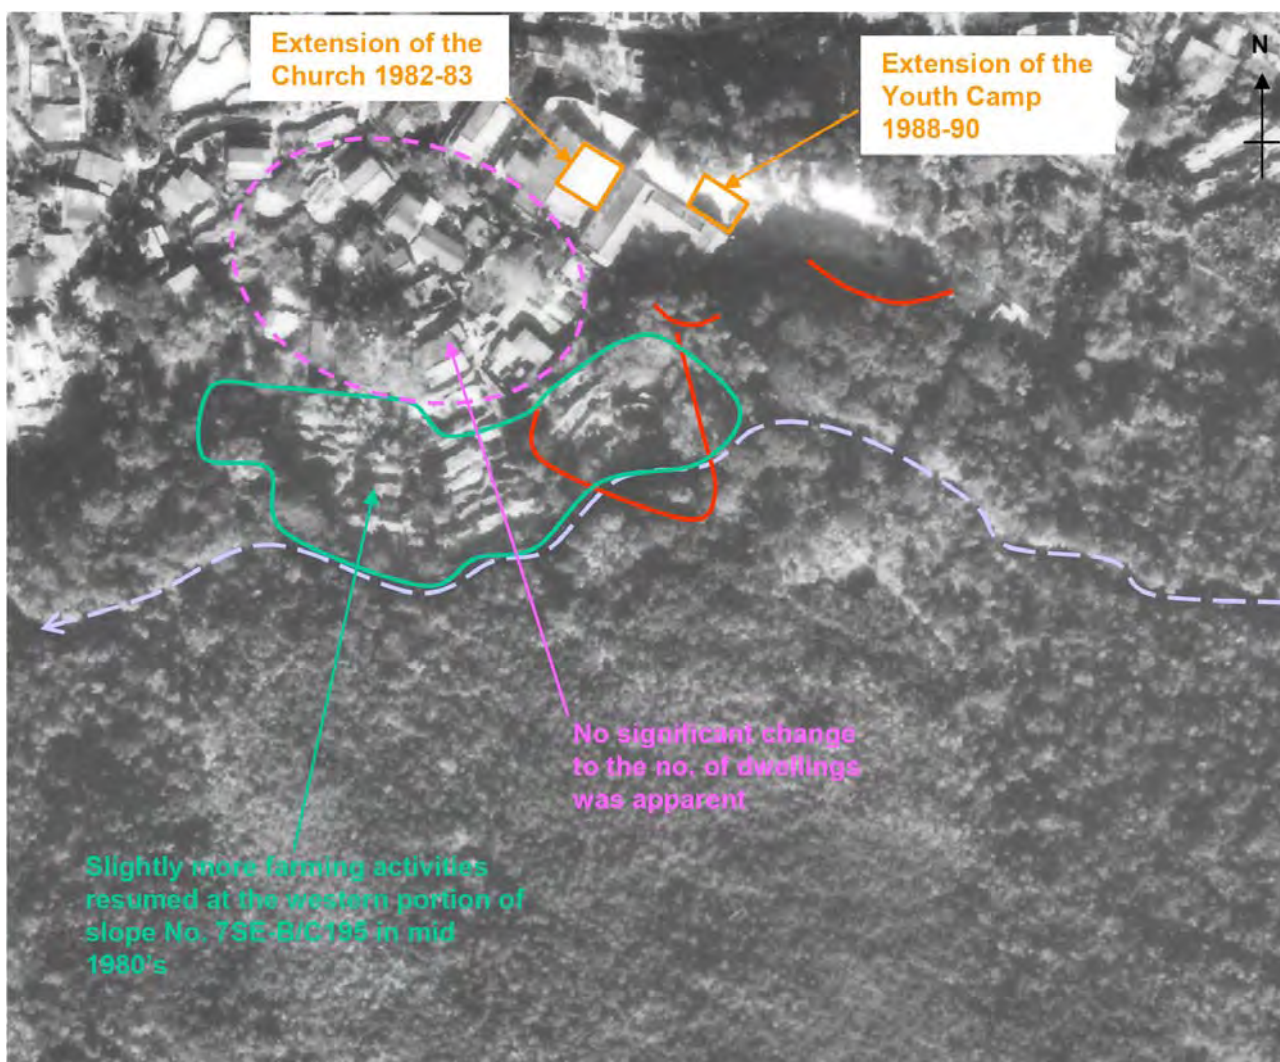
Plate A6 - Aerial Photograph Interpretation (1985 Photograph)

- Slightly more farming activities could be visible at the western portion of slope No. 7SE-B/C195 in mid 1980's.
- An extension of the church below the 2005 landslide was built at some time between 1982 and 1983 and another one to the Youth Camp was built between 1988 and 1990.
- No significant change to the number of dwellings immediately below the landslide site was apparent.

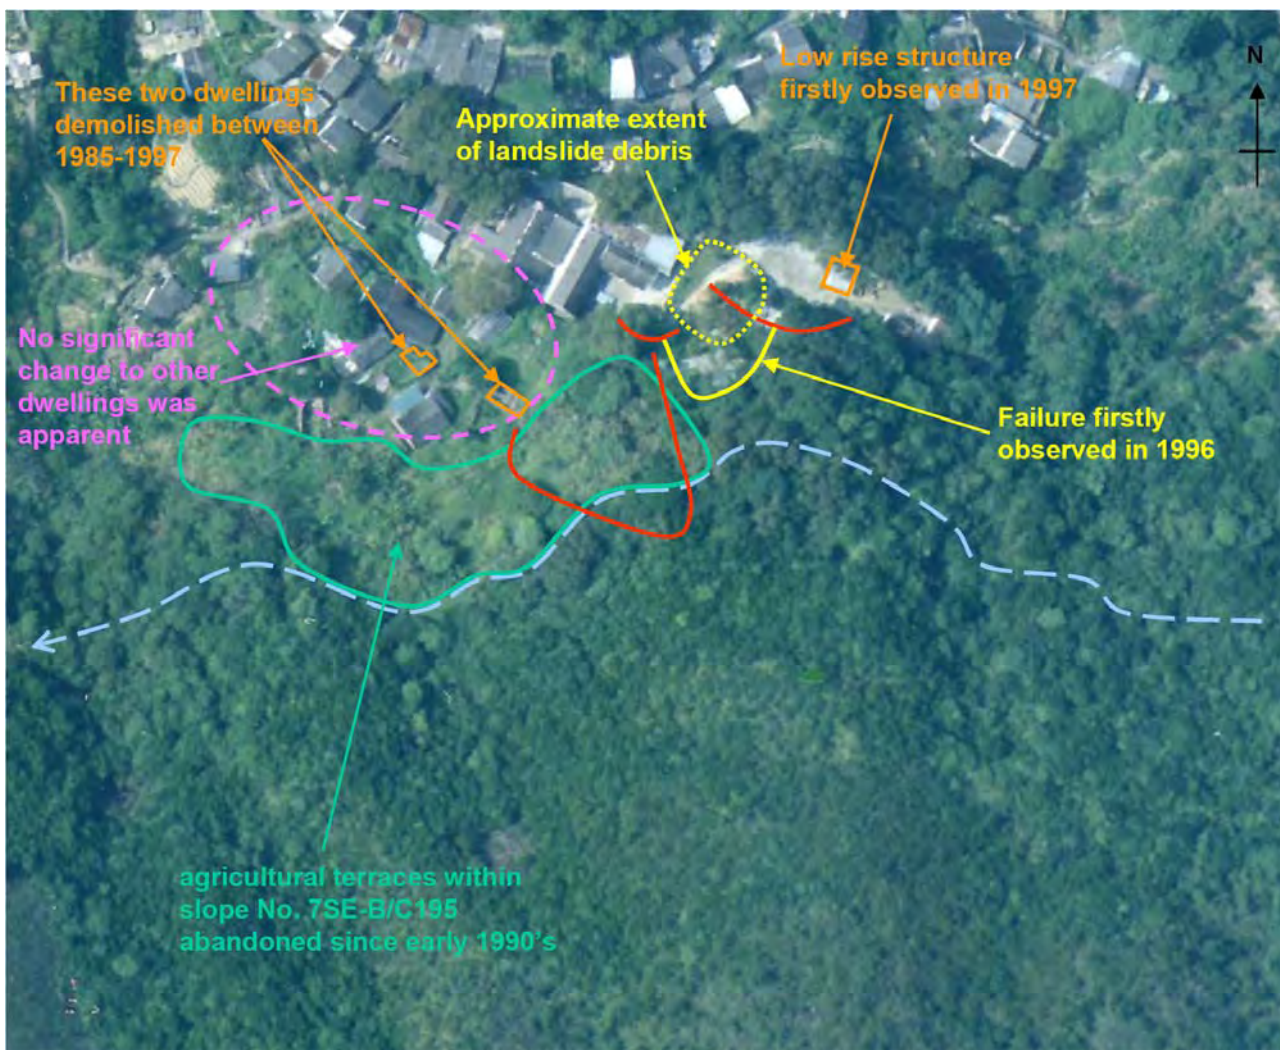
- First date of good quality and low altitude aerial photo available after 1985.
- Photos available from 1988 - 1996 are blurred or covered by haze or taken at high altitude.
- A landslide was observed at slope No. 7SE-B/C122 and the landslide was firstly observed in the 1996 photos. It is believed that this landslide is associated with the 1995 landslide incident ME1995/7/2.
- Some surface protection appeared to have been applied on the landslide scar and vegetation started to grow on top of the landslide debris.
- A new low rise structure has been constructed to the east of the Church below one of the 2005 landslide scars.
- No significant change to the number of dwellings immediately below the 2005 landslide site was apparent.
- The agricultural terraces within slope No. 7SE-B/C195 were abandoned since early 1990's.
- No significant change to the study area was noted since 1997.
