**DETAILED STUDY OF THE
20 AUGUST 2005 LANDSLIDE
ON SLOPES NOS. 11SE-A/C285,
11SE-C/DT1 AND 11SE-C/DT6
ABOVE TAI HANG DRIVE
HAPPY VALLEY**

GEO REPORT No. 217

**GEOTECHNICAL ENGINEERING OFFICE
CIVIL ENGINEERING AND DEVELOPMENT DEPARTMENT
THE GOVERNMENT OF THE HONG KONG
SPECIAL ADMINISTRATIVE REGION**

**This report was originally produced in March 2007
as GEO Landslide Study Report No. LSR 2/2007**

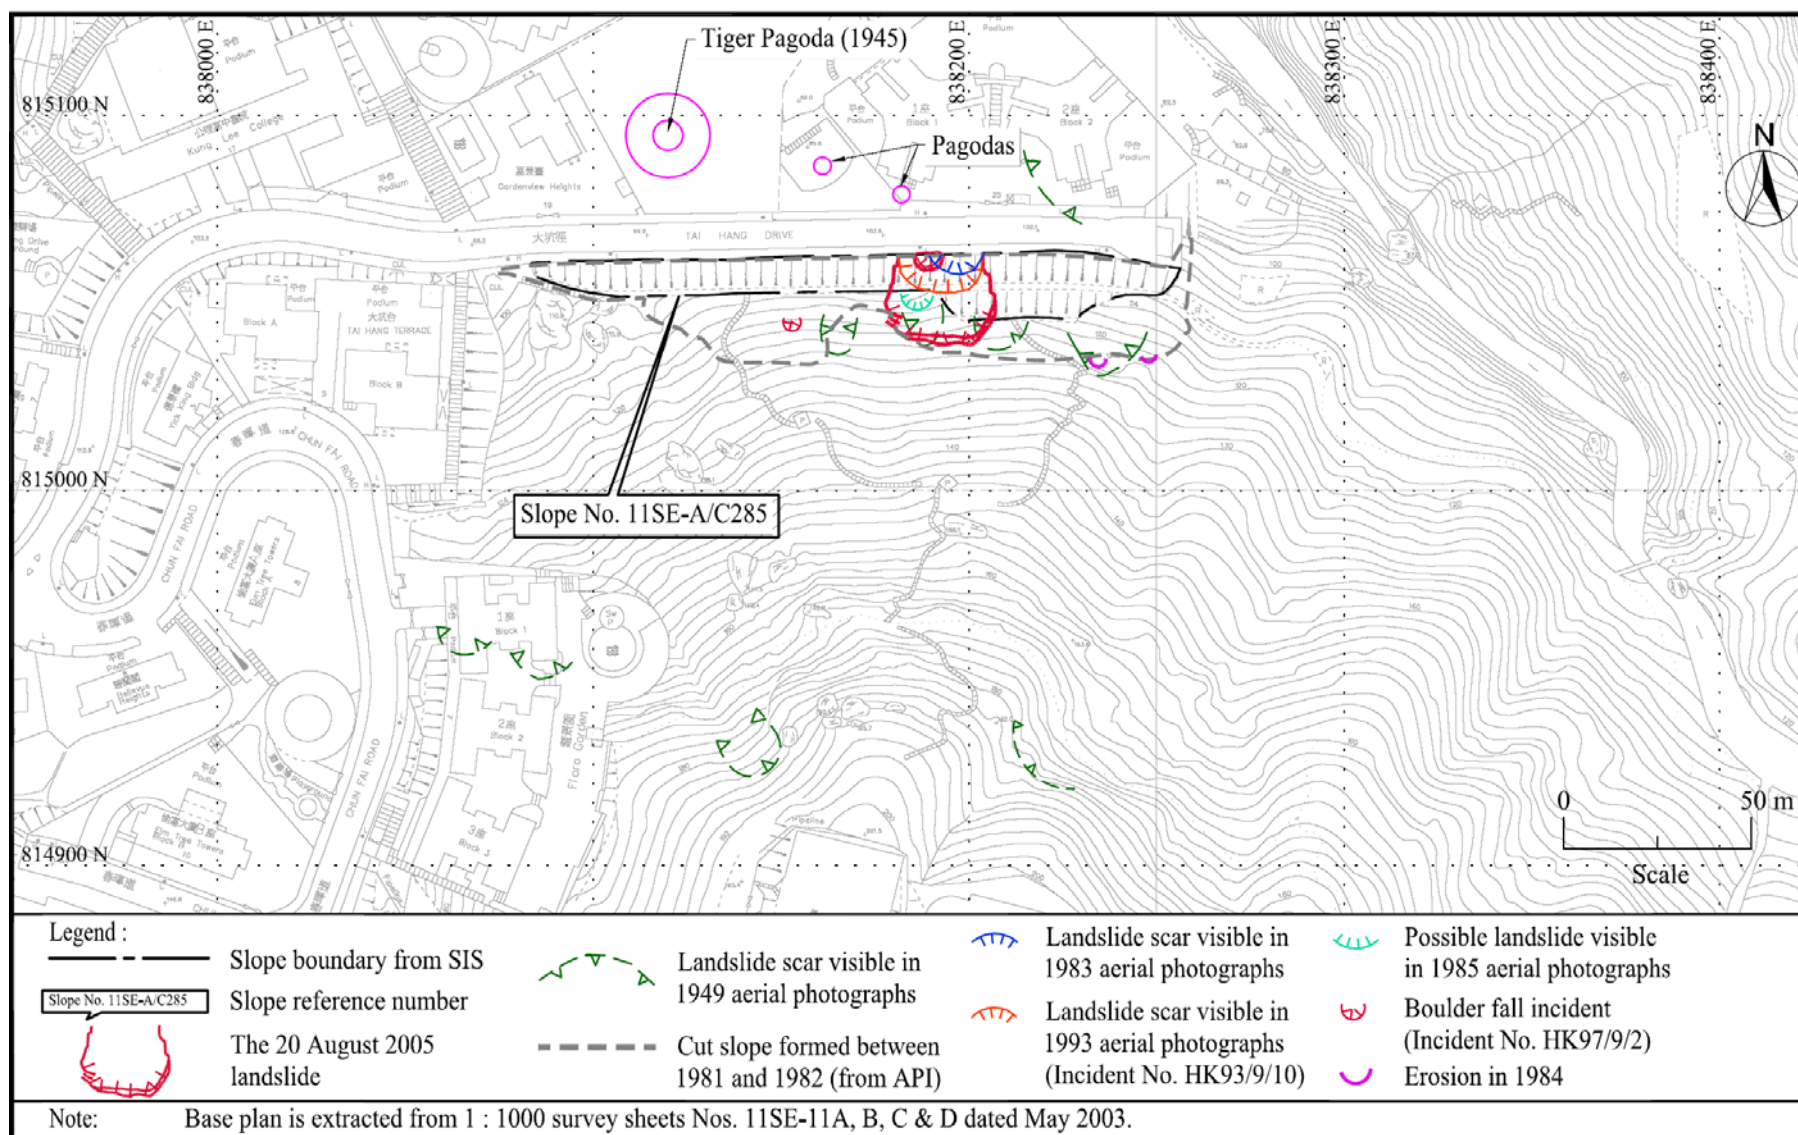
Figure 9 - Past Instability

In the 1949 aerial photographs, a few relict landslide scars at the site and the hillside above are observed (Figure 9). The approximate dimensions of the scars are up to 15 m long by 15 m wide.

Two light tones, being signs of possible erosion, located near the crest at the eastern side of slope No. 11SE-A/C285 are visible in the 1984 aerial photographs (Figure 9). A small landslide is noted above the central portion of slope No. 11SE-A/C285 opposite Ronsdale Garden in the 1985 aerial photographs (Figure 9).

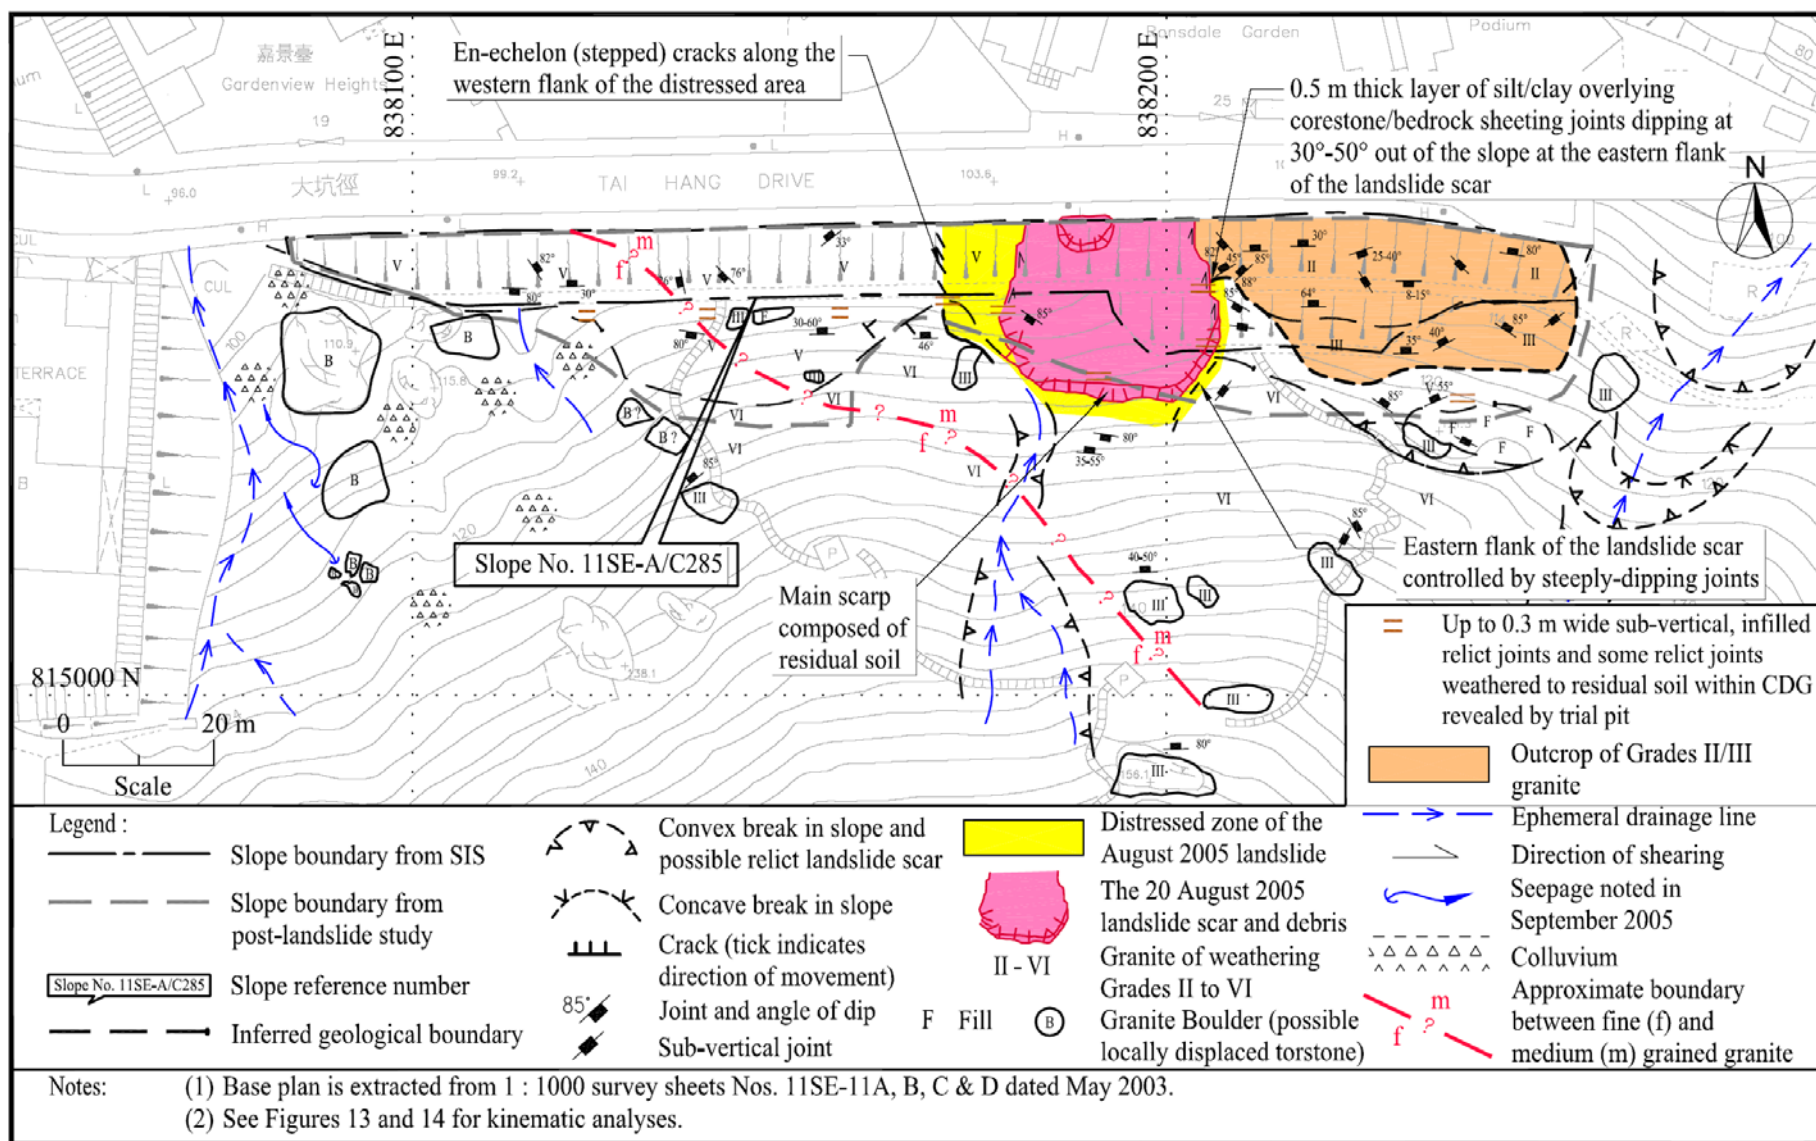
Figure 12 - Geological Mapping of the Landslide Site

The western flank of the landslide scar showed some surficial deformation with stepped (en-echelon) cracks within the slope-forming material and signs of bulging between the cracks (Figure 12 and Plate 27). At the eastern flank of the landslide scar, the interface between soil and rock was exposed at the lower slope batter (Figure 12 and Plate 28).

A distressed zone was identified on the western flank of the landslide scar, which comprised a soil cut slope with a severely cracked stepped channel on the lower batter, and an area of tension cracking and minor slope displacement adjacent to the baffle wall at the southwestern part of the landslide scar (Figure 12 and Plate 29). A similar distressed zone was also identified behind the southeastern part of the landslide scar (Figure 12 and Plate 30).

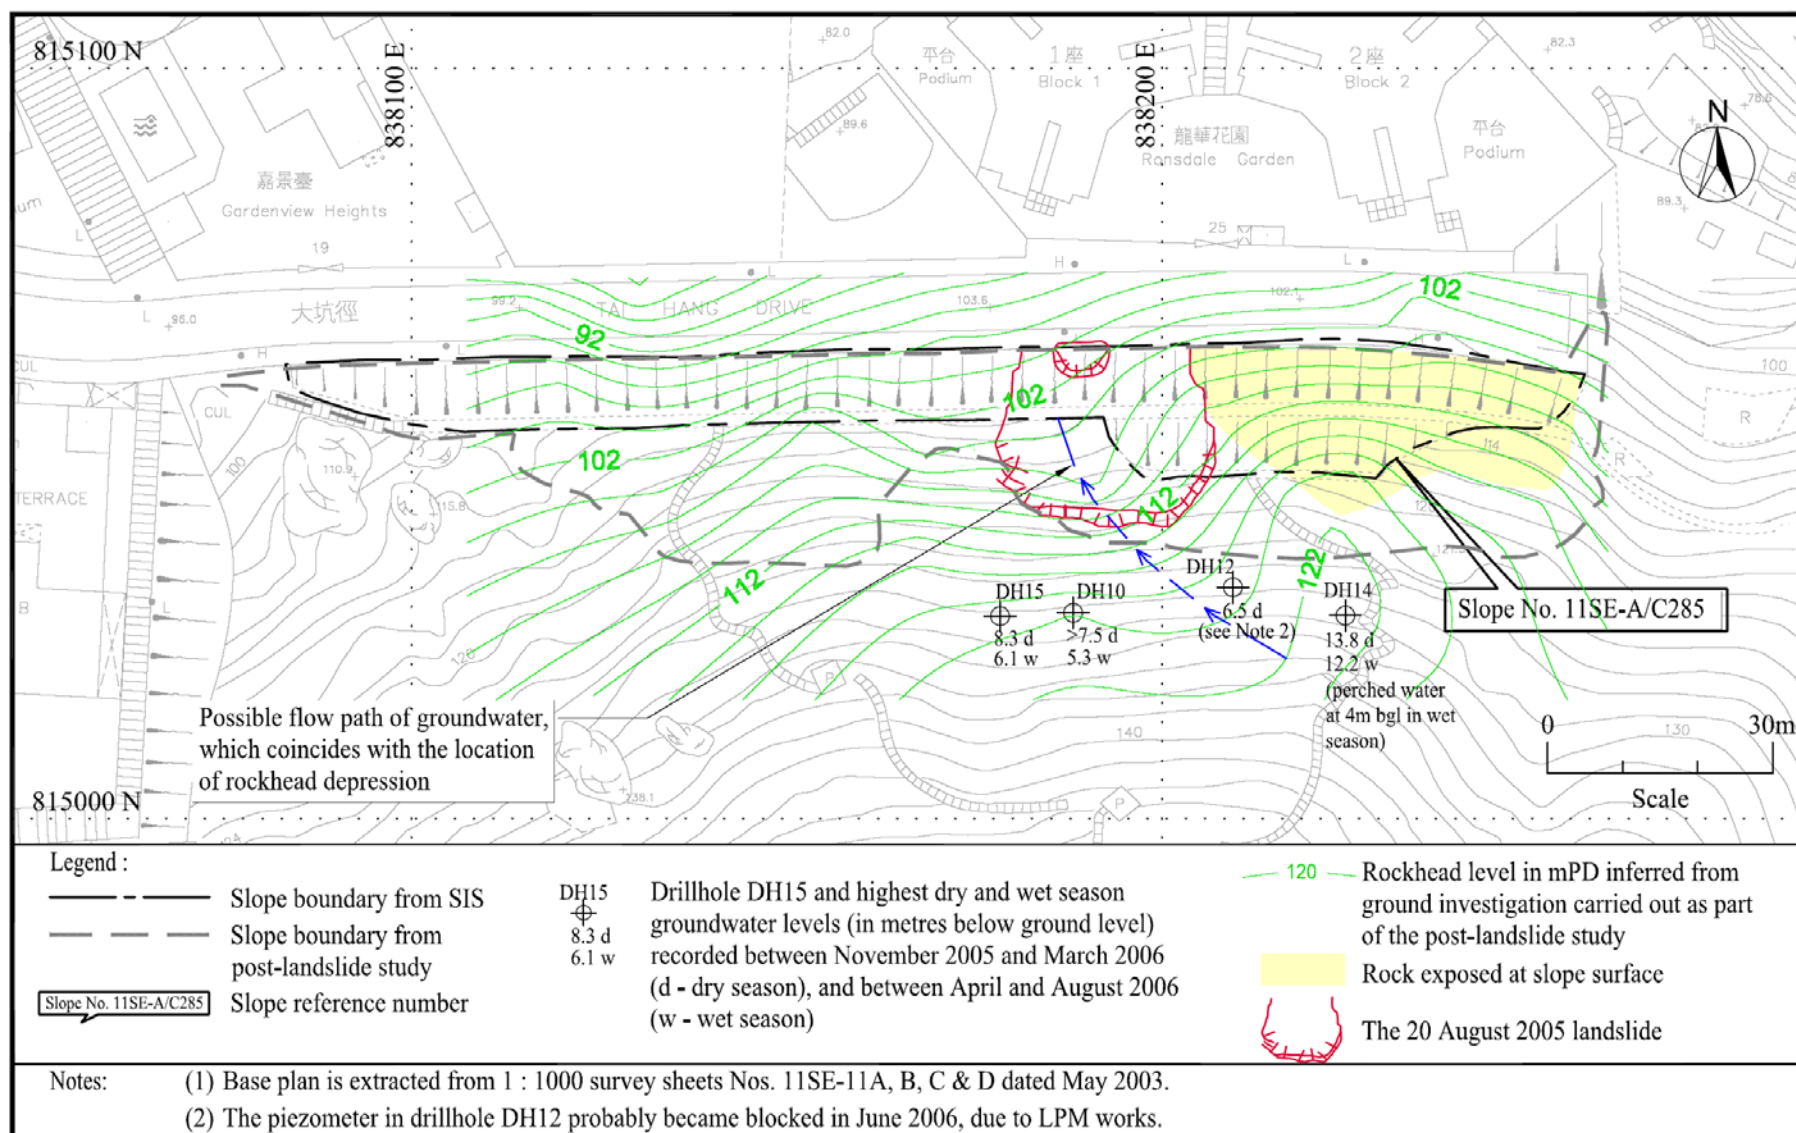
Figure 16 - Inferred Rockhead Contours

As depicted by the inferred rockhead contour plan (Figure 16), which was derived from the previous and post-failure ground investigations, and as seen from the rockhead profile exposure during the LPM works, there appears to be a rockhead depression, with a NW-SE trending axis located within and above the 20 August 2005 landslide site, which may direct sub-surface seepage towards the landslide site. The axis of the inferred rockhead depression runs approximately parallel to the strike of the steeply dipping joint set ($85^\circ/210^\circ$) and the NW-SE trending fault, which is located at about 70 m to the northeast of the landslide site (see Section 2.3).

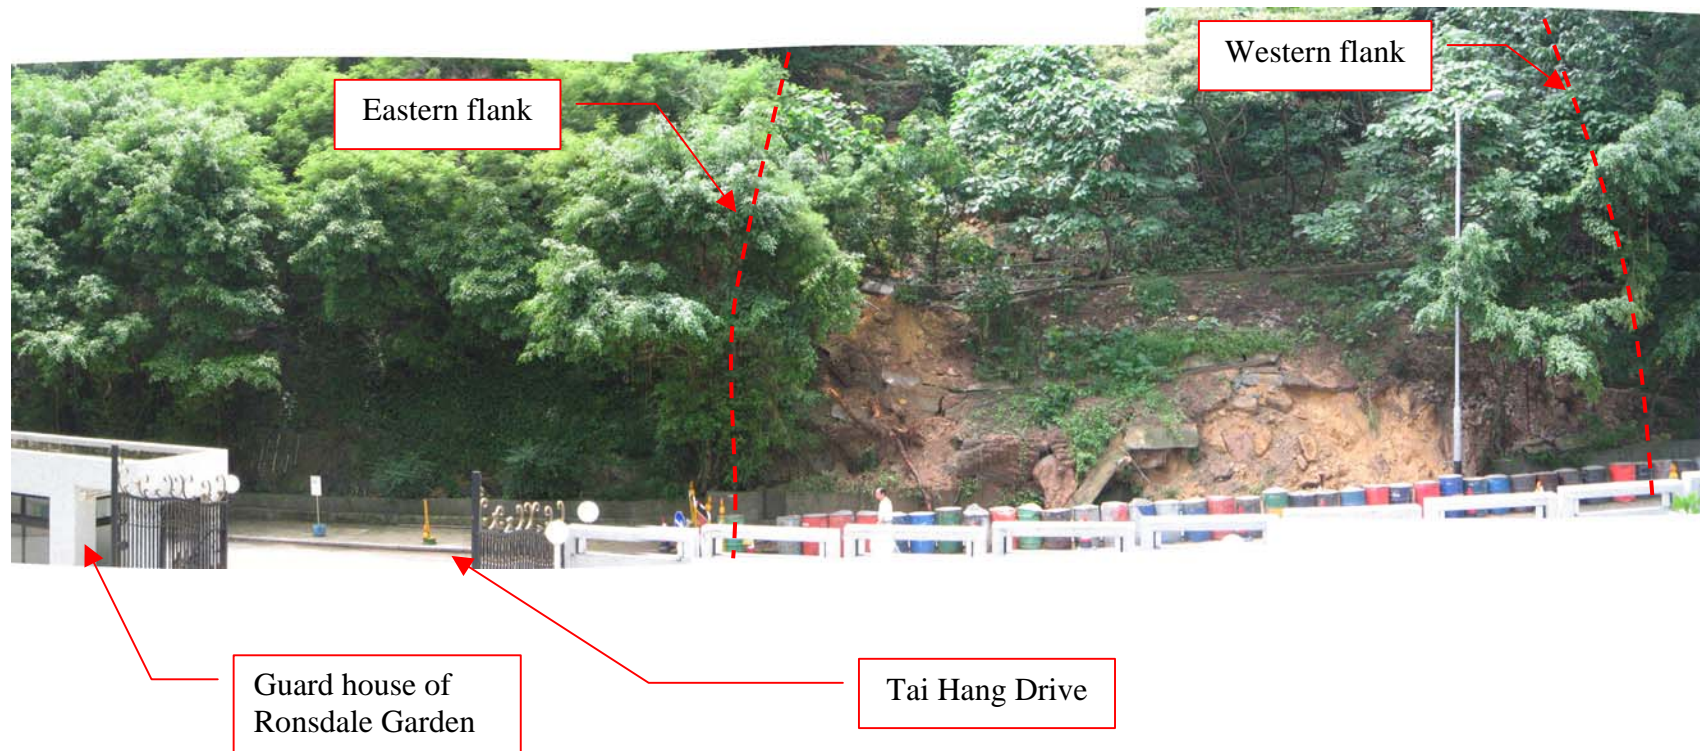
The displaced ground mass was up to a maximum 29 m wide by 27 m long, and the main scarp was at about 18 m above the road level (Figure 12, and Plates 1 and 2). The failure was of limited mobility, with a downward displacement of about 2 m at the main scarp (horizontal displacement at the toe being unknown as some of the debris at the toe had been cleared by the time FSW first visited the landslide site). The failed ground mass, which remained largely intact, did not completely detach from the slope. The near-surface material of the displaced mass comprised dislocated and generally broken concrete surface channels in a matrix of CDG and disturbed soil of granitic origin (Plate 1). The main scarp was up to 2 m high and was inclined at an angle of about 65° (Plate 9). No seepage from the main scarp or the surface of the displaced ground mass was observed during the inspections.

Plate 1 - General View of the 20 August 2005 Landslide (Photograph taken by FSW on 24 August 2005)

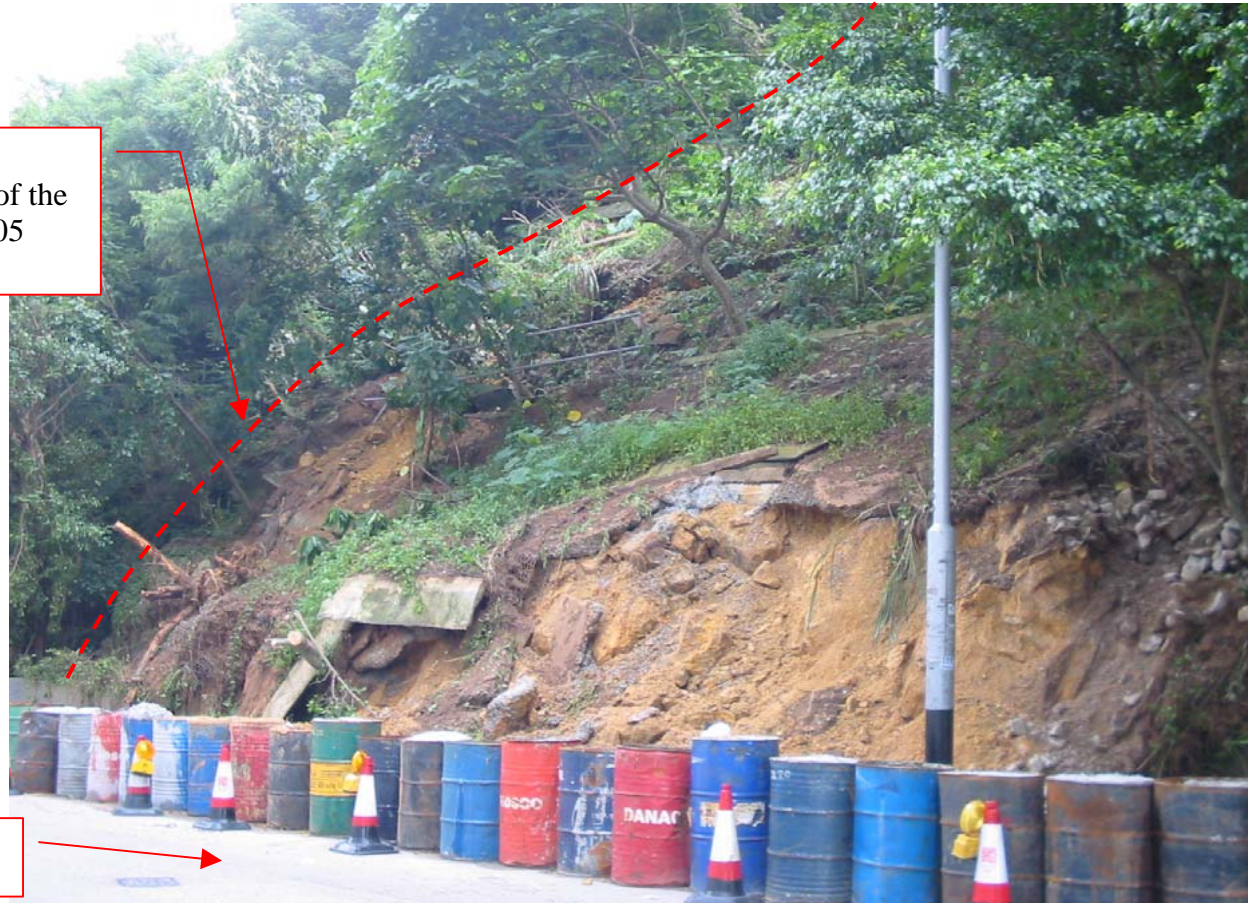
Localised detachment of about 40 m³ of soil, occurred over an area of about 8 m wide by 5 m long, at the toe of the displaced mass (Figure 2 and Plate 3). The debris derived from this local failure comprised blocks of no-fines concrete, sections of broken concrete surface channels, wire mesh and cobble- and boulder-sized Grade III granite, some of which probably originated from the repair works to the 1983 and 1993 landslides (see Section 3.3 and Plate 3).

Plate 3 - View of the Localised Detachment at the Lower Portion of the Displaced Ground Mass
(Photograph taken by FSW on 22 August 2005)

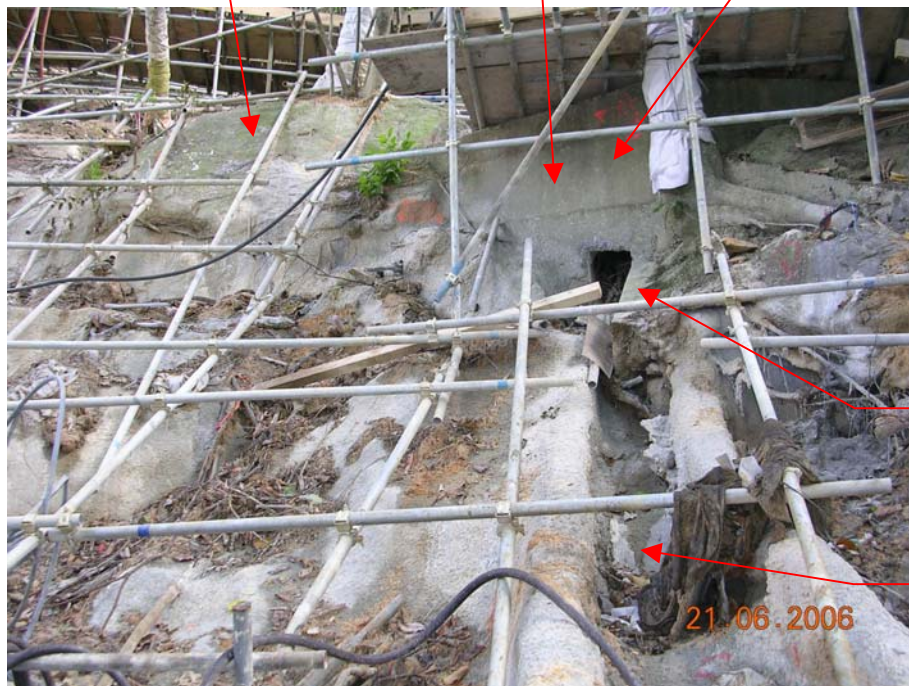
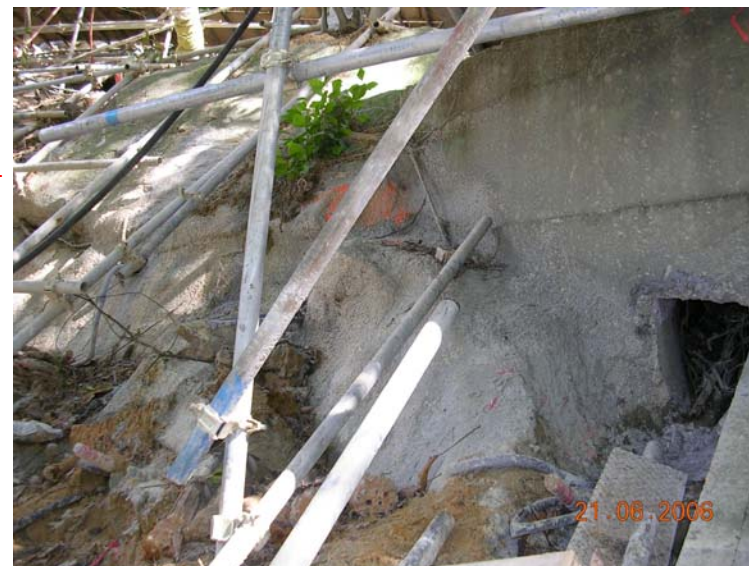
The 300 mm stepped channel, which was connected to the baffle wall above the cut slope prior to the landslide incident, was found to have broken, with the top 1 m long section also damaged and left in position (Plate 11). From the alignment of the remaining section (Plate 25), the stepped channel should have discharged surface water towards the area where the local detachment of soil was observed. The drainage channels on slope No. 11SE-A/C285 and the ephemeral drainage that discharges onto the 300 mm stepped channel via the baffle wall were found to be dry during the inspection on 22 August 2005. Also, the drainage channels located outside the landslide area were found to be generally free from blockage.

Broken section of 300 mm stepped channel remained on slope

Plate 11 - View of the Baffle Wall above Slope No. 11SE-A/C285 (Photograph taken by FSW on 21 June 2006)

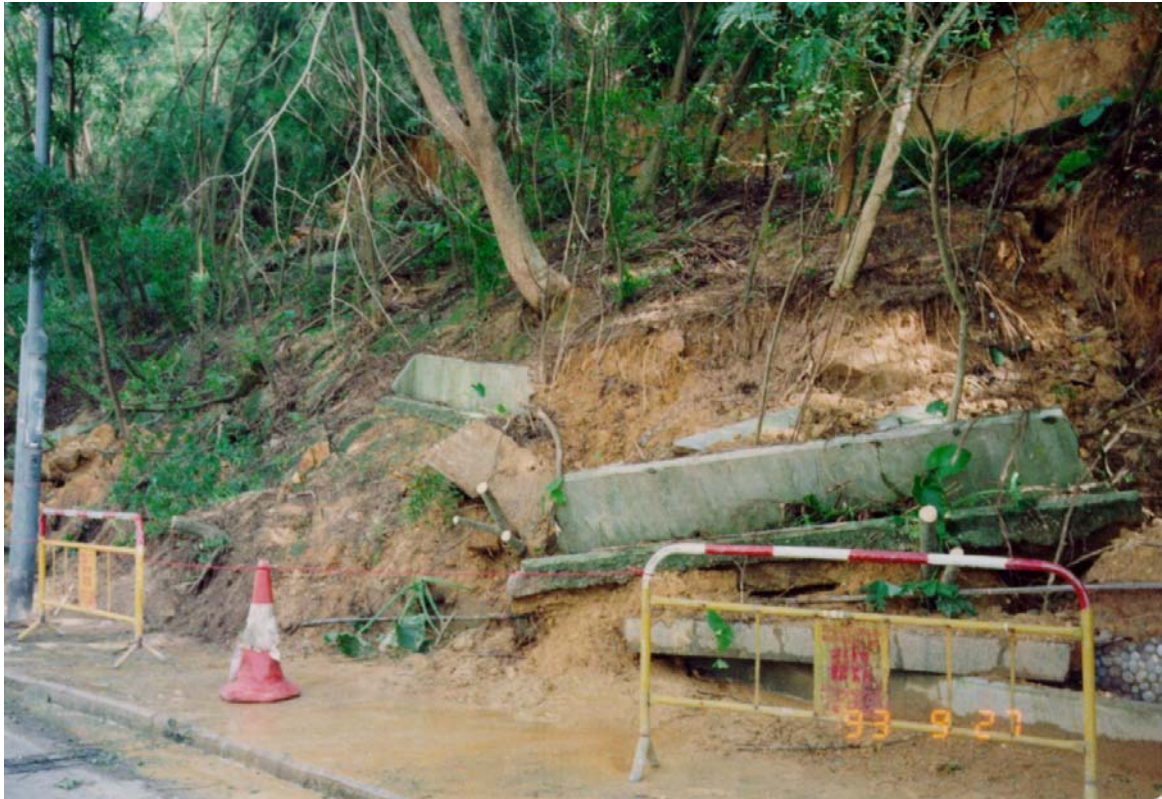
Plate 12 - Photographic Record of the Landslide on Slope No. 11SE-A/C285 in September 1993 (Photograph taken by GEO on 27 September 1993)

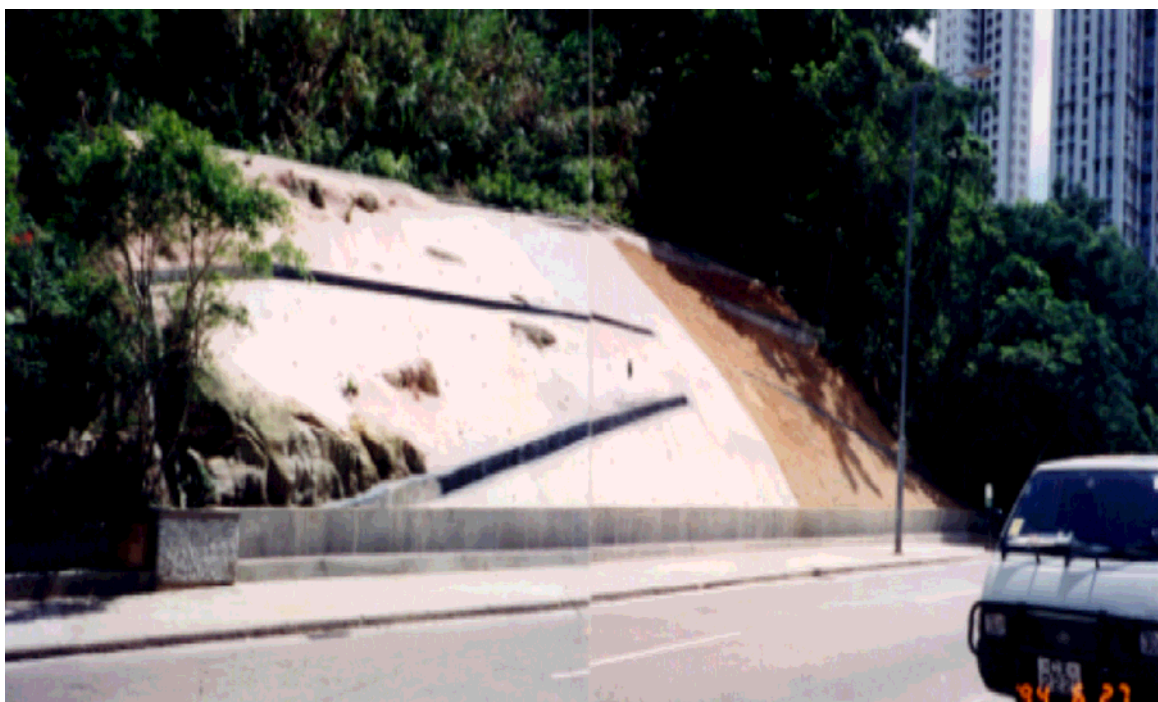
Plate 13 - View Showing the Completed Repair Works on Slope No. 11SE-A/C285 in June 1994 Following the Landslide in September 1993 (Photograph taken by GEO on 27 June 1994)

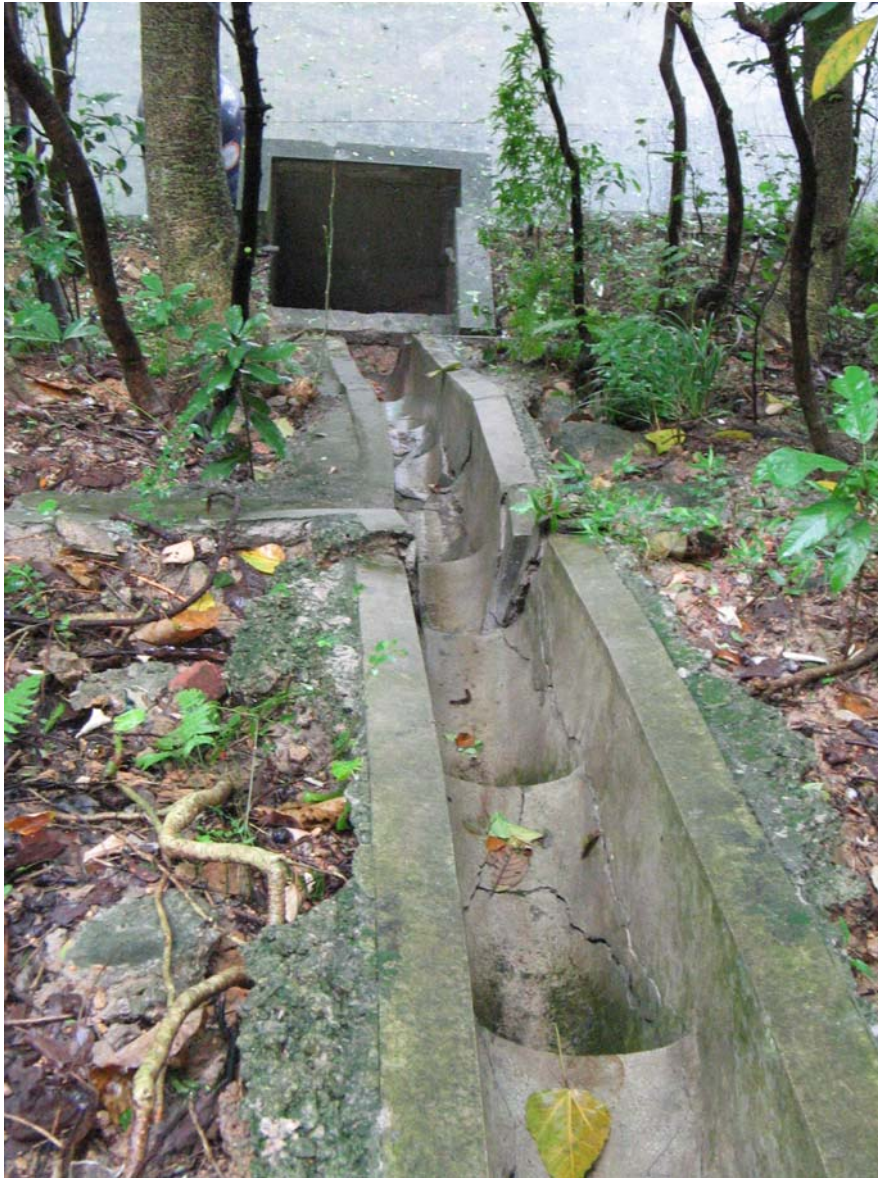
During the inspection on 24 August 2005 by FSW, the surface drainage channels in the western portion of the cut slope were noted to be generally dry and clear from debris while some stepped channels showed evidence of distress resulting from the landslide, as well as scouring, probably due to excessive flow of water (Plate 22). Some signs of distress in the form of minor cracking (up to 5 mm in width) were observed on the surface channels, catchpits and berm pavement (Plate 23). The chunam cover on the strip of area above the crest channel within this portion of the slope was cracked (up to 10 mm wide) with vegetation growing inside the cracks (Plate 24).

Plate 22 - Stepped Channel Showing Signs of Distress Resulting from the Landslide and from Scouring due to Excessive Flow of Water (Photograph taken by FSW on 24 August 2005)

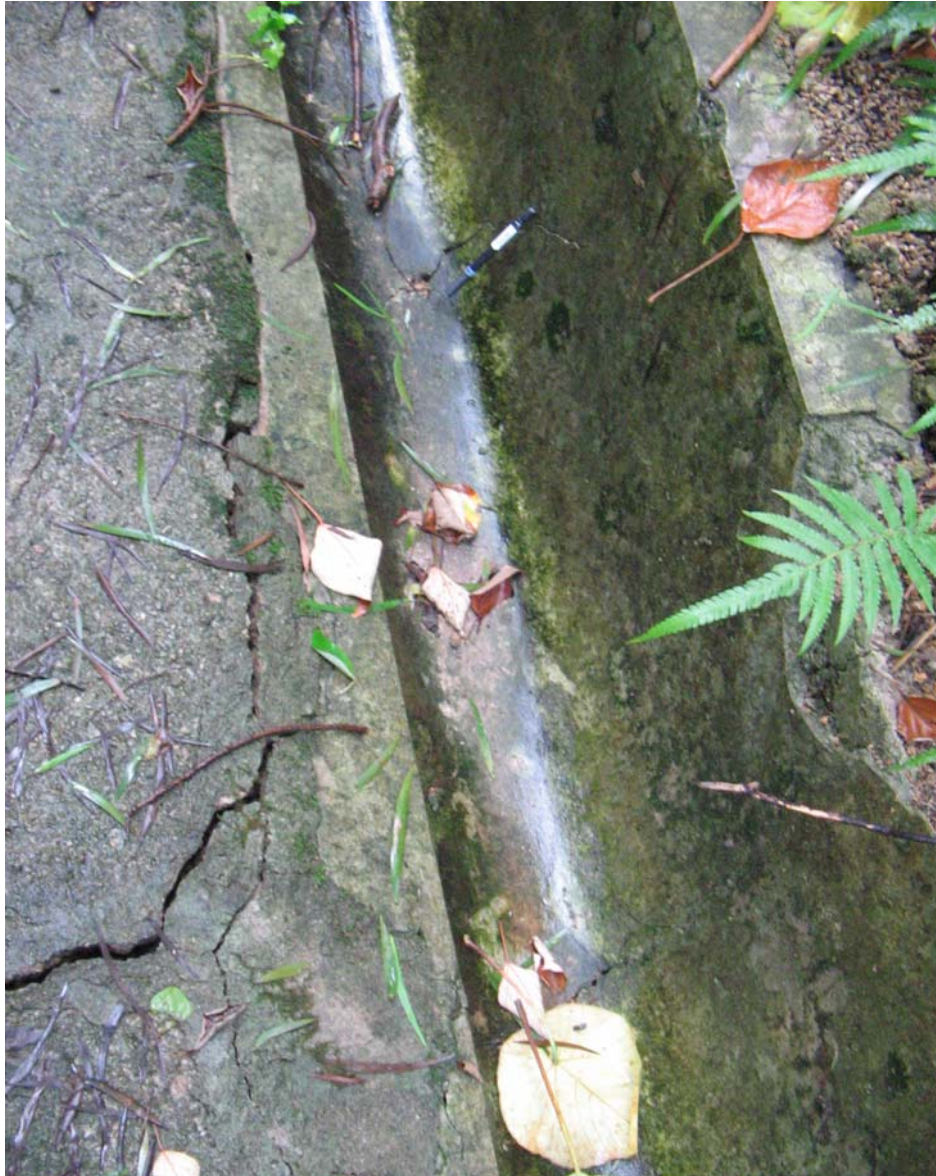
Plate 23 - View of a Surface Channel with Minor Cracks (Photograph taken by FSW on 24 August 2005)

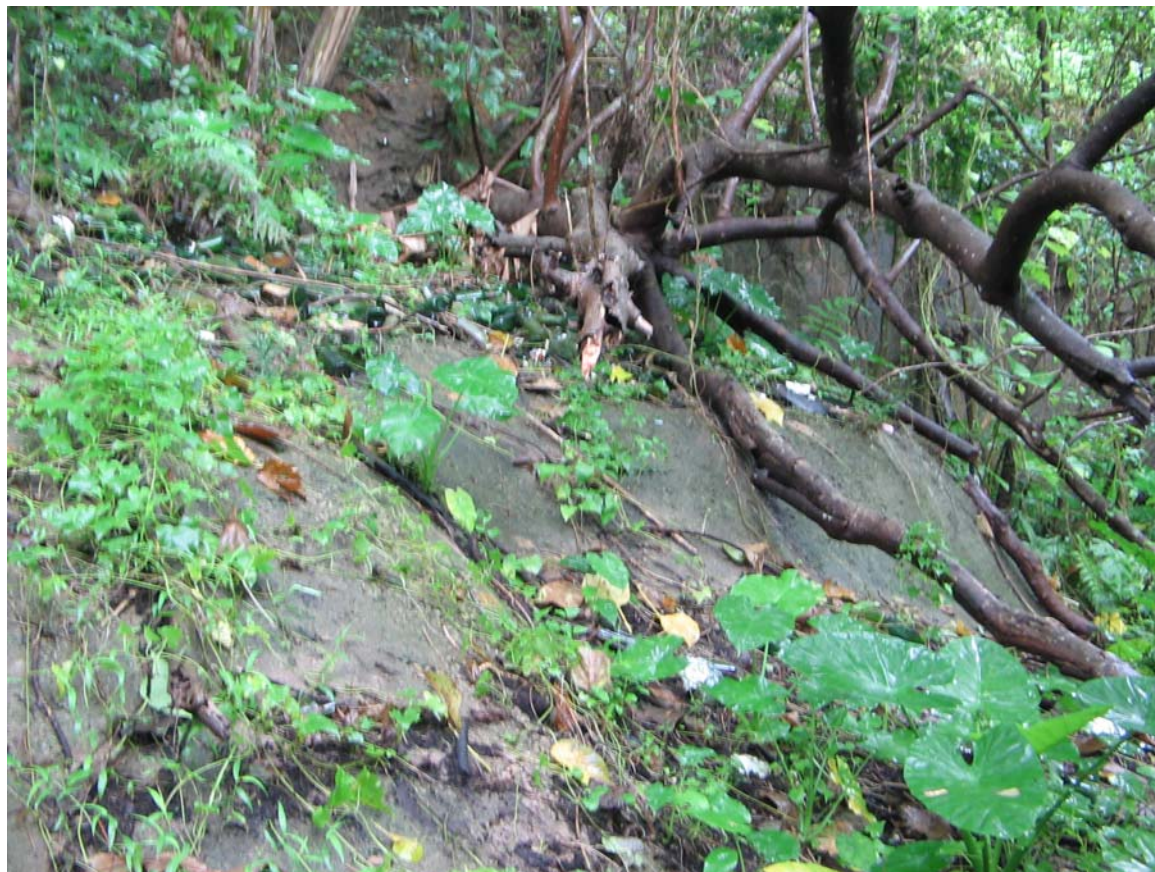
Plate 24 - View of a Cracked Chunam Cover above the Main Scarp (Photograph taken by FSW on 24 August 2005)

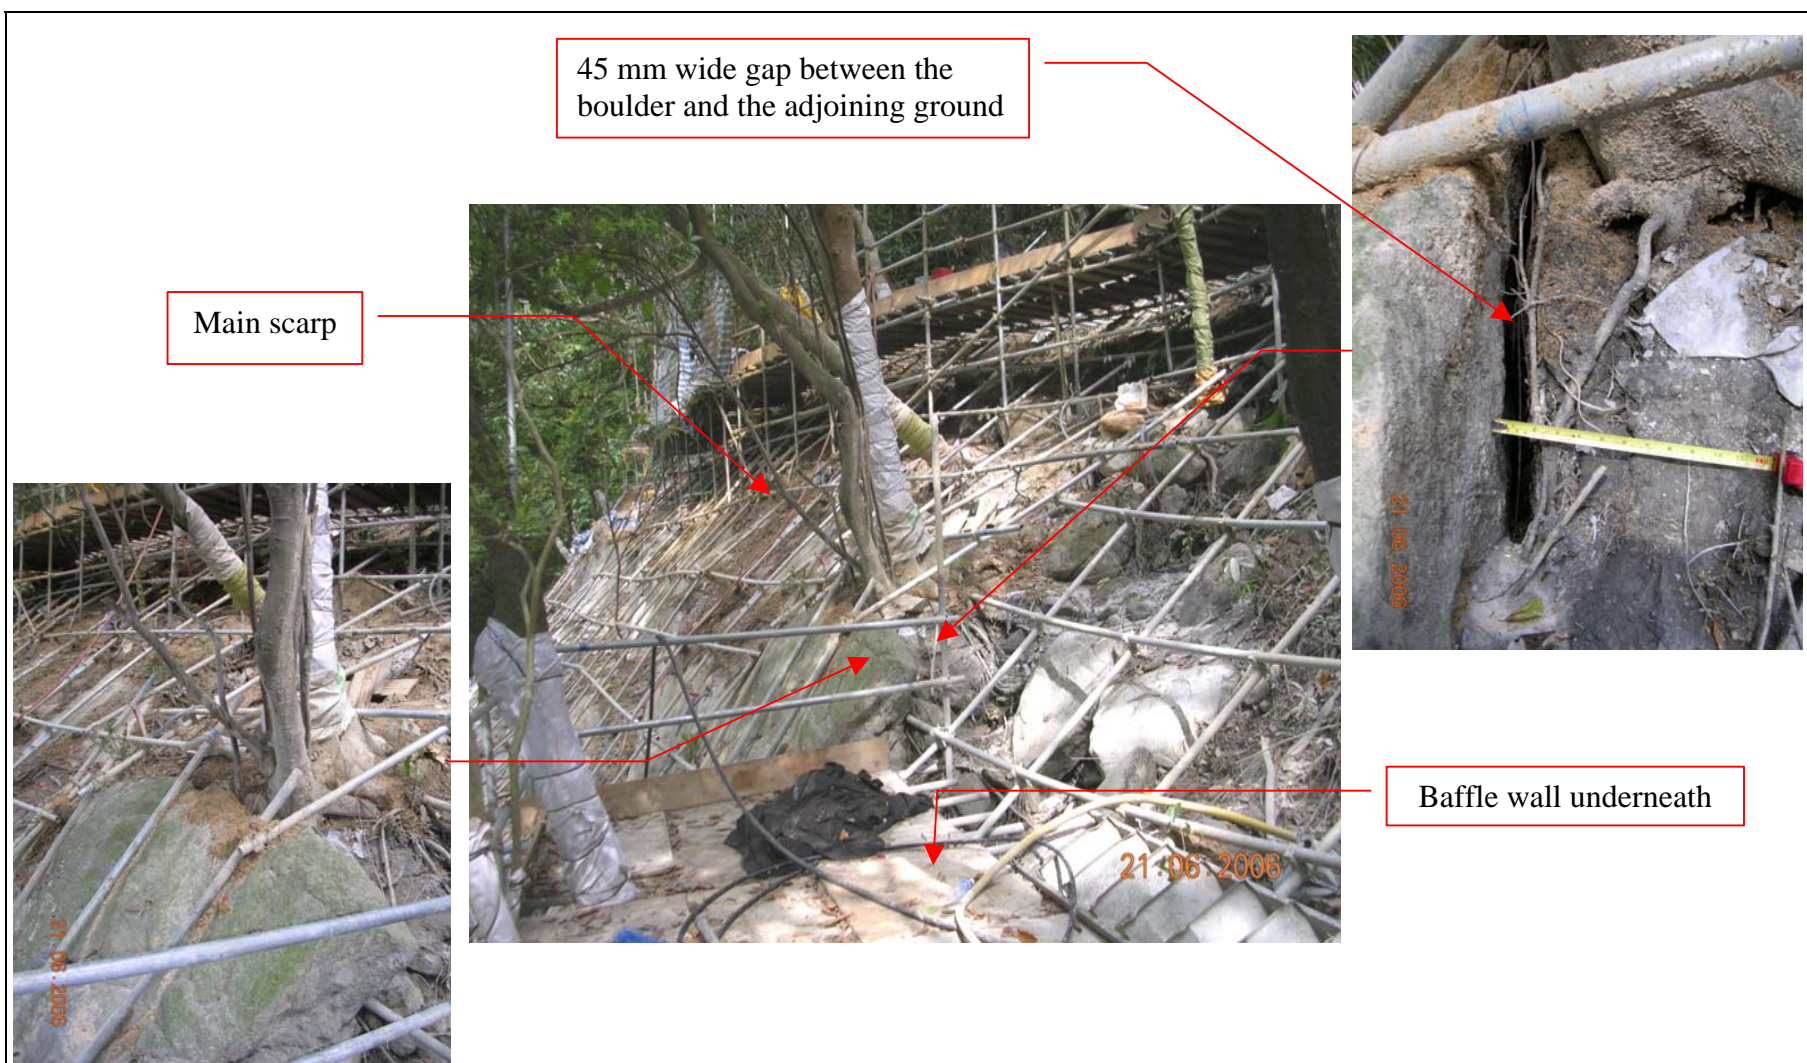
Between the western end of the main scarp and the baffle wall, an in-situ boulder of Grade II granite (2.6 m by 2.5 m) was noted to have moved forward by about 45 mm. However, the observed movement might have been due to root action of an adjacent tree instead of being related to the present landslide (Plate 26).

Plate 26 - View of a Boulder Adjacent to the Baffle Wall (Photograph taken by FSW on 21 June 2006)

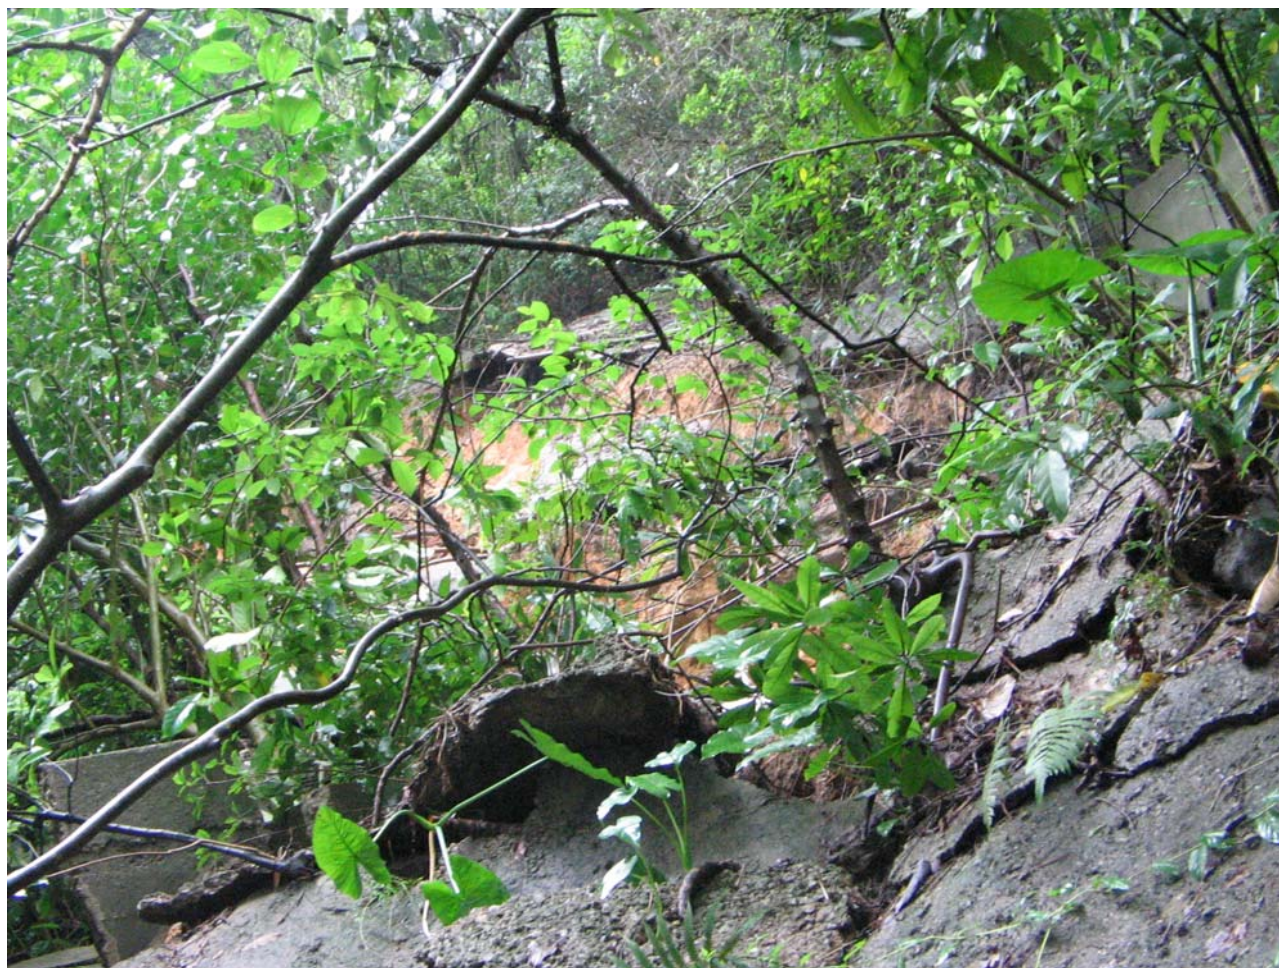
Plate 27 - View of a Cracked Chunam Cover at the Western Flank (Photograph taken by FSW on 24 August 2005)

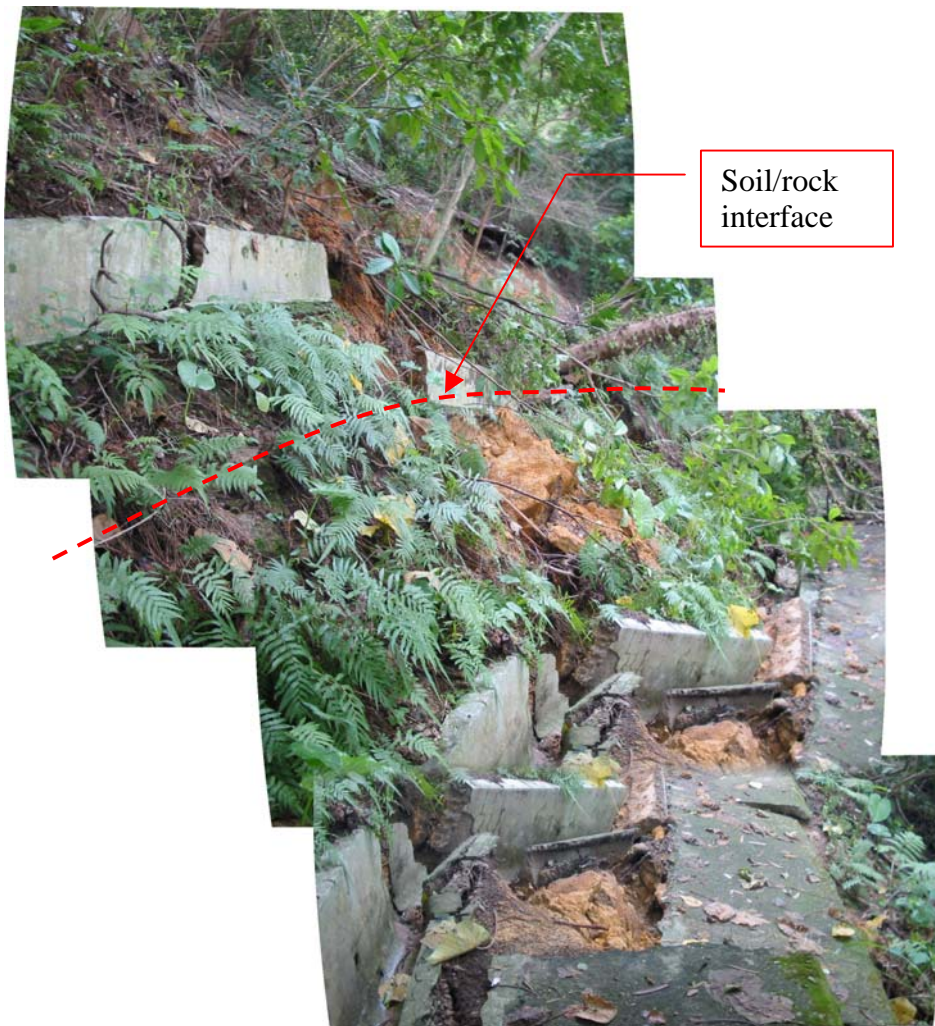
Plate 28 - View of the Soil/Rock Interface at the Lower Slope Batter
(Photograph taken by FSW on 24 August 2005)

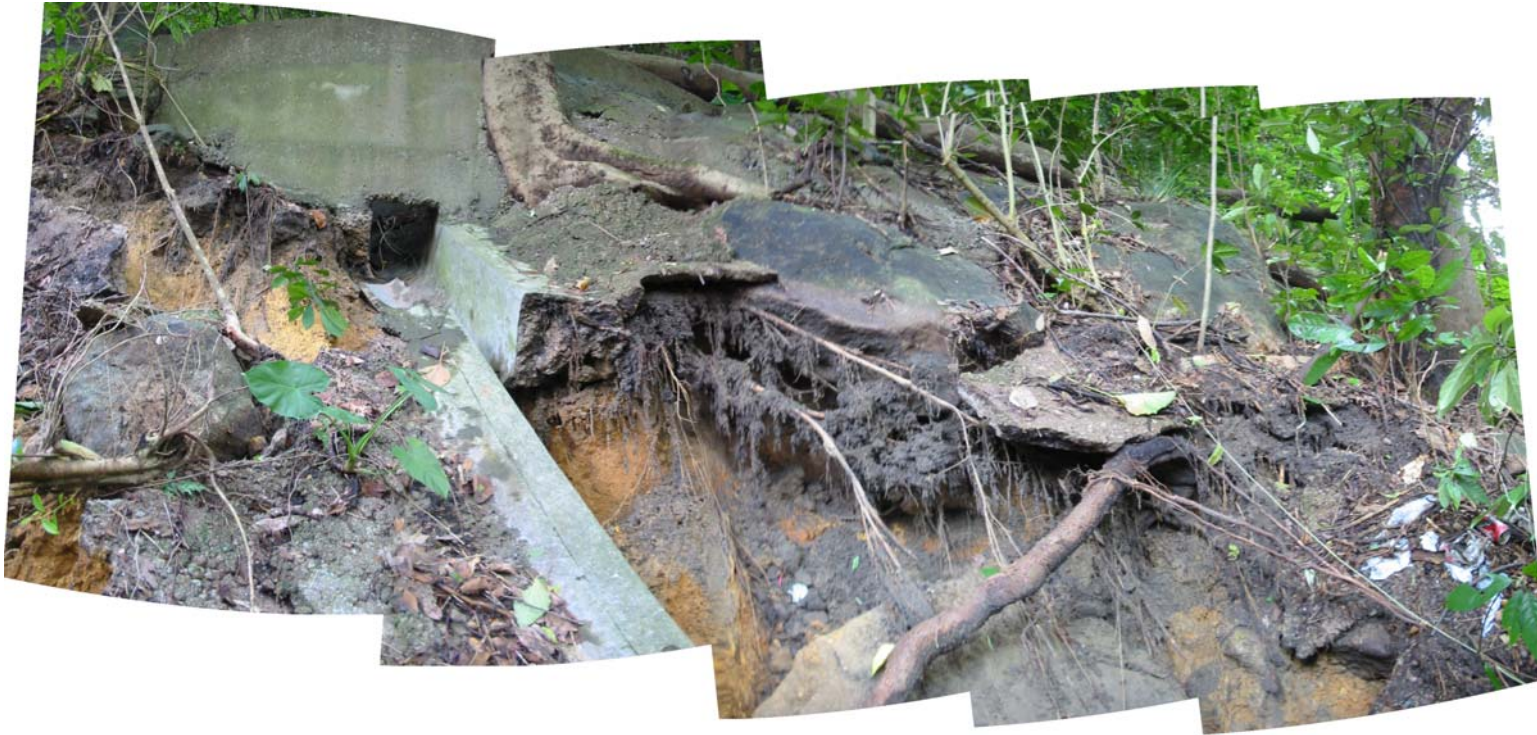
Plate 29 - View of the Minor Slope Displacement adjacent to the Baffle Wall at the Southwestern Part of the Landslide Scar
(Photograph taken by FSW on 24 August 2005)

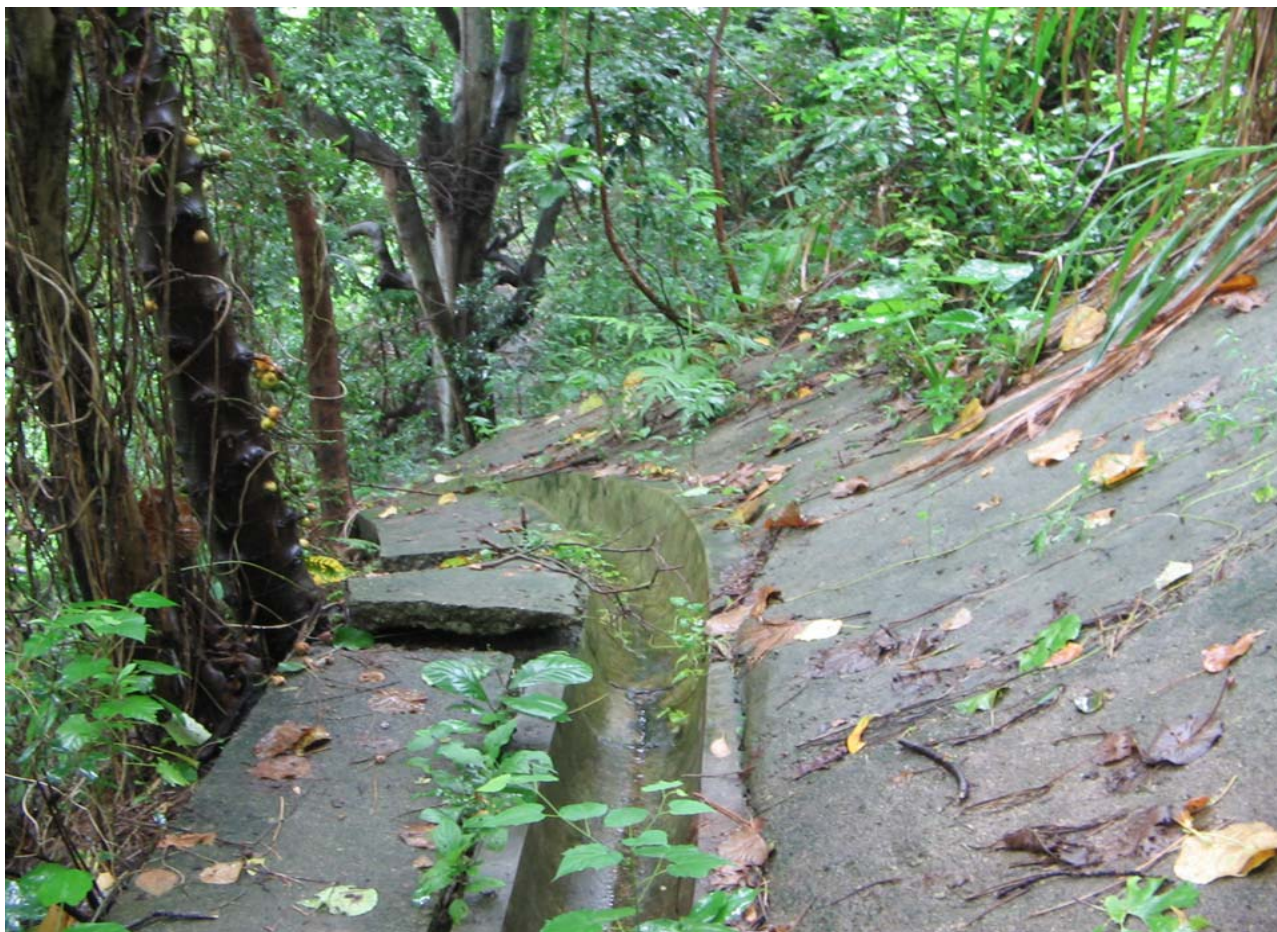
Plate 30 - View of the Distressed Zone behind the Southeastern Part of the Landslide Scar
(Photograph taken by FSW on 24 August 2005)
