**DETAILED STUDY OF THE
20 AUGUST 2005 LANDSLIDE
ON SLOPES NOS. 11SE-A/C285,
11SE-C/DT1 AND 11SE-C/DT6
ABOVE TAI HANG DRIVE
HAPPY VALLEY**

GEO REPORT No. 217

**GEOTECHNICAL ENGINEERING OFFICE
CIVIL ENGINEERING AND DEVELOPMENT DEPARTMENT
THE GOVERNMENT OF THE HONG KONG
SPECIAL ADMINISTRATIVE REGION**

**This report was originally produced in March 2007
as GEO Landslide Study Report No. LSR 2/2007**

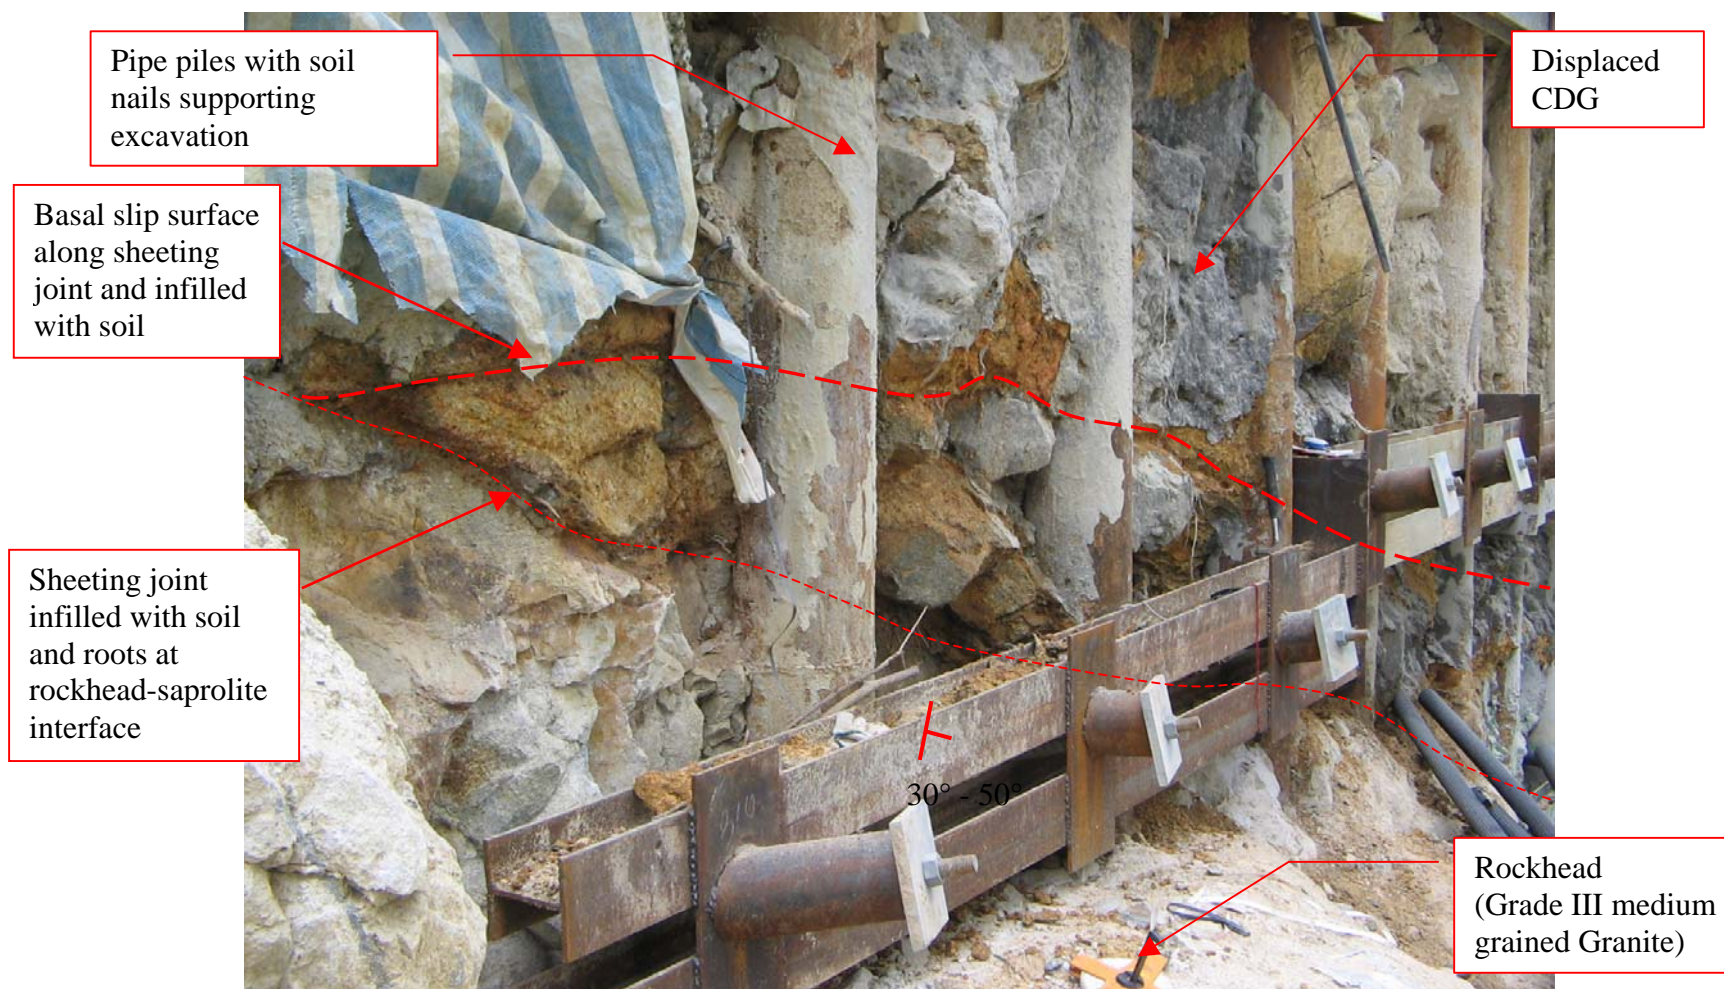
Plate 31 - View of the Basal Slip Surface and Sheeting Joint above Rockhead in the Excavation for LPM Works
(Photograph taken by FSW on 13 November 2006)

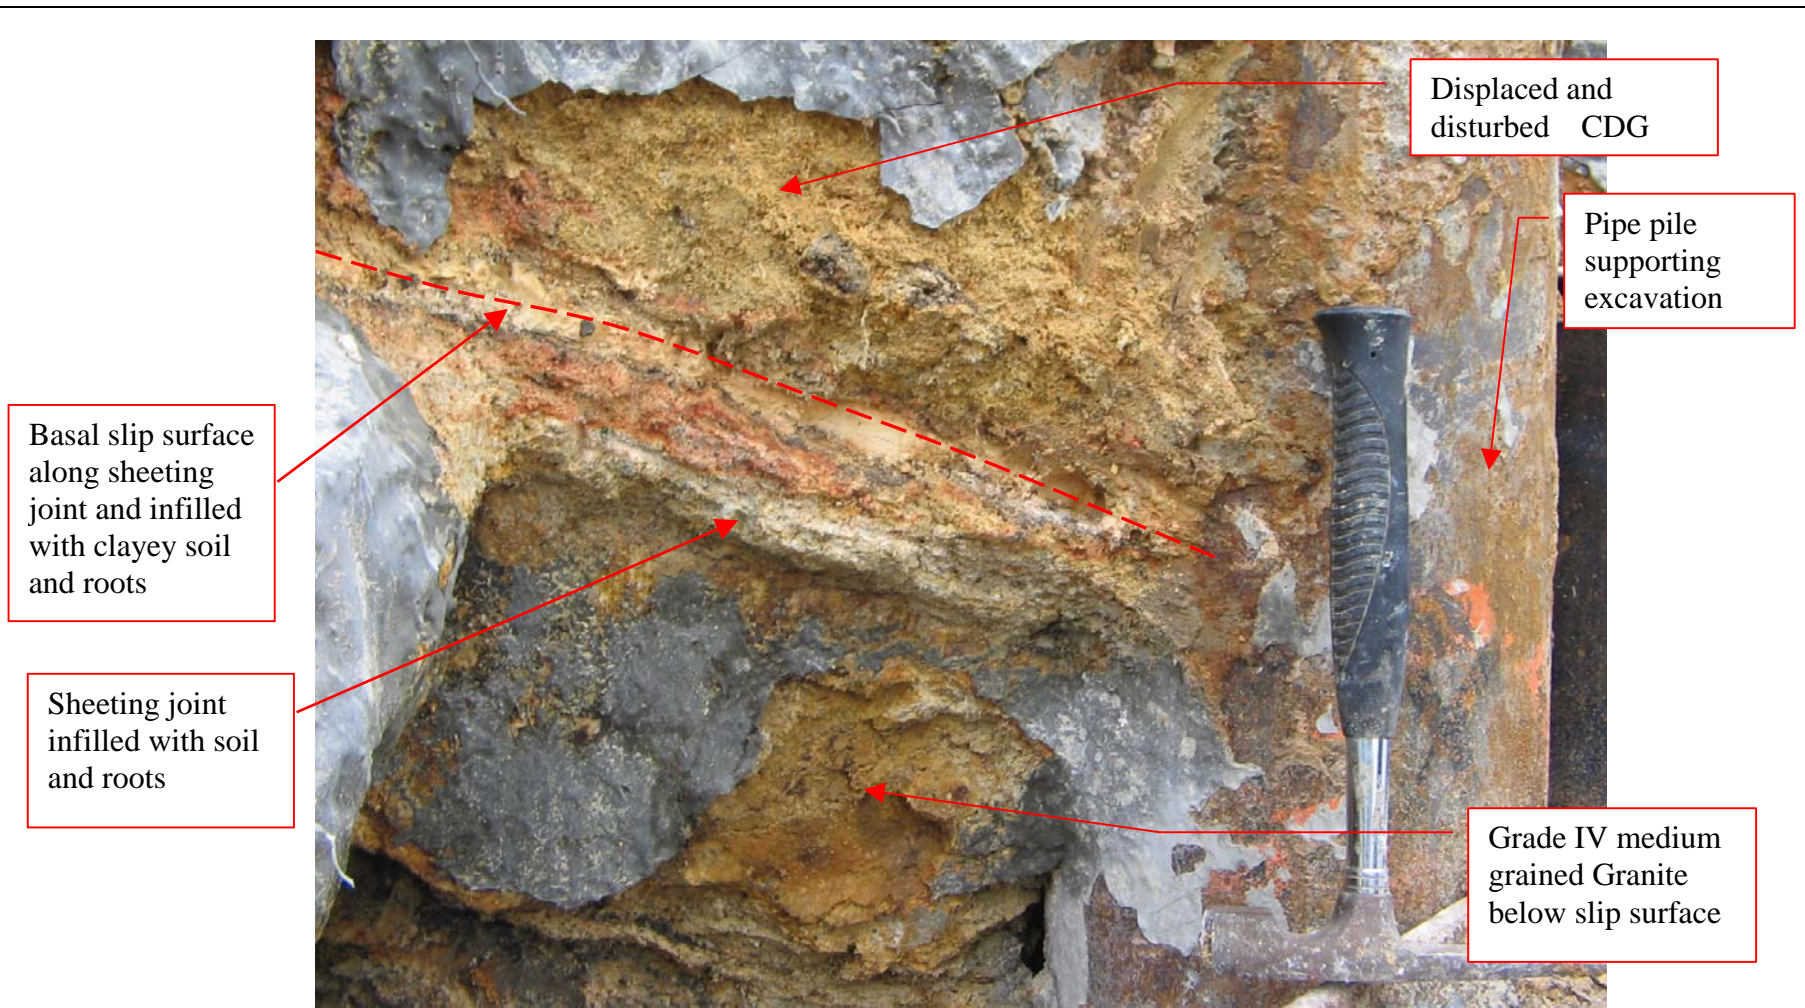
Plate 32 - Close-up View of the Basal Slip Surface and Sheeting Joint in the Excavation for LPM Works
(Photograph taken by FSW on 13 November 2006)

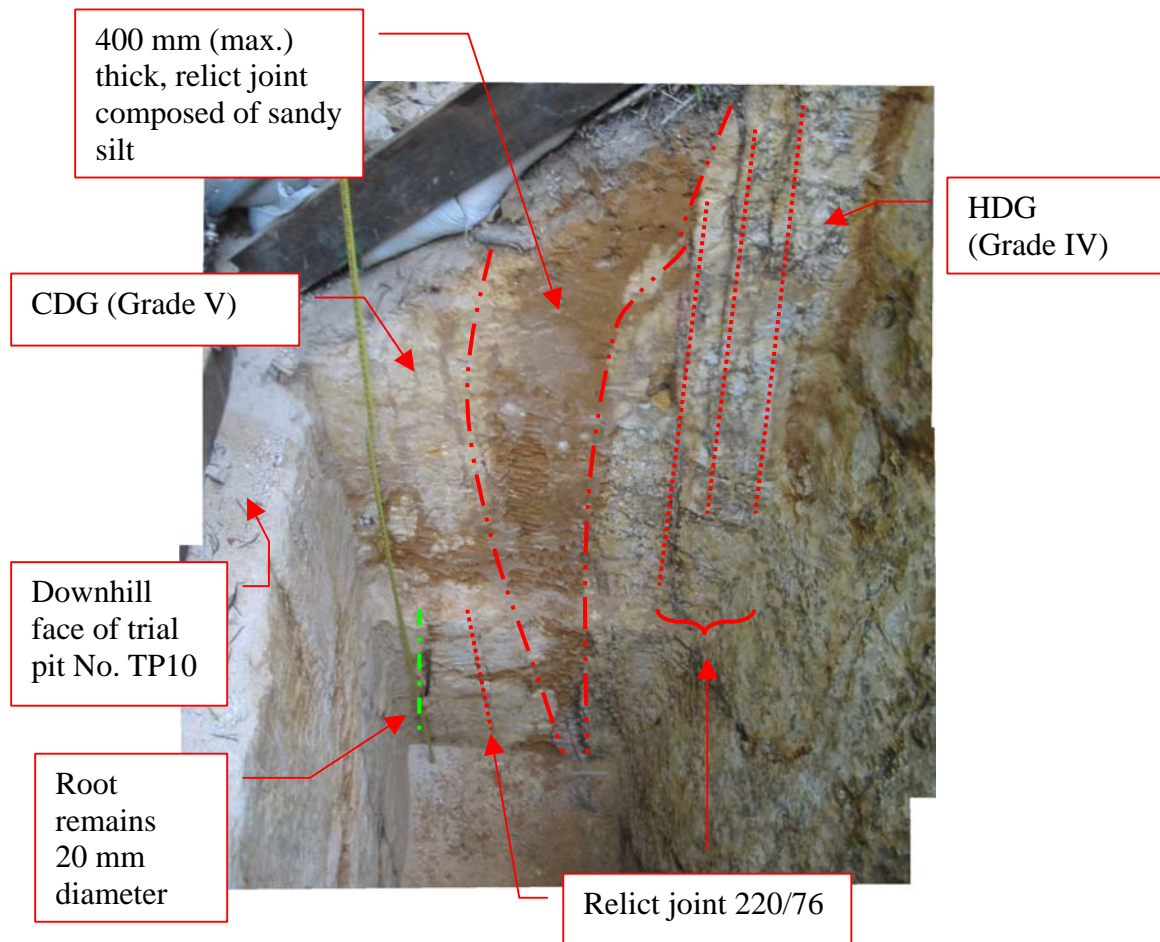
Plate 34 - View of Relict Joints Weathered to RS within CDG and HDG at TP10, in the Western Portion of Slope No. 11SE-A/C285 (Photograph taken by FSW on 12 December 2005)

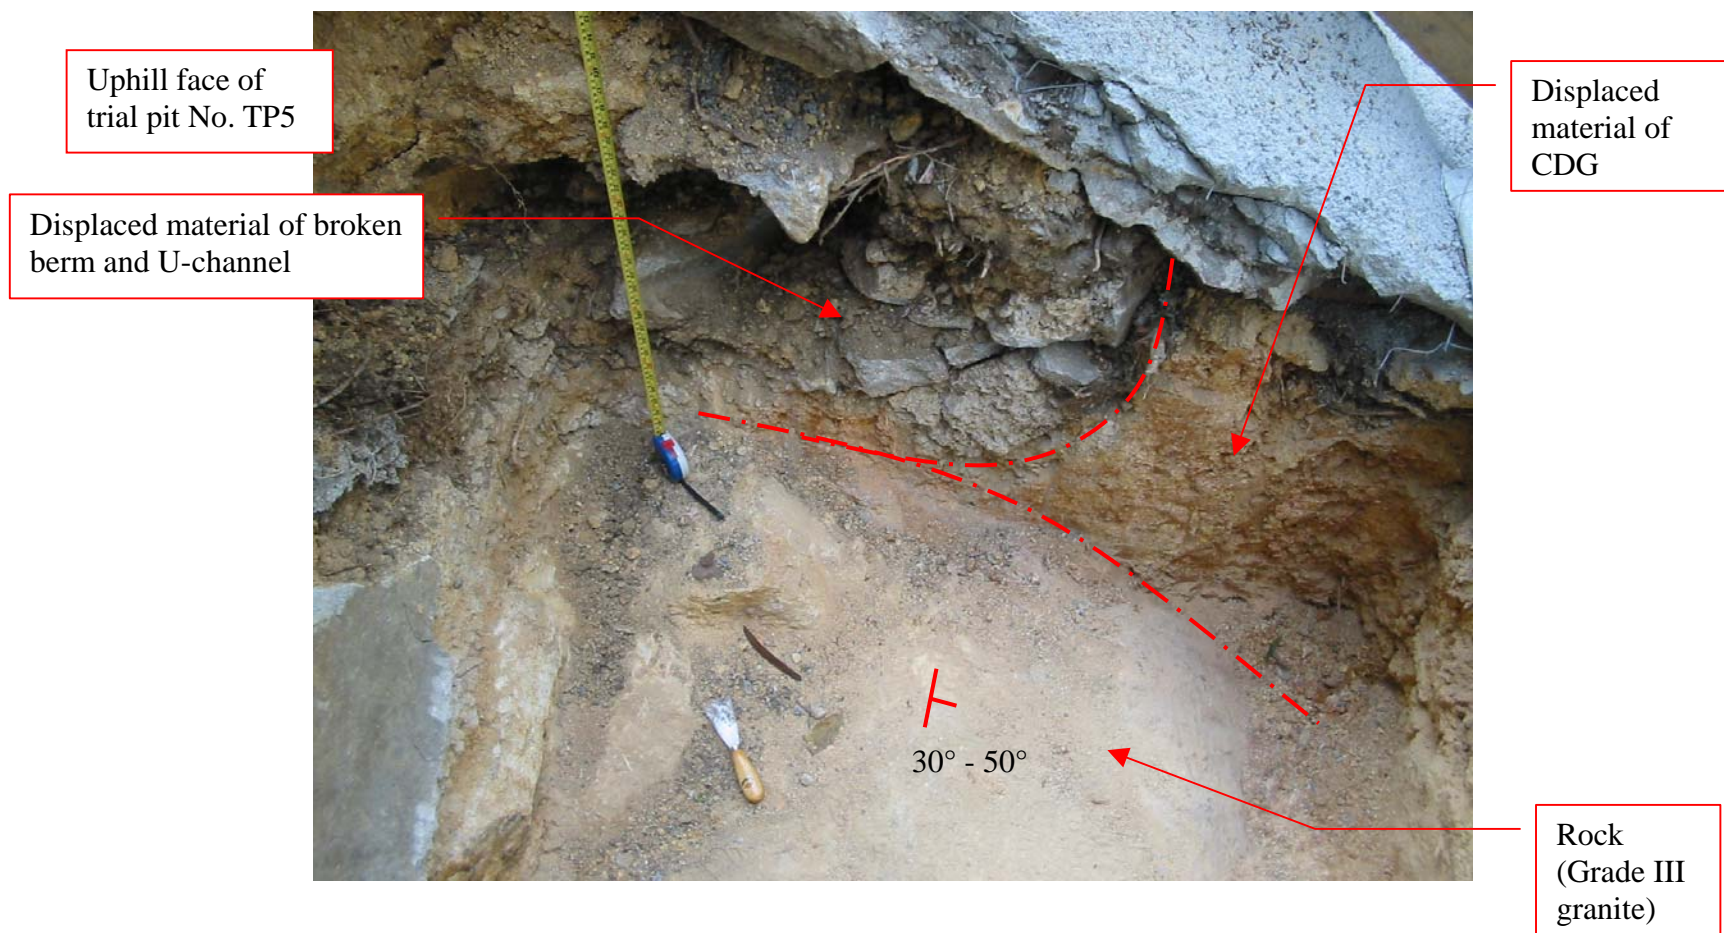
Plate 36 - View of Displaced Material of CDG Overlying Rock at TP5, at the Eastern Flank of the 20 August 2005 Landslide Site (Photograph taken by FSW on 24 November 2005)
