REVIEW OF SELECTED LANDSLIDES INVOLVING SOIL-NAILED SLOPES

GEO REPORT No. 222

F.H. Ng, M.F. Lau, K.W. Shum & W.M. Cheung

**GEOTECHNICAL ENGINEERING OFFICE
CIVIL ENGINEERING AND DEVELOPMENT DEPARTMENT
THE GOVERNMENT OF THE HONG KONG
SPECIAL ADMINISTRATIVE REGION**

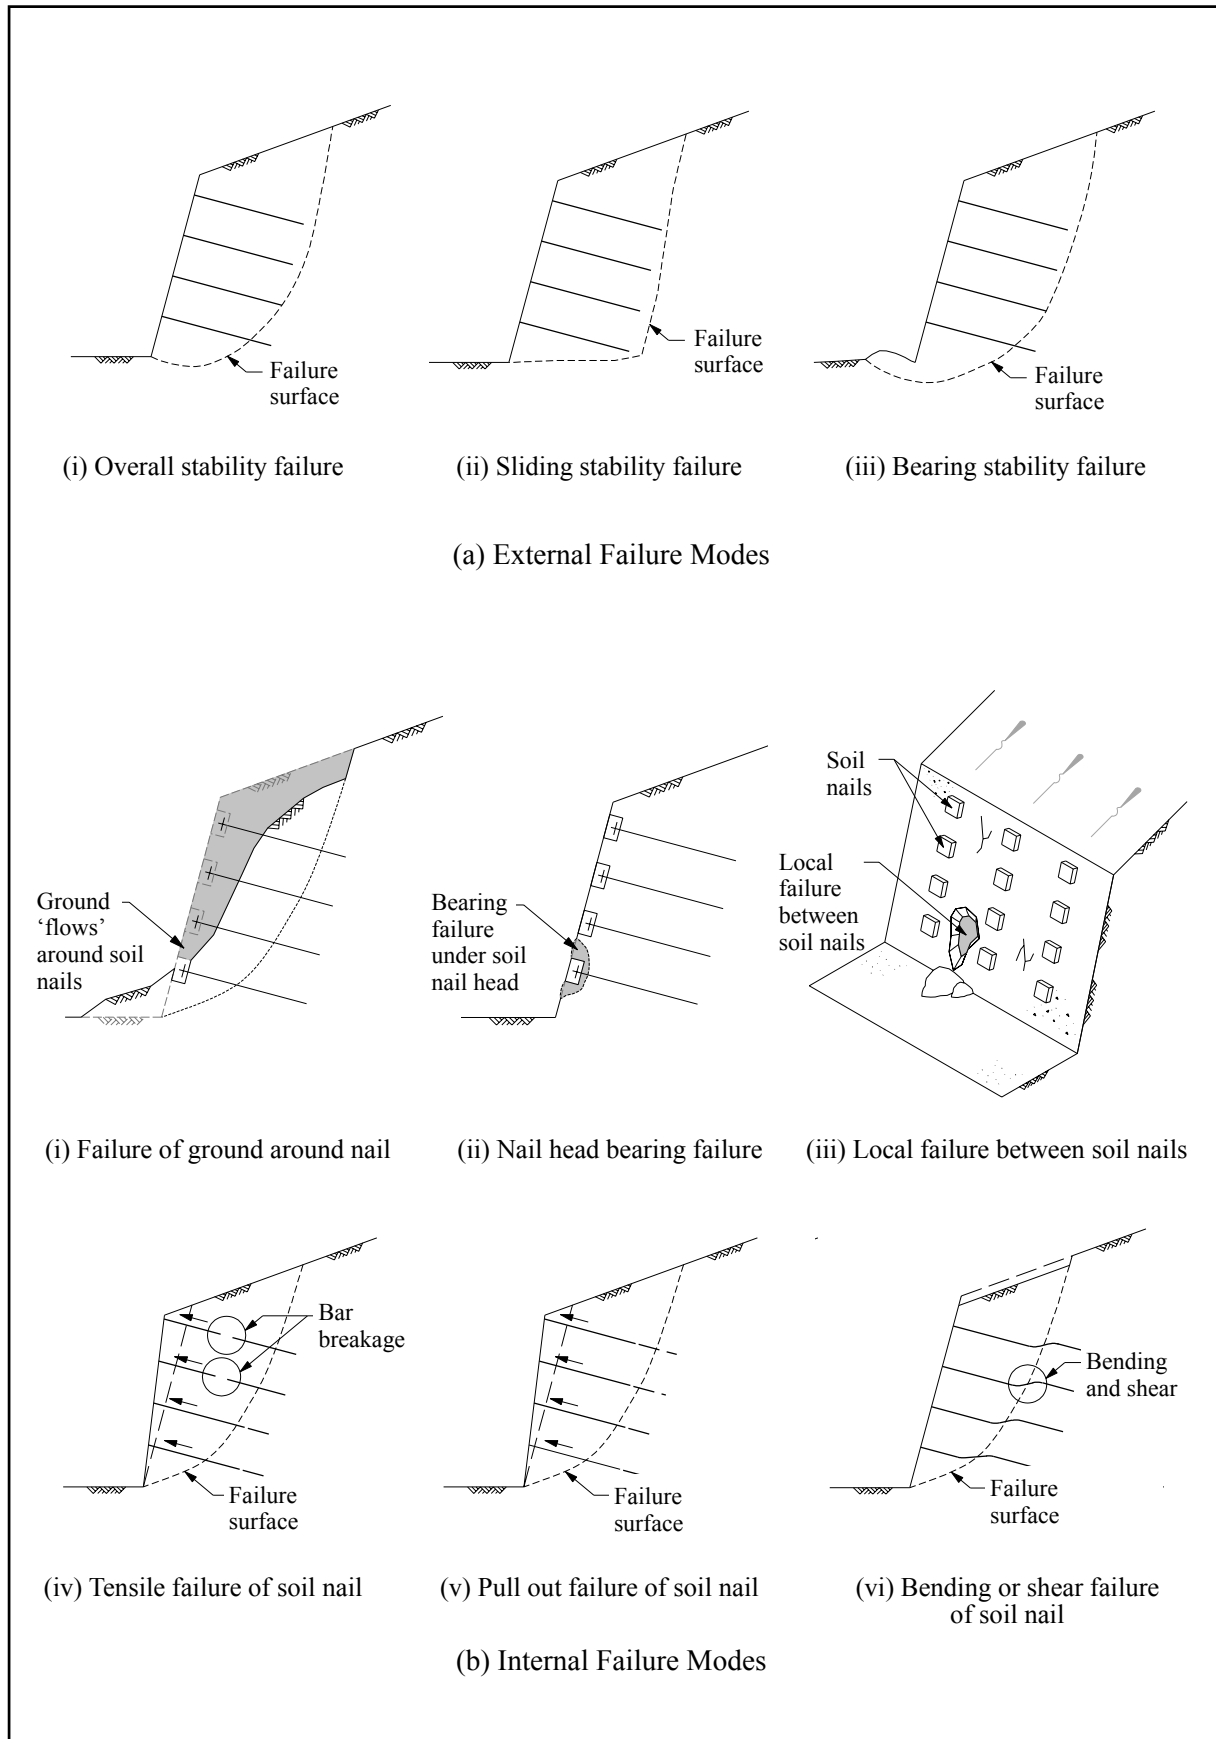
The failure modes of soil nailed slopes can be generally classified into two main categories (see Figure 1). The first category is external failure, where the installed soil nails are essentially within the deformed soil mass and hence the soil nails offer minimal resistance to the failure, which is basically in the form of rotation or sliding. In other words, the nails are too short and do not pass through the slip surface.

The second failure category refers to internal failure that may occur either in the active zone (namely, failure of ground around soil nail, soil nail head bearing failure, local failure between soil nails, soil nail tensile failure, and soil nail bending and shearing failure, see Figures 1(b)(i) to (iv) and (vi)), or in the passive zone (namely, soil nail pull out failure, see Figures 1(b)(v)) of a soil-nailed slope. CIRIA (2005) defines the active zone as the region in front of the potential failure plane, which contains the proximal end of the soil nails. The passive zone is defined as the resistant zone behind the potential failure plane, which contains the distal end of the soil nails with sufficient bond length to prevent the reinforcement being pulled out.

Figure 1 – Various Failure Modes of Soil-nailed Slopes

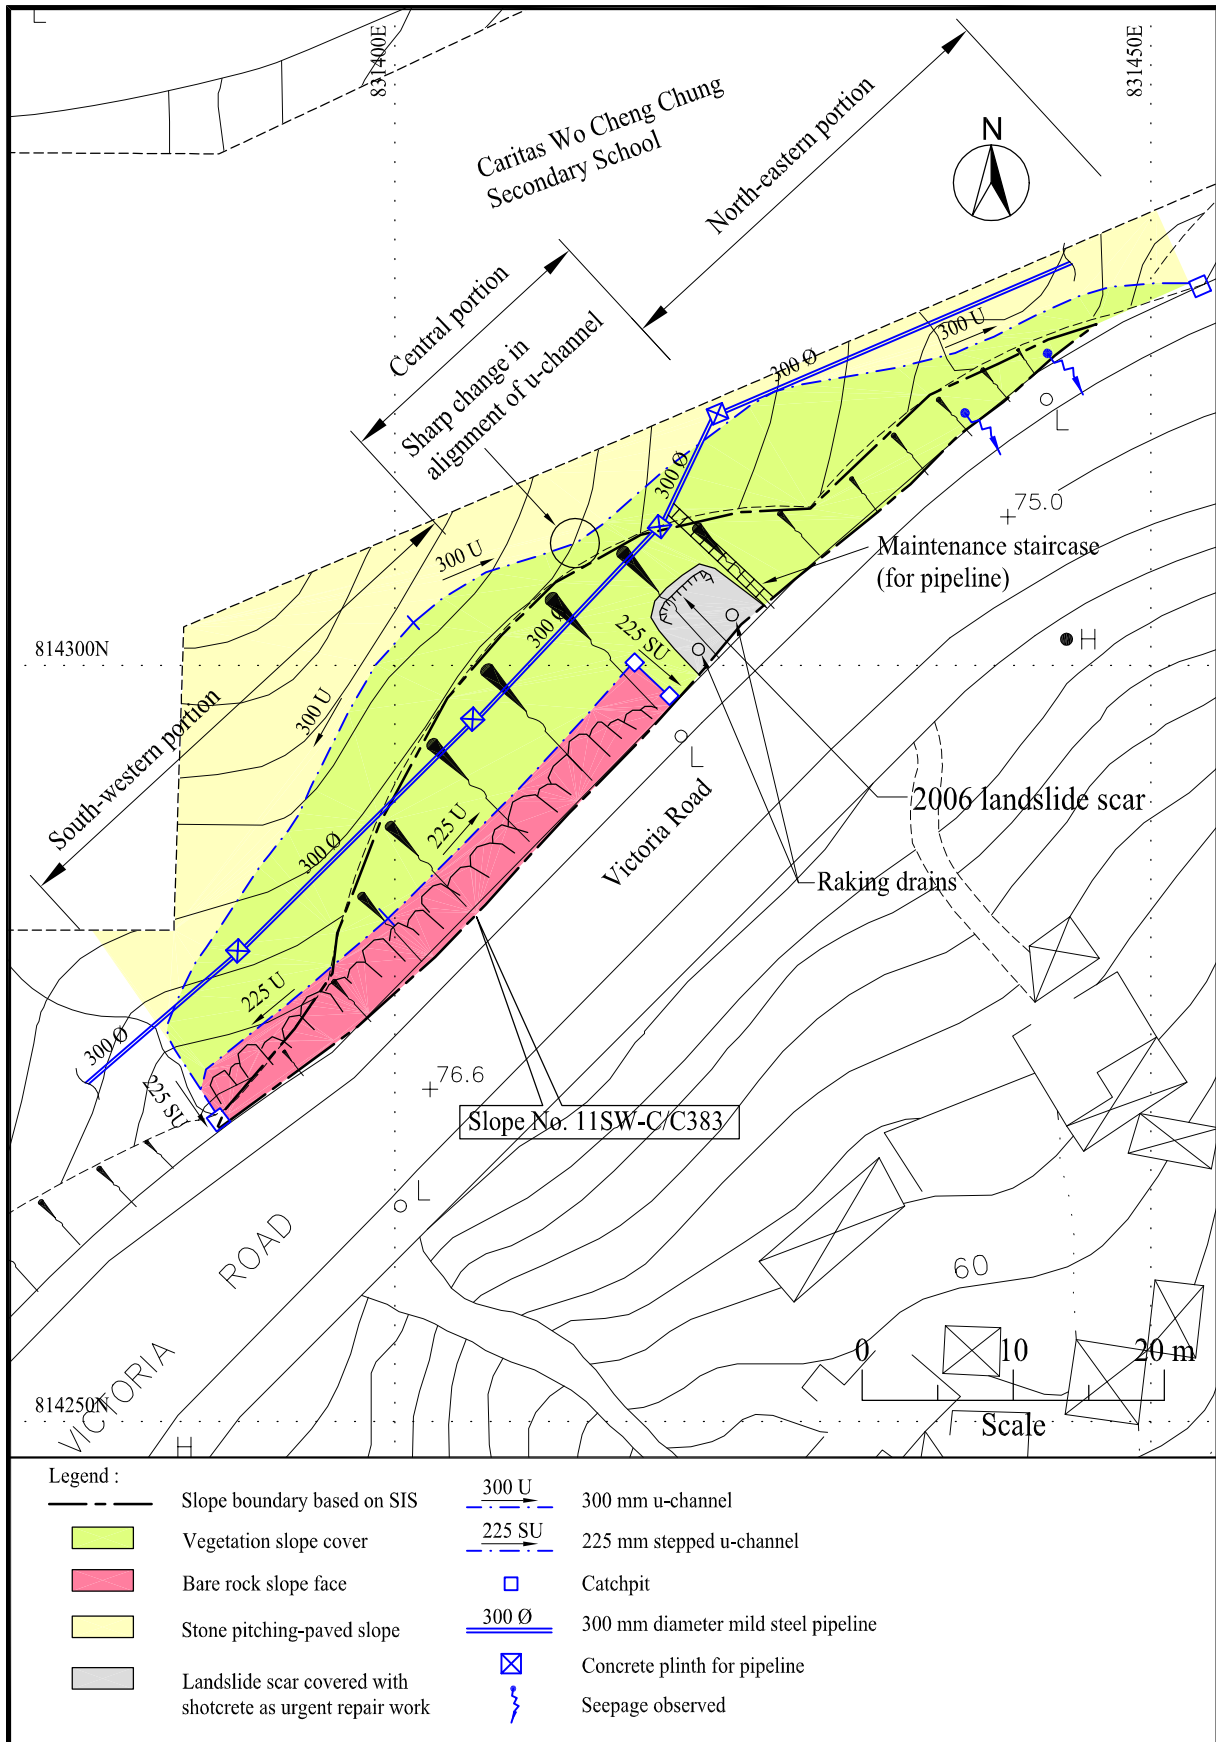
A subsequent site inspection on 13 October 2006 revealed that shotcrete with weepholes had been applied to the landslide scar, extending down to the toe planter (Figure 3 and Plate 2). No seepage was observed from either the weepholes or the raking drains during the inspection. However, continuous water seepage was observed at two locations from the toe planter near the north-eastern end of the slope (Figure 3), one of which was in line with the location observed by the GEO in January 2005.

The 300 mm U-channel at the slope crest was clear at the time of the inspection. The channel has a relatively steep gradient with a sharp change in alignment above the landslide scar (Figure 3). The stone pitching covering the sloping ground above the crest of the slope was in good condition.

The landslide scar is situated below an area of sloping ground covered by stone pitching. The crest drainage channel is steeply inclined with a sharp change in alignment above the landslide scar. It is postulated that the September 2006 landslide was caused by a combination of direct infiltration and possible overspill from the crest drainage channel during heavy rainfall.

Figure 3 - Site Plan and Field Observations (Slope No. 11SW-C/C383)

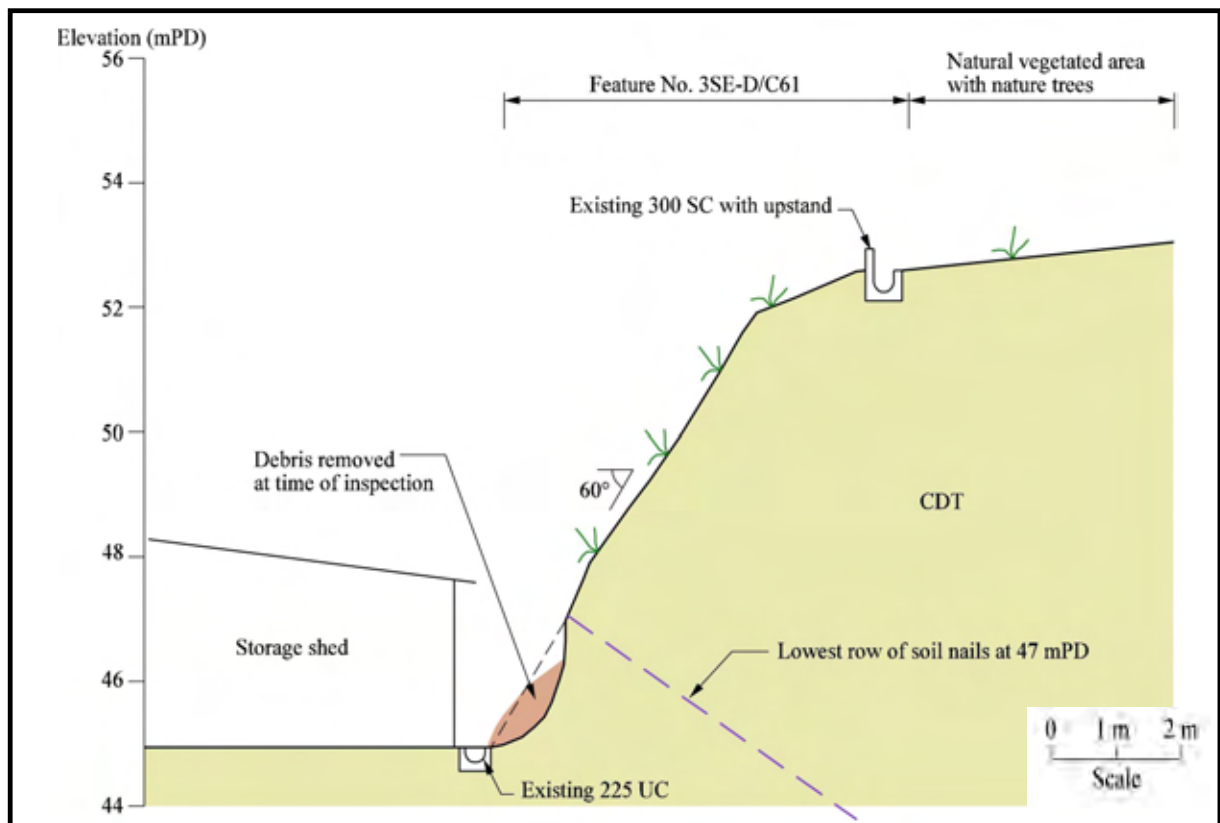
The landslide scar was about 2.4 m wide by 2 m high by 0.5 m deep located near the slope toe, just below the lowest row of soil nails (Figure 5). At the time of inspection in November 2006, a no-fines concrete buttress had been constructed to backfill the landslide scar. No signs of distress or seepage from other parts of the slope were observed.

The shallow landslide that occurred on the steep cut face below the soil nails was probably caused by wetting up of the near-surface material due to direct infiltration.

Figure 5 – Cross Section A – A (Slope No. 3SE-D/C61)

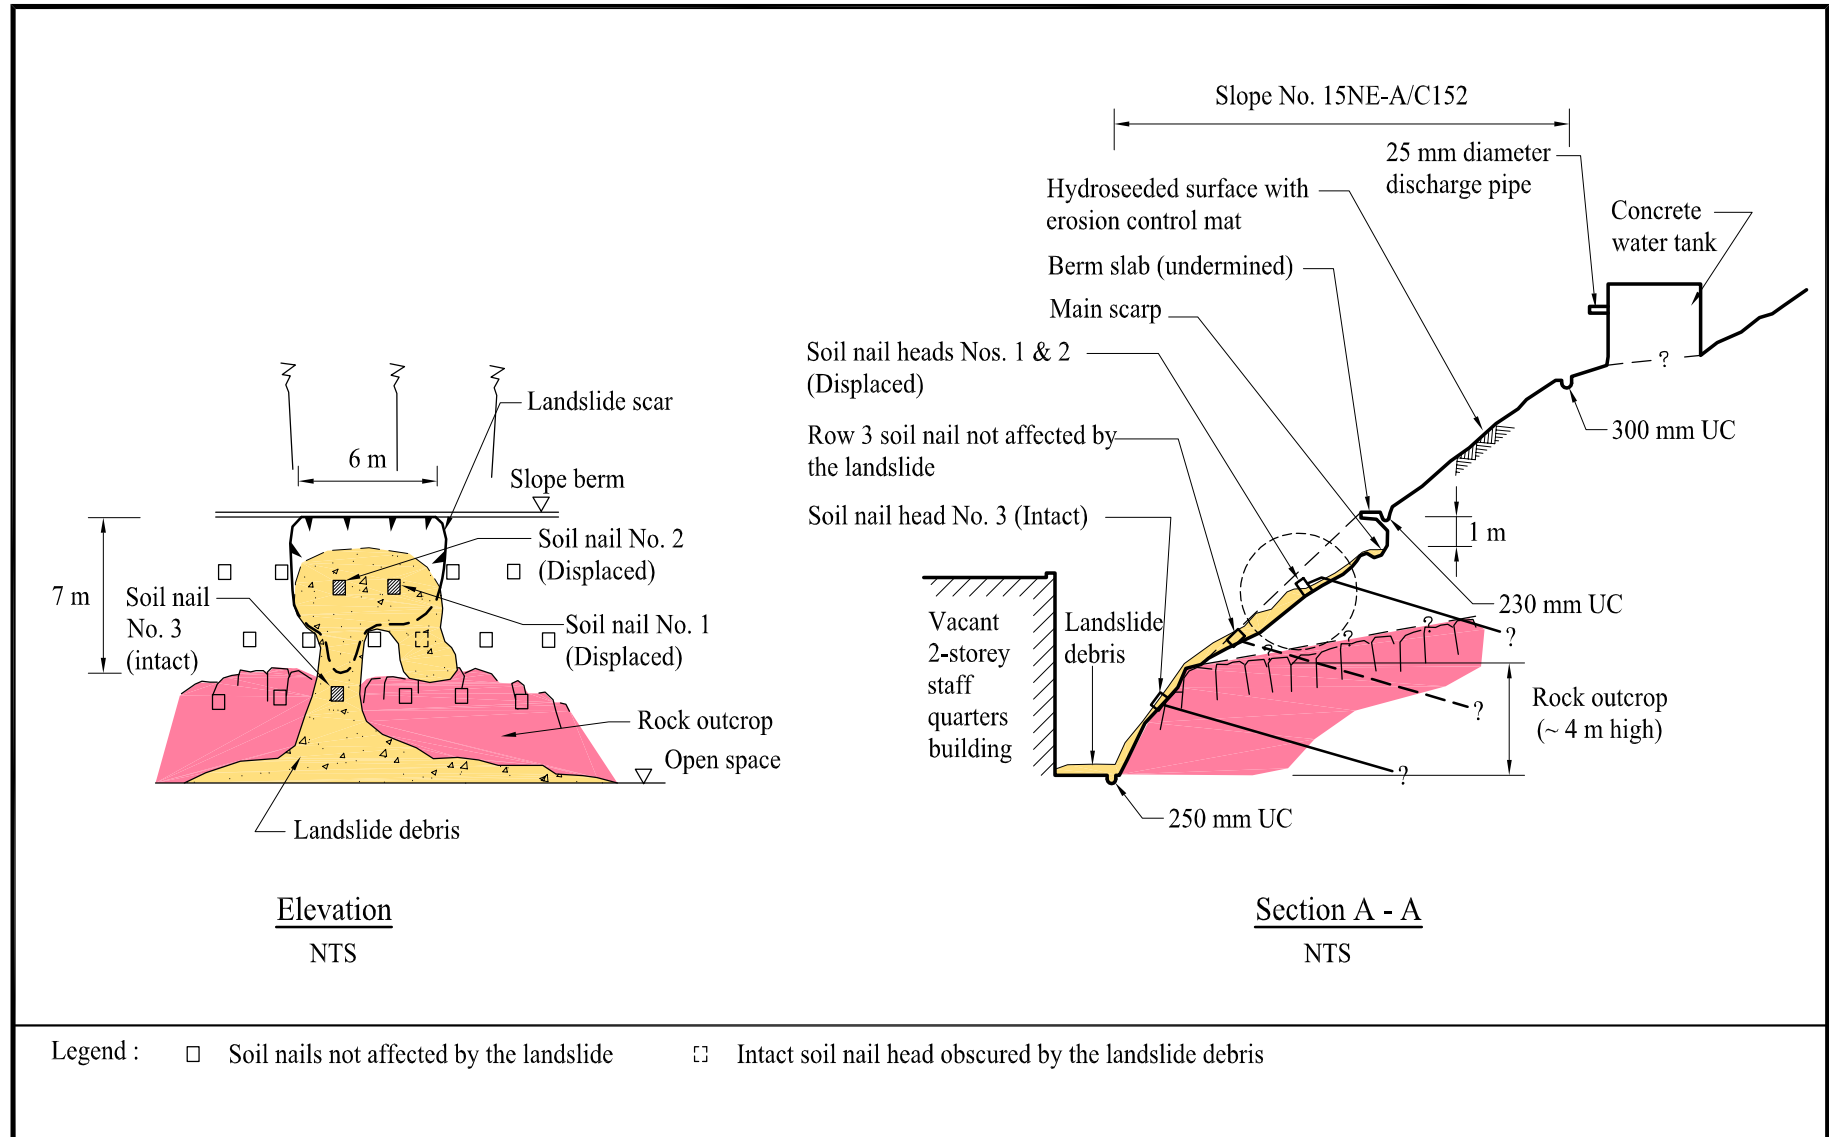
Two soil nail heads (denoted as soil nail Nos. 1 and 2, with dimensions of 400 mm and 500 mm square respectively), which are about 3 m below the berm and 1.7 m apart, were exposed within the landslide scar (Figure 7). The debris immediately behind nail head No. 1 was removed to facilitate inspection. It was noted that the exposed portion of the soil nail bar was bent downward to about 30° below the horizontal. The cement grout underneath the nail bar had spalled, probably due to bending of the soil nail as a result of the landslide (Plate 5).

Taking cognisance of the observation of persistent seepage at the soil/rock interface below the failure scar, it is likely that the landslide was triggered by the build-up of transient perched water pressure above the soil/rock interface. Water ingress through direct infiltration into the relatively gently inclined vegetated slope during moderate rainfall might have been a

Figure 7 - Section A - A and Elevation View (Slope No. 15NE-A/C152)

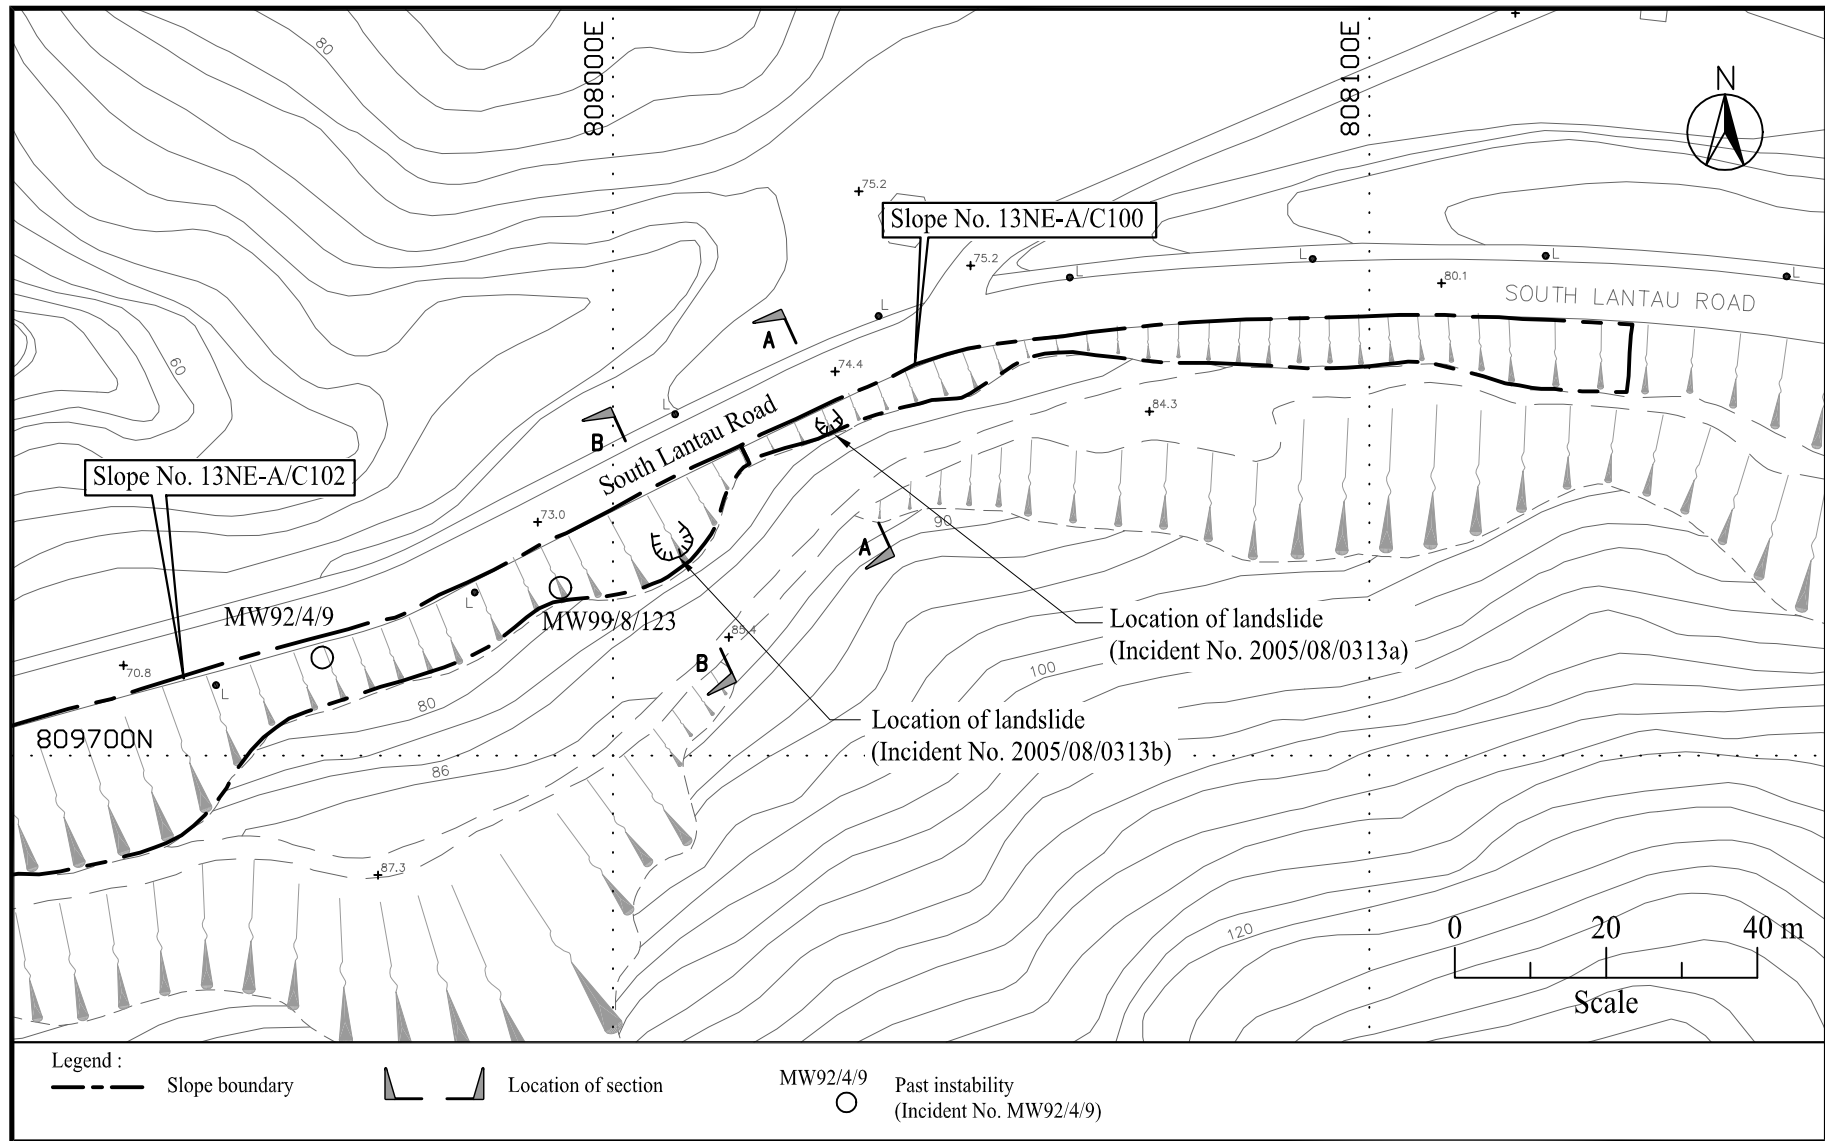
Based on GEO's landslide database, two minor landslides (Incident Nos. MW92/4/9 and MW99/8/123 with failure volumes of 5 m³ and 15 m³ respectively) occurred on the slope in 1992 and 1999 respectively (Figure 8).

Figure 8 - Site Plan (Slope Nos. 13NE-A/C100 and 13NE-A/C102)

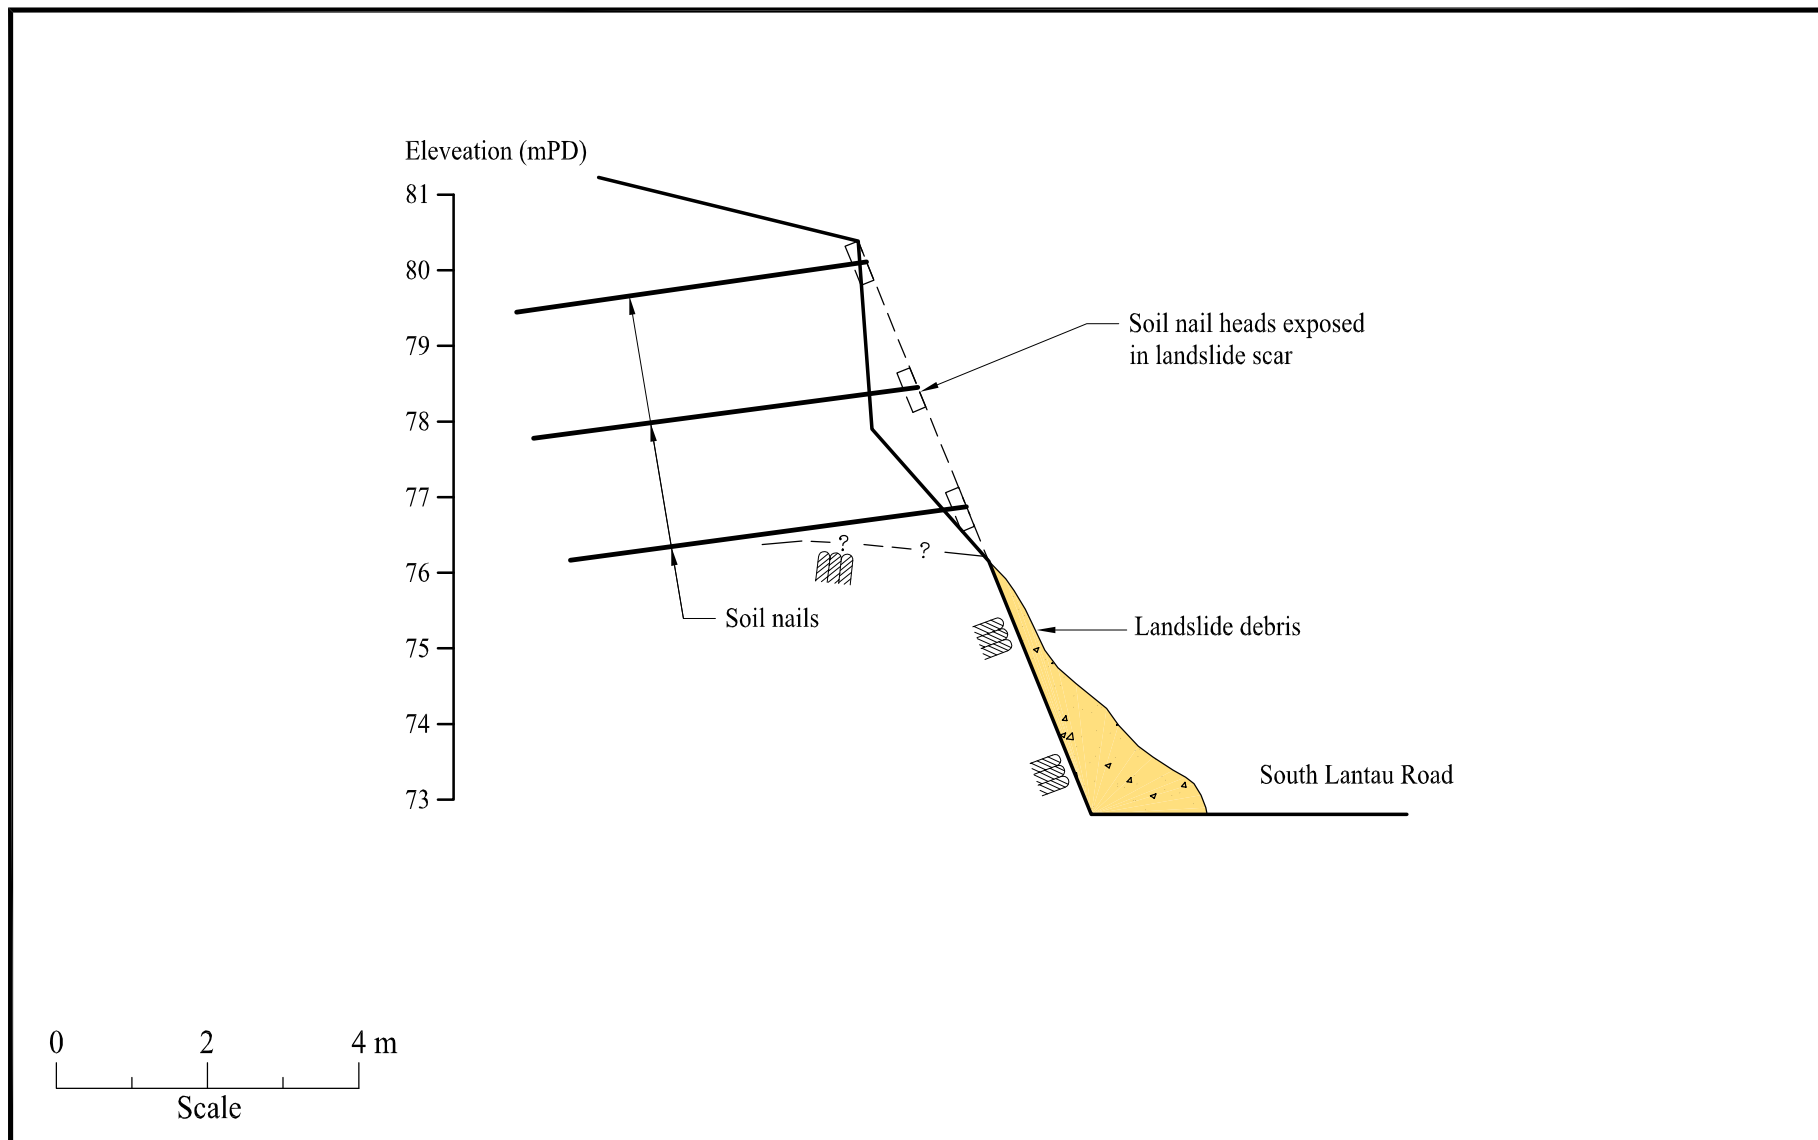
The top surfaces of the recessed concrete soil nail heads of dimensions of 400 mm by 400 mm were exposed in the landslide scar, and they did not appear to have been significantly affected by the failure. Rock was exposed along the surface of rupture near the toe of the landslide scar and over the lower portion of the slope. Debris from the landslide was deposited on the slope below the scar and along a portion of the west bound lane of South Lantau Road, which had been cleared away by the time of inspection. The landslide debris on the slope below the scar was very wet and comprised mainly brown sandy, gravelly SILT with many cobbles (C/HDT).

Figure 10 - Section through Landslide Scar at Slope No. 13NE-A/C100 (Section A - A in Figure 8)

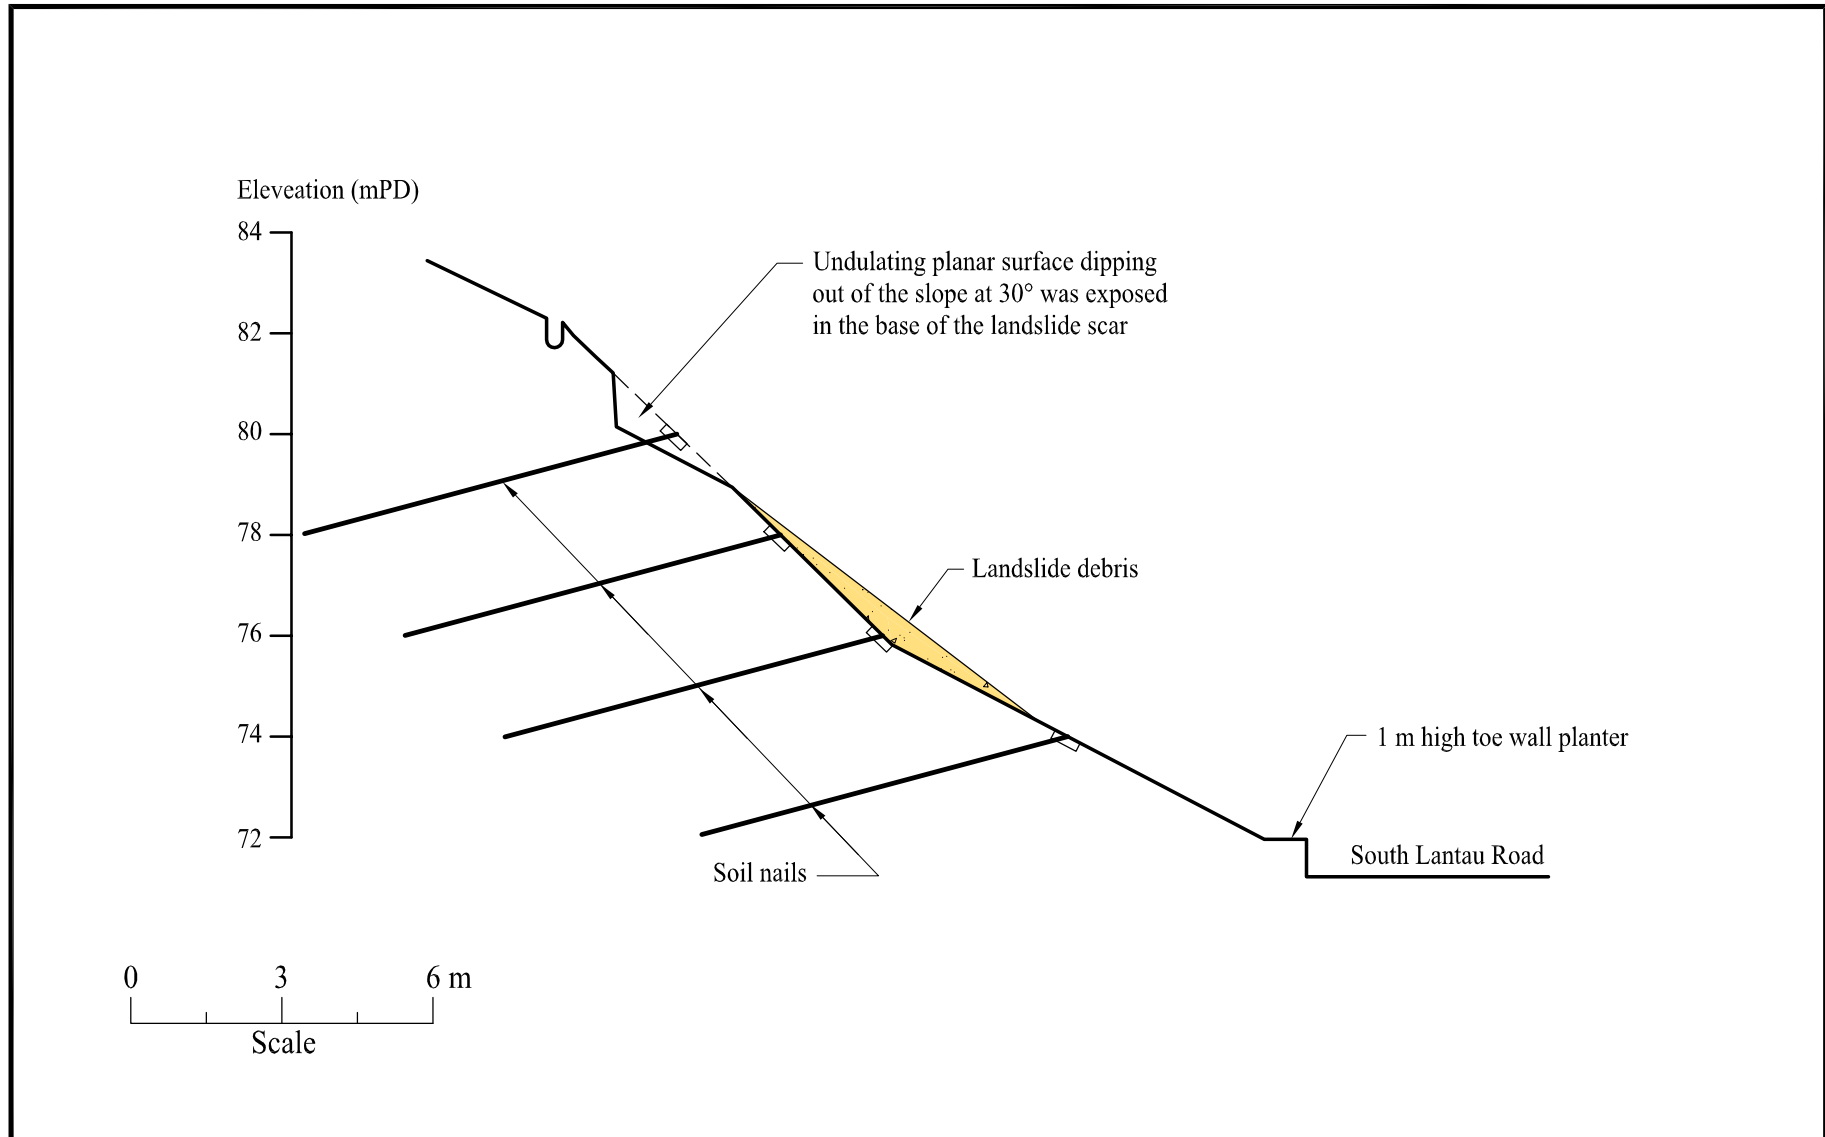
A minor failure occurred near the crest of the eastern end of slope No. 13NE-A/C102 on 20 August 2005 (Incident No. 2005/08/0313b). The slope angle at the failure location was between 25° and 35°. The source area of the landslide was estimated to be about 6 m wide by 3.5 m high and up to 0.5 m deep, with an estimated debris volume of about 5 m³ (Figure 11 and Plate 7).

The surface of rupture comprised an undulating planar surface dipping out of the slope at about 30°. The area above the slope did not appear to have been affected by the landslide and no signs of overland flow or subsurface seepage were observed during the site inspection on 23 August 2005.

Figure 11 - Section through Landslide Scar at Slope No. 13NE-A/C102 (Section B - B in Figure 8)

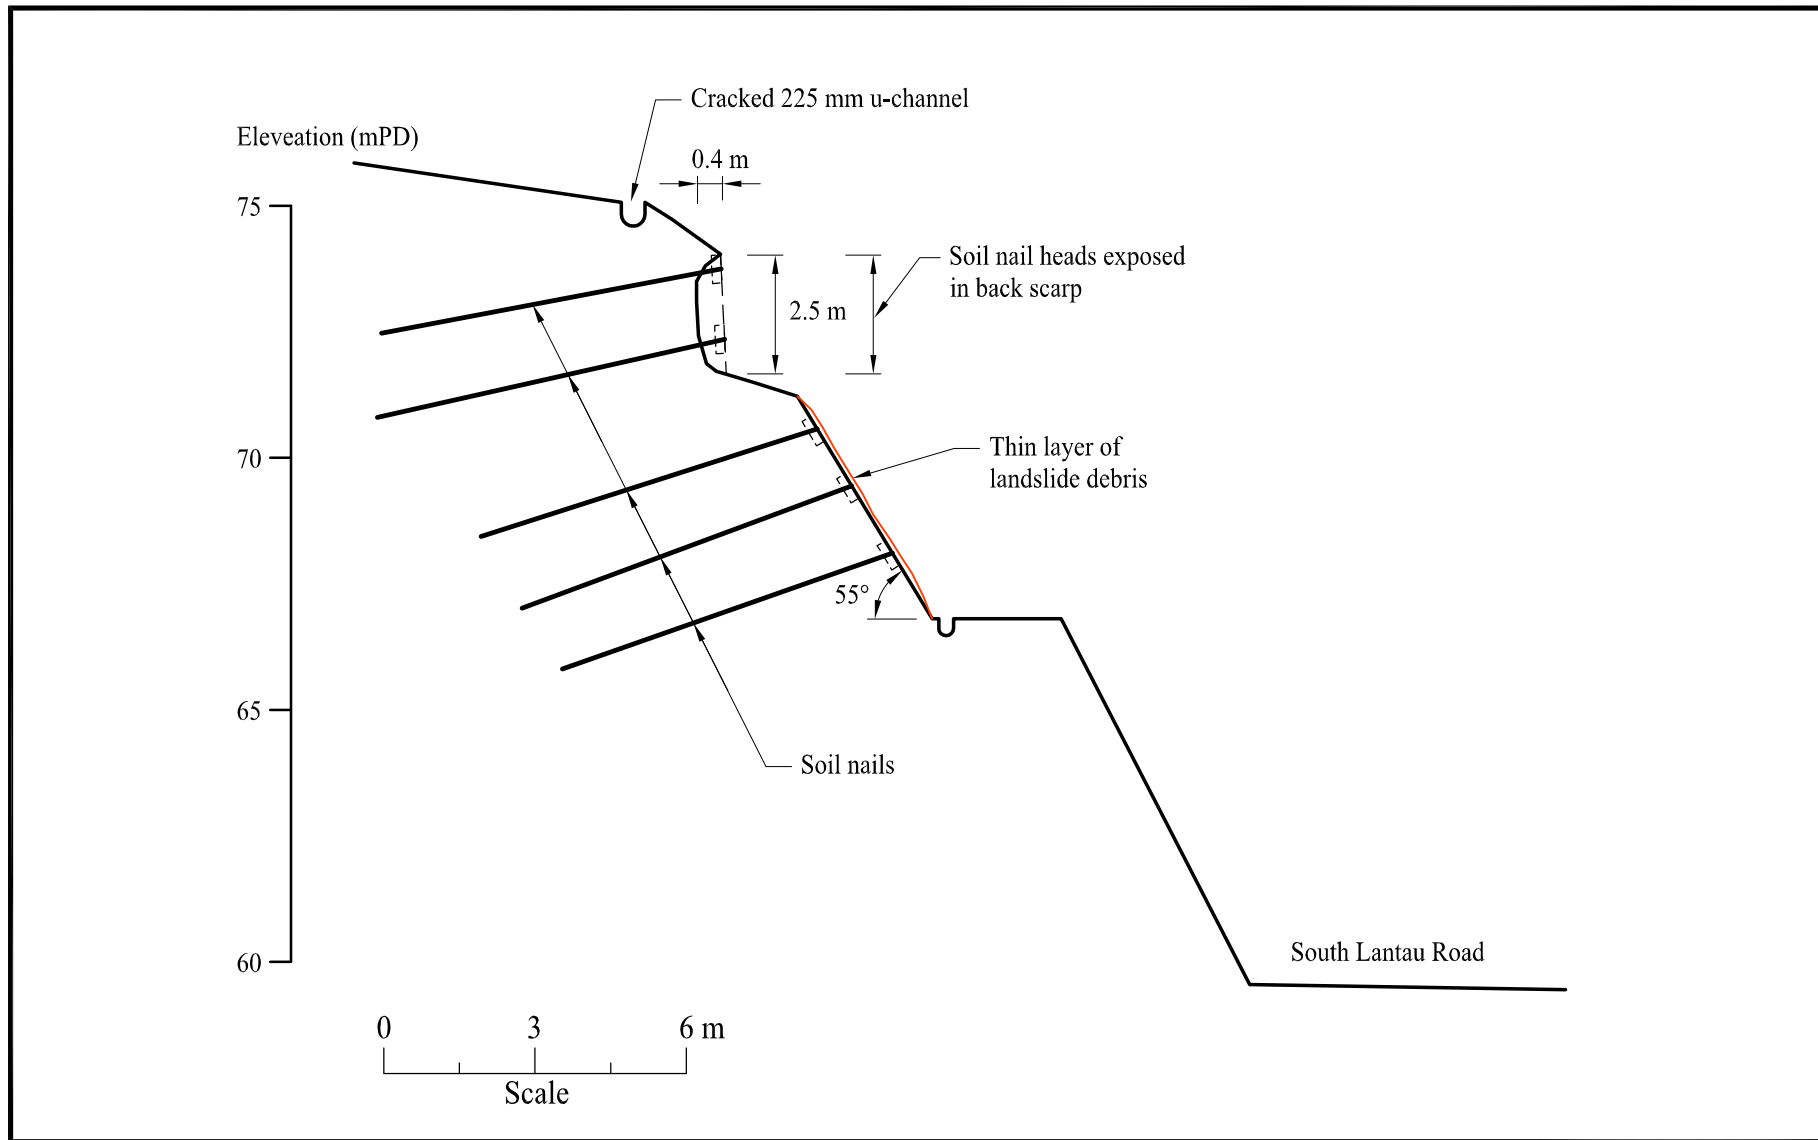
The source area of the larger landslide (Scar A) was about 2.5 m wide by 2.5 m high and up to 0.4 m deep (Figure 12 and Plate 8), with a debris volume of about 1 m³. The source area of the smaller failure (Scar B) was about 1.5 m wide by 2 m high and up to 0.4 m deep, with a debris volume of about 0.5 m³ (Figure 13 and Plate 9).

The timing of the three incidents suggests that the landslides were probably triggered by the intense rainfall during 19 and 20 August 2005. These landslides comprised minor, shallow failure of the soil layer above the nail heads on the slopes. The soil nails within the landslide scars were not affected by the minor surface detachment.

Figure 12 - Section through Landslide Scar A at Slope No. 13NE-A/C108 (Section C - C in Figure 9)

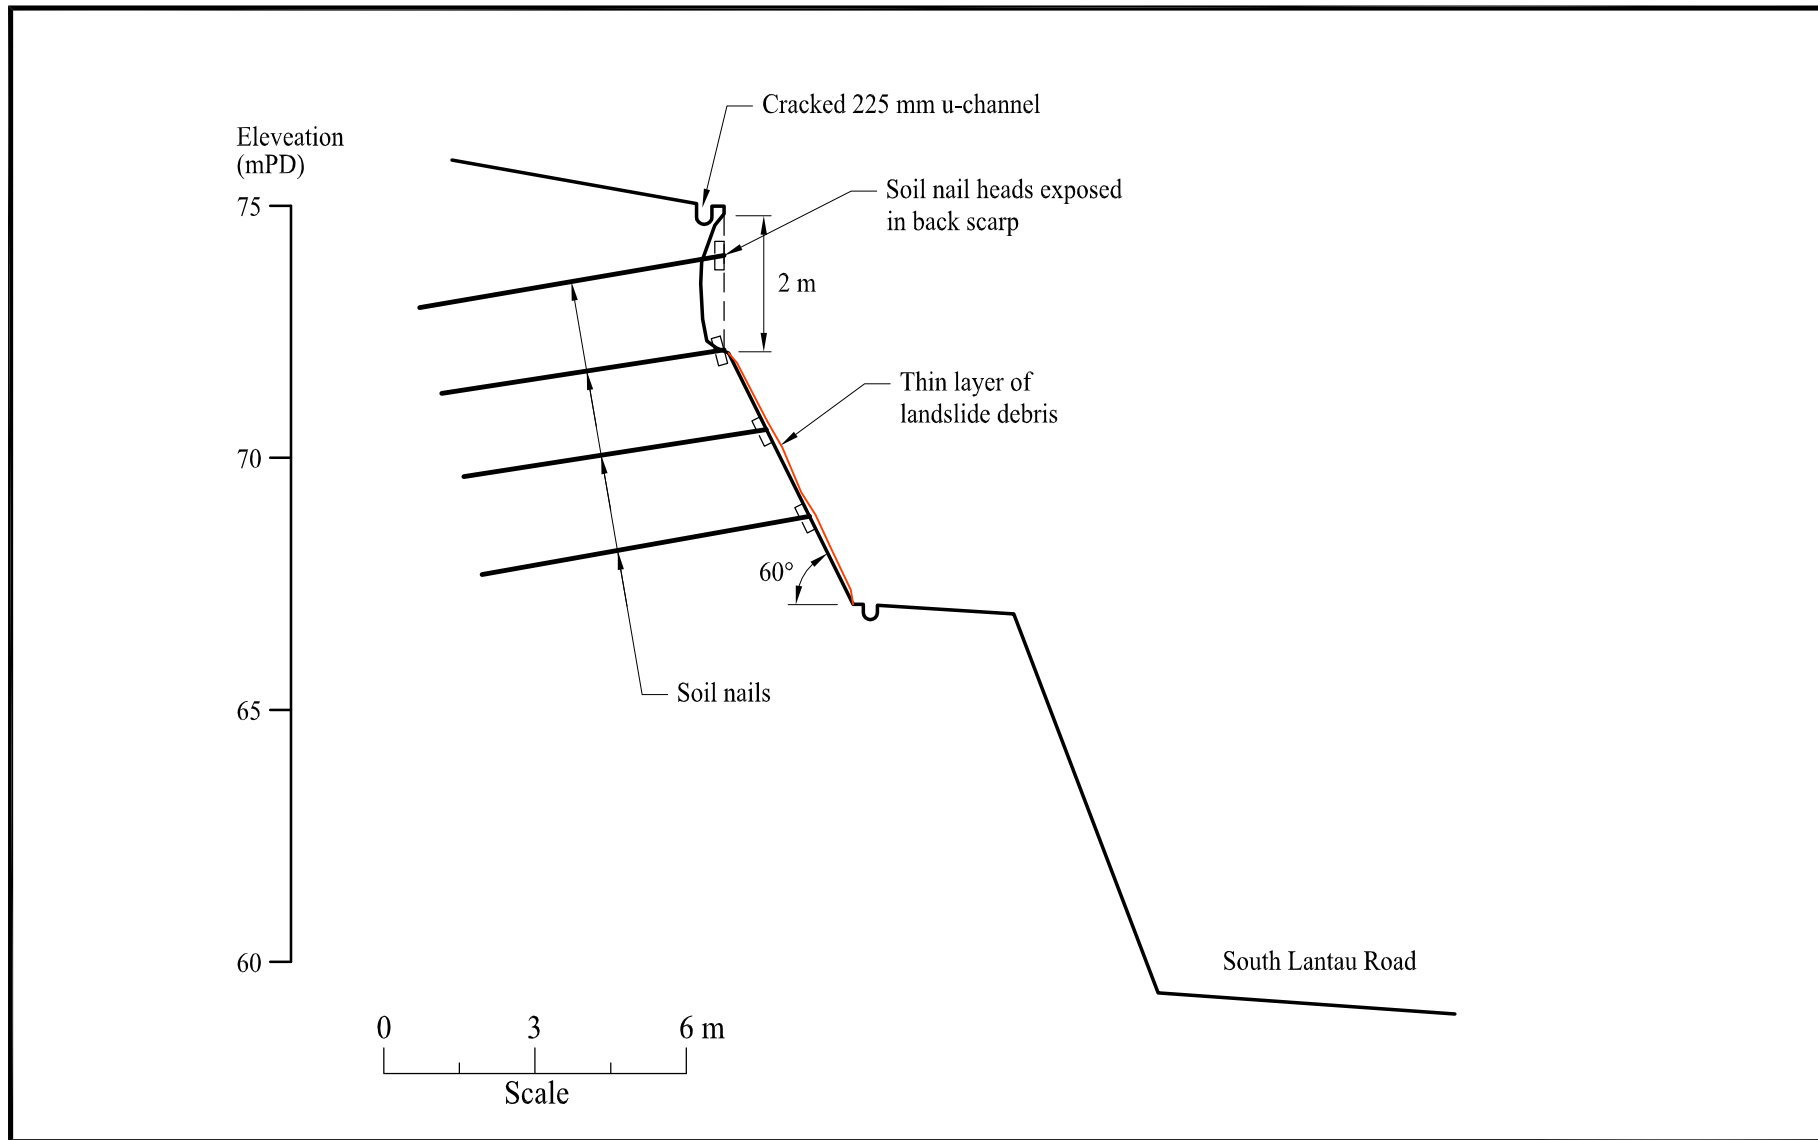
Figure 13 - Section through Landslide Scar B at Slope No. 13NE-A/C108 (Section D - D in Figure 9)

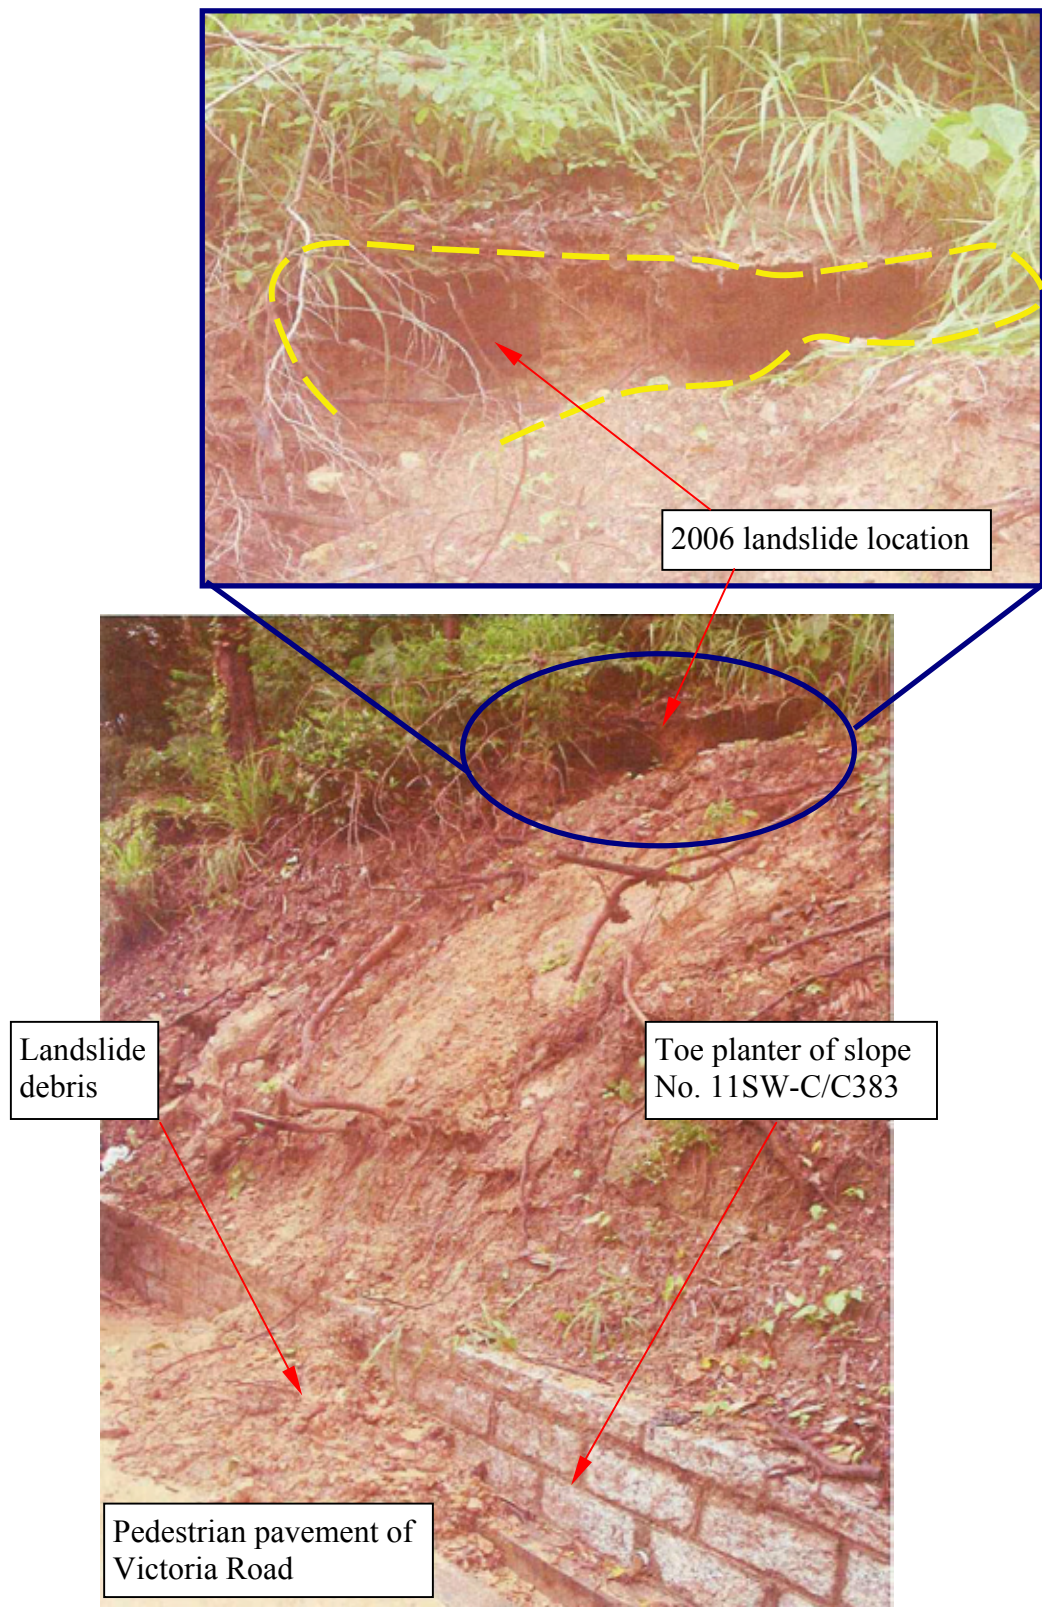
The minor landslide was reported to the GEO on 13 September 2006 when the Landslip Warning and the Amber Rainstorm Warning were in force. The exact timing of the failure is not known. Debris from the landslide was deposited on the pedestrian pavement. No casualties were reported as a result of the landslide.

0.4 m deep, with an estimated failure volume of about 0.5 m³. A shallow washout failure involving erosion of topsoil was also observed above the landslide source area. In this incident, three soil nail heads were exposed and they did not appear to have been affected by the landslide.

Plate 1 – View of the September 2006 Landslide on Slope No. 11SW-C/C383
(Extracted from Incident Report No. 2006/09/0709 from the GEO)
